FACT SHEET in O.A. No. 776/2018, Ramchandra Chaurasia Vs State of Jharkhand in light of Hon'ble NGT order dated 11.09.2019, O.A. No. 23/2017(EZ), Syed Arhad Nasar Vs Union of India & Oths. and O.A No. 373/2019, Pradeep Kumar Singh Vs state of Jharkhand

Joint Inspection Report

OA No. 776/2018

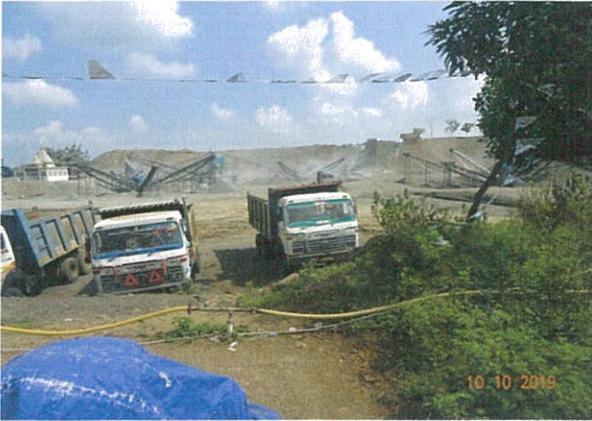
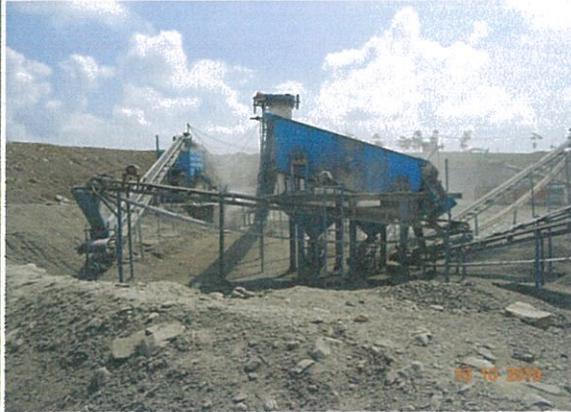
- The unit was provided CTO which has the validity up to March,2021
- The unit was under operation during the time of visit. It was infested with dust in the operating zone(see photos 1,2,3,4&5). Unit has very few Sprinklers inside the operating system which is unsatisfactory.

Photo 1 & 2 :Photo of dust emissions in the crusher unit of M/s Shiv Shakti stone works

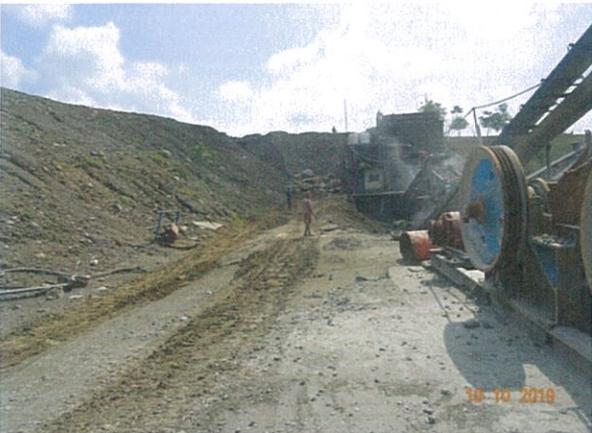
- Wind breaking wall was not erected in the periphery of the unit. However, on one side of the premises the OB of the mines were kept at a certain height and reported it as a wind breaking wall which is an un-appropriate method(see photo 3 & 6).

Photo3: Photo of overburden material on one side of the crusher unit of M/s Shiv Shakti stone works

9. State Pollution Control Board should cancel the CTO, if the conditions are not complied.
10. Inspected Crushing Units has no wind breaking walls except one or two. The walls of the individual Crushers may be erected immediately.

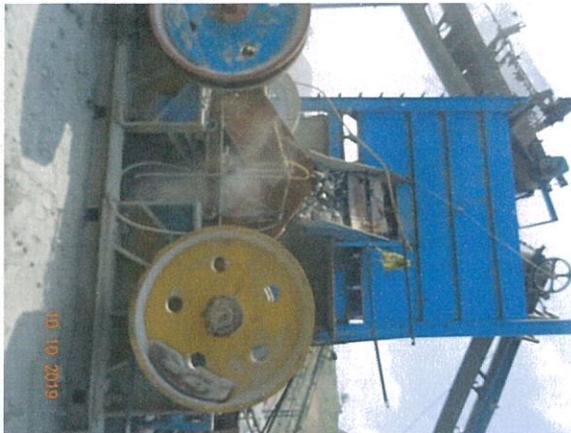
Photo4 : Photo of water sprinkling by a pipe. Dust emissions can be seen

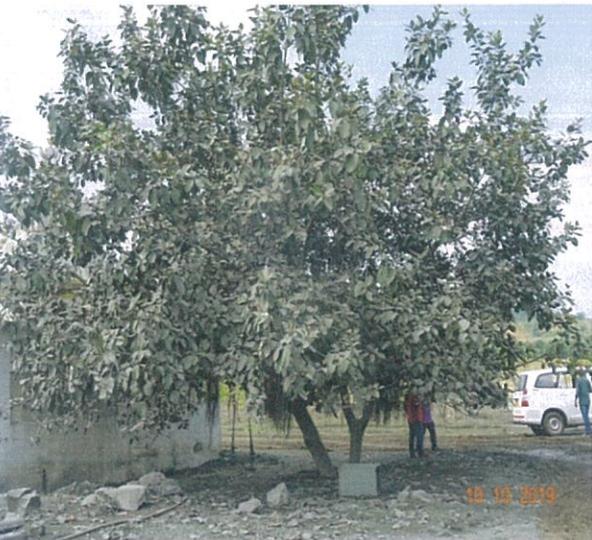
Photo 5:Photo of dust layers on a tree near the of crusher unit of M/s Shiv Shakti stone works.

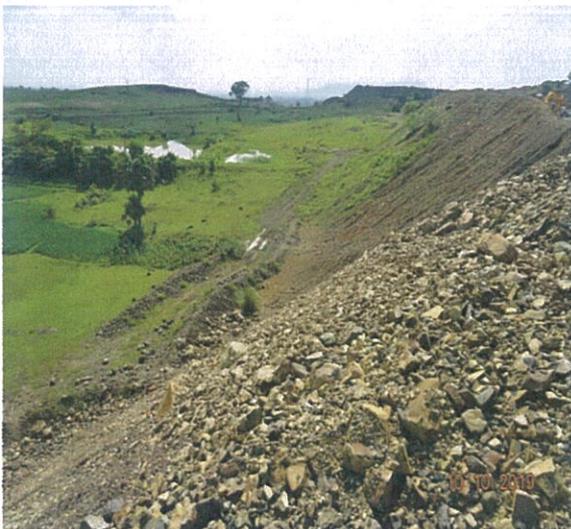
- Mines were found to be left in abandoned condition (see photo 12, 15, & 16).
- In most of non operational inspected mines it was found that the CTO and EC condition were not followed.
- The committee did not see proper bench formation in these mines reflected in the photographs annexed(see photo 12, 15, 16, 22, 27, 28).
- OB dump was deposited in the non mine lease areas(see photo 3 &6).

Photo 6:Photo of silted catch drains on one side OB dump adjacent to crusher of M/s Shiv Shakti stone works.

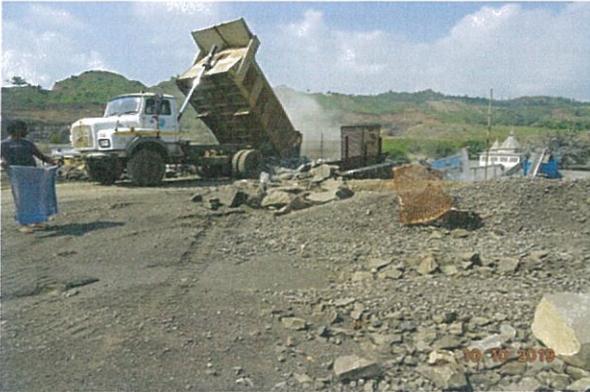
Photo7:Photo of dust emissions at hopper while raw materials unloading.

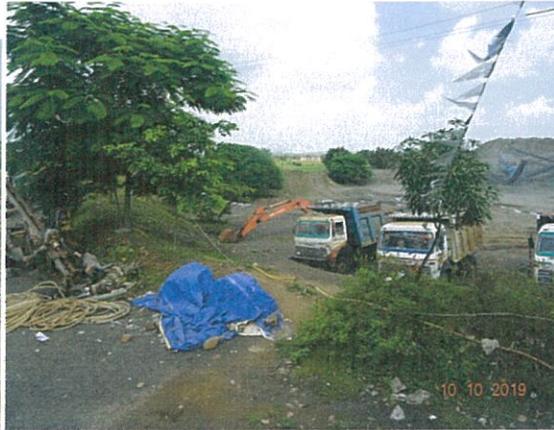
- Green belt developed in the periphery of the premises was found unsatisfactory. Some plants were found in the periphery as reflected in the photograph annexed (see photo 8),which is too scanty as per EC/CTO condition.

Photo 8:Photo of some plantation/trees at crusher of M/s Shiv Shakti stone works.

5. Plantation of local species is in few numbers around the crusher units. A large numbers of tree species need to be planted on a regular basis with replacement of dead plants.

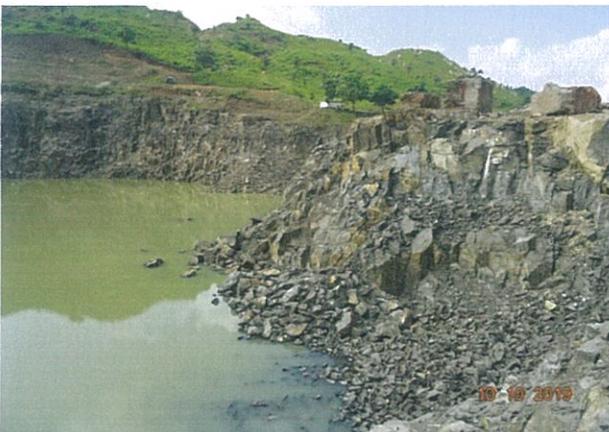
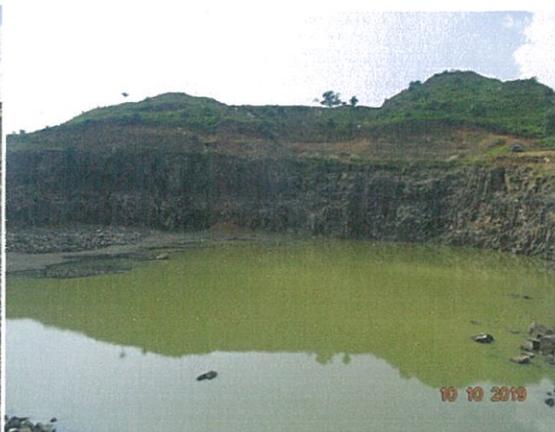
- During the time of inspection, mine was non operational.
- No machine or man power was deployed in the mines.
- Physically it is reflected that mining was not done in a scientific and systematic manner(see photo 9 & 10).
- No proper bench formation was done in the mines(see photo 9 & 10).
- Due to non operational status, no document or mine plan was made available to the committee members.
- Some pillar was erected around the mine.
- No approach pucca road was found inside the mines for the movement of the vehicle.
- Green belt of 7.5 meter was not developed in the mine periphery.
- Top soil dump was not observed.
- No catch drain was observed
- OB dump of the mines was transferred to the periphery of the stone crusher unit which is not permissible.

Photo9& 10:Photo of unsystematic mining with no benches/improper benches in the mines of Borna stone Mines of M/s Shiv Shakti stone works. Water accumulation in the lower portion can be seen.

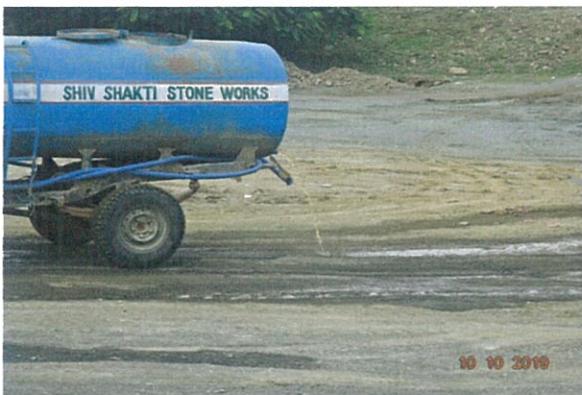
- There were no water spray arrangements in the hopper. Neither any spraying compound was found in the sieving or transfer area in the crusher unit.
- The water tanker was present in the unit but utilization is very scanty (see photo 11).

Photo11:Photo of water sprinkling by water tanker in crusher area of M/s Shiv Shakti stone works.

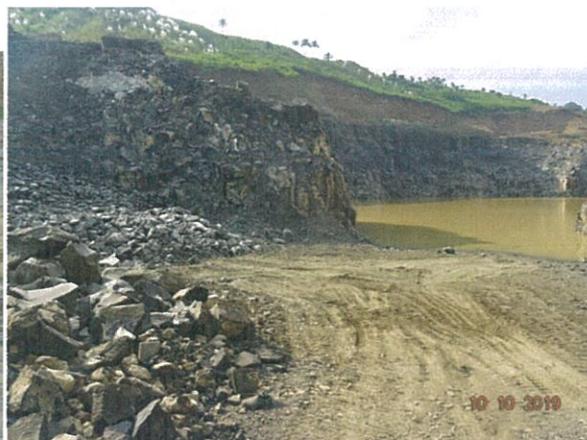
Photo 12 :Photo of unsystematic mining with no benches/improper benches in 2nd mines of Borna stone Mines of M/s Shiv Shakti stone works.

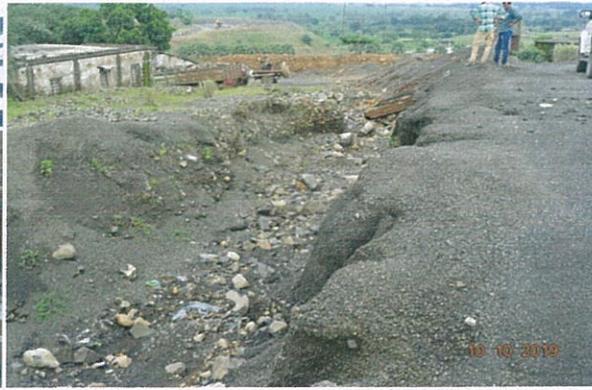
Photo 14: Photo of improper catch drains and siltation ponds around the stone dust fines dump area.

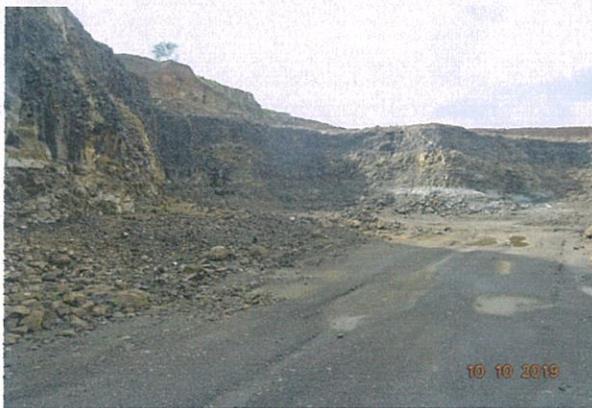
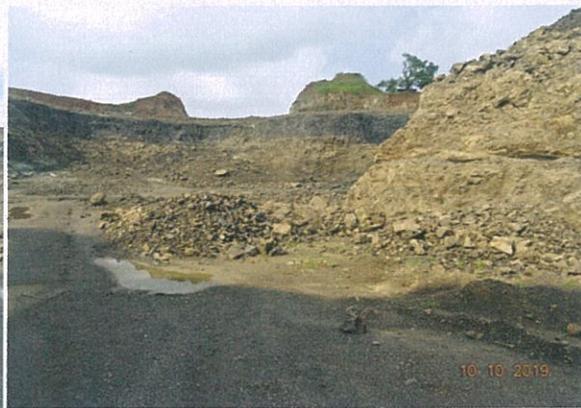
Photo 15& 16: Photo of unsystematic mining with improper bench formation. Mining in the midst of Borna hills.

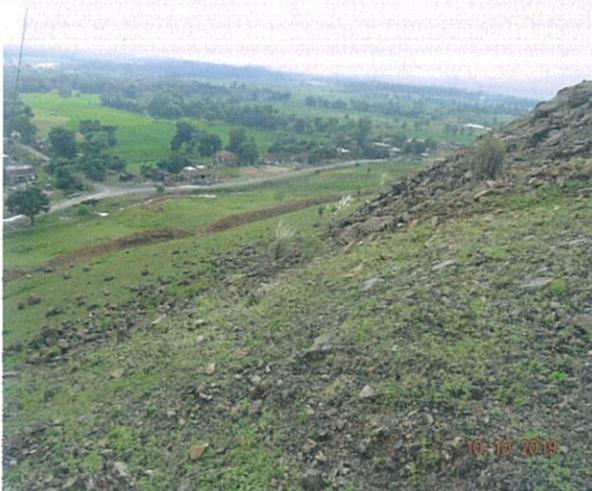
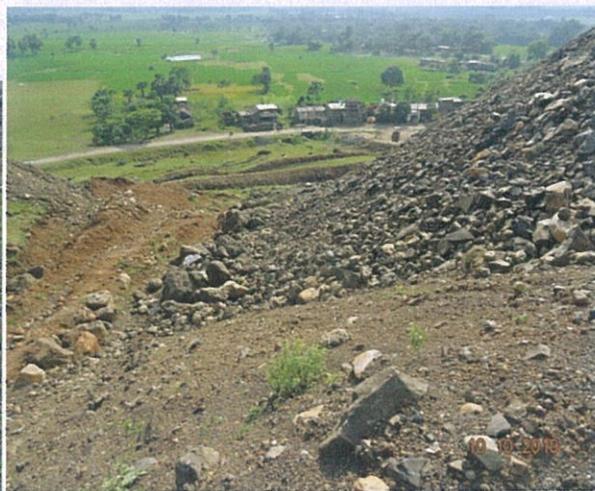
Photo 17& 18: Photo of some catch drains around the OB dump of mines near Borna stone crusher. Siltation ponds and retaining wall around the OB dump not made.

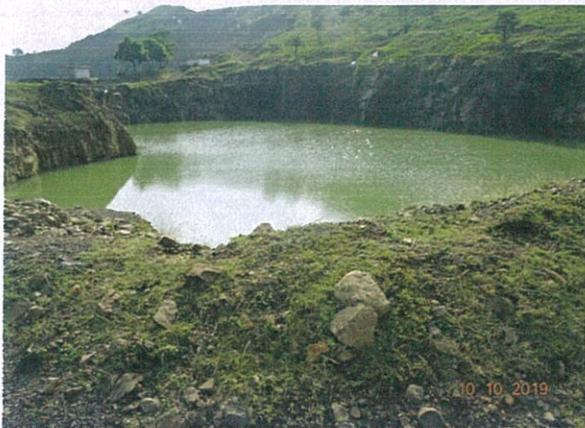
Photo 19: Photo of an abandoned mines in Borna area. No fencing around the mine periphery was done.

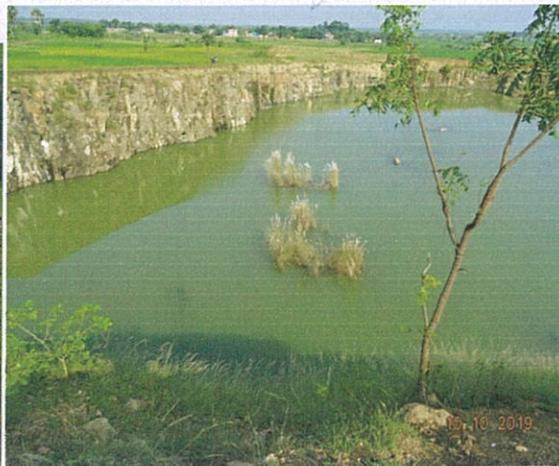
Photo 20: Photo of another abandoned mines. No fencing around the mine periphery done.

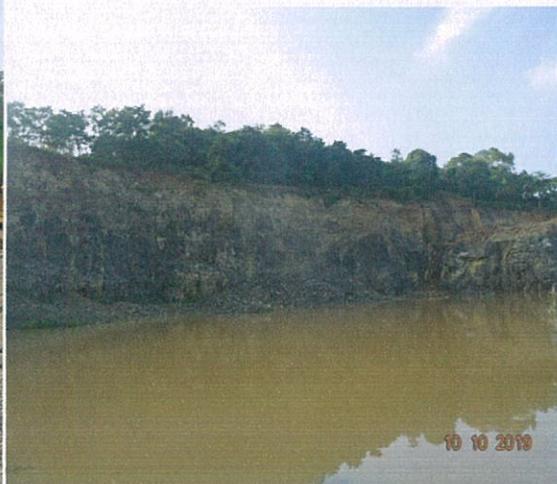
Photo22 : Photo of unsystematic mining with no benches/improper benches of Deo Blackstone mines.

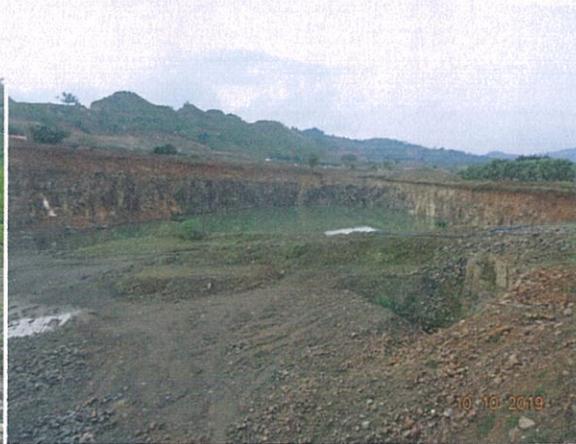
Photo 28:Photo of M/s Asraful Haque mines in Borna area.Bench formation not done. Waterlogged.

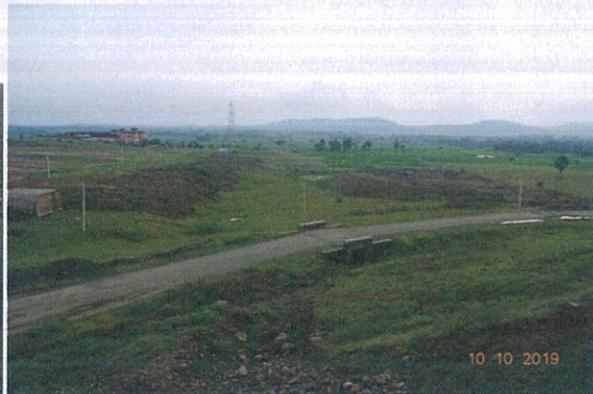
Photo30: Photo of OB material thrown near the road . At the extreme end is a school.

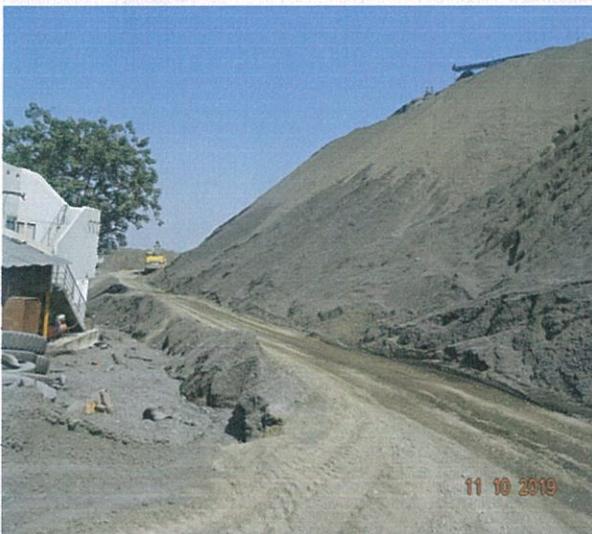
- The large slope of dumps of stone fines were so steep. As a result, the damage to the life and property may happen at any time (see photo 33).
- The unit has neither water reservoir nor rain water harvesting system to recharge the surrounding area.

Photo33:Photo of stone fines dump with steep angle of slope at M/s P.C Yadav crusher.

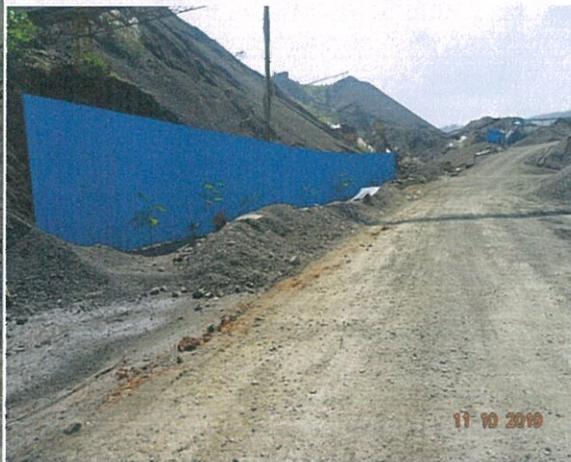
- No boundary wall was constructed
- Installation of thin metal sheets in some restricted areas were observed, which was to acts as a protection for the large dumps and small stone fines as reflected in the (see photo 34), but it was not satisfactory protection.

Photo 34:Photo of thin metal retaining Structure at toe of dumps.

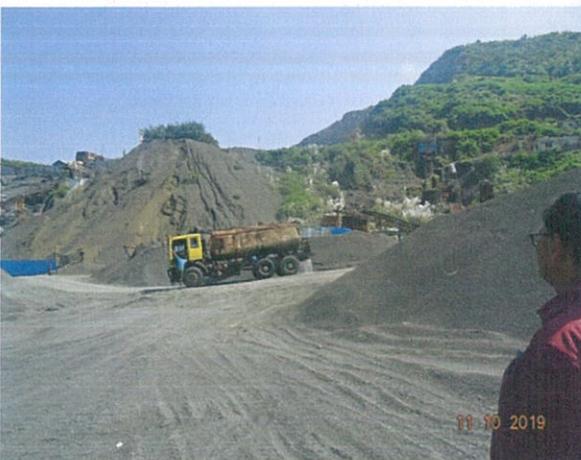
- Very scanty green belt observed in the periphery which could be seen in the project area.
- The unit has no fixed water sprinkling system in and around the crushing unit and around loading and transfer zone also. However, one tanker was observed sprinkling water inside the unit(see photo 35) which would not be sufficient since the area was quite large.

Photo35:Photo of water tanker at M/s P.C Yadav Crusher

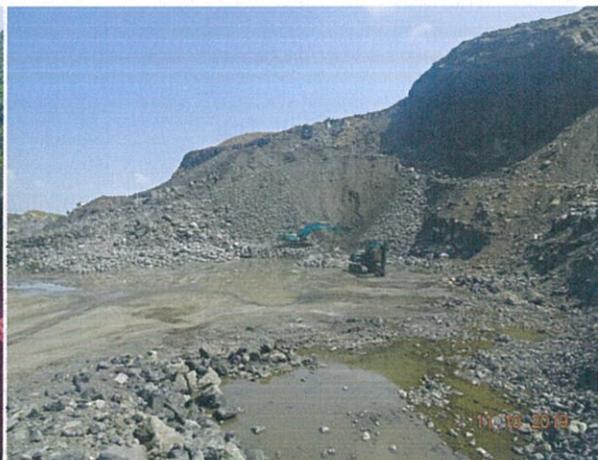
Photo36:Photo of improper benches at M/s Bajrangwalee stone mines.

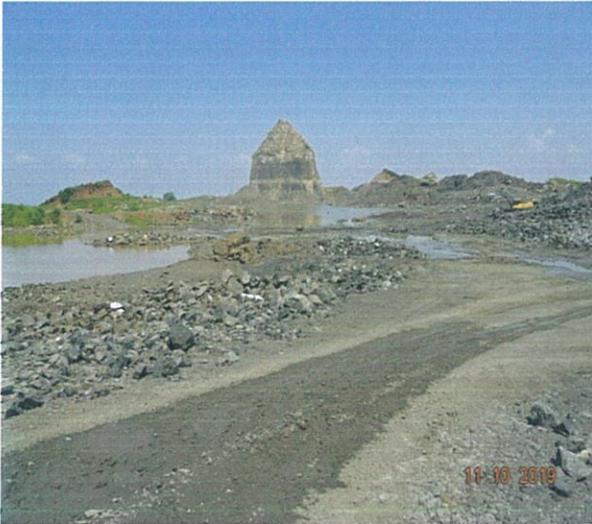
Photo37:Photo of unsystematic and unscientific mining done for a hillock.Such mining poses dangers to men and material(near to M/s Mineral India Mines)

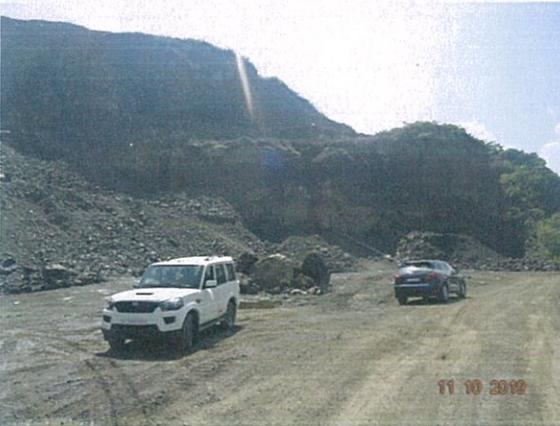
Photo39:Photo of improper & dangerous bench formation in M/s Bajrangwalee stone mines

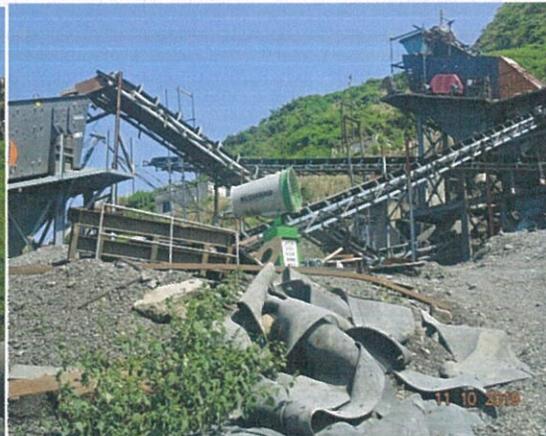
- The water/mist canon (see photo 42) was also observed but it was found non operational.
- There was huge stock of stone fines, small chips inside the Crushing area which makes the inside atmosphere unhealthy.

Photo42:Photo of water/mist canon at M/s Prakash Chandra Yadav stone crushers.

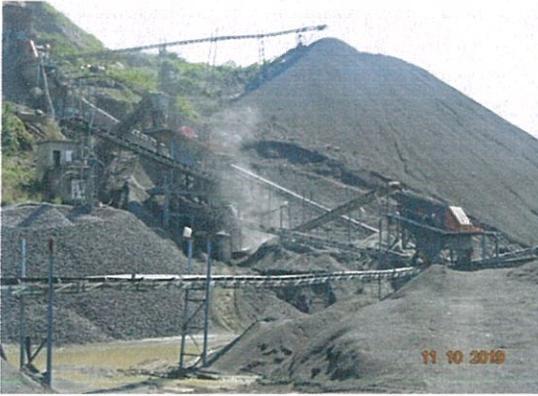
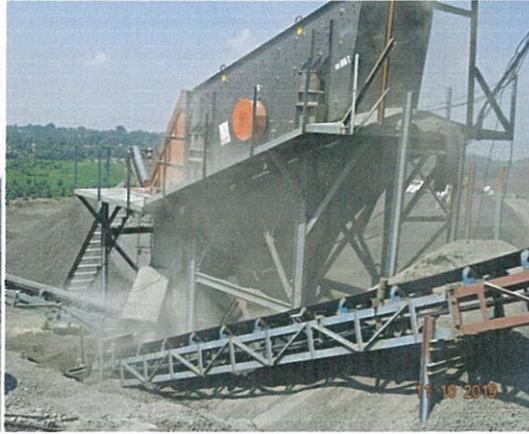
- There was huge dust emission inside the Crushing Unit. (see photos 43,44 & 45)
- The unit has spraying pipelines as well as sprinkler but the spraying was ineffective in dust suppression.

Photo 43& 44: Photo of dust emissions at M/s Prakash Chandra Yadav stone crushers.

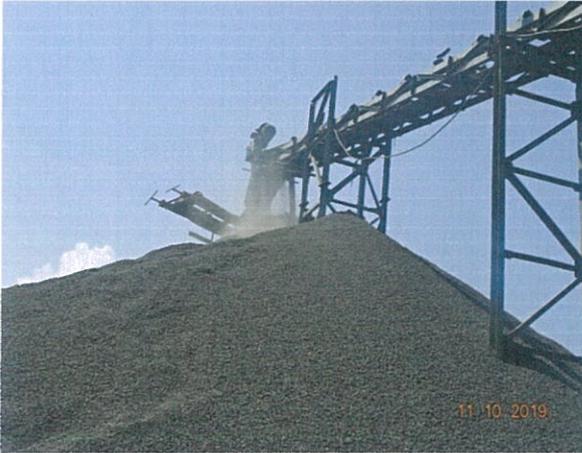
Photo 45: Photo of dust emissions at M/s Prakash Chandra Yadav stone crushers.

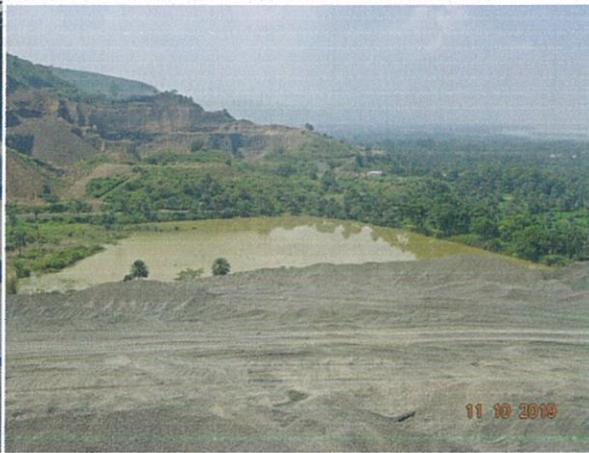
- The unit has no catch drain, siltation pond around the large dumps or near the stone fines which has every chance during rain for carrying the silt to the nearby low land areas, which has reservoir or pond beneath the dump area as reflected in the photograph annexed(see photo 46).

Photo 46: Photo of a water reservoir near the of M/s Prakash Chandra Yadav stone crushers.

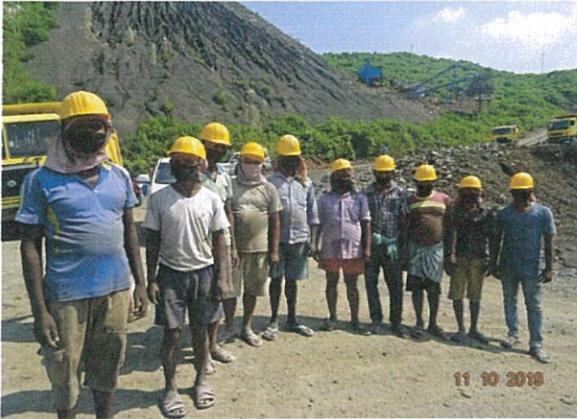
- However, there was neither rain water harvesting system observed nor any ground water recharge provision.
- The unit was devoid of any paved road.
- The workers in the unit were wearing dust masks & helmet (see photo 49).

Photo49:Photo of dust masks and helmets provided to workers at M/s Shetla stone works

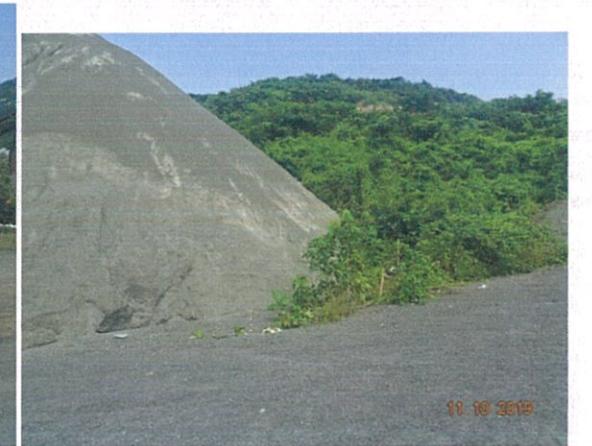
Photo52:Photo of Large stone fine dump just besides the green belt with no catch drains/ retaining wall.

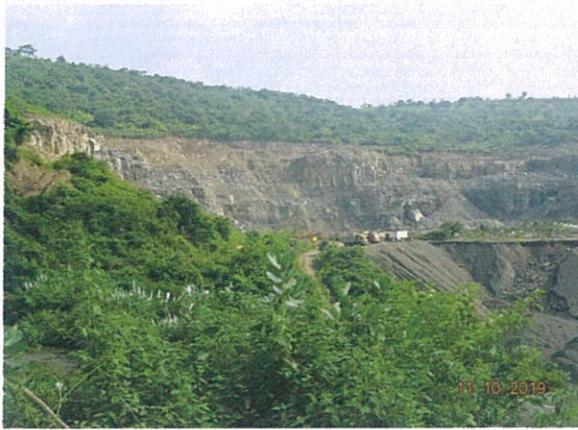
- Mine was non operational.
- No bench formation was seen.
- Bench slopes were significantly steep which was more than 70 to 80 degree angle, which is dangerous for man and machinery when the unit will be functional(see photo 53 & 55).
- Small low lying area was seen which acted as some storage of rain water but it was not satisfactory (see photo 55).
- No big sump was visible.
- Stand alone sprinkler was not noticed for sprinkling of water for roads and plants.
- OB dump was scattered here and there.
- Large dump of raw fines in the mines premises were observed.
- No catch drains or retaining wall observed.
- Large dump of stone fines could be observed as shown in the photo 52.
- Some plantation was done in the mine area but the green belt development was not satisfactory(see photo 56).
- Mine pillars were also not observed.
- No pucca approach road observed in the mine area.

Photo53:Photo of Demba Mines in premises of M/s Yash Raj Black stone works. Improper Benches can be seen.

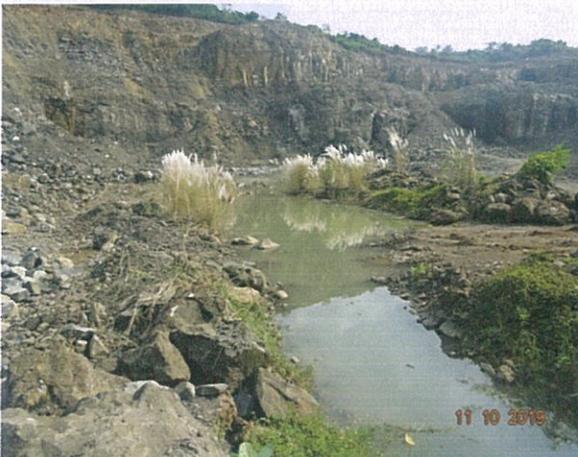
Photo55:Photo of some water in the lower portion of the Demba mines.

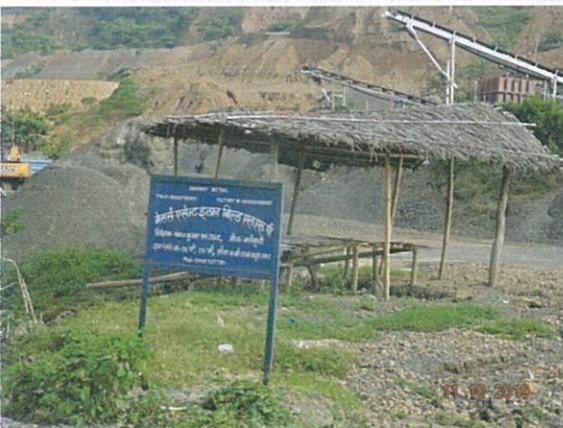
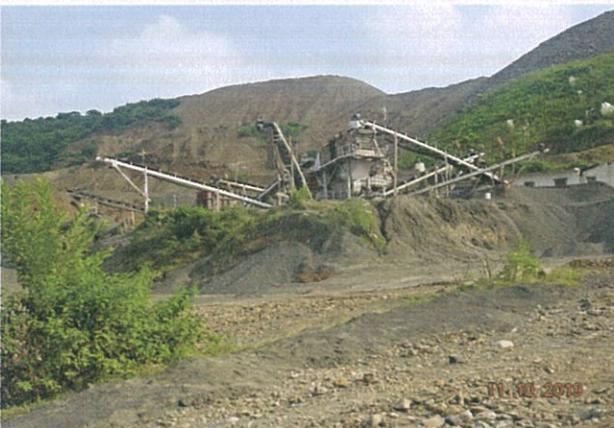
Photo57 &58:Photo of crushing unit of Ascent InfraBuild. Behind OB dumps of stone mines of different owners are heaped on the hills without any catch drains,retaining walls.

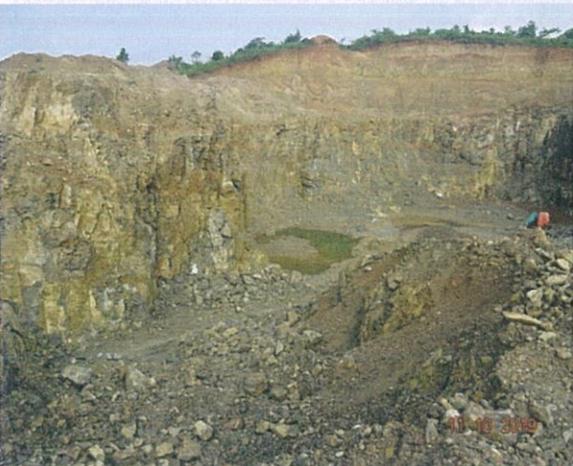
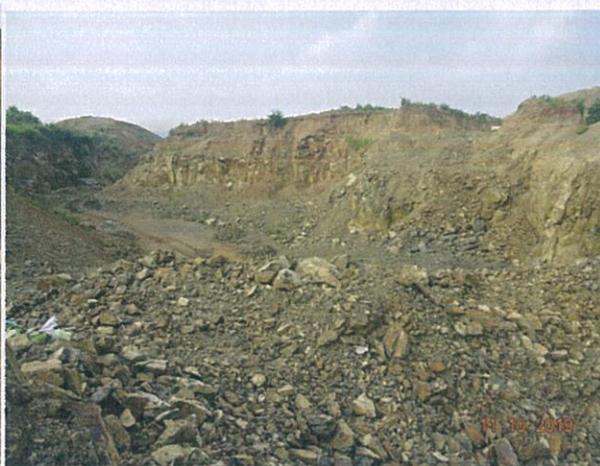
Photo63&64:Photo of unsystematic mining and improper benches in mine of M/s Bikash stone works.

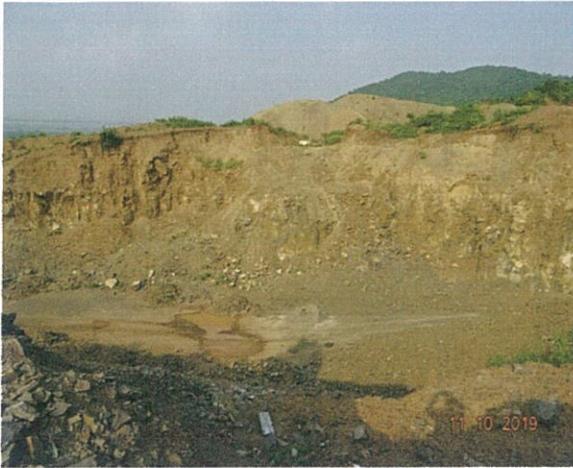
Photo65:Photo of OB dumps on the hills near the mines of M/s Bikash stone works

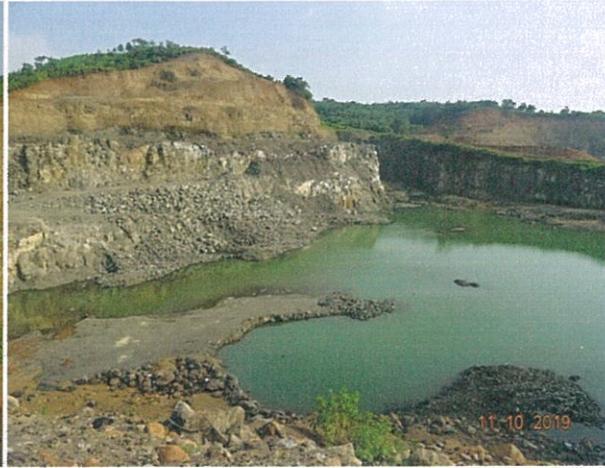
- The mine was found non operational.
- Some benches in overburden and ore could be observed. But they were not of proper height & width (see photo 66).
- Unscientific and unsystematic mining is being done.
- Large volume of water was stored in the mine in the sump(see photo 66 & 68).
- OB material was seen dump in the sump (see photo 68).
- Some plantation is being done on one side of the mine(see photo 67).
- Top soil dump could not be observed.
- Pucca approach road was not observed in the mine.
- Fixed water sprinkling system was absent.
- As the mine was closed, no paper from the mine could be obtained.

Photo66:Photo of benches and water in mines of M/s MaaAmba stone works
