**Inspection Report on Legal and Illegal Mines and stone crushing units in Sahibganj districts of Jharkhand**

As per the direction of Hon'ble NGT, order of OA No 23/2017 dated 22.01.2019 in the case of Sayed Arshad Naskar Vs Union of India and Others, a committee had to be constituted from the below mentioned organizations, i.e:

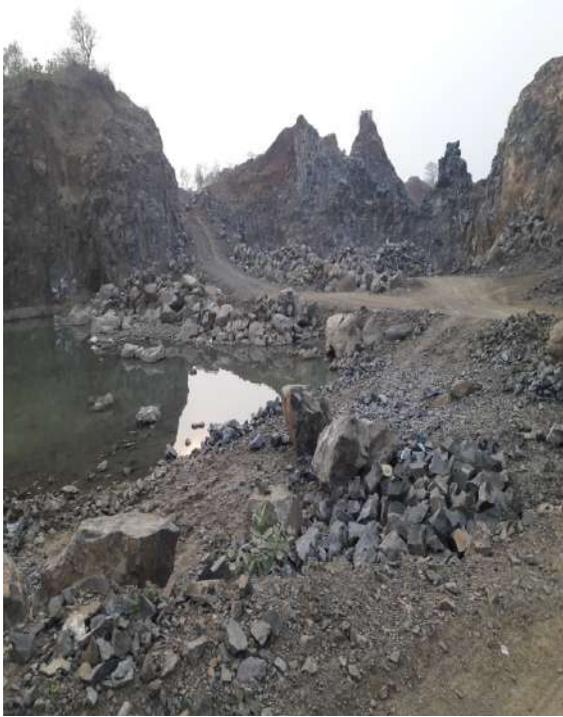
12. Mining is running in an unsafe, unsystematic and unscientific manner in Sahibganj district in almost all places ( see photo 1 & 3).
  13. No water sprinklers or water tankers observed in the legal crushing areas or in the legal mining areas except in one mining location (as can be seen from photo 20). Only one crushing unit had the water tanker provision( as can be seen from photo 30).

Photo 1: mining in an utmost unsafe and uncared manner

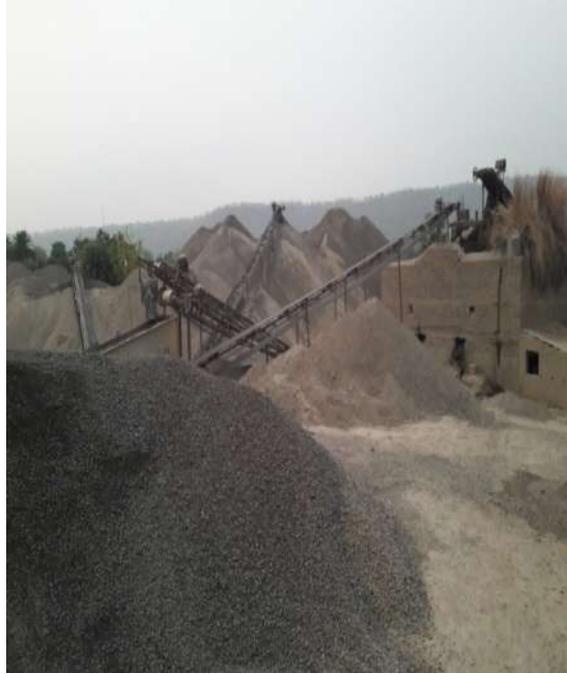
19. In all the crusher units raw material and the finished product are lying uncovered which may lead to dust pollution.
20. No dust catchers over uncovered spaces of processing and transfers are noticed (Photo no 2).

Photo 2: No dust catchers installed

15. All the Crushers must implement the system of dust catchers in their running system.

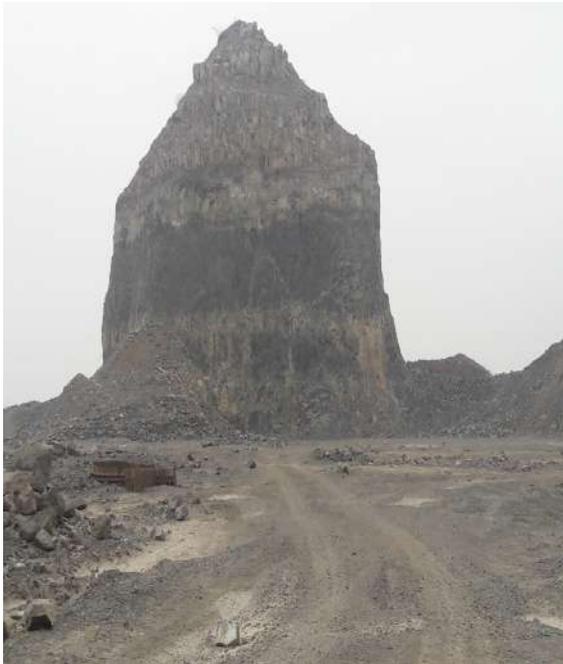
Photo 3: Unsafe mining at the Hill Top

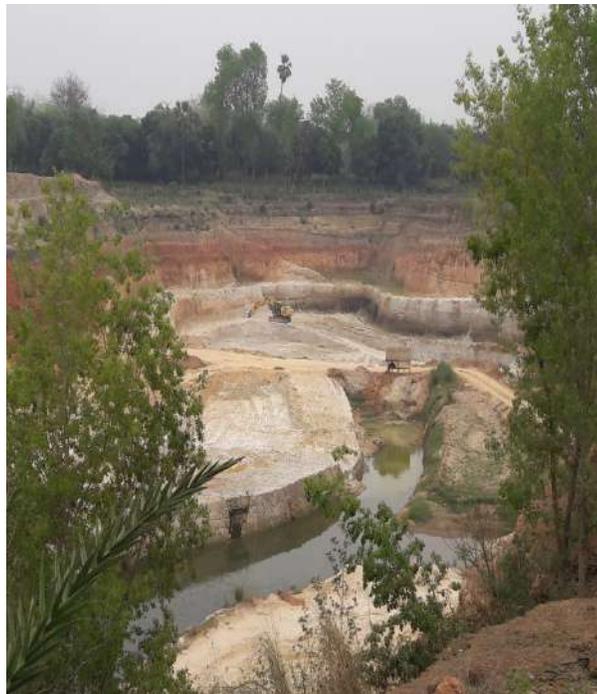
Photo 4: China clay mining areas of RQS Rajmahal

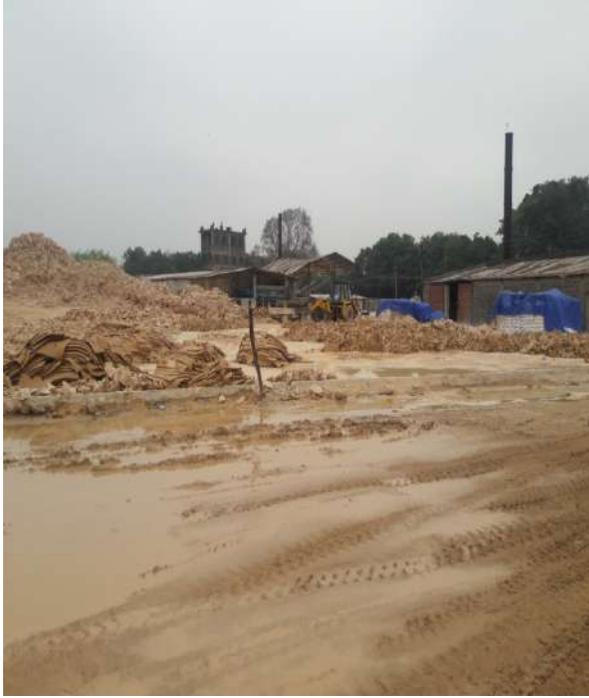
Photo 5: R Q S Rajmahal (China clay processing unit in the bank of River Ganga) Photo 6 : Katghar Village no mining activities observed.

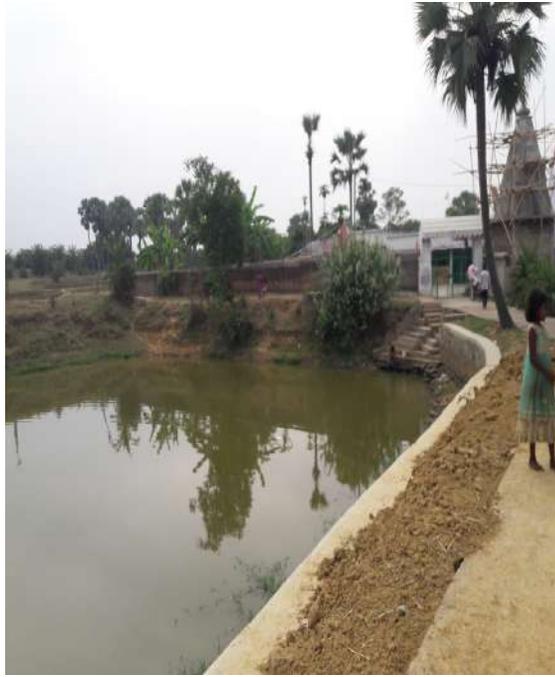
24. No minig ativities was observed in the Katghar village area where some local people and children brought /showed stones that looked like rice, dal, grains, etc( see photo 6)

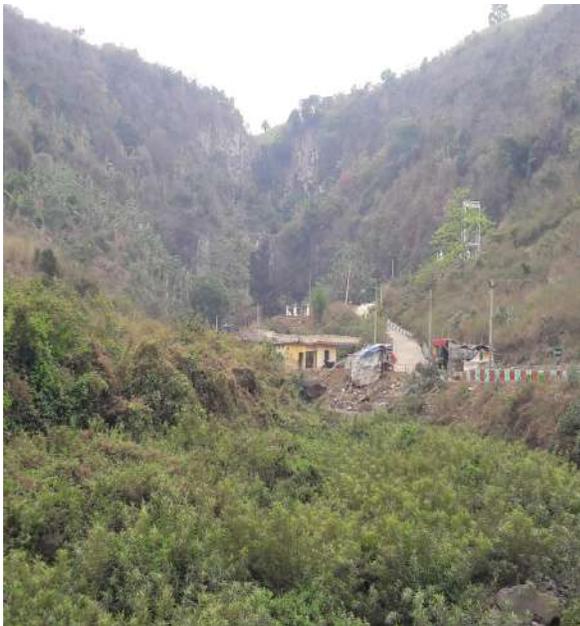
Photo7:MotiJharna(MotinathDham)  
no mining activity observed  
to the boat)

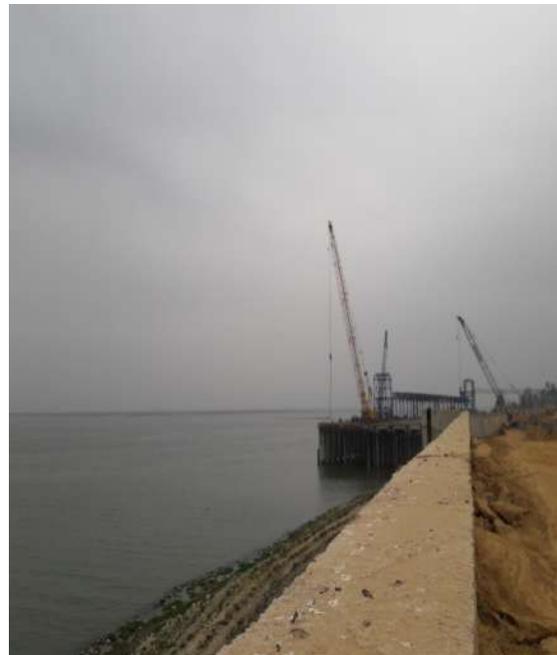
Photo8:Sakrigali Bandargah on Ganga river  
(Loading point of stone chips in

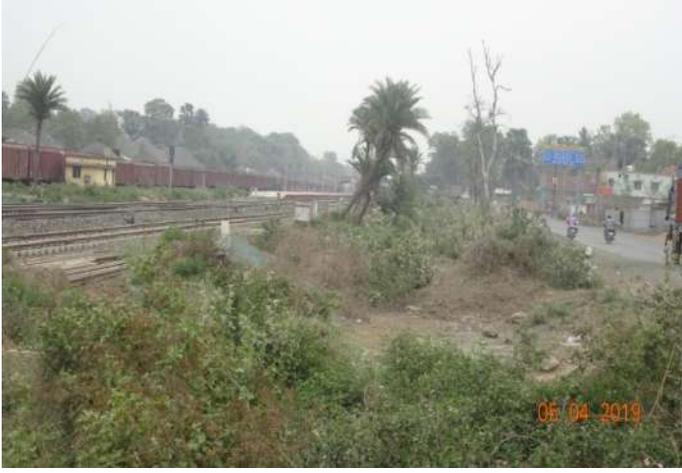
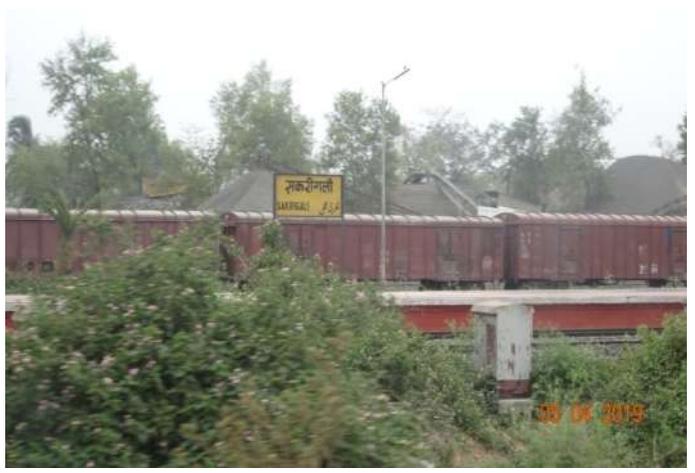
6. It was observed that there were many crusher units just beside the Railway siding at sakrigali as can be seen from photo 9 & 10. There were habitations & state roads just besides these crusher units as can be seen from photo 9. No water sprinklers/sprayers dust control equipments, wall, etc was installed in those crusher units

Photo9& 10: Photo of stone crushing units at Sakrigali Railway station near Sahibganj. Houses and dwellings can be seen in the close vicinity of the crushing units.

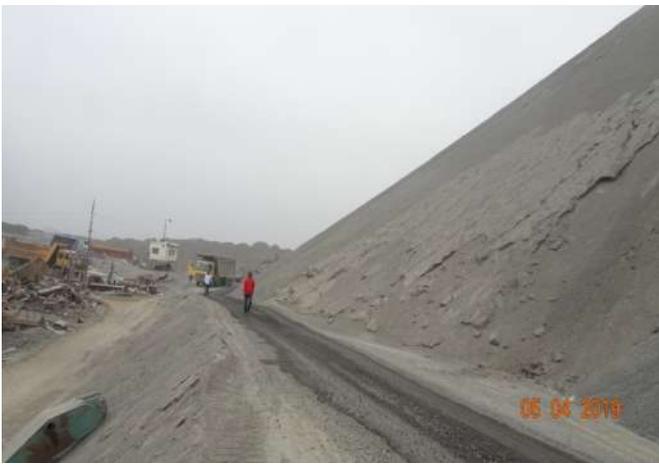
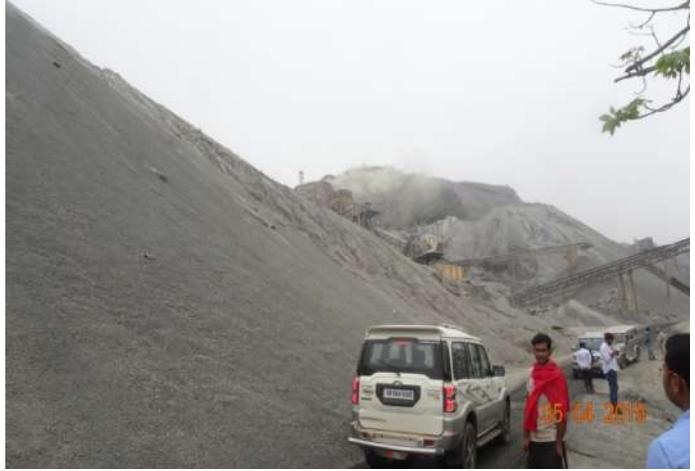
3. The waste of the stone crushers /fine stone materials at Baskola, Gadwa Mauza pahar was kept in a dump. The waste dump was unsystematic and unsafe. Angle of slope of dump was very high & could lead of disaster as can be seen from photo1 & 12.No retaining wall was made for such dumps leading to unsafe & unsystematic situation. It was told to concerned people on the site itself to situation. It was told to concerned

Photo11&12: Photo of waste dump Huge amount of stone chips sand dumped in Baskola Gadwamouza Pahar crushing unit with dangerously high gradient of slope, dust pollution from the crushing unit can also be seen.

- people on the site itself to lessen the slope of the waste dumps and to make benches & retaining wall in the dump
4. The crusher at Baskola, Gadwa Mauza pahar was located on the hill top in such a way that dust generated there would propagate to far places as can be seen from photos.12,13 &14. The crusher owners have kept only their convenience /preferentially mind while such site selection of such crusher installation environment / dust pollution was not at all kept in mind.

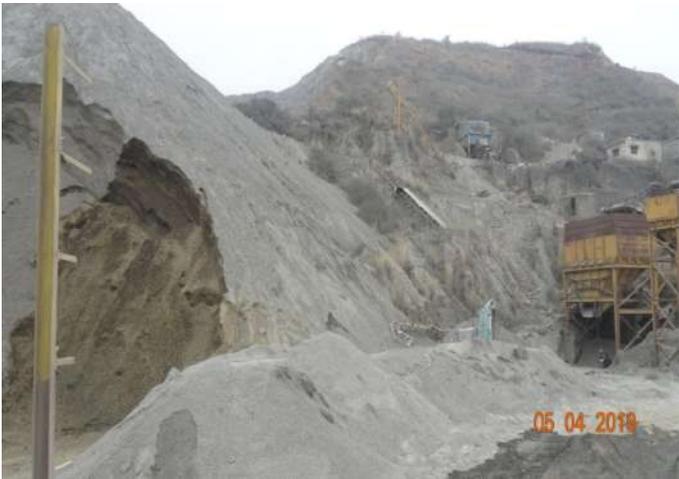
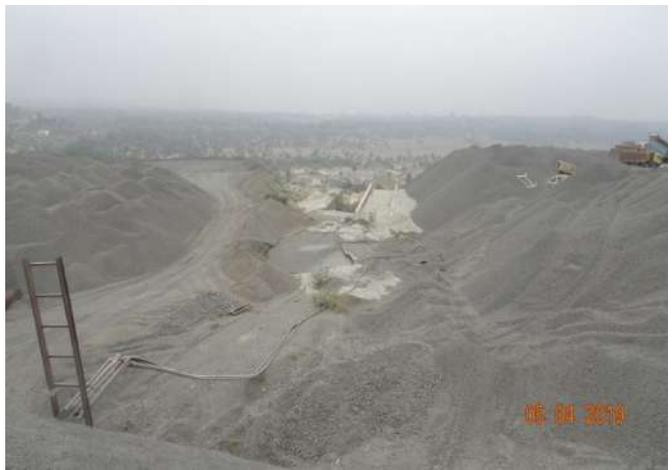
Photo13: Photo of crushing unit almost at the hill top. Photo14: Photo of stone chips stacked and downslope is the river Ganga approx 2.5 km from there.

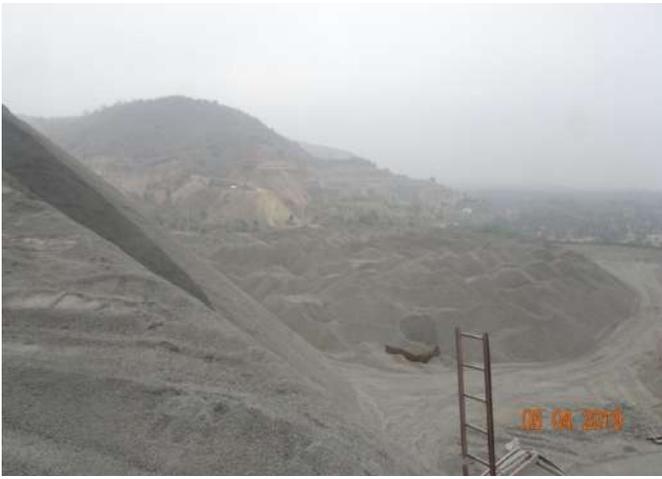
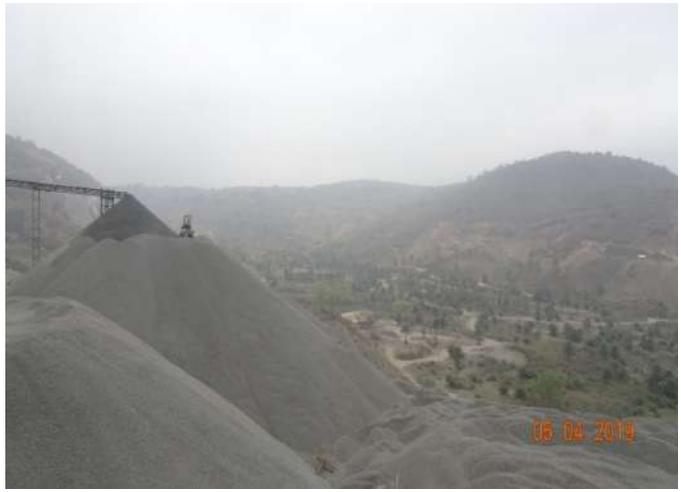
5. Mining had been carried out in the hills adjacent to the visited place (near Baskola, Gadwa Mauza pahar) as can be seen from photo.15 & 16.All the mines were not legal there. In any case there was no closer plan for such mines on the hillocks just plunder of stones and abandoning the mines was the norm it seemed.

Photo15& 16: Photo of mining being done on the hills besides the inspected crushing units. It appeared that the mines in the hills were left abandoned.

2. It was noticed that some Mines are left abandoned. Immediate mine closure plan may be implemented.

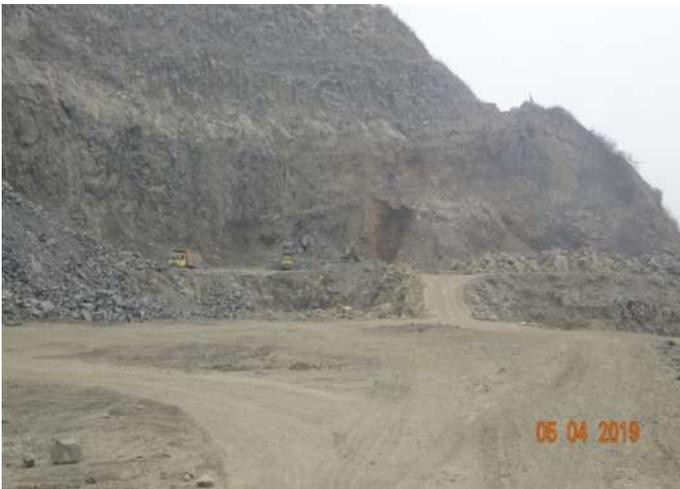
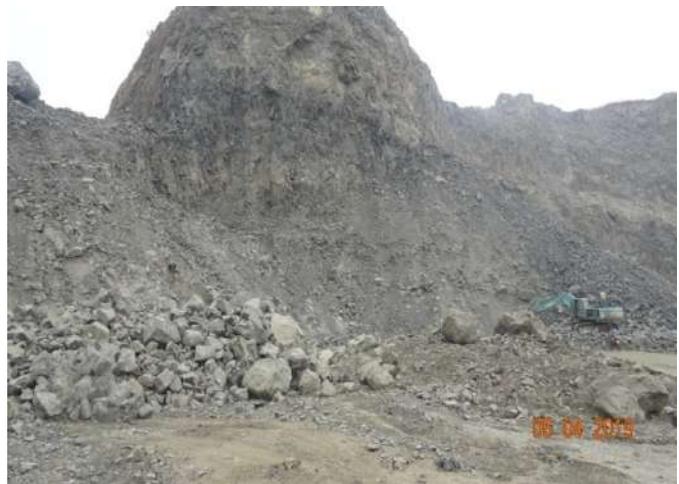
1. In one of the stone quarry/mines at Gadwa Mauza pahar the height of the excavation mass/material was more than the boom height of the excavator as can be seen from photo 17 & 18 resulting in unsafe situation for mine workers & machine. The statutory persons mate/foreman/mine manager who look after safety of the Mines & implement the safety guidelines of DGMS were in very less number / negligible.No person to look after environment management/protection was employed.

Photo17 & 18: Photo of unsafe mining as the height of excavation mass/ material is greater than the maximum boom height of the loader. Unsystematic and unscientific mining being done with proper height and width of benches.

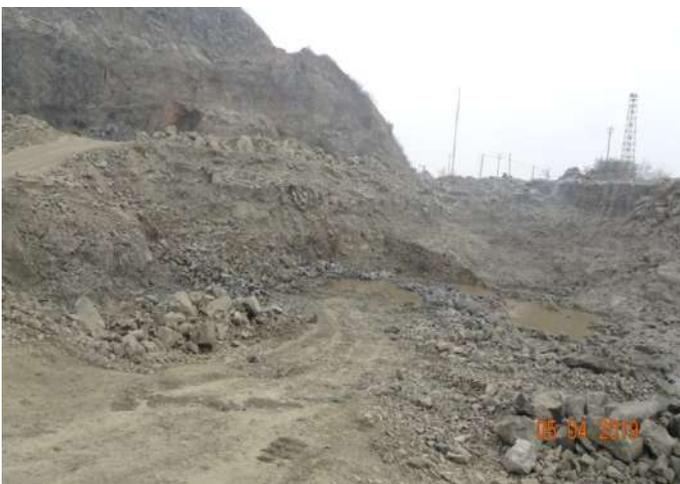
Photo19: Photo of a small sump made in the mine.

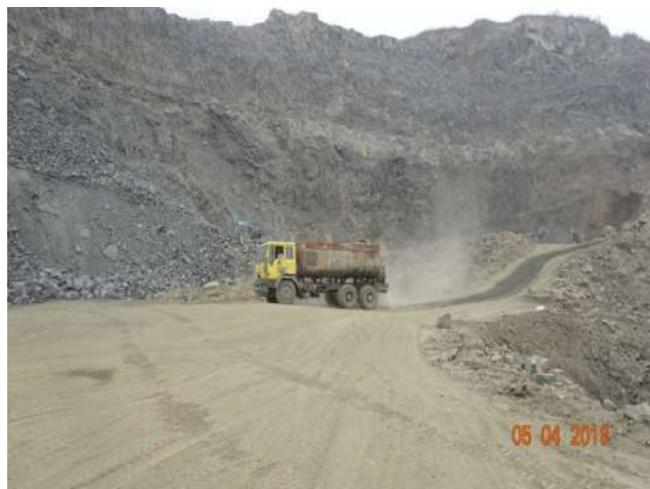
Photo20: Photo of a water tanker sprinkling water in one of the mine after instructions.

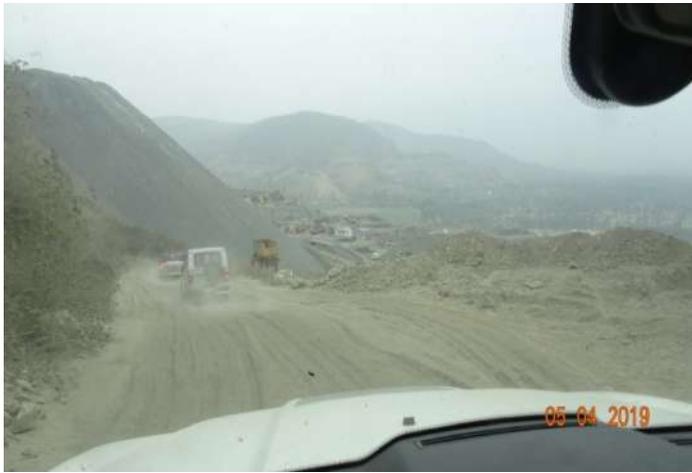
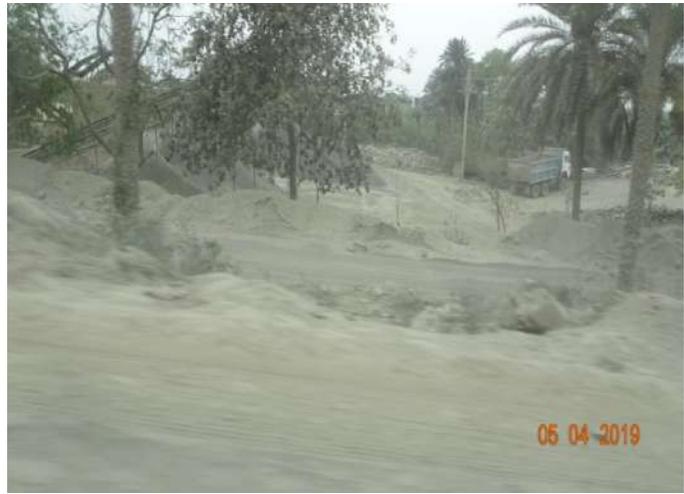
2. Approach road/haulage roads of mines were not black topped or asphalted and they were dust laden. Lot of dust was generated once the vehicles plied on the roads as can be seen from photo21 & 22.

Photo21 & 22 : Photo of dust emissions from approach roads to the mine and crushing unit. No black topped or asphalted roads constructed by project authorities.

6. In the mines sump be constructed to store rainwater, approach roads should be black topped, water sprinkling must be done to minimize/eliminate dust pollution. At some places fixed water sprinklers can also be provided.

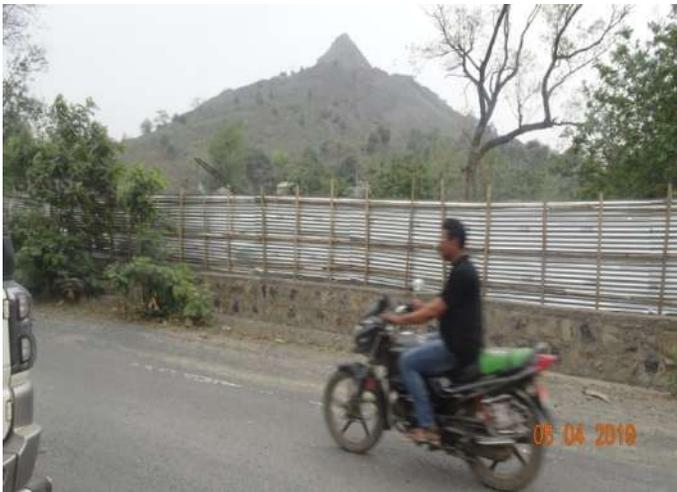
Photo23: Photo of a crushing unit just besides the road highway. Metal sheet dust barrier has been provided but its height not adequate.

13. Inspected Crushing Units has no wind breaking walls. The walls of the individual Crushers may be erected immediately.

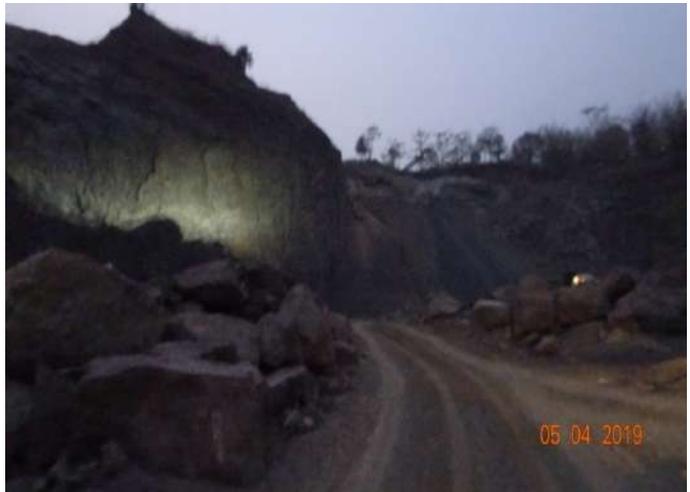
Photo24: Photo of another unscientific and unsystematic mining being done on the hill top with improper height and Width of benches and very poor O/B/ waste disposal mechanism.

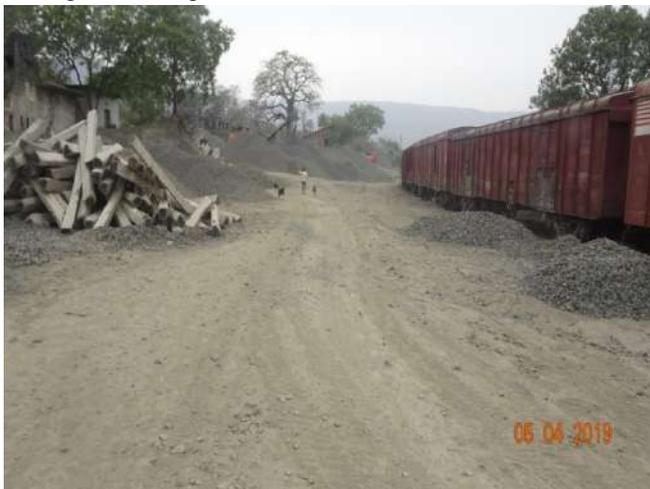
Photo25: Photo of crushing unit at the railway siding

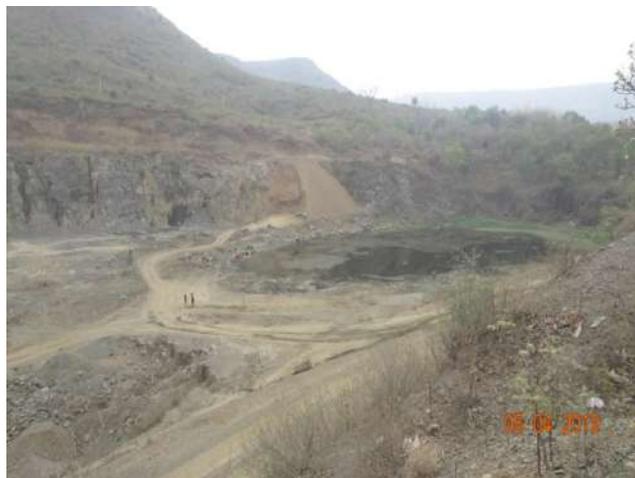
Photo26: Photo of mining in the hill. Proper height and width of benches not followed.

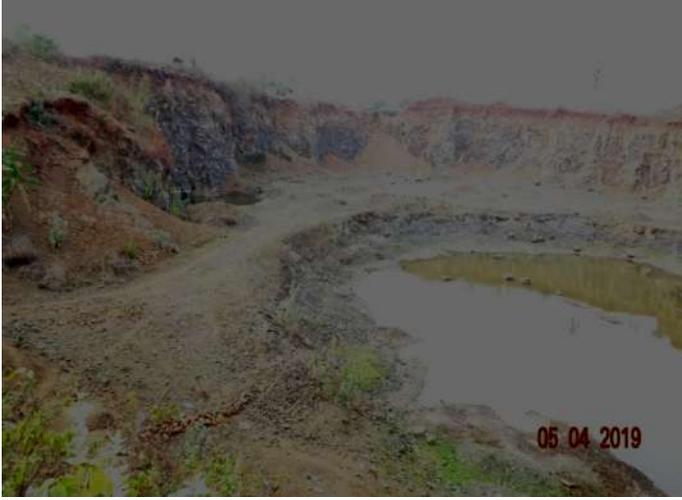
Photo27: Photo of an abandoned mines in the hills. Fencing Nobody was found there for any consultation/suggestion.

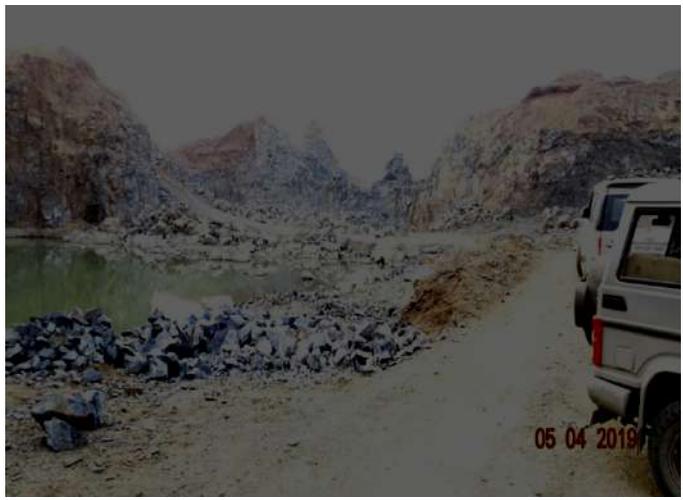
Photo28: Photo of unsystematic and unscientific mining in the hills.

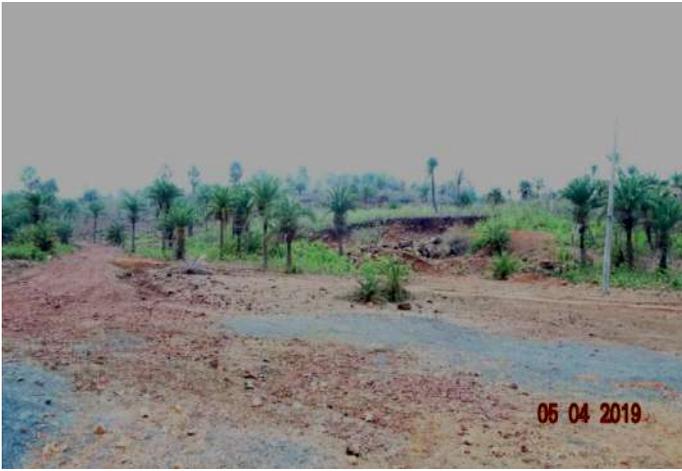
Photo29: Photo of illegal mining in the hills, seemed to be land.

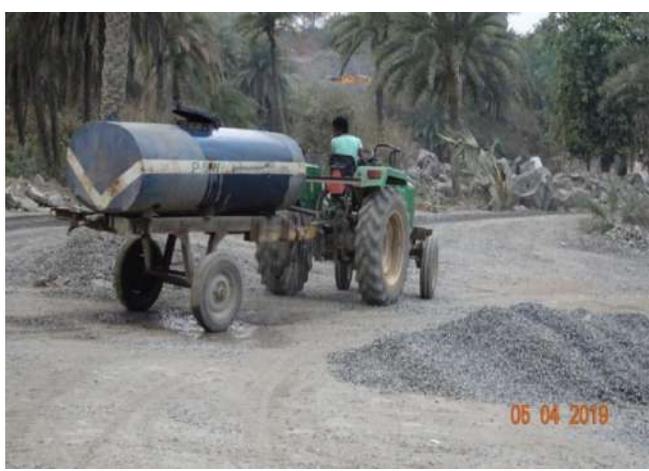
Photo30: Photo of water sprinkling by tanker in one of the forest crushing unit
