**BEFORE THE HON'BLE NATIONAL GREEN TRIBUNAL
EASTERN ZONE BENCH, KOLKATA
ORIGINAL APPLICATION NO. 14 OF 2026**

REPLY ON BEHALF OF THE RESPONDENT NO. 8, M/S VEDANTA LIMITED TO THE ORIGINAL APPLICATION

1. That the present Original Application has been instituted by the Applicant, alleging breach of the red mud pond/process water lake dyke on 15.09.2024 at the premises of Respondent No. 8, M/s Vedanta Limited [Alumina Refinery Unit], located at Lanjigarh, Kalahandi, Odisha, and its impact on the agricultural field and Bansadhara River. The Applicant further alleges that no environmental compensation has been imposed and collected from Respondent No. 8, M/s Vedanta Ltd.

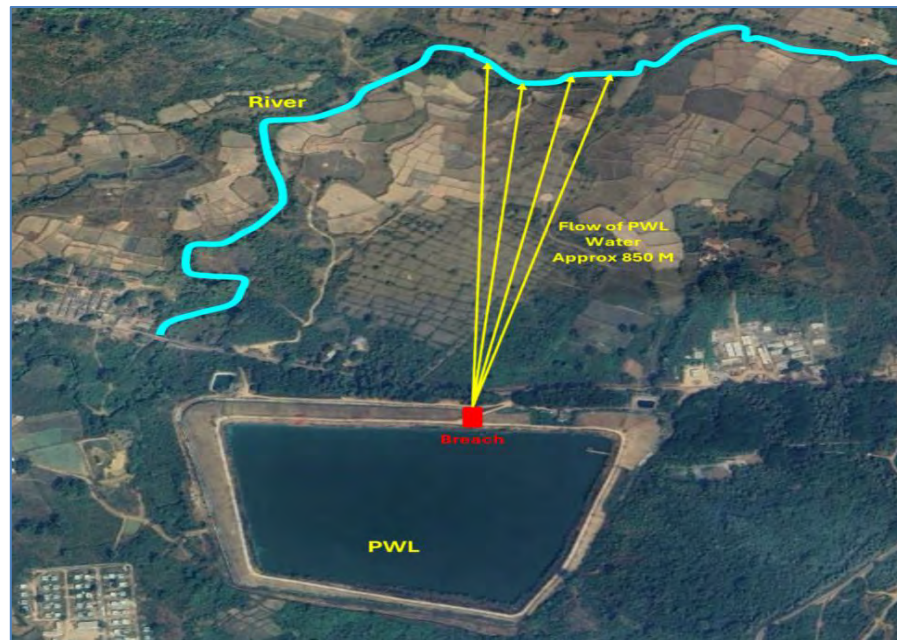
Figure-5 : Affected Area Photo

A portion of the dyke in the north side failed approximately 15 m in length and 7 meter in height releasing approximately 4 Lac M³ of alkaline water to the ground adjacent to the PWL and finally entering the Banshadhara River at around 850m from the point of breach. The goggle image is presented in **Figure-5**.

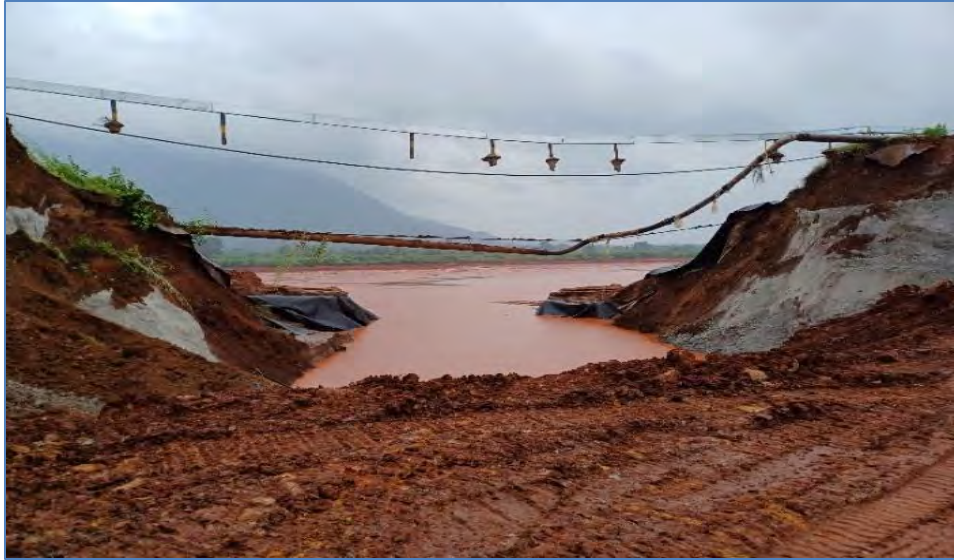
Figure-6 : Dyke Breach photograph

Date	Time	Event description
15-09-24	02:10	Loud sound heard near PWL entry by night operator and guard stationed nearby. They rushed to site and found water flowing out of the dyke. They immediately informed the Shift Incharge and other relevant people.
15-09-24	02:15	Waterflow from Dyke increased and section of dyke collapsed leading to high flow of water. A portion of the dyke in the north side failed 15m in length and 7 meter in height releasing approximately 4 Lac m ³ of alkaline water
15-09-24	02:25	Flow of water from RMP to PWL stopped
15-09-24	06:00	Water flow stopped from the dyke as level of water decreased and soil and bags placed

Before the breach, the free board of the pond was reported to be about 4.0 meters, thus the total volume of the water in the pond is estimated as 4.8 Lac m³. The calculation sheet submitted by the industry is annexed as **Annexure-III**.

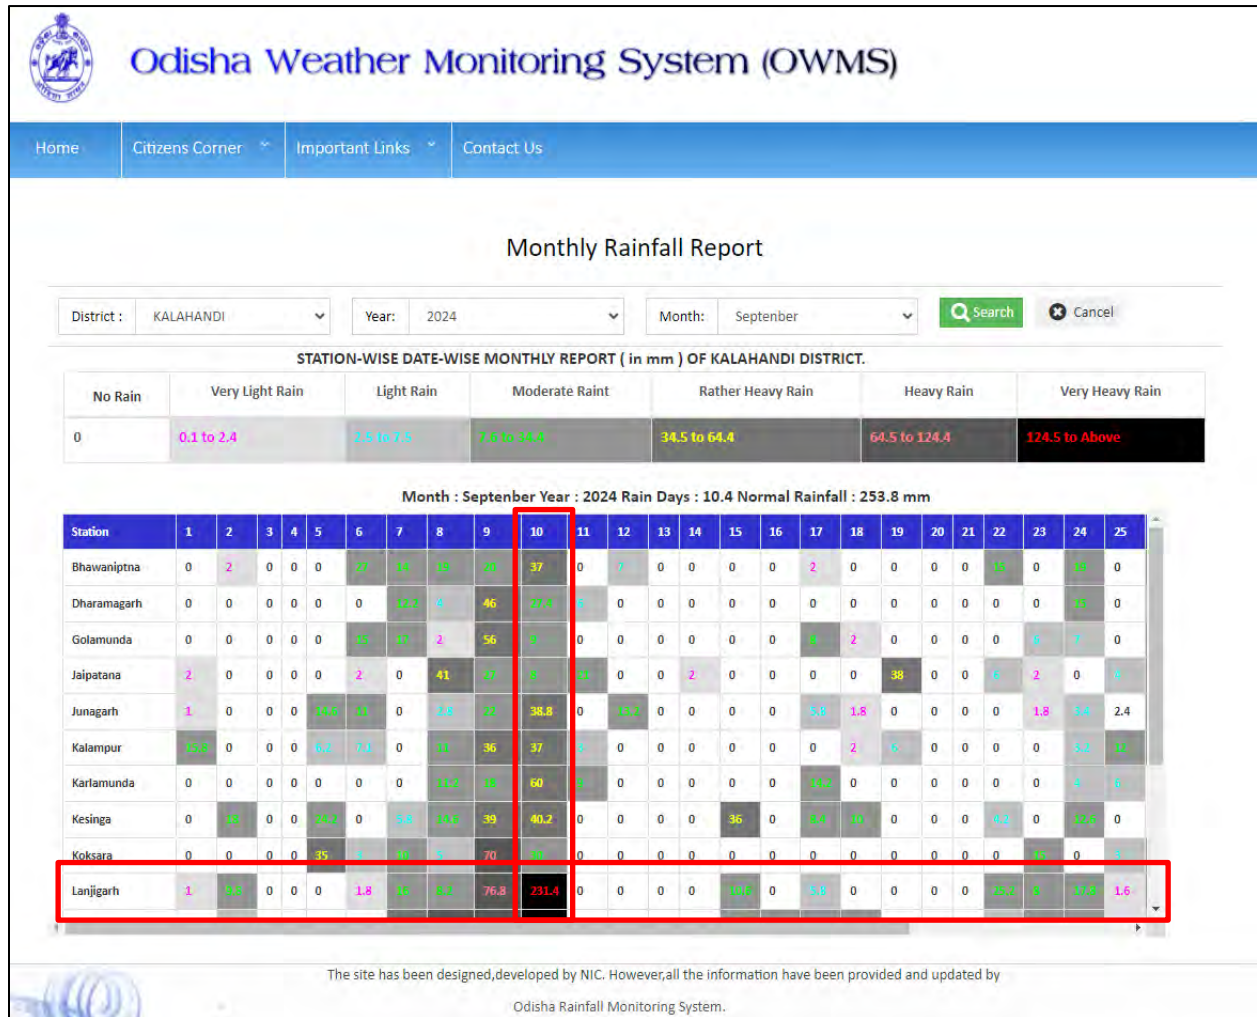
Figure-8 : Rain fall data
<https://rainfall.nic.in/rainfallnew/PublicDistWiseMonthlyReport.aspx>

There was heavy rainfall of 231.4 mm on the 10th of Sep 24 (as recorded by the Odisha Weather Monitoring System) recorded in Lanjigarh preceded by 76.8 mm rainfall on the 09th of

As reported by the industry during site visit, around 180mm rainfall was recorded in just 3 Hours causing massive flooding in all areas including plant and outside.

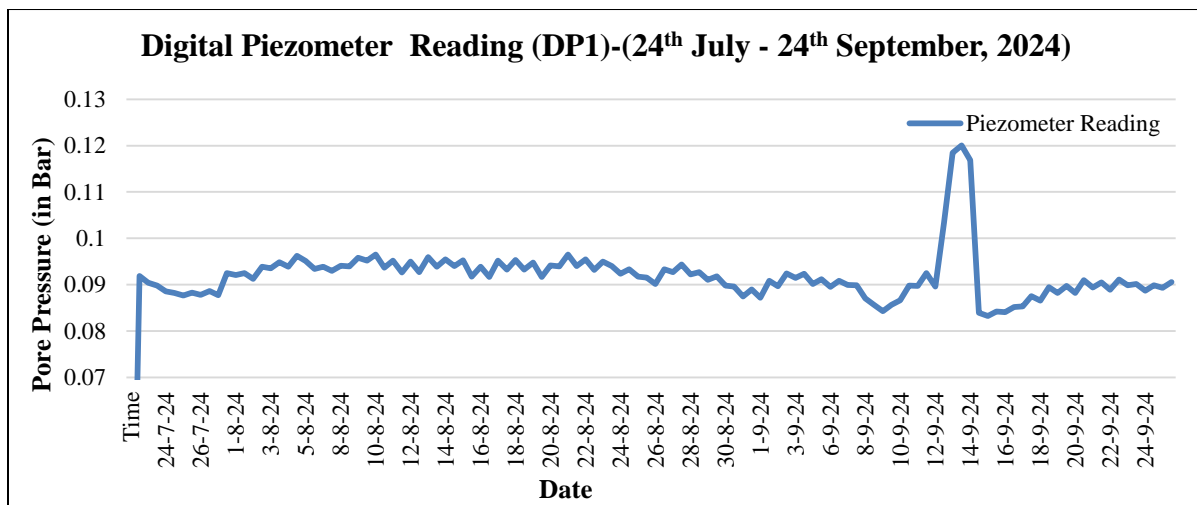
Figure-9: Digital Piezometer reading of DP1 from 24 .7.2024 to 24.09.2024

The breach has occurred on the North Dyke around 330 M from the North-West Corner and 235 M from the North-East Corner. The nearby piezometer installed towards breach point are Digital Piezometer (DP1) and Manual Piezometer (MP2) located around 70 M from the center of the breach area. The monitoring results for the period July 24 to September 24 of Digital piezometer is obtained from the unit and is presented as graph in **Figure-9**.

This high level of water rise in the PWL may have led to increase in water seepage to the dyke which is also indicated by the small spike in Piezometer readings on the 09th and 10th Sep 24.

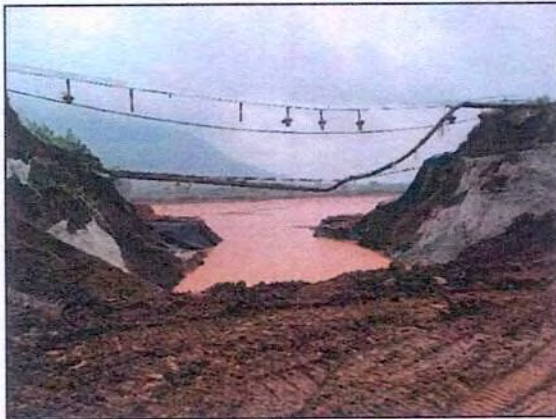
Fig. 2a: Dyke breach area

Though it is difficult to attribute a particular cause for the dyke breach, the analysis reveals that a particular combination of factors including high water level, presence of porous soil and damage to HDPE liner joints together might have caused the dyke breach.
