**BEFORE THE NATIONAL GREEN TRIBUNAL (SZ), SITTING
AT CHENNAI**

O.A No.229/2020

9F.05 Gas Turbine Fire Incident Root Cause Analysis

KPCL – Yelahanka, GT-1 (#GT247)

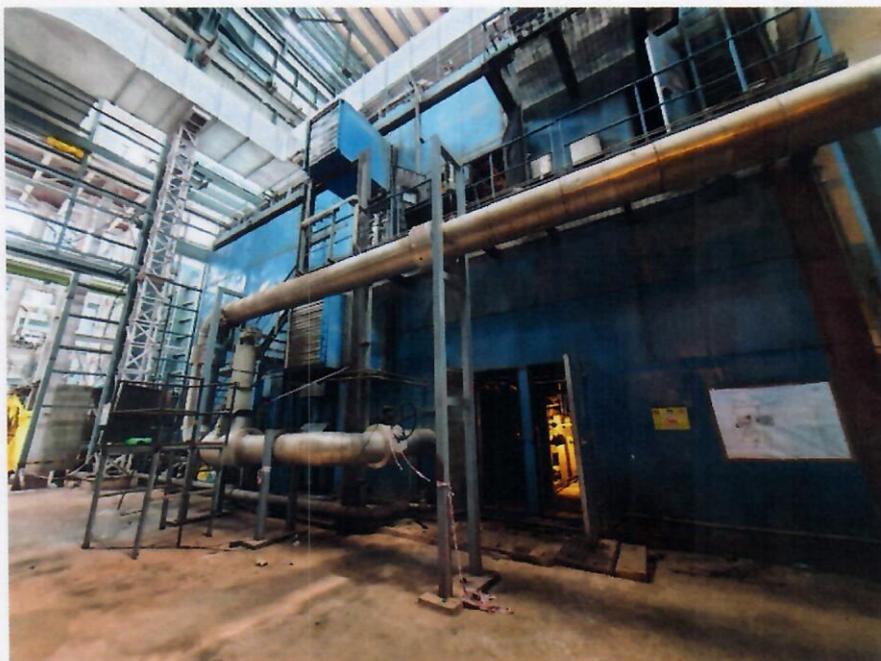
South side turbine compartment door

- The fire was localized only in exhaust and turbine compartments. No damages observed to components outside these two compartments.
- Deflagration occurred near the south side door and was visible from the north side of the exhaust compartment

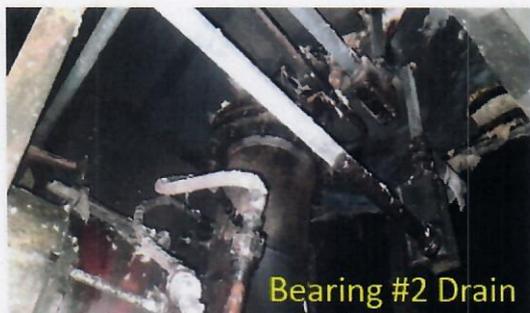
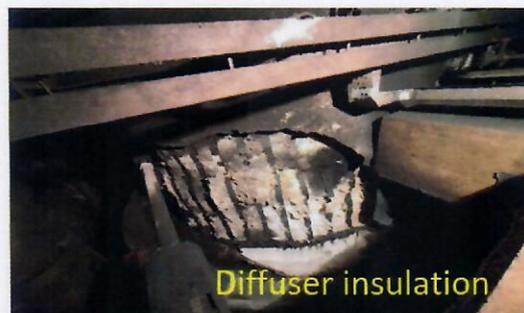
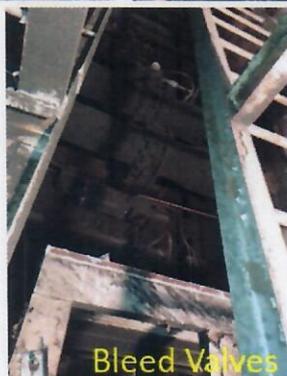
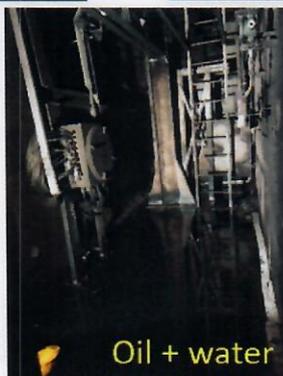
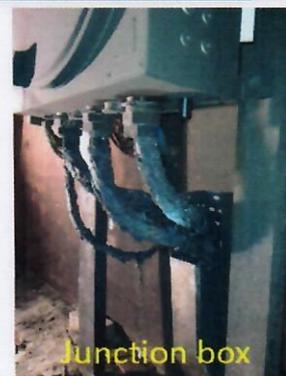
Inside exhaust compartment

- Components damaged due to fire exposure:
 - Instrumentation and cables inside the exhaust and turbine compartment
 - Insulations on compressor casing, exhaust frame & diffuser are partially damaged

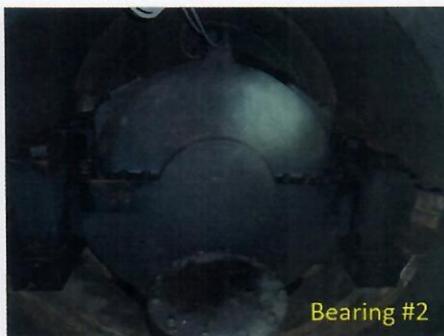
Bearing #2

Oil has leaked from the forward seal of bearing #2. This oil has taken three paths to reach the compartment floors.

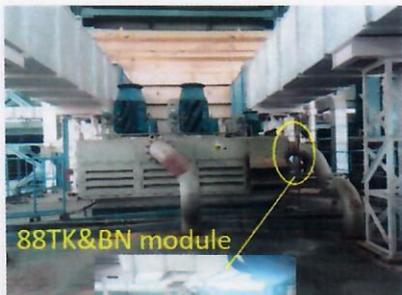
88TK&BN module

- Components in the load compartment & accessory compartment are in good condition
- Components on the roof top of the enclosure are in good condition (except a ruptured bellow & soot affected filter in the 88BN fan)

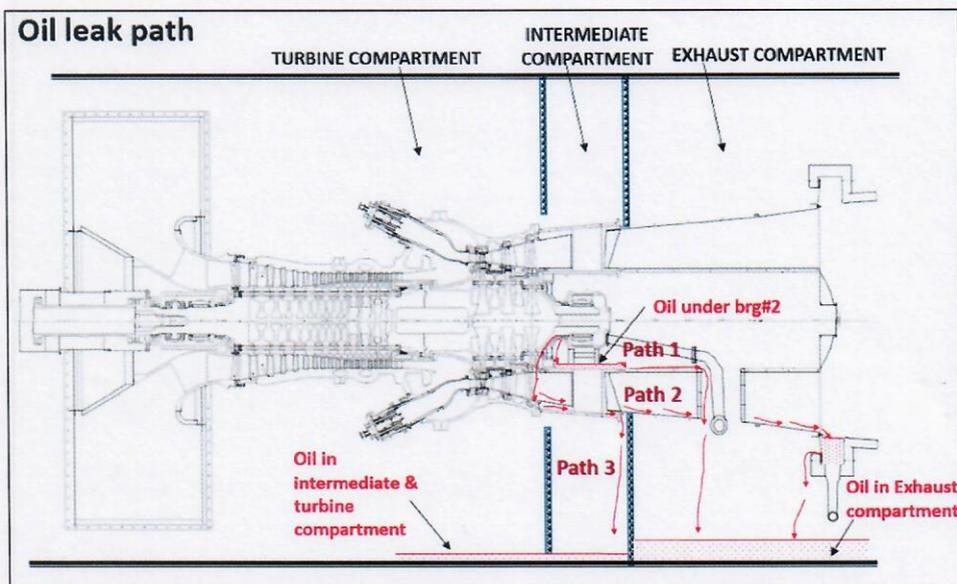
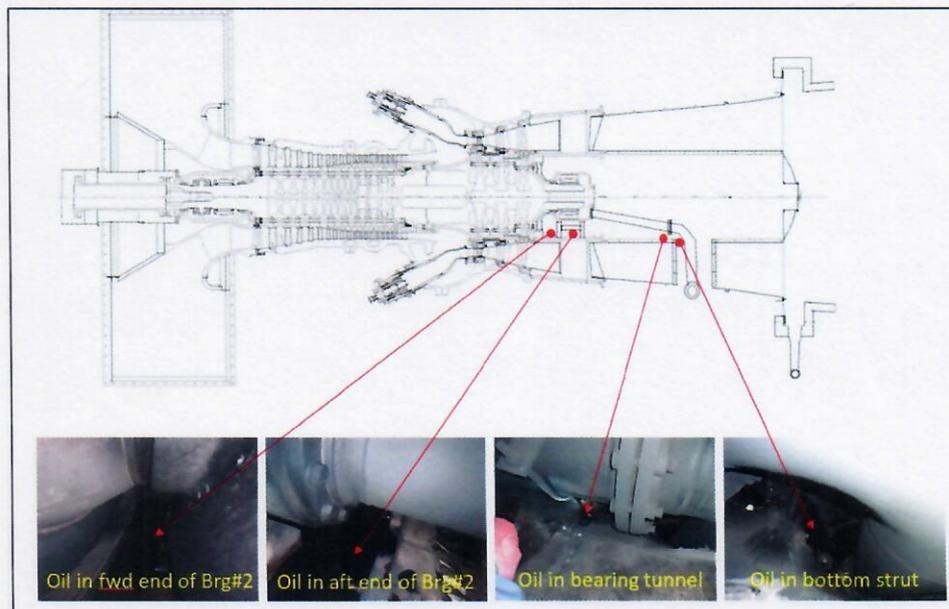
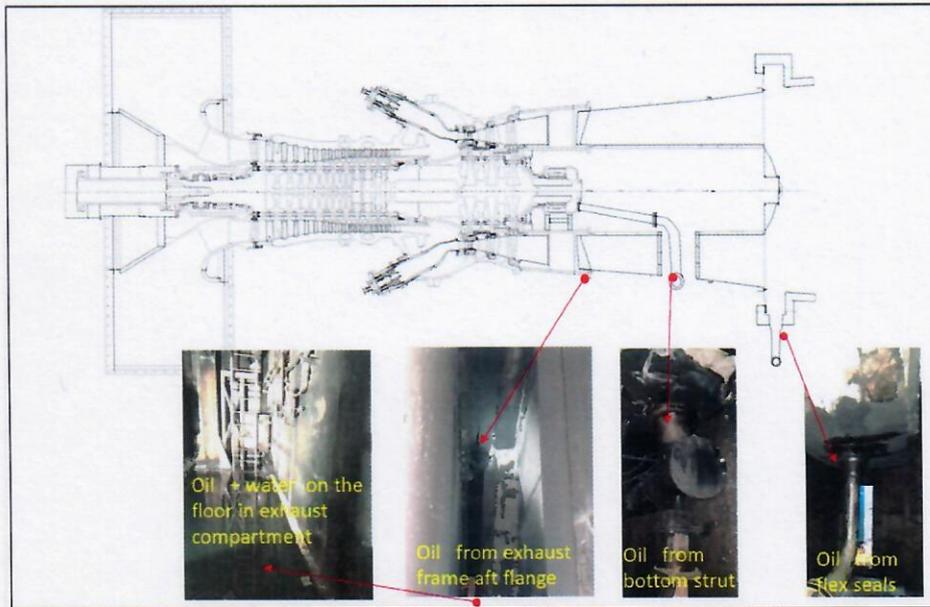
Oil leak path

- Path 1: Oil accumulated under the bearing housing has flown aft in the bearing tunnel, wet the insulation and leaked from the bottom strut of bearing tunnel into the exhaust compartment
- Path 2: Oil has leaked over the stage-3 bucket into the exhaust flow path and flow aft into the flex seal cavity of the diffuser duct. Oil has then leaked across the flex seal into the exhaust compartment.
- Path 3: Oil has leaked over the stage-3 bucket into the exhaust frame cooling air annular space. This oil has leaked from the aft flange of the exhaust frame into the intermediate compartment. Subsequently this oil has found a path into the turbine compartment.

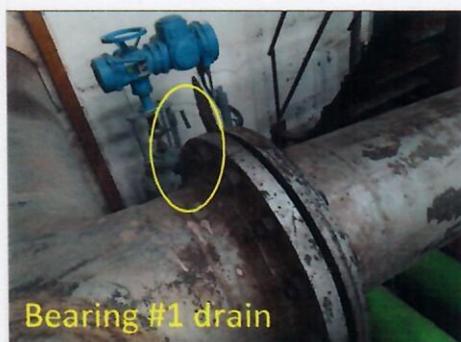
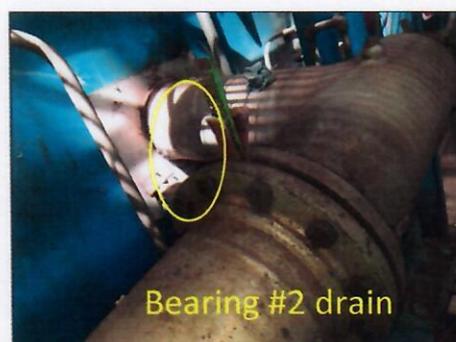
- Improper provisioning of Bearing sealing during commissioning at site
 - Mist eliminator vacuum from operational data is very low
 - However during lube oil system checks the mist eliminator performance found satisfactory
 - Bellow in bearing tunnel cooling fan is found damaged
 - Both the above can result in Low volume high duration leak
- Improper provisioning of Oil drain during installation at site
 - Detailed site simulation study undertaken by GE
 - Picture taken on 01.10.2020 10:45 AM by KPCL engineer indicate presence of strainer mesh in the drain line during operations on 1st & 2nd October 2020
 - Choking of this mesh during operation can lead to backing up of oil causing overflow from bearing seal. This will result in High volume low duration leak

- Low volume high duration leak
 - Damaged bellow and low mist eliminator vacuum can lead to Low volume high duration leak
- High volume low duration leak

- Retaining a mesh used during lube oil flushing during operation resulting in restricted drain
 - Restricted drain can lead to backing up of lube oil level in the bearing housing and cause High volume low duration leak
