Original Application No. 71 of 2021 (SZ)

Tribunal on its own motion-SUO MOTU
based on the News items in The New
Indian Express Newspaper, dated
10.02.2021, "Oil leak from titanium
factory hits Thiruvananthapuram coast,
public barred from affected stretch"

JOINT COMMITTEE REPORT SUBMITTED BEFORE THE HON'BLE NATIONAL GREEN TRIBUNAL, SOUTHERN ZONE, CHENNAI IN THE MATTER OF O.A. NO. 71/2021 - TRIBUNAL ON ITS OWN MOTION-SUO MOTU BASED ON THE NEWS ITEMS ON OIL LEAK INTO SEASHORE FROM M/S. TRAVANCORE TITANIUM (P) LTD.

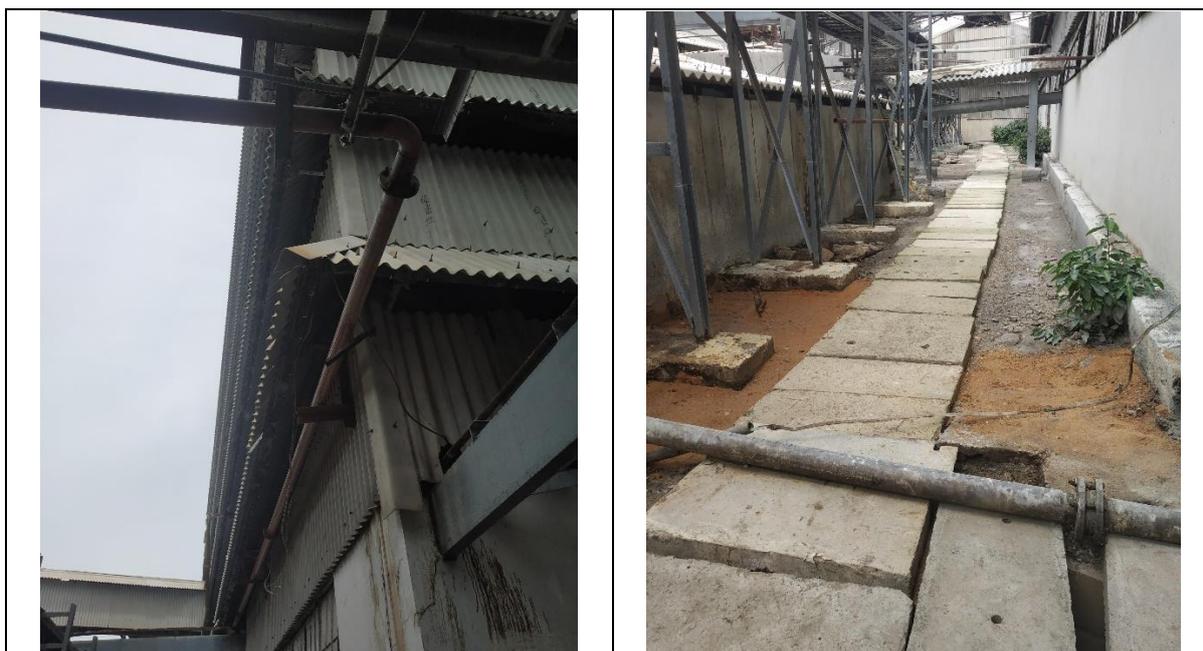
As per the information and records made available, the furnace oil spillage from the unit happened on 10.02.2021 at about 7.40am due to a breakage in the oil pipe line. The furnace oil is pumped from the storage tank, located outside the plant premises, to the boiler in the plant through a pipeline and some part of the pipeline is passing as overhead line within the plant. A leakage happened in the overhead line and the leaked oil reached the underneath drain within the plant, which ultimately meets the drain outside the unit leading to seashore. As per the unit representatives, the leakage was stopped before long, on notice, however till that time, approximately 4750 litres of furnace oil leaked into the internal drains and to the effluent drains and some quantity had spread to the sea shore. The records indicate that approximately 2500 litres of oil were collected from the internal drains of the company and the rest of the quantity had reached to the sea shore.

Overhead pipeline and the drain underneath through which oil leakage happened

During the visit of the Committee, it was observed that the unit has replaced the pipeline used for transportation of the furnace oil from the storage tank to the boiler. However some of the other recommendations, made by the Committee constituted by the Government of Kerala under the chairmanship of the Principal Secretary, Industries Department and other concerned members are yet to be fully implemented by the unit. It was informed by the unit that the same is in process and shall be completed.

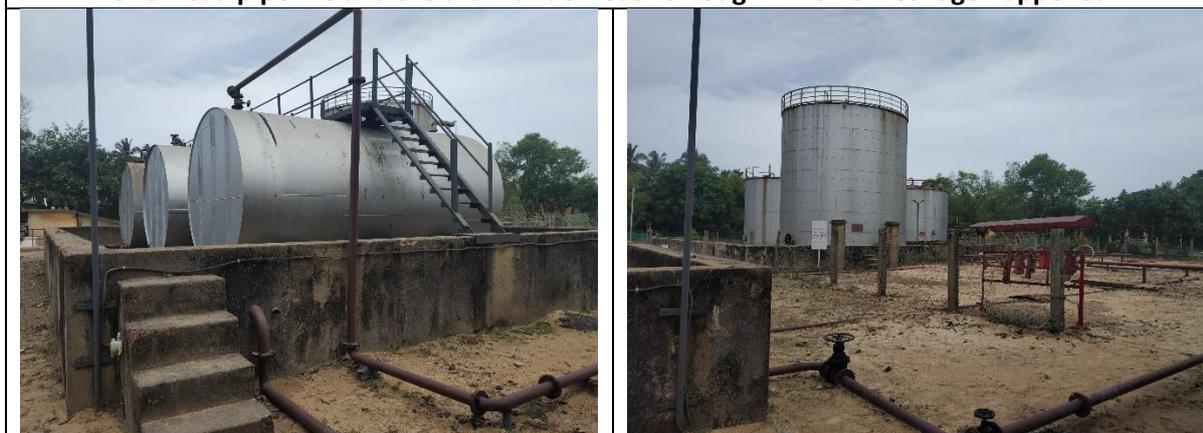
Furnace oil storage tanks and Acid storage tanks outside plant premises

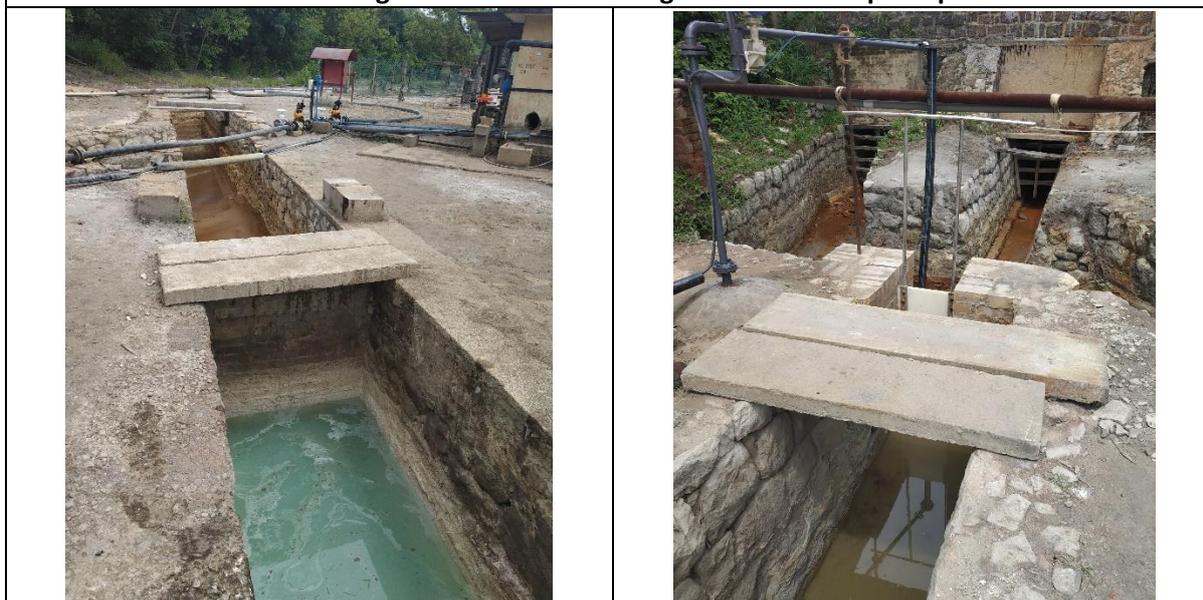
Internal drains of the unit, temporarily blocked, and joining outside drain

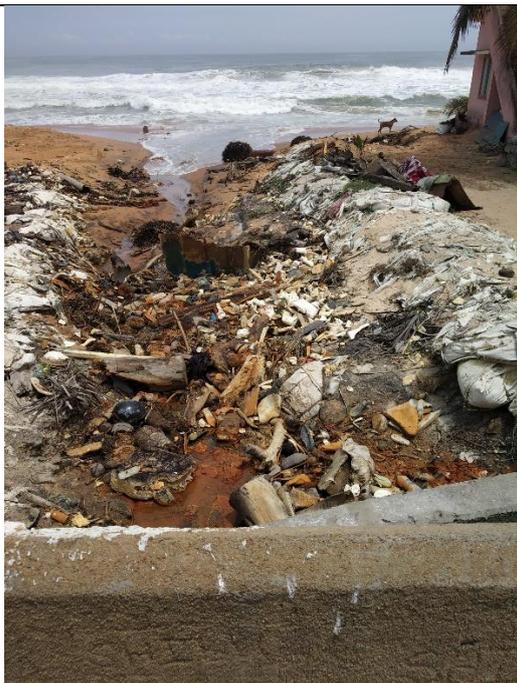
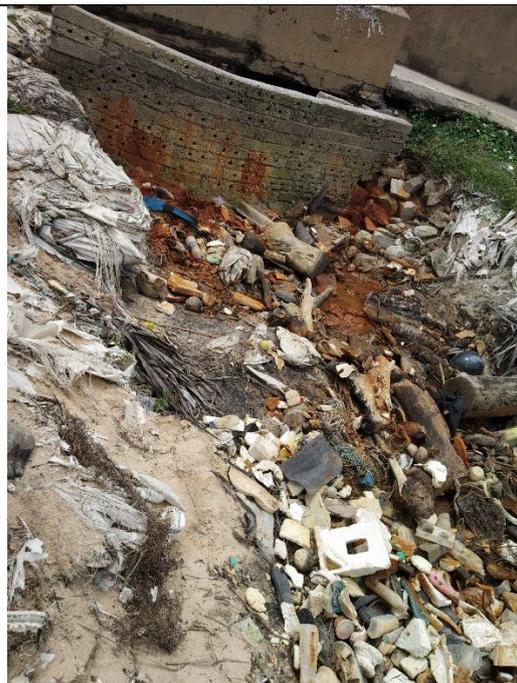
Drain reaching the seashore found temporarily blocked by wall construction

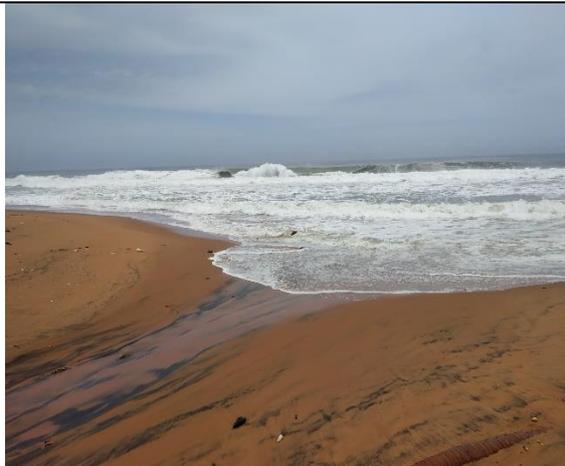
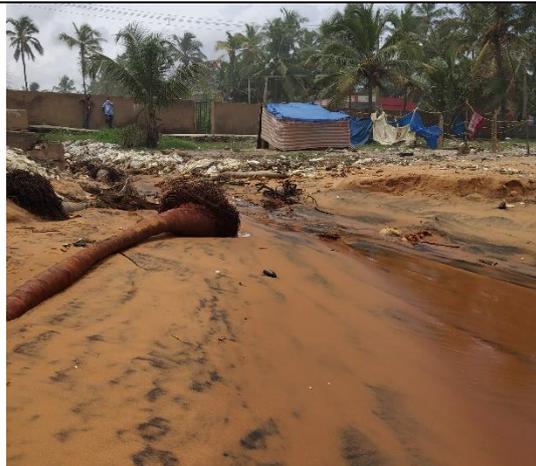
Effluent channel reaching the sea shore

- D. Considering that the unit has installed systems such as MFRO which facilitates reuse of treated effluent, the practise of discharge of effluent to the sea shore shall be discontinued by the unit. KSPCB may consider amendment of the Consent conditions to this extent after ensuring that reject management systems are installed by the unit to achieve Zero Liquid Discharge status.

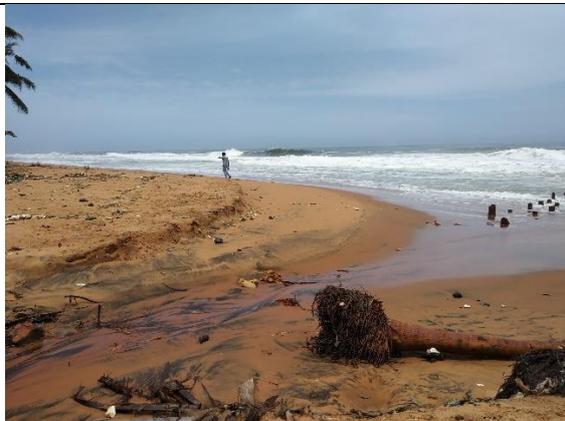
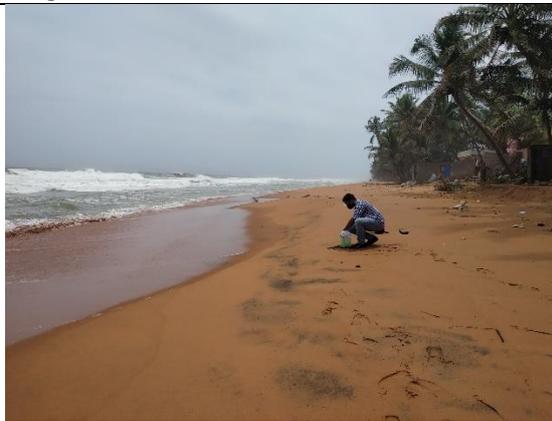
The KSPCB had also carried out some sampling of the bore wells in the vicinity of the plant and seashore during April, 2021 and the reports does not indicate oil contamination in the ground water. However the analysis results of the sea shore samples, collected by the Committee and afterwards by KSPCB, detailed in previous para, indicates the presence of oil & grease particles in the sea shore, even at **1 km** distance from the channel through which oil leakage reached the sea shore. The porous nature of the soil shall result in the capture of some quantity of oil particle, which have not yet evaporated out to the atmosphere.

Collection of sea shore soil samples

- C. The analysis results indicate presence of traces of oil & Grease still in the sea shore sand samples and a detailed investigation and risk assessment study for remediation of sea shore shall be carried out to assess the impacts occurring from activities handling oil and grease, acid etc. and extent of damage (spatial) to environment, ecology and livelihoods estimated. Based on these estimates, emergency response procedures (ERP) shall be developed and costs assigned in the annual budget for monitoring the ERP. In this regard, the entire expenditure for the investigation, risk assessment study and remediation shall be borne by the unit.

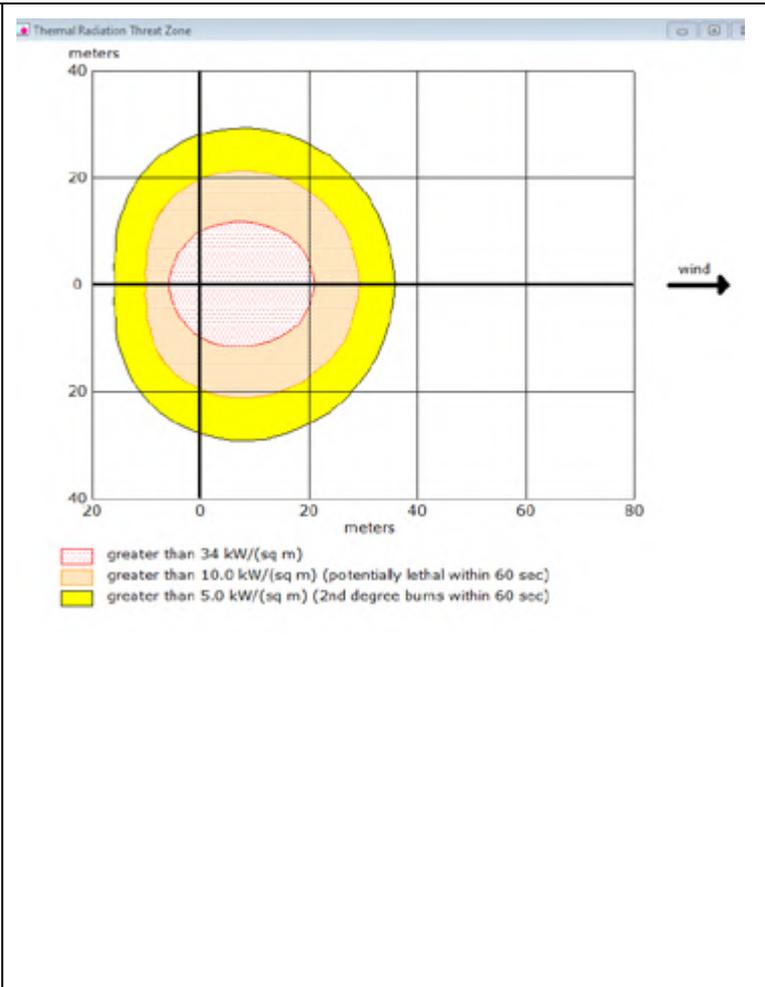
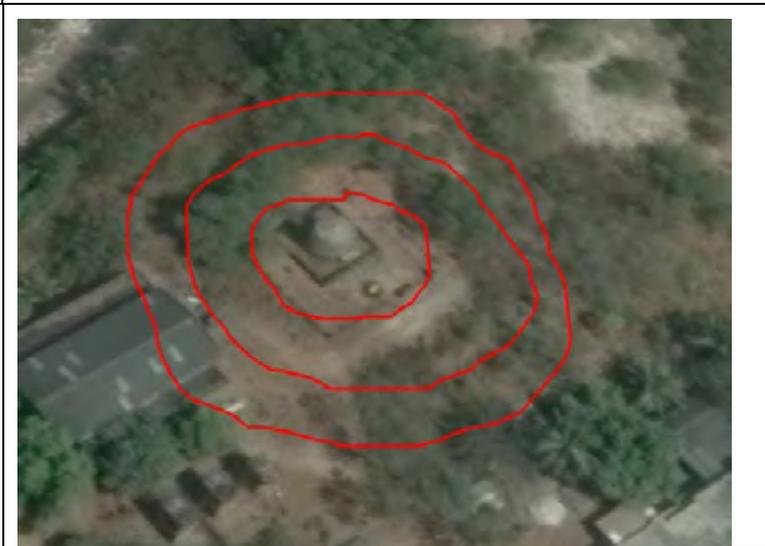
<p>2.</p>	<p>Circular Opening Diameter: 4 inches Max Flame Length: 15 meters Burn Duration: 1 hour Max Burn Rate: 415 kilograms/min Total Amount Burned: 24,401 kilograms Note: The chemical escaped as a liquid and formed a burning puddle. The puddle spread to a diameter of 10.0 meters.</p>	<p>Threat Modeled: Thermal radiation from pool fire Red : 21 meters --- (34 kW/(sq m)) - fatal Orange: 29 meters --- (10.0 kW/(sq m) = potentially lethal within 60 sec) Yellow: 36 meters --- (5.0 kW/(sq m) = 2nd degree burns within 60 sec)</p>

<p>All ignition sources within the diameter of the circle must be free from any ignition source. Switch off power supply to the area. Stop all vehicle movement so that source of ignition is eliminated. Outside battery limit will be within the danger zone.</p> <p><u>Inner envelop is 100% fatality.</u></p>

<p>Remedial measures: In case of fire cool the tanks with water. Water sprinkler system is suggested for all the tanks. However, the company is not having any fire fighting facility</p>

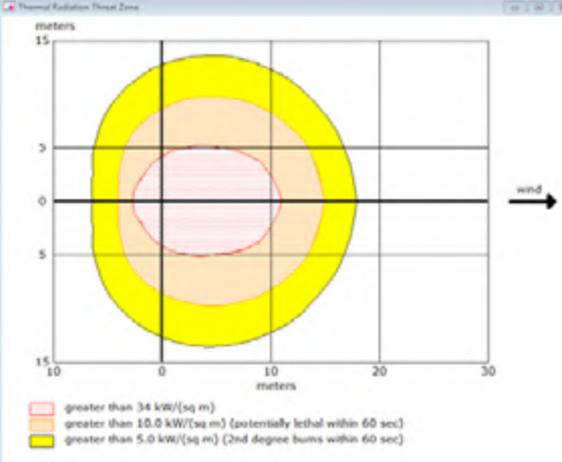
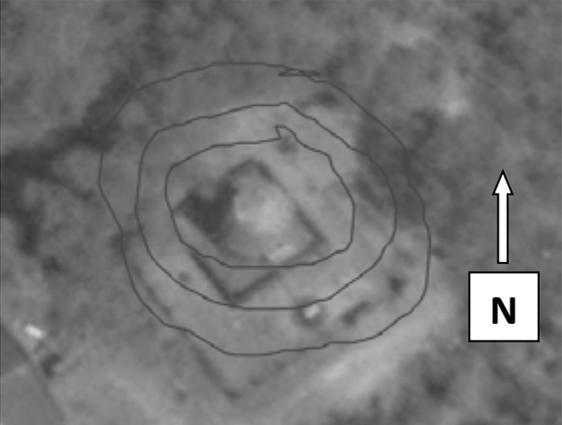
<p>4) Burning Puddle / Pool Fire Puddle Area: 17 square meters Average Puddle Depth: 3 inches Initial Puddle Temperature: Air temperature Flame Length: 9 meters Burn Duration: 13 minutes Burn Rate: 89.3 kilograms/min Total Amount Burned: 1,186 kilograms</p>	<p>Red : 11 meters --- (34 kW/(sq m))</p> <p>Orange: 15 meters --- (10.0 kW/(sq m) = potentially lethal within 60 sec)</p> <p>Yellow: 18 meters --- (5.0 kW/(sq m) = 2nd degree burns within 60 sec)</p>

<p>Effected area due to dyke fire. Drawn as per scale. Inner envelop=100% fatality.</p>

<p>Remedial Measures: Dyke leak and accumulated oil is to be collected. Full fledged fire fighting facility is to be installed at the earliest by proper design of the system including sprinkler system for tank shell cooling.</p>

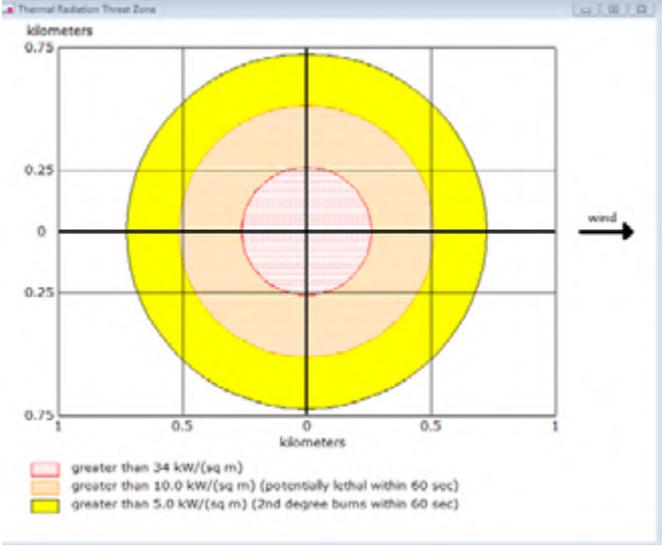
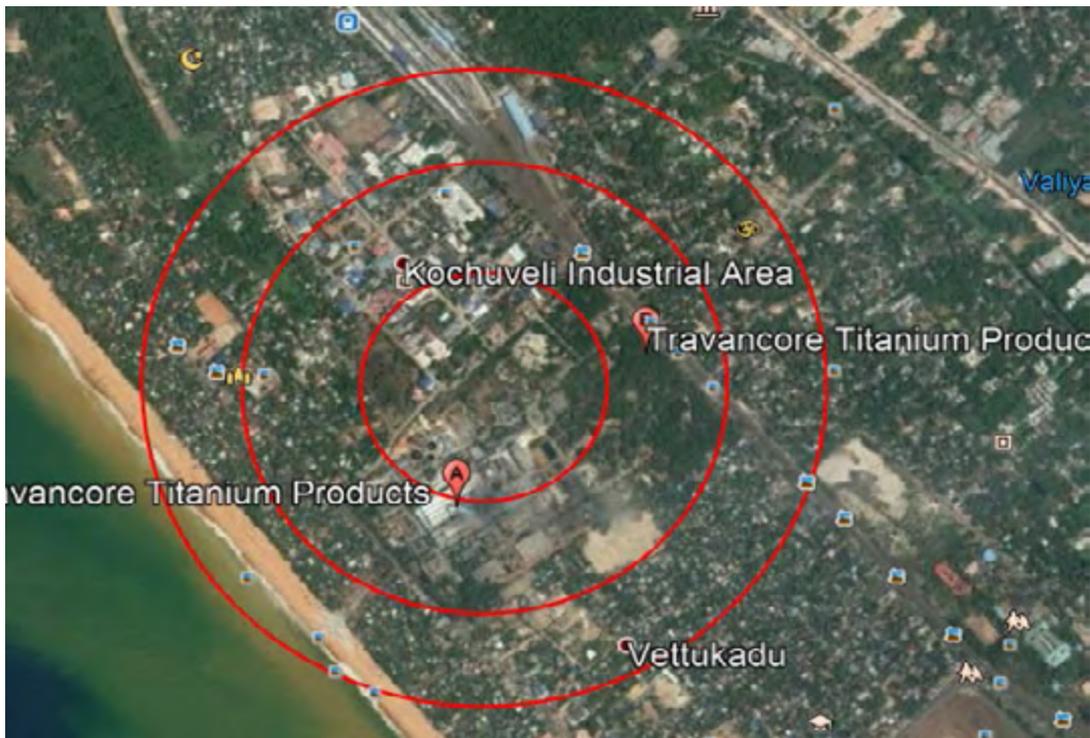
<p>5 BLEVE of flammable liquid in vertical cylindrical tank</p>	<p>Chemical Mass in Tank: 86.8 tons Tank is 95% full Percentage of Tank Mass in Fireball: 100% Fireball Diameter: 249 meters Burn Duration: 15 seconds Threat Modeled: Thermal radiation from fireball Red : 261 meters --- (34 kW/(sq m)) (100 % fatal) Orange: 514 meters --- (10.0 kW/(sq m) = potentially lethal within 60 sec) Yellow: 725 meters --- (5.0 kW/(sq m) = 2nd degree burns within 60 sec)</p>

Inner envelop = 100% fatality.

Remedial measures : The effect will be catastrophic all around as can be seen. As mentioned earlier, full fledged fire fighting facility is to be installed at the earliest.

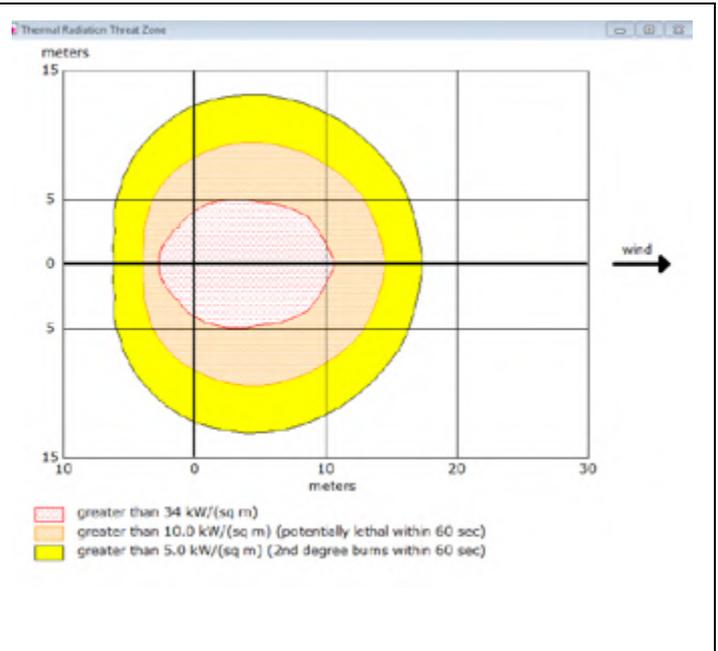
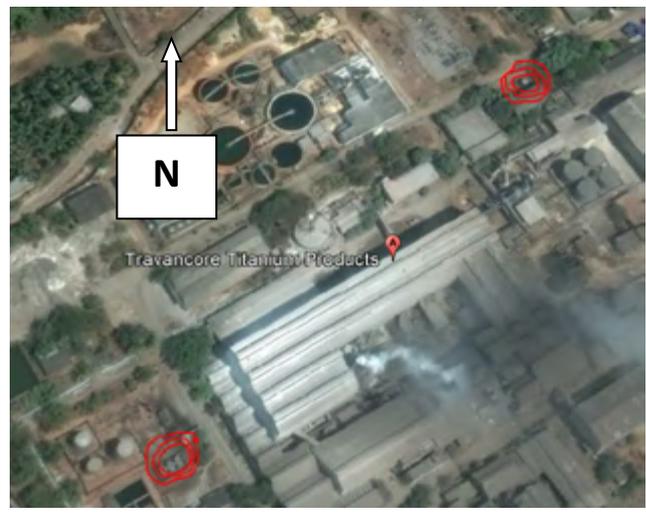
<p>4</p> <p>Burning Puddle / Pool Fire</p> <p>Puddle Area: 17 square meters</p> <p>Average Puddle Depth: 3 inches</p> <p>Initial Puddle Temperature: Air temperature</p> <p>Flame Length: 9 meters</p> <p>Burn Duration: 10 minutes</p> <p>Burn Rate: 88.6 kilograms/min</p> <p>Total Amount Burned: 877 kilograms</p>	<p>Heat Modeled: Thermal radiation from pool fire</p> <p>Red: 11 meters --- (34 kW/(sq m))</p> <p>Orange: 15 meters --- (10.0 kW/(sq m) = potentially lethal within 60 sec)</p> <p>Yellow: 17 meters --- (5.0 kW/(sq m) = 2nd degree burns within 60 sec)</p>
--	--

Area covered in the event of puddle fire.

Remedial measures: In unlikely case of fire, evacuate an area of 50m dia. Cool tanks with area within this area. Evacuate man power from the area. Isolate all source of ignition. However, proper fire fighting system is to be arranged at the earliest.
