**BEFORE THE NATIONAL GREEN TRIBUNAL,
PRINCIPAL BENCH, NEW DELHI.**

In re: News item published in the Indian Express Newspaper dated 02.01.2022 titled "Four Killed in Haryana Mine Landslide"

S.No	Particulars	Pages
1	Affidavit on behalf of Respondent-M/s Goverdhan Mines & Minerals, Hisar, Haryana	1-2
2	Compliance by respondent to the Report of DFO, Bhiwani and Report of DGM, Ghaziabad	3-11
3	ANNEXURE –R-1 /1 Report of DGMS, Ghaziabad dated 31.12.2020	12-14
4	ANNEXURE R-1/2 Photographs of Benches	15-18
5	ANNEXURE R-1/3 Chapter-XI of MMR 1961 and Circular 71 of 1963	19-20
6	ANNEXURE R-1/4 DGMS Technical Circular No.3/2019 along with format of status report on progress made into Mitigation of all the identified principal hazard	21-26
7	ANNEXURE R-1/5 Letter addressed by Govardhan Mines & Minerals to the Director of Mine Safety dated 22.12.2020	27
8	ANNEXURE R-1/6 E-mail dated 30.03.2022 submitting revised copy of the safety management plan	28
11	ANNEXURE R-1/7 Letter dated 13.4.2022 from Directorate General of Mines Safety to Manager Goverdhan Mines & Minerals	29
12	ANNEXURE R-1/8 Study on stability status of slopes in Dadam Stone Mine of M/s Govardhan Mines & Minerals,	31-51

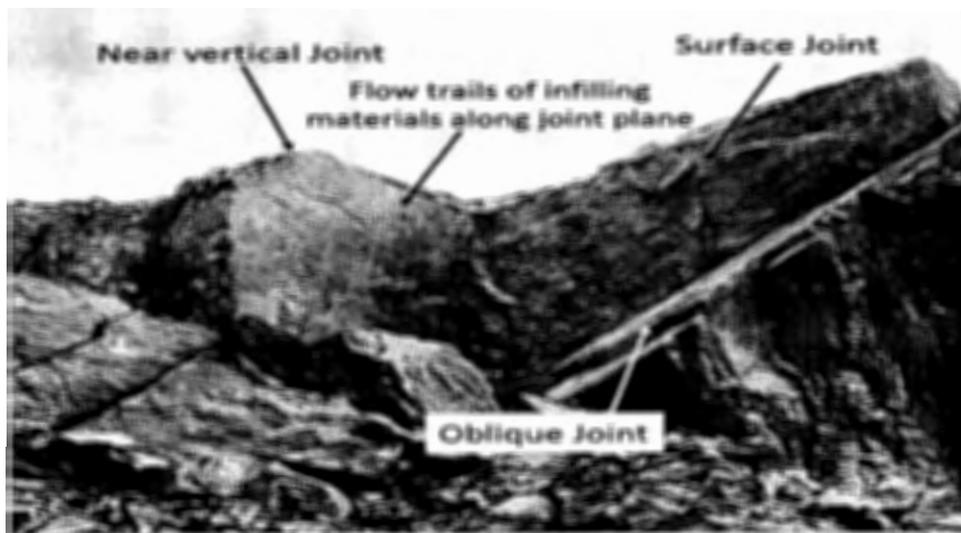
Figure 8(a): Joint Orientation and observed Staining in Pit No. 37 & 38

The exiting slope section consists of three sets of major joints with random ones (Fig. 8 a). The exposed joints are quite persistent (> 22 to 55 m) with wide to very wide spacing (8-10 m) that instigate the occurrence of very large to extremely large in-situ blocks potential for failure (Fig. 8b). The three-dimension profile of the pits scanned by Lidar is shown in Fig. 9.

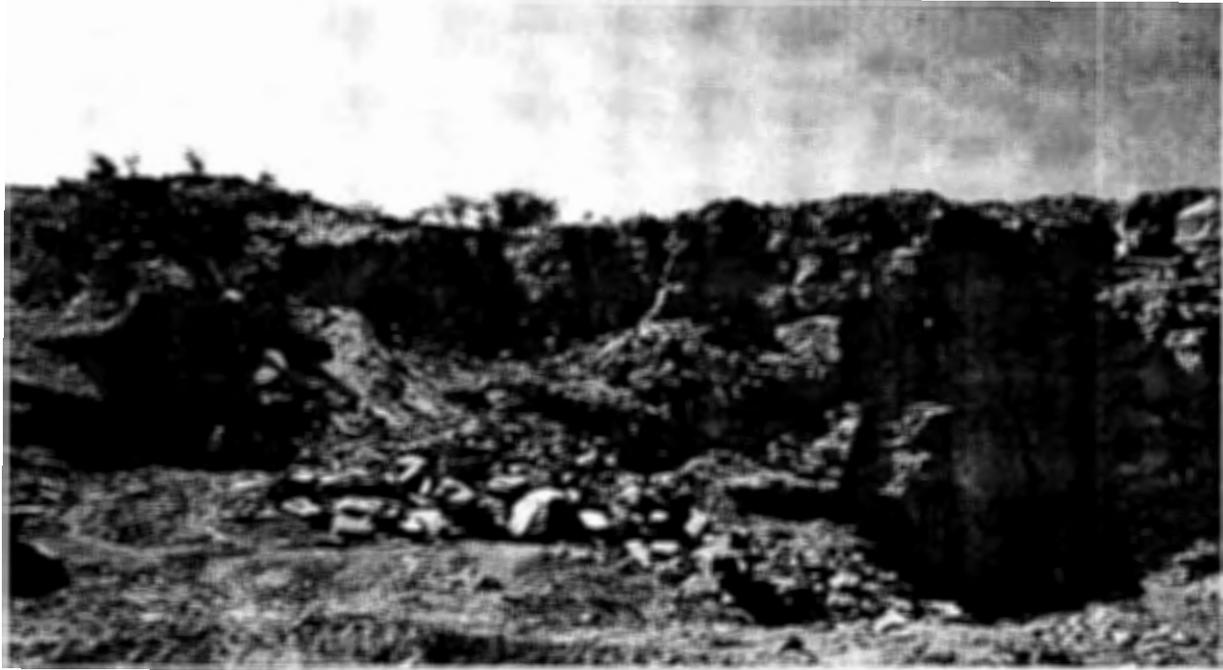
Figure 15: West wall in Pit No. 3

The west wall of the Pit No 3 is varying from 15 m to 20 m high with loose blocky masses overhanging on the slope and prone to failure (Fig. 15) and a 3D view of the slope has been shown in (Fig. 14). The weathering condition in the upper part of the slope is quite high and blocks are loosened up with wide-open joints. Thus, the adverse orientation of joints concerning the slope face, high weathering coupled with slope inclination allow the blocks to move from the slope face. The observed RMR_{basic} for the slope is 48 (Table 6).

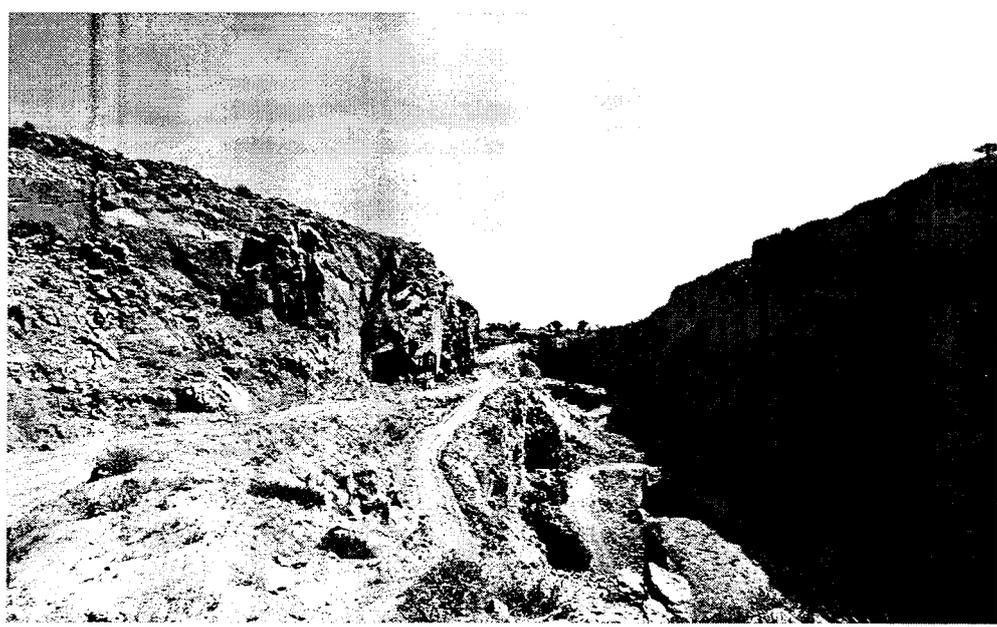
Figure 17: Field photograph of Pit No. 7, 8, & 9

Rock mass in Pits No. 7, 8, 9 & 14 is as shown in (Fig. 17). The west wall of the pit area is nearly vertical and the height of the same varies from 60 m to 80 m. The highly jointed and fractured rock mass is prone to fail. The east wall of pits 7, 8, 9 & 14 is observed to be fractured. The major joints are highly persistent and vertical to sub-vertically oriented into the slope which suggests toppling and wedges are likely.

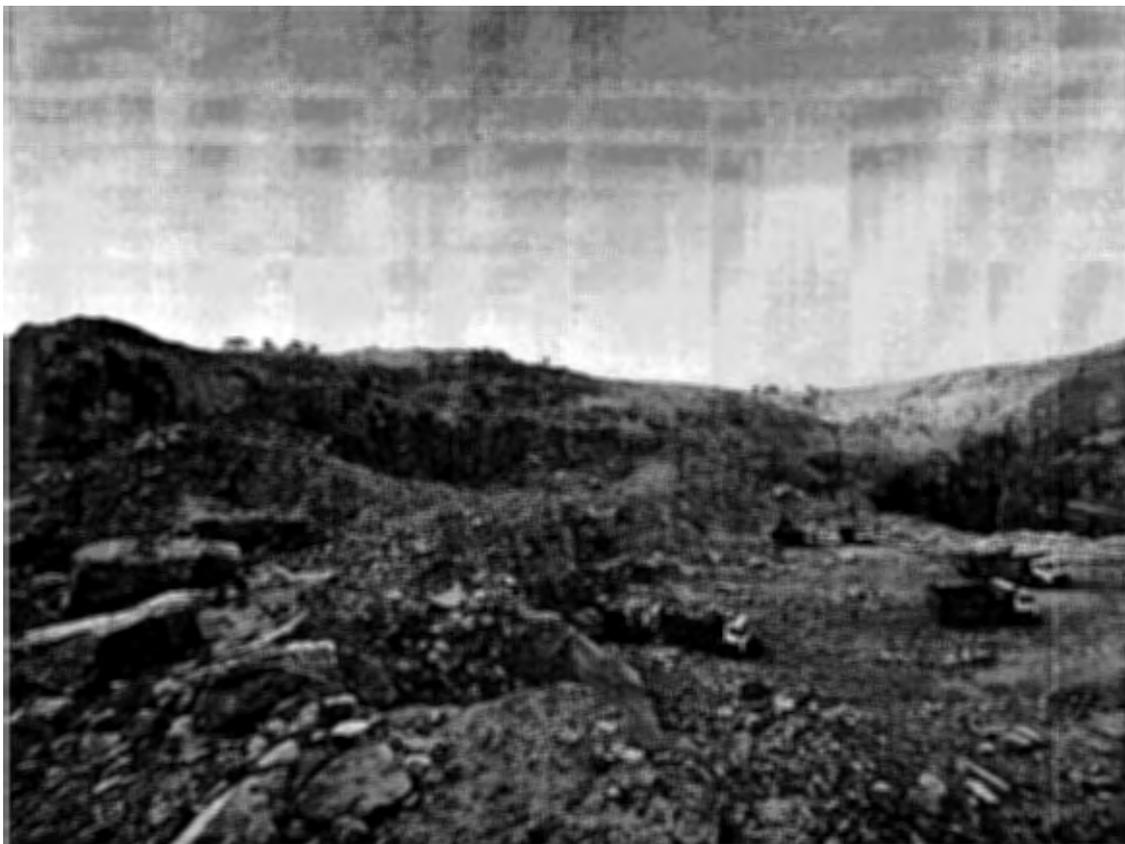
Figure 22: Field photograph of Pits No. 22 & 23

failures are observed to be feasible at some sections of the pit which can be dealt with pit geometry alteration.

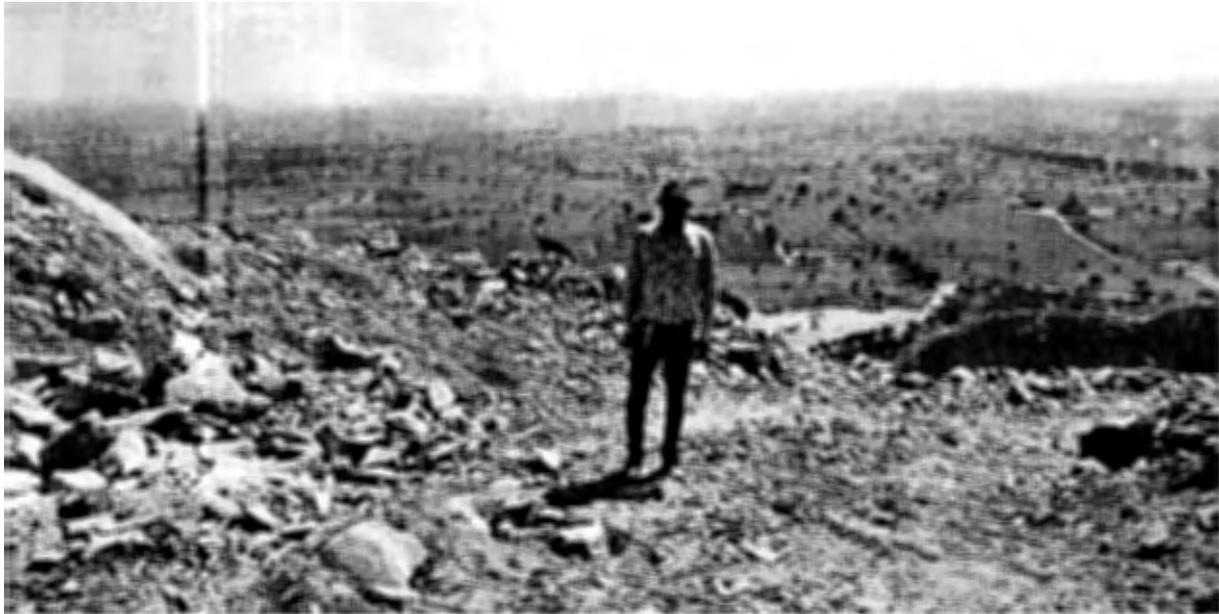
Figure 23: Field photograph of Pits No. 12, 13 & 24

These are working pits where sequential excavation of benches are being carried out from hill top. All the benches are height of 10 meter approximately with varying slope of 70 to 80 degrees. During the site visit CSIR-CIMFR firing sequence and blast pattern were modified as per the rock mass classification in view of maintaining the stability of pit benches. The figure no 23 and 24 presented below showing the field conditions of pits.

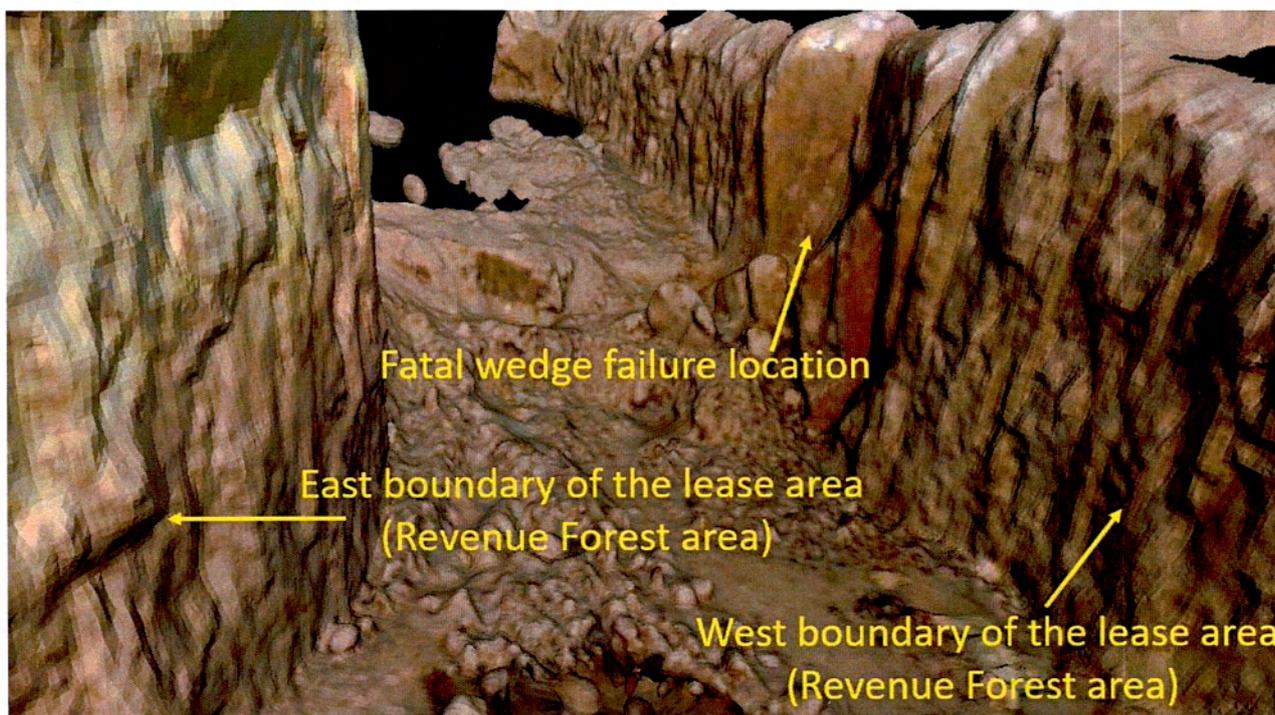
Figure 1. The mesh file generated from LiDAR point cloud data of Pit no. 37 & 38 showing multi-oriented joints and location of fatal slope failure and mine lease boundaries

Both these areas are under the jurisdiction of the State Forest Department. A preliminary enquiry report on this fatal failure had been submitted to the Director-General of Mine Safety, North Zone, Ghaziabad by M/s Govardhan Mines and Minerals dated 17/01/2022 concerning likely reasons for the slope failure and associated losses.

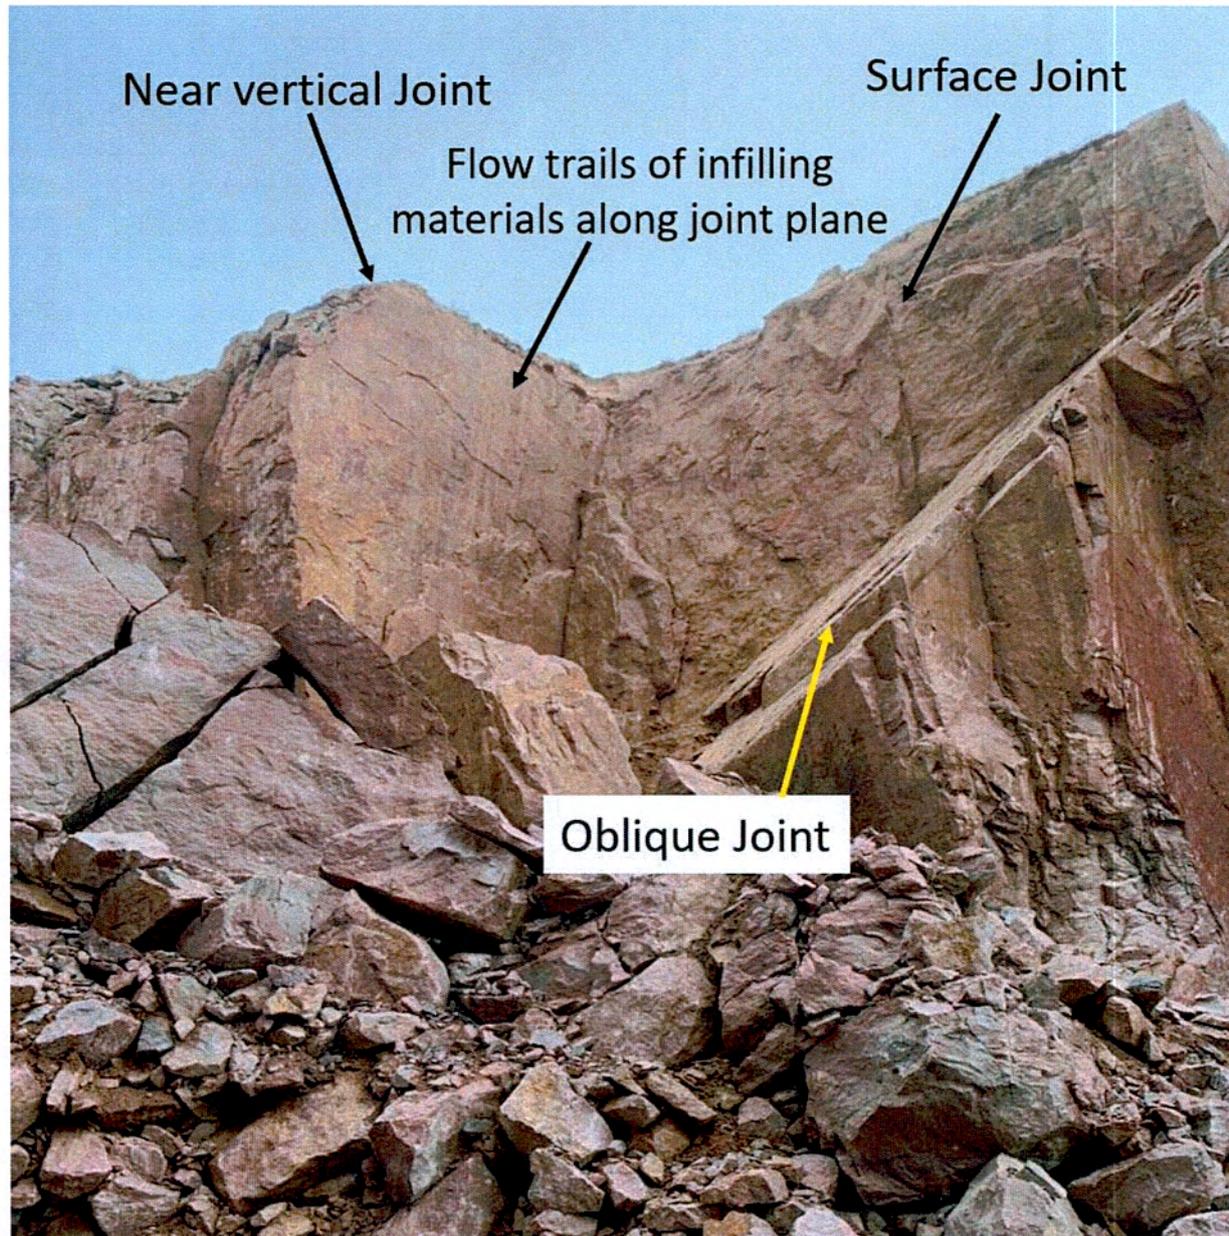
Figure 2. Post failure field photo showing included joint in the failure and water flow trails of infilling joint materials

instigates the occurrence of very large to extremely large in-situ blocks potential for failure (Figure 2 & 3).

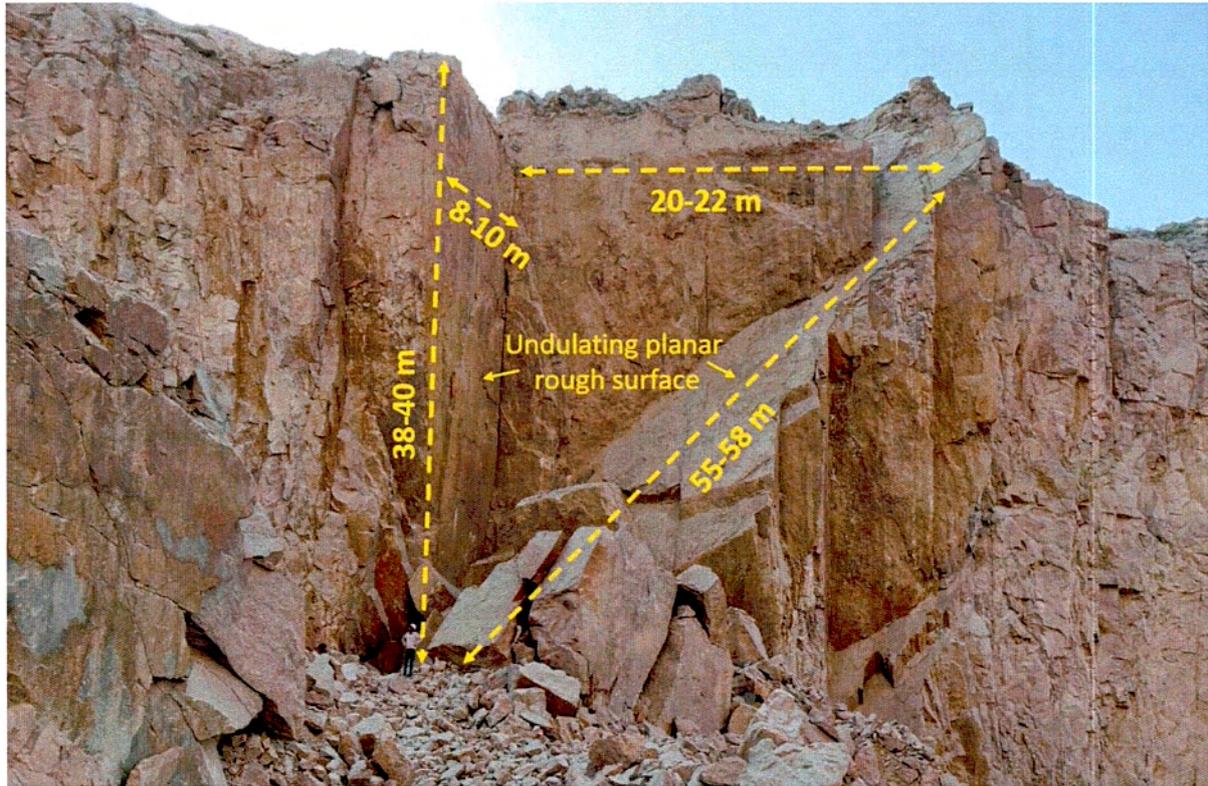
Figure 3. Probable dimension of the dislodged wedge

These mutual joints are orientated unfavourably leading to the formation of various unstable blocks that cause rock failures mainly wedges and toppling types. The stability condition degrades drastically as joints dilate due to progressive weathering (due to geo-environmental agents such as water, temperature variation etc.). The visual inspection suggests that pit slope are potential for geologically controlled block failures due to overhanging blocks.

Kinematic analysis of the failed slope suggests a high potential for large wedge type failure released from the near-vertical joint and gravitation sliding on the obliquely laid day-lighted joints (Figure 4a-d). Considering the back-calculated Slope Mass Rating using the continuous function (CSMR), the kinematically potential wedge falls CLASS IV & V (CSMR ranging from 16 to 27) which suggests completely unstable to unstable stability conditions. As per the SMR classification (Romana 1985), very large to large wedge or big planar failure is likely in that scenario (Figure 4a, b) that exactly had happened resulted dislodgment of extremely large wedge.
