**IN
ORIGINAL APPLICATION No. 1115/2024**

News Item titled "Rampant mining causes Joshimath-like crisis in Uttarakhand's Bageshwar" appearing in India Today dated 14.08.2024

SITE INSPECTION REPORT

Subject: Original Application No. 1115/2024 in respect of News Item titled "Rampant mining causes Joshimath-like crisis in Uttarakhand's Bageshwar" appearing in India Today dated 14.08.2024 before the Hon'ble National Green Tribunal, Principal Bench, New Delhi.

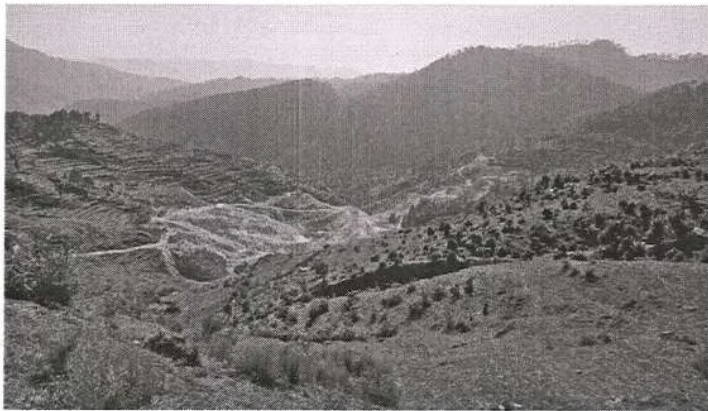
Photo 1: Open Cast Soap Stone Mining at Kanda Tehsil, Bageshwar

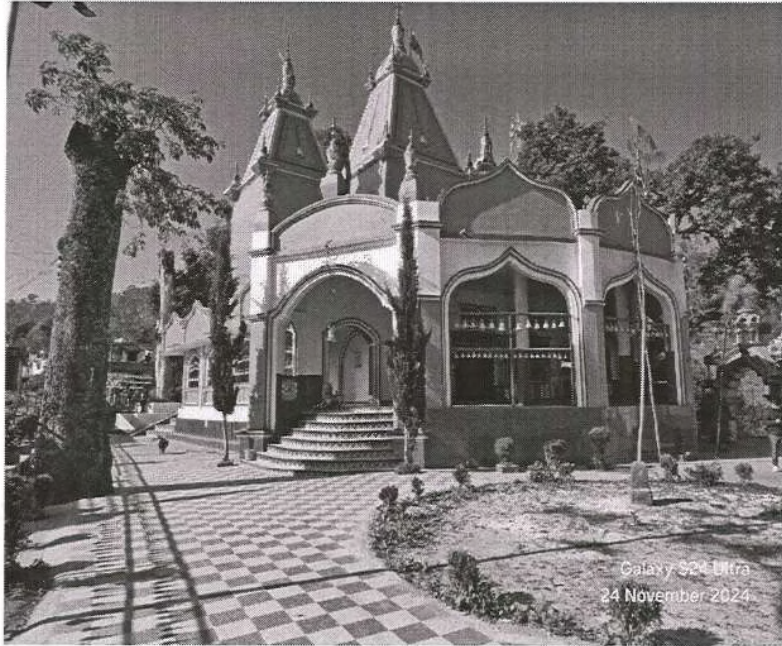
Photo 2: Kalika Temple in Kanda Tehsil

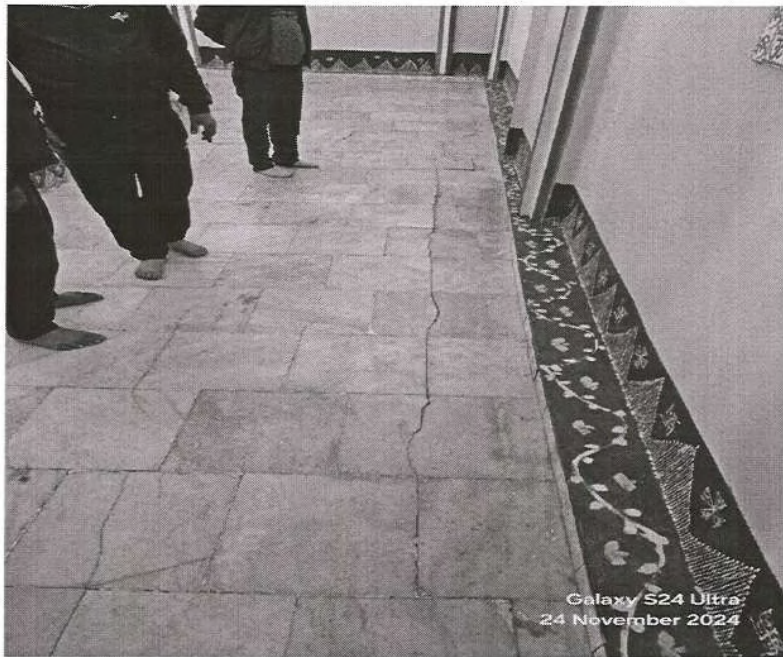
Photo 3- Cracks in flooring of Kalika Temple

In case of Kalika temple, approximately 40 m of the open cast mine, a curvilinear crack was observed on the floor of temple measuring 2-5 mm wide and 2-3 m long. Those cracks in the floor of temple prima facie appeared due to defacing of slope. The cracking patterns on the northern slope of the temple and house below were similar.

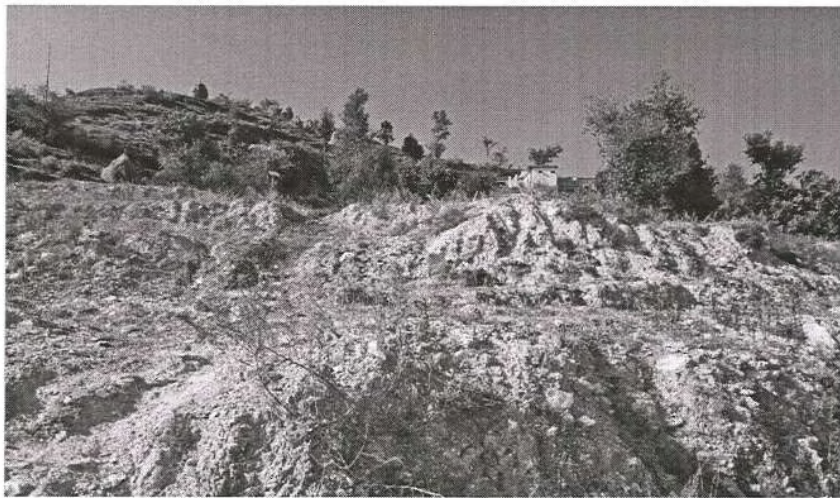
During the site visit, no mining was found operational near village and CNG Godown as it was closed by the District Administration on 01.06.2023. A few minor cracks were observed on the flooring inside the temple. Subsidence of roof and flooring at the backside of the temple were found unnoticeable through visual inspection. Architectural expertise would be required to assess the extent of subsidence. No major cracks were observed on the fields around temple as those cracks might have been previously filled by the Miner in compliance of orders by the District Administration.

Photo 4: Abandoned Opencast Mine behind Kalika Temple

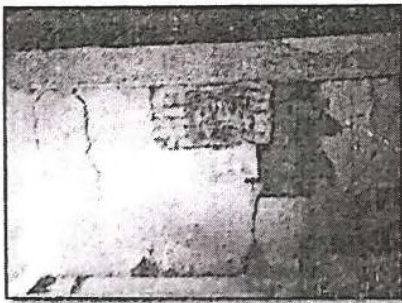
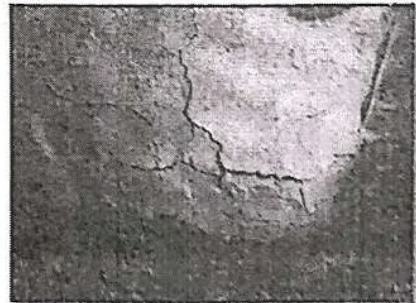
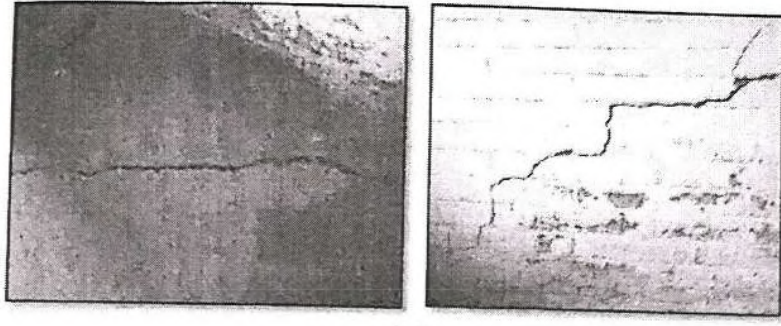
स्थल के चित्र

स्थल 01-हेम चन्द्र काण्डपाल पुत्र श्री प्रयाग दत्त-आवासीय भवन की बाहर की दीवार पर दरारें हैं, भवन के अन्दर कमरे में लगभग 01 सेमी० चौड़ी तथा 06 मी० लम्बी दरार है, जो फर्श से दीवार तक जा रही है। किचन के फर्श पर दरारें व गीली अवस्था में है। भवन के दूसरे कमरे के दरवाजे खोलने-बन्द करने में अटकरहे है। फर्श तथा दीवारों पर हल्की दरारें हैं। आंगन में चाहर दीवारी की ओर हल्का धंसाव है। परिवार भवन में निवास कर रहा है। निरीक्षण के दौरान भवन स्वामी द्वारा अवगत कराया गया की भवन लगभग 95 वर्ष पुराना है जिसमें वर्ष 2016 से दरारें आना शुरू हो गयी थी।

निरीक्षण के दौरान अवगत कराया गया कि आवासीय भवनों के पीछे ढालदार भूभाग के अपस्लोप से पानी भवनों की ओर प्रवाहित होता है एवं वर्षा में अत्यधिक मात्रा में पानी आता है। वर्तमान में भवनों के पीछे नाली है जिसमें पानी प्रवाहित हो रहा है तथा आवासीय भवनों के बायें किनारें पानी प्रवाहित है। भवनों के पीछे ढालदार भूभाग जल प्रवाह क्षेत्र प्रतीत होता है। स्थल से खनन क्षेत्र की दूरी लगभग 110 मी० है।

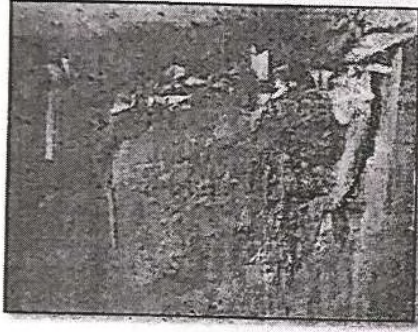
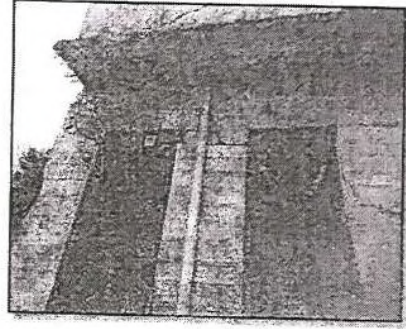
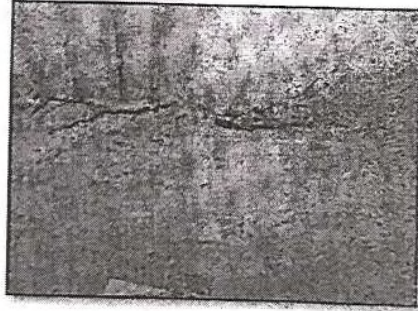
स्थल के चित्र

महेश चन्द्र काण्डपाल पुत्र श्री हरीश चन्द्र काण्डपाल—आवासीय भवन की बाहर तथा अन्दर की दीवारों पर अनवरत दरारें हैं, कमरों के दरवाजे तिरछे हो गये हैं। परिवार अन्यत्र निवास कर रहा है। आंगन में बायीं ओर हल्का धंसाव है। निरीक्षण के दौरान हेम चन्द्र काण्डपाल द्वारा अवगत कराया गया कि भवन लगभग 05 वर्ष पुराना है।

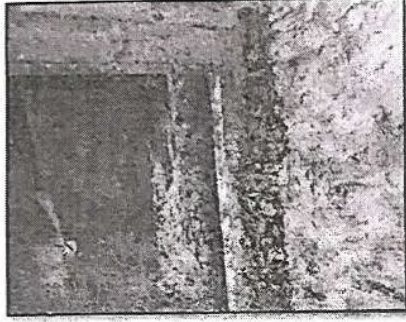
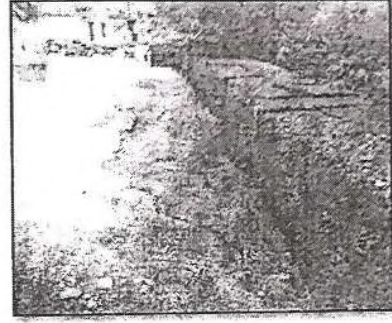
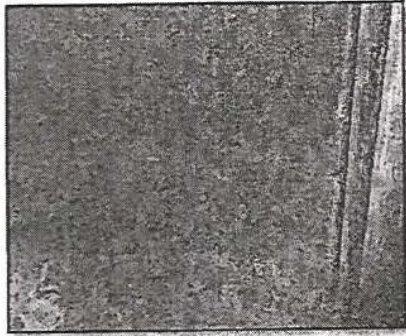
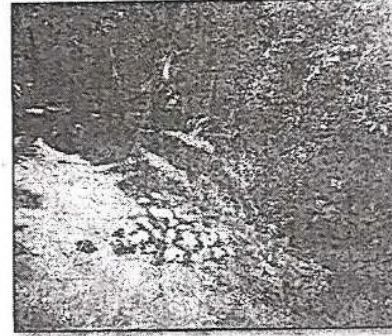
स्थल के चित्र

स्थल 02—साधू राम पुत्र श्री तिल राम—आवासीय भवन की बाहर व अन्दर की दीवार पर हल्की दरारें हैं जिनकी मरम्मत की गई है। आंगन के फर्श में चाहर दीवारीकी ओर दरारें हैं तथा हल्का धंसाव है। परिवार भवन में निवास कर रहा है। निरीक्षण के दौरान भवन स्वामी द्वारा अवगत कराया गया कि भवन लगभग 12 वर्ष पुराना है। शौचालय में हल्की दरारें हैं। अवगत कराया गया है कि 08/08/2024 को अतिवृष्टि से आंगन से लगभग 15 मी० की दूरी पर नीचे की ओर खेत धंस गये हैं, वर्तमान में यह पौधों तथा घास से ढका है। स्थल से खनन क्षेत्र की दूरी लगभग 30 मी० है।

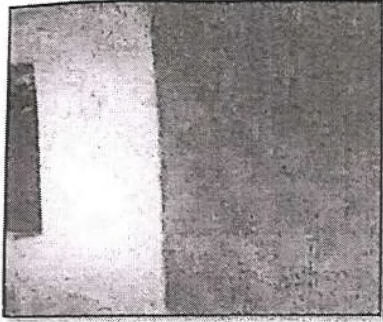
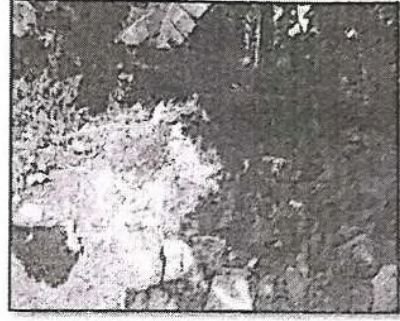
स्थल के चित्र

स्थल 03—किशन राम पुत्र श्री दौलत राम, पूरन राम पुत्र श्री दौलत राम, प्रेम राम पुत्र श्री दौलत राम—आवासीय भवन की बाहर की दीवार पर हल्की दरार है। आंगन में हल्का धंसाव व हल्की दरार है। आंगन के बाये किनारे पर हल्का धंसाव हो रहा है। परिवार भवन में निवास कर रहे हैं। निरीक्षण के दौरान भवन स्वामी द्वारा अवगत कराया गया कि भवन लगभग 25-30 वर्ष पुराना है। भवन से लगभग 20 मी० की दूरी पर मोटर मार्ग है। स्थल से खनन क्षेत्र की दूरी लगभग 25-30 मी० है।

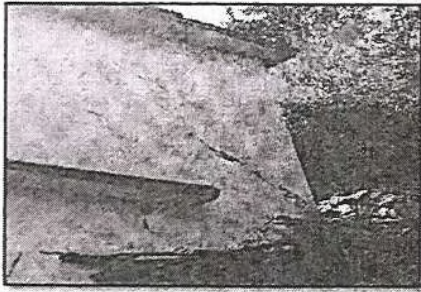
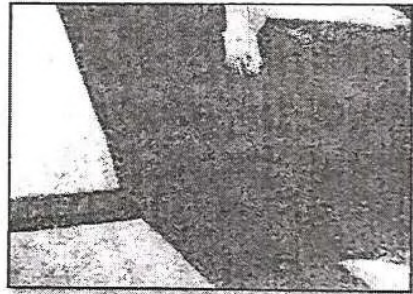
स्थल के चित्र

स्थल 04—हरीश राम पुत्र श्री कुवर राम—आवासीय भवन के बाहर किनारे की दीवार पर हल्की दरार है। परिवार भवन में निवास कर रहा है। निरीक्षण के दौरान भवन स्वामी द्वारा अवगत कराया गया कि भवन लगभग 30 वर्ष पुराना है। स्थल से खनन क्षेत्र की दूरी लगभग 45 मी० है।

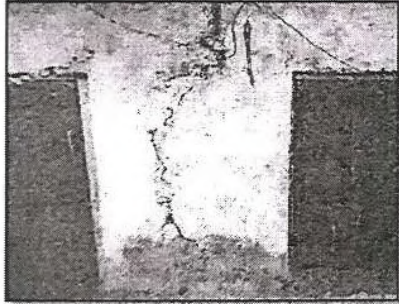
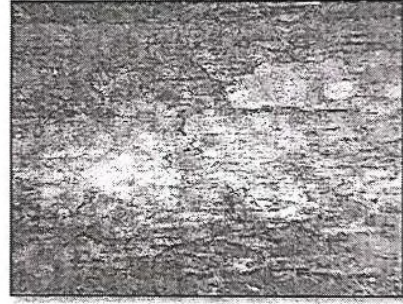
स्थल के चित्र

स्थल 06—जोगा राम पुत्र श्री लछम राम—निरीक्षण के दौरान भवन स्वामी द्वारा अवगत कराया गया की भवन के अन्दर कमरे में दरार थी जिनकी मरम्मत की गई है। भवन के किचन में सीलन है। शौचालय में हल्की दरारें हैं। गौशाला की बाहर तथा अन्दर की दीवारों पर दरारें हैं। परिवार भवन में निवास कर रहा है। निरीक्षण के दौरान भवन स्वामी द्वारा अवगत कराया गया की भवन लगभग 12 वर्ष पुराना है। आवास से लगभग 20-25 मी० दूरी पर दक्षिण-पूरब दिशा में प्राकृतिक जल स्रोत तथा मोटर मार्ग है। अवगत कराया गया है कि जल स्रोत में वर्ष भर पानी रहता है। स्थल से खनन क्षेत्र की दूरी लगभग 50-60 मी० है।

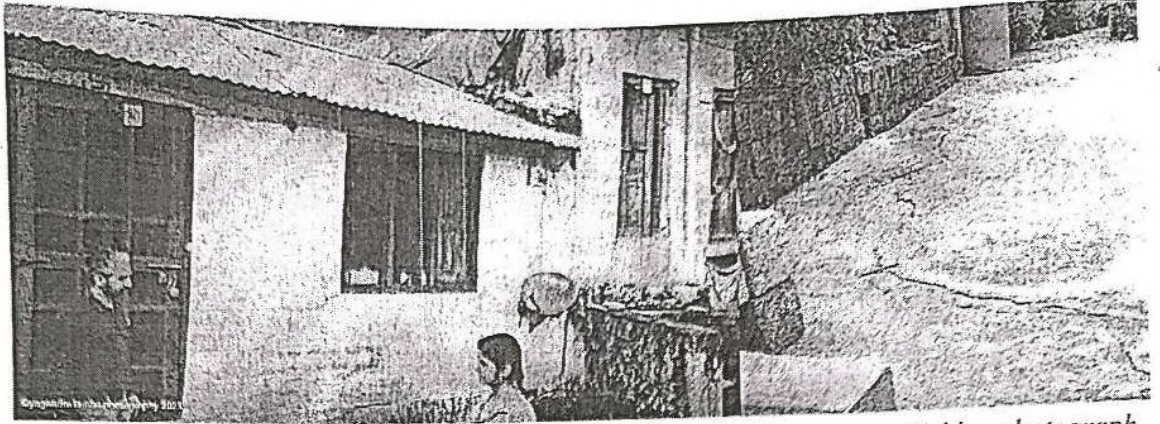
House-1: During the field inspection, multiple cracks were observed in the walls and floor of the house (Fig. 3) at coordinates N 29°49'42.01", E 79°53'31.48" but no ground crack were found. (The house is located in a natural depression, with water seepage observed about 30 meters upslope. The development of cracks is mainly due to its location, which acts as a conduit for subsurface water, as indicated by seasonal springs and seepage.) Although a channel was built to manage the seepage, its lining is damaged, causing water to flow underneath the house. This water movement saturates the slope material beneath,

gradually leading to ground settlement. While the house is situated in an unsuitable area, the primary cause of cracks in the house is due to gradual piping action (removal of fines) controlled by water seepage. The suitable remedial measures are given under conclusion and recommendations heading.

House-2: During the field inspection, a linear crack was observed near the outer boundary of the house porch at coordinates N 29°49'38.79", E 79°53'32.04" (Fig. 4). No cracks were found in the walls or ceiling of the house. The cracks at the outer edge of the porch are likely due to the defacing of a steep bench created downslope. The concrete slab is not provided with any reinforcement and it is usual to develop such cracks in outer part. These cracks are not related to the open cast mine soapstone mine, which is situated about 70 meters south of the house.

Fig. 3: Field photograph showing cracks in House-1 of Kanda Kaniyal Village.

Fig. 4: Field photograph showing cracks in the porch of House-2 of Kanda Kaniyal Village.

1. **Kanda Kaniyal Village:** The House-1 is located in a natural depression and a seasonal spring/seepage is present behind the house. It is recommended to provide a deep lined trench with weep holes to the upslope of the house to collect and divert the subsurface water and establish proper drainage to direct the water downslope. This solution may address the current issue, but given the house's location in a natural depression, surface water flow during heavy rains could still pose a risk. The cracks at the outer edge of the porch in House-2 can be mitigated by constructing a retention wall with weep holes to support the steep face of the bench, if required. The cracks in Kalika Temple prima facies appear to result from defacing of slope but the role of open cast soapstone mine cannot be denied. Therefore, it is recommended to collect photos and videos before backfilling of the mine to better understand its impact on the destabilization of areas present upslope to these mines.

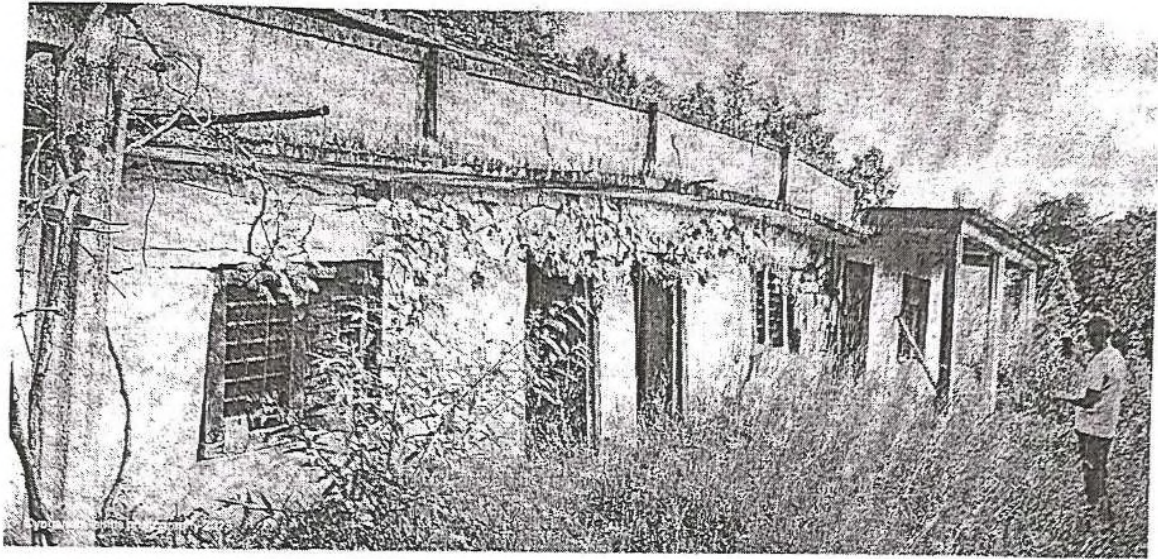
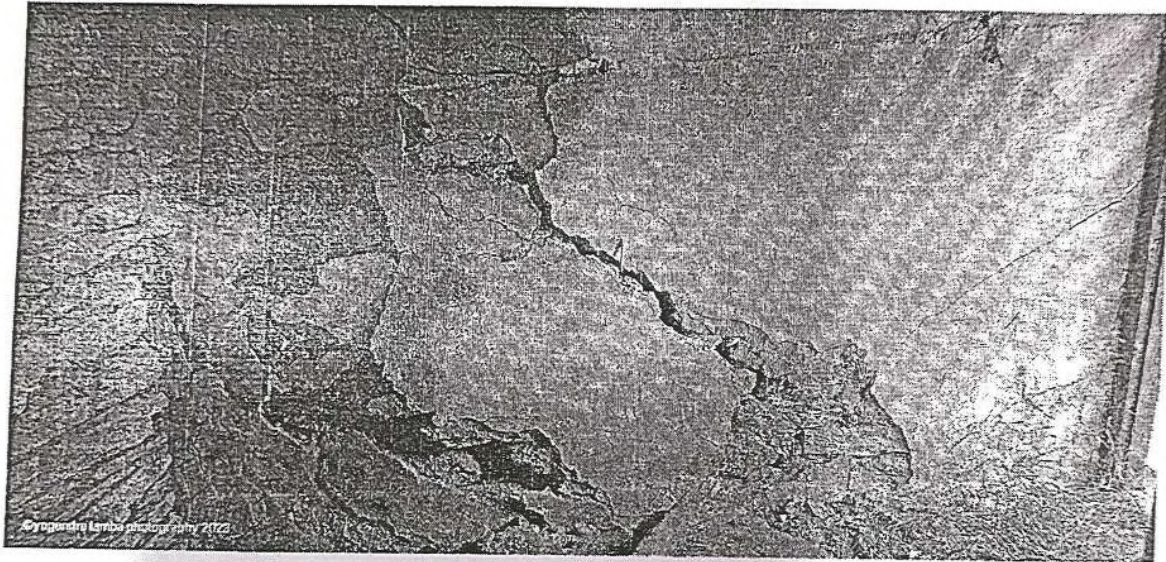
- b) **Seri village:** The GSI team, accompanied by Smt. Ritu Goswami, Naib Tehsildar, and other local authorities, visited Seri village. The team examined six damaged houses, some of which had been rehabilitated in 2016-17 and 2019-20, with new cracks appearing in two of them. Additionally, several seepages, paleo subsidence scars, and sinkhole locations reported by local villagers were also noted down. The field photograph of one of the damaged house are shown in Fig. 5. The residents of this house have been rehabilitated by administration.

Fig. 5: Severely damaged house with inside photograph from Seri village.

2. **Seri village:** The ground subsidence problem in Seri village primarily stems from the free flow of spring water at the crown of the paleo slide and erosion along the nala flank. Based on these preliminary findings, it is recommended to establish controlled drainage for the spring water originated upslope of Seri village and to line the nalas on the northern and southern side of Seri village. The detailed study of the village will be helpful in developing a proper slope management plan.

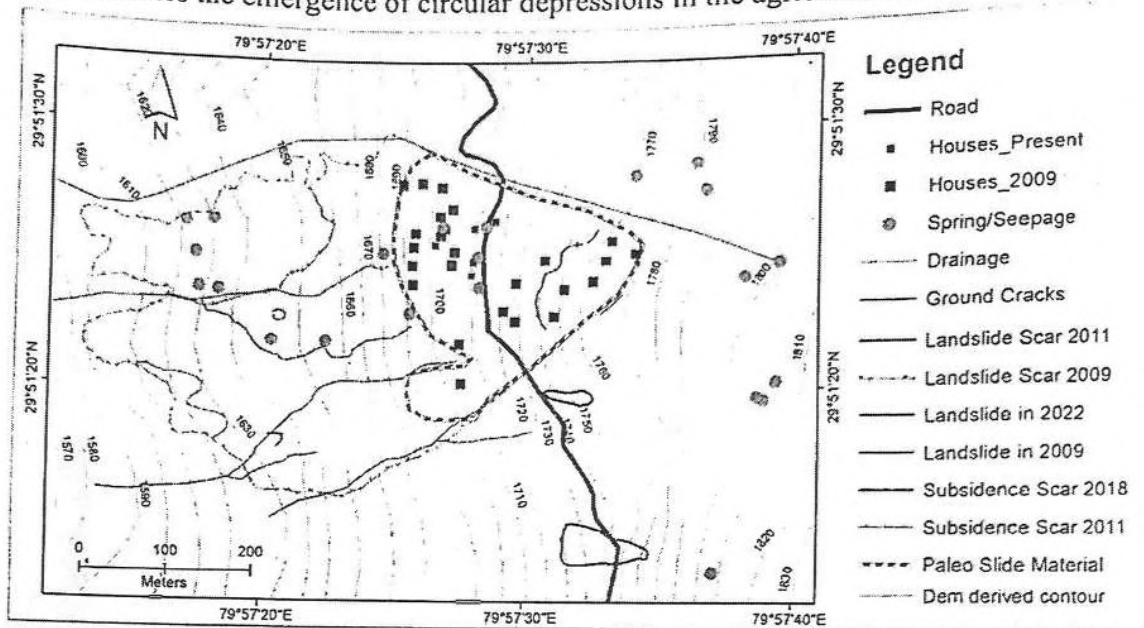
Over time, new springs have formed, feeding the cone's crown and causing water to seep down its slopes (Fig. 6). This subsurface water percolation through the overburden material washes away finer particles, leading to sinkholes near the crown and subsidence in the mid-section. The spring-fed nala has also contributed to the slow undercutting of the slide material, causing instability along its flank, evident from the tilted trees.

Fig. 6: Map showing different ground deformation and hydrological features of Seri Village.

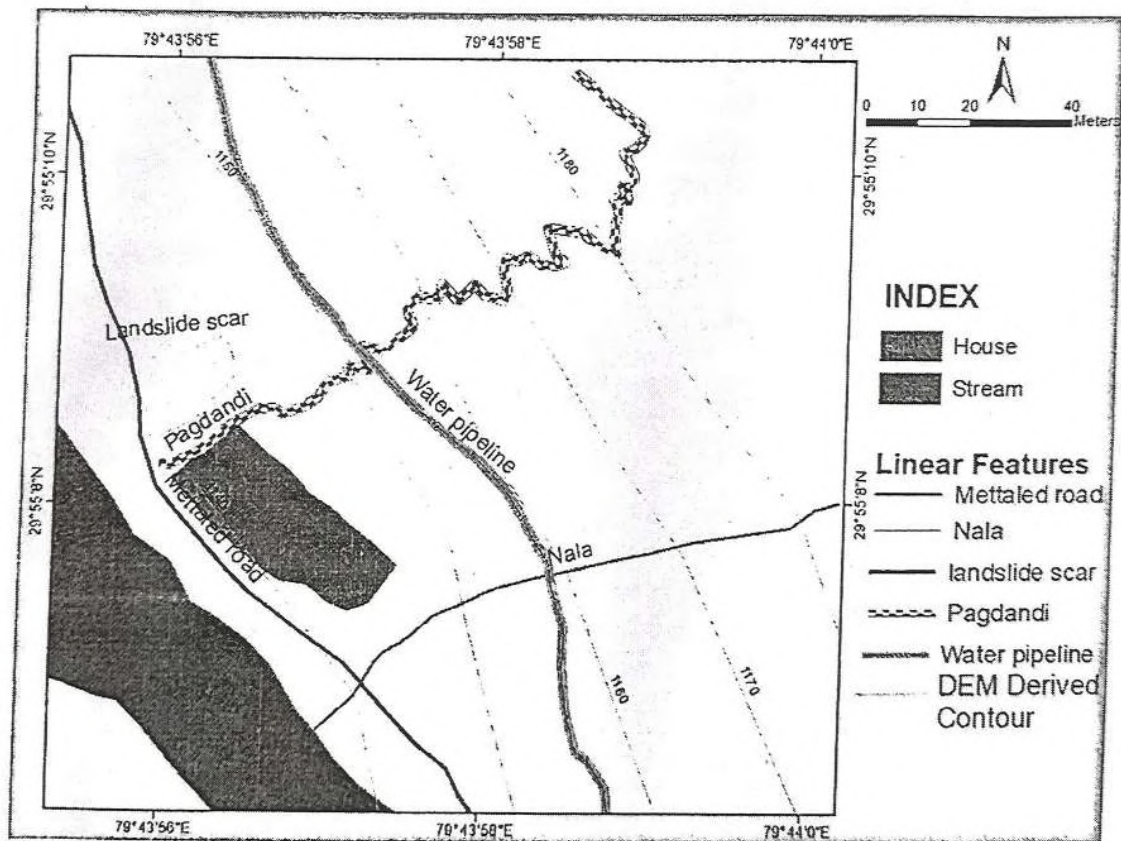
Fig. 7: Map showing ground features of affected area in Jakh village.

Imagery revealed that a landslide was triggered in 2012 during road construction. As per the information from local people a gabion wall was installed for support to this landslide. However, the 2020 water surge reactivated the landslide, increasing the risk of calcrete boulders rolling down and threatening the safety of residents. To mitigate this risk, the administration relocated the affected families to a safer location. The old scars of ground cracks were observed in agricultural land present above the landslide scar indicating its retrogressive nature.

3. **Jakh Village:** The landslide present on the road section is retrogressive in nature as suggested by ground cracks in the agricultural land. In view of this, it is recommended to place a retaining wall with weep holes instead of gabion wall at the toe of the landslide to mitigate the risk in future.

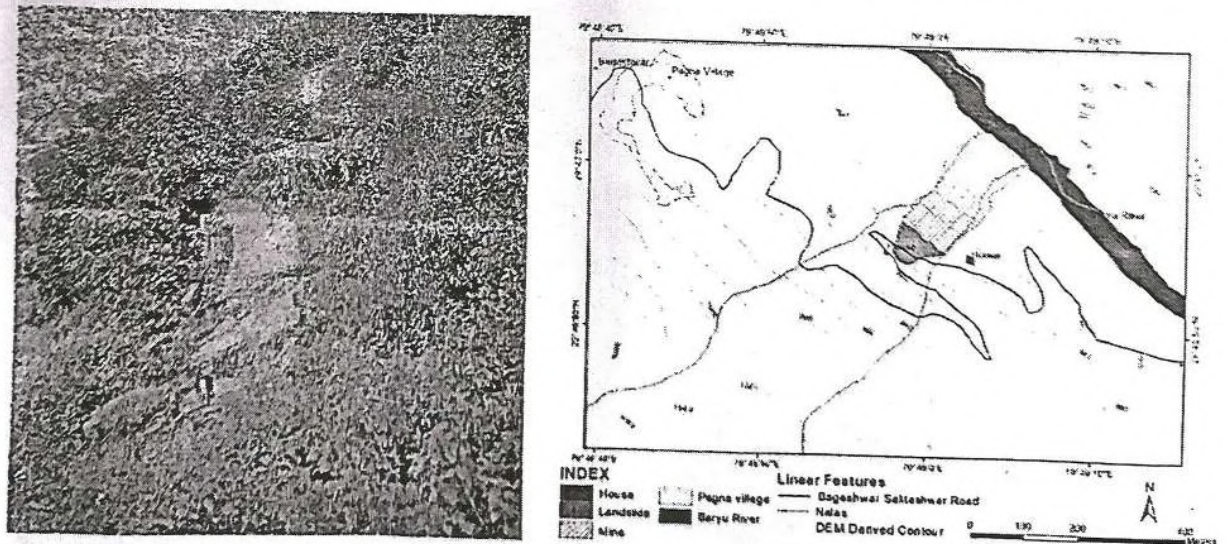
The road subsidence caused due to landslide measures approximately 90 meters in length, 60 meters in width, and 4 meters in depth, with a downslope movement of 1 to 2 meters. A soapstone mine is located just beneath the subsidence area (see Fig. 8). The landslide was triggered by the removal of toe support for soapstone extraction. The failed material consists mainly of weathered soapstone-bearing rock and overburden, categorizing it as a shallow translational failure. The landslide may continue to retrogress until it reaches the overlying competent bedrock, which is dolomitic limestone. A 42-geoparametric data sheet can be found in Annexure-1.

Fig. 8: Field photograph of road subsidence along with map showing ground features of Pagna-Sakteshwar road subsidence location.

4. **Pagna-Sakteshwar Road Subsidence:** Geological assessments indicates that mining activities in the downslope of the affected area have already compromised the natural stability of the material. Currently, the excavated area of the mine has been backfilled, making it difficult to assess changes in the natural slope profile. As a result, it is recommended to document the excavated slope through photos and videos before backfilling in the future. This documentation will provide valuable information on the potential impact on the stability of upslope areas if any ground instability issues arise. Restoring the natural stability of the material appears unlikely, as engineering solutions may not economically prevent the already triggered landslide, especially considering that the bedrock beneath is soft soapstone. The landslide is expected to retrograde uphill, and it is suggested that the recently constructed house near the crown of the landslide be

relocated. A detailed study is also recommended to evaluate the area's suitability for restoring the existing road.

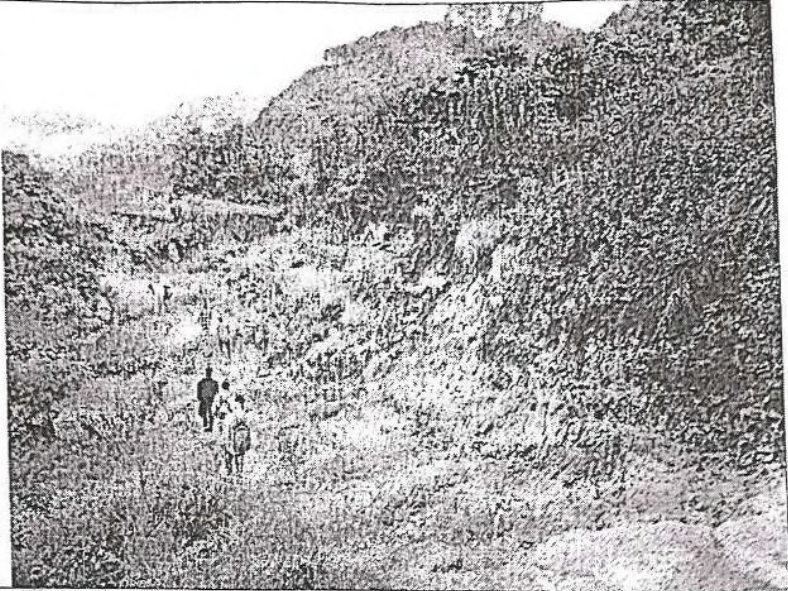
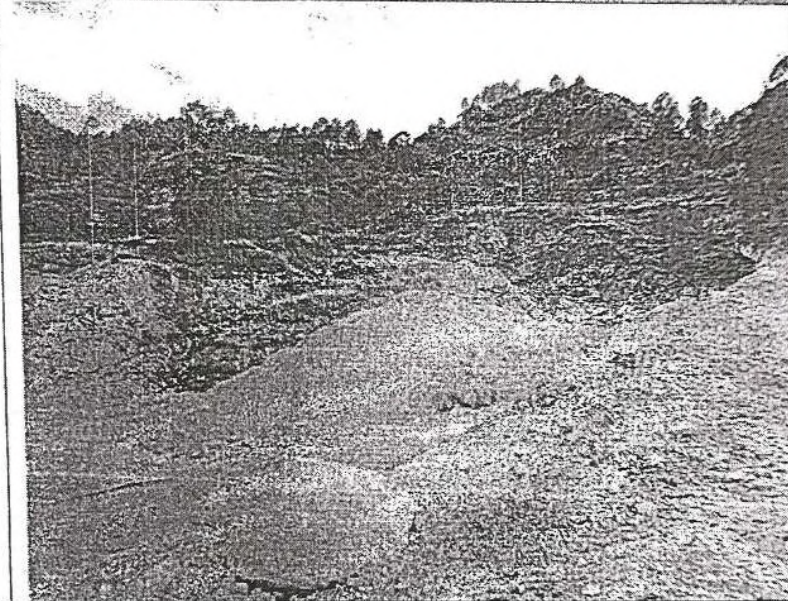
39	Photos/ Sketches/Sections

36	Geo-scientific causes	Removal of toe support during excavation for soapstone.
37	Remedial measures	Rehabilitation of newly constructed house along with detailed study is recommended for restoring the existing road.
38	Remarks
