FINAL SURVEY REPORT (LANDSLIDE)

Ref. No.: JSLA-UII-2023-701-CAR

Final Survey Report towards insurance claim against losses due to landslide in locality of project site of **M/s. Shivalik Build Tech Pvt. Ltd. & Ministry of Road Transport and Highways** – Gumma to Fediz section (km. 94.900 to km. 103.550) of NH-707 on night of 10/11.07.2023

A/c. - M/s. Shivalik Build Tech Pvt. Ltd. & Ministry of Road Transport and Highways

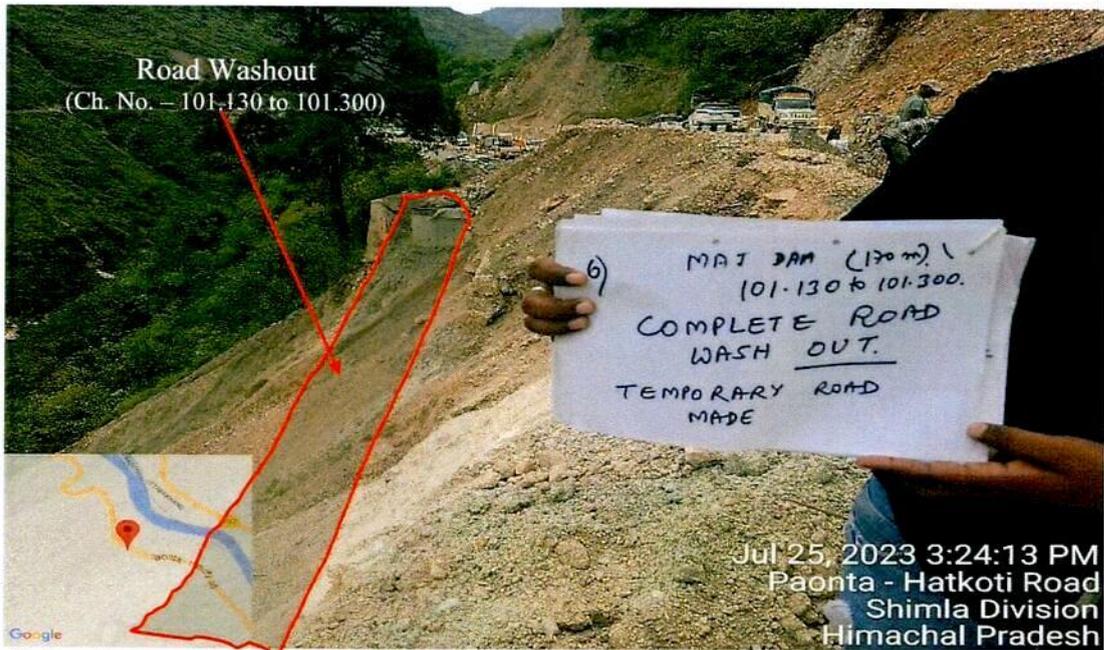
Major damage location – 2 (Ch. – 101.130 to 101.300) complete Road Wash Out

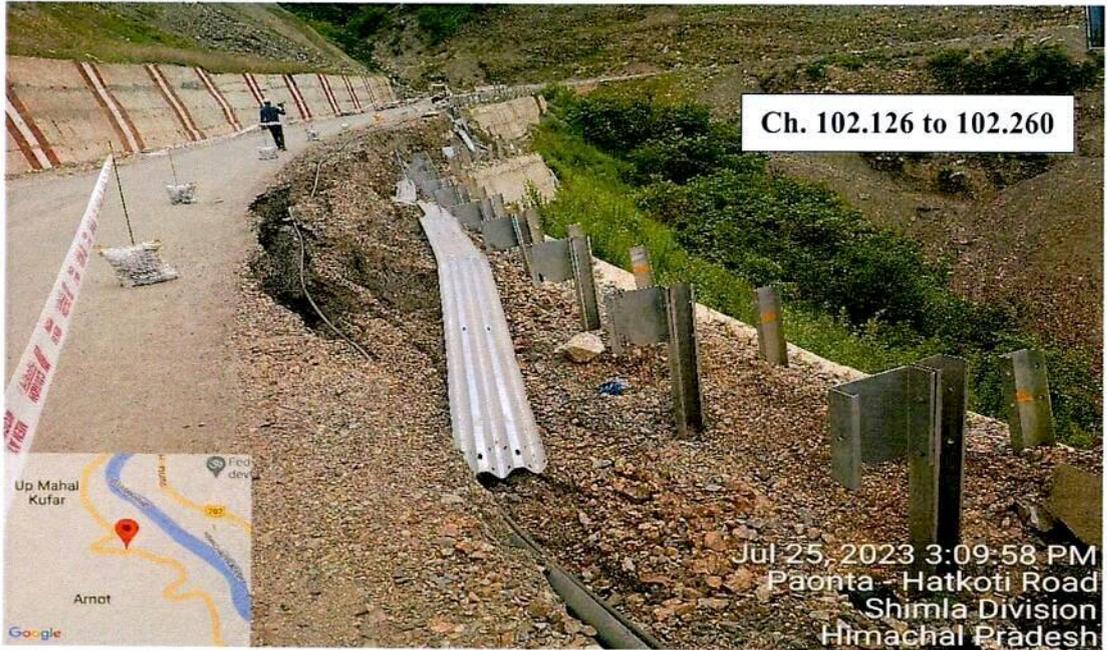
Major damage location – 1 (Ch. – 102.126 to 102.260) Retaining wall valley side – 134 mtr. had got dislocate by about 1 mtr. due to landslide.

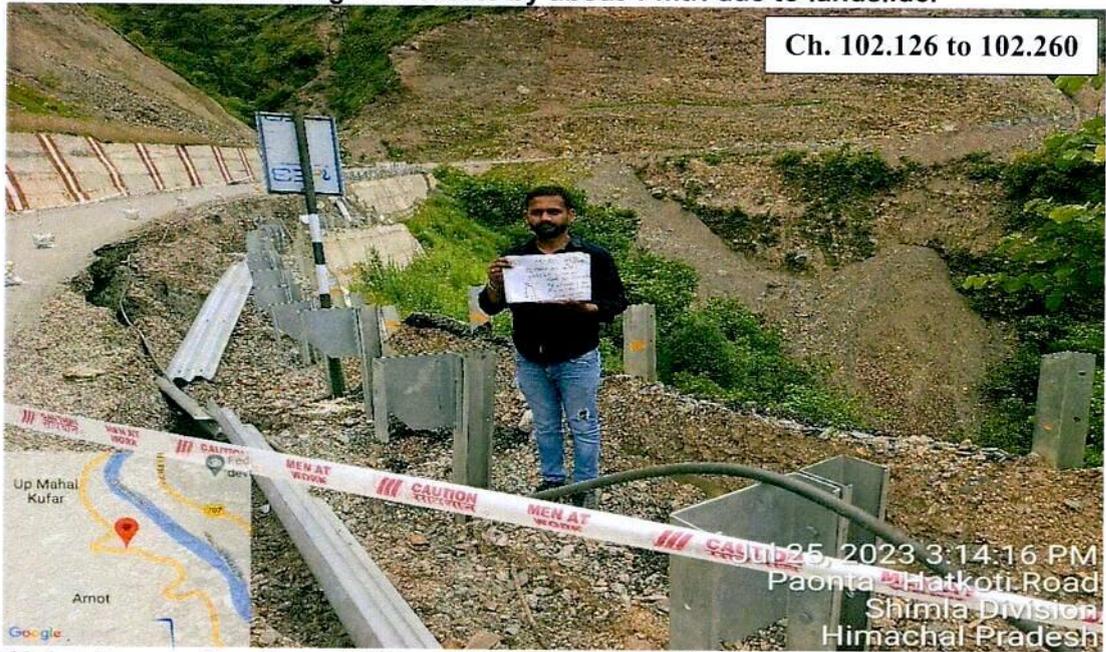
Major damage location – 1 (Ch. – 102.126 to 102.260) Retaining wall valley side – 134 mtr. had got dislocate by about 1 mtr. due to landslide.

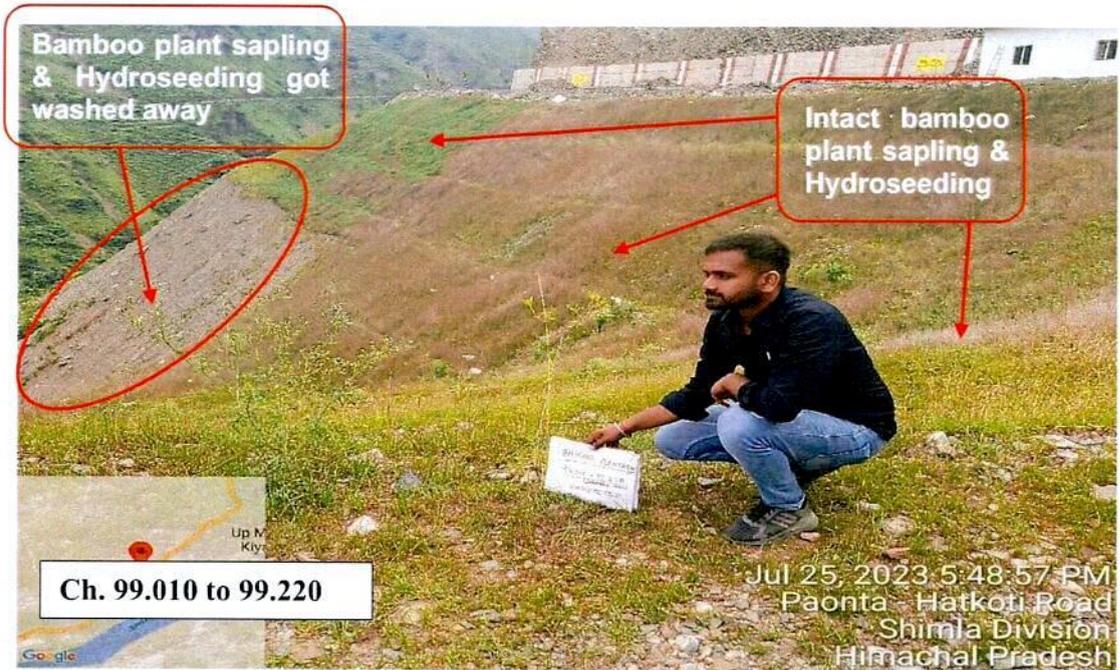
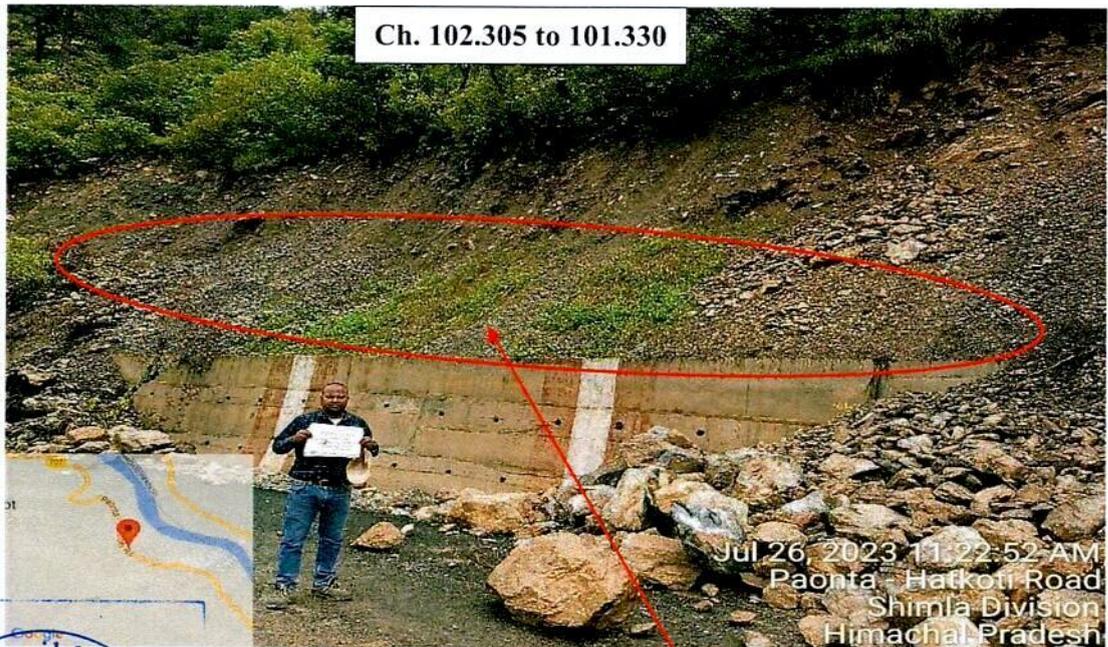
Ch. no. - 101.305 to 101.330 – Hill Side (Bamboo plant got damaged)

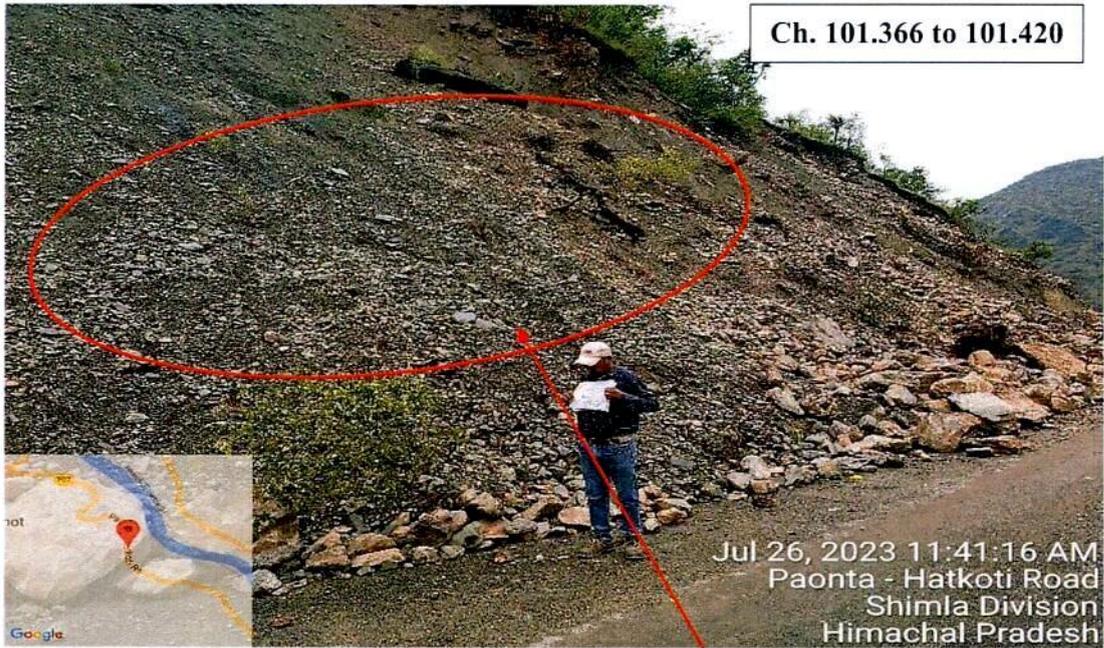
Ch. 101.366 to 101.420

Ch. no. - 101.366 to 101.420 – Hill Side (Geocell damaged due to landslide)

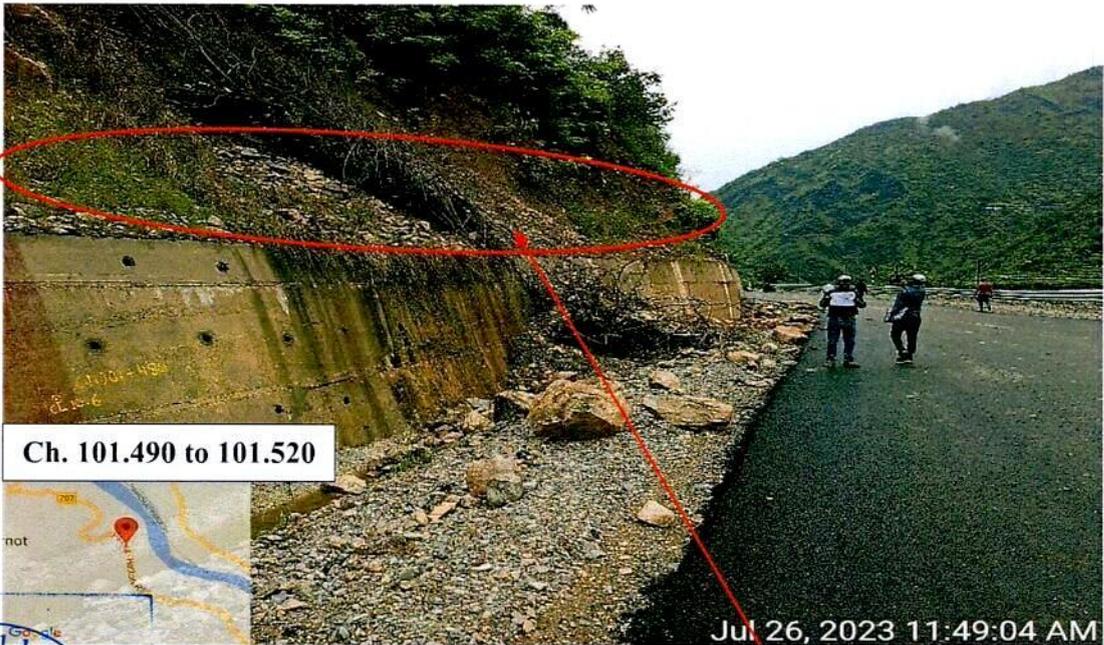
Ch. 101.490 to 101.520

Ch. no. - 101.490 to 101.520 – Hill Side (Bamboo plant + Hydroseeding damaged due to landslide)

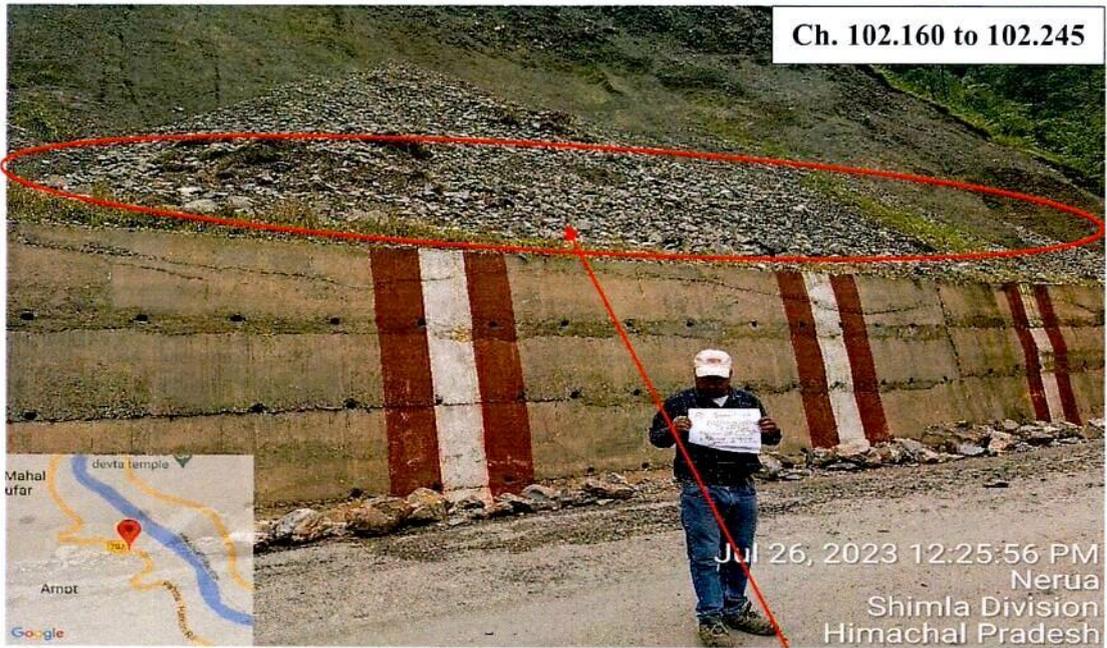
Ch. no. - 102.160 to 102.245 – Hill Side (Bamboo plant + Geocell damaged due to landslide)

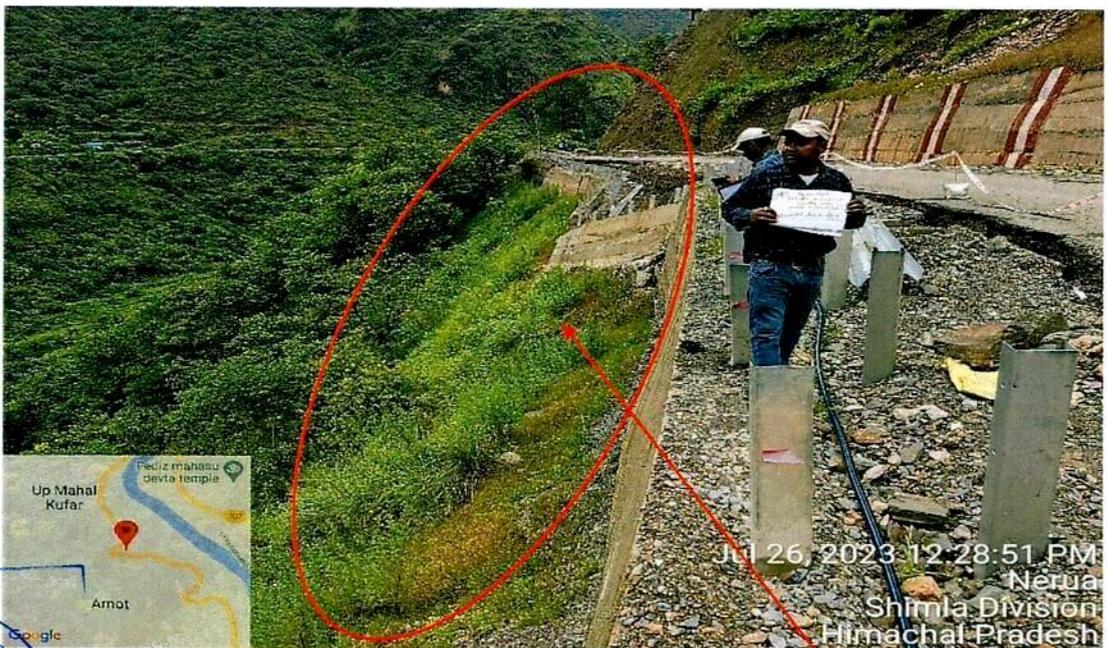
Ch. no. - 102.126 to 102.220 – Valley Side (Some Bamboo plant damaged & balance likely to be damaged at time of road widening)

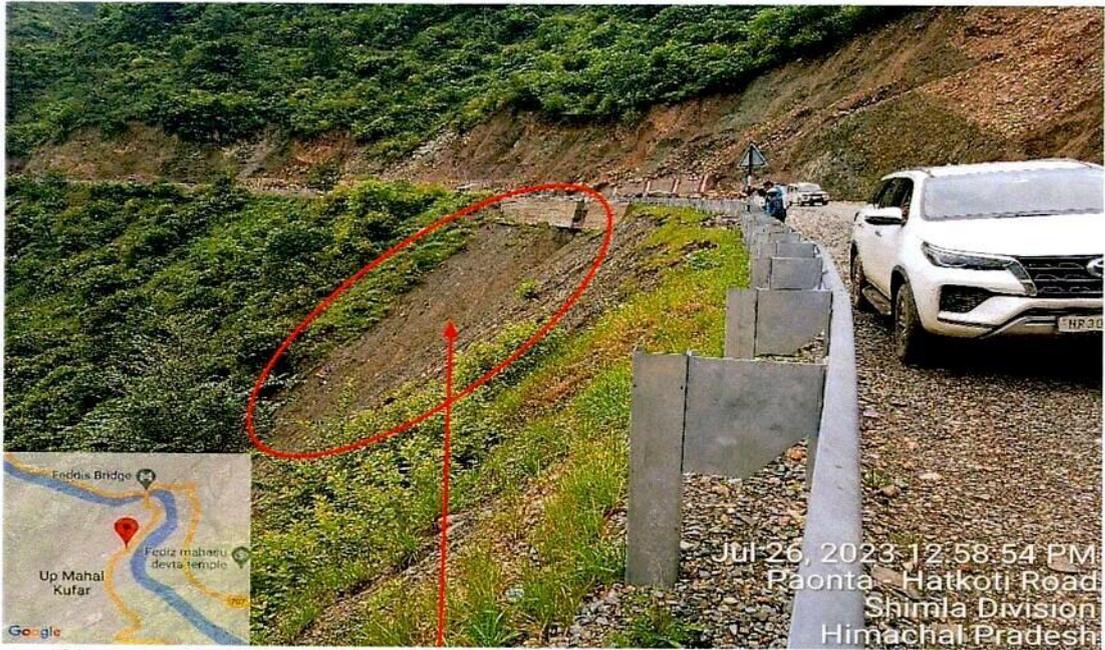
Ch. no. - 102.740 to 102.831 – Vally Side (Bamboo plant + Geocell damaged)

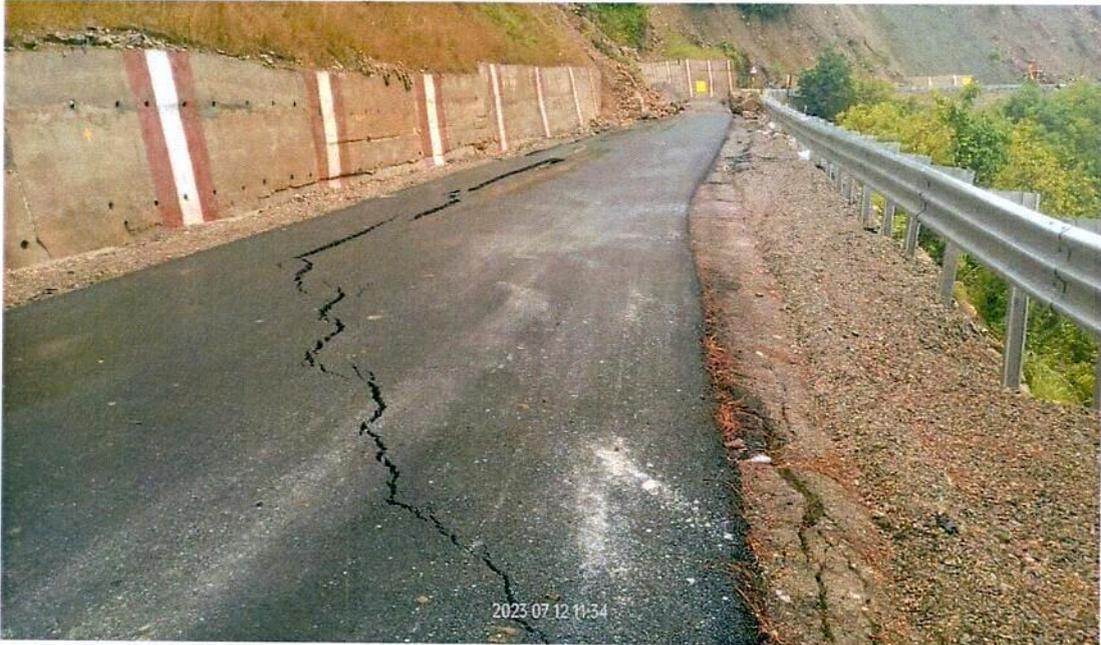
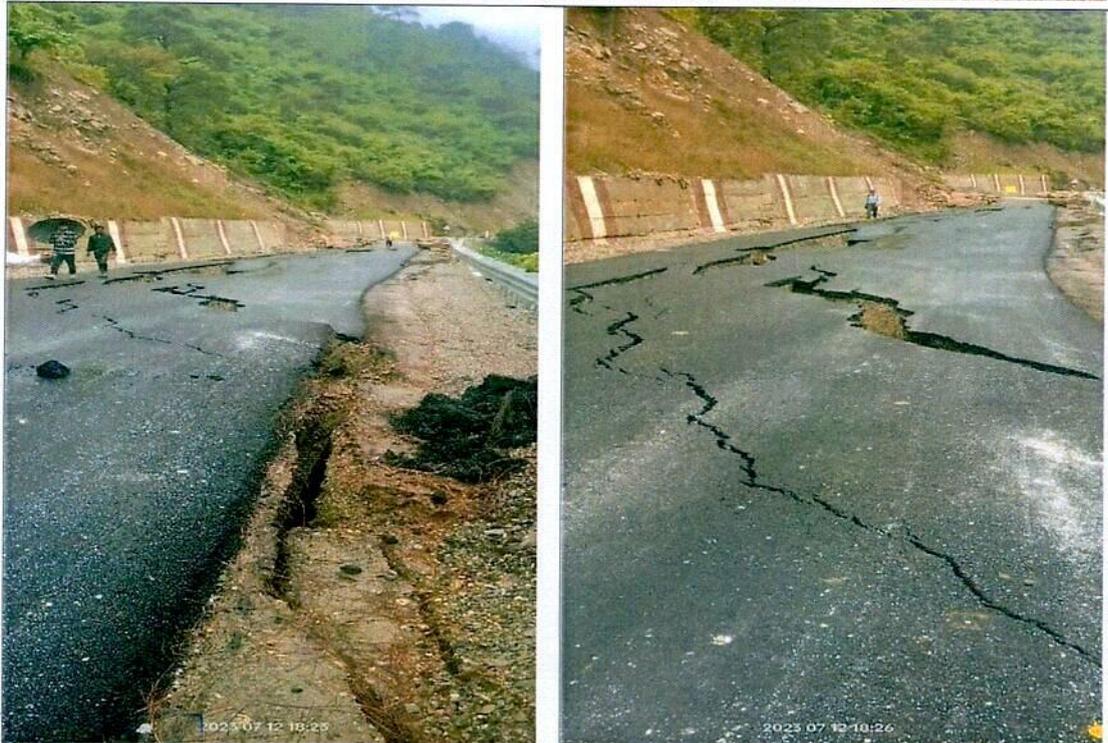
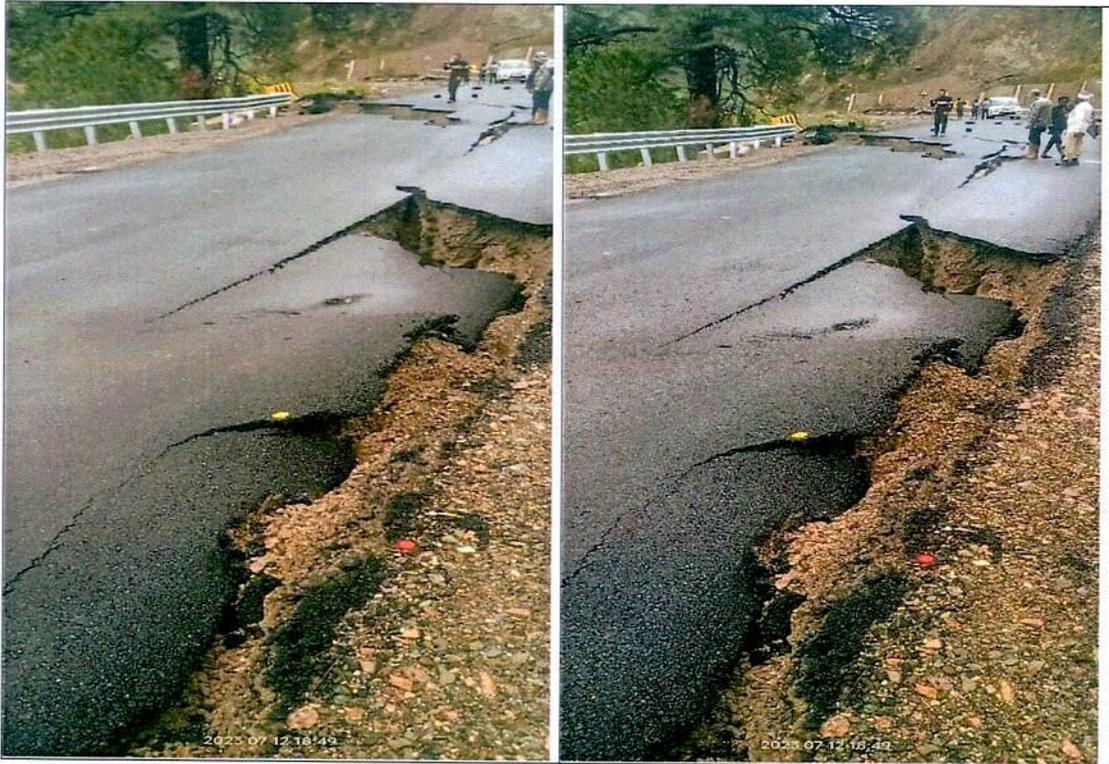
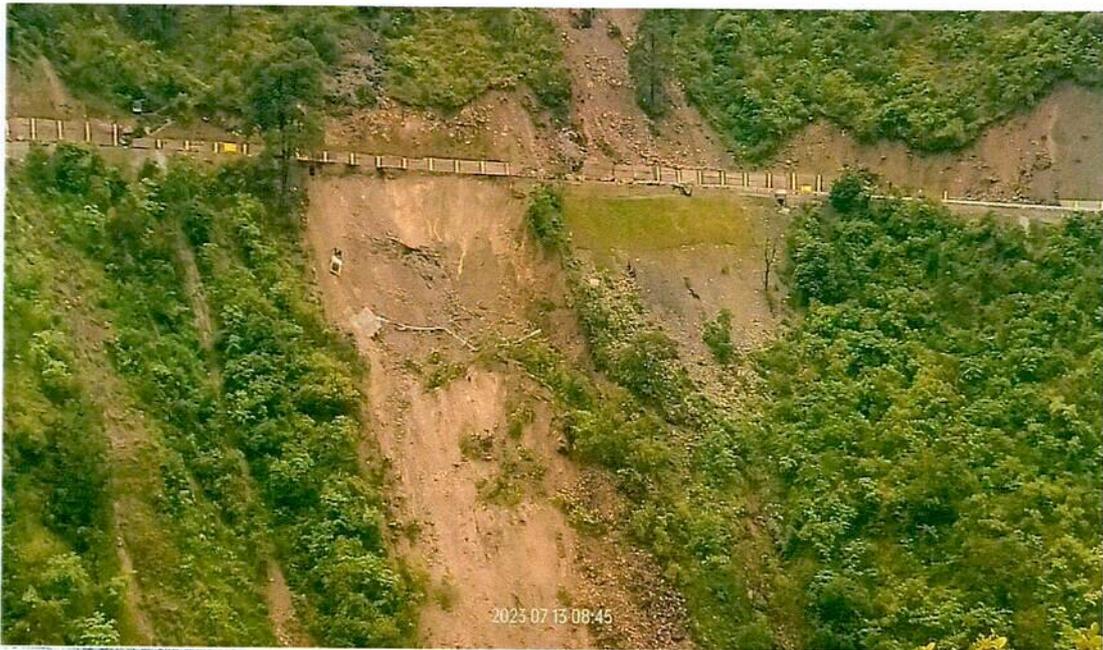
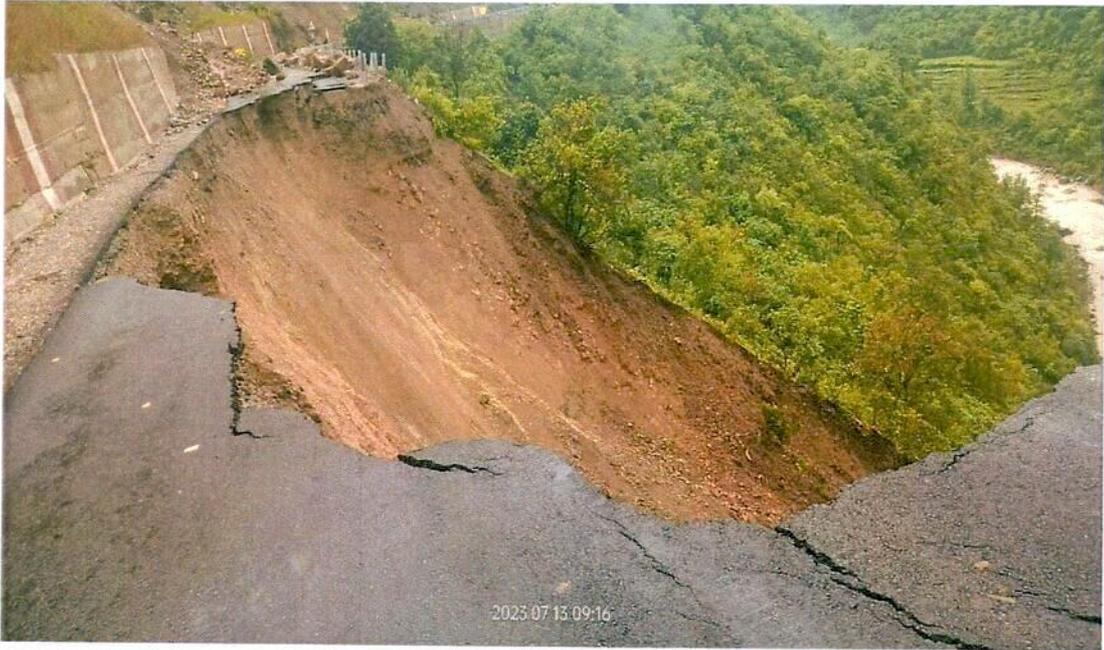
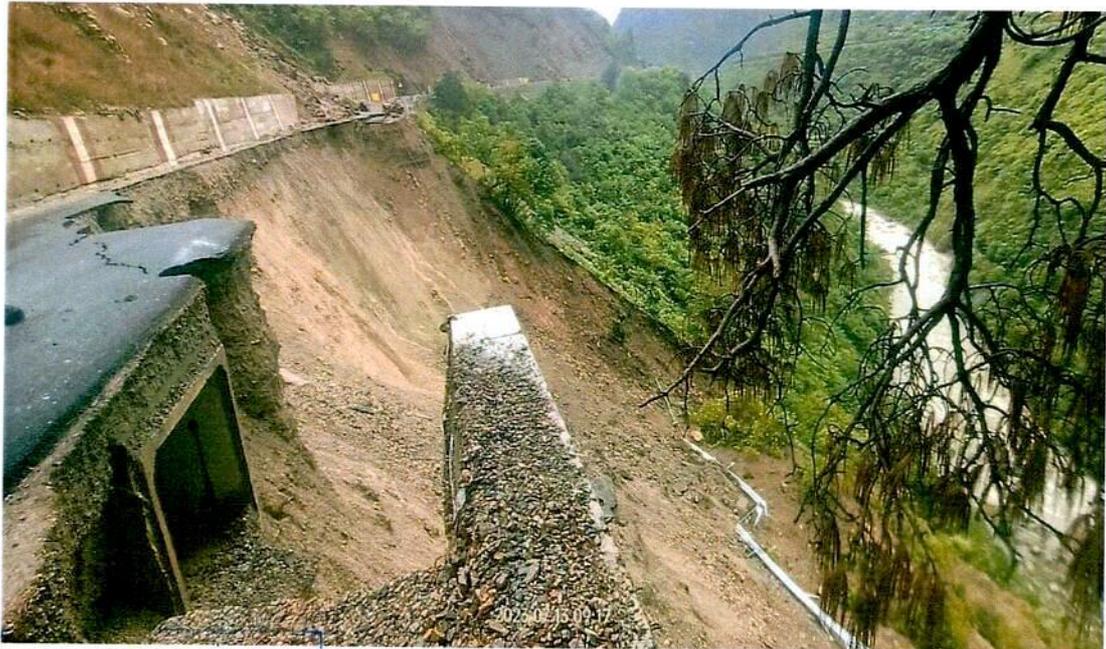
Few photographs submitted by Insured of this location during developing cracking on Road / washing out road at location is attached hereunder -

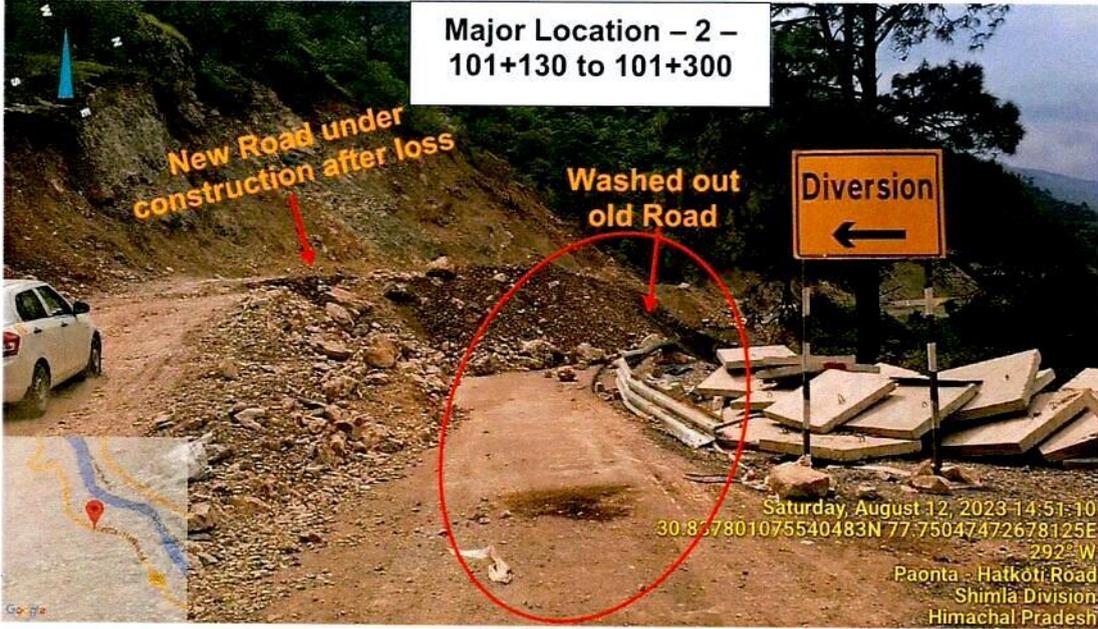
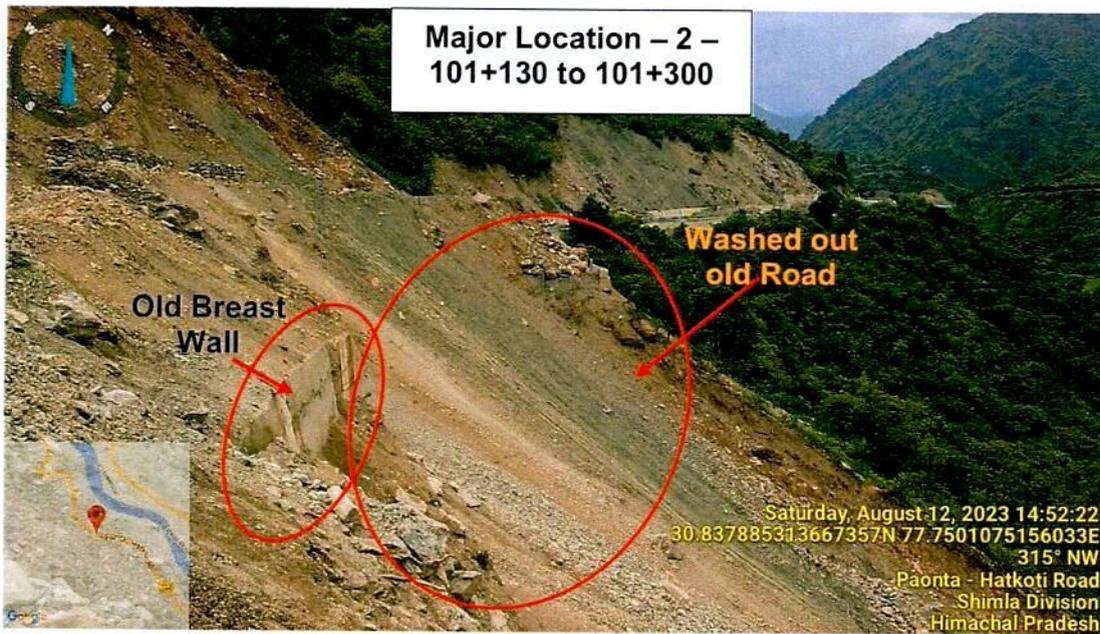
2) Major Location – 2 – 101+130 to 101+300 (Complete Road washout) – most serious damage location

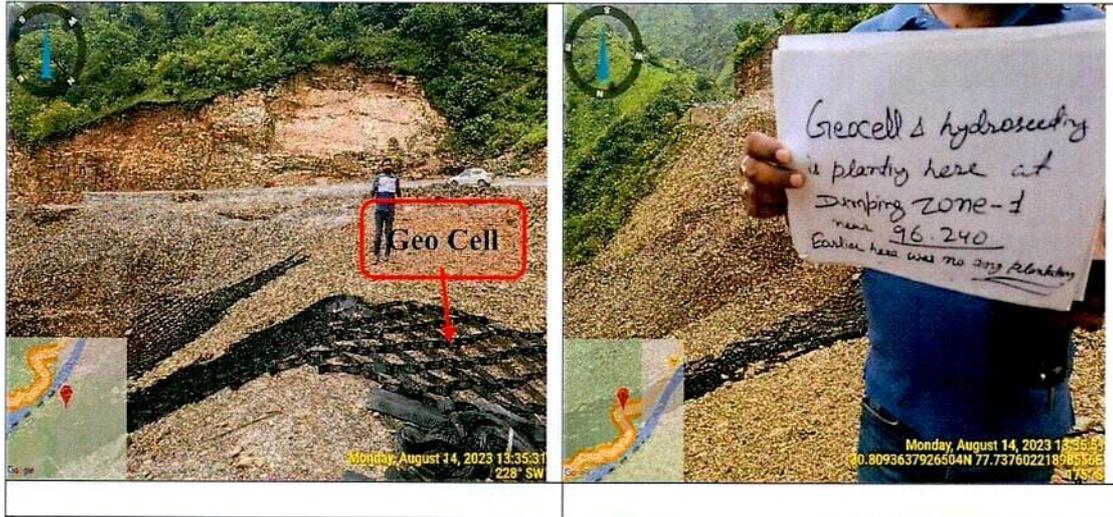
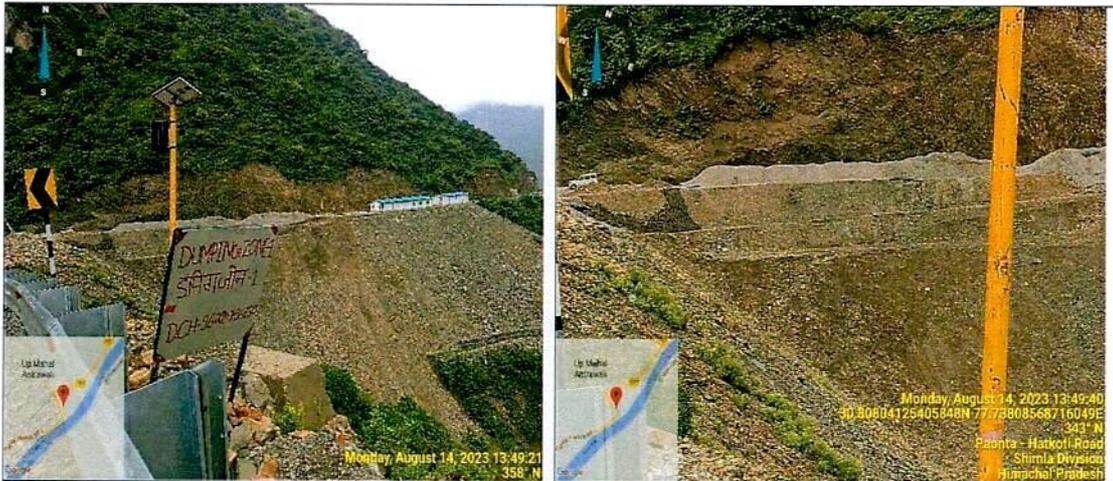
Dumping Zone – 1 (Unclaimed location) – Here Geo cell was being laid & few bamboo plants had been planted & also hydroseeding had been done here after our earlier visit (in our absence).

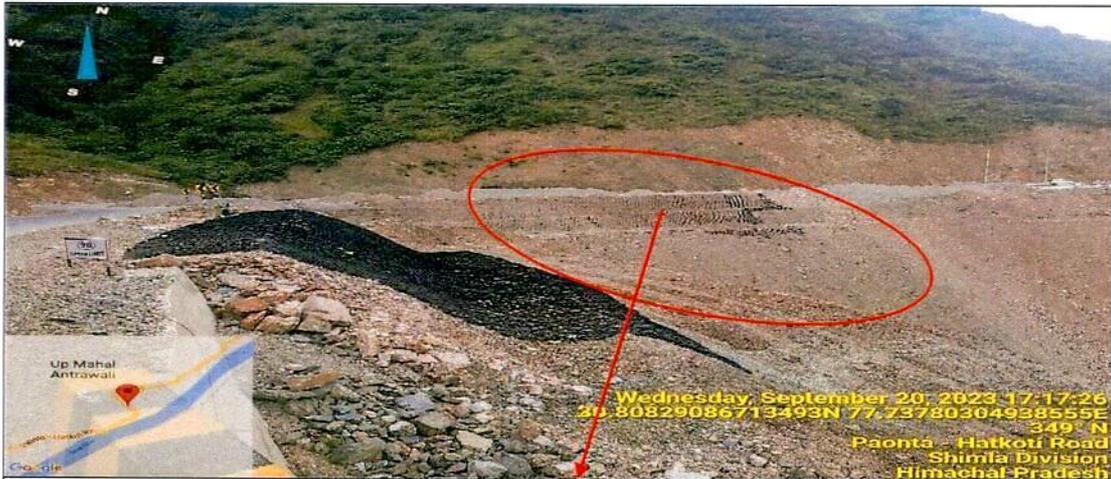
Dumping Zone - 1 - Geocell Hydrocedding plantation work is under process (This location is not under claim)

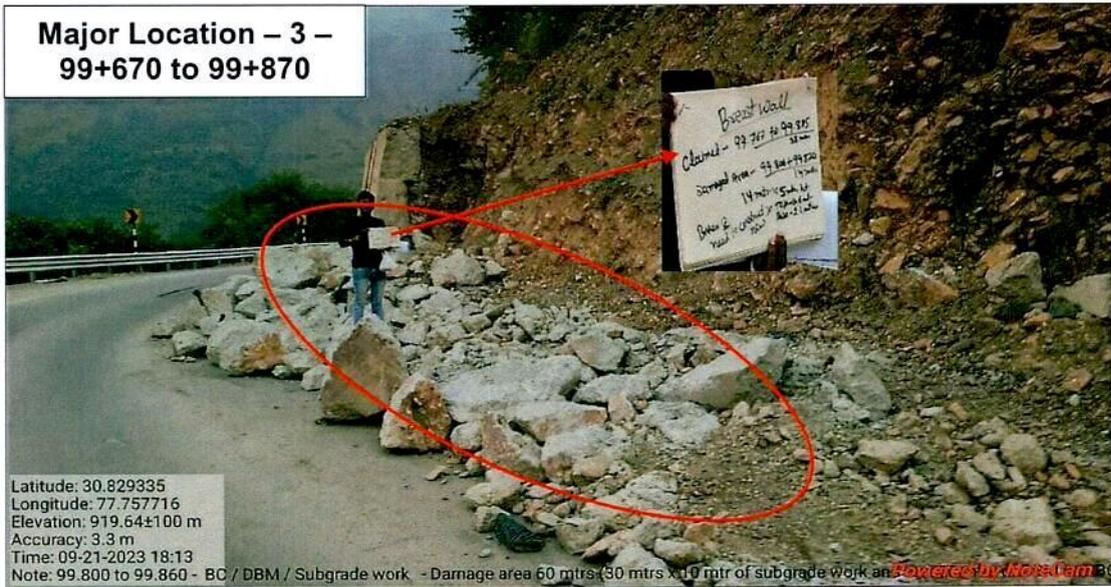
Major Loss Location – 3 (99+670 to 99+870) – Breast wall was damaged in this area – under construction

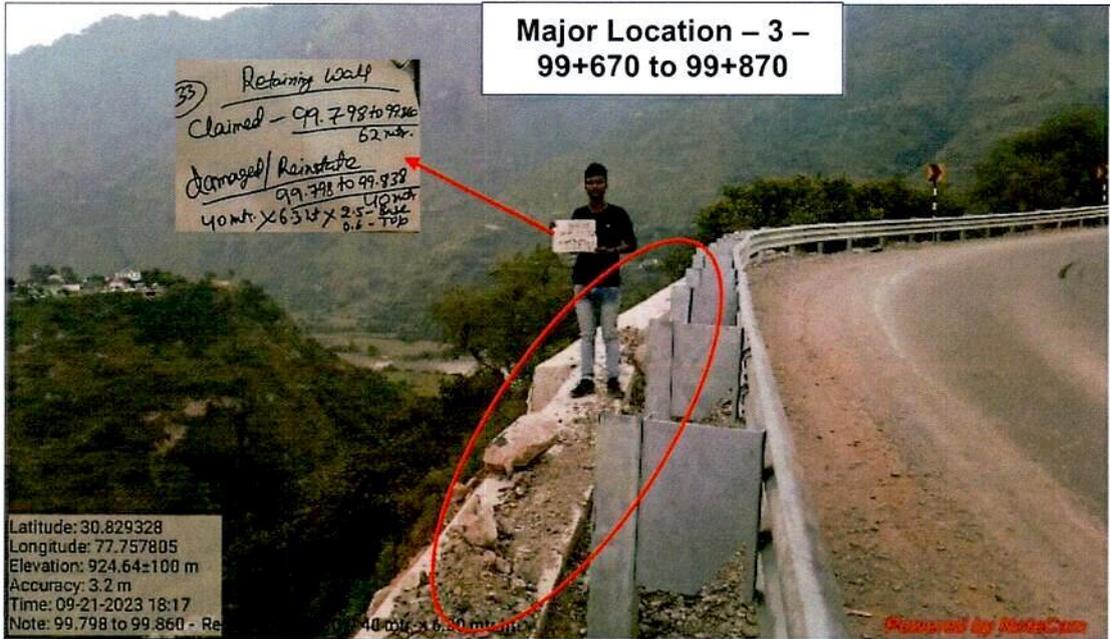
Major Loss Location – 3 (99+670 to 99+870) – Retaining Wall (40 mtr. x 6.30 mtr. height constructed new)

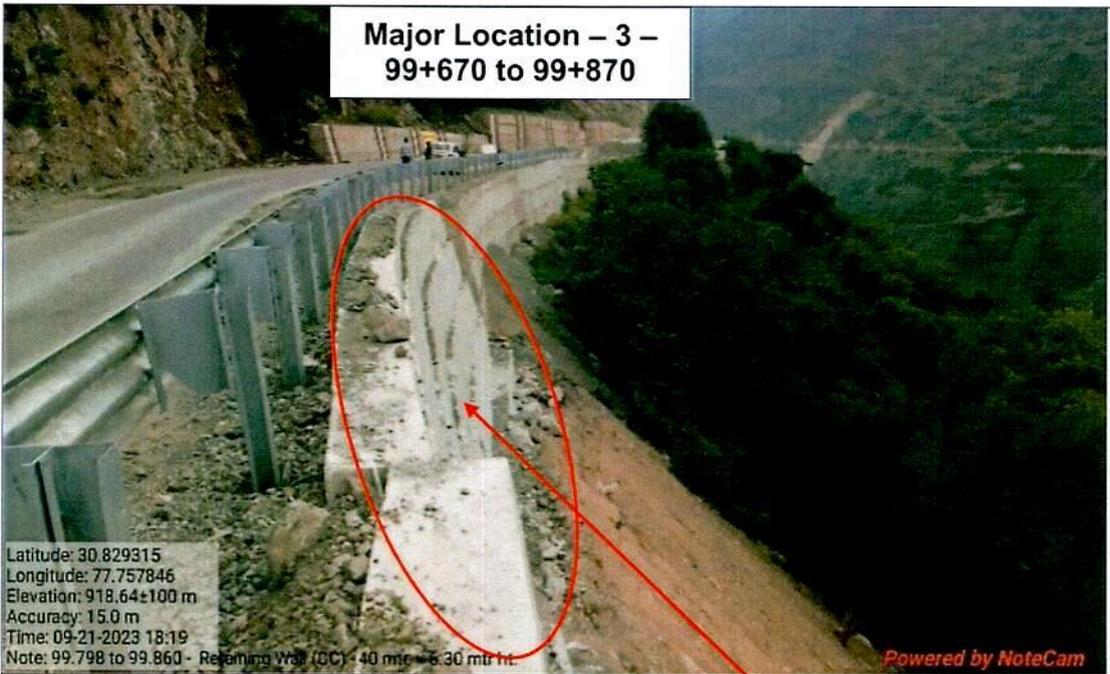
Major Loss Location – 3 (99+670 to 99+870) – Retaining Wall (40 mtr. x 6.30 mtr. height constructed new)

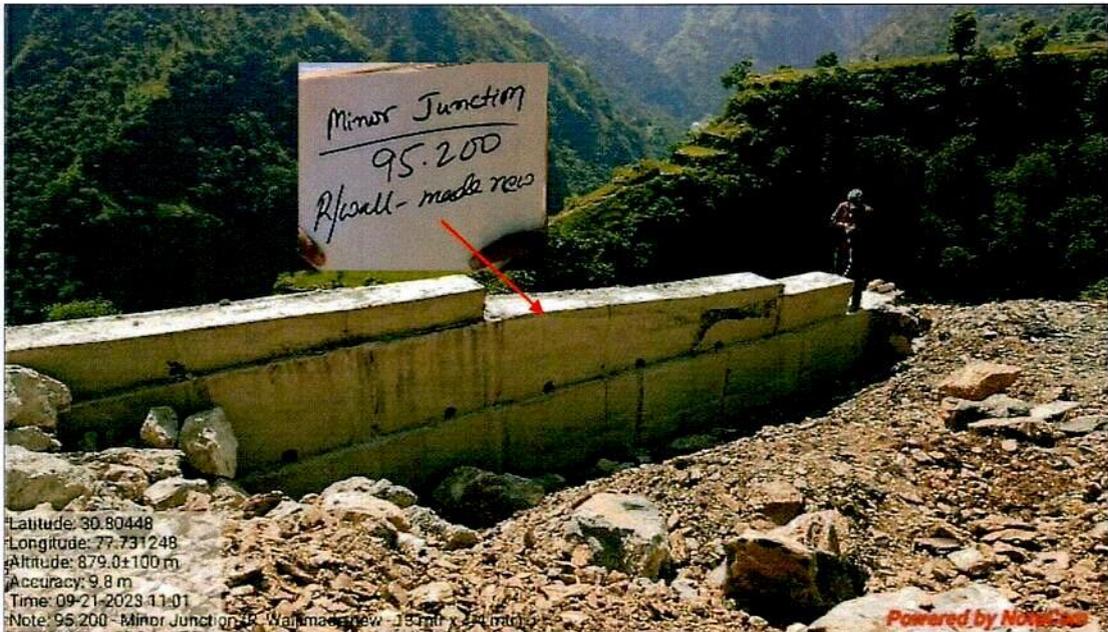
Minor Junction at Ch. No. - 95.200 (here Retaining Wall made new)

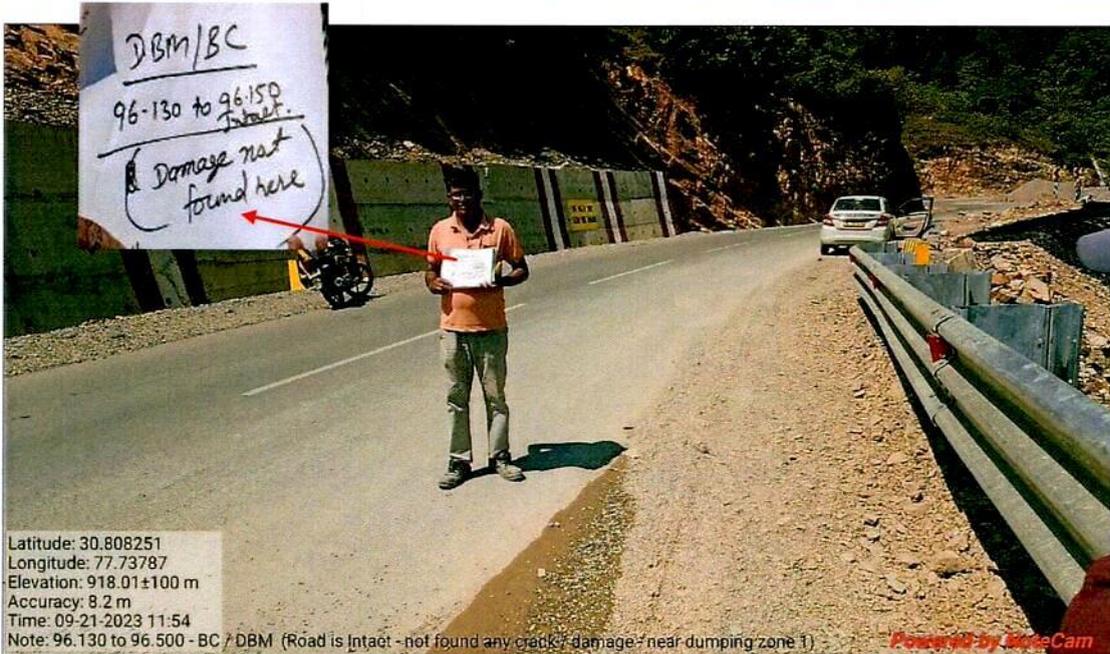
Ch. No. – 96.130 to 96.500 (Damage not found here)

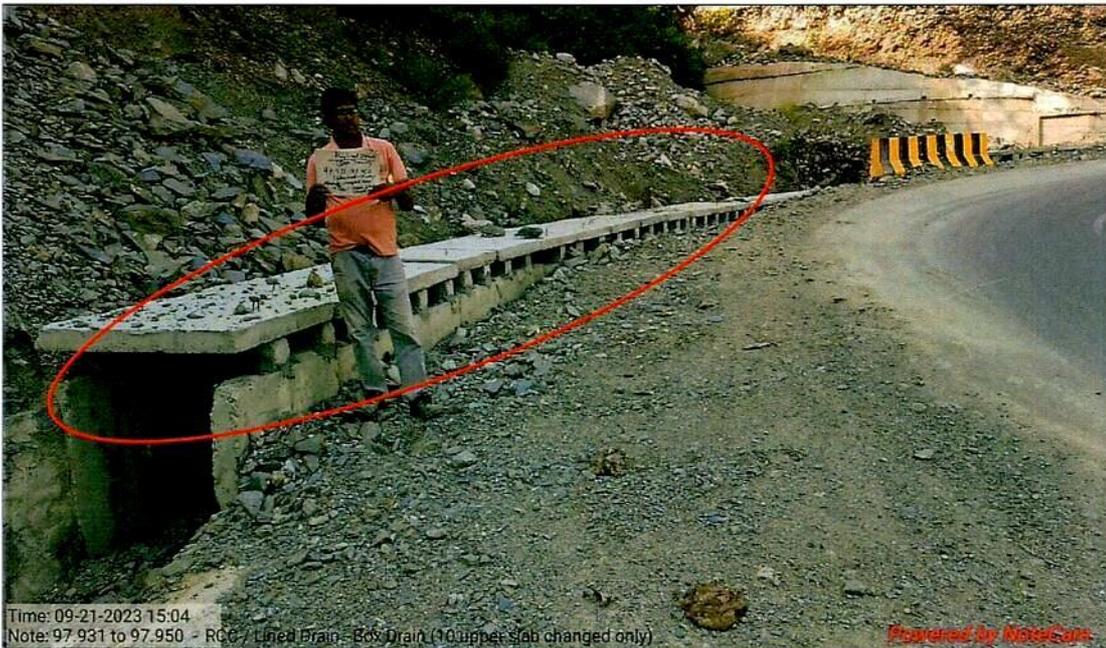
Time: 09-21-2023 15:04
Note: 97.931 to 97.950 - RCC / Lined Drain - Box Drain (10 upper slab changed only)

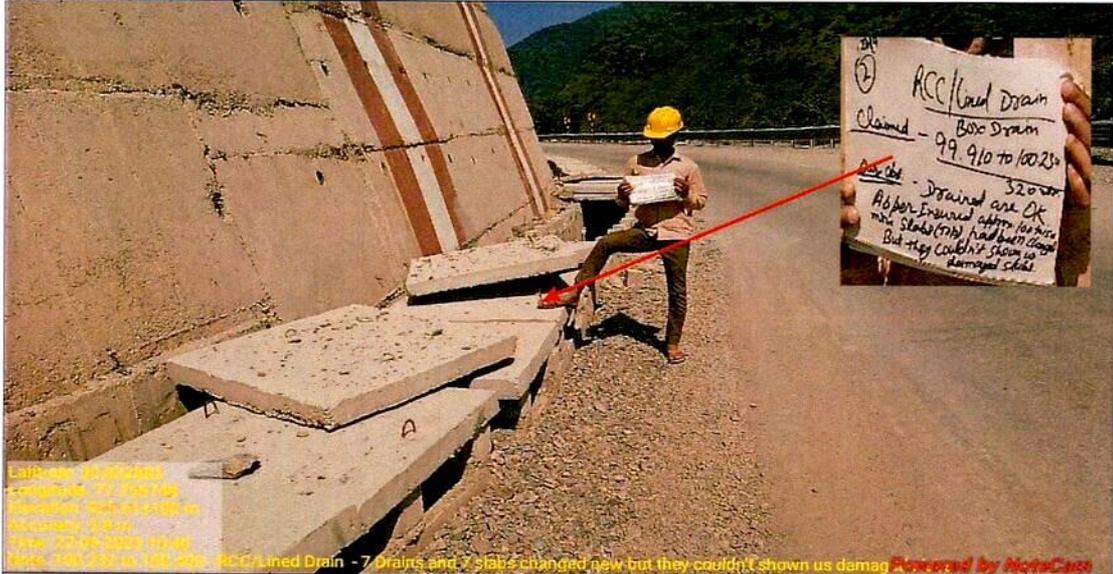
Ch. No. - 99.910 to 100.230 (RCC / Lined Drain - Drain are ok, as per Insured approx. 150 mtrs. slabs had been changed & to be change but they couldn't produced damaged slabs.

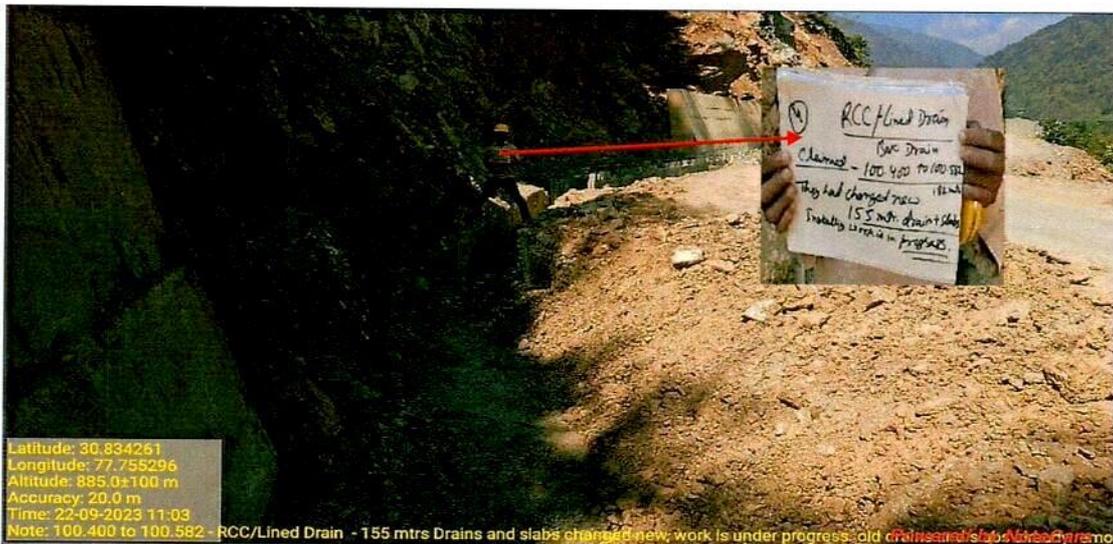
Ch. No. - 100.400 to 100.582 (RCC / Lined Drain - 155 mtrs. Drains and slabs changed new (work is under progress) but they couldn't produced damaged drains & slabs.
