10.0) Reinstatement confirmation

Road damage claim A/c - M/s. Shivalik
Buildtech (P) Ltd.
NH 707 (Gumna - Fediz Road)

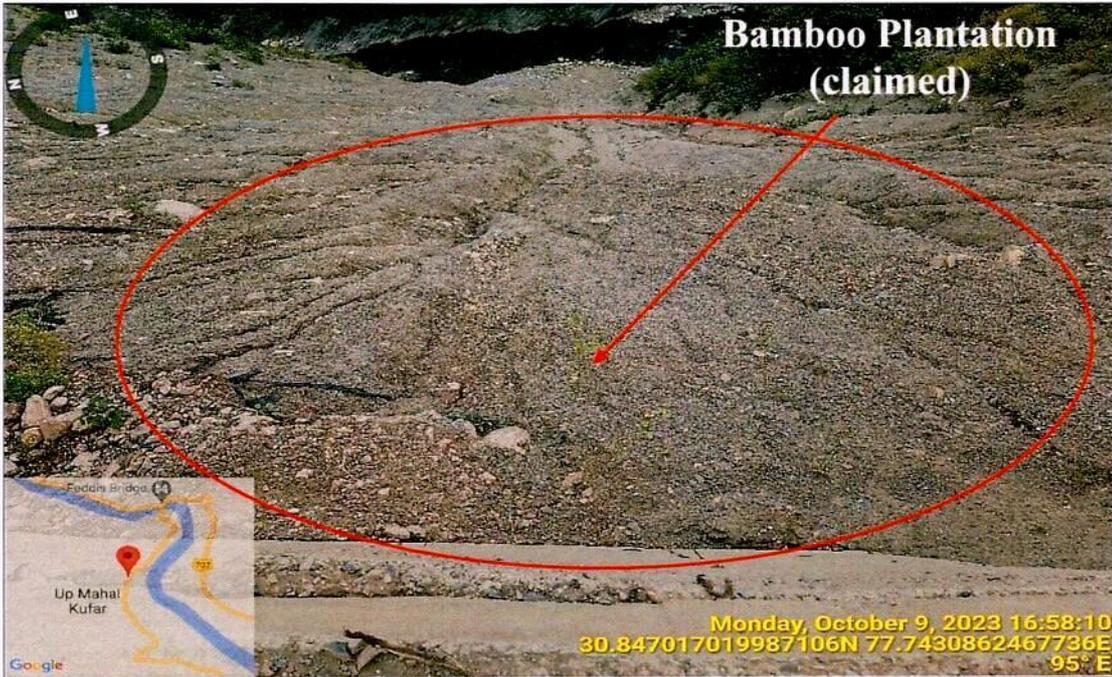
Bamboo Plantation – Valley Side - (102.760) – 3000 Sq. Mtr. – Planted

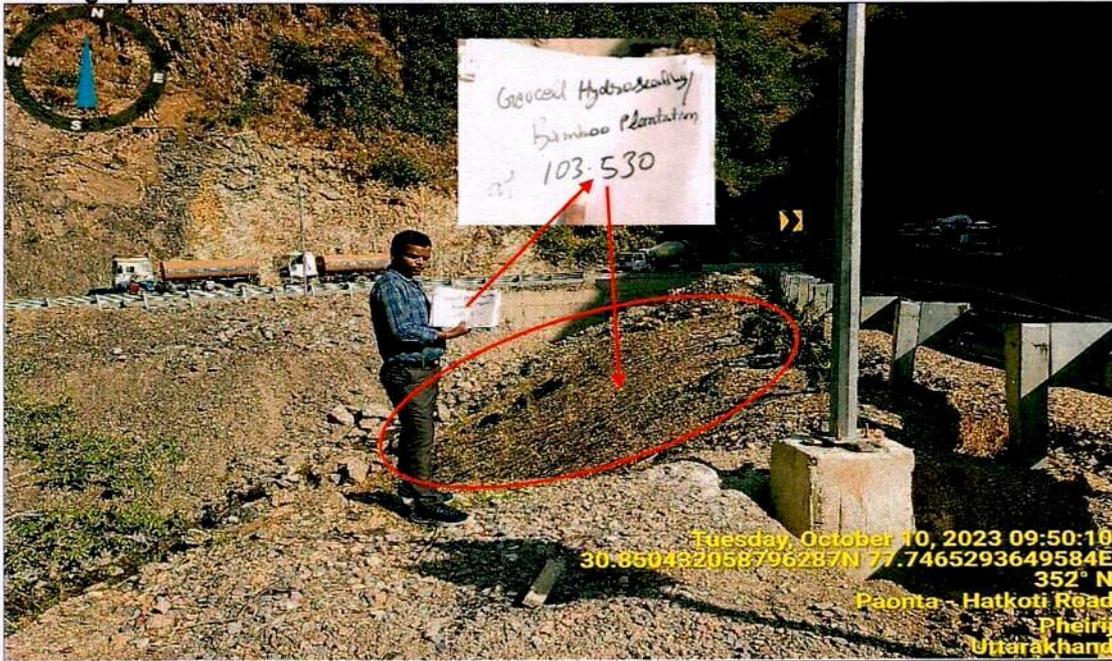
Geocell Hydroseeding / Bamboo Plantation (Valley Side) at 103.530

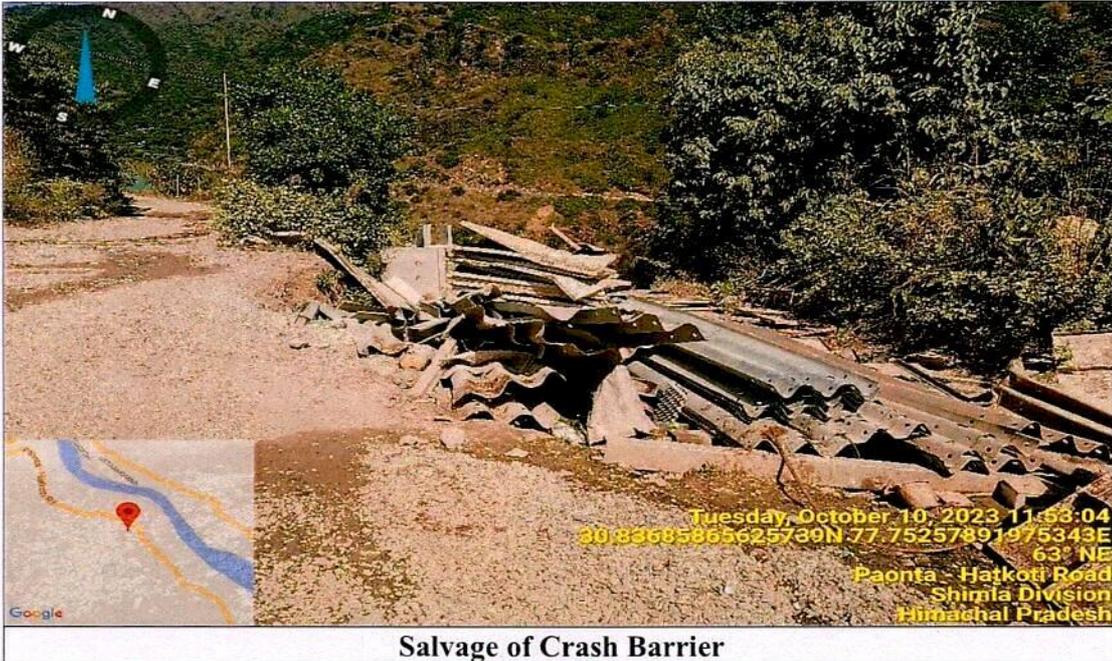
Salvage of Crash Barrier

Salvage of above crash barrier to be check.

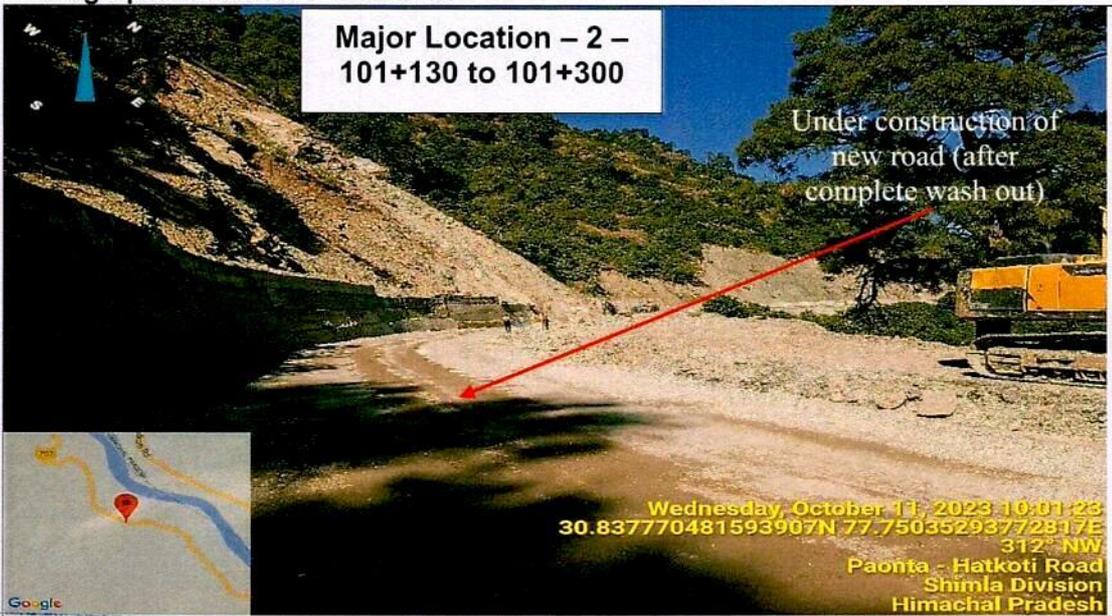
Major Loss Location - 2 (101.130 to 101.300)

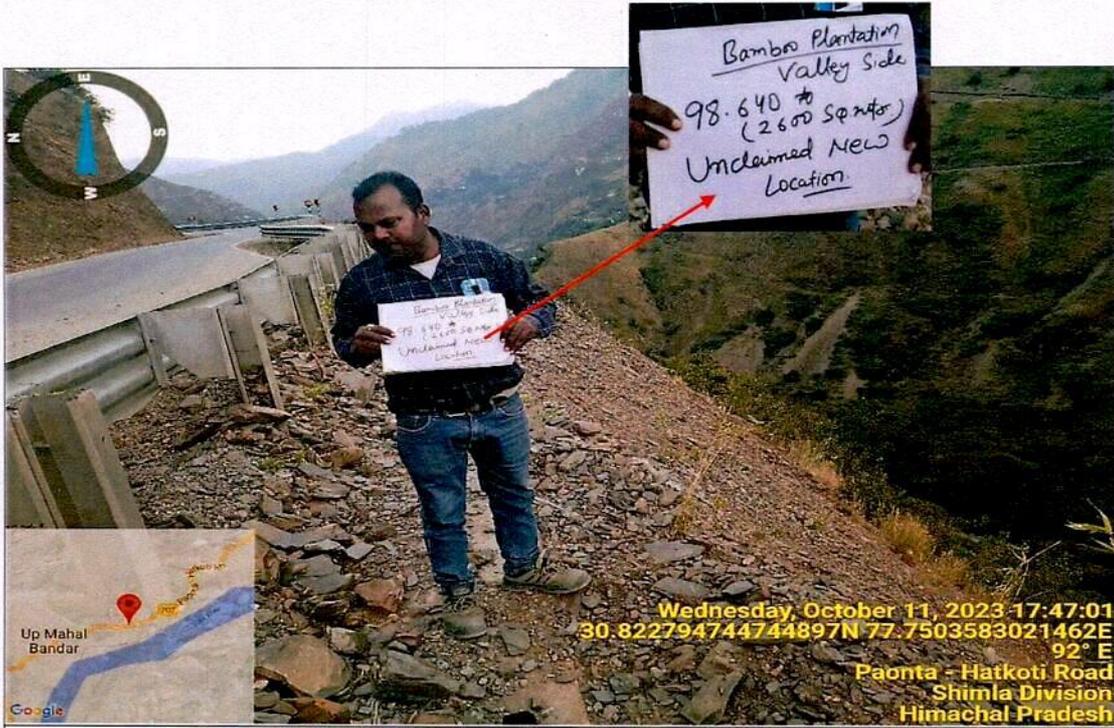
Bamboo Plantation (Valley Side) at 98.640 (2600 Sq. Mtr.) – Unclaimed New Location

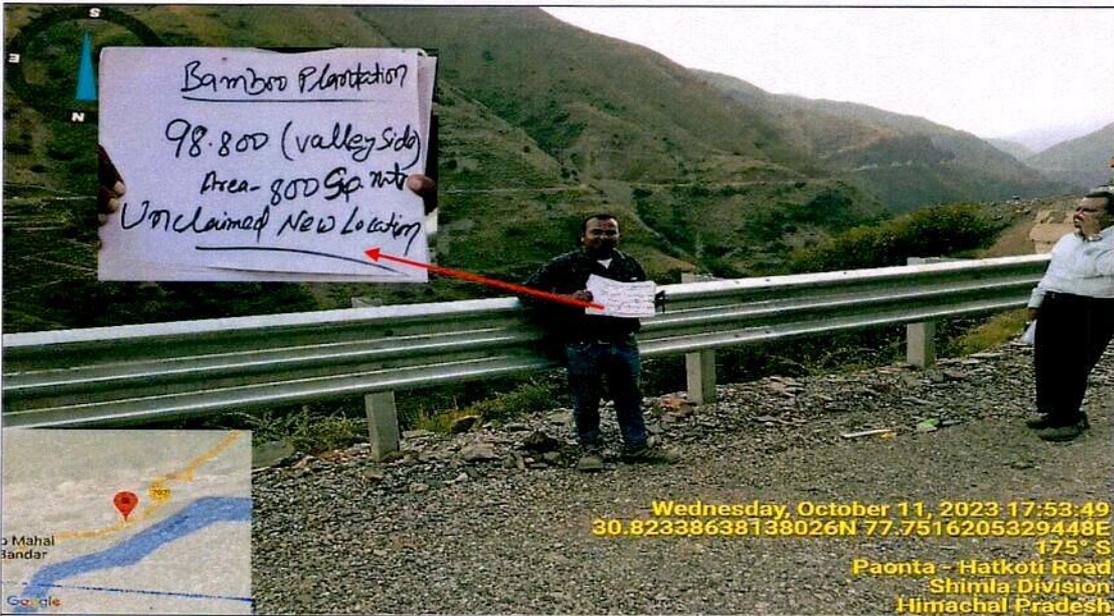
Bamboo Plantation (Valley Side) at 98.800 (800 Sq. Mtr.) – Unclaimed New Location

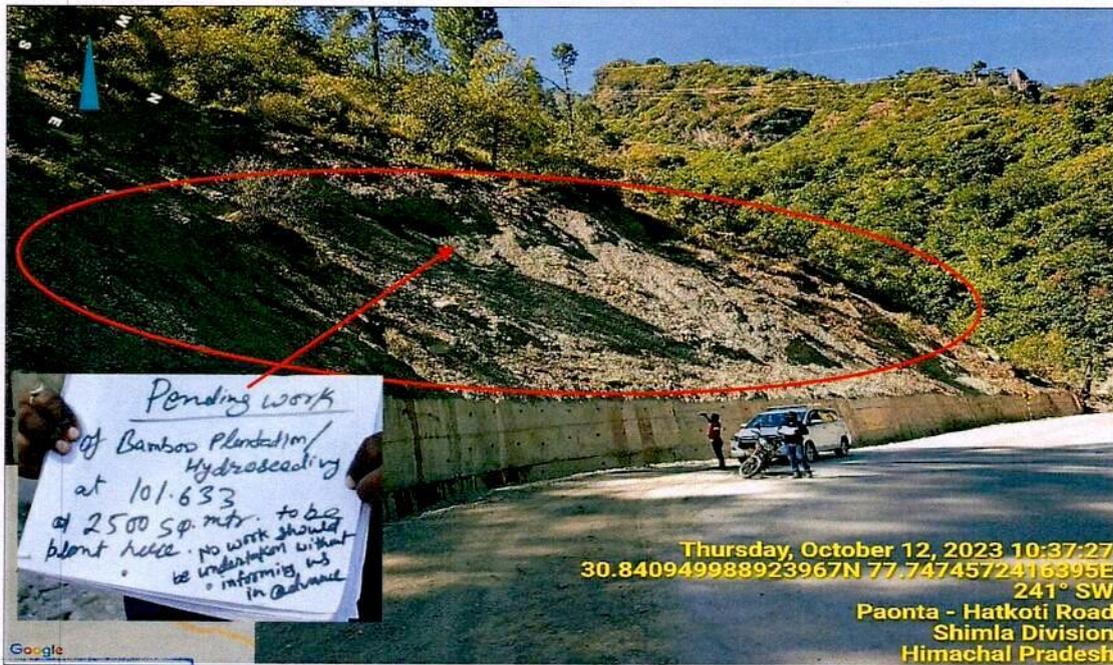
Pending Work of Geocell Hydroseeding / Bamboo Plantation (Hill side) at 101.633 (2500 Sq. Mtr.)

No work should be undertaken without advance.
Pending bamboo plantation work - Nil
However at location 101.633 - 2500 Sq mtr. (Hill side) plantation may have to be done if NHAI authority permit for same.

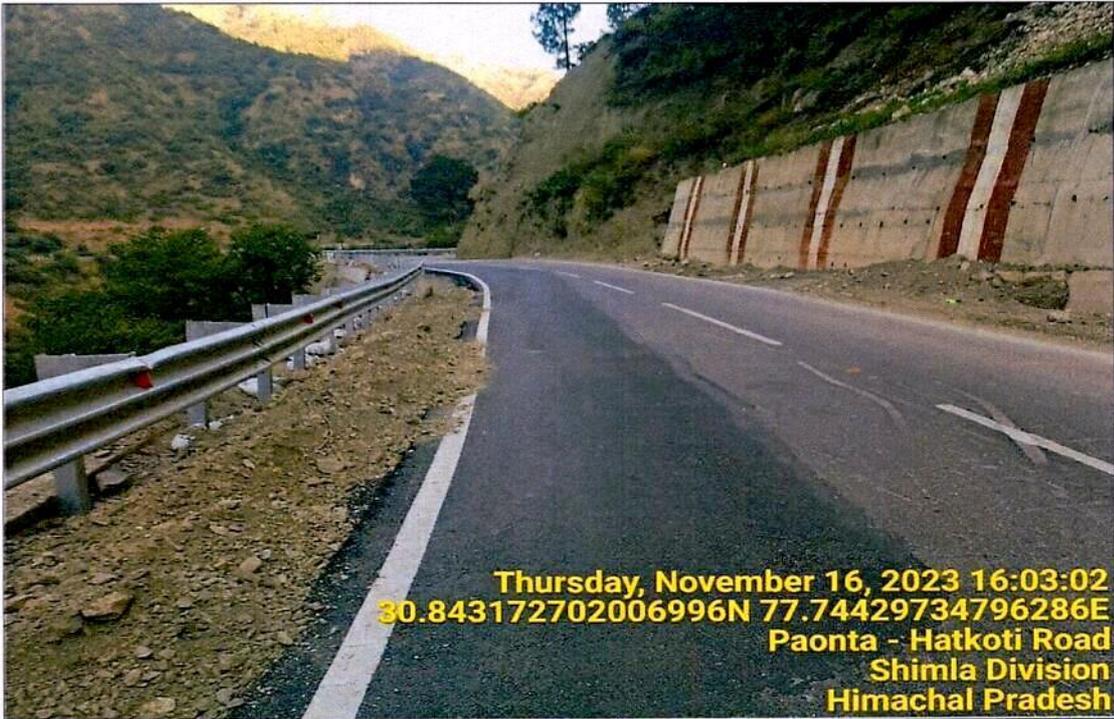
Major Loss Location – 1 (102.126 to 102.246)

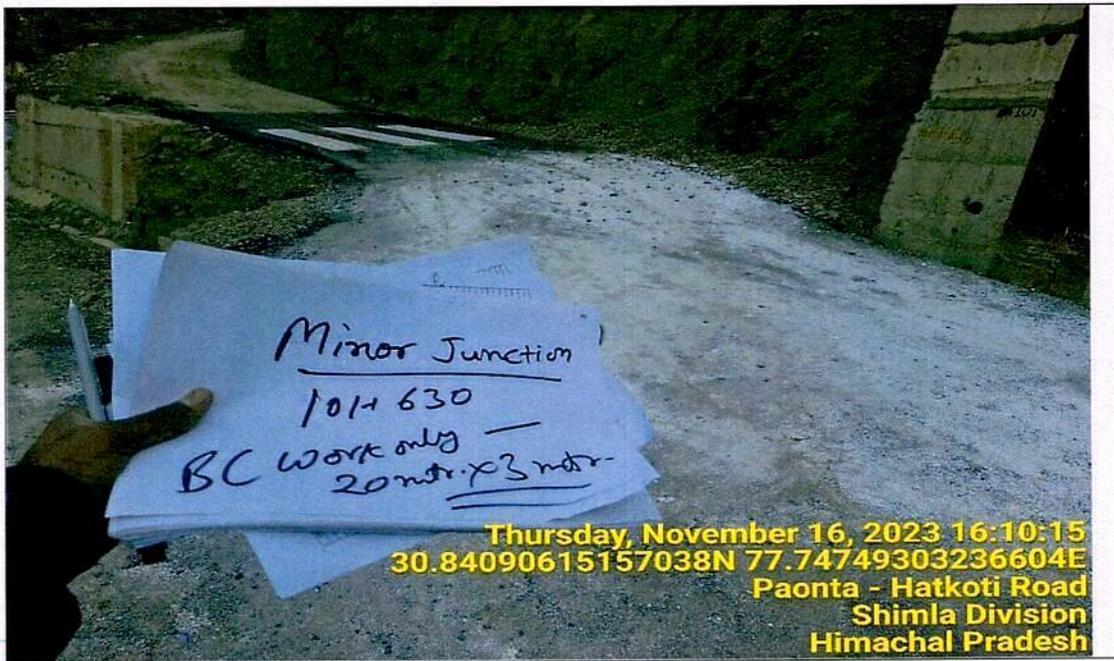
Minor Junction at 101.630 – BC Work only (20 mtr. x 3 mtr)

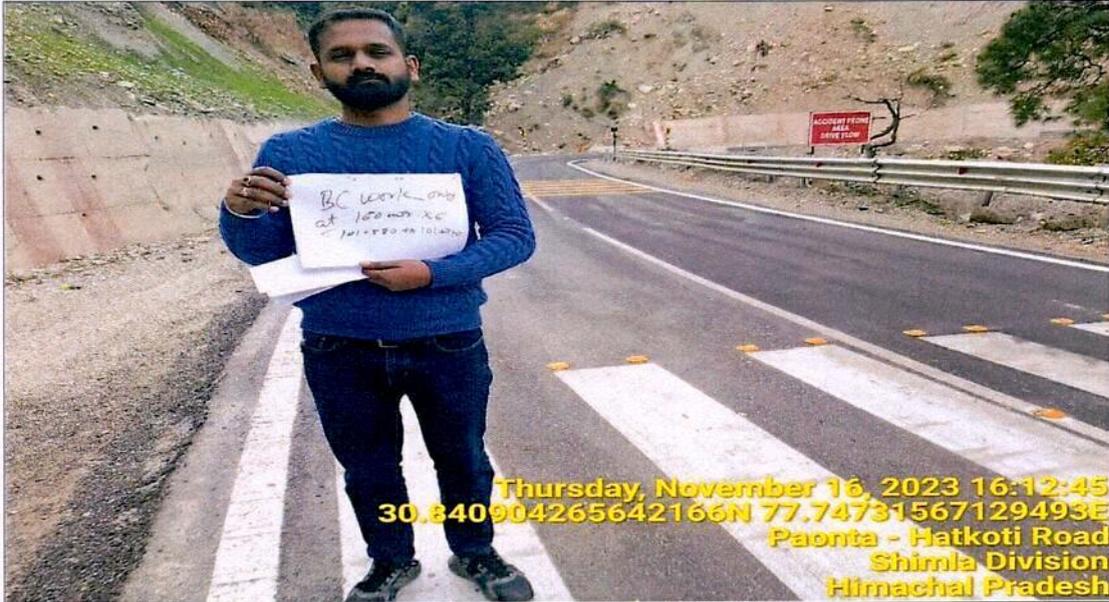
101.580 to 101.770 – BC Work only (160 mtr. x 6 mtr)

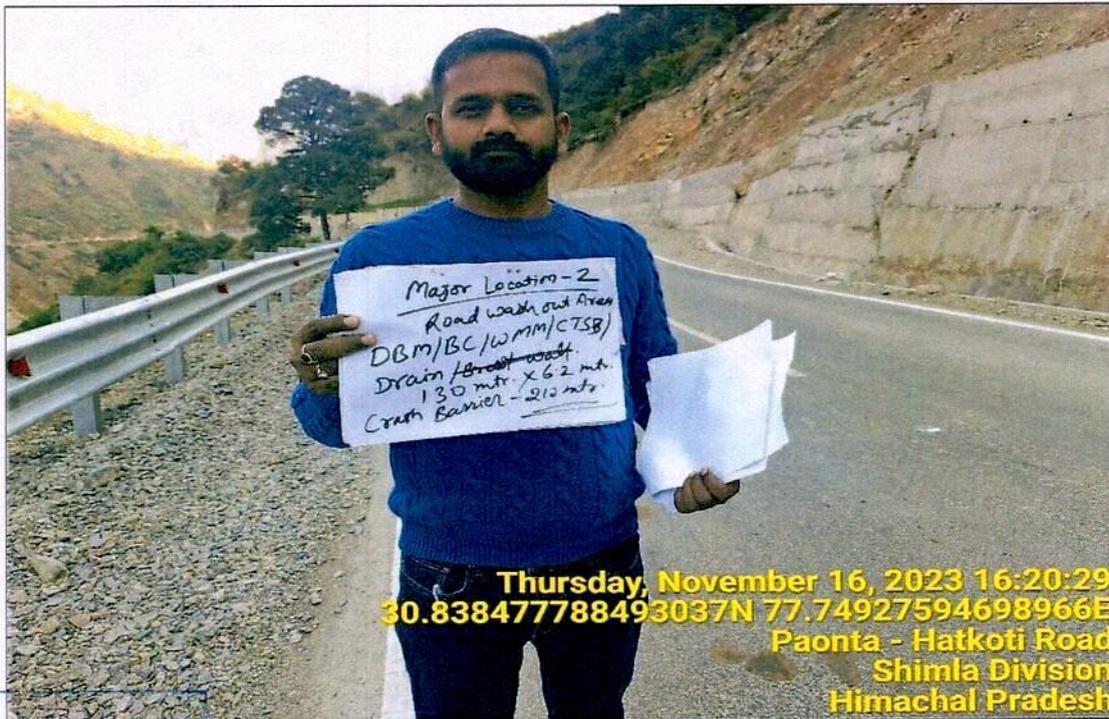
Major Loss Location - 2 – (130 mtr. x 6.2 mtr)

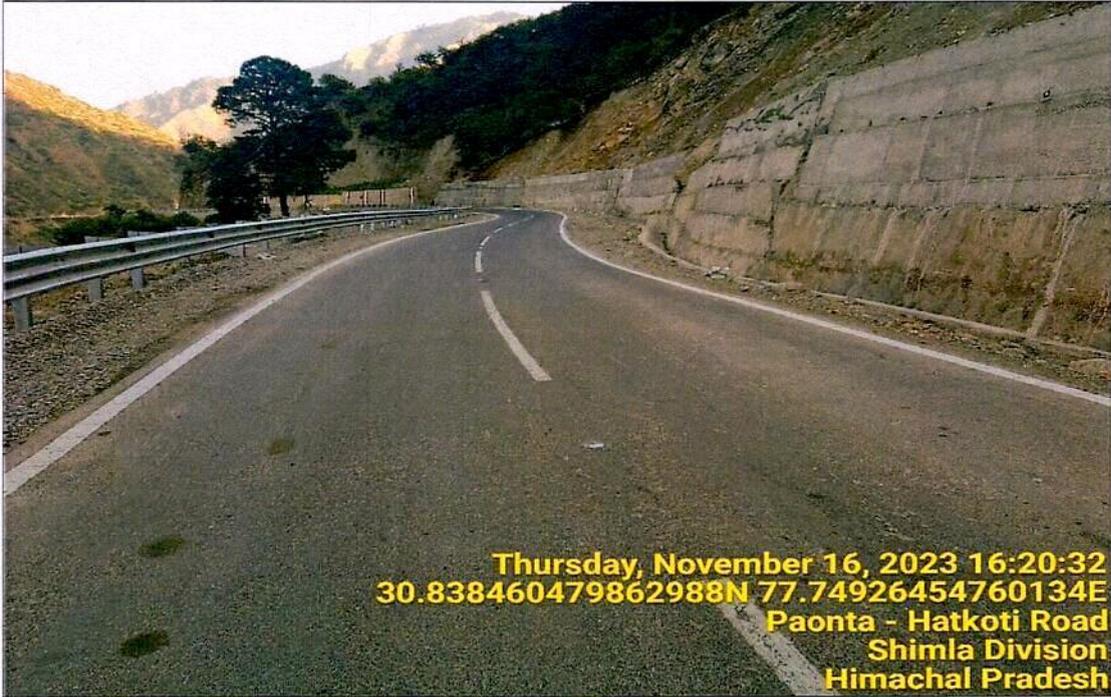
Major Loss Location - 2 – Crush Barrier (210 Mtr.)

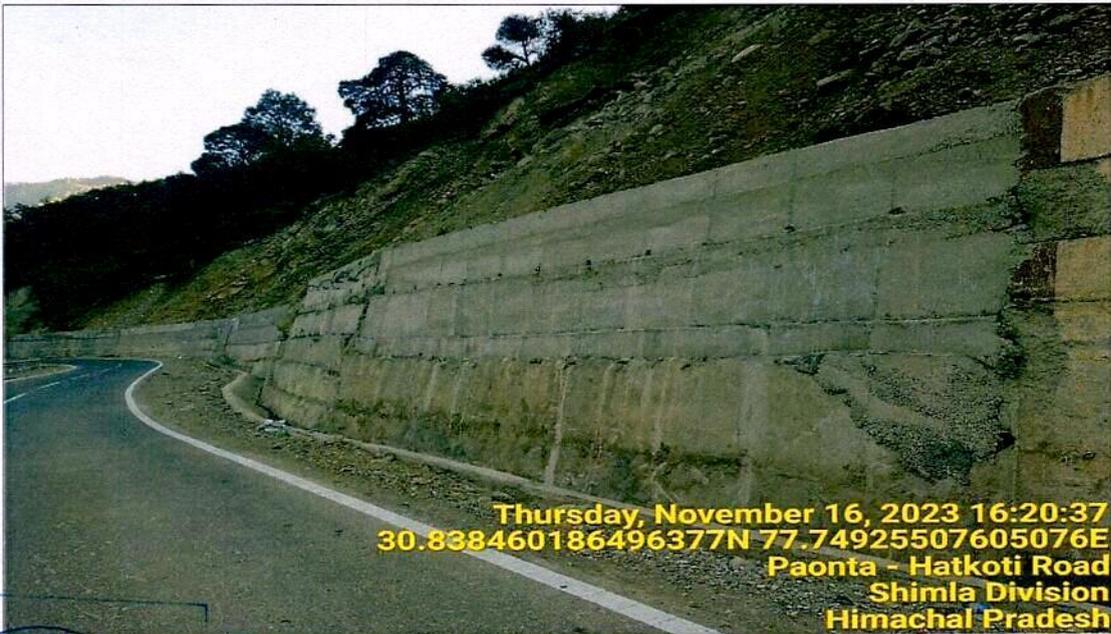
Major Loss Location - 2 – Breast Wall Constructed New (140 RMT)

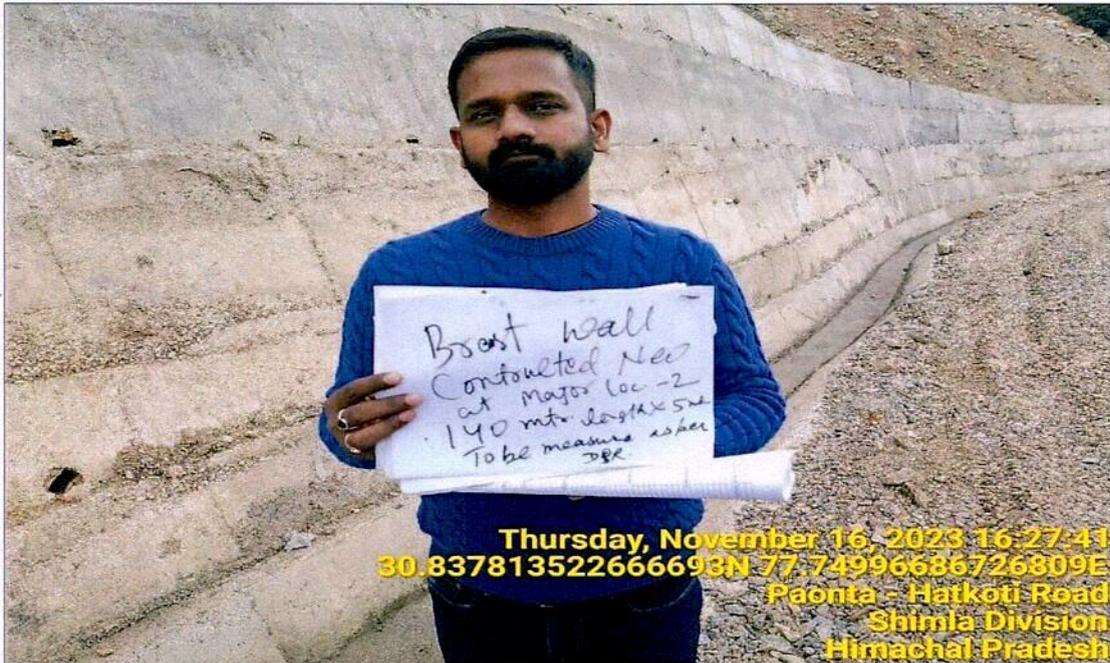
Major Loss Location - 2 – Breast Wall Constructed New (140 RMT)

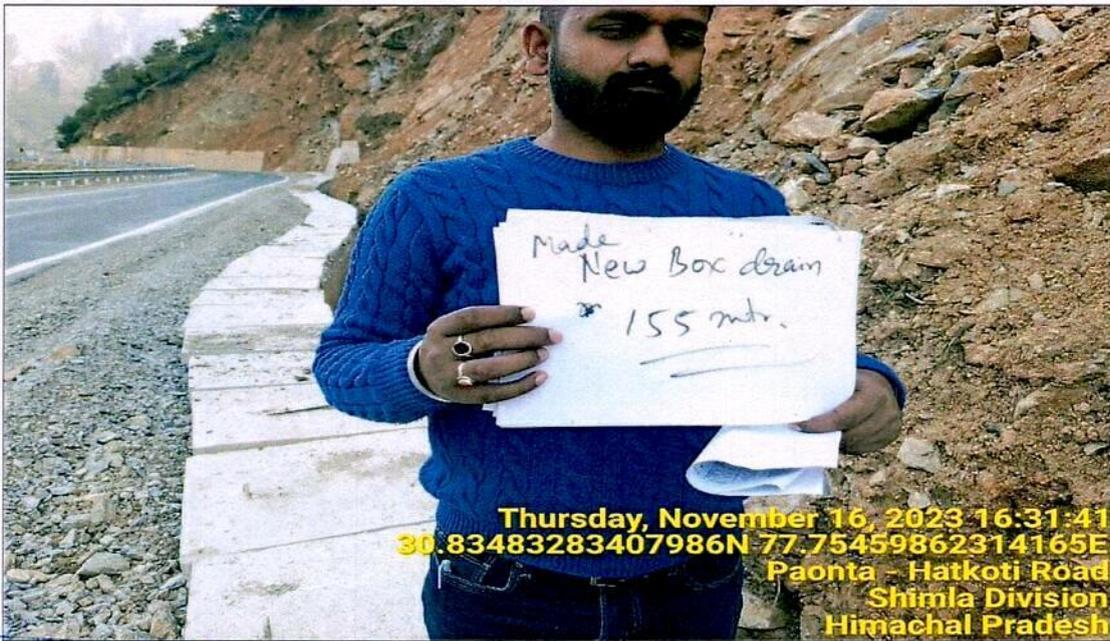
Box Drain constructed new (155 mtr.)
