EA NO. 23/2024
IN
ORIGINAL APPLICATION NO. 295/2016

7.	Annexure R-2/6 True copy of the JKPCC site visit report dated 10.01.2025.	101-184
8.	Annexure R-2/7 True copy of e-mail dated 22.10.2024.	185-228
9.	Proof of service.	229

**COMPLIANCE REPORT ON BEHALF OF RESPONDENT NO.2/NHAI
IN TERMS OF ORDER DATED 15.07.2024 & 15.10.2024**

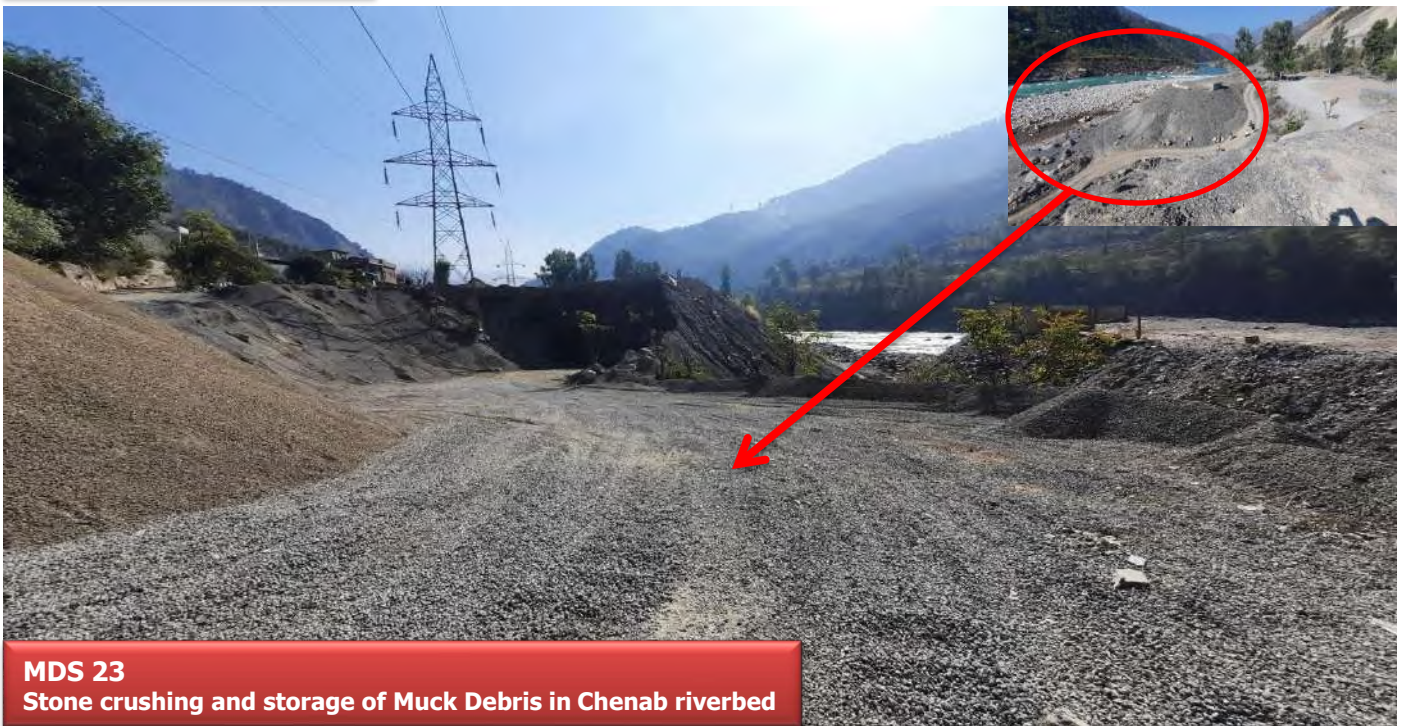
MDS 23
Stone crushing and storage of Muck Debris in Chenab riverbed

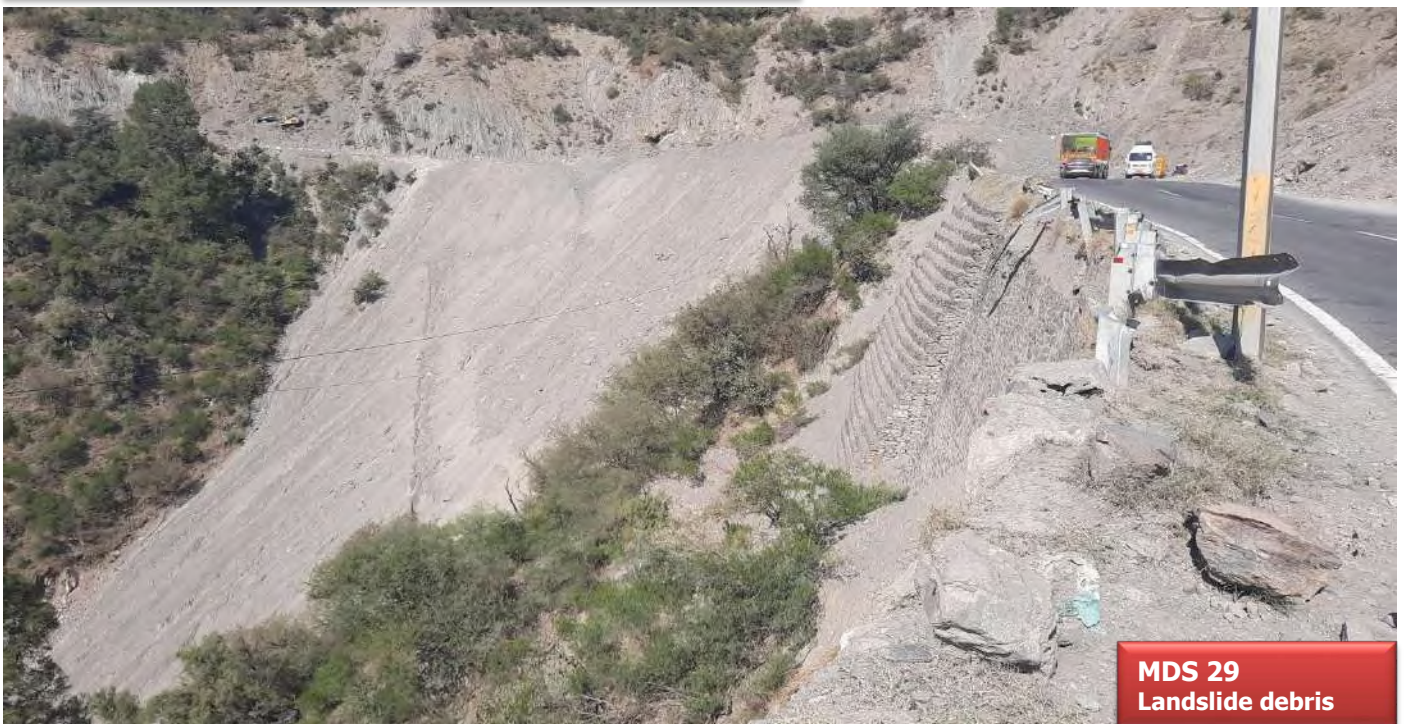
MDS 29
Landslide debris

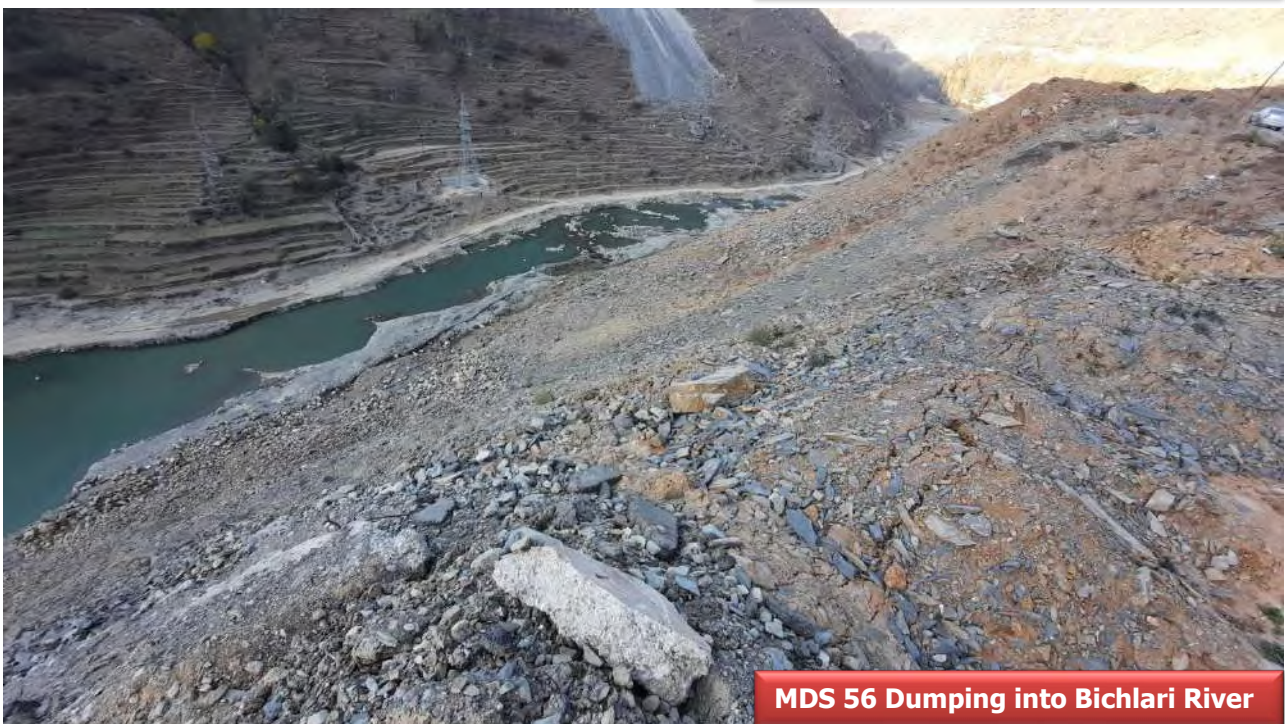
MDS 56 Dumping into Bichlari River
