**BEFORE THE HON'BLE NATIONAL GREEN TRIBUNAL,  
WESTERN ZONE BENCH AT PUNE**

Original Application 26/2024  
( Earlier Letter Petition O.A. 792/2023 P.B)

**FIRE AUDIT REPORT FILED BY RESPONDENT NO-3 P.C.M.C.**

**Subject :** Fire safety Audit report where fire Incident occurred M/S. Shivraj Enterprises (inside of M/S. Rana Fabrication Company) Jyotiba Nagar, Talwade Dated on 08/12/2023.

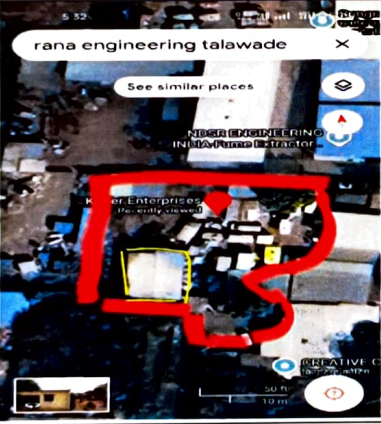
मे. शिवराज एंटरप्रायजेस या मिळकतीचे शेड हे मे. राणा इंजिनिअरिंग कंपनीच्या अंतर्गत भागात असून सदर शेडच्या चोहोबाजुने राणा इंजिनिअरिंगचे मेटल, वेल्डींग/कटिंग विषयक कामकाज वेगळ्या व्यवसाय चालक/मालक मार्फत सुरु होते. (एकुण २२ गुंठे जमिनीपैकी १२०० स्के.फु. क्षेत्र मे. शिवराज एंटरप्रायजेस यांना भाडेतत्वावर देण्यात आलेले समजुन येते.)	मे. शिवराज एंटरप्रायजेस या मिळकतीचे शेड व नामफलक त्वरीत दिसून येत नसल्यामुळे सदर मिळकतीवरील ठिकाणी पोहोचणे करिता अडथळा निर्माण होतो.
२

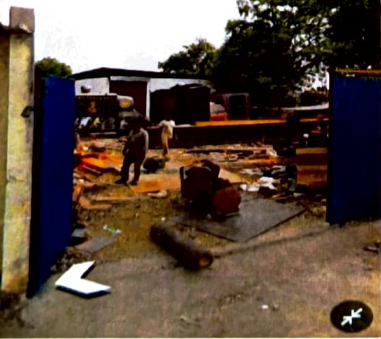
मे. शिवराज एंटरप्रायजेस हि मिळकत बाहेरील बाजुने दिसून येत नाही. जेव्हा राणा इंजिनिअरिंग कंपनीच्या मुख्य प्रवेशद्वारा मार्फत आतमध्ये प्रवेश केला जातो तेव्हा व्यवस्थित रित्या निरीक्षण केल्यानंतर देखील सदरील मे. शिवराज एंटरप्रायजेसचे शेड (नामफलक) नसल्याने त्वरीत लक्ष्यात येत नाही.	मे. शिवराज एंटरप्रायजेस मिळकतीबाहेर मार्गदर्शक फलक/नामफलक असणे गरजेचे आहे.

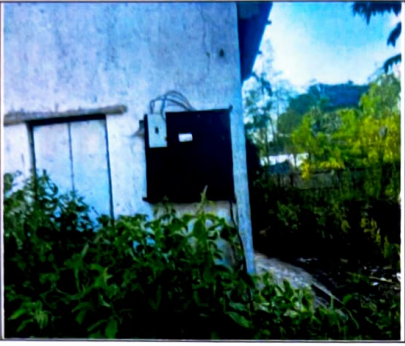
८

<p>सदर इमारतीतील इलेक्ट्रिक वायरिंग, पॅनल व उपकरणे अग्निसुरक्षिततेच्या दृष्टिने असुरक्षित असल्याचे दिसून येते.</p>	<p>इमारतीतील विद्युत उपकरणे, पॅनल व वायरिंग इ. सामुग्री विद्युत निरीक्षकामार्फत तपासणी करून घेणे आवश्यक होते पण तसे झालेले दिसून येत नाही.</p>
---	---	--	--

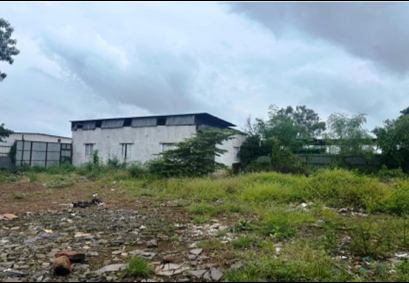
३

<p>Building Structure- 30*40 sq.ft cement concrete wall and 1200 sq.ft. roof with sheet shed area at ground level.</p>	<p>The said business turned out to be relatively unsafe due to inadequate construction and area for manufacturing Spark Candles, a highly flammable material.</p>
४	 	<p>Exit / way out- In the above 1200 sq.ft. construction area building, there is only one iron shutter of 9 ft. height and 8 ft. width (which obstructs the opening and closing of the said shutter) and no other shutter is visible on the building.</p>	<p>As one way available to go in and out of the said building is not enough, it is necessary to have another way.</p>
५

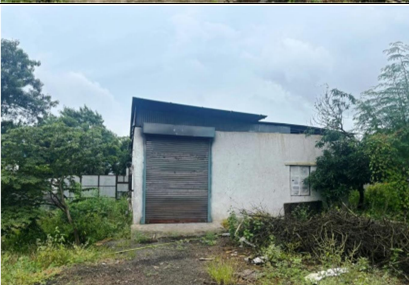
<p>Safety margins - The side safety margin is not visible on the right and rear side of the building. To the left and to the front is a space which is leased to another business.</p>	<p>It is necessary to have a safety margin in terms of fire safety inside and outside the said business.</p>

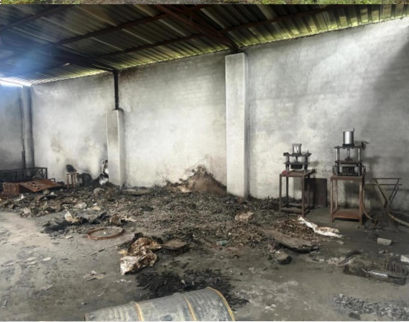
६

<p>Structure inside the building- Inside the building, two iron Scraps, two Sparkle Candle manufacturing machines and the highly flammable material required for making sparkle candles in the form of dust powder can be seen Scattered.</p>	<p>The interior space of the building shows that various items useful for making Sparkle Candles have been arranged insecurely.</p>
७

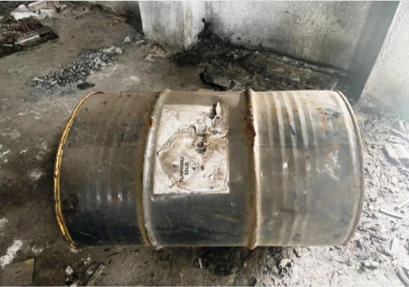
<p>Flammable materials- The use of highly flammable and explosive chemicals used to make sparkle candles can be seen in the charred remains of the building.</p>	<p>It is seen that highly flammable materials are being used in the said building without any fire safety measures.</p>
८	 	<p>It appears that the electrical wiring, panels and equipments in the said building are unsafe in terms of fire safety.</p>	<p>Electrical wiring, panels and equipment etc. in the said building should have been inspected by an electrical inspector but it does not appear to have been done.</p>
