INSPECTION REPORT**Sub: - Widespread fish mortality at Velsao Beach, in Mormugao**

As directed, the undersigned official of the Board JEE – Siddhant Desai, along with Smt. Milagrina Colaco(JLA) & Shri. Sanmesh Borkar (SA) inspected Velsao Beach and M/s Paradeep Phosphates Limited located at Survey No. 110-252, Zuarinagar, Sancoale, Mormugao-Goa (hereafter referred to as “Unit”) on 08/06/2024, with regards to the above-mentioned subject.

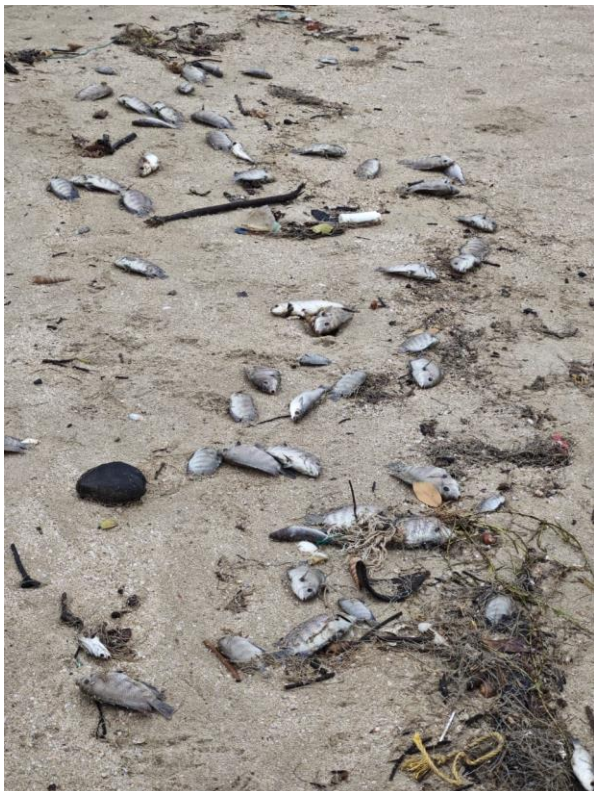
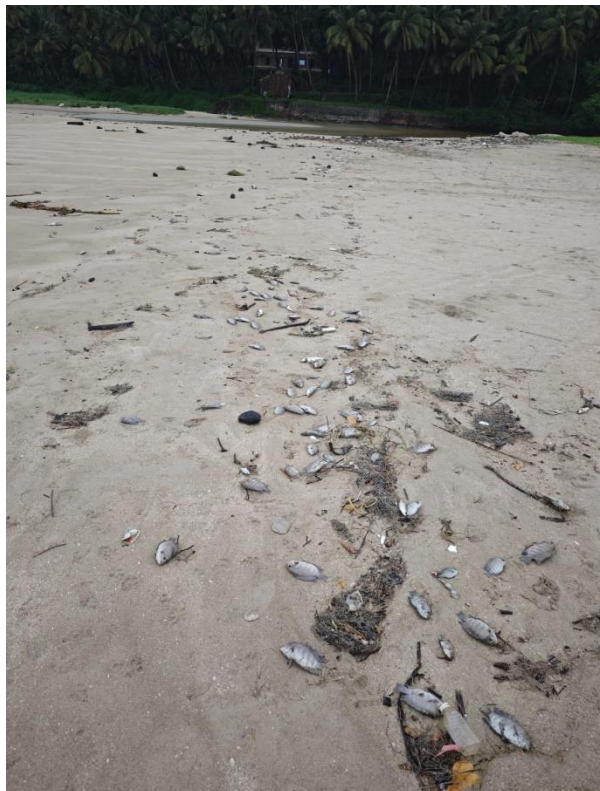
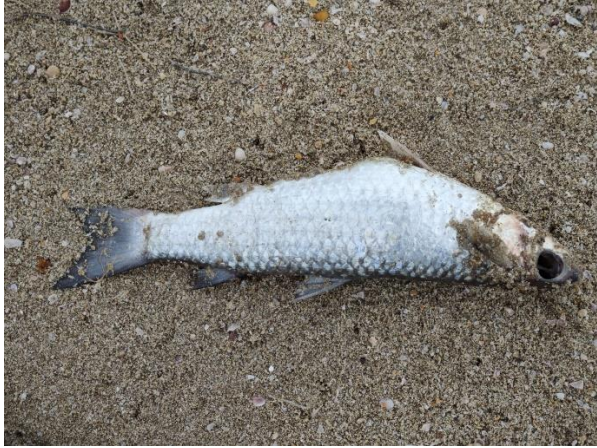
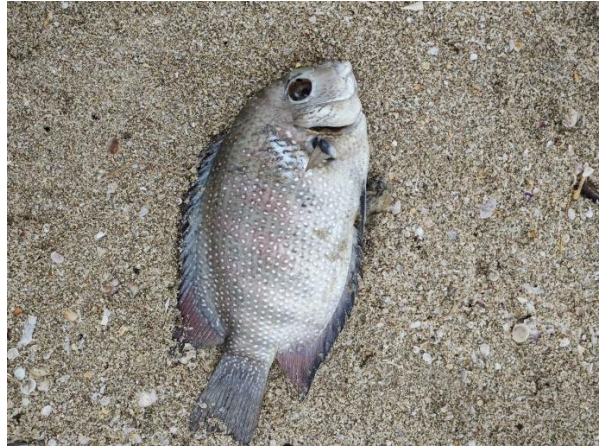
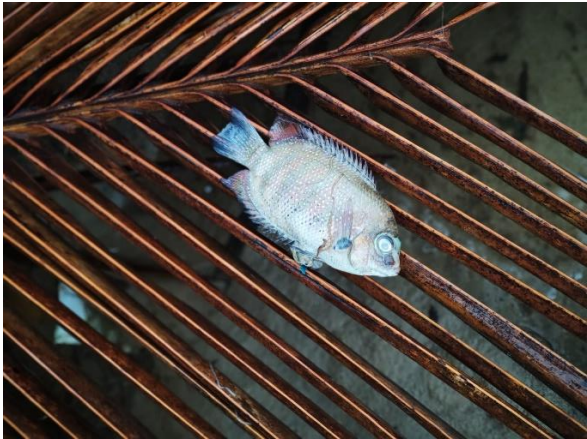
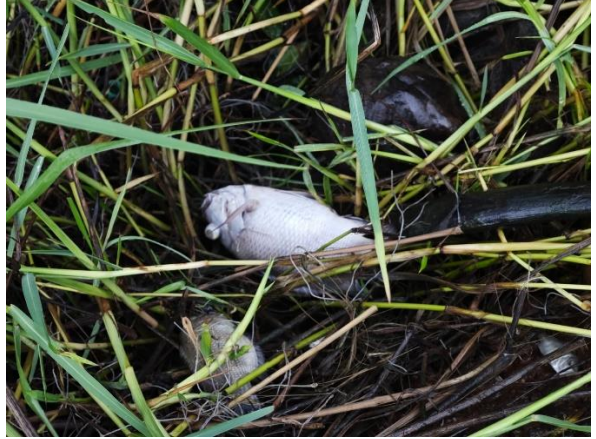
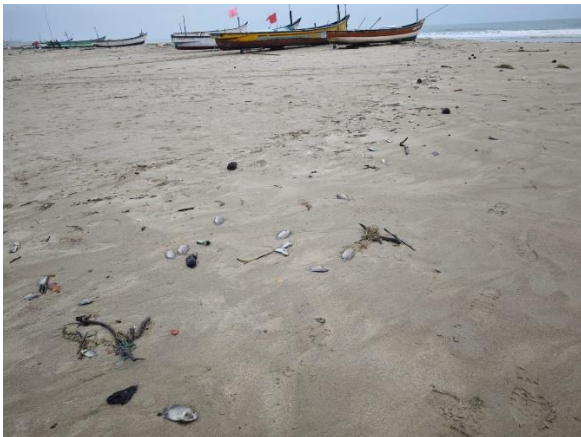
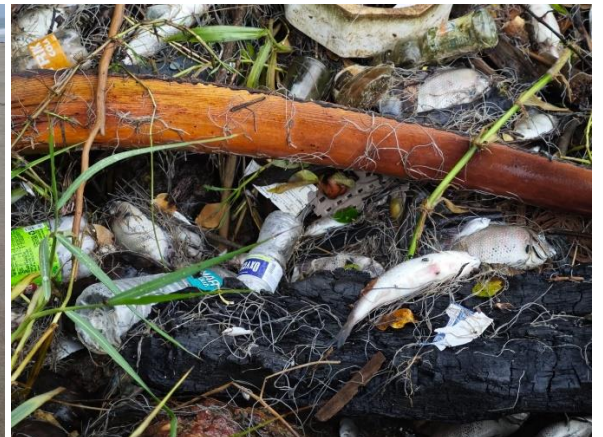
- i. Schools of dead fish were washed ashore and scattered all over the beach.
- ii. Several types of fish were found dead. (pictures of the same have been attached below).

Figures 1, 2, 3, 4, 5, 6, 7 & 8: show various dead fish washed ashore on the Velsao Beach

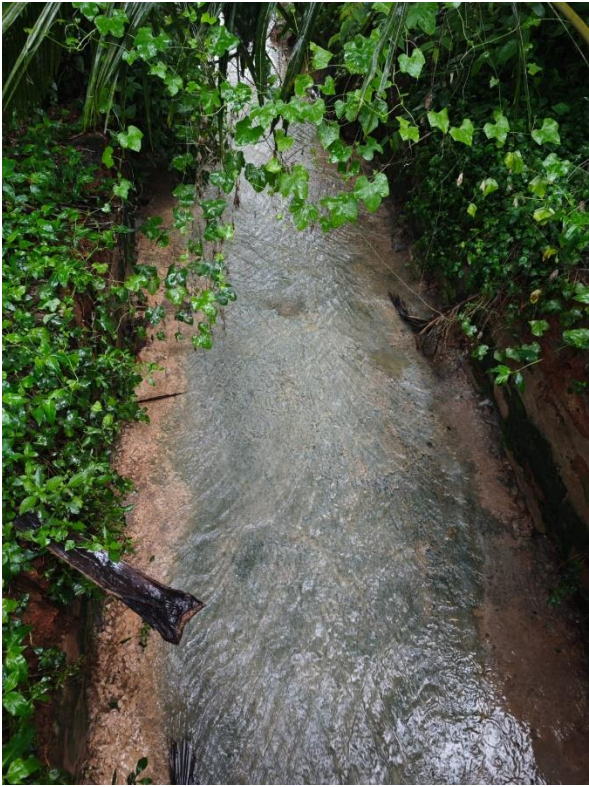
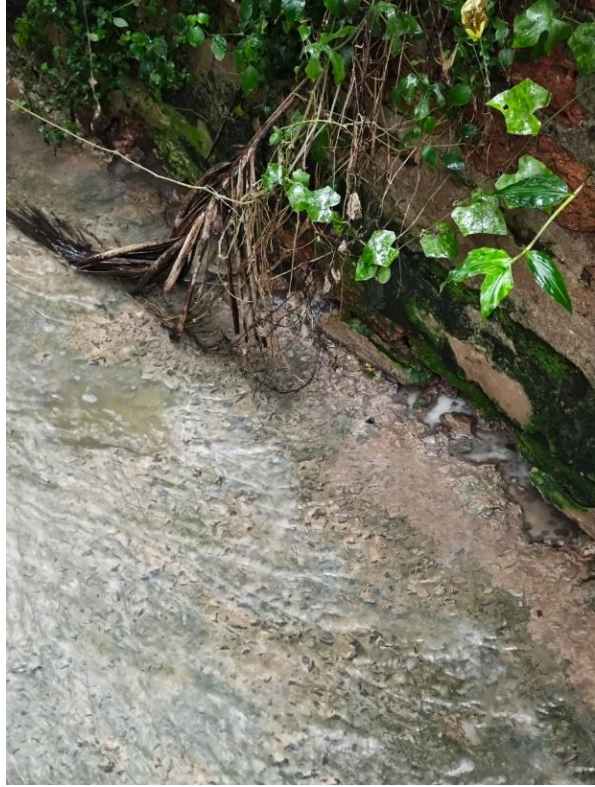
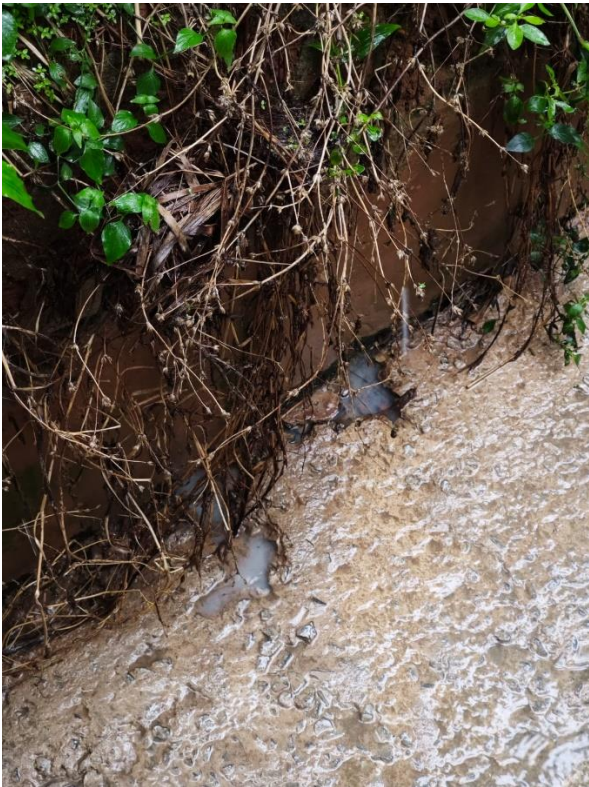
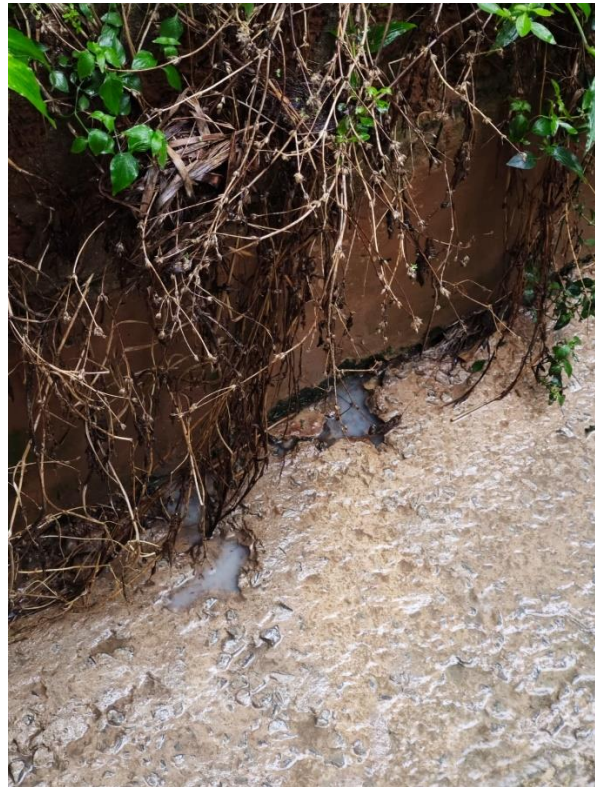
- iii. At the time of sample collection at the creek the team observed a storm water drain from Paradeep Phosphate Ltd. Leading to the beach and upon closer inspection it was observed that the colour of the water flowing in the storm water drain was slightly milky. Further, sediments of this white substance were also observed on the wall of the Storm water drain. (Photographs have been attached below)

- iv. Accordingly, a sample was taken from the discharge point of this storm water drain, which is the creek of the River, i.e., Sample 1 – mouth of creek – (Coordinates: 15.370699, 73.872664), It may be noted that smell of Ammonia was observed at the time of sampling.

Fig: 9, 10, 11 & 12 shows storm water drain from Paradeep Phosphate Ltd. Leading to the beach having a milky white appearance & sediments of this white substance were also observed on the wall of the Storm water drain

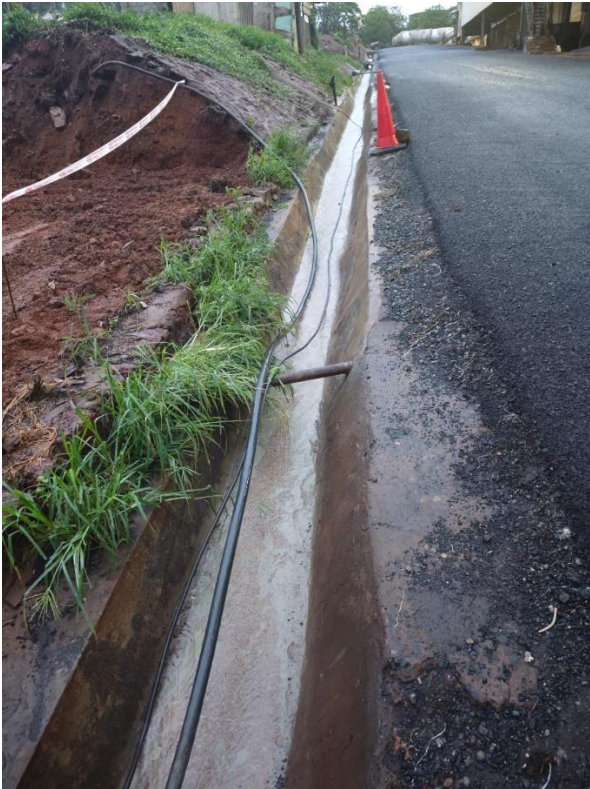
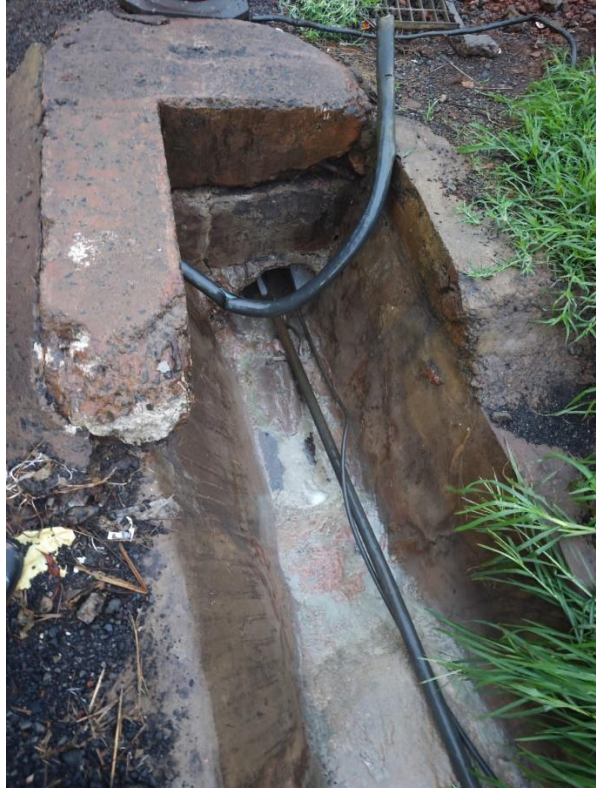
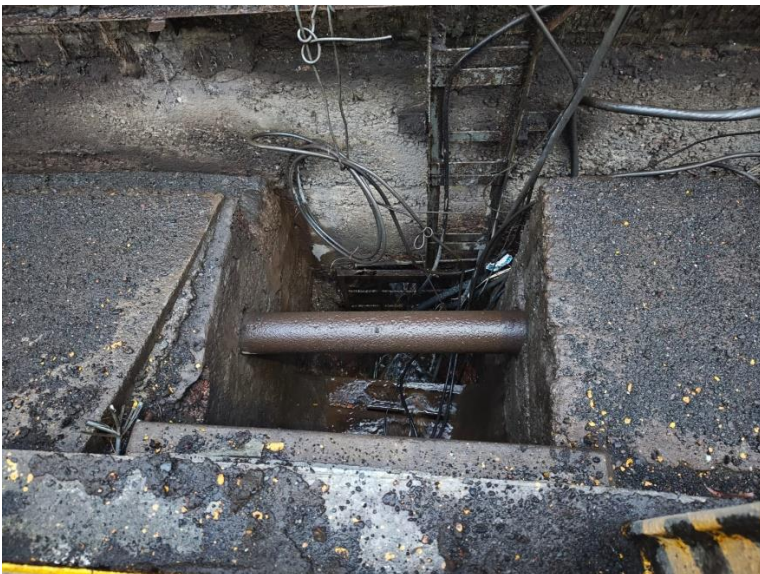
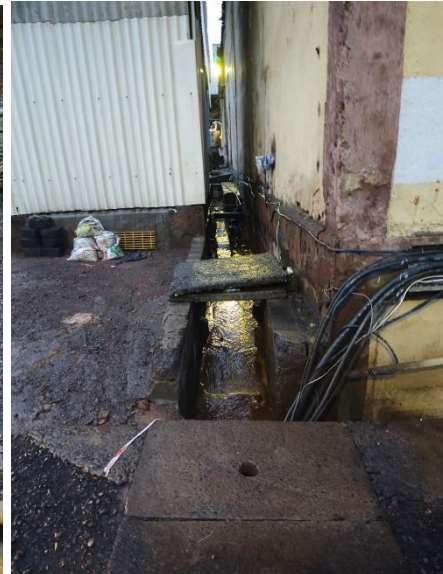
- vi. The Team then proceeded to the premises of M/s Paradeep Phosphates Limited to inspect and identify any possible discharge from their premises.
- vii. The garland drains/storm water drains along the boundary of the Unit were inspected and there were traces of similar milky white water flowing in the storm water garland drains near the Urea loading gantry of the Unit. There were white sediments settled on the walls of the drains similar to that observed at the storm water drain near the creek. (Photographs attached below)

- viii. Accordingly, a final sample was collected from this drain that leads to the outside the Unit premises, i.e., Sample 5 – Storm water drain of PPL – (Coordinates: 15.372613, 73.870969)
- ix. The team also inspected the ETP of the unit and There were no pipelines or any other possible means observed for discharge of Untreated Effluent.
- x. The unit representative informed that a Culvert catchment pit has been built by the Unit to gather the surface runoff water and the said pit has two water submersible pumps, to pump the water back to the holding pond within the plant premises.
- xi. Traces of sedimentation caused due to Surface runoff water from the unit can be clearly seen on google images. (refer image attached below)

Fig 13, 14, 15 & 16: show the storm water garland drains within the unit premises near the Urea Loading gantry, having the same milky white appearing run off water.

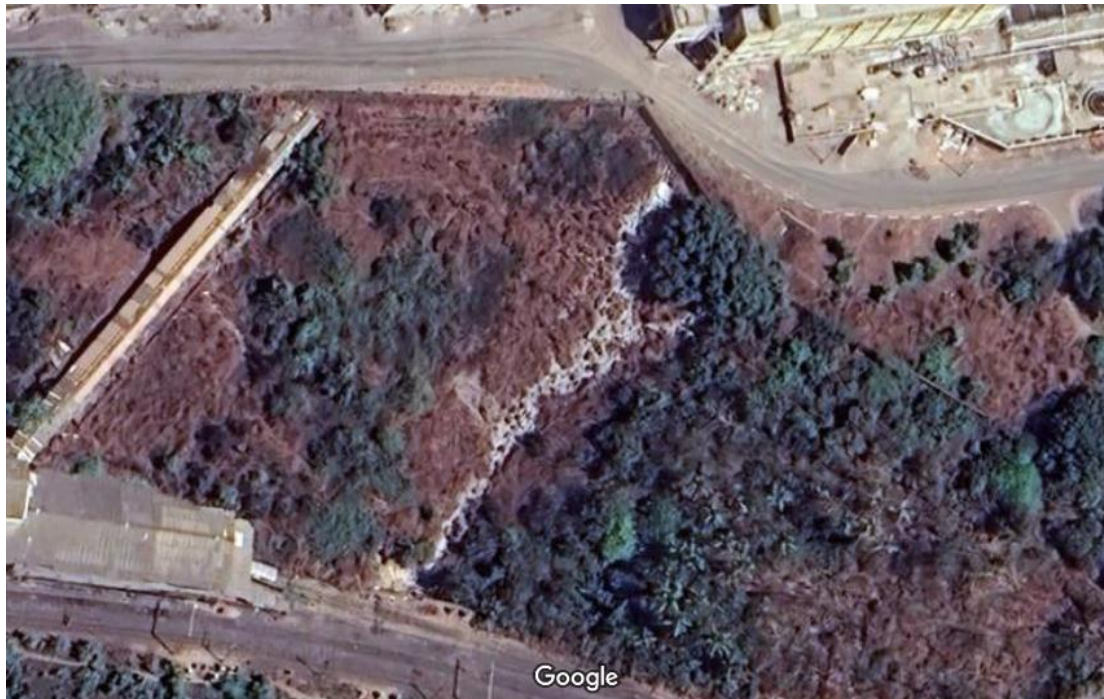
Fig 17: shows Google Earth image of surface runoff traces flowing from the unit

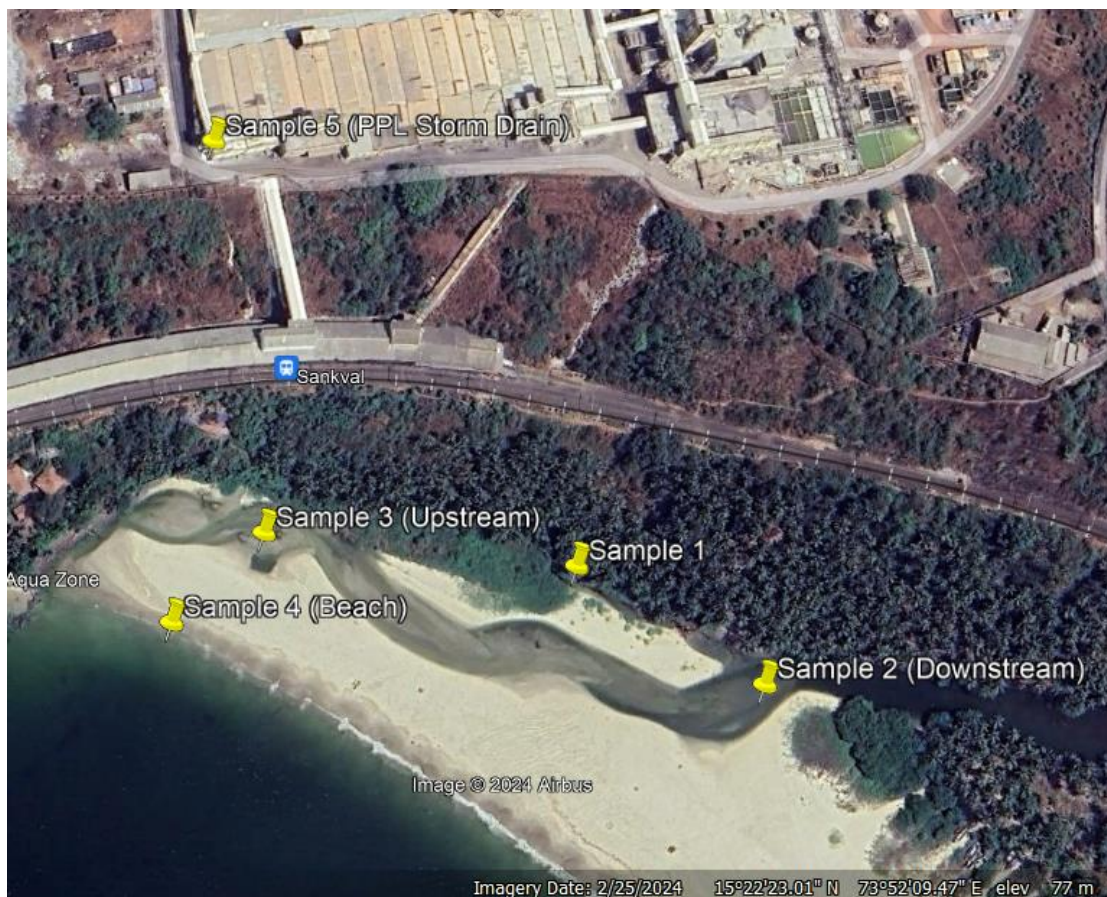
Sample Number	Location	Co-ordinates
2	Downstream of rivulet	15.370155, 73.873505
3	Upstream of rivulet	15.370862, 73.871207
4	Beach water Sample	15.370475, 73.870776

Fig 18: shows Google image of locations from where the team collected Samples for testing.
