Report on environmental pollution by Monnet Daniel Washery situated at Khalari Block of Ranchi District, Jharkhand, in the matter of Krishna Chouhan Vs State of Jharkhand in O.A No. 479/2022 pending before Hon'ble National Green Tribunal, Principal Bench, New Delhi.

The above committee members inspected/visited Monnet Daniels Coal Washery situated in the area of KDH in Khalari Block of District Ranchi on 16.03.2023.

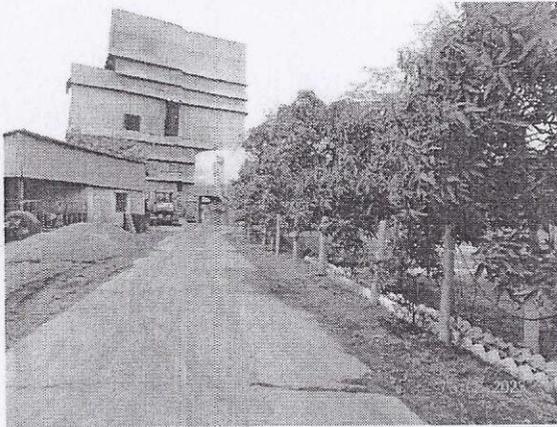
Photo 01: Photo of clean internal concrete roads in the project.

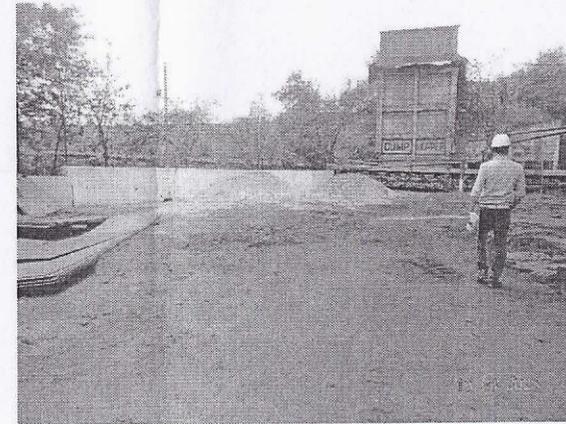
Photo 02: Photo of wall to prevent silt/rejects from washery to Sonadubi river.

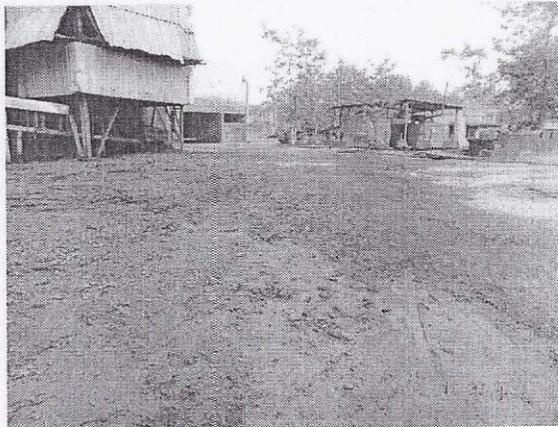
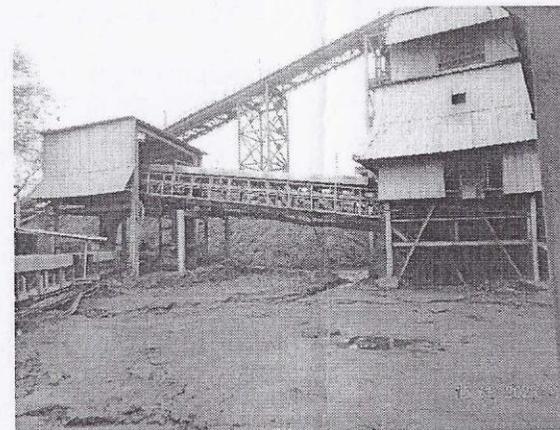
Photo 03&04: Photo of coal wastes/rejects near the processing unit around which a hump is required.

Make catch drains, siltation ponds, concrete humps/wall around coal dumps, washed coal, rejects so as to ensure that no coal dust/slurry flows in river/ other low lying areas.

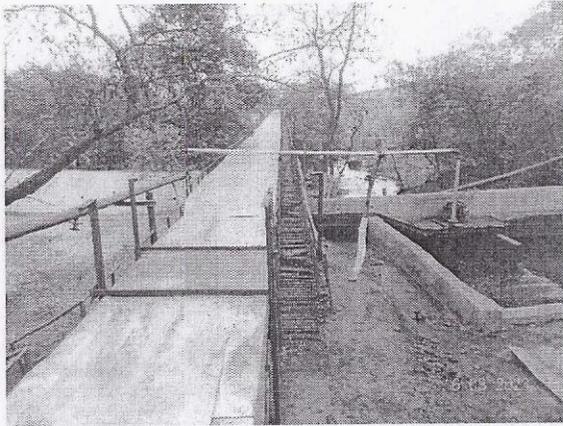
Photo 05: Photo of closed conveyor in the project

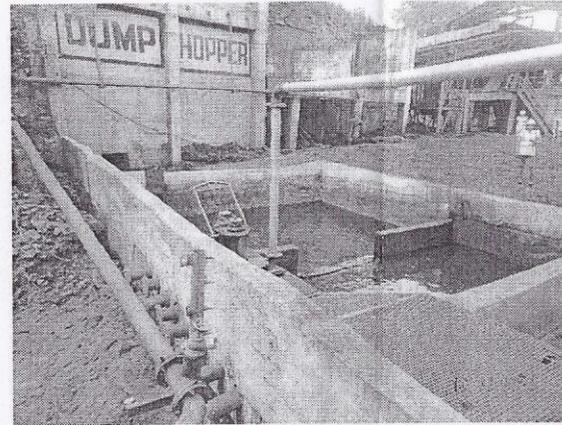
Photo06:Photo of tank in the project just adjacent to river where water from project and outside accumulates

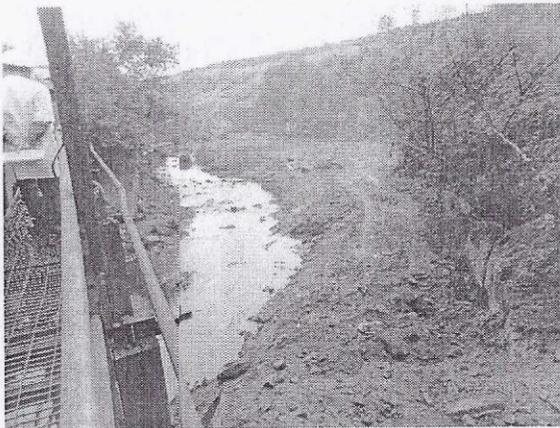
Photo 07: Photo of some grassing and vegetation on the slope between river and railway siding.

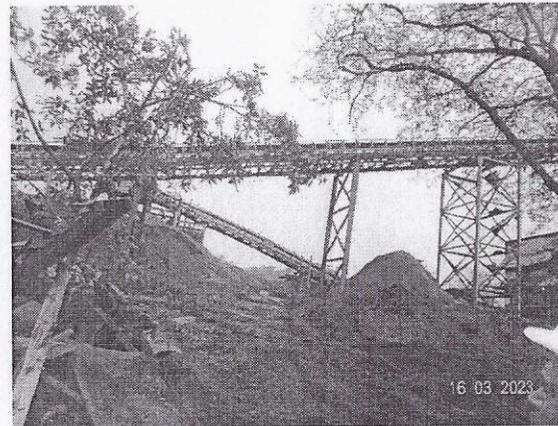
Photo 08: Photo of uncovered conveyor belts in the project.

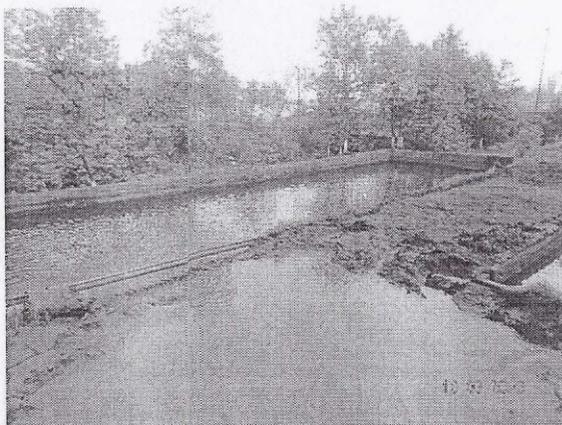
Photo 09: Photo of large concrete tank in the project adjacent to river Sonadubi.

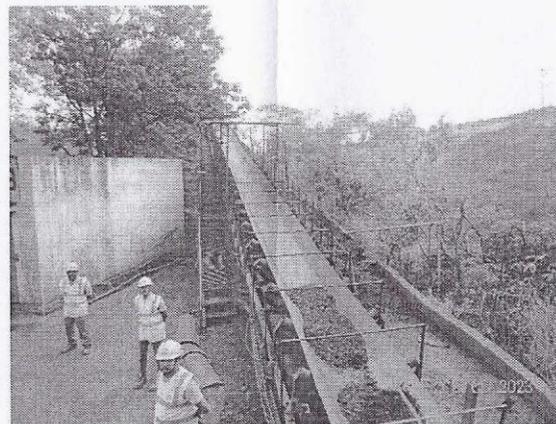
Photo 10: Photo of uncovered conveyor belt in the project.

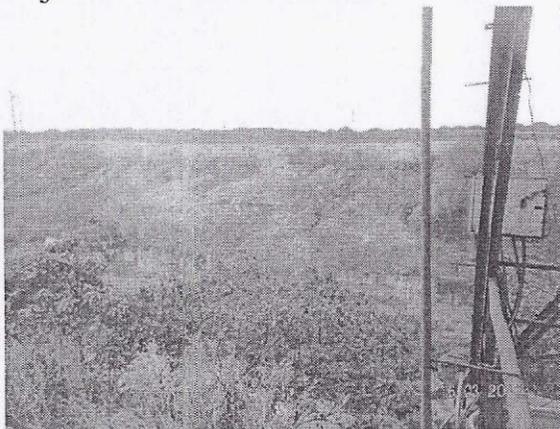
Photo 11: Photo of grassing and vegetation on the slopes between railway siding and river Sonadubi.

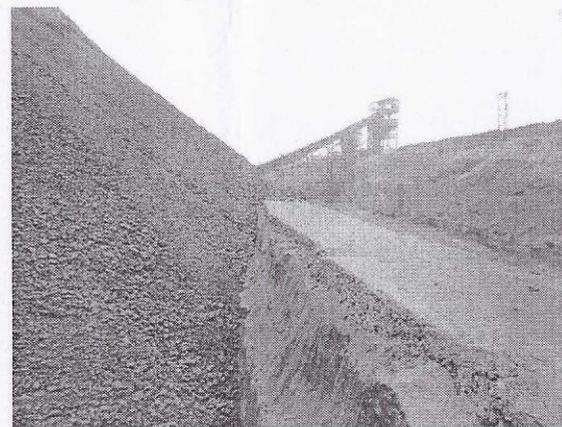
Photo 12: Photo of coal spillage on the walls of the project and adjacent to river

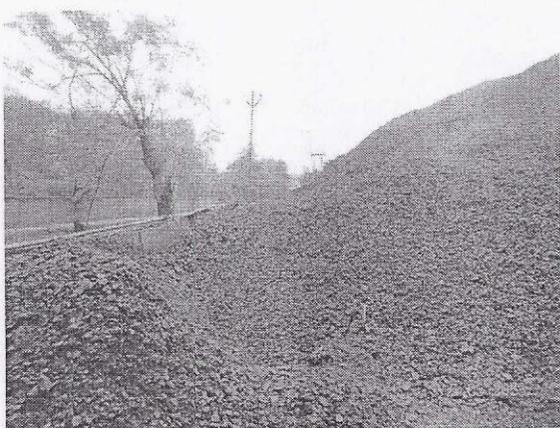
Photo 13: Photo of coal spillage over the wall of the project.

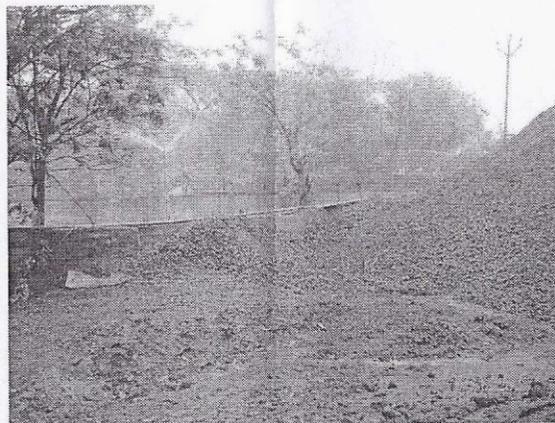
Photo 14: Photo of fixed water sprinklers in the project

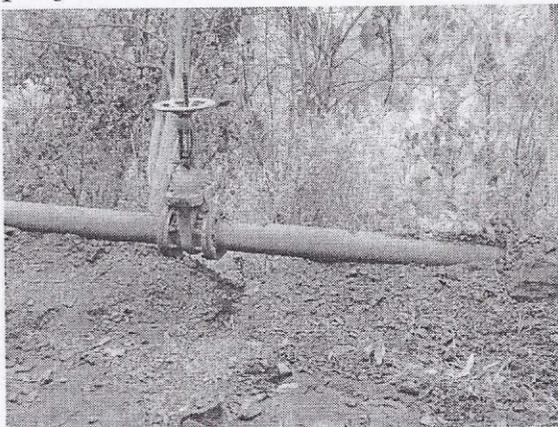
Photo 15: Photo of places in the project from where leakage of coal silt can occur to river

**New short wall construction needs to be done for some portion (30m) between stacker and transfer conveyor area so that coal silt would not flow from that side into river (See photo 15). Catch drain and siltation ponds also needs to be constructed at that side and accordingly instructions were given to PP who assured to construct the same soon (before rainy season).**

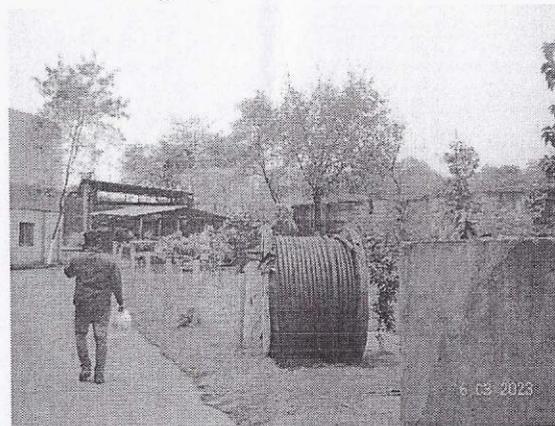
Photo 16: Photo of some plantations in the project near boundary

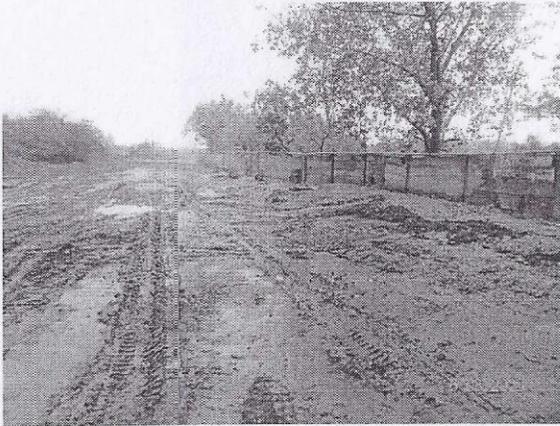
Photo 17: Photo of new plantations near boundary of the project

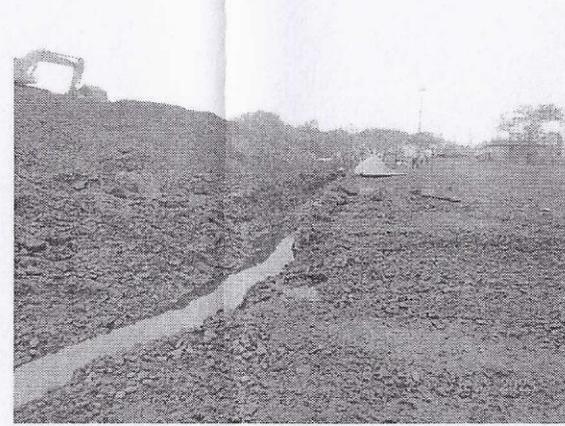
Photo 18: Photo of boundary wall construction in the north direction near gate no 2

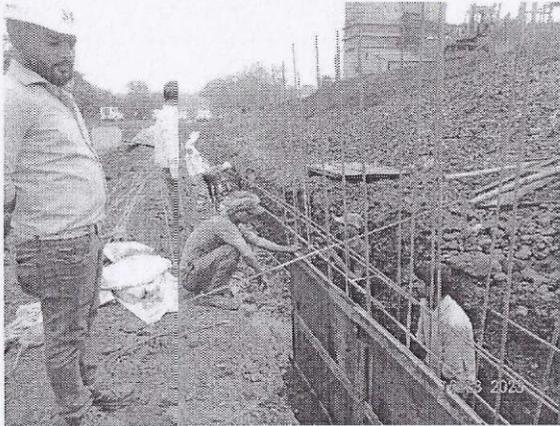
Photo 19: Photo of boundary wall construction in the north direction.

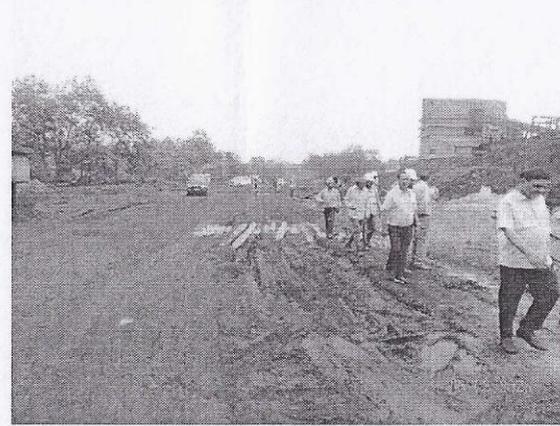
Photo 20: Photo of no jamming on the coal transportation road near earlier weighbridge location.

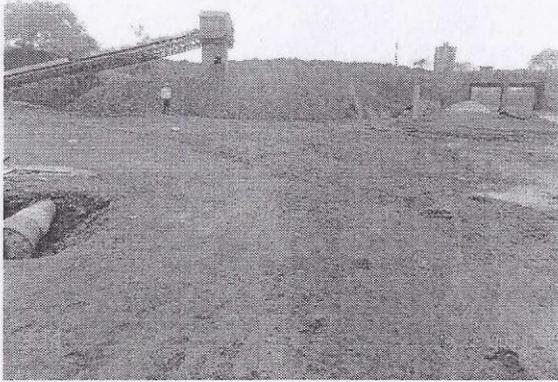
Photo 21: Photo of relatively clean road on the coal transportation route

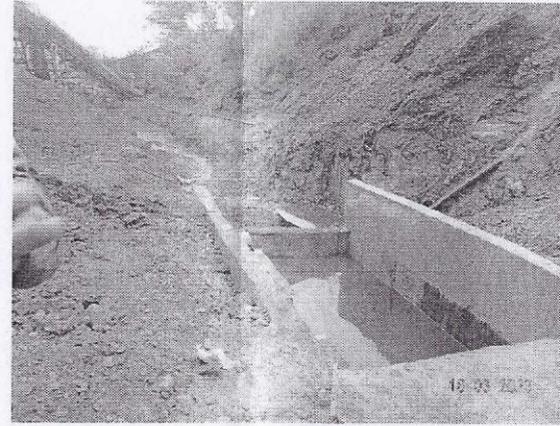
Two siltation ponds were constructed in the north west direction (see photo 22) in which water from railway siding and other areas would come and settle before flowing towards project.

Photo 22: Photo of siltation pond constructed by PP

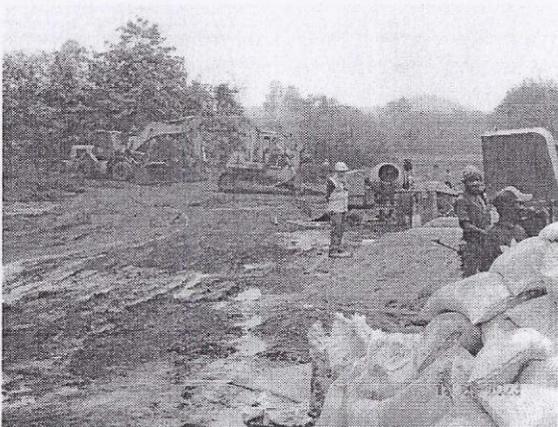
Photo 23: Photo of dozing on the coal transportation route for road cleaning

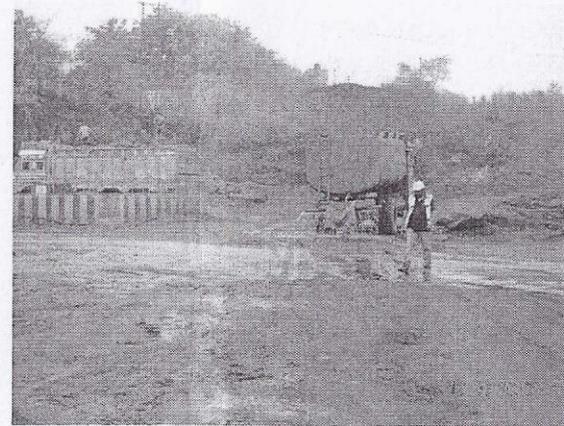
Photo 24: Photo of water tanker used for water sprinkling on the coal transportation route

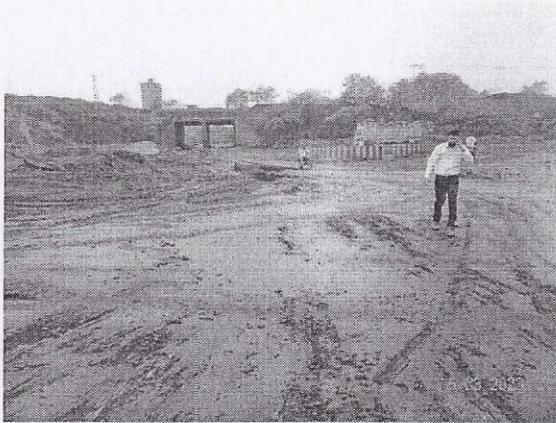
Photo 25: Photo of wet roads adjacent to projects

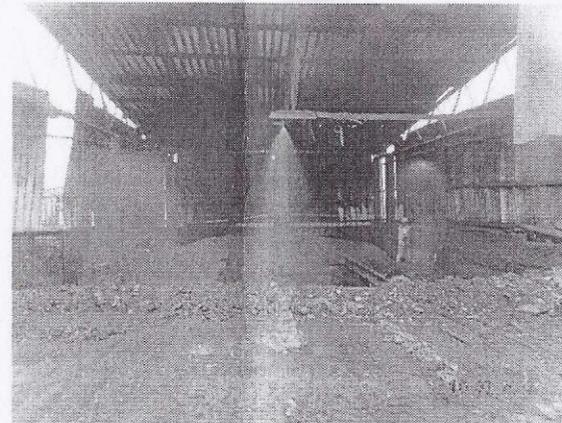
Photo 26: Photo of water spraying arrangement on coal hopper

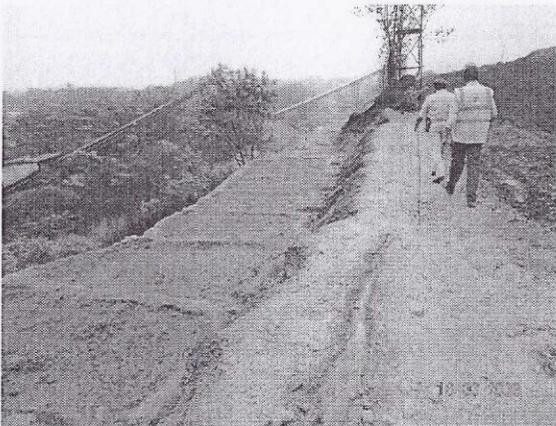
Photo 27& 28: Photo of new grassing and vegetation on the upper portion of the slope between railway sidng and river Sonadubi.

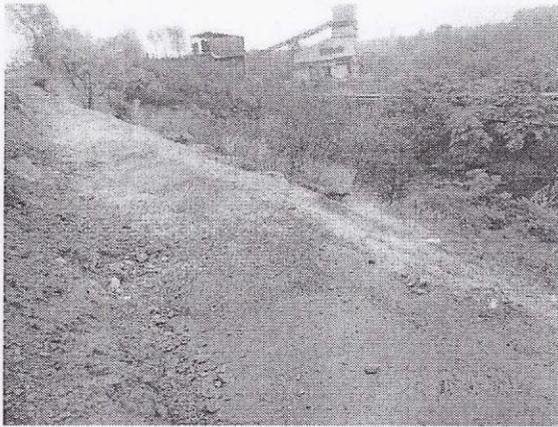
Photo 29: Photo of new grassing and vegetation

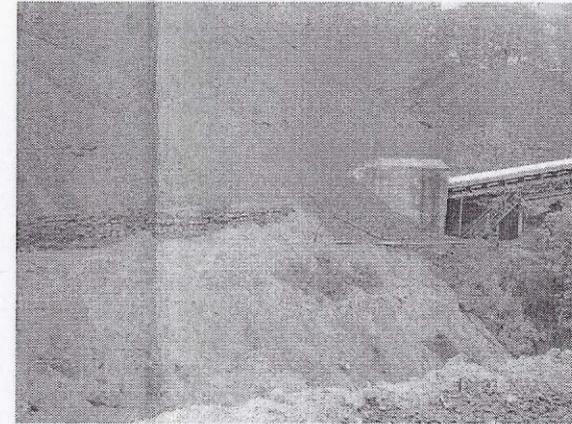
At some places wall of the project were still found to be broken adjacent to river ( see photo 30,31,32) and it was instructed to repair urgently.

Photo 30: Photo of coal spillage over the walls of the project and adjacent to river Sonadubi

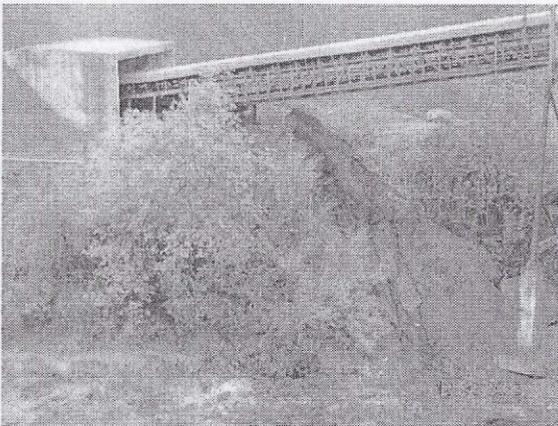
Photo 31: Photo of coal spillage under the conveyor project adjacent to river Sonadubi

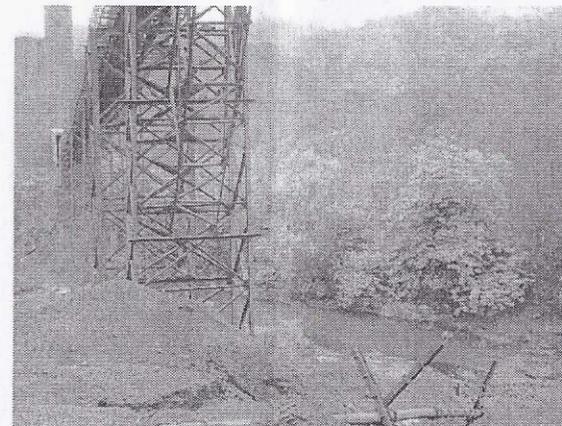
Photo 32: Photo of broken wall in the adjacent to river Sonadubi

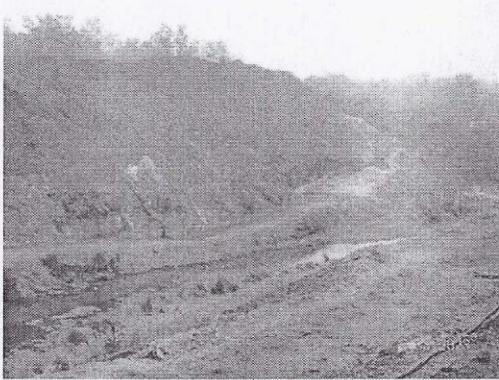
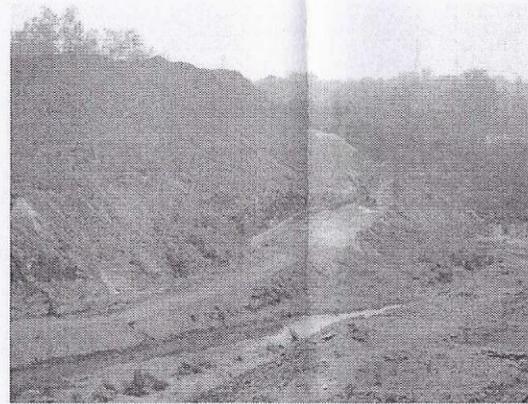
Photo 33& 34: Photo of wall under construction and spillage of coal over old wall adjacent to river .

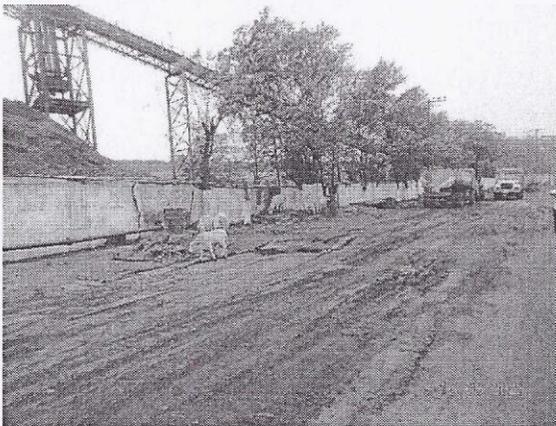
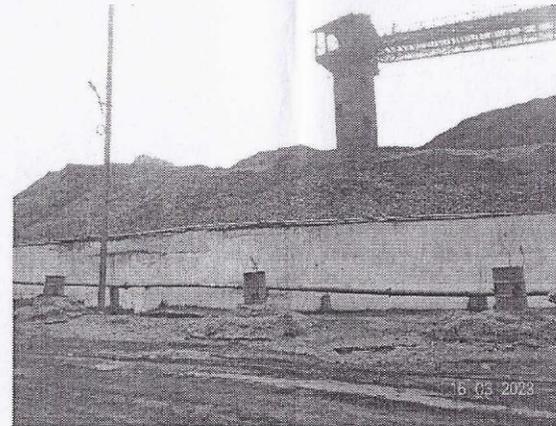
Photo 35& 36: Photos of pucca wall constructed in east and south east direction . new plantations can also be seen .

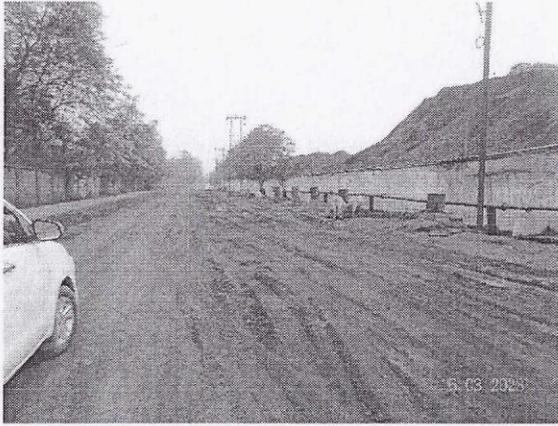
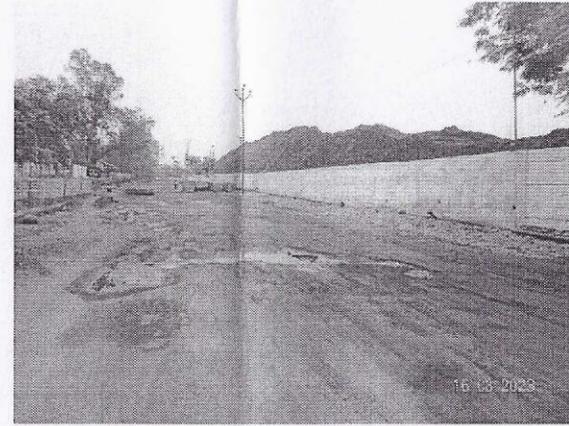
Photo 37& 38: Photo of pucca wall constructed in east and south east and relative clean road there. New plantations can also be seen.
