## **Joint report of CPCB and GPCB on status of restoration processes in place for dumped Gypsum and ground water contamination**

### **Background:**

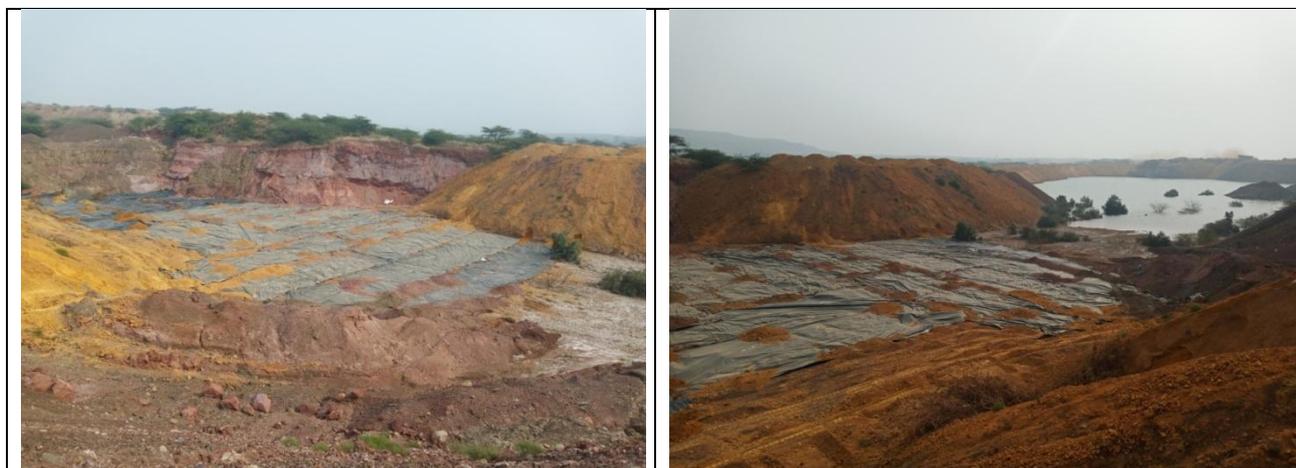
1. HDPE liner (0.2 mm) has been provided in about 2000 M<sup>2</sup> area of mine (Photograph shown below).
2. Storage /stacking of lifted Gypsum was observed around mines. Dumping of Gypsum in mines was yet to be started (Photograph shown below).

3. As per record submitted by the unit in GPCB, 8382 MT Gypsum has been lifted & stored at mines site during last three months.
4. It is informed that back filling capacity of mine is 5 lakh MT.
5. During visit rain water was observed stored /accumulated in one portion i.e. the south side of mines (Photograph shown below).

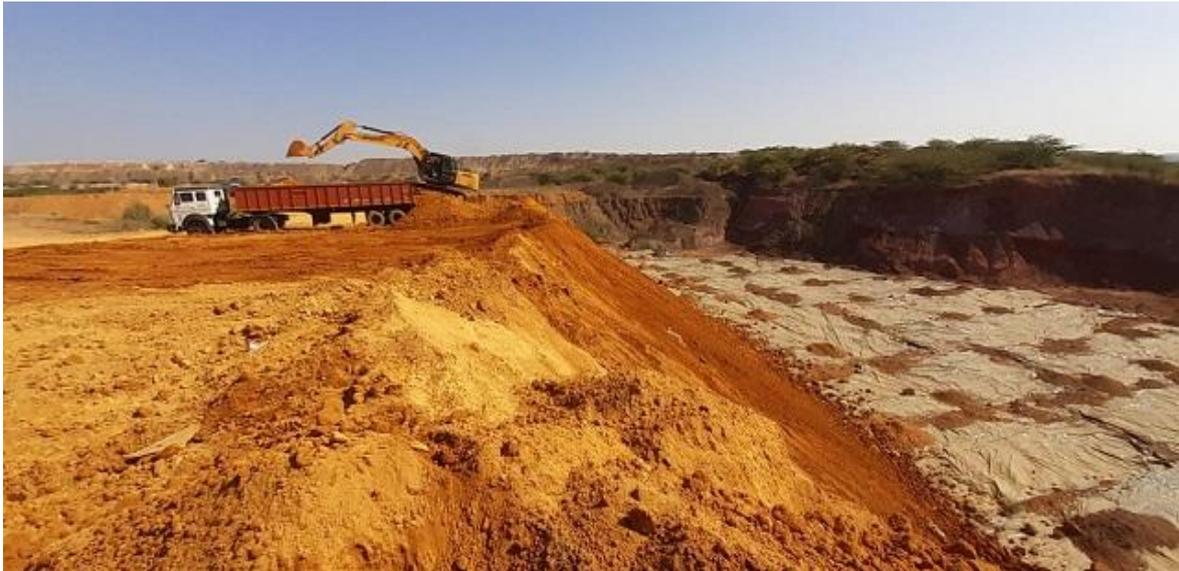
1. The joint team has observed during inspection on 05-06.02.2020 that the unit has started back filling of mines with waste Gypsum at Survey no. 189/P, Village: Mata no Madh, Taluka: Lakhpat, Dist: Kutch (Photograph shown below).
2. As per record provided in GPCB, unit has disposed 85739 MT Gypsum waste to cement industries for co-processing & 14864 MT for the back filling of abandoned mines during Jan-2019 to Jan-2020.

*Backfilling of abandoned mine is in-progress*

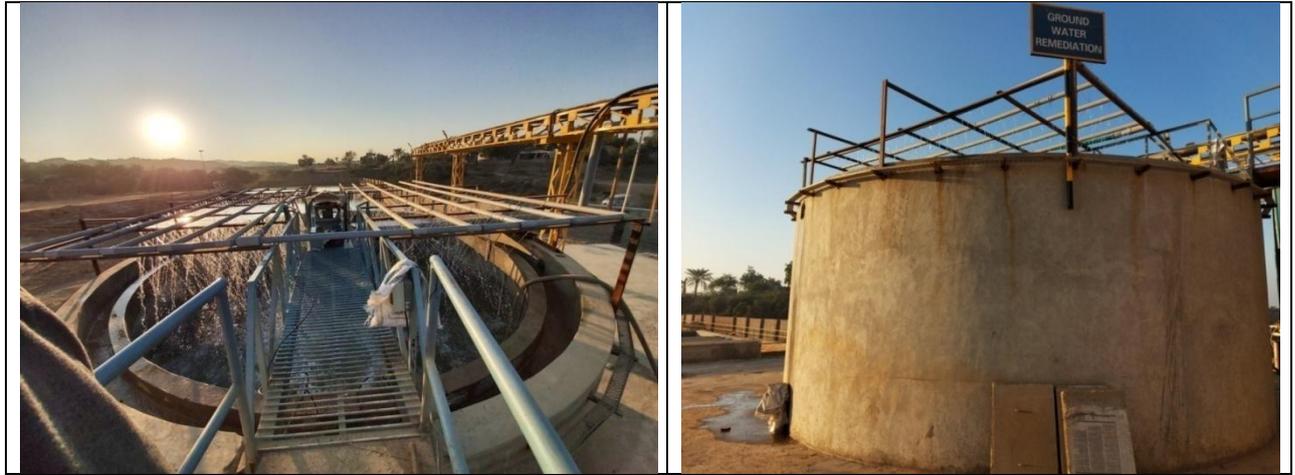
*Pumping of ground water @ 70 M<sup>3</sup>/Day from contaminated borewell to a collection tank (150 M<sup>3</sup>) inside the unit premises. The tank is provided with sprinkler system along with*

aeration. The water after aeration is fed to the RO system (already existing) and the permeate is used in the process and reject is sent to existing evaporation pond.

**RCC Tank with sprinkler system along with aeration**

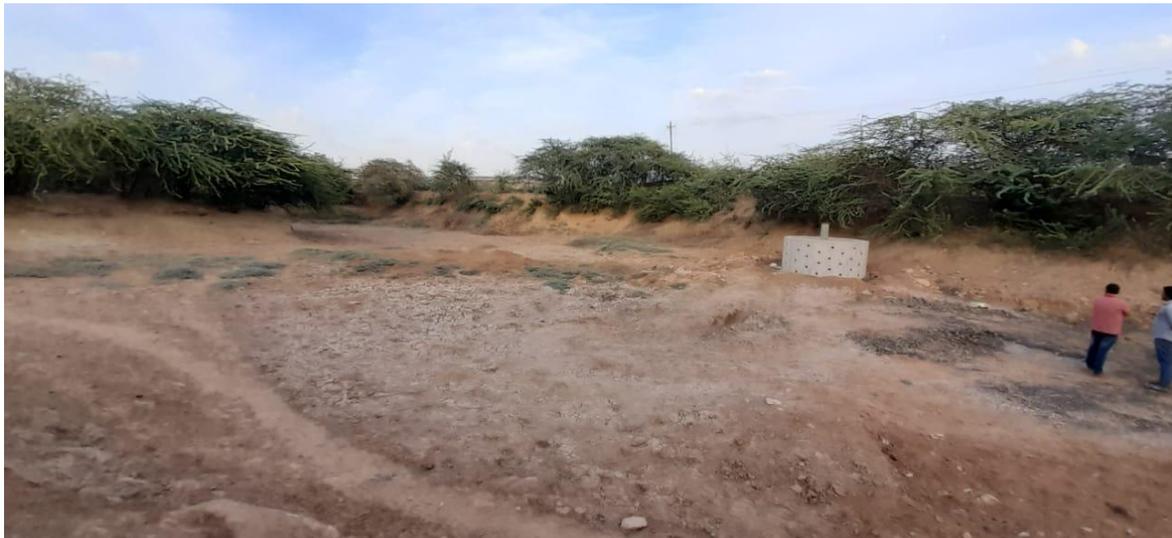
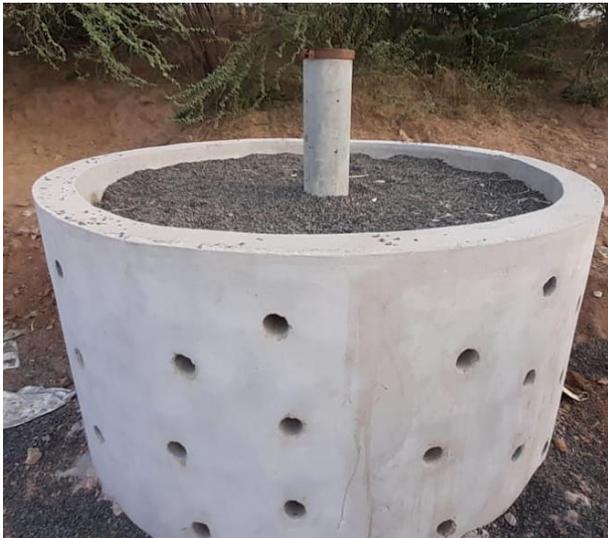
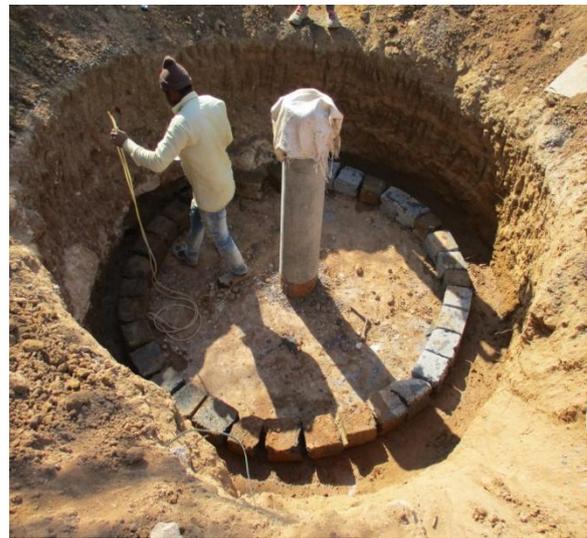
The unit is in the process of establishing one ground water recharge well at 100 m south-west side from unit (outside premises). The well is provided with perforated concrete conduit in the middle (reportedly 460 feet deep) to recharge the ground water strata (**Photographs shown below**).

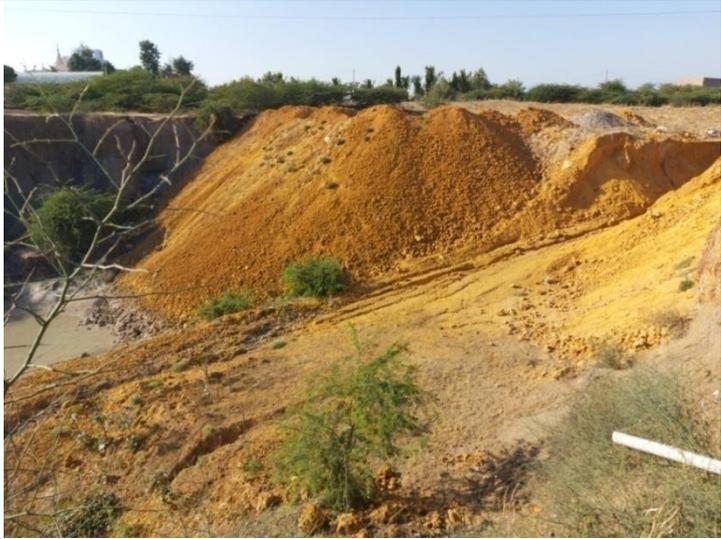
Status Report of Gypsum Lifting Activity as on 31.12.2019			
Sr. No.	Location/Area	As on 31/12/2019	Photograph
1.	Behind Lehriya Hanuman Temple, Old stone mine, Kukma Village  Geographical Coordinates 23° 13' 21" N, 69° 46' 21" E	The site is an abandoned stone mine. Gypsum was observed dumped in the mine.

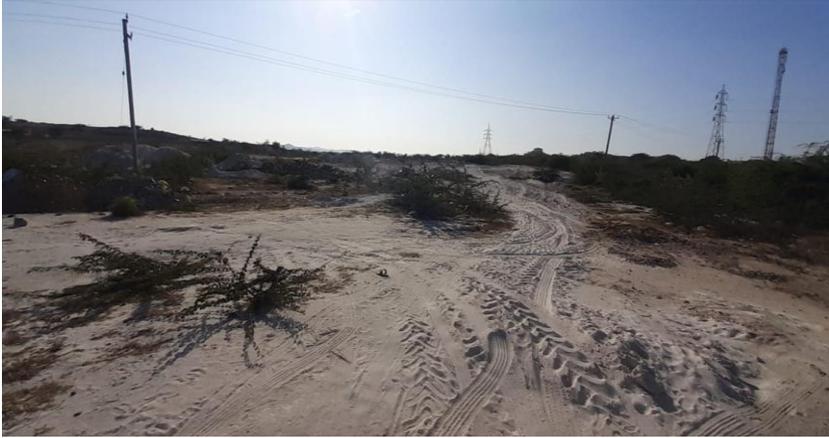
2.	Opposite to Lehriya Hanuman Temple, Kukma-Bhuj Road, Kukma Village  23° 13' 13" N 69° 46' 17" E	The site is an abandoned area. Gypsum was not observed at this site and top surface is covered with silica sand. Reportedly, the unit has lifted the dumped Gypsum from this site.

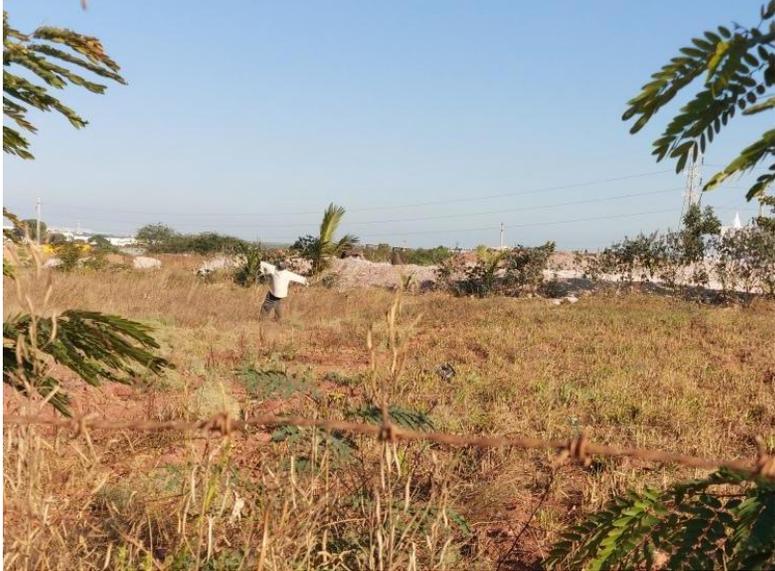
<p>3.</p>	<p>Besides Lehriya Hanuman Temple, Kukma Village</p> <p>23° 13' 24" N 69° 46' 19" E</p>	<p>The site is an abandoned area. Gypsum was not observed at this site and top surface is covered with soil. Reportedly, the unit has lifted the dumped Gypsum from this site.</p>

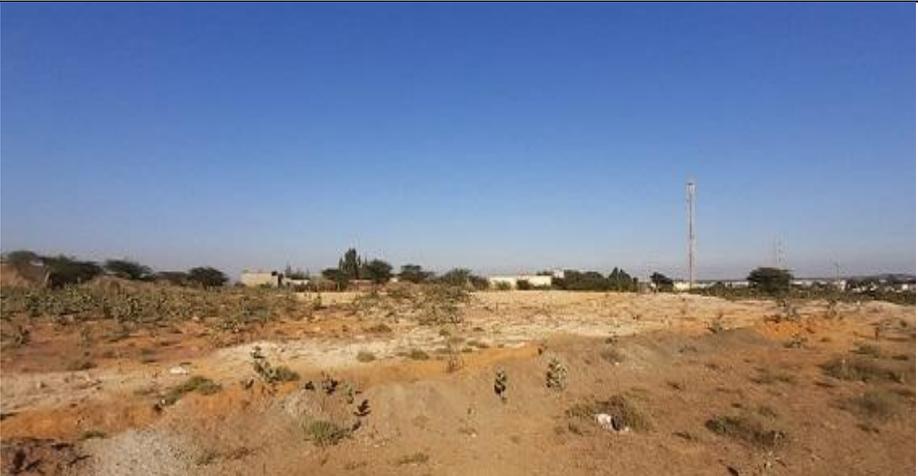
<p>4.</p>	<p>Old stone mine of Prakash Patel, Survey No:331, Besides old HotMix plant, Kukma Village</p> <p>23° 13' 16" N 69° 46' 3" E</p>	<p>The site is low lying abandoned area (abandoned stone mine). Gypsum was found spread in about 700 -800 M<sup>2</sup> area.</p>

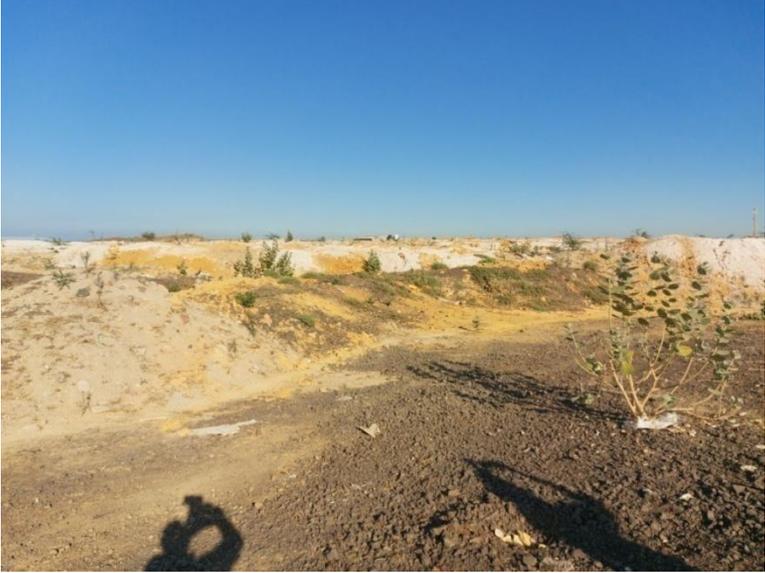
<p>5.</p>	<p>Behind khatri mills (Besides site described at S. No. 4 above), Traverse survey no: 331, government land, Kukma Village</p> <p>23° 13' 20" N 69° 45' 58" E</p>	<p>The site is an abandoned stone mine. Gypsum was observed dumped in the mine.</p>

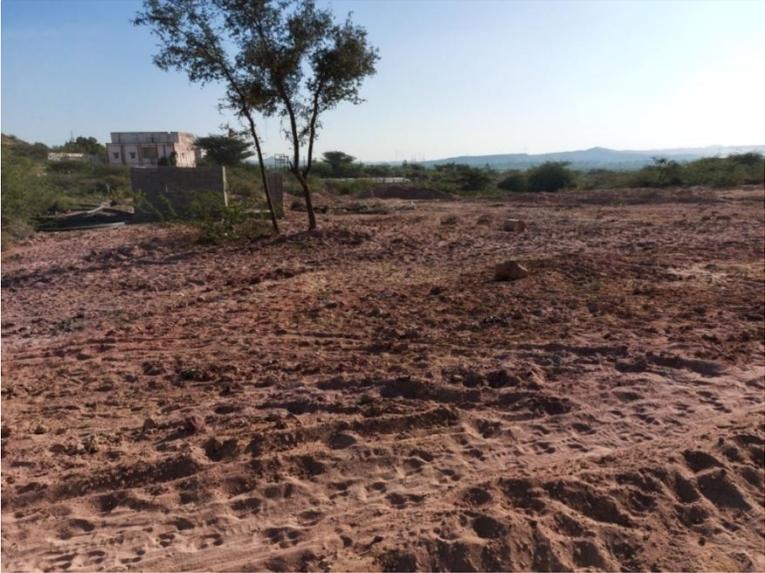
<p>6.</p>	<p>Besides water tank of GWIL Sump, Kukma Village</p> <p>23° 13' 18" N 69° 45' 46" E</p>	<p>The site is an abandoned area. Gypsum was not observed at this site and top surface is covered with loose soil. Reportedly, the unit has lifted the dumped Gypsum from this site.</p>

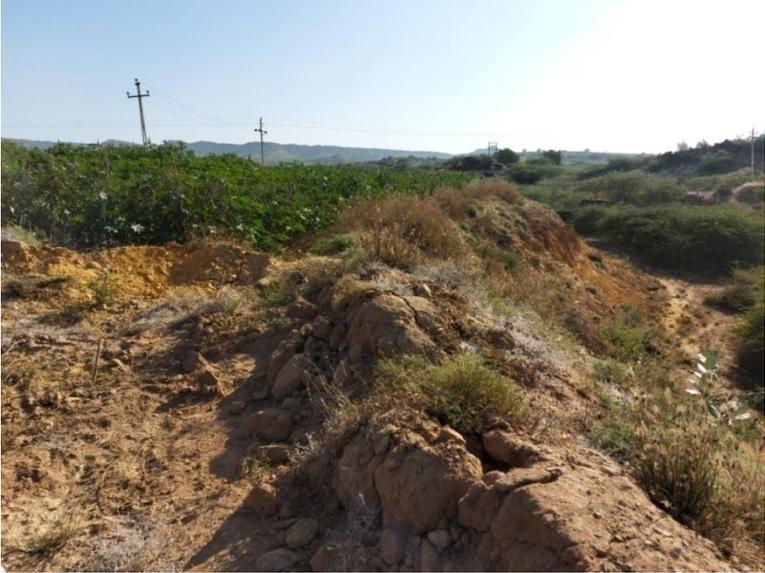
<p>7.</p>	<p>Natural drain between farm of Dinesh Maharaj and Govind Vanker, survey no : 218, Kukma Village</p> <p>23° 11' 56" N 69° 46' 47" E</p>	<p>The site is an agricultural land. Gypsum is mixed with soil on this agricultural land. Also some Gypsum is dumped on sides of the farm for making bund. During inspection Caster crop is observed in the farm.</p>

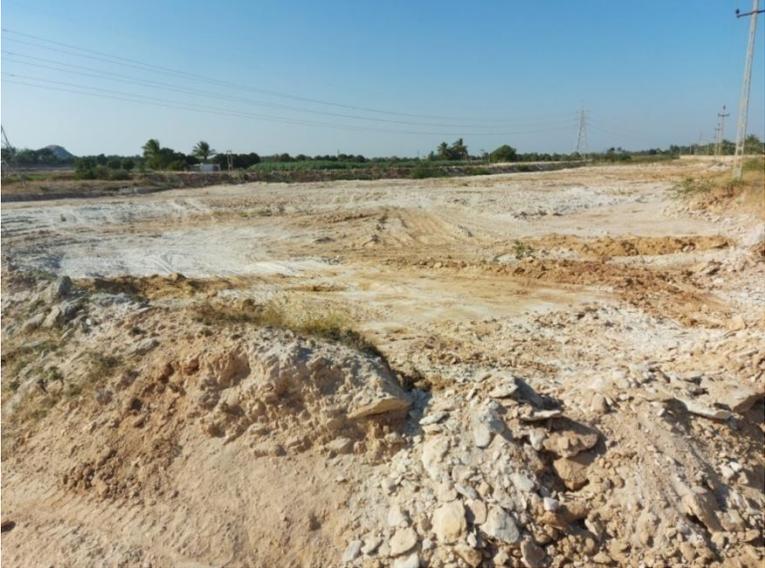
<p>8.</p>	<p>Vavdi Village</p> <p>23° 11' 35" N 69° 49' 42" E</p>	<p>The site is an abandoned low lying area. Gypsum was not observed at this site and top surface is covered with silica sand. Reportedly, the unit has lifted the dumped Gypsum from this site.</p>

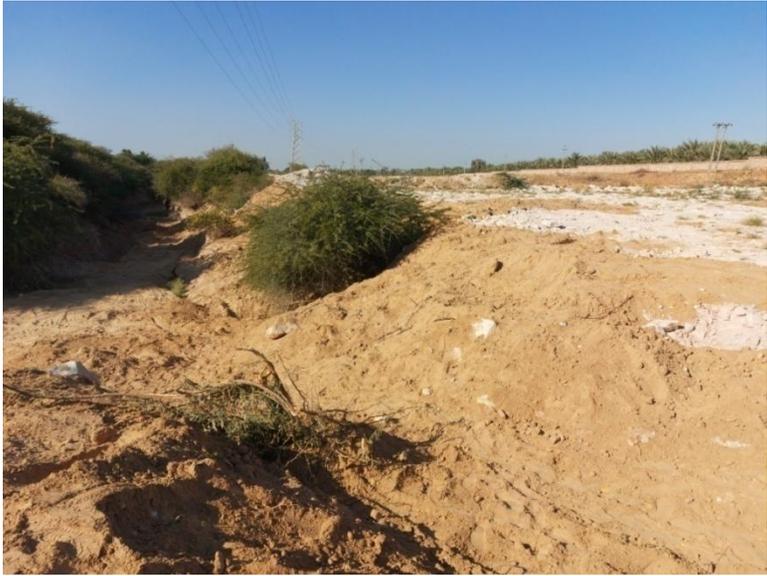
<p>9.</p>	<p>Vavdi Village, opposite to survey no: 85/1</p> <p>23° 11' 31" N 69° 49' 45" E</p>	<p>The site is an abandoned low lying area. Gypsum was not observed at this site and top surface is covered with loose soil and silica sand. Reportedly, the unit has lifted the dumped Gypsum from this site.</p>

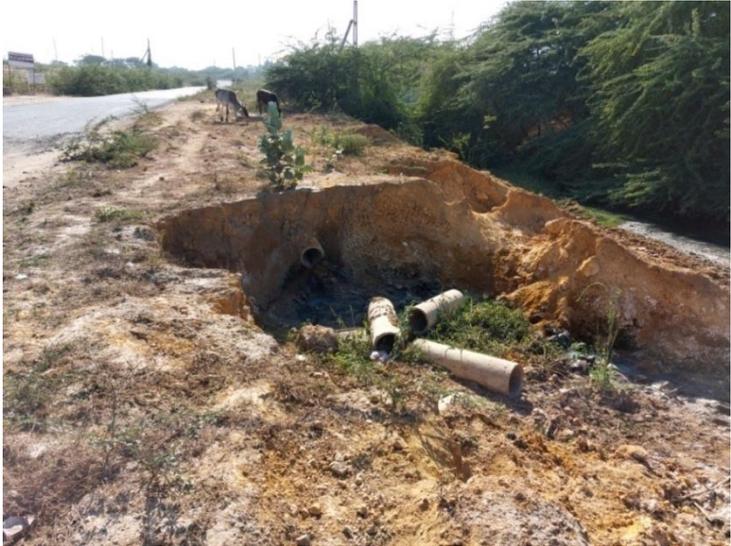
<p>10.</p>	<p>Kukma- Lakhond villageRoad</p> <p>23° 13' 50" N 69° 46' 48" E</p>	<p>The alleged site is along Kukma- Lakhond villageRoad. Gypsum is dumped along the low lying side of the road in about 1 KM stretch.</p>

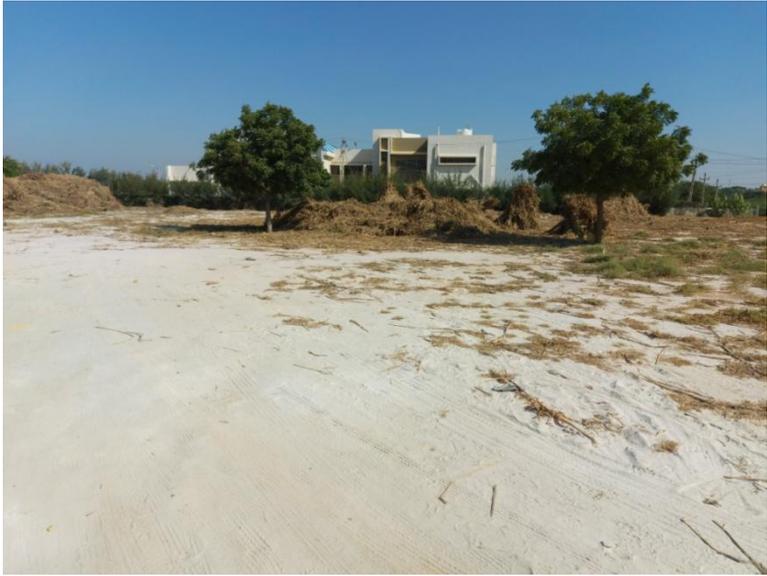
<p>11.</p>	<p>Vrundavan Gir Gaudham, ShreeSwaminarayan Mandir, BesidesAshapura Colony,Bhachau Road</p> <p>23° 13' 49" N 69° 46' 48" E</p>	<p>The site is open barren land. Gypsum was observed spread in about 2000M<sup>2</sup> flat land which is covered with silica sand.</p>

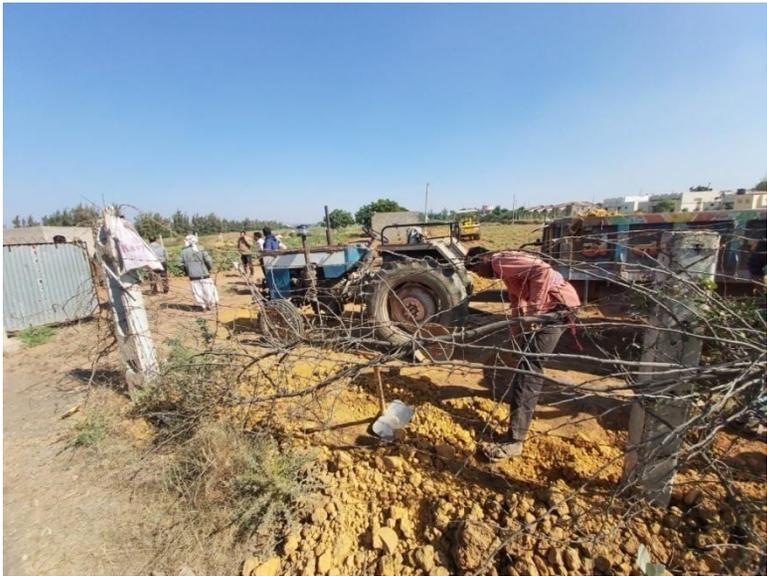
<p>12.</p>	<p>Behind AshapuraFoundation School,AshapuraColony, Bhachau road, Kukma</p> <p>23° 14' 7" N 69° 46' 26" E</p>	<p>The site is agricultural land. Gypsum was observed stacked on one corner of the land (small quantity) and also mixed with soil. However gypsum lifting activity through tractor was under progress.</p>

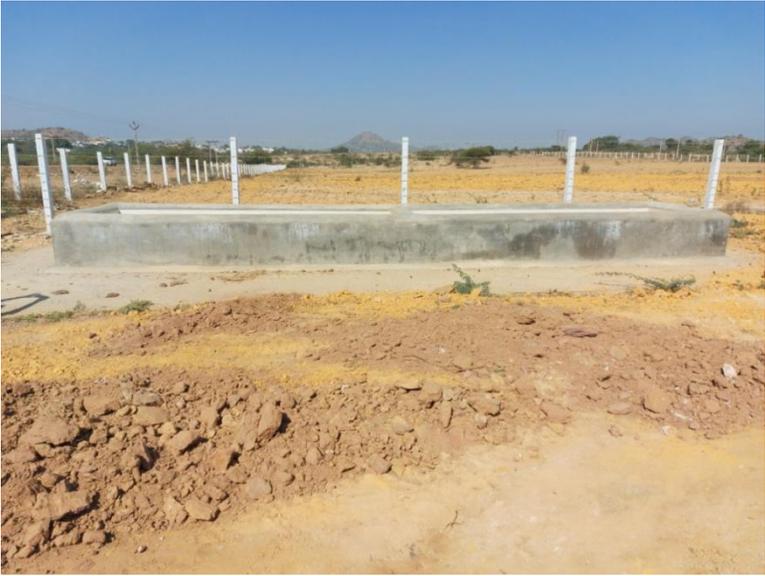
<p>13.</p>	<p>Farm on Lakhond Road</p> <p>23° 13' 49" N 69° 46' 52" E</p>	<p>The site is agricultural land. Gypsum was observed on this site mixed with soil and spread in about 1000 M<sup>2</sup> area.</p>

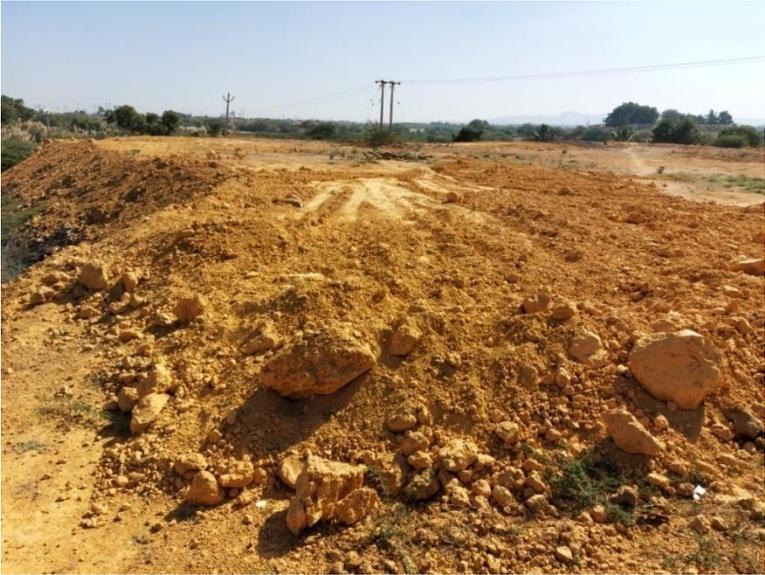
<p>14.</p>	<p>Land of Lakhond Village</p> <p>23° 15' 12" N 69° 46' 41" E</p>	<p>The site is a barren land where Gypsum is dumped in low lying areas.</p>

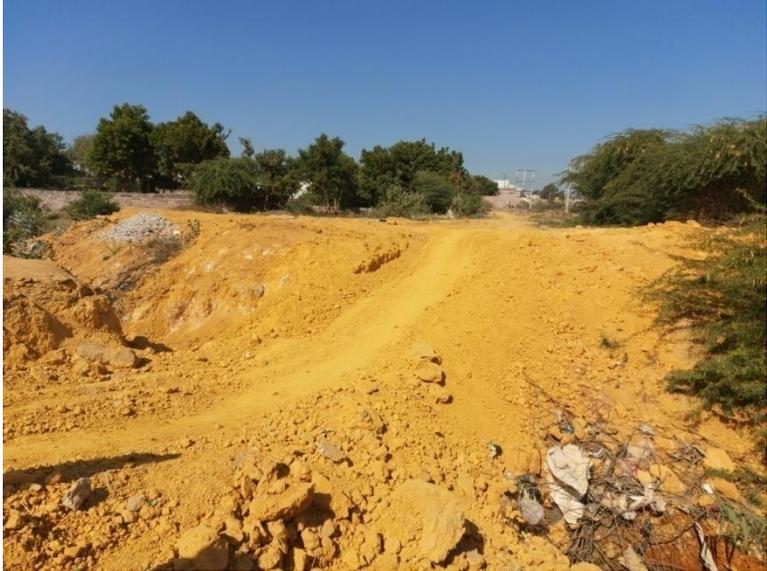
<p>15.</p>	<p>Adjacent to the site mentioned above at S.No. (14). Land of Lakhond Village</p> <p>23° 15' 11" N 69° 46' 40" E</p>	<p>The site is an abandoned land where Gypsum was found dumped in voids and corners.</p>

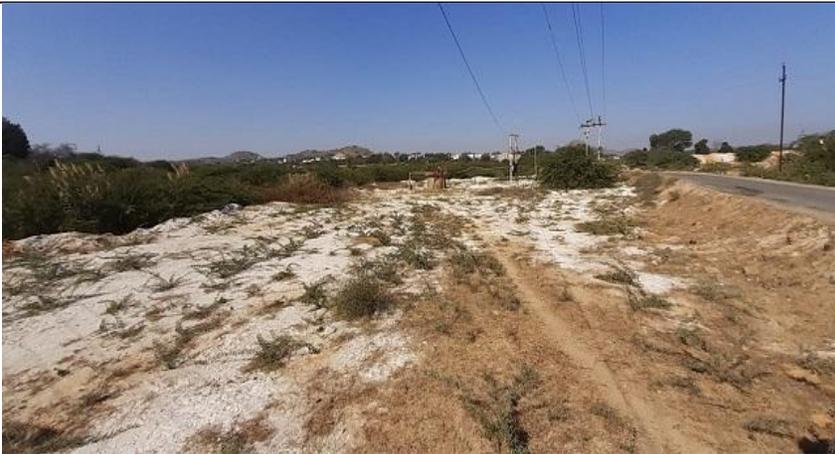
<p>16.</p>	<p>Lakhond- kali Talavadi Road, Village Lakhond</p> <p>23° 15' 03" N 69° 46' 48" E</p>	<p>The site is an abandoned low lying area along Lakhond- kali Talavadi Road. Gypsum was observed dumped on this site (probably for filling of low lying area) which is covered with silica sand.</p>

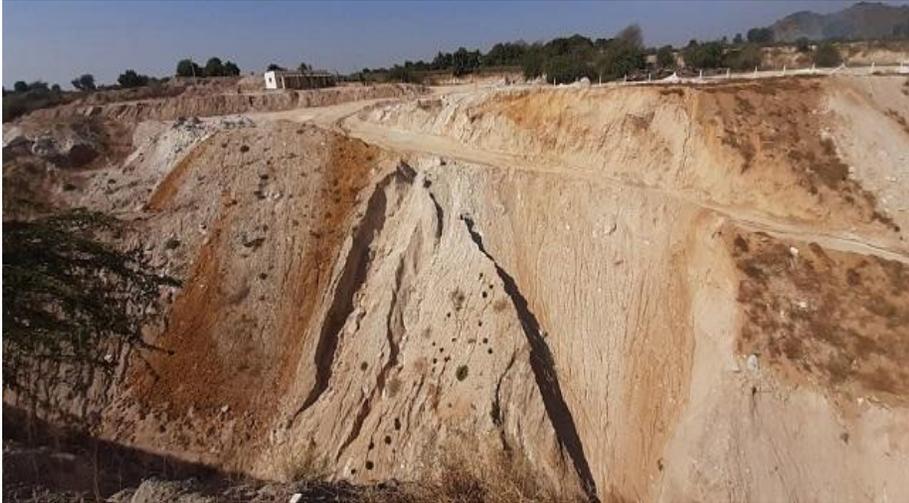
<p>17.</p>	<p>China Clay mine of Vastabhai, Village lakhond, Abandoned mine</p> <p>23° 15' 39" N 69° 47' 17" E</p>	<p>The site is an abandoned china clay mine. Gypsum was observed dumped in the mine.</p>

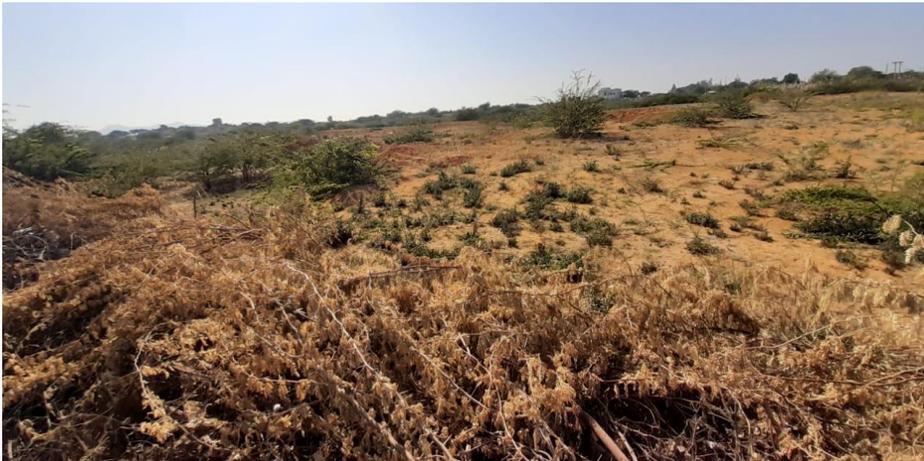
<p>18.</p>	<p>Government land on Padhdhar village</p> <p>23° 14' 29" N 69° 48' 44" E</p>	<p>The site is an abandoned location where Gypsum was found spread on top soil in about 1000 M<sup>2</sup> area.</p>

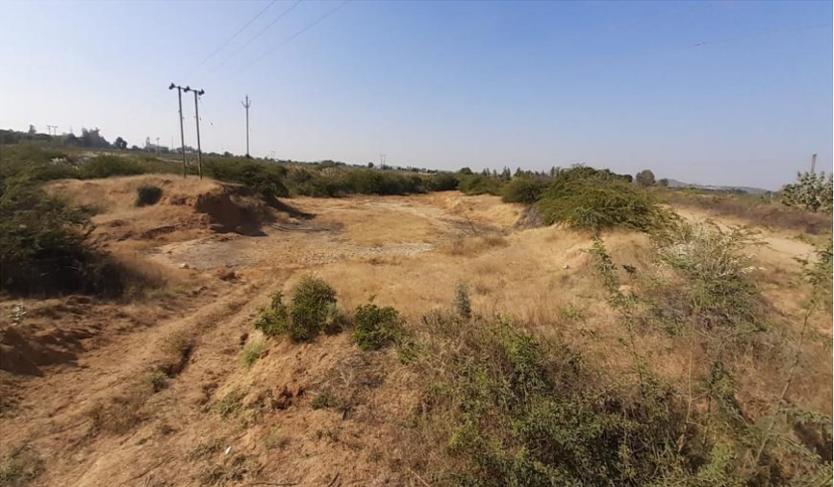
<p>19.</p>	<p>Land opposite and besides of Paddhar village police station.</p> <p>23° 14' 29" N 69° 48' 38" E</p>	<p>The site is an abandoned low lying area where no Gypsum was observed. Reportedly the unit has lifted the dumped Gypsum from this site.</p>

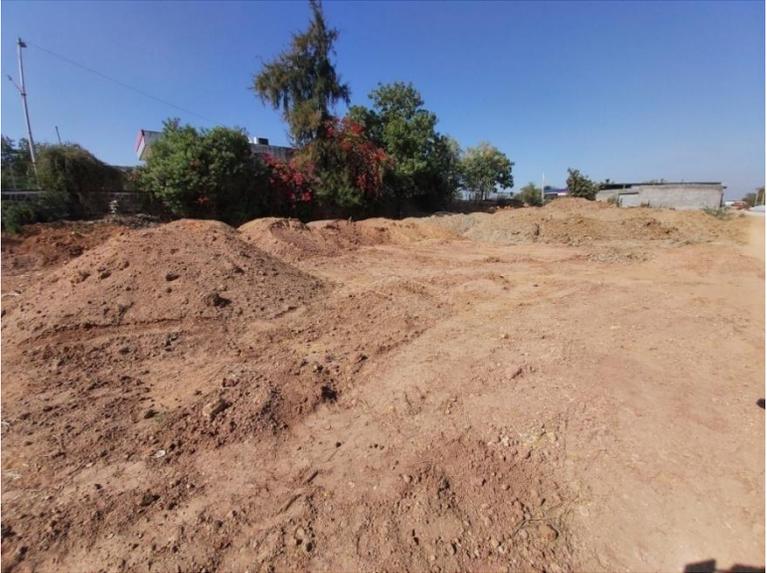
<p>20.</p>	<p>Behind Balaji Petrol Pump, ShaikhpirChokdi, Bhuj Anjar Highway.</p> <p>23° 13' 41" N 69° 45' 44" E</p>	<p>Gypsum was not observed on this location. Some heaps of loose soil were observed at the site. Reportedly, dumped Gypsum has been lifted from this site by the unit.</p>

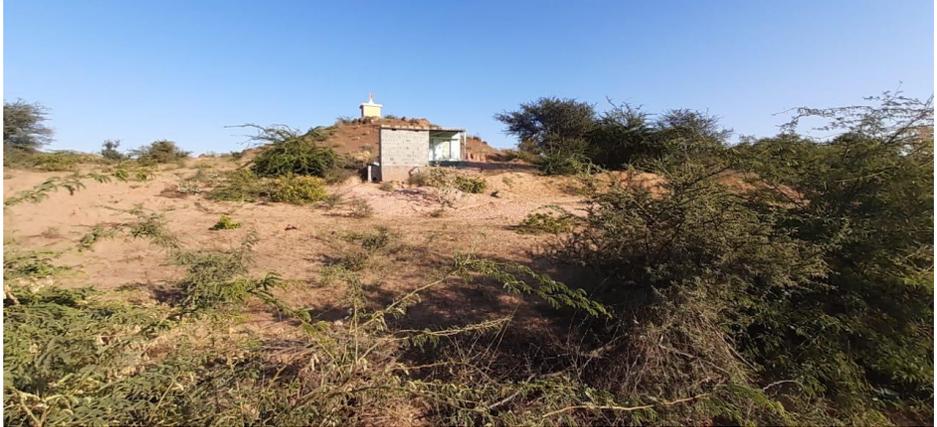
<p>21.</p>	<p>Near Matiyadev Mandir, Kukmavillage, Near kukma water distribution tank</p> <p>23° 14' 03" N 69° 46' 15" E</p>	<p>The site is a barren area. No Gypsum was observed at this site. Reportedly, the unit has lifted the dumped Gypsum from this site.</p>

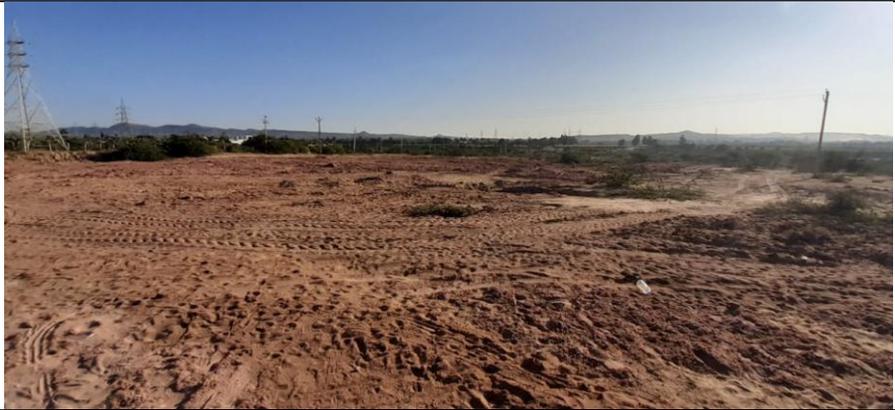
<p>22.</p>	<p>Land between Swaminarayan Vadi and water sump of GWIL, Kukma Village</p> <p>23° 14' 05" N 69° 45' 45" E</p>	<p>The site is a barren land. Gypsum was not observed on this site and top surface is covered with loose sandy soil. Reportedly, the unit has lifted the dumped Gypsum from this location.</p>

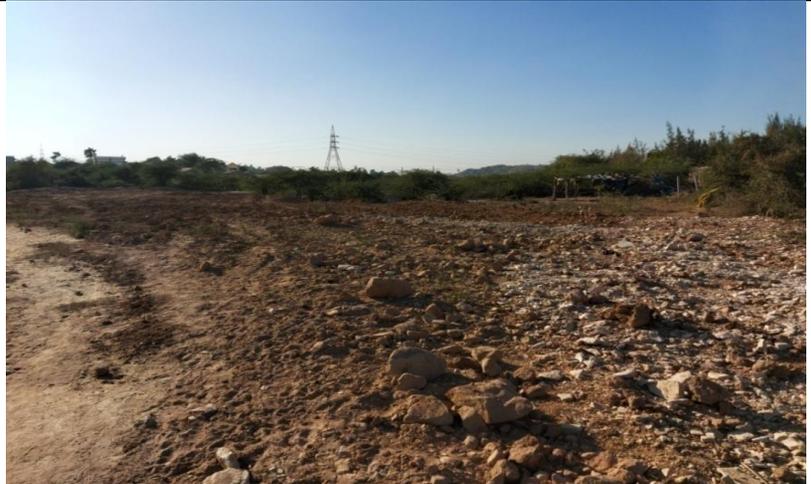
<p>23.</p>	<p>Natural Drain near Sanjot Nagar, Behind Swaminarayan Vadi</p> <p>23° 14' 05" N 69° 45' 45" E</p>	<p>The site is a barren area. Gypsum was not observed on this site and top surface is covered with loose soil. Reportedly, the unit has lifted the dumped Gypsum from this location.</p>

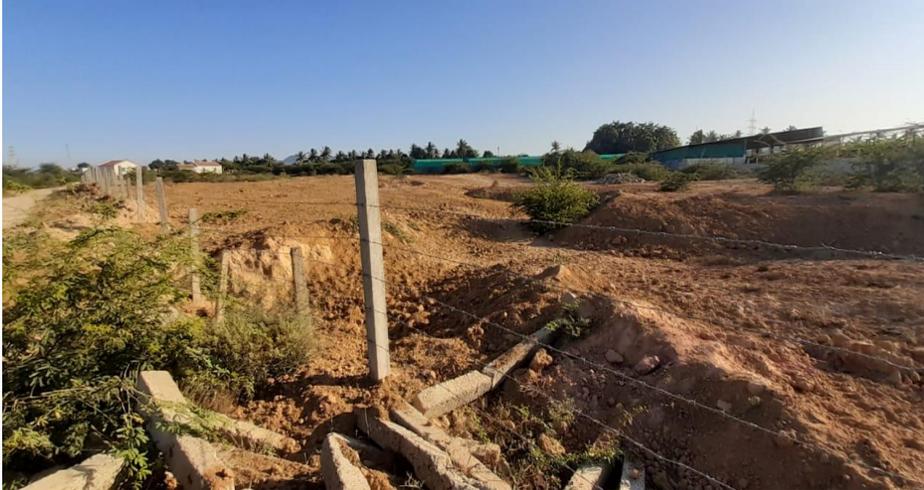
24.	<p>North side of Swaminarayan Vadi.</p> <p>23° 12' 50" N 69° 46' 9" E</p>	<p>The site is an open area. Gypsum was not observed on this site and top surface is covered with loose soil. Reportedly, the unit has lifted the dumped Gypsum from this location.</p>

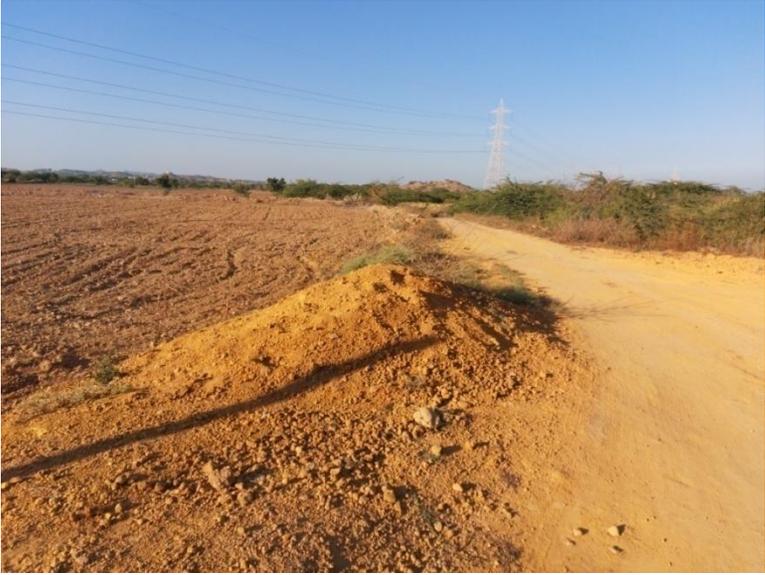
25.	<p>Besides Balubha Rathod's Lake, Ler Village.</p> <p>23° 11' 47" N 69° 46' 17" E</p>	<p>The site is kaccha internal road of Ler village along agricultural fields. Gypsum was observed dumped on sides of kaccha road and also mixed with soil for agricultural purpose.</p>

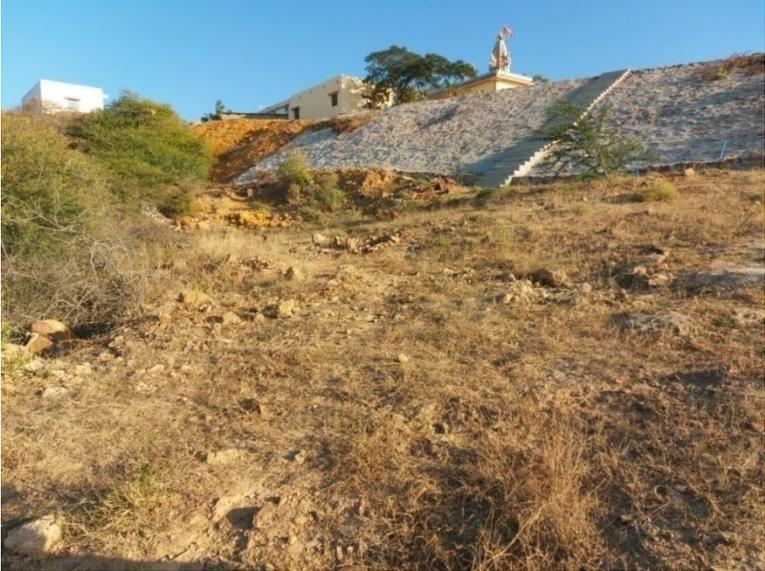
<p>26.</p>	<p>Pithoradada Mandir, Ler Village.</p> <p>23° 10' 23" N 69° 46' 05" E</p>	<p>The site is outer boundary of Pithoradada Mandir. Gypsum is dumped on the side slope of temple boundary.</p>

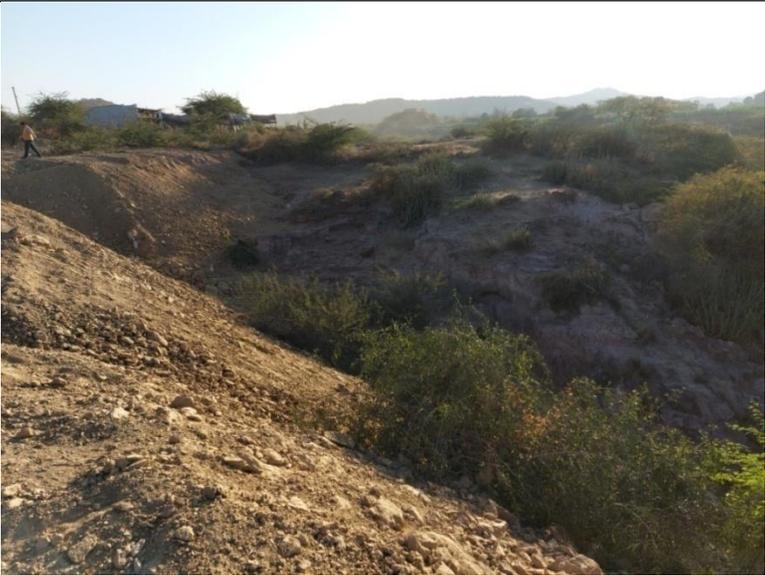
<p>27.</p>	<p>Land of Hetubha Jadeja. Ler Village</p> <p>23° 12' 07" N 69° 45' 34" E</p>	<p>The site is a low lying barren area. No gypsum was observed on this site and loose soil was found spread on slopes. Reportedly, the unit has lifted the dumped Gypsum from this location.</p>

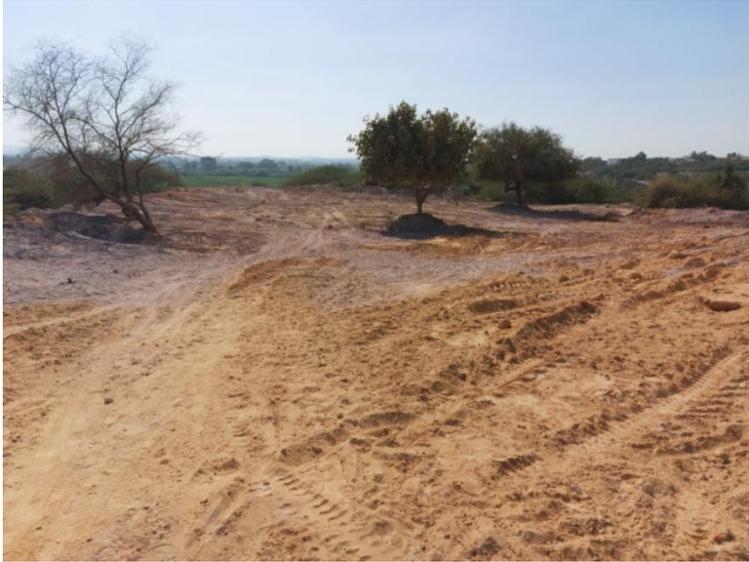
<p>28.</p>	<p>Dargah, Village: Lakhond</p> <p>23° 15' 31" N 69° 46' 55" E</p>	<p>The site is an abandoned area where Gypsum was not observed, however the site was covered with loose soil. Reportedly the unit has lifted the dumped Gypsum from this site.</p>

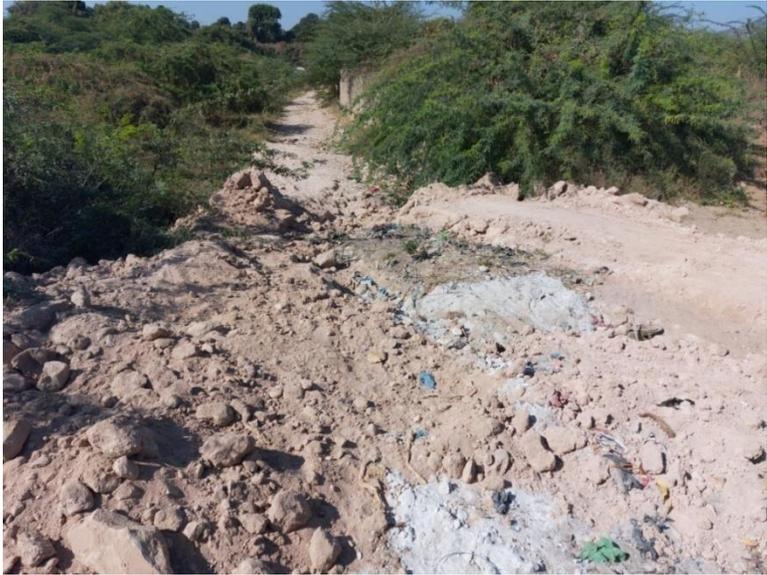
<p>29.</p>	<p>Village: Lakhond</p> <p>23° 15' 39" N 69° 46' 44" E</p>	<p>The site is an abandoned low lying area where Gypsum was not observed, however dumps of loose soil was observed. Reportedly the unit has lifted the dumped Gypsum from this site.</p>

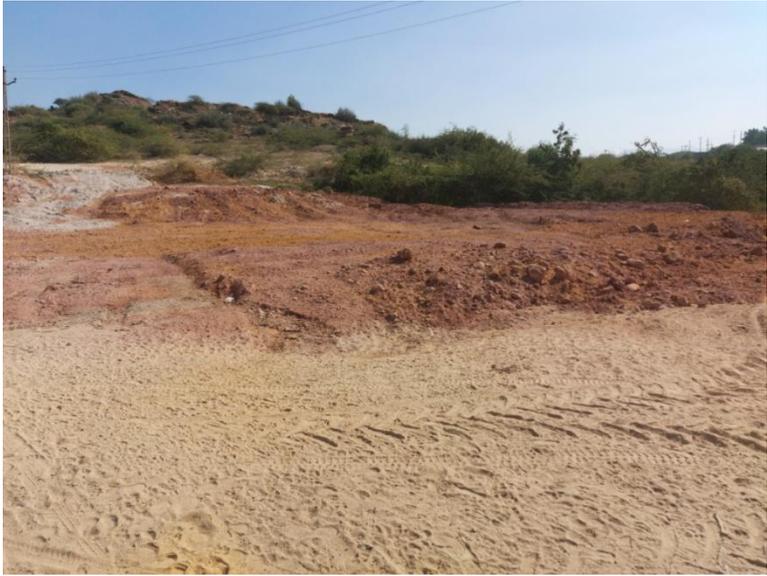
30.	<p>Village: Lakhond</p> <p>23° 15' 36" N 69° 46' 48" E</p>	<p>The site is an abandoned area where Gypsum was not observed. The site is covered with loose soil. Reportedly the unit has lifted the dumped Gypsum from this site.</p>

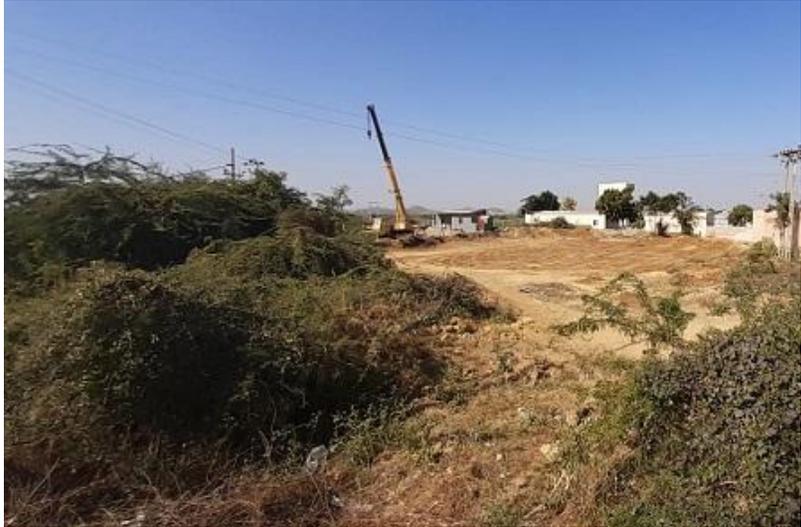
31.	<p>At near Toll Gate, Lakhond</p> <p>23° 15' 36" N 69° 46' 48" E</p>	<p>The site is an abandoned land where Gypsum was not observed. The site is covered with loose soil. Reportedly the unit has lifted the dumped Gypsum from this site.</p>

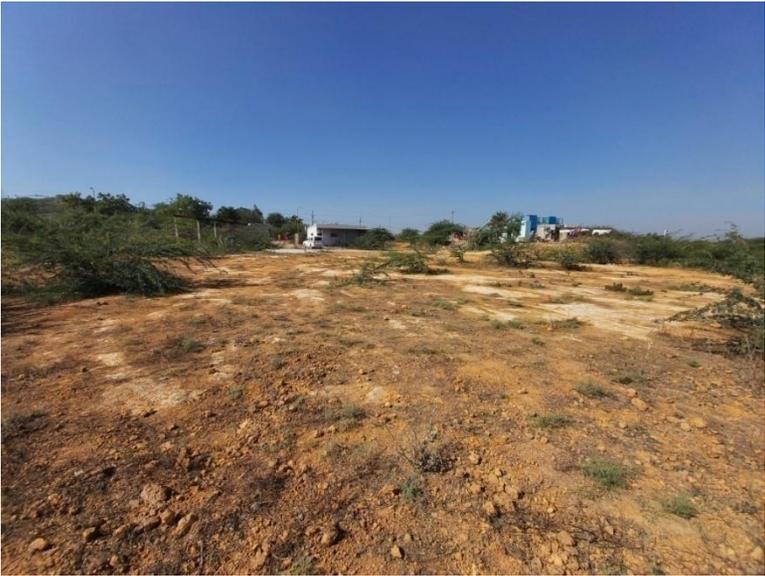
32.	At Shekhpur parle road 23° 13' 40" N 69° 45' 33" E	Gypsum was observed spread on top surface and also on sides at this site in about 1.5 KM area.

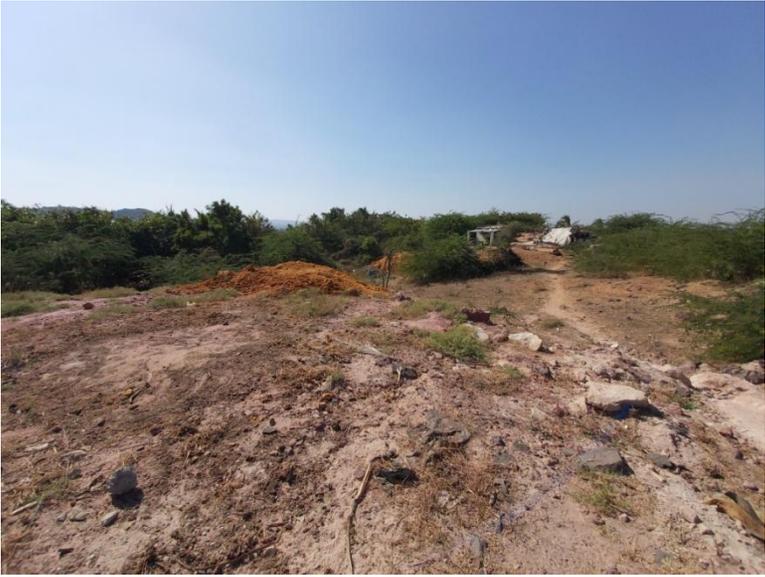
33.	At Shekhpur parle road 23° 13' 33" N 69° 45' 28" E	Some heaps of Gypsum was observed on this site, although the quantity was small.

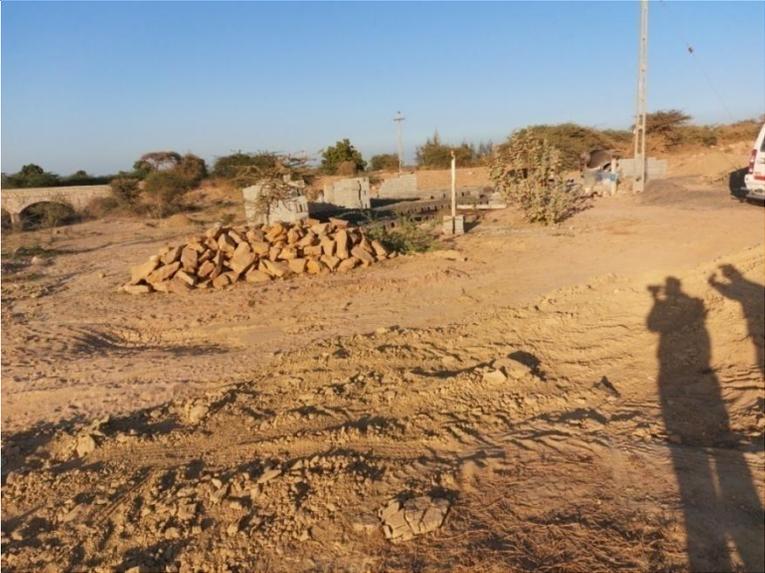
<p>34.</p>	<p>At Block factory, Village Ler</p> <p>23° 12' 06" N 69° 45' 34" E</p>	<p>The site is an open land area where cement brick manufacturing activity was in process. No Gypsum was observed at this location. Reportedly, the unit has lifted the dumped Gypsum from this location.</p>

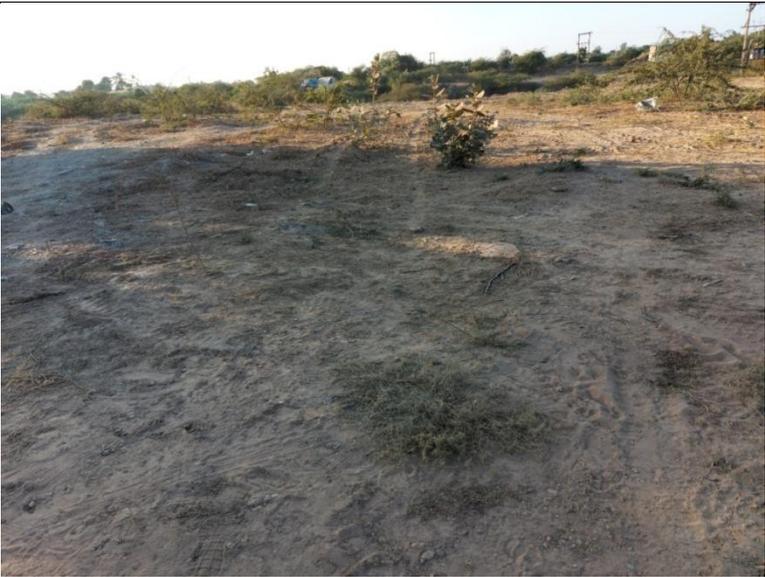
<p>35.</p>	<p>Near Block factory (adjacent to the site mentioned at s.no. 34), Village: Ler</p> <p>23° 12' 5" N 69° 45' 35" E</p>	<p>The site is open barren land. No gypsum was observed on this location and top surface is covered with loose soil. Reportedly, the unit has lifted the dumped Gypsum from this location.</p>

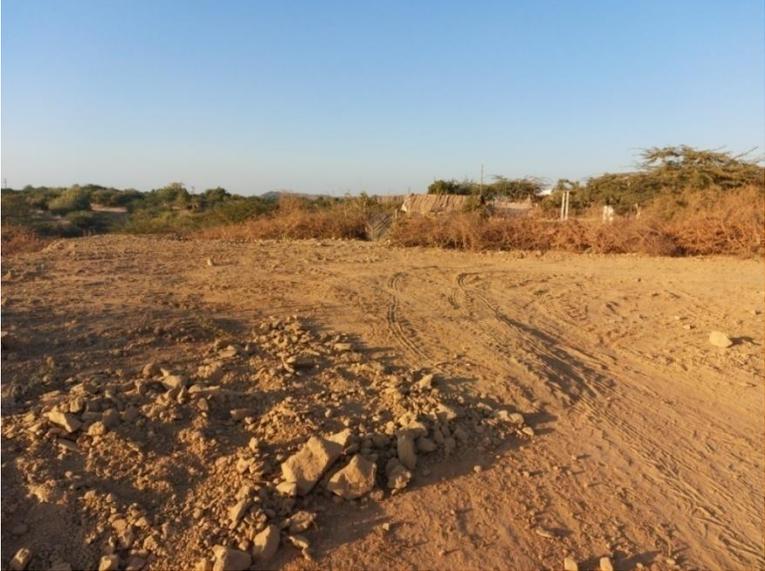
36	<p>Near Block factory (adjacent to the site mentioned at s.no. 34 &amp; 35), Village: Ler</p> <p>23° 12' 03" N 69° 45' 34" E</p>	<p>The site is open barren land. No gypsum was observed on this location and top surface is covered with loose soil. Reportedly, the unit has lifted the dumped Gypsum from this location.</p>

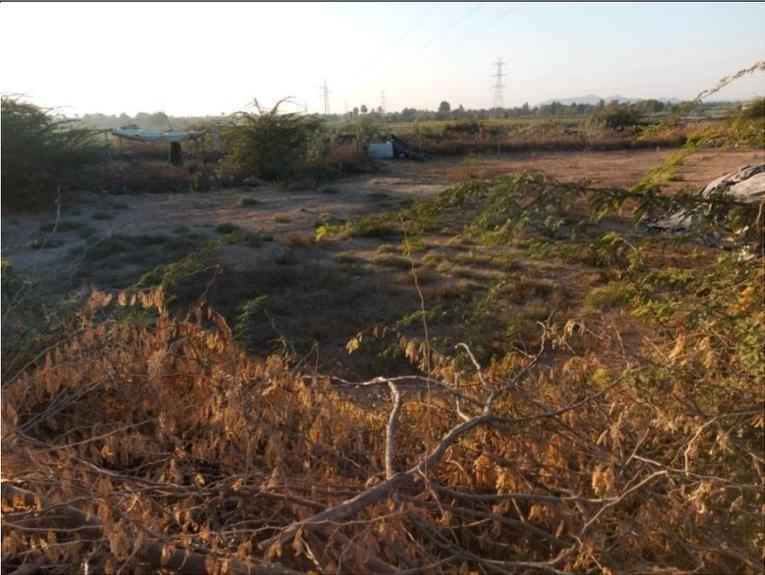
37.	<p>Land near Village Ler</p> <p>23° 12' 43" N 69° 44' 28" E</p>	<p>The site is open barren land alongside agricultural fields. No gypsum was observed on this location. Reportedly, the unit has lifted the dumped Gypsum from this location.</p>

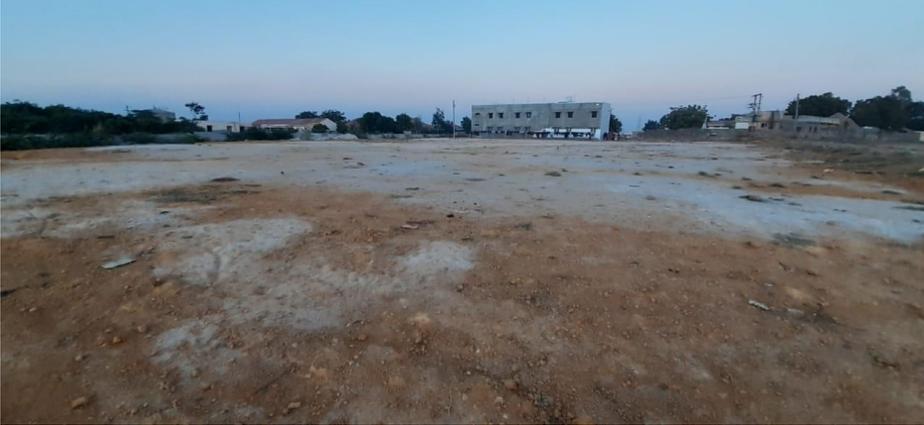
38.	<p>Maldhari Mangal Mandir Chhatralay, Bhujodi</p> <p>23° 13' 45" N 69° 44' 09" E</p>	<p>The site is open land of about 100 × 150 M<sup>2</sup>. Gypsum was found spread in this land area covered with white silica on top.</p>
