## **Joint report of CPCB and GPCB on status of restoration processes in place for dumped Gypsum and ground water contamination**

### **Background:**

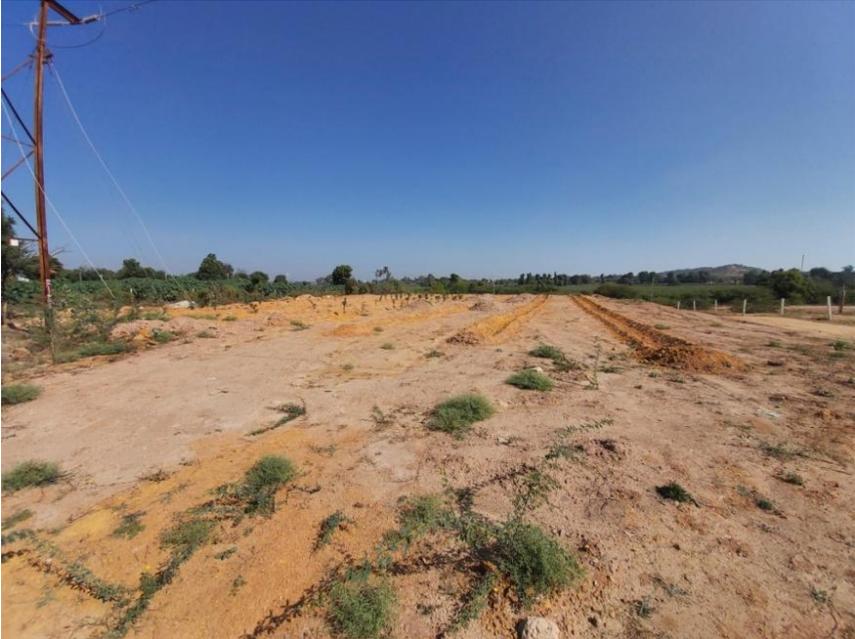
39.	<p>Shri Vakal Mata Mandir, Village: Bhujodi</p> <p>23° 13' 35" N 69° 44' 41" E</p>	<p>Gypsum was observed on this site in about 1.5 KM area. Most of the Gypsum was mixed with soil where new plantation was observed on some patches. Also Gypsum was observed stacked on sides of the land area.</p>

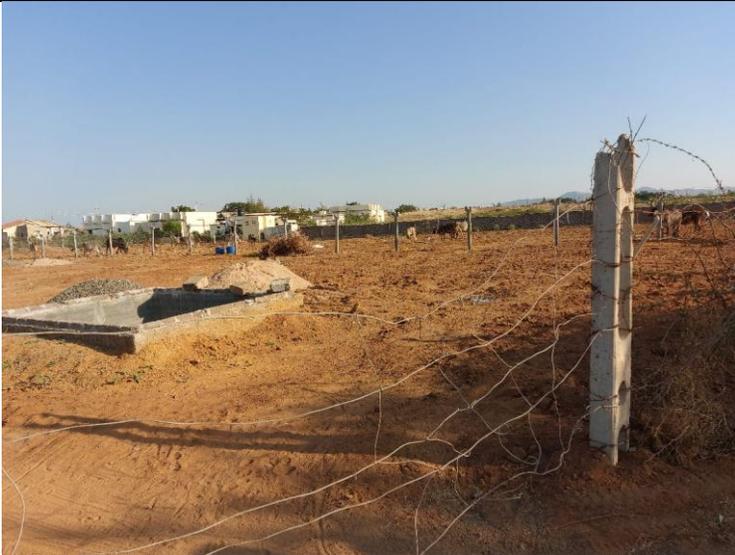
Status Report of Gypsum Lifting Activity as on 06.02.2020			
Sr. No.	Location/Place	As on 06/02/2020	Photograph
1.	Behind Ashapura Foundation School, Ashapura Colony, Bhachau road, Kukma  23° 14' 7" N 69° 46' 26" E	Dumped gypsum is lifted from this location and top surface is covered with loose soil.

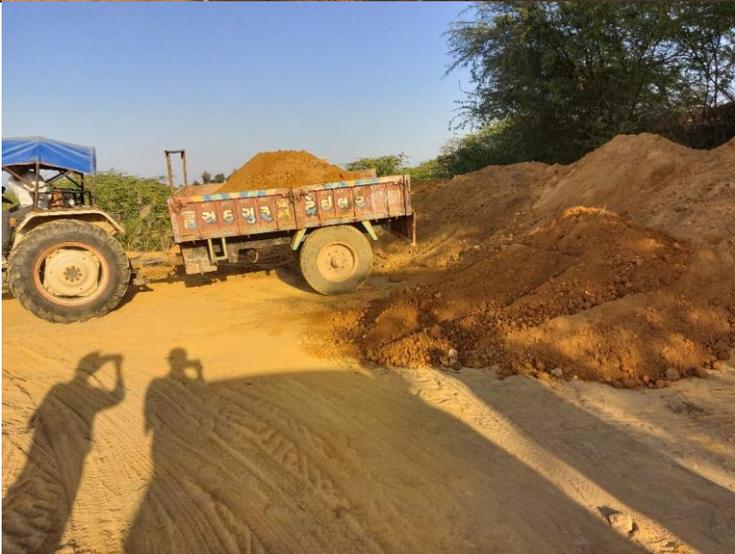
2	Besides BalubhaRathod's Lake, Ler Village.  23° 11' 47" N 69° 46' 17" E	Dumped Gypsum was collected from the area and stacked at one place from where it is loading in tractor trolley for disposal.

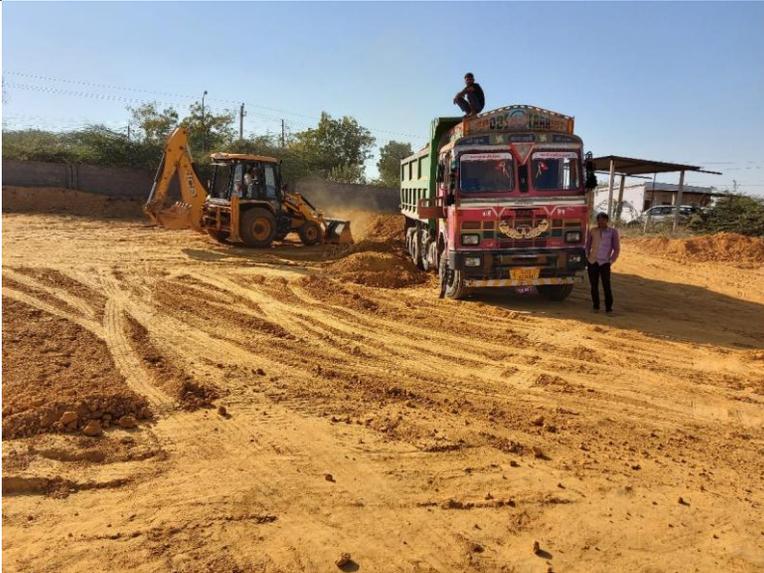
3	At Shekhpurparle road 23° 13' 40" N 69° 45' 33" E	Gypsum was observed on the site, however gypsum lifting activity was under progress.

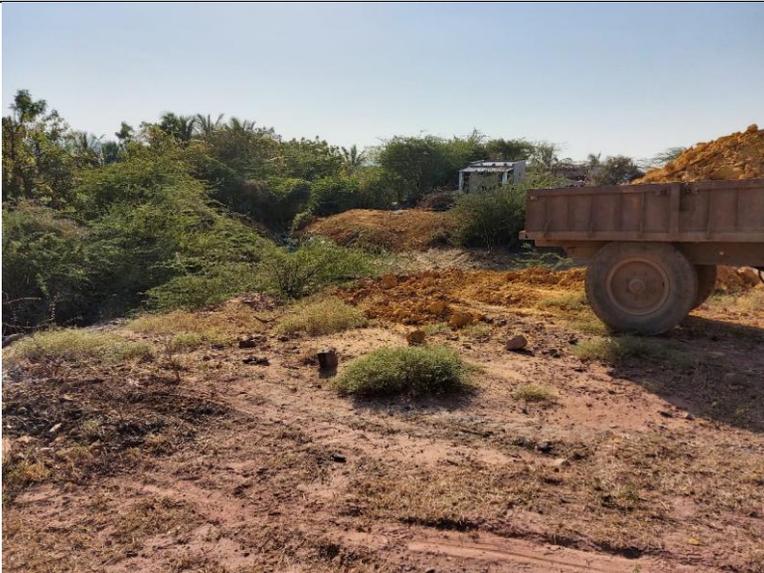
A photograph showing a yellow excavator loading a red truck with gypsum. The truck is parked on a dirt road, and a person is standing next to it. The background shows a clear blue sky and some trees.
4	At Shekhpurparle road 23° 13' 33" N 69° 45' 28" E	Gypsum was observed stacked on two places and lifting activity was under progress.

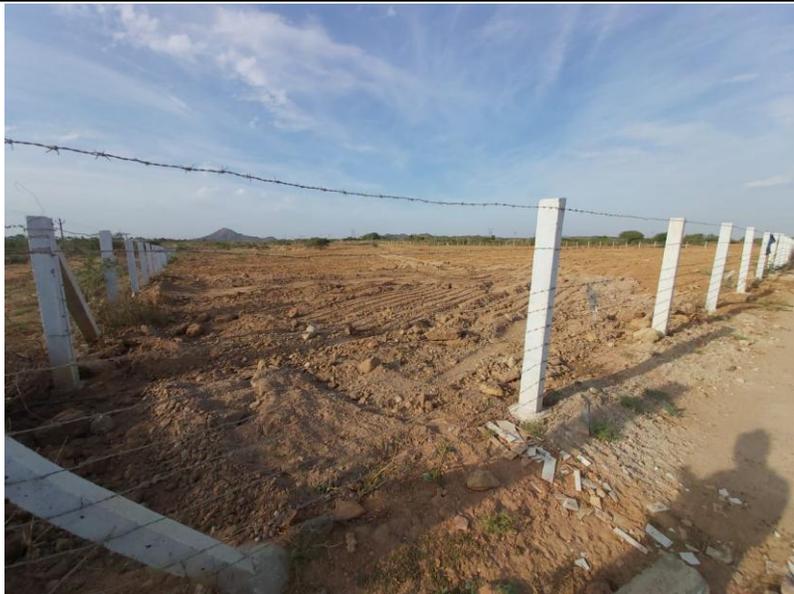
Status Report of Gypsum Lifting Activity as on 16.03.2020			
Sr. No.	Location/Area	As on 16/03/2020	Photograph
1.	Farm on Lakhond Road 23° 13' 49" N 69° 46' 52" E	Dumped gypsum is lifted from this location and top surface is covered with loose soil.

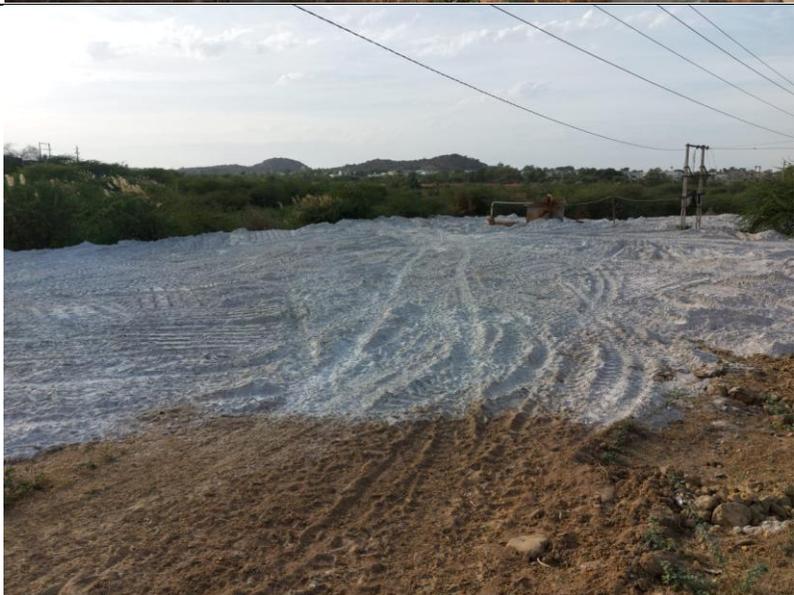
2.	Lakhond- kali Talavadi Road, Village Lakhond 23° 15' 03" N 69° 46' 48" E	Dumped gypsum is lifted from this location and top surface is covered with silica sand.

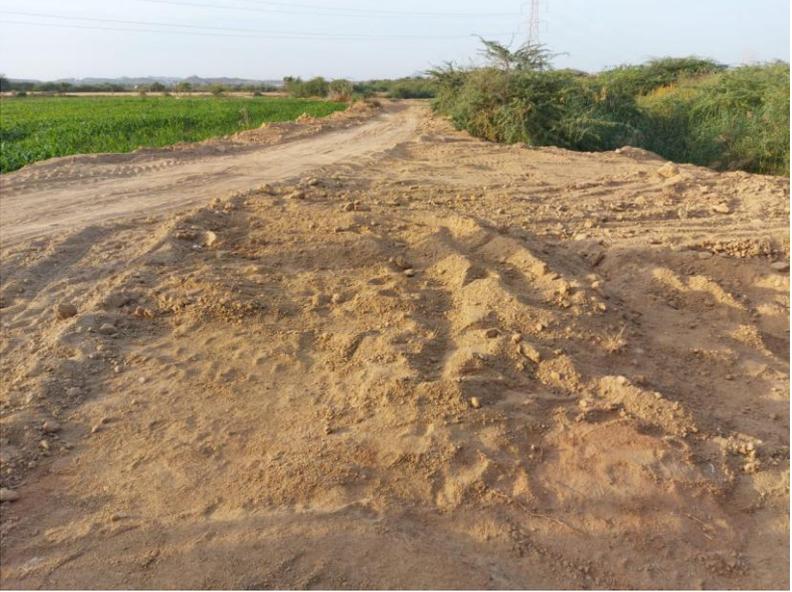
3.	Besides Balubha Rathod's Lake, Ler Village.  23° 11' 47" N 69° 46' 17" E	Dumped gypsum is lifted from this location and top surface is covered with loose soil.

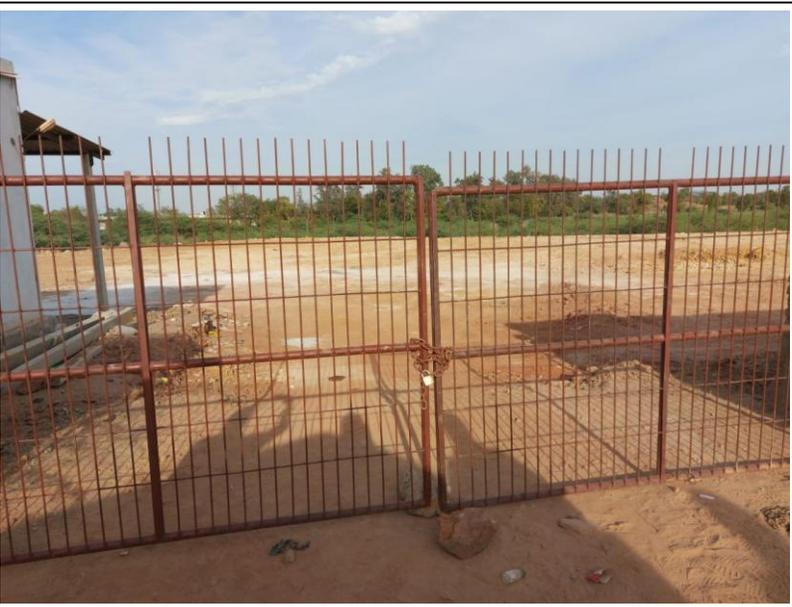
4.	At Shekhpur parle road  23° 13' 40" N 69° 45' 33" E	Dumped gypsum is lifted from this location and top surface is covered with loose soil.  The main entrance gate was found locked.

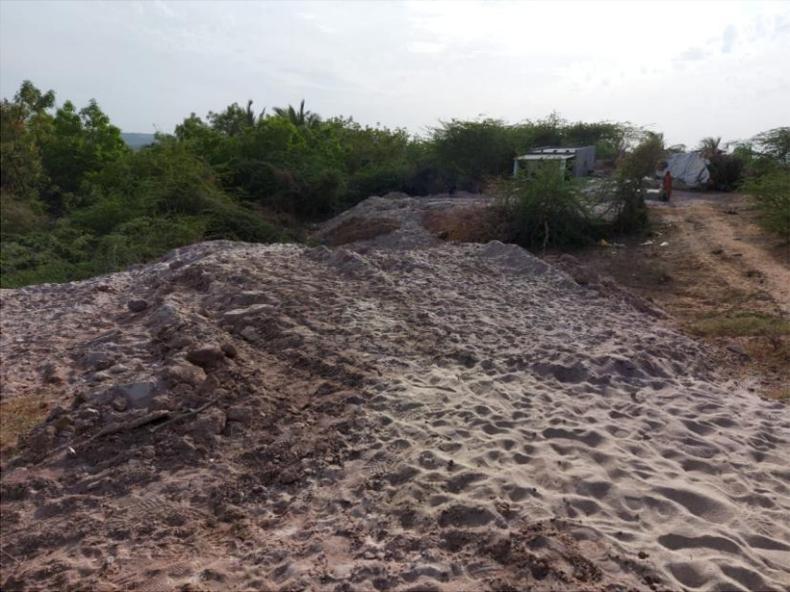
5.	At Shekhpur parle road 23° 13' 33" N 69° 45' 28" E	Dumped gypsum is lifted from this location and top surface is covered with loose soil/silica sand.
