Joint Inspection Report
(22.12.2020)
of
M/s Rudra-bilas Kisan Sahkari Chini Mills, Ltd. Bilaspur, Distt.
Rampur (U.P.)

In the Matter Of
M/s Kisan Sahkari Chini Mills Ltd. Vs Member Secretary,
UPPCB and Ors.

Appeal No. 23/2020, 24/2020 & 25/2020

-Prepared by-
The Joint Committee of CPCB & UPPCB

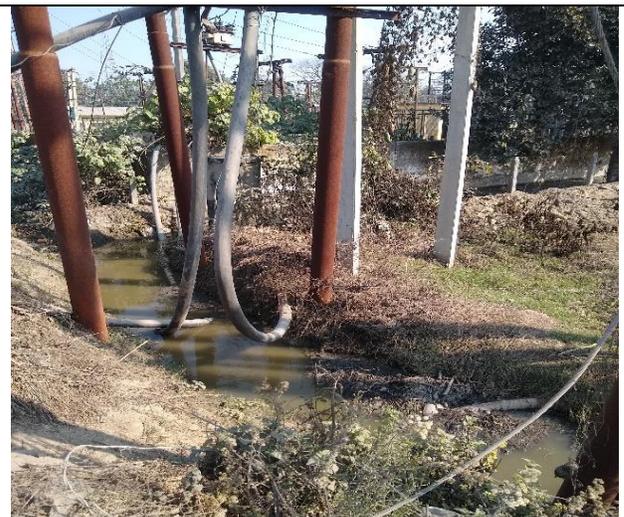
12. The analysis results of bypass effluent collected from **the drain outside the unit (flowing along its boundary wall)** shows non-compliance w.r.t. **pH-3.9** (against 5.5-8.5), **COD- 4335 mg/l** (against 250 mg/l), **BOD- 2535 mg/l** (against 30 mg/l), **TSS- 248 mg/l** (against 30 mg/l) for surface water discharge.

2. Drain outside the industry premises

1. The unit shall immediately dismantle the bypass channel from ETP inlet, after spray pond overflow and outside its boundary wall.
2. The unit shall maintain the functioning of each treatment units of ETP system in order to operate the ETP properly.

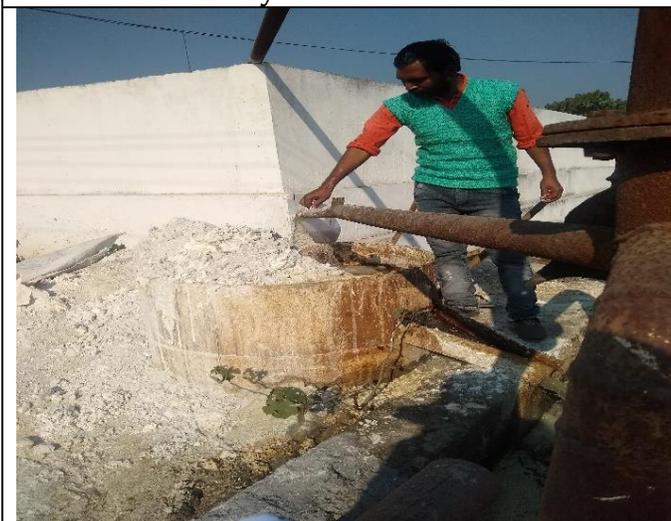
13. The analysis result of sample collected from **ETP inlet** shows the value of **pH-3.5, COD- 8234 mg/l, BOD- 5100 mg/l, TSS- 762 mg/l**.
14. The analysis results of **effluent collected from bypass channel after spray pond** shows non-compliance w.r.t. **pH-4.1** (against 5.5-8.5, **COD- 614 mg/l** (against 250 mg/l), **BOD- 333 mg/l** (against 30 mg/l), **TSS- 87 mg/l** (against 30 mg/l) for surface water discharge.

3. ETP Inlet

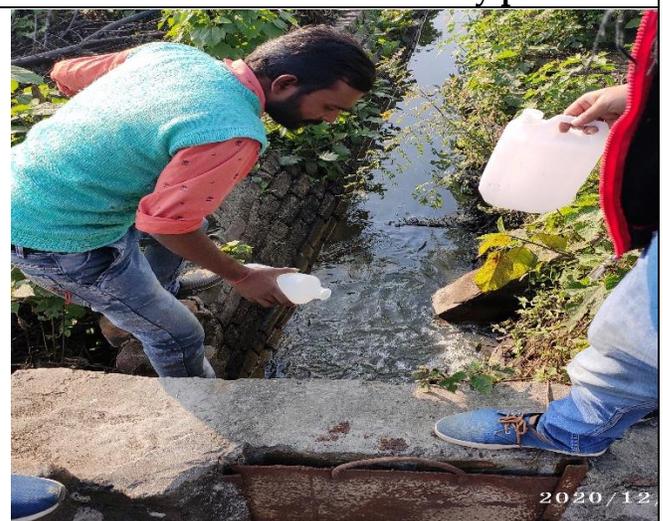
9. The inspection team observed that the raw effluent generated in the process was reaching the ETP inlet from where it was diverted through a bypass channel which was extended beyond the spray pond such that spray pond overflow could also be discharged into the same channel. The channel appears to be reaching all the way till the boundary wall however the immediate vicinity of the boundary wall inside Unit premise was not approachable due to thick over growth of vegetation. A similar channel/drain was observed outside the boundary wall and flowing along it till the agriculture fields and beyond.

4. Bypass at ETP Inlet

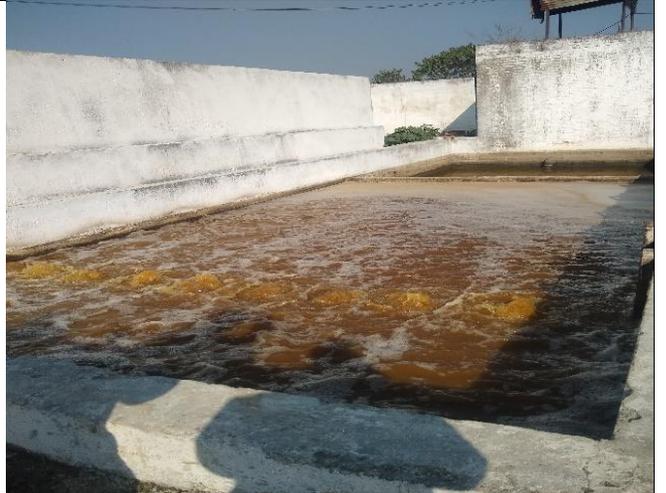
6. Aeration Tank

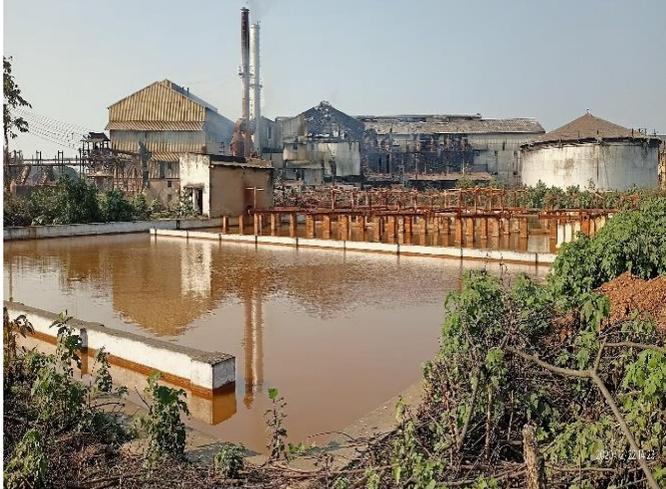
- Aeration Tank
 - Empty/dry storage lagoonThus only the lime dosing, equalization tank and surge tank were operational at the time of inspection.
8. At the time of inspection, the spray pond overflow treatment system was also not in operation and flow meters were not installed at inlet and outlet of spray pond over flow.

7. Dysfunctional Spray Pond

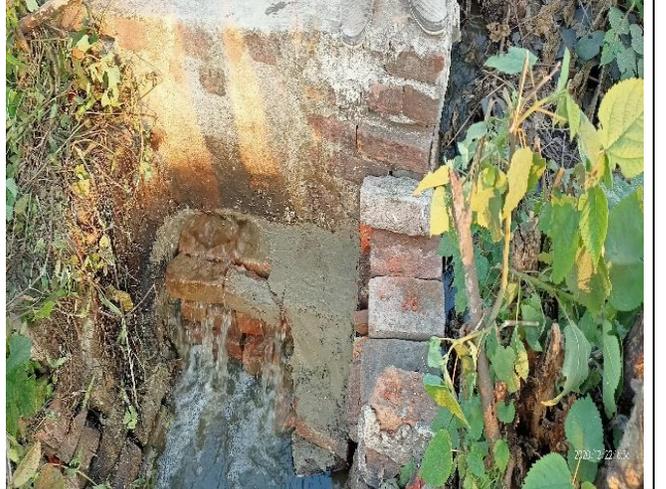
8. Bypass After Spray Pond Overflow

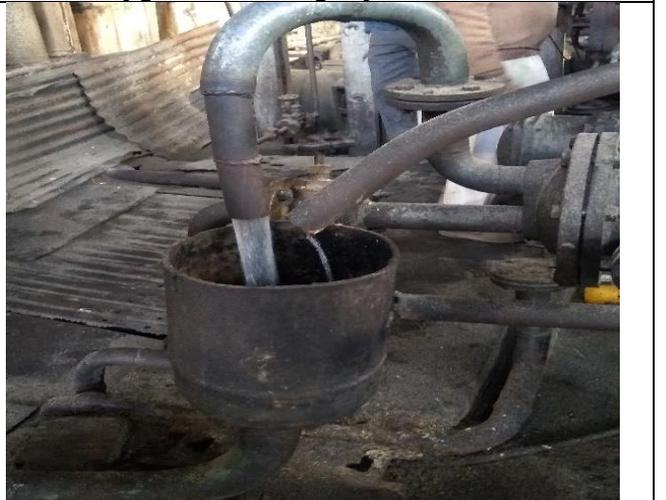
31. Housekeeping of the mill was poor. The joint team also observed littering of bagasse in the air around the mill premises
32. Flow meters for hot water recycling system at Mill house were installed at imbibition water, sugar melting, pan boiling, molasses conditioning. But the readings of the flow meters were not accessible because the location of installed flow meters were unapproachable. Flow Meters were also not installed at cold water recycling points.

10. Hot Water Imbibition at Mill

10. Wet scrubber needs maintenance in order to control the particulate matter (PM) in the mill premises and surrounding area.
11. The unit shall relocate the flow meters inside the Mill House at accessible places.

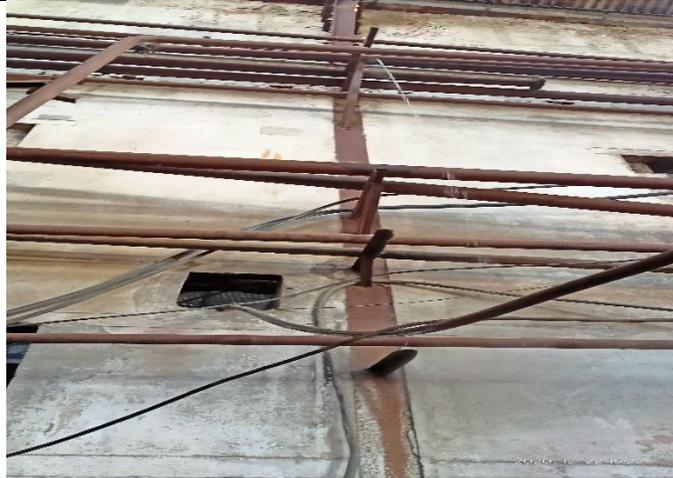
29. The joint team observed leakages in the overhead pipes in the mill house and mill staff were observed working without personal protective equipment.

9. Overhead leakages from Pipe in Mill House

9. The machineries inside the mill house and boiler house needs rigorous maintenance and refurbishment as leakages were observed in mill house during the inspection.

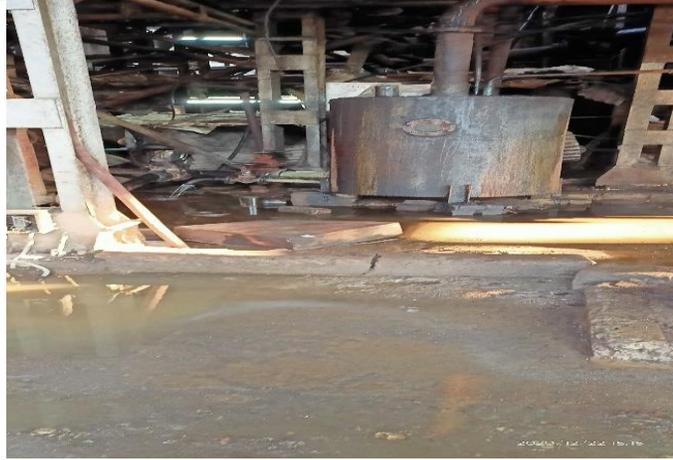
11. Poor housekeeping inside the industry premises

13. The unit shall improve its overall housekeeping.
14. The unit needs to make a proper management of bagasse and arrangements shall be made to feed the bagasse via closed chute into boiler.

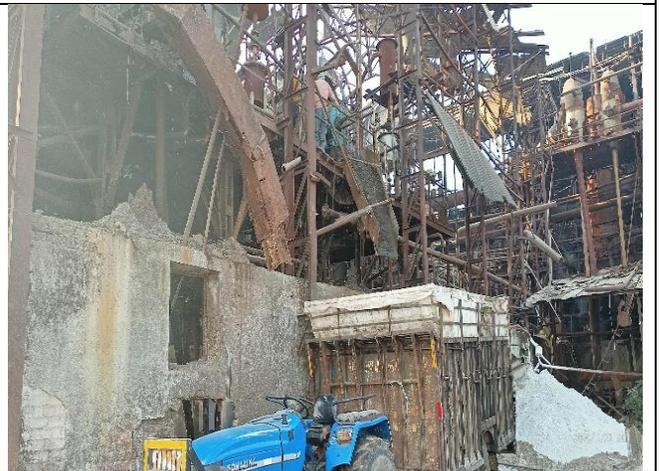
14. Poor Condition of Machinery

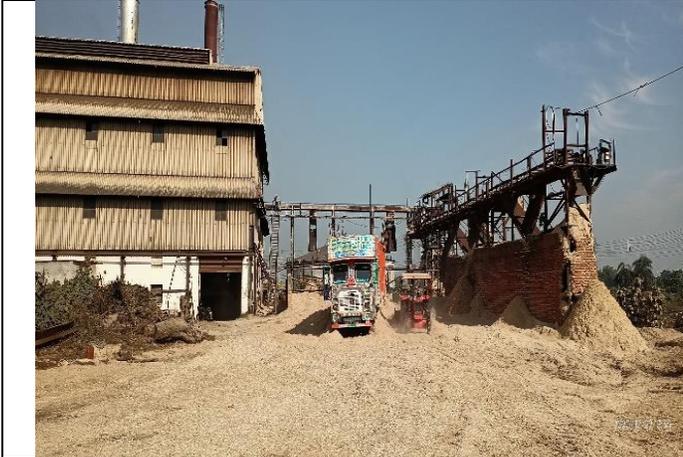
15. Open dumping and mismanagement of bagasse storage

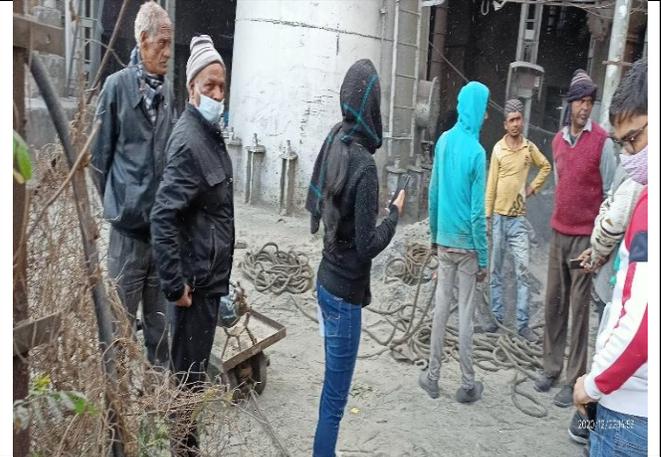
16. Fugitive emission of bagasse near boiler

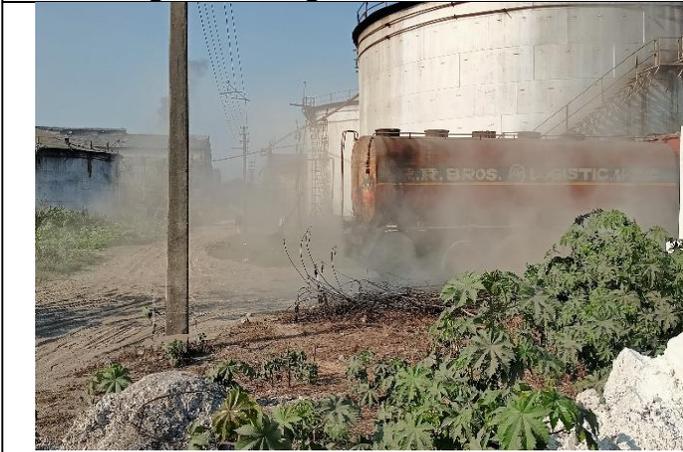
33. Press mud dumping in an open area near the bypass channel after spray pond was observed and the concerned log book was not maintained.
34. The unit has one low pressure boiler having capacity of 20 kg/cm².
35. The unit has not stored boiler ash according to CPCB/SPCB guidelines and log book for the same not maintained.
36. No hazardous tank was observed by the joint team at the time of inspection.
37. Flow meters were not installed at outlet of mill house, boiling house as well as outlet of steam generation house.
38. The roads inside the unit premises was found unpaved and full of dust and no water sprinkling was observed.

17. Dust emission from the movements of Heavy duty vehicle(s)

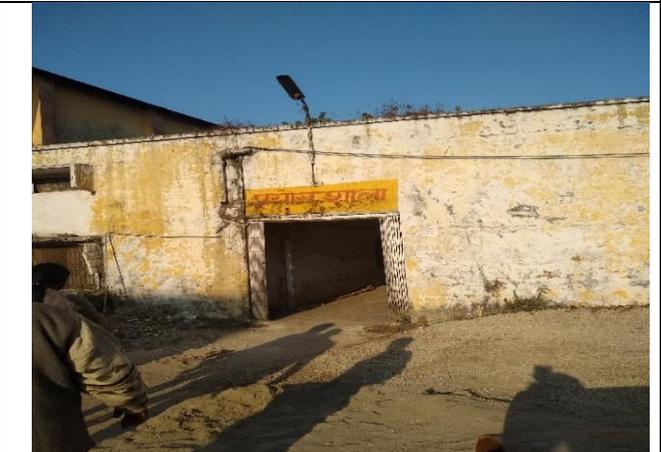
27. The unit has separate environmental laboratory facility for analysis of daily parameters of ETP effluent, however the required equipments for analysis and lab analysis log book were not maintained properly.

18. In-House Laboratory

7. The unit shall upgrade the environmental laboratory for daily analysis of parameters and maintain record for the same.
8. The unit shall install OCEMS sensor at final outlet of ETP and shall maintain the calibration record for the same.

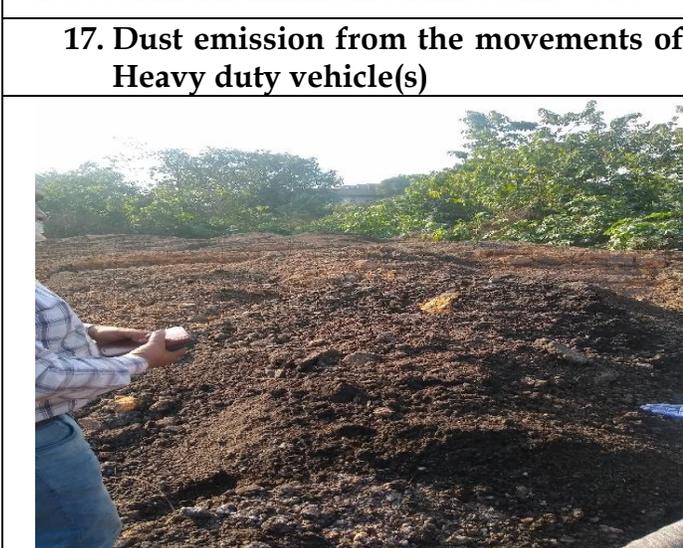
19. Press Mud found dumped

15. The unit shall make proper arrangement for disposal of press mud in a proper way and keep proper log book for the same.
16. The unit shall maintain Hazardous Tank for collection of wash water generated during chemical/mechanical cleaning of evaporator tubes along with the logbook of the same.
17. The various passages inside the industry needs to be paved to reduce dust and subsequent air pollution.
18. The unit shall submit the analysis report of ground water by the NABL accredited laboratory periodically.
19. The unit shall install Sewage Treatment Plant (STP) for treatment of generated domestic waste water from the residential colony within the premises.

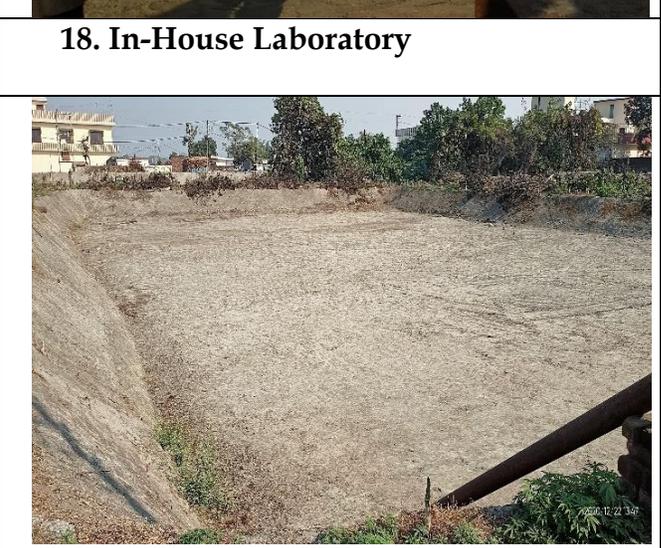
18. At the time of inspection, the lagoon having capacity 6000 m³ for storage of treated effluent was found completely empty and dry. Thus, it can be deduced that the Unit is not operating the ETP properly and bypassing the untreated effluent instead of holding treated water for the irrigation purpose as per the conditions of consent.

20. Dry and Empty Lagoon-No treated water for irrigation
