**Original Application No. 229 of 2020 (SZ)**

**JOINT COMMITTEE REPORT SUBMITTED BEFORE THE HON'BLE NATIONAL GREEN TRIBUNAL, SOUTHERN ZONE, CHENNAI IN THE MATTER OF O.A. No. 229/2020 - Tribunal on its own motion-SUO MOTU based on the News item on Gas turbine explosion at Power plant:**

**9F.05 Gas Turbine Fire Incident Root Cause Analysis**

**KPCL – Yelahanka, GT-1 (#GT247)**

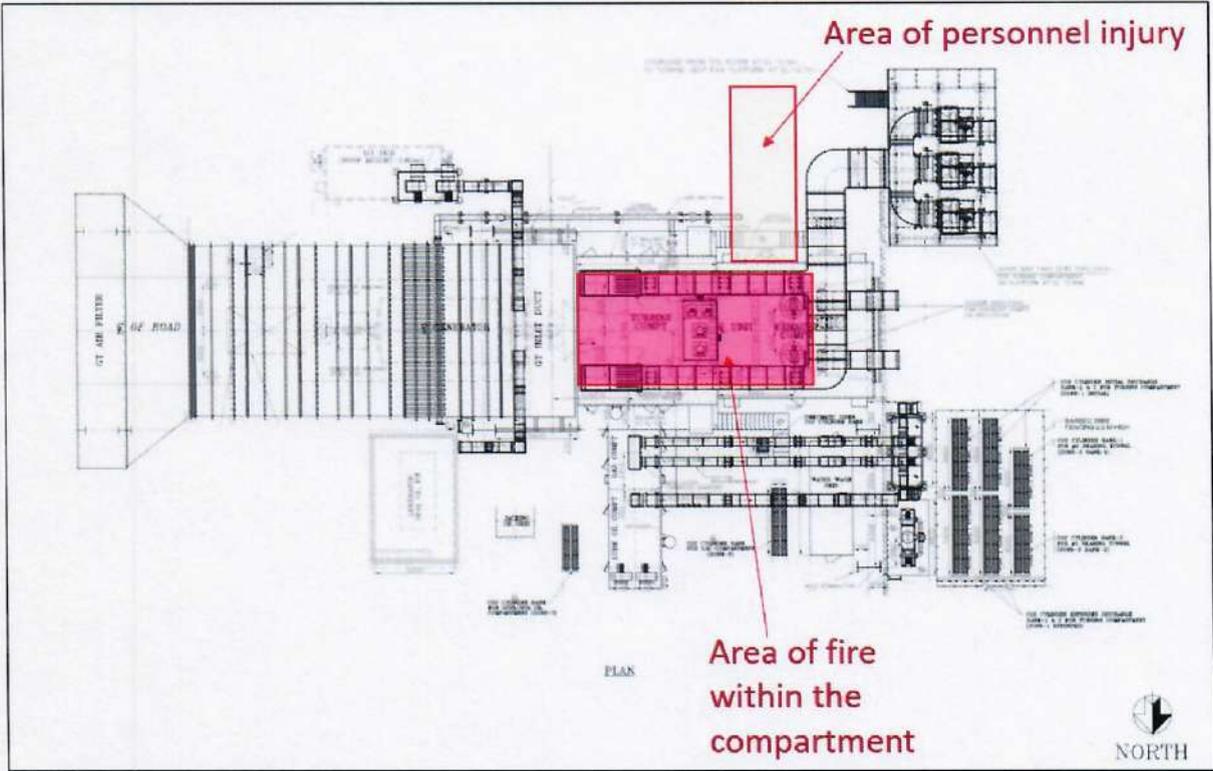
- The fire was localized only in exhaust and turbine compartments. No damages observed to components outside these two compartments.
- Deflagration occurred near the south side door and was visible from the north side of the exhaust compartment

➤ The pictorial representation of the area of fire is below:

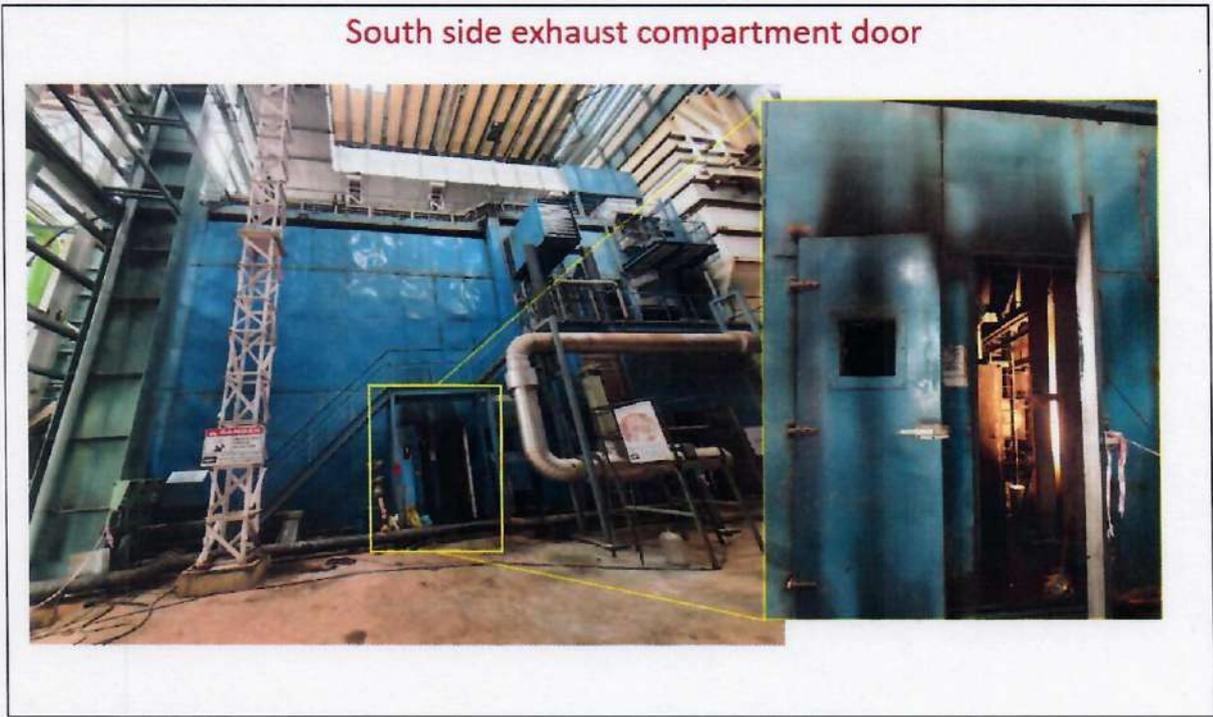
➤ The photographs depicting the damages is below:

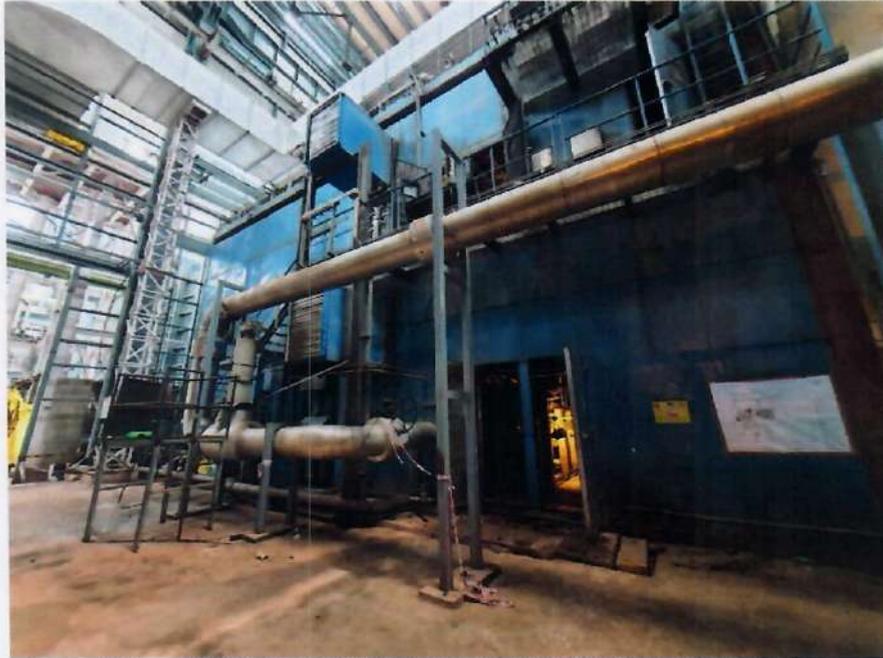
South side turbine compartment door

- ❖ Based on eyewitness accounts the root cause of the deflagration near the south side of the exhaust compartment was due to accidental opening of the compartment doors while the automatic CO<sub>2</sub> fire protection system was operational, thus interfering with its efficacy in limiting oxygen supply to the fire.

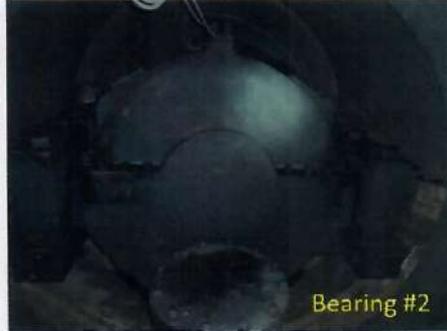
Bearing #2

- ❖ Based on available evidence, the root cause of the oil leak from bearing #2 is non removal of mesh in the oil drain line which was temporarily used during oil flushing. The mesh choked and caused oil backup into the bearing and overflow into the tunnel and subsequently to the compartments. Since this overflowing oil passed through the hot gas path, it had picked up enough heat to cause a fire within the compartment.

Oil has leaked from the forward seal of bearing #2. This oil has taken three paths to reach the compartment floors.

- ❖ Advanced Electronic Control Management system should be adopted in the plant including CCTV cameras and voice recording system.
- ❖ Unit shall explore feasibility in consultation with the design team to make provisions and install the necessary lube oil leakage sensors adjacent to all the bearings including the bearing no. 2, where the leakage occurred presently.

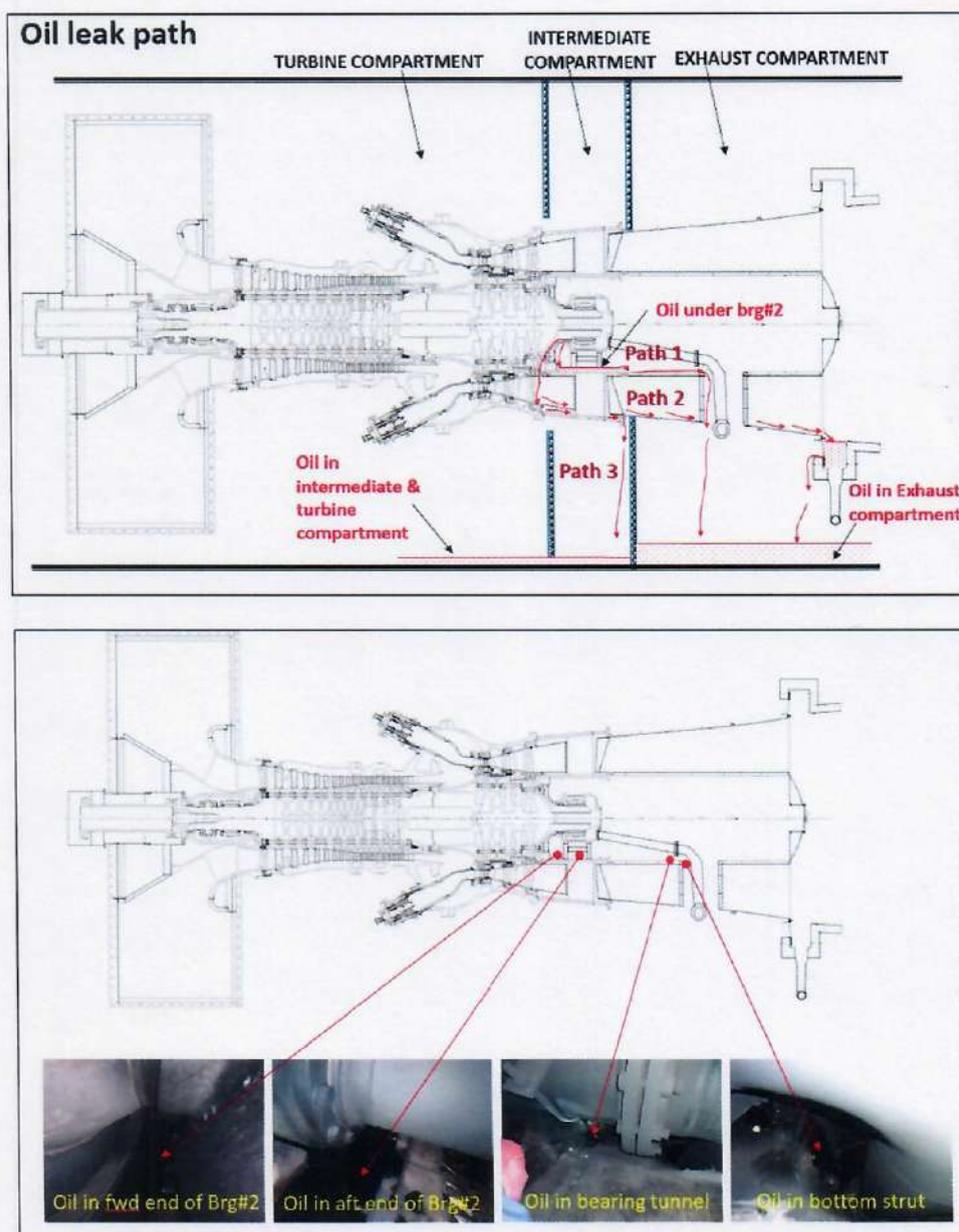
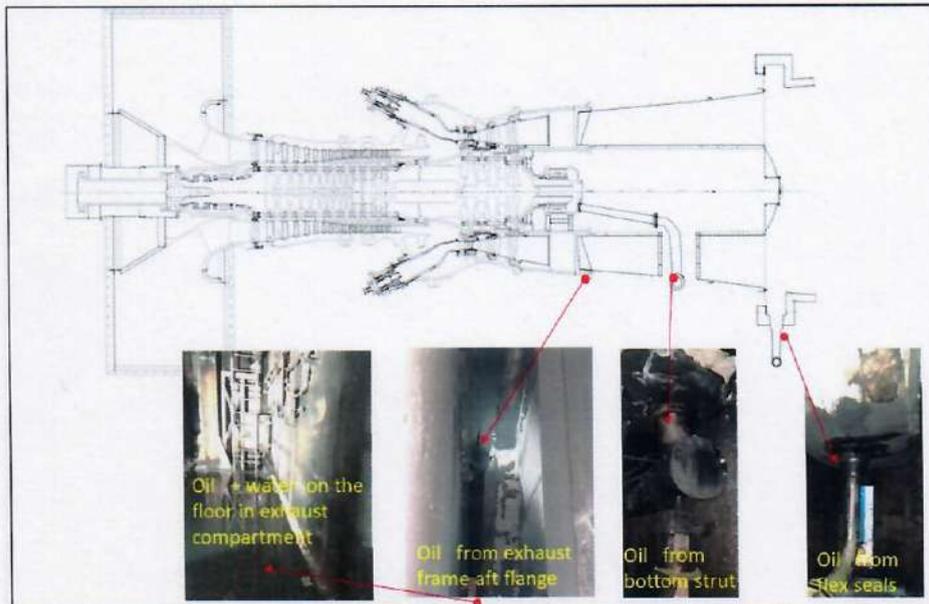
### Oil leak path

- Path 1: Oil accumulated under the bearing housing has flown aft in the bearing tunnel, wet the insulation and leaked from the bottom strut of bearing tunnel into the exhaust compartment
- Path 2: Oil has leaked over the stage-3 bucket into the exhaust flow path and flow aft into the flex seal cavity of the diffuser duct. Oil has then leaked across the flex seal into the exhaust compartment.
- Path 3: Oil has leaked over the stage-3 bucket into the exhaust frame cooling air annular space. This oil has leaked from the aft flange of the exhaust frame into the intermediate compartment. Subsequently this oil has found a path into the turbine compartment.

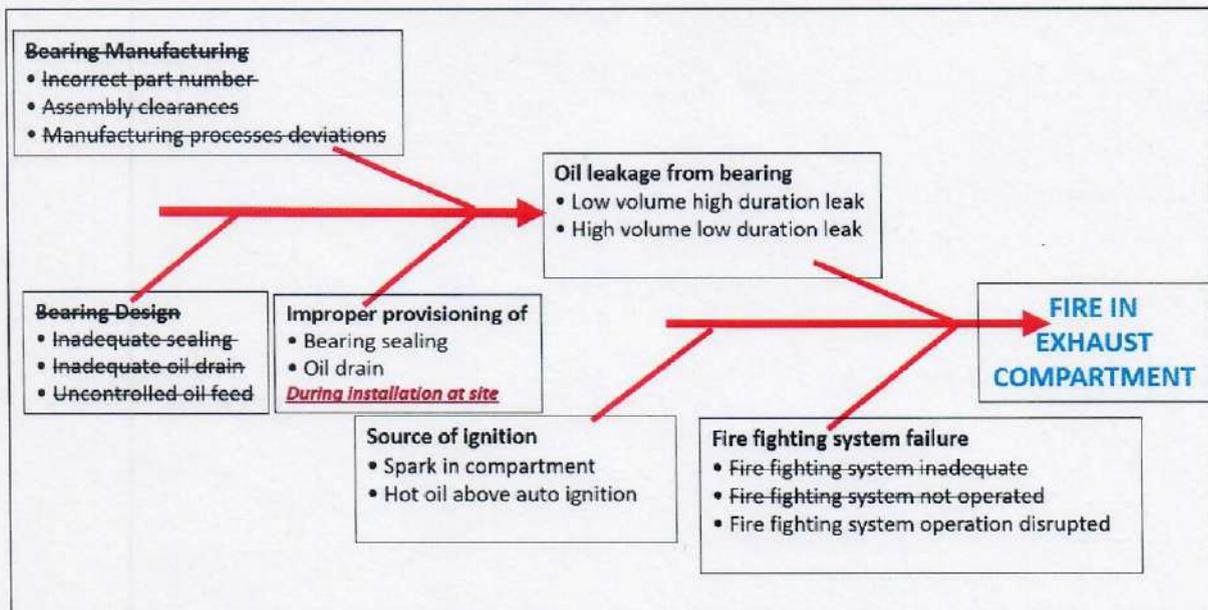
### Analysis – Fish bone

Following causes from the Fish bone taken up for further evaluation

- Improper provisioning of Bearing sealing / Oil drain during installation at site
- Oil leakage from bearing : Low volume high duration leak / High volume low duration leak
- Source of ignition: Spark in compartment / Hot oil above auto ignition
- Firefighting system failure : Firefighting system operation disrupted
