BEFORE THE NATIONAL GREEN TRIBUNAL,
SOUTH ZONE, CHENNAI

ORIGINAL OA NO. 16 OF 2022(SZ)
[OA.NO.614/2018(PB)]

**REPLY TO IRRIGATION DEPT REPORT DT 22.12.2022 FILED BY
APPLICANT**

PICTORIAL DOCUMENTATION OF FIELD SURVEY OF
BAM RUKNUD DOWLAH LAKE, NEHER E HUSSAINI BOWLI,
FROM BUND VIEW AND GROUND VIEW
ON 26 JULY 2024
(ALL PICTURES ARE GEO-TAGGED)

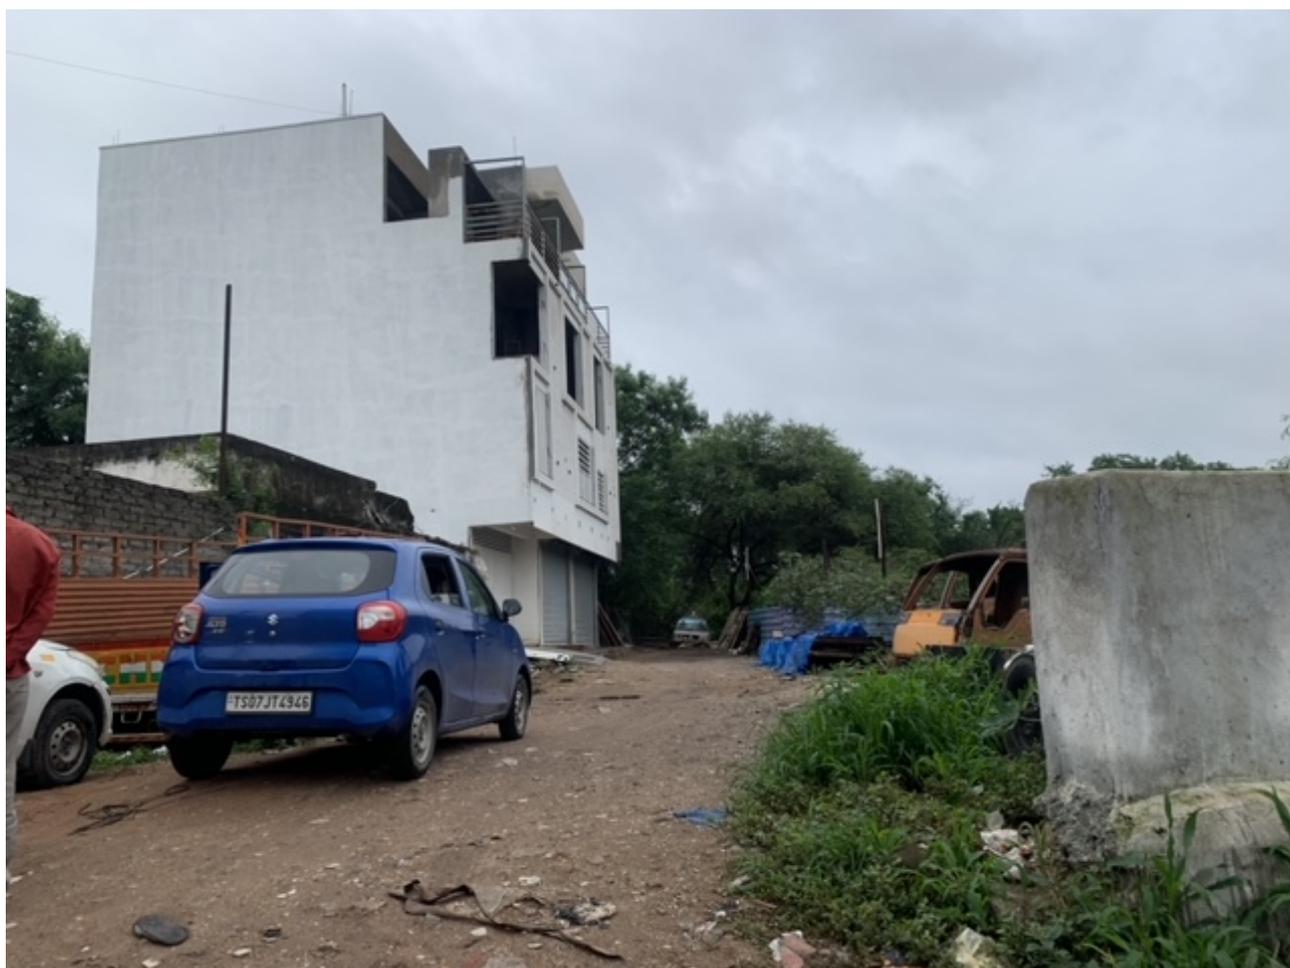
1- CONSTRUCTIONS BETWEEN BUND AND BOWLI - INSIDE HMDA WALL

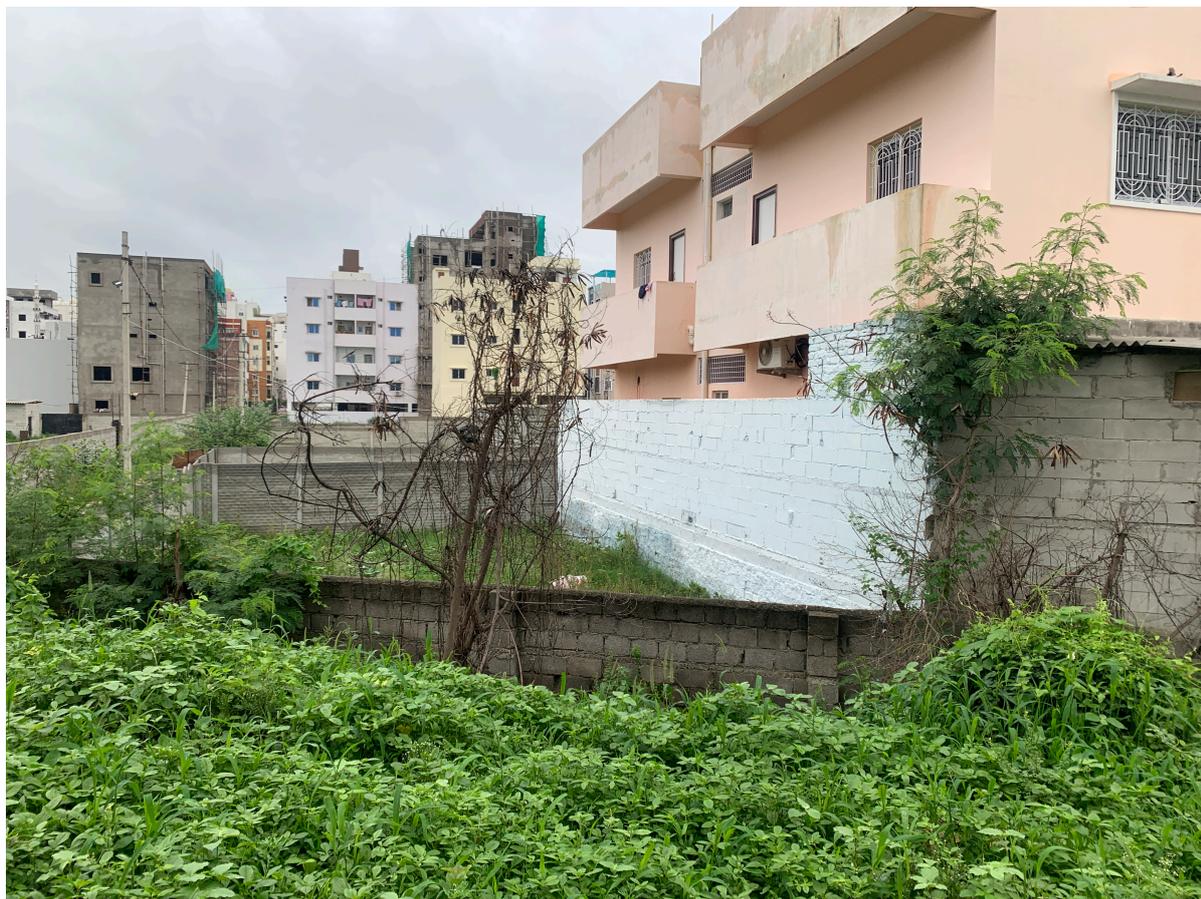
2- CONSTRUCTIONS INSIDE FTL / BUFFER ZONE ON WESTERN SIDE OF THE LAKE (BUND VIEW)

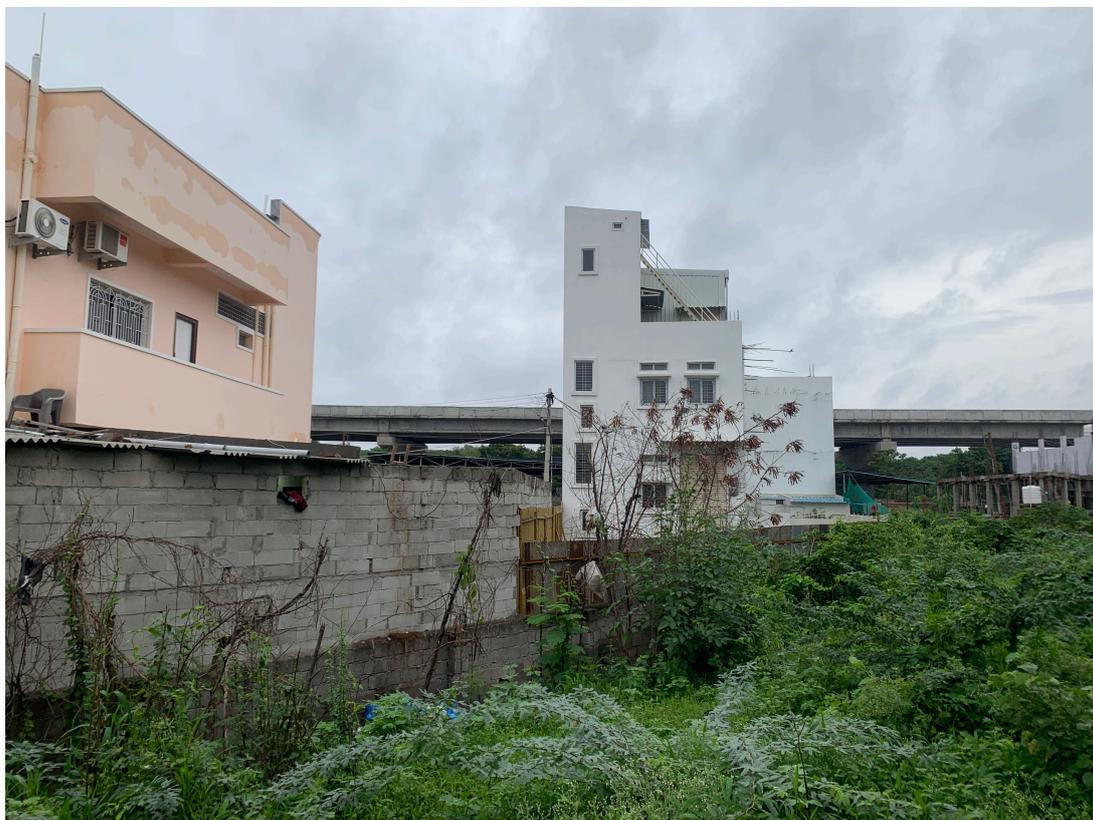
3- CONSTRUCTIONS INSIDE FTL / BUFFER ZONE ON WESTERN SIDE OF THE LAKE (BUND VIEW)

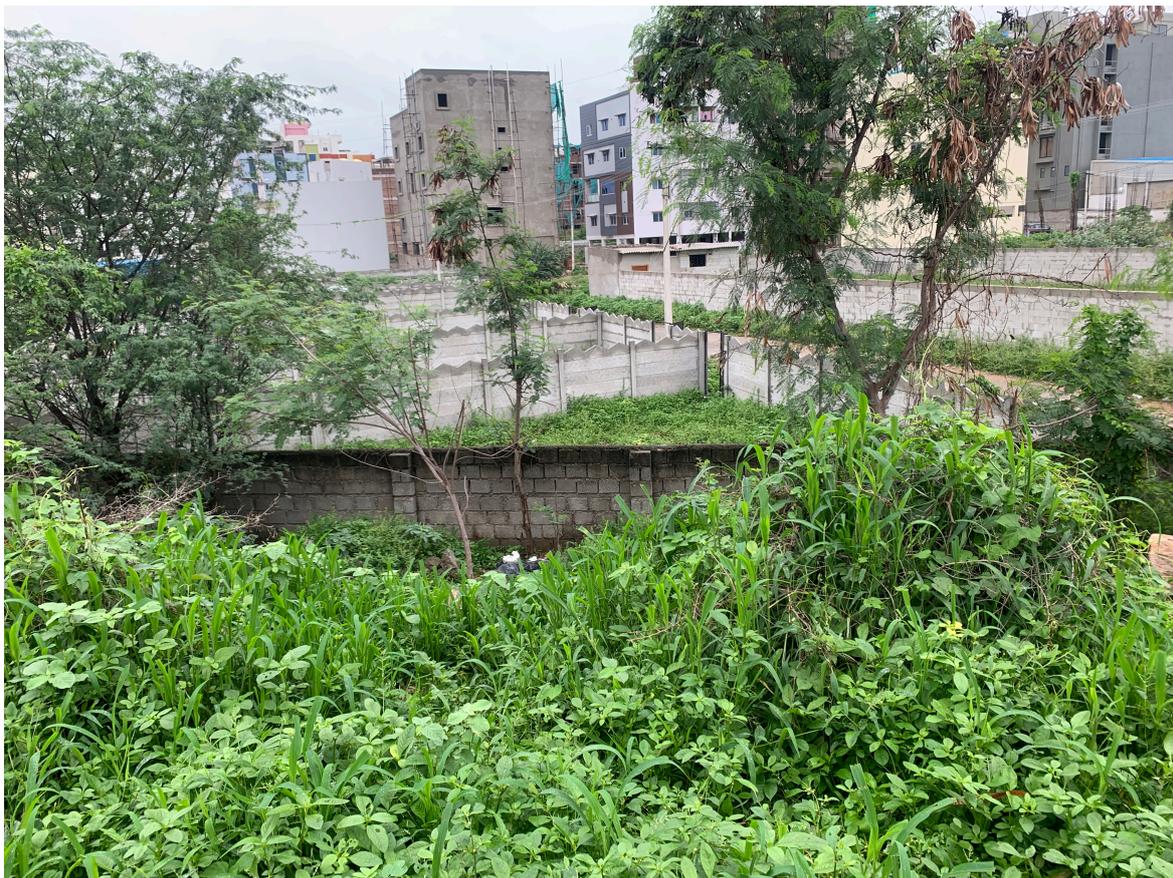
**4- COMPOUND WALLS, BT ROADS, CONSTRUCTIONS ELECTRIC POLES INSIDE FTL/
BUFFER ZONE - WESTERN SIDE OF THE LAKE - BUND VIEW**

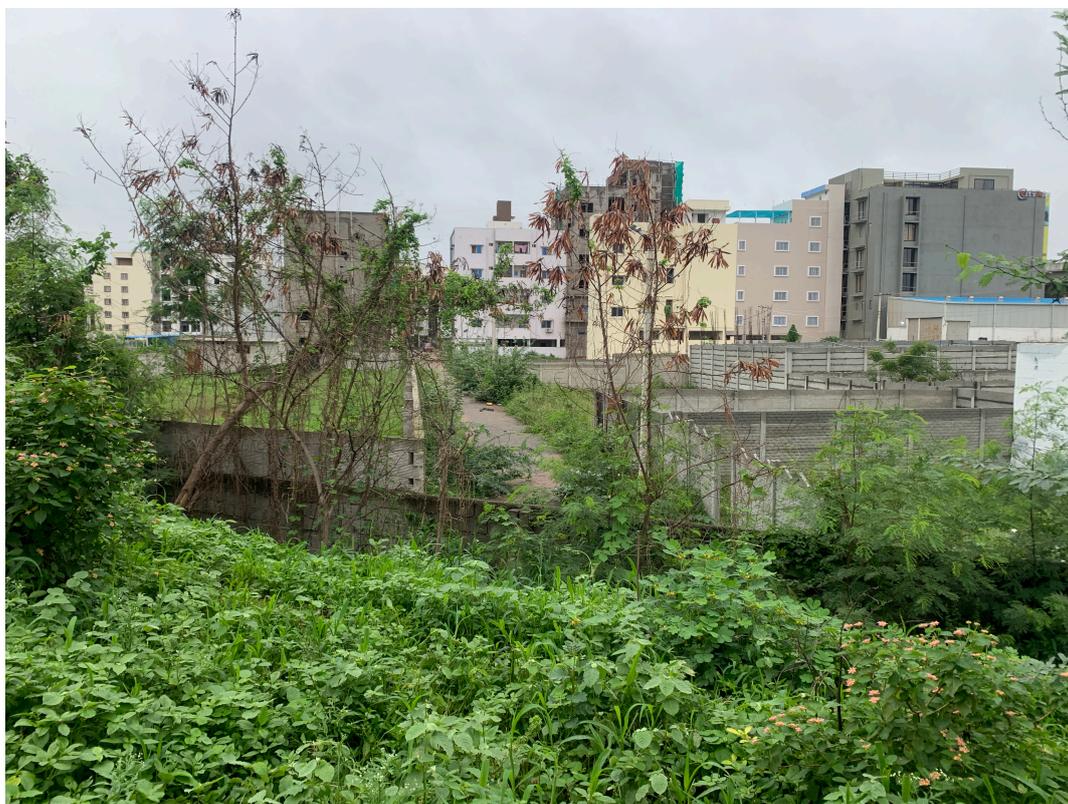
**5- COMPOUND WALLS, BT ROADS, CONSTRUCTIONS ELECTRIC POLES INSIDE FTL/
BUFFER ZONE - WESTERN SIDE OF THE LAKE - BUND VIEW**

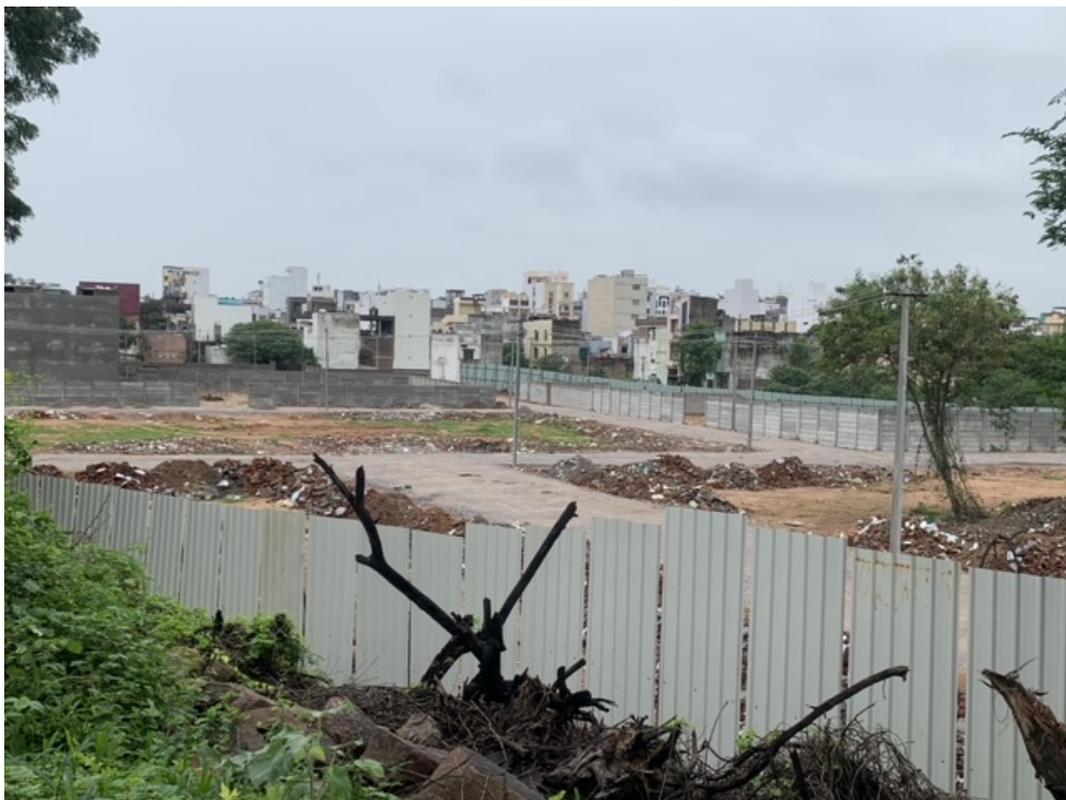
**6- BT ROADS, COMPOUND WALLS, ELECTRIC POLES, CONSTRUCTIONS INSIDE FTL/
BUFFER ZONE OF THE LAKE - EASTERN SIDE OF LAKE - BUND VIEW**

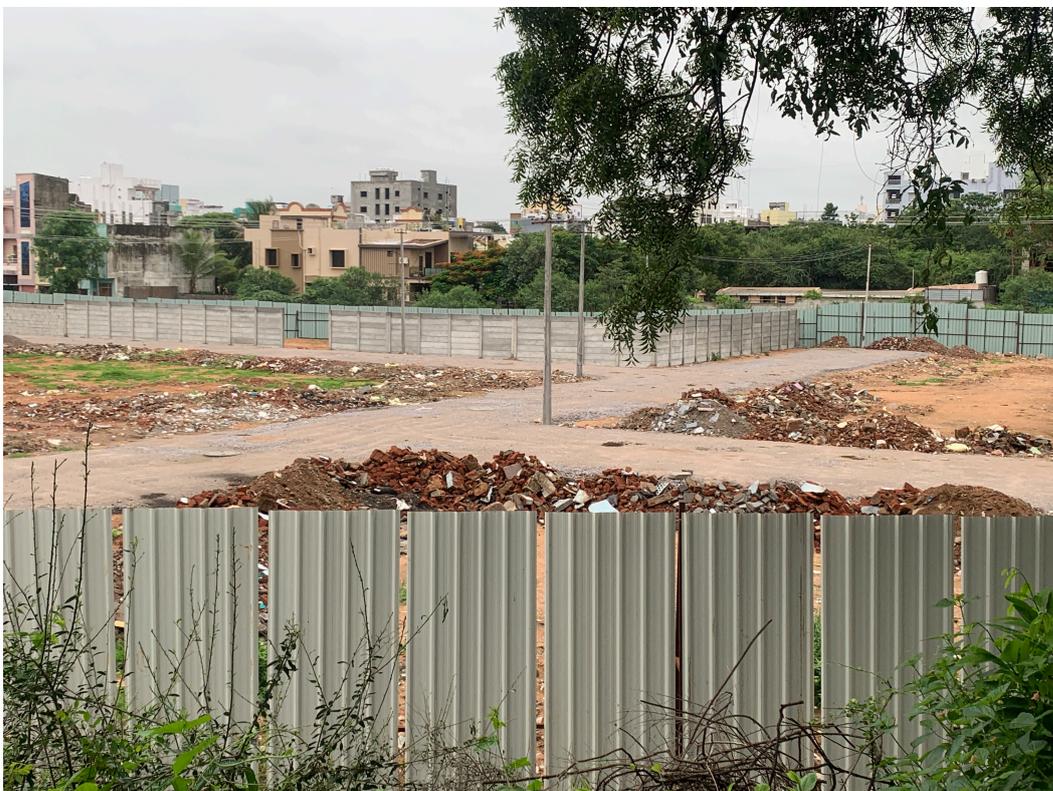
**7- BT ROADS, COMPOUND WALLS, ELECTRIC POLES, CONSTRUCTIONS INSIDE FTL/
BUFFER ZONE OF THE LAKE - EASTERN SIDE OF LAKE - BUND VIEW**

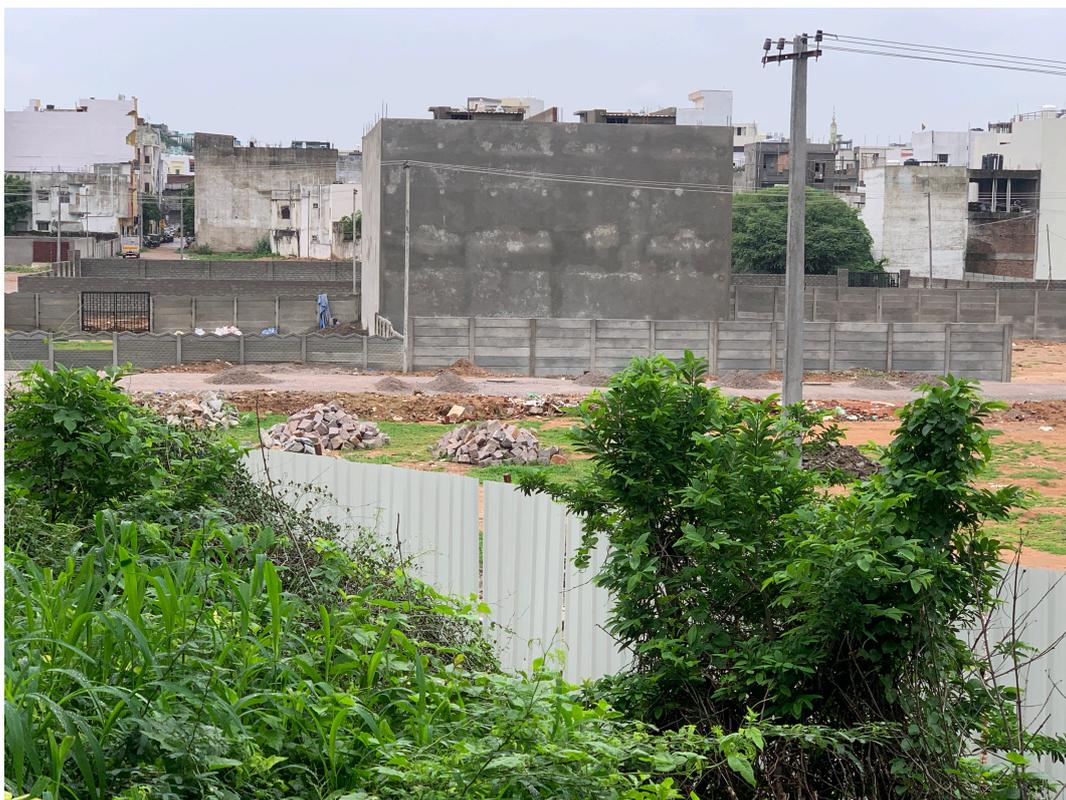
**8- BT ROADS, COMPOUND WALLS, ELECTRIC POLES, CONSTRUCTIONS INSIDE FTL/
BUFFER ZONE OF THE LAKE - EASTERN SIDE OF LAKE - BUND VIEW**

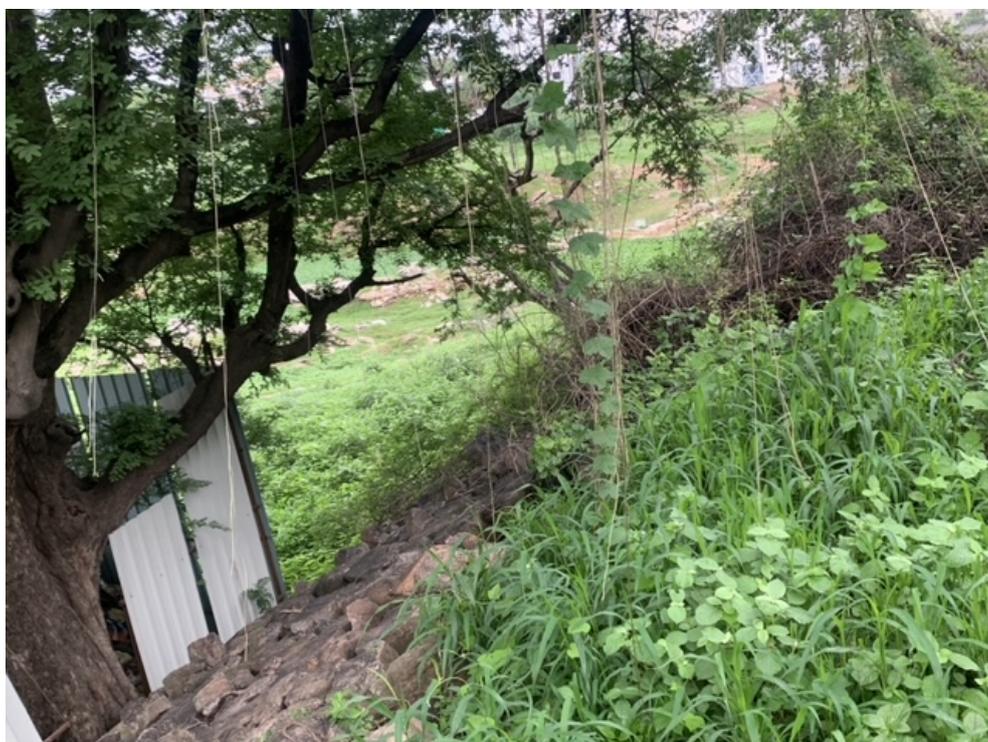
**9- SHEETS, COMPOUND WALLS ABBUTTING BUND OF THE LAKE INSIDE FTL
- EASTERN SIDE OF LAKE - BUND VIEW**

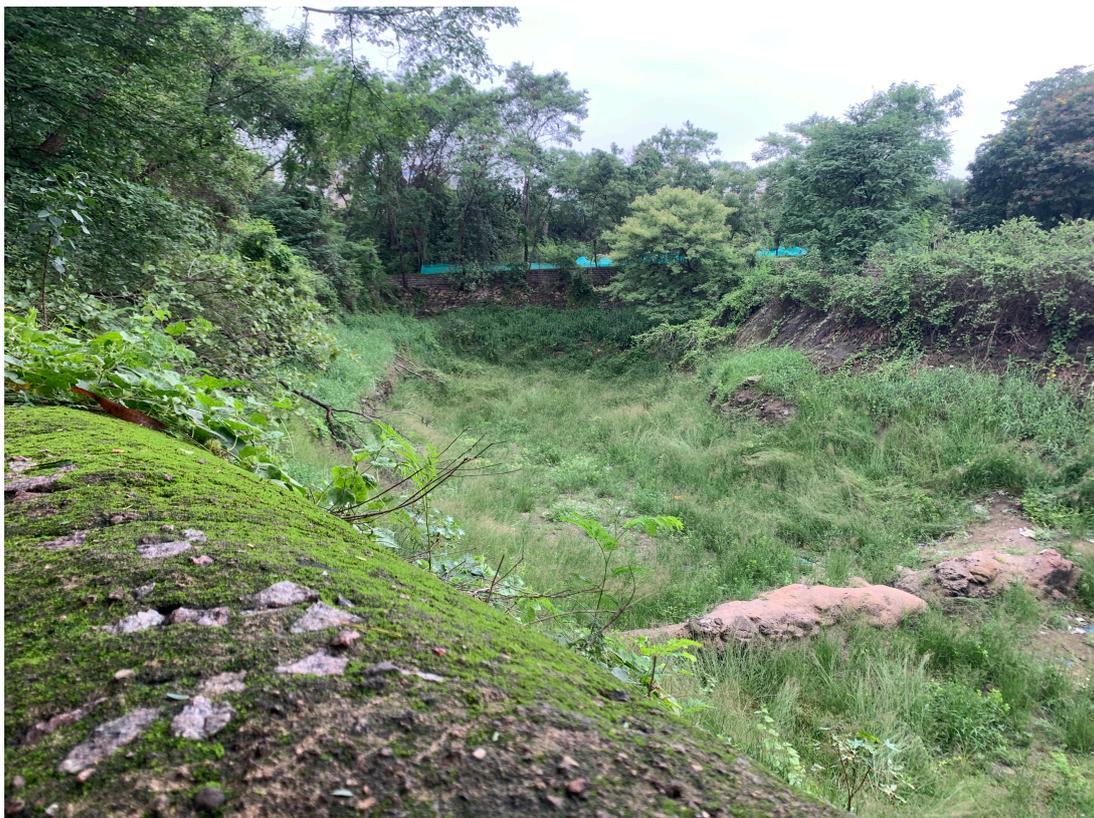
10- WESTERN SIDE OF NEHER E HUSSAINI HERITAGE BOWLI ABBUTTING THE BUND OF BUM RUKNUD DOWLAH - NORTH OF LAKE, BUND VIEW

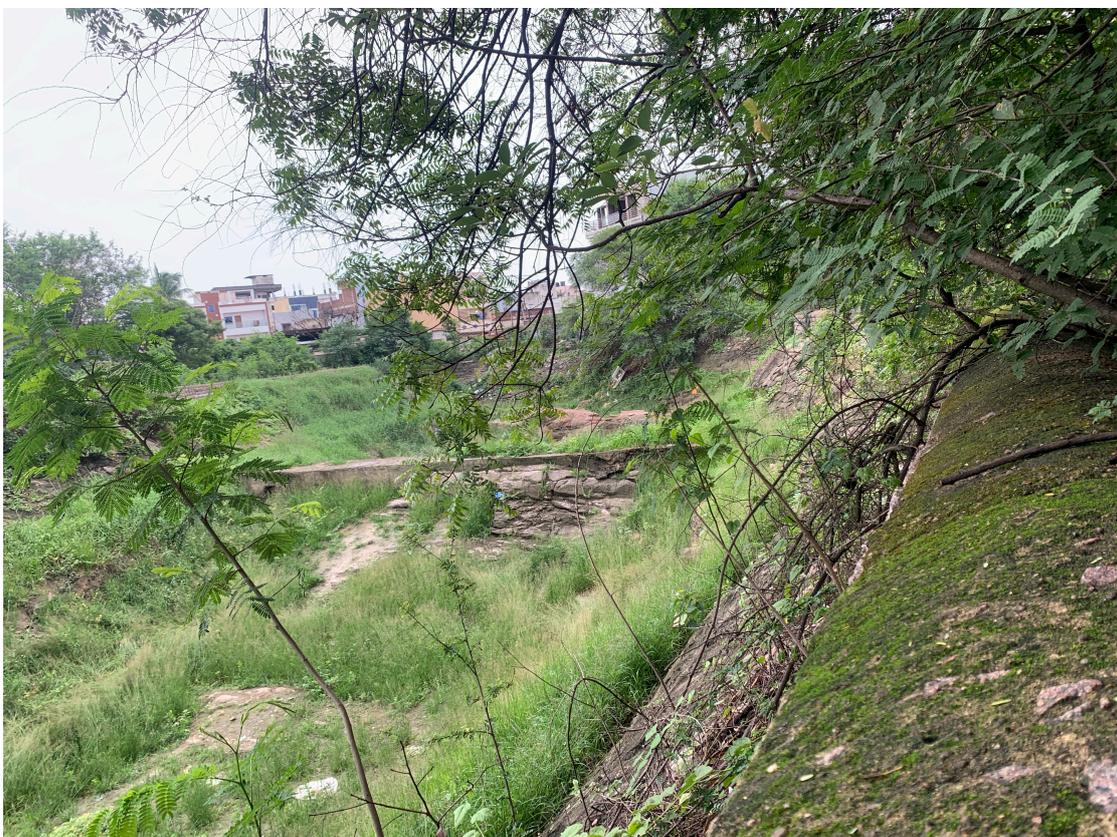
11- EASTERN SIDE OF NEHER E HUSSAINI HERITAGE BOWLI ABBUTTING THE BUND OF BUM RUKNUD DOWLAH - NORTH OF LAKE, BUND VIEW

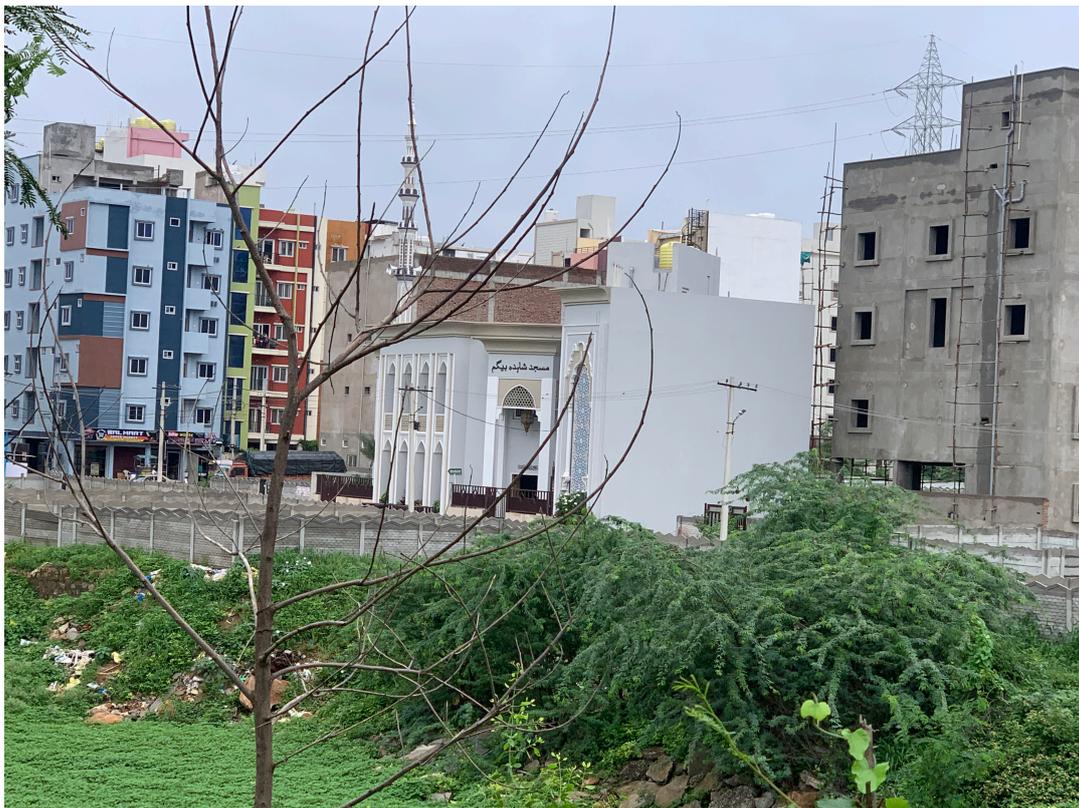
12- MASJID INSIDE FTL/BUFFER ZONE OF LAKE - WESTERN SIDE OF LAKE - BUND VIEW

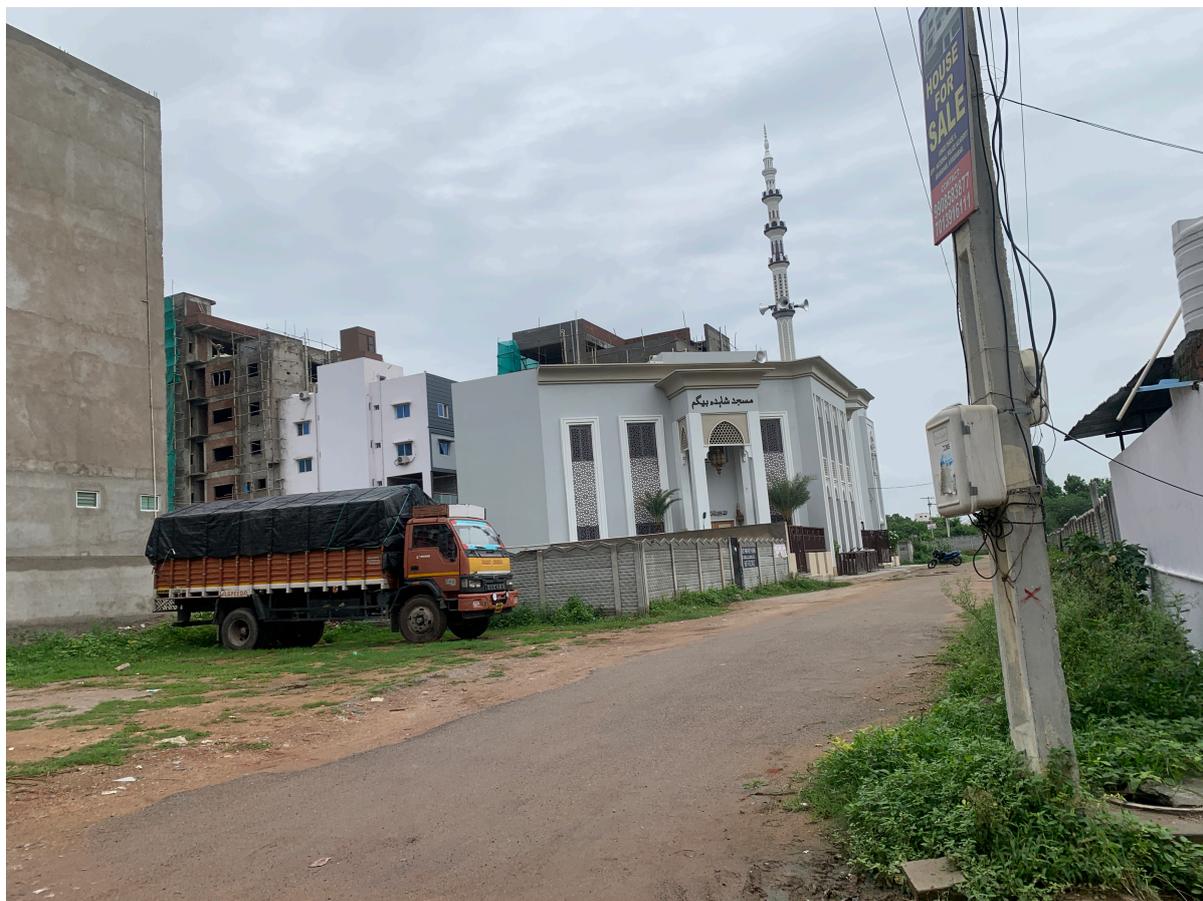
13- MASJID INSIDE FTL/BUFFER ZONE OF LAKE - WESTERN SIDE OF LAKE - GROUND VIEW

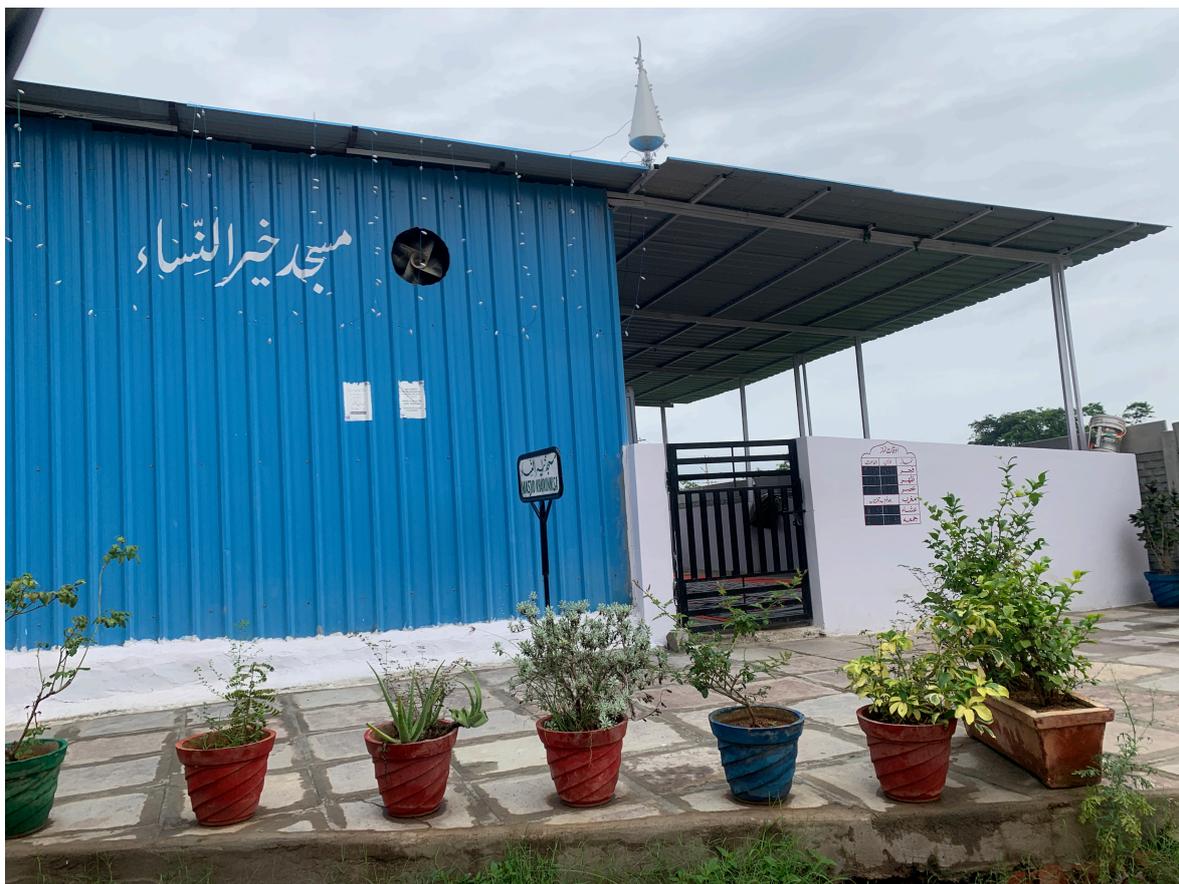
14- MASJID INSIDE FTL/BUFFER ZONE - SOUTHERN SIDE - GROUND VIEW

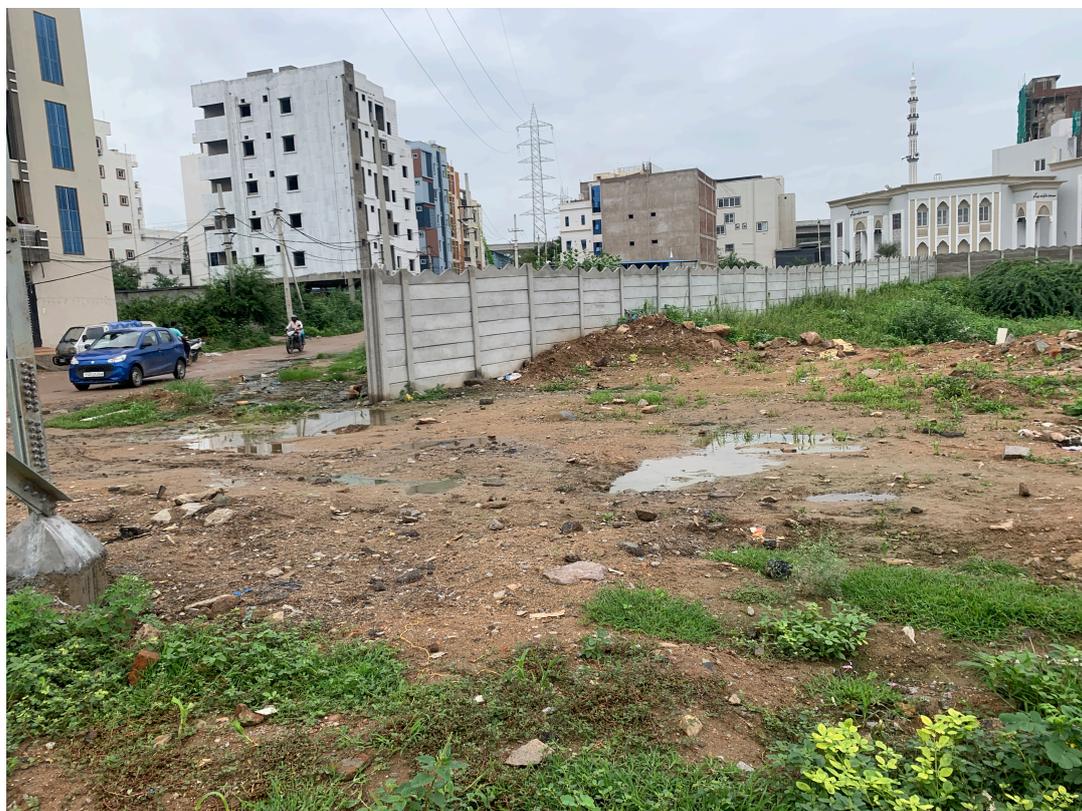
a) pipes laid to carry sewage of residential colonies have been laid inside the FTL of the lake, which has no legal, scientific basis. These pipes are always a threat to the health of the lake waters.

15- SEWAGE FLOW INTO THE LAKE, COMPOUND WALLS INSIDE LAKE

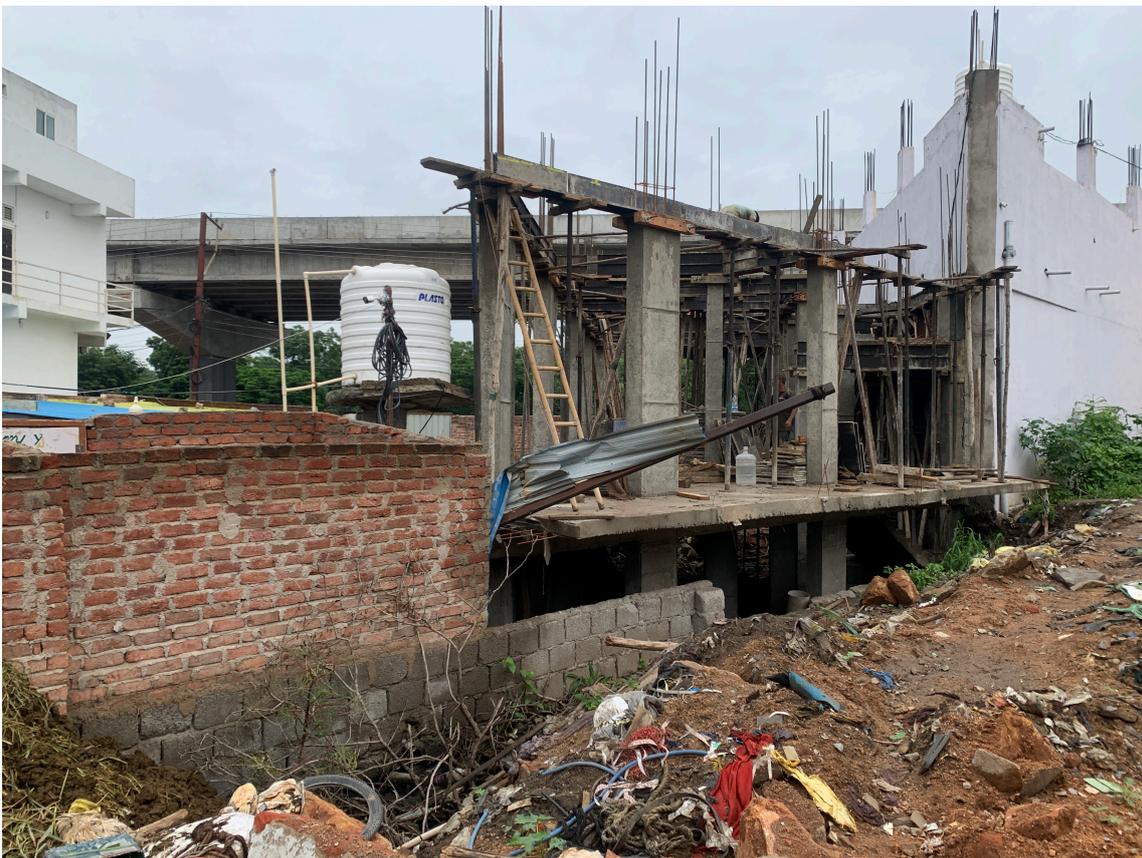
- 15- In reply to para 10, it is to submit that, contrary to claims about working towards bund strengthening, it is observed that the heritage bund that is in S shape has been dumped and destroyed at various places. The stone wall bund is a construction marvel with steps embedded in it and it slopes towards both sides that is the bowli side and the lake side.
- 16- In reply to para 10, it is to Sumit that, the necessity to construct sluice/weir is not justifiable. Before the new sluice/weir construction, the outflow channel from Bam Ruknud Dowlah to downstream Mir Alam tank was functional. Heavy rains caused huge outflows towards downstream as the lake was encroached and land filled.
- 17- In reply to para 11, it is to submit that, the Irrigation Officials have filed 2 FIRs for damage to government property on eastern side land fills since

16- ONGOING CONSTRUCTIONS INSIDE FTL OF LAKE ABBUTTING THE BUND - BUND BROKEN - WESTERN SIDE OF LAKE

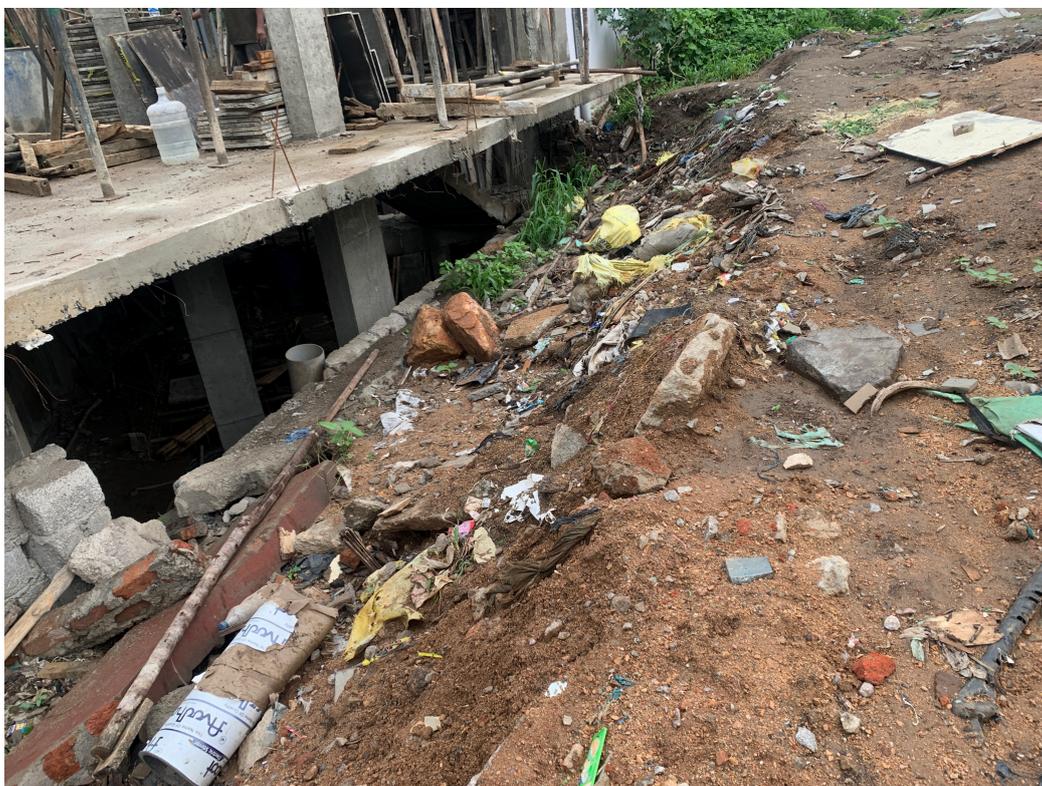
17- ONGOING CONSTRUCTIONS INSIDE FTL OF LAKE ABBUTTING THE BUND - BUND BROKEN - WESTERN SIDE OF LAKE

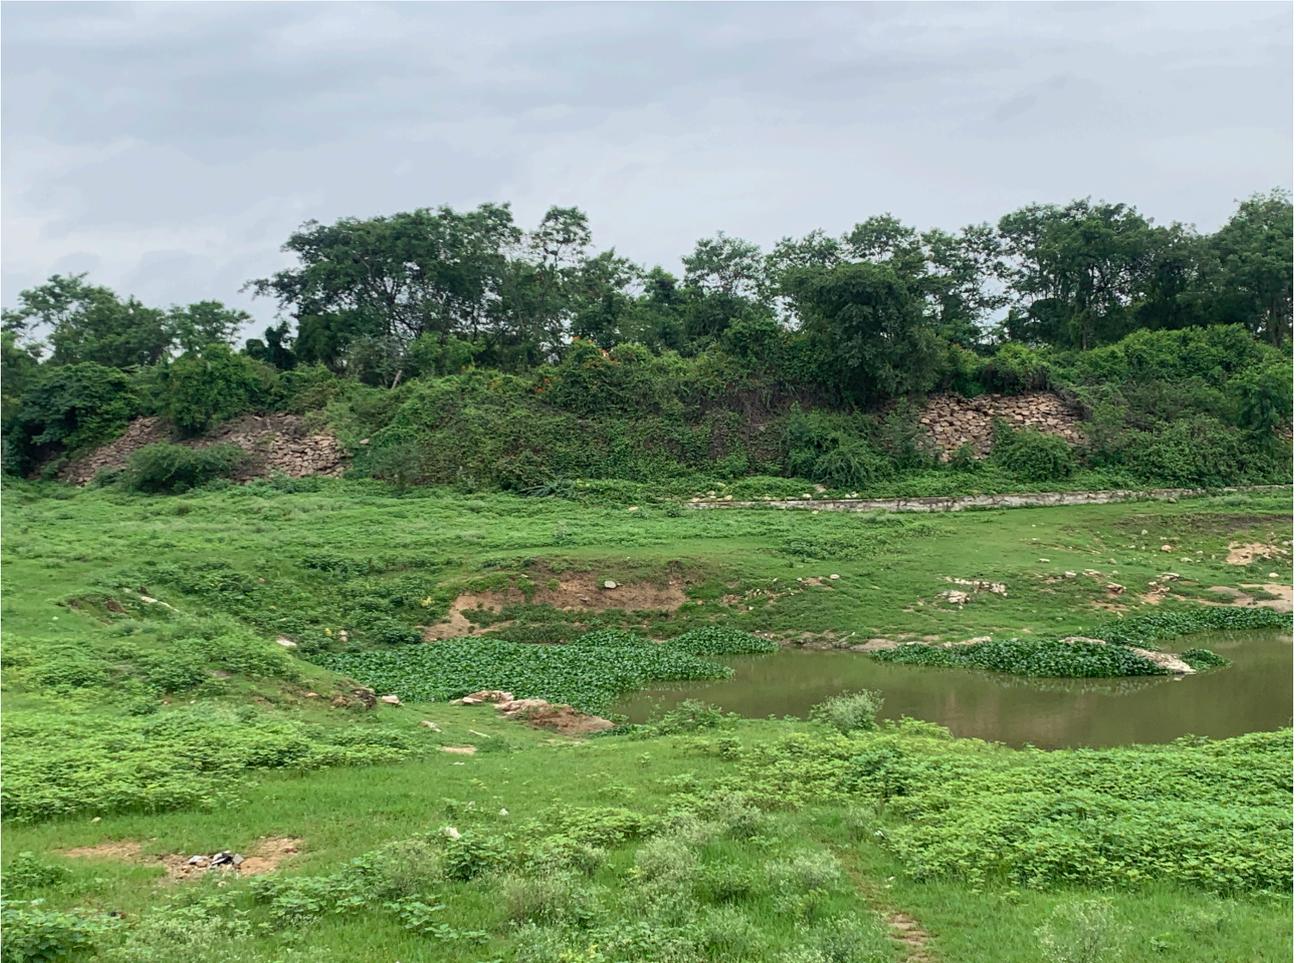
**18- VIEW OF THE HERITAGE STONE WALL BUND IN BACKGROUND
PUDDLE OF SEWAGE AND WEED GROWTH**

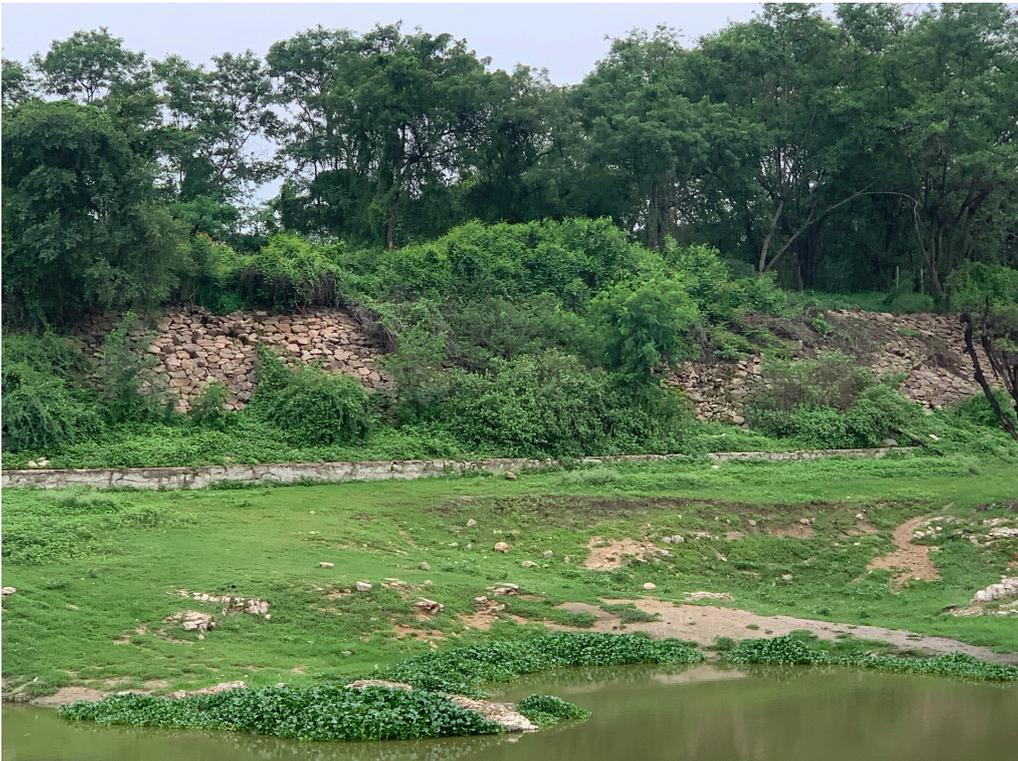
19- NEAR VIEW OF THE STONEWALL BUND - FORESHORE VIEW

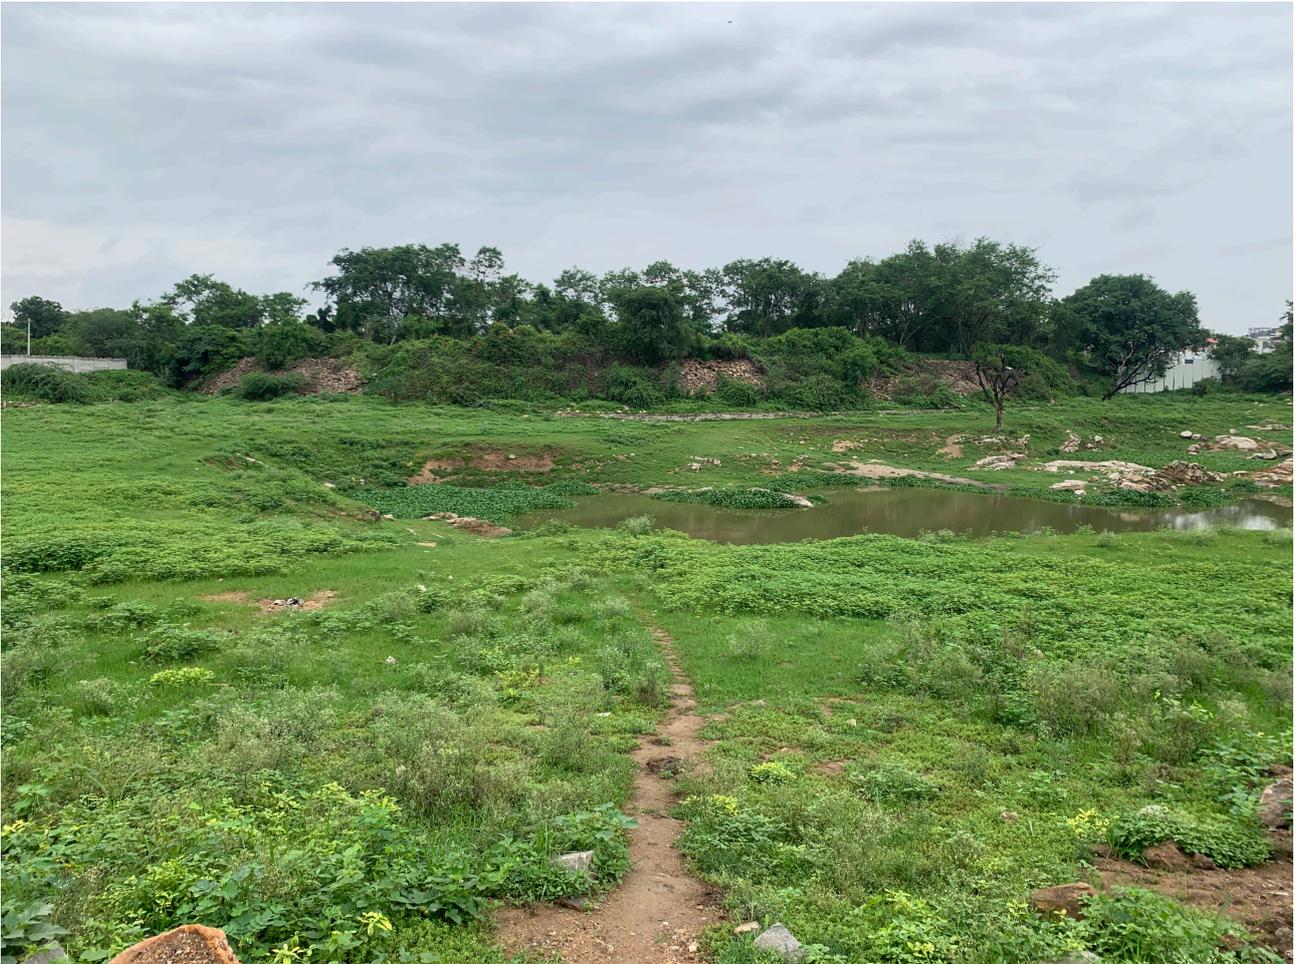
20- DISTANT VIEW OF THE STONEWALL BUND OF THE LAKE WITH ENCROACHMENT SHEETS VISIBLE BOTH ON THE WESTERN AND THE EASTERN SIDE OF THE LAKE

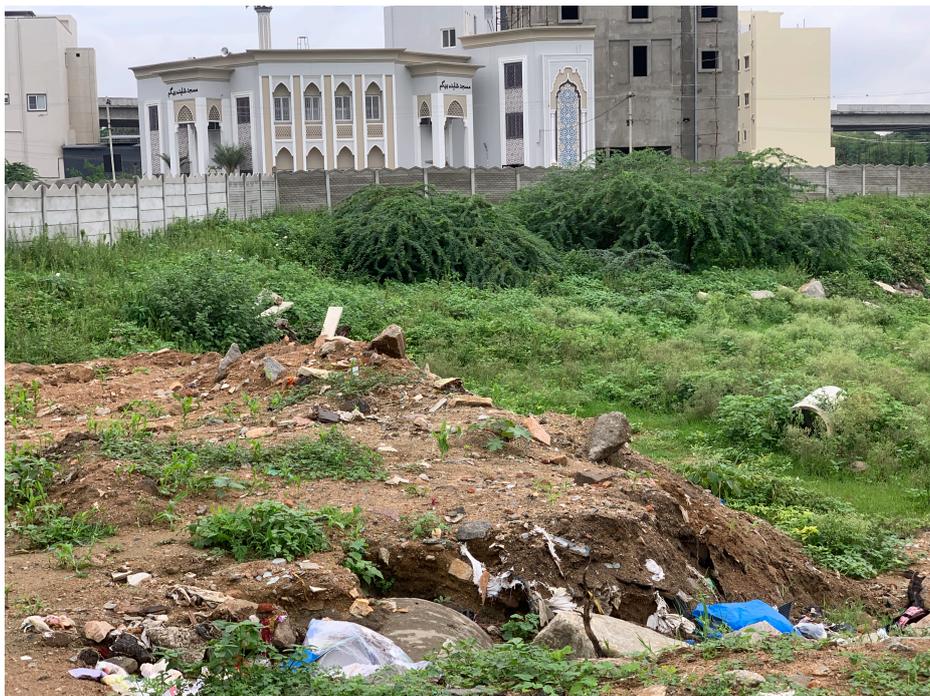
21- WESTERN SIDE SHEETS ENCLOSING THE ENCROACHMENTS INSIDE THE LAKE

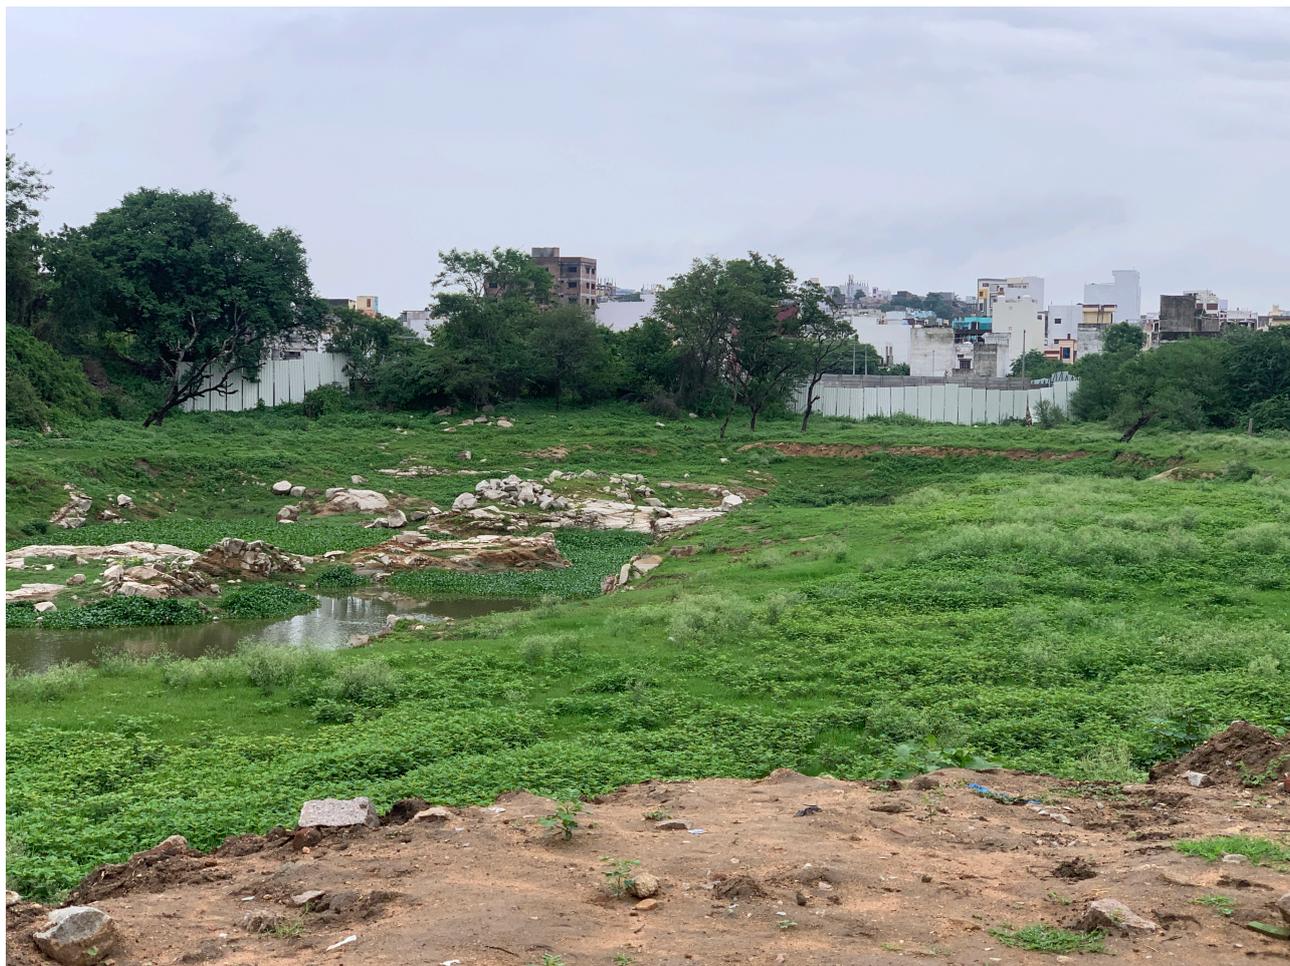
22- EASTERN SIDE SHEETS ENCLOSING THE ENCROACHMENTS INSIDE THE LAKE

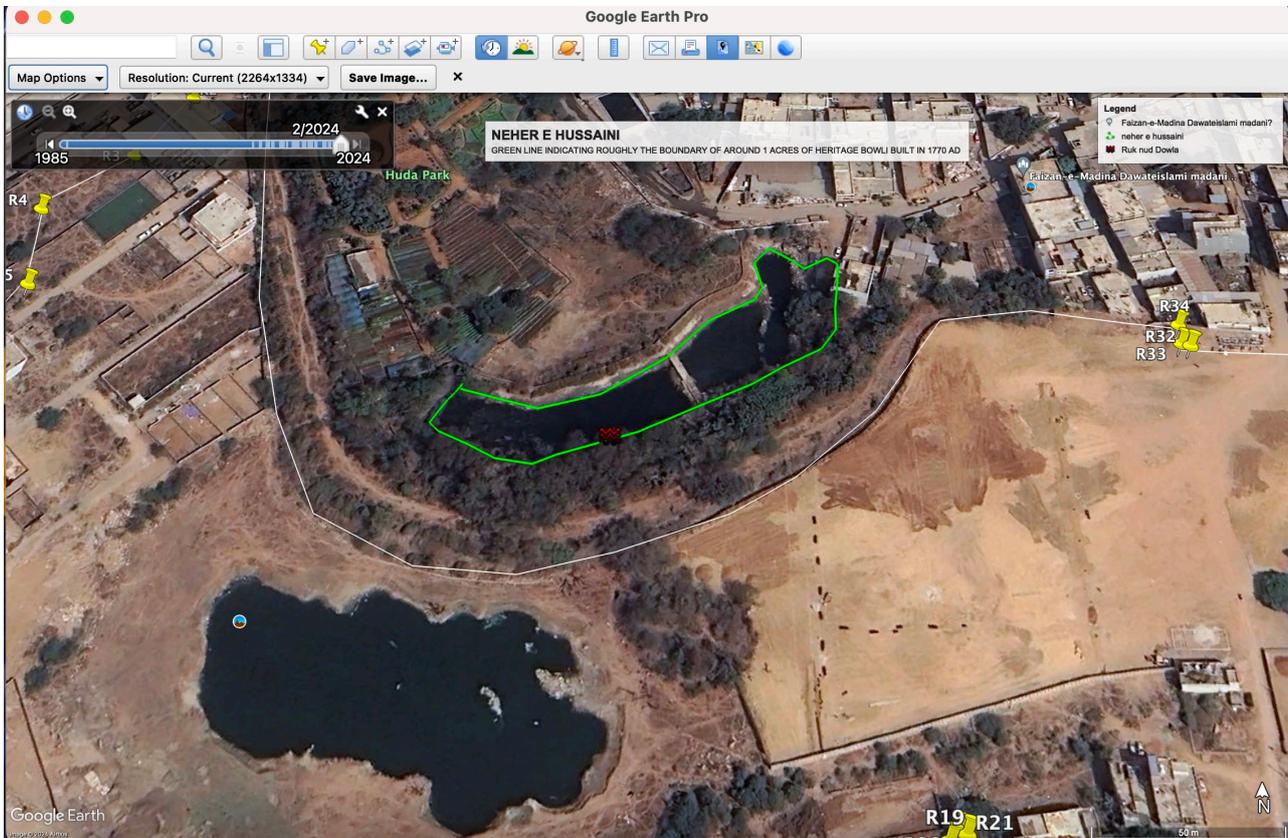
6. It is to submit that, during our survey of 26 July 2024, it was observed that the Neher e Hussaini bowli that is around 1 acre, was totally dry. Even during peak summers the bowli was never dry. As evident from satellite imagery in February 2024 the bowli was full but owing to encroachment at the bowli and due to the entire eastern side of the lake being levelled, the bowli is seen dry for the first time.
(ANNEXURE 5)

PIC 1: Neher e Hussaini that shows full of water in February 2024
