BEFORE THE NATIONAL GREEN TRIBUNAL,
SOUTH ZONE, CHENNAI

ORIGINAL OA NO. 16 OF 2022(SZ)
[OA.NO.614/2018(PB)]

**REPLY TO IRRIGATION DEPT REPORT DT 22.12.2022 FILED BY
APPLICANT**

PICTORIAL DOCUMENTATION OF FIELD SURVEY OF
BAM RUKNUD DOWLAH LAKE, NEHER E HUSSAINI BOWLI,
FROM BUND VIEW AND GROUND VIEW
ON 26 JULY 2024
(ALL PICTURES ARE GEO-TAGGED)

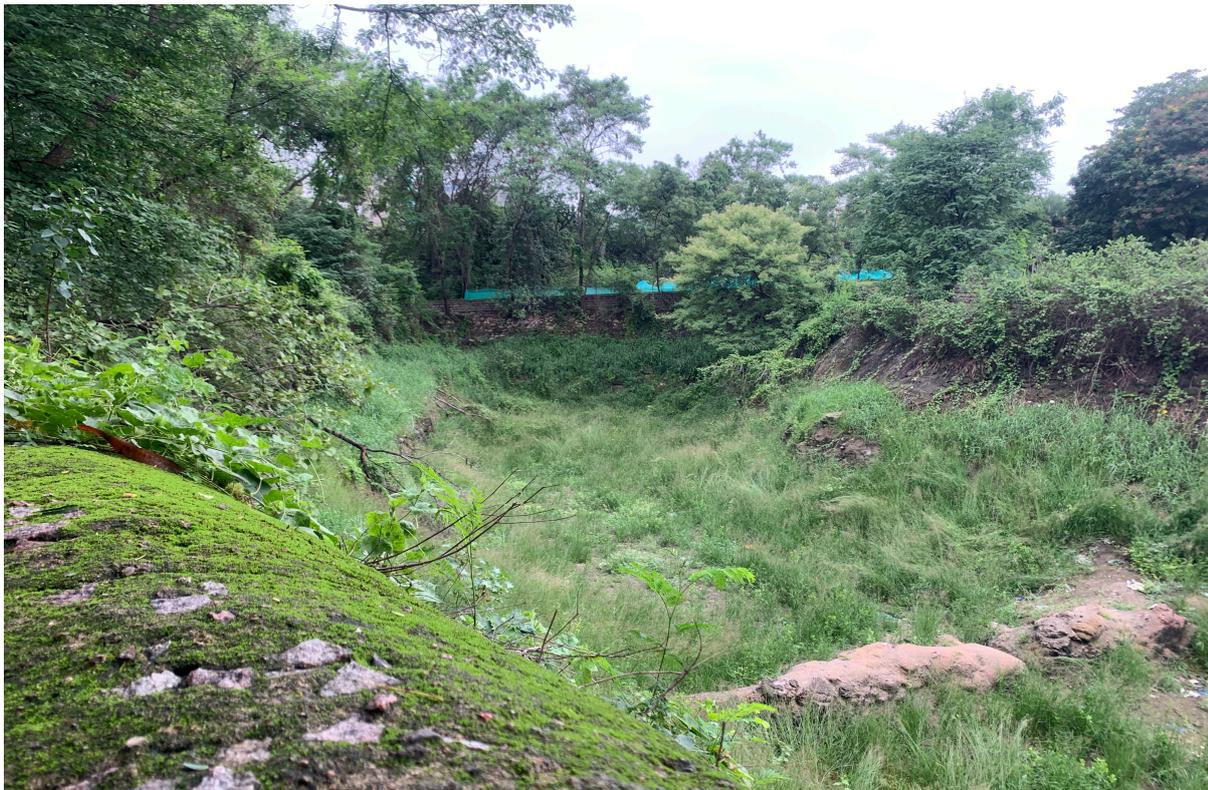
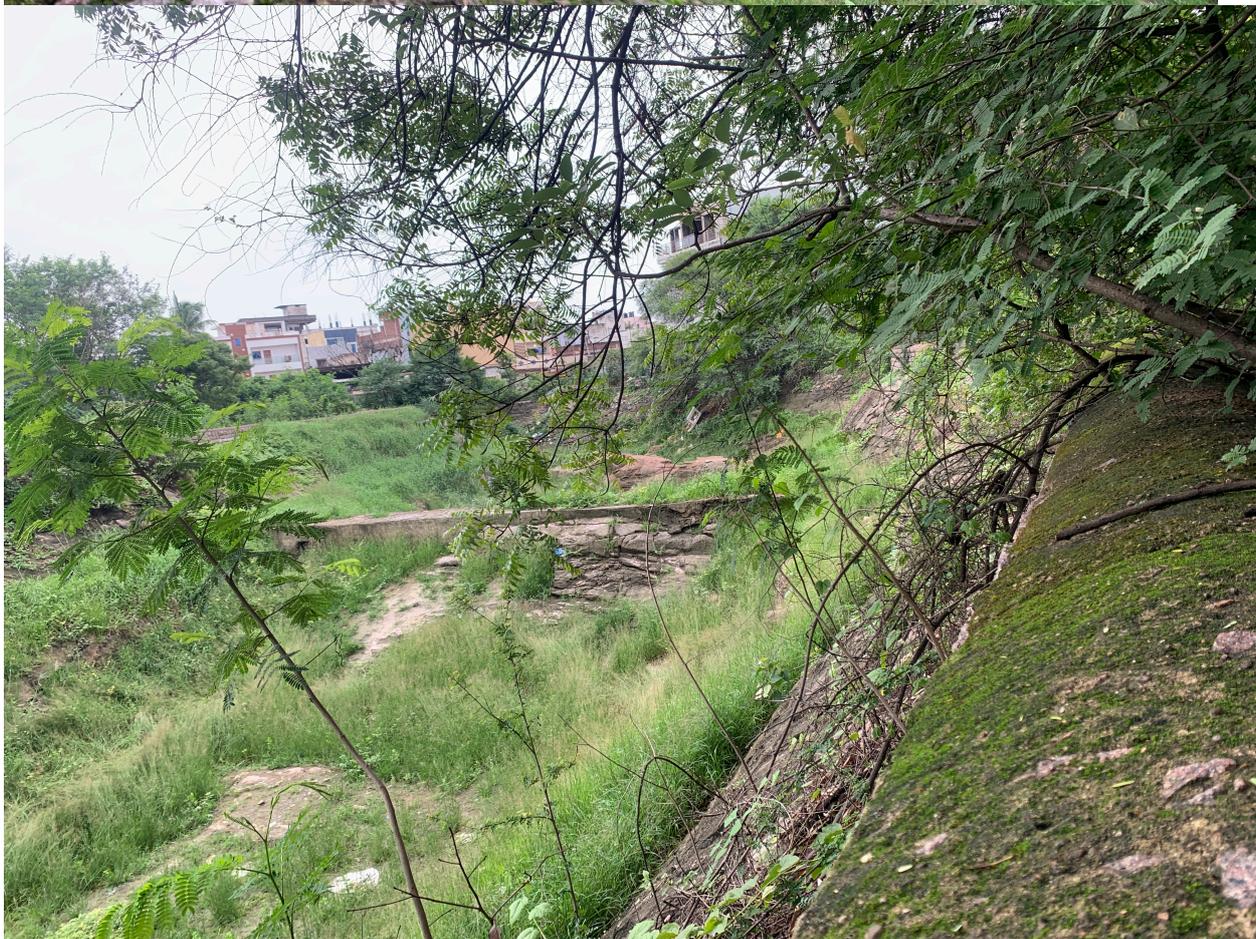
6. It is to submit that, during our survey of 26 July 2024, it was observed that the Neher e Hussaini bowli that is around 1 acre, was totally dry. Even during peak summers the bowli was never dry. As evident from satellite imagery in February 2024 the bowli was full but owing to encroachment at the bowli and due to the entire eastern side of the lake being levelled, the bowli is seen dry for the first time.
(ANNEXURE 5)

WESTERN SIDE and EASTERN SIDE IMAGE OF COMPLETELY DRY
NEHER E HUSSAINI BOWLI (PICS OF SURVEY DT 26.07.2024)
