BEFORE THE NATIONAL GREEN TRIBUNAL SOUTHERN ZONE,
CHENNAI

O.A. No. 230 of 2025

REPLY FOR THE CORRESPONDING PHOTOS FILED IN ANNEXURES TO THE APPLICATION

The present status of the pipe lines photographed by the petitioner is as detailed below:

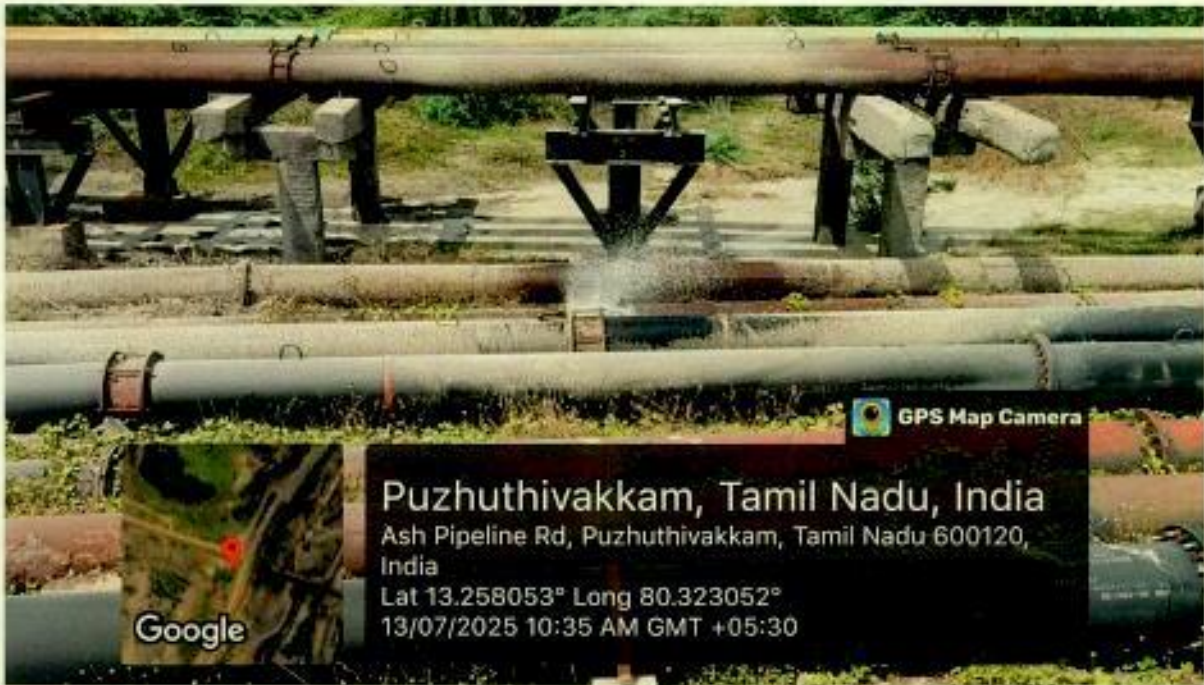
(1) Annexure A1, Page 12. Refer Google Drive video link if available

GPS Location: 13.258053 N, 80.323052 E Dated: 13.07.2025 Leak in the newly laid pipes as directed by the Court.

The leakage is in **Ash Slurry Disposal line No.5** due to damage in the O-ring. These O-rings are consumable items and are subjected to wear and tear due to continuous operation under high pressure and temperature conditions. This may also cause due to pressure fluctuations and mechanical vibrations during starting and stopping of pump. However the Minor leakage in sleeve coupling was attended by replacing Sleeve coupling and welding sleeve provide. Utmost care is taken to replace the O-ring at the weeping stage.

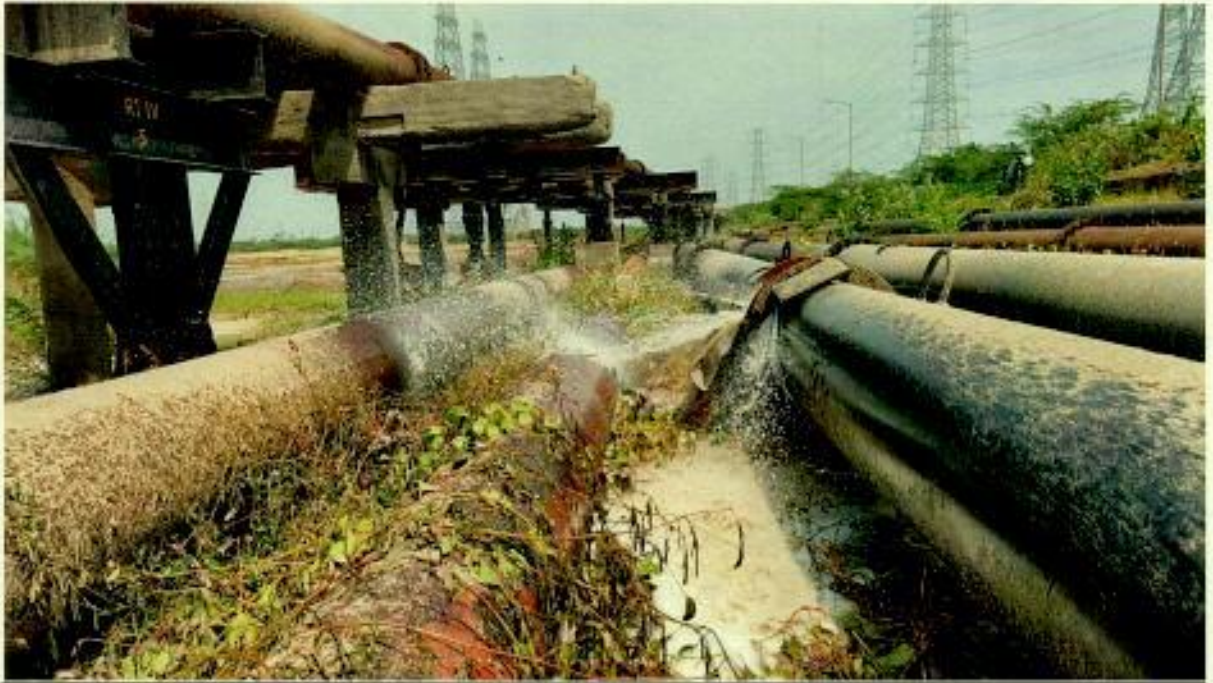
(2) Annexure A1, Page 12. Refer Google Drive video link if available:

The leakage is in **Ash Slurry Disposal line No.5** due to damage in the O-ring. These O-rings are consumable items and are subjected to wear and tear due to continuous operation under high pressure and temperature conditions. This may also cause due to pressure fluctuations and mechanical vibrations during starting and stopping of pump. However the Minor leakage in sleeve coupling was attended by replacing Sleeve coupling and welding sleeve provide. Utmost care is taken to replace the replace the O ring at the weeping stage.

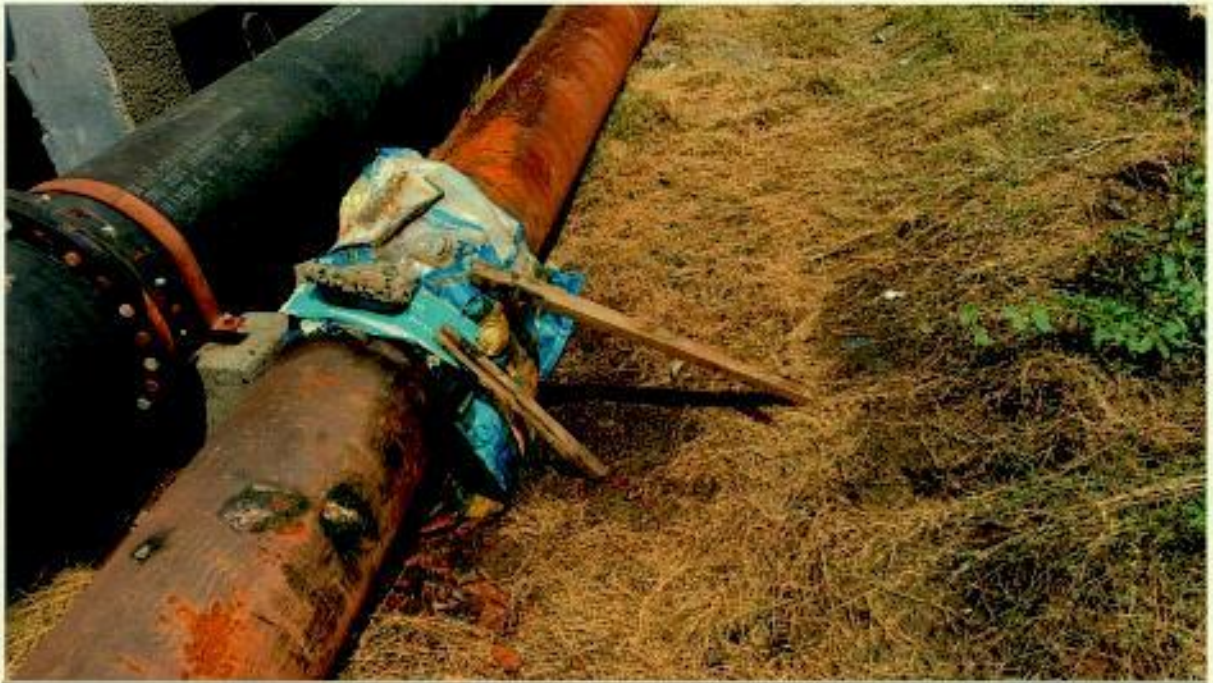
(3) Annexure A1, Page 13. Refer Google Drive video link if available.

It is clarified that the line in which the O-ring leak occurred is not an **Ash Slurry Line**, but the **Recovery Water Line (R3)**, which carries decanted saline water recovered from the Ash Pond for recirculation and reuse within the plant system. However the leak was attended immediately by replacing new O-ring.

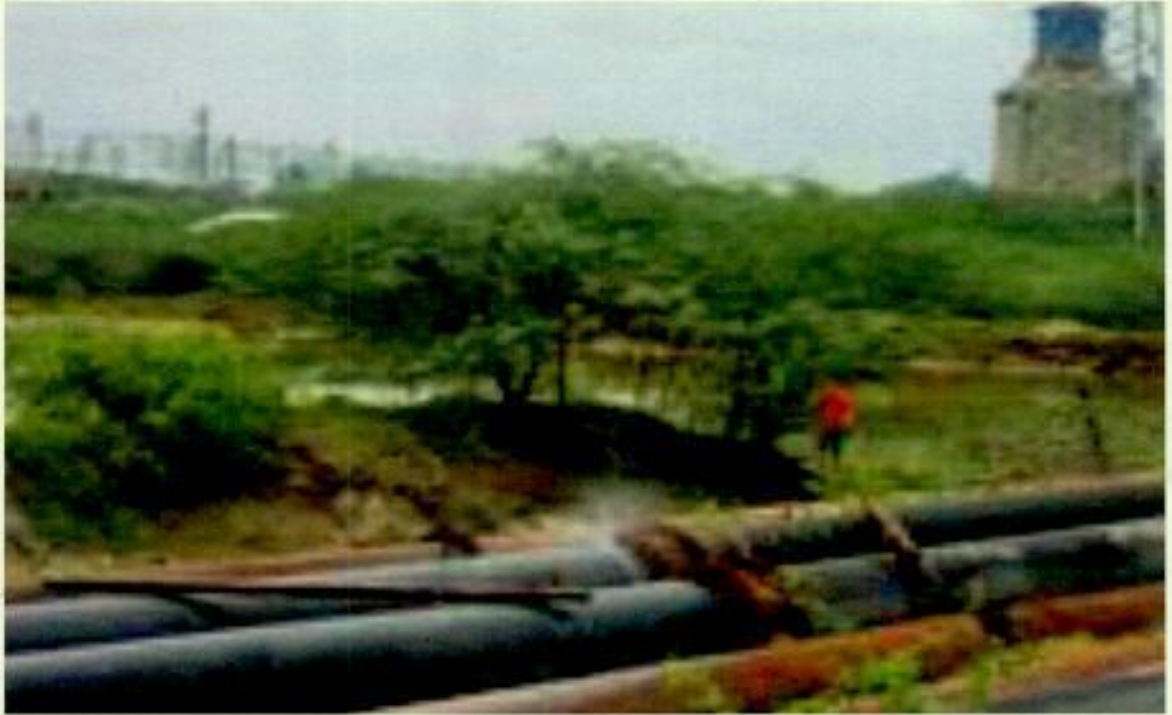
(4) Annexure A1, Page 15.

Leak from new pipeline with rusted coupling.

The leakage is in **Ash Slurry line No.5** due to damage in the O-ring. These O rings are consumable items and are subjected to wear and tear due to continuous operation under high pressure and temperature conditions. This may also cause due to pressure fluctuations and mechanical vibrations. However the Minor leakage in sleeve coupling was attended by replacing the O ring immediately. Utmost care is taken to replace the replace the O ring at the weeping stage.

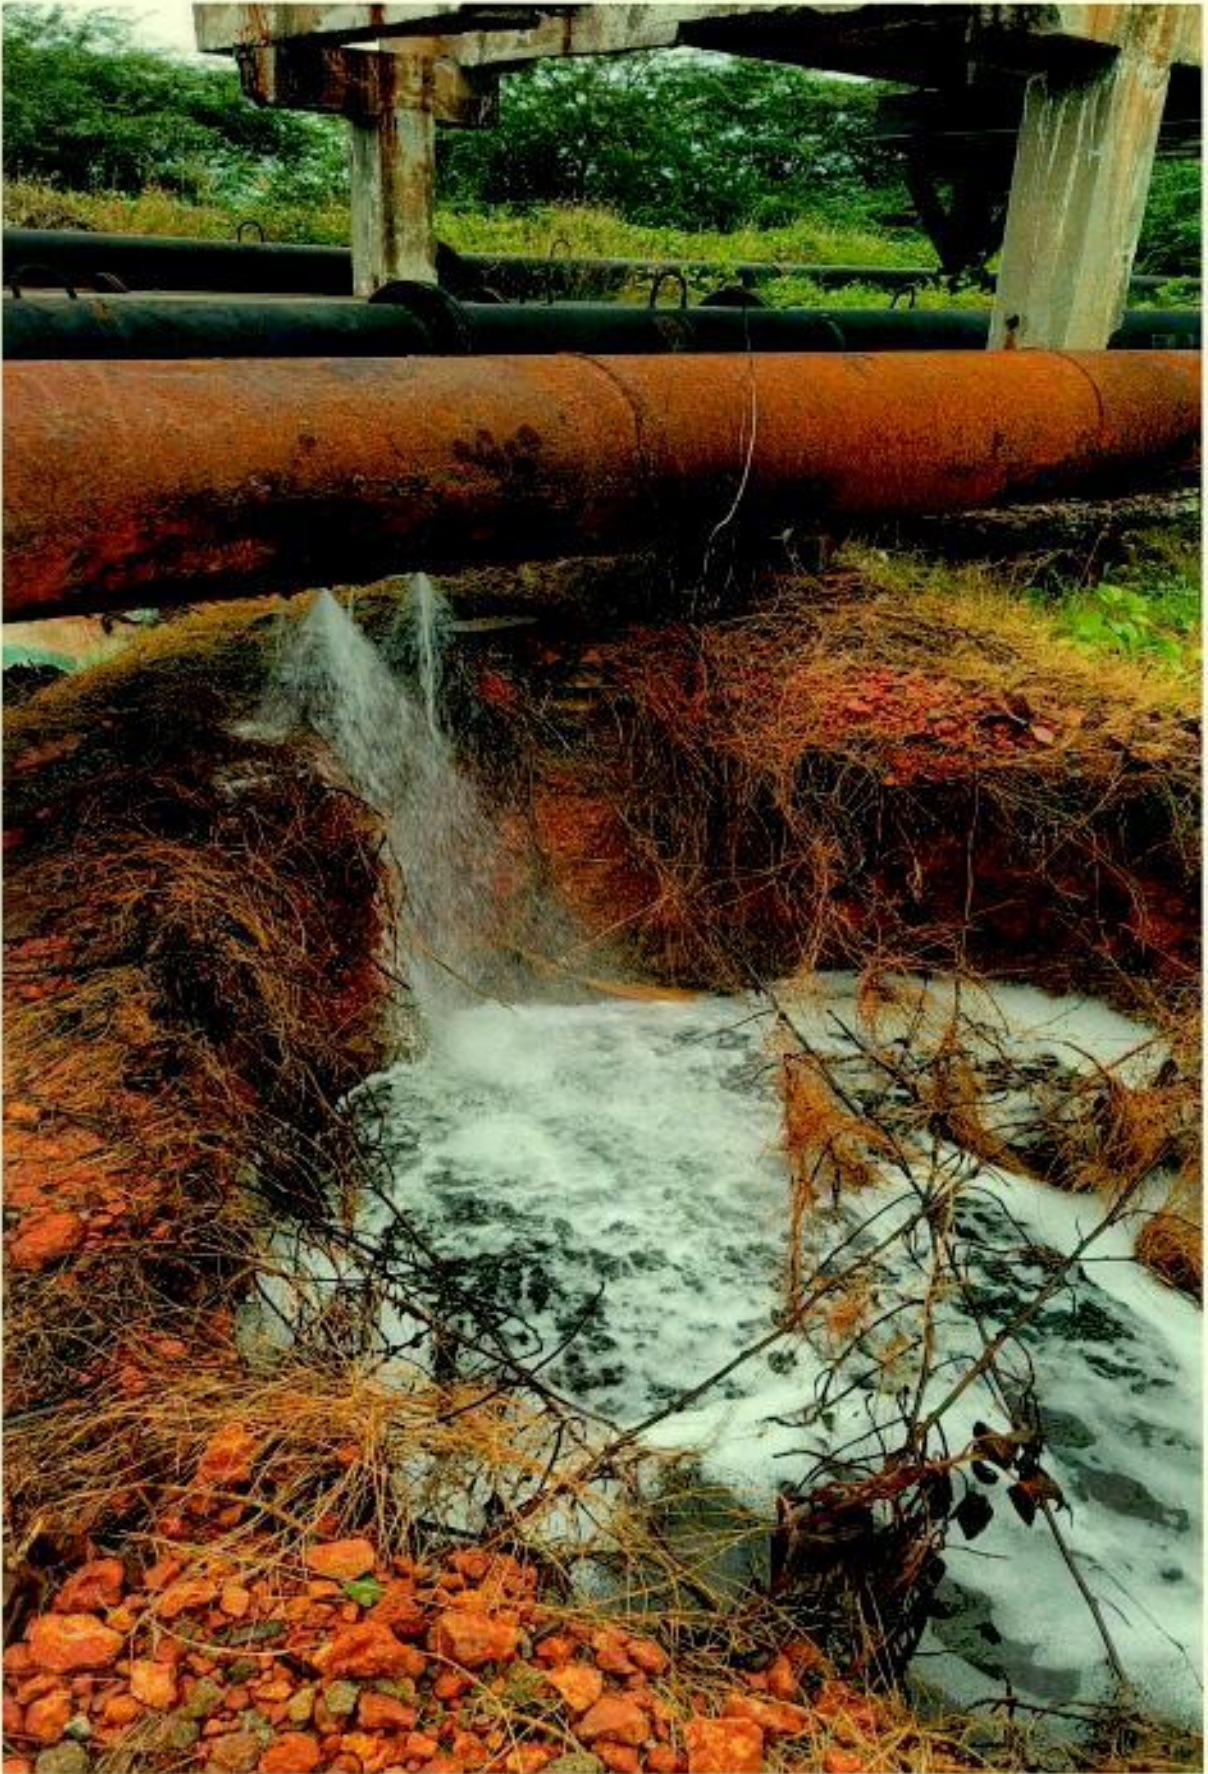
(7) Annexure A1, Page 19.

The line in which the leak occurred **is not an Ash Slurry Line, but the Recovery Water Line (R2)**, which carries decanted saline water recovered from the Ash Pond for recirculation and reuse within the plant system. However the leak was attended immediately by patch welding.

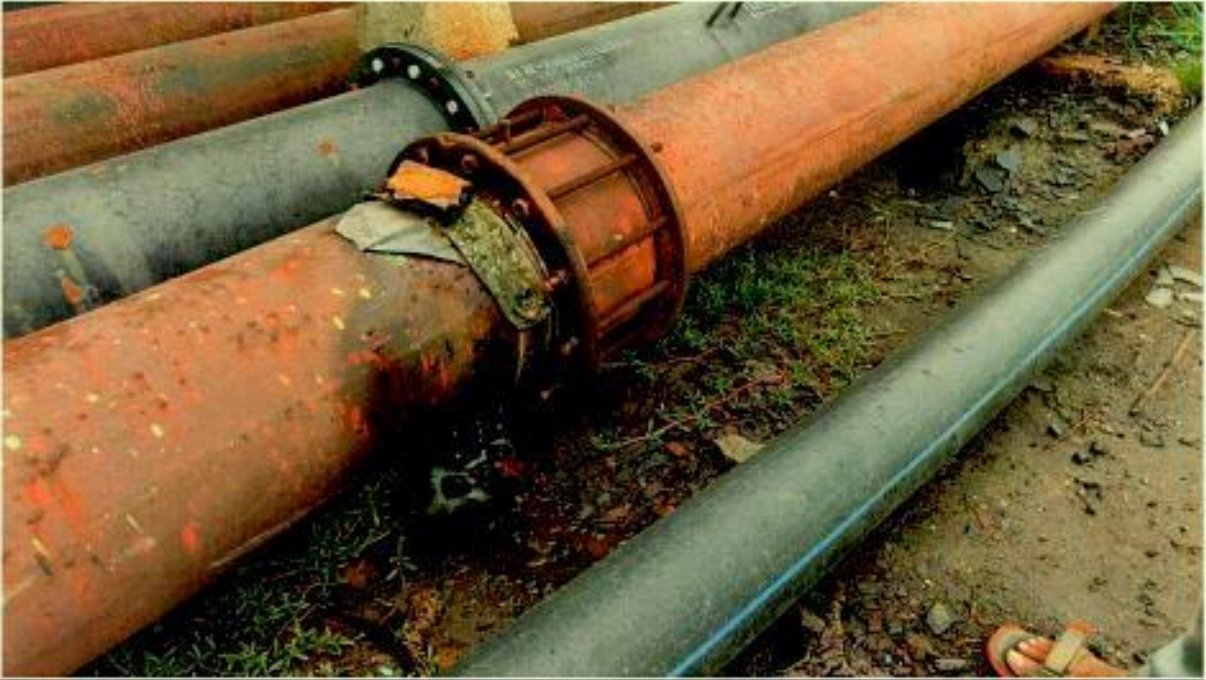
(8). Annexure A1, Page 20.

The line in which the leak occurred due to O-ring **is not an Ash Slurry Line, but the Recovery Water Line (R3)** which carries decanted saline water recovered from the Ash Pond for recirculation and reuse within the plant system. However the leak was attended immediately by replacing the O-ring.

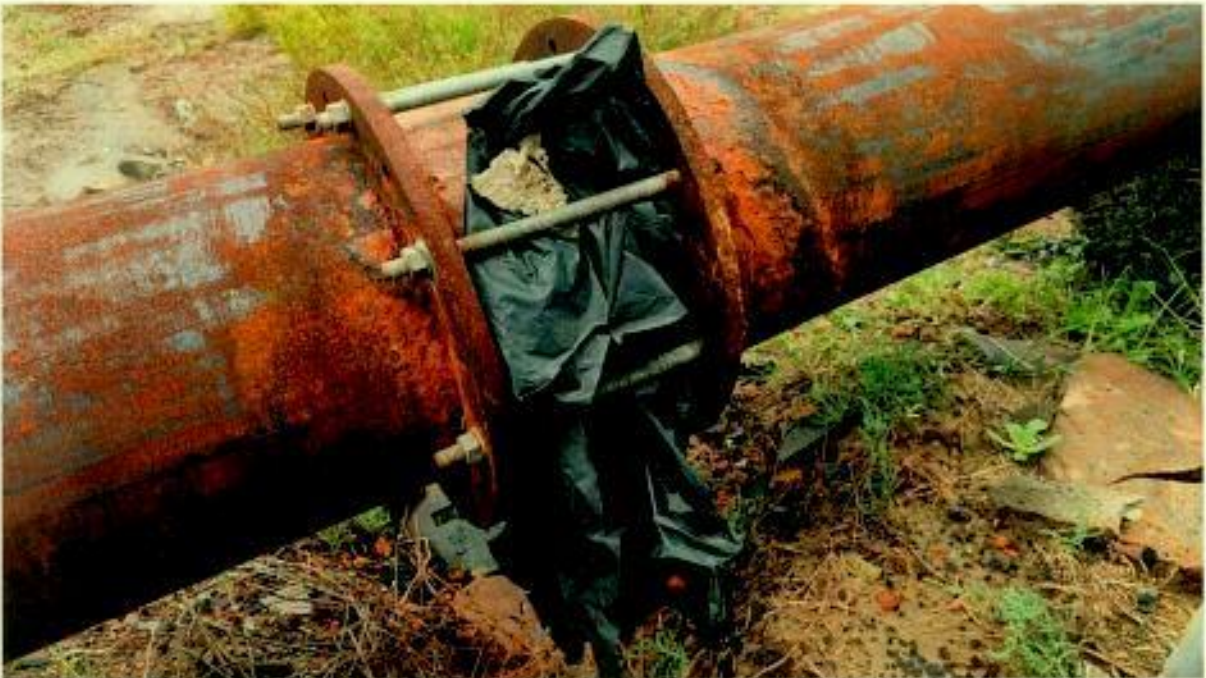
(9) Annexure A1, Page 20. (Picture No.2)

There is **no leak in the pipe however the plastic cover has been removed.**

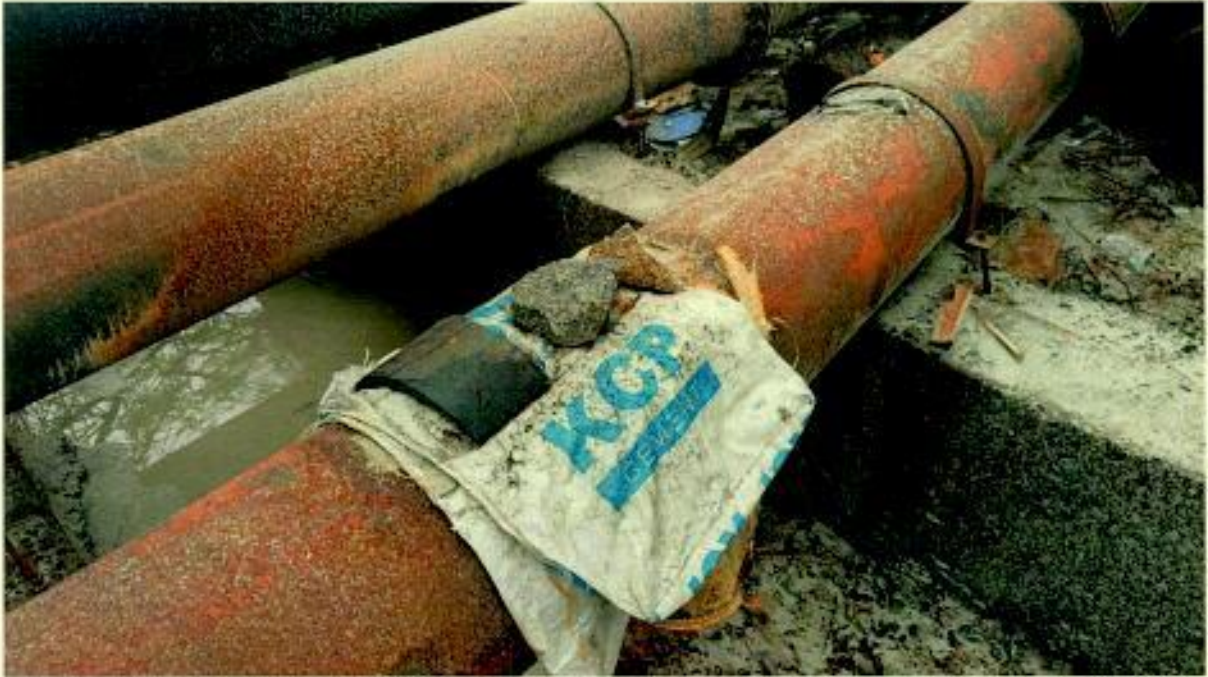
(10) Annexure A1, Page 21 (Picture No.1)

The leakage was noticed in the ASDL line No. 3 welding joint. The Pipe has been renewed with new pipe.

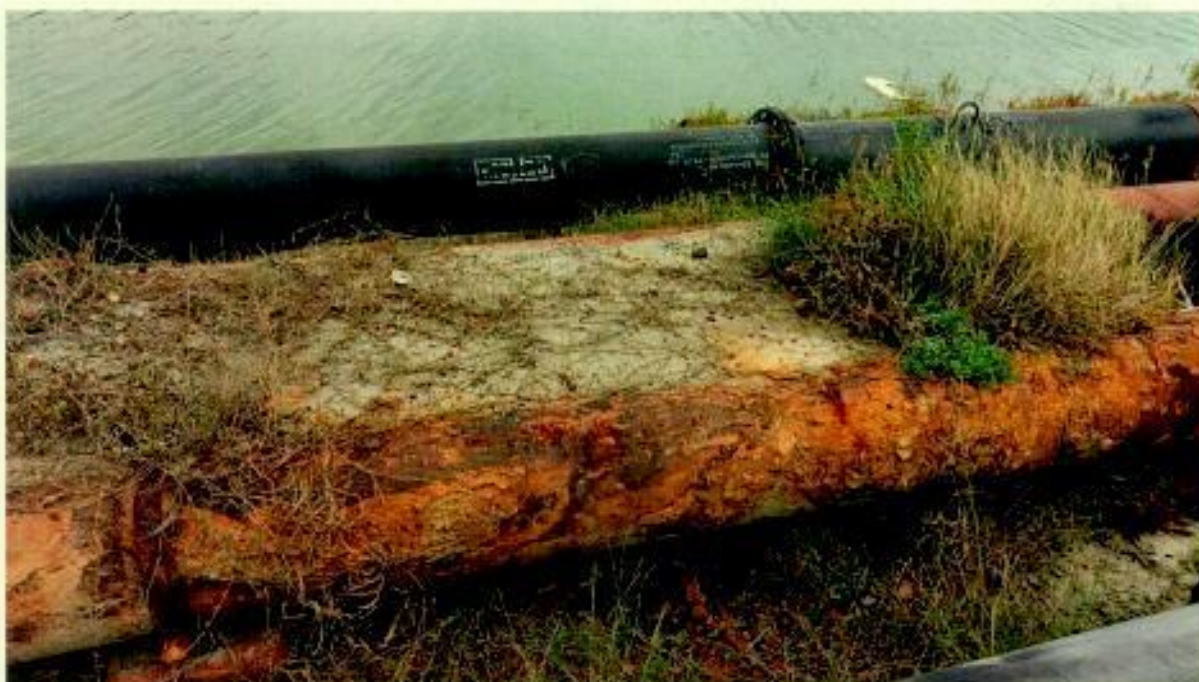
(12) Annexure 1, Page No. 22 (Picture No.1)

These lines (**ASD line 2 and 3**) are laid near to dyke and when water nearby got stagnated the debris and red sand got deposited over the pipes making a rusty look and Since the inner layer is coated with Cast basalt liners there is no potential risk of leak but however the **Pipes will be painted periodically.**

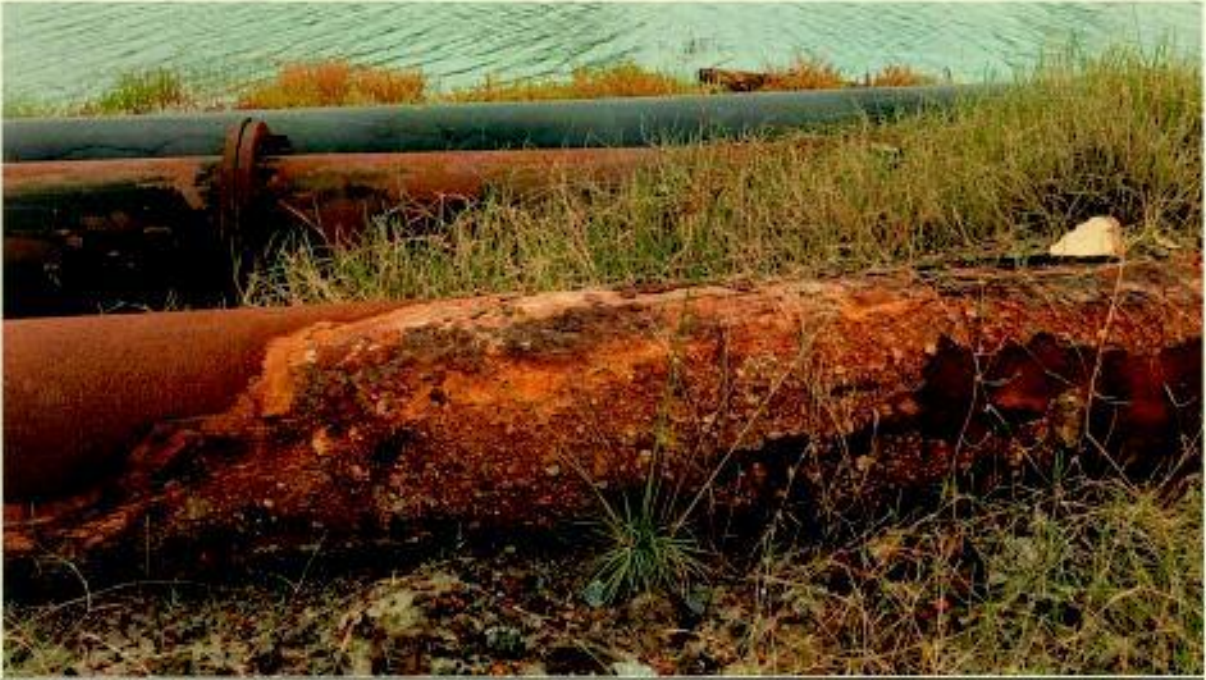
(13) Annexure A1, Page 22 (Picture No.2)

These lines (**ASD line 2 and 3**) are laid near to dyke and when water near by got stagnated the debris and red sand got deposited over the pipes making a rusty look and Since the inner layer is coated with Cast basalt liners there is no potential risk of leak but however the **Pipes will be painted periodically.**

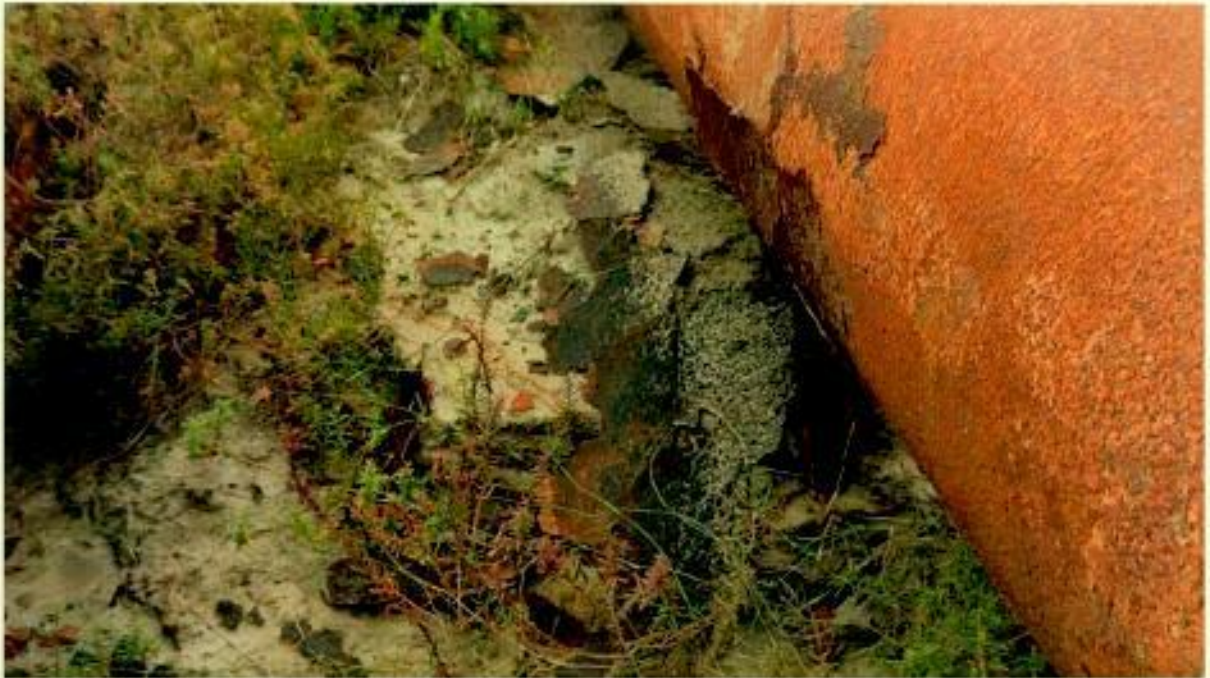
(14) Annexure -1, Page No. 23 (Picture No.1)

The line shown is the **ASDL No. 3** laid during the year 2021 and the outer layer got corroded and **painting proposal under progress.**

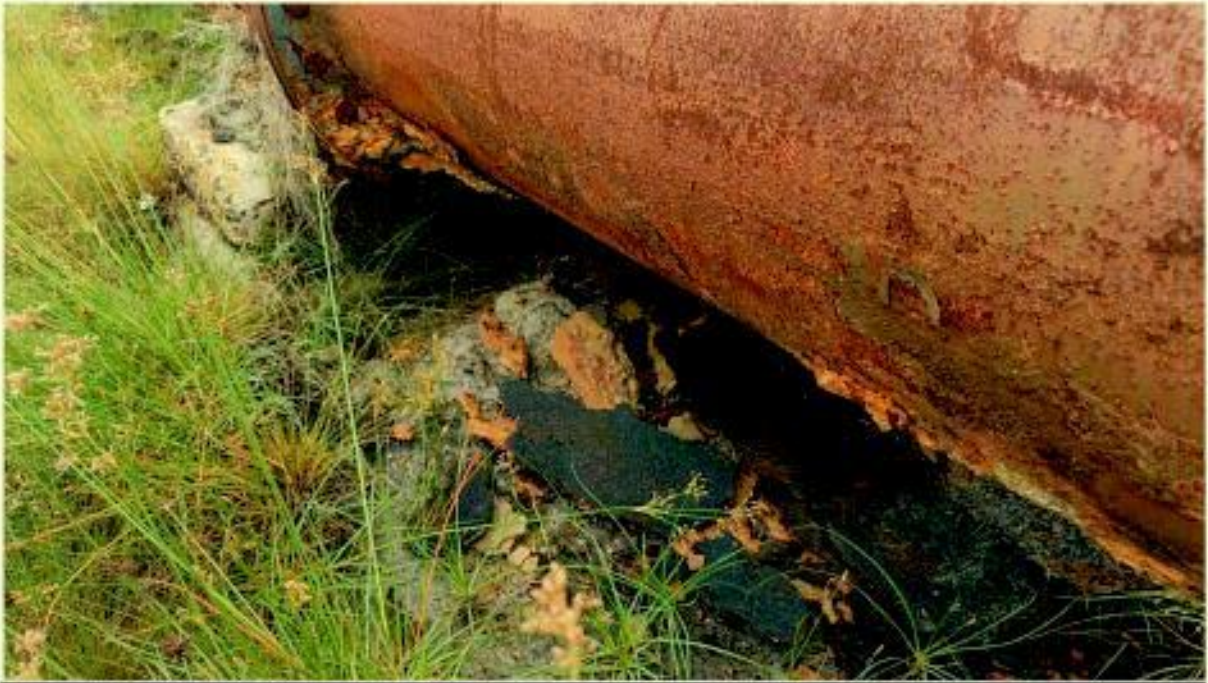
(15) Annexure 1 page No.23 (Picture No.2)

The line shown is the **ASDL No.3** line laid during the year 2021 and the outer layer got corroded and **painting proposal under progress.**

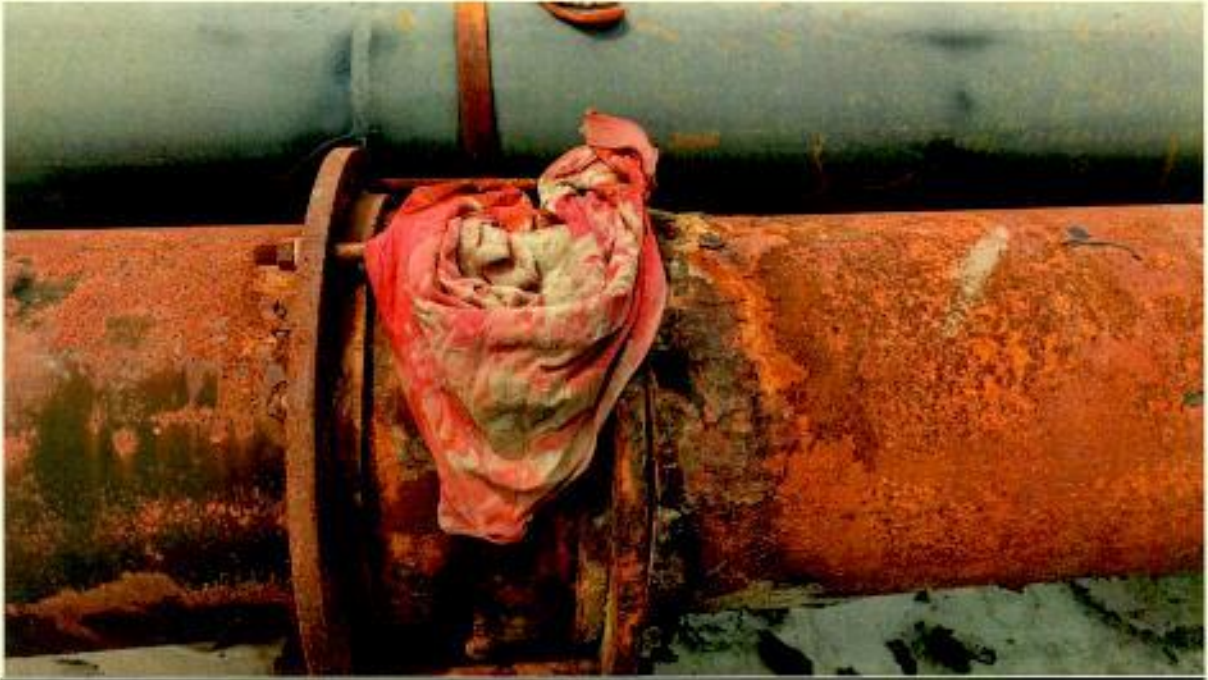
(16) Annexure 1, Page No. 24 (Pictures 1)

It is submitted that, the observation made by the petitioner appears to be misinterpreted. The cloth seen in the photograph over the slurry line is not an intentional attempt to conceal a leak. The Ash Slurry Disposal System of NCTPS-I conveys ash slurry at a **minimum pressure of 5 kg/cm² (ksc)**. **Under such pressure conditions, a piece of cloth or any fabric material cannot physically arrest or hide a leak.** Any leakage under these conditions would be forceful and immediately visible. It might be leftover by the maintenance personnel or an act of outsiders since the pipe lies along the open corridor. **The O-ring of the ASDL No.2 coupling has been replaced as weeping noticed.**

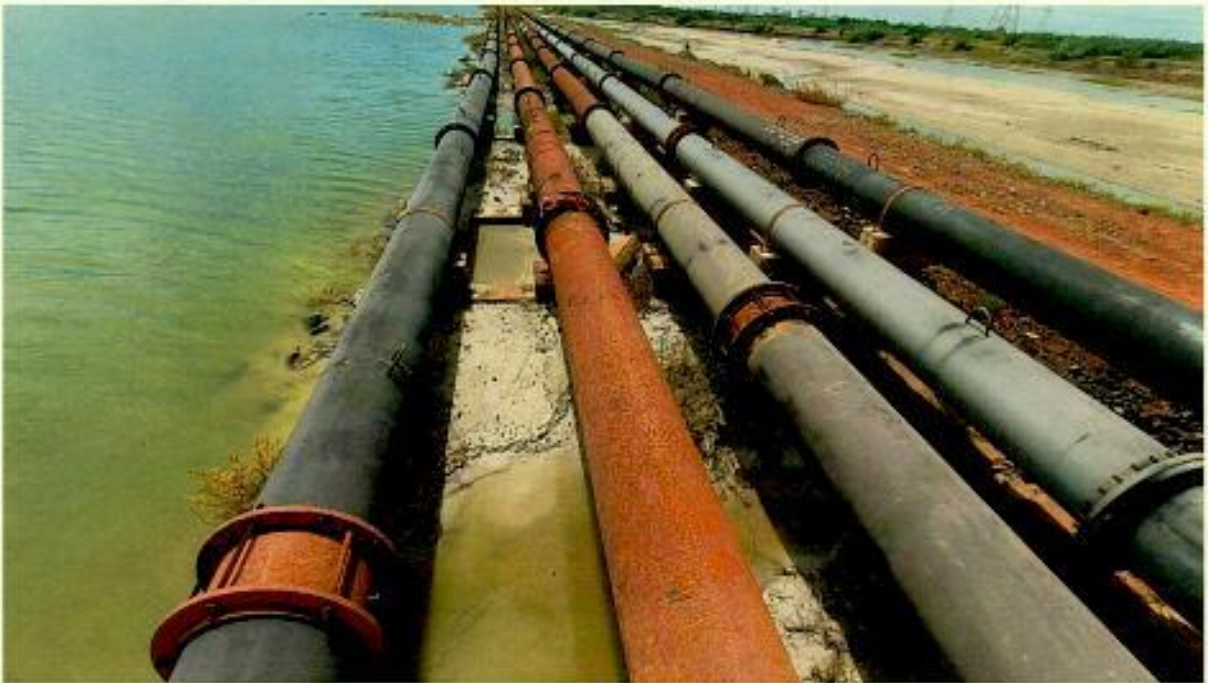
(18) Annexure A1, Page 25 (5 Nos. of Pictures)

The Pipes and coupling were procured from different agencies and the pipe was painted with black paint and the Sleeve coupling was supplied with red oxide paint. Hence it seems to be varying. However it is hereby stated that the coupling is not old and there is no structural damage in the pipes /couplings. **The painting proposal for the ASDL No.2 and 3 is under progress and periodical painting will be carried out in future.**

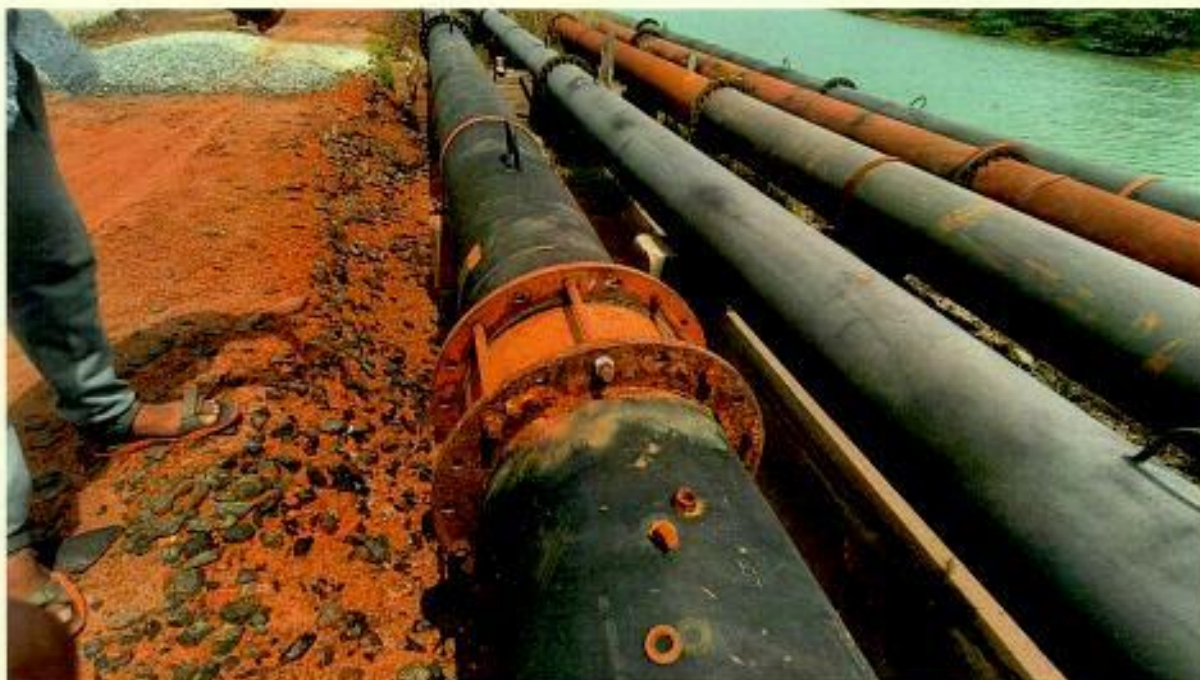
(20) Annexure A1 page No.26 (Picture No.1)

The Pipes and coupling were procured from different agencies and the pipe was painted with black paint and the Sleeve coupling was supplied with red oxide paint. Hence it seems to be varying. However it is hereby stated that the coupling is not old and there is no structural damage in the pipes /couplings. **The painting proposal for the ASDL No.2 and 3 is under progress and periodical painting will be carried out in future.**

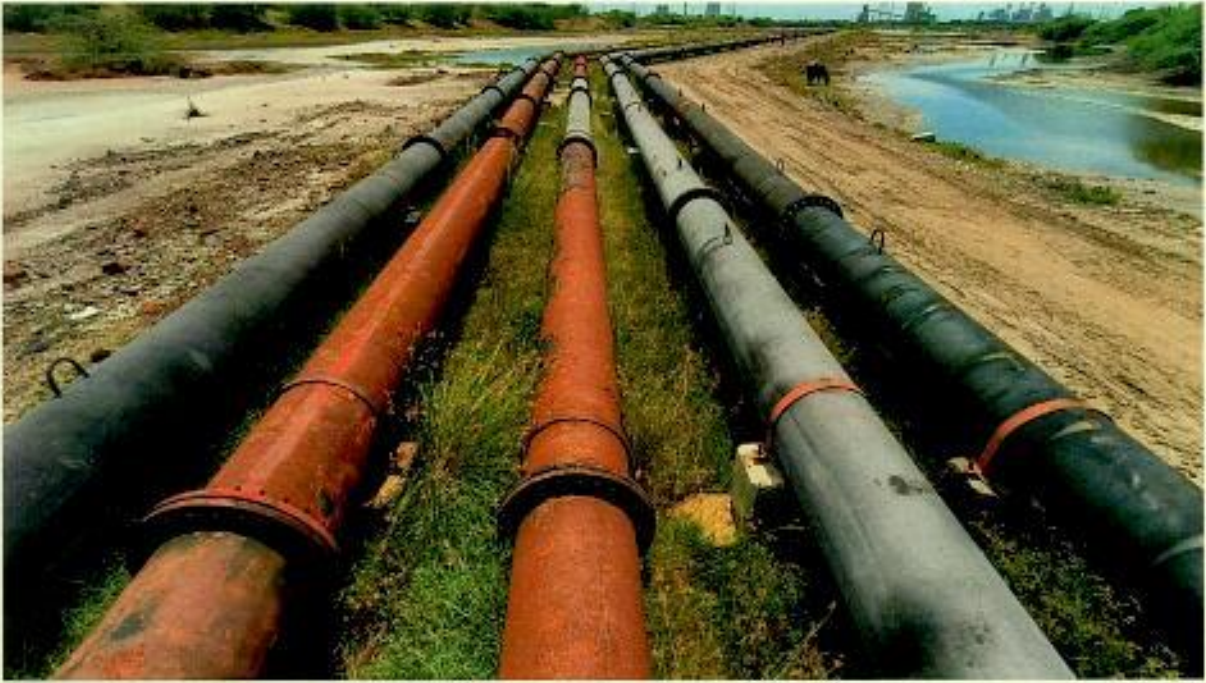
(22) Annexure A1, Page No.27 (Picture No.1)
 14. GPS: 13°16'38.5"N 80°18'21.6"E dated 04.10.2025

The ASDL lines depicted in the photograph are not partially replaced of pipes. The **pipes were renewed in a phased manner from 2021 to 2025** in the order of ASDL 3(2021-22), ASDL 2 (2022-23), ASDL4 (2023-24), ASDL 5(2024-25, ASDL1(2024-25). Hence there is no partial replacement. Also new pipes were replaced in the existing pipes ASDL 3 and 2 whenever emergency rises. Also written submission were filed before the Hon'ble NGT after replacement of ASDL pipes as directed by the Hon'ble NGT.

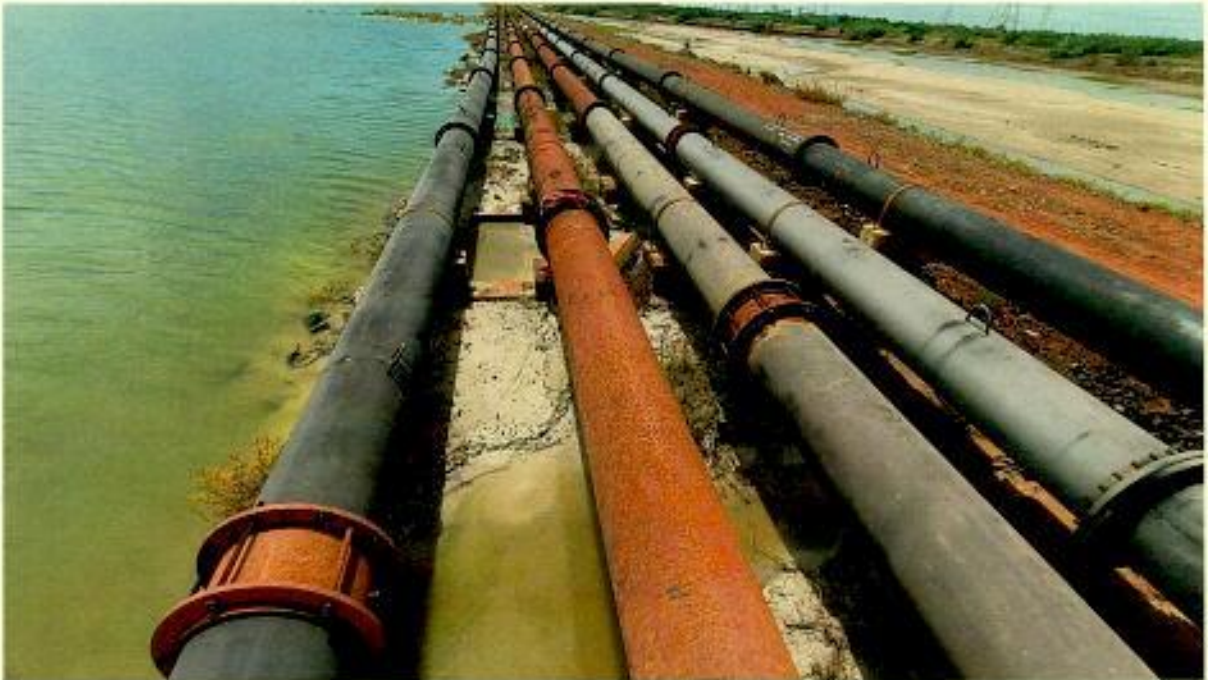
(23) Annexure A1, page No.27 (Picture No.2)

The ASDL lines depicted in the photograph are not partially replaced of pipes. The **pipes were renewed in a phased manner from 2021 to 2025** in the order of ASDL 3(2021-22), ASDL 2 (2022-23), ASDL4 (2023-24), ASDL5(2024-25, ASDL1(2024-25). Hence there is no partial replacement. Also new pipes were replaced in the existing ASDL 3 and 2 whenever emergency rises.

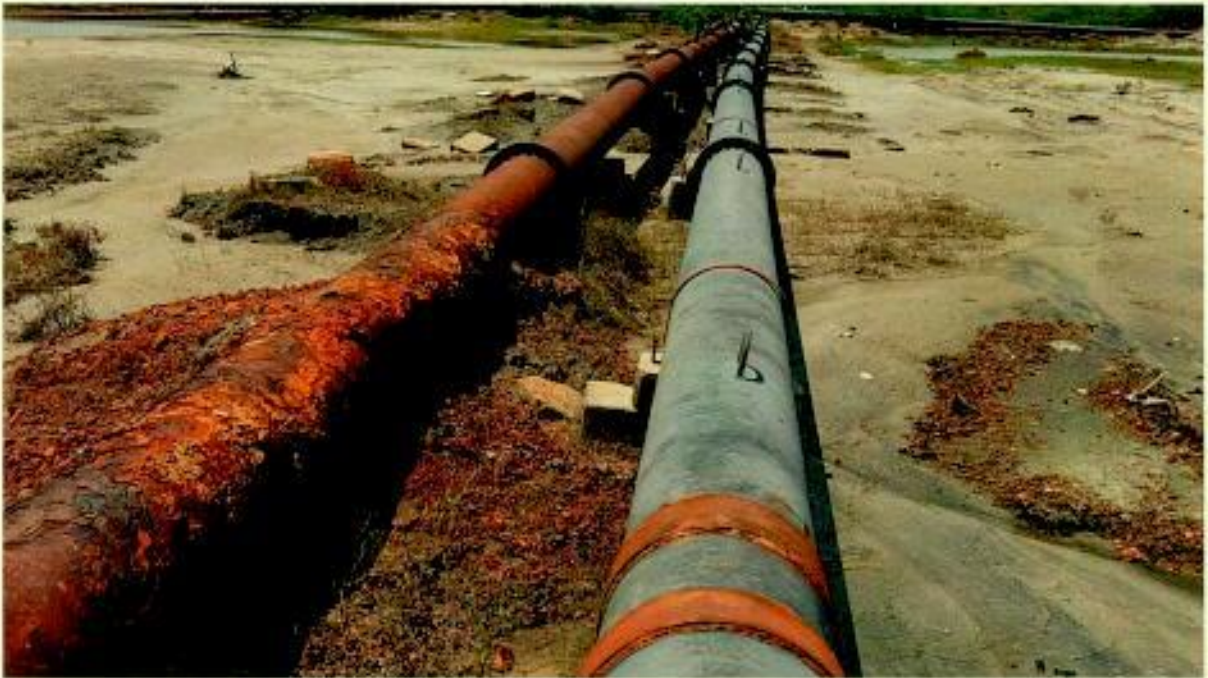
(24) Annexure A1, page No. 28 (Picture No.1 and 2)

During rainy season the pipes got submerged and the Red soil and tiny stone particles got stuck to the pipe lines showing a rusty look and **beyond the soil area it could be seen clear.**

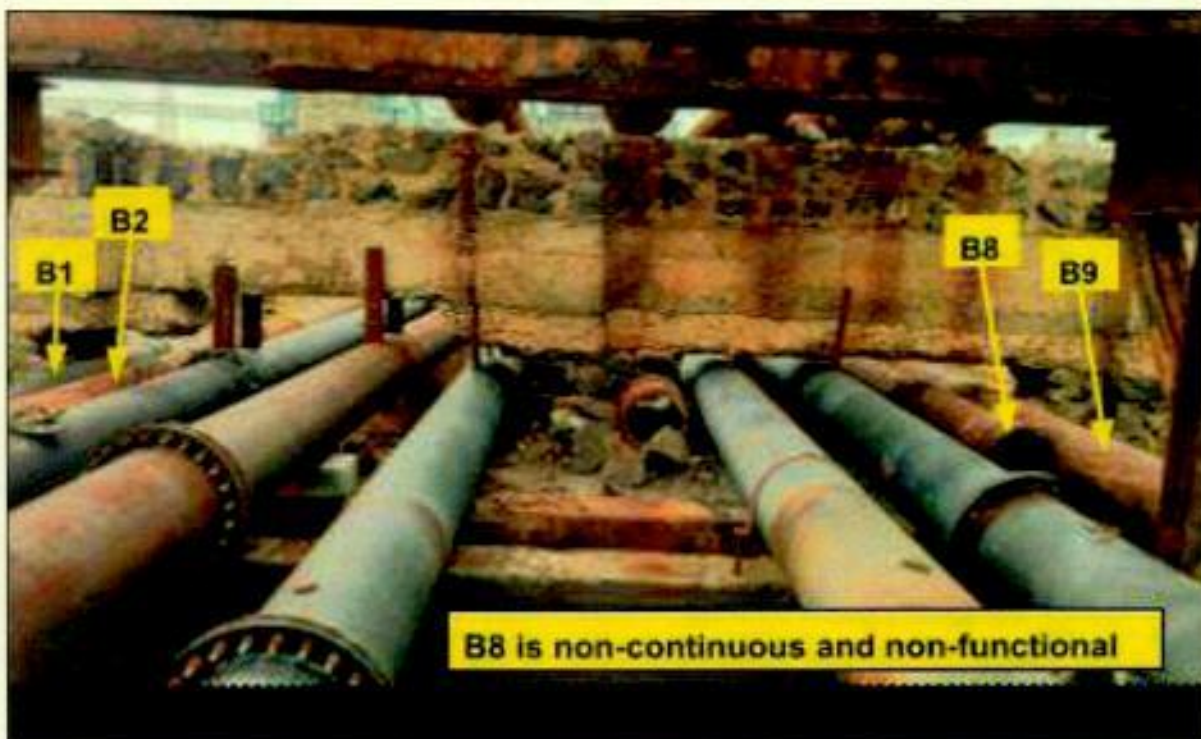
(28) Annexure A7, Page No.60 (Picture No.3)

The B8 mentioned is **recovery water line and is not in service at present.** It was kept as a standby line for the recovery water system. At present Tender to be called for the procurement of pipe lines (Entire length of 2,910 M) for the Recovery

water line No.1 (B8) and Administrative approval for Recovery water line No. 2 (B9) (Entire length of 2,910 M) is awaited from Board Level Tender Committee and tender is in process for the partial replacement of the Recovery water line No. 3 (B2) (816M) for replacement in phased manner as mentioned previously.

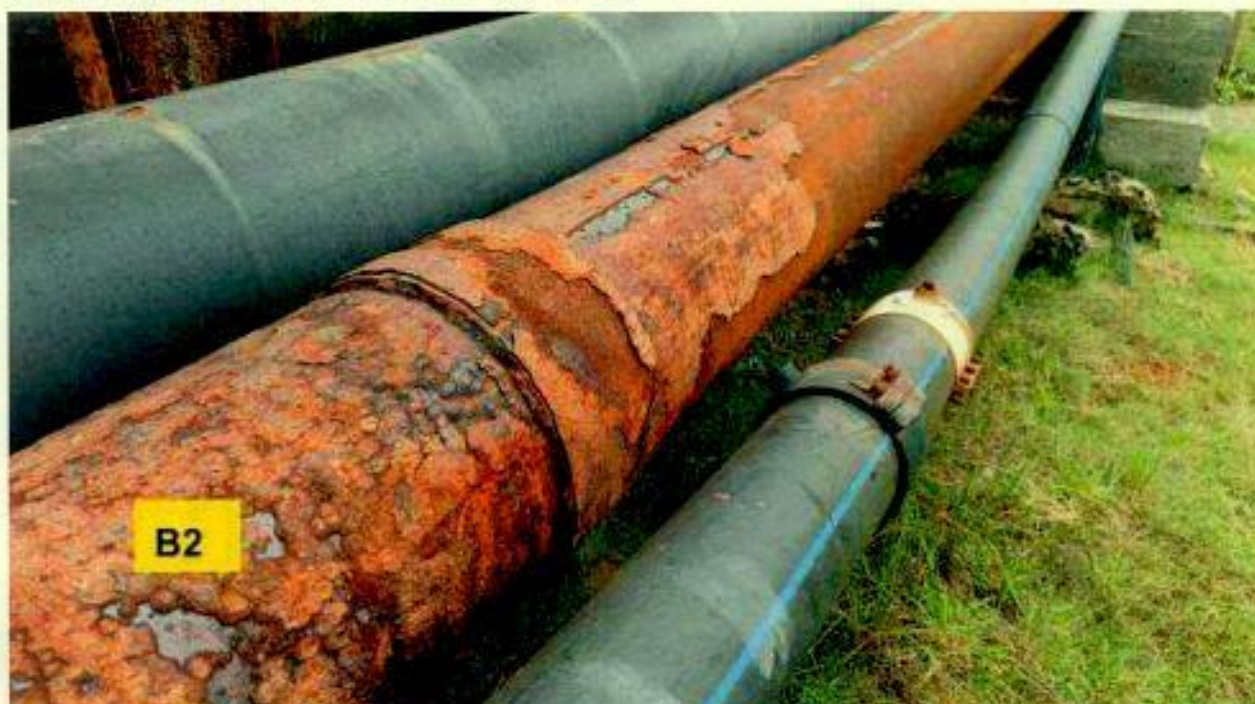
(30) Annexure A7, Page No. 63 (Picture No. 2)

B2 line is also Recovery water line (R3) and proposal has been sent for obtaining administrative approval **for the replacement of the entire length of 2,910 M** to the Board Level Tender Committee and after obtaining the Administrative Approval tendering process will be initiated. For the **B4 line is an Ash Slurry Disposal Line for which the painting proposal is under progress.**

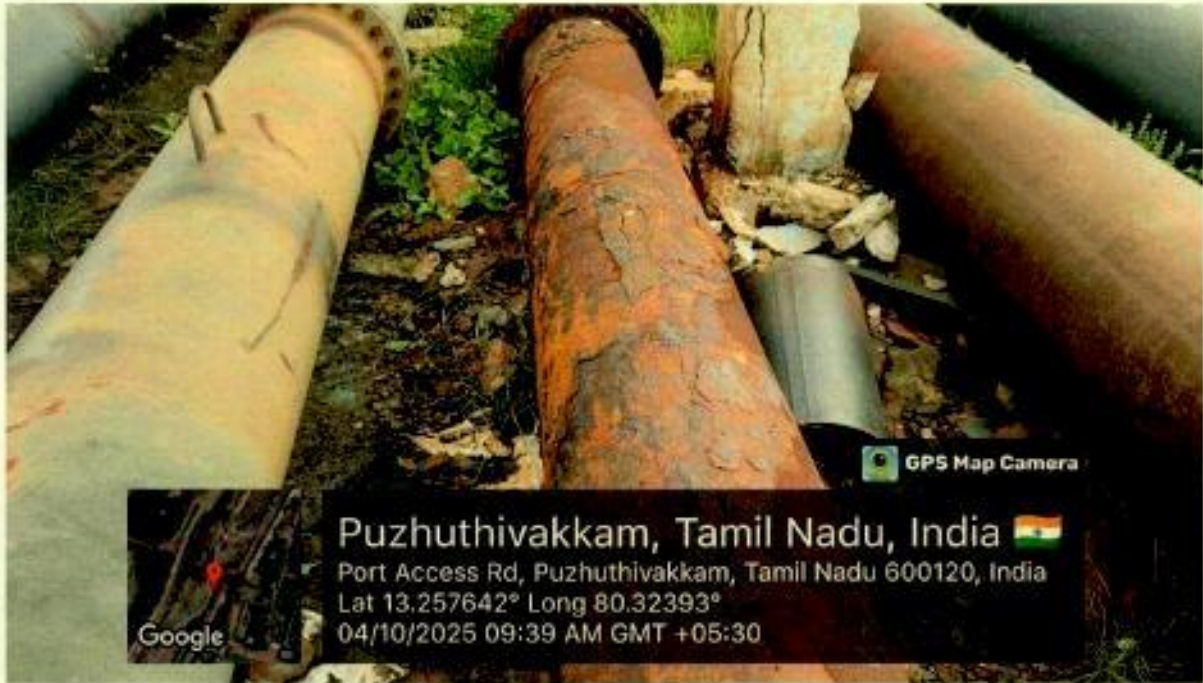
(33) Annexure A7, Page No.65 (Picture No.1) GPS: 13°15'27.5"N

The **Ash Slurry Disposal Line No. 3** was commissioned during the year **2021**. The corrosion is due to prolonged exposure to saline and humid coastal atmosphere, accelerating oxidation. The lines are lined with cast basalt lining of 20 mm Thickness. However **proposal is under progress for protective coating by painting with epoxy paint and the work will be completed before May'2026**.

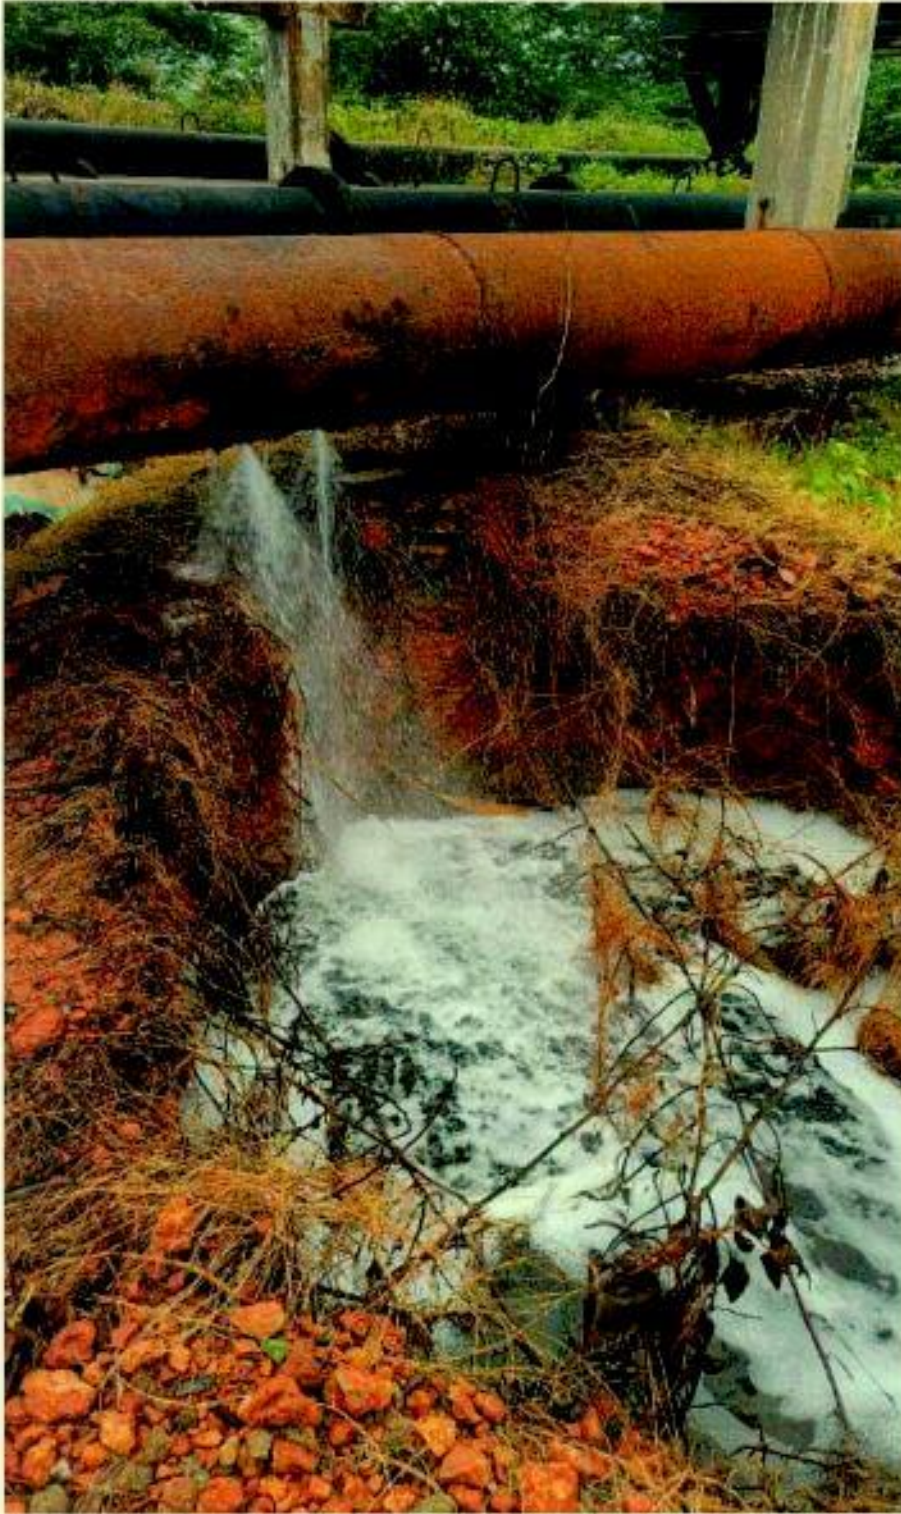
(37) Annexure A7, Page No.68 (Picture No.1)

It is submitted that the photograph referred to by the petitioner **does not pertain to an ash slurry disposal line, but rather to a recovery water line that conveys decanted saline water from the Recovery Water Pump House back to the NCTPS-I for reuse / recirculation in the Ash Handling System** and other auxiliary processes. The leak has been attended.

The recovery water system is a closed-loop circuit designed to minimize freshwater intake by re circulating the decanted supernatant water from the ash pond after the heavier ash particles have settled at the dyke. The recovered water thus transported contains **only trace suspended solids** within permissible limits and no fly ash or bottom ash particles in significant quantity.

The Ash Slurry Disposal Lines are of **higher diameter 406 mm** and specifically designated for ash transport. But the Recovery water line is smaller in diameter than Slurry line i.e. **350 mm dia.**

However the leak is due to mechanical failure and a pinhole puncture occurred which was attended immediately.
