BEFORE THE NATIONAL GREEN TRIBUNAL SOUTHERN ZONE,
CHENNAI

O.A. No. 230 of 2025

REPLY FOR THE CORRESPONDING PHOTOS FILED IN ANNEXURES TO THE APPLICATION

The present status of the pipe lines photographed by the petitioner is as detailed below:

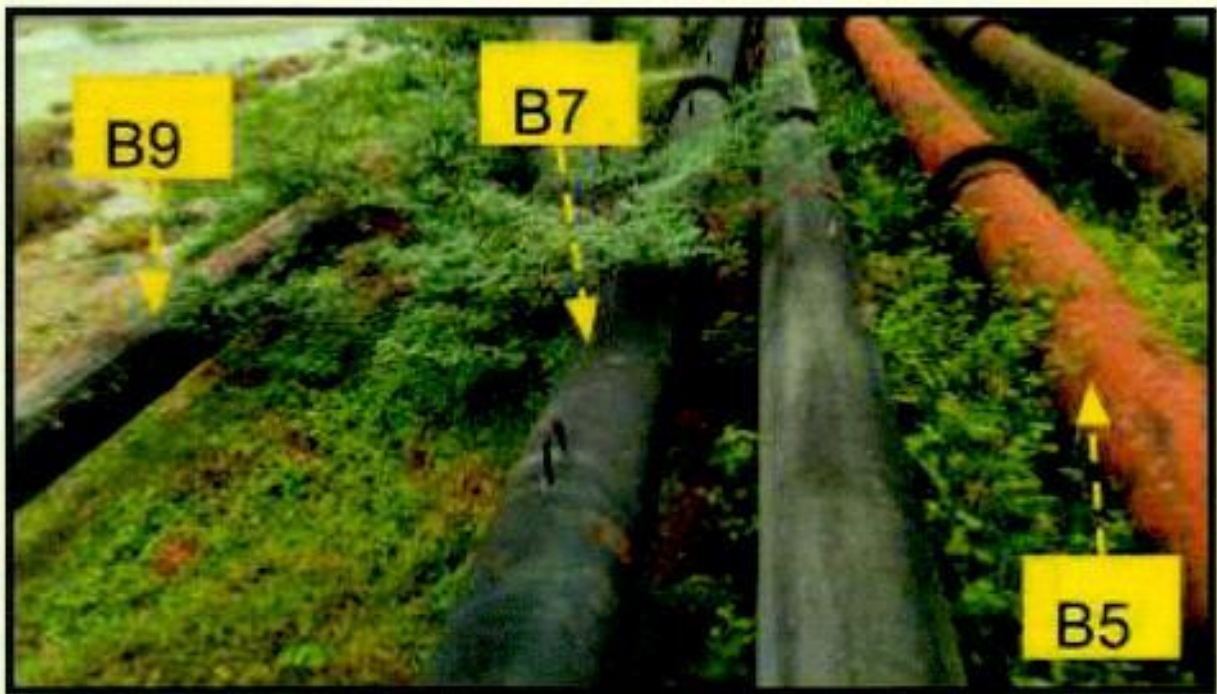
It is submitted that, since the lines are laid along the coastal region the pipes gets corroded due to prolonged exposure to saline and humid coastal atmosphere, accelerating oxidation. Corroded sections are proposed to be replaced in a phased manner based on condition assessment. Preventive maintenance measures including providing protective epoxy coating are planned to arrest further corrosion.

The replacement of entire length of (2,910 M) B9 (R2) recovery water line (R2) will be completed before November 2026.

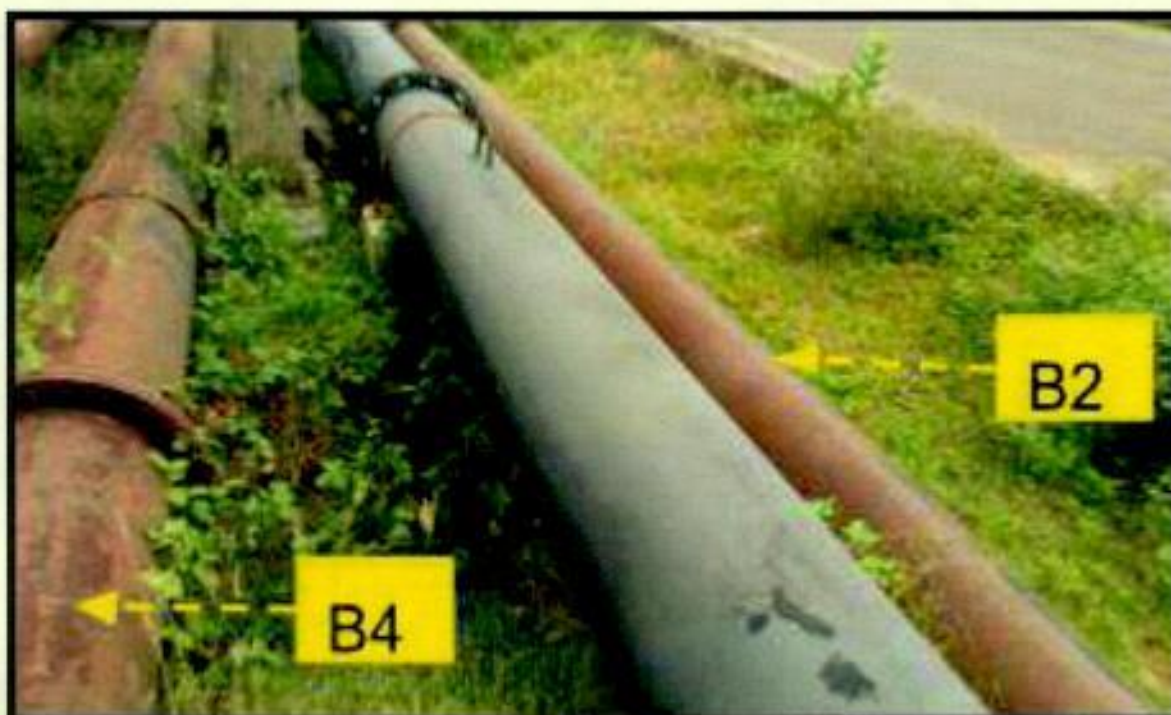
It is submitted that, since the lines are laid along the coastal region the pipes gets corroded due to prolonged exposure to saline and humid coastal atmosphere, accelerating oxidation. Corroded sections are proposed to be replaced in a phased manner based on condition assessment. Preventive maintenance measures including providing protective epoxy coating are planned to arrest further corrosion.

B4 line which is the ASDL line **painting of the line will be completed by May'2026. The B2 line is recovery water line (R3) and partial replacement of the damaged lines (816 M) will be completed on or before July 2026.**

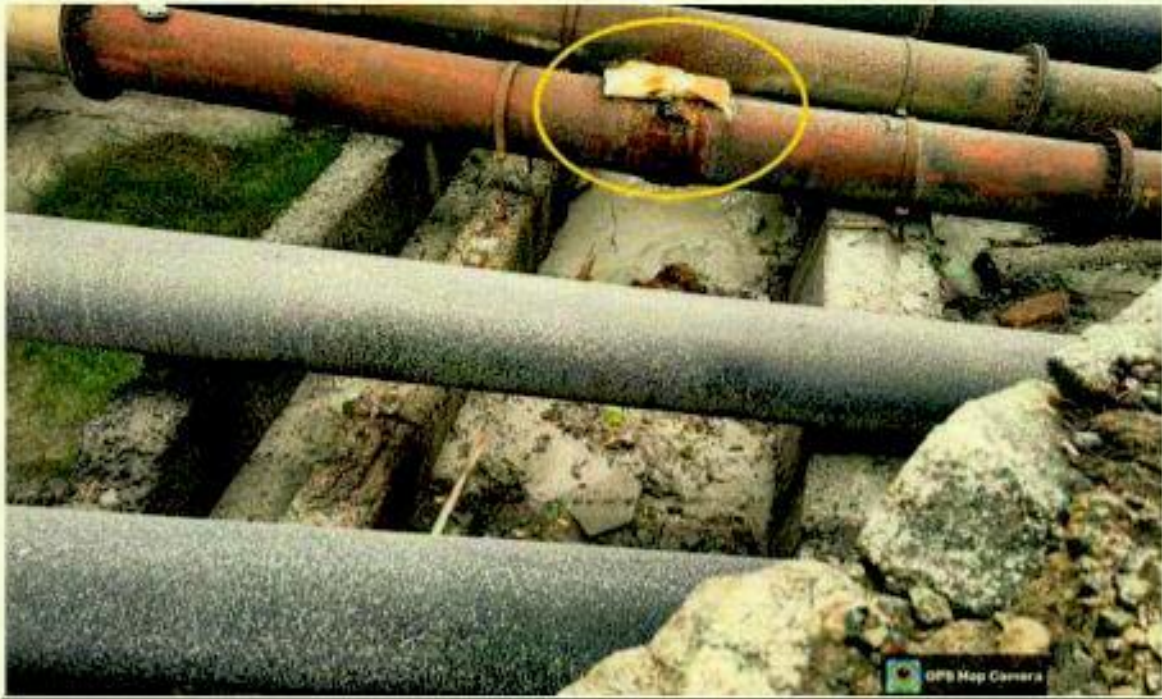
(44) Annexure A7, Page No.72 (Picture No.1)

The leakage was noticed in the Slurry line No 3 welding joint and immediately attended by patch welding and later replaced the pipe line.

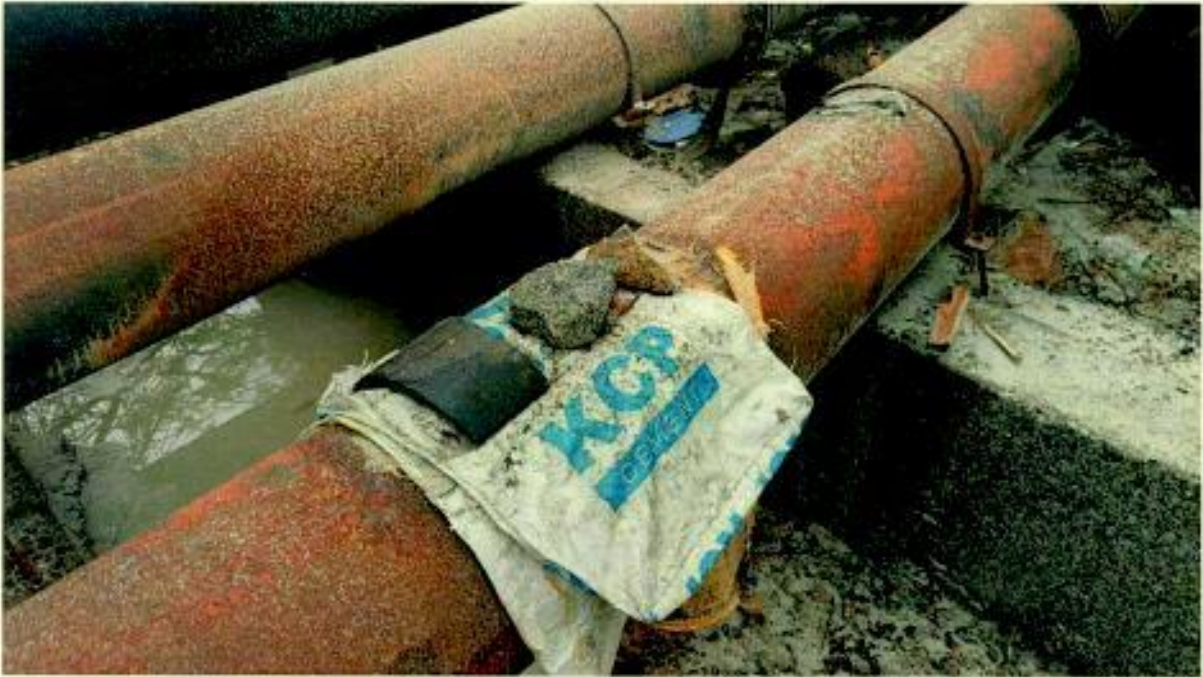
(45) Annexure A7, Page No. 72 (Picture No.2)

Same image from Annexure A1, Page 21. The leakage was noticed in the ASDL line No. 3 welding joint. The Pipe has been renewed with new pipe.

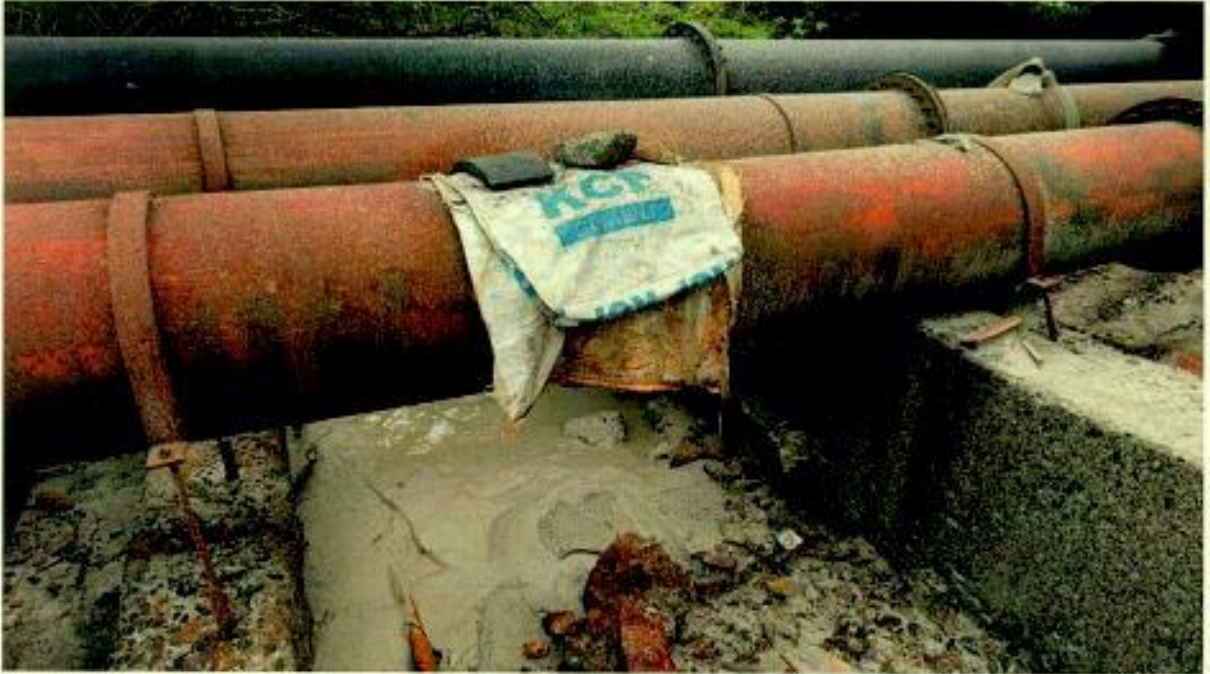
(46) Annexure A7, Page No.73 (Picture No.1)

Same image from Annexure A1 page 21 from different angle. The leakage was noticed in the ASDL line No. 3 welding joint. The Pipe has been renewed with new pipe.

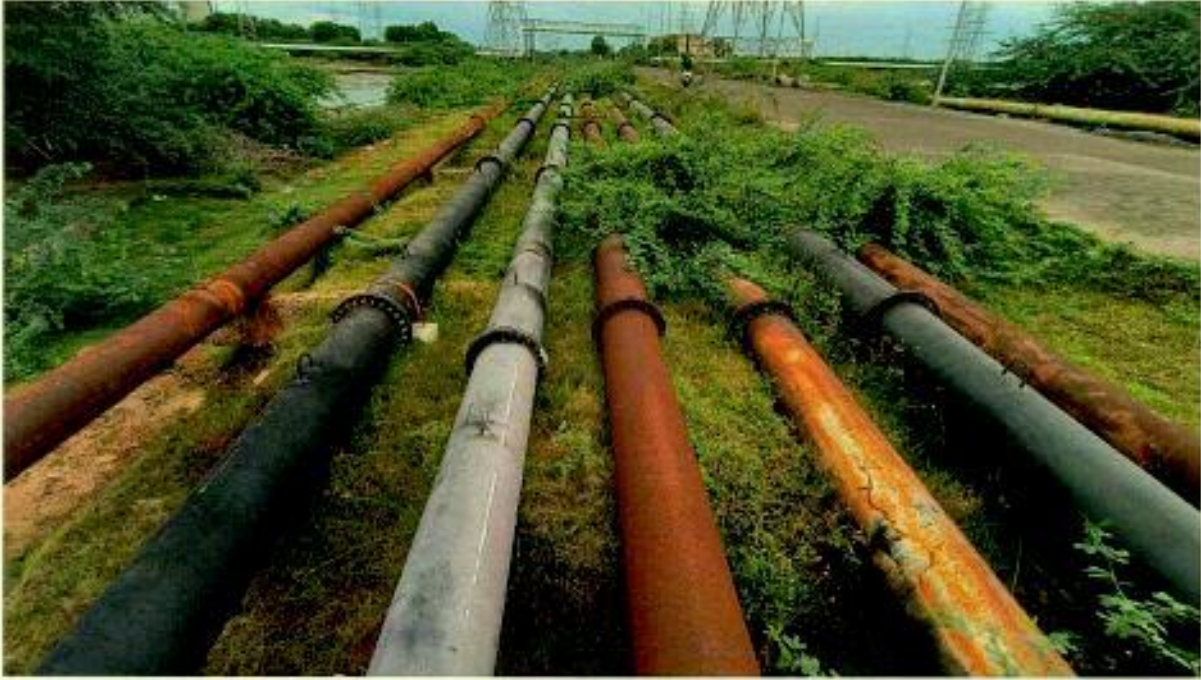
(47) Annexure A7, Page No.75, (Picture No. 1)

The B2 line is also recovery water line (R3) and the tender for the partial replacement of the damaged lines (**816 M**) is in progress and the work will be completed on or **before July 2026**.

The B9 line is also recovery water line (R2) and the administrative approval from the Board Level Tender Committee is awaited and after obtaining the Administrative approval is obtained tendering process will be initiated for the replacement of the entire length of **2,910 M** and the work is expected to complete on or **before November 2026**.

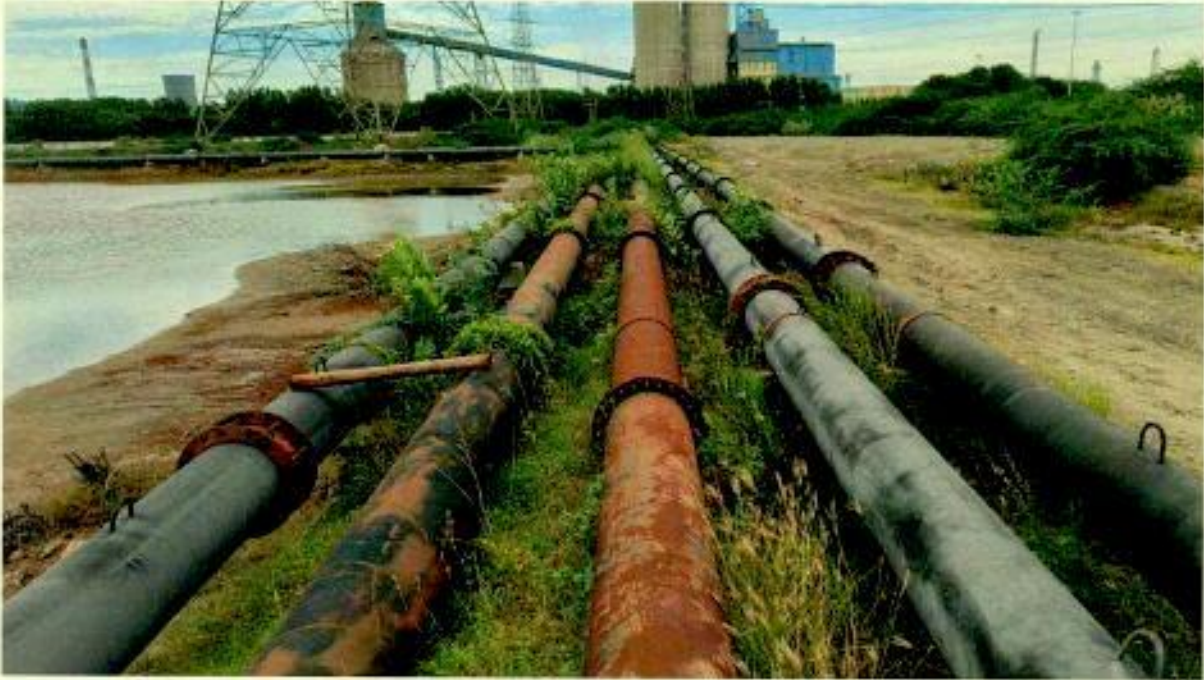
The Ash Slurry Disposal Line No. 3, commissioned during the year 2021-22, is part of the Ash Handling System that conveys fly ash and bottom ash in slurry form from NCTPS-I to the Ash Dyke, located approximately 5.5 km away along the coastal stretch. The corrosion is due to Prolonged exposure to saline and humid coastal atmosphere, accelerating oxidation. The lines are lined with cast basalt lining of 20 mm Thickness. However proposal is under progress for protective coating by painting with epoxy paint.

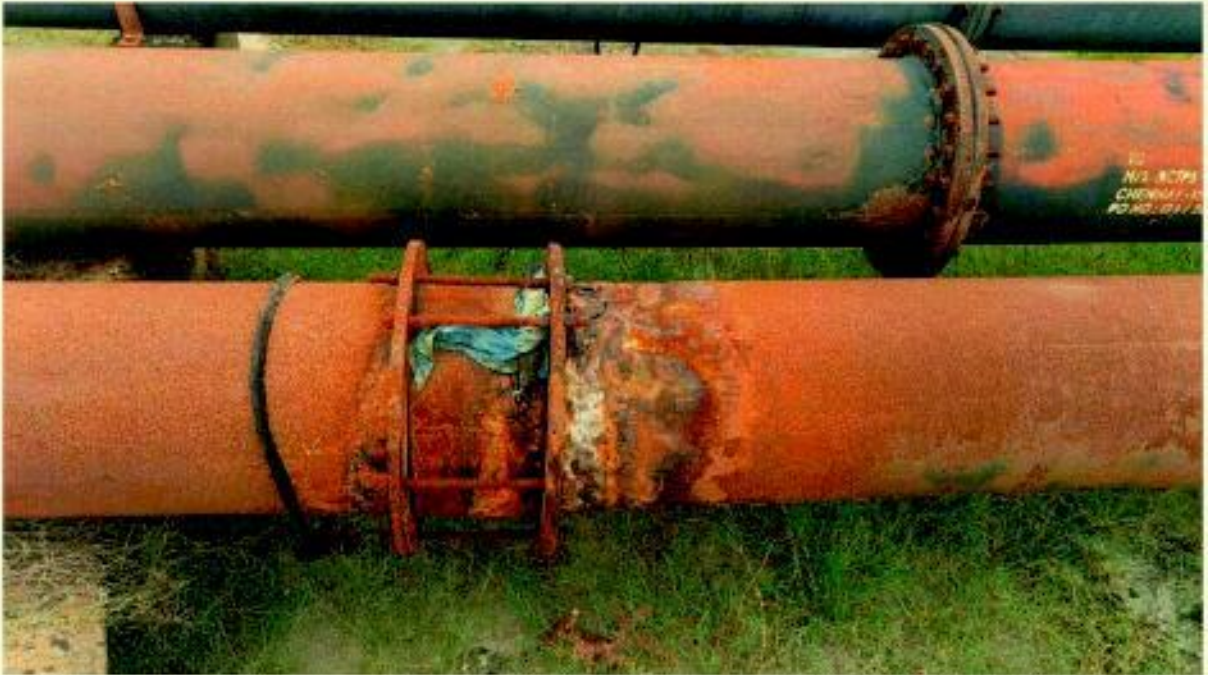
(51) Annexure A7, page No.78(Picture No.2)

It is clarified that the Ash Slurry Disposal Lines convey the Wet ash slurry at a pressure above 6 Ksc and the leak could not be stopped by a piece of cloth and the leak is due to **O-ring slippage in the sleeve coupling and have been attended by replacement of the O-ring.**

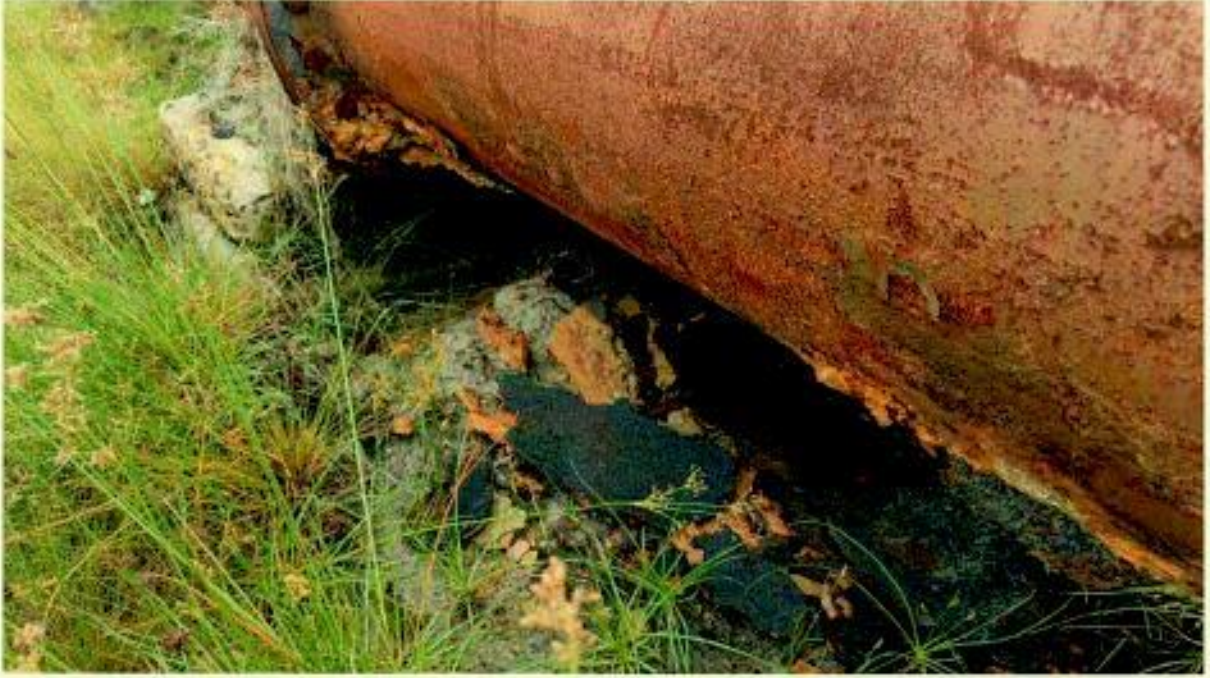
(53) Annexure A7, Page No.79 (Picture No.2)

These lines S2 (B4) and S3 (B5) were erected during the year 2021 to 2022 and laid along the coastal area there. Since the inner layer is coated with Cast basalt liners there is no potential risk of leakage of Wet Ash, however proposal for Painting of the Pipe lines is proposed **and will be painted on or before May'2026.**

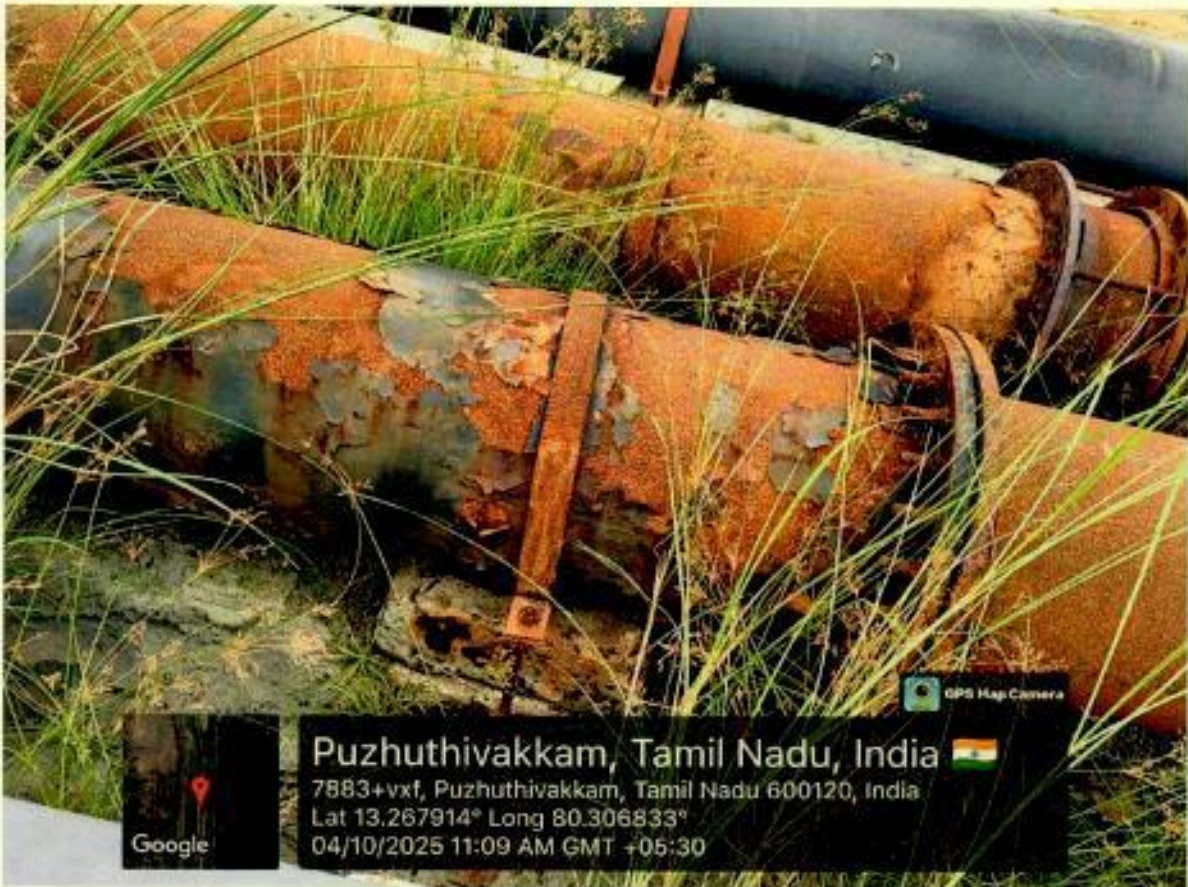
(56) Annexure A7, Page No. 81(Picture No.1)

The clamps are generally made of Mild steel and due to continuous exposure to saline atmosphere and humid coastal atmosphere the surface protection of the clamps and pipes gets easily deteriorated. During painting of the pipe lines the clamps also will be painted and **the work will be completed on or before May'2026.**

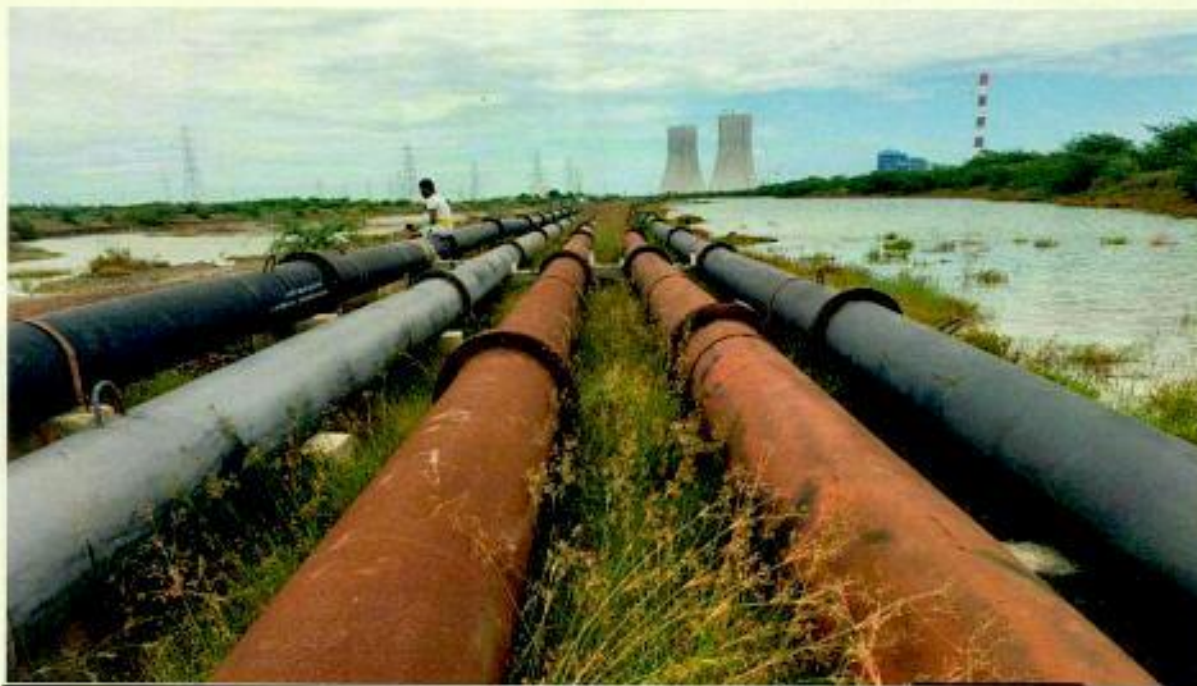
These lines S2 (B4) and S3 (B5) were erected during the year 2021 to 2022 and laid along the coastal area there. Since the inner layer is coated with Cast basalt liners there is no potential risk of leakage of Wet ash slurry. However the proposal for painting these Pipes are in progress and will be painted on or before May'2026.

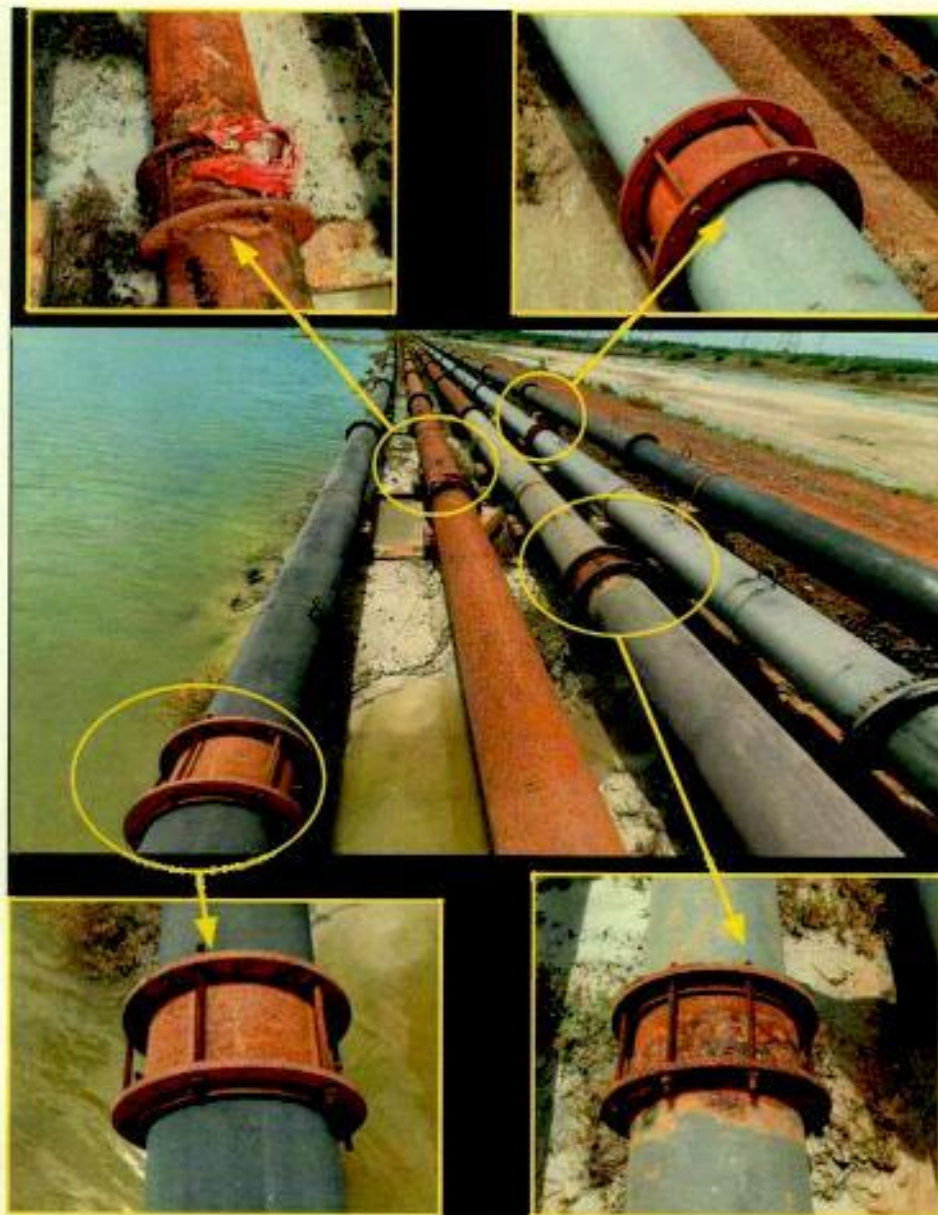
(61) Annexure A7, Page No.85 (all the 5 Nos. of Pictures)

Same image from Annexure A1, Page No.25

The Pipes and coupling were procured from different agencies and the pipe was painted with black paint and the Sleeve coupling was supplied with red oxide paint. Hence it seems to be varying. However it is hereby stated that the coupling is not old and there is no structural damage in the pipes /couplings. **The painting proposal for the ASDL No.2 and 3 is under progress and periodical painting will be carried out in future.**

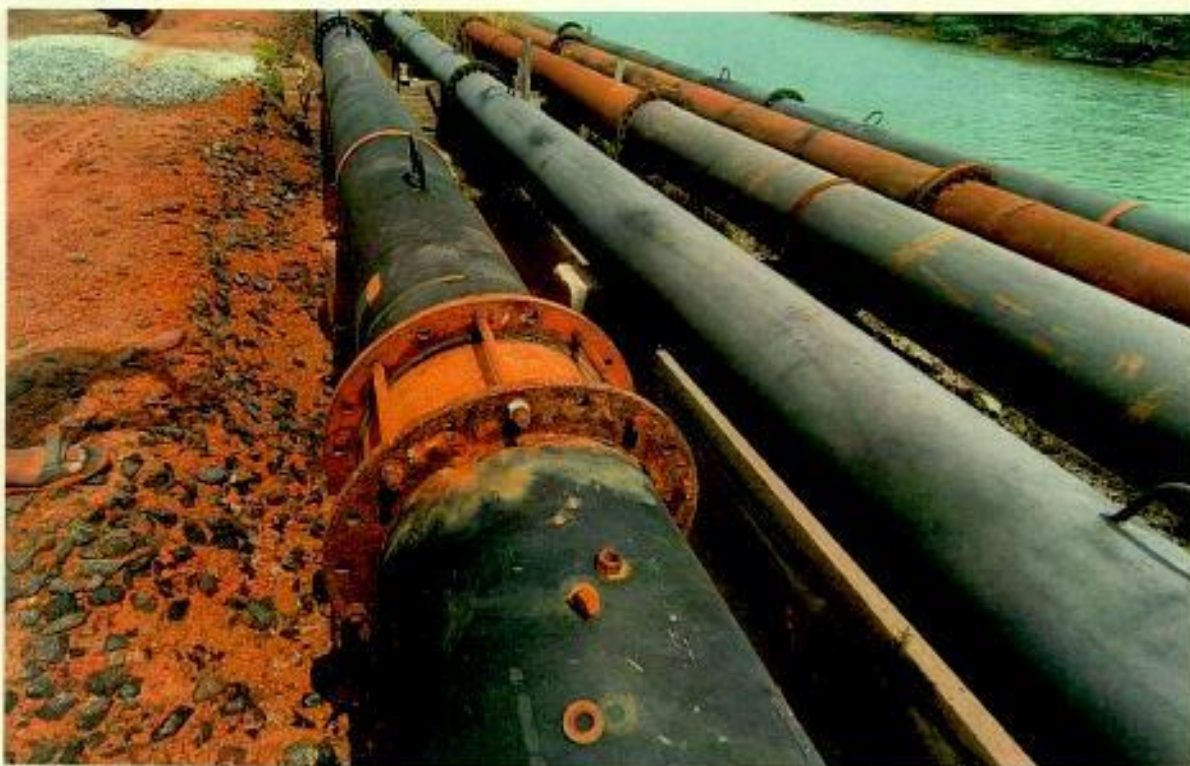
(62) Annexure A7, Page No.86 (Picture No.1)

**Same image in Annexure A1, Page No.26**

The Pipes and coupling were procured from different agencies and the pipe was painted with black paint and the Sleeve coupling was supplied with red oxide paint. Hence it seems to be varying. However it is hereby stated that the coupling is not old and there is no structural damage in the pipes /couplings. **The painting proposal for the ASDL No.2 and 3 is under progress and periodical painting will be carried out in future.**

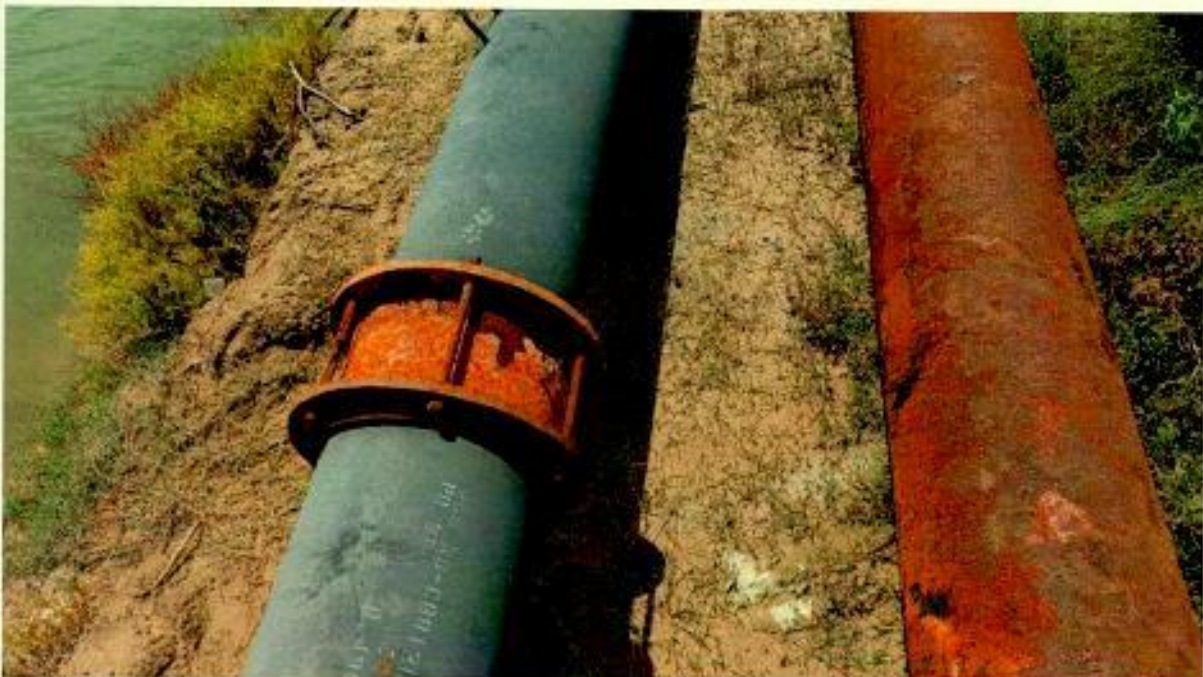
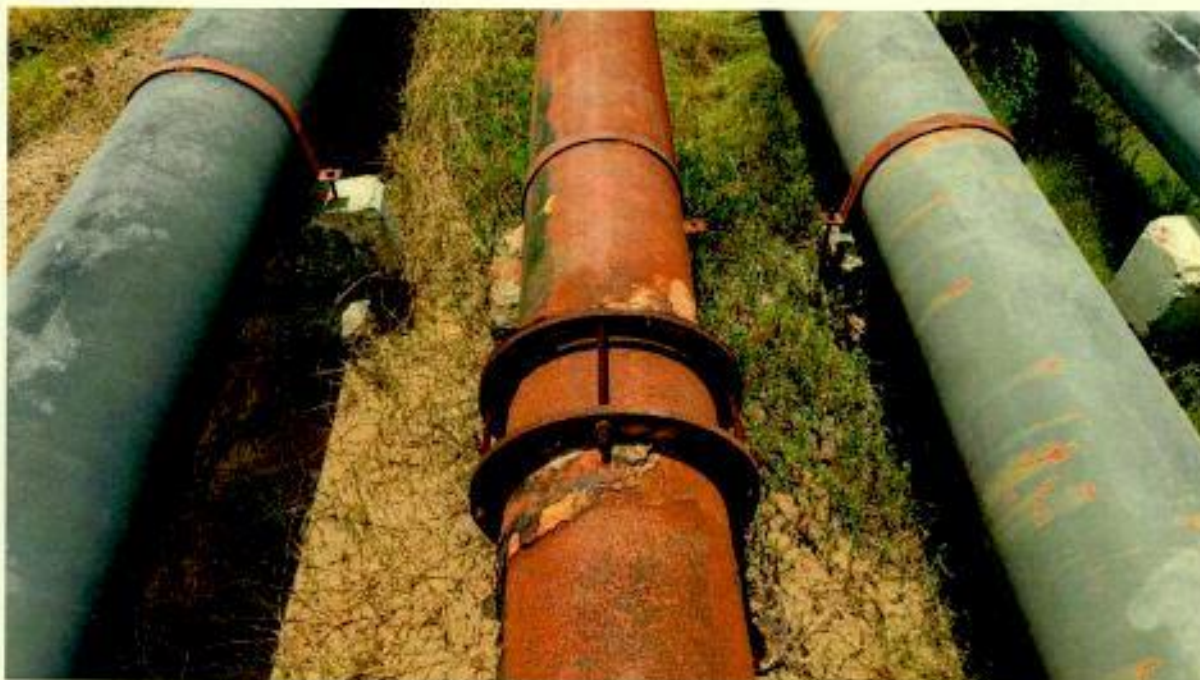
(64) Annexure A7, Page No.87 (Picture No.1 & 2)

The Pipes and coupling were procured from different agencies and the pipe was painted with black paint and the Sleeve coupling was supplied with red oxide paint. Hence it seems to be varying. However it is submitted that the coupling is not old and there is no structural damage in the pipes /couplings. **The painting proposal for the ASDL No.2 and 3 (B4 and B5) is under progress and will be completed by May'2026.**

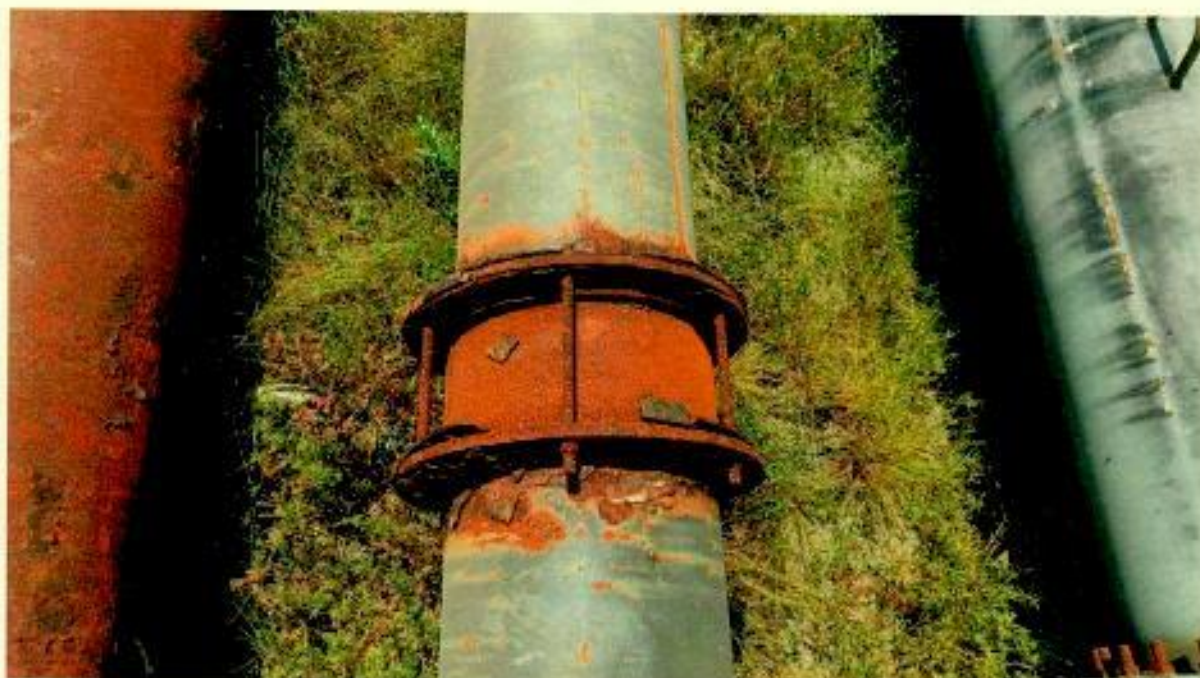
(65) Annexure A7, Page No.88 (Picture No.1)

The painting proposal for the ASDL No.2 and 3 (B4 and B5) is under progress and will be completed by May'2026. While painting the ASDL No.2 & 3, clamps in all the ASDL lines will also be painted.

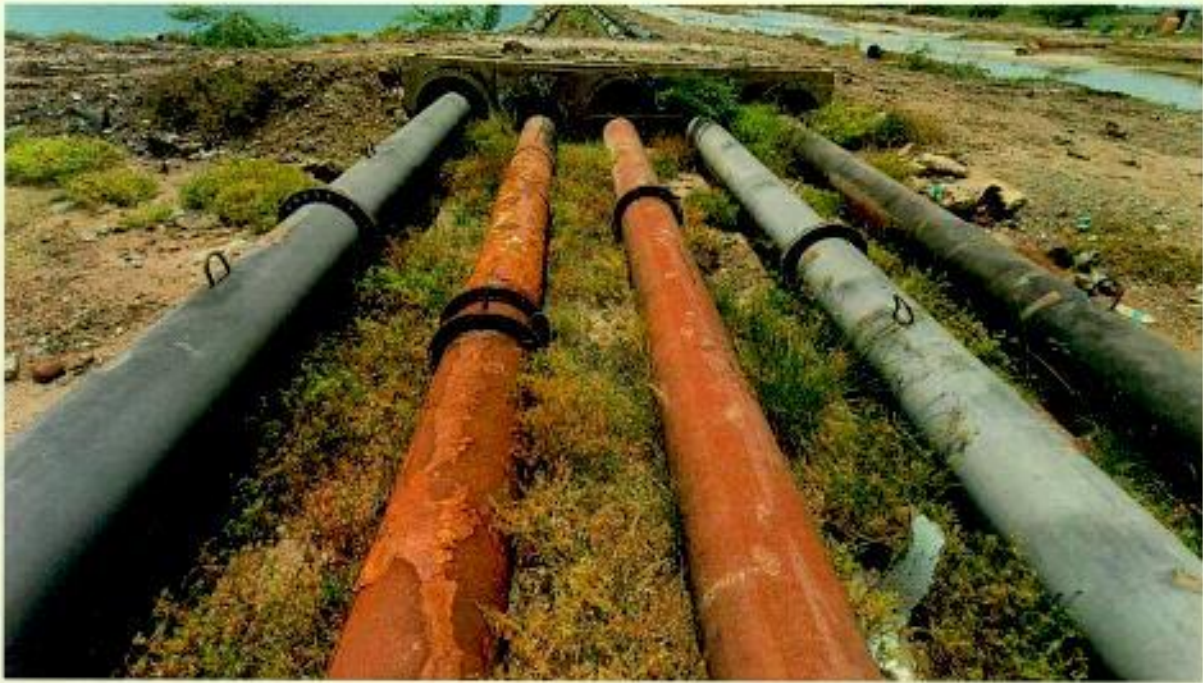
(66) Annexure A7, Page No.88 (Picture No.2)
GPS 13°16'31.9"N 80°18'22.4"E:

The painting proposal for the ASDL No.2 and 3 (B4 and B5) is under progress and will be completed by May'2026. While painting the ASDL No.2 & 3, the portions of the other **ASDL line which are heavily rusted will also be painted.**

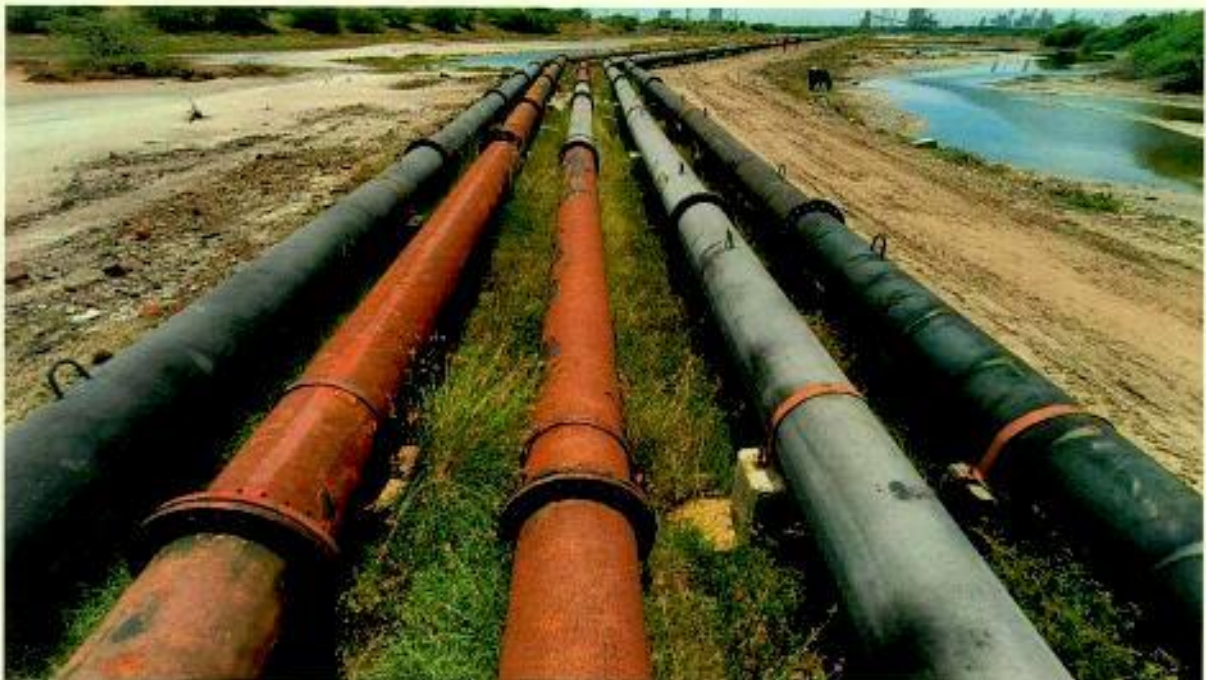
The painting proposal for the ASDL No.2 and 3 (B4 and B5) is under progress and will be completed by May'2026. While painting the ASDL No.2 & 3, the portions of the other **ASDL line which are heavily rusted will also be painted.**

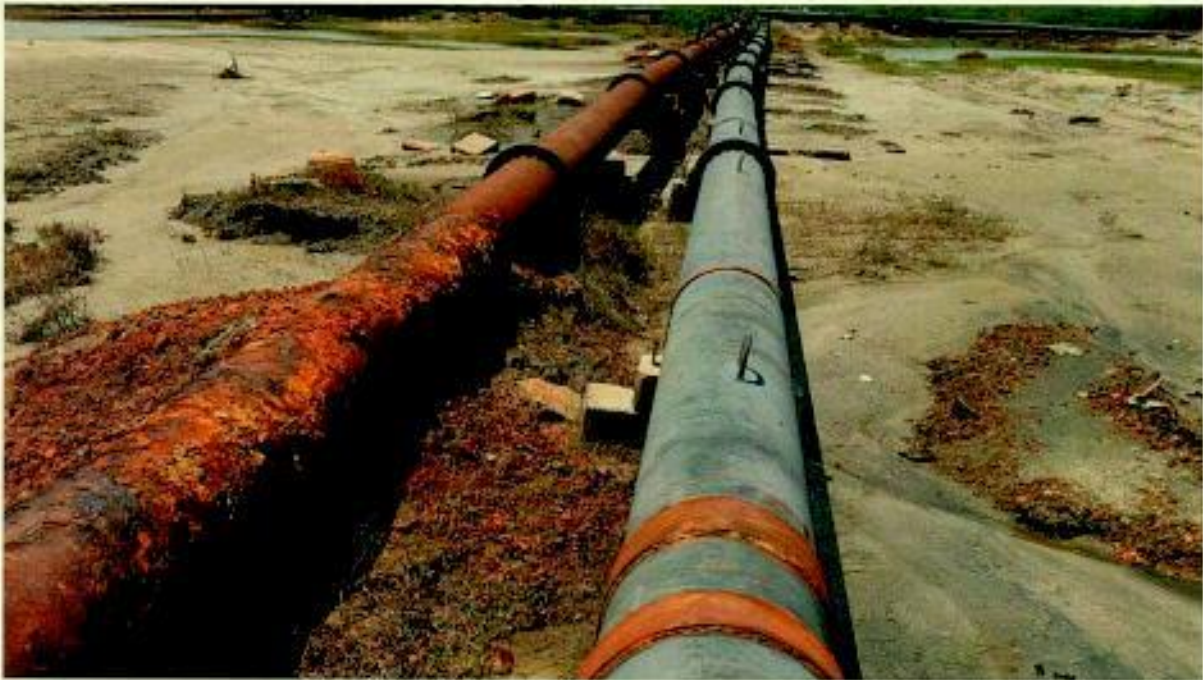
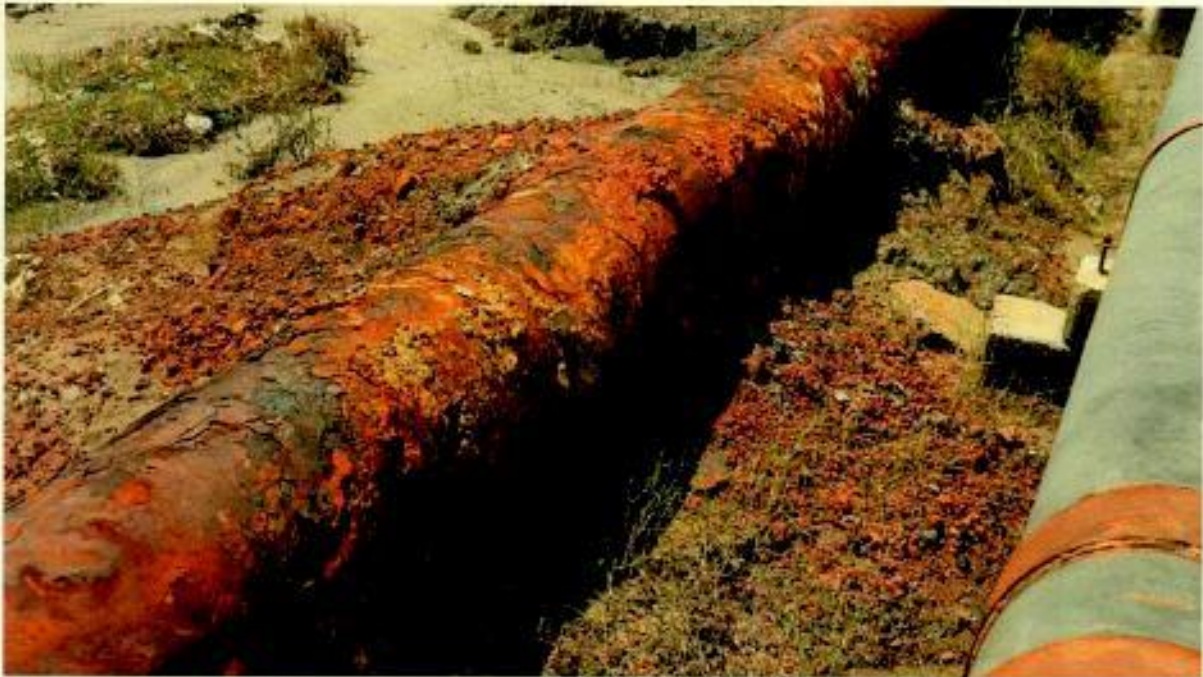
The pipe B5 was erected during the year 2021-22. Due to continuous exposure to saline and coastal humid atmosphere the pipes Sleeve coupling/clamps gets easily corroded. Proposal for Protective coating with epoxy coating has been prepared and work will be completed on or before May'2026.
