**BEFORE THE HON'BLE NATIONAL GREEN TRIBUNAL,  
SOUTHERN ZONE, CHENNAI**

**ORIGINAL APPLICATION NO. 261 OF 2024  
(EARLIER ORIGINAL APPLICATION NO. 1055/2024- PB)**

Tribunal on its own motion Suo Moto based on News Item titled "Unscientific work by NHAI led to Shirur landslide Geological Survey of India report" appearing in the Indian Express dated 02.08.2024

National Highways Authority of India & Ors.

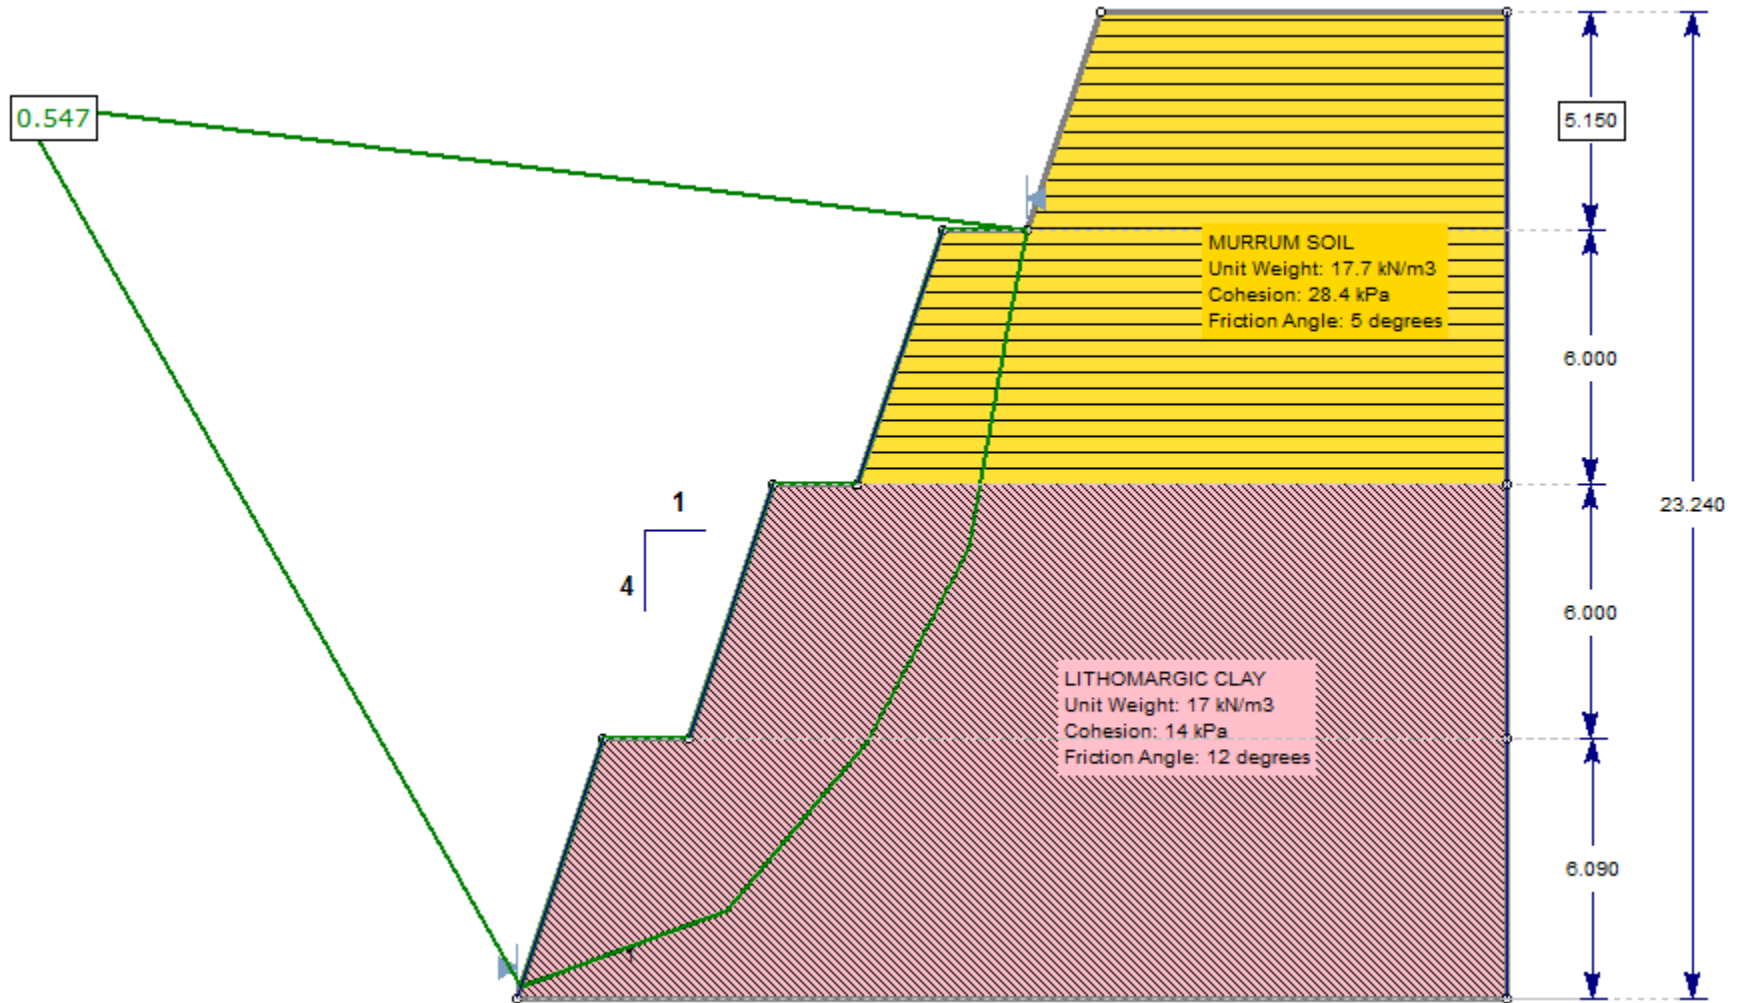
Fig.2 Stability analysis of existing slope at 160.020 km chainage (FS= 0.547, UNSAFE)

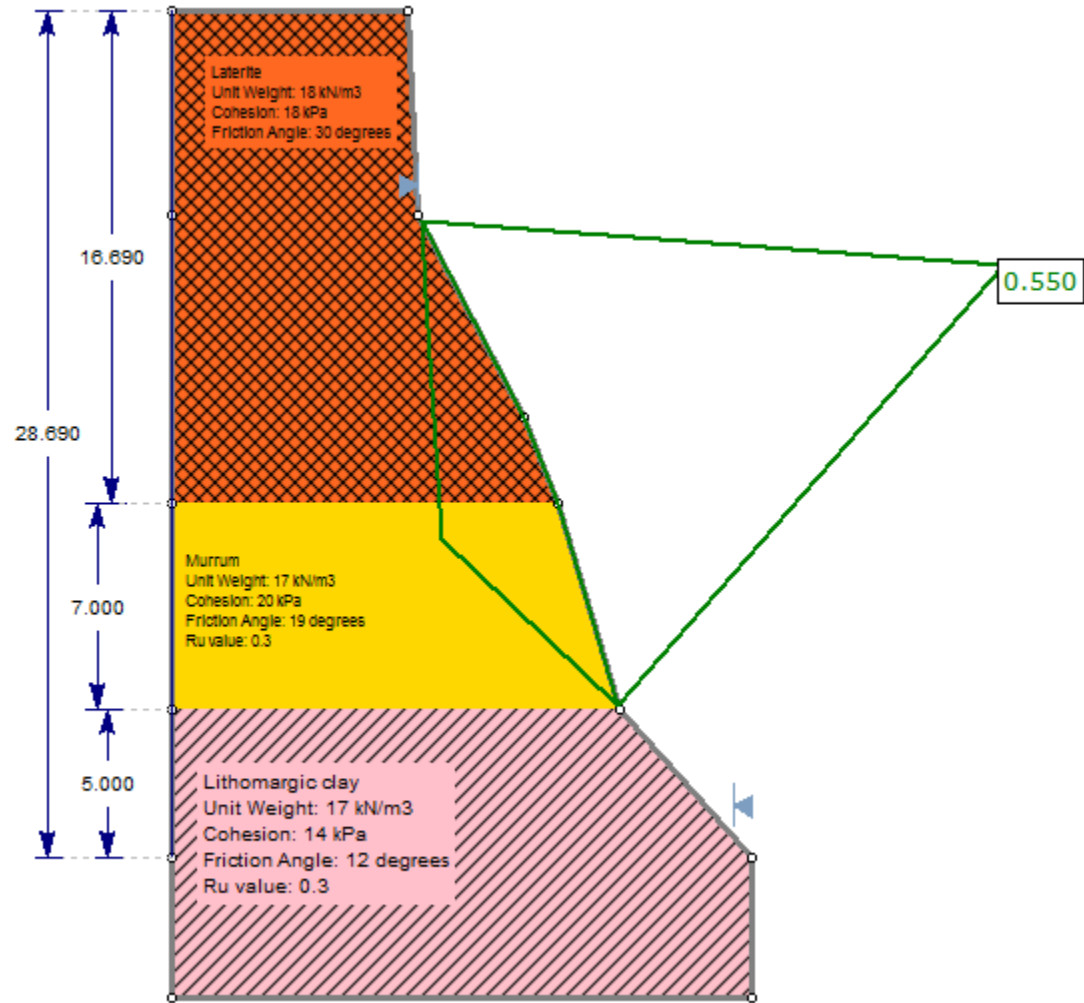
Fig. 7 Stability analysis of existing slope at 190.640 km chainage (FS= 0.550, UNSAFE)

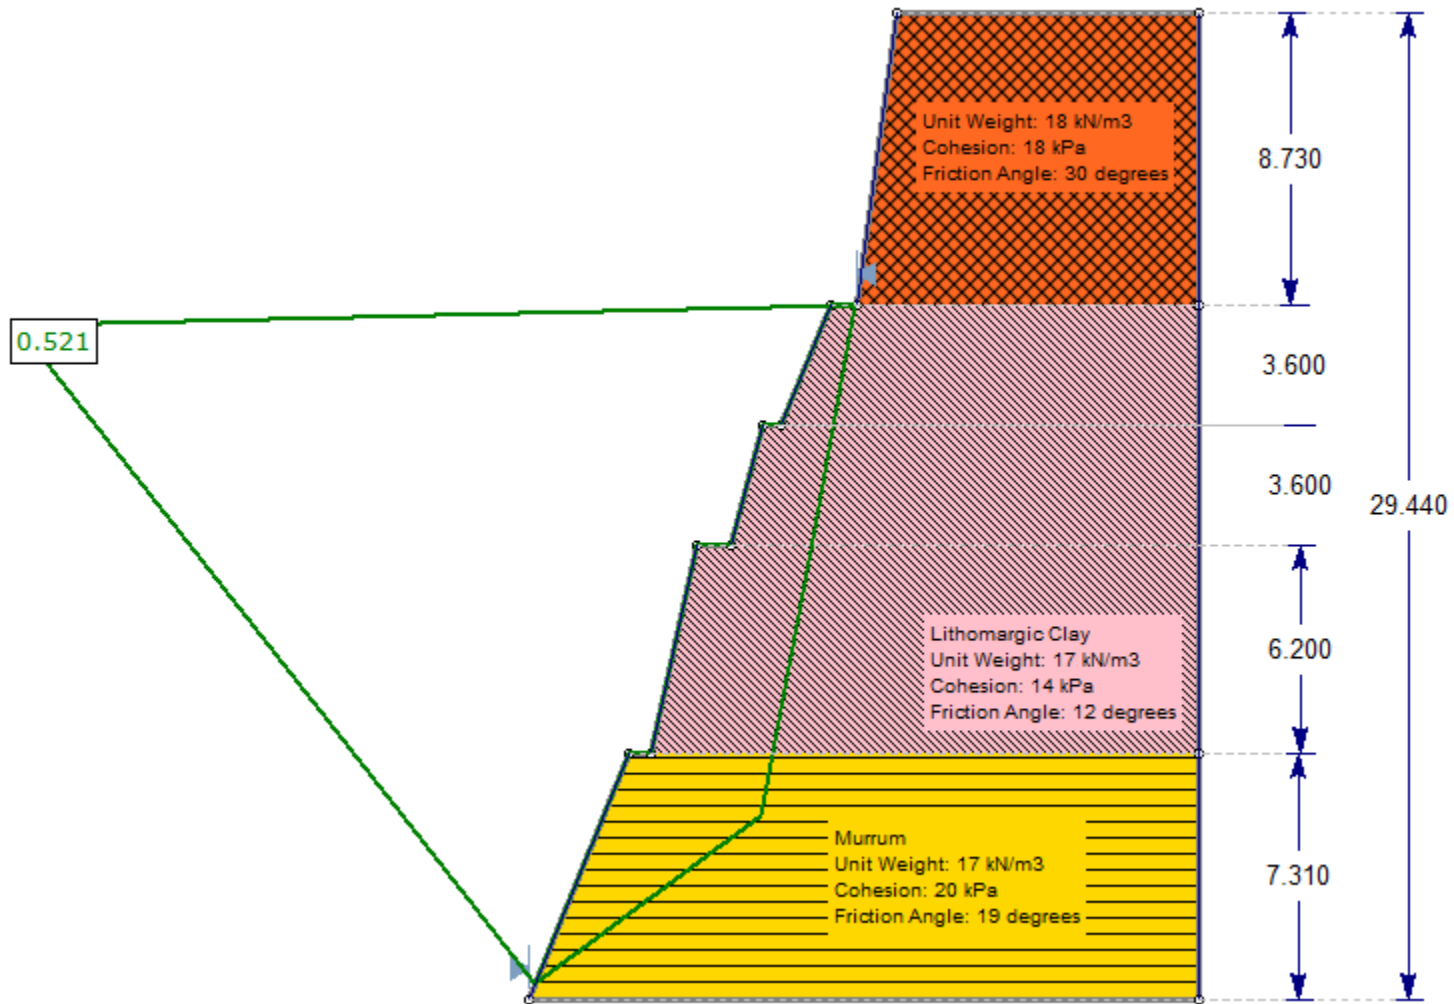
Fig.12 Stability analysis of existing slope at 246.900 km chainage (FS= 0.521, UNSAFE)

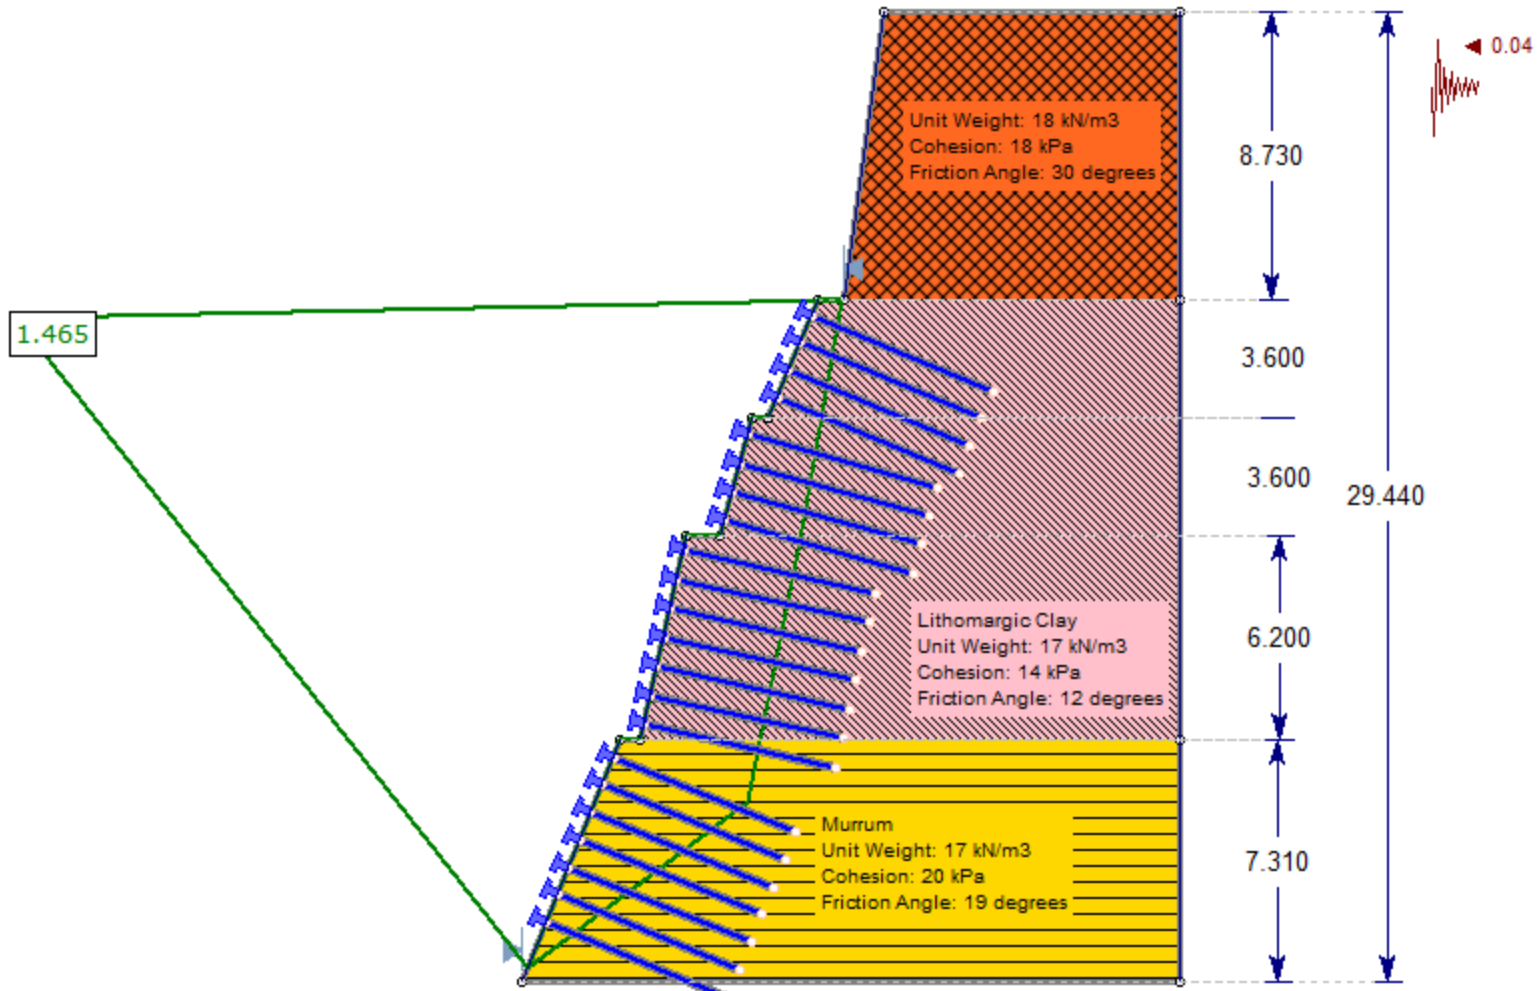
Fig.15 Stability analysis of slope at 246.900 km chainage ,providing 22 numbers of soil nails of 6 m length at spacing of 0.9m seismic coefficient 0.04 (FS= 1.465, SAFE)

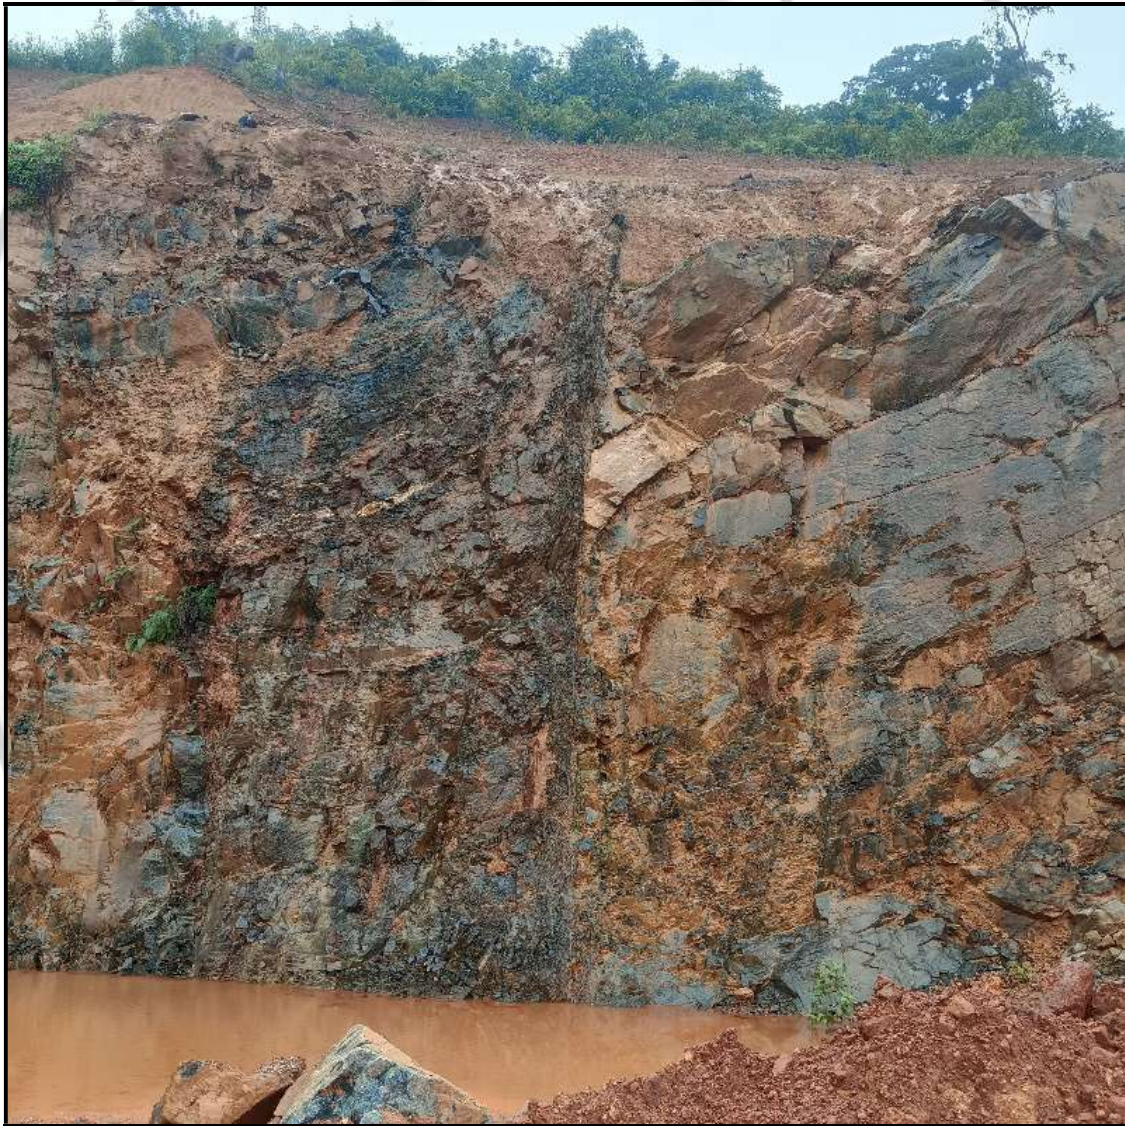
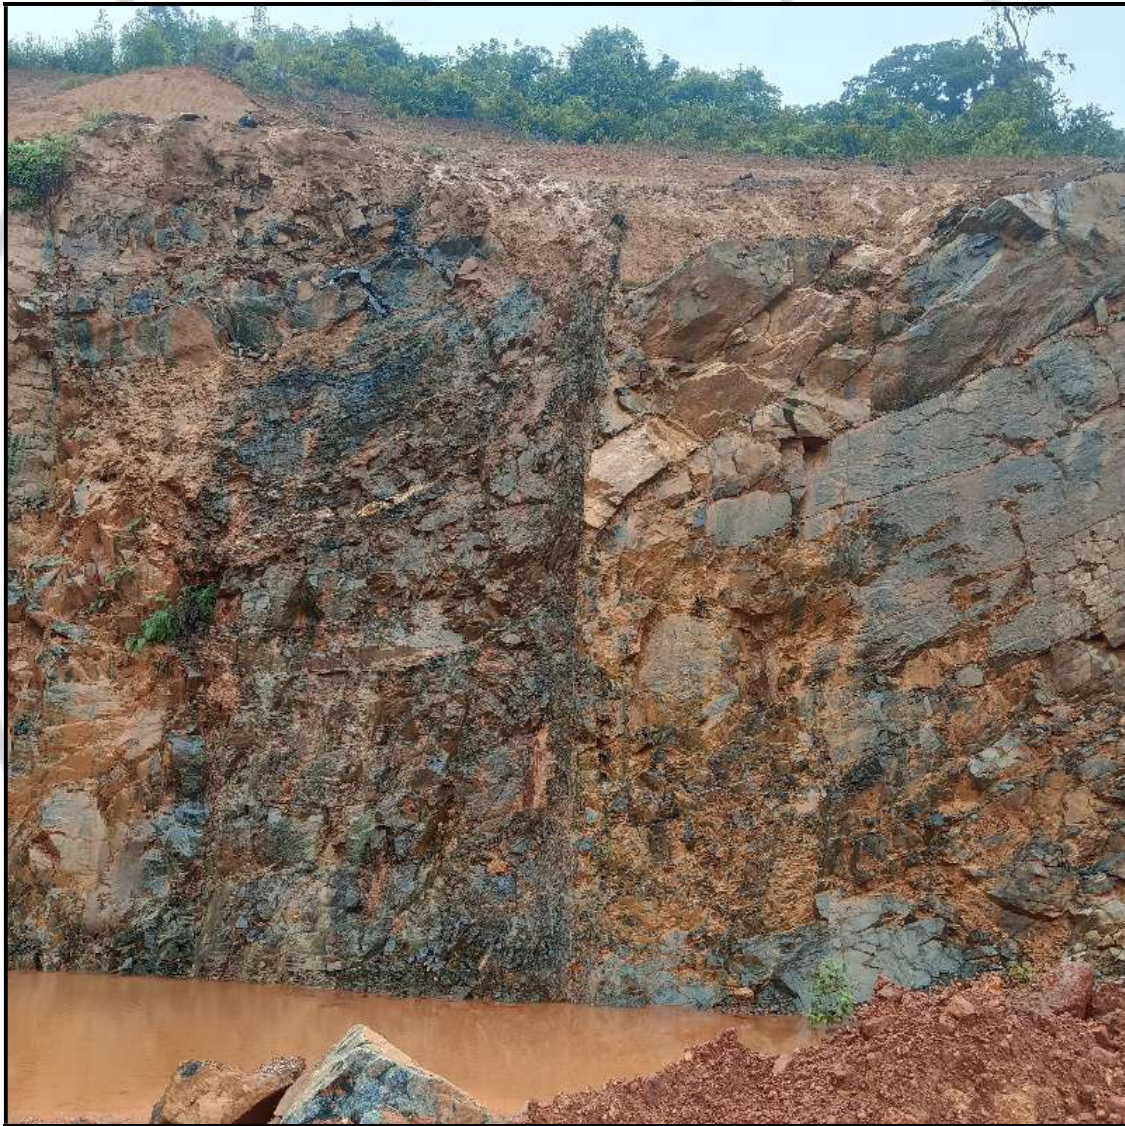
Fig. 1.5: Minor Fault observed at the base of the cut slope on the right flank of the slide

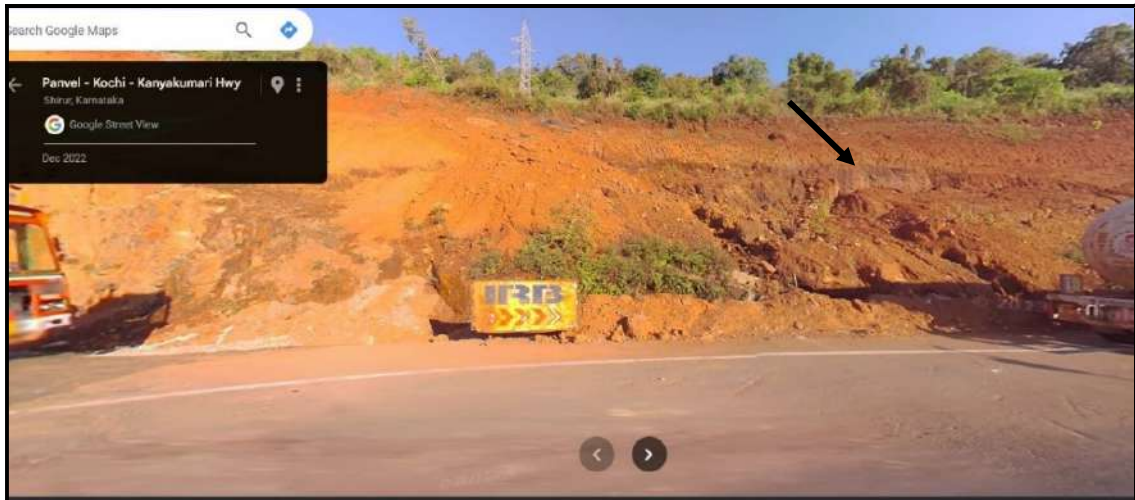
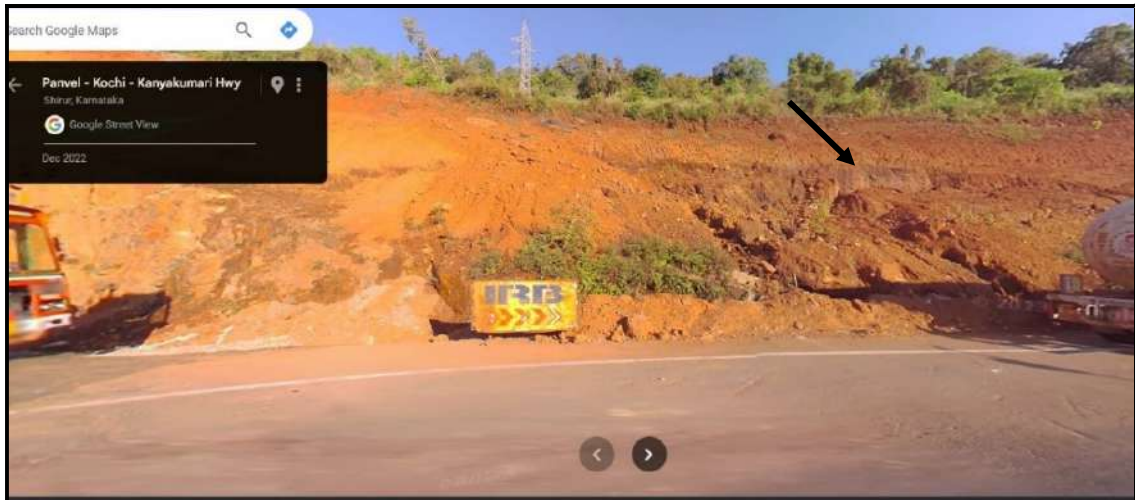
- a. **Chainage 148.000:** Prior signs of slope instability include at least two minor slumps observed in Google Street View (Fig. 1.8 & 1.9).

Fig. 1.8: Slump as seen through Google Street View of the Shirur landslide site

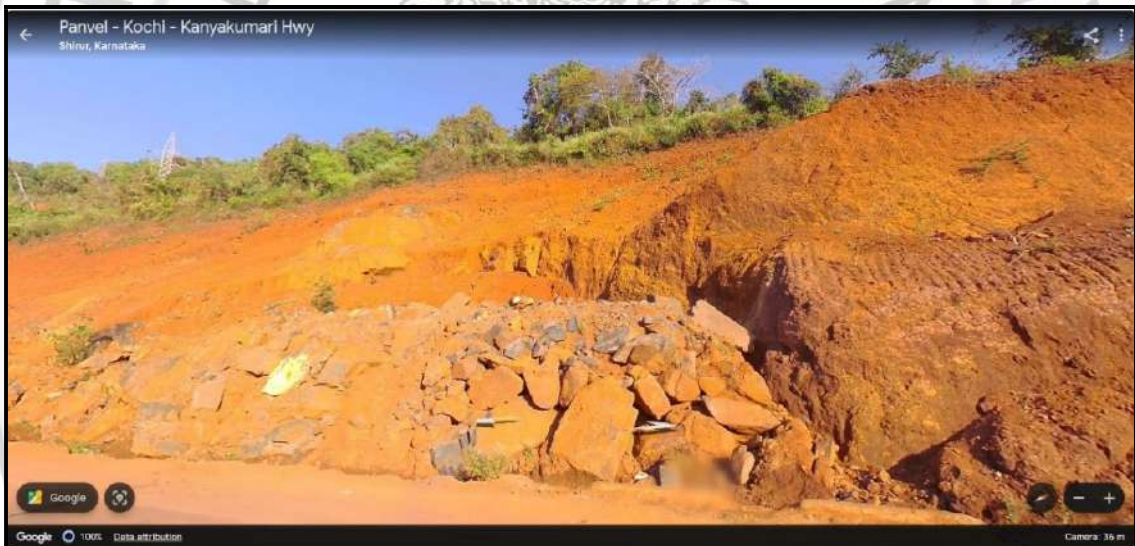
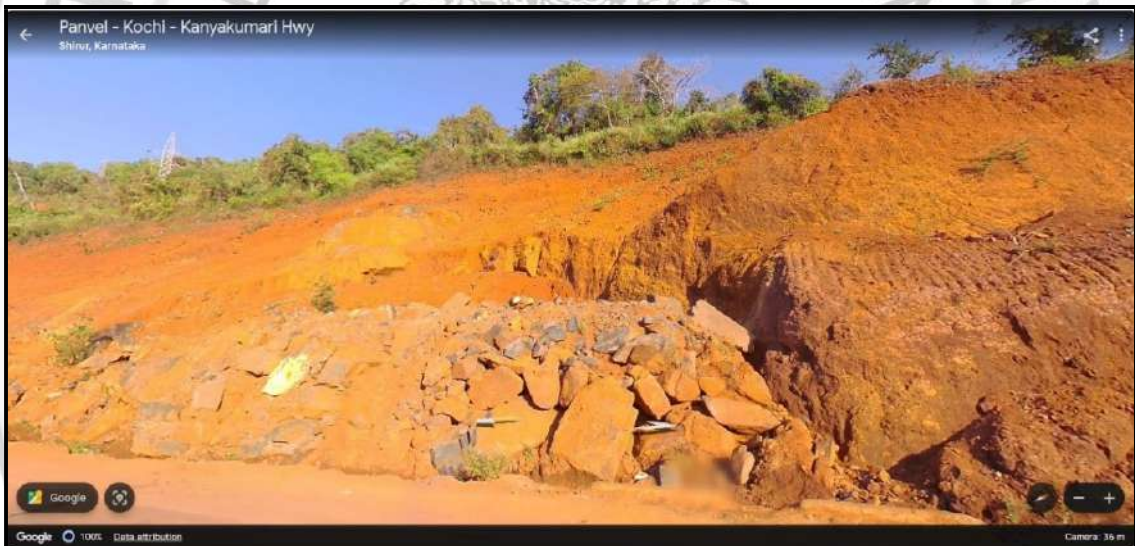
Fig. 1.9: Slump as seen through Google Street View of the Shirur landslide site

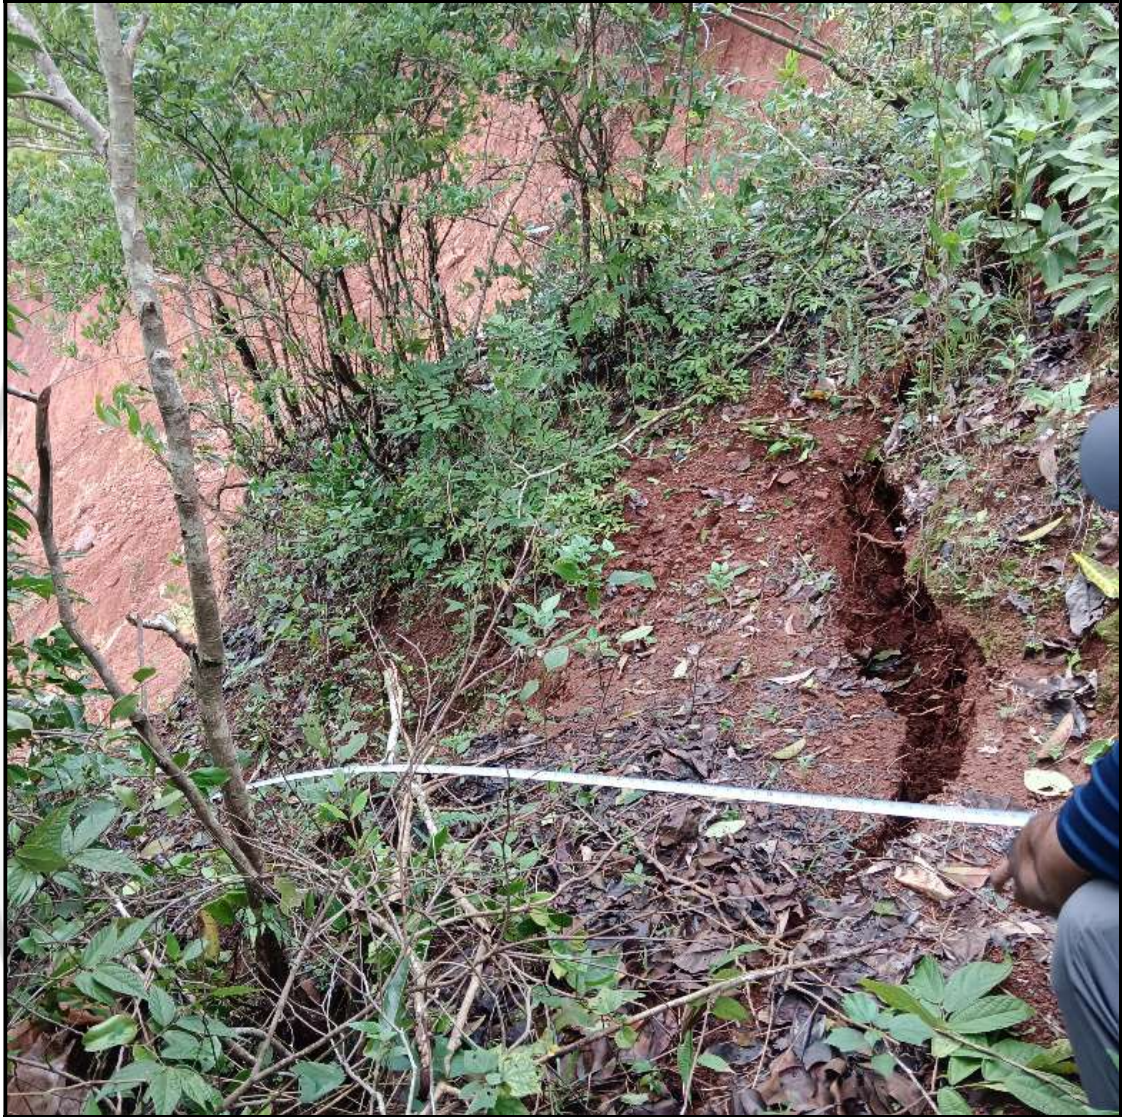
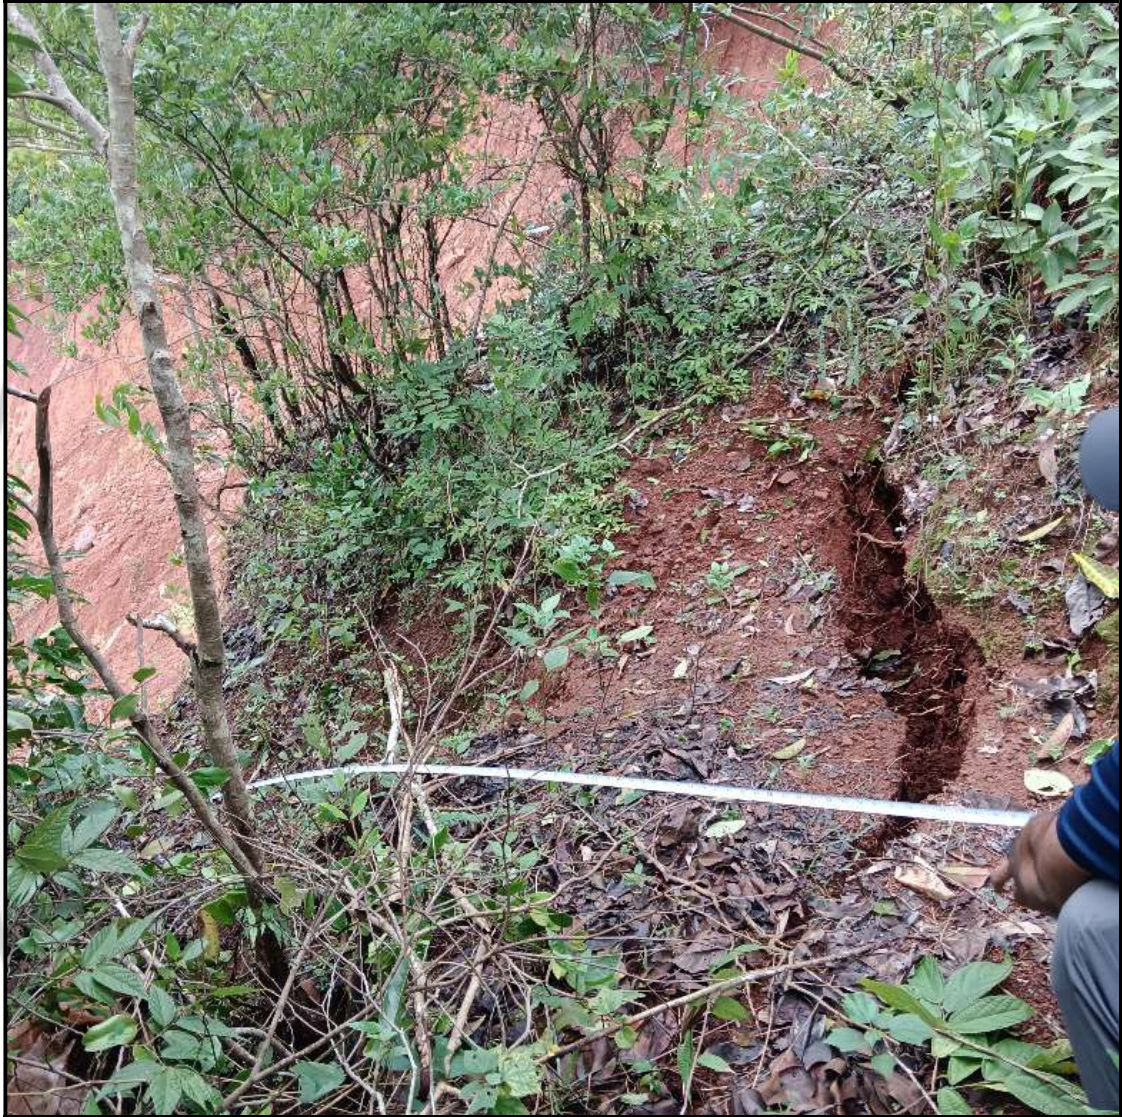
Fig. 1.10: Tension cracks behind the side scar of the slide trending N120°

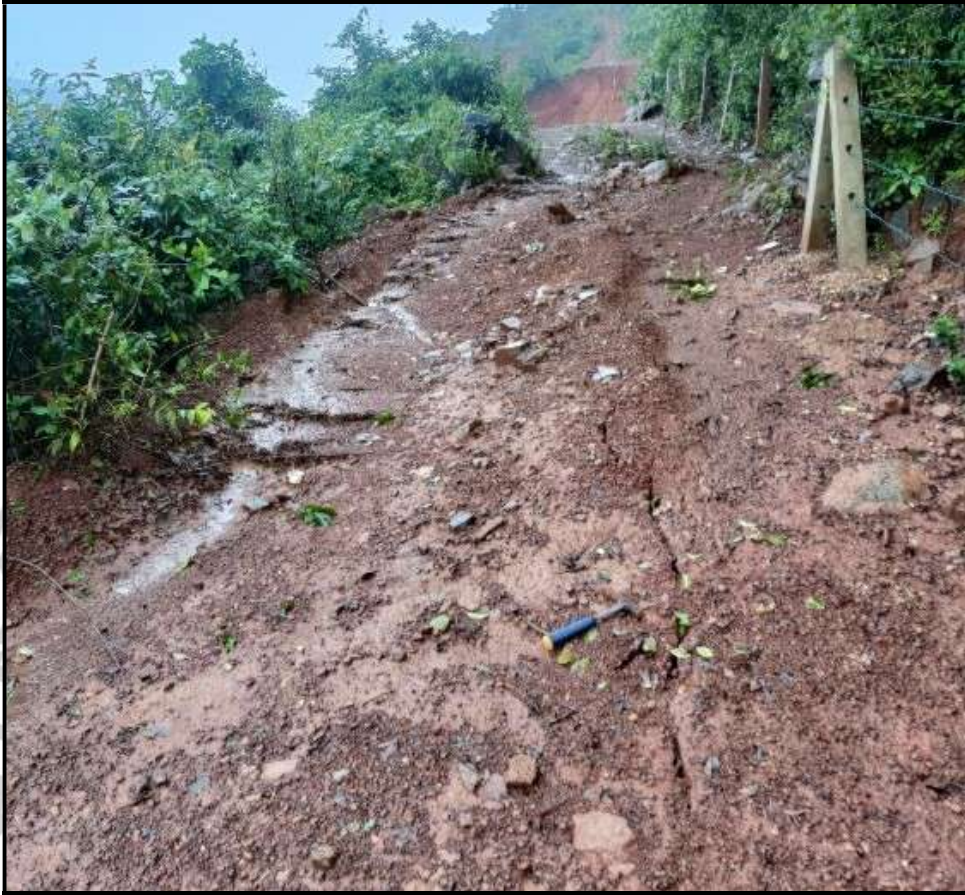
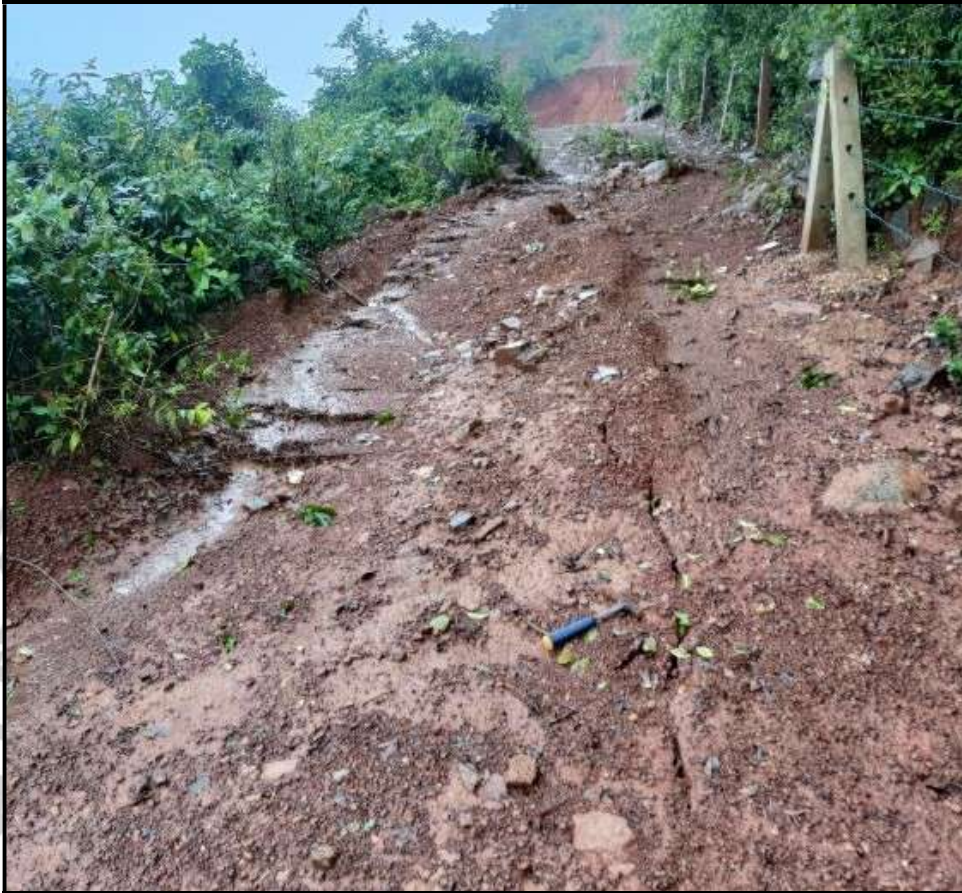
at a lower elevation (Fig. 1.11) trending N80° (30m long, 2 ft deep), with no visible expansion by 25<sup>th</sup> July 2024. The Crack in the right flank (Fig. 1.12) trends N15° (15m long, 2m behind the scarp). Here, in the right flank there is relatively thicker soil with 6-7 m while the left flank exposes at least 3-4m of soil. No visible cracks were noticed on the crown area. The main scarp exposes soil of about 3-4 m (Fig. 1.13).

Fig. 1.11: Tension cracks at lower elevation of the left flank of the slide

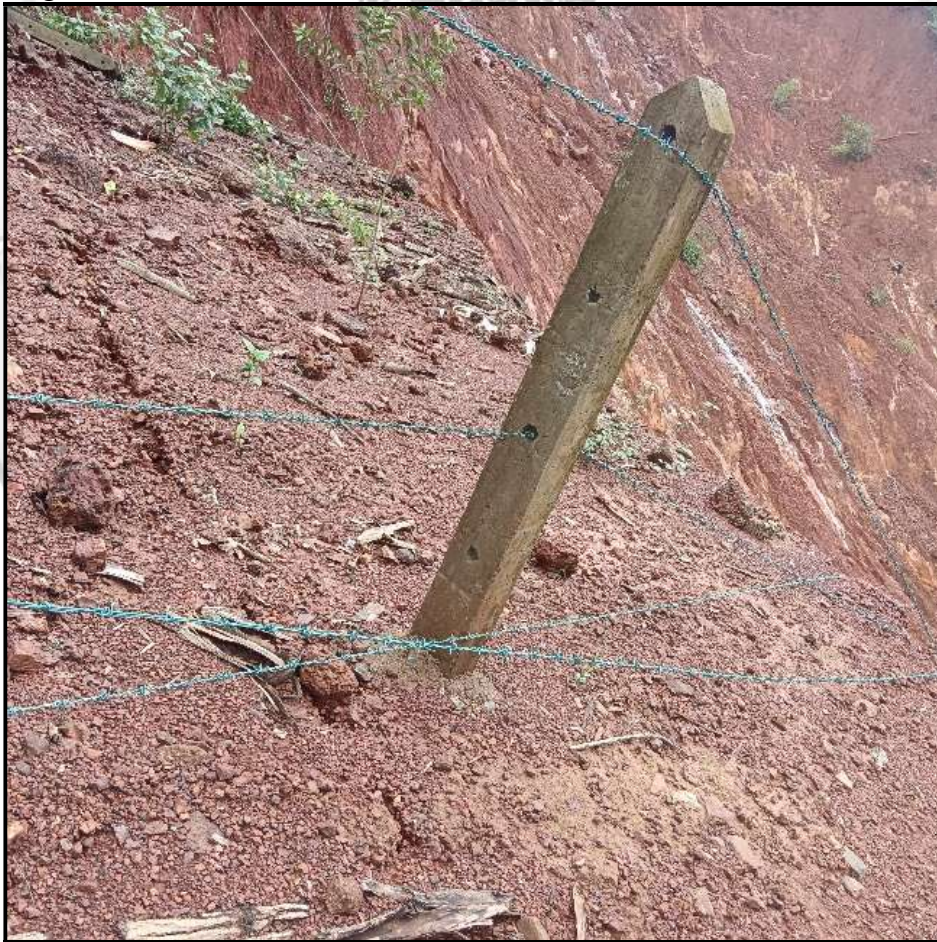
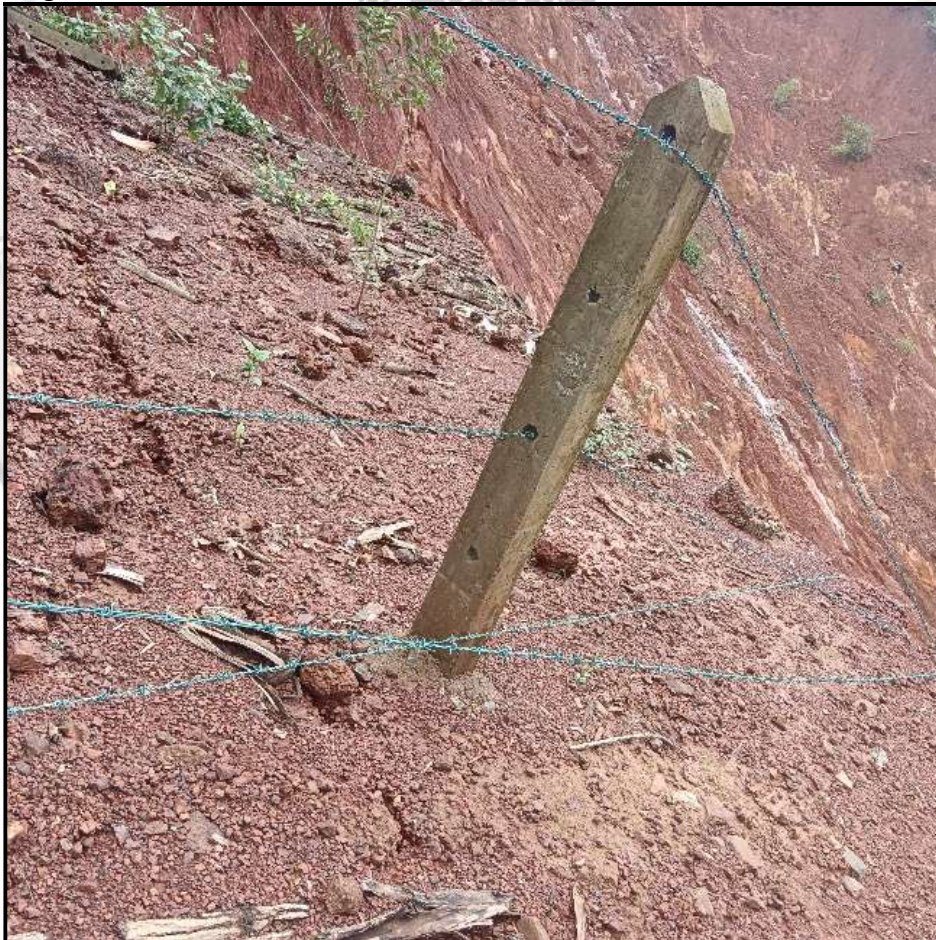
Fig. 1.12: Transverse cracks at the right flank of the landslide trending N15°

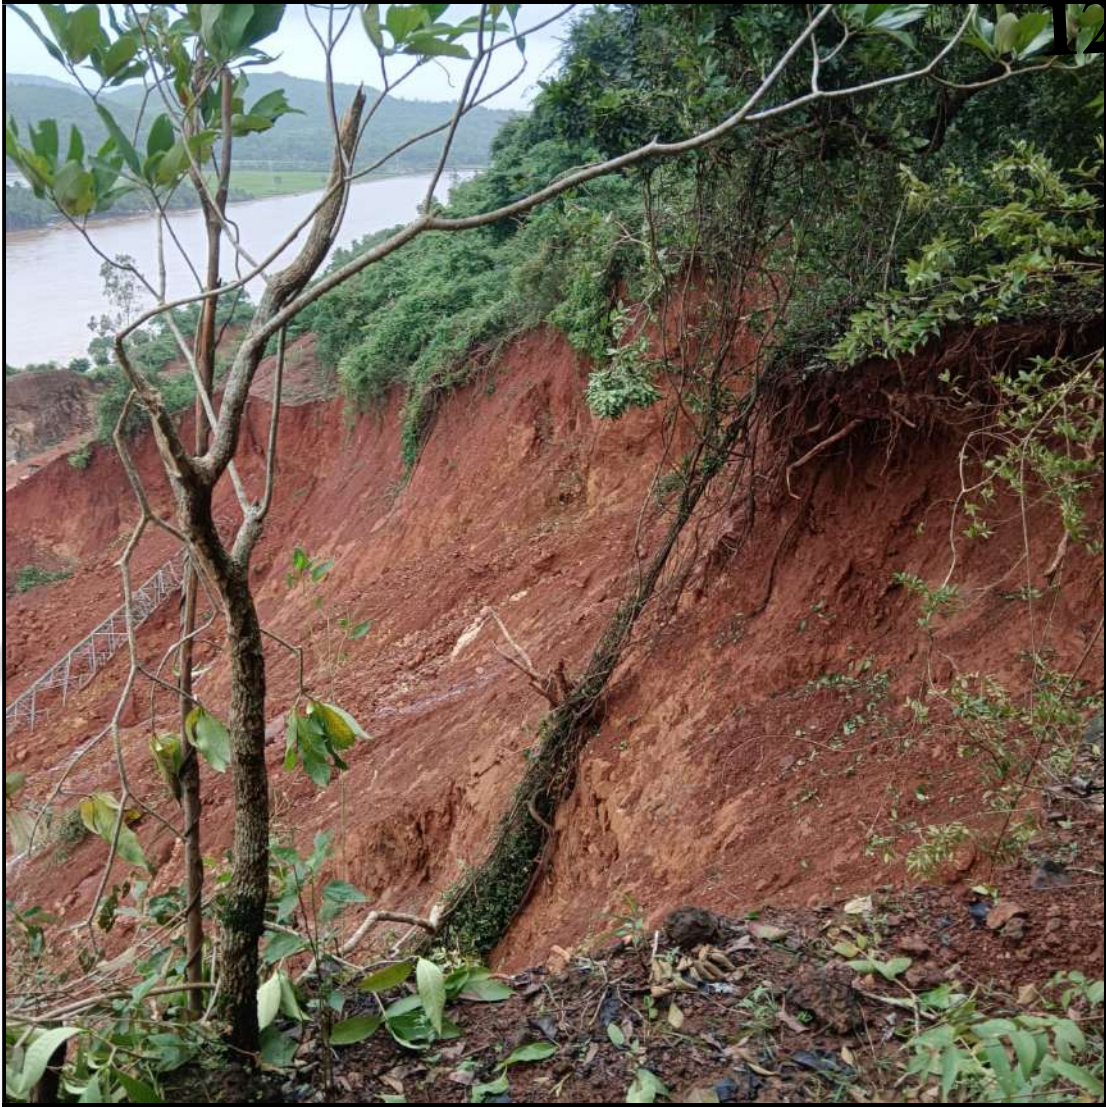
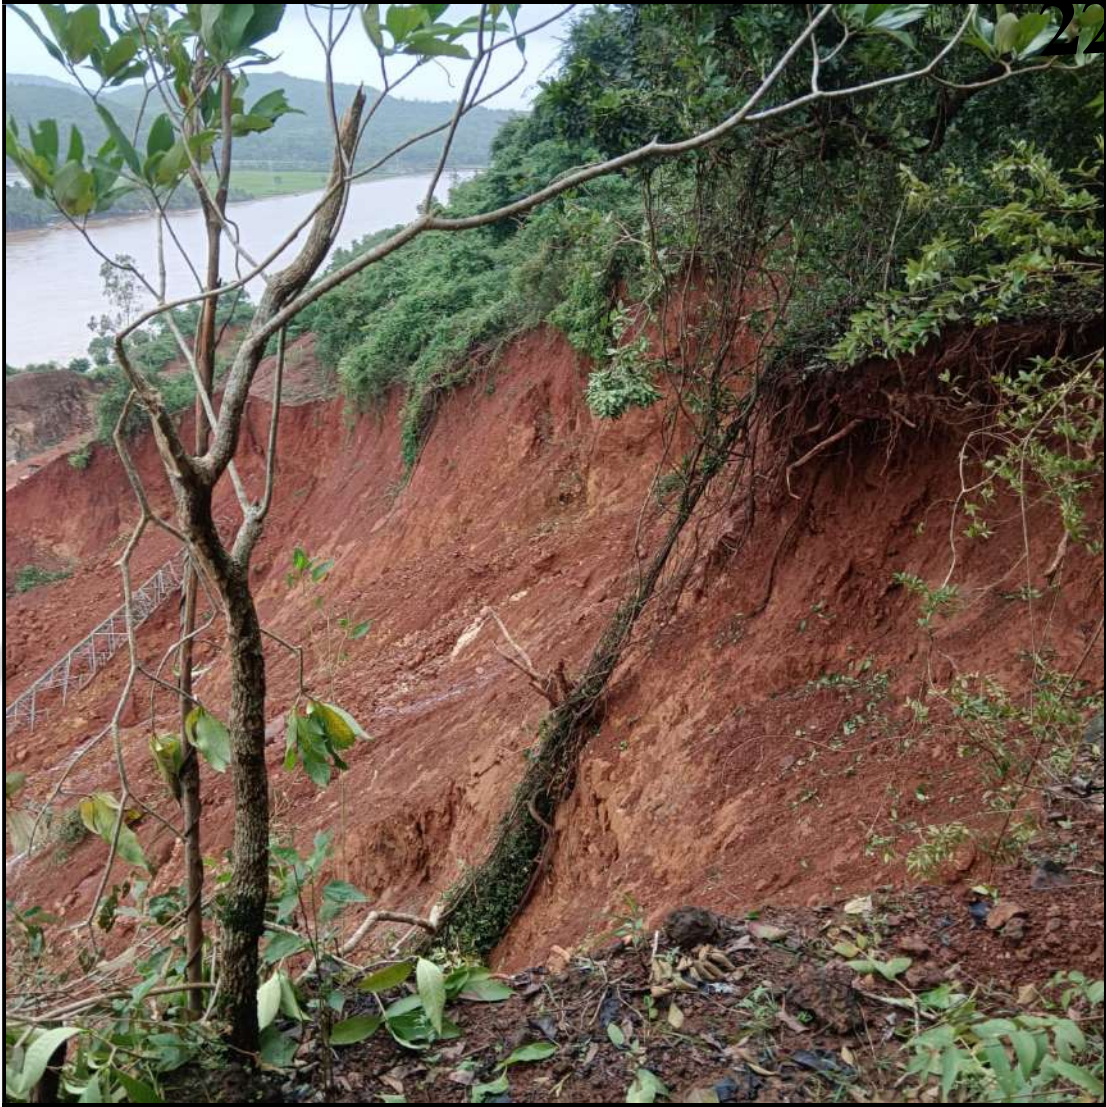
Fig. 1.13: Thickness of overburden at the main scarp

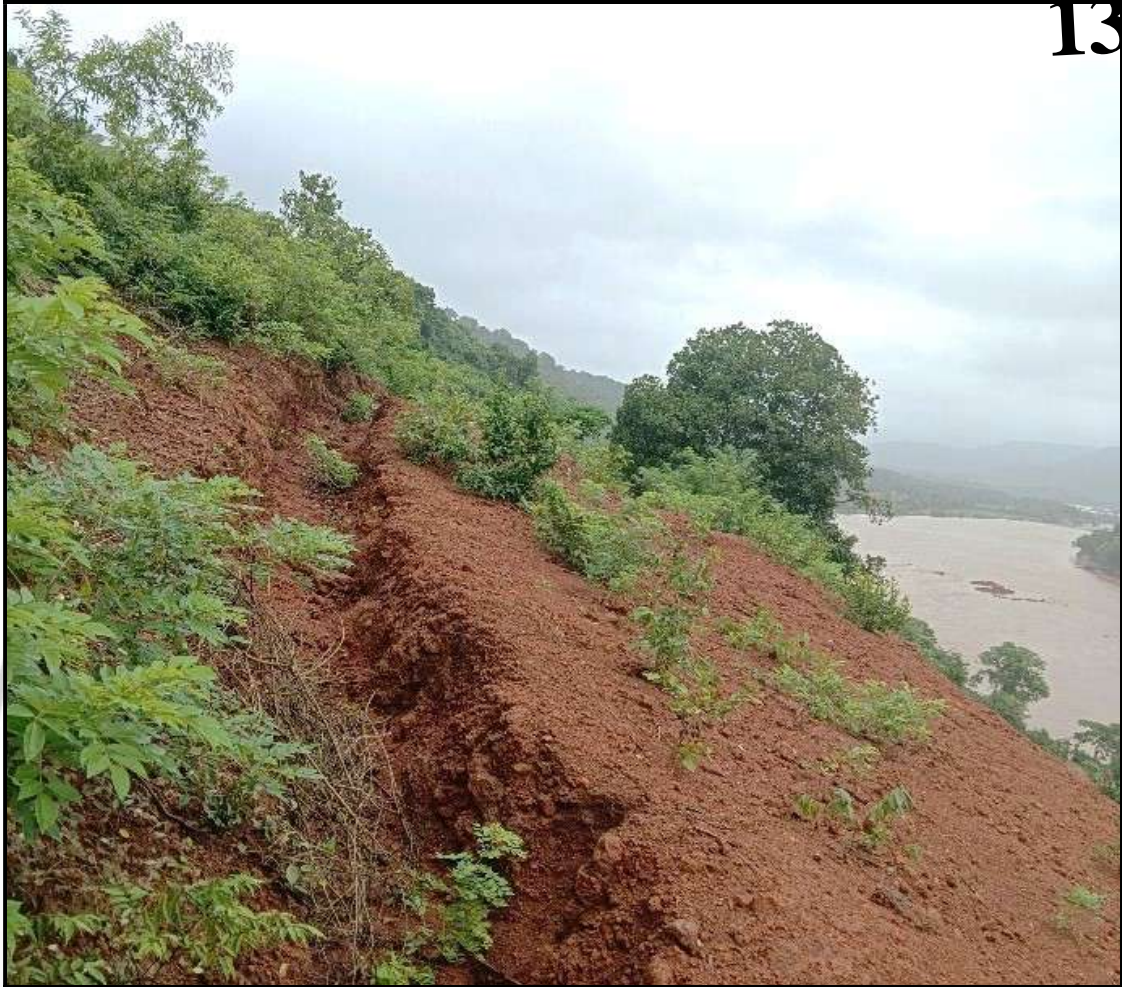
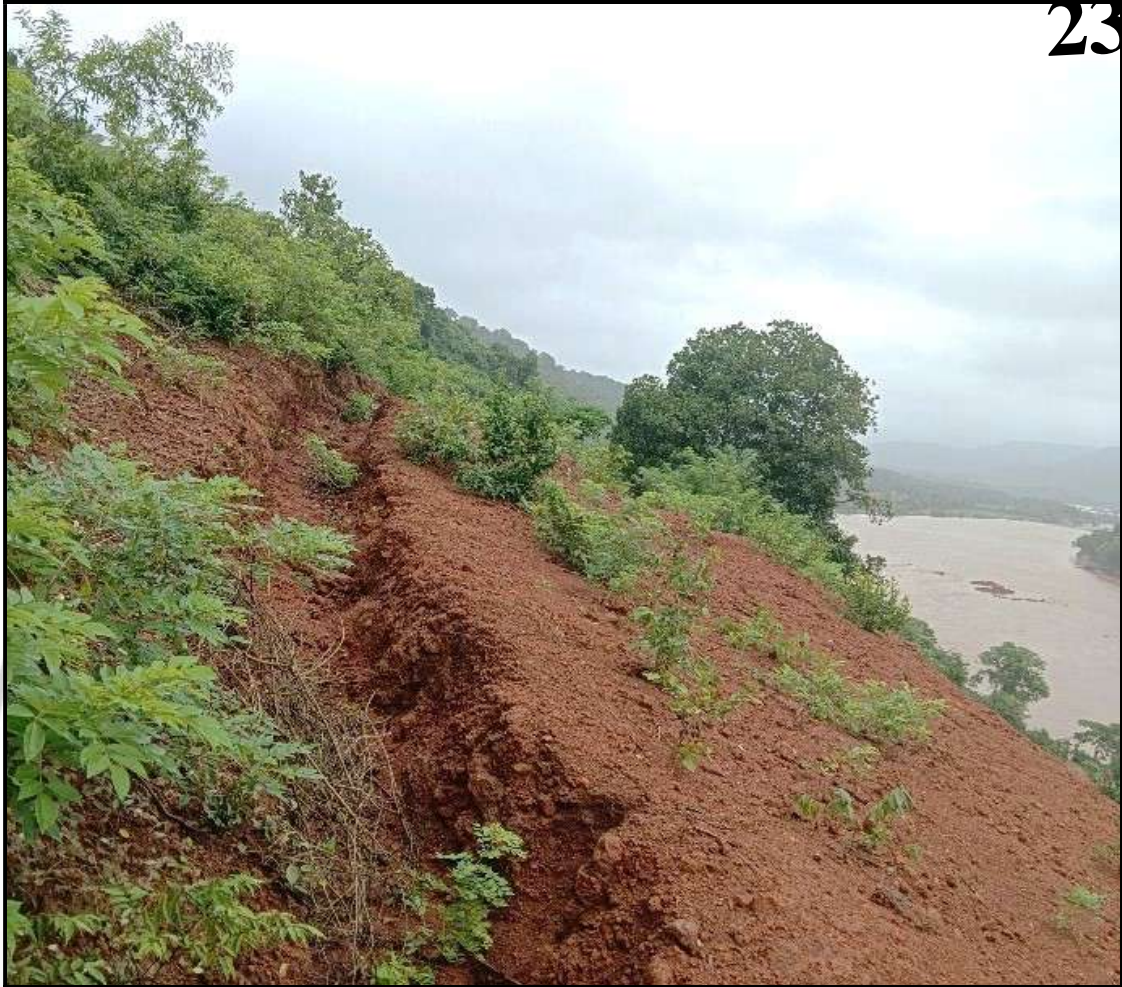
Fig. 1.15: Trenches observed above the Ch. no. 147.500

5. **Monitoring and Surveying:** It is recommended to monitor and survey for signs of instabilities even above the Right of Way especially for slope sections with higher relative relief on the right and left flanks of Shirur landslide. Shirur landslide is a classic case where the rupture surface extended beyond the ROW due to higher relief above the cut slope. Deploy flaggers for traffic control and restrict access to high-risk areas.
