**BEFORE THE HON'BLE NATIONAL GREEN TRIBUNAL,  
SOUTHERN ZONE, CHENNAI**

**ORIGINAL APPLICATION NO. 261 OF 2024  
(EARLIER ORIGINAL APPLICATION NO. 1055/2024- PB)**

Tribunal on its own motion Suo Moto based on News Item titled "Unscientific work by NHAI led to Shirur landslide Geological Survey of India report" appearing in the Indian Express dated 02.08.2024

National Highways Authority of India & Ors.

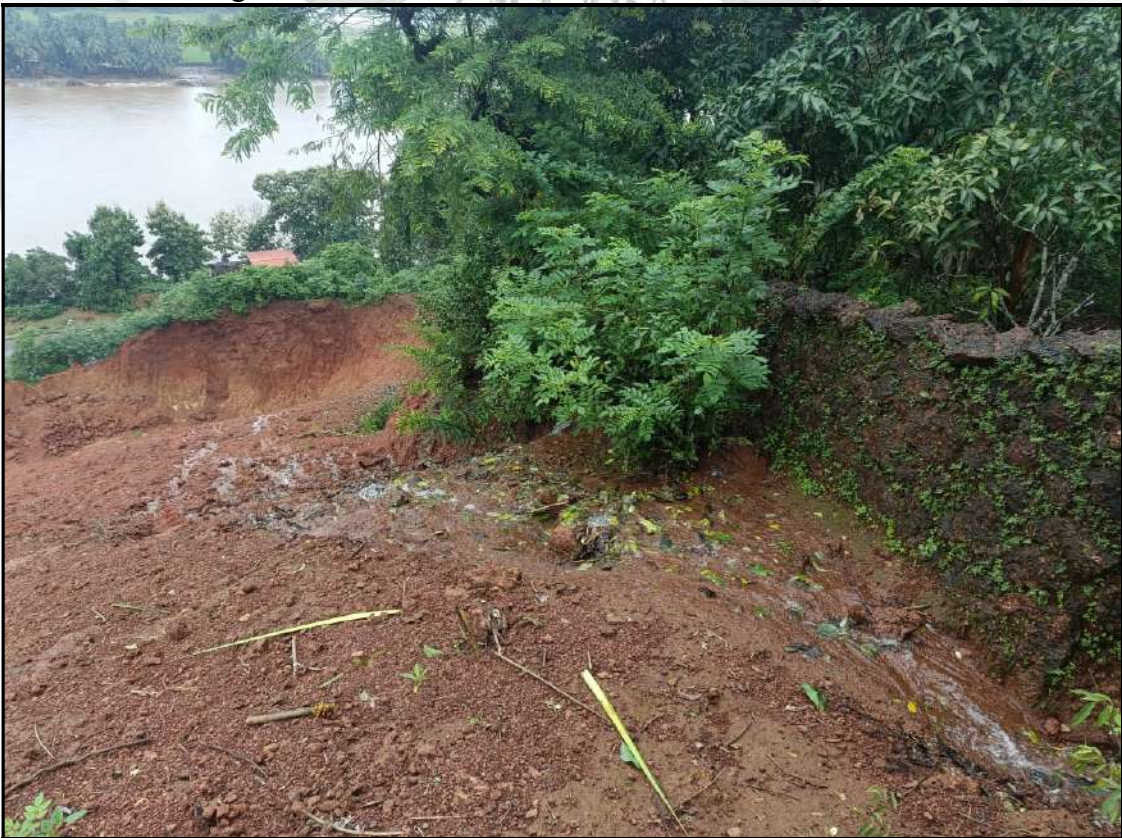
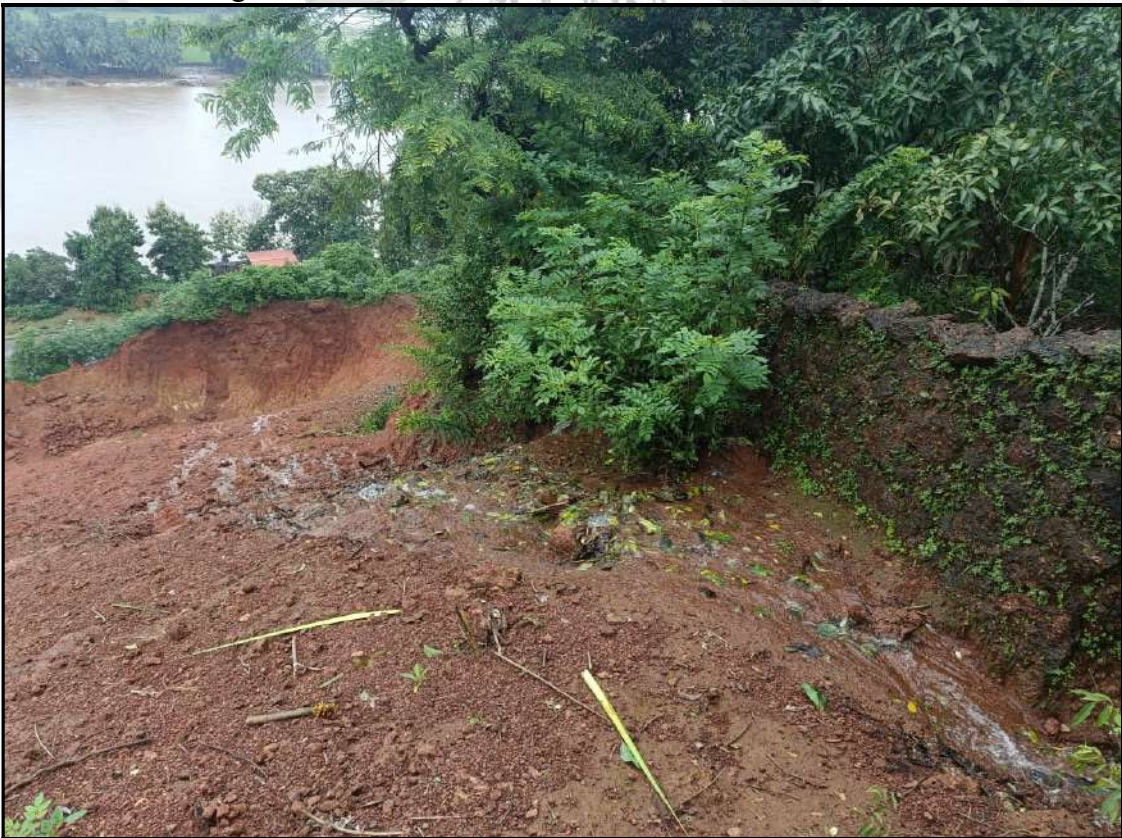
Fig. 1.16: Unguided surface water flowing along the slope above the Ch. no. 147.500

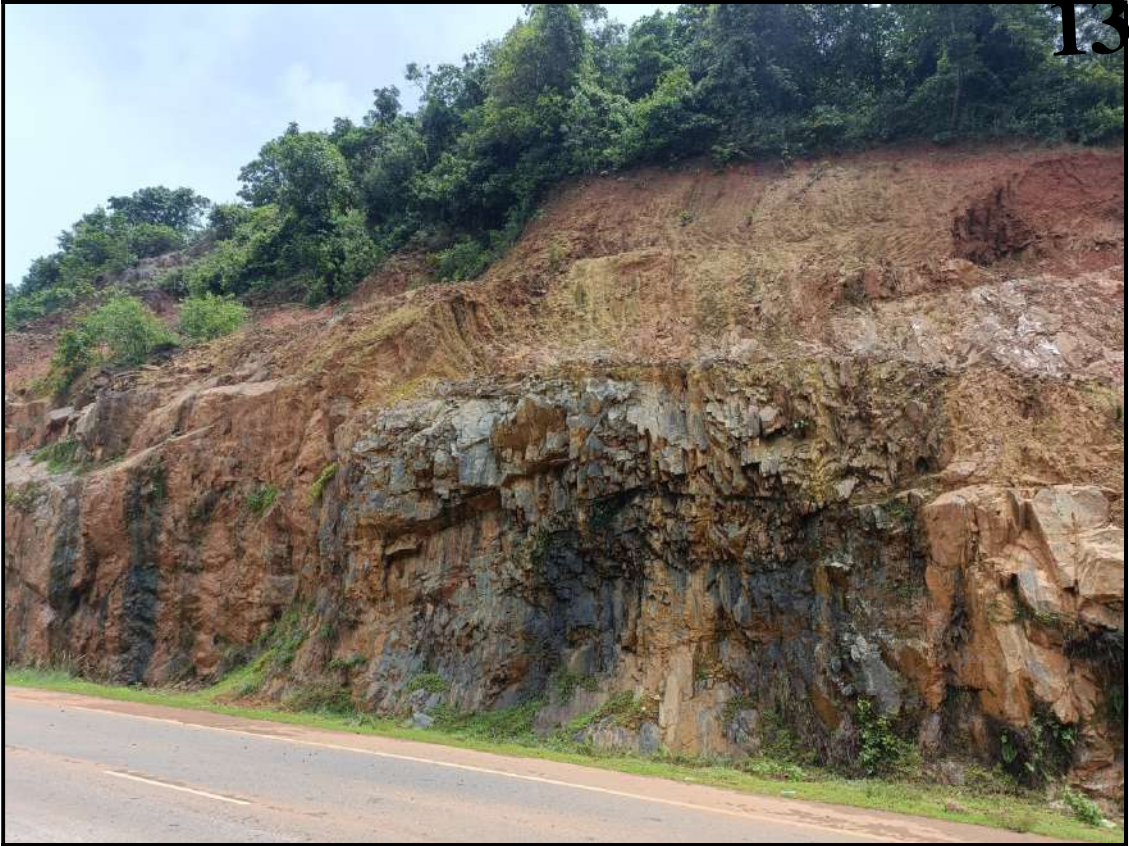
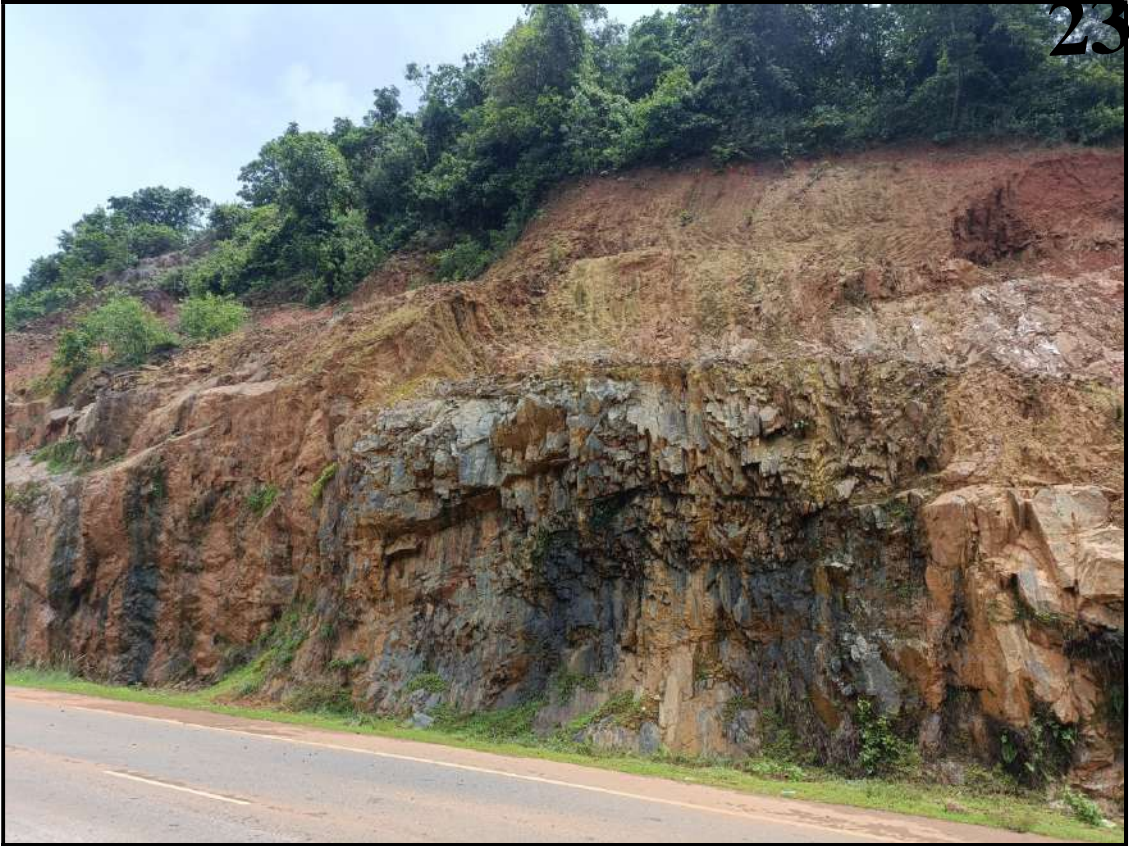
- The debris thickness is high and is cut at a steeper angle where minor failures are observed along the exposed debris face (Fig. 2.1).
- Drainage from the upslope saturates the debris thereby reducing its strength and resulting in a rotational failure (Fig. 2.2)
- The groundwater is seeping between the rock-debris interface and debris is sliding down the interface due to a reduction in friction between the layers.

Fig. 2.1: Typical cut section in the sector showing rock-debris interface

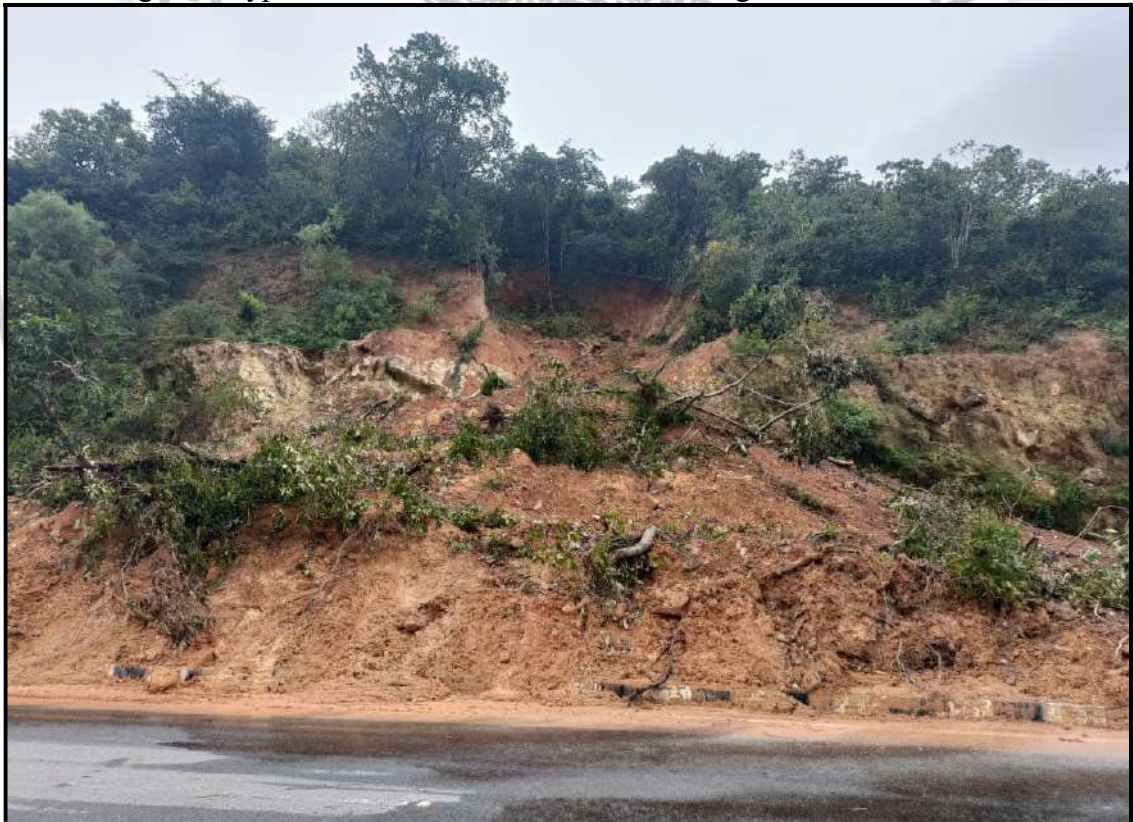
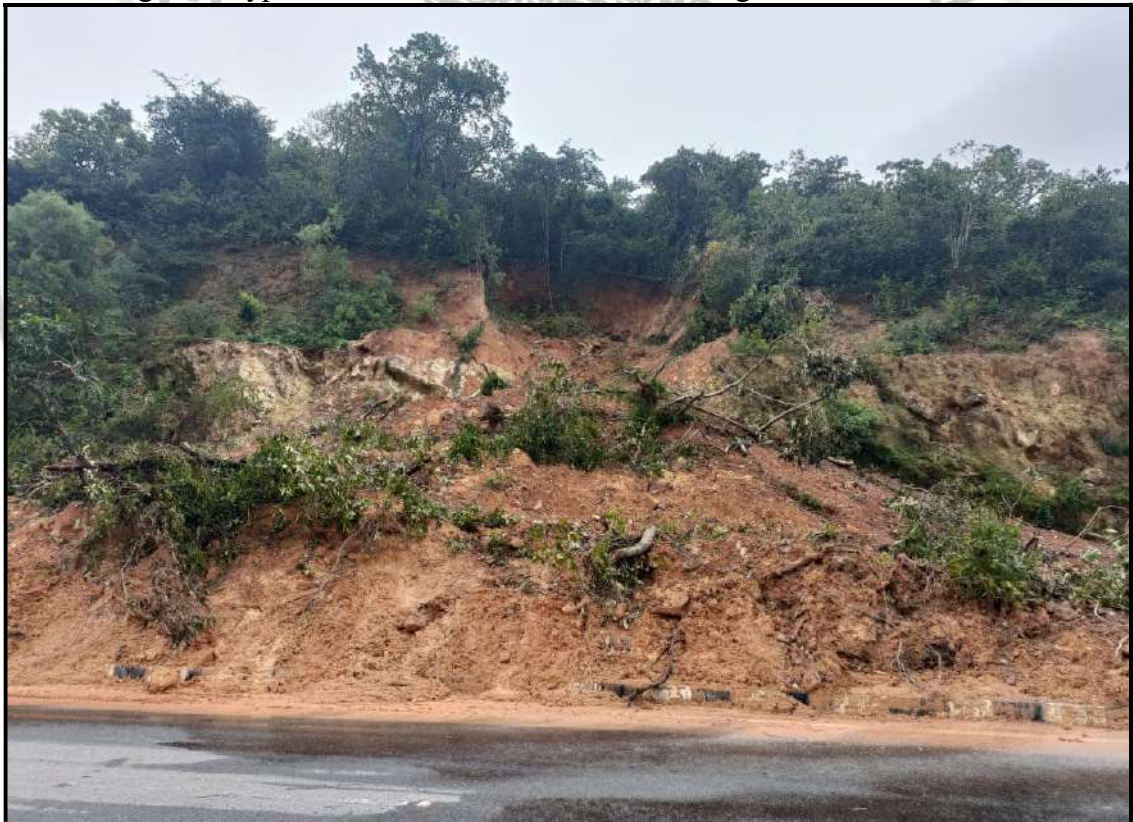
Fig. 2.2: Deep rotational failure with possible piping at chainage 160.080

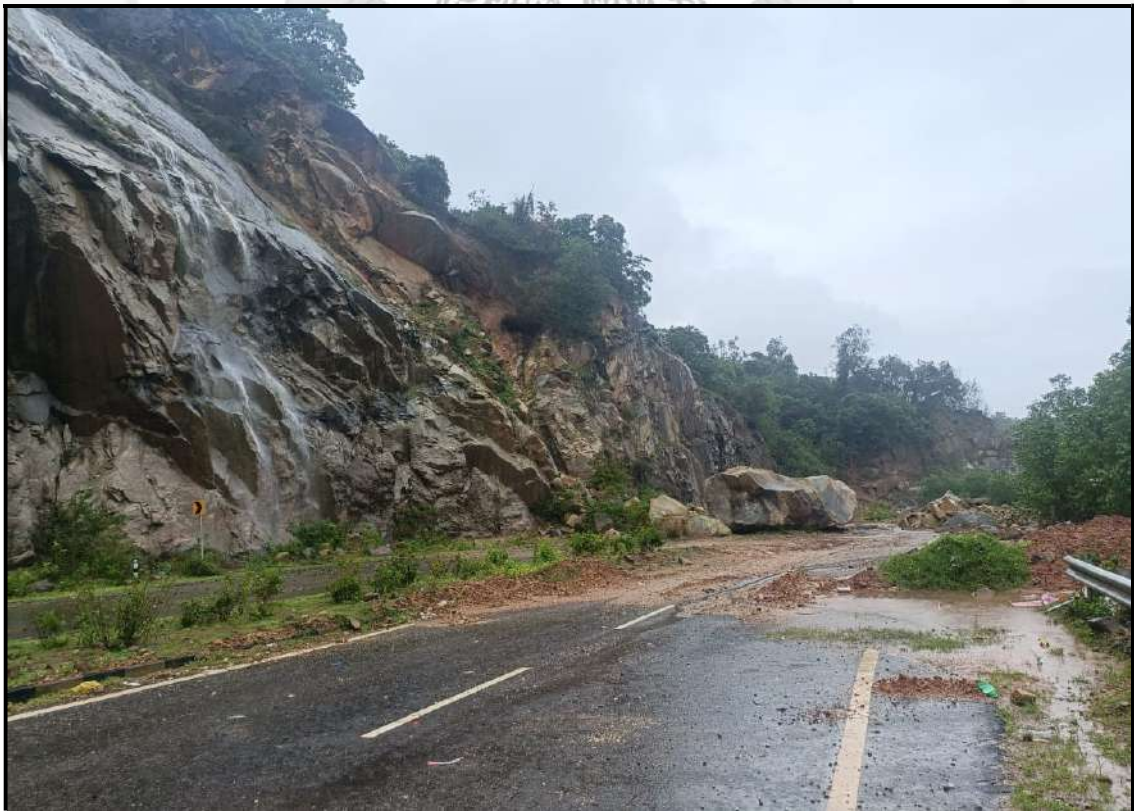
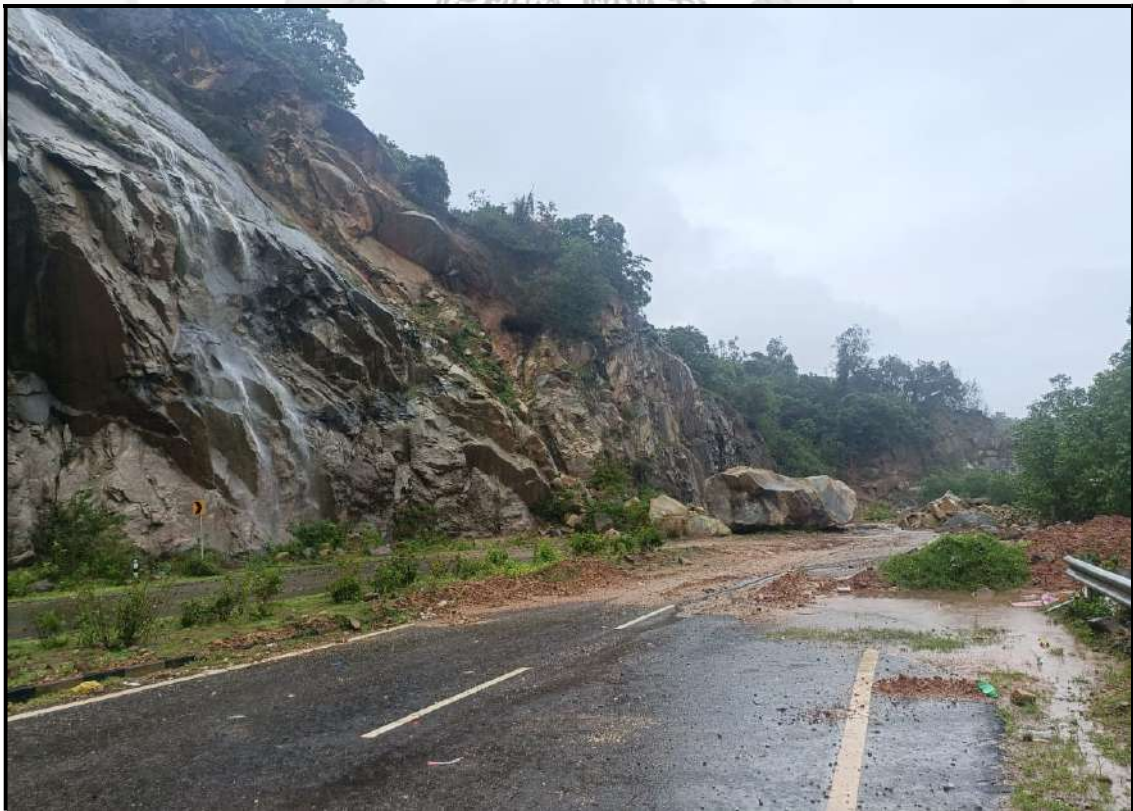
At chainages 111.300 to 111.400 where the relative relief is very high and the road cut is steep, the rocks are highly jointed with some having near vertical dips. The rocks also exhibit exfoliation joints which are formed due to repeated heating and thawing of the rocks. The intersection of these two planes produces blocks, which fall along the slope (Fig. 2.3). The stretch requires a detailed study to figure out engineering solutions such as rock bolting intervals, shotcreting, etc. However, if the land is available, a slight deviation (20m) in the road alignment towards the south western side away from the vertical slope cut can be considered after detailed studies to minimize the risk factor associated with rock falls (Fig. 2.4).

Fig. 2.3: Rockfall incidence at chainage 111.400

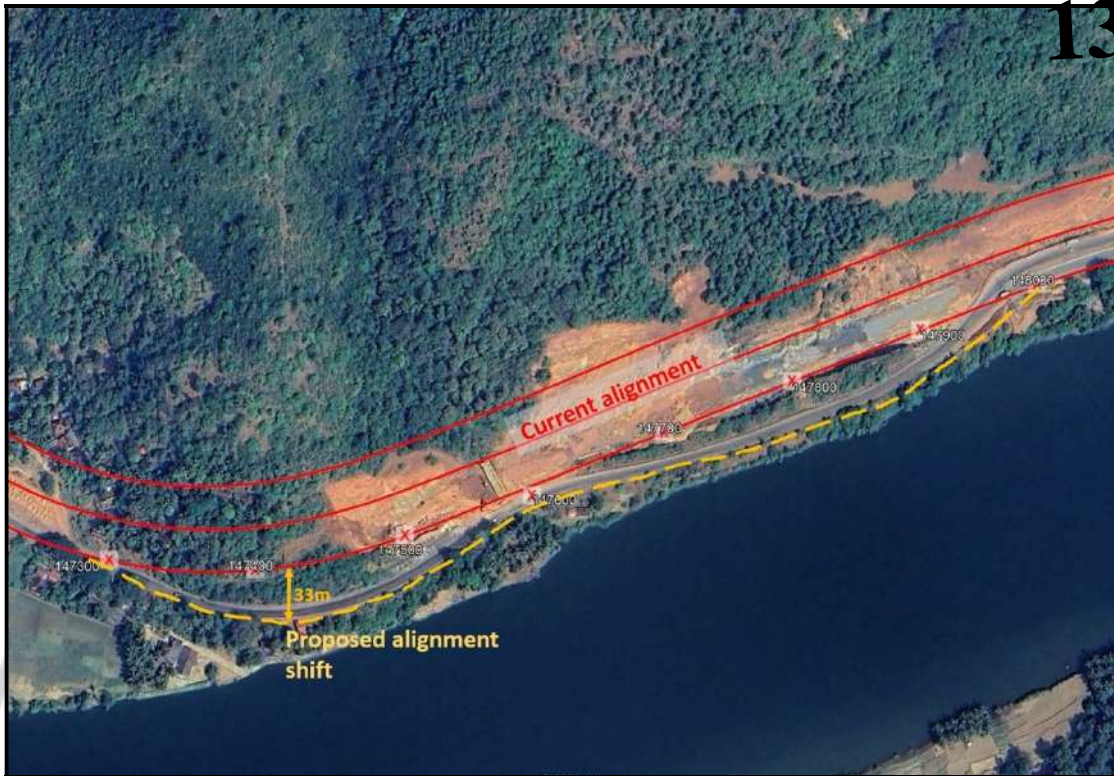
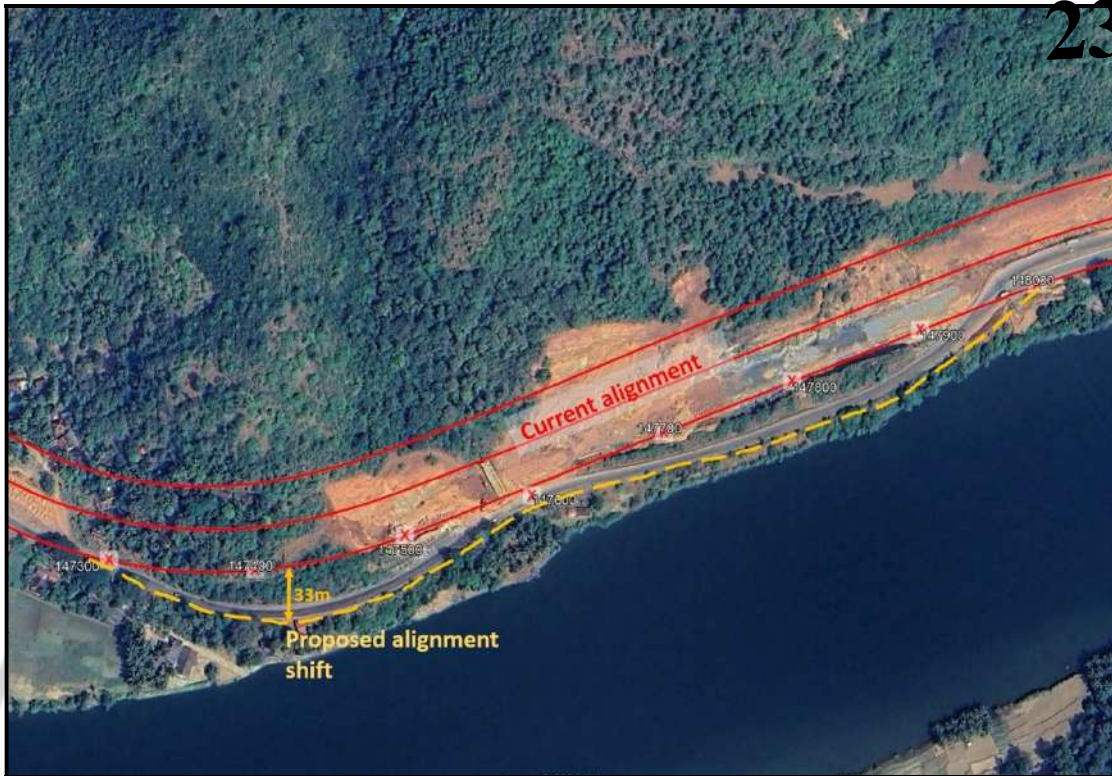
Geomorphologically, the planned slope cut from chainages 147.300 to 147.500 will be cutting across a “spur” which could cause slope instability issues post-modification. If the alignment shift is not feasible, it is recommended to provide the newly cut slope with adequate drainage management and support measures immediately. However, it is advised to avoid or minimize slope cuts in the location as far as possible.

Fig. 2.6: Proposed alignment shift to prevent further slope failures at the Shirur site.

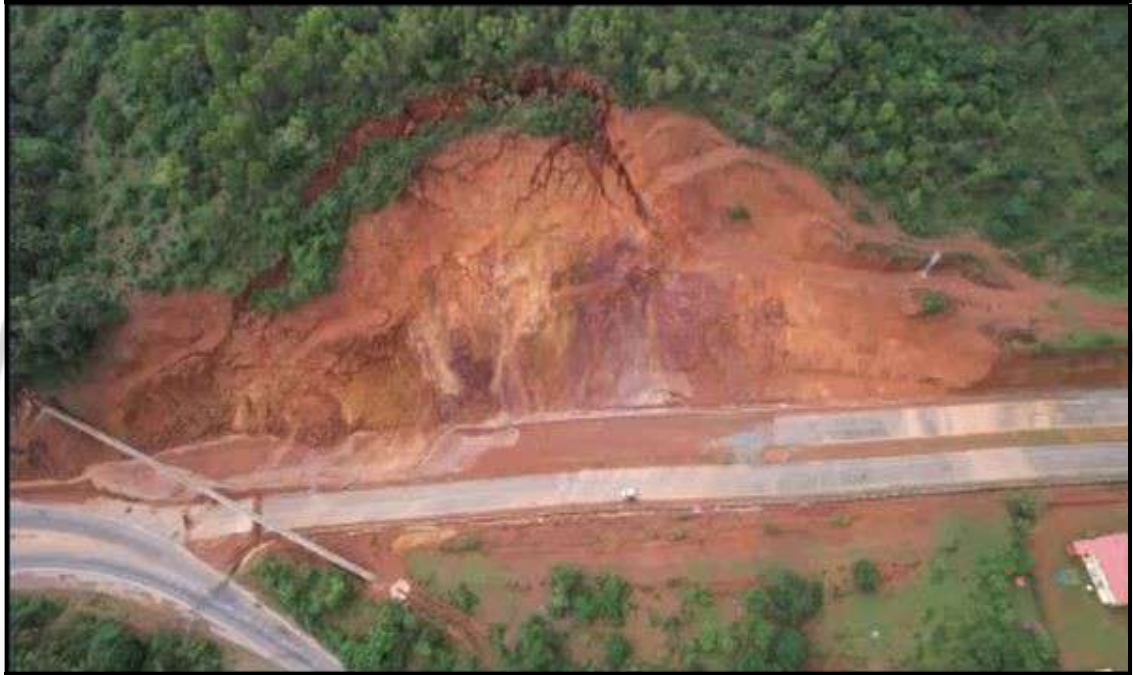
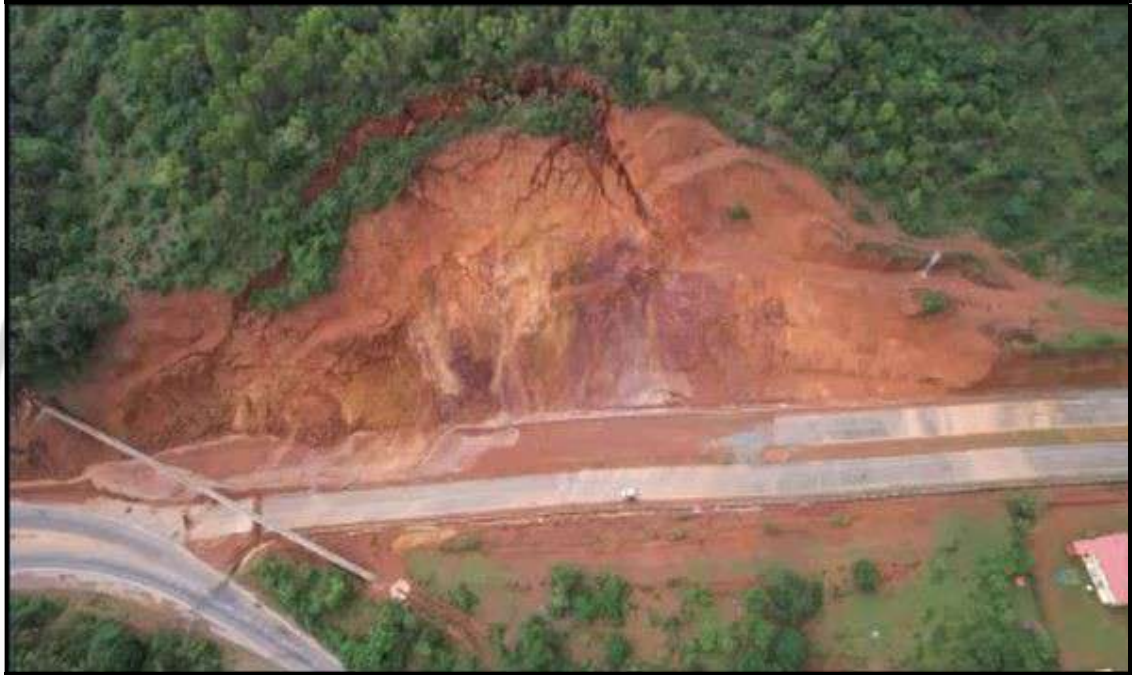
Fig. 2.7: Drone footage showing the recent landslide scar at 166.250

there are settlements opposite to the slope cut. It is recommended to monitor the slope for any crack development and take immediate action if any movement is noticed. It is also recommended to sensitize the local population regarding the potential hazard and the families living just opposite the slope may be shifted in case of any crack development. Detailed studies for proper slope grading, drainage provisions and to arrest gully erosion are recommended.

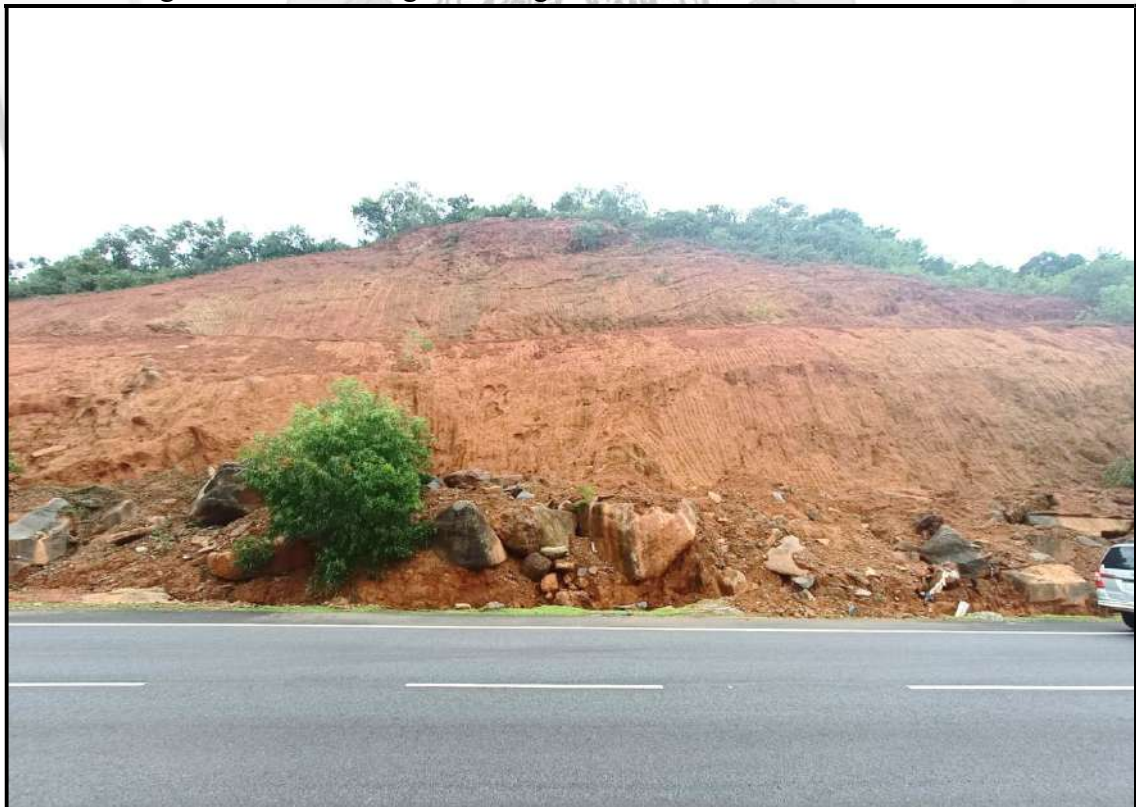
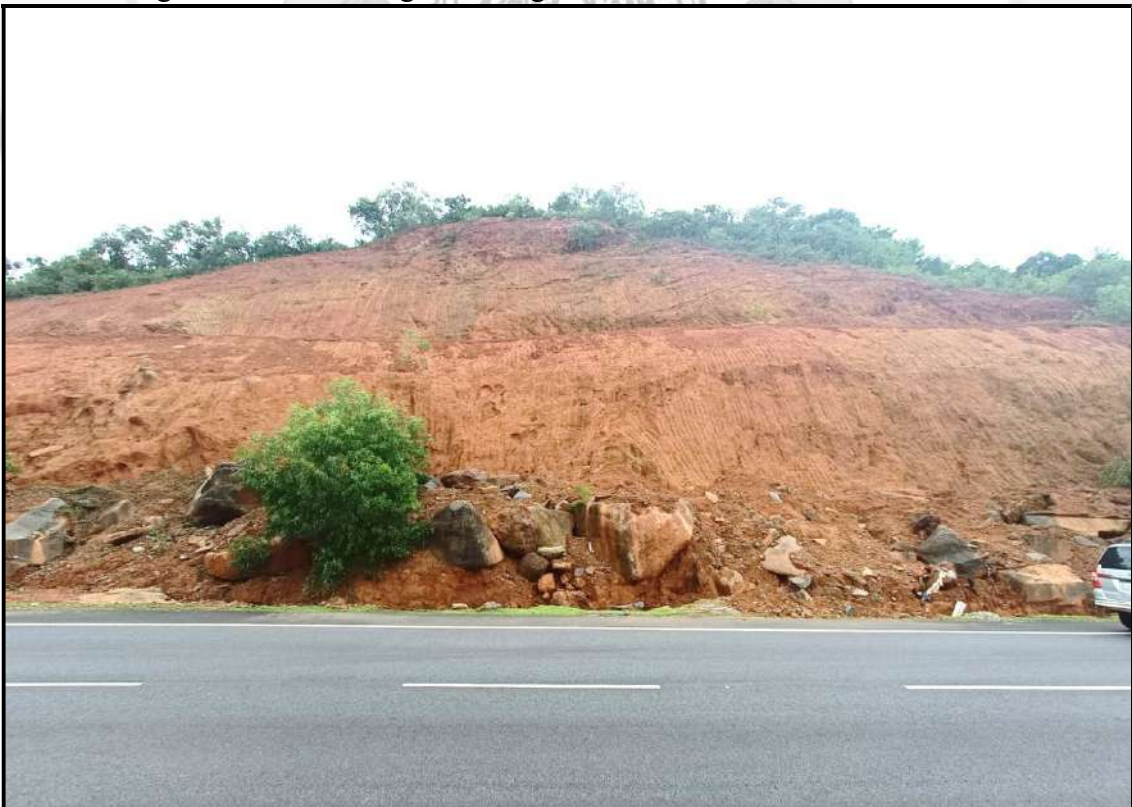
Fig. 2.8: Slope cut at chainage 168.200 exposing lithomarge and debris

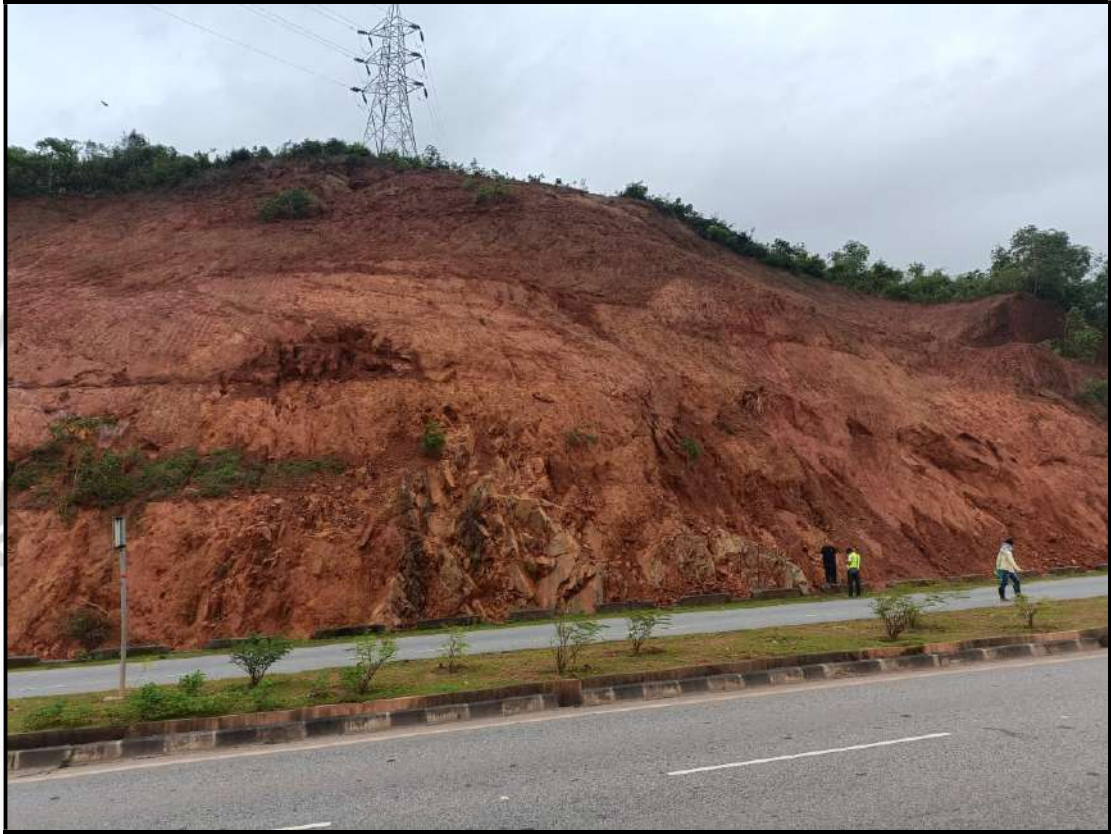
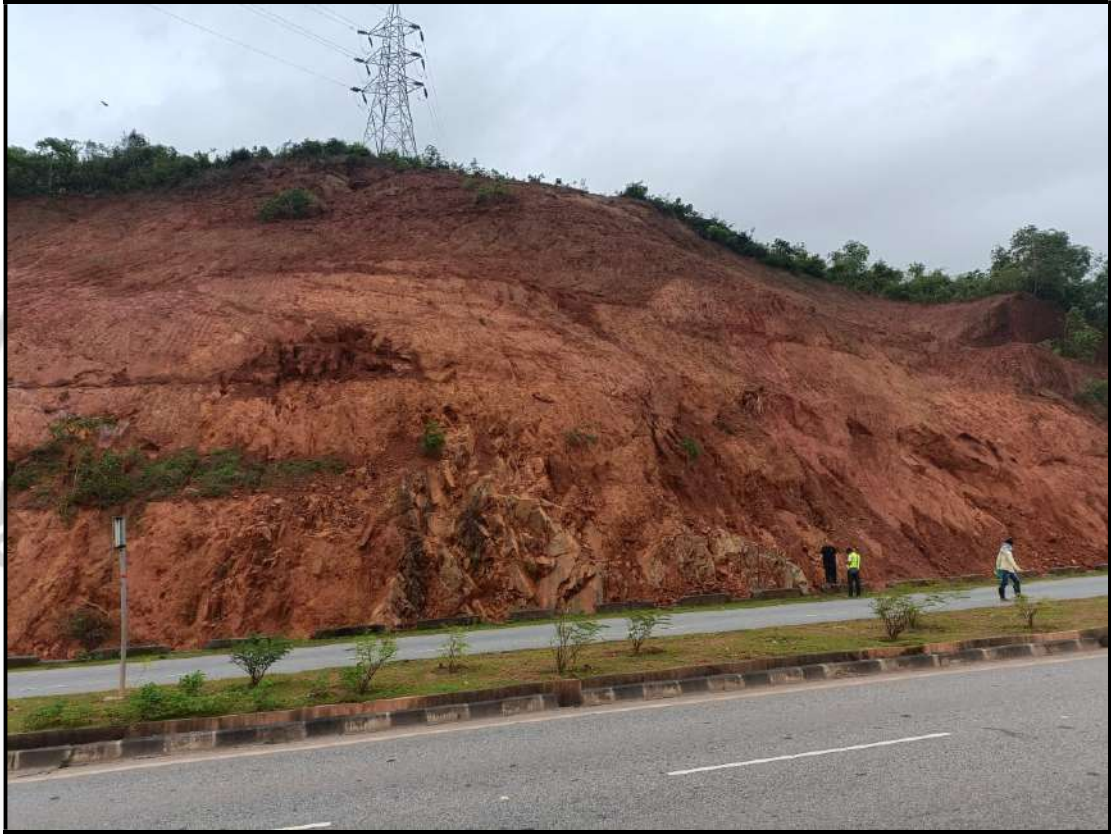
Another similar slope cut was observed at chainage 168.700 where a 50 m horizon of lithomarge and debris is exposed in the slope cut (Fig. 2.9). There are approximately 12 buildings opposite to the slope cut. It is recommended to conduct a detailed site-specific study to provide mitigation measures for the slope.

Fig. 2.9: Slope cut at chainage 168.700 showing the debris and minor scars

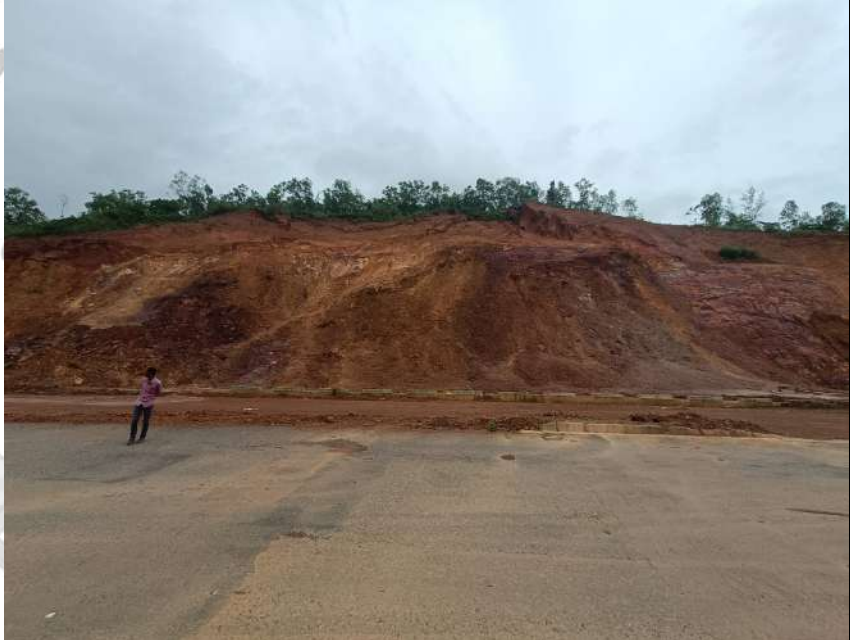
| 38 | Remarks, if any | The latest drone footage has revealed a major scar developed. |

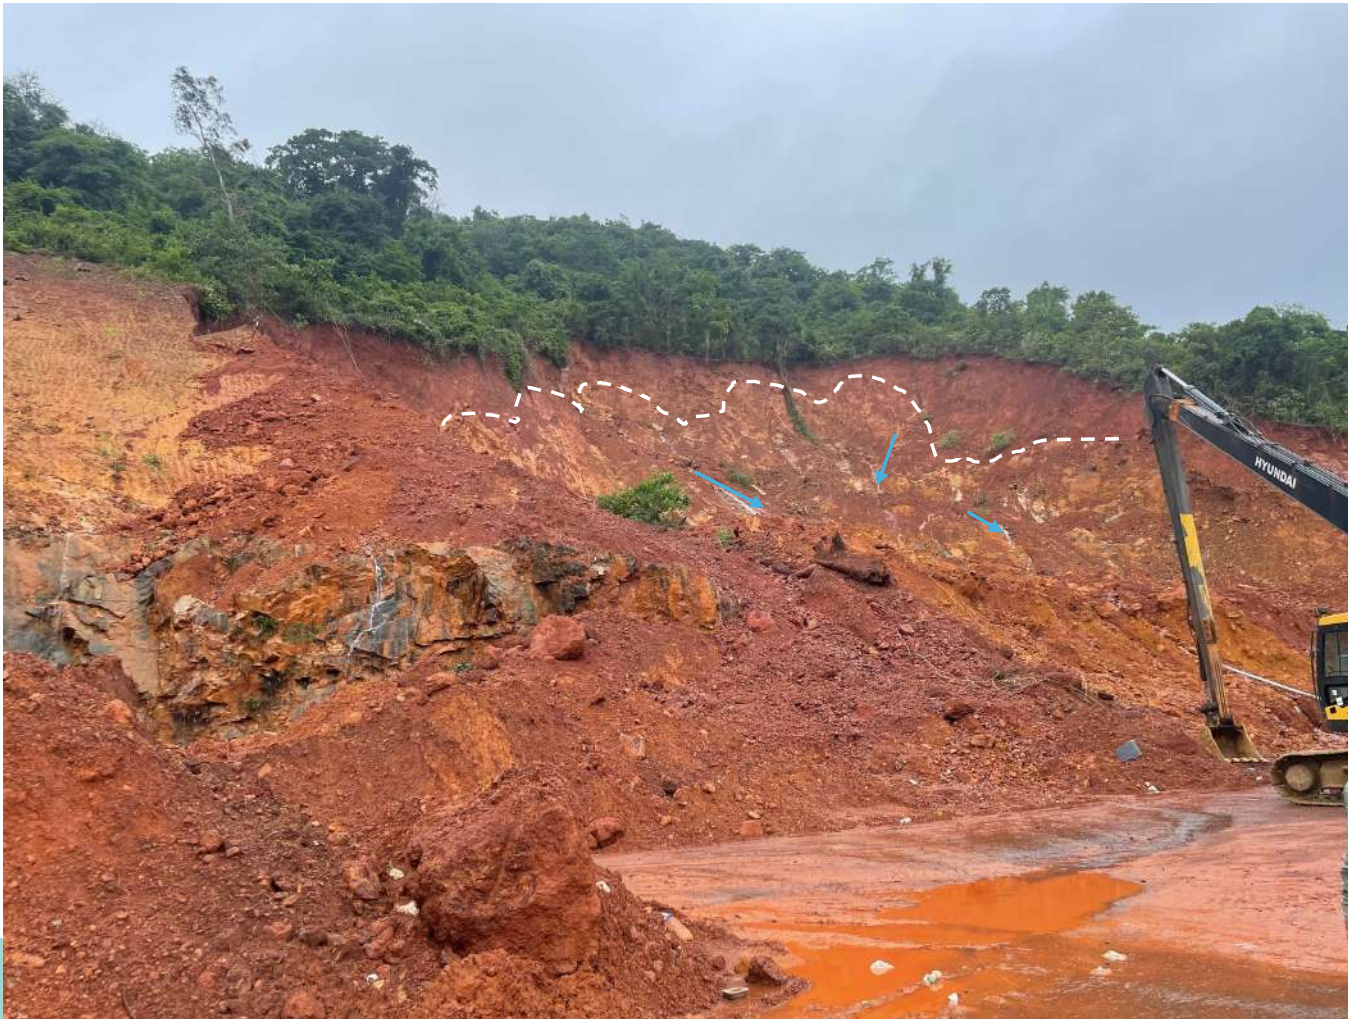
Picture Showing the crown, main scarp, and left flank of the landslide

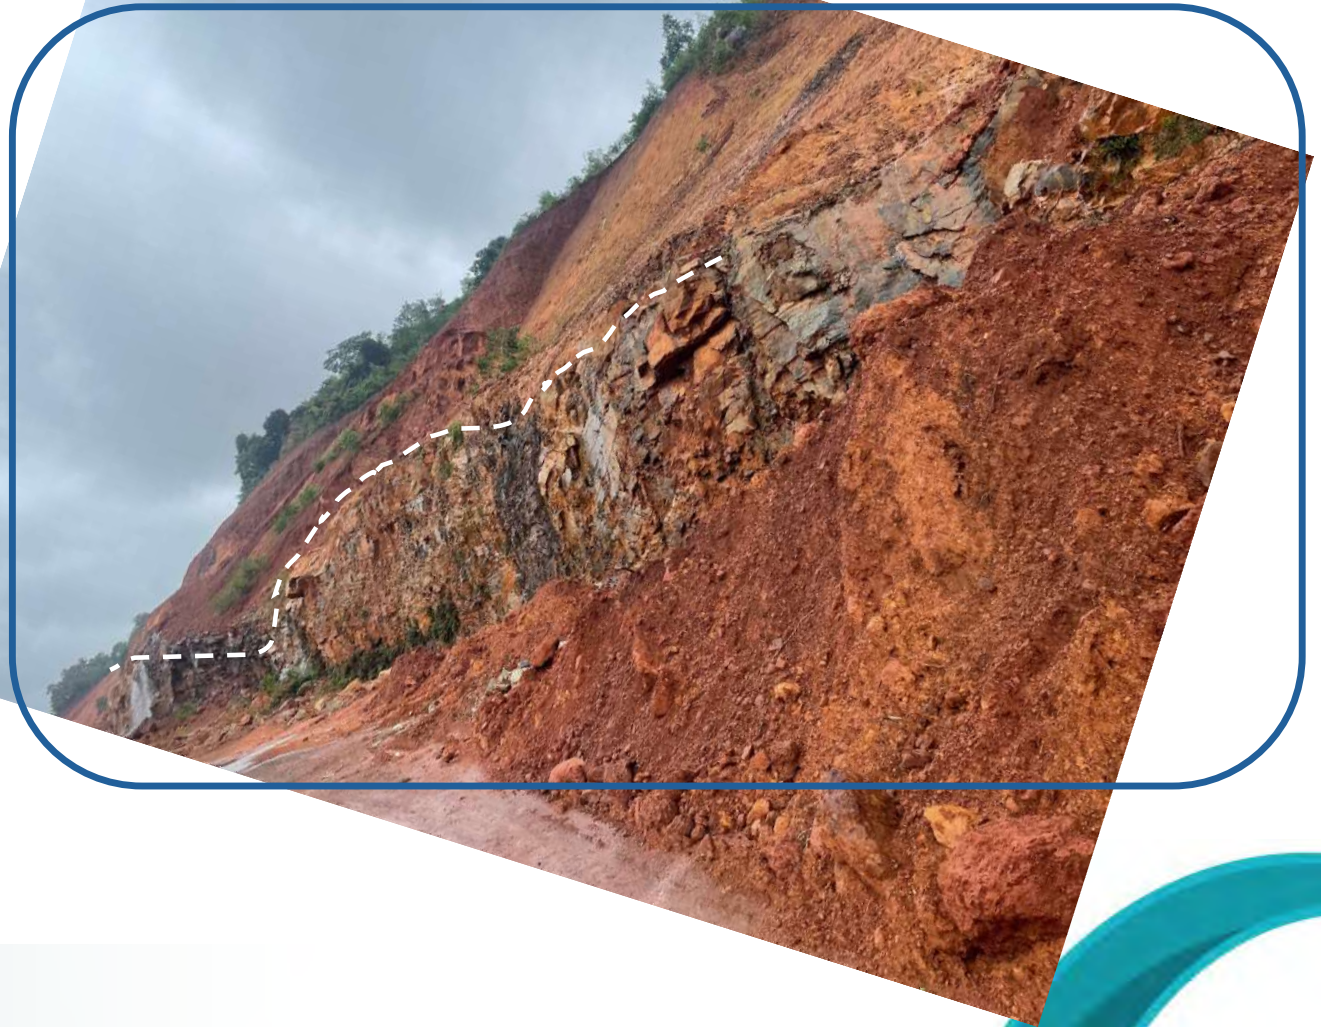
A local fault was clearly visible at the adjacent cut with folding strata

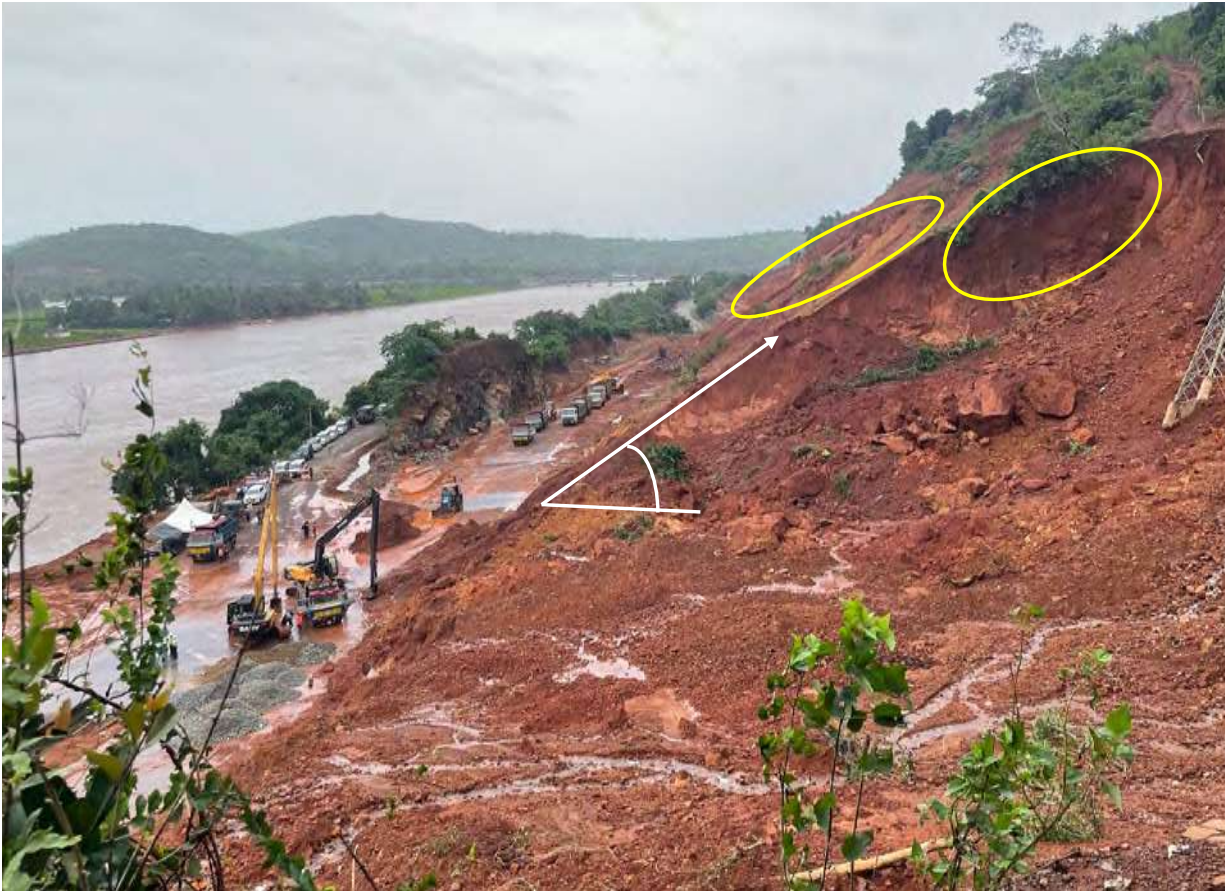
Picture showing the right flank of the slide.

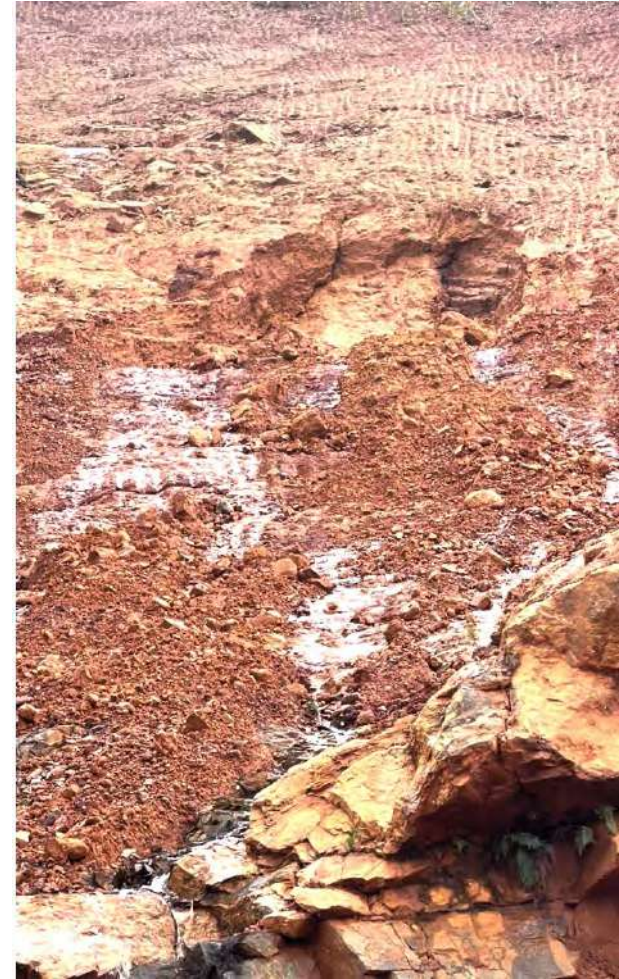
Various stages of piping phenomenon due to heterogeneous soil strata can be seen at different stage of evolution. At extreme stage even sink-holes are caused in similar strata.

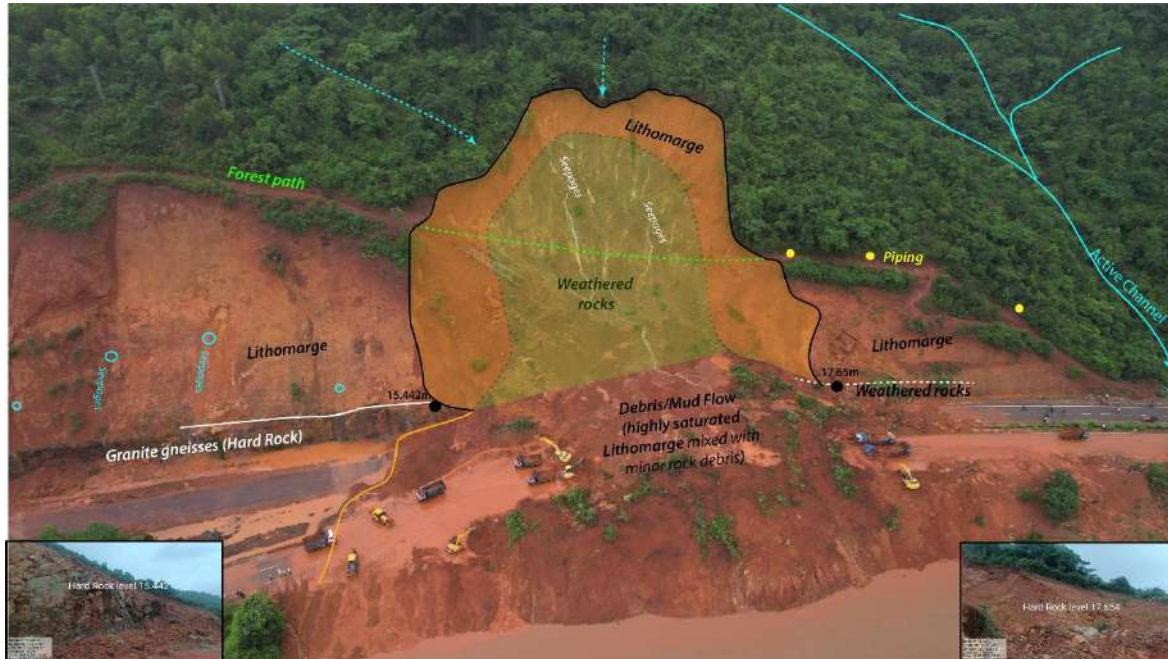
- The residual slope is constituted of the weathered rock and experiences seepage even after the debris-mud flow (Fig. 6).
- At places, the piping phenomenon is observed in the surrounding slope, suggesting the channelization of seepage water, though the piping is not well developed.
- Adjoining slopes are experiencing seepage of percolating water above the hard rocks exposed at the slope toe. This suggests a similar saturation loading of the slope prior to failure.

Figure 6: The basic morphological features of the Shirur landslide zone.

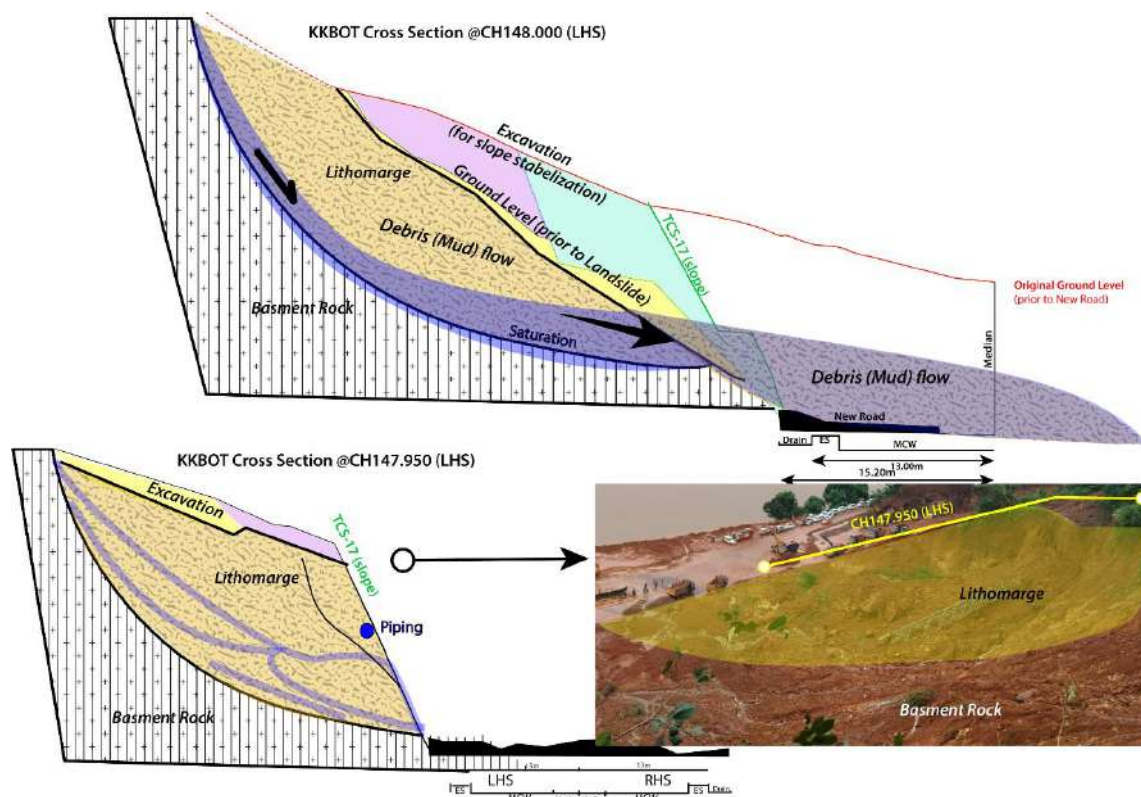
Figure 8: Slope profiles across the landslide zone (CH 148.000) and existing slope (CH 147.950). Please note the episodic removal of Lithomarge soil (marked in blue, purple, and yellow colors) to stabilize the slope by reducing the gradient. Also note the channelization of the seepage along the Lithomarge (soil) and rock interface, which acted as a slip surface facilitating the mass movement of saturated lateritic soil. The adjoining slope with several seepages by piping and at the rock-soil interface at the toe of the hill slope is also stressed, subject to the removal of excess water in the Lithomarge soil.
