O.A.261 OF 2024

Suo moto News Item titled "Unscientific Work by NHAI led to Shirur landslide Geological Survey of India Report appearing in the Indian Express dated 02.08.2024

REPORT ON
SHIRUR LANDSLIDE, ANKOLA TALUK, UTTARA KANNADA DISTRICT,
KARNATAKA
&
LANDSLIDE SUSCEPTIBILITY ALONG NH-66 (KARWAR TO NORTH OF BAINDUR)

M4LS/NC/SR/SU-KG/2024/50072

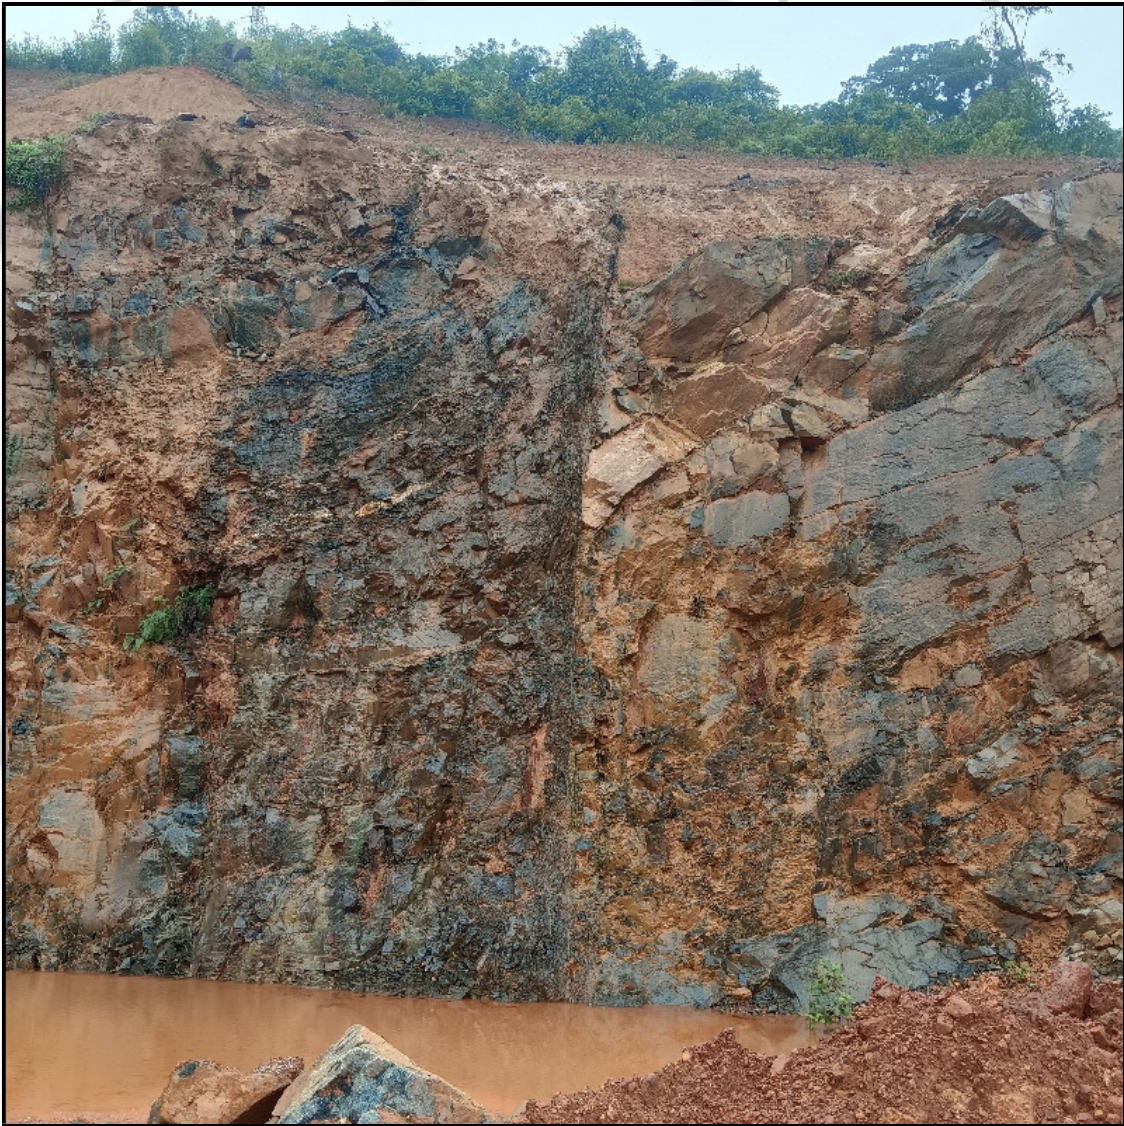
Fig. 1.5: Minor Fault observed at the base of the cut slope on the right flank of the slide

The toe area of the right flank exposes hard, compact pyroxenite, with rock mass quality assessed as fair according to RMR_{basic} (Bieniawski, 1989). The area features at least four prominent joint sets, i.e. two sub-vertical (NW-SE, NE-SW) and two moderately dipping (NE-SW, NW-SE) along with numerous fractures allowing free water flow. Open folding is observed, with the left limb oriented $155^{\circ}/30^{\circ}$ (Strike/Dip) and the right limb $335^{\circ}/10^{\circ}$ and affected by radial fractures along the hinges. Localized faults trending NW-SE are present on both the left and right flanks of the landslide (Fig. 1.5).

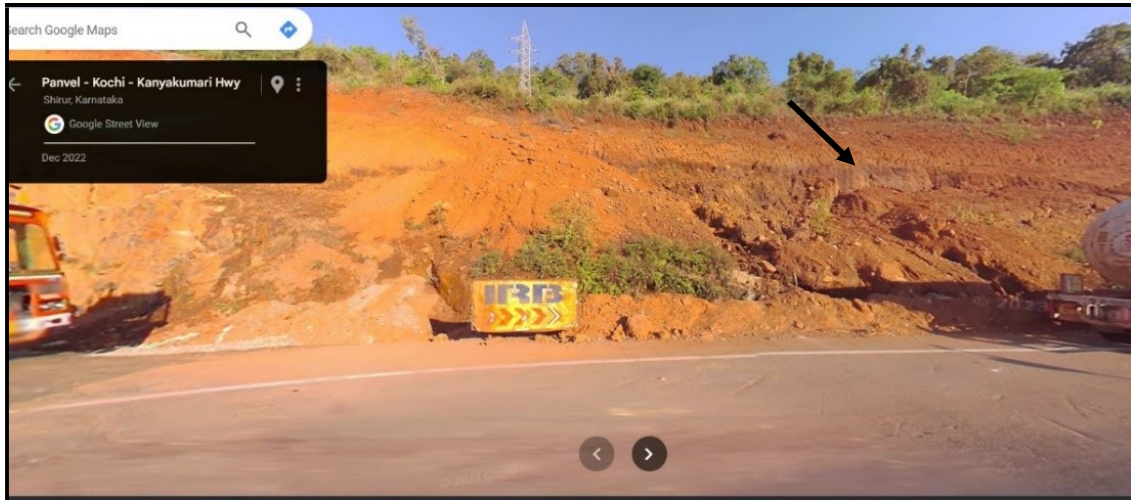
Fig. 1.8: Slump as seen through Google Street View of the Shirur landslide site

- a. **Chainage 148.000:** Prior signs of slope instability include at least two minor slumps observed in Google Street View (Fig. 1.8 & 1.9).

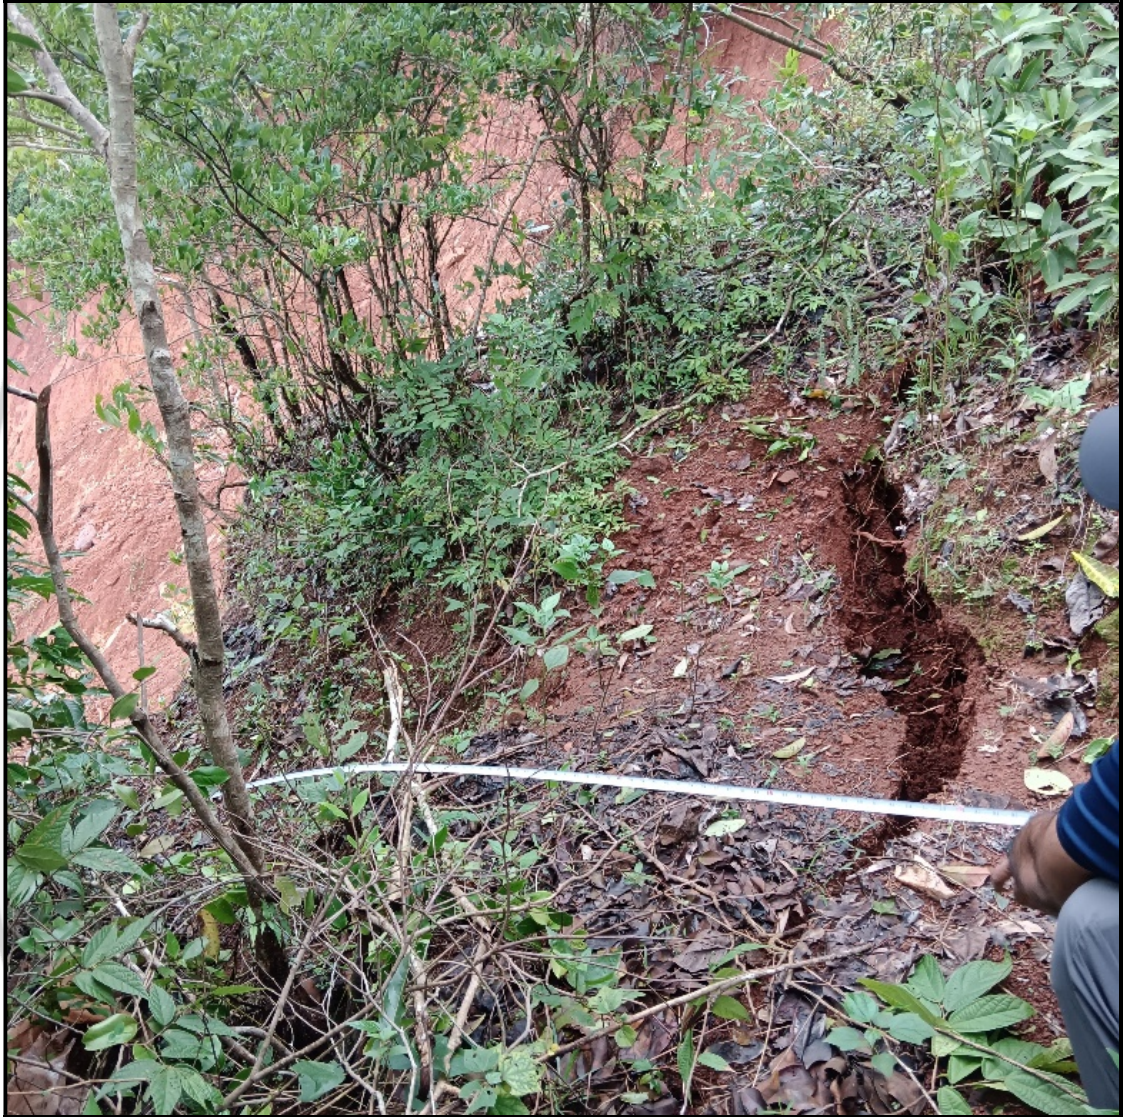
Fig. 1.10: Tension cracks behind the side scar of the slide trending N120°

- b. **Right Flank:** Fresh pyroxenite at the base tapers towards the toe of the rupture, providing minimal natural buttress due to rock unit warping and thick soil development. Extensive rill erosion was observed pre-landslide.
- c. **Slope Material:** The site investigation of the slopes shows that the slope-forming material has a striking variation both along the depth and the lateral extension of the cut slope section. The upper part is hard ferruginous laterite while the lower sections expose mottled clay-rich horizons where hydrostatic pressure has built up. The hard rock is inconsistently present only at the toe area.
- d. **Tension Cracks:** The left flank has two transverse cracks at different elevations – a crack at a higher elevation (Fig. 1.10) trending N120° (20m long, 1.5m deep) and also

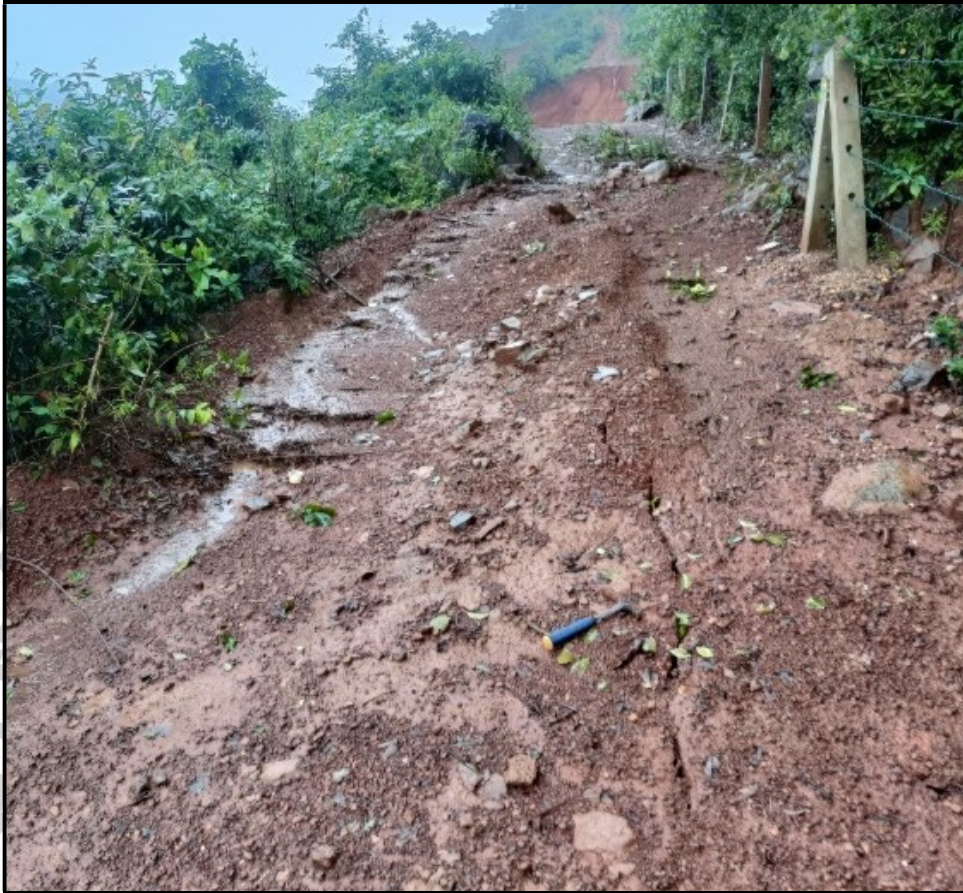
Fig. 1.11: Tension cracks at lower elevation of the left flank of the slide

at a lower elevation (Fig. 1.11) trending N80° (30m long, 2 ft deep), with no visible expansion by 25th July 2024. The Crack in the right flank (Fig. 1.12) trends N15° (15m long, 2m behind the scarp). Here, in the right flank there is relatively thicker soil with 6-7 m while the left flank exposes at least 3-4m of soil. No visible cracks were noticed on the crown area. The main scarp exposes soil of about 3-4 m (Fig. 1.13).

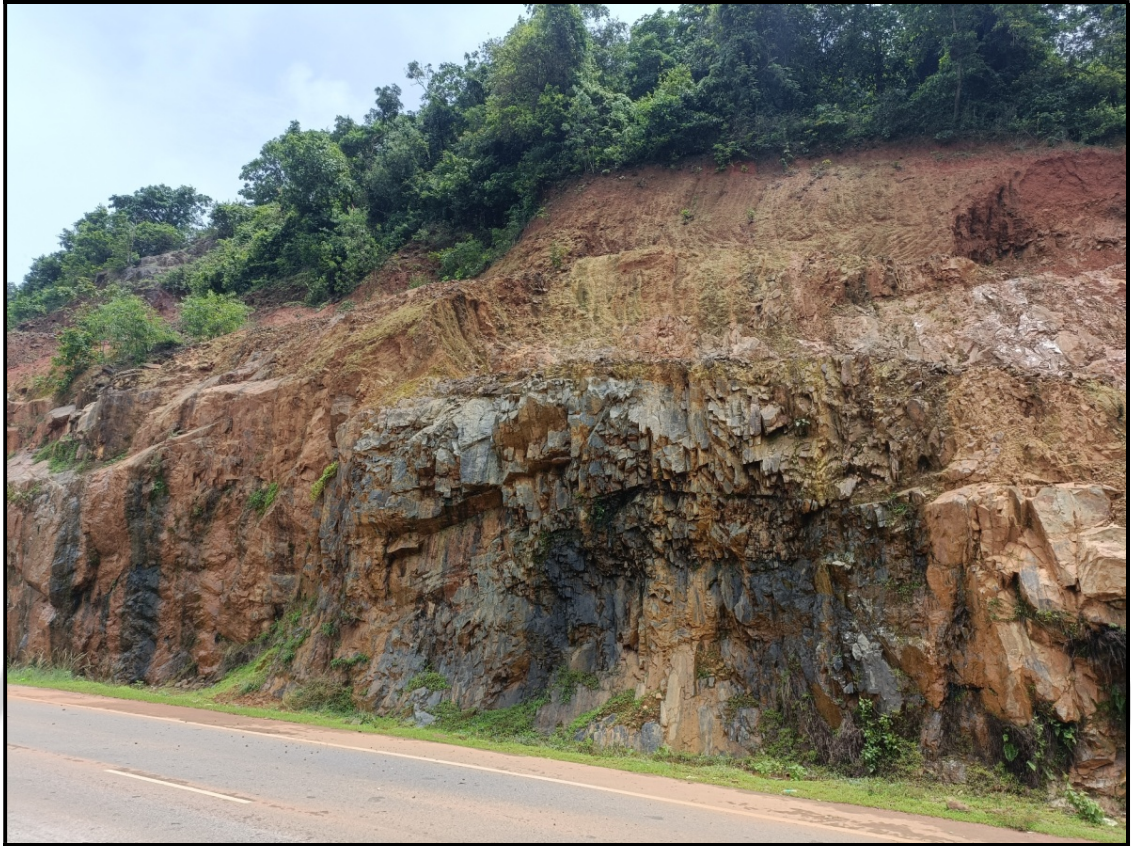
Fig. 2.1: Typical cut section in the sector showing rock-debris interface

- The debris thickness is high and is cut at a steeper angle where minor failures are observed along the exposed debris face (Fig. 2.1).
- Drainage from the upslope saturates the debris thereby reducing its strength and resulting in a rotational failure (Fig. 2.2)
- The groundwater is seeping between the rock-debris interface and debris is sliding down the interface due to a reduction in friction between the layers.

- Arrest surface water erosion by channelling the streams to proper drainage systems. Geo jutes installation with suitable grass (Vetiver) varieties can also be implemented.
- Reducing debris saturation by providing effective horizontal drainage systems. The existing horizontal drainage systems installed in the corridor are observed to be ineffective in discharging water.

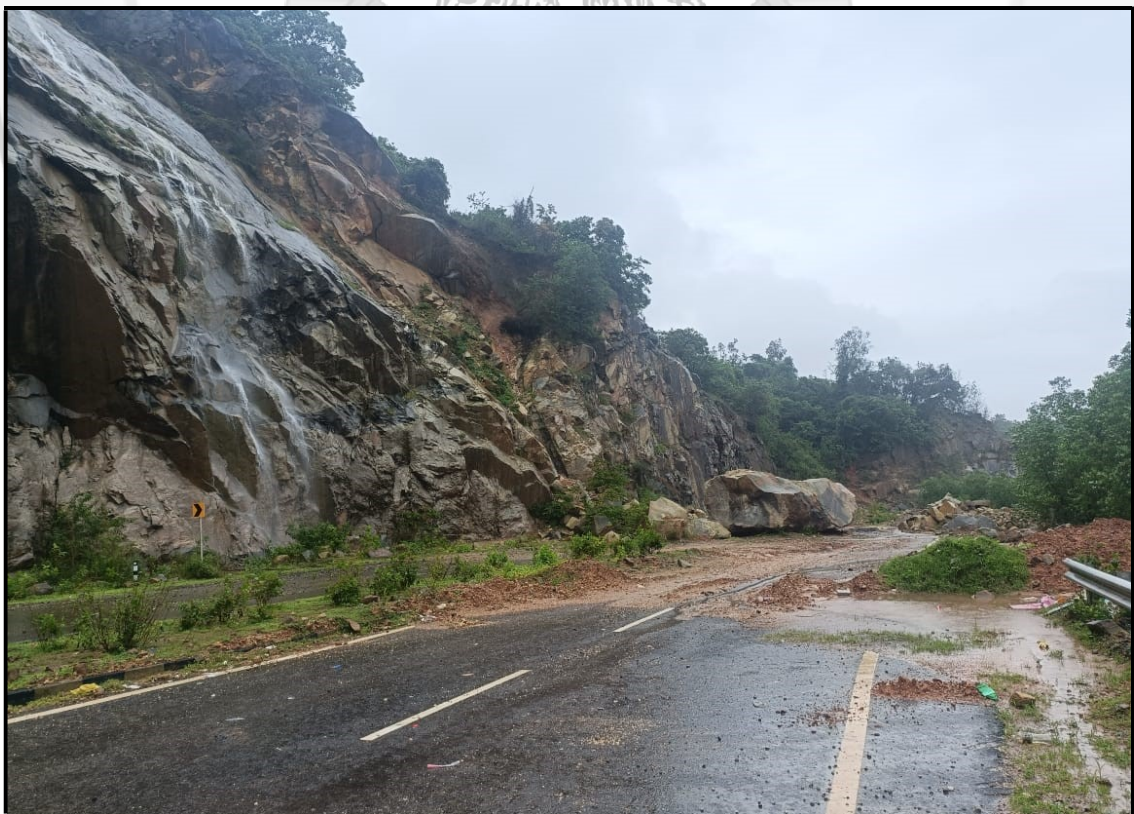
Fig. 2.3: Rockfall incidence at chainage 111.400

At chainages 111.300 to 111.400 where the relative relief is very high and the road cut is steep, the rocks are highly jointed with some having near vertical dips. The rocks also exhibit exfoliation joints which are formed due to repeated heating and thawing of the rocks. The intersection of these two planes produces blocks, which fall along the slope (Fig. 2.3). The stretch requires a detailed study to figure out engineering solutions such as rock bolting intervals, shotcreting, etc. However, if the land is available, a slight deviation (20m) in the road alignment towards the south western side away from the vertical slope cut can be considered after detailed studies to minimize the risk factor associated with rock falls (Fig. 2.4).

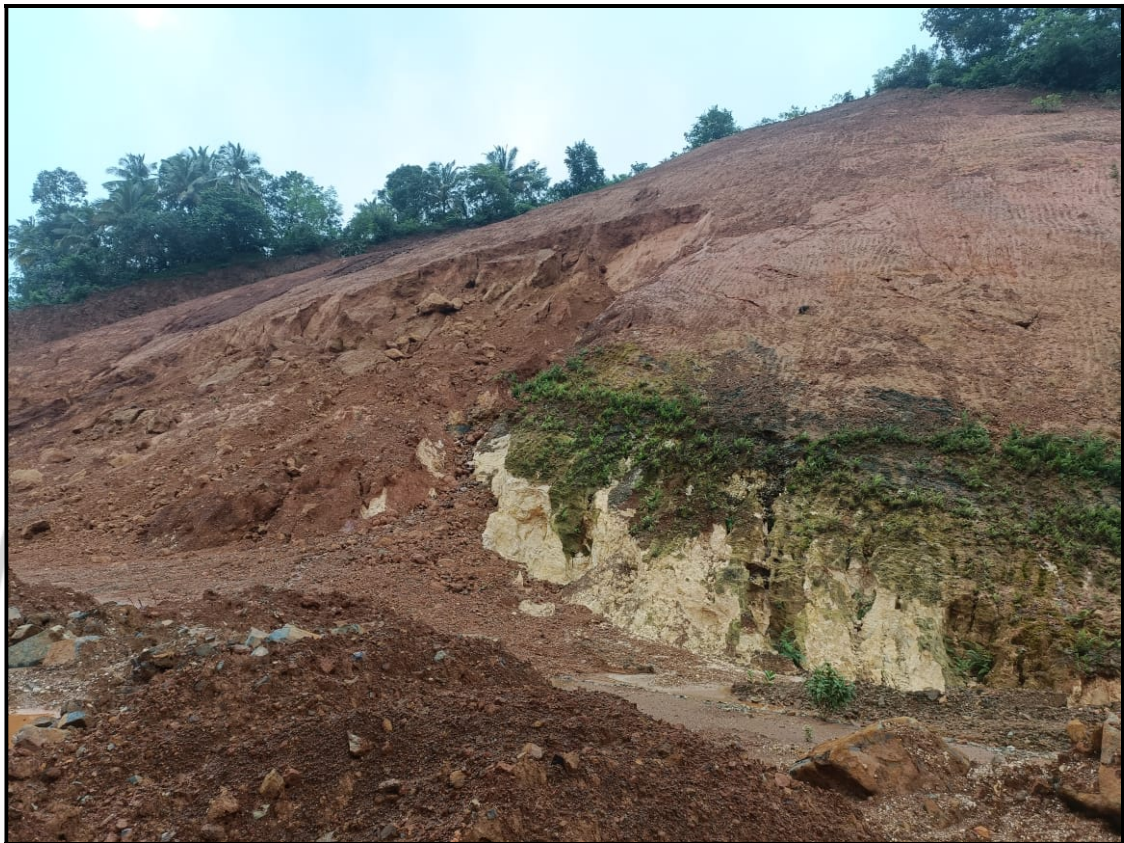
Fig. 2.5: Variability in lithounits near the right flank of the Shirur landslide

This sector exposes Gneisses of PGC, Pyroxenites of Layered Ultramafic Complex and Hornblende Actinolite Chlorite schist of Dharwar Supergroups. The areas where the road corridor intersects rocks of the Layered Ultramafic Complex were observed to cause complex slope instability problems.

by shifting the alignment wherever land is available and providing efficient surface and subsurface drainage solutions.

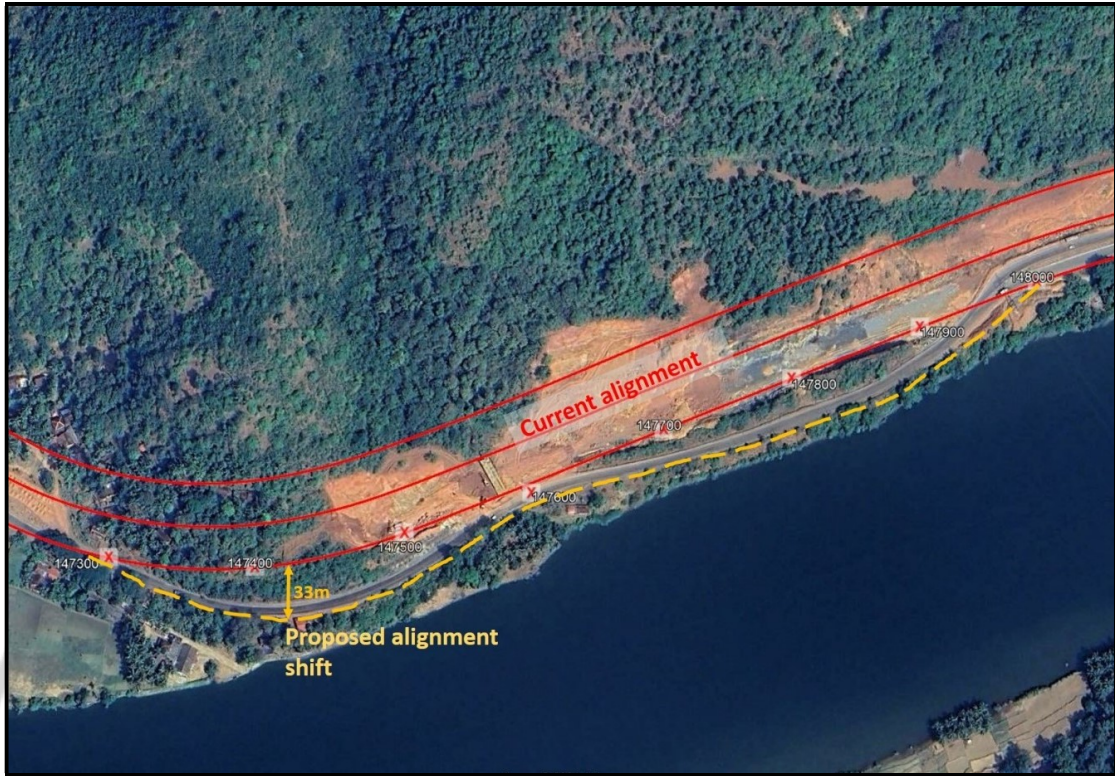
Fig. 2.6: Proposed alignment shift to prevent further slope failures at the Shirur site.

Geomorphologically, the planned slope cut from chainages 147.300 to 147.500 will be cutting across a “spur” which could cause slope instability issues post-modification. If the alignment shift is not feasible, it is recommended to provide the newly cut slope with adequate drainage management and support measures immediately. However, it is advised to avoid or minimize slope cuts in the location as far as possible.

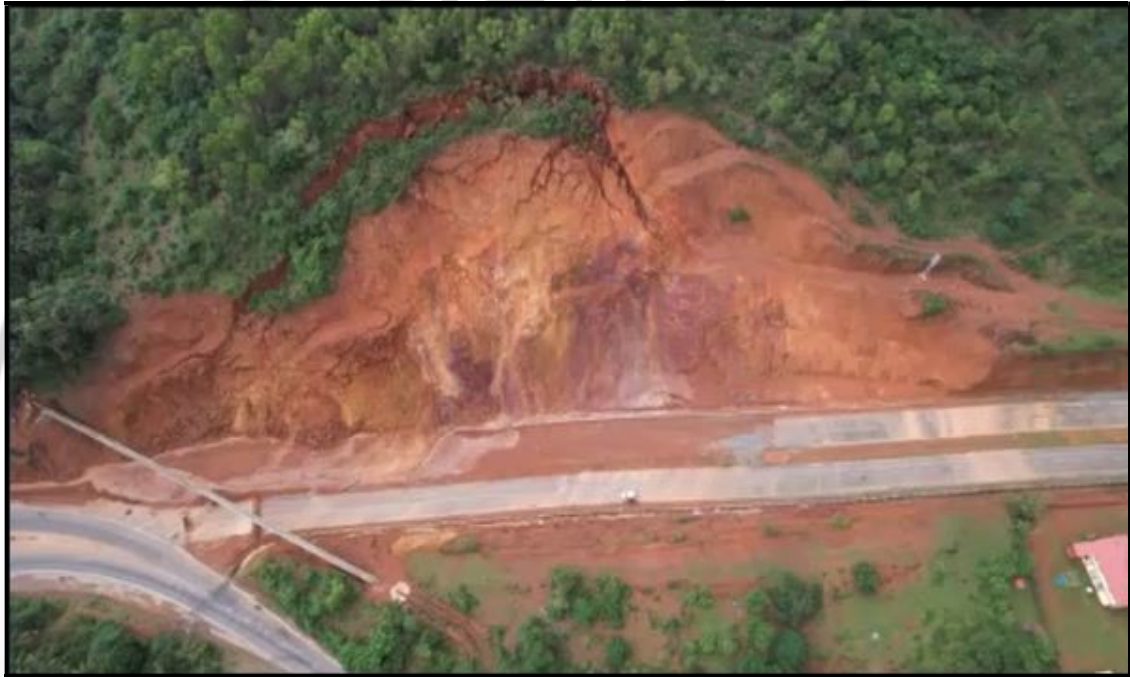
Fig. 2.7: Drone footage showing the recent landslide scar at 166.250

The landslide at 166.250 is a 90m in length and 120m in width debris slump that has occurred in the cut slope made for the road (Fig.2.7). The cut slope exposes a thick lithomarge and laterite cover developed over Gabbroic rocks. The laterite layer is not strong enough to withstand the existing overburden slope profile which resulted in a slump. A drone survey was conducted at the site by IRB which revealed a large crack at the top of the cut slope. Widening of the slide parallel to the slope is possible due to the similar lithology and slope cut on the southern side. A detailed study in the zone is recommended to analyse possible slope stabilization measures or road alignment changes.

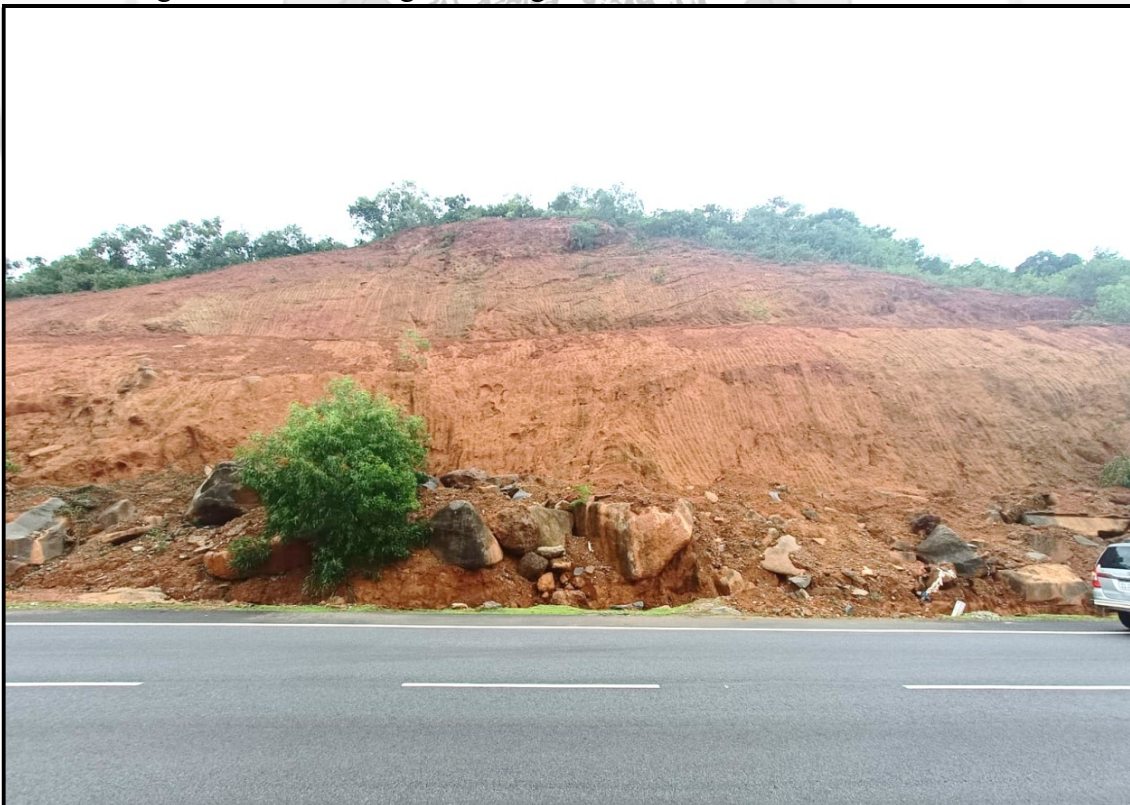
Fig. 2.8: Slope cut at chainage 168.200 exposing lithomarge and debris

Another potentially vulnerable zone was observed at 168.200 where the slope has been cut almost vertically for a length of approximately 60m (Fig. 2.8). During the field visit, minor tension cracks were observed on the slope. The road passes right beneath the slope and

there are settlements opposite to the slope cut. It is recommended to monitor the slope for any crack development and take immediate action if any movement is noticed. It is also recommended to sensitize the local population regarding the potential hazard and the families living just opposite the slope may be shifted in case of any crack development. Detailed studies for proper slope grading, drainage provisions and to arrest gully erosion are recommended.

The zones at 168.200 and 168.700 have settlements in the down-slope area which significantly increases the risk involved in case of any slope failures. The residents may be made aware of early slope failure signatures and instructed to inform local authorities in case of any observed movement. They may also be instructed to shift to safer locations in case of any observed movement in the slope.

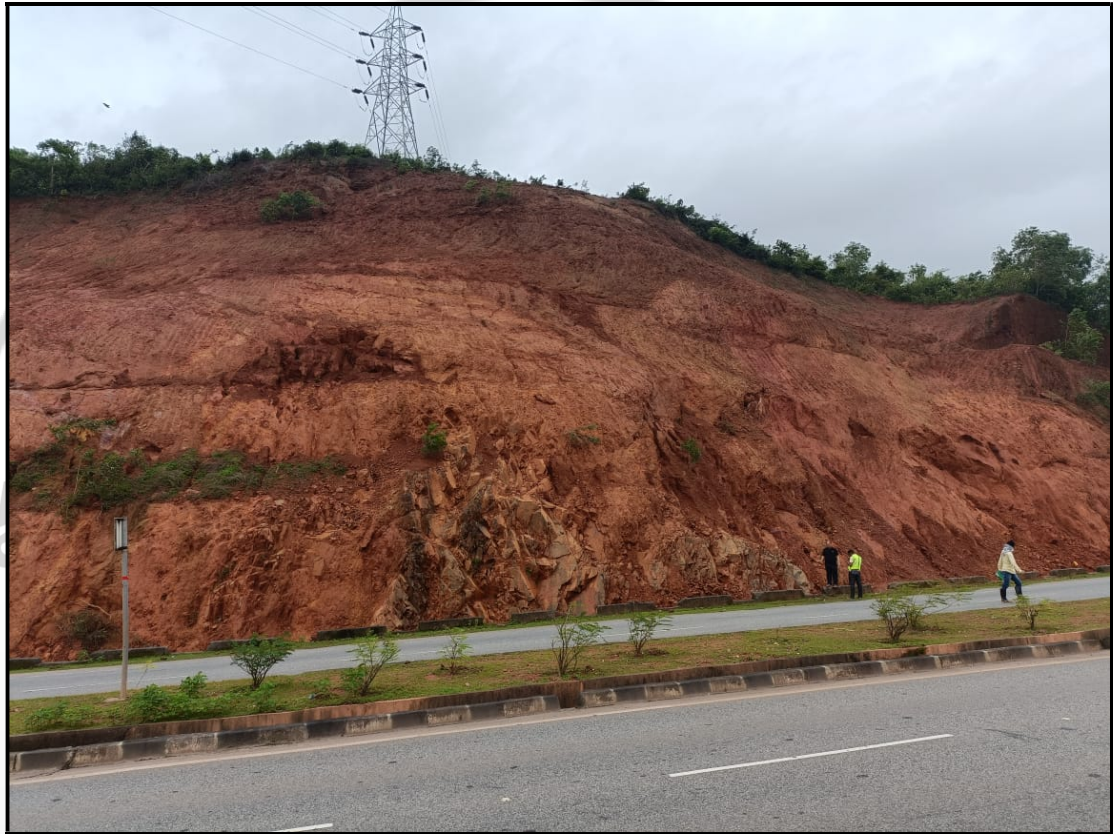
Fig. 2.9: Slope cut at chainage 168.700 showing the debris and minor scars

Another similar slope cut was observed at chainage 168.700 where a 50 m horizon of lithomarge and debris is exposed in the slope cut (Fig. 2.9). There are approximately 12 buildings opposite to the slope cut. It is recommended to conduct a detailed site-specific study to provide mitigation measures for the slope.

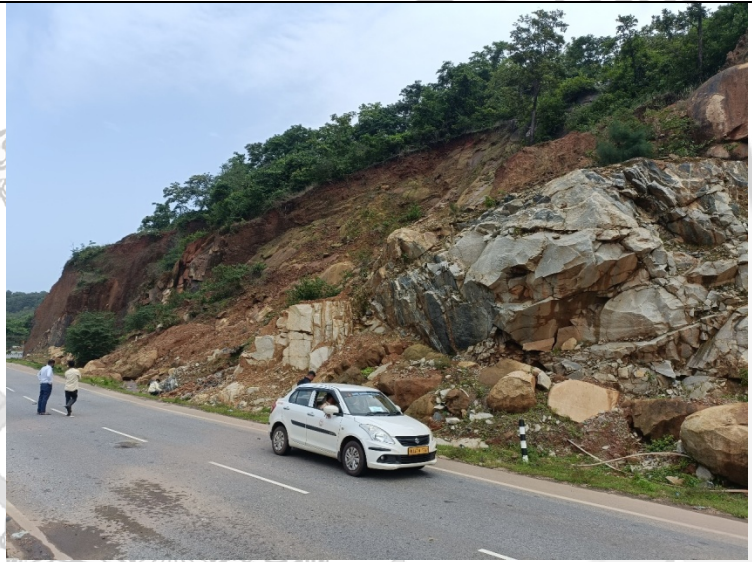
No	Field	Description
1	Slide No (LS .No.)	KA/UK/48J01/2024/01
2	State	Karnataka
3	District	Uttara Kannada
4	Toposheet	48J/01
5	Name of the slide	--
6	NH/SH/Locality	NH-66 (Chainage – 110.200)
7	Latitude	14.781677° N
8	Longitude	74.136913° E
9	Length	~ 40m
10	Width	~ 60m
11	Height	~ 35m
12	Area	~ 2400m ²
13	Depth	~2-5m
14	Volume	--
15	Run out distance	NA
16	Type of Material	Debris
17	Type of movement	Slide
18	Rate of movement	Very rapid
19	Activity	Suspended
20	Distribution	Retrogressive
21	Style	Single
22	Failure mechanism	Shallow rotational failure
23	History	Old landslide
24	Geomorphology	Low dissected hills
25	Geology	Granitoids of Peninsular Gneissic Complex
26	Structure	Foliation - 55°→30° ; J1- 78° →135 ; J2- 80° →85° ; J3- 6° →25°
27	Land use/ Land cover	Forest
28	Hydrological condition	Flowing
29	Triggering Factor	Rainfall
30	Death of persons	Nil
31	People affected	Nil
32	Live-stock loss	Nil
33	Communication	Road

36	Geo-scientific Causes	Slope cut has been done in a high-relief area exposing the rock-debris interface. The landslide has occurred in the debris due to saturation of the material.
37	Remedial measures	Monitor the slide area regularly for any movement. Any further slope modification might contribute to further instability
38	Remarks, if any	The debris has been depleted from the slide area. Debris exposed on the crown and the flanks of the slide may lead to minor slides during intense rainfall events.
39	Photos. Sketch of Plan & section of the slide

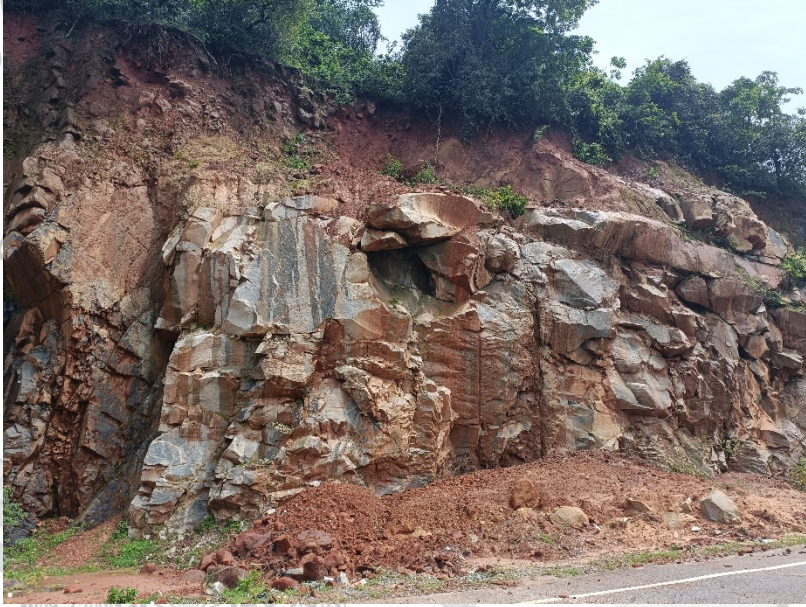
No	Field	Description
1	Slide No (LS .No.)	KA/UK/48J01/2024/02
2	State	Karnataka
3	District	Uttara Kannada
4	Toposheet	48J/01
5	Name of the slide	--
6	NH/SH/Locality	NH-66 (Chainage 110.340)
7	Latitude	14.782055° N
8	Longitude	74.138237° E
9	Length	~ 6m
10	Width	~ 10m
11	Height	~ 5m
12	Area	~60m ²
13	Depth	~ 1-2m
14	Volume	--
15	Run out distance	~ 25m
16	Type of Material	Debris
17	Type of movement	Slide
18	Rate of movement	Extremely rapid
19	Activity	Active
20	Distribution	Retrogressive
21	Style	Single
22	Failure mechanism	Shallow rotational failure
23	History	Initiated in 07/2024
24	Geomorphology	Low dissected hills
25	Geology	Peninsular Gneissic Complex
26	Structure	J1-75:240, J2 – 18:10, J3 - 78:145
27	Land use/ Land cover	Forest
28	Hydrological condition	Dripping
29	Triggering Factor	Rainfall
30	Death of persons	Nil
31	People affected	Nil
32	Live-stock loss	Nil
33	Communication	Road blocked
34	Infrastructure	Nil
35	Agriculture/forest/Barr en	Forest

36	Geo-scientific Causes	The road cut is along a 25m thick rock layer overlain by lithomarge and soil. The steep cut in the soil layer has caused the slide.
37	Remedial measures	Easing of the soil layer and providing adequate drainage measures.
38	Remarks, if any	--
39	Photos. Sketch of Plan & section of the slide

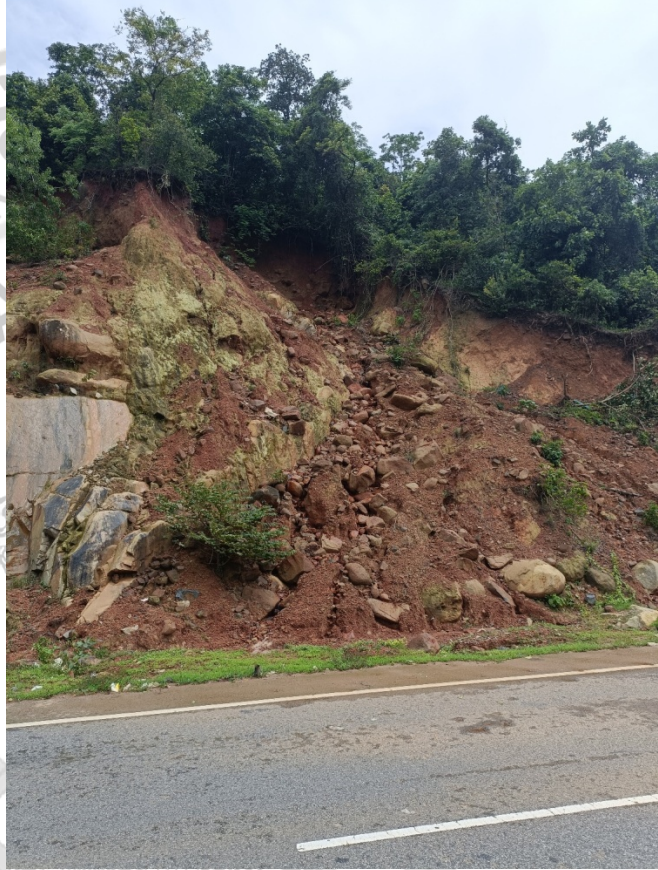
No	Field	Description
1	Slide No (LS .No.)	KA/UK/48J01/2024/03
2	State	Karnataka
3	District	Uttara Kannada
4	Toposheet	48J/01
5	Name of the slide	--
6	NH/SH/Locality	NH-66 (Chainage 110.430)
7	Latitude	14.782712° N
8	Longitude	74.138830° E
9	Length	~ 8m
10	Width	~ 12m
11	Height	~ 7m
12	Area	~ 96m ²
13	Depth	~ 2-4m
14	Volume	--
15	Run out distance	~ 20m
16	Type of Material	Debris
17	Type of movement	Slide
18	Rate of movement	Very rapid
19	Activity	Active
20	Distribution	Retrogressive
21	Style	Single
22	Failure mechanism	Shallow rotational failure
23	History	Initiated on 07/2024
24	Geomorphology	Low dissected hills
25	Geology	Peninsular Gneissic Complex
26	Structure	--
27	Land use/ Land cover	Forest
28	Hydrological condition	Flowing
29	Triggering Factor	Rainfall
30	Death of persons	Nil
31	People affected	Nil
32	Live-stock loss	Nil
33	Communication	Road blocked
34	Infrastructure	--
35	Agriculture/forest/Barren	Forest
36	Geo-scientific Causes	Reduction of strength of soil layer due to saturation and steep slope gradient.

37	Remedial measures	Slide movement should be monitored. Detailed studies should be carried out before any future slope modification.
38	Remarks, if any	--
39	Photos. Sketch of Plan & section of the slide

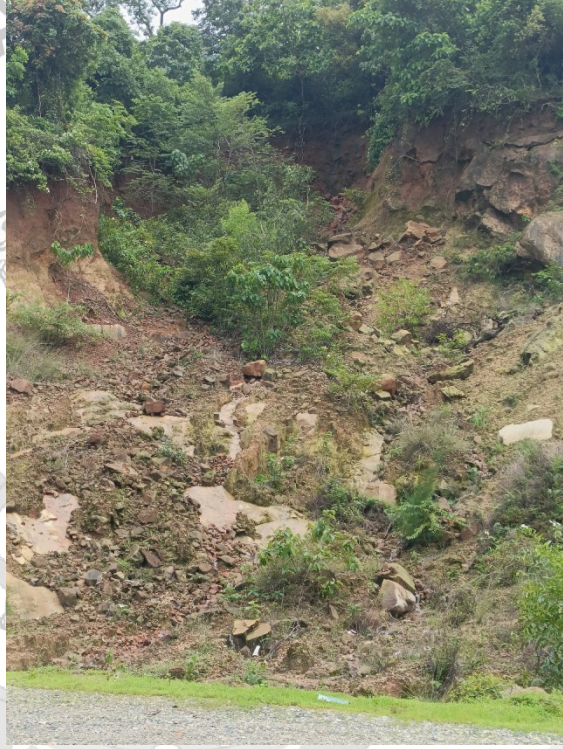
No	Field	Description
1	Slide No (LS .No.)	KA/UK/48J01/2024/04
2	State	Karnataka
3	District	Uttara Kannada
4	Toposheet	48J/01
5	Name of the slide	--
6	NH/SH/Locality	NH-66 (Chainage- 110.530)
7	Latitude	14.783218° N
8	Longitude	74.139477° E
9	Length	~ 15m
10	Width	~ 20m
11	Height	~ 12m
12	Area	~ 300m ²
13	Depth	>5m
14	Volume	--
15	Run out distance	~ 25-30m
16	Type of Material	Debris
17	Type of movement	Slide
18	Rate of movement	Rapid
19	Activity	Active
20	Distribution	Enlarging
21	Style	Single
22	Failure mechanism	Deep rotational failure
23	History	Initiated prior to 2024
24	Geomorphology	Low dissected hills
25	Geology	Peninsular Gneissic Complex
26	Structure	
27	Land use/ Land cover	Forest
28	Hydrological condition	Flowing
29	Triggering Factor	Rainfall
30	Death of persons	Nil
31	People affected	Nil
32	Live-stock loss	Nil
33	Communication	--
34	Infrastructure	--
35	Agriculture/forest/Barren	Forest

36	Geo-scientific Causes	Reduction of strength by saturation of debris in the slope which has been cut steeply.
37	Remedial measures	Slide movement should be monitored. Detailed studies should be carried out before any future slope modification.
38	Remarks, if any	--
39	Photos. Sketch of Plan & section of the slide

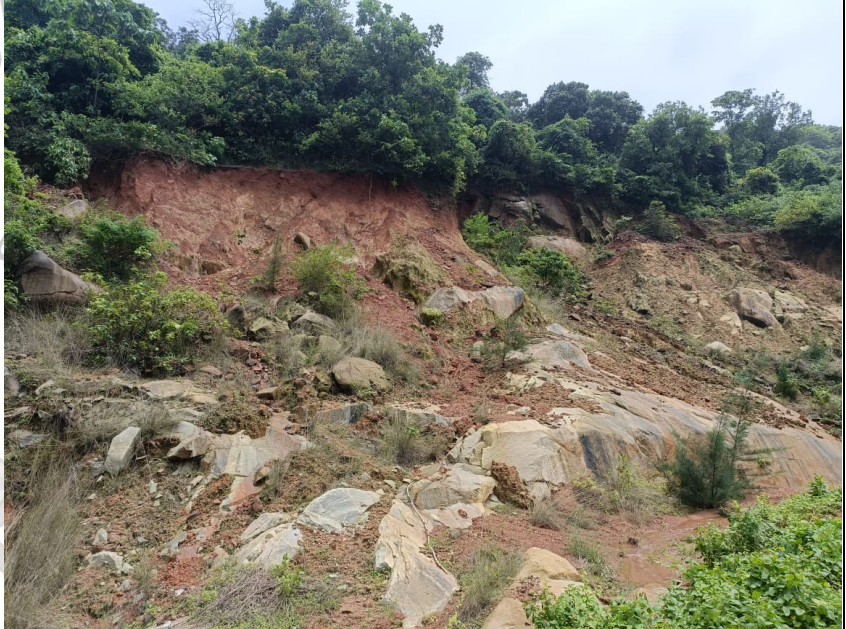
No	Field	Description
1	Slide No (LS .No.)	KA/UK/48J01/2024/05
2	State	Karnataka
3	District	Uttara Kannada
4	Toposheet	48J/01
5	Name of the slide	--
6	NH/SH/Locality	NH-66 (Chainage- 110.620)
7	Latitude	14.783530° N
8	Longitude	74.140167° E
9	Length	~ 15m
10	Width	~ 40-45m
11	Height	~ 10-12m
12	Area	--
13	Depth	>5m
14	Volume	--
15	Run out distance	~ 25-30m
16	Type of Material	Debris
17	Type of movement	Slide
18	Rate of movement	Extremely rapid
19	Activity	Active
20	Distribution	Enlarging
21	Style	Single
22	Failure mechanism	Deep rotational failure
23	History	Initiated during 2022
24	Geomorphology	Low dissected hills
25	Geology	Peninsular Gneissic Complex
26	Structure	J1-68:40, J2 – 89:110, J3 - 20:180
27	Land use/ Land cover	Forest
28	Hydrological condition	Flowing
29	Triggering Factor	Rainfall
30	Death of persons	Nil
31	People affected	Nil
32	Live-stock loss	Nil
33	Communication	Road blocked
34	Infrastructure	--
35	Agriculture/forest/Barren	Forest

36	Geo-scientific Causes	Saturation of debris in a steeply cut slope.
37	Remedial measures	Slide movement should be monitored. Detailed studies should be carried out before any future slope modification.
38	Remarks, if any	--
39	Photos. Sketch of Plan & section of the slide

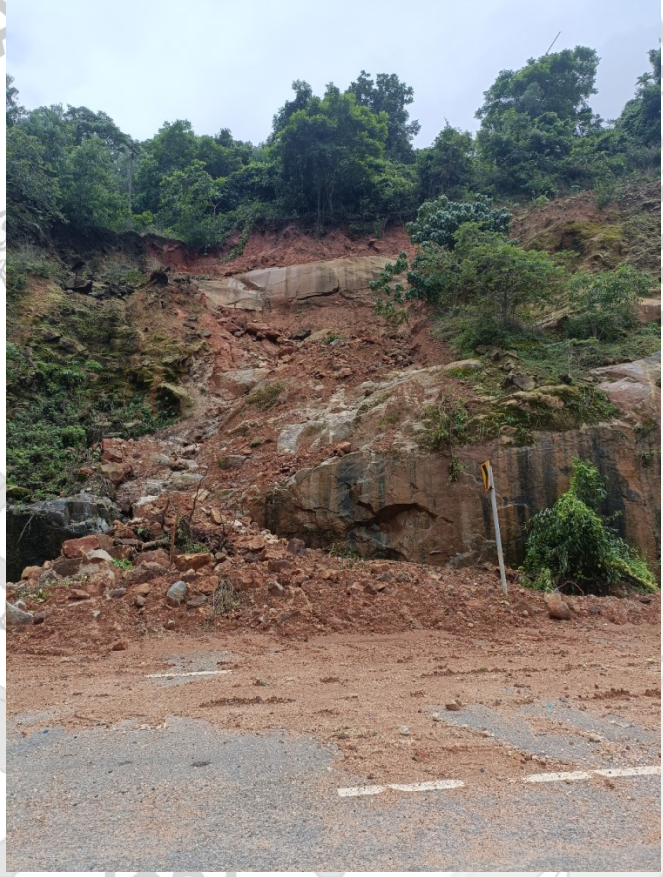
No	Field	Description
1	Slide No (LS .No.)	KA/UK/48J01/2024/06
2	State	Karnataka
3	District	Uttara Kannada
4	Toposheet	48J/01
5	Name of the slide	--
6	NH/SH/Locality	NH-66 (Chainage- 110.690)
7	Latitude	14.783522° N
8	Longitude	74.140903° E
9	Length	~ 10-15m
10	Width	~ 20m
11	Height	~ 12m
12	Area	~ 200m ²
13	Depth	<5m
14	Volume	--
15	Run out distance	~ 25-30m
16	Type of Material	Debris
17	Type of movement	Slide
18	Rate of movement	Very rapid
19	Activity	Active
20	Distribution	Retrogressive
21	Style	Single
22	Failure mechanism	Shallow rotational failure
23	History	3 rd week of July 2024
24	Geomorphology	Low dissected hills
25	Geology	Peninsular Gneissic Complex
26	Structure	J1-78:18, J2 – 70:70, J3 - 15:150
27	Land use/ Land cover	Forest
28	Hydrological condition	Flowing
29	Triggering Factor	Rainfall
30	Death of persons	Nil
31	People affected	Nil
32	Live-stock loss	Nil
33	Communication	Road blocked
34	Infrastructure	--
35	Agriculture/forest/Barren	Forest

36	Geo-scientific Causes	Saturation of debris in a steeply cut slope.
37	Remedial measures	Detailed analysis of the slope is required for long term remedial measures.
38	Remarks, if any	--
39	Photos. Sketch of Plan & section of the slide

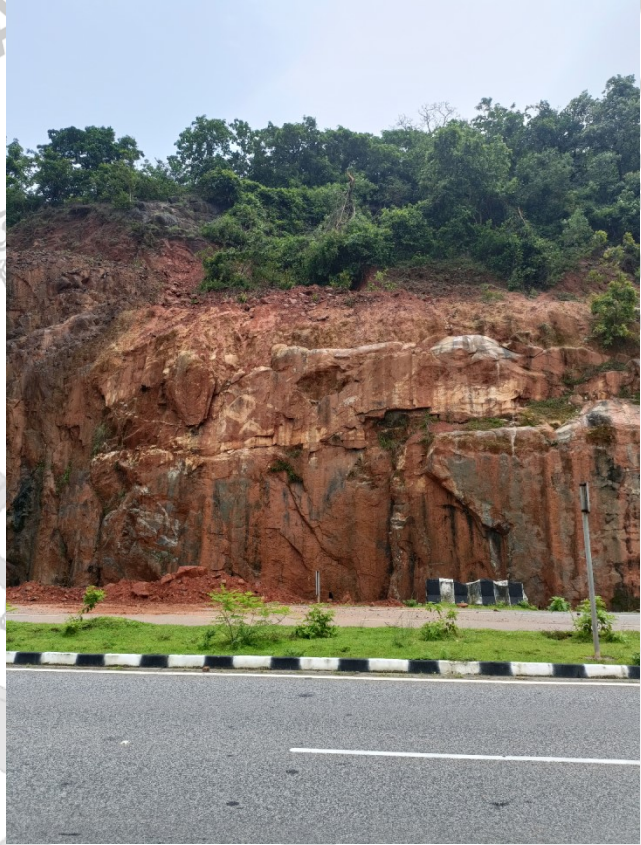
No	Field	Description
1	Slide No (LS .No.)	KA/UK/48J01/2024/07
2	State	Karnataka
3	District	Uttara Kannada
4	Toposheet	48J/01
5	Name of the slide	--
6	NH/SH/Locality	NH-66 (Chainage- 110.750)
7	Latitude	14.783217
8	Longitude	74.141485
9	Length	~ 15m
10	Width	~ 25m
11	Height	~ 10m
12	Area	--
13	Depth	<5m
14	Volume	--
15	Run out distance	~ 40-50m
16	Type of Material	Debris
17	Type of movement	Slide
18	Rate of movement	Extremely rapid
19	Activity	Active
20	Distribution	Enlarging
21	Style	Single
22	Failure mechanism	Shallow rotational failure
23	History	July 2024
24	Geomorphology	Low dissected hills
25	Geology	Basic intrusives
26	Structure	J1-85:10, J2 – 78:145, J3 - 80:255
27	Land use/ Land cover	Forest
28	Hydrological condition	Dripping
29	Triggering Factor	Rainfall
30	Death of persons	Nil
31	People affected	Nil
32	Live-stock loss	Nil
33	Communication	Road blocked
34	Infrastructure	--
35	Agriculture/forest/Barren	Forest

36	Geo-scientific Causes	Saturation of debris in a steeply cut slope. Failure is along the rock-debris interface
37	Remedial measures	Adequate drainage measures like horizontal perforated pipes for discharging the water from the debris. Detailed geotechnical study is required for long term stabilization measures.
38	Remarks, if any	--
39	Photos. Sketch of Plan & section of the slide

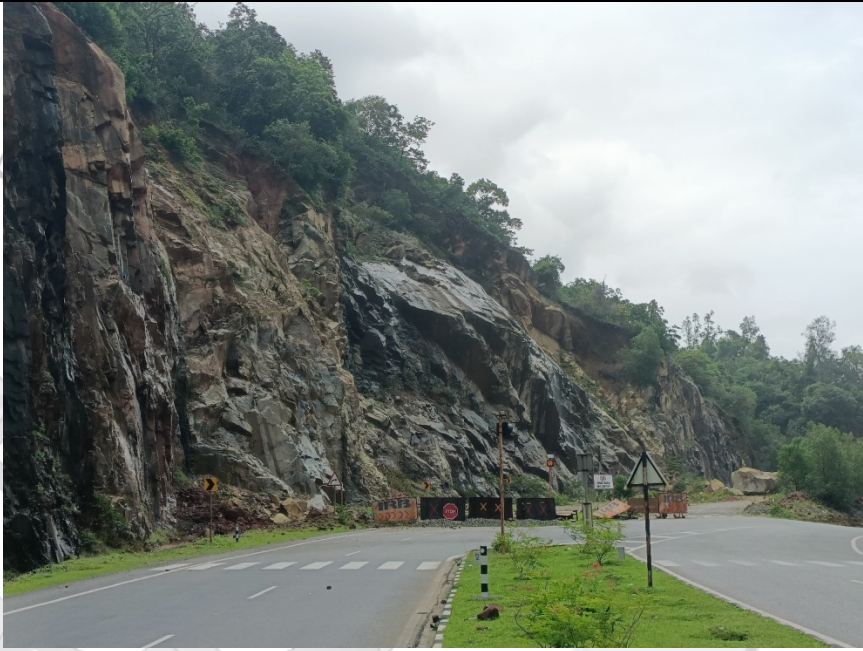
No	Field	Description
1	Slide No (LS .No.)	KA/UK/48J01/2024/08
2	State	Karnataka
3	District	Uttara Kannada
4	Toposheet	48J/01
5	Name of the slide	--
6	NH/SH/Locality	NH-66 (Chainage 111.380)
7	Latitude	14.781229° N
8	Longitude	74.146864° E
9	Length	~ 40m
10	Width	~ 81 m
11	Height	~ 40m
12	Area	~
13	Depth	~ >5m
14	Volume	~
15	Run out distance	~ 40m
16	Type of Material	Rock
17	Type of movement	Fall
18	Rate of movement	Extremely rapid
19	Activity	Active
20	Distribution	Widening
21	Style	Multiple
22	Failure mechanism	Deep translational
23	History	
24	Geomorphology	Low dissected hills
25	Geology	Peninsular Gneissic Complex
26	Structure	Slope direction → N200° ; Exfoliation joints parallel to the slope
27	Land use/ Land cover	Forest
28	Hydrological condition	Dripping
29	Triggering Factor	--
30	Death of persons	Nil
31	People affected	Nil
32	Live-stock loss	Nil
33	Communication	Road blocked and damaged
34	Infrastructure	--
35	Agriculture/forest/Barren	forest

36	Geo-scientific Causes	The slope has a road cut of approximately 30m in height. The cut has exposed highly jointed rock mass. The thick exfoliation joints in the rock surface dip sub parallel to the slope. This along with the vertical joints in the rock creates blocks of rocks without support. The rock falls occur along the exfoliation joint plane.
37	Remedial measures	Detailed studies are required along the Chainage 111.300 to 111.450. Precarious blocks may be removed and adequate support measures like proper netting should be provided for the slope.
38	Remarks, if any	The area is highly susceptible to rock falls. Traffic may continue in the old parallel alignment and only be resumed after geotechnical interventions are made in the slope
39	Photos. Sketch of Plan & section of the slide

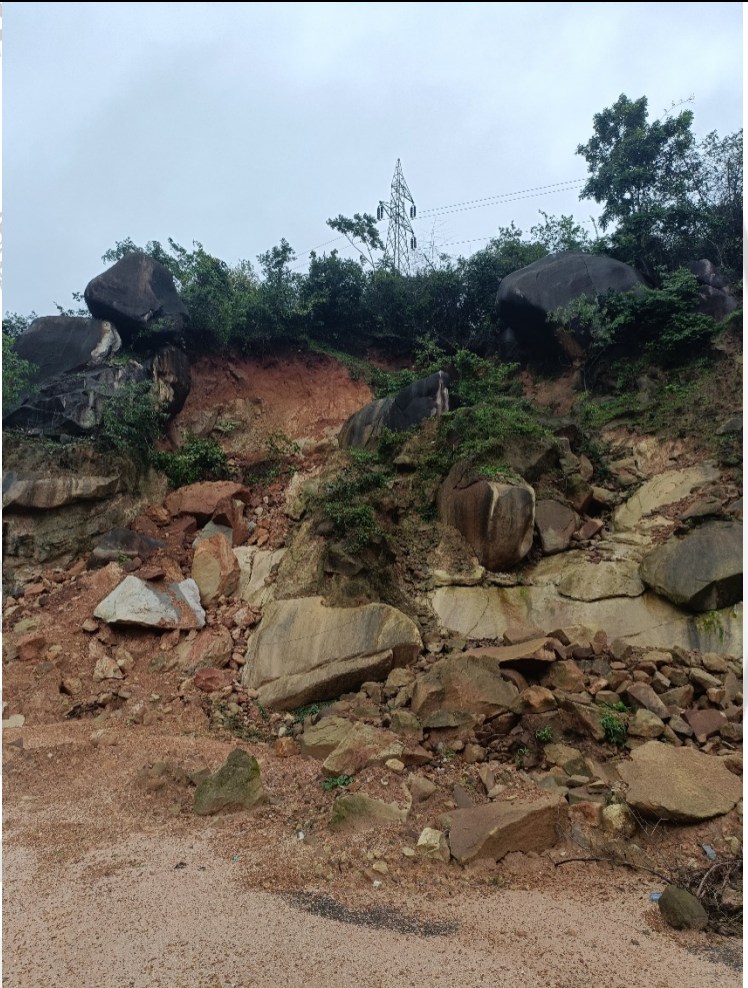
No	Field	Description
1	Slide No (LS .No.)	KA/UK/48J01/2024/09
2	State	Karnataka
3	District	Uttara Kannada
4	Toposheet	48J/01
5	Name of the slide	--
6	NH/SH/Locality	NH-66 (Chainage 122.220)
7	Latitude	14.759265° N
8	Longitude	74.234887° E
9	Length	~ 10-12m
10	Width	~ 15m
11	Height	~ 10m
12	Area	--
13	Depth	<5m
14	Volume	--
15	Run out distance	--
16	Type of Material	Debris
17	Type of movement	Slide
18	Rate of movement	Rapid
19	Activity	Active
20	Distribution	Widening
21	Style	Single
22	Failure mechanism	Shallow rotational
23	History	--
24	Geomorphology	Low dissected hills
25	Geology	Peninsular Gneissic Complex
26	Structure	J1-80:130, J2 – 50:230, J3 - 20:20
27	Land use/ Land cover	Forest
28	Hydrological condition	Flowing
29	Triggering Factor	Rainfall
30	Death of persons	Nil
31	People affected	Nil
32	Live-stock loss	Nil
33	Communication	Road blocked
34	Infrastructure	--
35	Agriculture/forest/Barren	Forest

36	Geo-scientific Causes	Saturation and lack of support for the debris material exposed after steep slope cut.
37	Remedial measures	Remove the precarious boulders mechanically. Easing of the slope.
38	Remarks, if any	--
39	Photos. Sketch of Plan & section of the slide

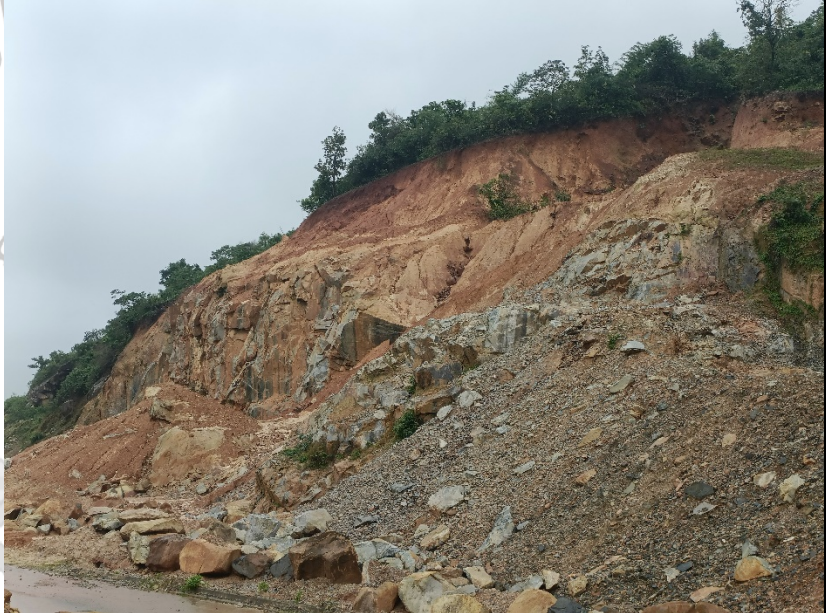
No	Field	Description
1	Slide No (LS .No.)	KA/UK/48J01/2024/10
2	State	Karnataka
3	District	Uttara Kannada
4	Toposheet	48J/02
5	Name of the slide	--
6	NH/SH/Locality	NH-66 (Chainage-124.090)
7	Latitude	14.749197° N
8	Longitude	74.248513° E
9	Length	~ 20m
10	Width	~ 40m
11	Height	~ 15m
12	Area	--
13	Depth	>5m
14	Volume	--
15	Run out distance	--
16	Type of Material	Debris
17	Type of movement	Slide
18	Rate of movement	Very rapid
19	Activity	Active
20	Distribution	Enlarging
21	Style	Single
22	Failure mechanism	Deep rotational failure
23	History	Initiated during 2024
24	Geomorphology	Low dissected hills
25	Geology	Peninsular Gneissic Complex
26	Structure	J1-20:195, J2 – 89:110, J3 - 70:340
27	Land use/ Land cover	Forest
28	Hydrological condition	Dripping
29	Triggering Factor	Rainfall
30	Death of persons	Nil
31	People affected	Nil
32	Live-stock loss	Nil
33	Communication	Road blocked
34	Infrastructure	--
35	Agriculture/forest/Barren	Forest

36	Geo-scientific Causes	Saturation and lack of support for the debris material exposed after steep slope cut.
37	Remedial measures	Easing of the slope of the debris layer. Providing erosion control mats like geo jute with suitable grass variety plantation can be an effective solution for such slopes
38	Remarks, if any	The location has chances for further landslides
39	Photos. Sketch of Plan & section of the slide

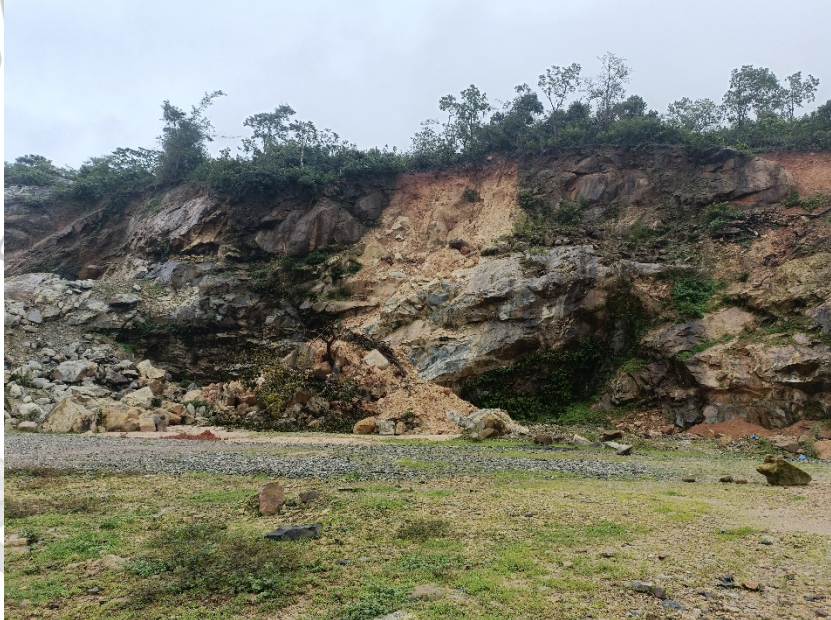
No	Field	Description
1	Slide No (LS .No.)	KA/UK/48J01/2024/11
2	State	Karnataka
3	District	Uttara Kannada
4	Toposheet	48J/06
5	Name of the slide	--
6	NH/SH/Locality	NH-66 (Chainage-124.620)
7	Latitude	14.745973° N
8	Longitude	74.251330° E
9	Length	~ 25m
10	Width	~ 20m
11	Height	~ 22m
12	Area	--
13	Depth	>5m
14	Volume	--
15	Run out distance	~ 30-40m
16	Type of Material	Rock and debris
17	Type of movement	Slide
18	Rate of movement	Extremely rapid
19	Activity	Active
20	Distribution	Confined
21	Style	Single
22	Failure mechanism	Shallow planar failure
23	History	--
24	Geomorphology	Low dissected hills
25	Geology	Peninsular Gneissic Complex
26	Structure	J1-40:40, J2 – 60:220, J3 - 75:95
27	Land use/ Land cover	Forest
28	Hydrological condition	Dripping
29	Triggering Factor	Rainfall
30	Death of persons	Nil
31	People affected	Nil
32	Live-stock loss	Nil
33	Communication	Road blocked
34	Infrastructure	--
35	Agriculture/forest/Barren	Forest

36	Geo-scientific Causes	Lithomarge and soil layer exposed in a vertical slope cut.
37	Remedial measures	Easing of the slope
38	Remarks, if any	--
39	Photos. Sketch of Plan & section of the slide
