O.A.261 OF 2024

Suo moto News Item titled "Unscientific Work by NHAI led to Shirur landslide Geological Survey of India Report appearing in the Indian Express dated 02.08.2024

REPORT ON
SHIRUR LANDSLIDE, ANKOLA TALUK, UTTARA KANNADA DISTRICT,
KARNATAKA
&
LANDSLIDE SUSCEPTIBILITY ALONG NH-66 (KARWAR TO NORTH OF BAINDUR)

M4LS/NC/SR/SU-KG/2024/50072

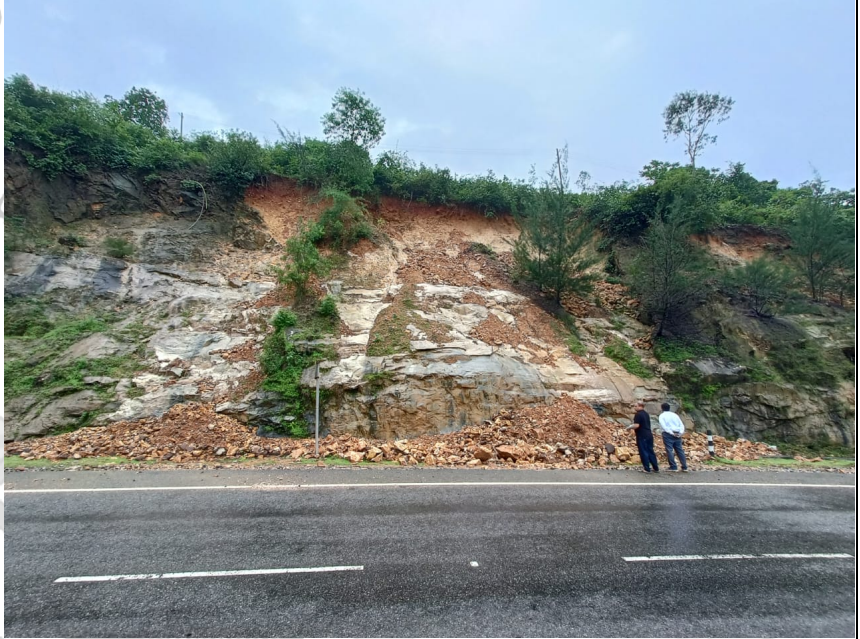
36	Geo-scientific Causes	The road cut is along an approximately 15 m height section which exposed granite gneiss at the bottom and clay rich laterite at the top. The failure is due to the saturation of the laterite layer due to rainfall.
37	Remedial measures	The slope may not be disturbed by any excavation as it may further destabilize the slope.
38	Remarks, if any	The area is susceptible to minor slope failures from the laterite layer.
39	Photos. Sketch of Plan & section of the slide

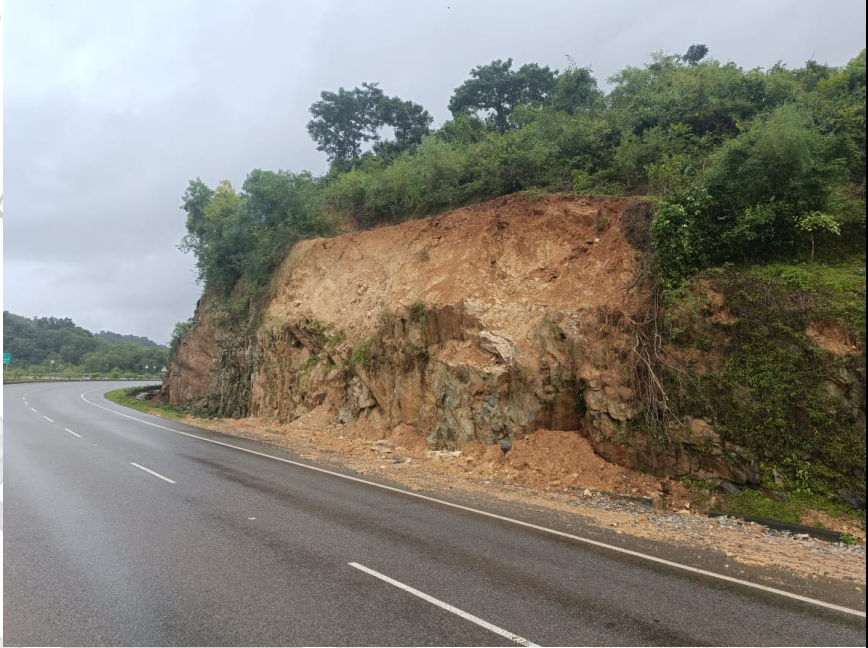
36	Geo-scientific Causes	The section exposes a 6-7 m thick lithomarge and clay-rich lateritic soil over the granite gneiss. The section is vertically cut, thereby facilitating minor slides in the unsupported soil horizon
37	Remedial measures	The slope may not be disturbed by any excavation as it may further destabilize the slope.
38	Remarks, if any	The area is susceptible to minor slope failures from the laterite layer.
39	Photos. Sketch of Plan & section of the slide

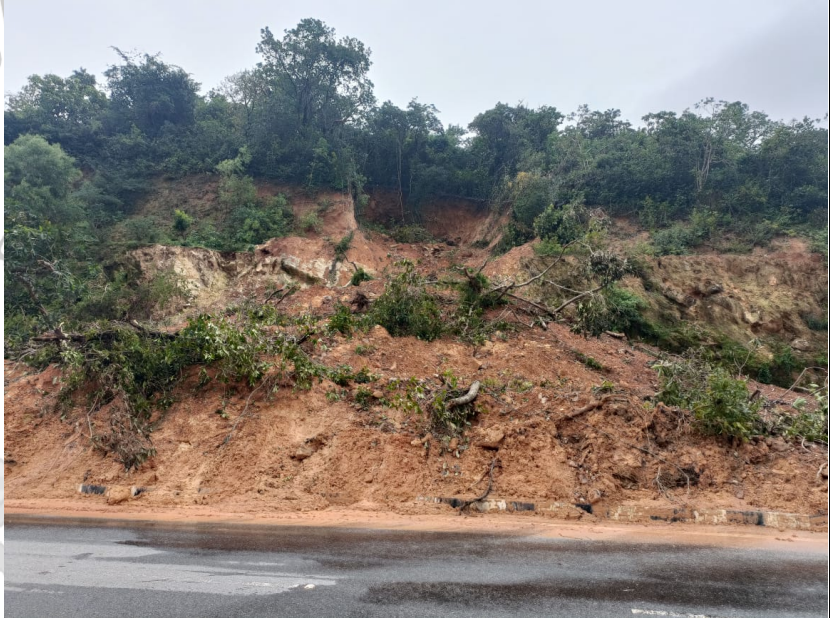
36	Geo-scientific Causes	The debris flow is caused by oversaturation and resultant piping in the soil layer
37	Remedial measures	Remove the debris from the run-out zone. Any further slope modification without detailed studies is not recommended.
38	Remarks, if any	The area is susceptible to similar failures in the future.
39	Photos. Sketch of Plan & section of the slide

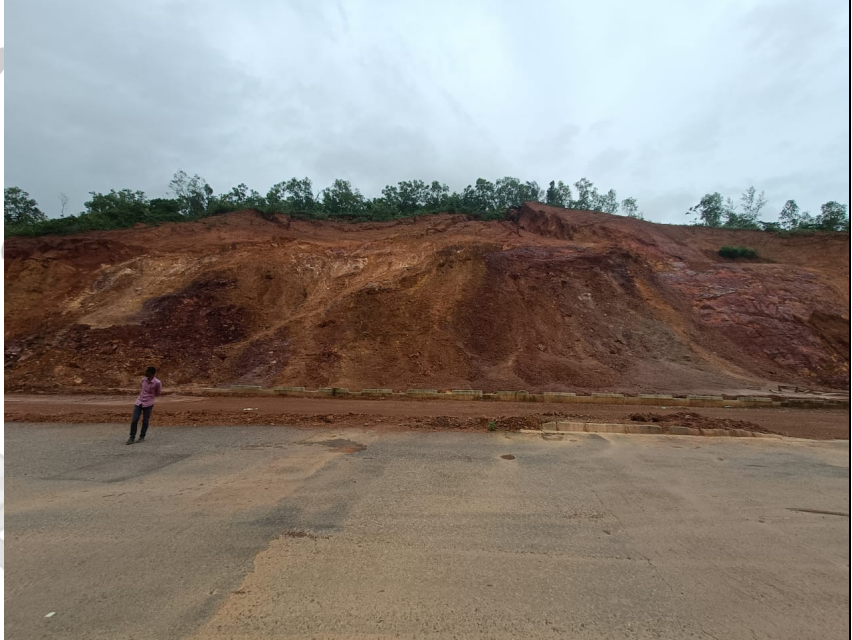
36	Geo-scientific Causes	The road cut is through a thick lithomarge and laterite cover developed over Gabbroic rocks. The laterite layer is not strong enough to withstand the existing slope profile resulting in a slump.
37	Remedial measures	A detailed study on the slope section is recommended with emphasis on drainage management, slope geometry modification and structural support measures. Since the slide scar has almost reached the hilltop, major retrogression may not occur, but widening of the slide is likely
38	Remarks, if any	The latest drone footage has revealed a major scar developed.
39	Photos. Sketch of Plan & section of the slide

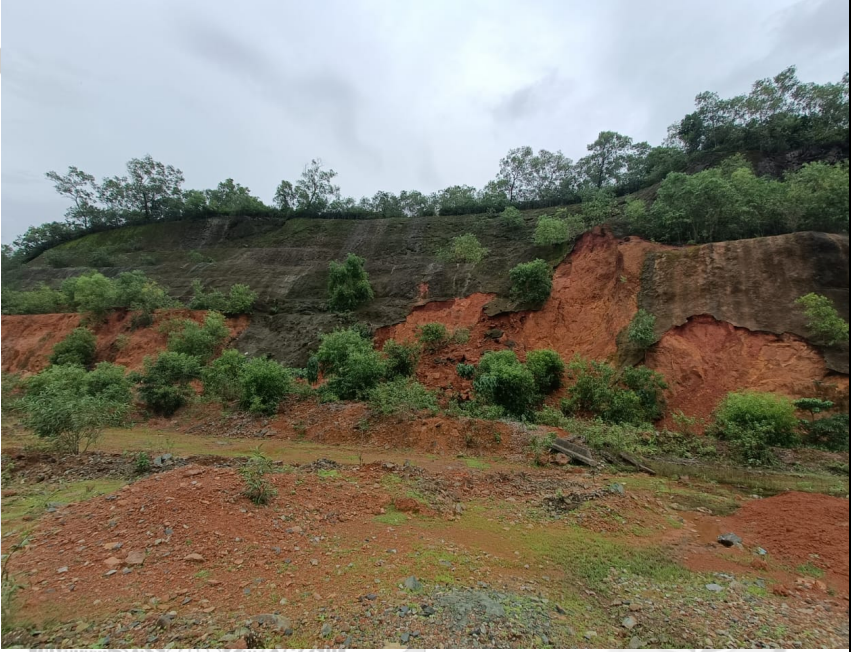
36	Geo-scientific Causes	Steep cut in lateritic horizon. The shotcrete provided in the slope is observed to be falling off due to the development of pore water pressure in the laterite.
37	Remedial measures	Adequate horizontal drainage measures may be provided for the slope.
38	Remarks, if any	--
39	Photos. Sketch of Plan & section of the slide

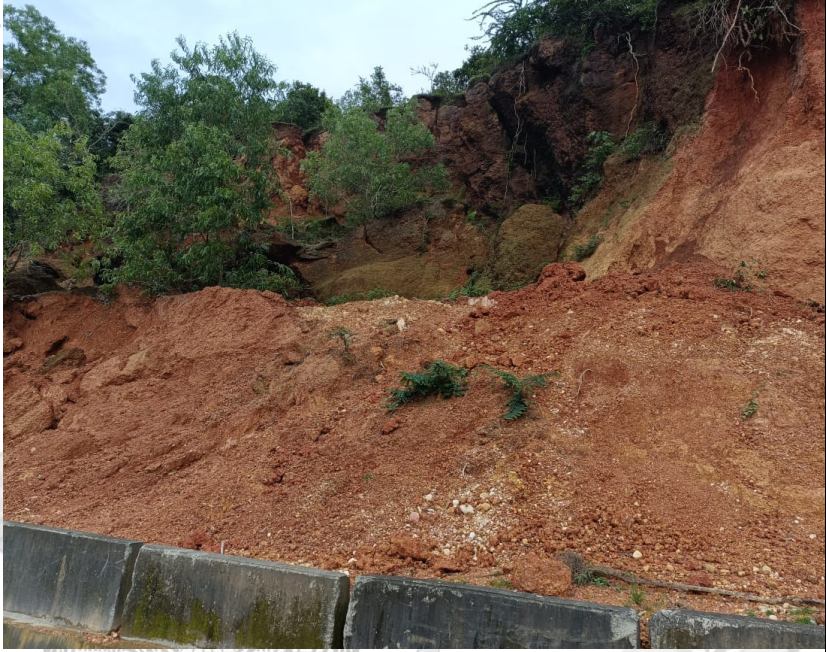
36	Geo-scientific Causes	The hard and ferruginous blocks of laterite in the upslope have fractures within them. The blocks of laterite are sliding down after being detached from the surface.
37	Remedial measures	The existing retaining wall may be continued till the slide location to arrest the movement of the blocks till the road. Else steel piles may also be erected instead of the RCC wall. Enough provisions should be provided for the unhindered flow of the subsurface water.
38	Remarks, if any	The slope is not susceptible to deep rotational failure
39	Photos. Sketch of Plan & section of the slide
