**Investigation into Alleged Environmental Violations by
Central Coalfields Ltd in Amrapali OCP:**

**Report of Committee appointed by Hon'ble National Green
Tribunal in *Sanjay Chauhan vs CCL & Ors (OA 28/2020/EZ)*
*vide order dt.11.05.2020***

Date of submission: 14 September 2020

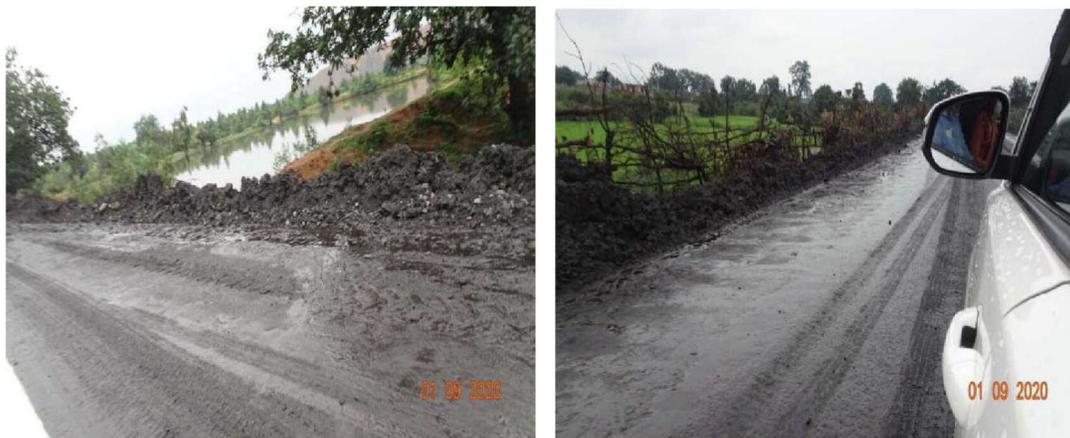
- b) About a year ago, the Shivpur siding was commissioned, and at the time of the field visit by this Committee, **coal was being sent by road to the Shivpur siding located at ~6km from the mine.**
- c) Furthermore, the field visit showed that road transport of coal was resulting in much spillage of coal on the road and consequent air and water pollution. **Coal dust was observed to be flowing off the road** into forest areas and agricultural fields, nullahs and ponds (see Figure 3 and Figure 4). In the dry season, this dust will also create serious air pollution. It may be noted that there are some settlements on the way.

Figure 3. Coal dust on road used to transport coal to Shivpur siding

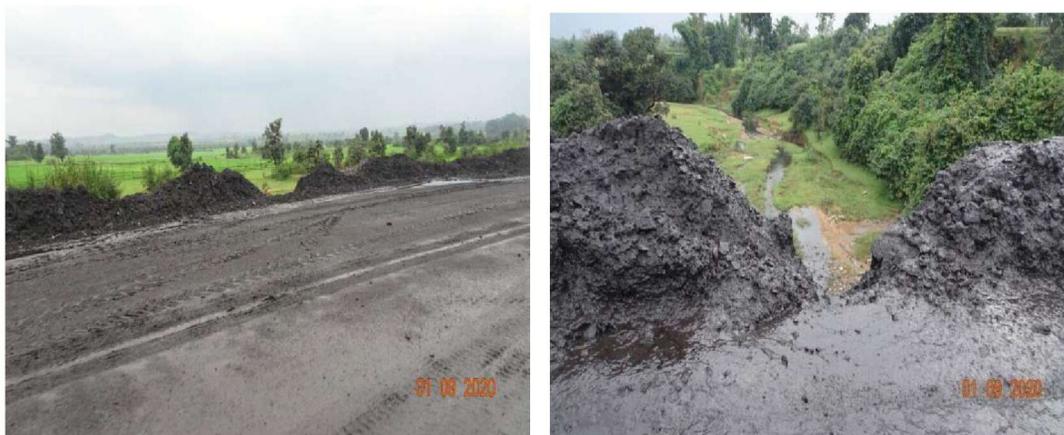
Figure 4. Coal dust on road used to transport coal to Shivpur siding (left) and coal dust flowing off the road into a nullah (right)

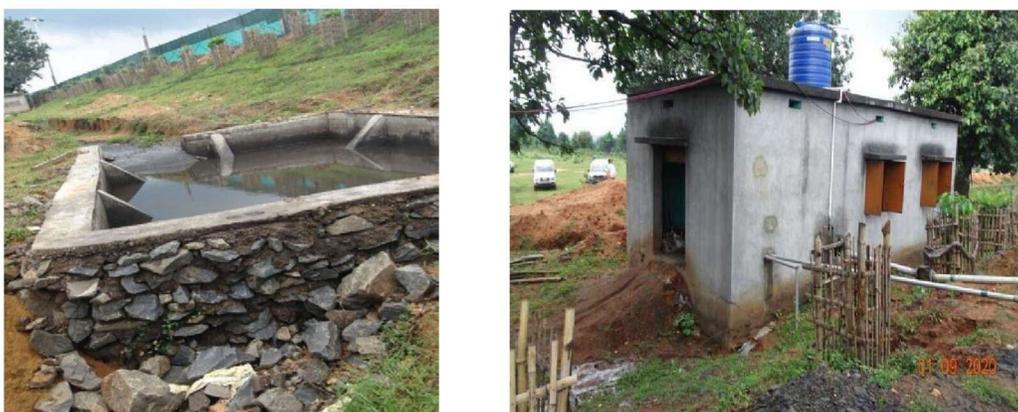
- d) Finally, the Shivpur siding is only in partial compliance with CPCB's 2015 guidelines environmental management of railway sidings; while windscreen, plantations, catch drain and sedimentation pond are in place (see Figure 5-left), **the water being used for sprinkling is coming from a borewell that does not have CGWA approval (Figure 5-right).**
- e) Committee members were of the view that to minimize coal spillage on roads, a gap of 5-10 cm may be left (from top edge of trucks) while loading the transportation trucks.

Figure 5. Shivpur siding: Sedimentation pond to catch runoff (left); pumphouse for borewell used to supply water to sprinklers (right)

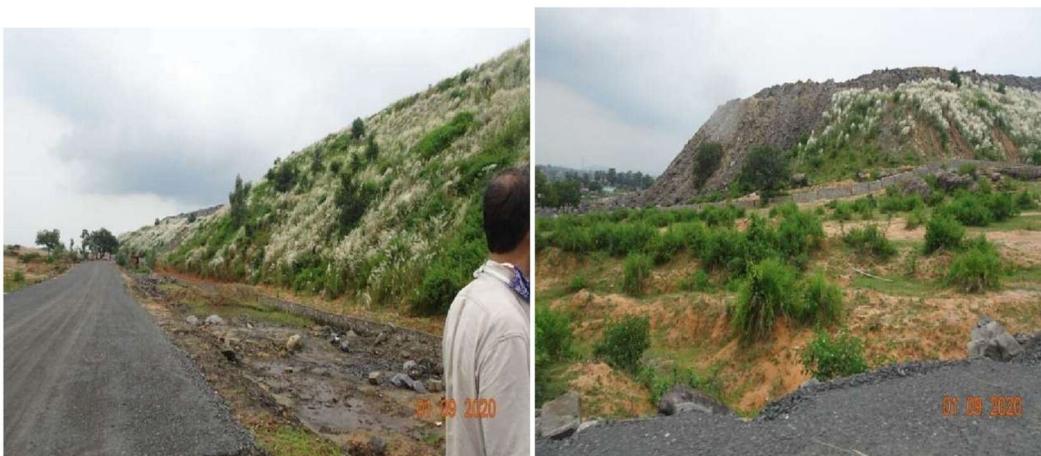
Figure 6. Grassing and vegetation on Binglat OB dump: recently done (left) and barren patches remaining (right)

- b) Grassing and vegetation had been developed over the slopes of Binglat OB dump (see Figure 6-left) but there are still large portions where grassing and vegetation has not come up (see Figure 6-right).

Overall, plantation and green belt development was not found to be satisfactory. While planting activity has recently been carried in many places, several patches on the OB dumps were still found bereft of vegetation cover, and Project authorities have not done plantations as per their commitment in EIA/EMP report.

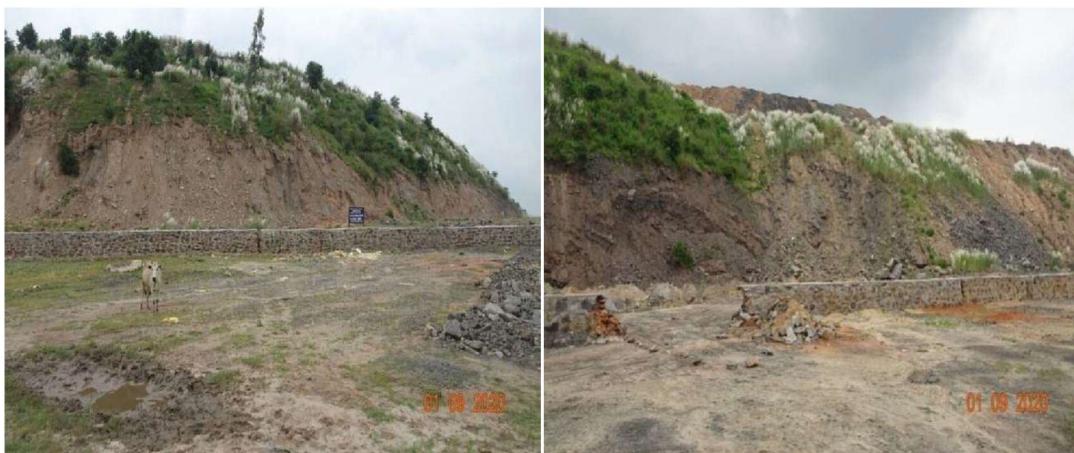
- a) A retaining wall had been constructed around Honhe OB dump (see Figure 7). However, gaps have been left in the wall at many places (see Figure 7-left) and the wall is broken in a few places (see Figure 7-right). This may lead to water and silt exiting the wall area and ultimately silt flow to outside area/low lying area. The wall construction also appeared weak (without cement grouting) in several places. Retaining wall around the Binglat OB dump is older and more secure although gaps have been left in the wall at few places there also. The top soil dump also had a retaining wall and catch drain.

Figure 7. Retaining wall around Honhe OB dump, with gap (left) and broken portion (right).

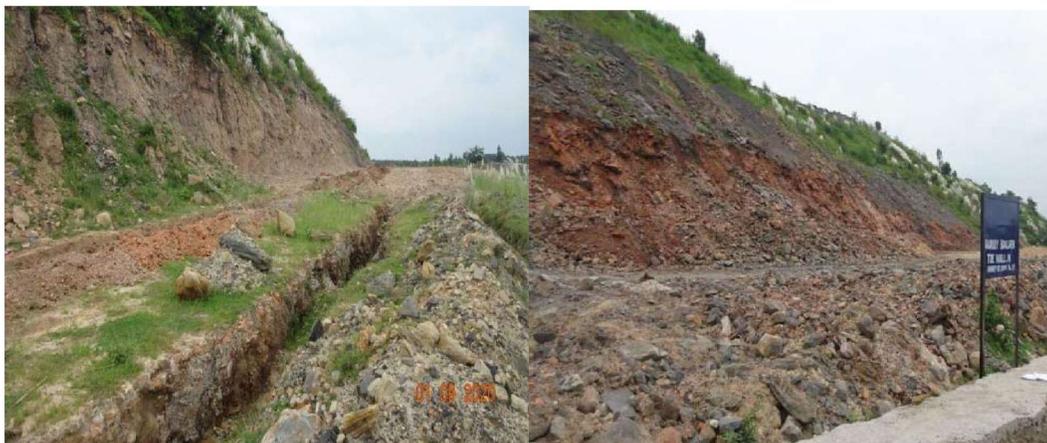
- b) Catch drains have also been constructed around the Honhe OB dump in between the dump and the retaining wall (see Figure 8-left). However at some places it was observed that road construction work was being carried out in between retaining wall and OB dump (see Figure 8-right) and there were no catch drains at those places. Similarly, siltation ponds have been constructed to catch the silt from the catch drain. But at one place, the flow from the catch drain was being directed out of the project boundary, without any sedimentation tank being provided, so that water with silt would flow to low lying area and ultimately to the nearby river

Figure 8. Catch drain around Honhe OB dump (left) and places where road construction has covered catch drain (right)

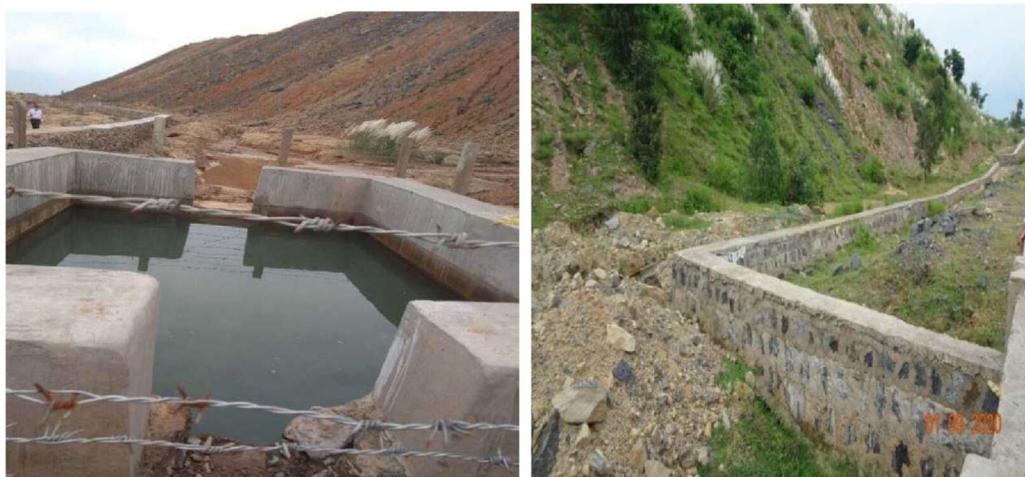
Figure 9. Siltation ponds linked to the catch drains (left); place where catch drain is let out directly (right)

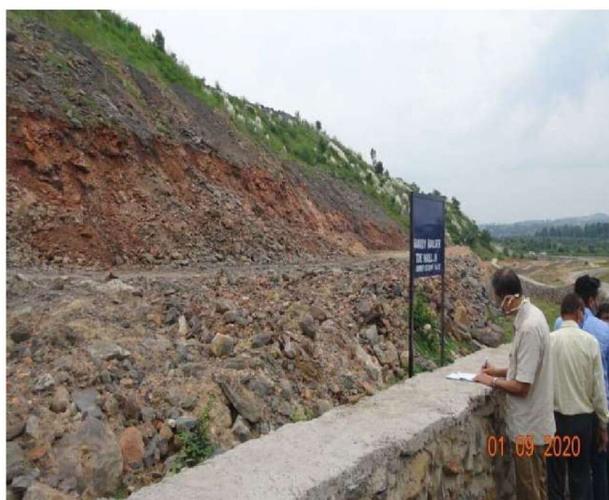
Figure 10. Honhe OB dump slope being dug into for making road

- c) At the Honhe OB dump, road construction work was being carried out using OB material excavated from the dump (see Figure 10), resulting in loss of grass cover and rendering the slope of the dump unstable.

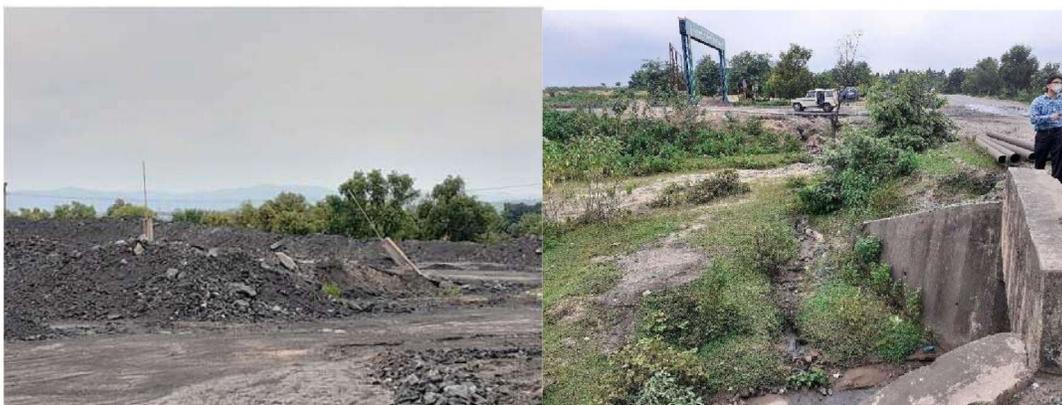
- a) The weigh bridge area (where coal bearing trucks are weighed and lot of coal spillage and heaps are observed) is located at a higher elevation from which runoff (from rain and sprinklers) will end up in low lying areas and eventually into the river. There was no catch drain or walls around this area and water carrying coal flows in the low lying area and ultimately to river Barki (see Figure 11).
- b) Similar problems of uncontained runoff were observed at the backside (Kumarang Kalan side) of the weigh bridge and one more weighbridge.

Figure 11. Coal heaps in weigh bridge area (left) and runoff from weigh bridge area entering nullah (right), which eventually joins Barki river.

Overall, there remain several places where coal dust runoff from coal dump, weighbridge areas, etc. is not properly contained in drains and sedimentation ponds.

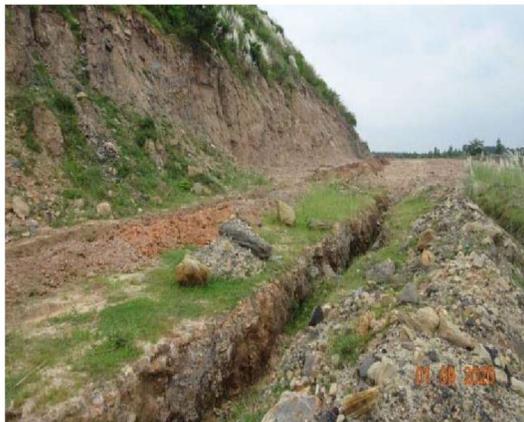
Photo 01: Photo of catch drain around the Honhe OB dump

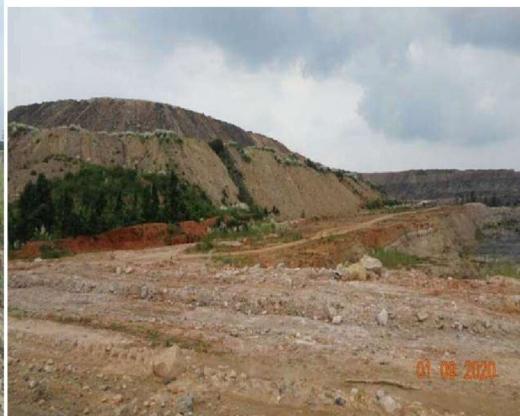
Photo 02: Photo of top soil dump adjacent to Honhe OB dump.

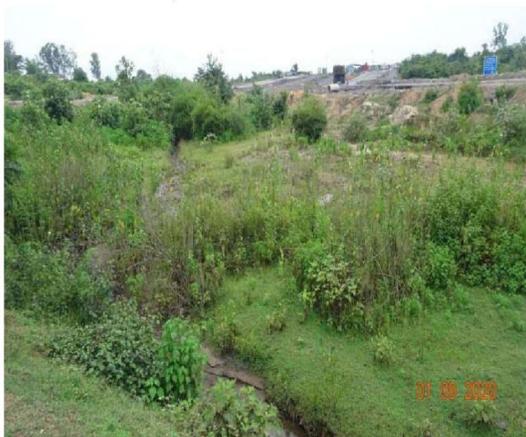
Photo03:Photo of low lying area adjacent to coal heaps around weigh bridge.Water flows into the river within close distance from there.

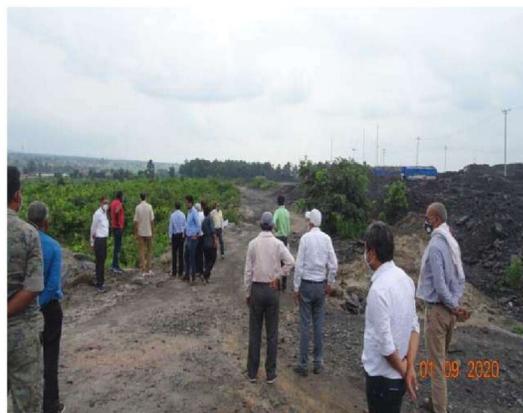
Photo04:Photo of coal heaps/dump near a weigh bridge with no catch drains/siltation ponds around

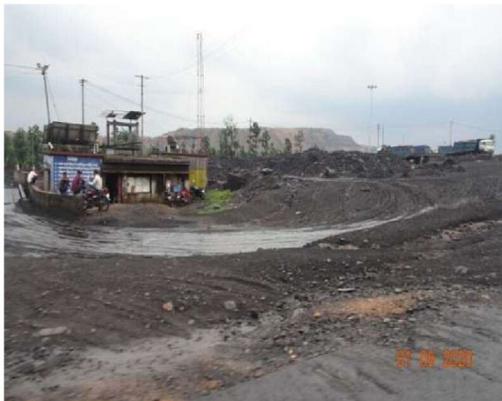
Photo 05: Photo of one of the weigh bridges with

no catch drains/siltations ponds around coal heaps.

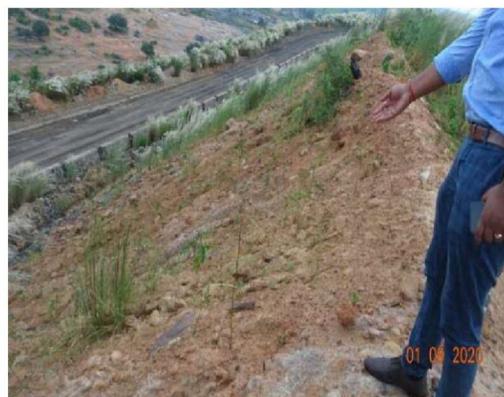
Photo 06: Photo of wall at the toe of the Bingalat

OB dump ,new grassing and plantation can also be seen at some portions of the slopes .

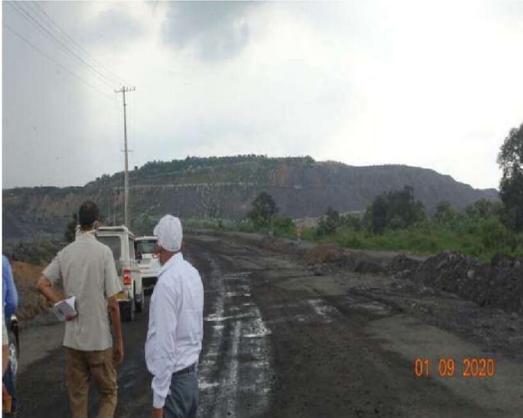
Photo07: Photo of Bingalat OB dump with grassing and vegetation in some portions .

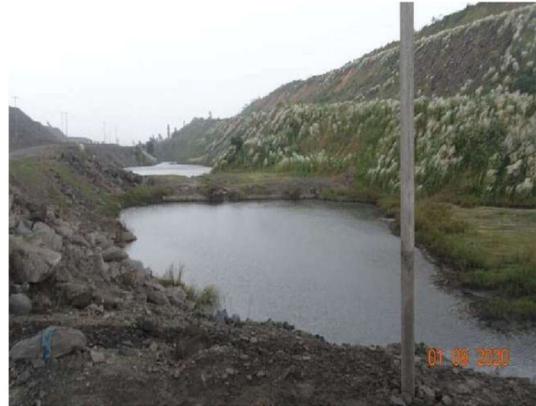
Photo08:Photo of sedimentation ponds cum check dam over local stream/nallah adjacent to OB dump
