BEFORE THE NATIONAL GREEN TRIBUNAL SOUTHERN ZONE,
CHENNAI

Application No.272 of 2024 (SZ)

Status report filed by the 2nd Respondent (as on 13.11.2025)

Condition photos of existing Major Bridge at km. 55+350

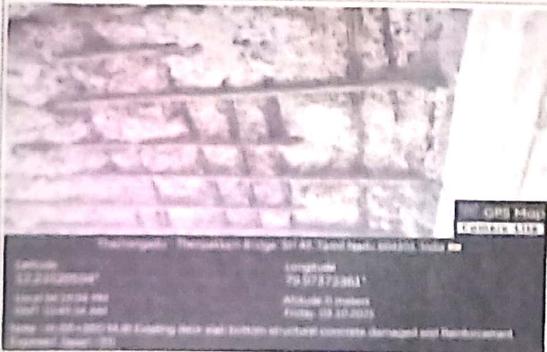
Span 31, Deck Slab Bottom Structural Concrete Damaged and Reinforcement Exposed

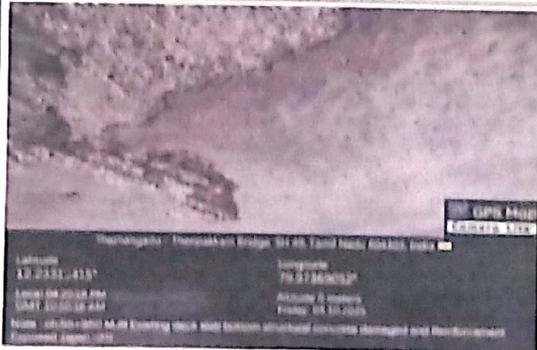
Span 31, Deck Slab Bottom Structural Concrete Damaged and Reinforcement Exposed

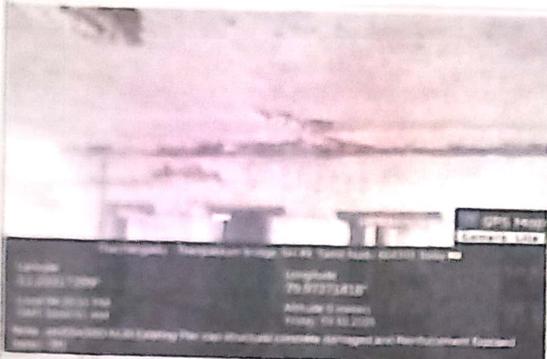
Span - 31 Pier Cap Structural Concrete Damaged and Reinforcement Exposed

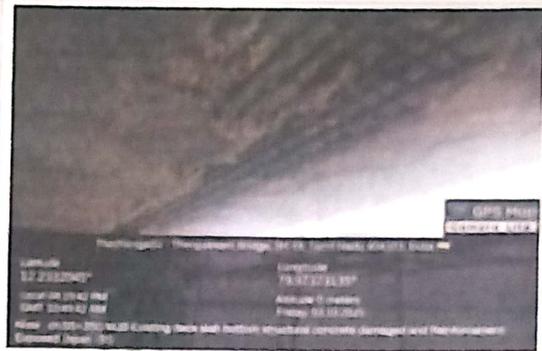
Span - 31 Deck Slab Bottom Structural Concrete Damaged and Reinforcement Exposed

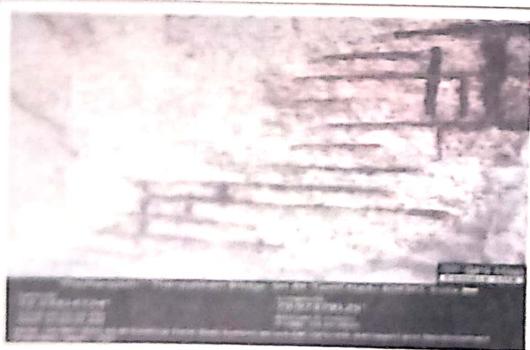
Span - 32 Deck Slab Bottom Structural Concrete Damaged and Reinforcement Exposed

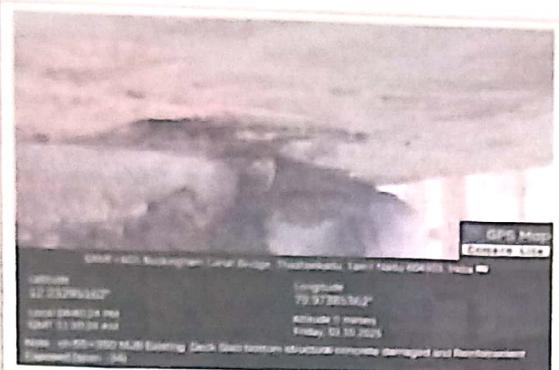
Span -34 , Deck Slab Bottom Structural Concrete Damaged and Reinforcement Exposed

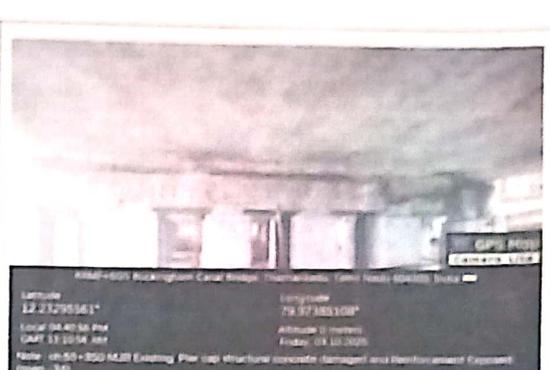
Span -34 , Pier Cap Structural Concrete Damaged and Reinforcement Exposed

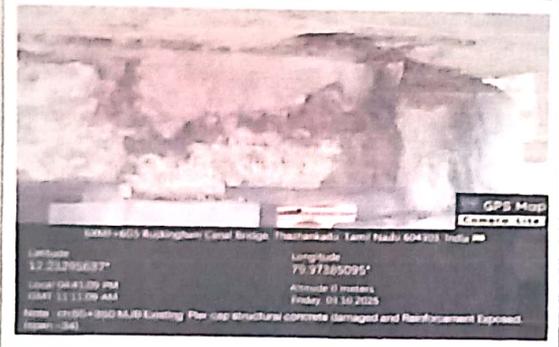
Span -34 , Pier Cap Structural Concrete Damaged and Reinforcement Exposed

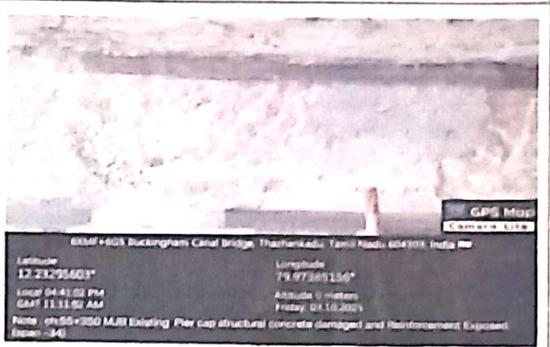
Span -34 , Pier Cap Structural Concrete Damaged and Reinforcement Exposed

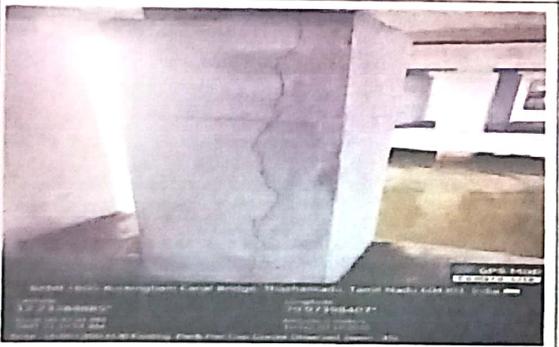
Span - 35, Pier Crack Observed

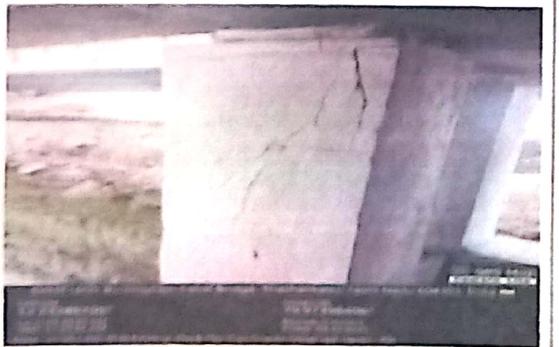
Span - 35, Pier Crack Observed

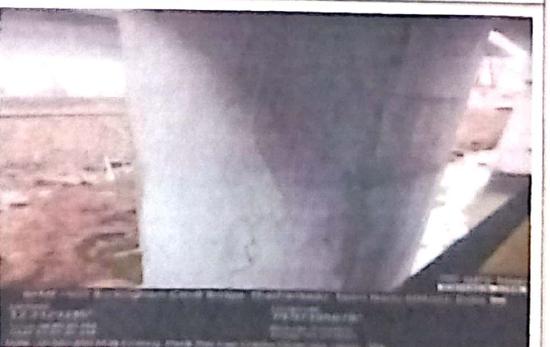
Span - 35, Pier Crack Observed

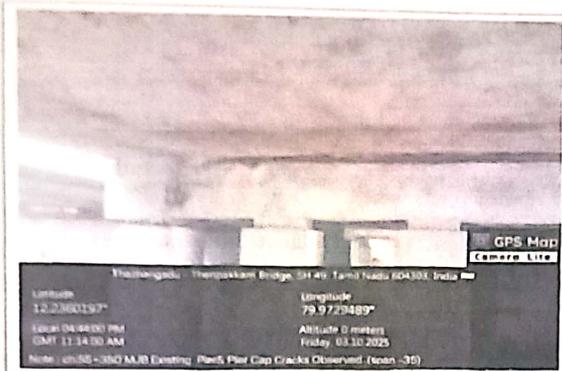
Span - 35, Pier Cap Crack Observed

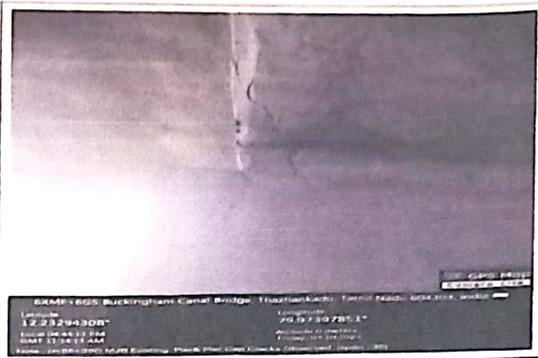
Span - 35, Pier Cap Crack Observed

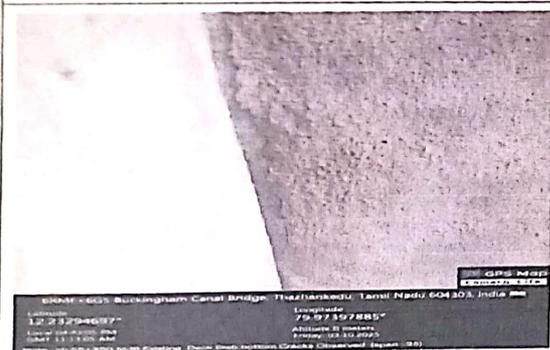
Span - 35, Deck Slab Crack Observed

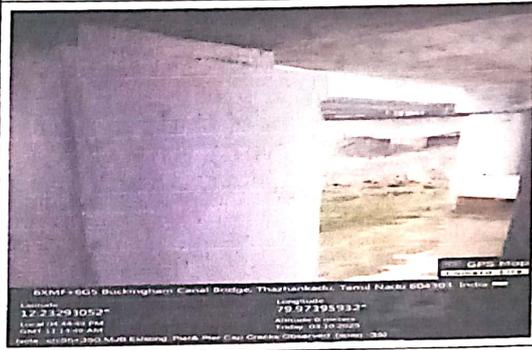
Span - 35, Pier Crack Observed

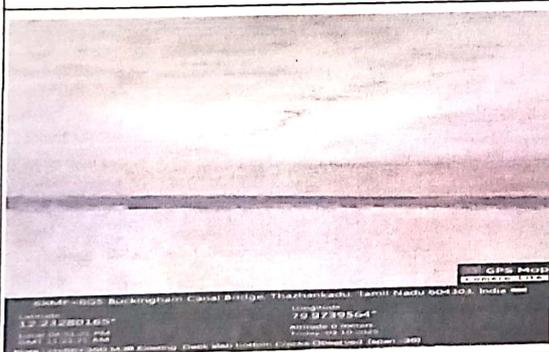
Span - 36, Deck Slab Crack Observed

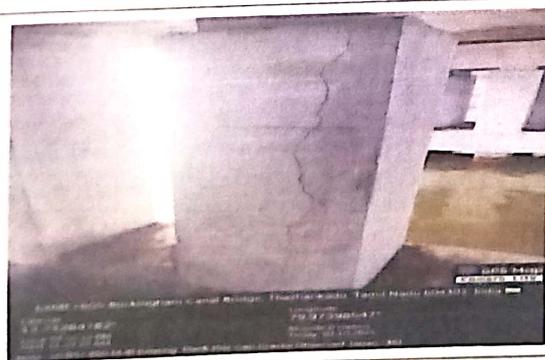
Span - 36, Pier Crack Observed

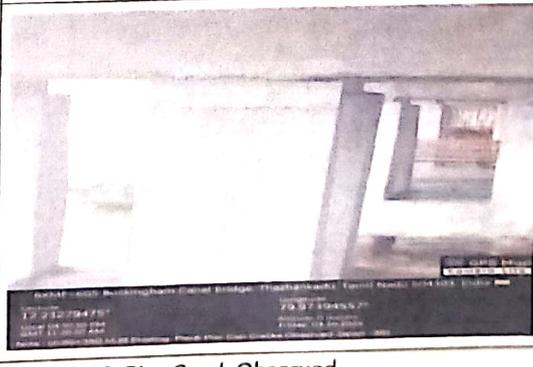
Span - 36, Pier Crack Observed

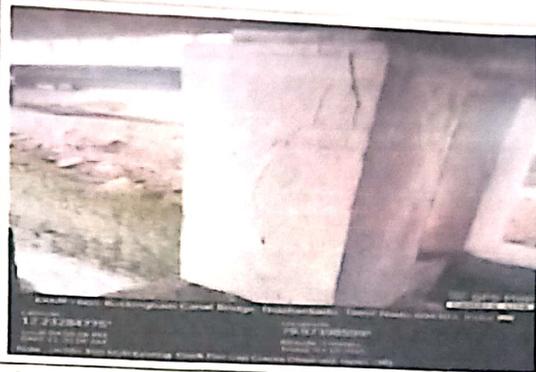
Span – 36, Pier Crack Observed

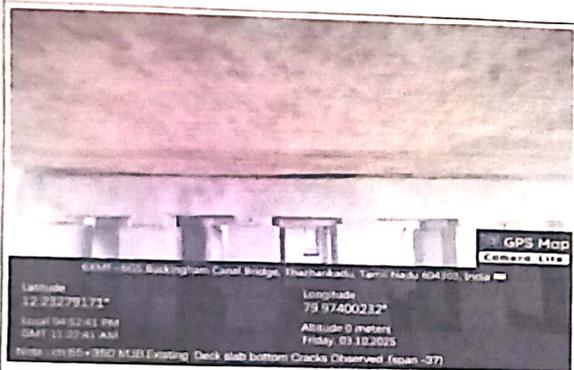
Span – 37, Deck Slab Crack Observed

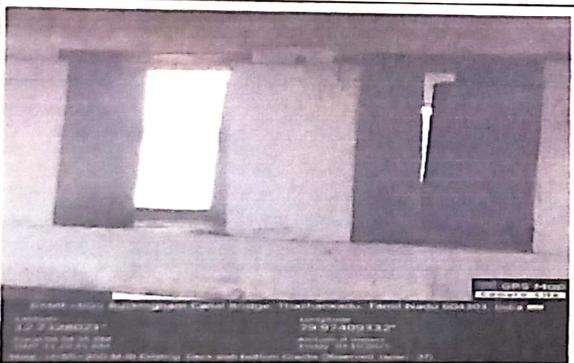
Span – 37, Pier Crack Observed

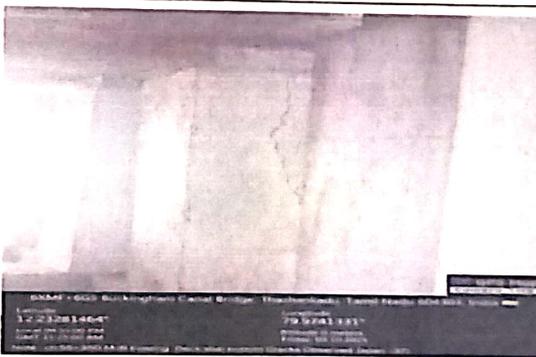
Span – 37, Pier Crack Observed

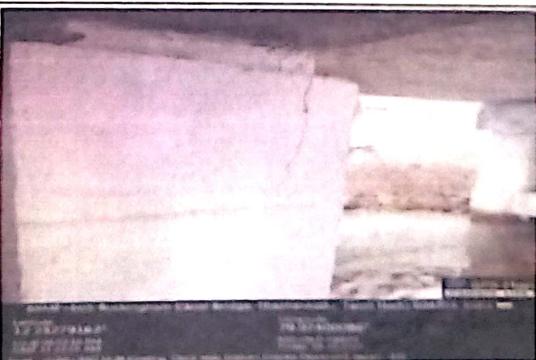
Span – 37, Pier Crack Observed

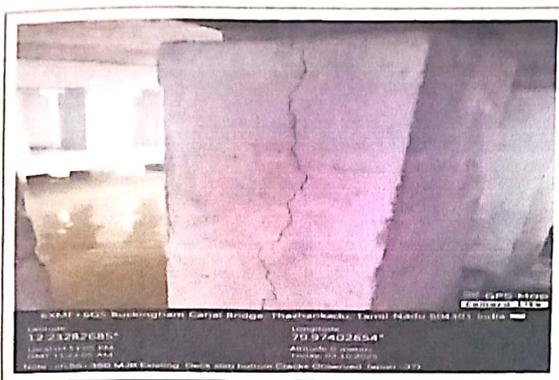
Span – 37, Pier Crack Observed

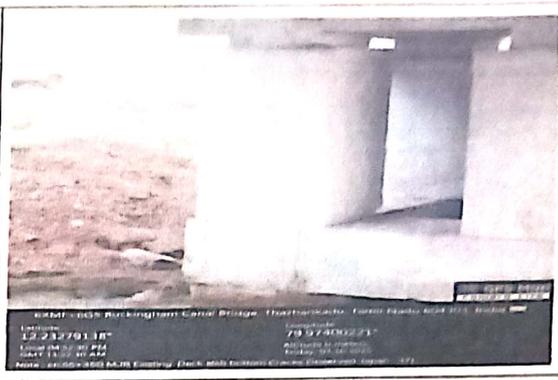
Span – 37, Pier Crack Observed

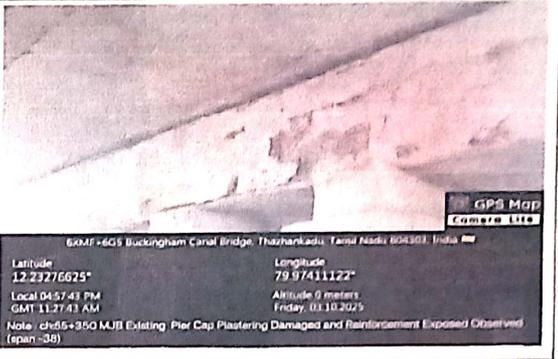
Span -38 , Pier Cap Structural Concrete Damaged and Reinforcement Exposed

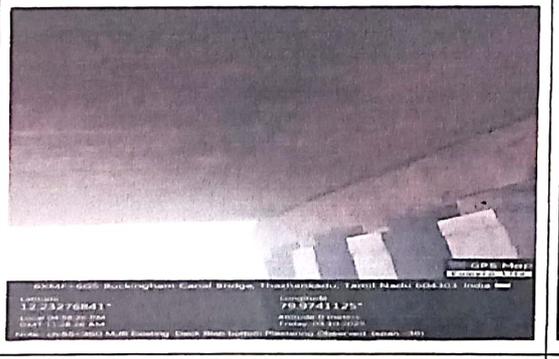
Span – 38, Deck Slab Crack Observed

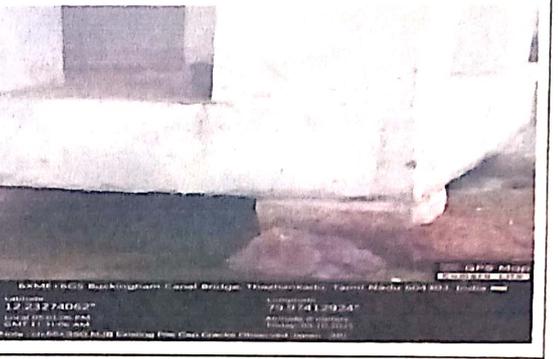
Span – 38, Pile Cap Crack Observed

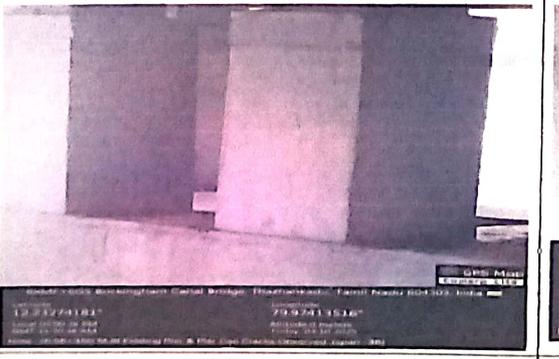
Span – 38, Pier Crack Observed

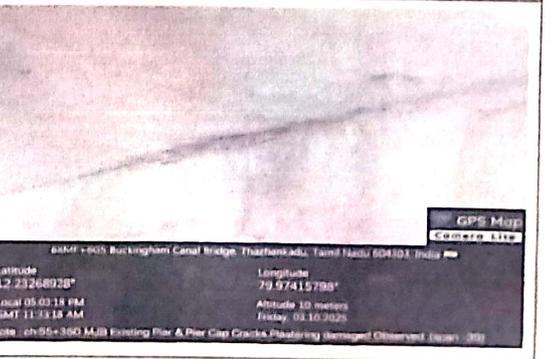
Span – 39, Pier and Pier cap Crack Observed

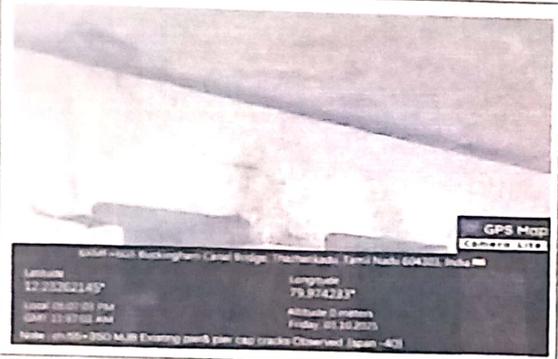
Span - 40, Pier Cap Crack Observed

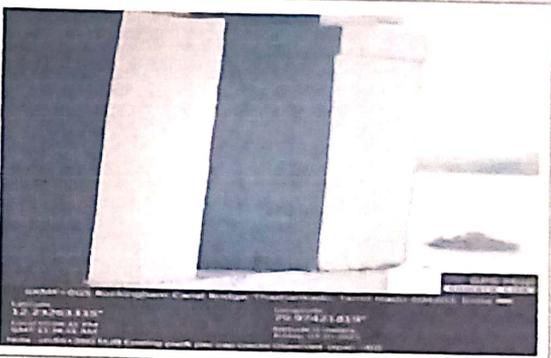
Span - 40, Pier Crack Observed

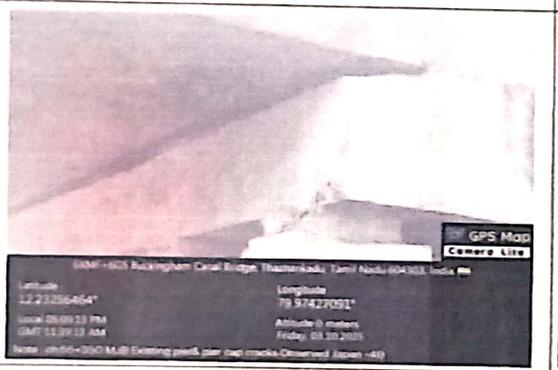
Span - 41, Pier Cap Crack Observed

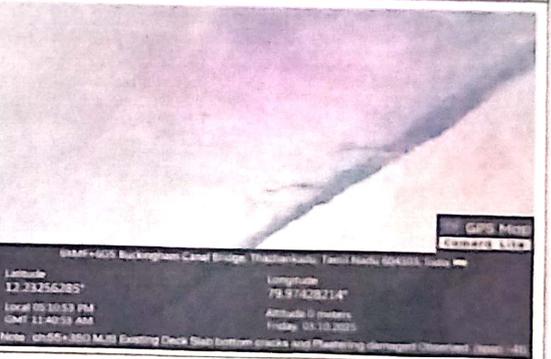
Span - 41, Deck Slab Crack Observed

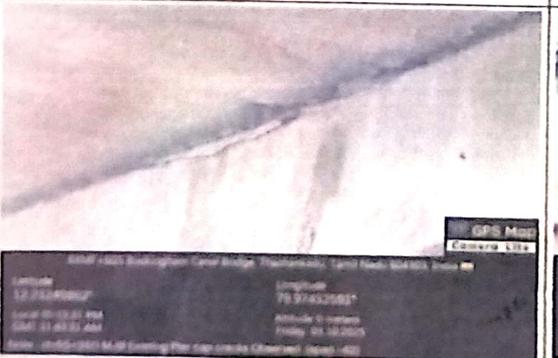
Span - 42, Pier Cap Crack Observed

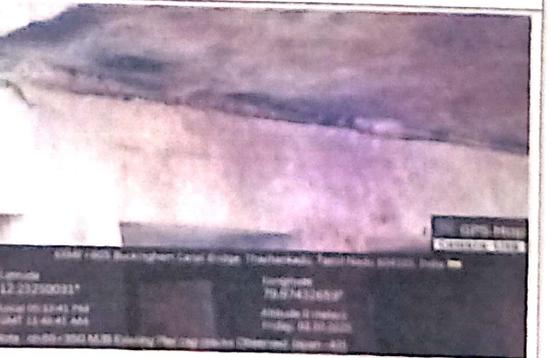
Span - 42, Pier Cap Crack Observed

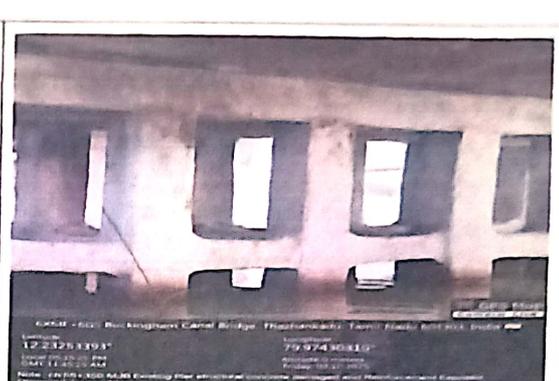
Span -42 , Pier Structural Concrete Damaged and Reinforcement Exposed

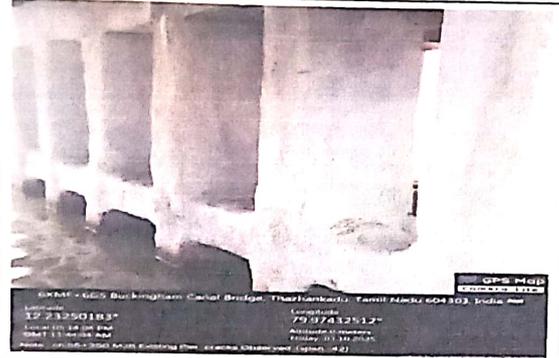
Span - 42, Pier Crack Observed

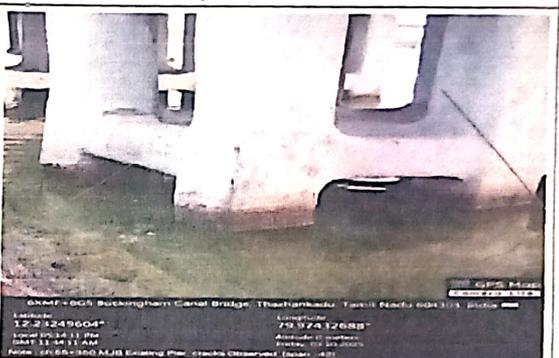
Span -42 , Pier Structural Concrete Damaged and Reinforcement Exposed

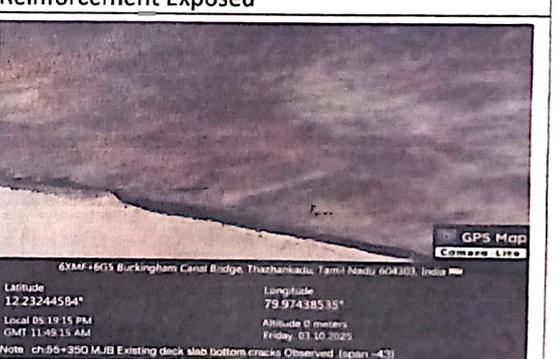
Span - 43, Deck Slab Crack Observed

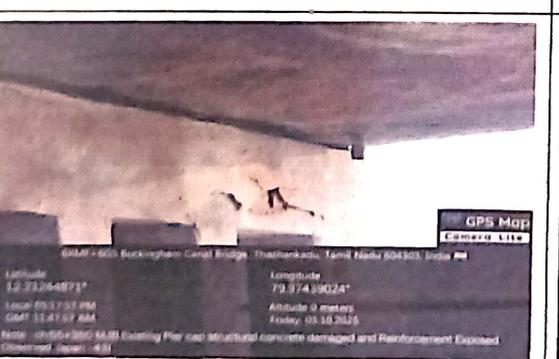
Span -43 , Pier Cap Structural Concrete Damaged and Reinforcement Exposed

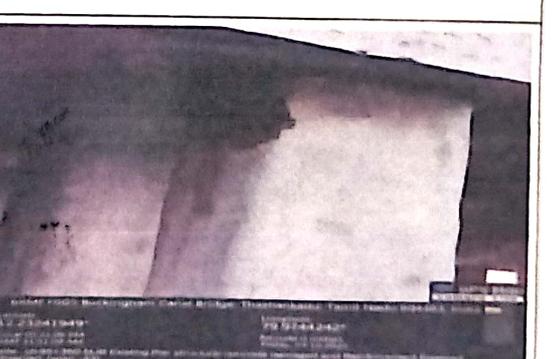
Span -43 , Pier Structural Concrete Damaged and Reinforcement Exposed

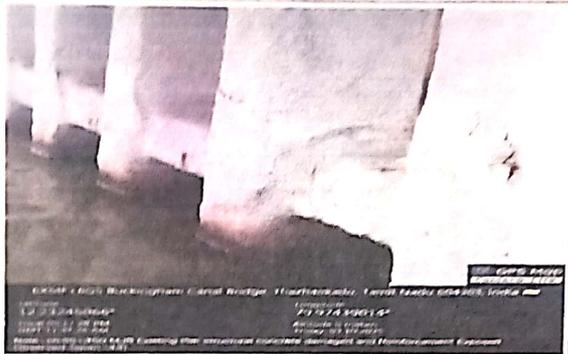
Span -43, Pier Structural Concrete Damaged and Reinforcement Exposed

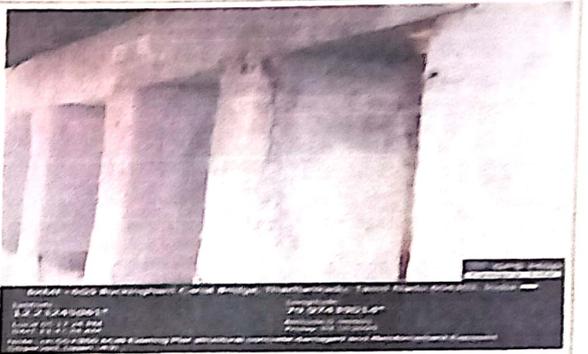
Span -43, Pier Structural Concrete Damaged and Reinforcement Exposed

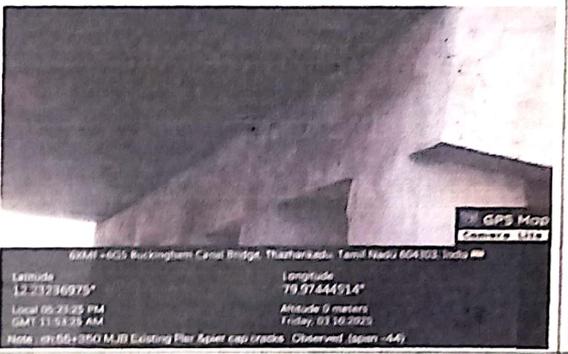
Span - 44, Pier and Pier Cap Crack Observed

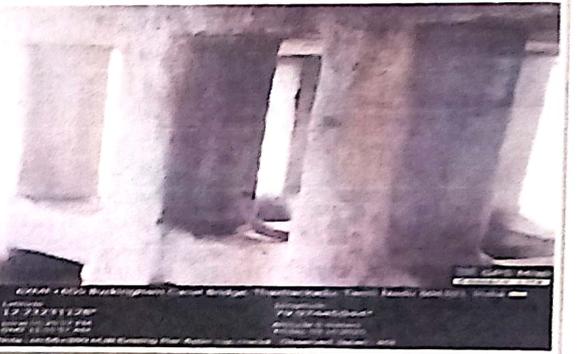
Span - 45, Pier Crack Observed

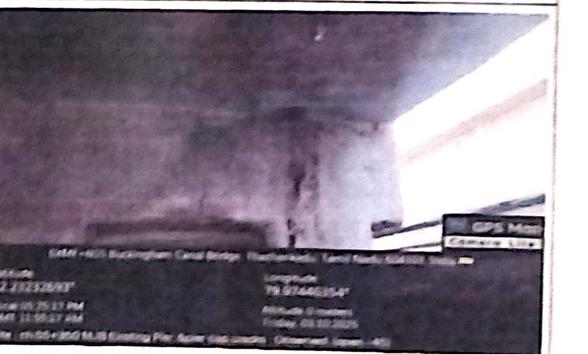
Span - 45, Pier Cap Crack Observed

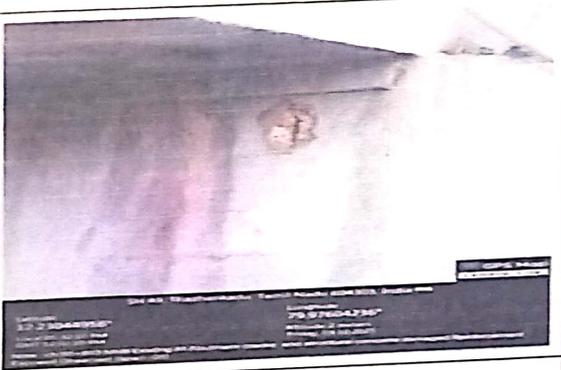
Span - 1, A1 Abutment Structural concrete Damaged and Reinforcement Exposed	Span - 1, A1 Abutment Structural concrete Damaged and Reinforcement Exposed

Span - 1, A1 Abutment Structural concrete Damaged and Reinforcement Exposed	Span - 2, A2 Abutment Crack Observed

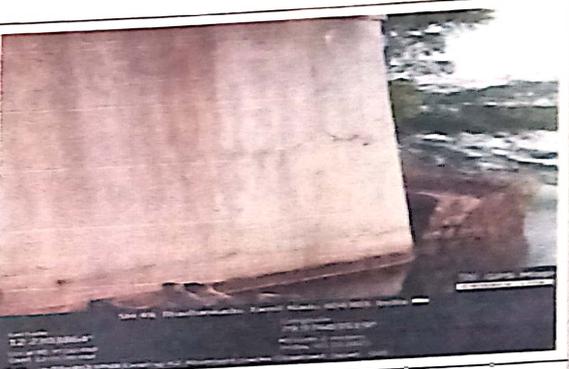
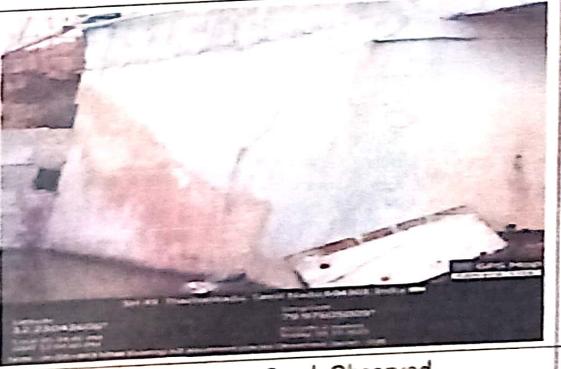
Span - 2, A2 Abutment Crack Observed	Span - 2, Deck Slab Crack Observed
