Original Application no: 187 of 2023 (SZ)

**PLAN OF ACTION REPORT AND ENCLOSURES FILED BY THE 5th
RESPONDENT**

THIRUKULAM REPORT - 2025

சென்னை மயிலாப்பூரில் அமைந்துள்ள அருள்மிகு கபாலீசுவரர் திருக்கோயில் திருக்குளத்தின் நீர்தேக்கும் திறனை மேம்படுத்துதல் மற்றும் புனரமைத்தல் தொடர்பாக மேற்கொள்ளப்பட்ட கள மற்றும் ஆய்வுக்கூட பரிசோதனைகளின் ஆய்வறிக்கை

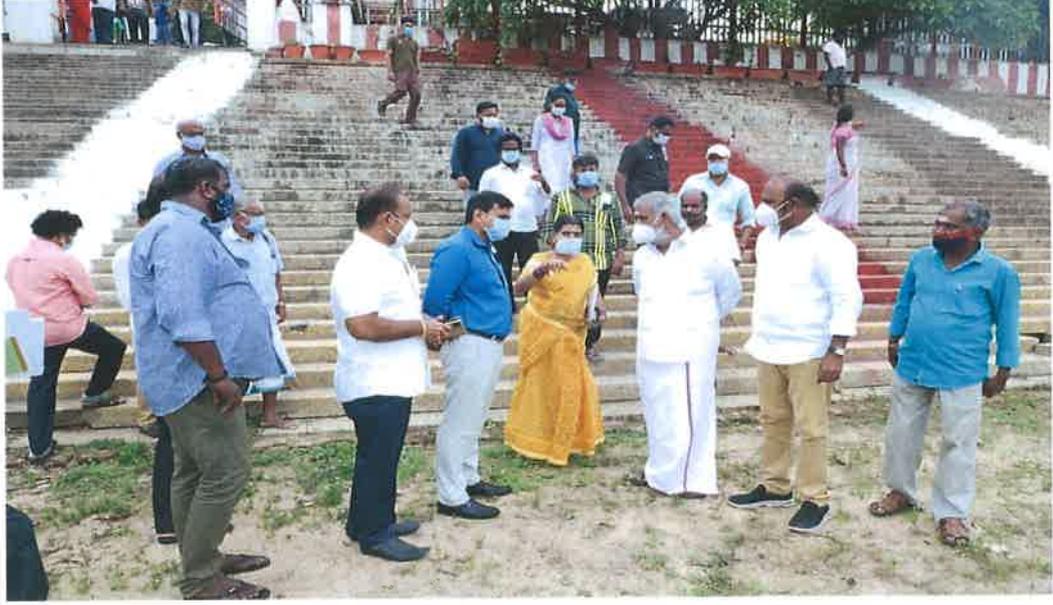
மாண்புமிகு அறநிலையத்துறை அமைச்சர் ஆய்வு
Inspection by Hon'ble Minister for HR & CE

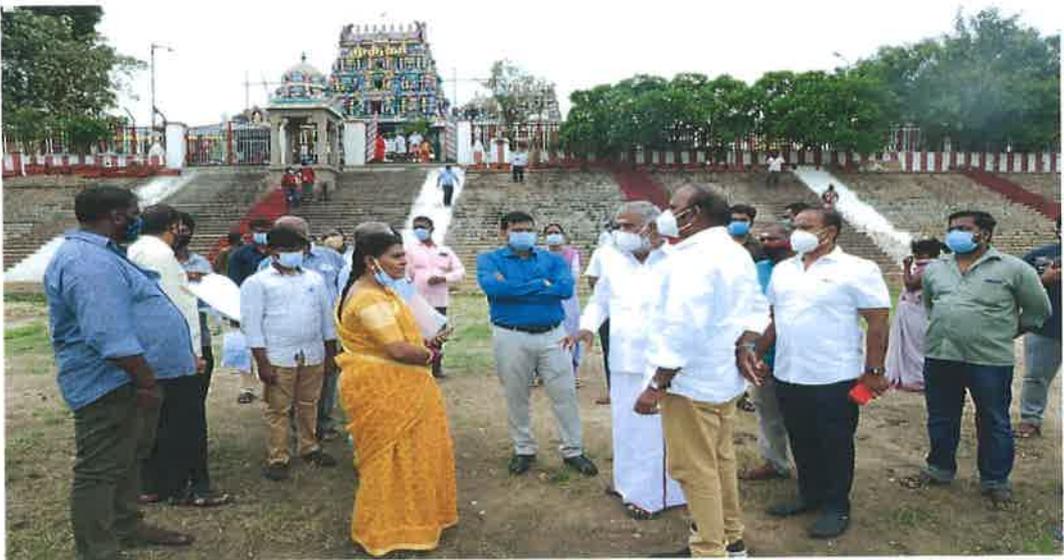
மாண்புமிகு அறநிலையத்துறை அமைச்சர் ஆய்வு
Inspection by Hon'ble Minister for HR & CE

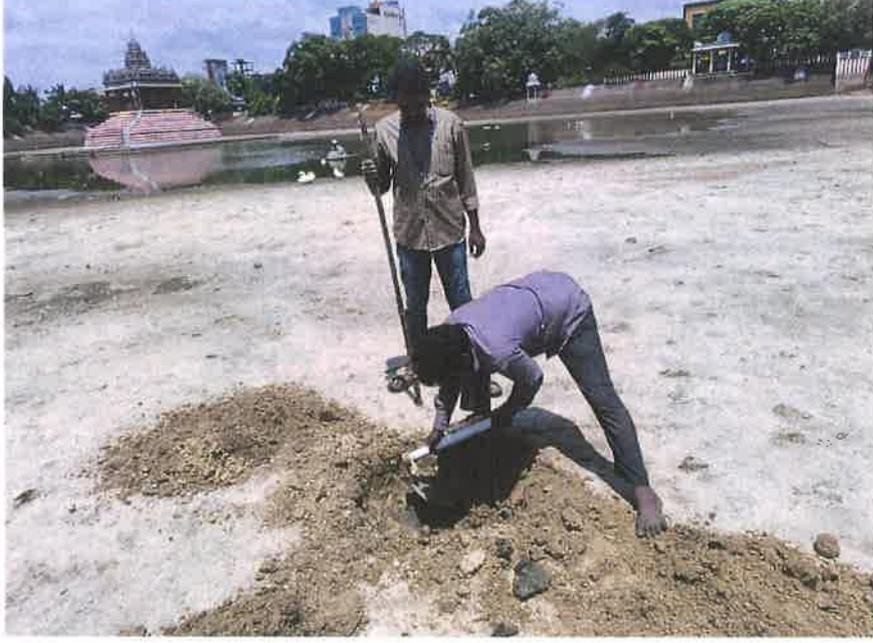
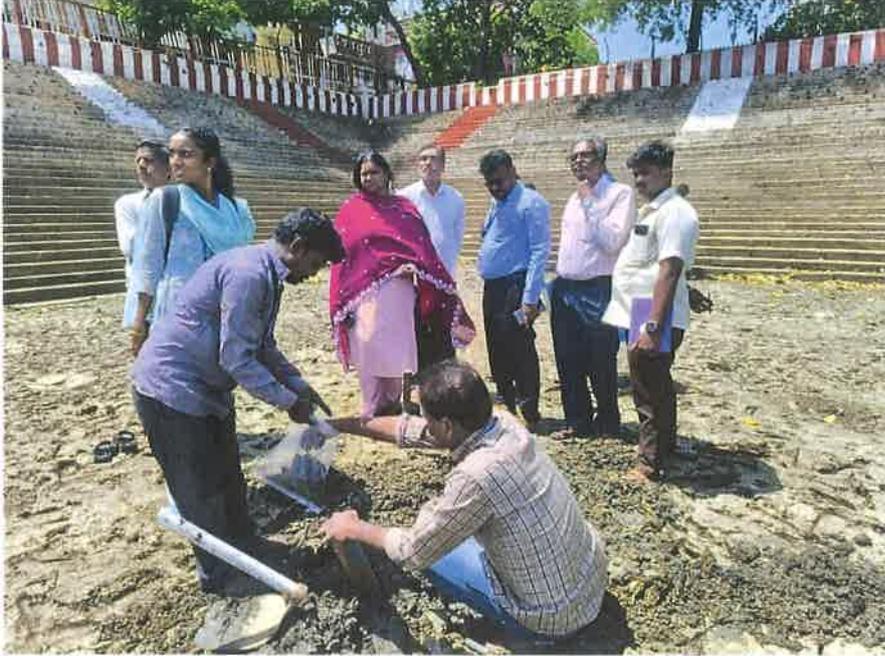
நீர்வள ஆதாரத்துறையின், மண் பரிசோதனை
Soil Test by Water Resources Department

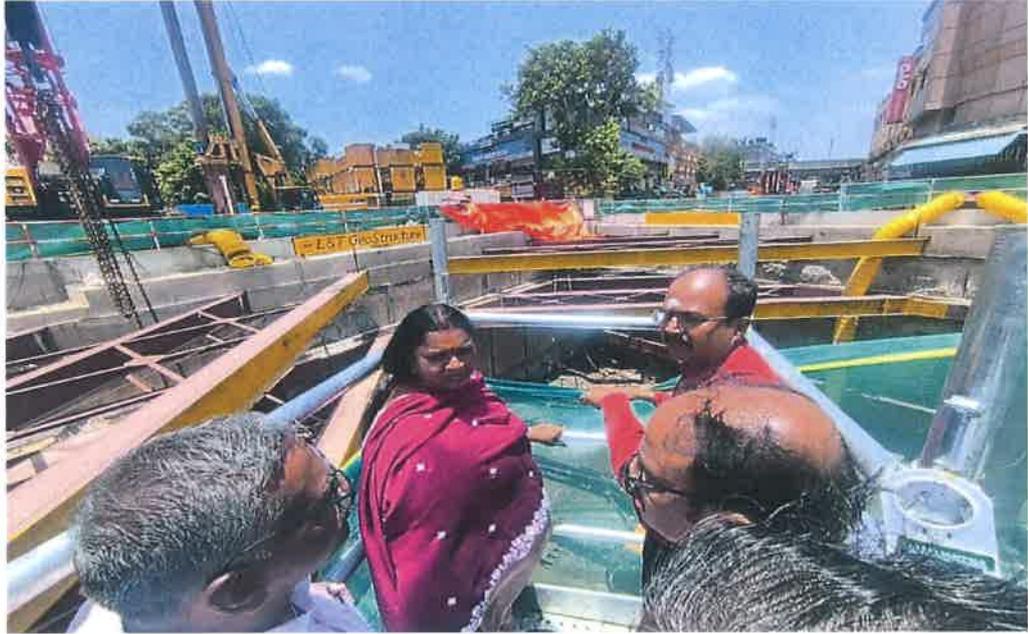
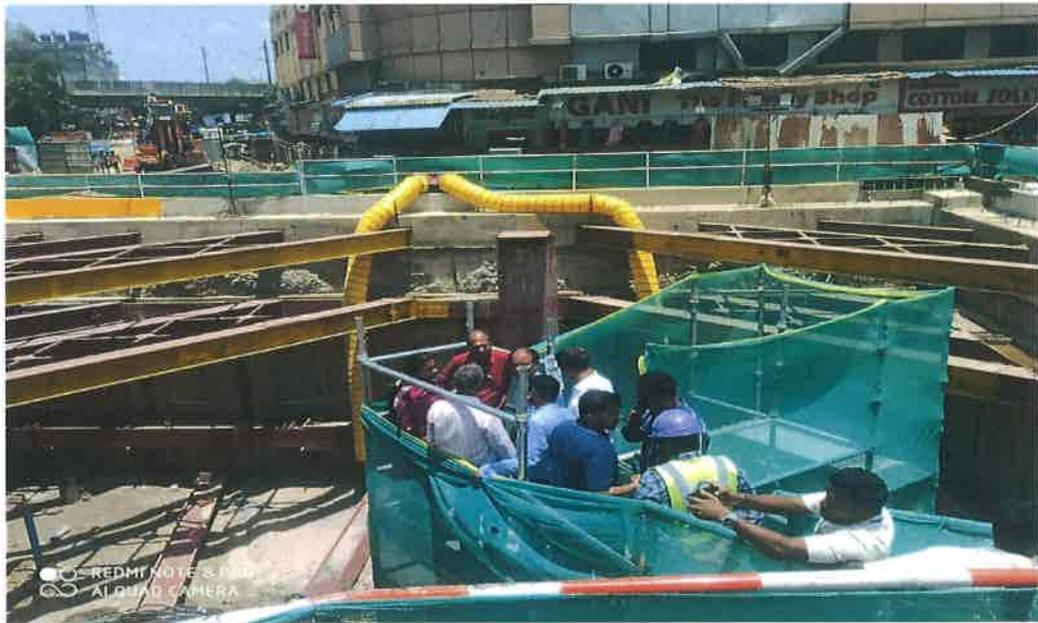
சென்னை மெட்ரோ இரயில் பணி மேற்கொள்ளும் இடத்தில் ஆய்வு
Inspection at Metro Rail Site

4. As per the advice of the Executive Engineer of the Water Resources Department, the Joint Commissioner of the Temple (Acting Officer), the Water Resources Department Officer, Chennai Zone 2 Executive Engineer and the Chennai Metro Rail Manager and officers conducted a survey at Luz Church Junction to see if the groundwater level was decreasing in the area due to the Metro Rail work.

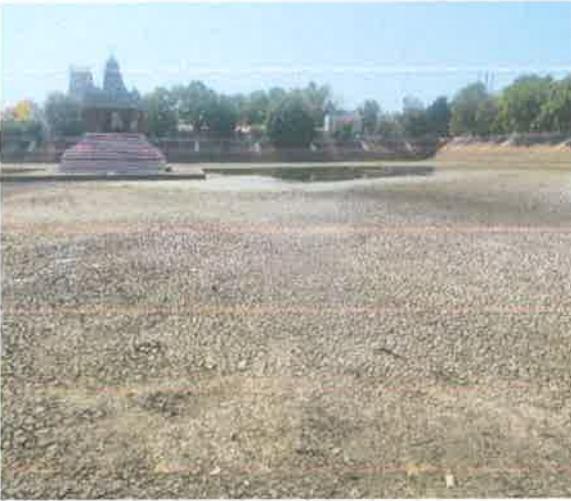
- திருக்குளத்தின் நீராழி மண்டபத்திற்கு மேற்கு பகுதியில் வறட்சி வெடிப்புகள் காணப்பட்டன. இவ்வாறான வறட்சி வெடிப்புகள் களிமண் பாங்கான மேற்பரப்பு நிலத்தில் மட்டுமே ஏற்படும் நிகழ்வாகும்.

திருக்குளத்தின் அடிப் பாகத்தில் வறட்சி வெடிப்புகள்

- Drought outbreaks were observed in the western part of the Thirukkulam water reservoir. Such drought outbreaks occur only in clay-like topsoil.

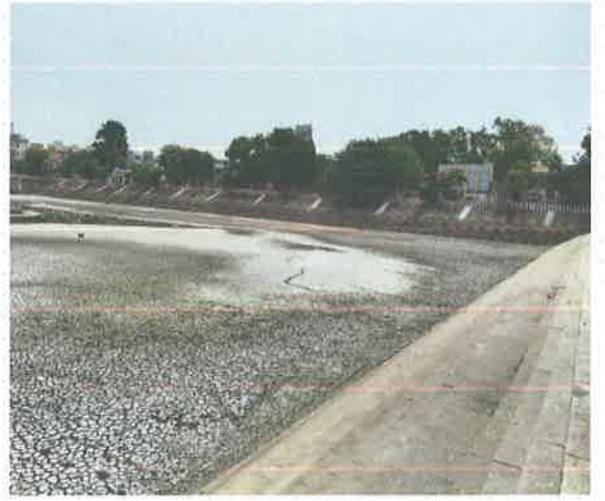
சேரும் சகதியுமான பகுதிகள்

- நீராழி மண்டபத்தில் வடக்கு, தெற்கு மற்றும் கிழக்கு பகுதிகளில் ஆங்காங்கே நீர் தேங்கி, சேரும் சகதியுமாக காட்சியளித்தது.
- மேலும் திருக்குளத்தின் வடகிழக்கு மூலையில் மணல் படிந்த மணற்பாங்காக தென்பட்டது.
- நீராழி மண்டபத்தின் கிழக்கு பகுதியிலும் மணல் பாங்கான பரப்பே காணப்பட்டது. இந்த மணல் பாங்கான நிலப்பரப்பானது திருக்குளத்தின் கிழக்குப்படி பகுதியின் விளிம்பிலிருந்து நீராழி மண்டபத்தின் இடையே சிறிது தூரம் வரை பரவி இருந்தது.
- திருக்குளத்தின் தென்மேற்கு மூலையில் நீர் உட்புகும் வகையில் ஓர் சுரங்கவழி மற்றும் வண்டல் படிவு தடுப்பு அமைப்பு அமைந்துள்ளது. இந்த கட்டுமான அமைப்பு ஆங்காங்கே சிதலடைந்து புணரமைக்கப்பட வேண்டிய நிலையில் உள்ளது.

- Water stagnated in the northern, southern, and eastern parts of the Neerazhi Mandapa, creating a muddy appearance.
- Also, a sandbank was seen in the northeast corner of Thirukkulam.
- A sandy area was also found in the eastern part of the Neerazhi Mandapa. This sandy area extended from the eastern edge of the Thirukkulam to a short distance in the middle of the Neerazhi Manadapa.
- A tunnel and silt barrier are located in the southwest corner of the Thirukkulam to allow water to enter. This structure is in a state of disrepair in places and needs to be renovated.
- Furthermore, boreholes of approximately 50 to 70 feet deep have been constructed at the bottom of this Thirukulam.

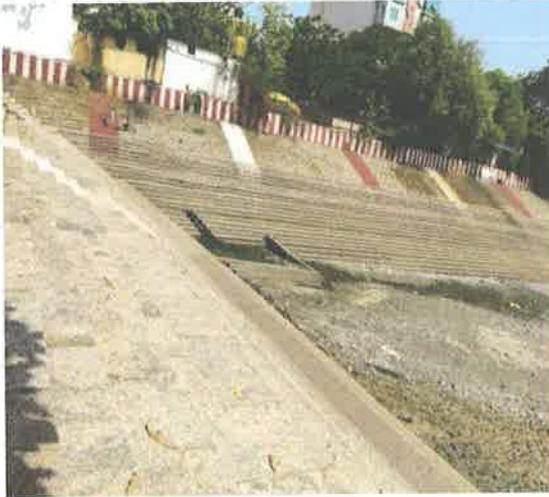
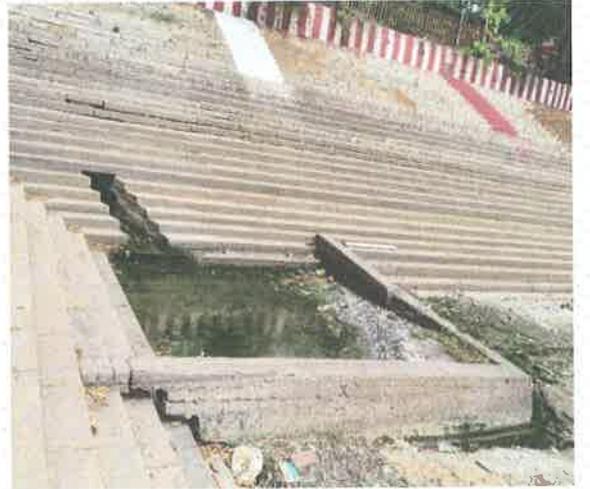
சுரங்கவழி மற்றும் வண்டல் படிவு

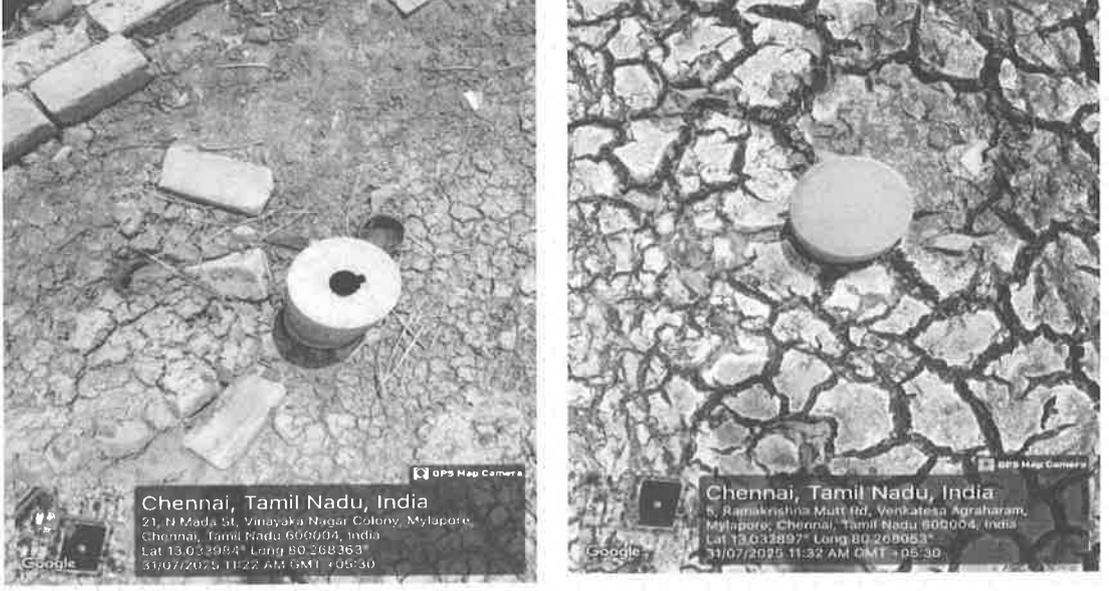
- மேலும், இத்திருக்குளத்தின் அடிமட்டத்தில் சுமார் 50 முதல் 70 அடி வரை ஆழத்திலான துளைக்கிணறுகள் அமைக்கப்பட்டுள்ளது.

திருக்குளத்தின் அடிமட்டத்தில் அமைக்கப்பட்டுள்ள துளைக் கிணறுகள்

- திருக்கோயிலின் சுற்றுப்பாதை மற்றும் நந்தவணப் பகுதிகளில் 4 துளைக்கிணறுகள் அமையப் பெற்றுள்ளது. இதில் மேற்கு நந்தவண புல்வெளியில் அமையப்பெற்றுள்ள துளைக்கிணறு மட்டும் சுமார் 300 அடி ஆழம் கொண்டதாக அறியப்பட்டுள்ளது. மற்ற துளைக்கிணறுகள் சுமார் 100 அடி ஆழம் உள்ளது என அறியப்படுகிறது.
- இந்த துளைக்கிணறுகளில் 3 மட்டுமே செயல்பாட்டில் உள்ளது.

- ❖ Of the seven bore wells in the vicinity of Thirukkulam, only three are currently operational. Three more bore wells have been identified through geological surveys. As per the above water supply assessment, a total of 6 bore wells (3 existing and 3 proposed) can provide 4,96,000 litres (496 KLD) of water per day, based on 8 hours of pumping per day. This 496 KLD of water is a small amount compared to the capacity of the larger Thirukkulam. The use of 6 bore wells daily will offset the losses due to evaporation and groundwater infiltration.

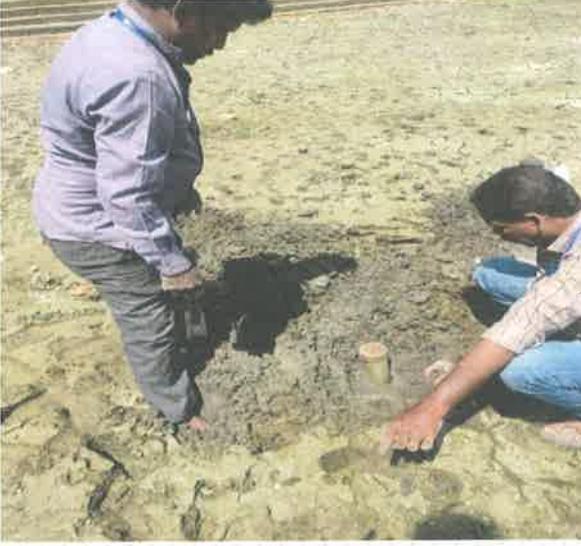
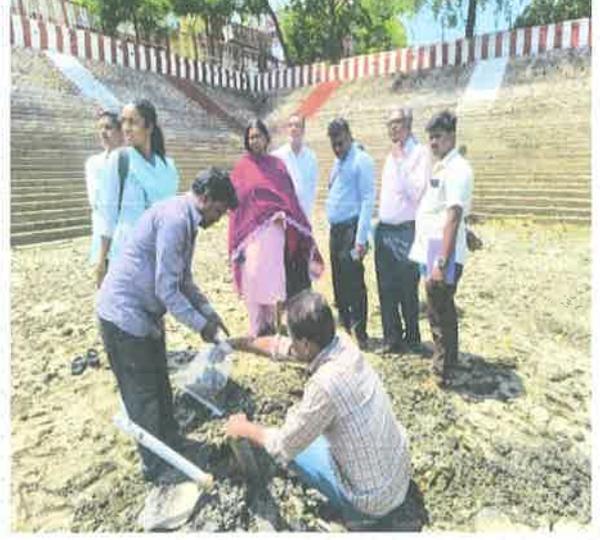
நீர்வளத்துறையின், மண்தன்மை மற்றும் ஆராய்ச்சிக் கோட்ட அலுவலர்கள் 29.07.2025 அன்றே திருக்குளத்தின் நீர் தேங்கியுள்ள பகுதிகள் நீங்கலாக பிற பகுதிகளில் ஏழு இடங்களில் மண்மாதிரிகளை சேகரிப்புக் குழாய்களின் (UDS- Undisturbed Sampling Tubes) மூலம் சேகரித்து, தரமணியில் உள்ள ஆய்வுக் கூடத்திற்கு எடுத்துச் சென்று ஆய்வுக்கு உட்படுத்தினர்.

சேகரிப்புக் குழாய்களின் மூலம் மண் மாதிரிகளை சேகரித்தல்

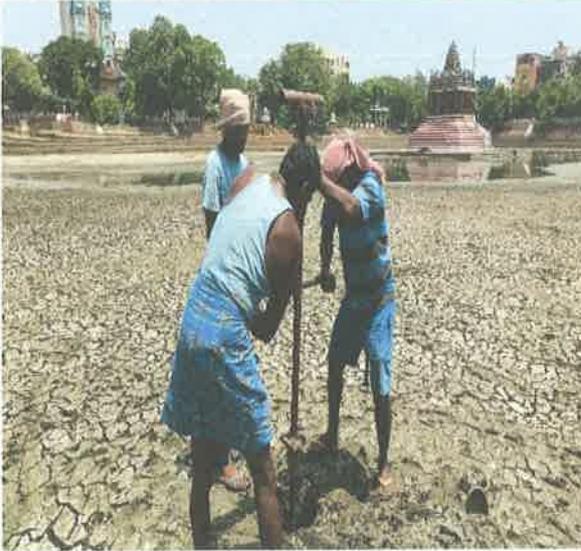
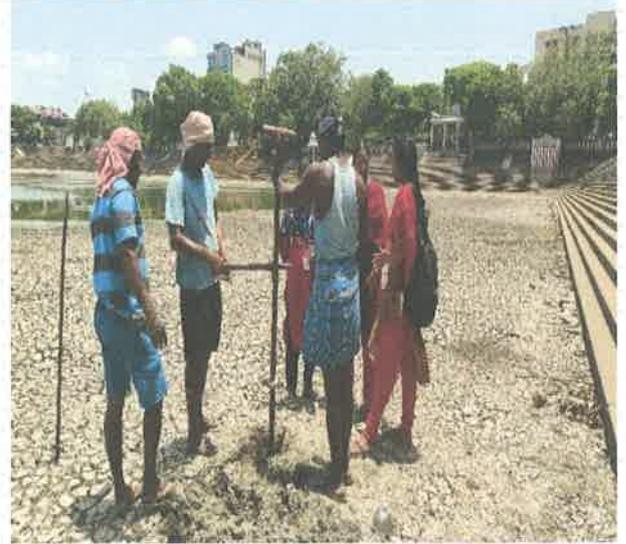
அதைத் தொடர்ந்து, 30.07.2025 அன்று சுமார் 2 மீட்டர் ஆழம் வரை கைத்திருகி மண் அகழ்வியின் மூலம் துளையிட்டு திருக்குளத்தின் அடிமட்டத்தின் கீழுள்ள பல்வேறு அடுக்குகளின் மண்மாதிரிகள் சேகரிக்கப்பட்டு உரிய பரிசோதனை மேற்கொள்ளும்பொருட்டு ஆய்வுக் கூடத்திற்கு எடுத்துச் செல்லப்பட்டது.

கைத்திருகி மண் அகழ்வியின் மூலம் மண் மாதிரிகளை சேகரித்தல்

- ❖ During the above field survey, when drilling with a hand-operated soil auger to collect soil samples, **the groundwater level was found to be 0.6 meters-0.9 meters (2 feet to 3 feet) below the bottom of the Thirukkulam. This groundwater level indicates that the groundwater levels in the surrounding areas are declining.**
- ❖ The clay layer on the surface of the bottom of the Thirukkulam is only 20-25 cm thick and in most areas this clay layer is mixed with silt. Therefore, these layers have lost their ability to retain water, and therefore, this layer is unable to collect water.
- ❖ There is a sandy layer 0.7 meters below the bottom of the Thirukkulam. Since these layers have the ability to conduct water, the groundwater level cannot store water.

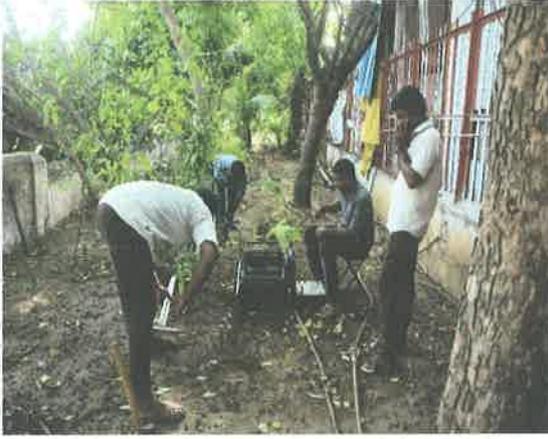
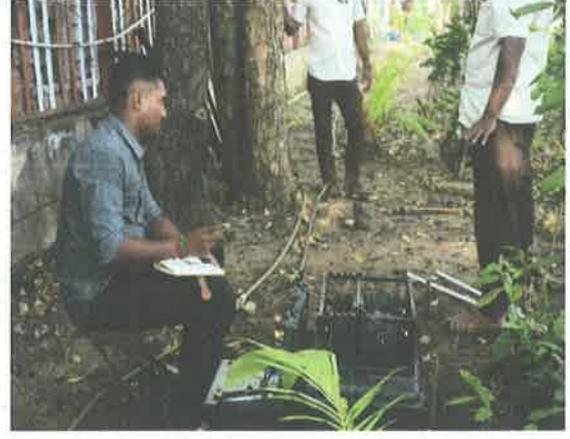
புவிபௌதீக (Geophysical Resistivity Survey) ஆய்வுகள்

பாறை அமைப்பு (Lithology)	ஆழம் (Depth)	
மேல்மண் (Topsoil)	1-2 மீட்டர்	
மணற்களிமண் (Clayey sand)	3-5 மீட்டர்	
மணல்அடுக்குகள் (Sand layer)	6-18 மீட்டர்	
சிதைவுற்றபாறை (Weathered rock)	19-22 மீட்டர்	
பிளவுற்றபாறை (Fractured rock)	22-30 மீட்டர்	
முறிவுகொண்ட கடின பாறை (Jointed rock)	30 மீட்டர்	
	ஆழத்திற்கு கீழே

- Through analysis of geophysical data, eroded rock and fractured hard rocks are found at depths of 20 to 25 meters.
- Low electrical resistivity values indicate the presence of joints and fractures in the rock, through which groundwater may be available as a source in those rocks.
- The Charnockite rocks found in this area are devoid of primary permeability (primary porosity). Therefore, groundwater levels are only found through secondary porosity in areas of fractured and fractured rock.
- Open wells and bore wells are suitable systems for extracting groundwater in this area.

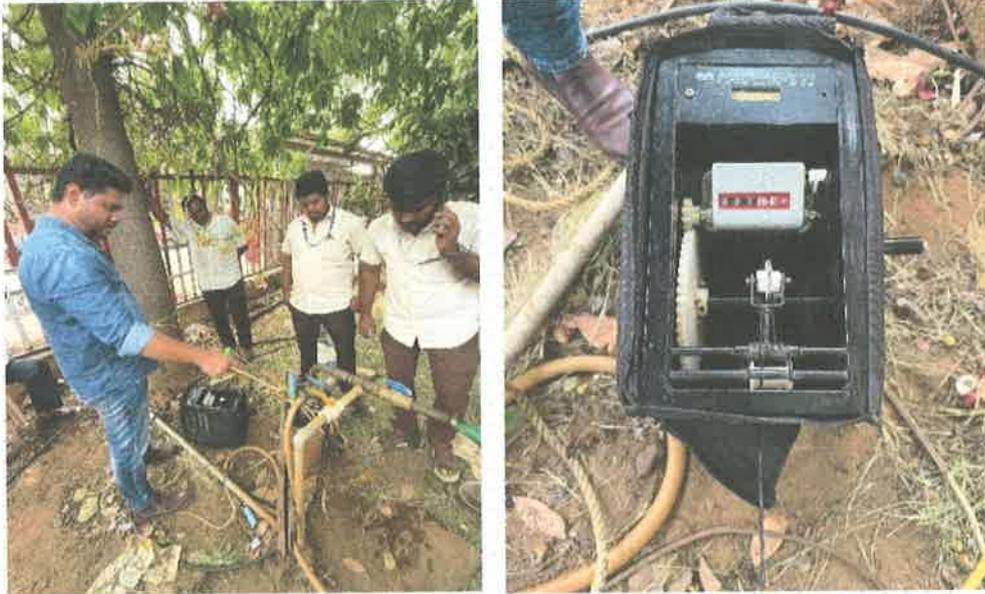
நிலத்தடிநீர் இறைவை சோதனை

ஒரு துளை கிணறின் நீரளிப்பு திறன் நிமிடத்திற்கு 150 லிட்டர் (150 lpm) எனும் அளவில் ஒரு நாளைக்கு 72,000லிட்டர் என கண்டறியப்பட்டது. மேலும் இரண்டு துளை கிணறுகளிலும் சேர்த்து மொத்தம் மூன்று துளை கிணறுகளிலும் 2,16,000லிட்டர் அளவு தண்ணீரை எடுக்க முடியும். மேலும், பரிந்துரைக்கப்பட்ட இடங்களில் அமைக்கப்படும் கூடுதல் 3 துளை கிணறுகளிலிருந்து, நாளொன்றுக்கு 2,80,000 லிட்டர் அளவிலான நீரை பாதிப்பு ஏதுமின்றி எடுக்க முடியும். இருப்பில் உள்ள மற்றும் பரிந்துரைக்கப்பட்ட துளை கிணறுகளிலிருந்து, மொத்தமாக தினமும் 4,96,000 லிட்டர் (496 KLD) அளவிலான நீரை எடுத்து உபயோகித்துக் கொள்ளலாம். இது கோயில் வளாகத்திற்குள் தோட்ட பராமரிப்பு மற்றும் தெப்பக்குளத்தில் நீர் சேகரிப்பு பயன்பாட்டிற்கு உதவும்.

- Based on a pumping test carried out on a bore well located on the western side of Thirukkulam, near R.K. Madam Road, it has been found that its water yield is 150 litres per minute.

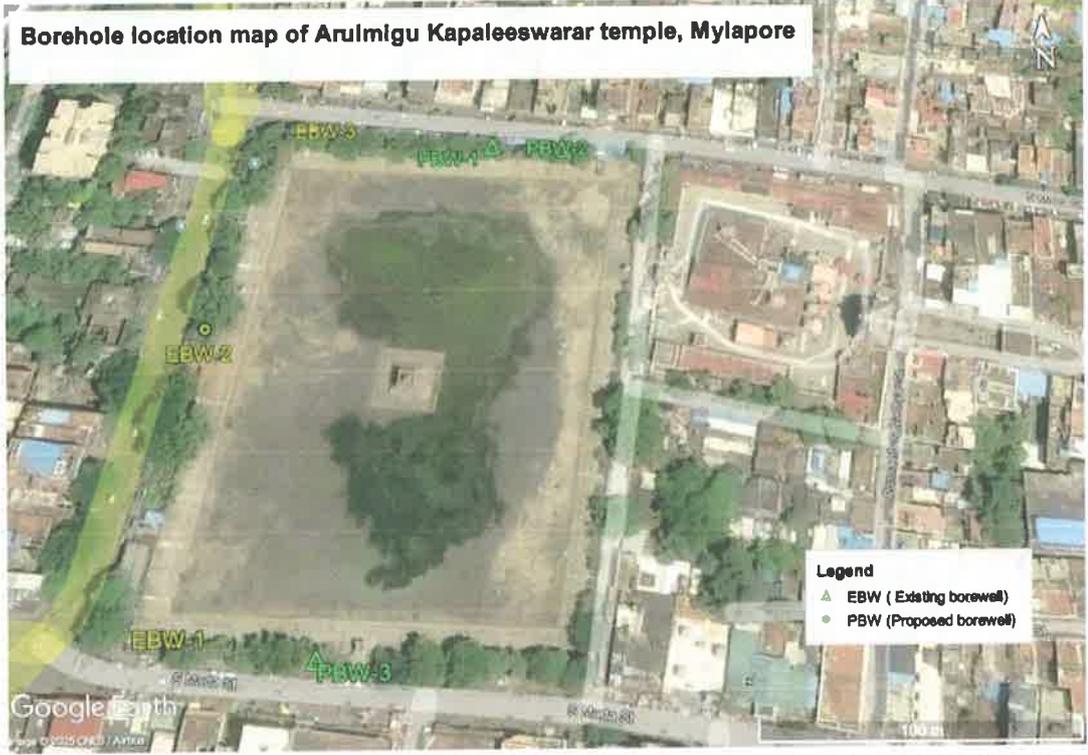
திருக்குளத்தின் துளைகிணறுகளின் விவரங்கள்

- Of the seven bore wells in the vicinity of Thirukkulam, only three are currently operational. Geological surveys have identified suitable locations for three new bore wells.
- As per the above water supply estimate, a total of 6 bore wells (3 existing and 3 proposed) can provide 4,96,000 litres (496 KLD) of water per day, based on 8 hours of pumping per day. This 496 KLD of water is a small amount compared to the capacity of the large Thirukkulam, and the daily use of 6 bore wells will offset the losses due to evaporation and groundwater infiltration.

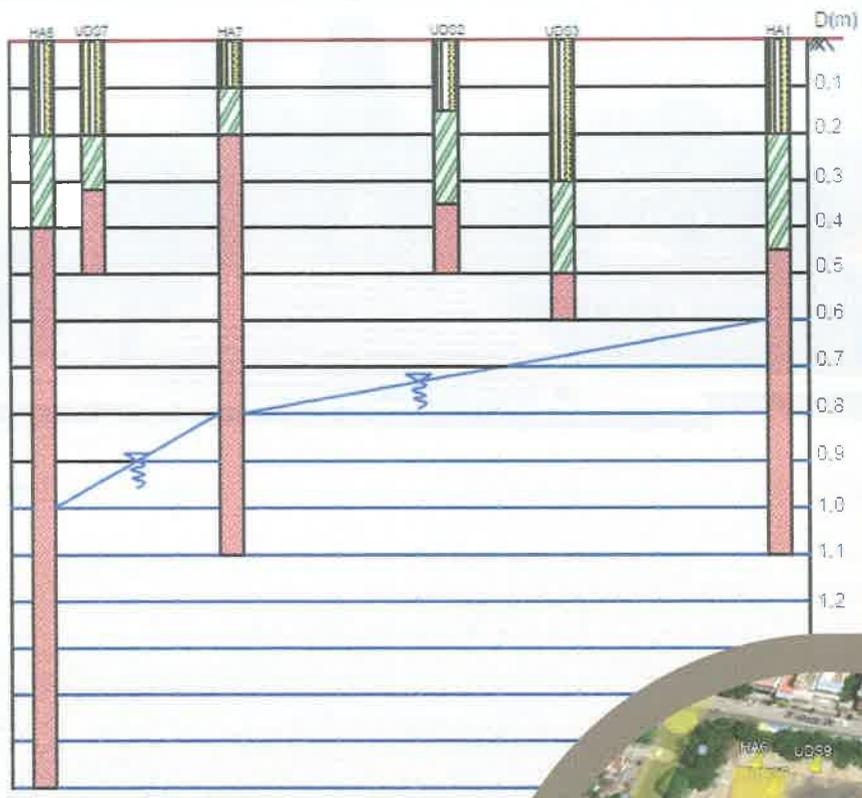
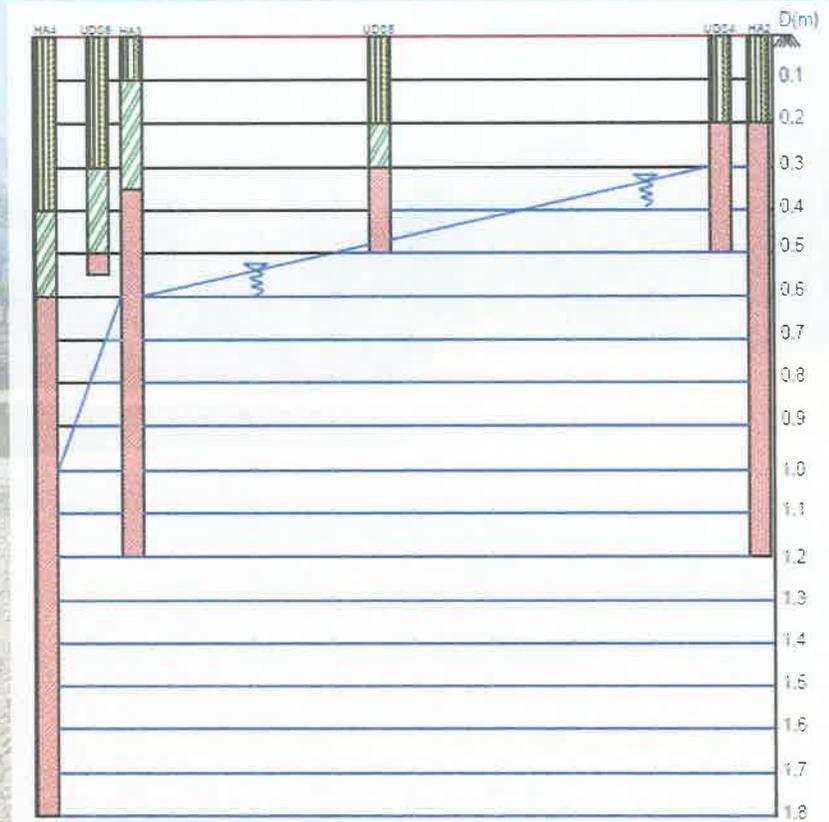
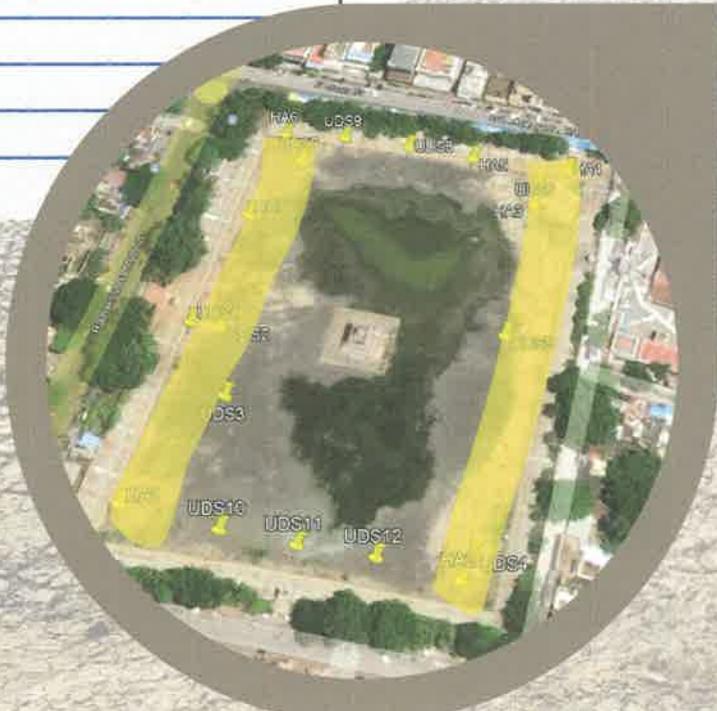
SOIL PROFILE ALONG WESTERN BOUNDARY IN N-S ORIENTATION

SOIL PROFILE ALONG EASTERN BOUNDARY IN N-S ORIENTATION

- ❖ The upper layer of the Thirukkulam consists of 10 cm thick, permeable soil with alluvial siltstones.
- ❖ Following this layer is clay, which is found to be about 25 cm thick on average. The permeability of this clay soil has been found to be 1×10^{-7} to 1×10^{-8} cm/second (cm/s). This clay layer is an impermeable soil layer.

- ❖ Following this layer (from about 70 cm to 200 cm below the bottom of the Thirukkulam) a layer of poorly graded sand has been found. The water permeability factor of this layer is 1×10^{-3} to 1×10^{-4} cm/second (cm/s). These soil layers are considered to be permeable soil layers.

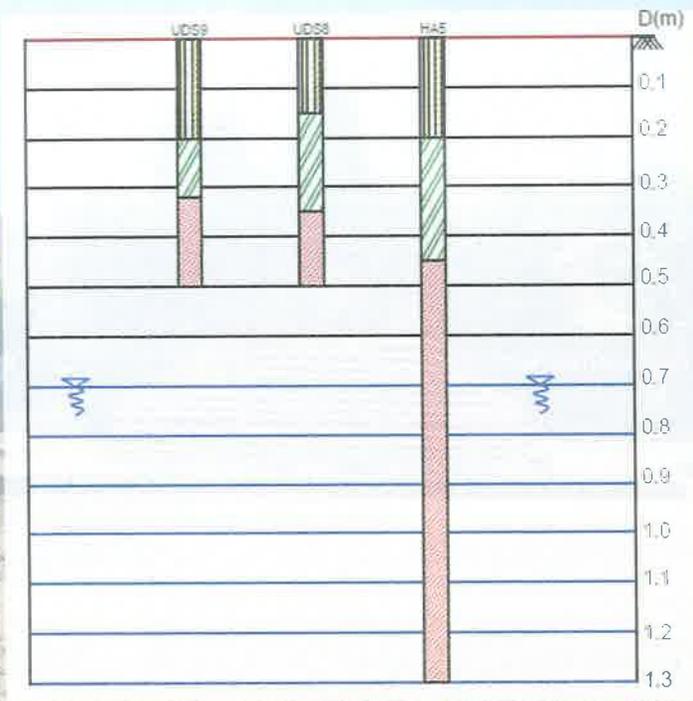
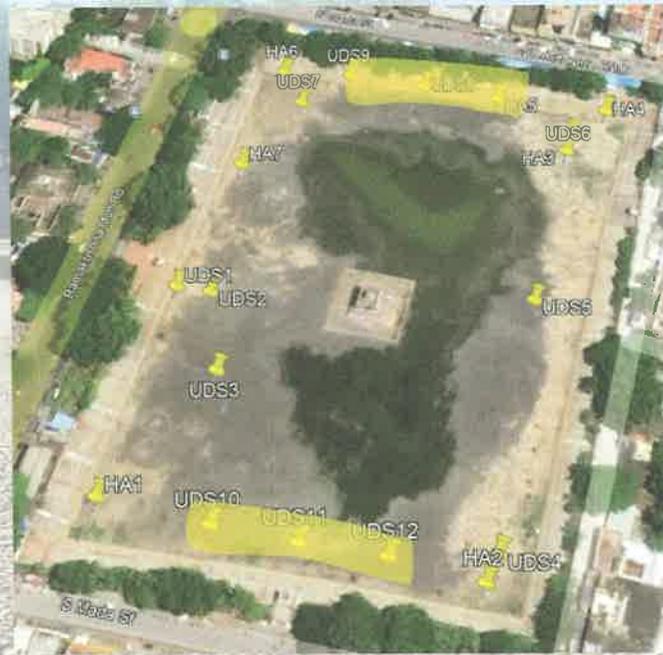
● SOIL PROFILE ALONG NORTHERN BOUNDARY IN W-E ORIENTATION
