BEFORE THE HON'BLE NATIONAL GREEN TRIBUNAL**O.A. No. 327 OF 2023**

In ref: News item published in India Today dated 30.04.2023 titled "3 minors among 11 dead in Ludhiana gas leak, Punjab govt. announces Rs 2 lakh ex-gratia".

**Reply in the form of Affidavit by Surabhi Malik, IAS,
Deputy Commissioner, Ludhiana**

**Report of Magisterial Enquiry in Giaspura gas leak incident on
30.4.2023 at Giaspura, Ludhiana**

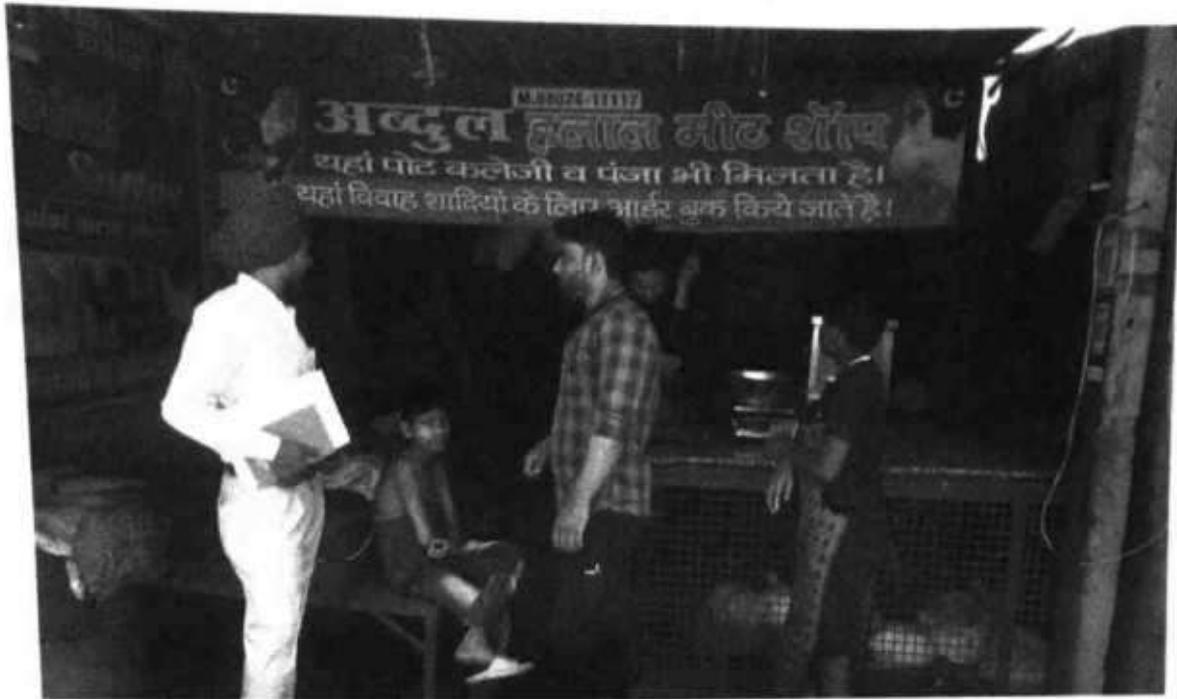
UNAUTHORIZED MEAT/SLAUGHTERING SHOPS

Cluster of meat shops are located in the upstream of the incident point which are discharging the washing water with high Organic loads into sewers

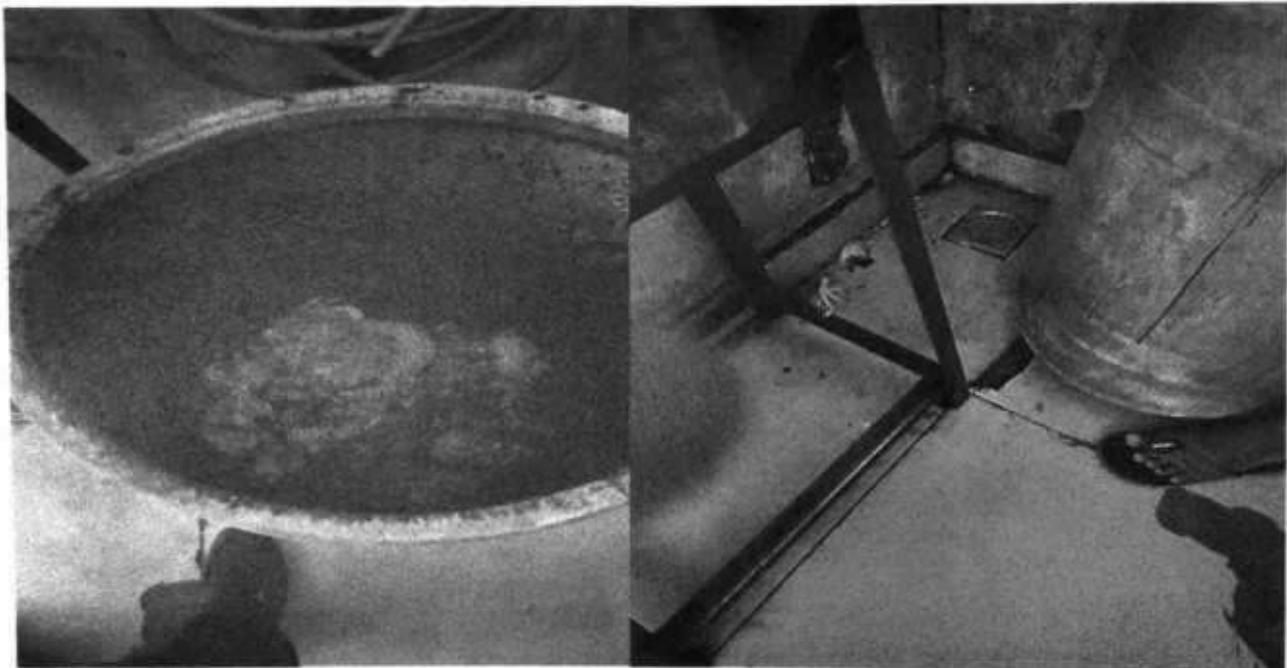
No adequate solid waste handling which leads to choking of sewers

Illegal Outlet for discharge of high organic load directly into sewer .

NO OR POOR VENTILATION IN THE HOUSES OF THE DECEASED

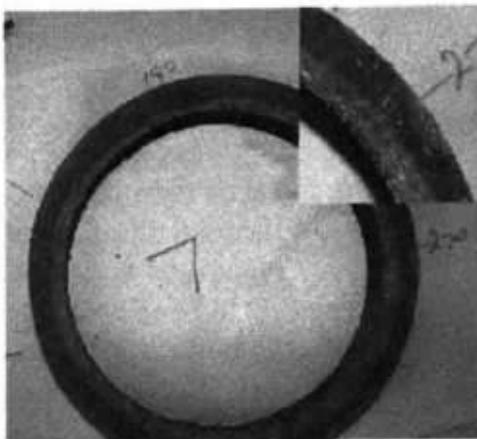
Figure 6: *AC Sewer rising main-internal leaching due to H₂S gas*

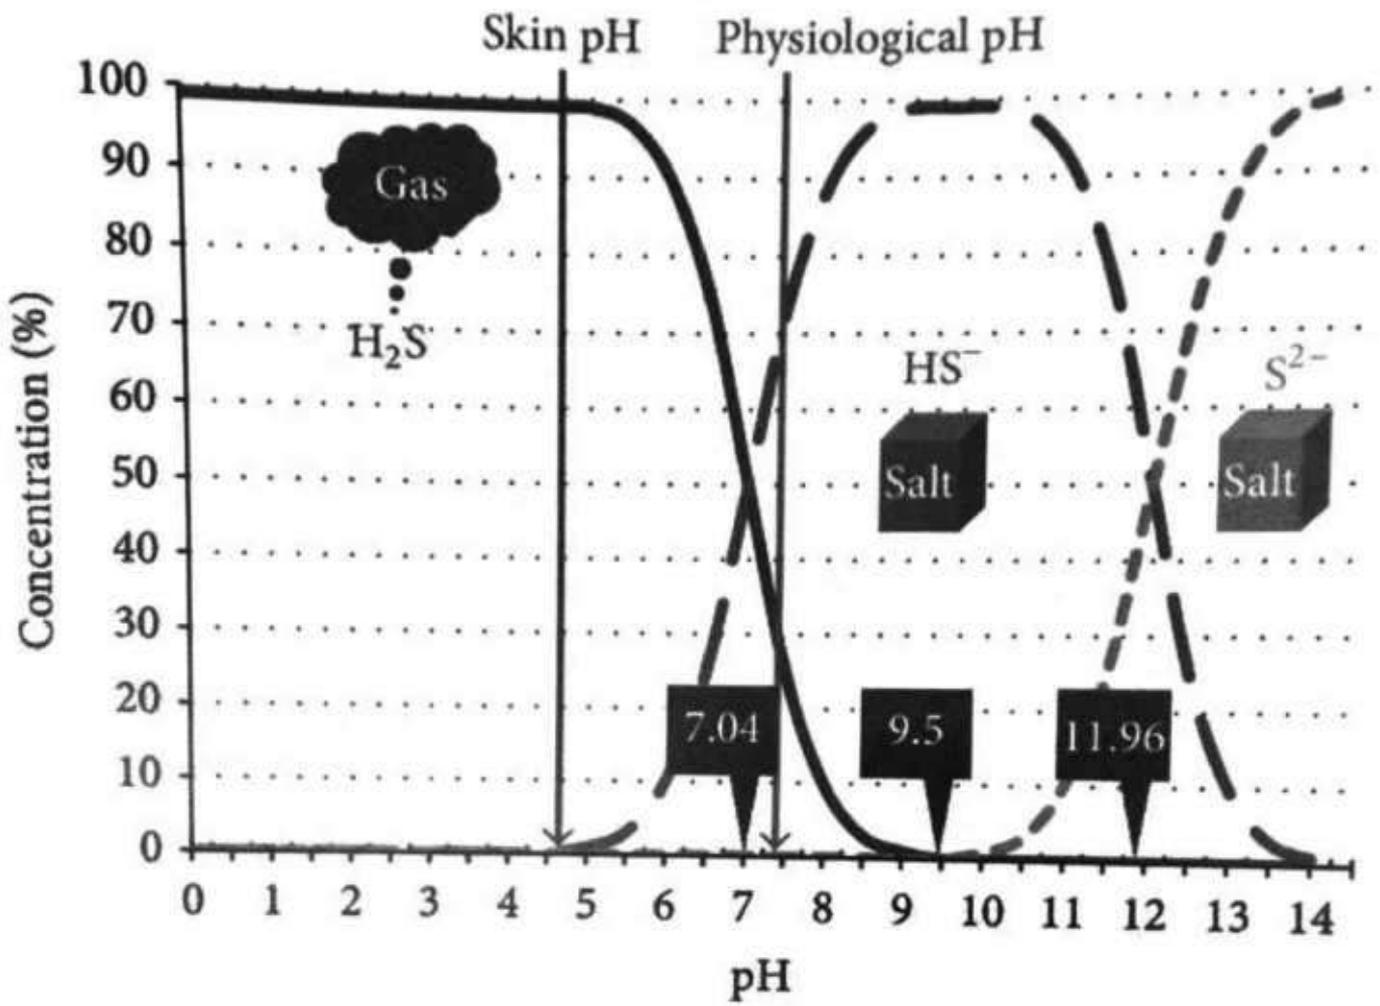
BIOGENIC SULPHURIC ACID ATTACK ON CONCRETE PIPE

In concrete pipes carrying aged sewage, in warm climates, the interior surface above the effluent level is subject to attack by sulfuric acid generated by bacterial action at the pipe wall, making use of hydrogen sulfide gas in the sewer atmosphere. The production of hydrogen sulphide and the consequential deterioration of concrete sewer pipes is first and foremost a function of sewer design and environmental factors. This process, known as "H₂S attack", can lead to very rapid deterioration.

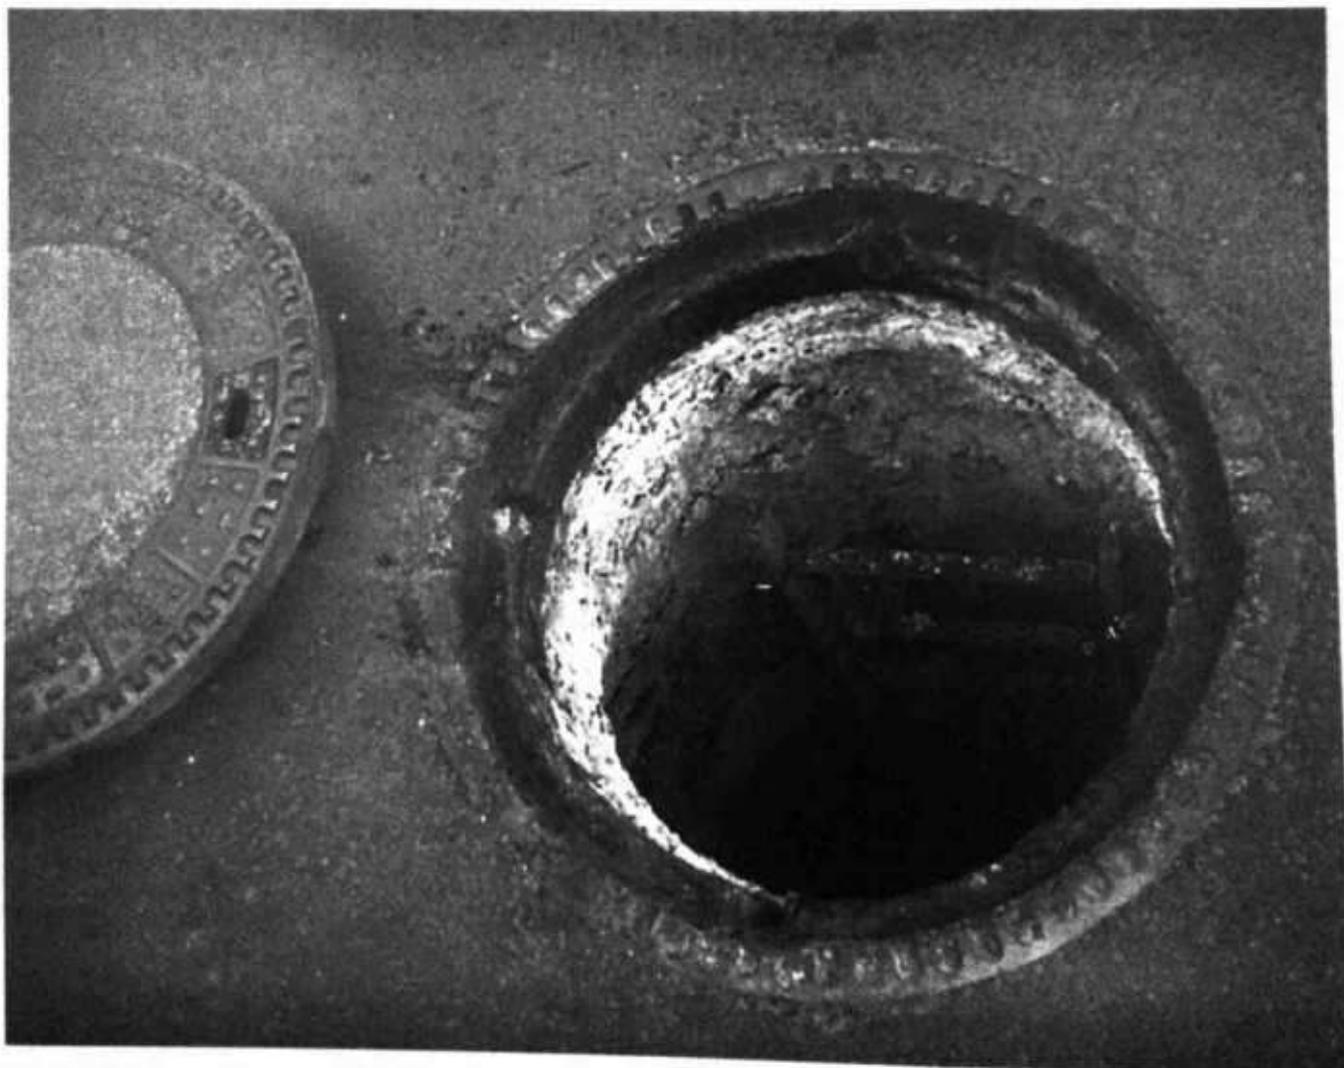
Damage in a manhole caused by biogenic sulfuric acid corrosion (BSC)
