## **Joint report of CPCB and GPCB in compliance with order of the Hon'ble NGT (Principal Bench, Delhi) in the matter O.A. No. 669 of 2018; Marvada Amrutlal Becharlal Vs. State of Gujarat**

# **Annexure-1**

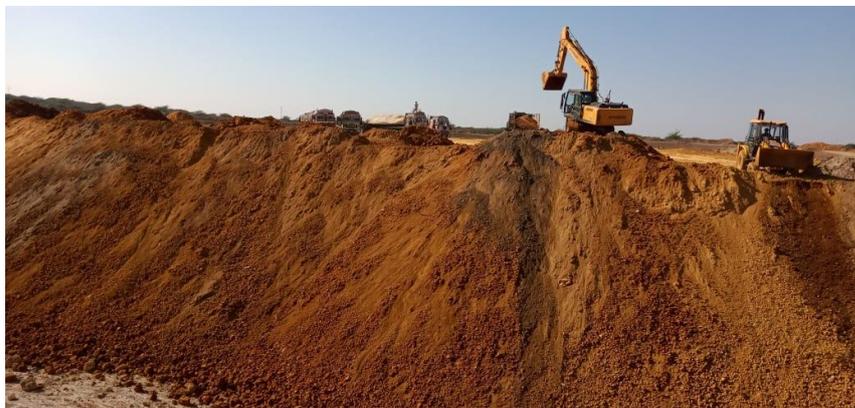
*Backfilling of abandoned mine of M/s. Ashapura Minechem Ltd. is in-progress*

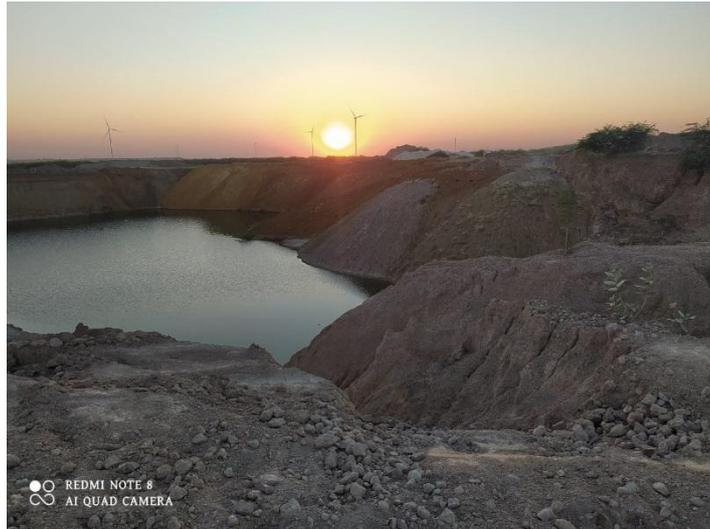
*Rain water accumulated in abandoned mine of M/s. Manico Minerals*

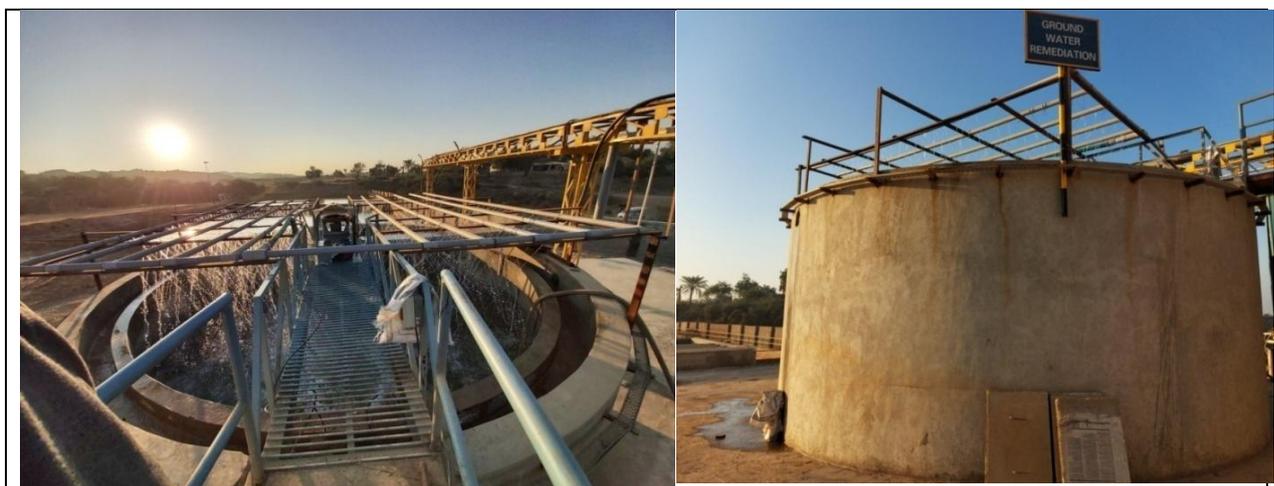
*RCC Tank with sprinkler system along with aeration*

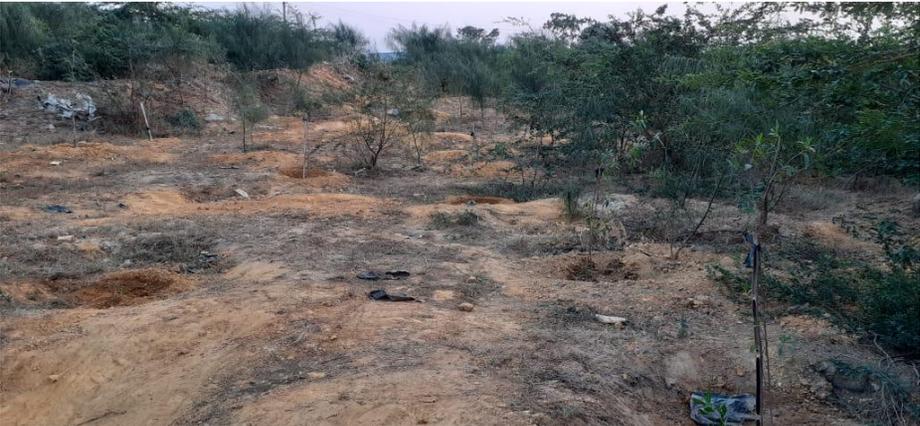
Sr. No.	Location/ Place	Observations	Photograph on 09& 10 /12/2020
1.	Behind Lehriya Hanuman Temple, Old stone mine, Kukma Village  23° 13' 21" N 69° 46' 21" E	1. Planataion carried out in about 1300 M <sup>2</sup> area on soil where Gypsum waste was dumped. 2. As per record, 150 plants of different species viz. Gulmohar, Neem, Cornocarpus, Badam and rain tree. 3. Irrigation is done through tankers.

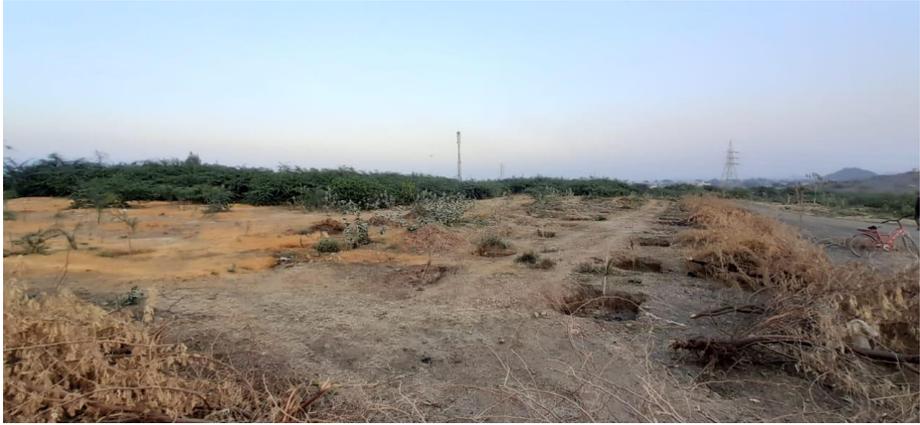
2.	Old stone mine of Prakash Patel, Survey No:331, Besides old HotMix plant, Kukma Village  23° 13' 16" N 69° 46' 3" E	1. Planataion carried out in about 1000 M <sup>2</sup> area on soil where Gypsum waste was dumped. 2. As per record, 150 plants of different species viz. Gulmohar, Neem, Cornocarpus, Badam and rain tree. 3. Irrigation is done through tankers.

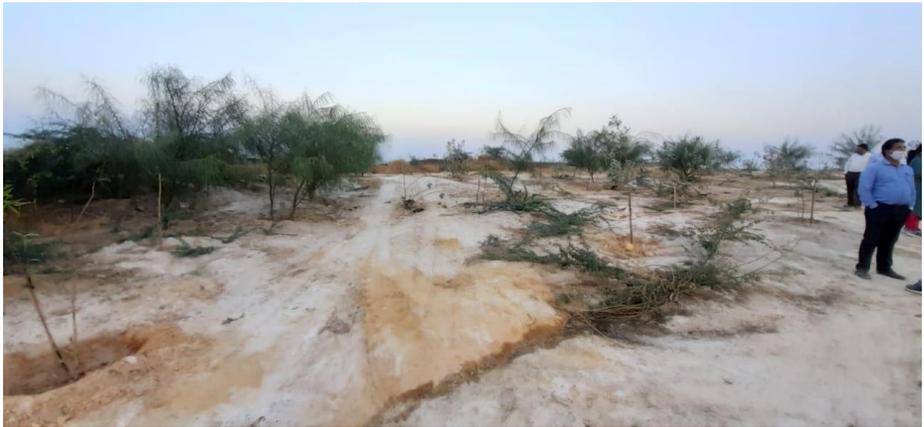
3.	<p>Behind khatri mills, Besides of above site, Traverse survey no: 331, government land, Kukma Village</p> <p>23° 13' 20" N 69° 45' 58" E</p>	<ol style="list-style-type: none"> <li>1. Planataion carried out in about 1200 M<sup>2</sup> areaon soil where Gypsum waste was dumped.</li> <li>2. As per record, 200 plants of different species viz. Gulmohar, Neem, Cornocarpus, Badam and rain tree.</li> <li>3. Irrigation is done through tankers.</li> </ol>

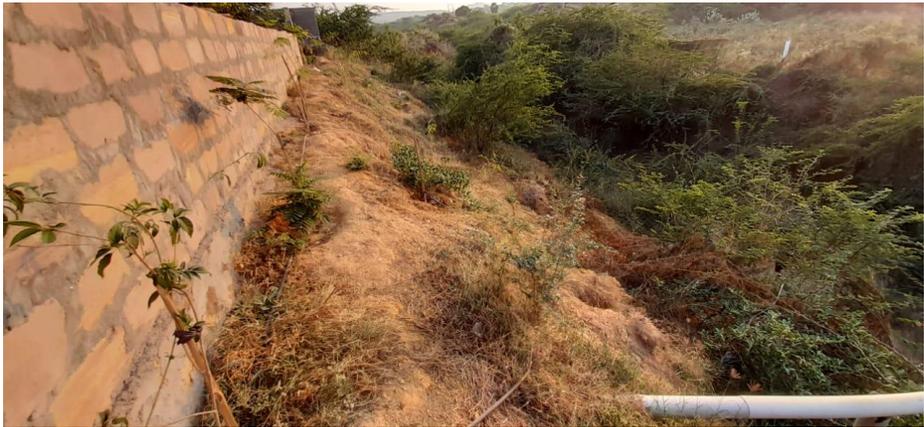
4.	<p>Natural drain between farm of Dinesh Maharaj and GovindVanker, survey no : 218, Kukma Village</p> <p>23° 11' 56" N 69° 46' 47" E</p>	<ol style="list-style-type: none"> <li>1. The area is a slope of a natural drainwhere Gypsum waste was dumped. Planataion carried out in about 500 M<sup>2</sup> area.</li> <li>2. As per record, 120 plants of different species viz. Gulmohar, Neem, Cornocarpus, Badam and rain tree.</li> <li>3. Drip-irrigation system is provided which is connected to Dinesh Maharaj bore-well.</li> </ol>

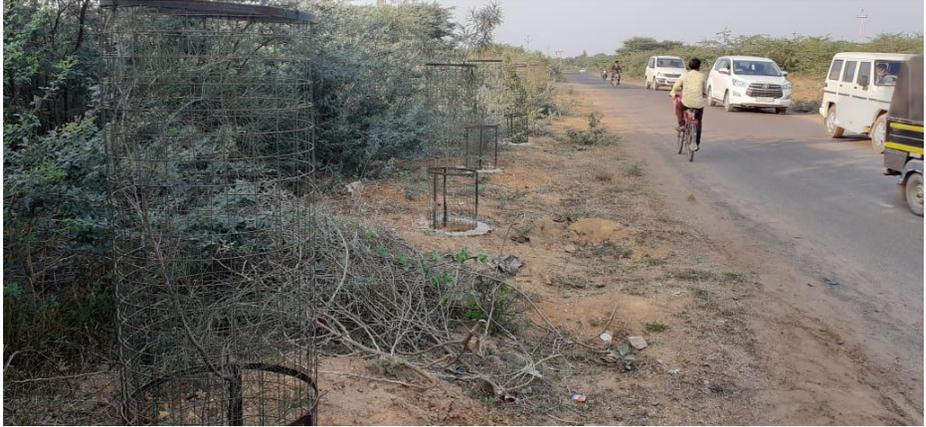
5.	<p>Besides of Kukma- Lakhond villageRoad</p> <p>23° 13' 50" N 69° 46' 48" E</p>	<ol style="list-style-type: none"> <li>1. Planataion carried out in about 1.5 km length along the road sidewhere Gypsum waste was dumped.</li> <li>2. As per record, 150 plants of different species viz. Gulmohar, Neem, Cornocarpus, saru, badam tree.</li> <li>3. Irrigation is done through tankers.</li> </ol>

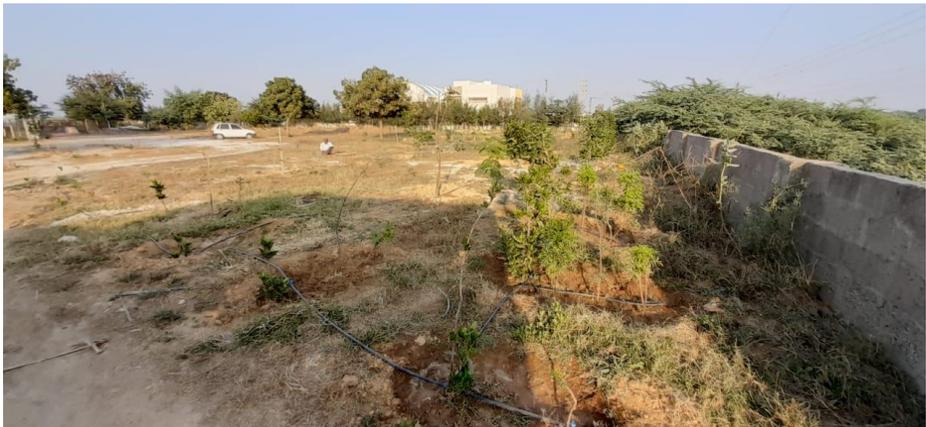
6.	<p>VrundavanGirGau dham, ShreeSwaminaray an Mandir, BesidesAshapura Colony,Bhachau Road</p> <p>23° 13' 49" N 69° 46' 48" E</p>	<ol style="list-style-type: none"> <li>1. Planataion carried out in about 1200 M<sup>2</sup> areaon soil where Gypsum waste was dumped.</li> <li>2. As per record, 200 plants of different species viz. Gulmohar, Neem, Cornocarpus, saru, badam tree.</li> <li>3. Drip-irrigation system is provided which is connected to GWIL line of gir gaudhan.</li> </ol>

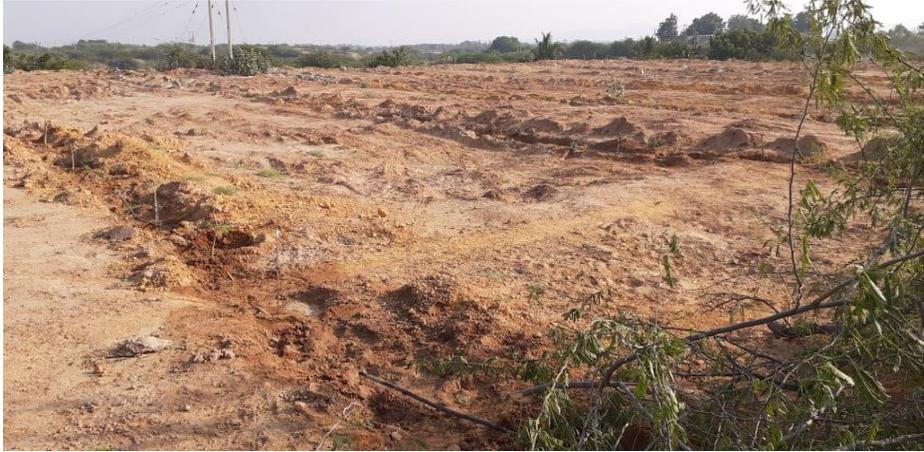
7.	<p>Land of Lakhond Village</p> <p>23° 15' 12" N 69° 46' 41" E</p>	<p>1. Planation carried out in about 4500M<sup>2</sup> area on soil where Gypsum waste was dumped.</p> <p>2. As per record, 500 plants of different species viz. Gulmohar, Neem, Cornocarpus, badam tree, rain tree, banyan tree.</p> <p>3. Drip-irrigation system is provided which is connected to the nearby bore-well.</p>

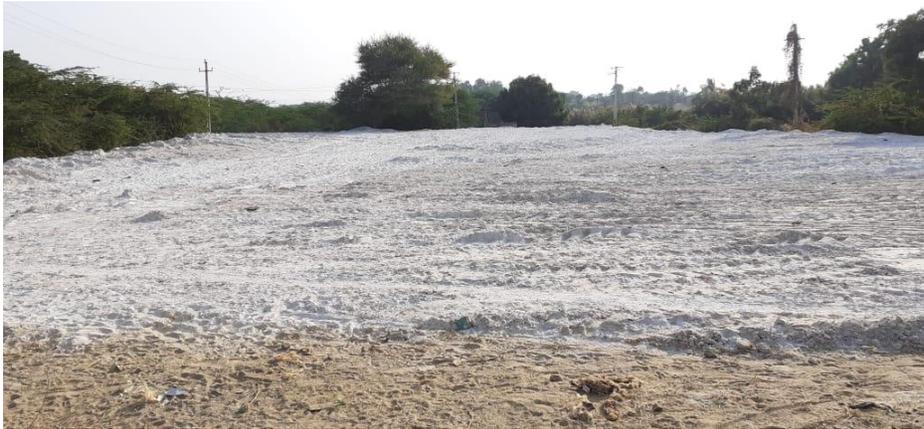
8.	<p>Adjacent above site as mentioned in sr no (14). Land of Lakhond Village</p> <p>23° 15' 11" N 69° 46' 40" E</p>	<p>About 280 MT dumped Gypsum waste has been lifted and the location is covered with silica sand.</p>

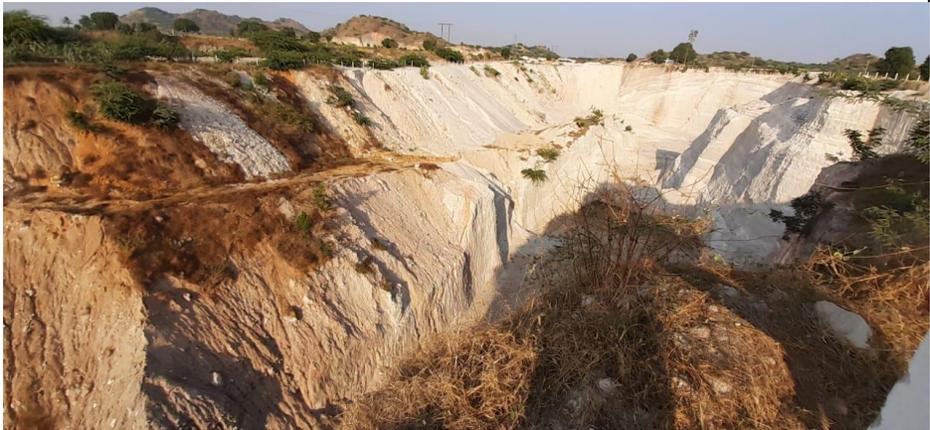
<p>9.</p>	<p>China Clay mine of Vastabhai, Village lakhond, Abandoned mine</p> <p>23° 15' 39" N 69° 47' 17" E</p>	<p>The dumped Gypsum waste could not be removed / managed from this site which is an abandoned mine due legal dispute between the mine owner and local administration (FIR has been lodged on the mine owner for carrying out excess mining).</p>

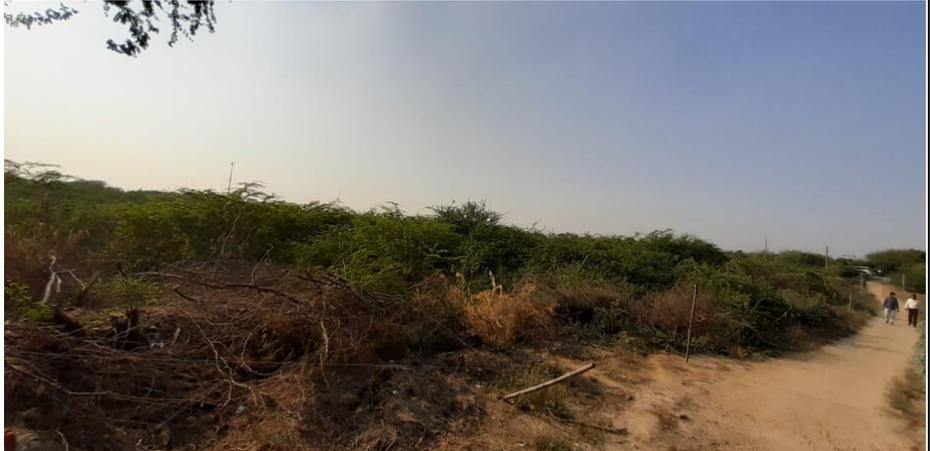
<p>10.</p>	<p>On Government land on Padhdharvillage</p> <p>23° 14' 29" N 69° 48' 44" E</p>	<p>The location is covered naturally with dense wild bushes (Prosopis Julifora) and hence no further plantation is required.</p>

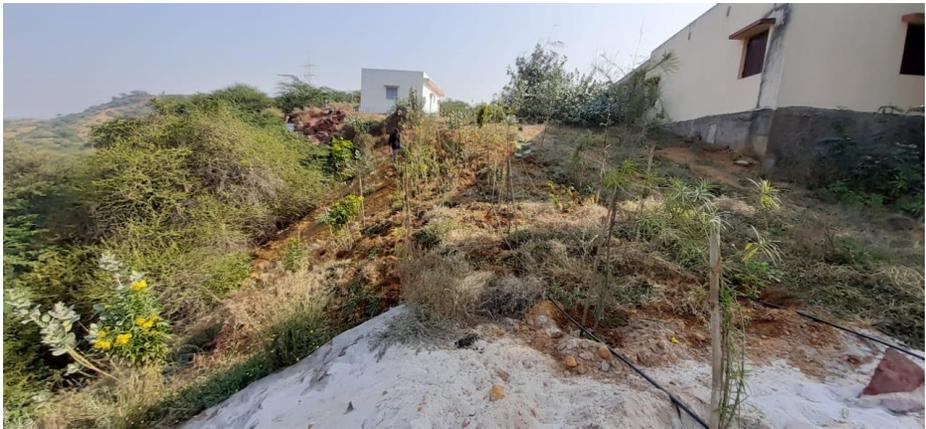
11.	<p>PithoradadaMandi r, Ler Village.</p> <p>23° 10' 23" N 69° 46' 05" E</p>	<ol style="list-style-type: none"> <li>1. The area belongs to a temple of Ler village. Planataion carried out in about 300 M<sup>2</sup> areawhere Gypsum waste was dumped.</li> <li>2. As per record, 150 plants of different species viz. Gulmohar, Neem, Cornocarpus, saru.</li> <li>3. Drip-irrigation system is provided which is connected to the GWIL line.</li> </ol>

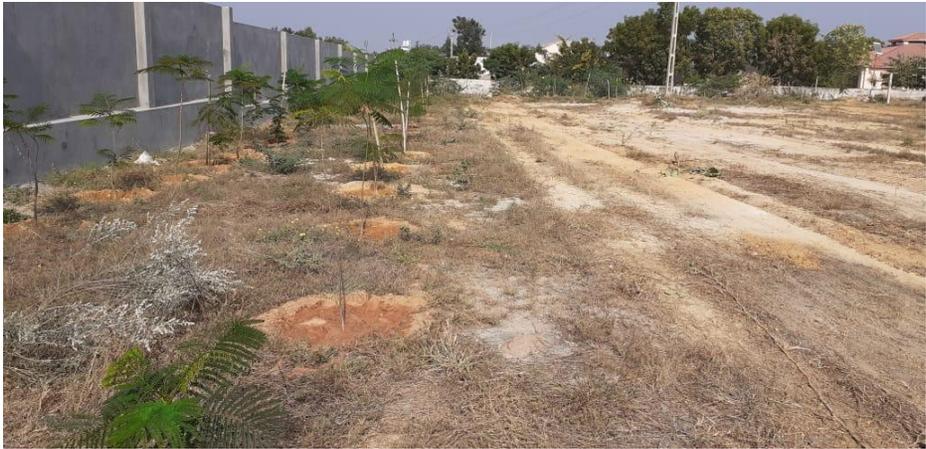
12.	<p>MaldhariMangal MandirChhatralay , Bhujodi</p> <p>23° 13' 45" N 69° 44' 09" E</p>	<ol style="list-style-type: none"> <li>1. The area is an open ground of a school cum hostel and planataion carried out in about 1200 M<sup>2</sup> area on the sides of the ground. It is informed that land scaping of middle part of the ground will be done by the unit as per request of the school administration.</li> <li>2. As per record, 150 plants of different species viz. Gulmohar, Neem, Cornocarpus.</li> <li>3. Irrigation is done through tankers.</li> </ol>

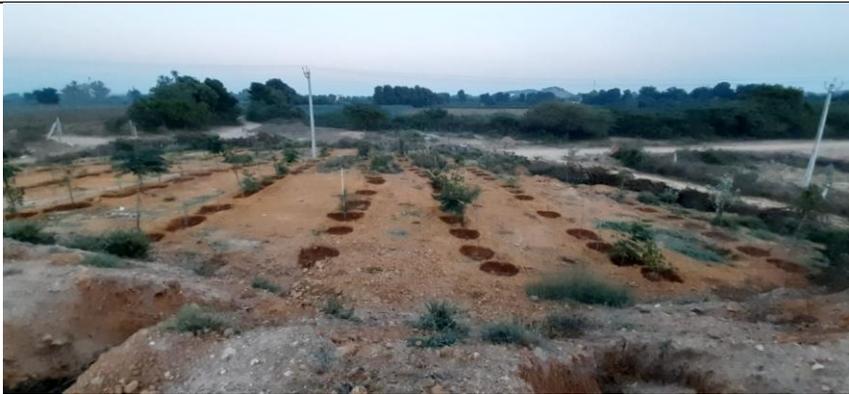
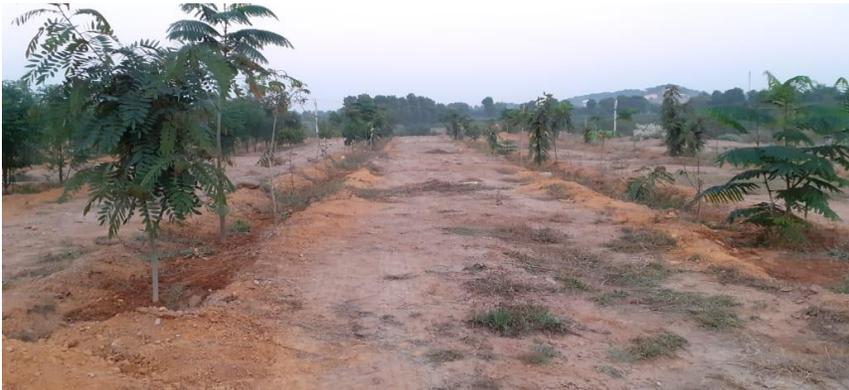
13.	Shri Vakal Mata Mandir, Village: Bhujodi  23° 13' 35" N 69° 44' 41" E	<ol style="list-style-type: none"><li>1.The area is an open land and planataion carried out in about 1200 M<sup>2</sup> area where Gypsum waste was dumped.</li><li>2. As per record, 550 plants of different species viz. Gulmohar, Neem, Cornocarpus, badam tree, rain tree, banyan tree and saru.</li><li>3. Irrigation is done through tankers.</li></ol>
-----	-----------------------------------------------------------------------------------	---------------------------------------------------------------------------------------------------------------------------------------------------------------------------------------------------------------------------------------------------------------------------------------------------------------------------------------------------------------
