**BEFORE THE NATIONAL GREEN TRIBUNAL,
CENTRAL ZONE BENCH, BHOPAL
ORIGINAL APPLICATION NO. 62/2023 (CZ)**

**FACTUAL REPORT OF ILLEGAL SAND MINING ACTIVITIES IN
THE KHARI NADI RIVER BED**

1. That by order dated 31.07.2023 this Hon'ble Tribunal has appointed the undersigned as Amicus Curiae in the present matter to undertake inspection and give correct observation about the relevant issues raised in the present matter. In view of the said order the undersigned took physical inspection and visited the concerned areas alongwith the members of the joint committee or their representatives on 19.08.2023 and 09.09.2023 and apprise this Court about the factual position.

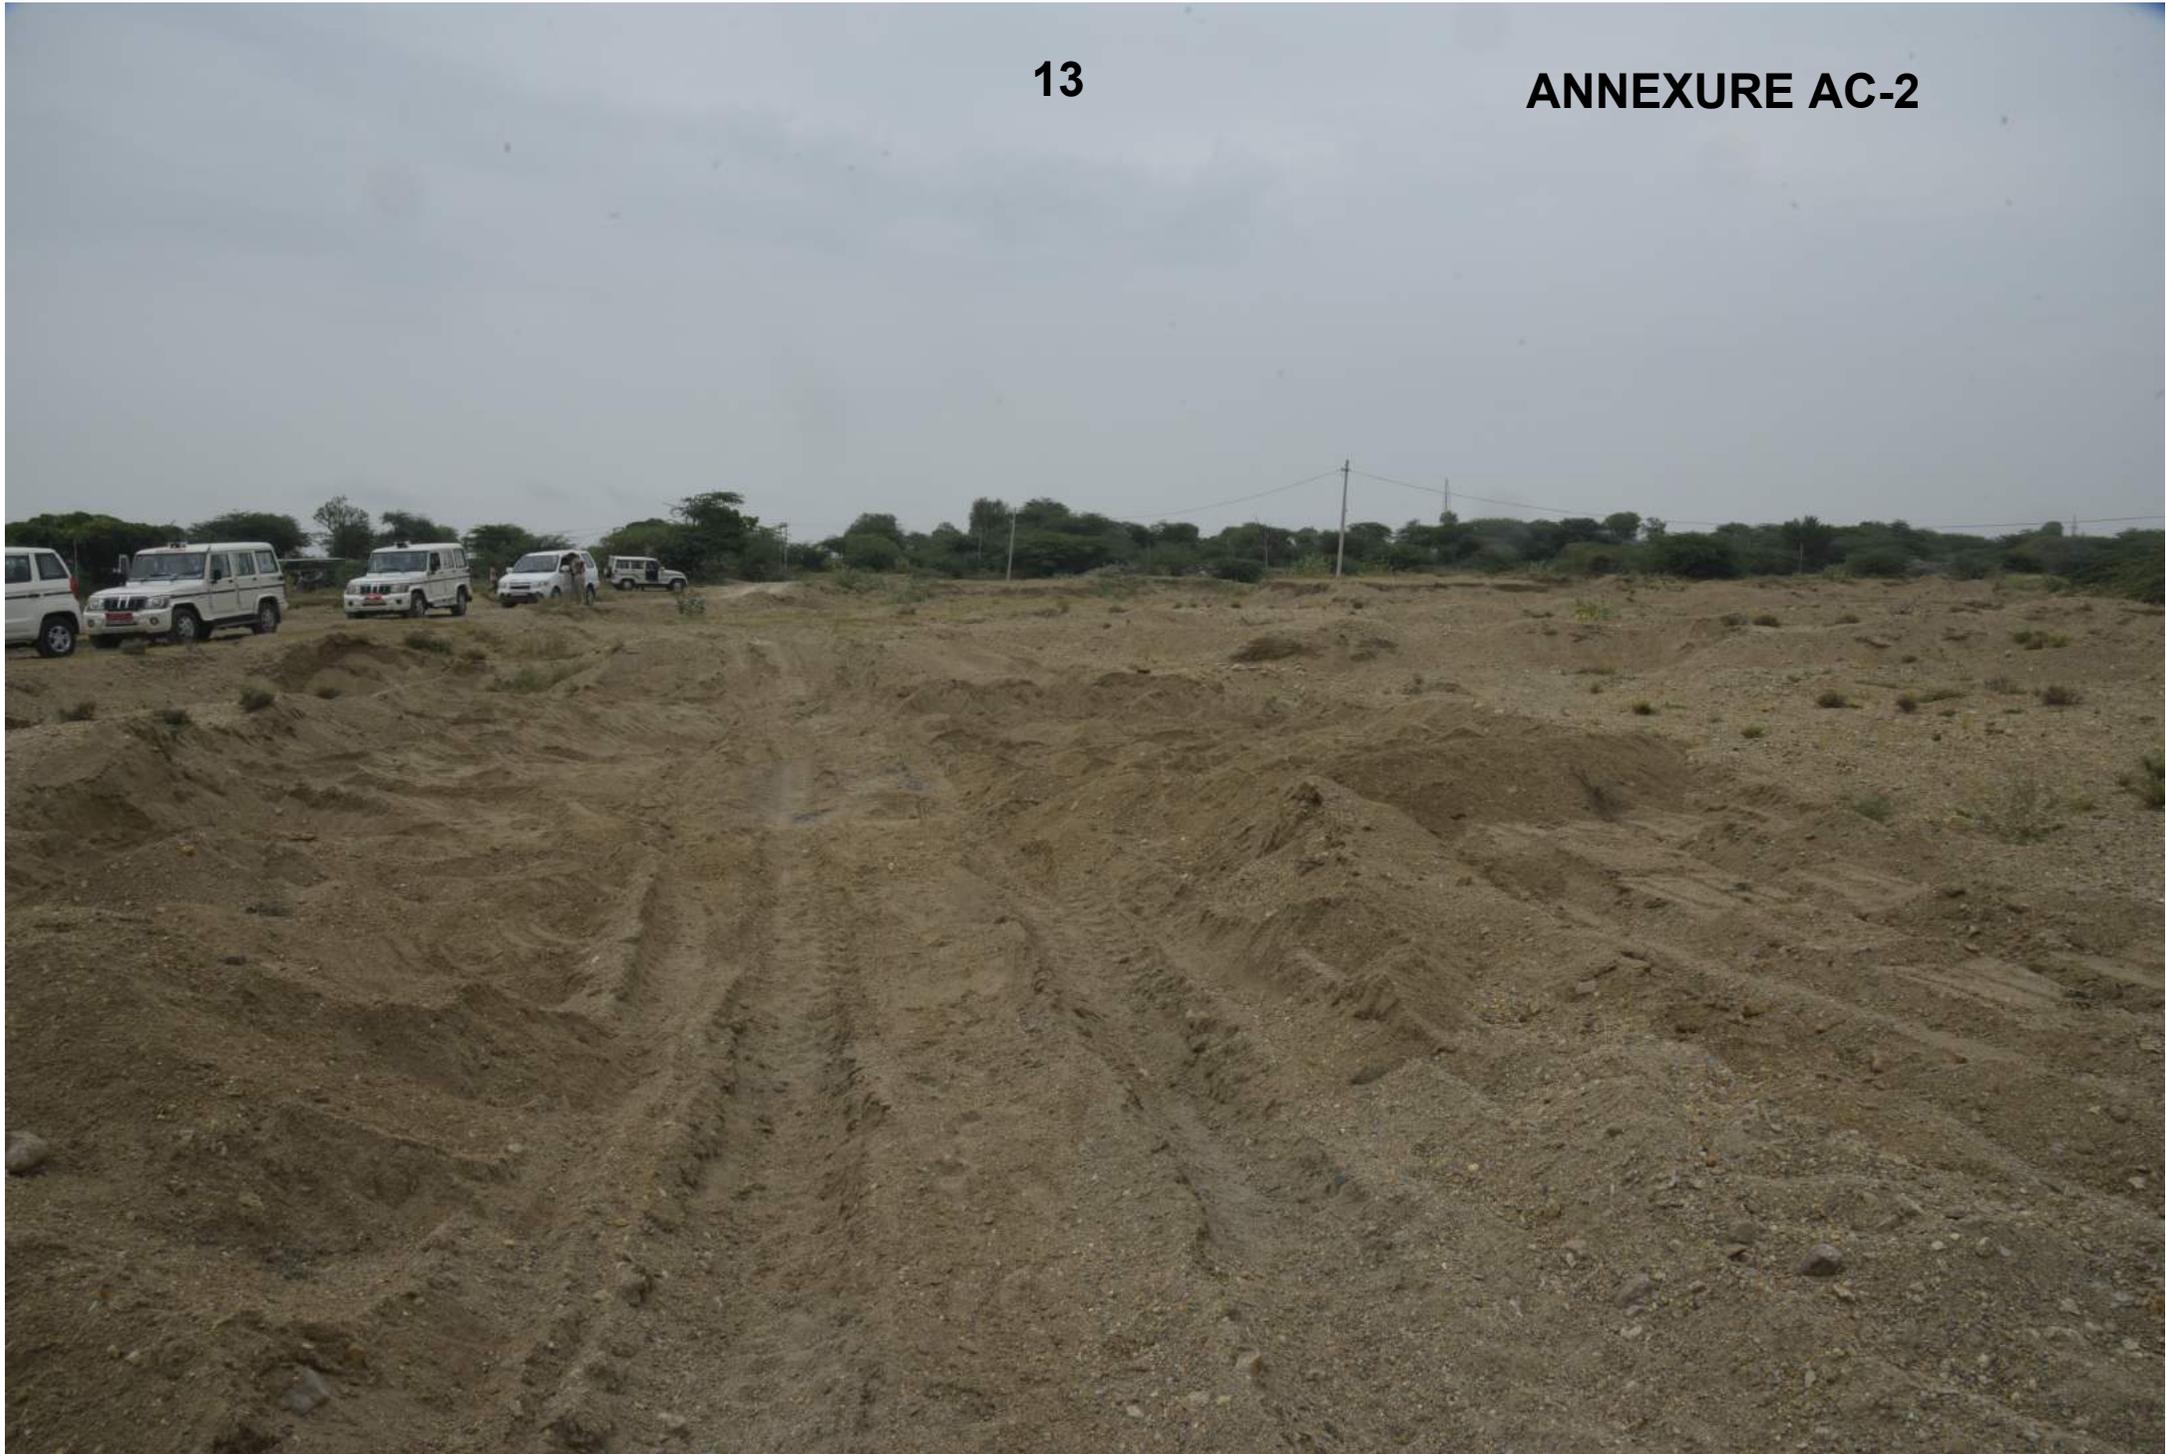
- During inspection it was informed that no mining activities are carried out by the lease holders due to expiry of lease and onset of monsoon, therefore, presence of dumpers and other heavy vehicles is not seen on the mining site. But at illegal mining site at Baral presence of fresh marks of tyres of heavy vehicles is seen and the same is verified by the member of CPCB and other committee members. Relevant photographs of the presence of fresh tyres marks of heavy vehicles at Baral is **ANNEXURE AC-2 (Pg. No. 13)**

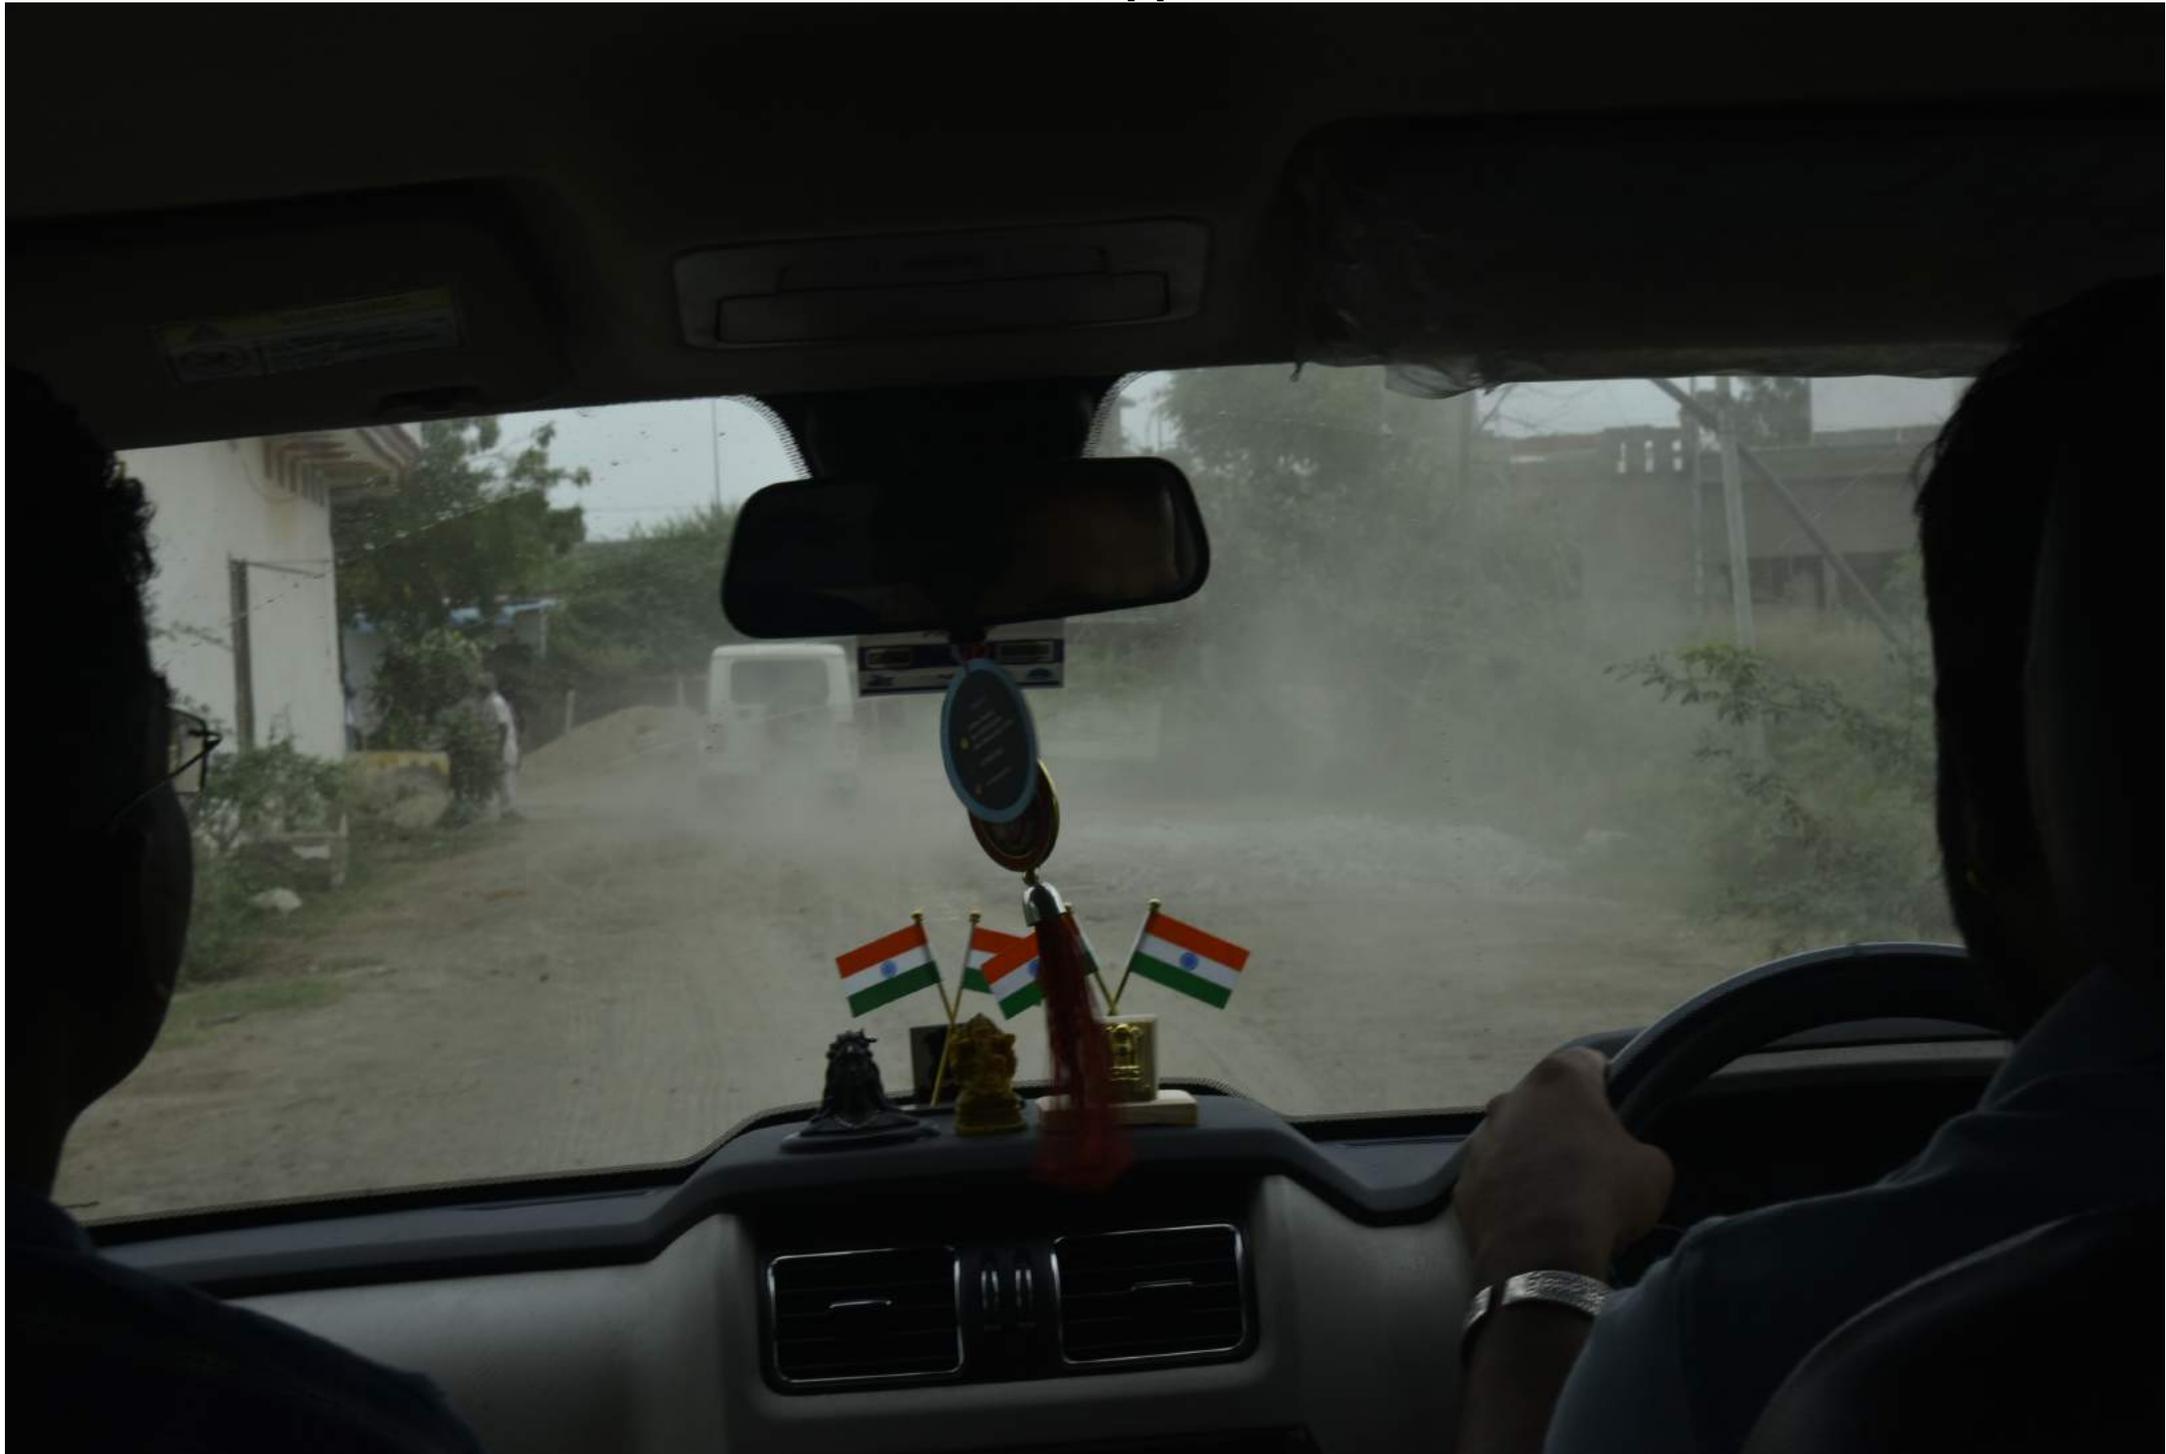
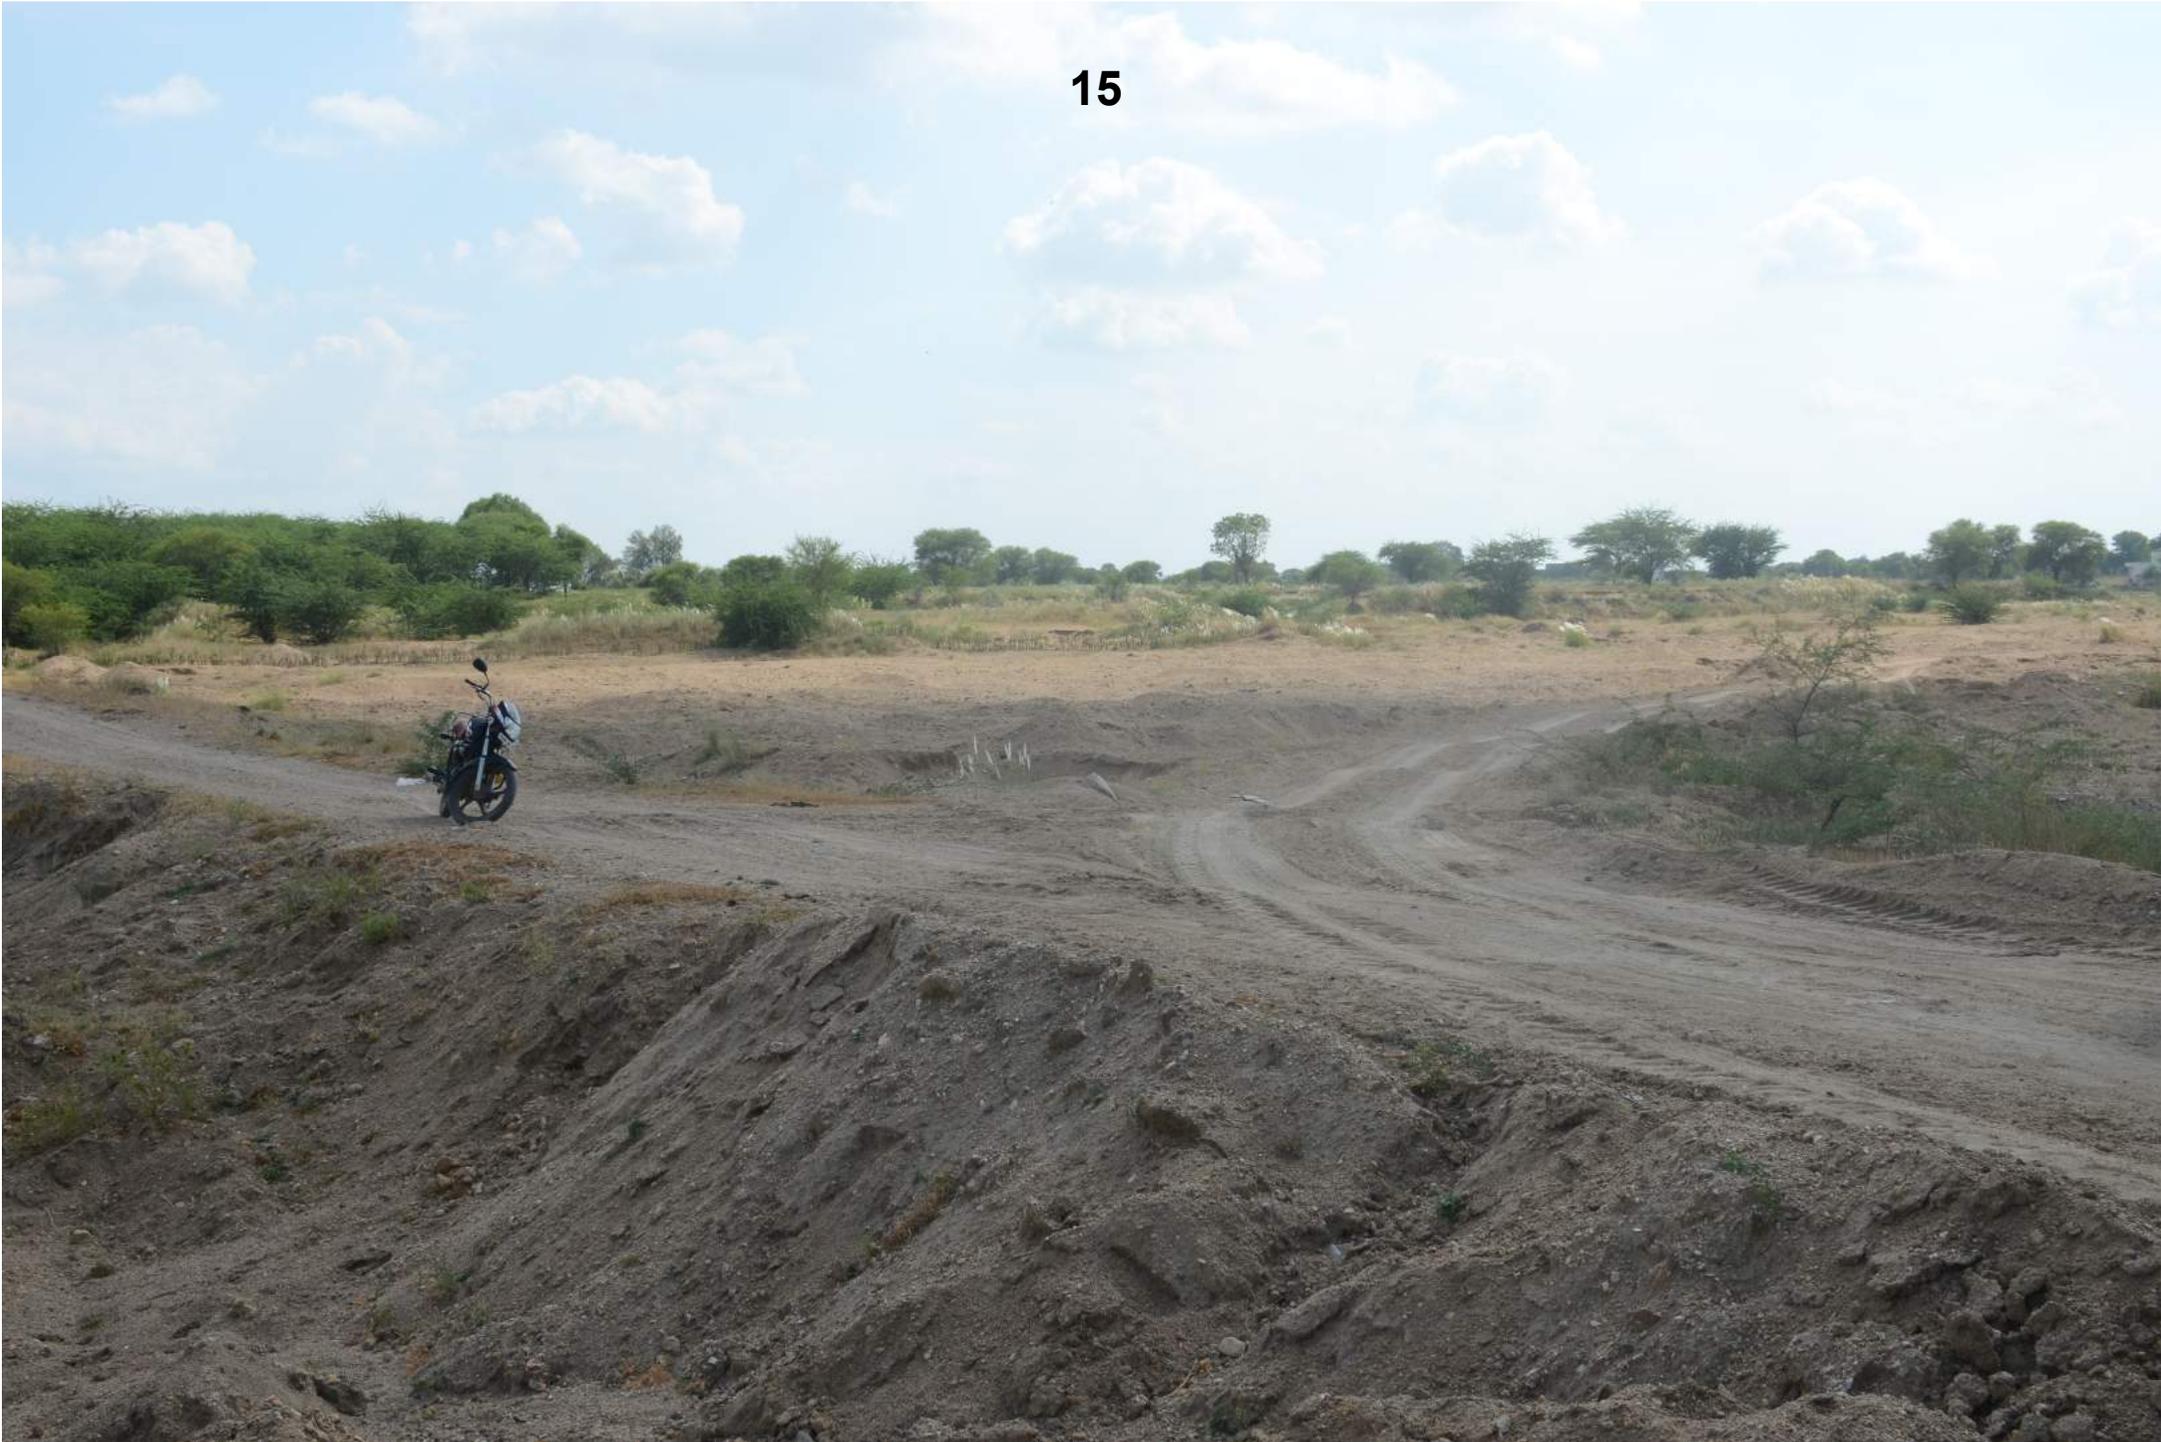
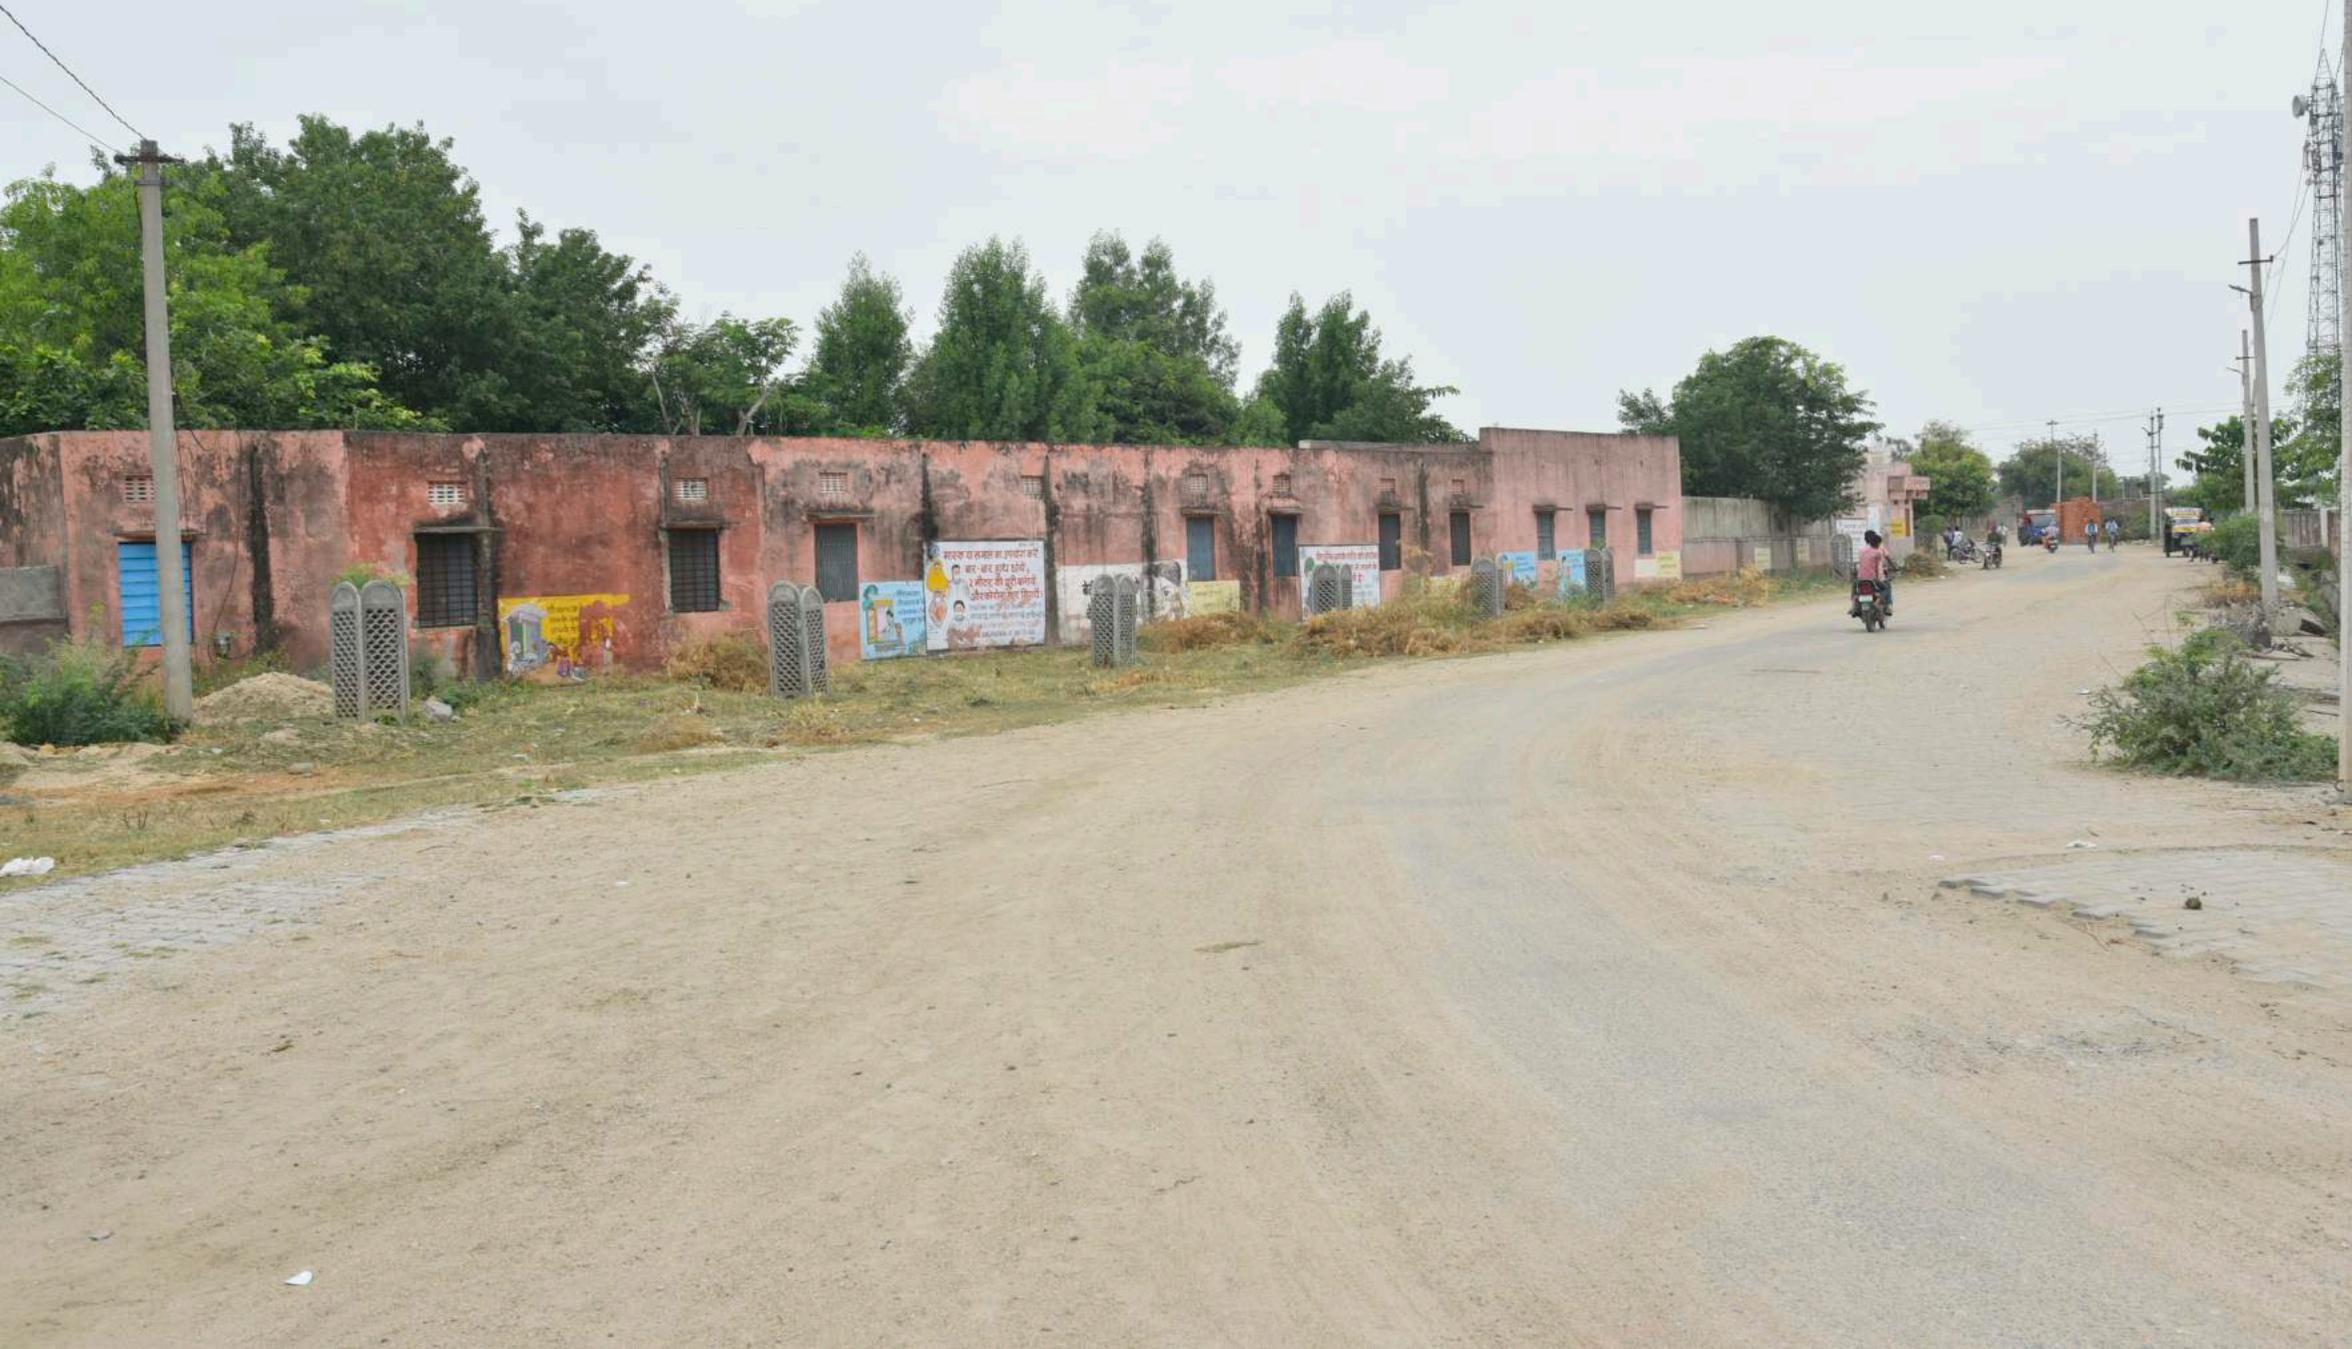
- Approach road from villages to mining sites are generally kacha. Roads connected to villages at most of the places are generally found to be damaged. Villagers present at the sites complained that the village roads were damaged due to usage of heavy vehicles like dumpers on the roads by the lease holders.
- Fugitive dust can be commonly seen at the places where there is kacha roads. Relevant photographs of the fugitive dust due to running of vehicles on kacha road is **ANNEXURE AC-3**(Pg. No. 14-16)

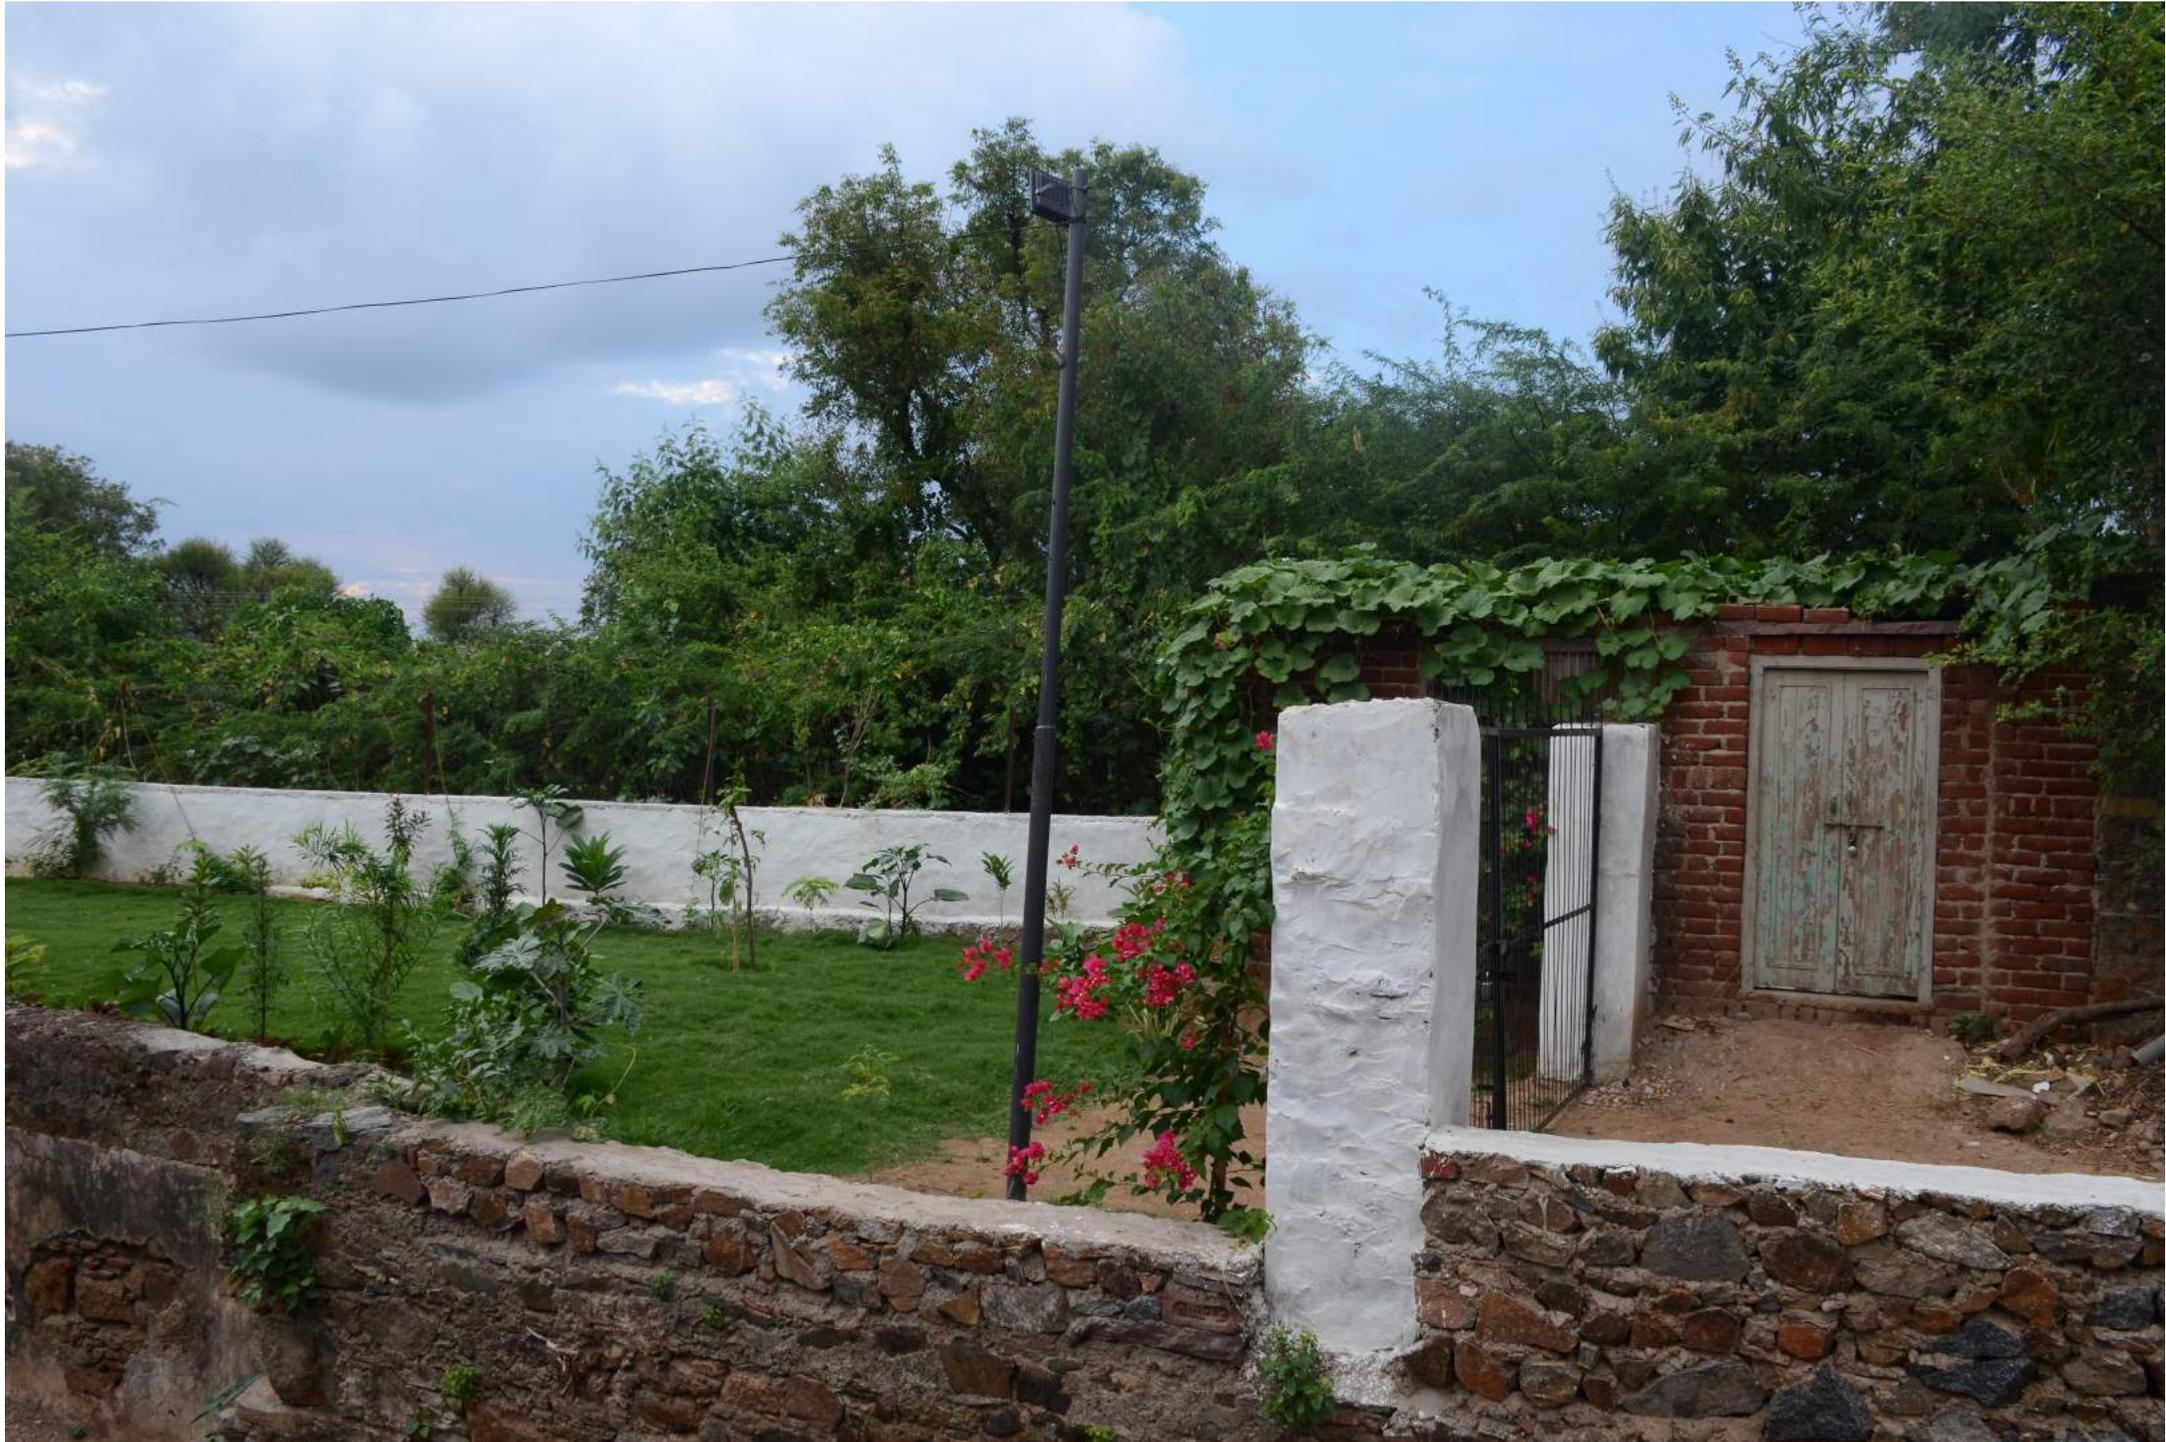
Bhinay	<p>No fresh mining activity was seen.</p>	<p>No plantation is being done in and around mining area.</p> <p>Around 590 saplings were claimed to be planted at various locations. On verification for showing plants the leaseholder took to a site around 20kms away from mining site and there also it was found that they were not trees but flowering plants of temple area. was found that they were not trees but flowering plants. Recent photograph of saplings of flowering plant shown to be planted</p>

by leaseholder is <u>ANNEXURE CA-14</u> (Pg. No. 49)
--	--	--
