REPORT

**THE FACT-FINDING JOINT COMMITTEE
(FFJC)**

in Original Application no. 327/2023

*(News item Published in India Today dated
30.4.2023 titled "3 minors among 11 dead in
Ludhiana Gas leak", Punjab Govt. announces 2
Lakh Ex-Gratia)*

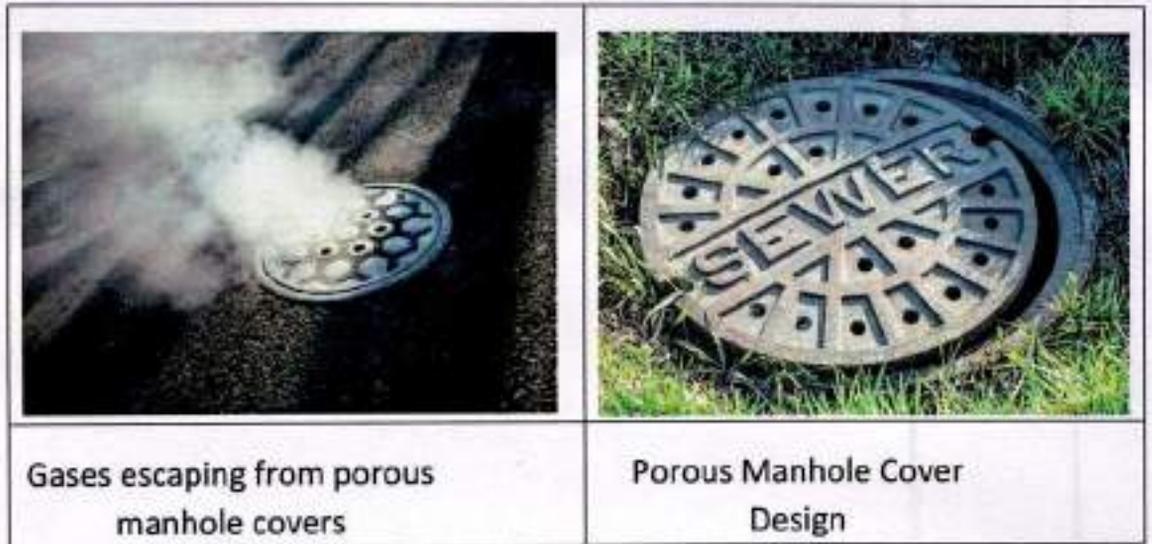
3. The manhole covers are sometimes provided with perforations, through which the sewer gets exposed to the atmosphere. This will help in achieving some ventilation, but will cause more nuisances (Pictures attached).

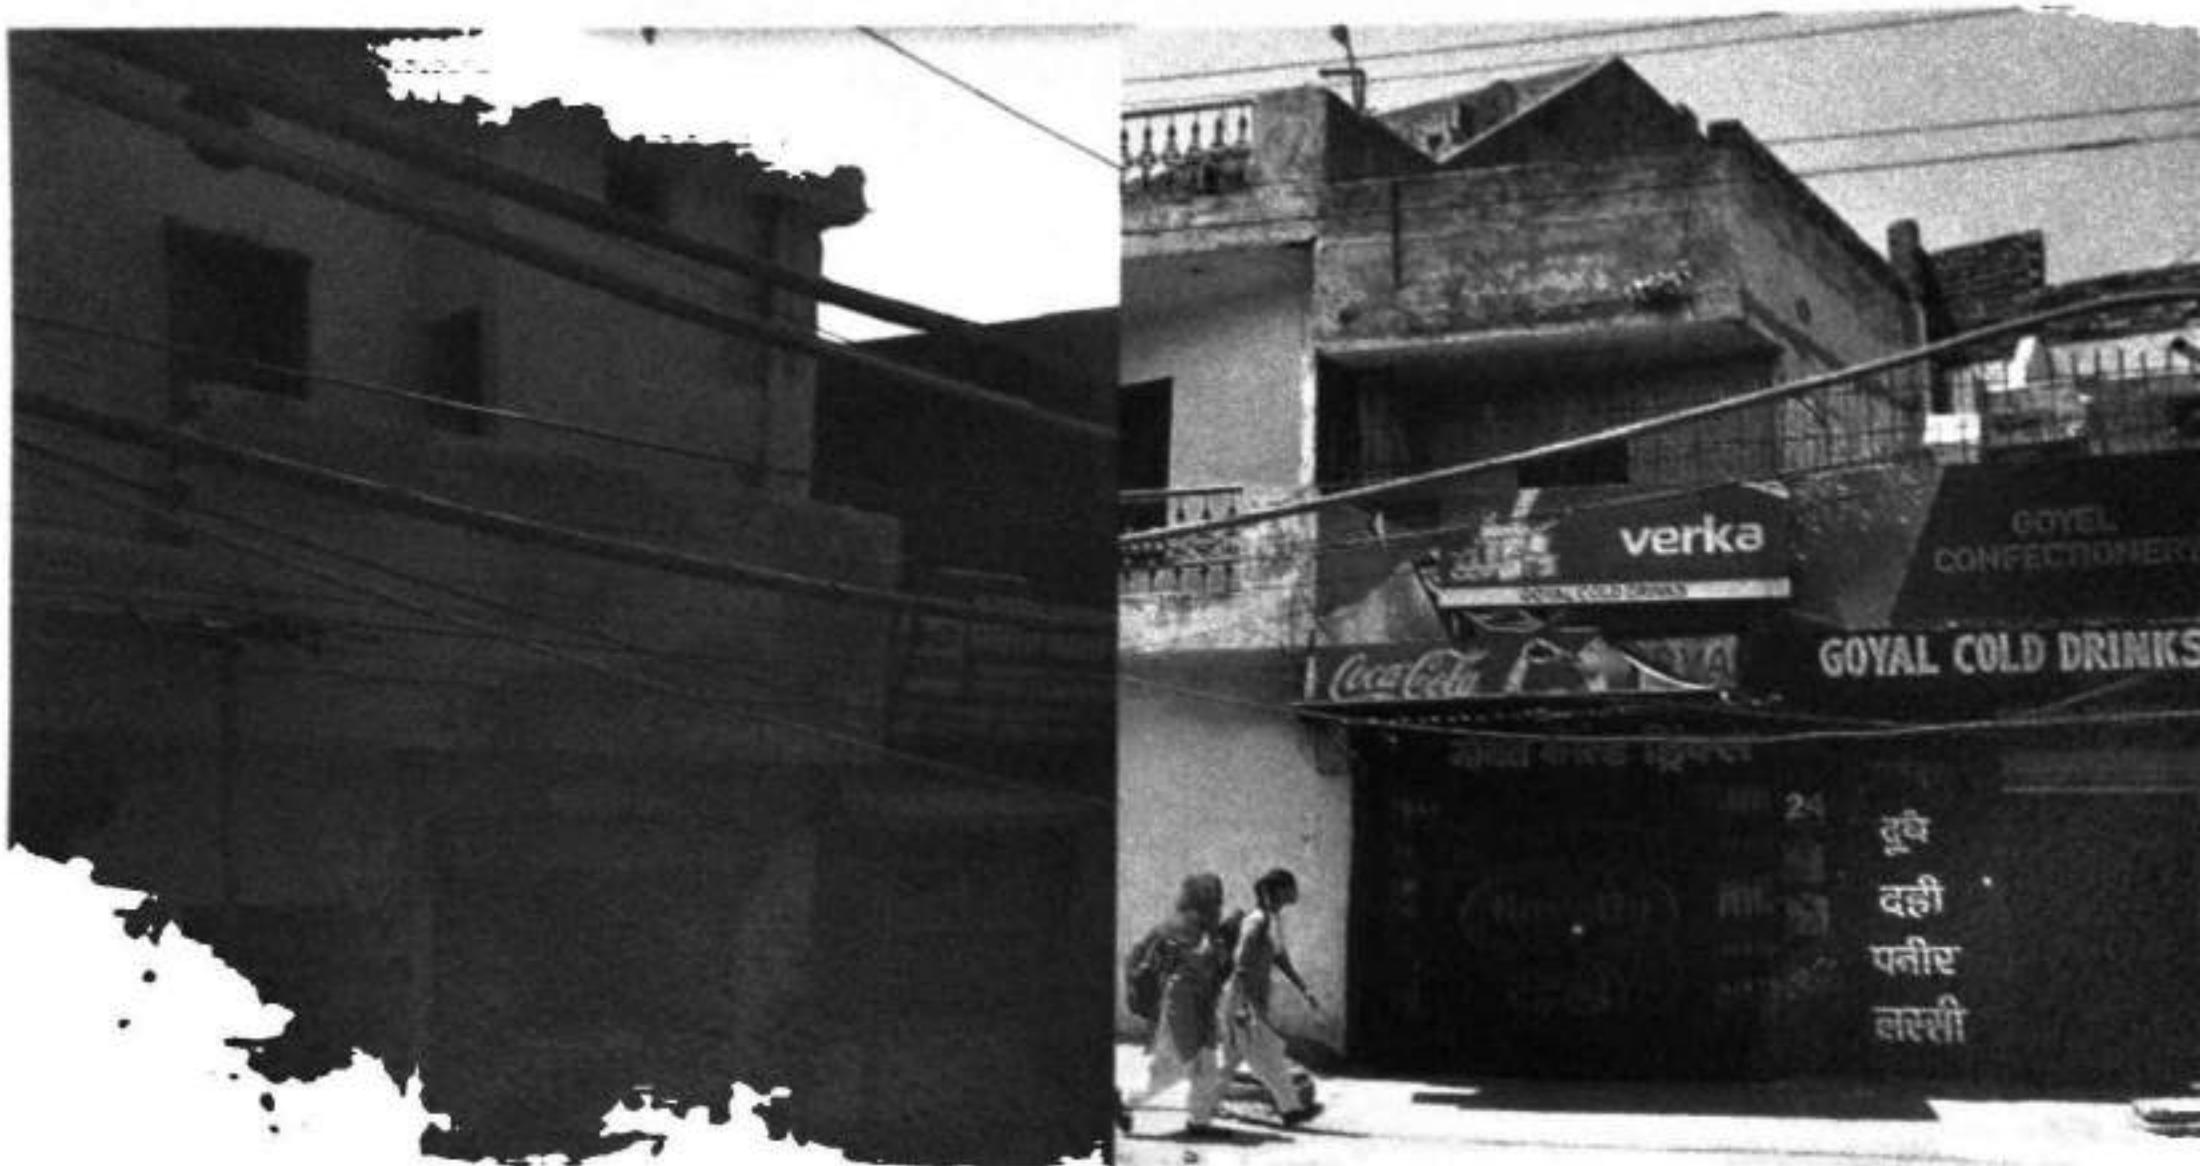
NO OR POOR VENTILATION IN THE HOUSES OF THE DECEASED

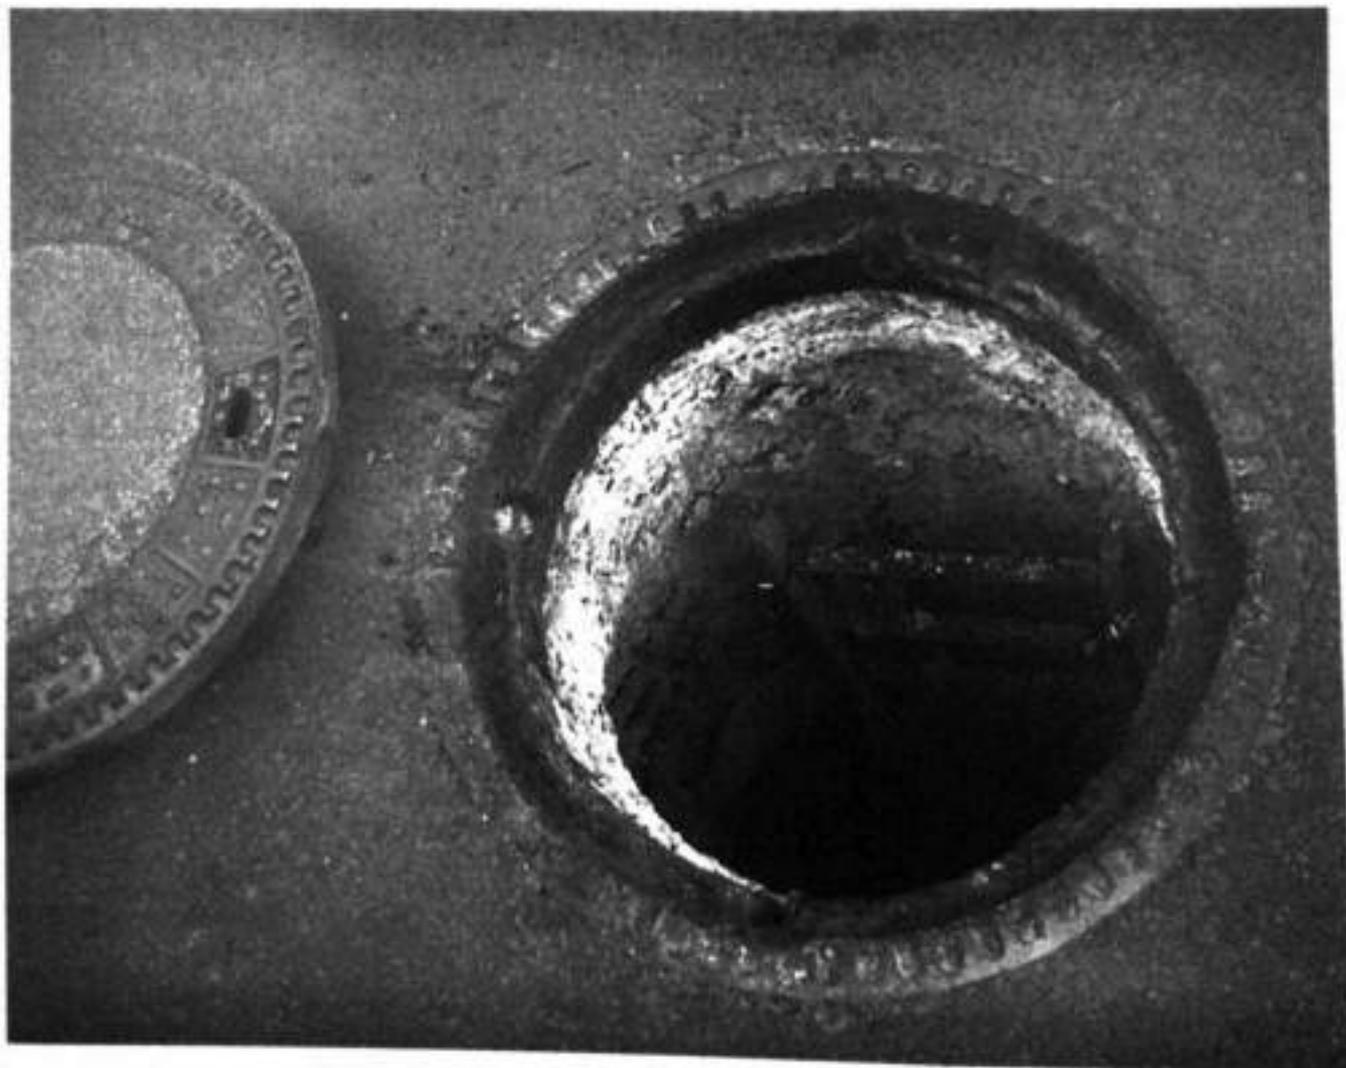
Damage in a manhole caused by biogenic sulfuric acid corrosion (BSC)

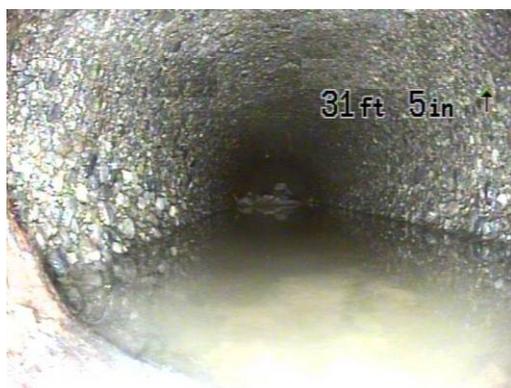
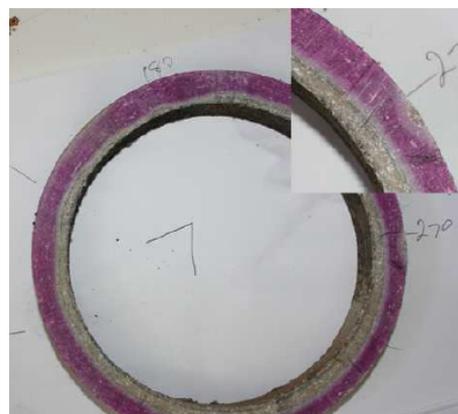
Figure 5: *Corroded concrete pipe* **Figure 6:** *AC Sewer rising main-internal leaching due to H₂S gas*

- Concrete – microbial induced corrosion via acid attack (refer figure 5)
- Asbestos cement pipe – lime leaching making pipe susceptible to cyclic failure (refer Figure 6)
- Ferrous – found in older pipes and fittings, knifegate valves, penstocks, inlets etc.
- Plastic – not likely but some evidence of pock-marks in HDPE pipe

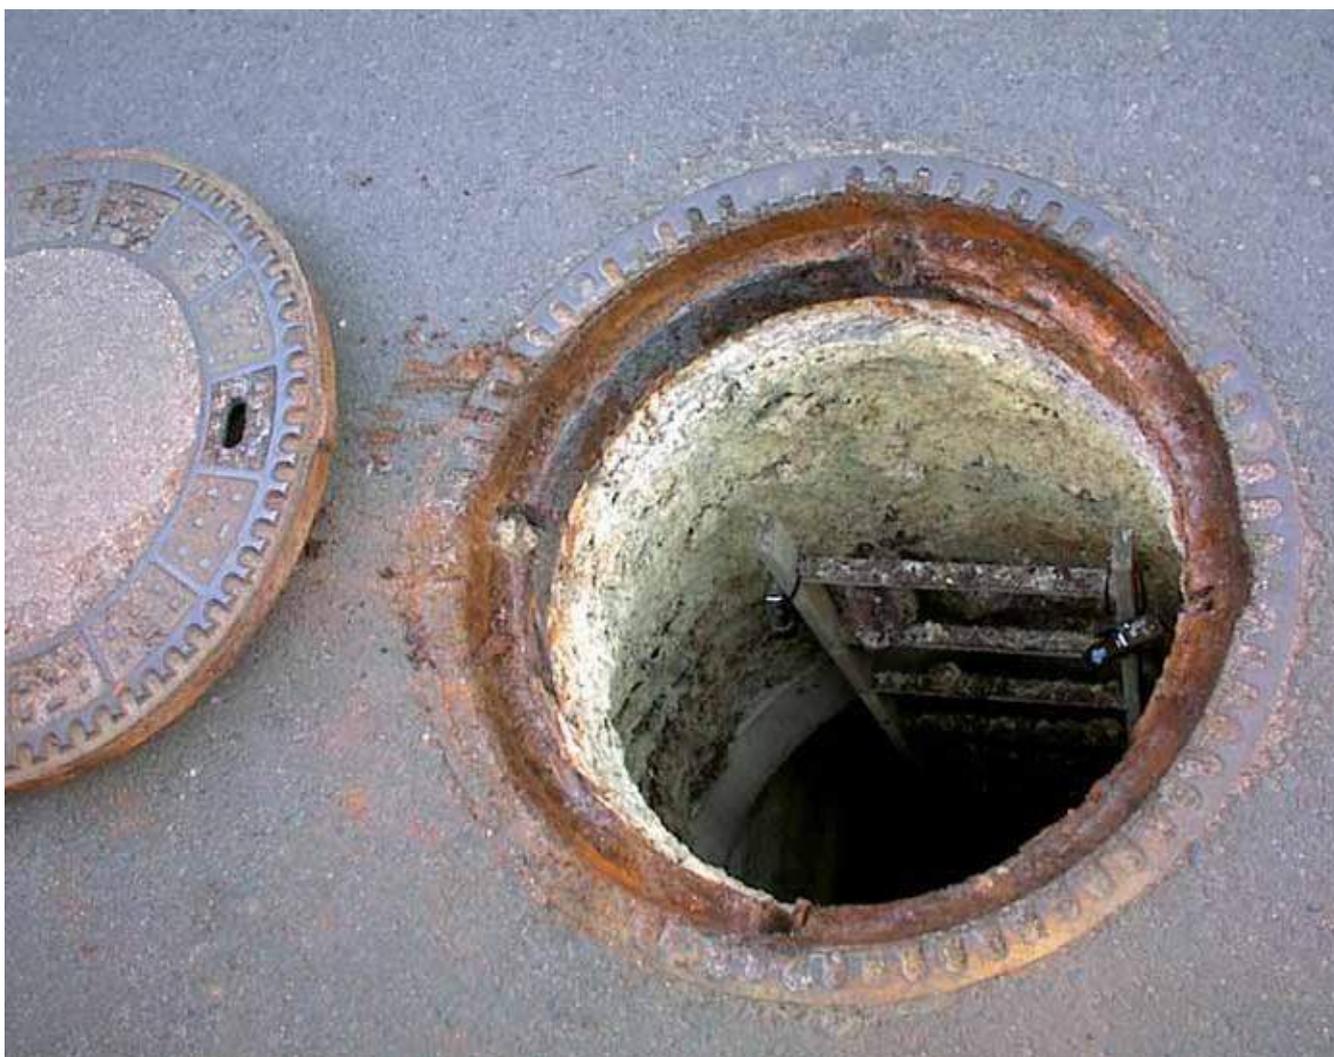
Damage in a manhole caused by biogenic sulfuric acid corrosion (BSC)
