Sub: Report of the High-Level Committee set up by the Hon'ble National Green Tribunal (Principal Bench) vide order dated 19.02.2021 in OA No. 43/20202(EZ), in the matter of Bonani Kakkar Vs. Oil India Limited

Re: Baghjan Blow out incident in Assam

Enclosed : Report of the High Level Committee

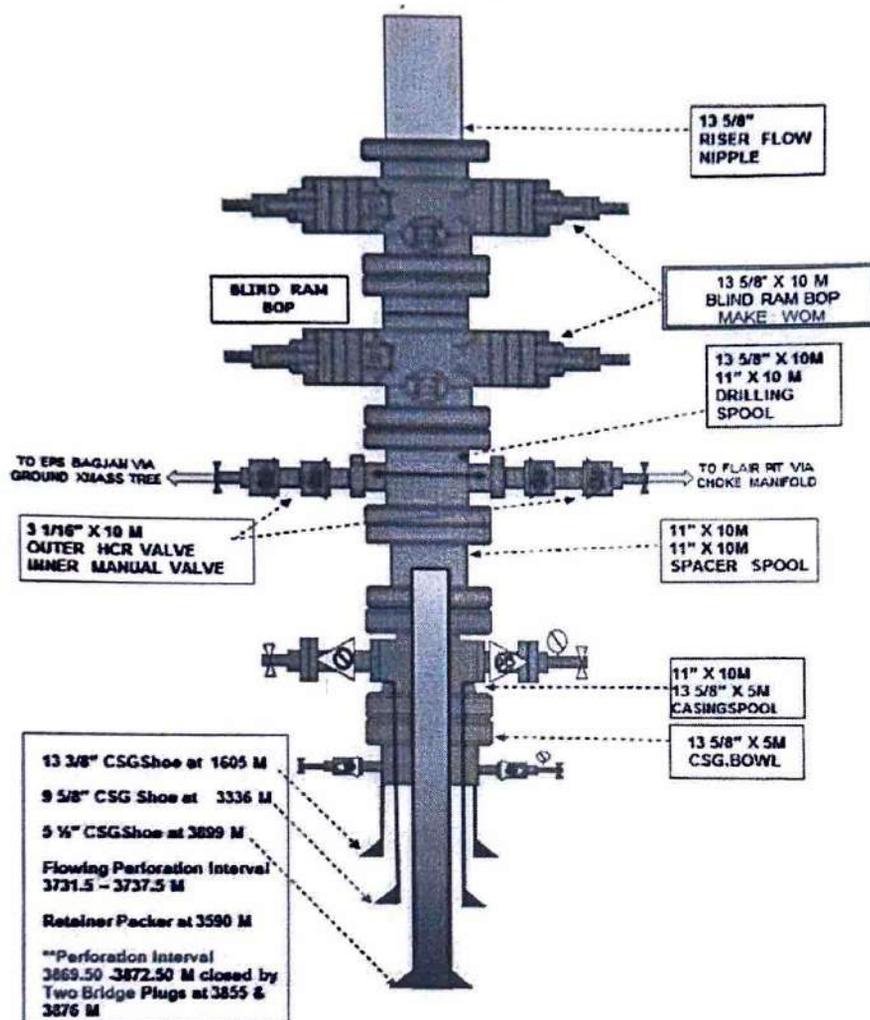
Baghjan#5 well after successful installation of capping assembly

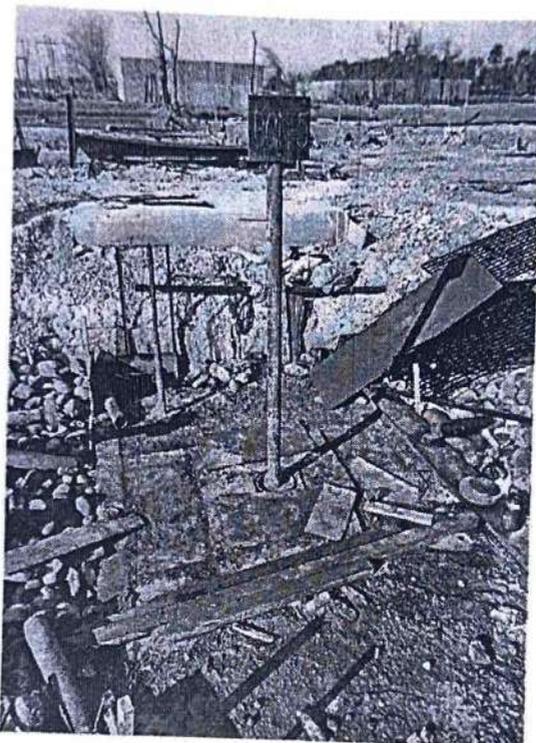
Well Baghjan#5 after blowout control and abandonment

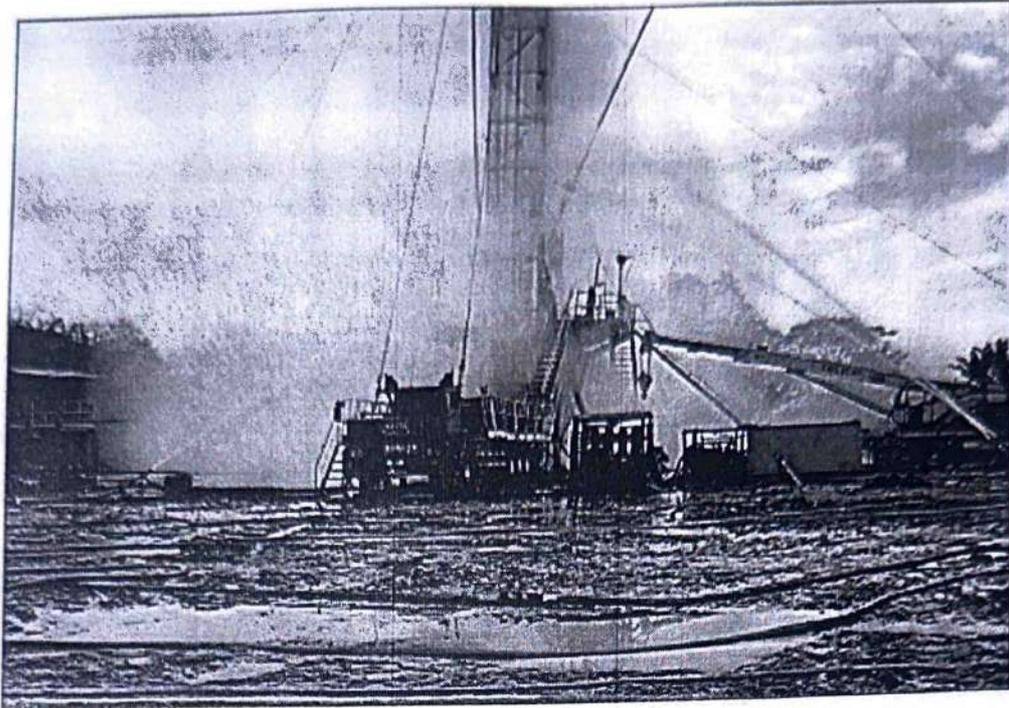
Well Baghjan#5 had blown out on 27th May, 2020 (Cooling in progress)

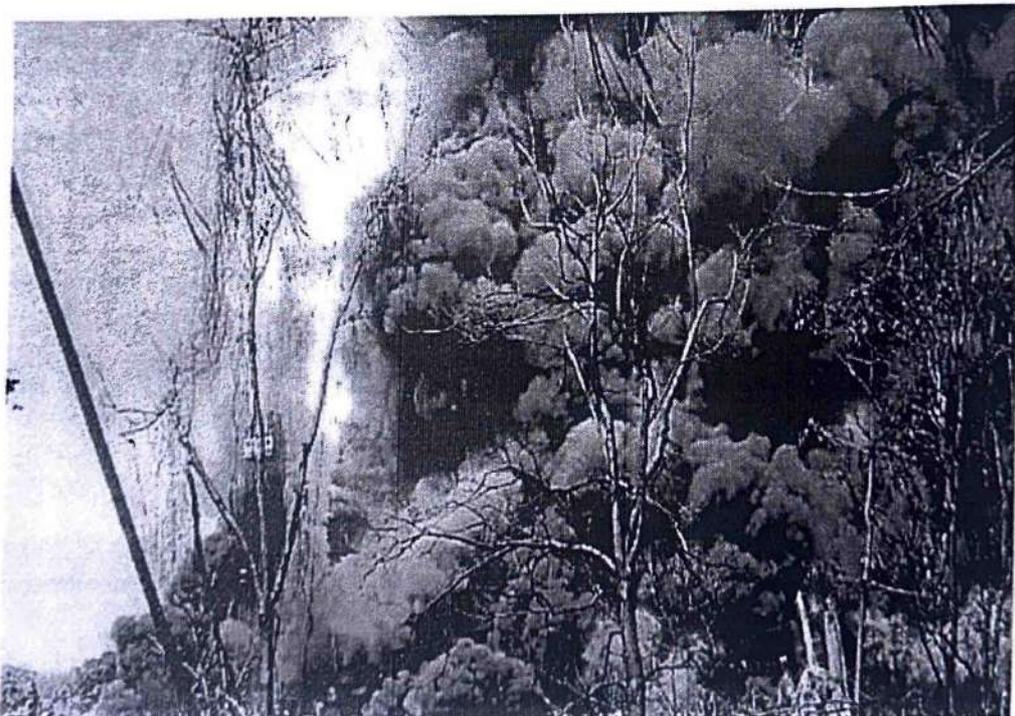
Well caught fire on 9th June, 2020

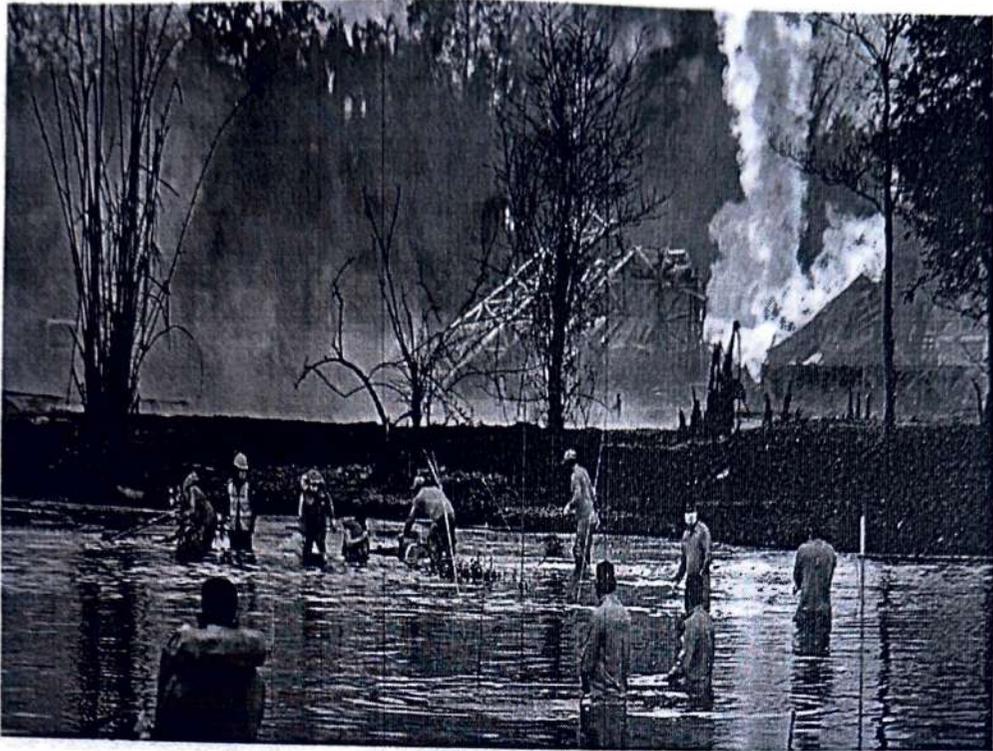
Search & rescue of missing fire personnel after well caught fire on 9th June, 2020

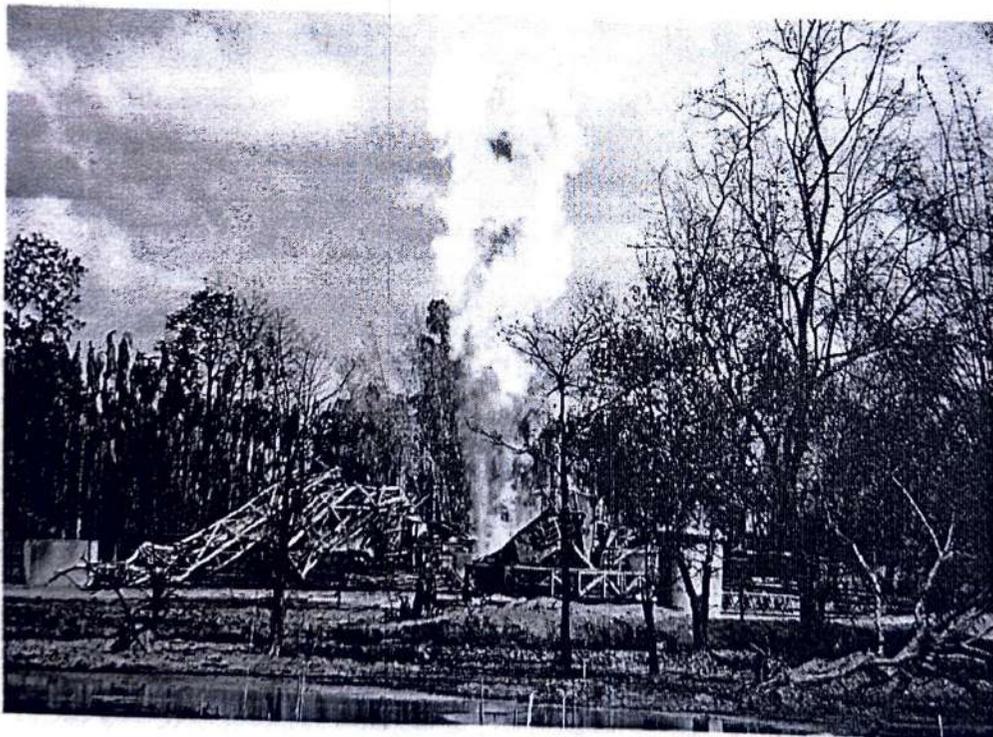
Rig debris after fire

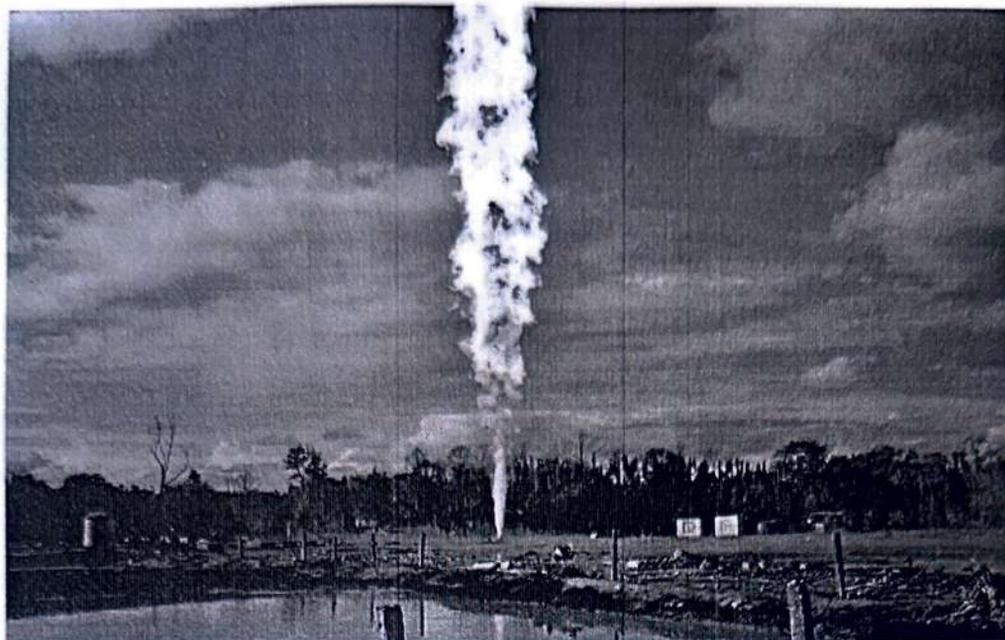
Well under fire (after removal of rig debris)

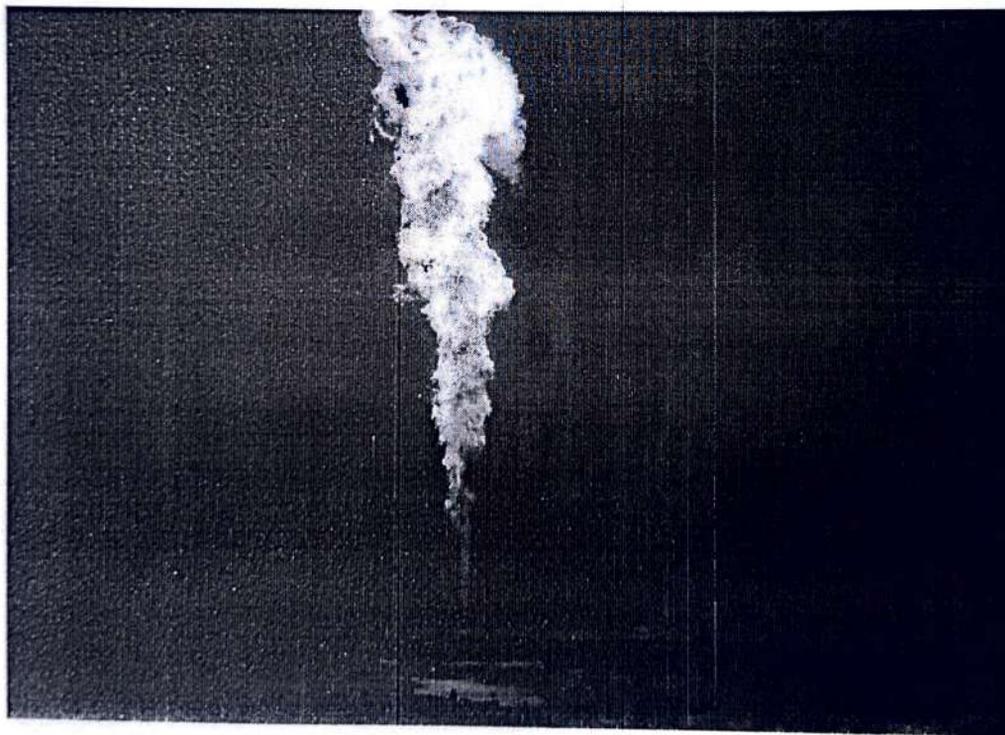
Well under fire (after removal of rig debris) – Night view showing enormity of fire

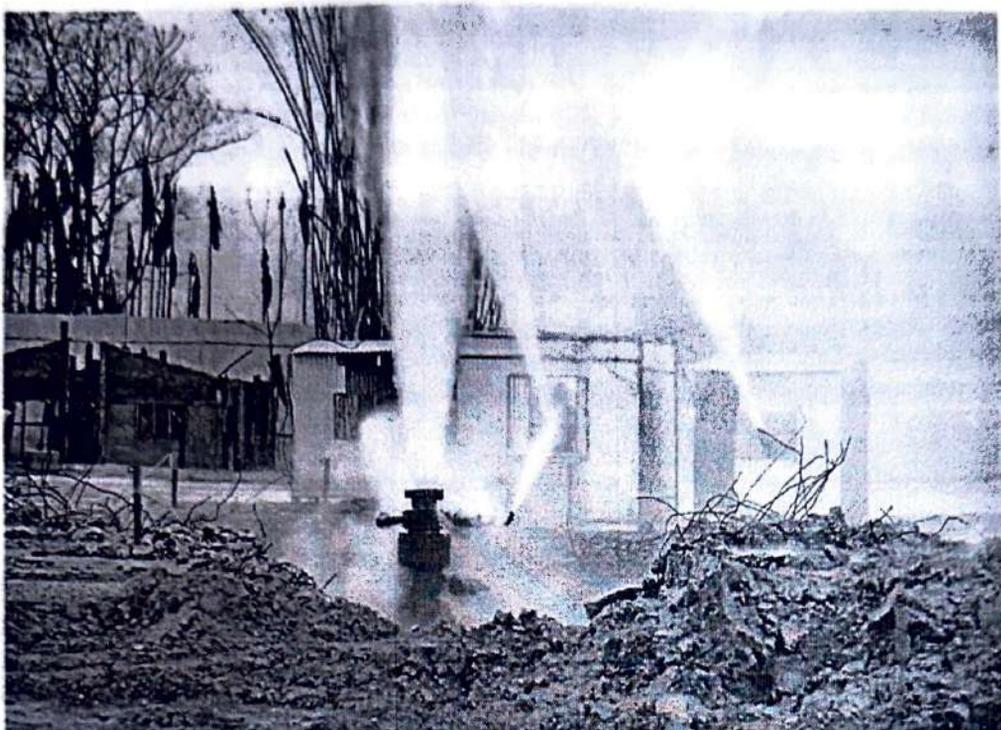
Well under fire (Cooling in progress, meanwhile making arrangements for well capping)

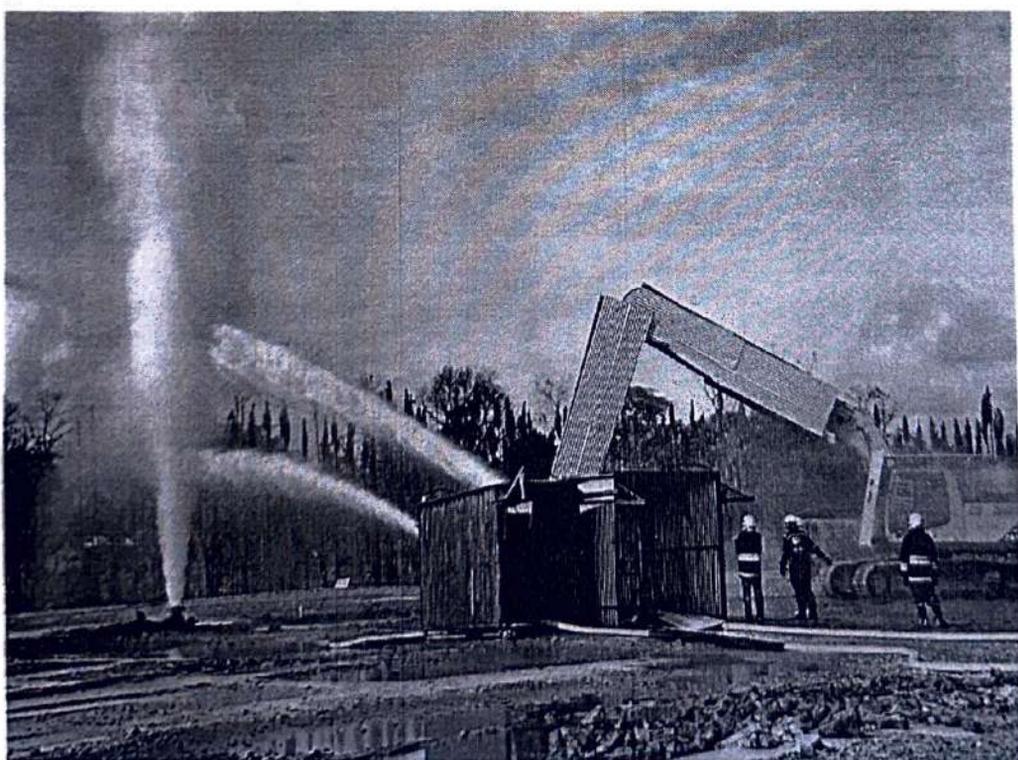
Well under fire (Cooling in progress, meanwhile making arrangements for well capping)

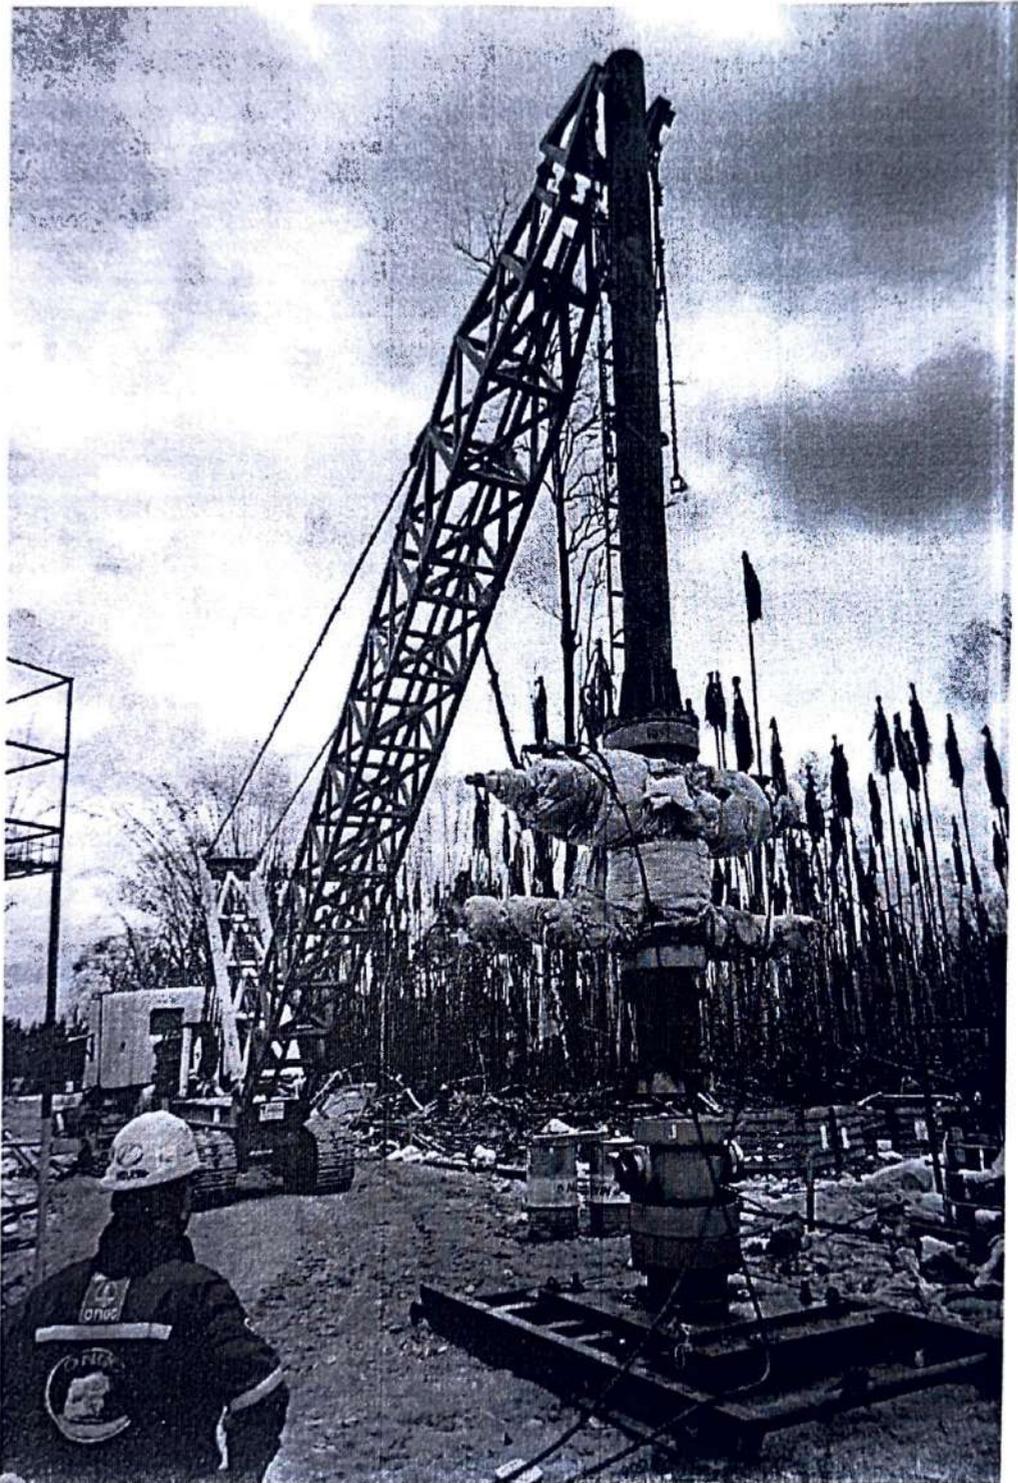
Athey Wagon at work - assembling BOP stack for capping

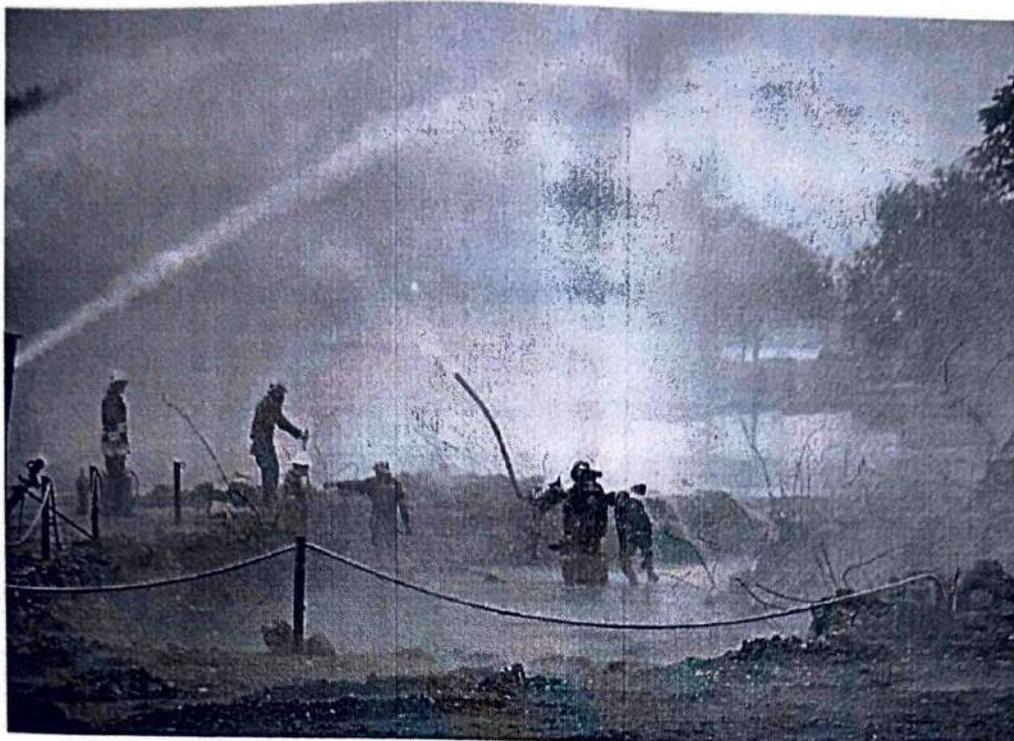
Well under fire (Cooling in progress, meanwhile making arrangements for well capping)

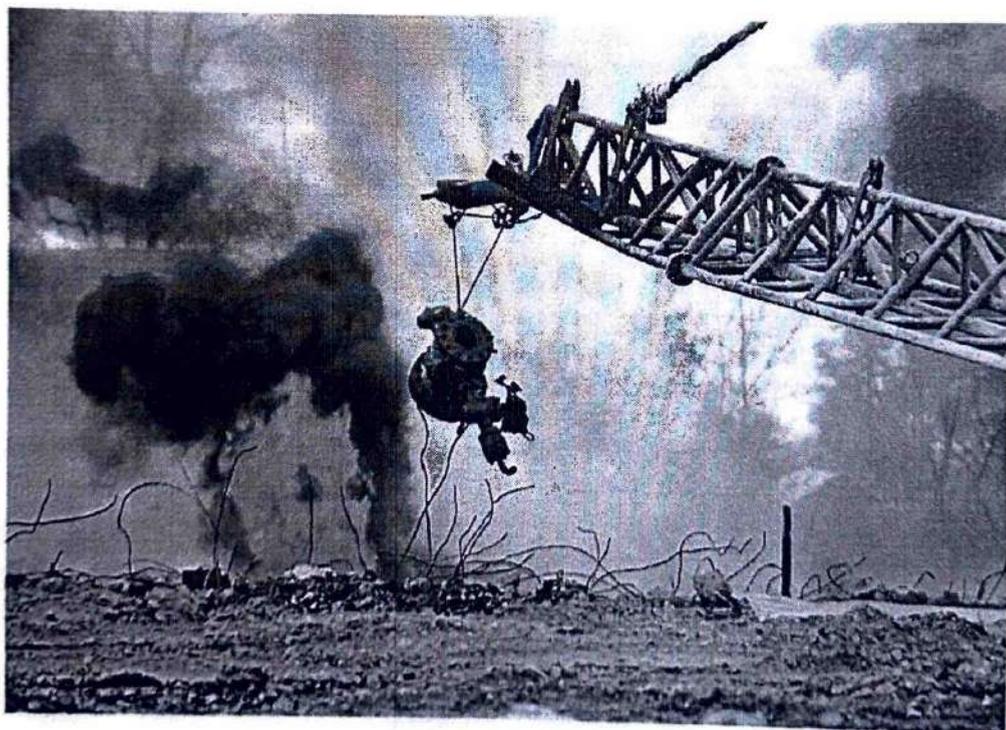
Well under fire (making arrangements for well killing)

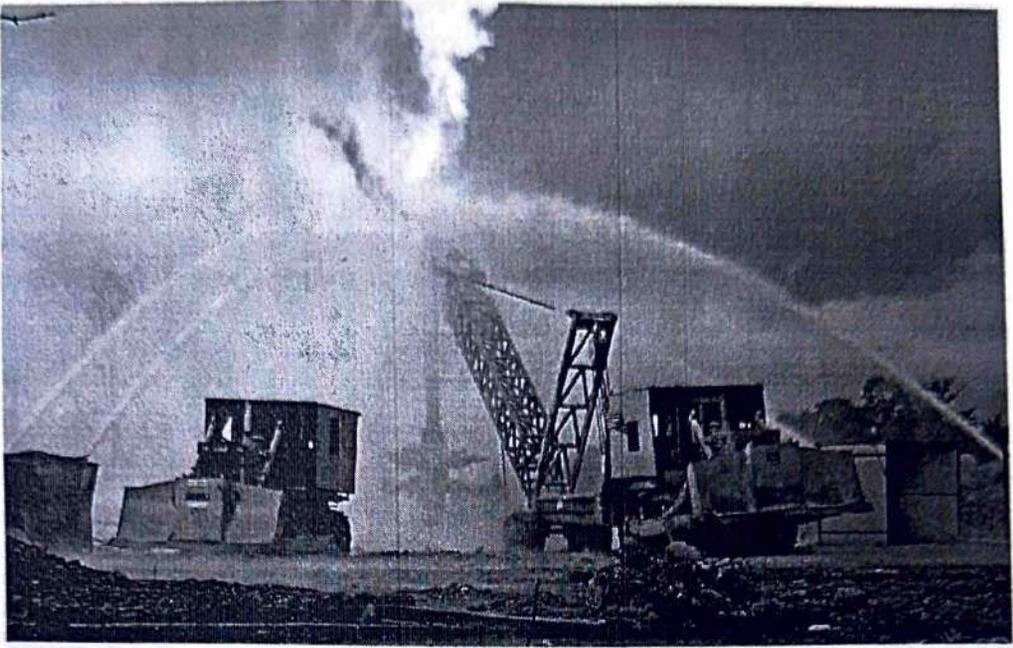
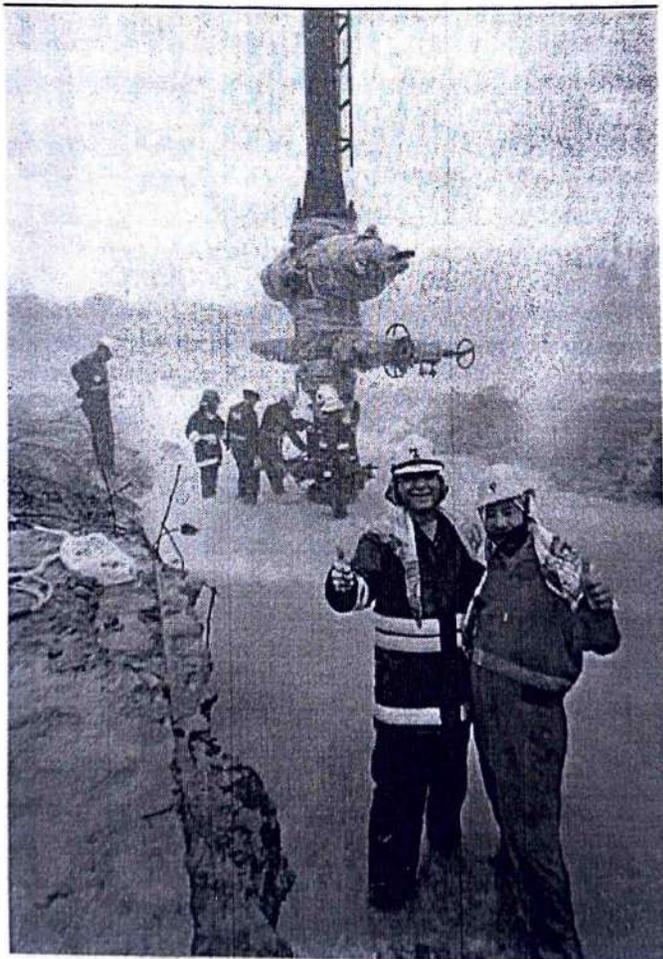
Well capped successfully on 17th August, 2020 in 3rd attempt

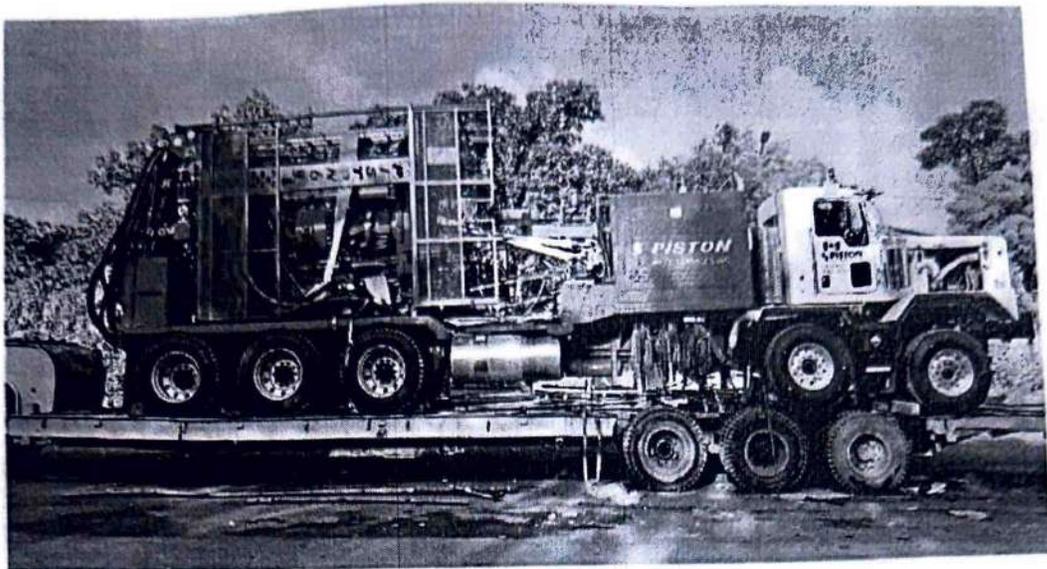
Snubbing Unit mobilized from Canada - under transportation for well killing

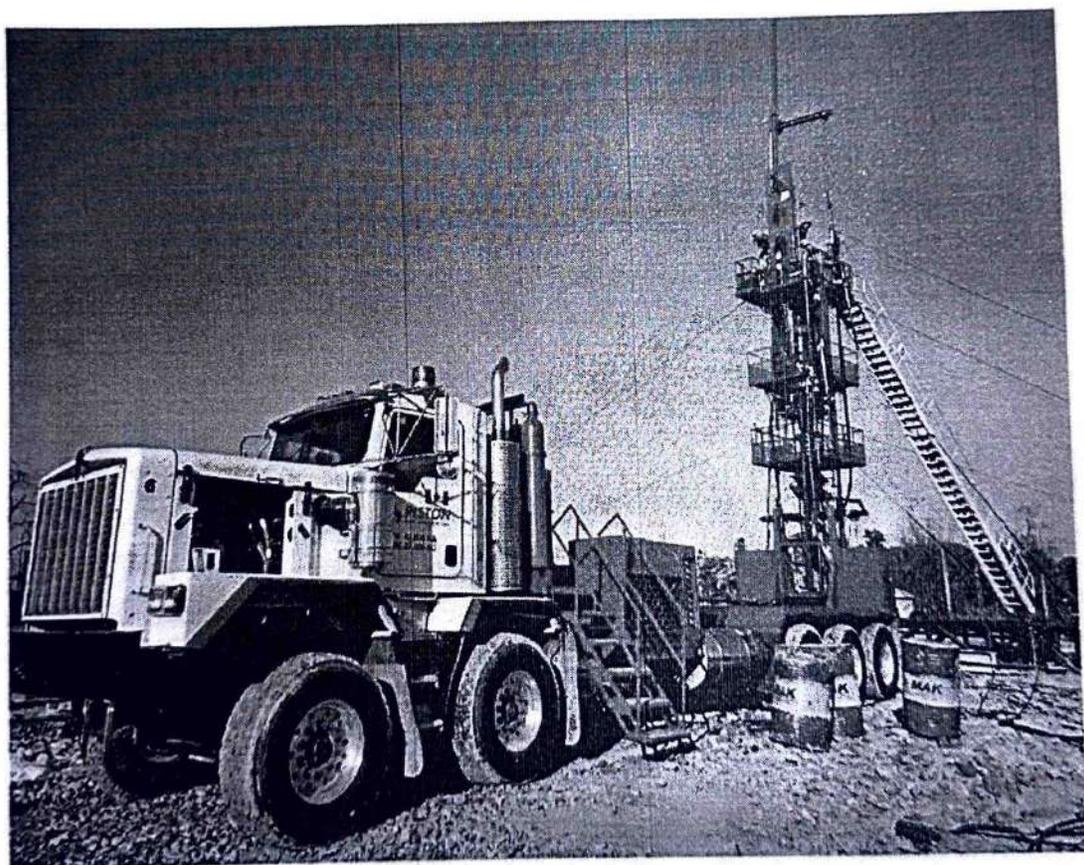
Snubbing unit rigged up for well killing

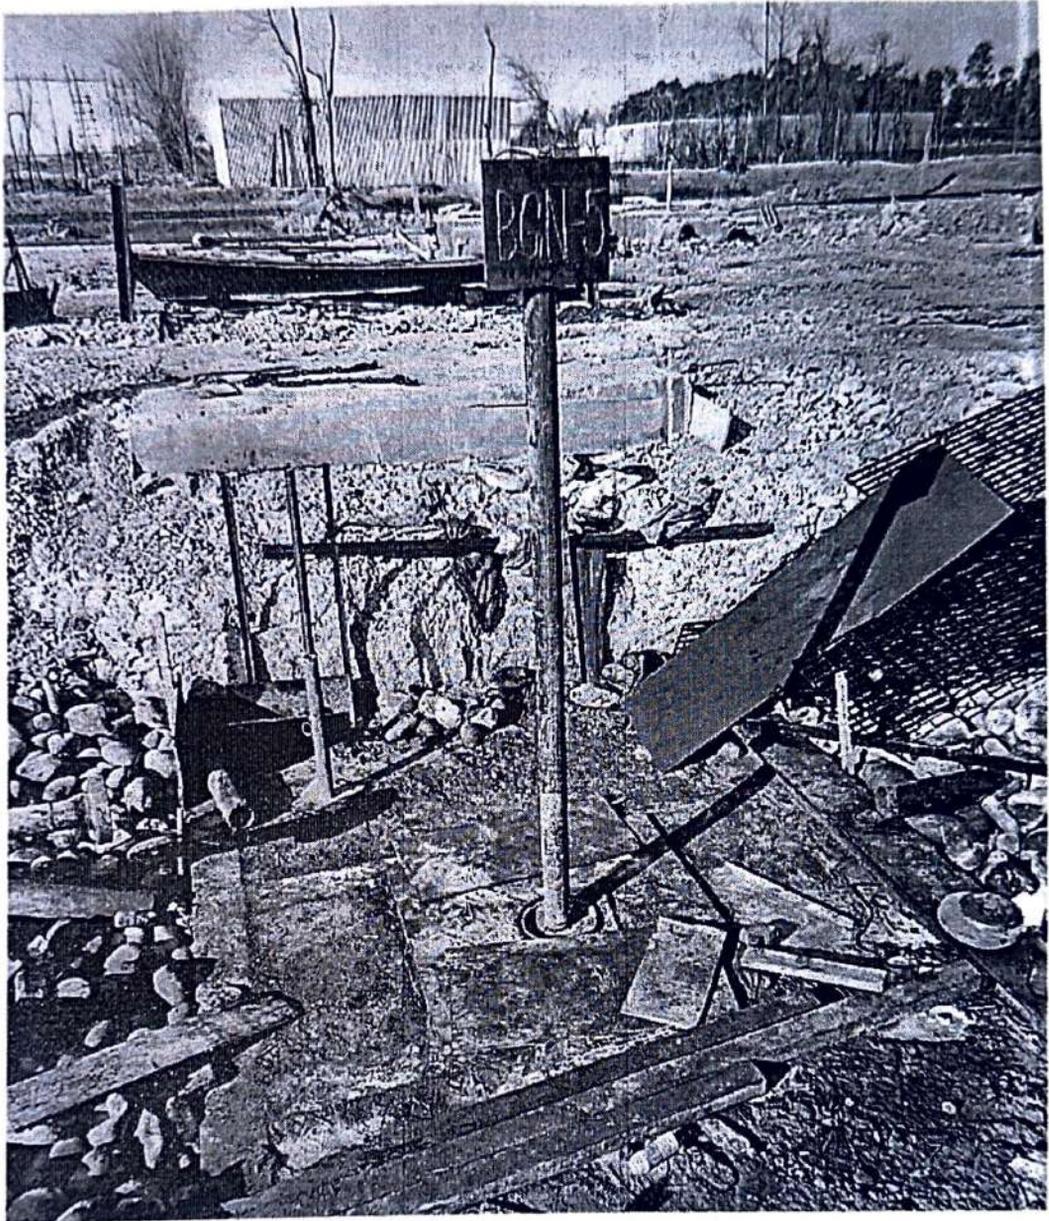
Well Baghjan#5 finally plugged and abandoned on 3rd December, 2020
