BEFORE THE NATIONAL GREEN TRIBUNAL**PRINCIPAL BENCH NEW DELHI**

ORIGINAL APPLICATION NO. 6 /2012

**FACTUAL STATUS REPORT BY THE COURT COMMISSIONER
IN COMPLIANCE OF ORDER DATED 09.04.2025**

Quick Glance of drain with help of google earth image and photos taken on 9th and 11th April, 2025:

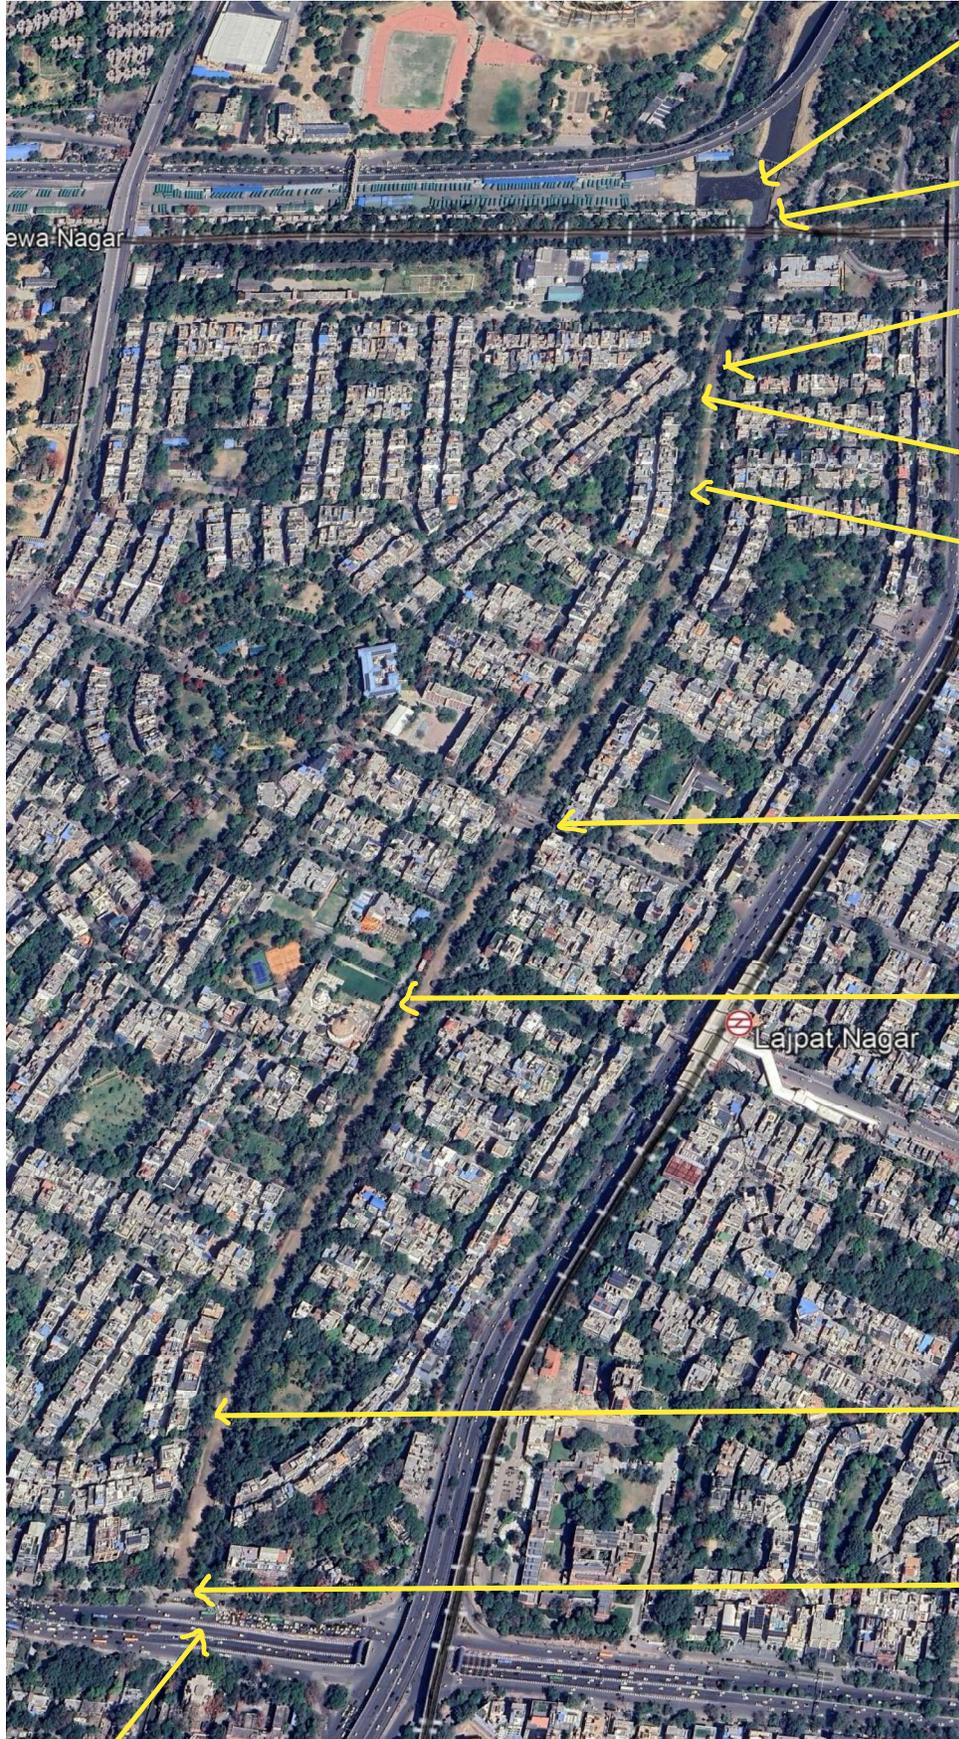
- h) Shri Kushagra Raghuvanshi Advocate
4. That the subject matter stretch of Kushak drain at Defence Colony (**hereinafter referred to as "Drain"**) starts from the Ring Road at Southern End and goes up to point of meeting Sunheri Drain in the Northern end. For convenience, the Google Earth image of the area is being referred, as shown below, for directions and further the undersigned has labelled various points (A,B,C,D, E,F,G,H,I -) on the Google Earth image for ease of understanding.

5. The drain is covered after point A, almost till the end point G with concrete construction over it with same width as of drain. The concrete covered structure has an elevation of 2.5 to 3 meter height from the adjacent colony road on west side. And has small entry gates with stair cases for reaching the euphemistic Nalla Park.

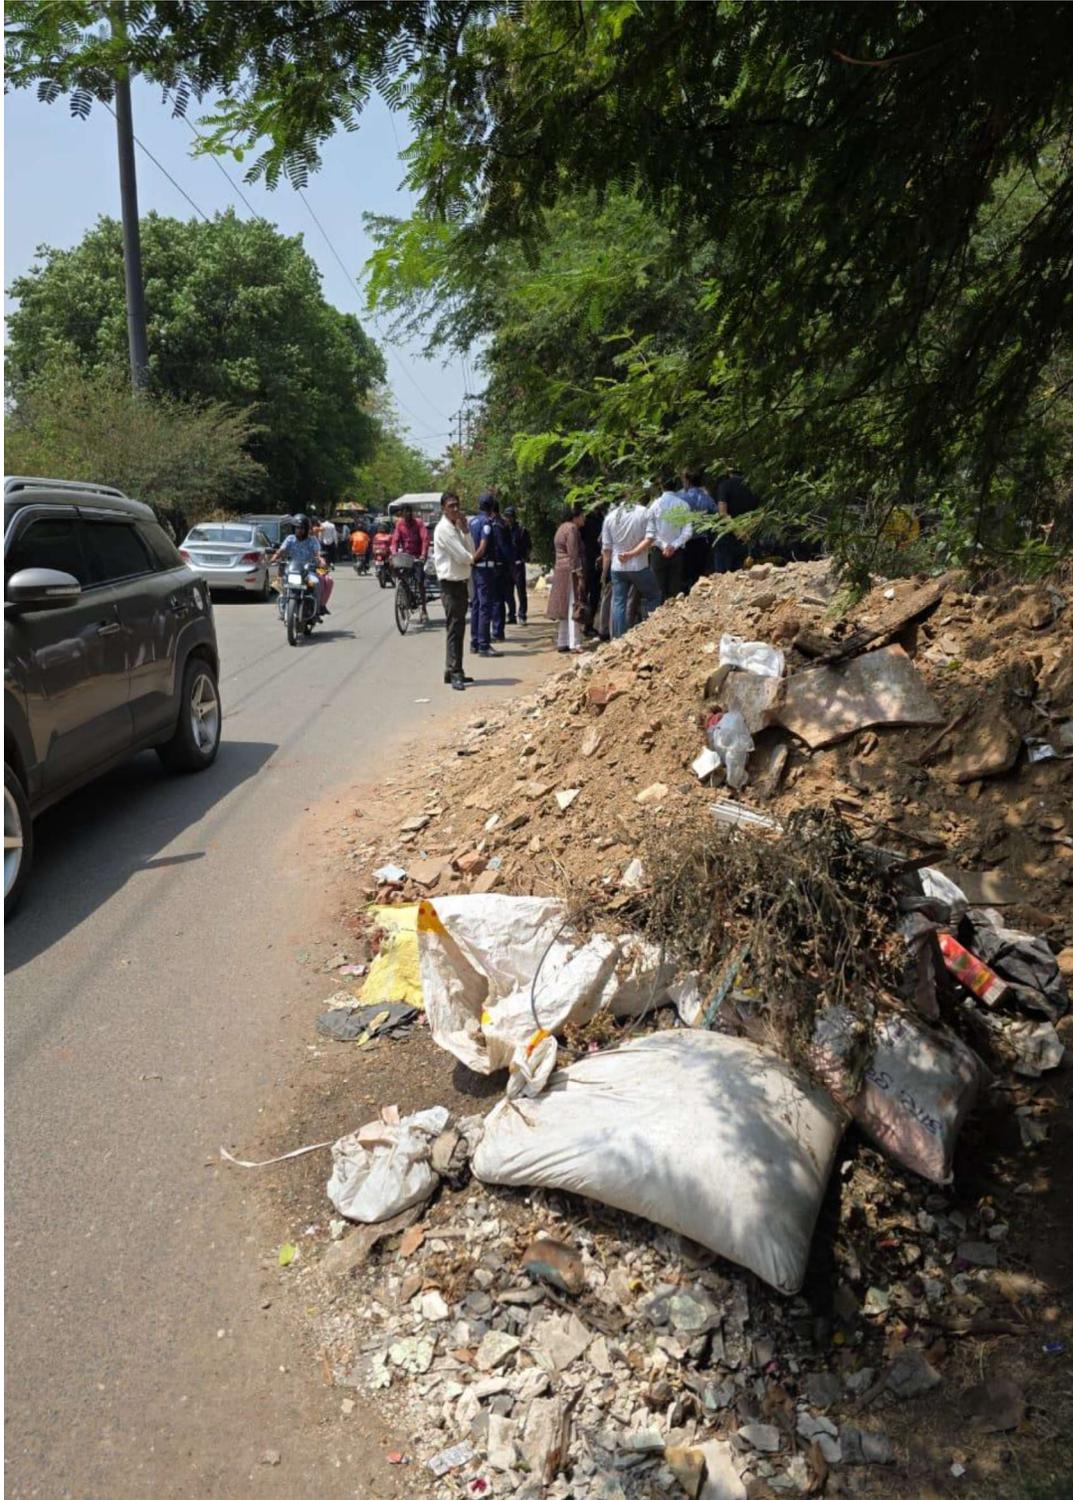
6. At service road/Ring Road. ↓

4. Point "A" was full of debris on both side of drain underneath the Ring Road culvert. And just below the starting point of concrete cover, huge amount of all type of waste including plastic waste (varying from small to large pieces) was found majorly on west side. The flow was found stagnant.

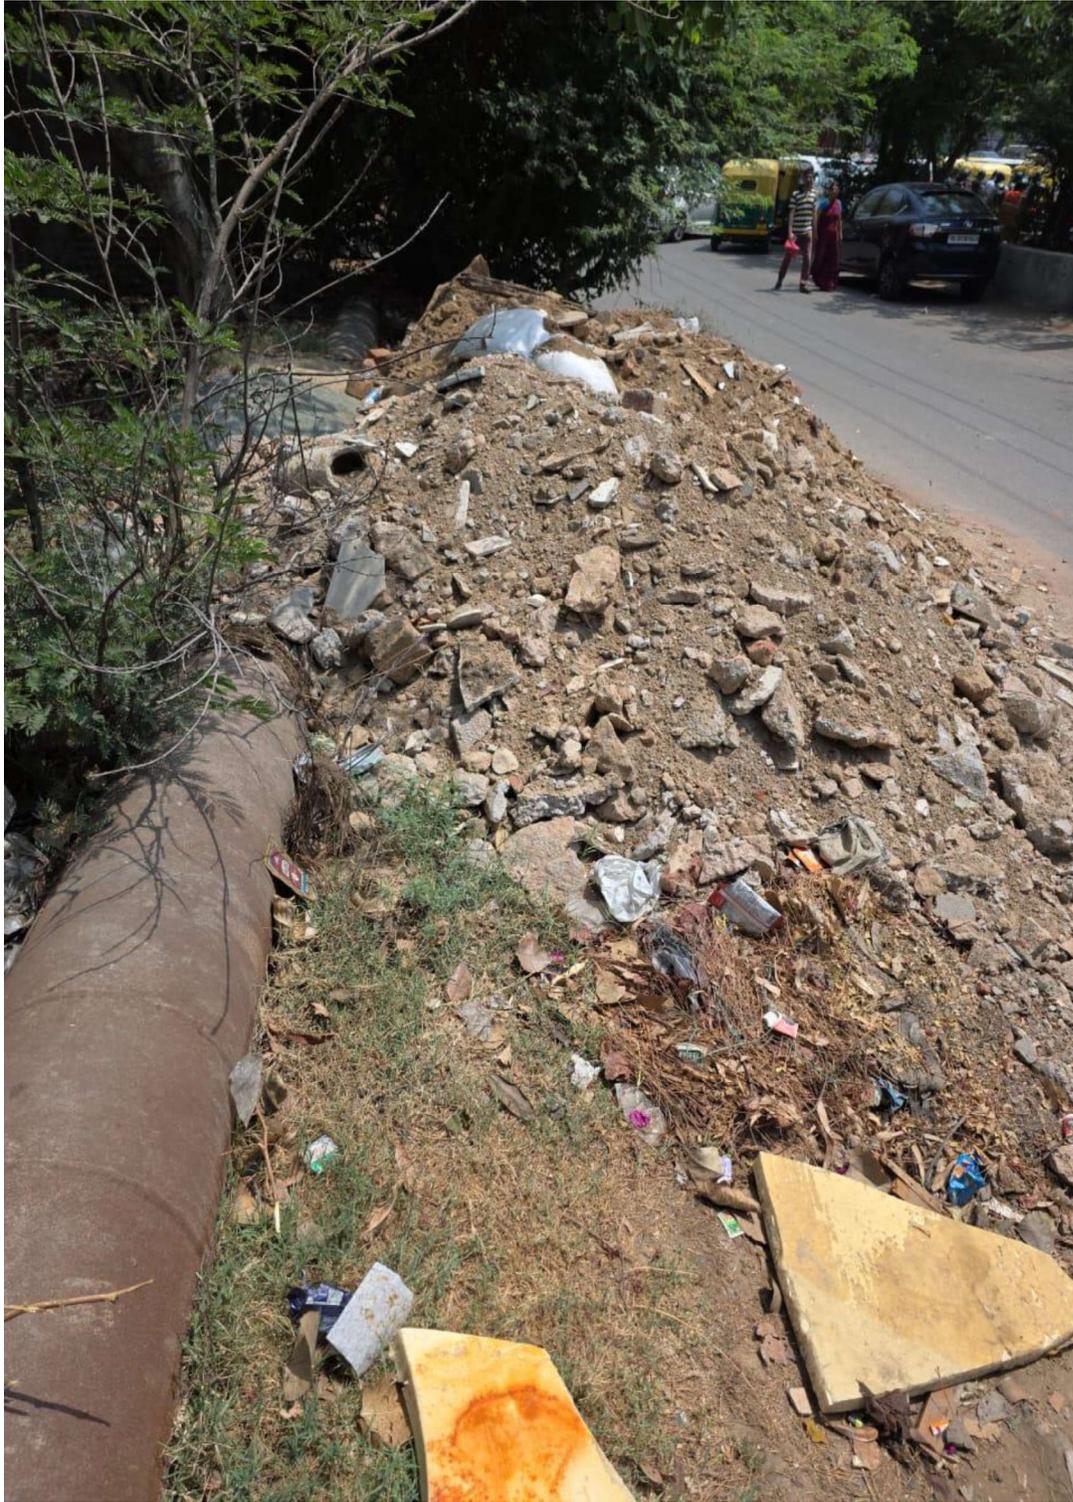
Muck/debris lying on service road

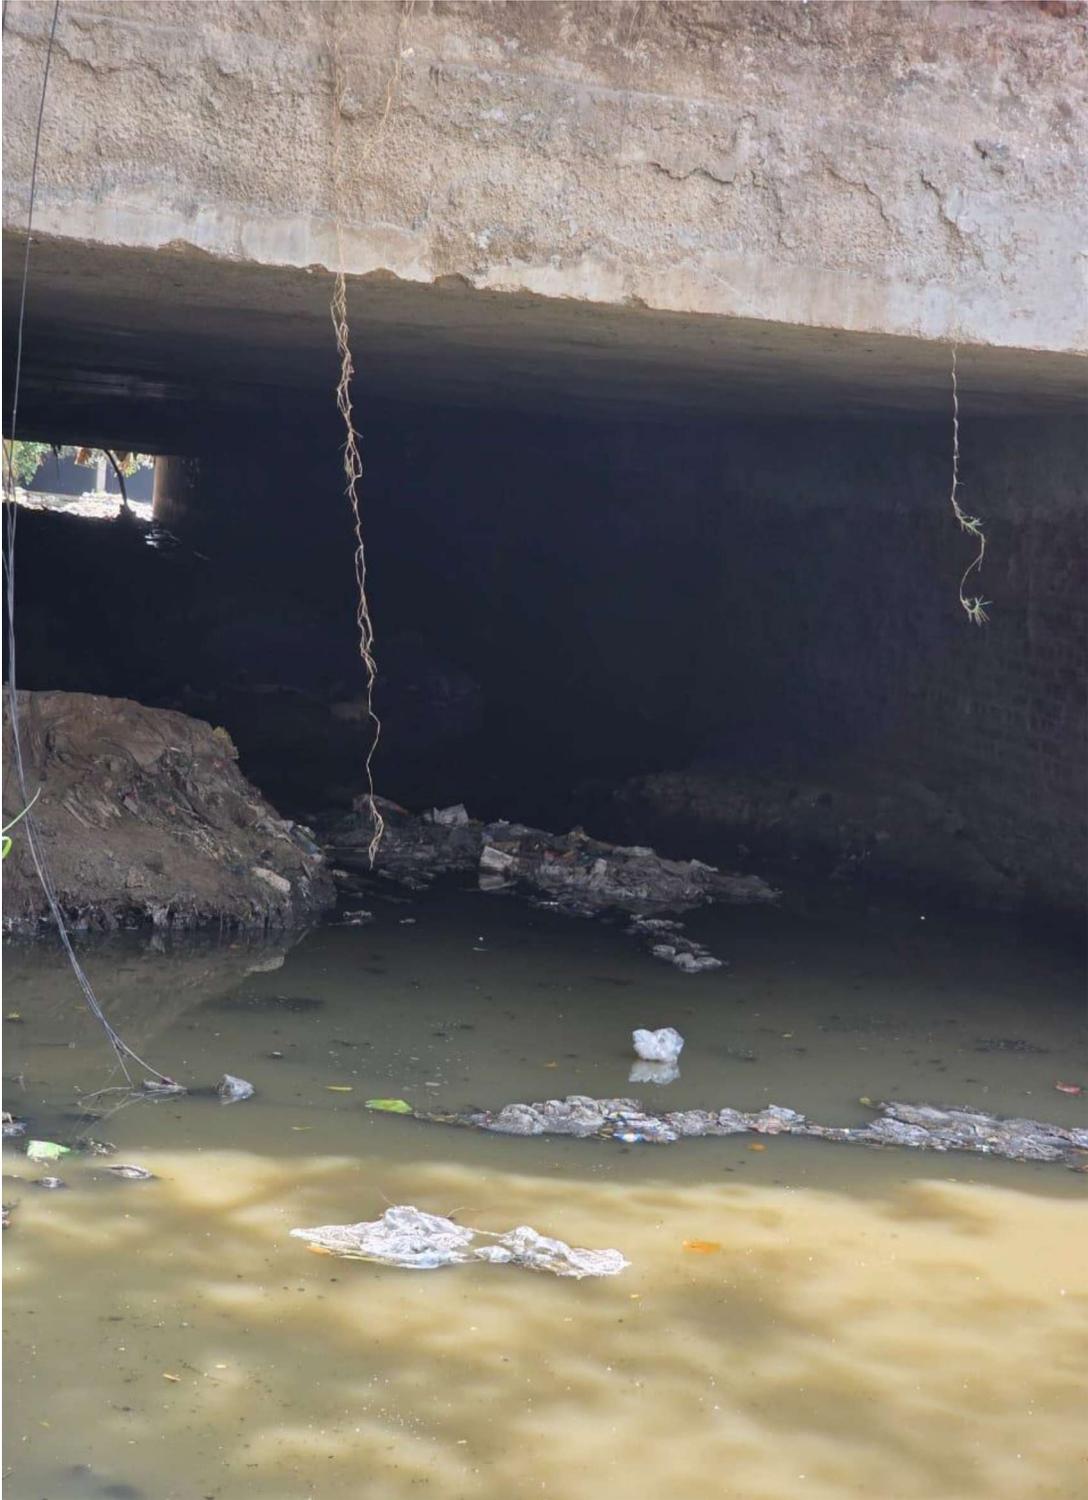
Channel coming towards the Defence Colony drain (below the Ring Road)
filled with debris (on eastern side)

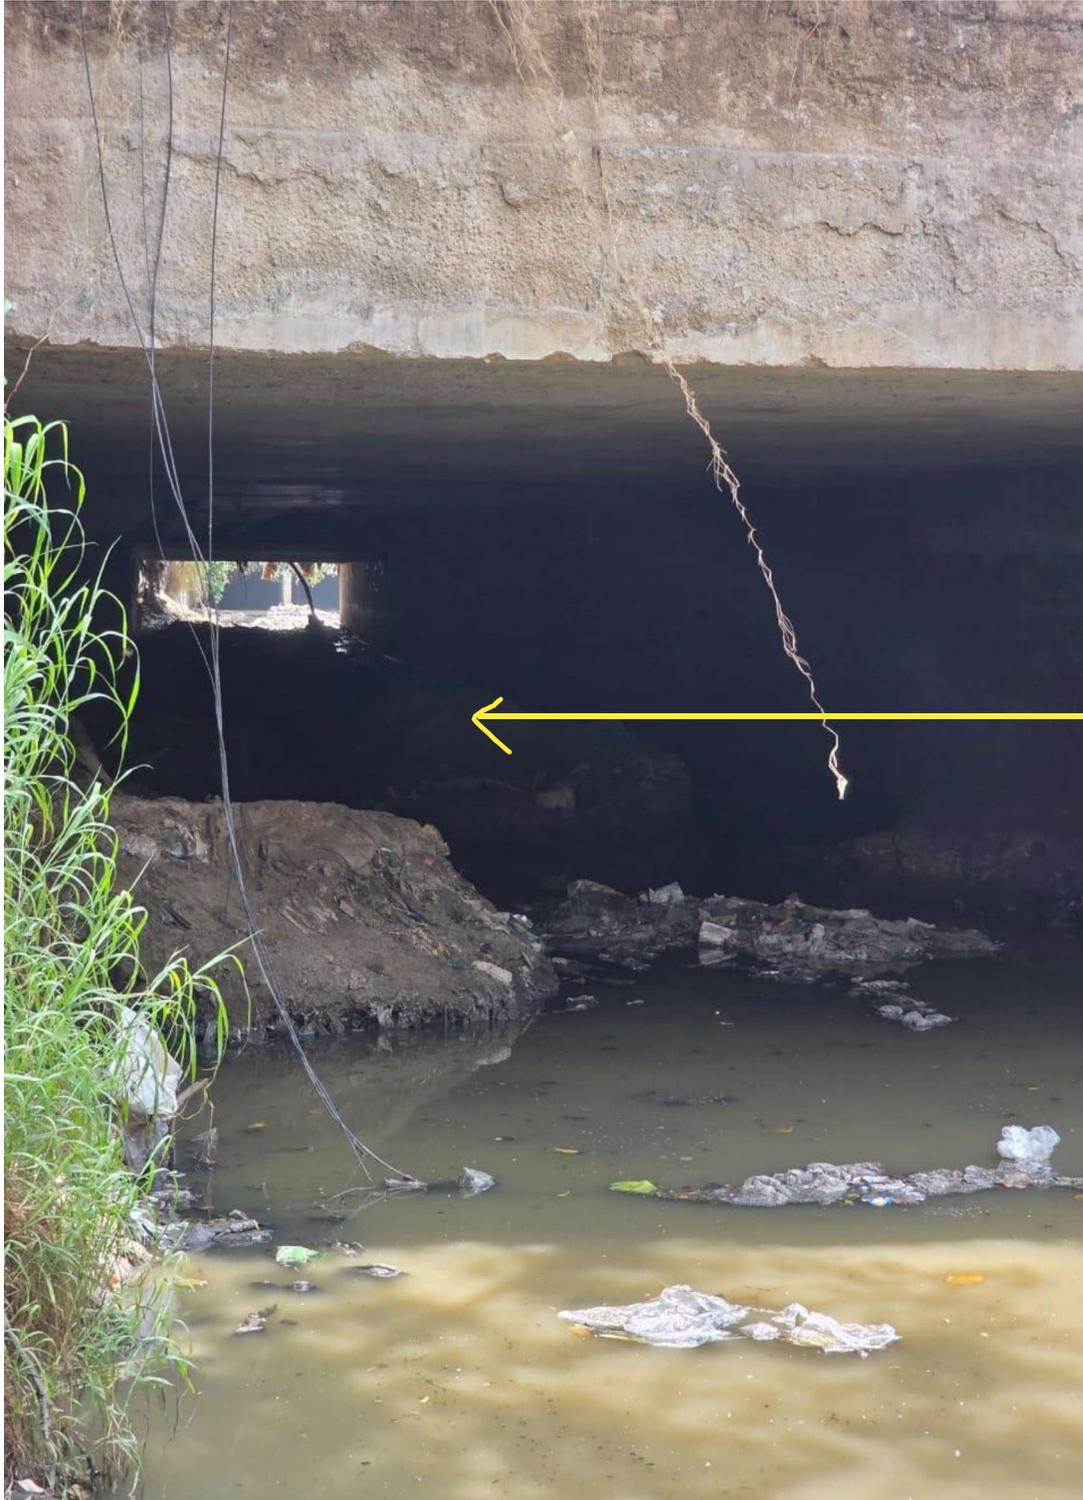
1st channel
filled/choked
with debris

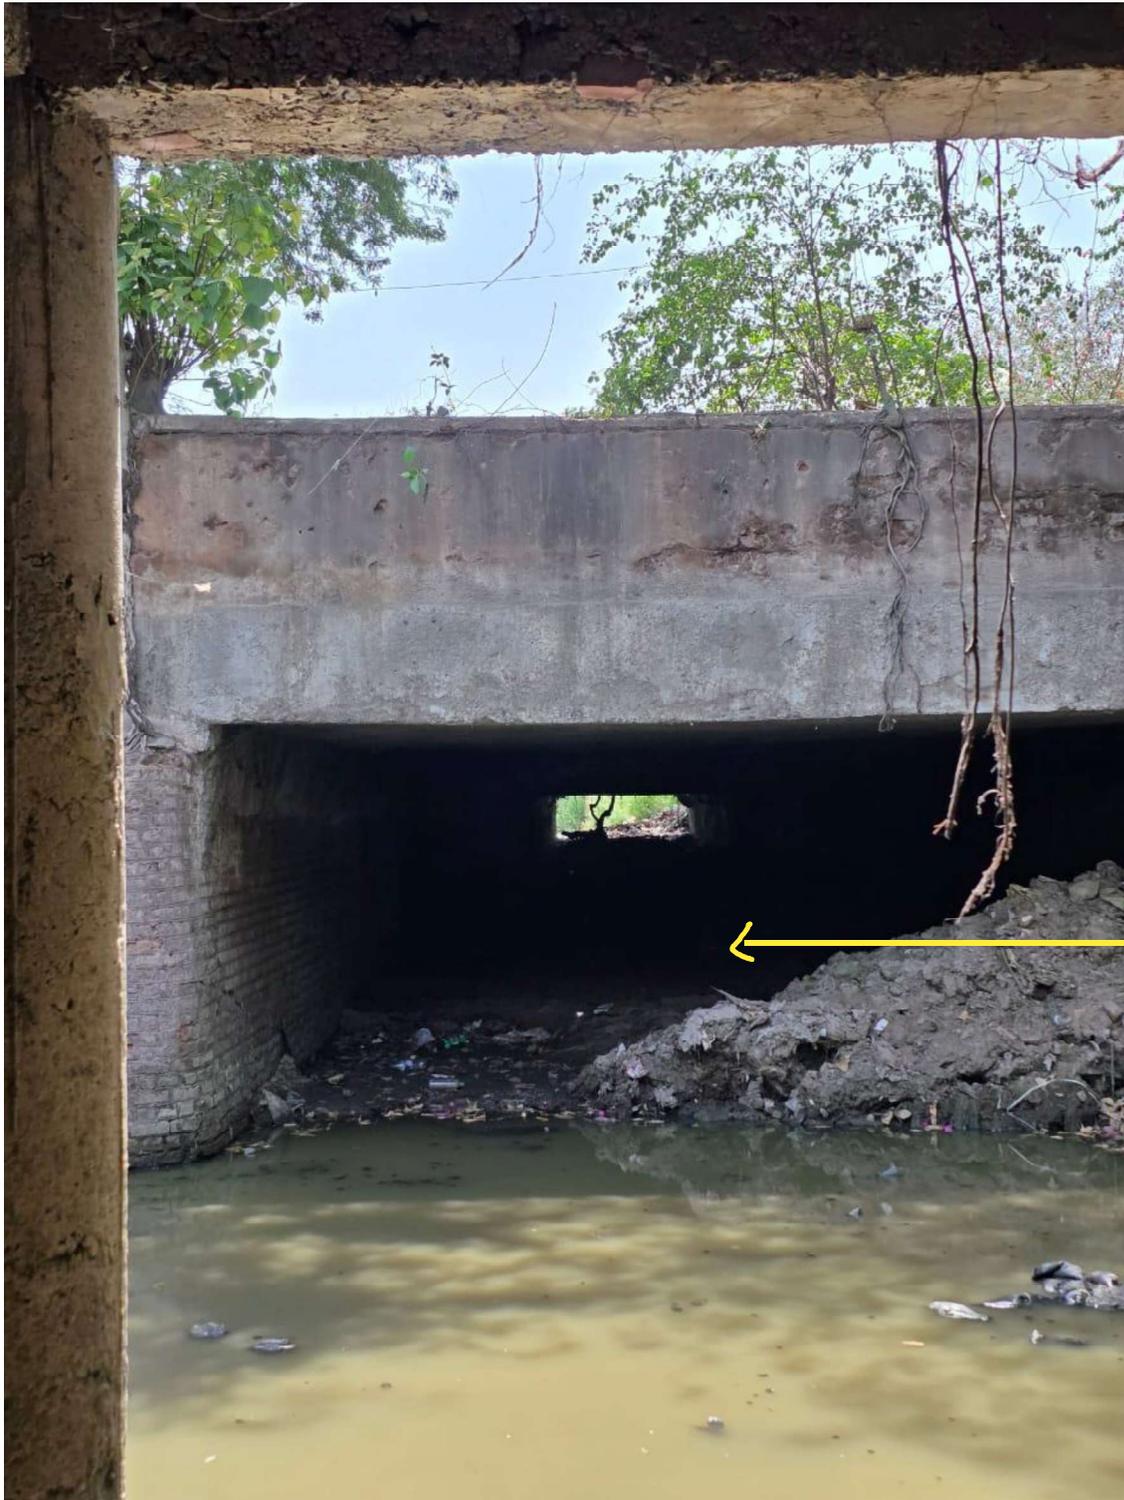
3rd channel

Channel coming towards the Defence Colony drain (below the Ring Road) filled with debris on Western side.

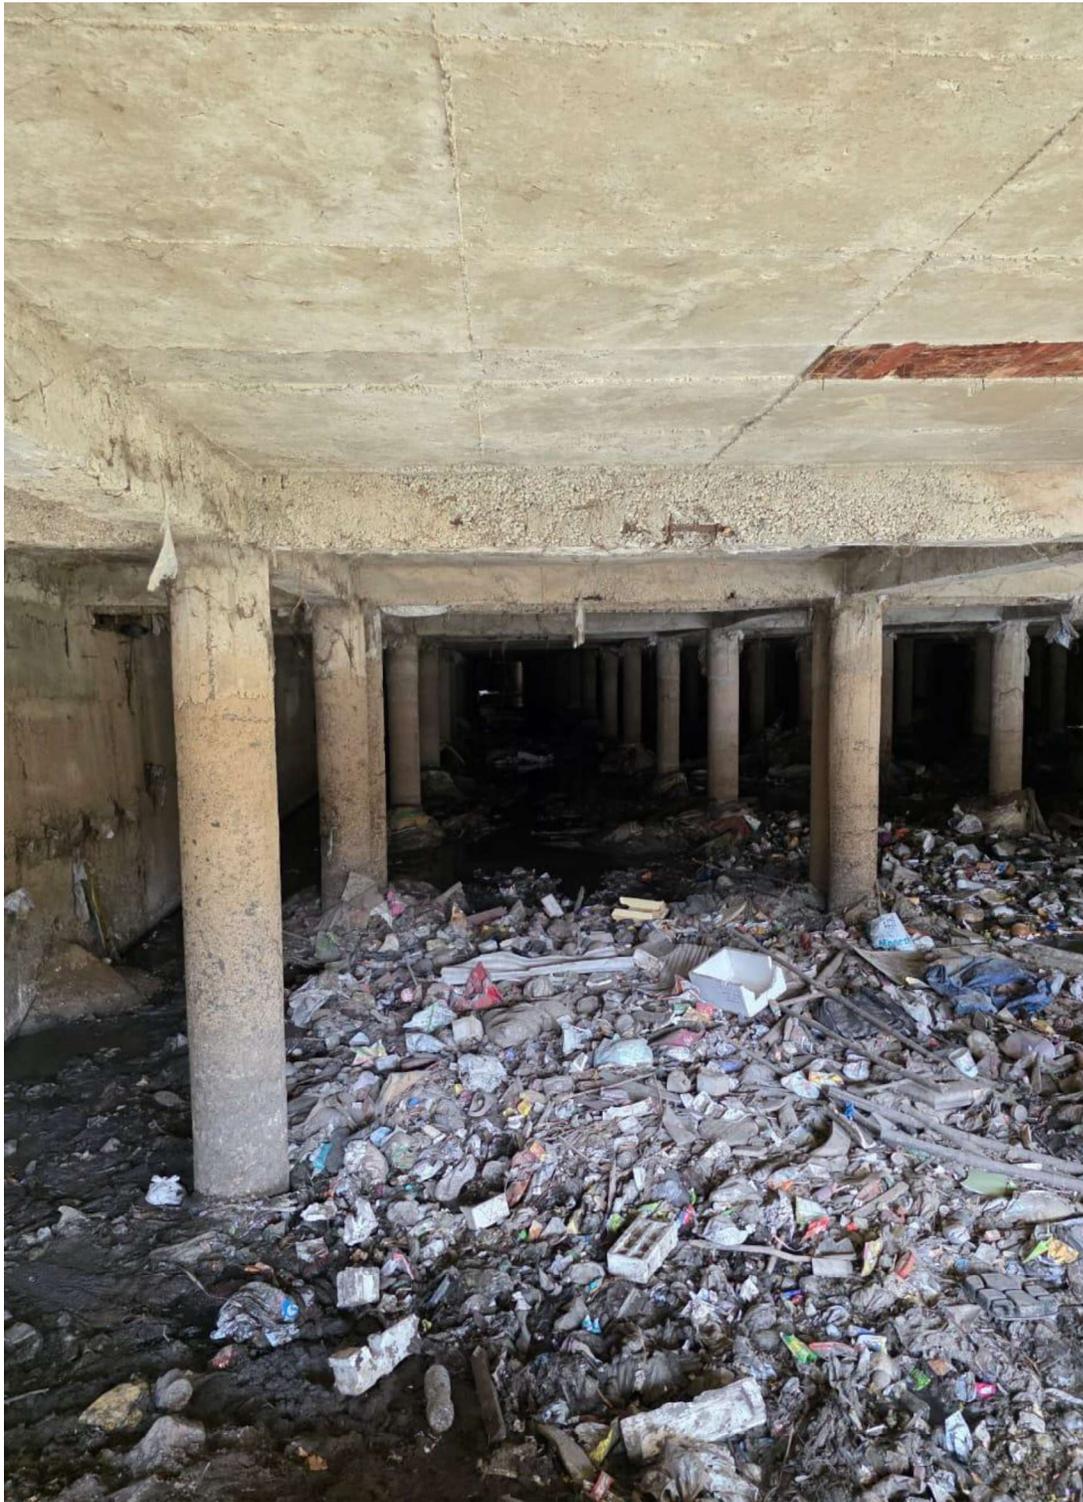
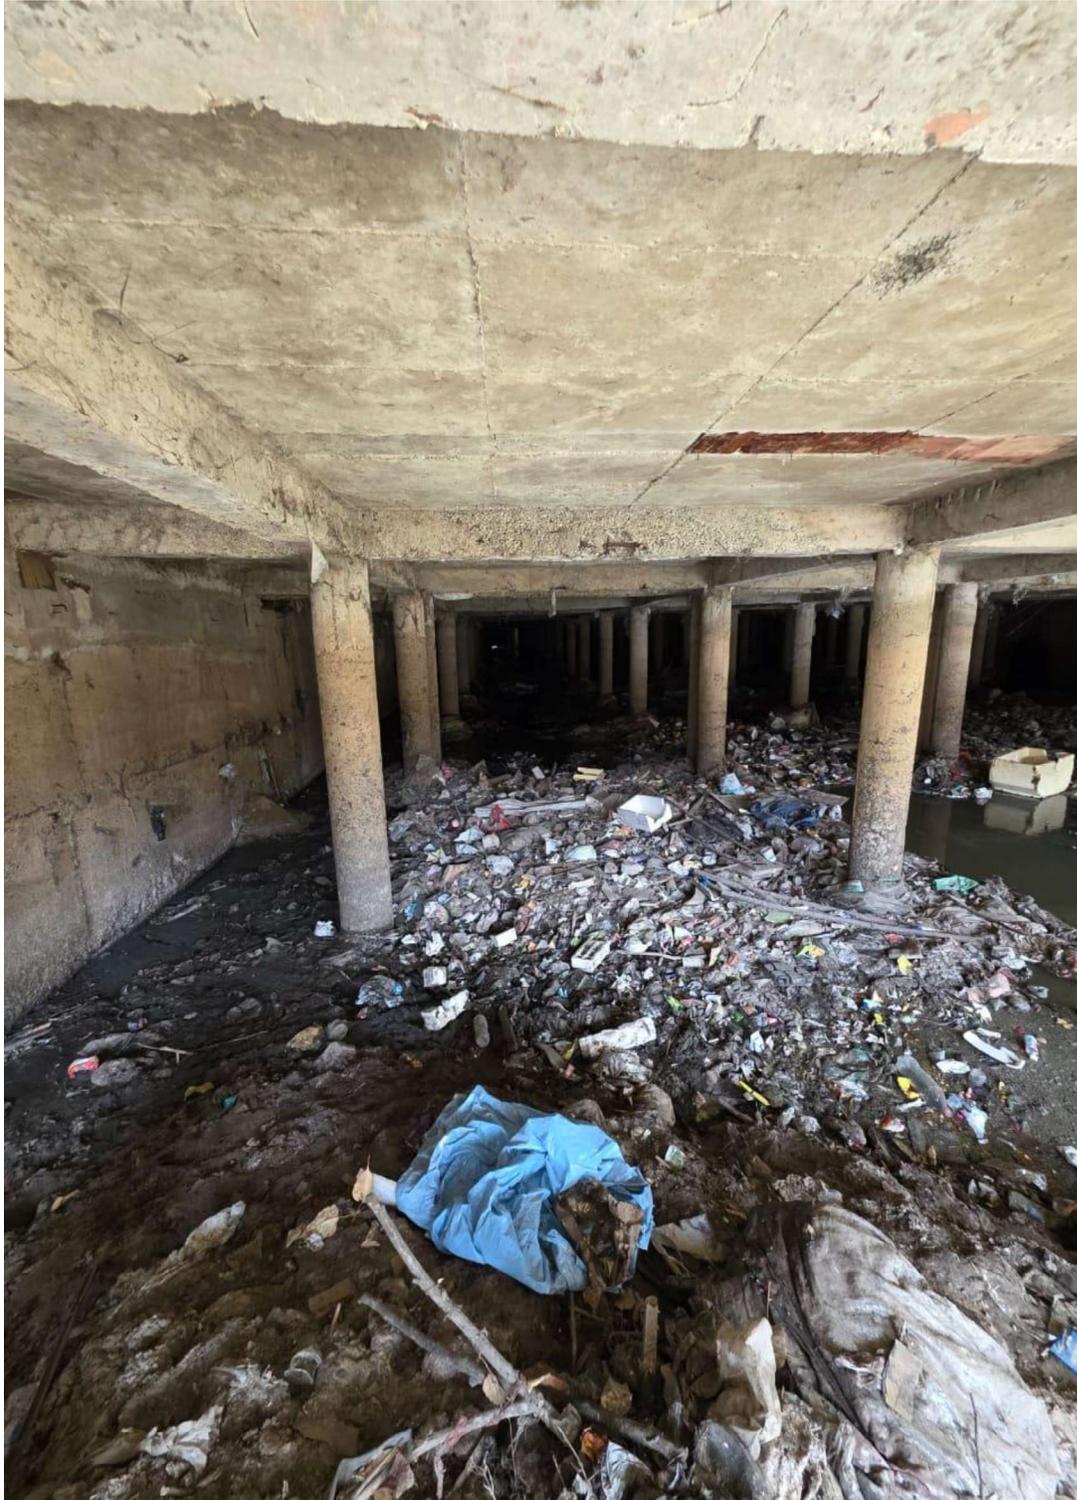
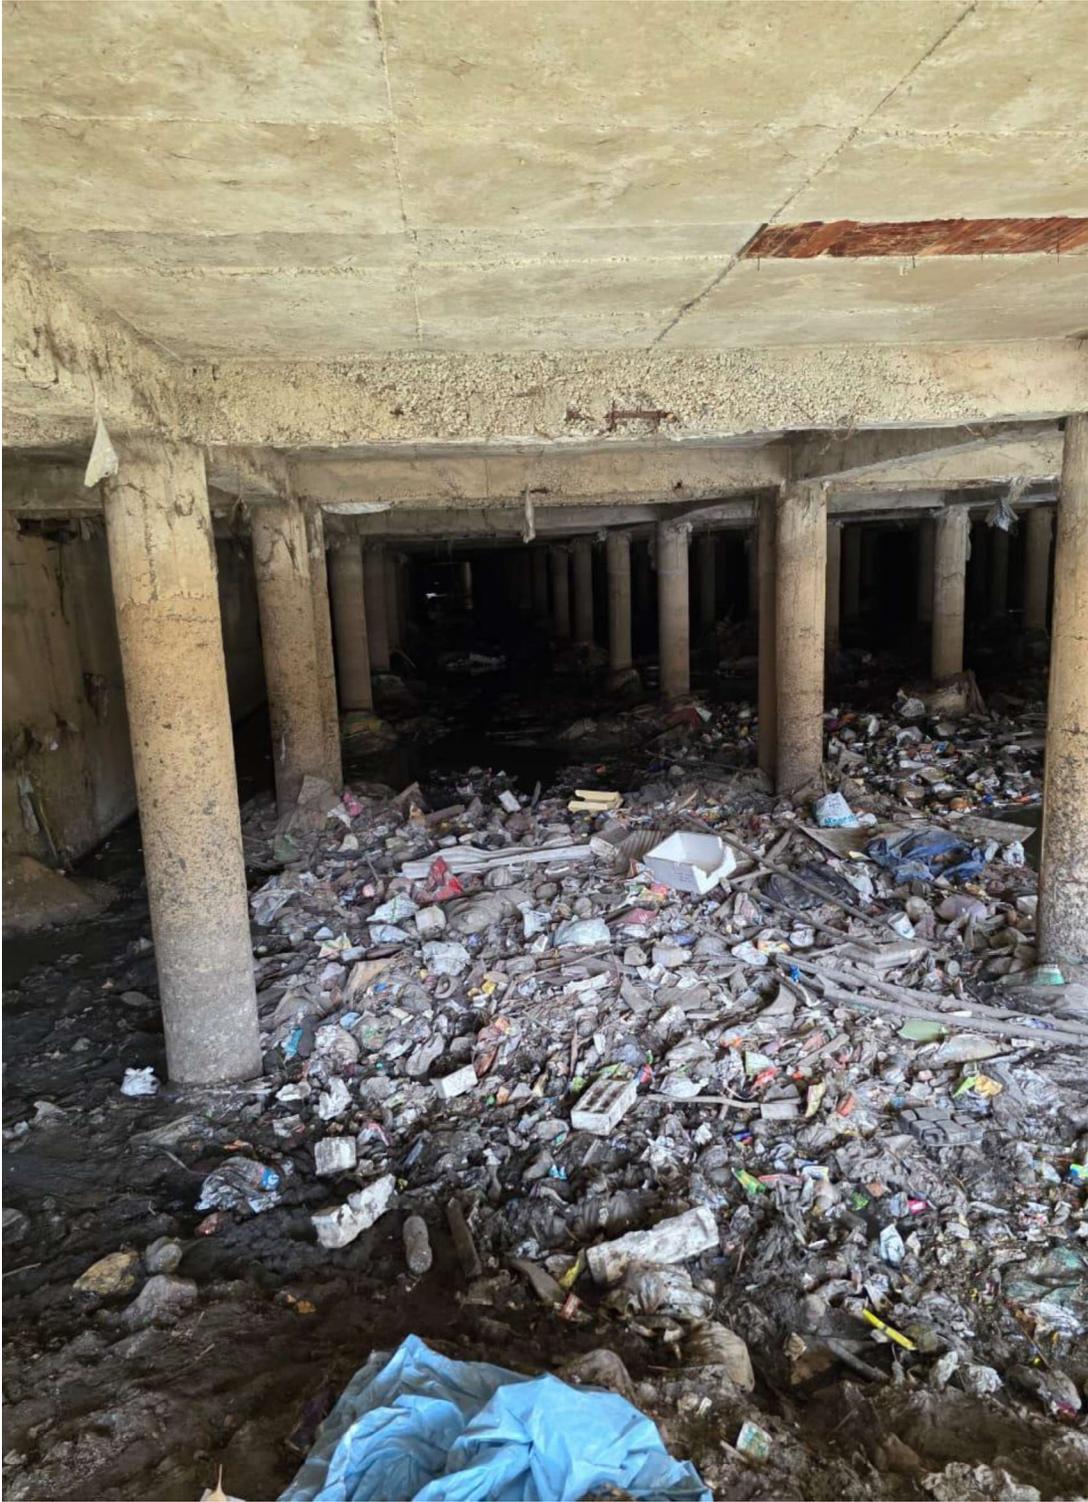
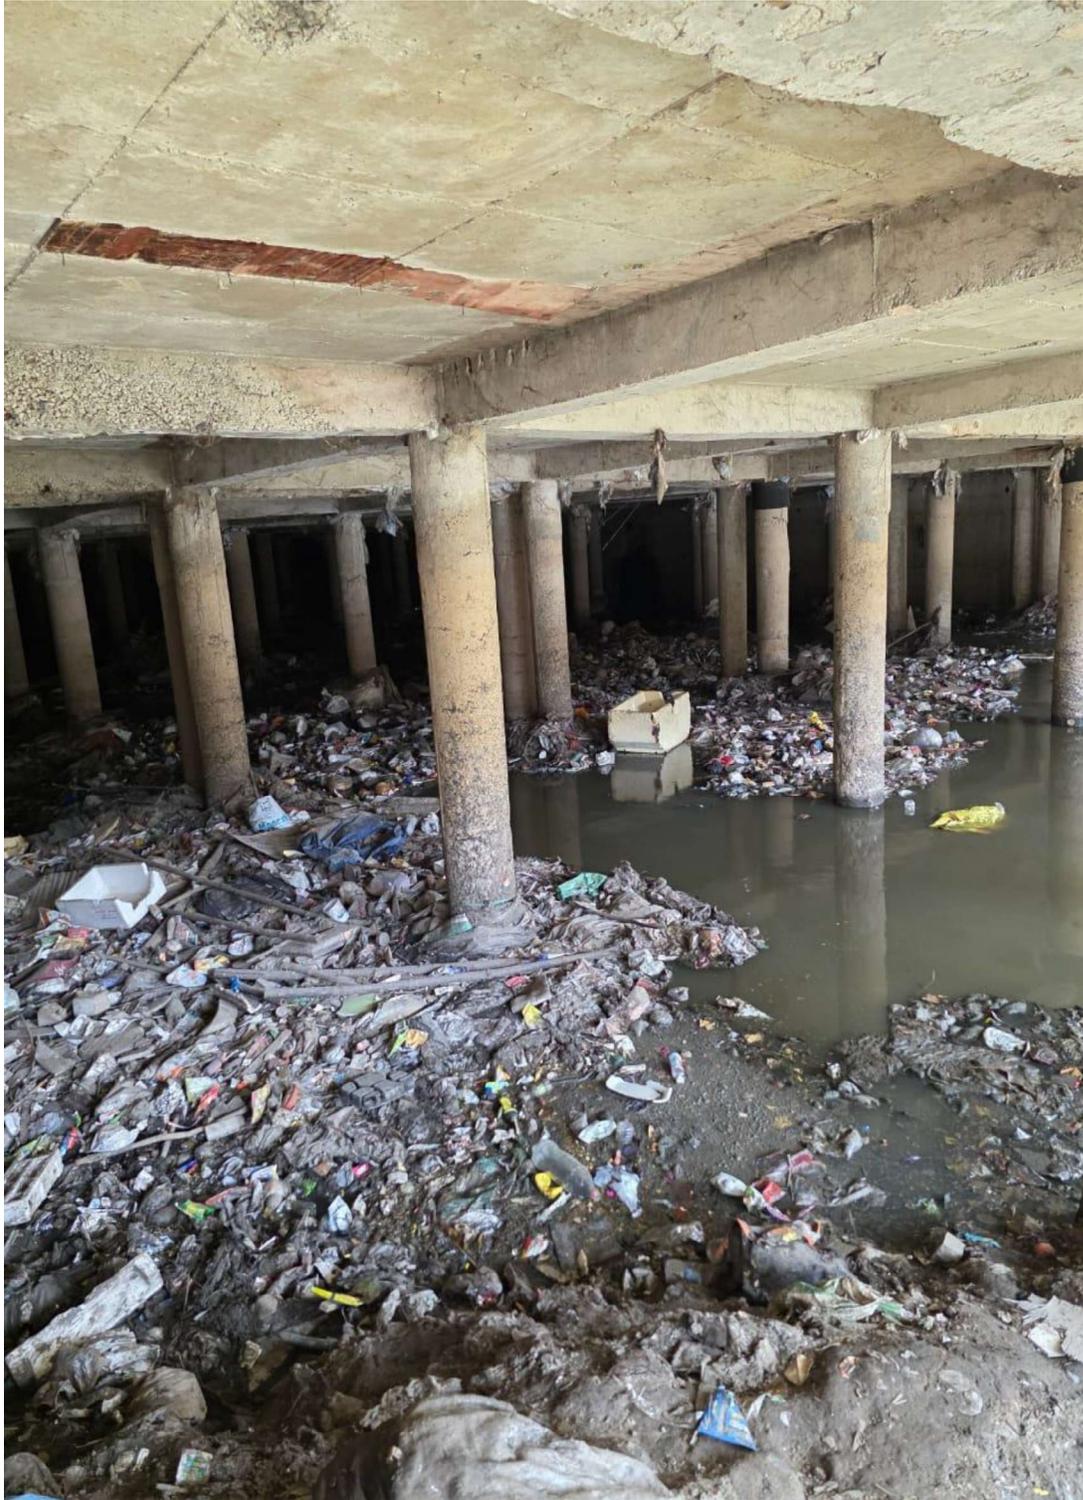
just below the
concrete
portion

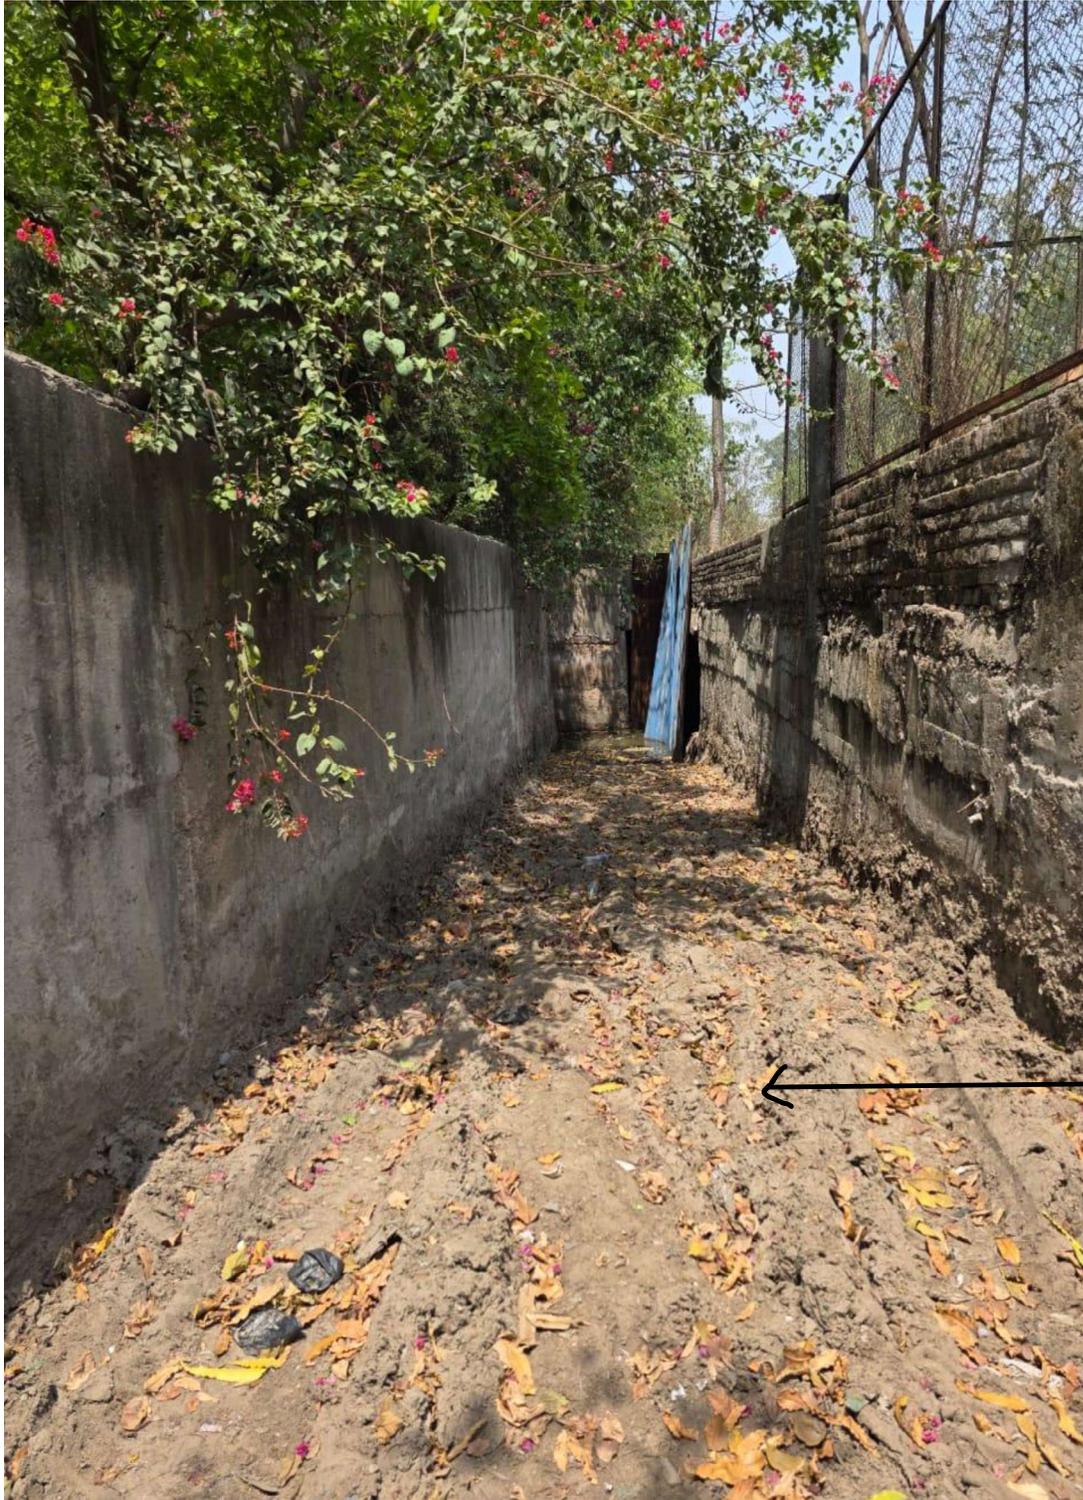
← dried sludge/
mud

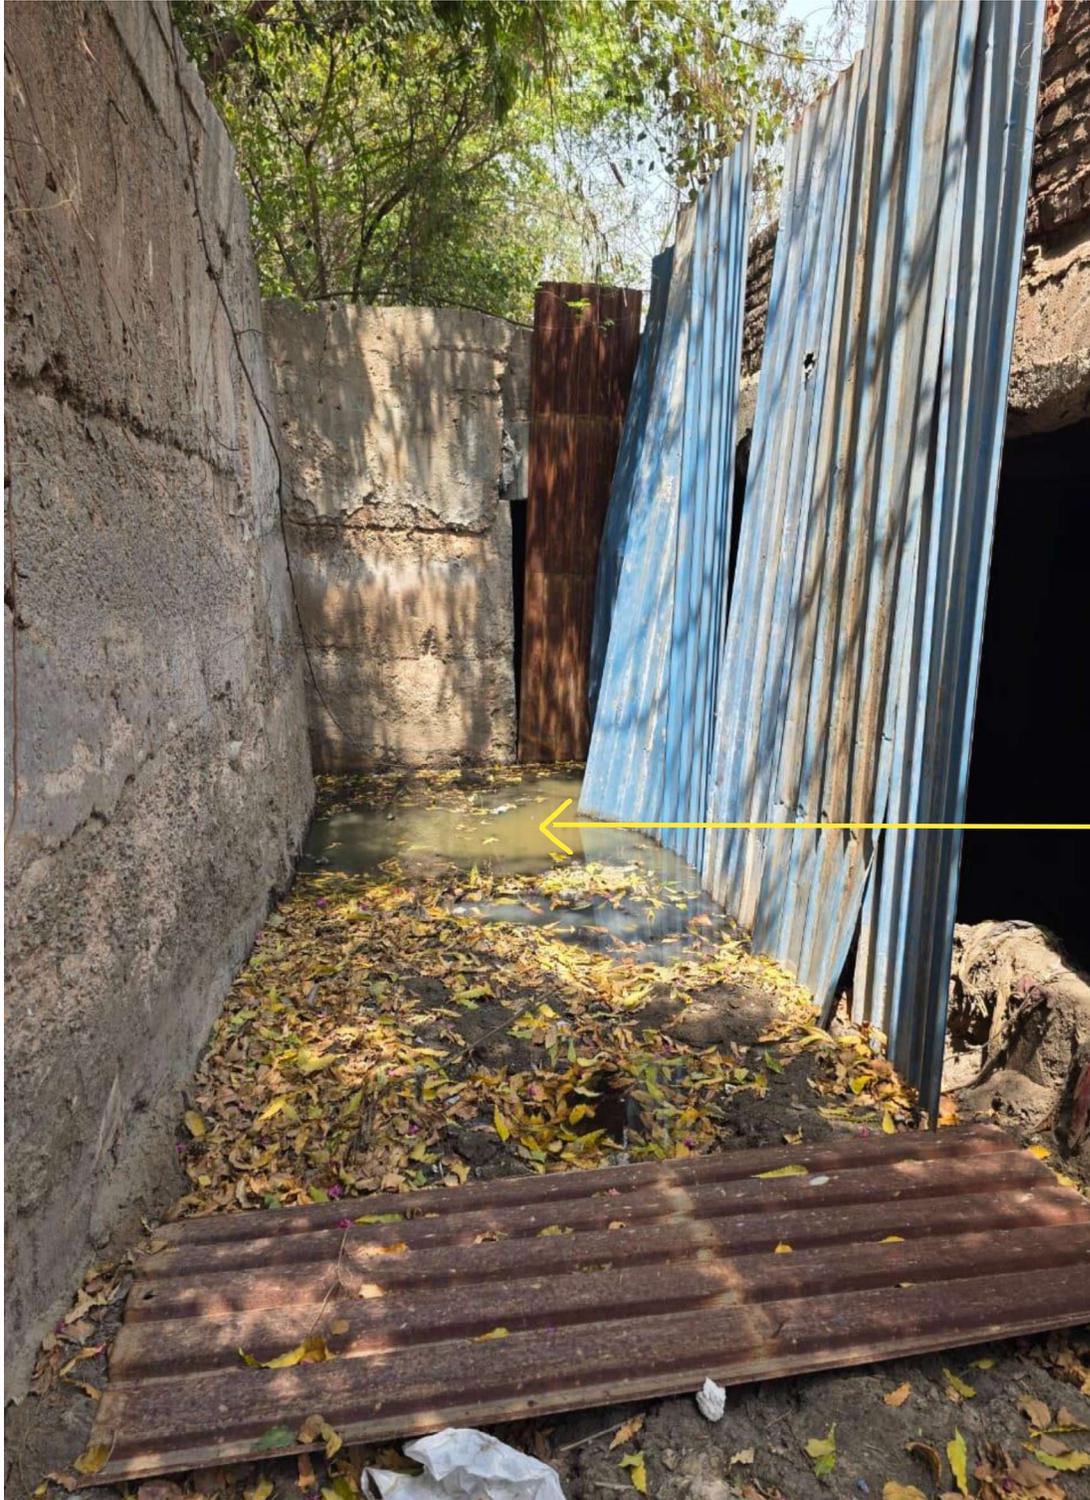
**stagnated
drain water**

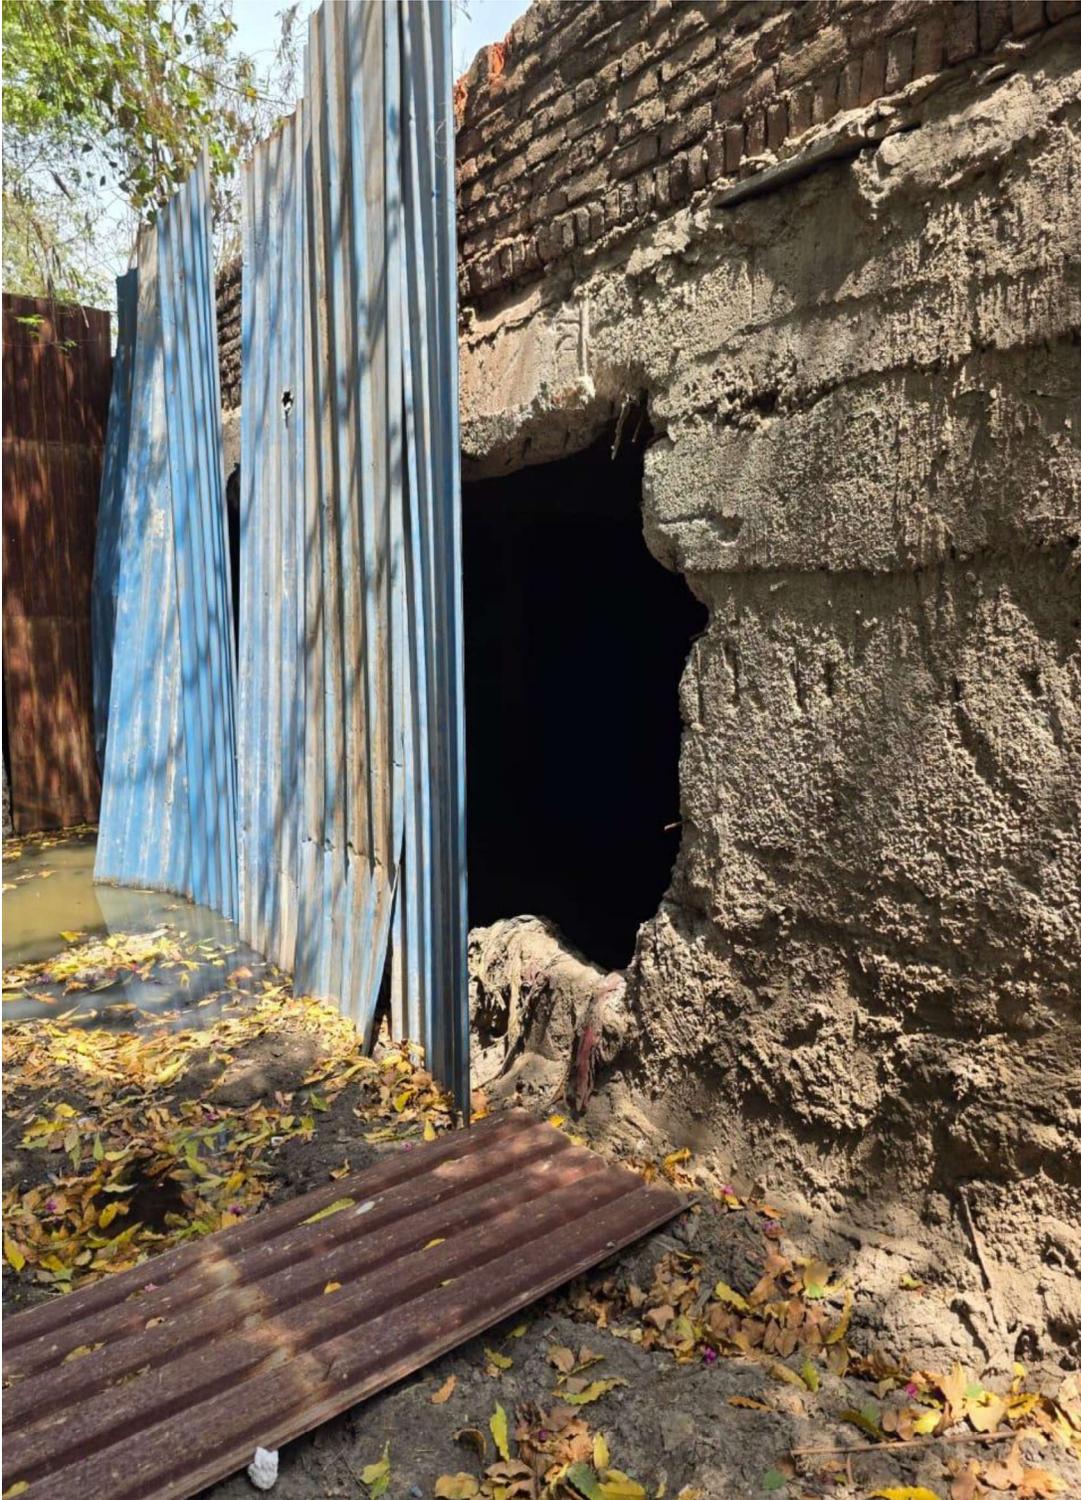
covered with tin sheet.

1. Along the entire drain there are only three entry points through ramp from adjoining road to approach the drain. These entry points are stated to be meant for cleaning the drain through JCB machine etc. First entry at point "B" was found to be inadequately covered with tin sheet. Second entry at point "C" was found to be covered with Tarpoline and at the Third entry at point "F" one JCB was found cleaning the drain on 11.04.2025. At First and Second entry points/ramps as shown/detailed in above placed photos, the drain/polluted water was found stagnated.
