BEFORE THE NATIONAL GREEN TRIBUNAL**PRINCIPAL BENCH NEW DELHI**

ORIGINAL APPLICATION NO. 6 /2012

**FACTUAL STATUS REPORT BY THE COURT COMMISSIONER
IN COMPLIANCE OF ORDER DATED 09.04.2025**

Quick Glance of drain with help of google earth image and photos taken on 9th and 11th April, 2025:

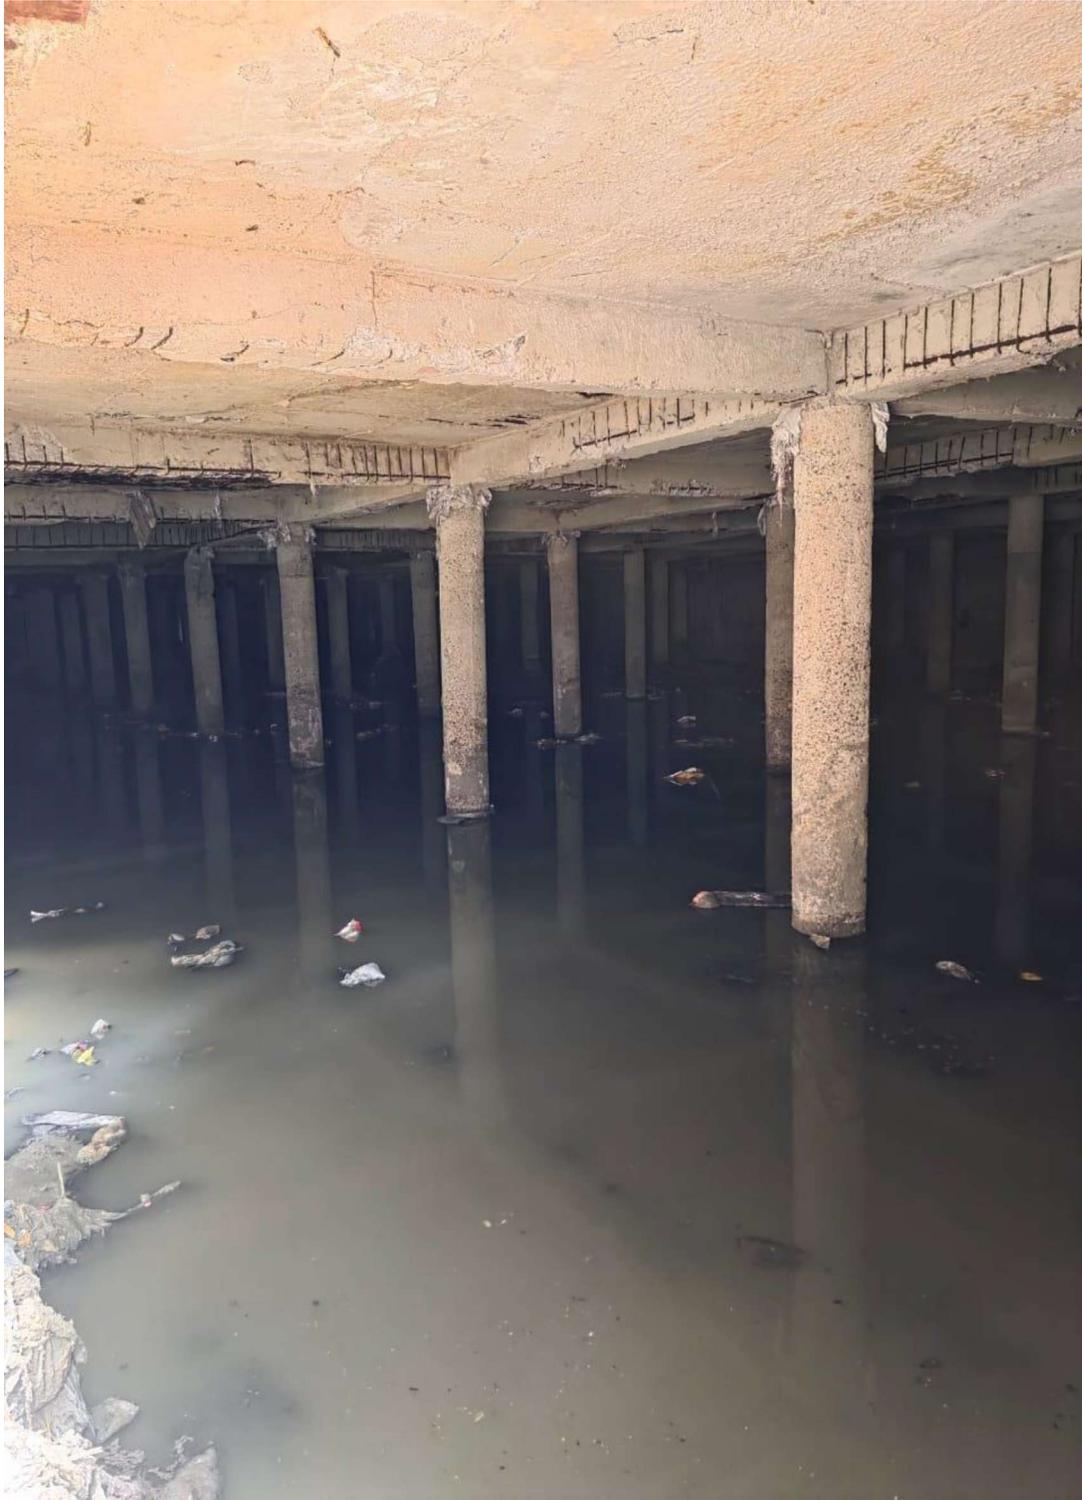
Stagnated drain with garbage.

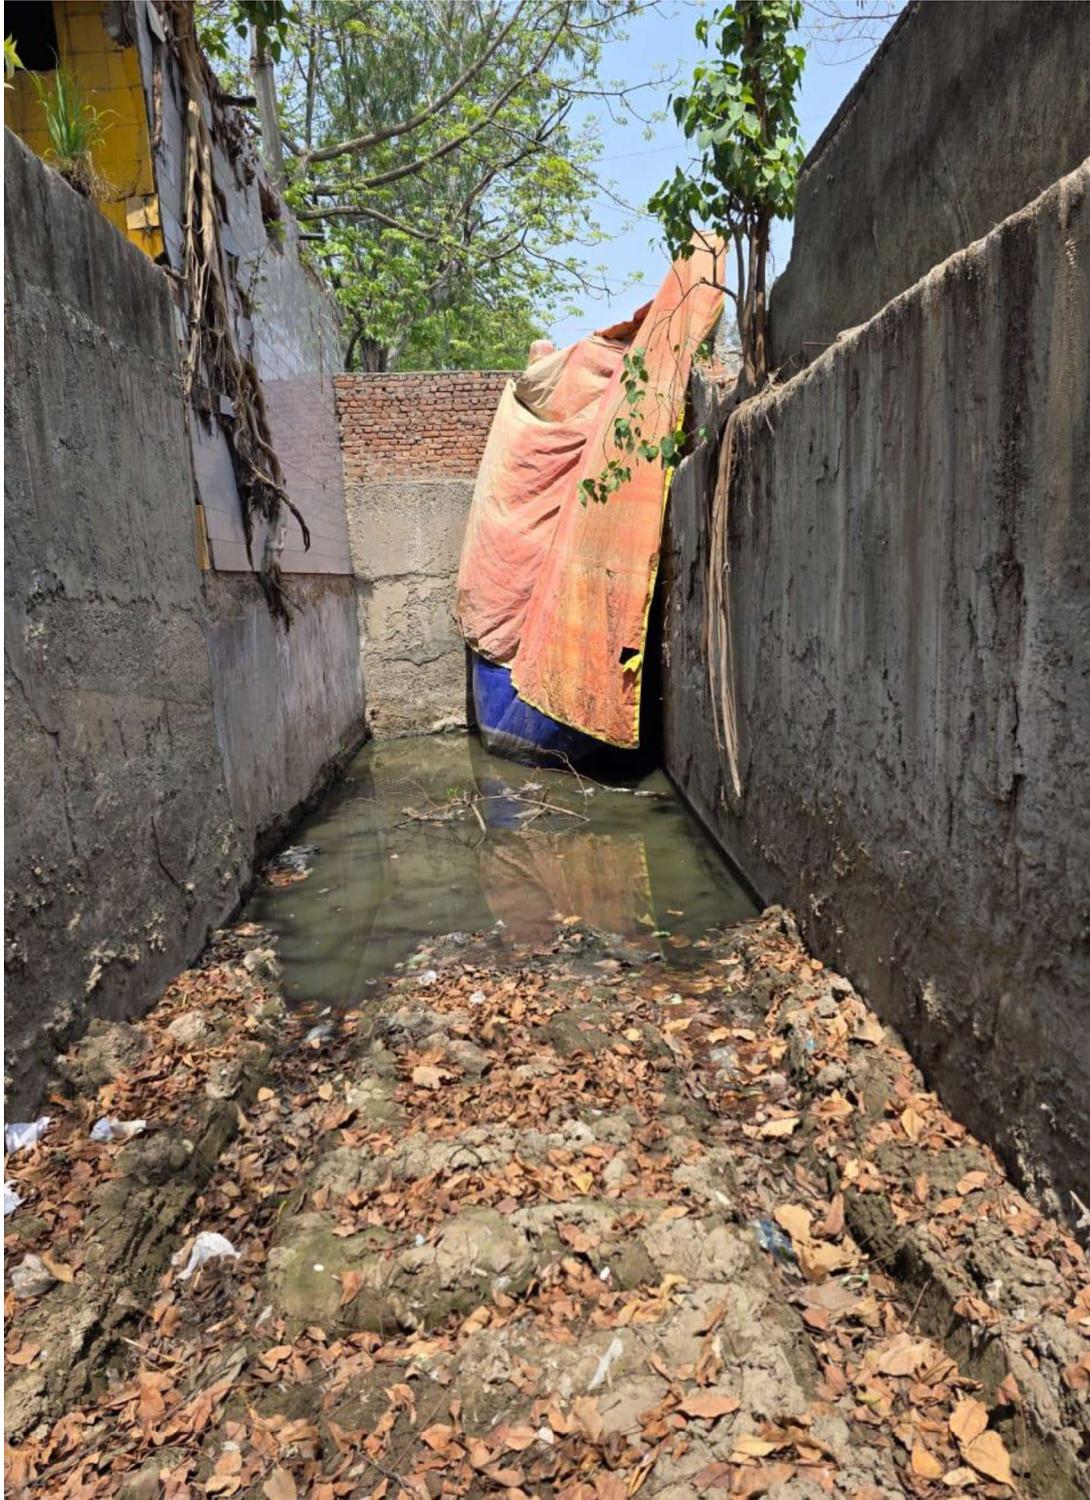
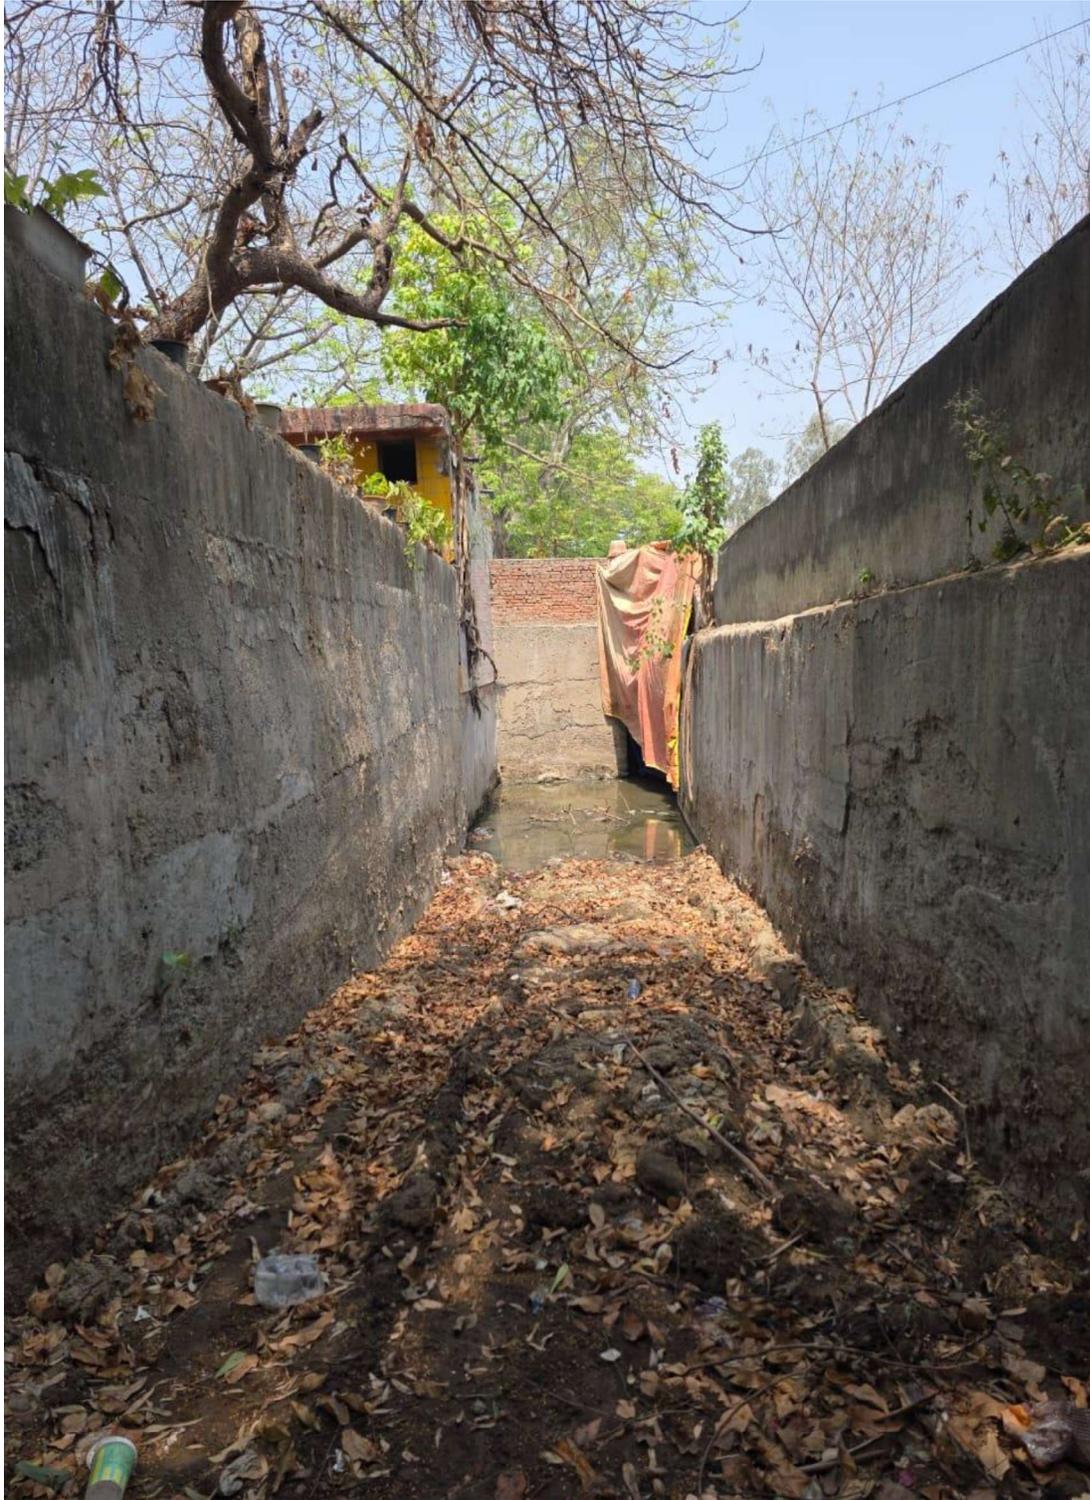
11. After walking further, there is Second ramp to approach (Infront of House No.C-159) the drain which was covered with tarpaulin sheet. Since sewage was stagnated, therefore it was not possible to approach the drain and take inside photographs. (Point 'C')

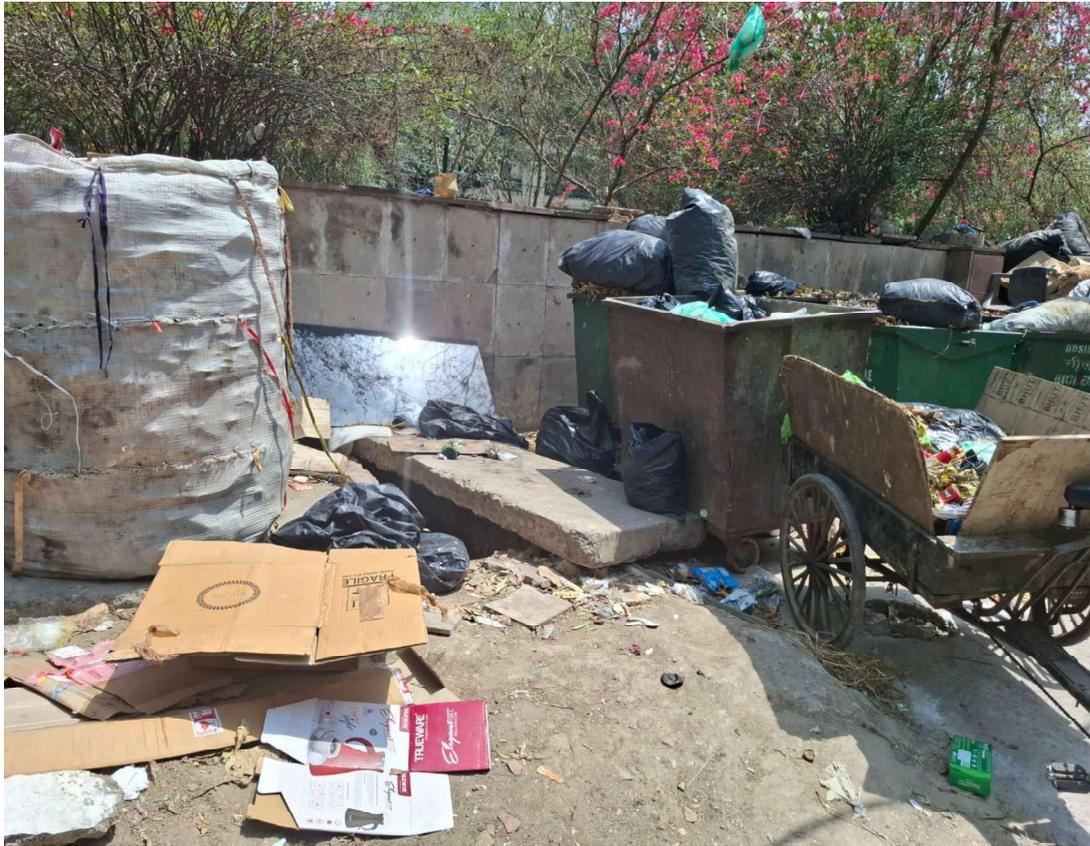
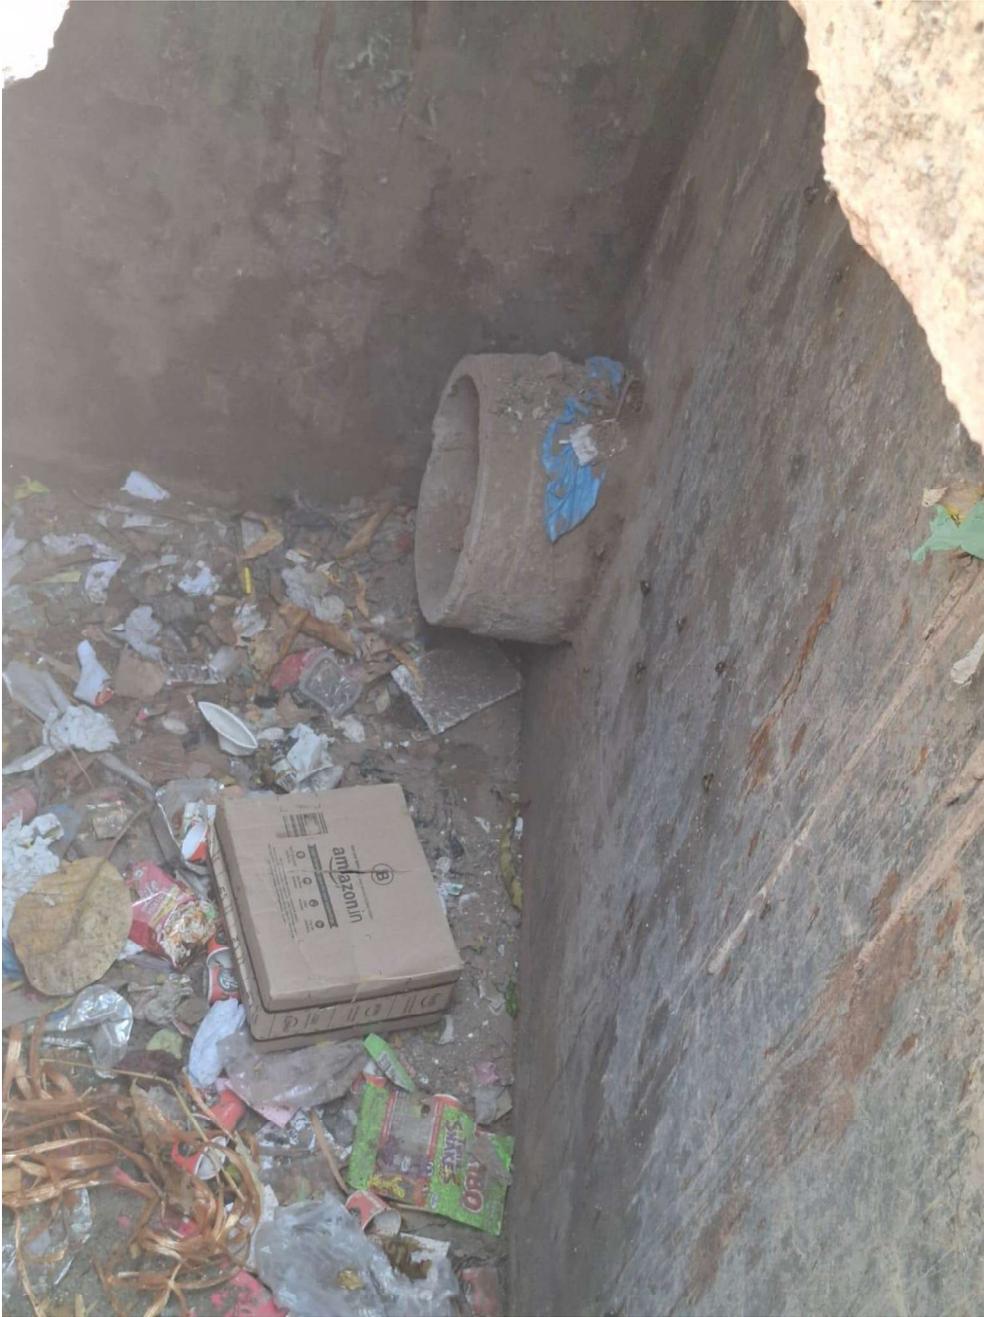
12. Rain Water Harvesting Pit loosely covered with concrete slab and garbage also found inside it.

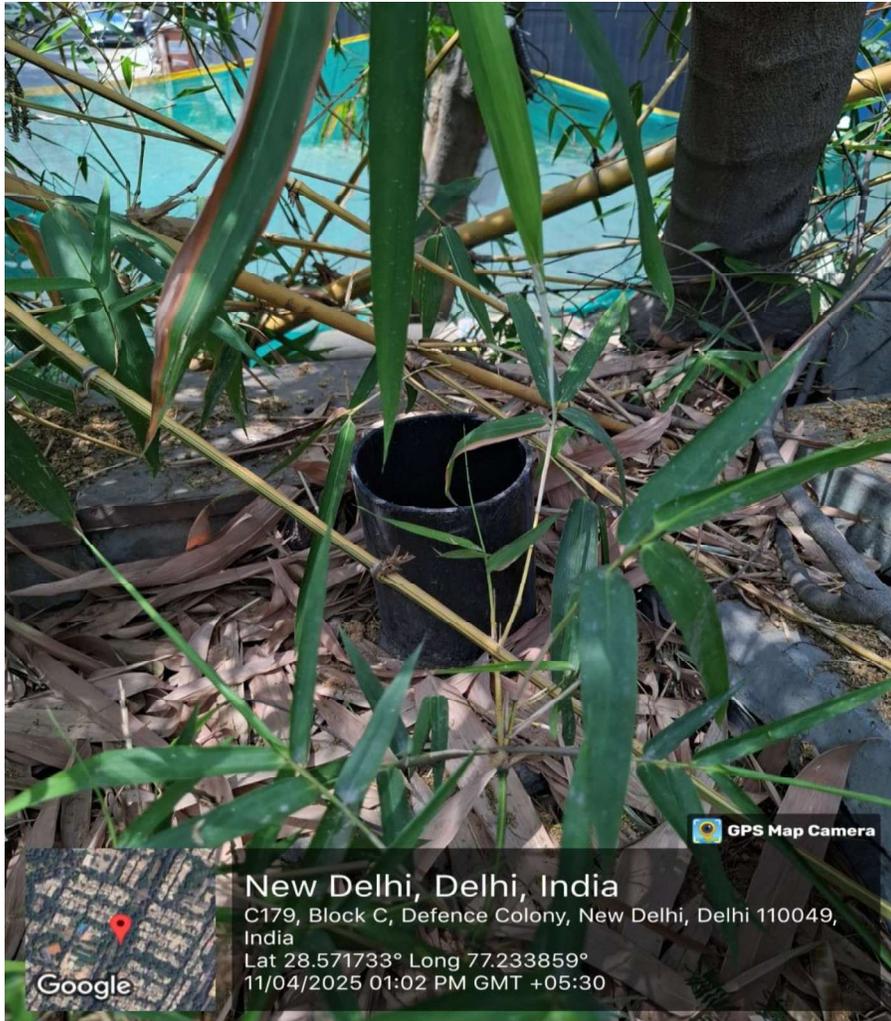
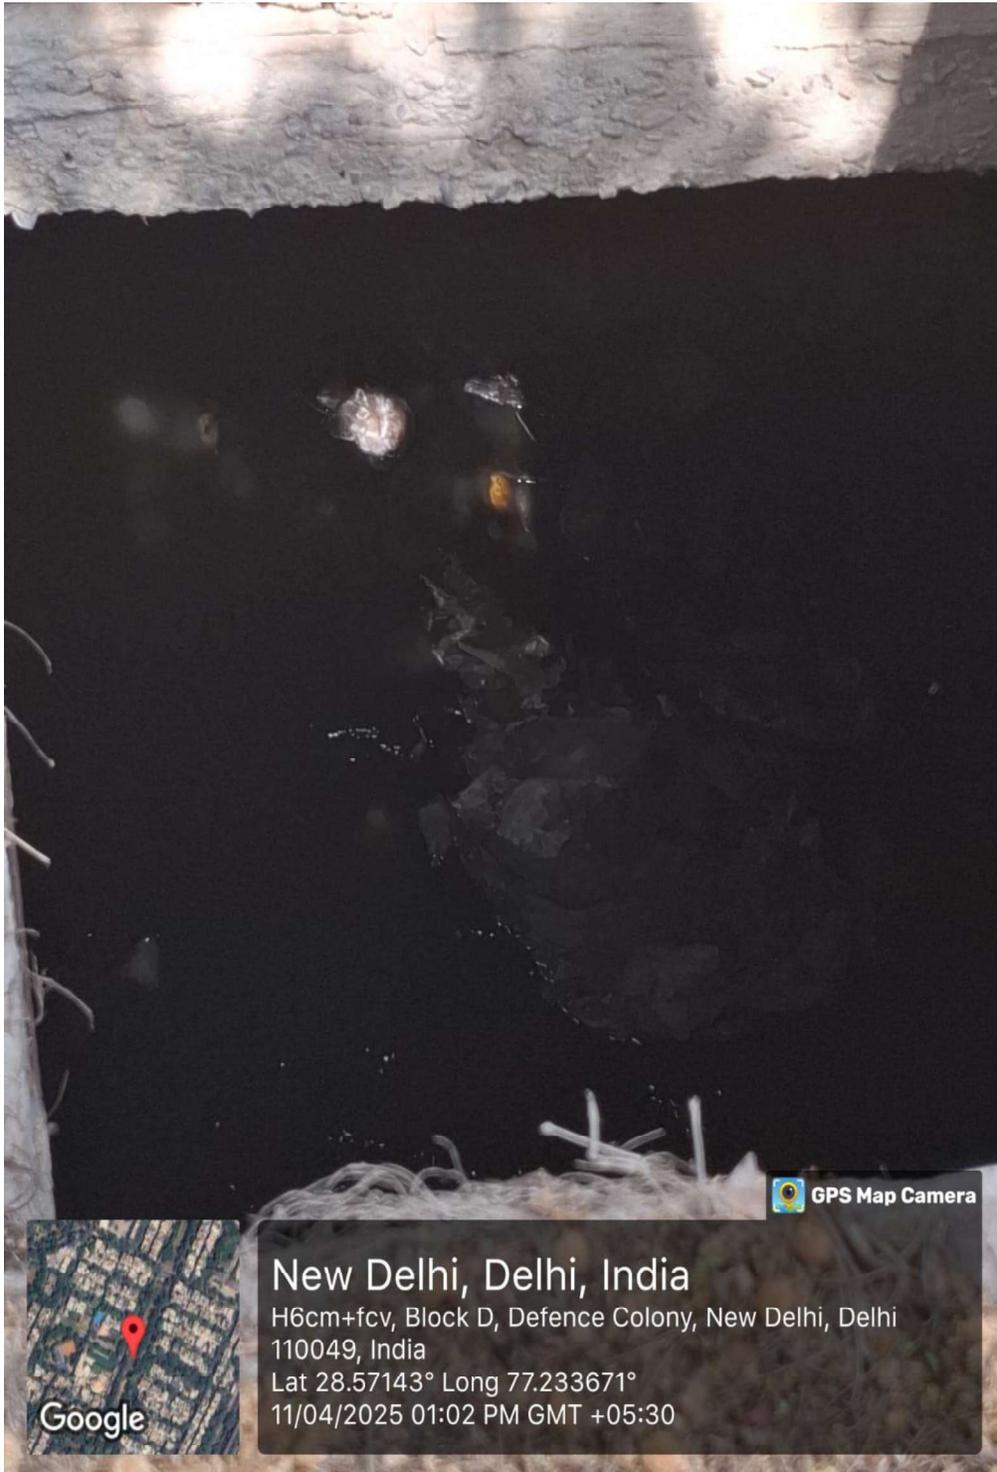
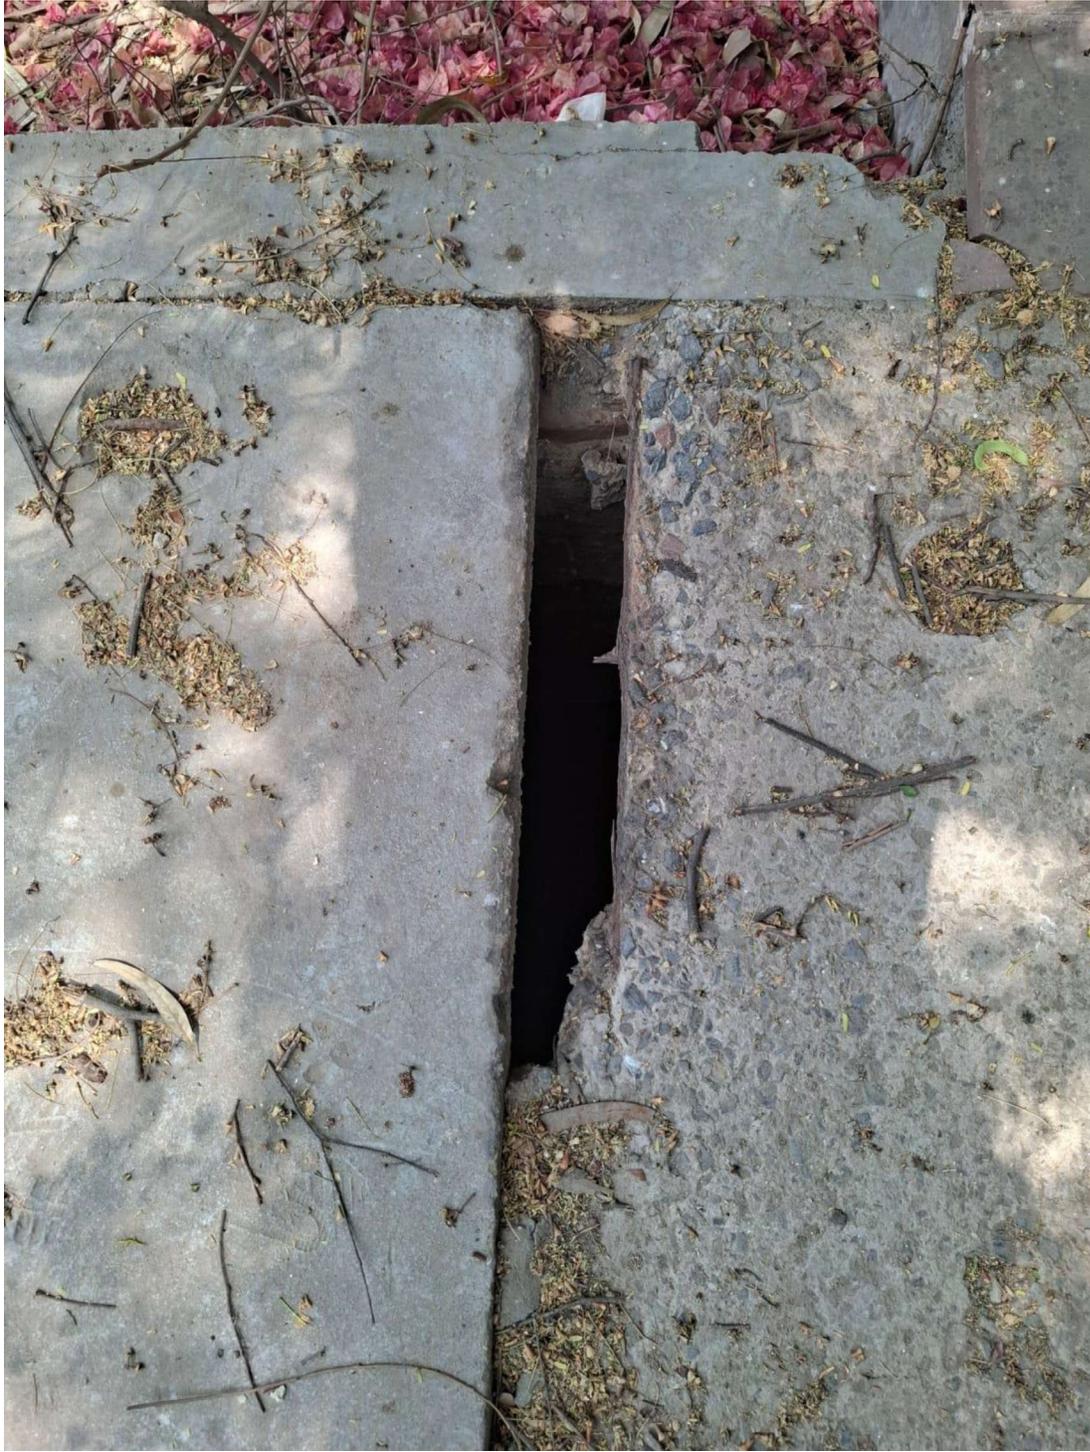
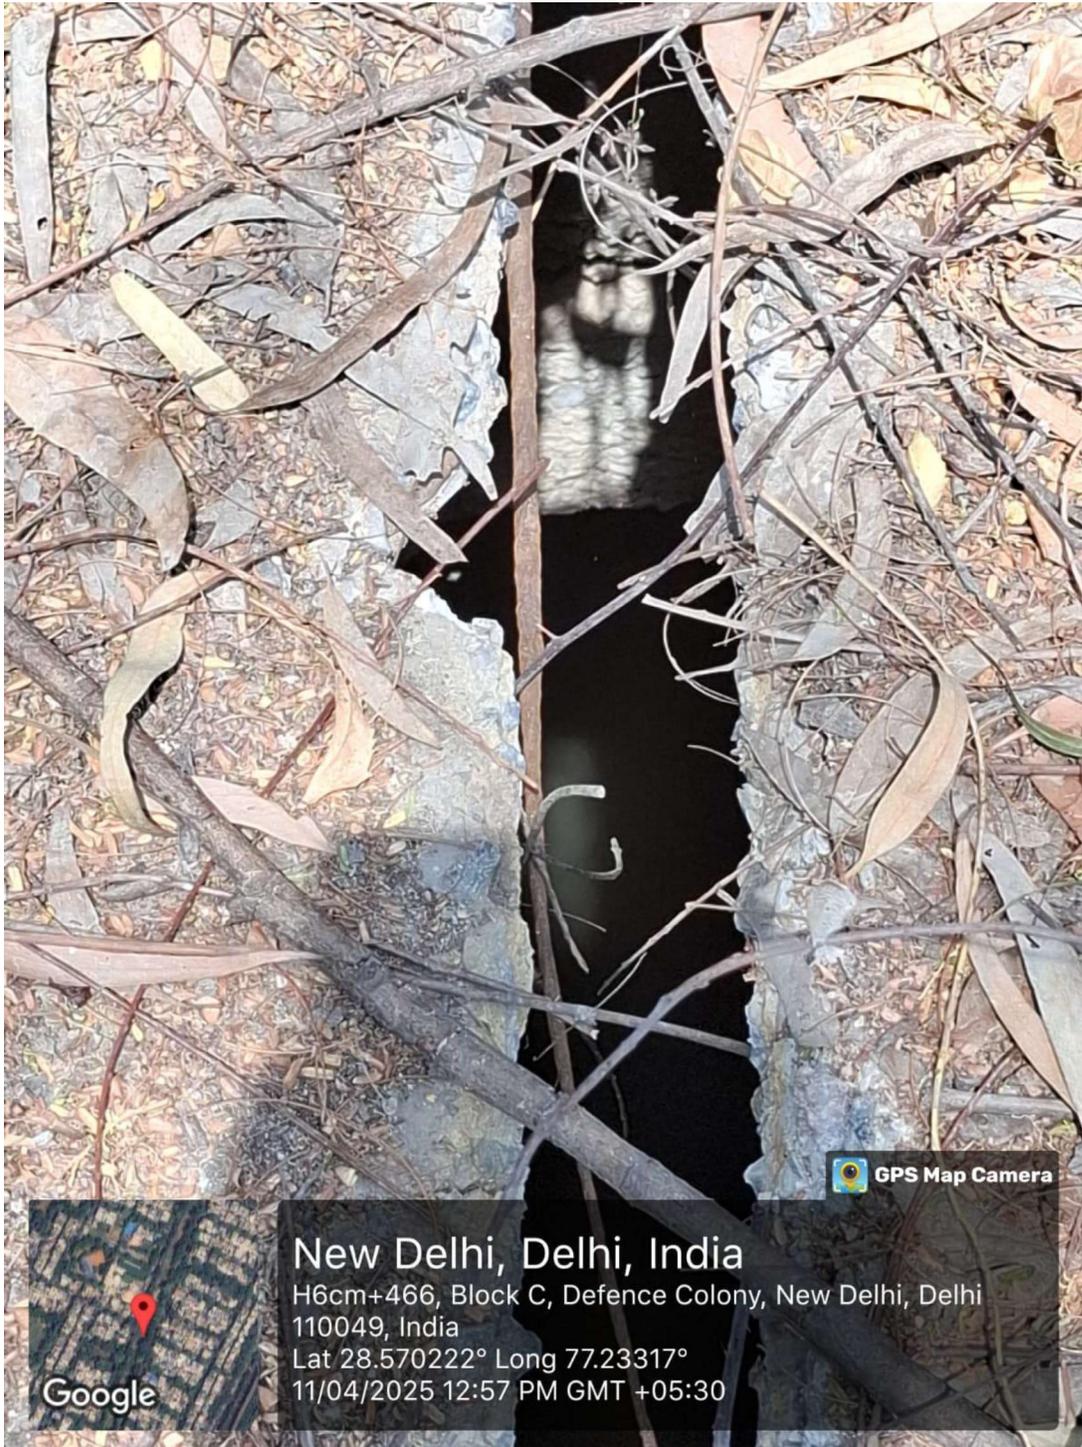
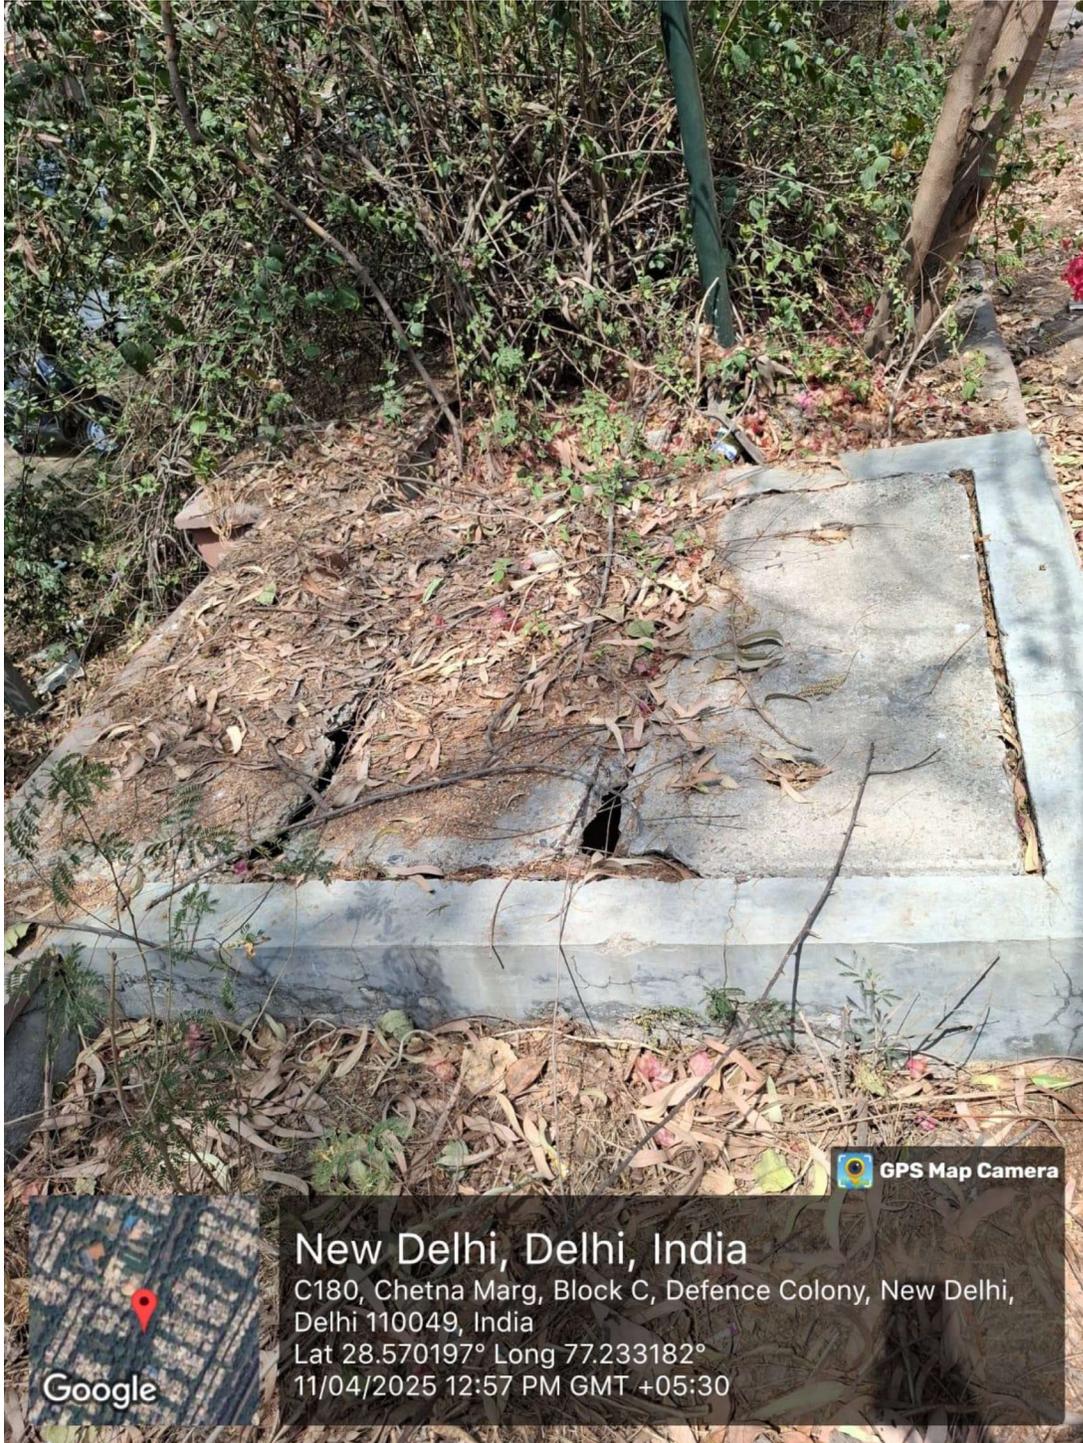
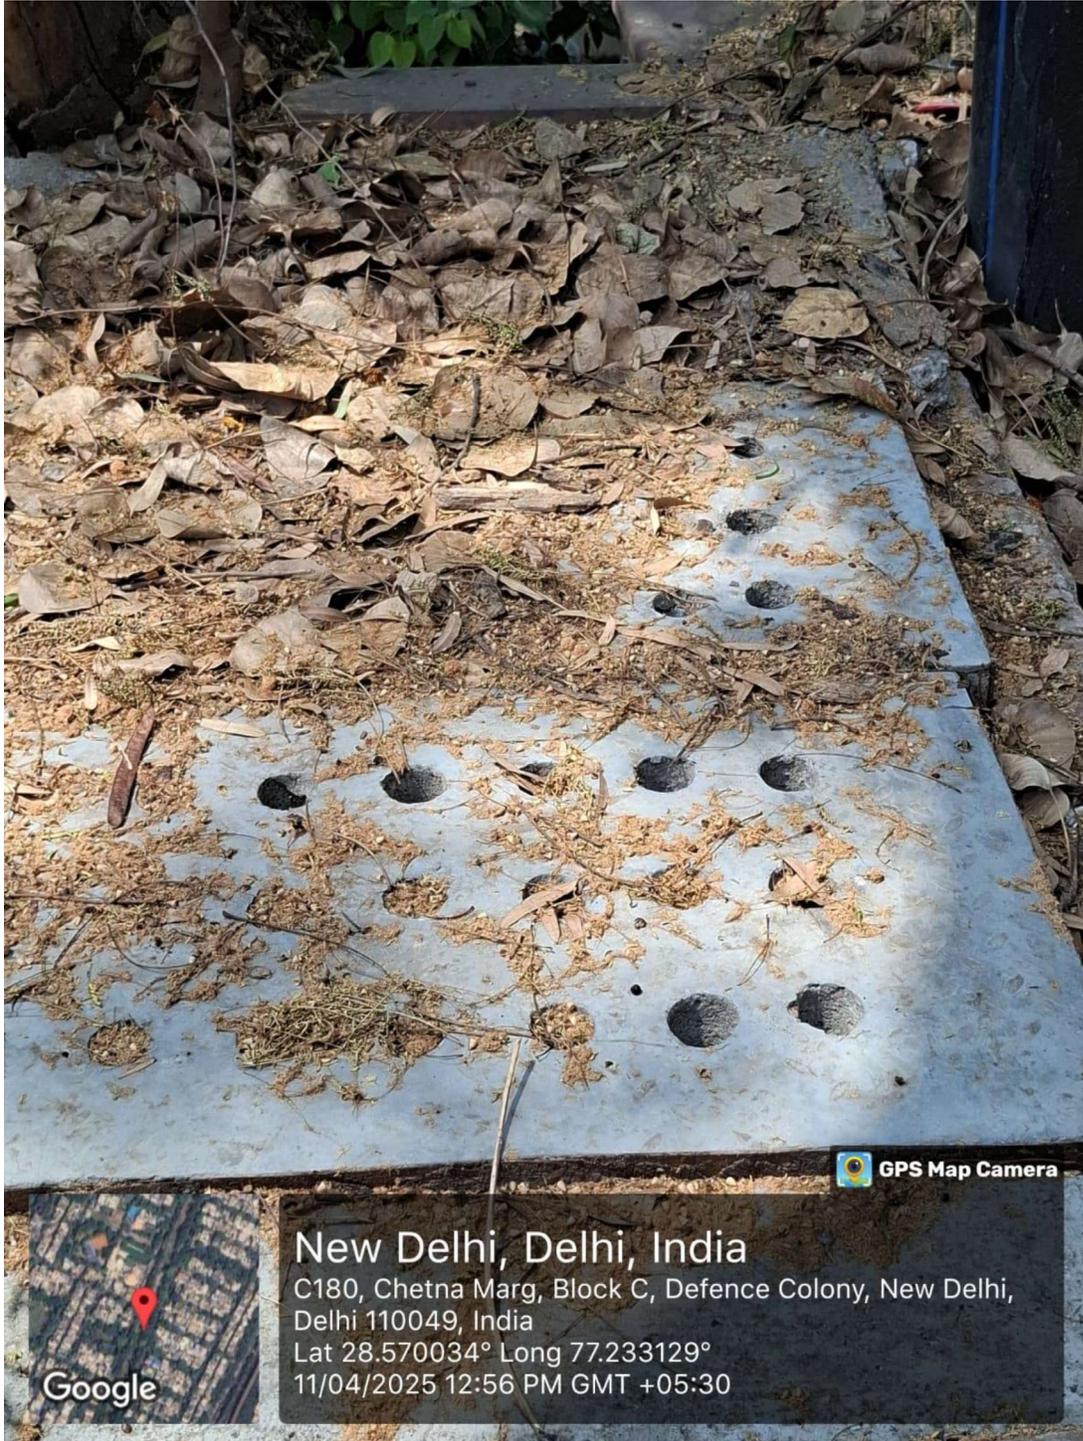
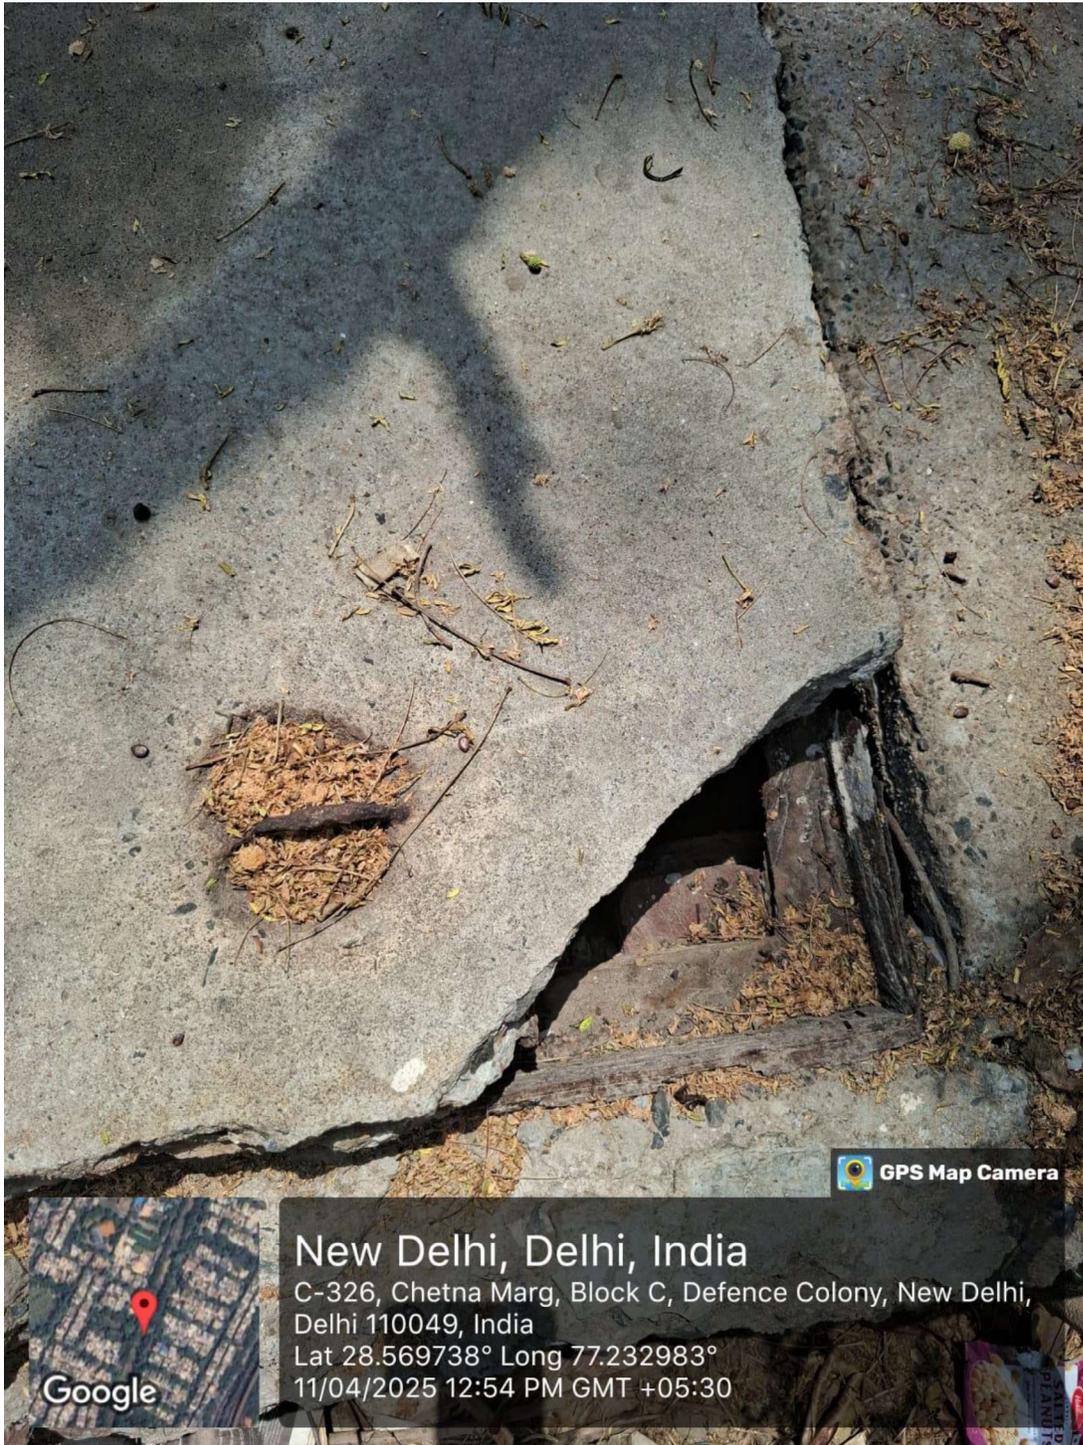
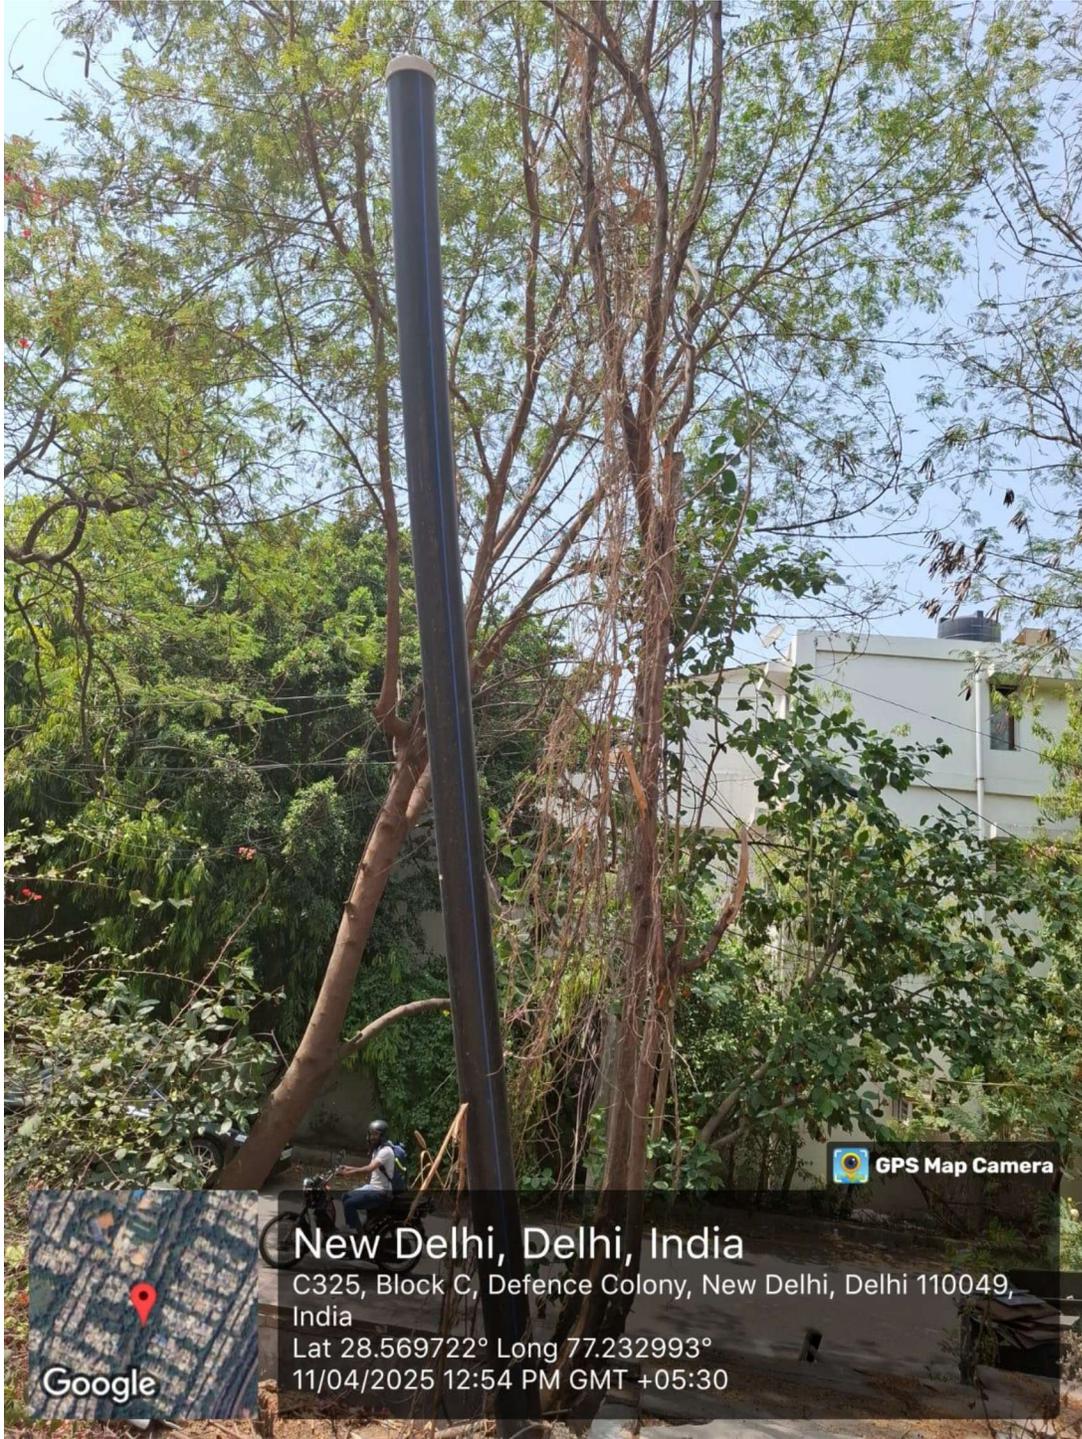
13. Moving further, Mr Sidharth Luthra, Senior Advocate drawn the attention on the top of the covered concrete area/park where various square shaped manhole/chambers on both boundaries giving access to the drain flowing underneath were situated. However, most of them had cracks and broken lids which were observed as releasing mild foul odour at close proximity to it. The exhumed pipes were visible with maximum height of 15-20 feet. And at some places the exhumed pipes were found broken and fallen on ground.
