BEFORE THE NATIONAL GREEN TRIBUNAL**PRINCIPAL BENCH NEW DELHI**

ORIGINAL APPLICATION NO. 6 /2012

**FACTUAL STATUS REPORT BY THE COURT COMMISSIONER
IN COMPLIANCE OF ORDER DATED 09.04.2025**

Quick Glance of drain with help of google earth image and photos taken on 9th and 11th April, 2025:

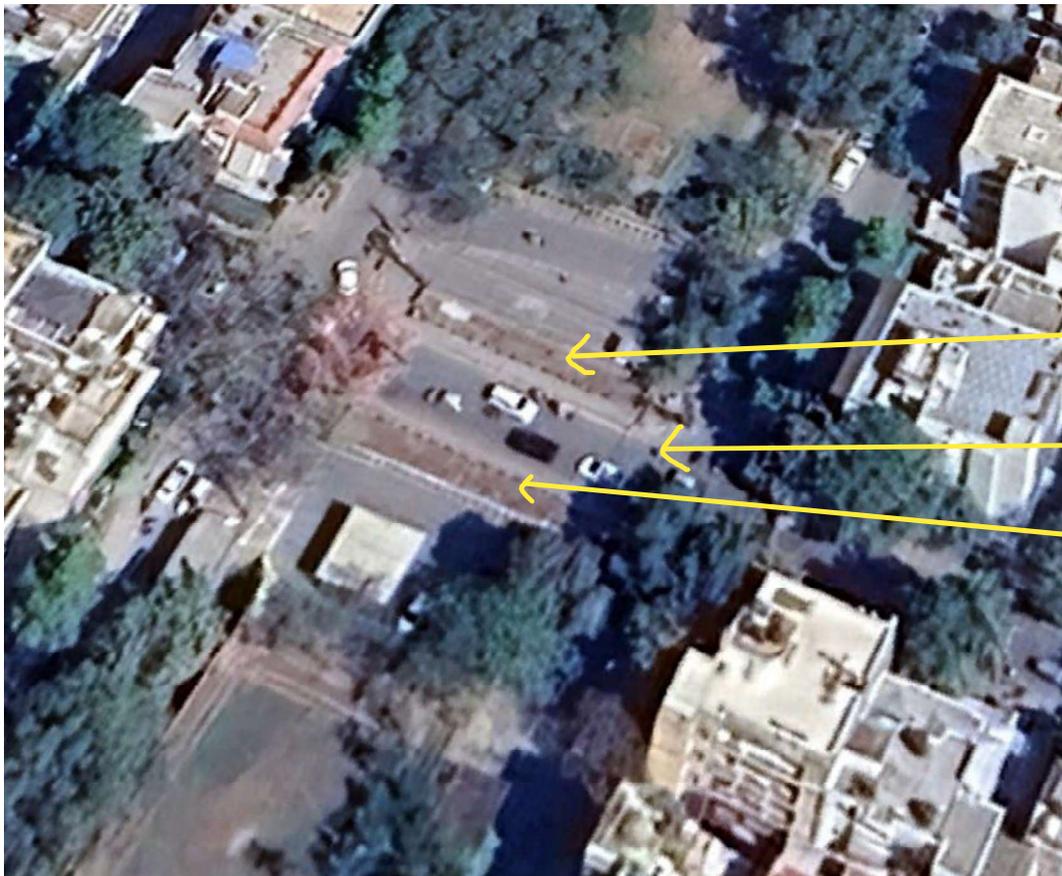
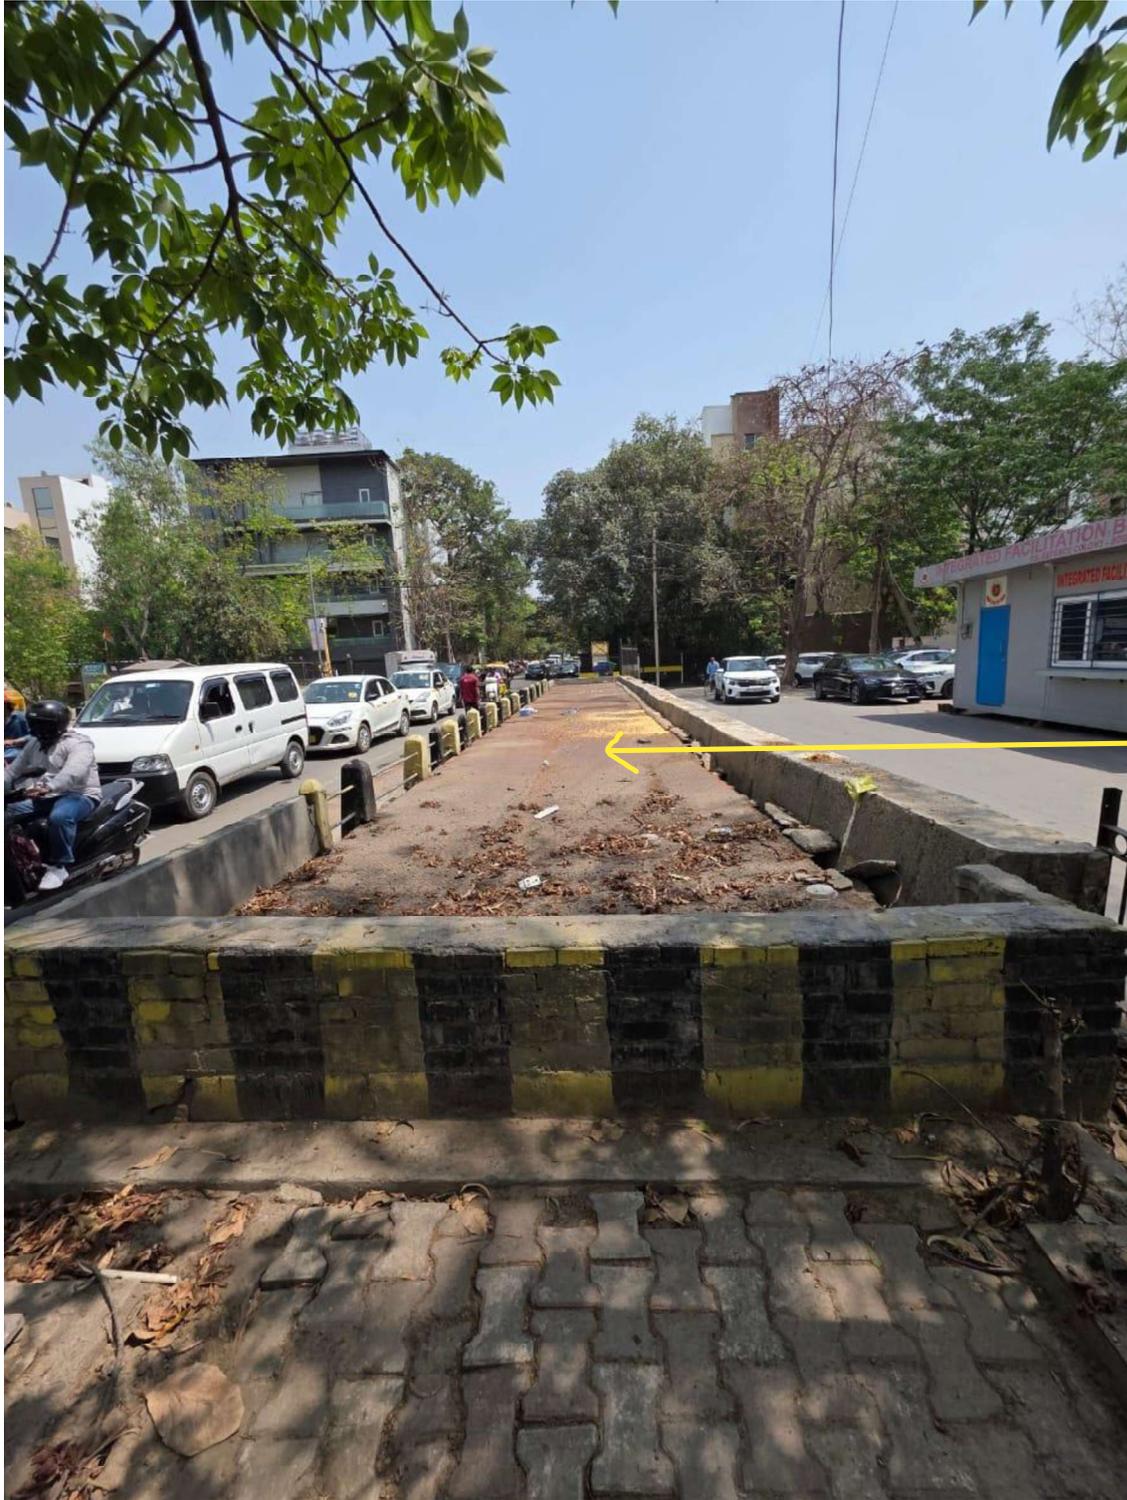
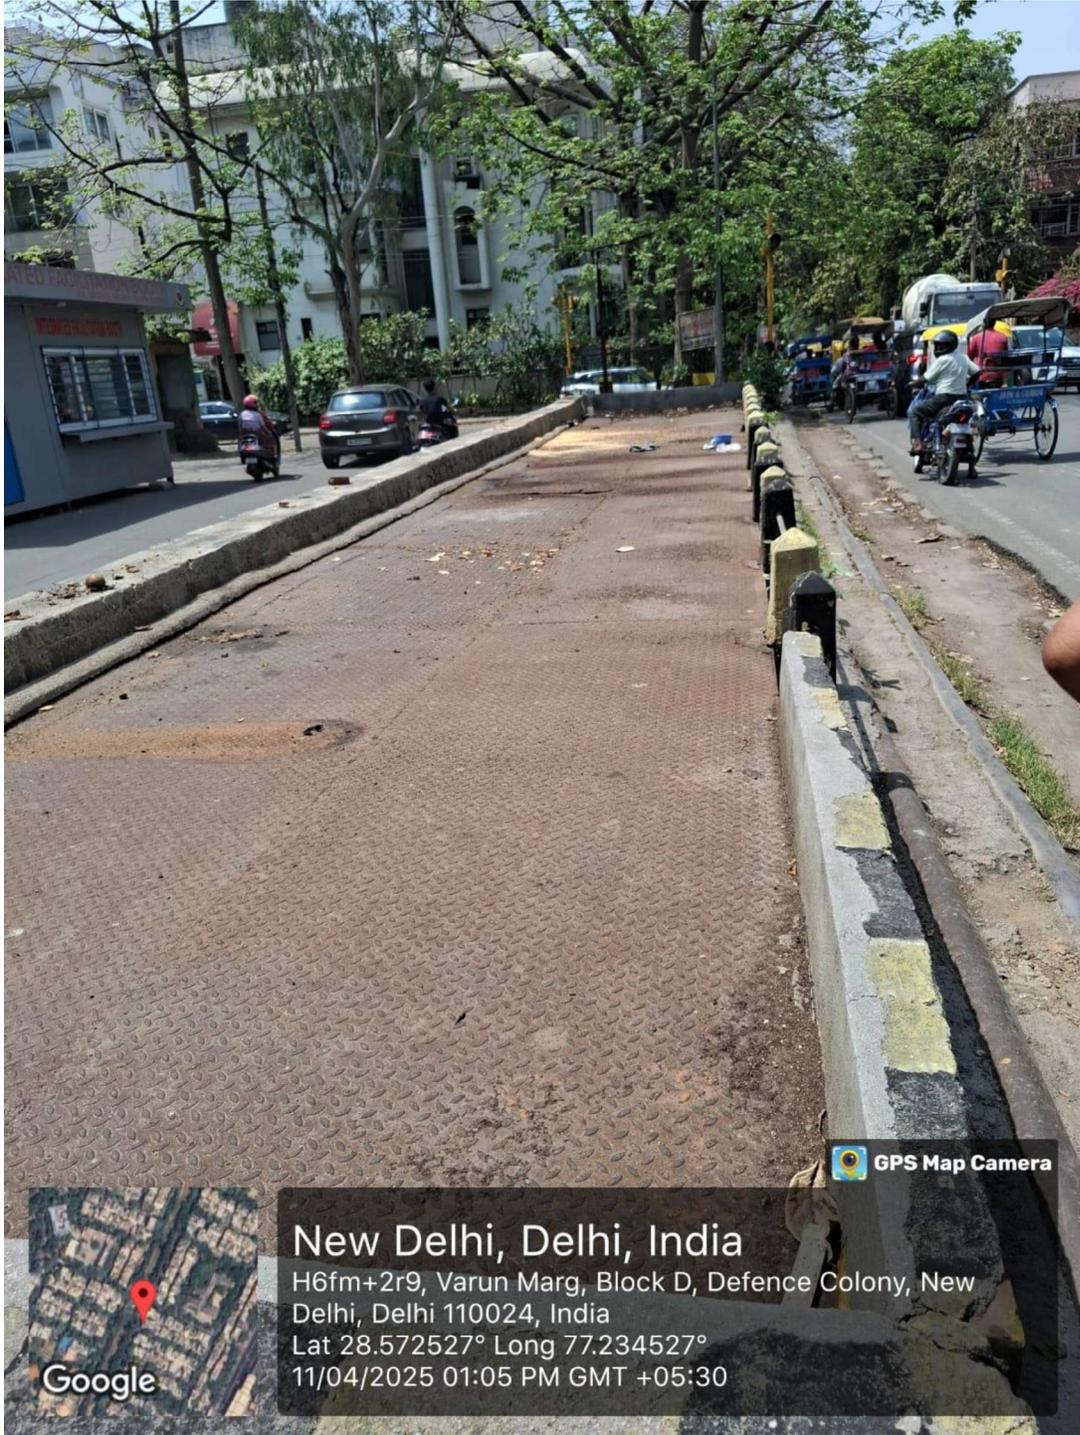
Point D
enlarged view

14. After reaching the mid point of drain at point D where the internal roads intersect, the drain was found covered with 2 big iron sheets (one each on 2 sides of intersecting road). The iron sheet has gained significant rust and developed holes. These holes were tried to be covered loosely with makeshift material.

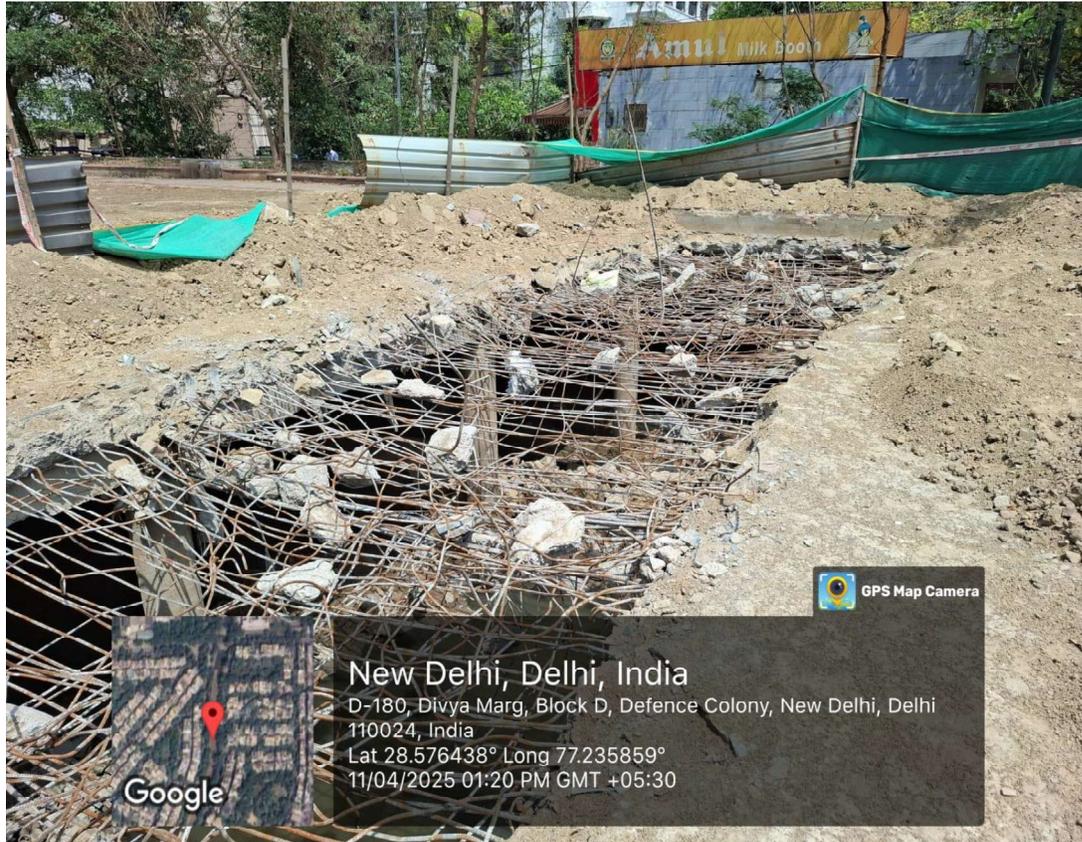
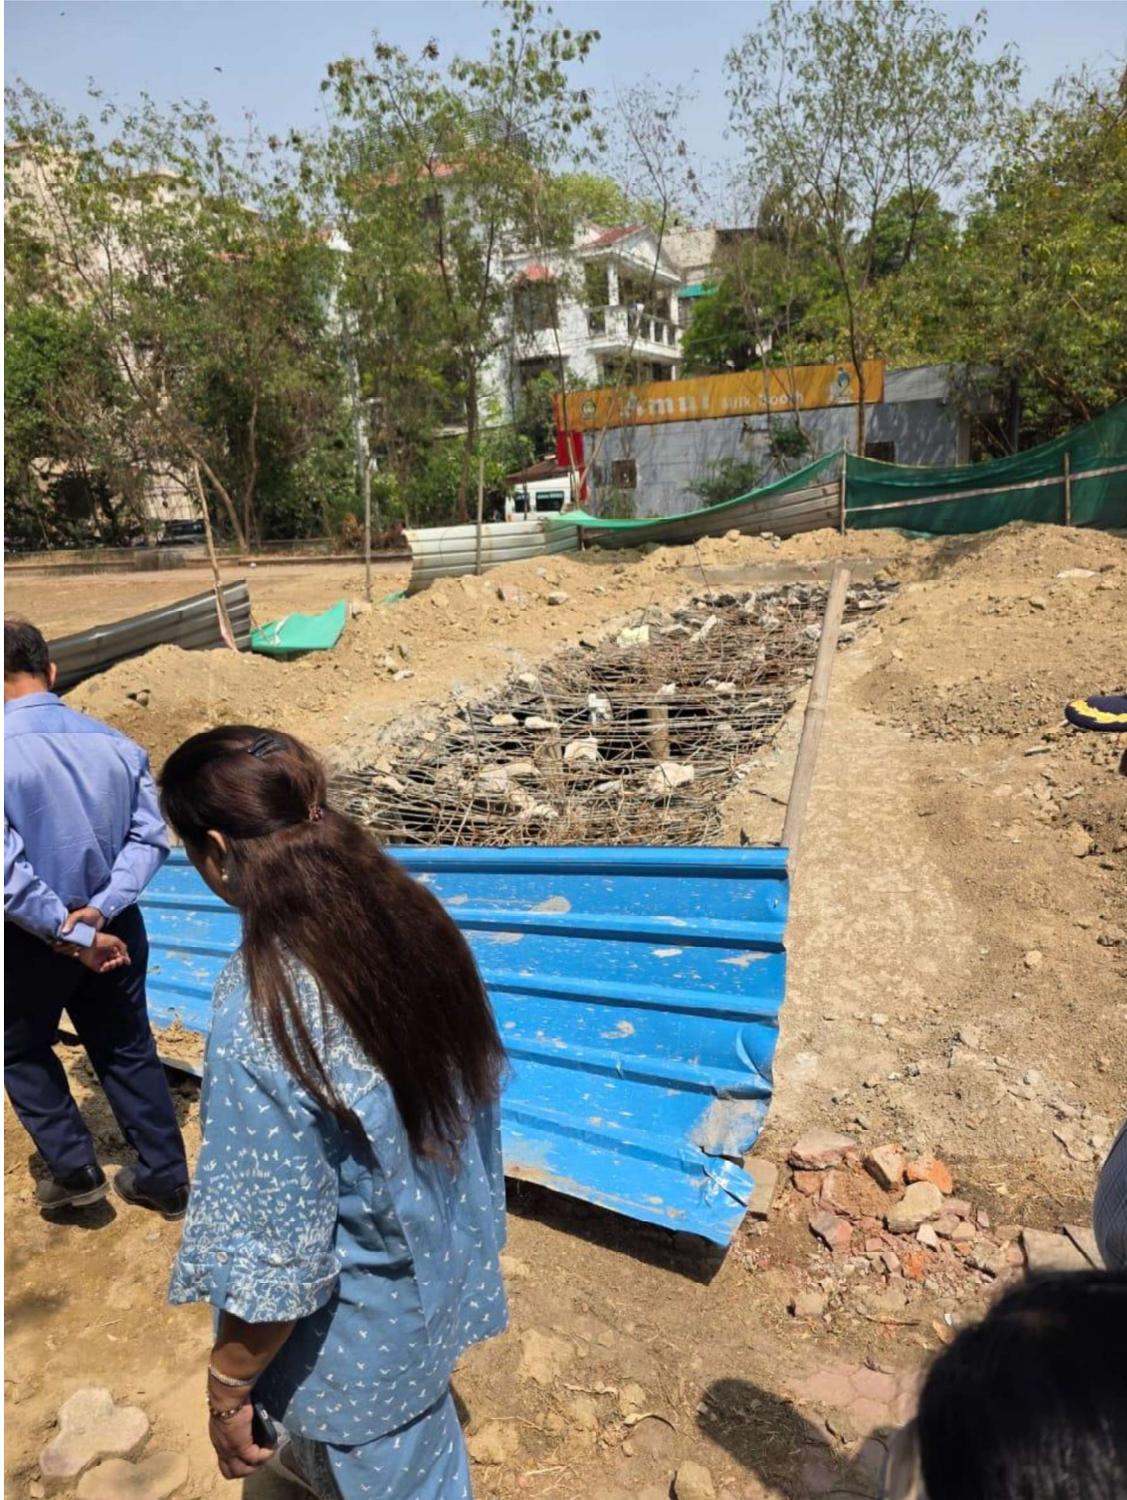
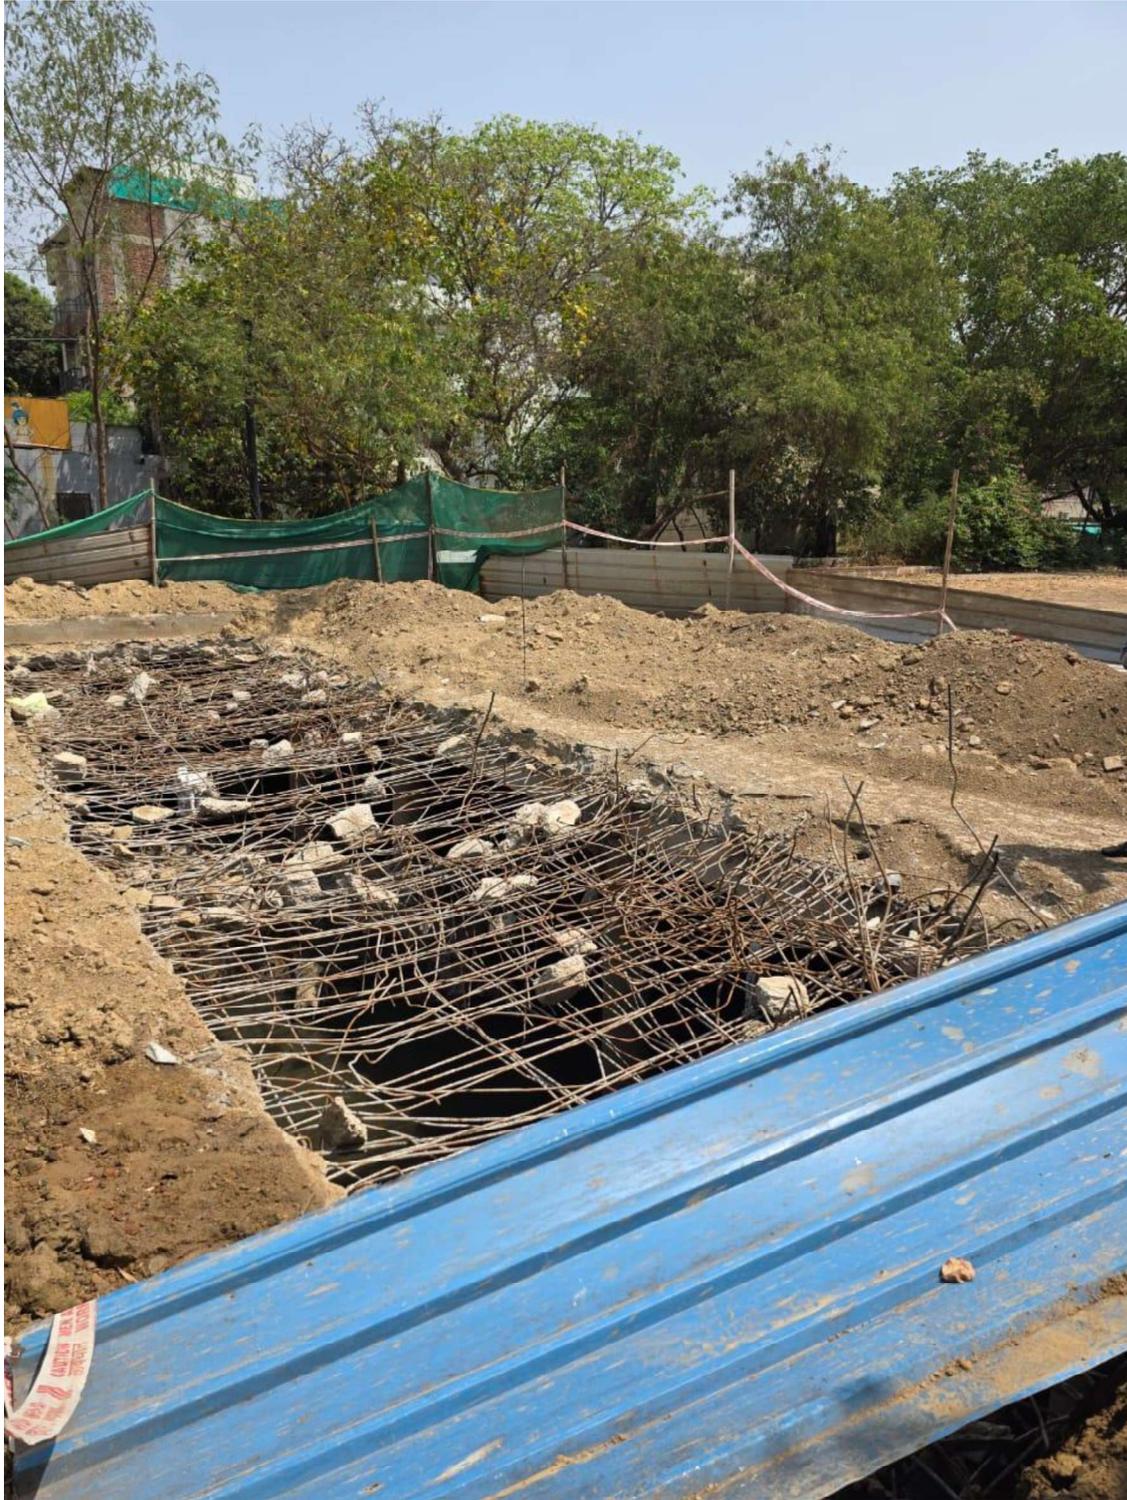
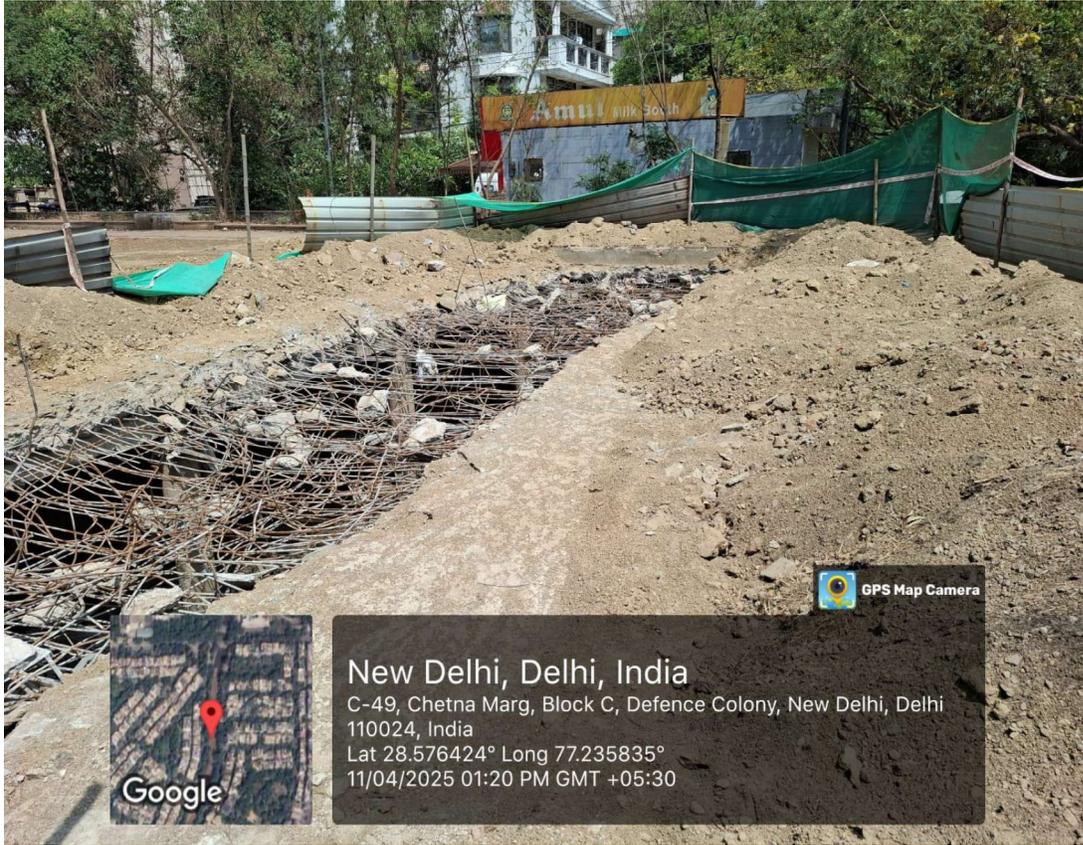
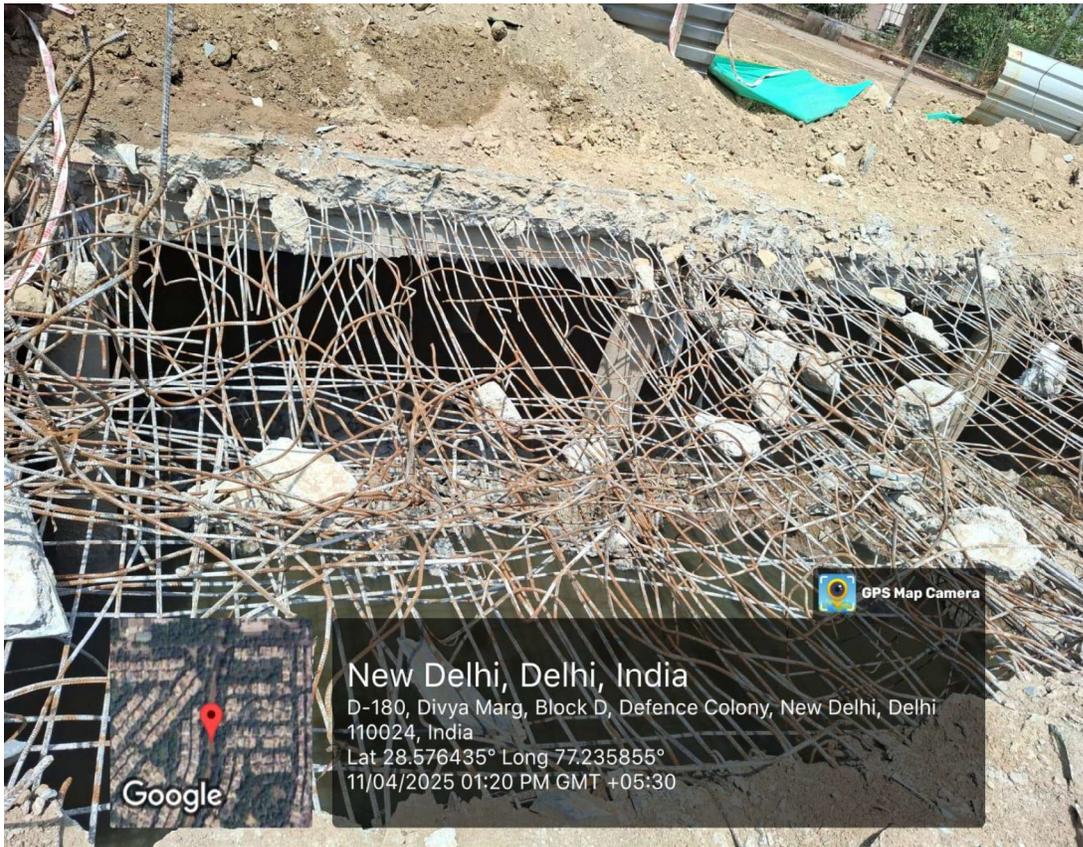
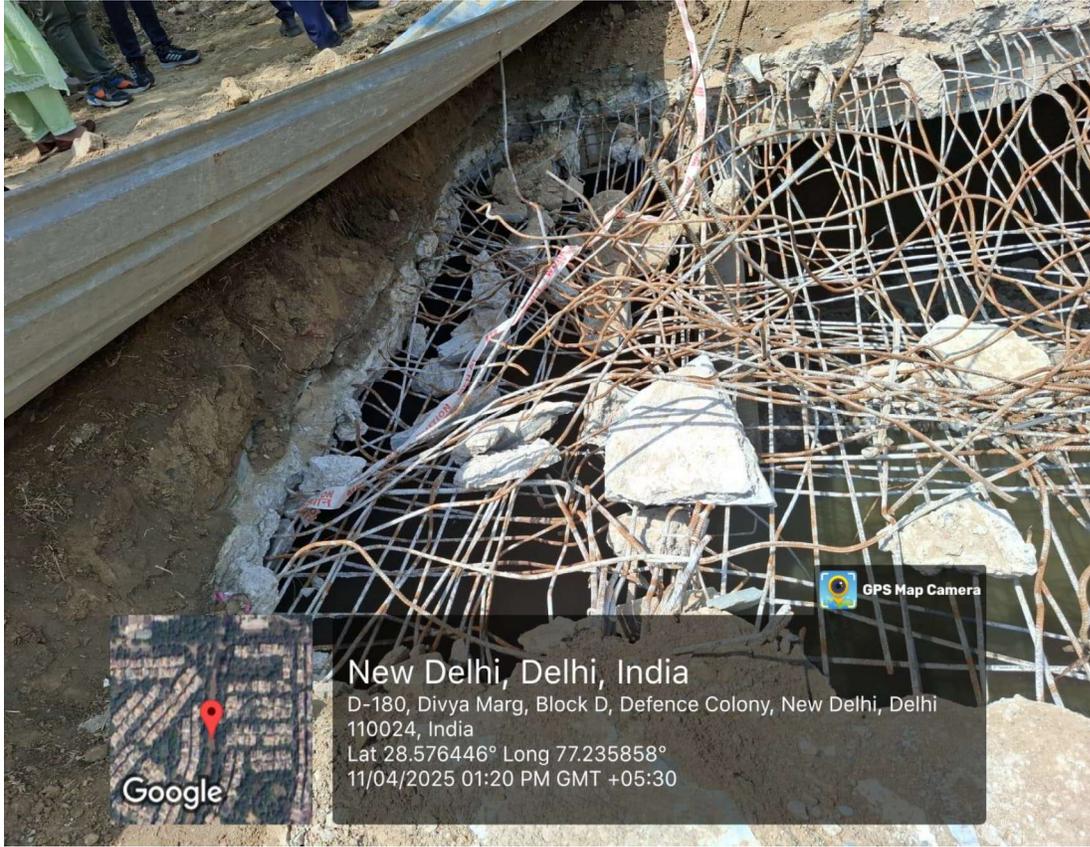
15. At point E towards the northern side reaching almost 50 meter before the end of drain, MCD has broken the concrete top cover of the drain and stated it as a Pilot project to uncover/break open the covered area of the drain at various points in order to clean it through sucker machines etc. The Lanter and iron bars were incompletely broken.

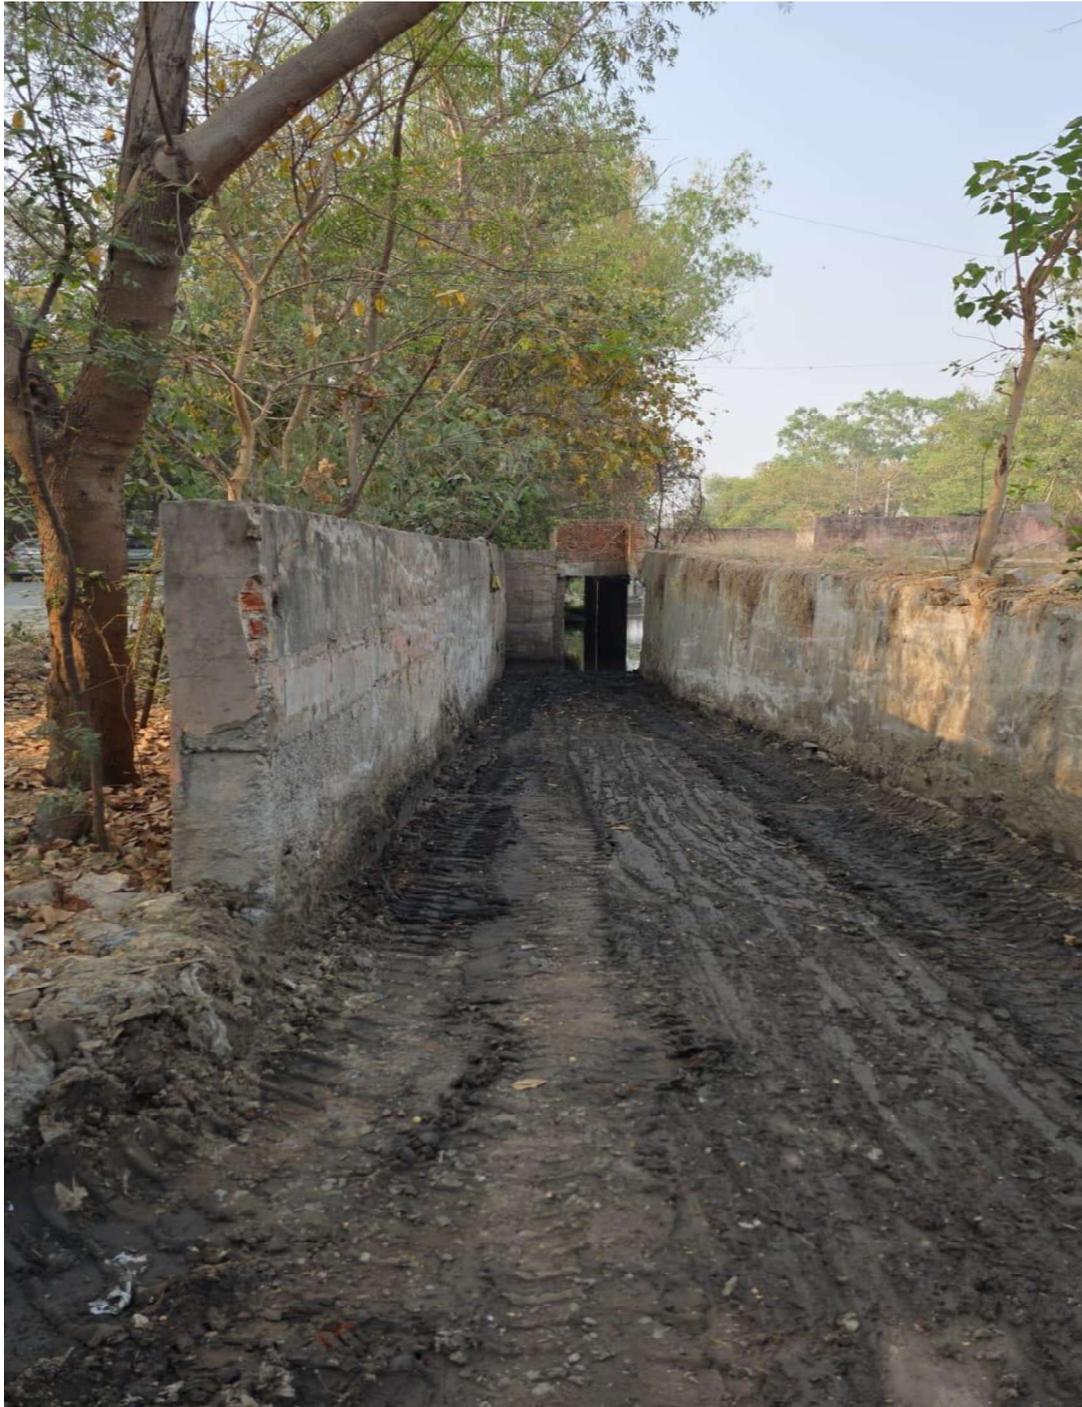
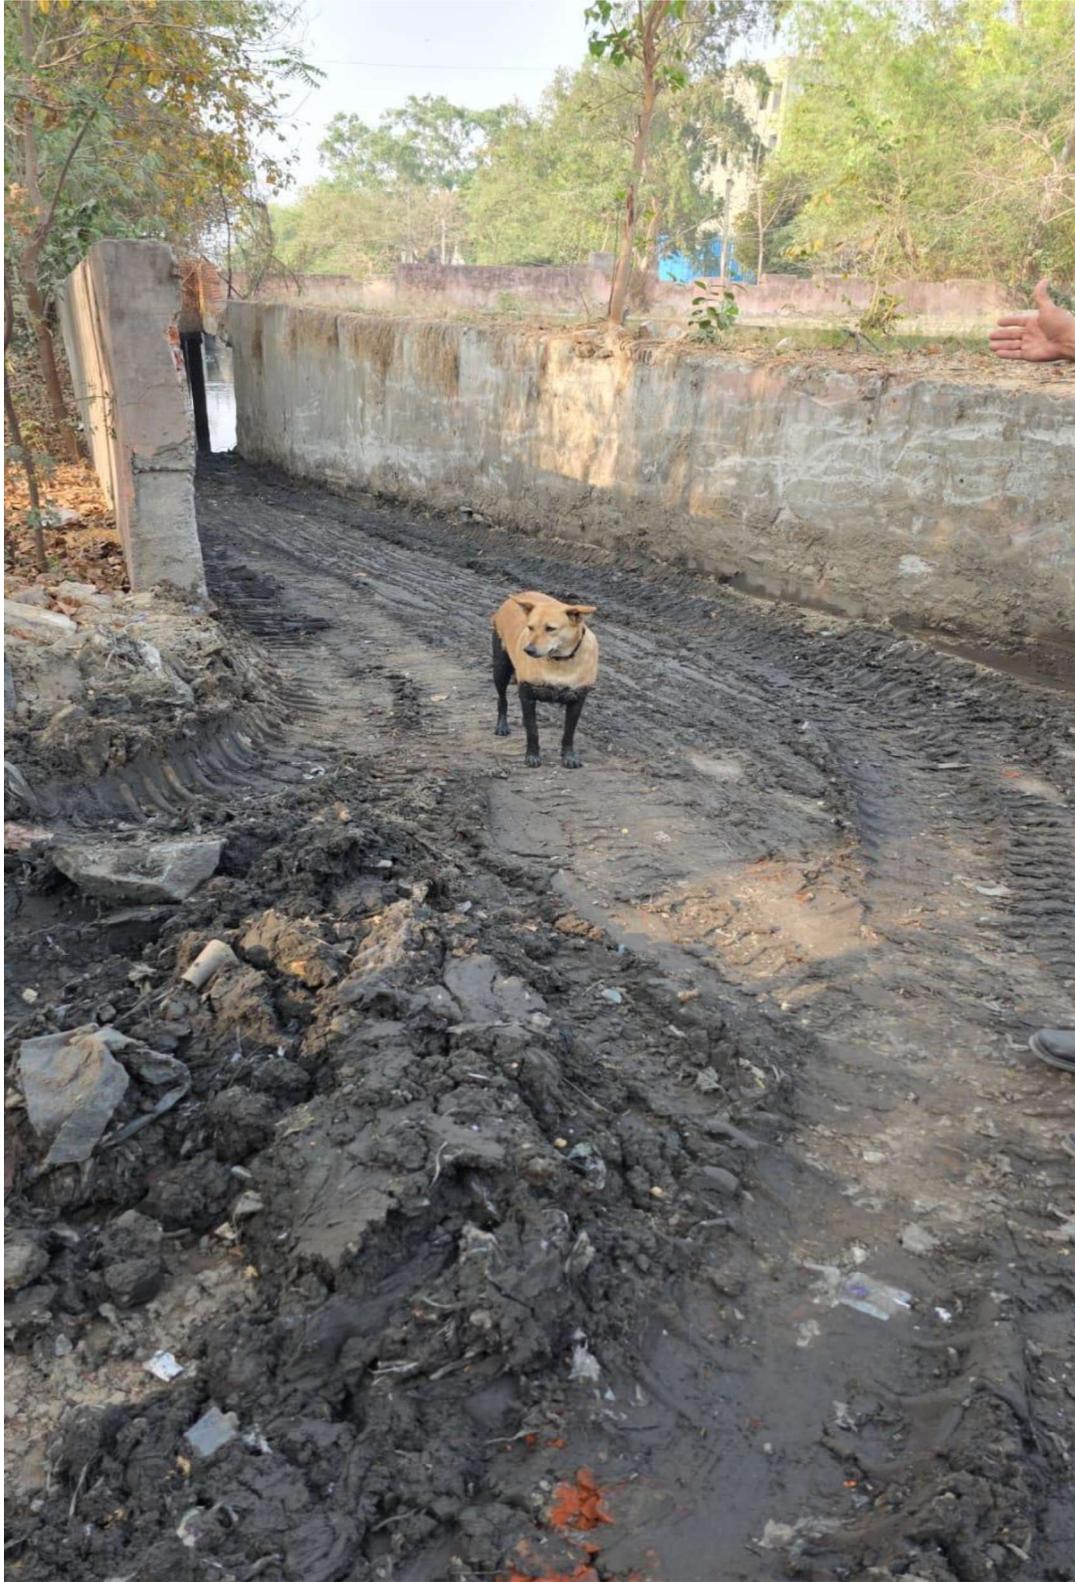
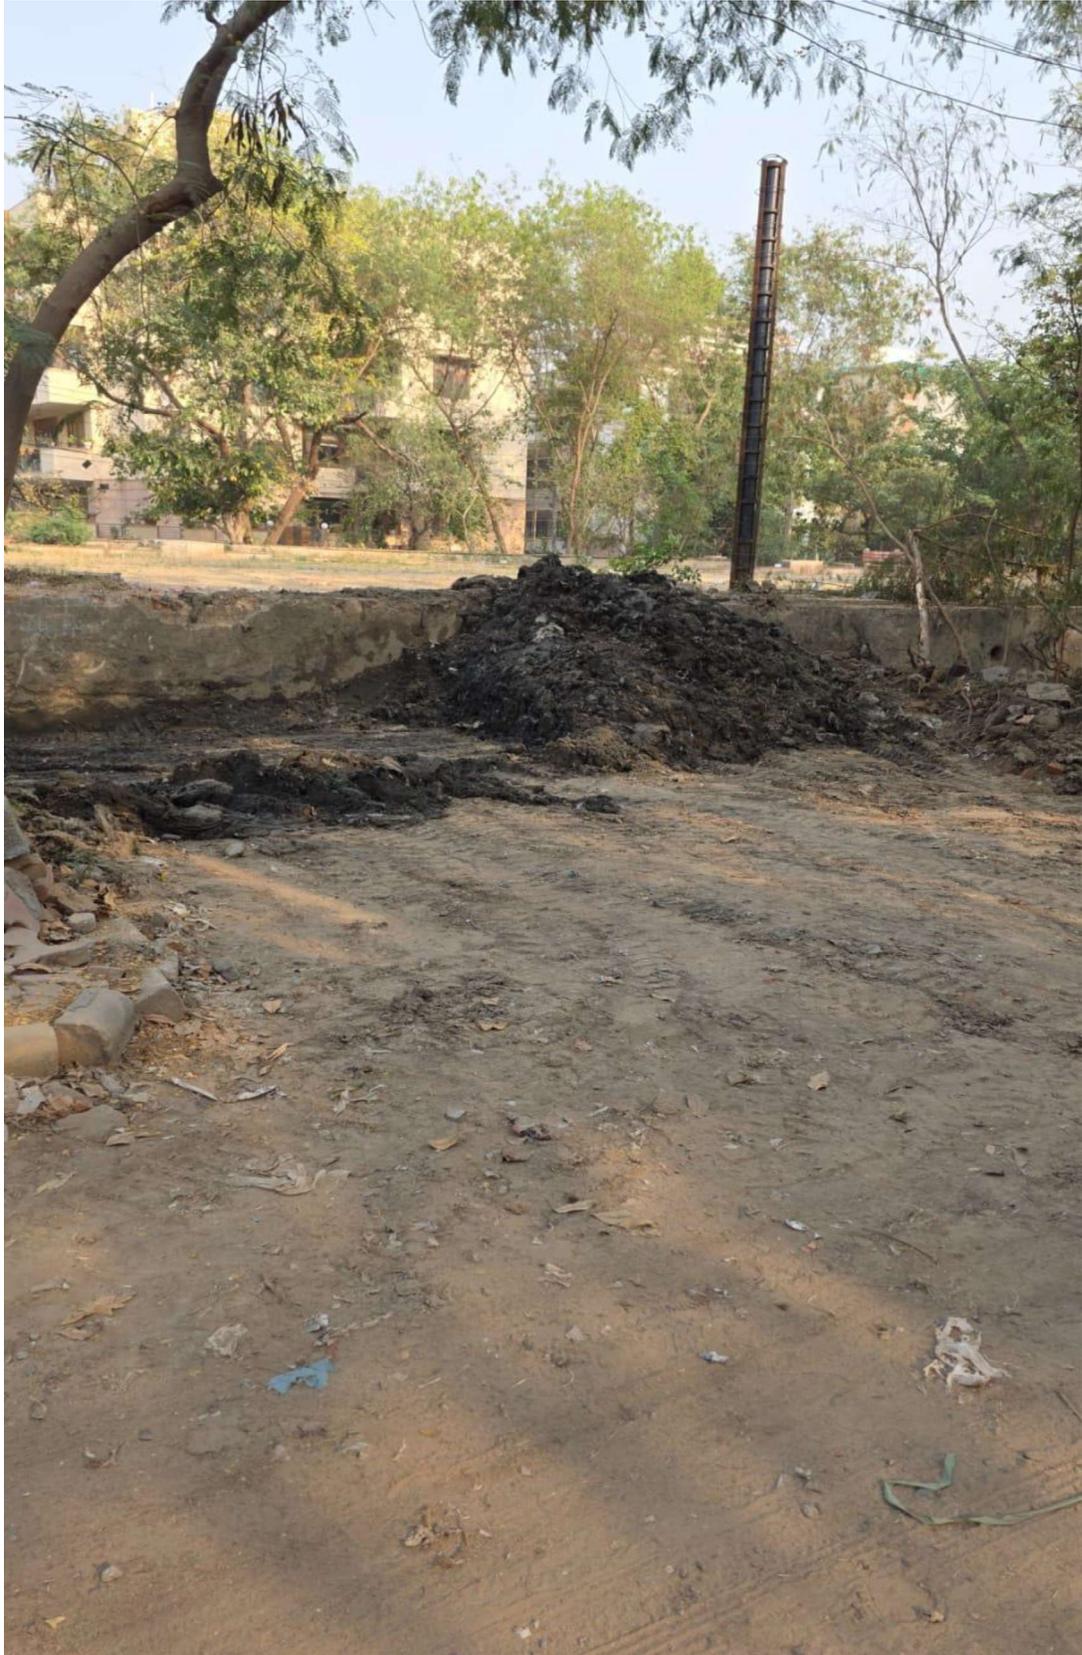
Photos of 3rd ramp taken on 09.04.2025

16. After reaching point F almost near to the end of drain, in front of Chetak Vithi signboard, there was 3rd ramp to approach the drain and on 11.04.2025 one JCB machine was found removing the silt through it. On observation it appeared to be black stinking sludge.

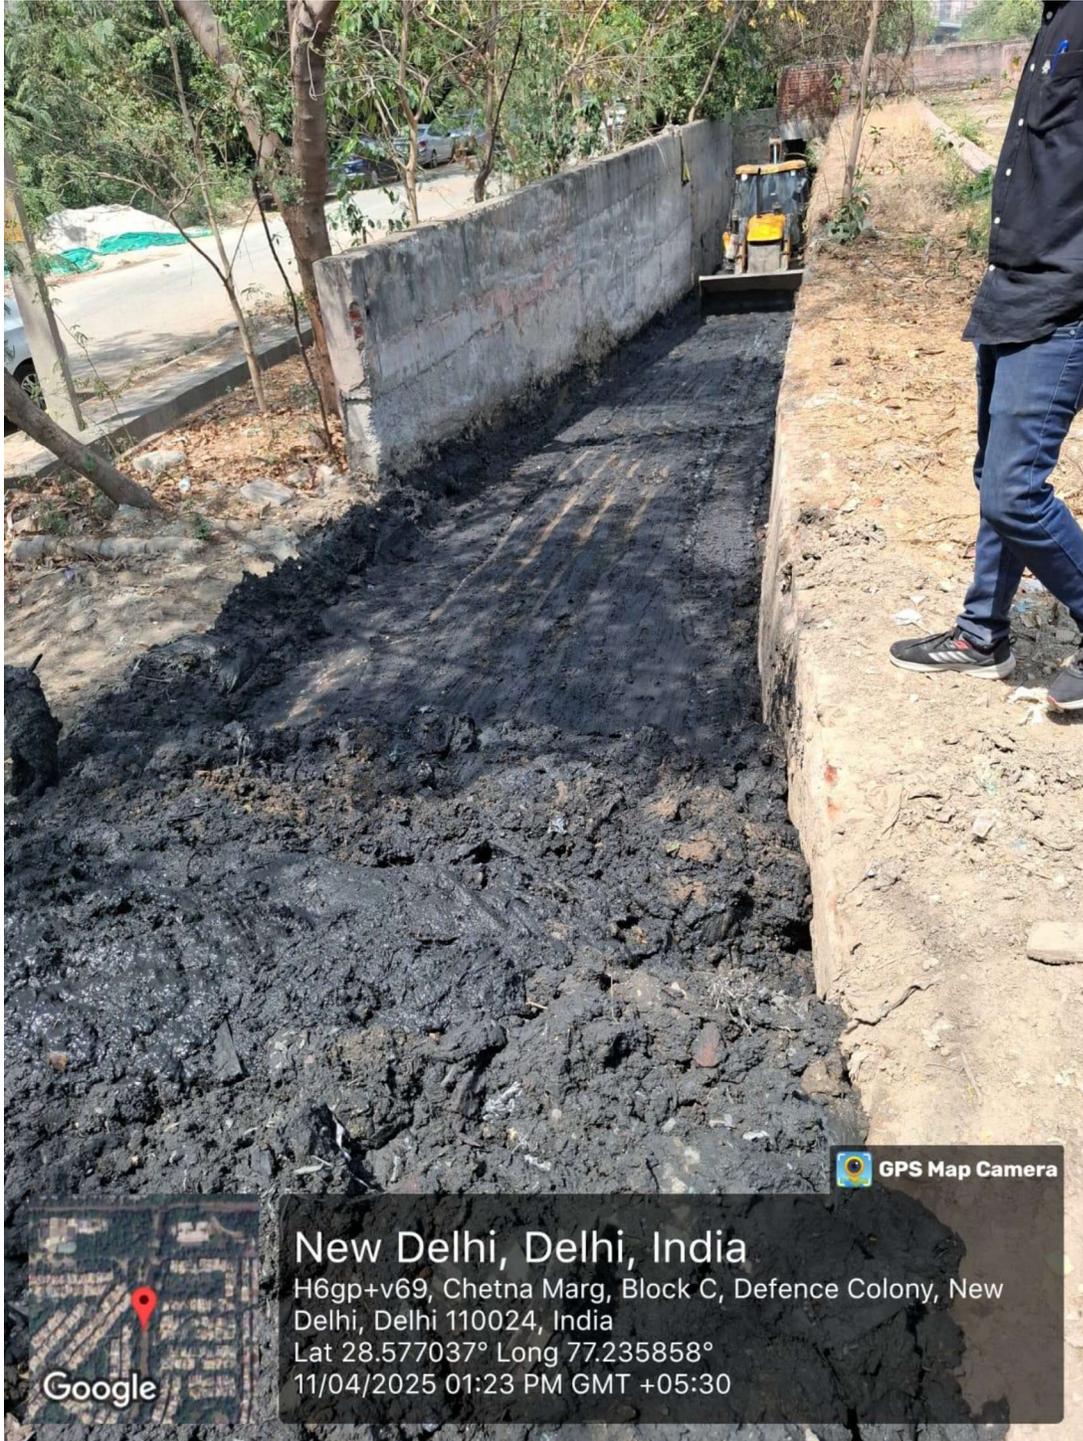
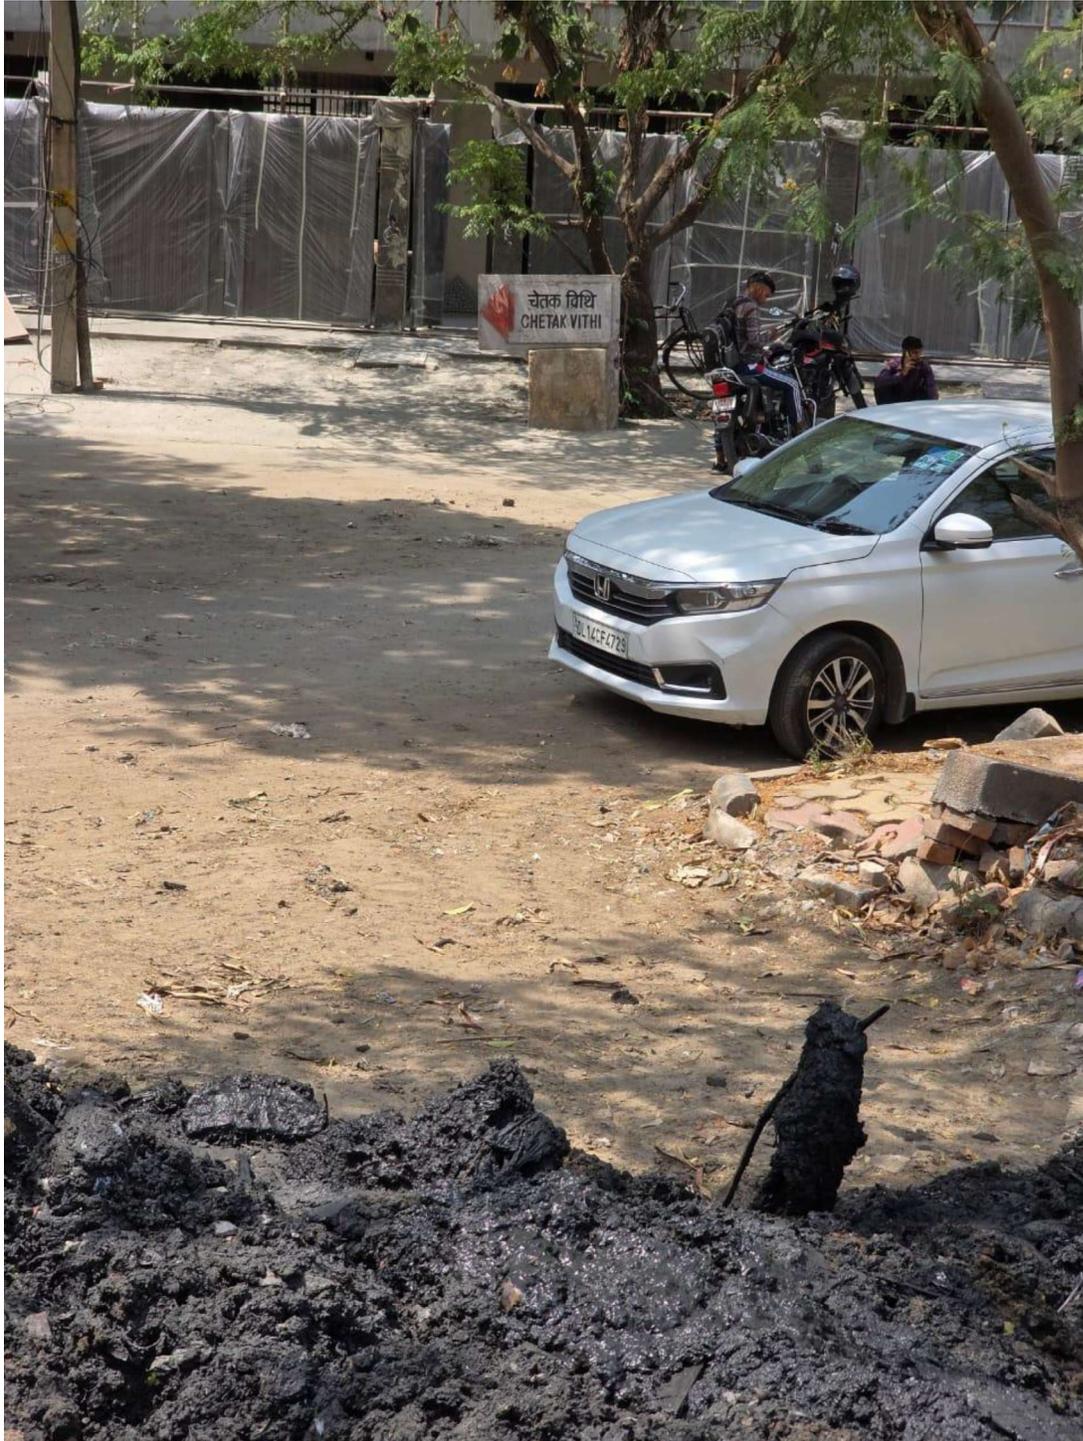
Photos of 3rd ramp taken on 11.04.2025

2. At the Third ramp made to approach the drain, the JCB machine was working on 11.04.2025, and it was observed that when the water was stable/stagnant then the colour was dark green and when the JCB arm scooped it then the underlying bottom layer of sludge got mixed with upper layer and turned into black sludge.
