BEFORE THE NATIONAL GREEN TRIBUNAL**PRINCIPAL BENCH NEW DELHI**

ORIGINAL APPLICATION NO. 6 /2012

**FACTUAL STATUS REPORT BY THE COURT COMMISSIONER
IN COMPLIANCE OF ORDER DATED 09.04.2025**

Quick Glance of drain with help of google earth image and photos taken on 9th and 11th April, 2025:

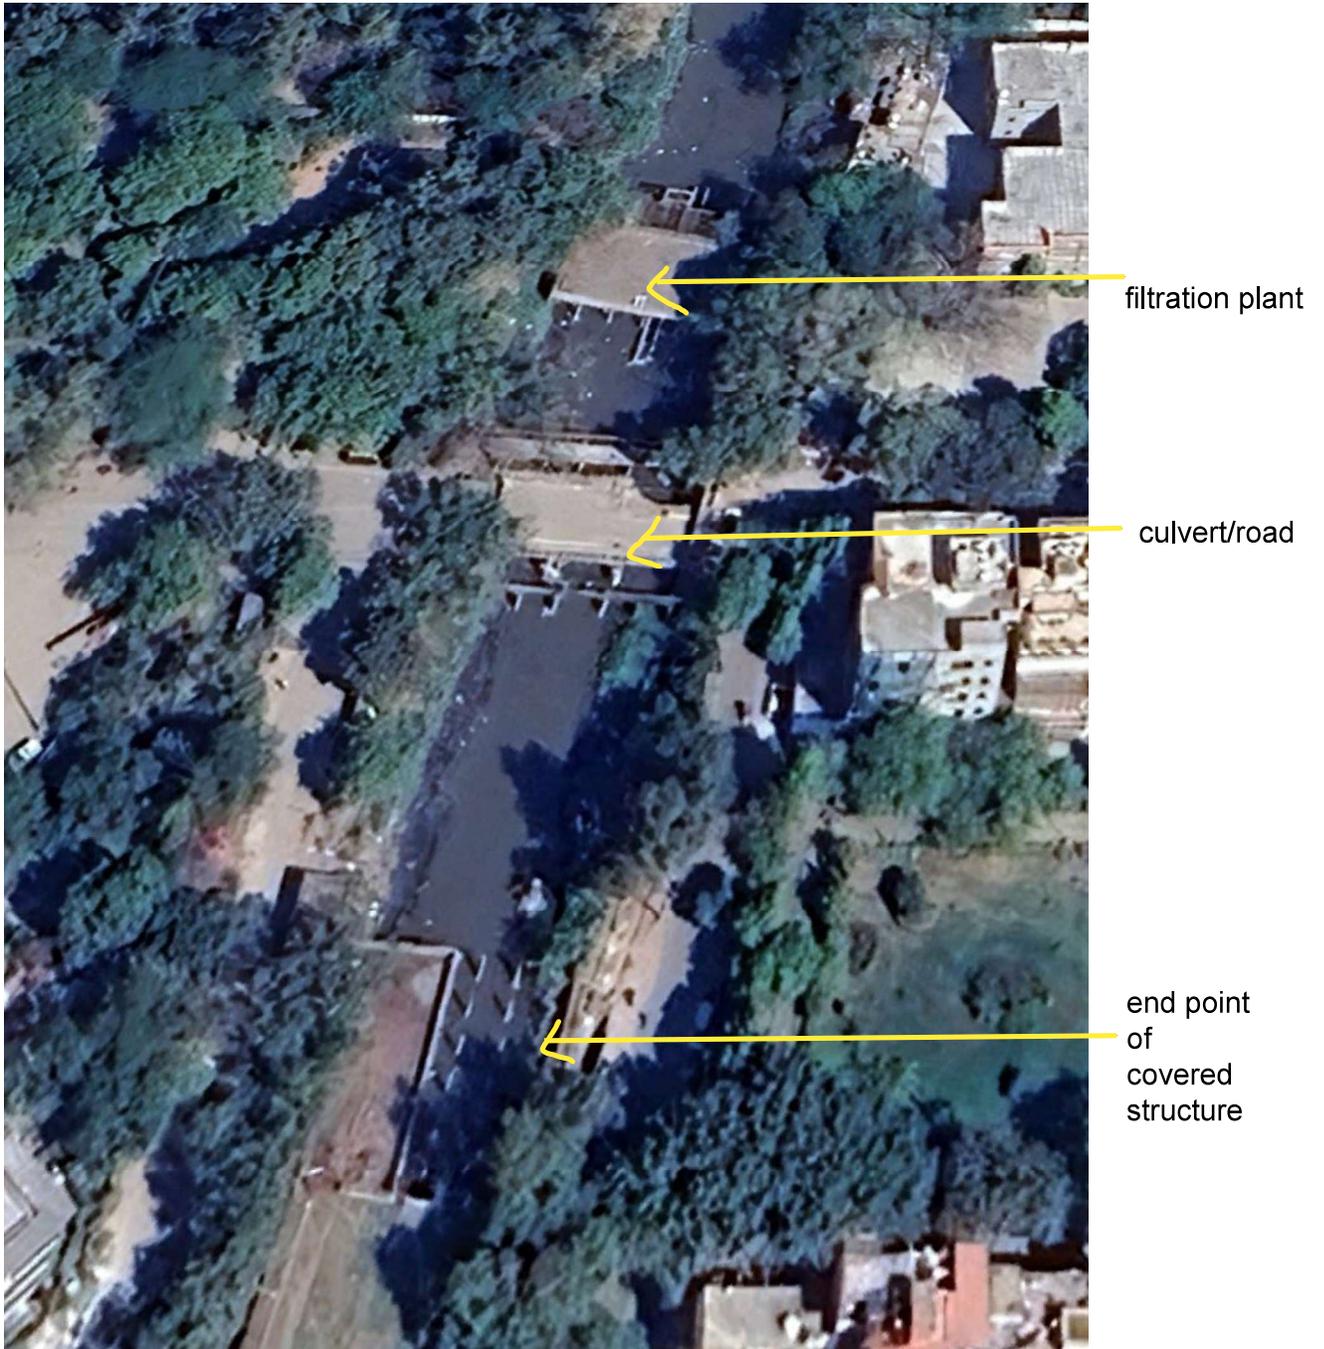
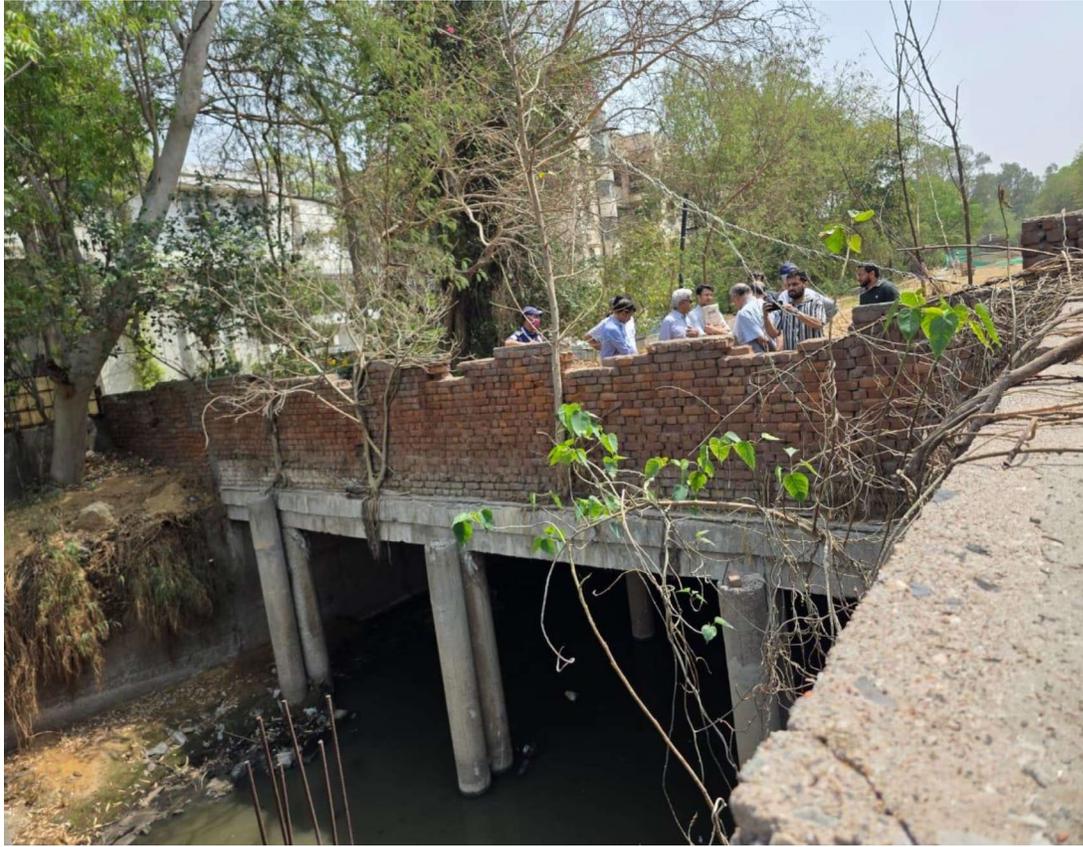
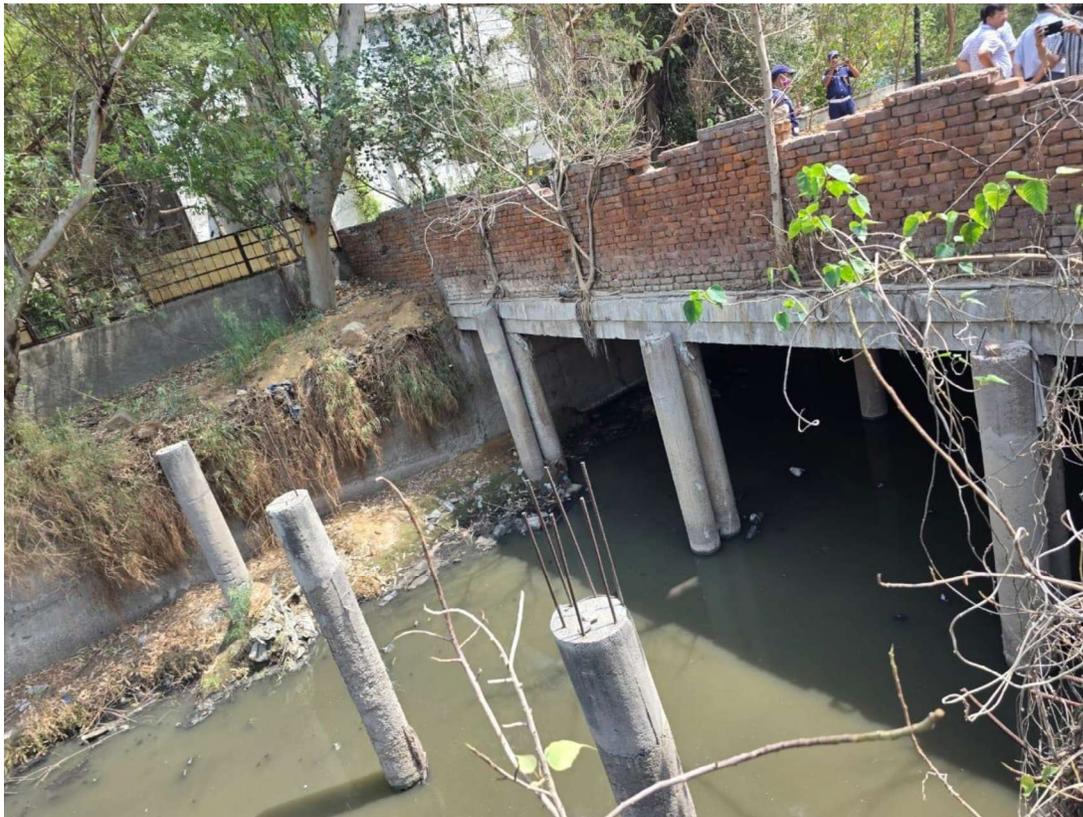
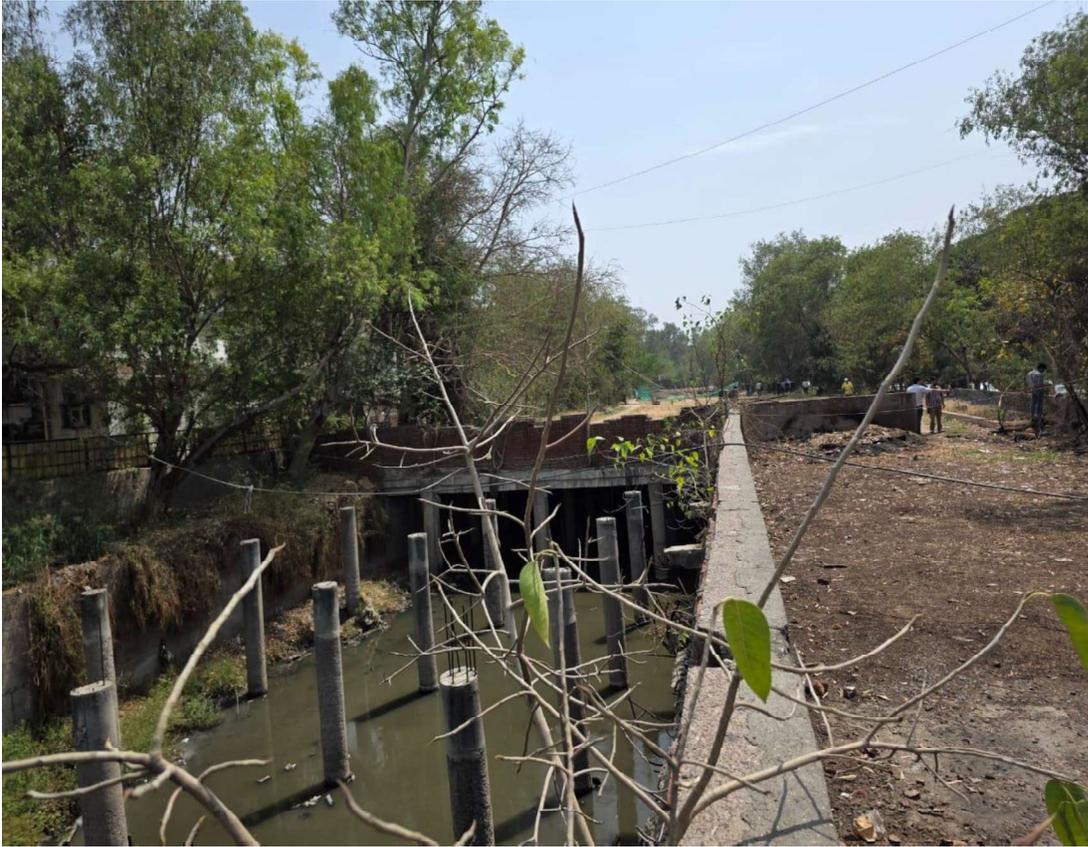
17. At end point of covered structure of Drain at point G only half portion along the width is covered. In other half portion pillars were there. After this point the drain is open except at culvert/road from Defence Colony towards Lajpat Nagar II.

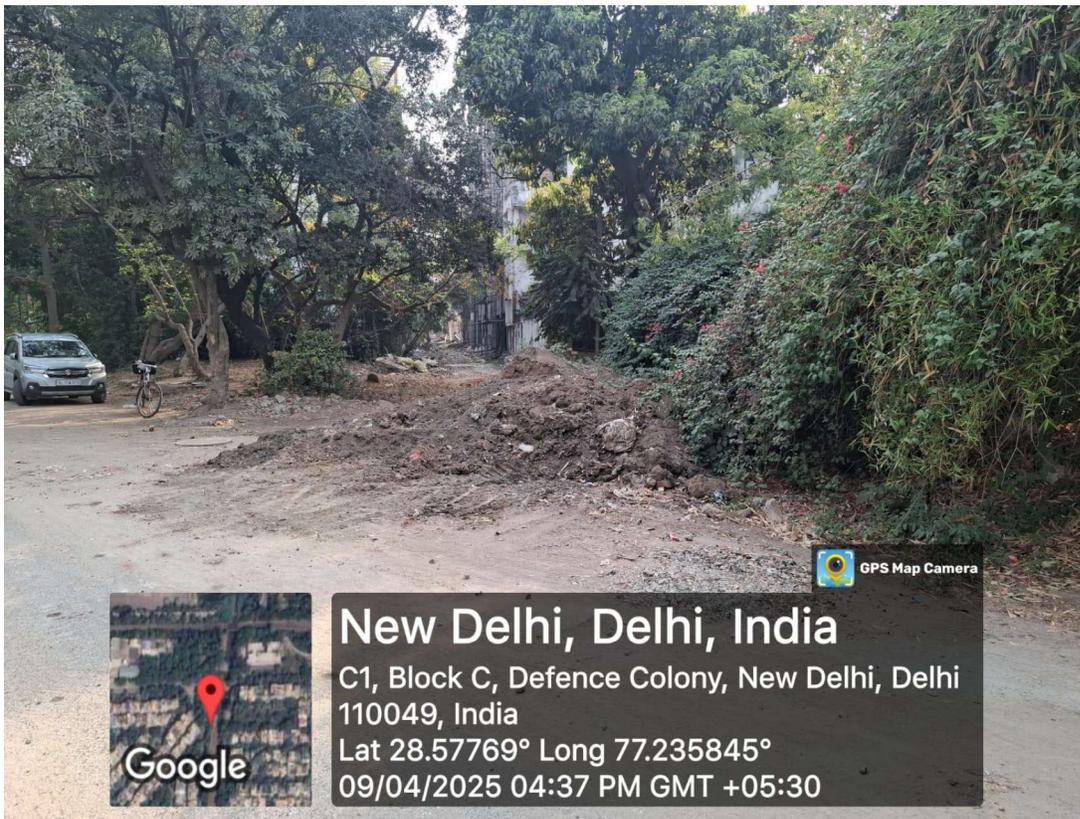
The removed silt having mixed earth was found lying at one place at the other side of road before the end point of colony road. ↓

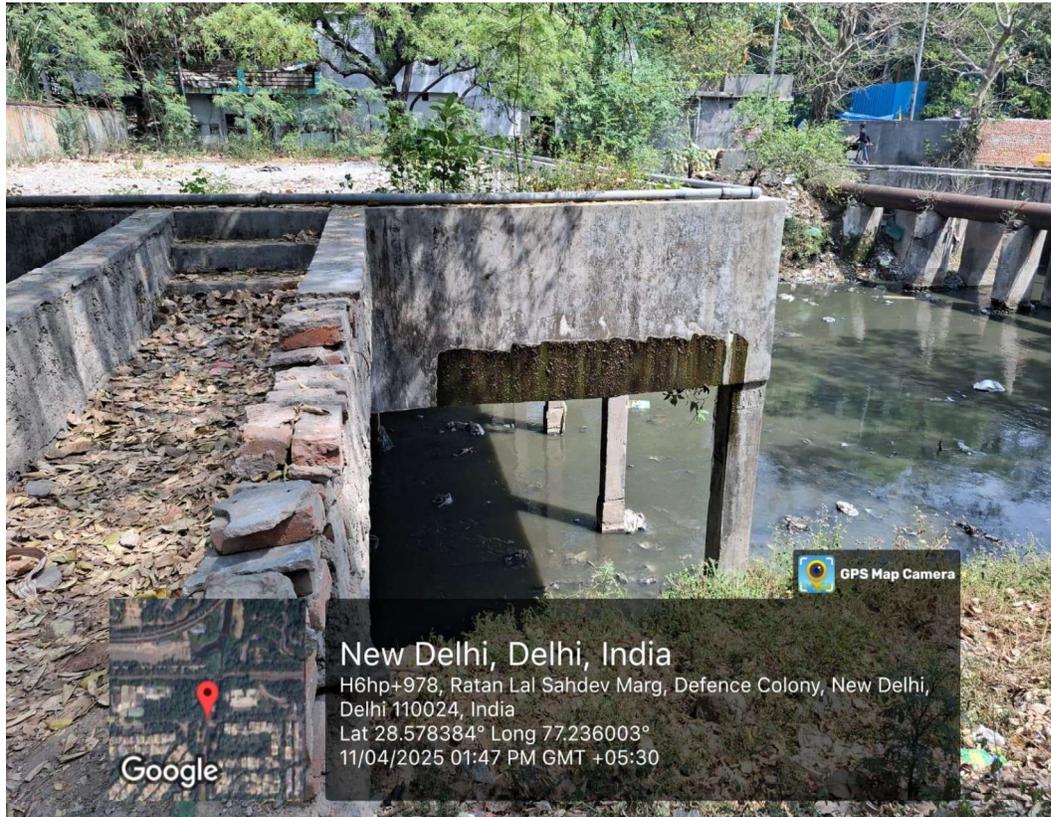
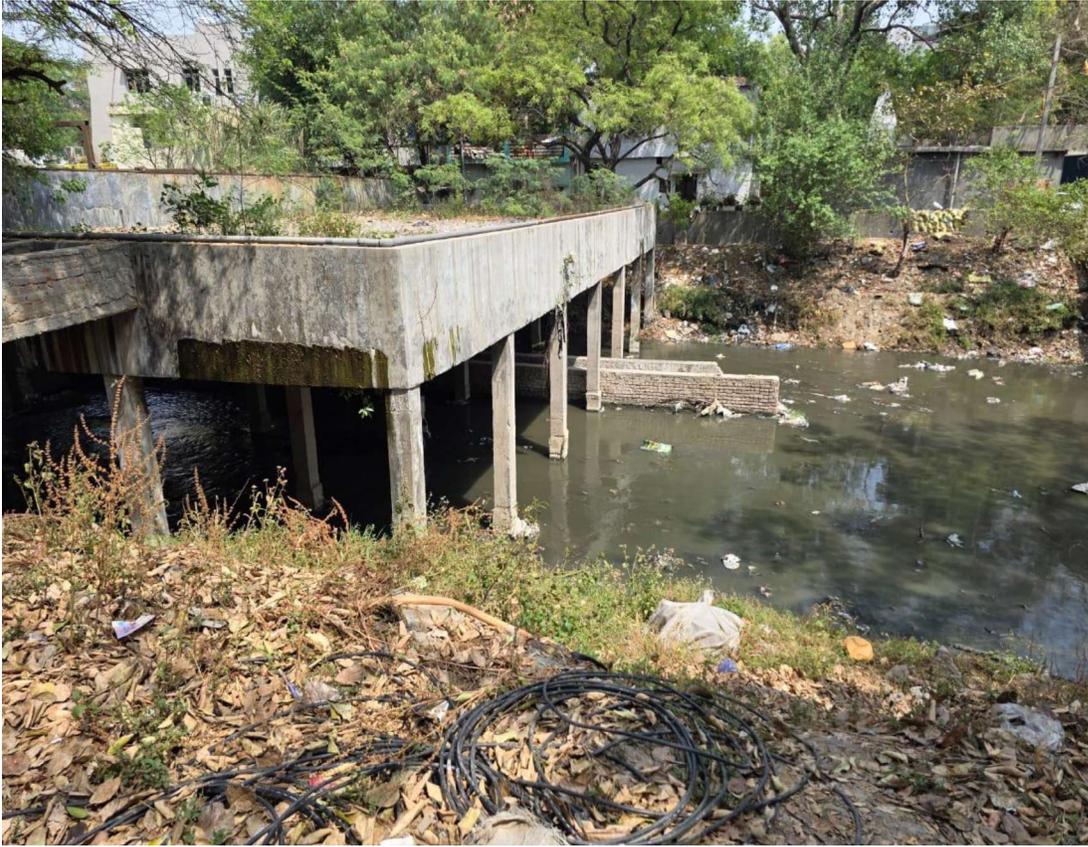
Photos of/near Filtration plant.

18. After culvert/road and before railway track, a filtration plant was found which appeared as non-functional. Some flow was observed in the drain near about this point.

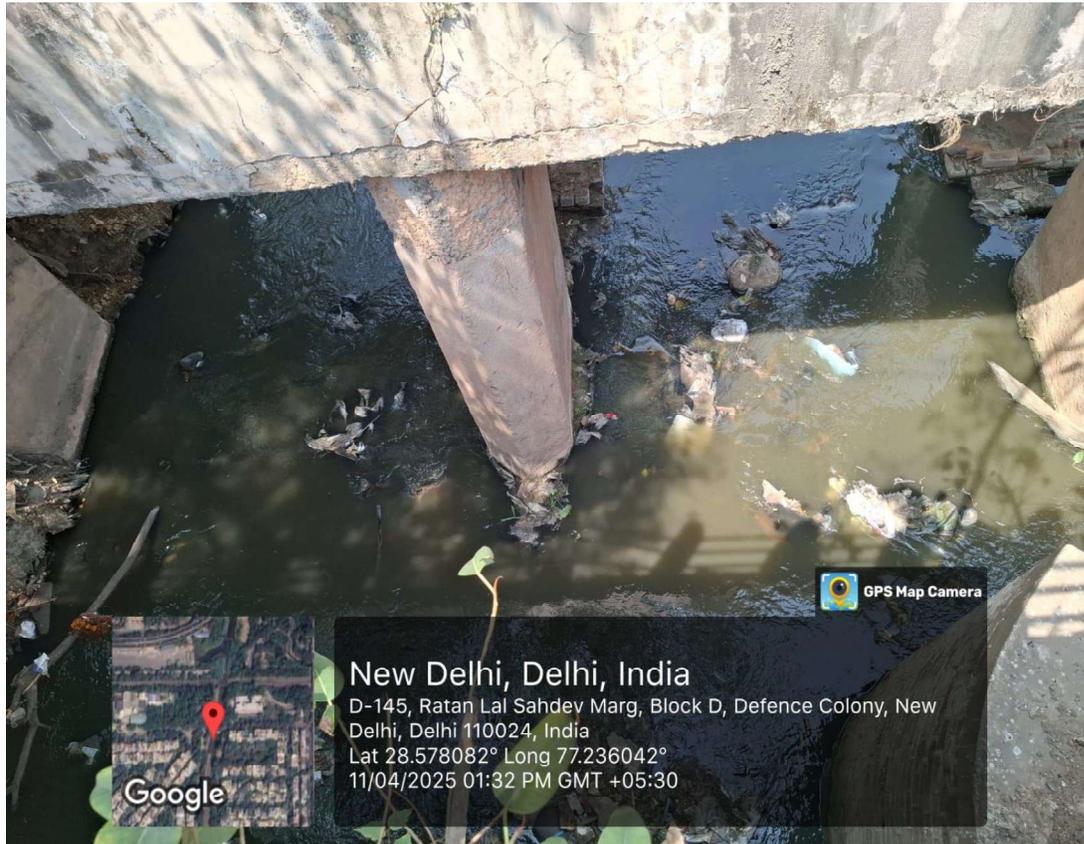
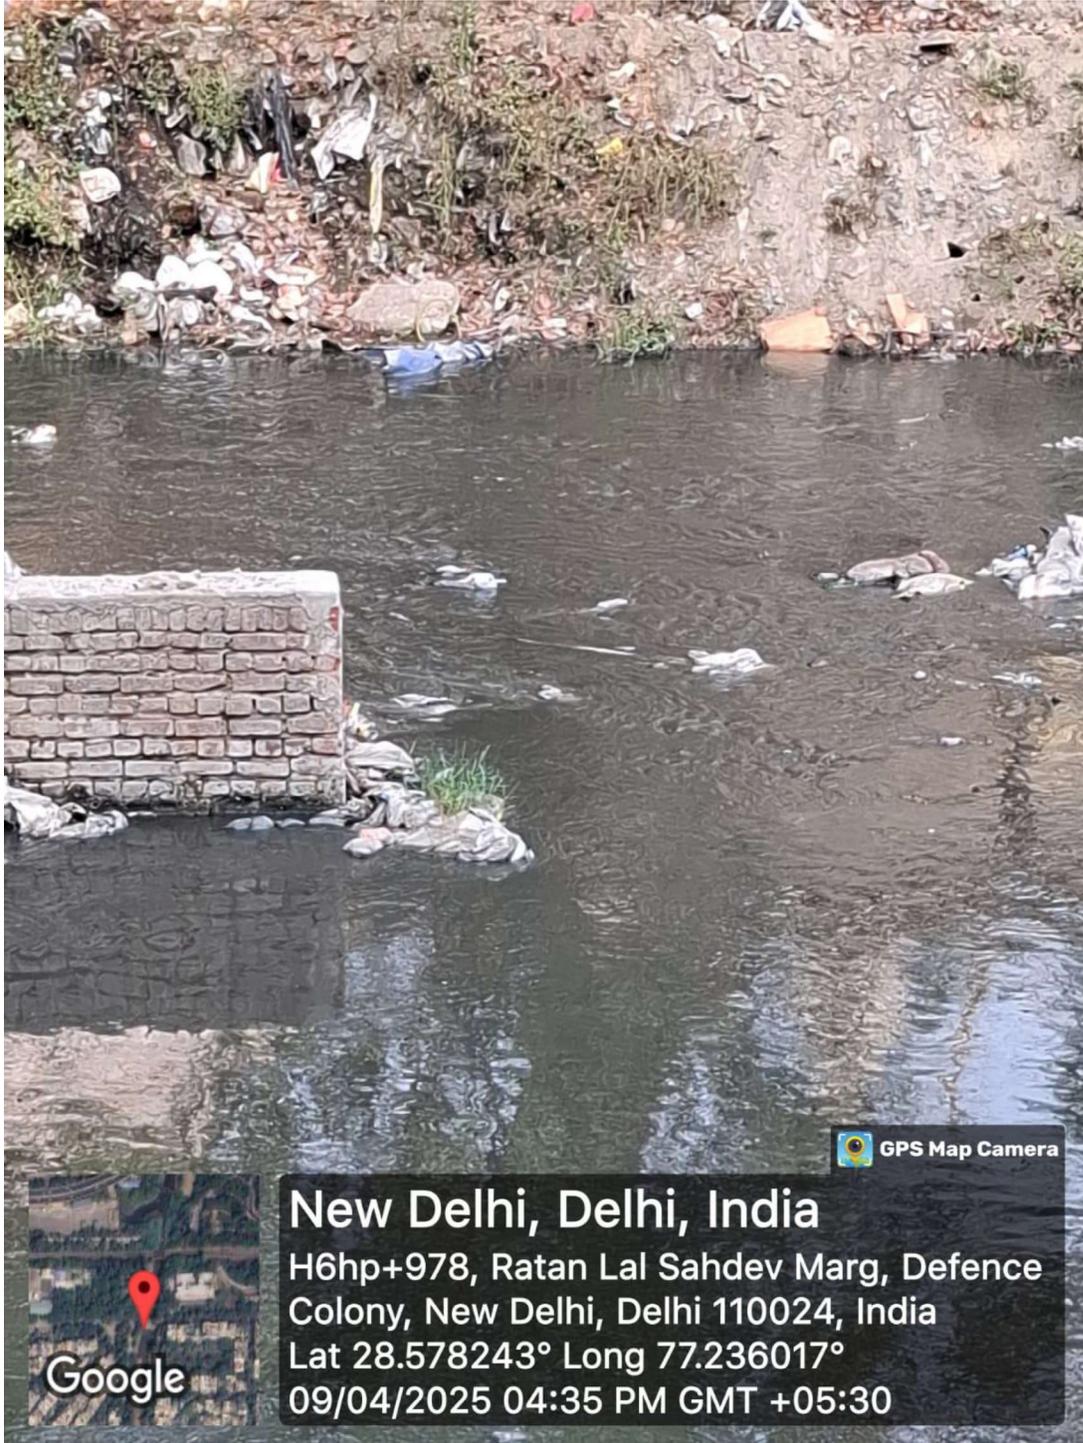
19. Under the filtration plant, the solid garbage was found in the drain.

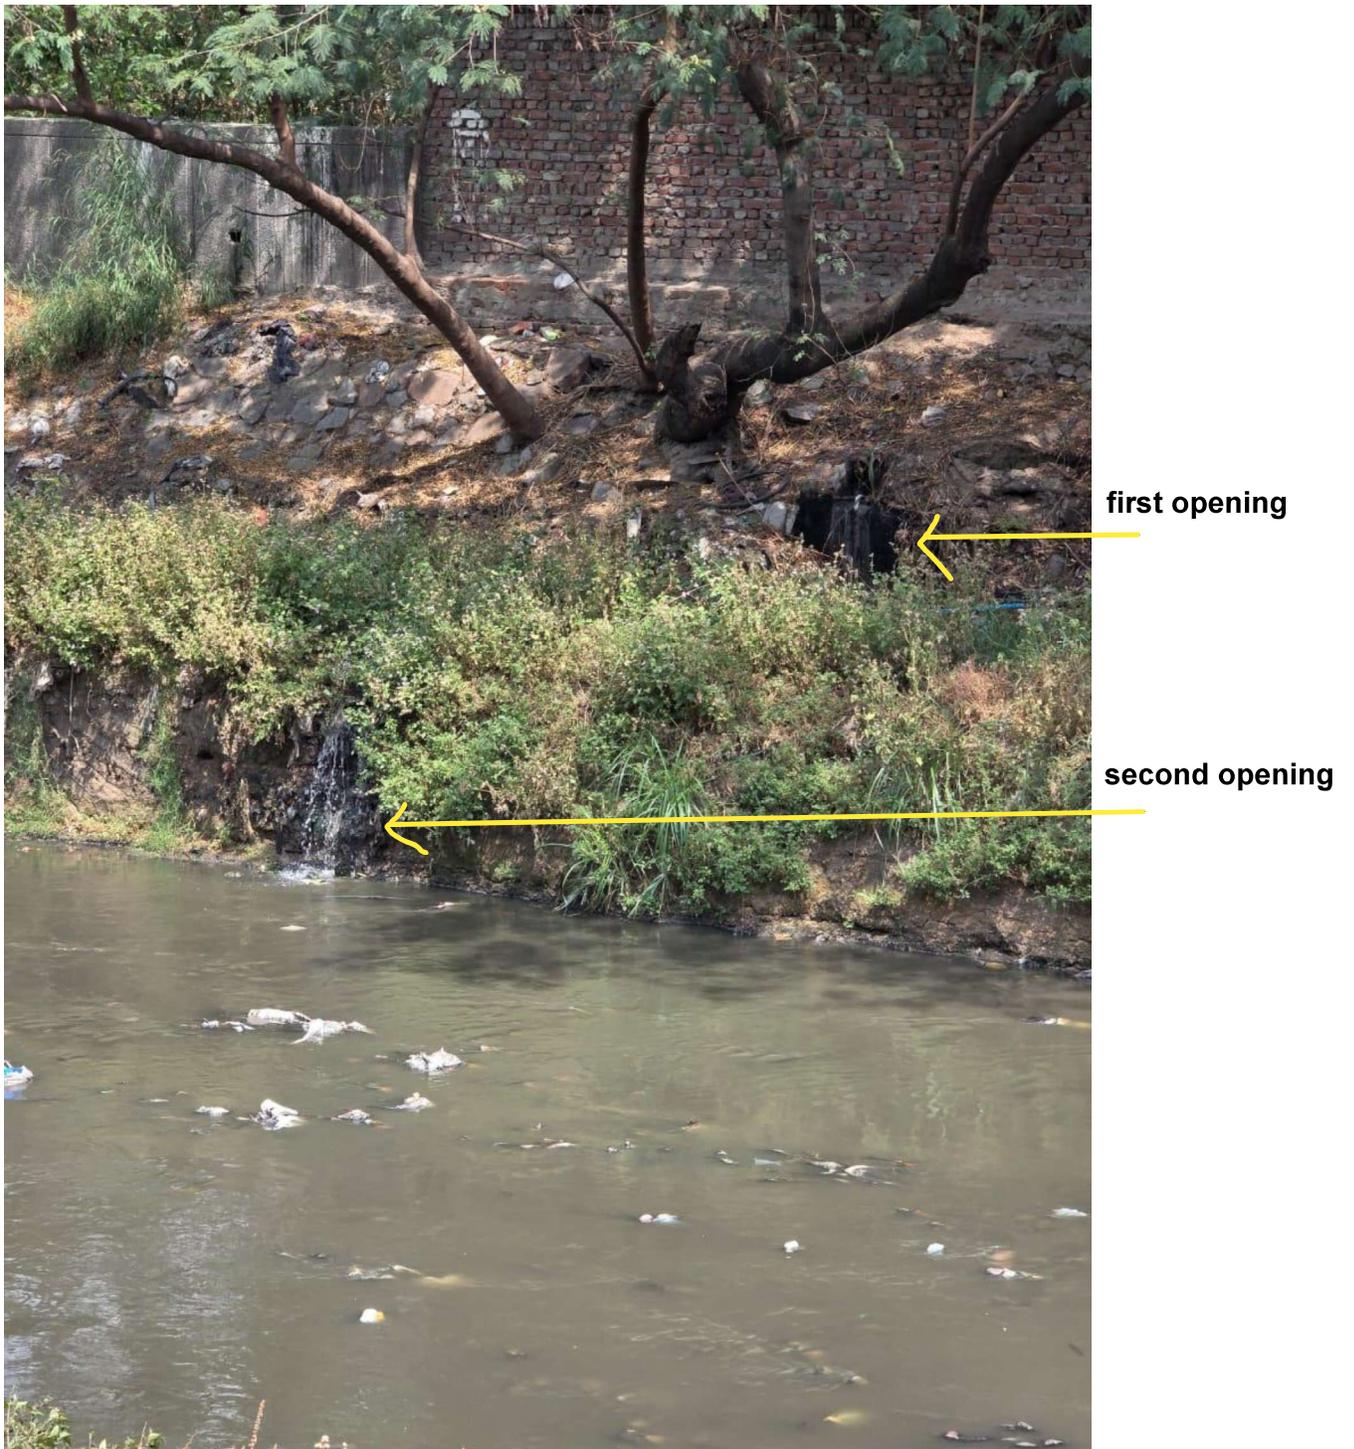
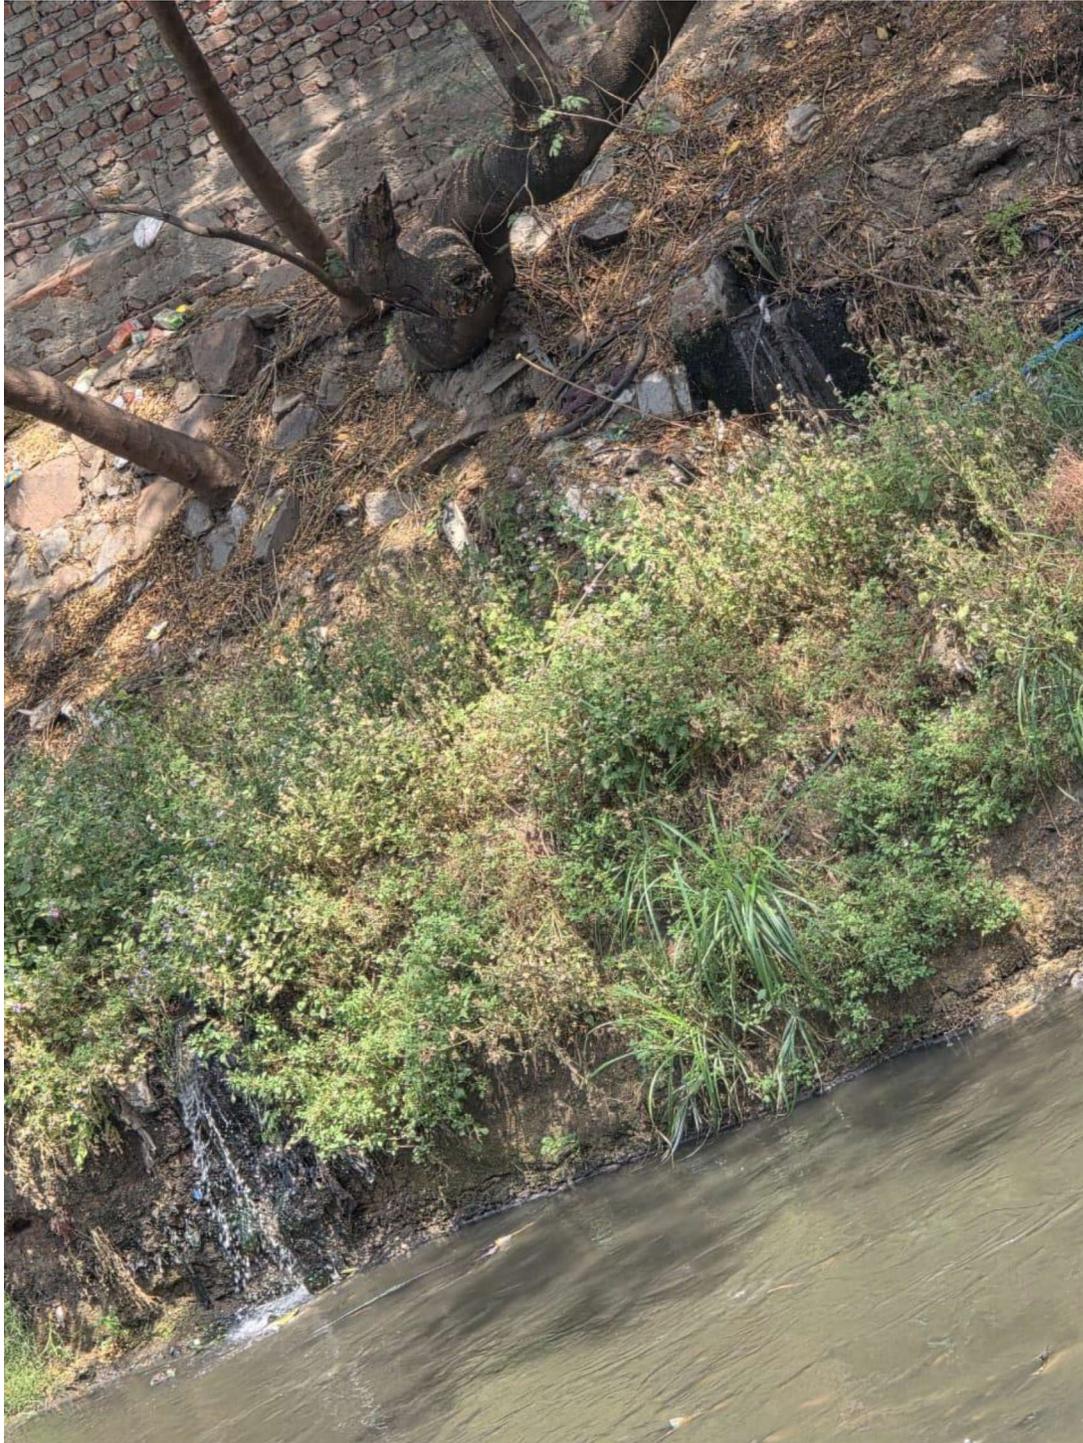
20. After filtration plant and before the Railway track, two small openings were found discharging the waste water in the Drain.

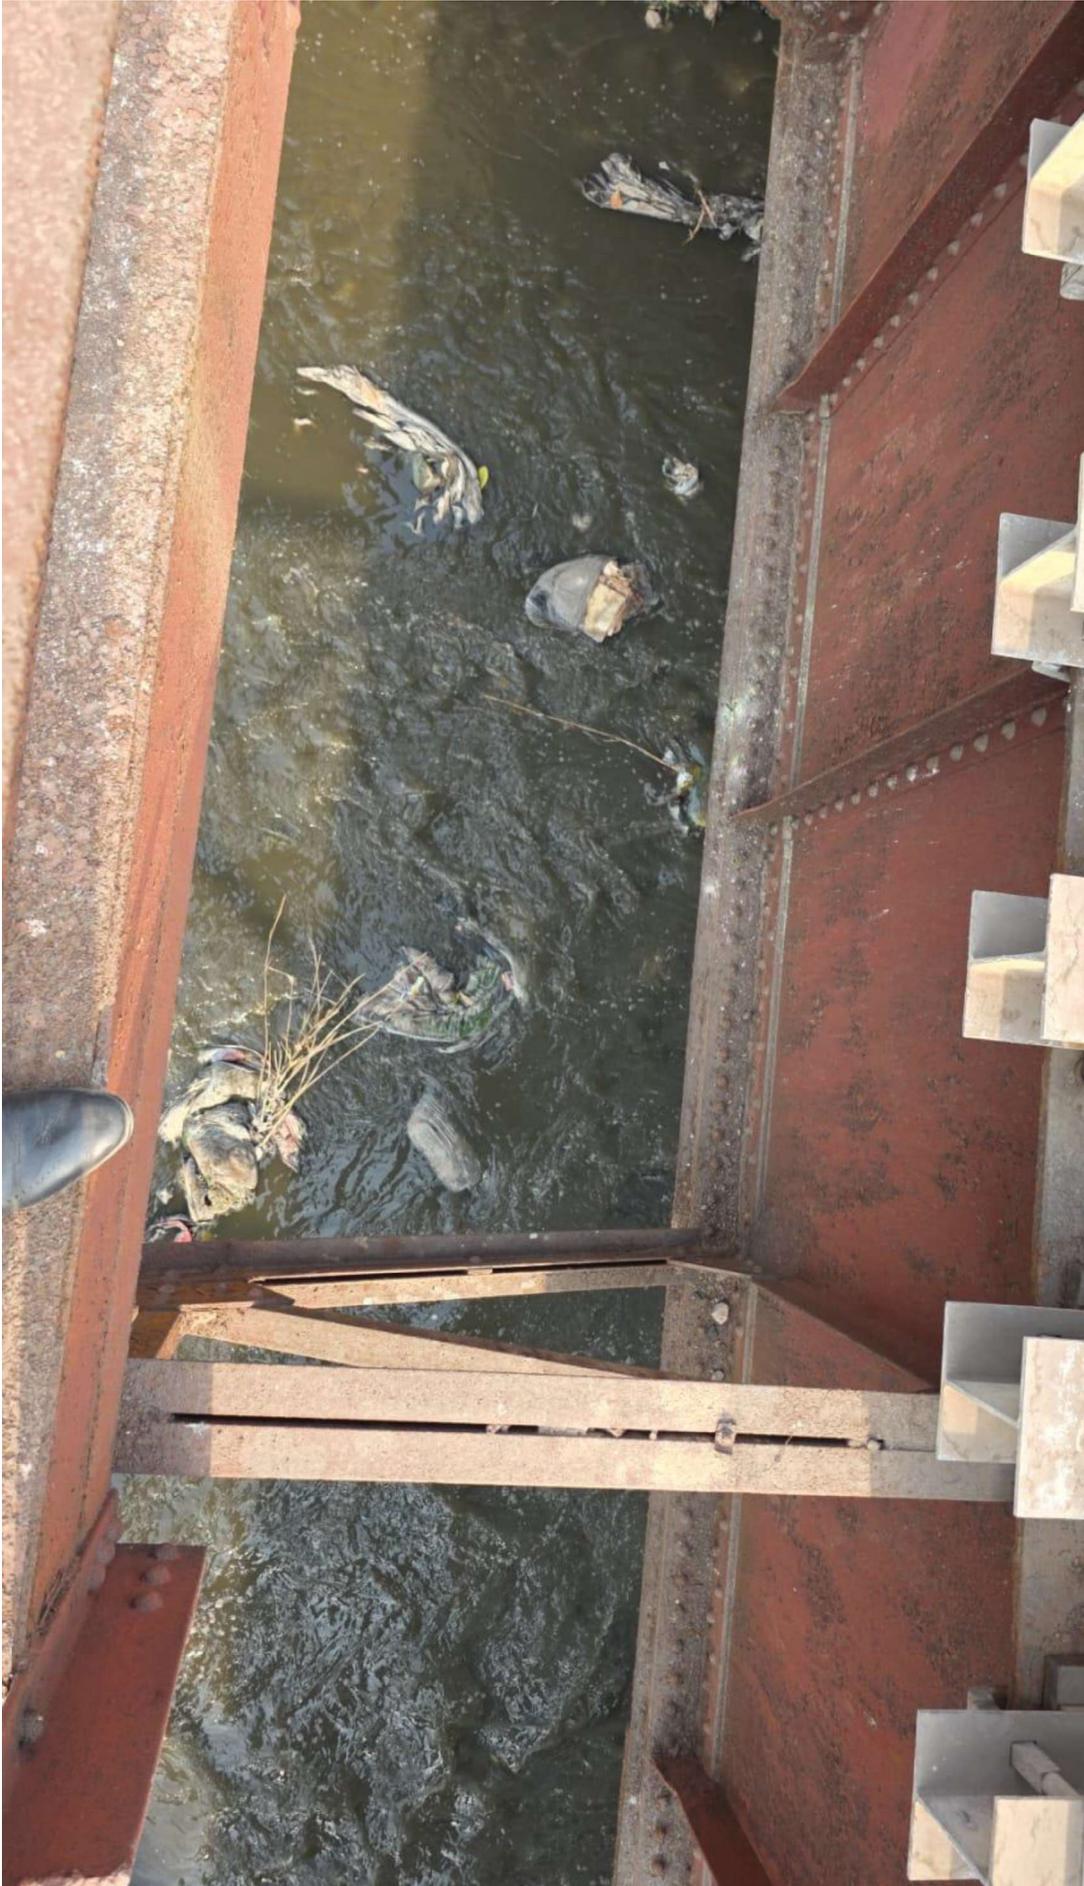
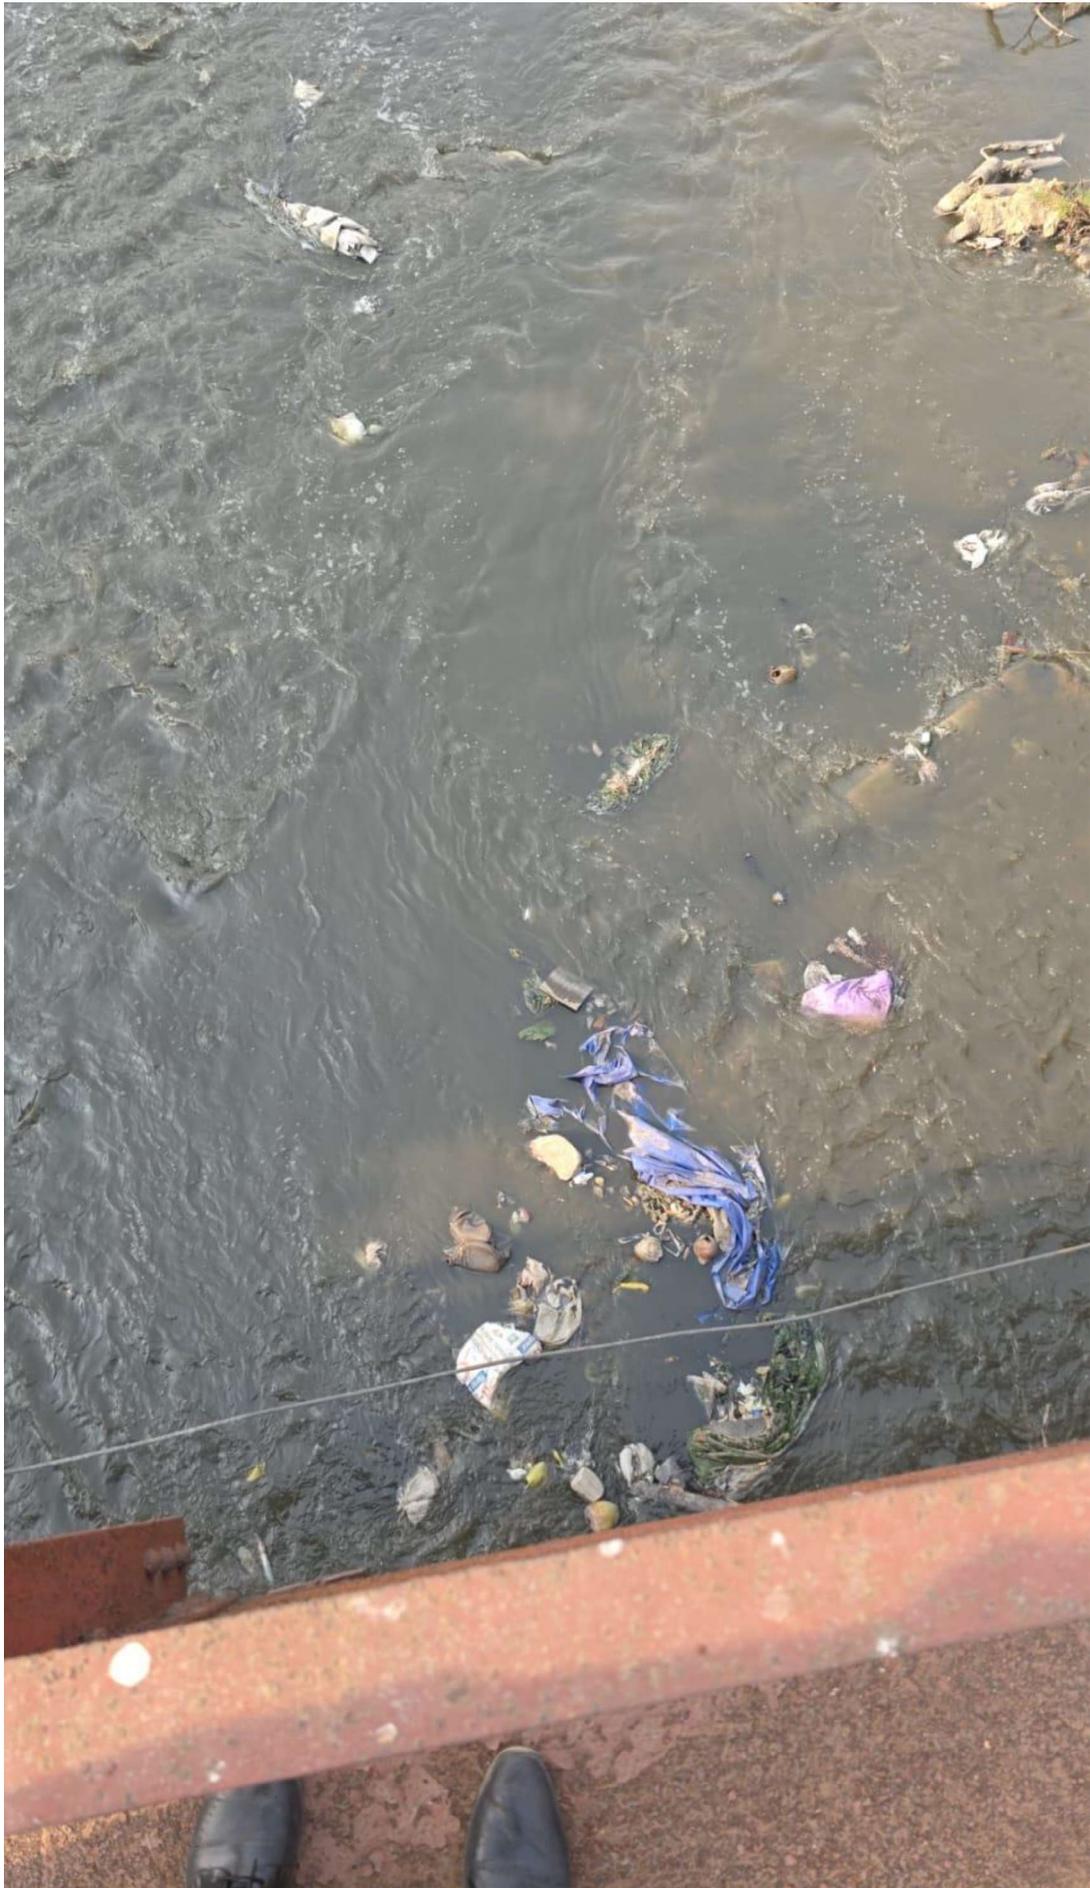
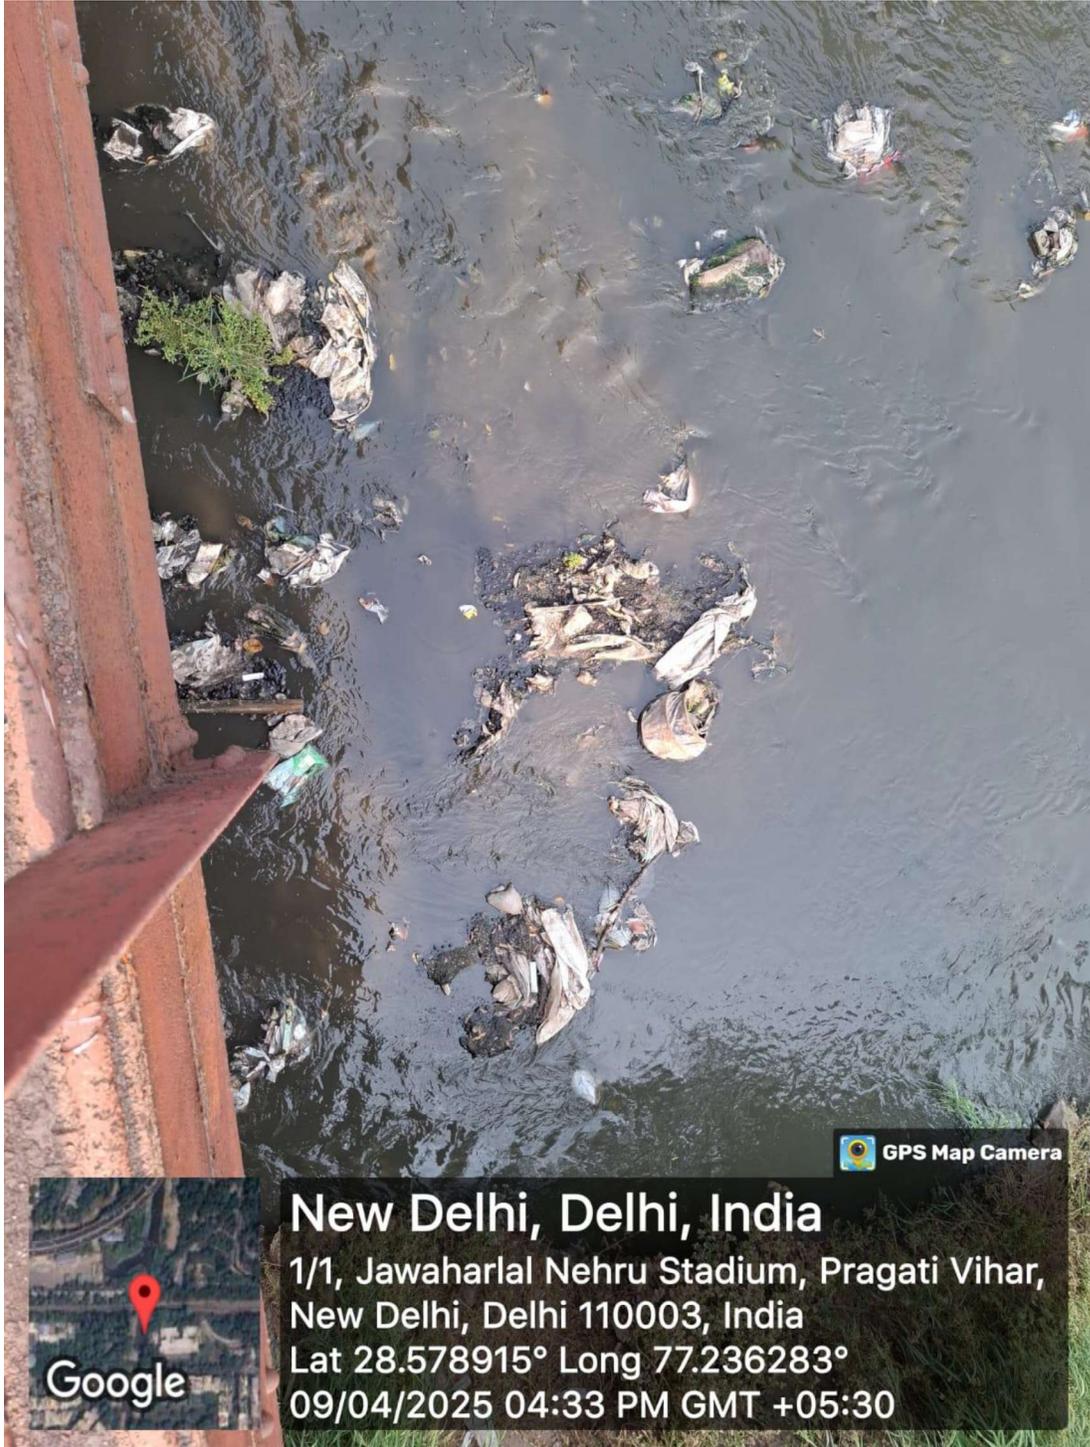
Point 'H'

21. The drain ends after railway track where it meets Sunheri drain. On 11.04.2025, it was not possible to cross the railway track due to dumping of soil at Kachcha path which was not dumped on 09.04.2025 (**Point 'H'**)

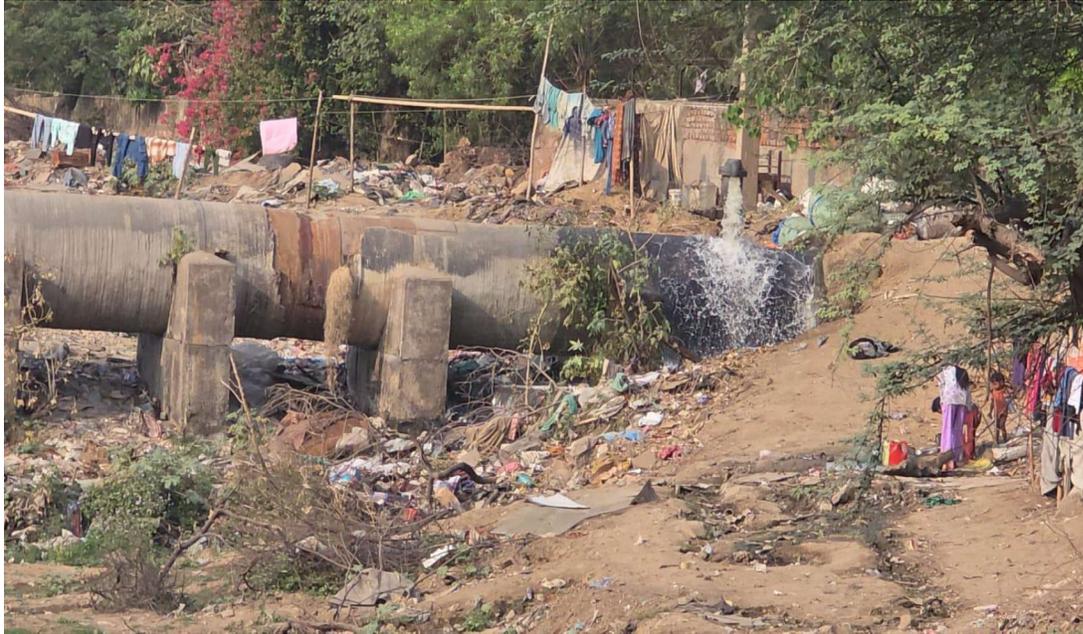
The water pipeline going over the meeting point area at point I was found over flowing and water falling into drain.
