Report of joint Site Inspection held on 08/03/2024 at Candolim Village, Bardez, Goa as per order dated 01/03/2024 by the Hon'ble NGT Pune in OA no:2/2024.

Background

As per the direction from Hon'ble NGT Pune the joint site inspection was conducted on 08/03/2023 of bund from Nerul bridge to Caculo House.the Joint committee comprises of District Collector North Goa,GCZMA and GSBB.

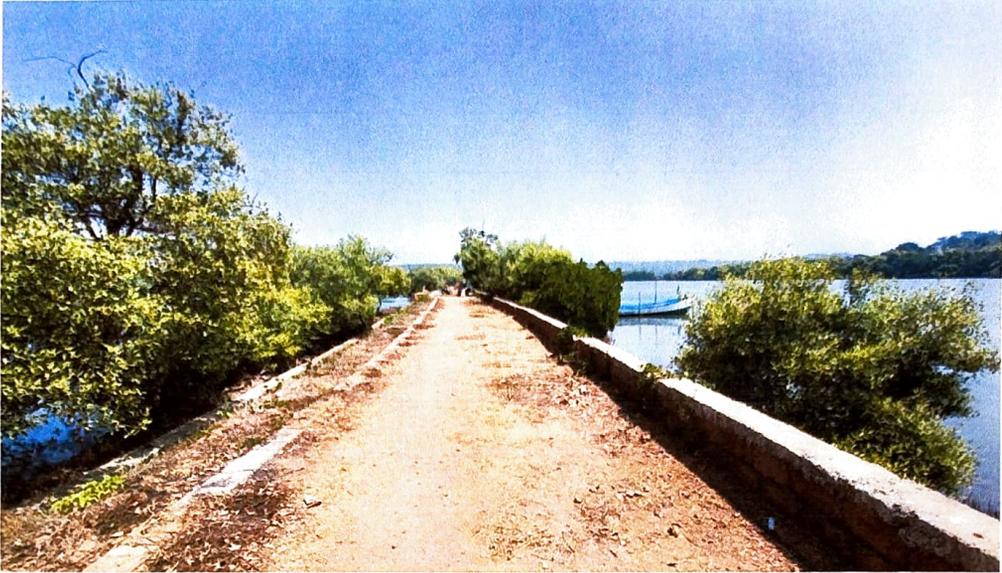
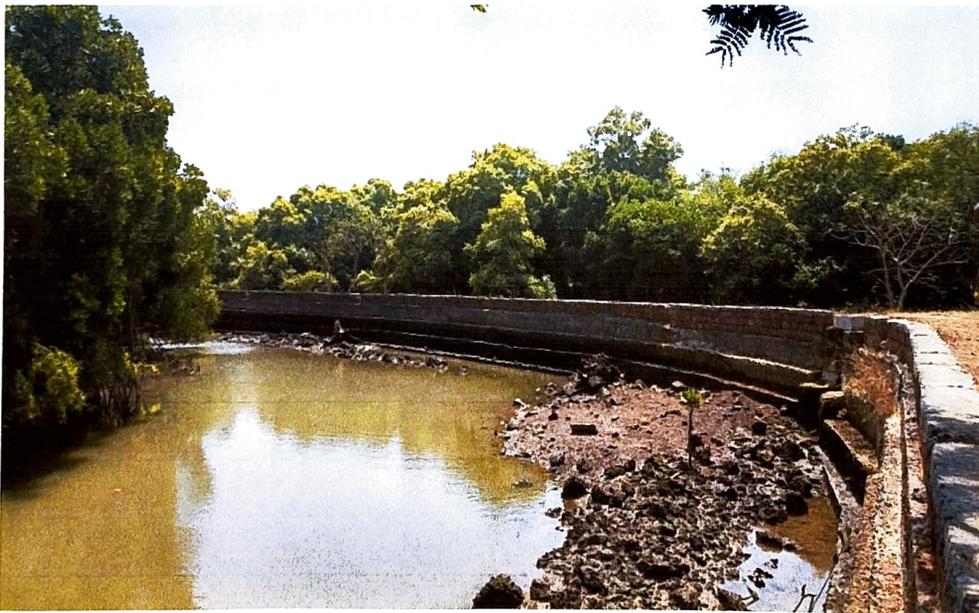
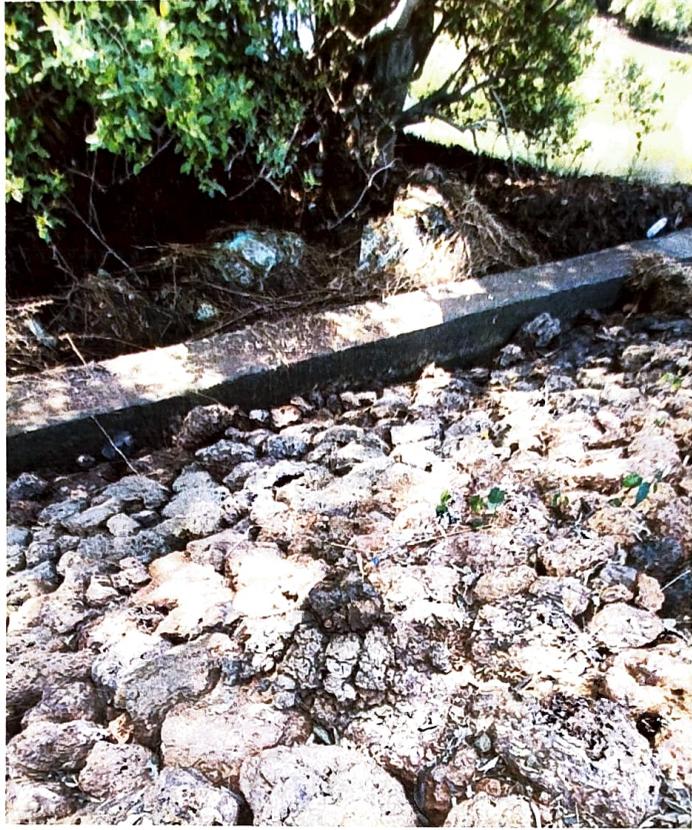
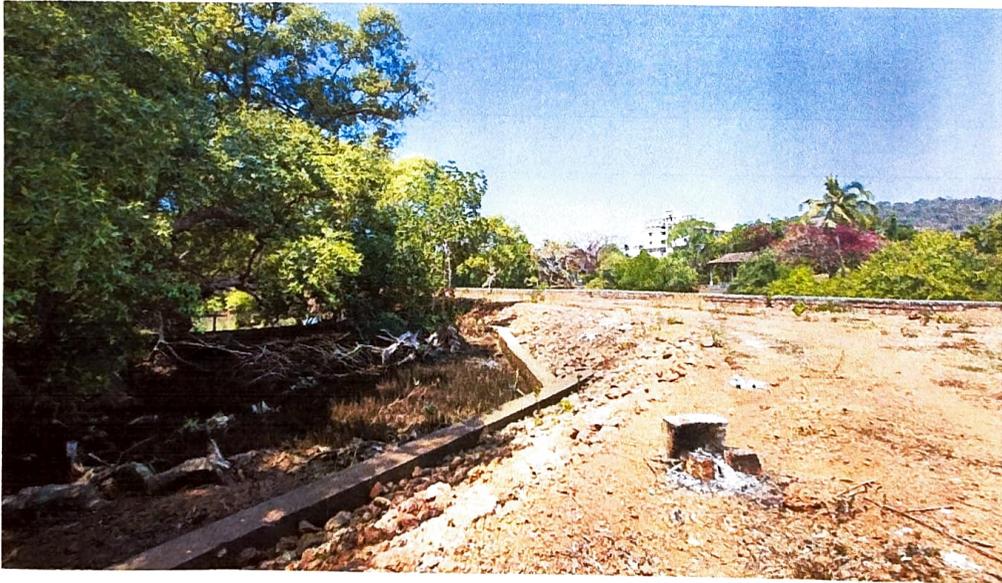
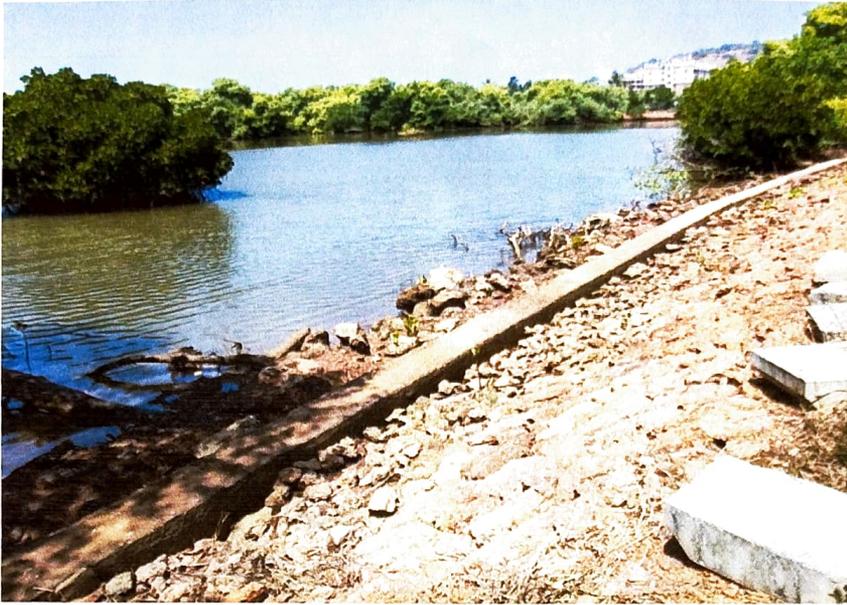
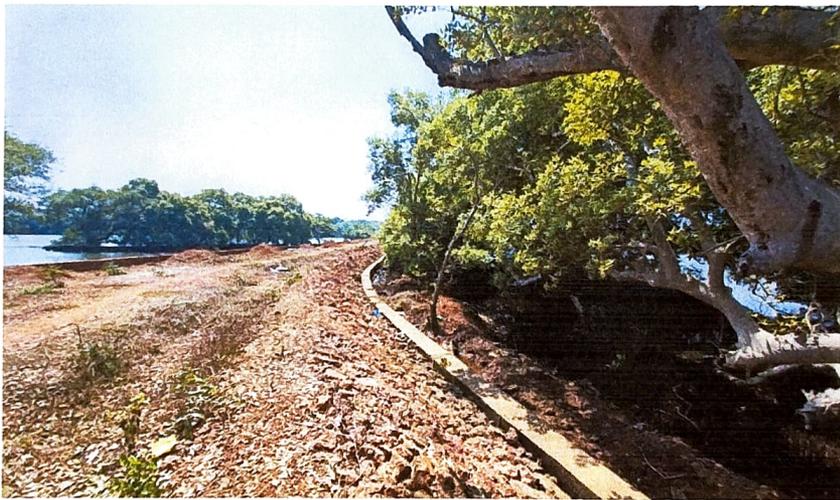
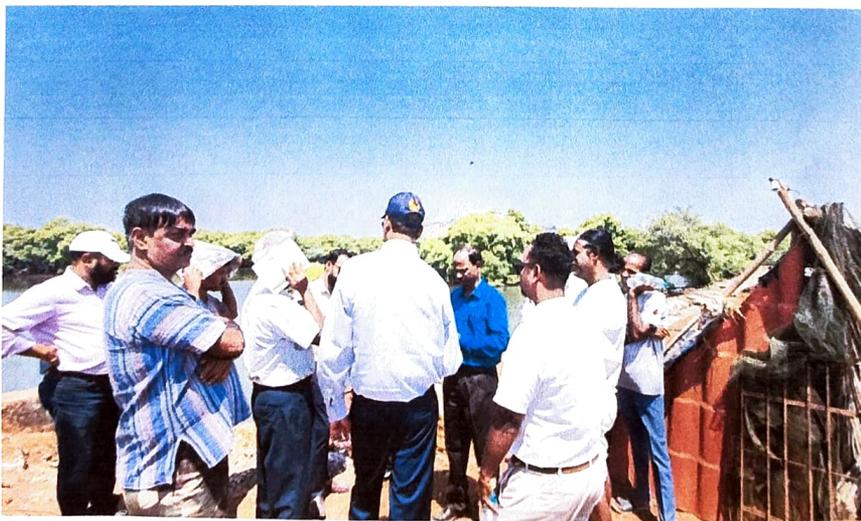
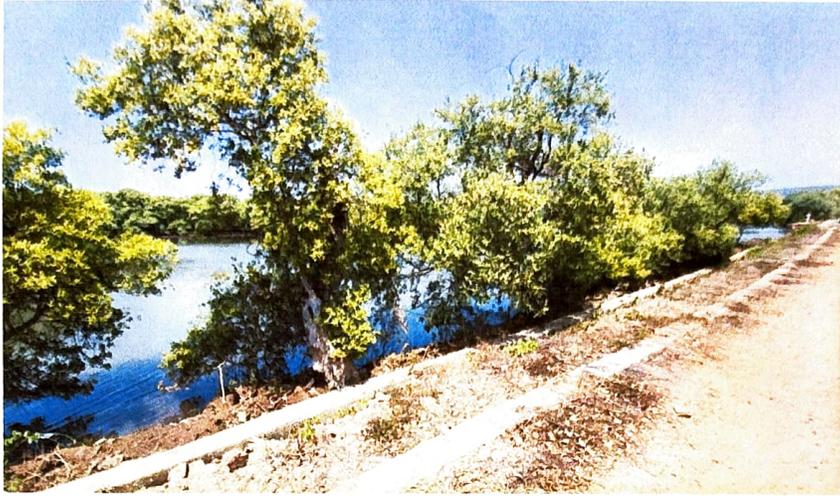
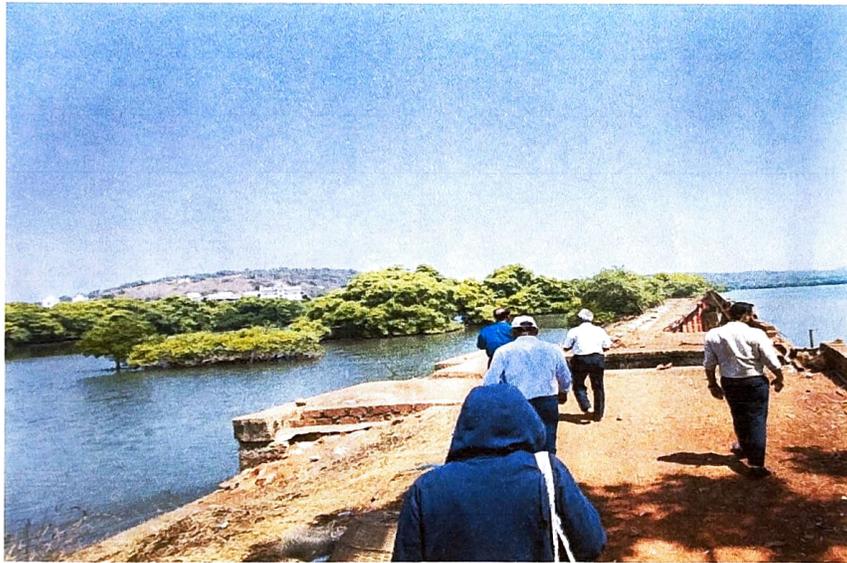
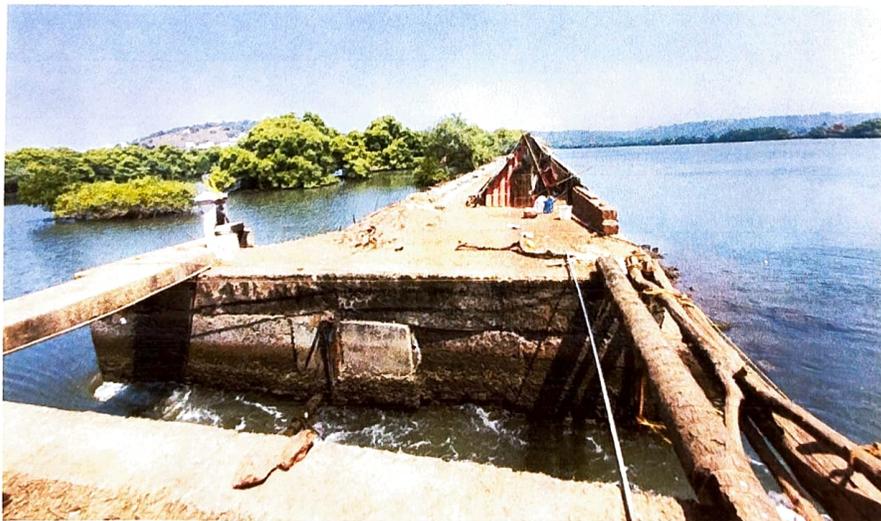
Annexure I

- 6) There exist one concrete retaining wall on the western side of the bund on the khazan land of height 0.5mtr and 0.4mtr wide.
- 7) It was noticed during the time of inspection that some trees were cut and mangroves uprooted at different location during the work undertaken for strengthening and renovation of existing bund.

- 8) It was noticed that some cleared dead mangroves wood/branches were seen in the vicinity of the bund at many places.
- 9) It was also noticed that at some places of the bund passes through thick mangrove stand.

- 3) The mangroves plantation and associated species in the area wherever destruction of mangroves has taken place should be carried out.
- 4) For any further renovation/strengthening of the bund , traditional method, based on ecological principles and with Eco friendly materials may take up for renovation or strengthening of bund.
- 5) More Plantation of Mangroves along the inner side of the bund is to be discouraged considering that this area can be potential for livelihood activities such as agriculture ,pisciculture etc if planned properly.It is also recommended to encourage plantation of mangroves associated species such as like *Salvadora persica* (*Meswak* plant traditionally having applications in oral medicines) which is found to be already growing in the area.This could create more livelihood opportunities in future.
