## REPORT OF JOINT SITE INSPECTION

Illegal reconstruction, renovation and repair undertaken by West Zone Hotel in survey no.54/5 and 55/3 on a sand dune between 200-500mtr in Colva Salcete Goa.

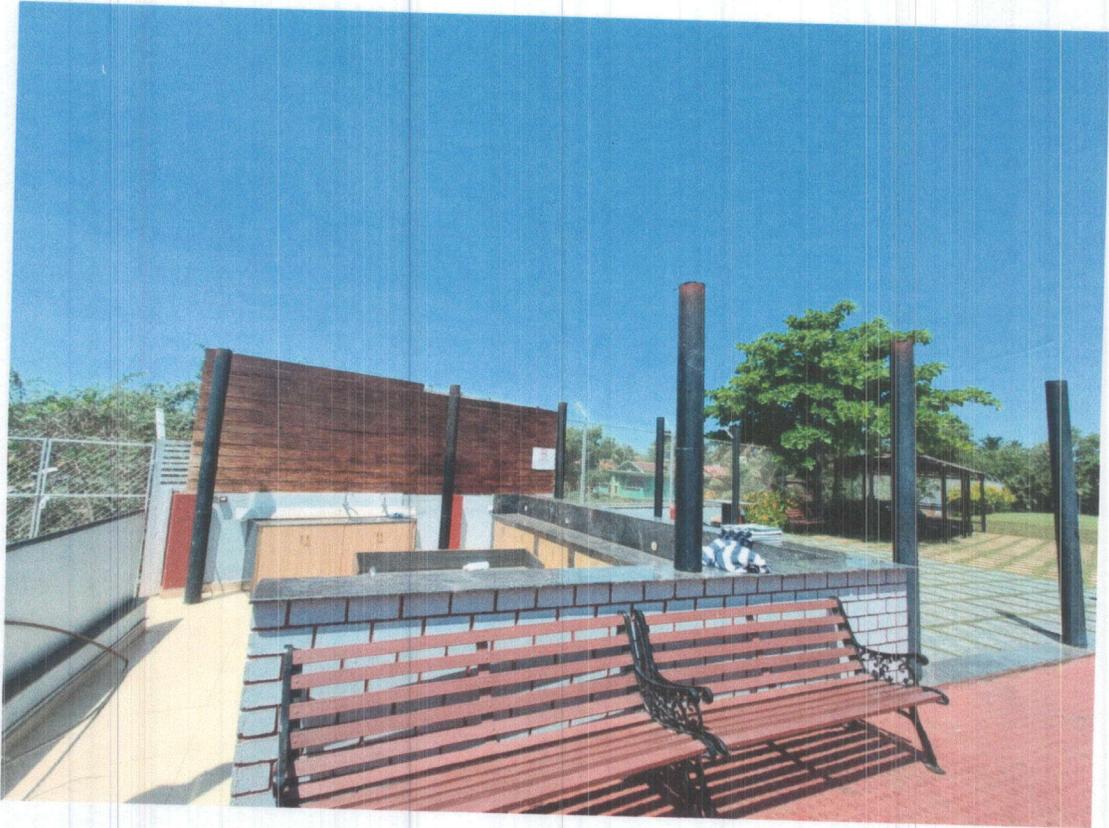
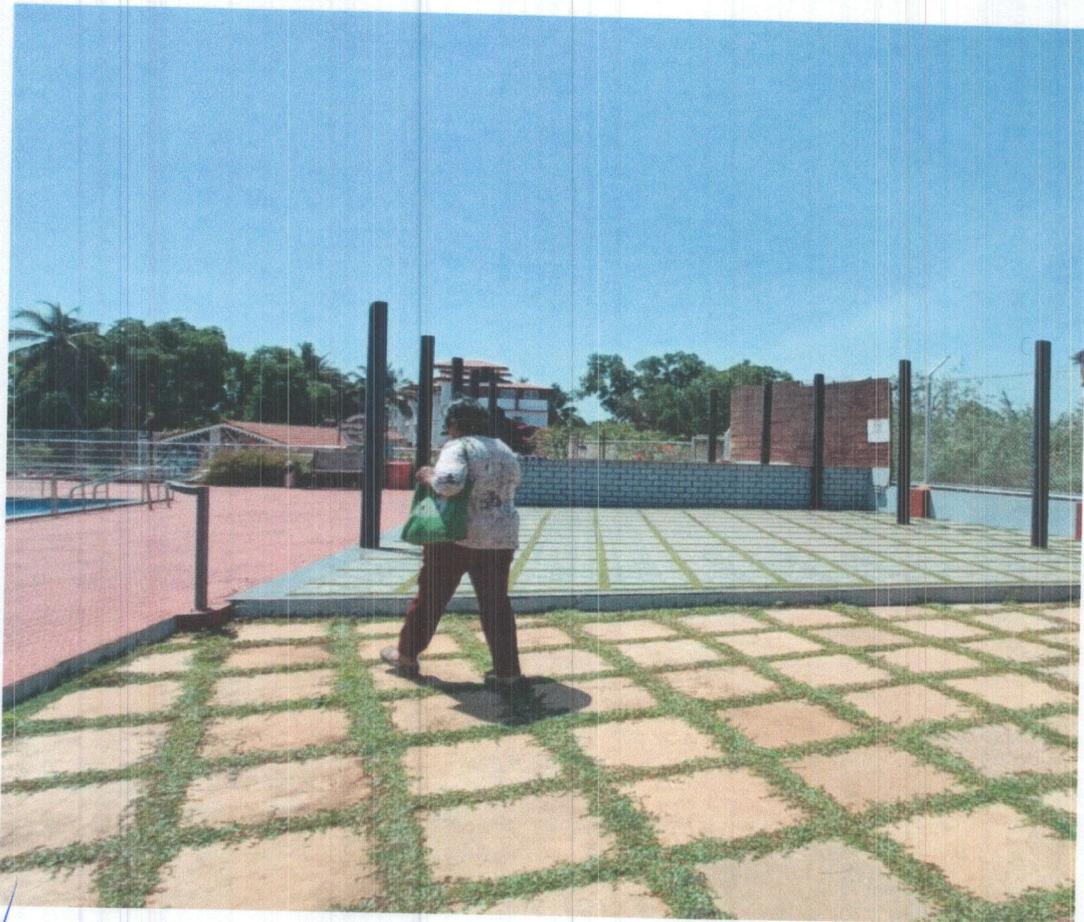
Annexure I

Sr.No	Demolition order as per NGT	Site Conditions as on date 24/03/2024
1	To demolish the pool side Restaurant in the survey nos.54/5	Restaurant roofing is dismantled,whereas the kitchen platform plinth and the supportive MS(mild steel) members are still intact on site.(site photographs attached in <b>Annexure I</b> )
2	Stage	Stage has been demolished.(Site photographs are attached in <b>Annexure II</b> )
3	Shower Room	Shower room has been demolished.
4	Fountain	Fountain has been demolished.(Site photographs are attached in <b>Annexure III</b> )
5	Basement below Swimming pool	The roofing of temporary extension to the swimming pool deck i.e GI sheets has been dismantled whereas the MS channels for the same and the permanent rooms below the swimming pool is still intact on site. (Site

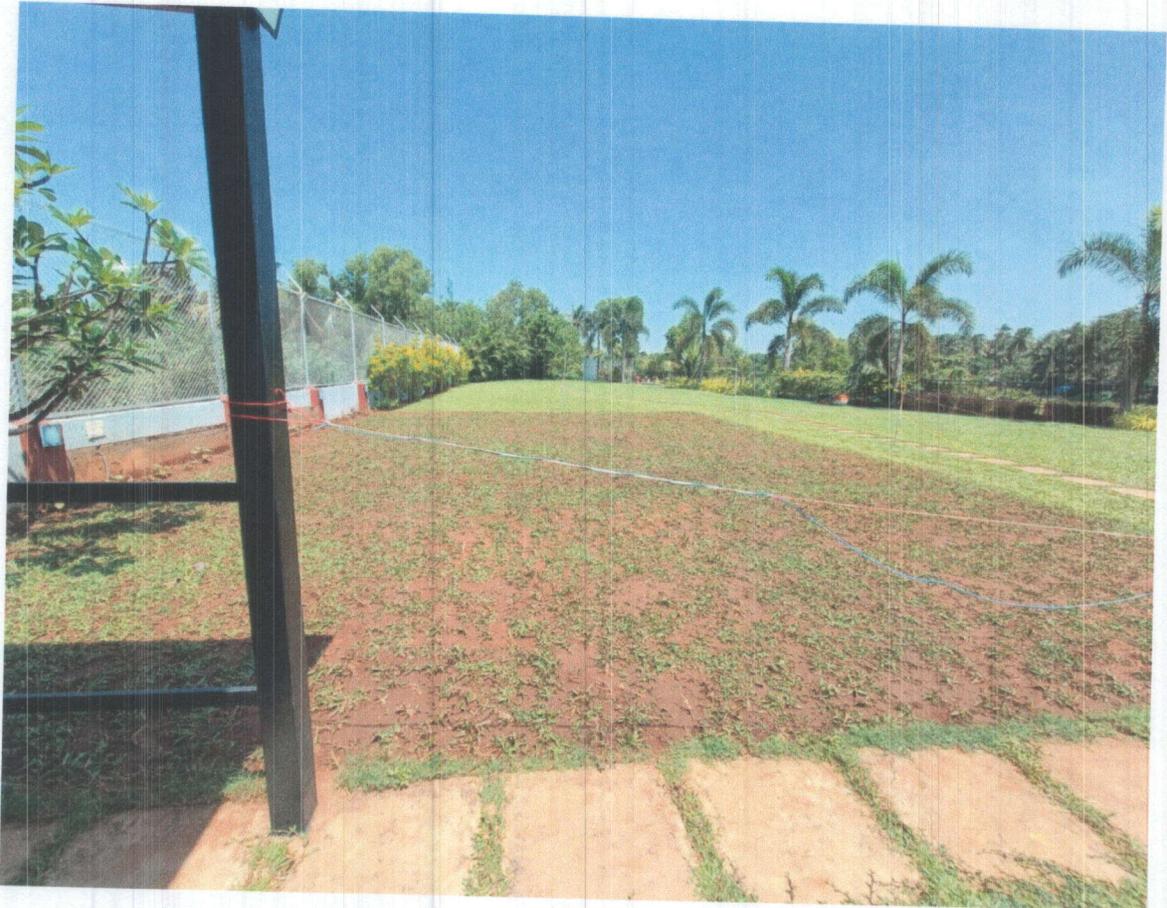
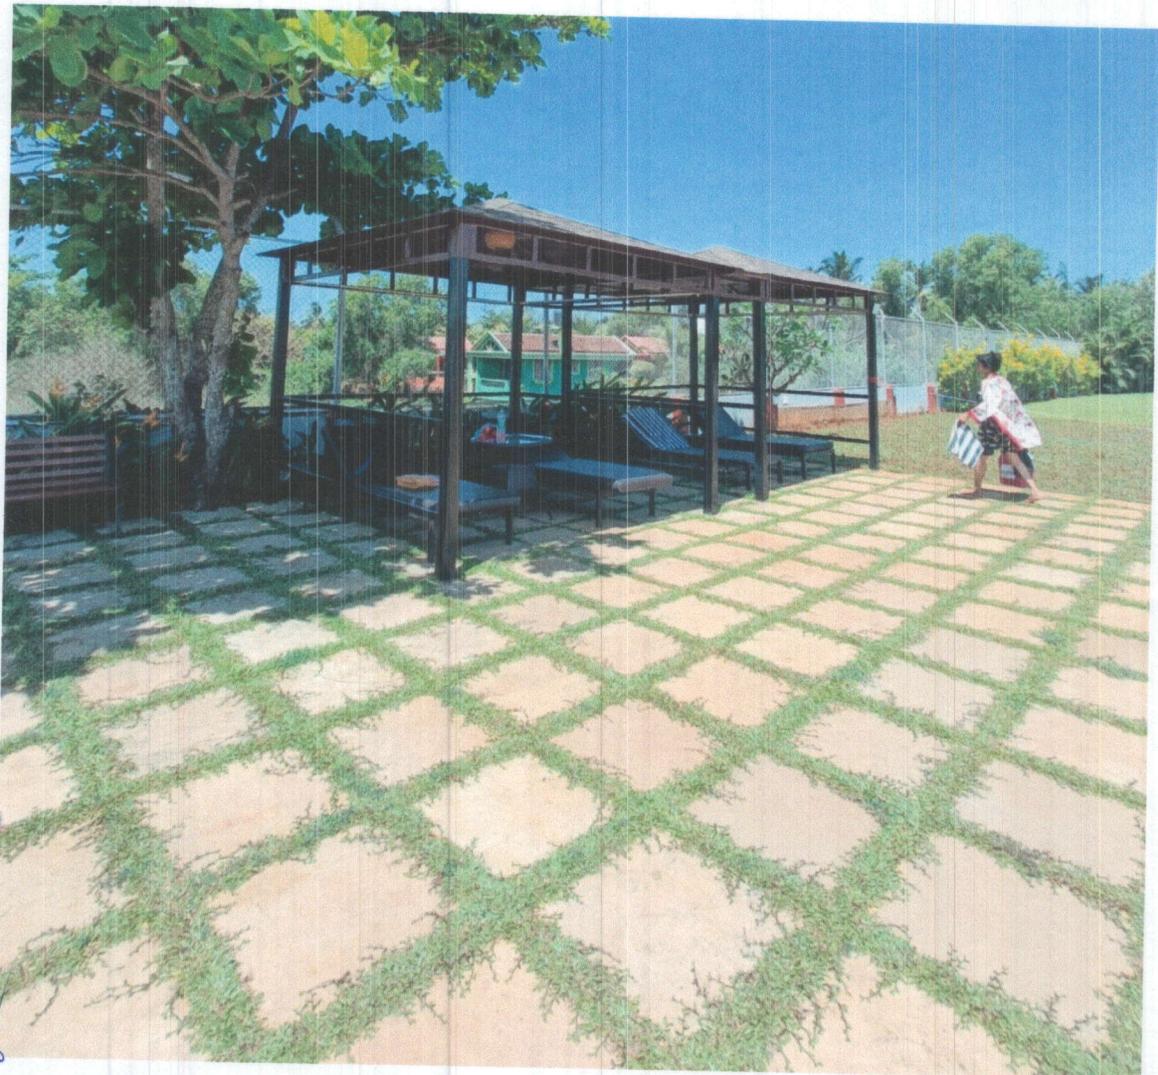
Annexure II

photographs are attached in <b>Annexure IV</b> )
6	Interlocking pavers on concrete base	Interlocking pavers near stag area is demolished.(Site photographs are attached in <b>Annexure II</b> )
7	Car Porch	Car porch is still intact on site.(Site photographs are attached in <b>Annexure V</b> )
8	Security Cabin	Roofing of security cabin is dismantled whereas the plinth for the same is still intact on site.(Site photographs are attached in <b>Annexure V</b> )
9	Cylinder Shed	As noticed that the cylinders are kept inside the MS(mild steel) grills shed and not yet demolished.

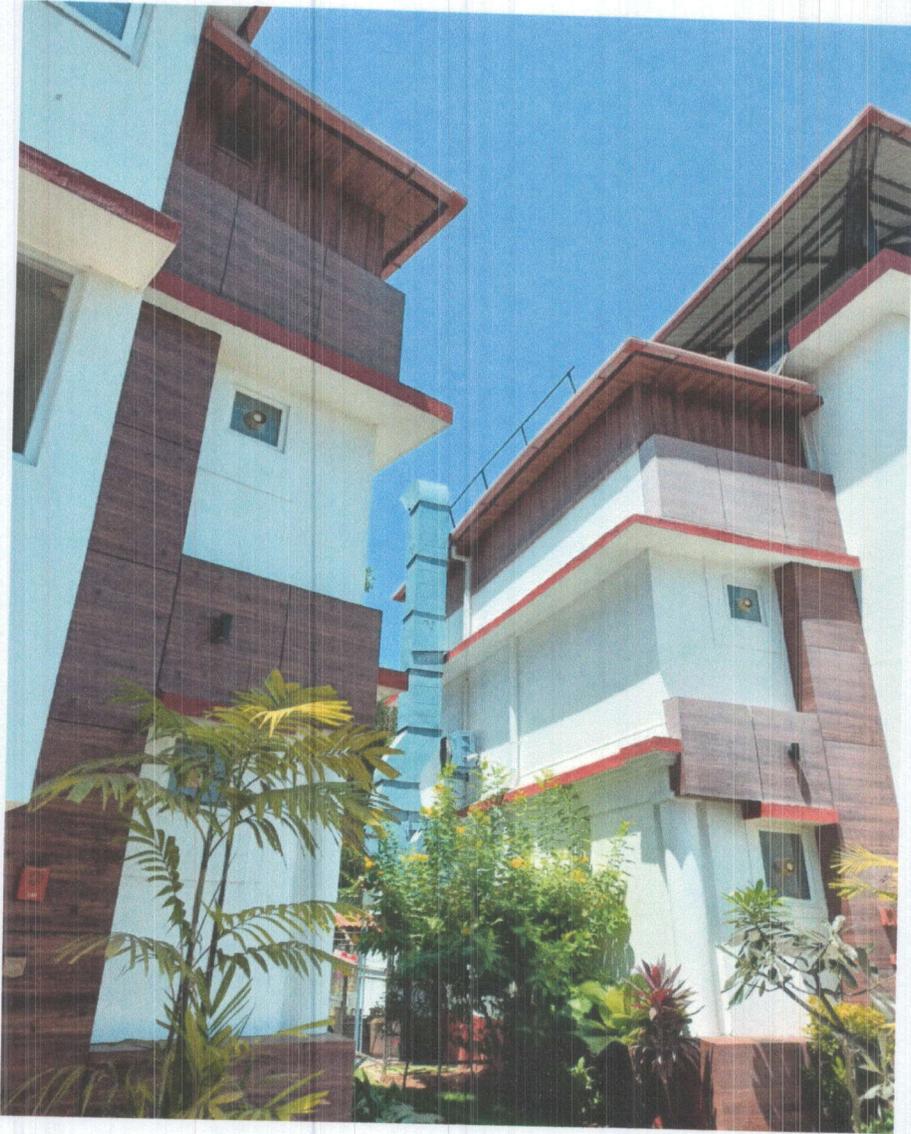
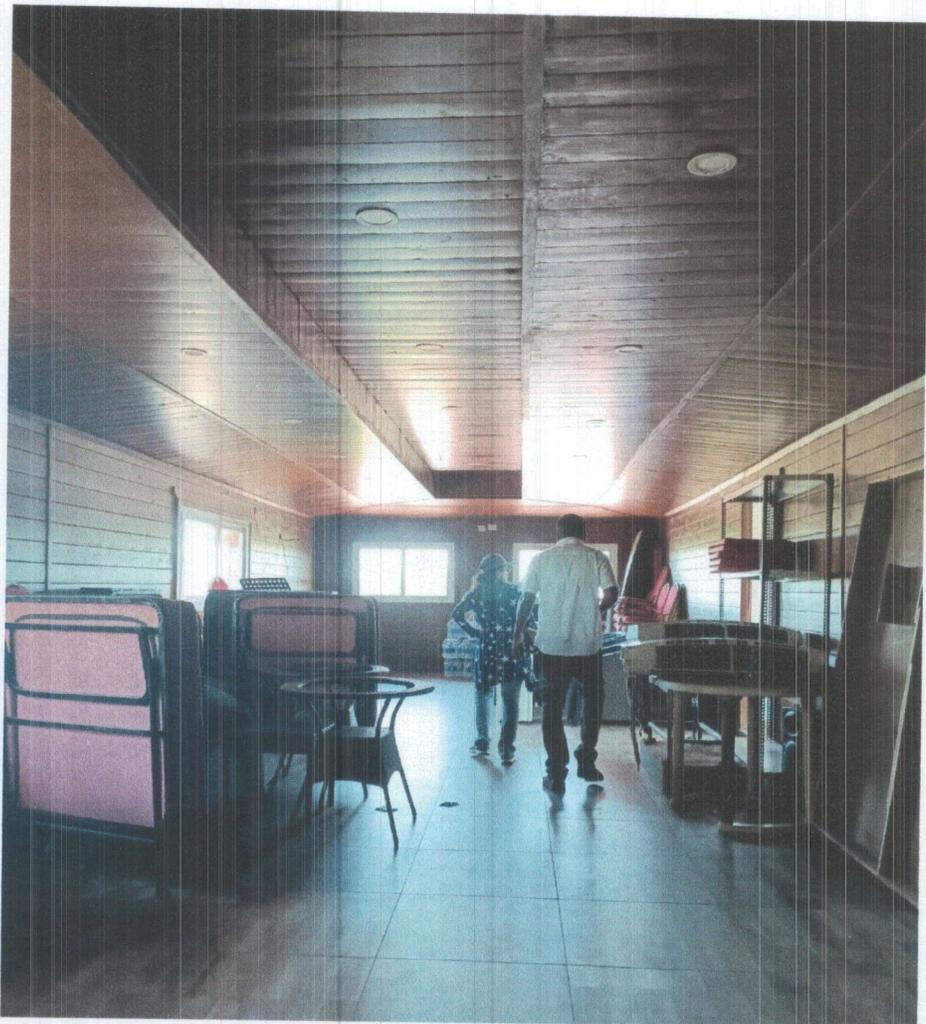
Annexure VI

- 5) As observed during the time of inspection that out of five permanent structures for two structures the temporary erected second floor is covered with the wood panelling forming a room which is used as a store room by the Respondent.(Photographs showing the same is attached in **Annexure VI**).

- 6) The store room is closed on all four side with wood panels and also with ceramic tiles flooring.(Photographs showing the same is attached in **Annexure VI**).

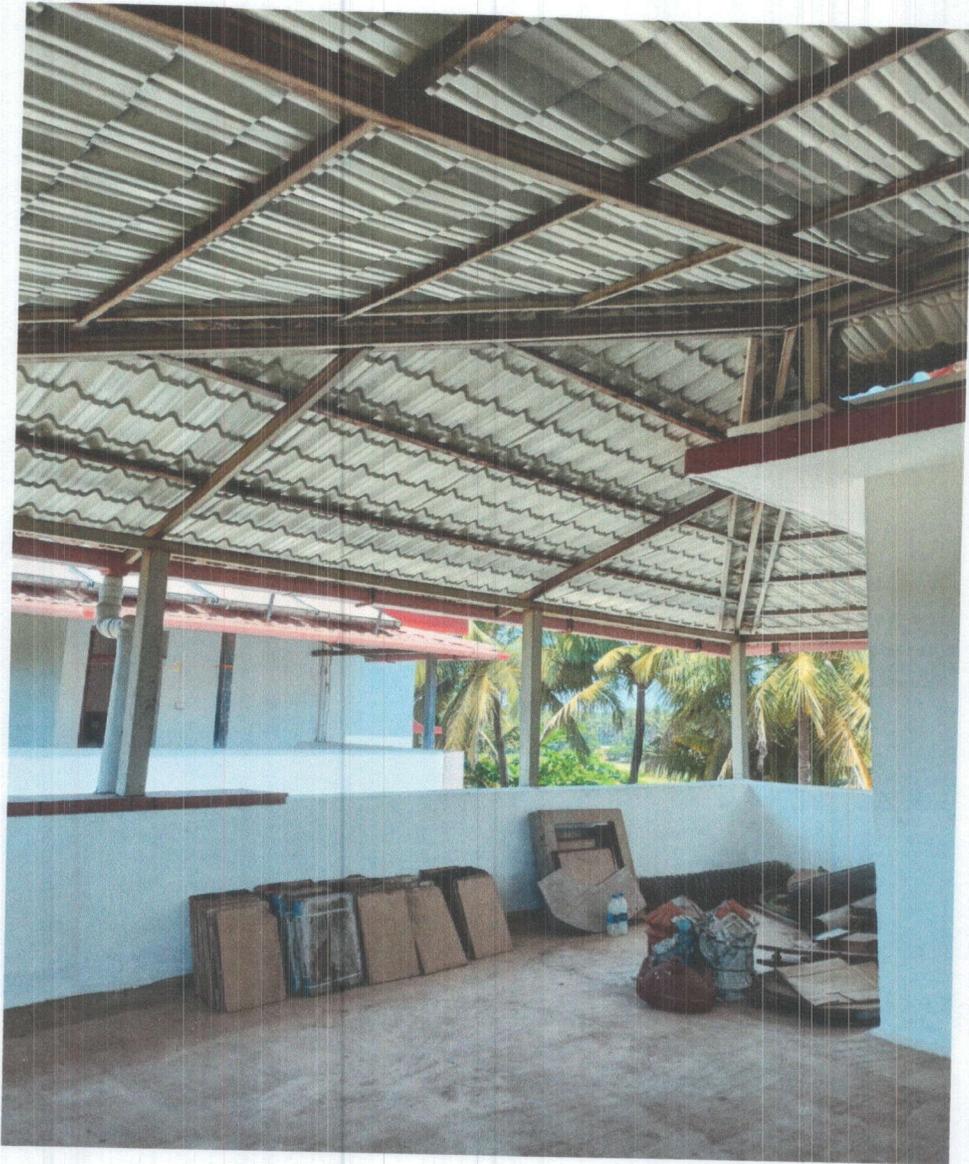
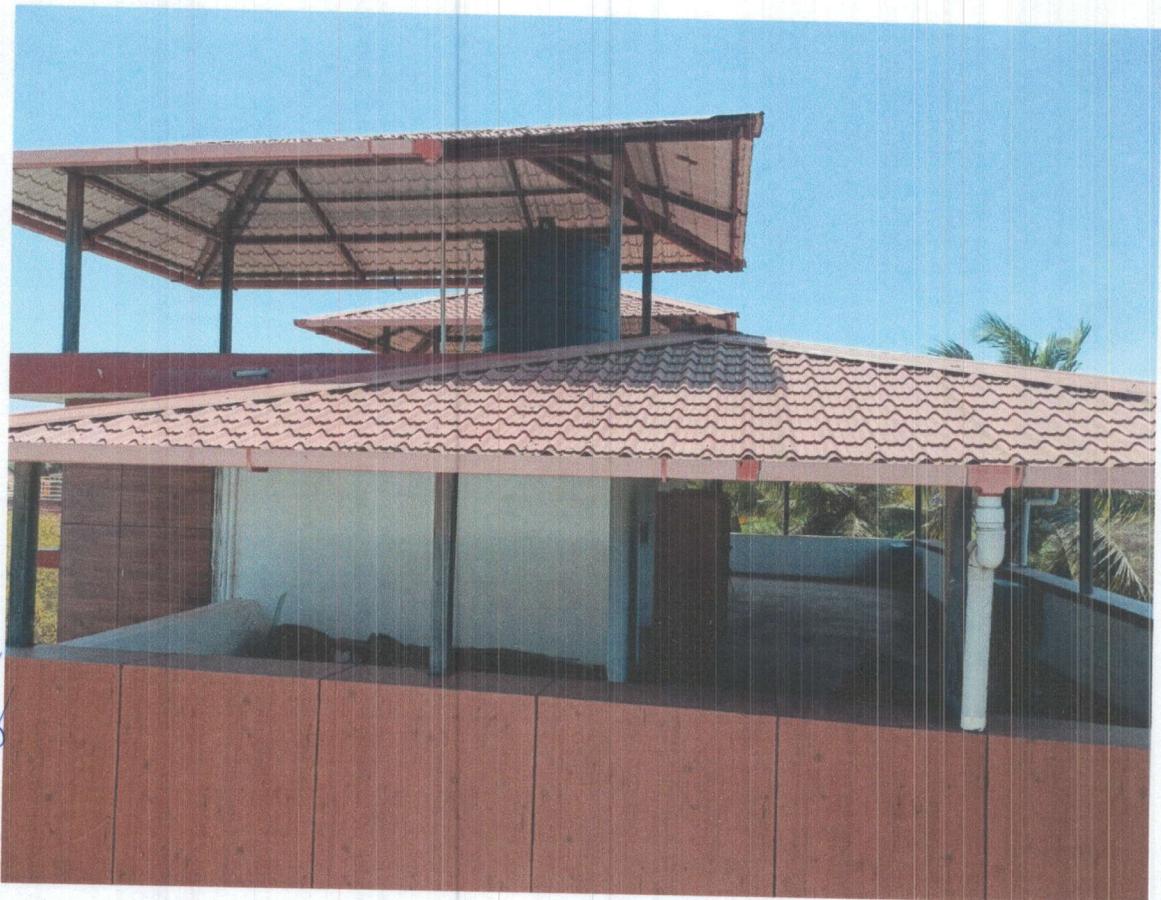
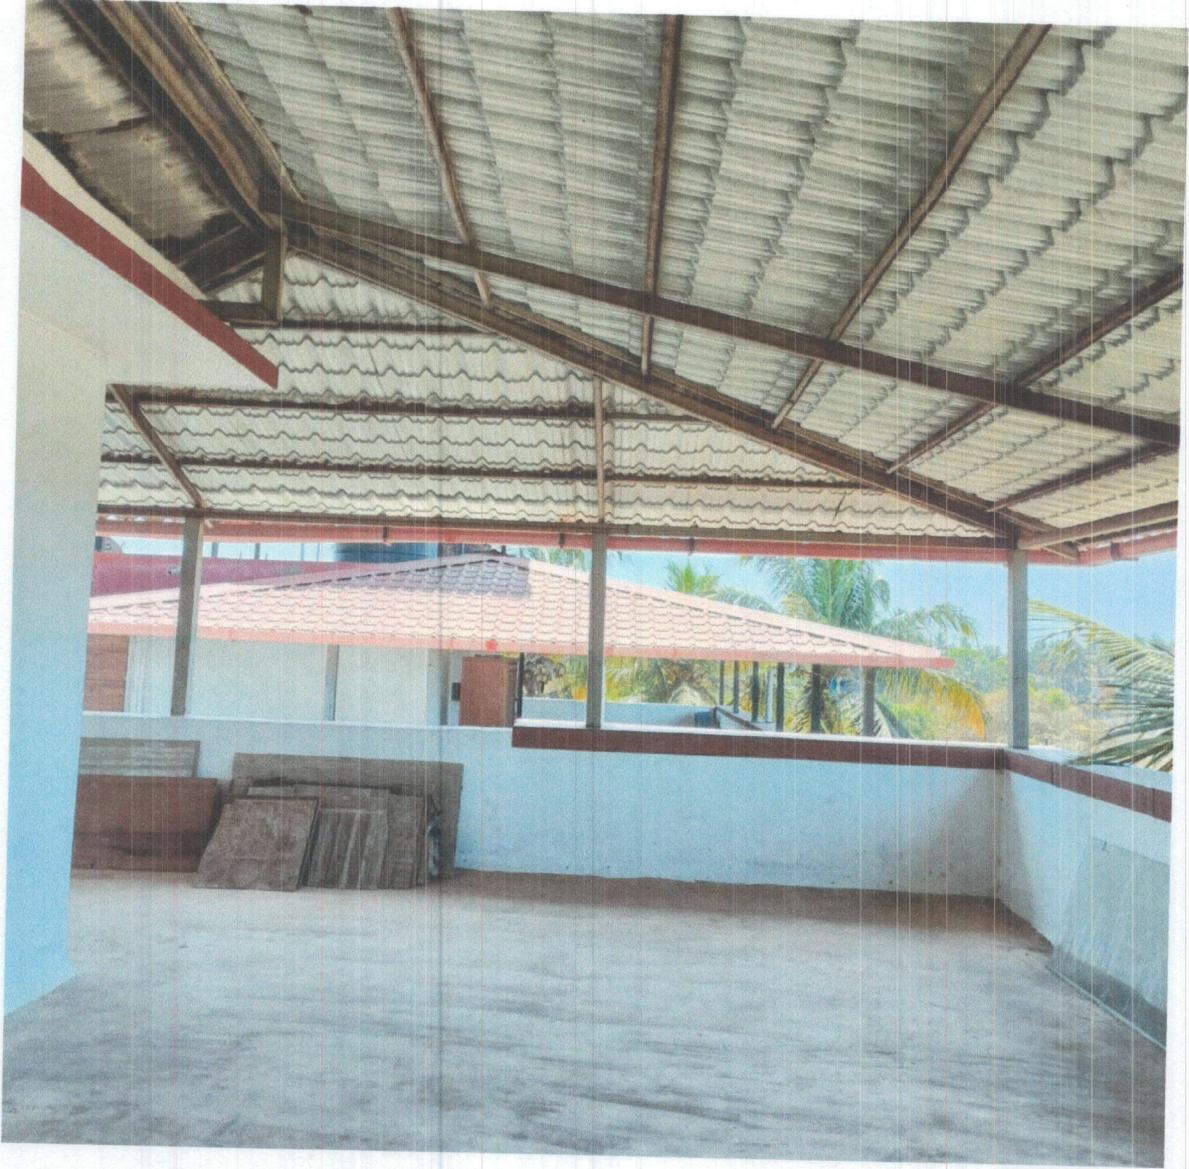
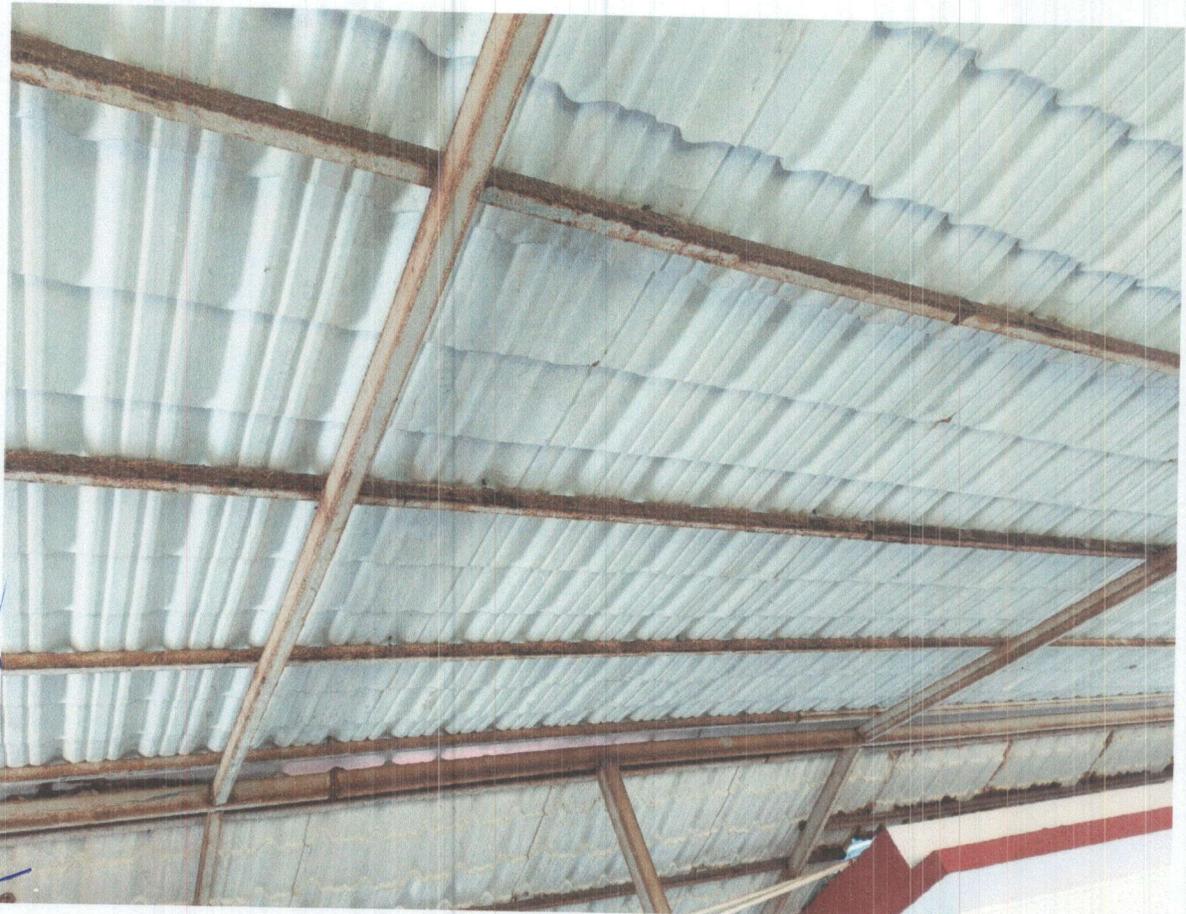
Annexure VII

- 7) The temporary floor erected on remaining three structures using GI sheets and MS (mild steel) channels framing is open on all four sides and it is unused.(Photographs showing the same is attached in **Annexure VII**).

- 8) The corrugated sheets with MS(mild steel) channels framing is erected to protect terrace from rain water damage/dampness, and some of the sheets are in deteriorated condition.(Photographs showing the same is attached in **Annexure VII**).
