Sub: Report of the joint site inspection held on 20/12/2024 from 11:15 am onwards at the property bearing survey no.16/7 of Sernabatim, Salcete, Goa.

REPORT OF THE JOINT SITE INSPECTION HELD ON 20/12/2024 FROM 11:15 AM ONWARDS AT THE PROPERTY BEARING SURVEY NO.16/7 OF SERNABATIM, SALCETE, GOA.

Site address: Survey No.16/7 of Sernabatim, Salcete, Goa

Date of inspection: 20/12/2024

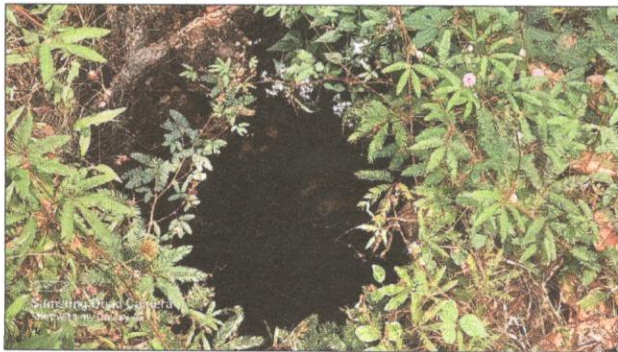
Pic 2: Dense growth of herbs, shrubs and creepers over a well on the eastern side of the property.

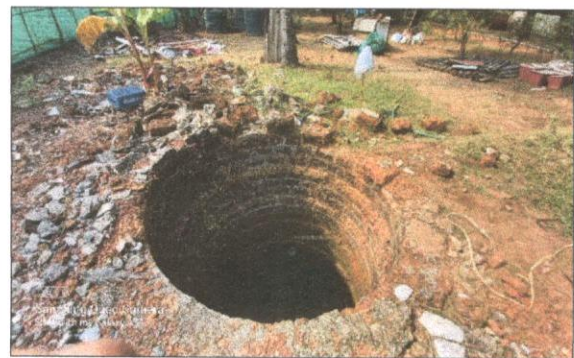
Pic 3: A well in use on the southern side of the property.

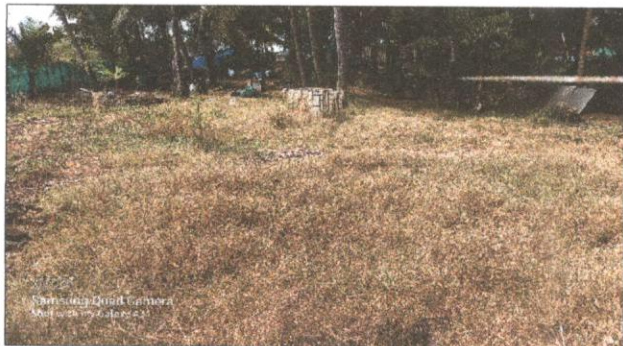
Pic 4: Overgrowth of dried diverse vegetation was observed at the site.

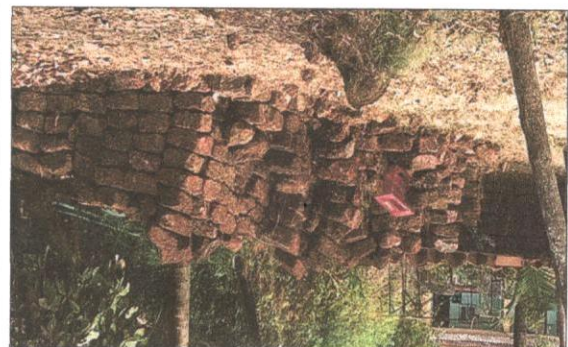
4. It was observed that septic tanks, plinths exist at the site. It was also noticed that plumbing pipes; underground pipes, wooden logs, PVC water storage tanks, construction debris, etc. lying in the inspected area (Photos attached). Lateritic stones, Mangalore roof tiles were seen stacked in the property; temporary tent like structure covered with plastic sheet is used to stack wooden planks and other materials.

Pic 5: Lateritic stones were seen stacked at the site.

- GCZMA may verify ownership and legalities regarding survey No.16/7.
- All the extraneous material such as plinths, stacked lateritic stones, Mangalore tiles, etc existing in the inspected property should be removed in such a way that there should be no leftovers which will interfere in the restoration process. Temporary tent like structures existing in this area should also be removed.

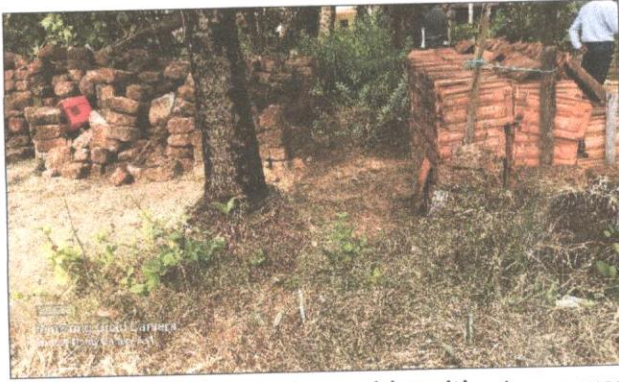
Pic 6: Mangalore roof tiles and lateritic stones were seen stacked at the site.

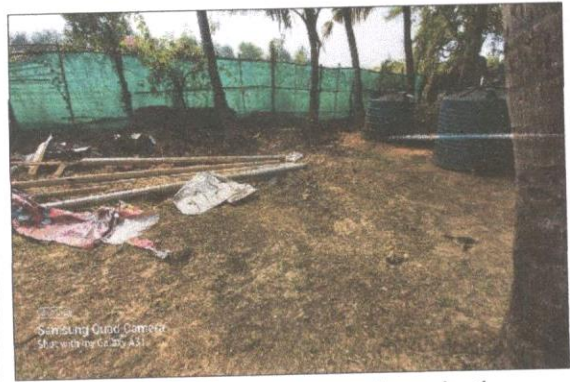
Pic 7: Plastic water storage tank and other materials are kept in the property

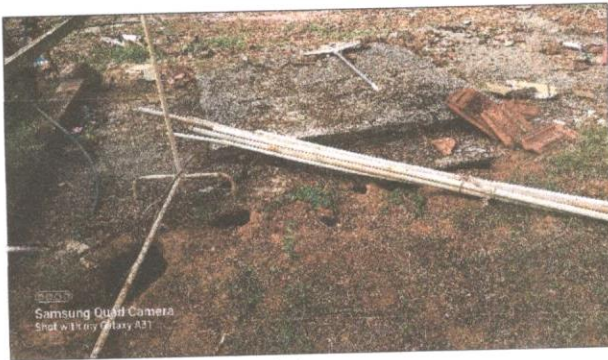
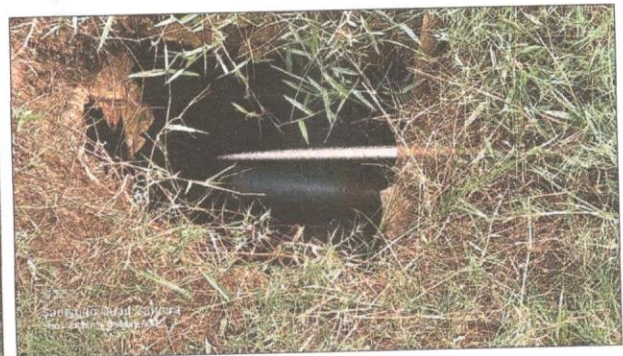
Pics 8: Photos (a) & (b) shows the presence of plumbing pipes, septic tanks and underground pipes.

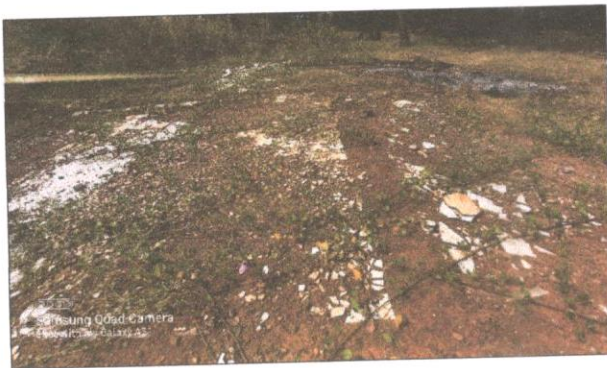
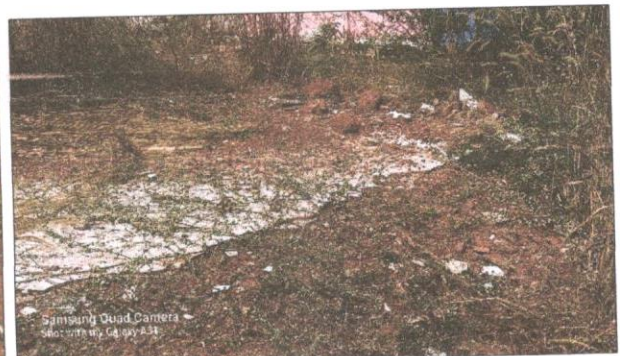
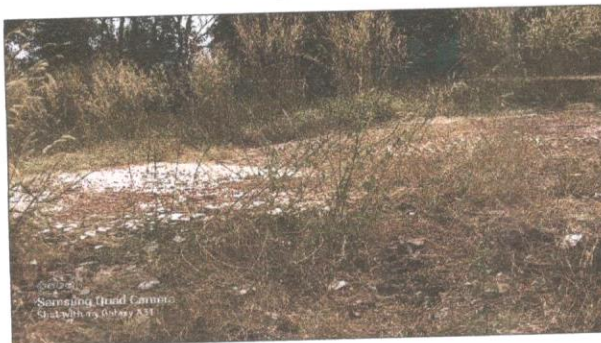
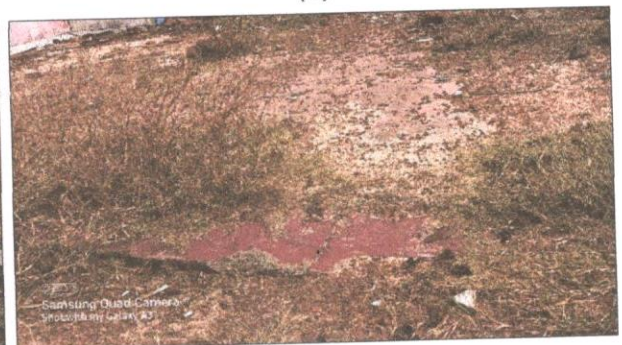
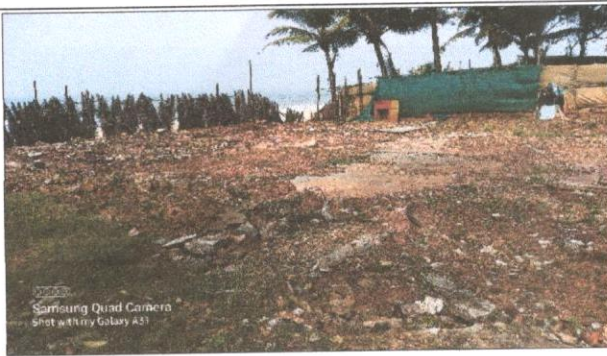
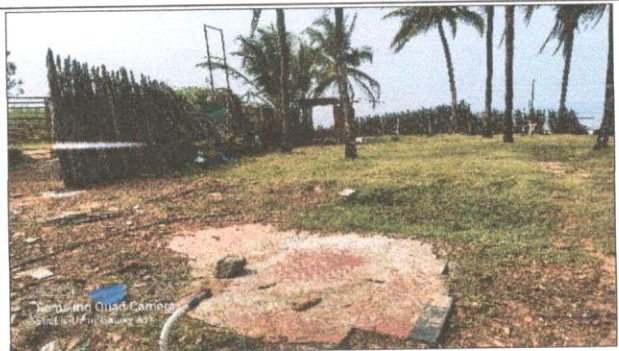
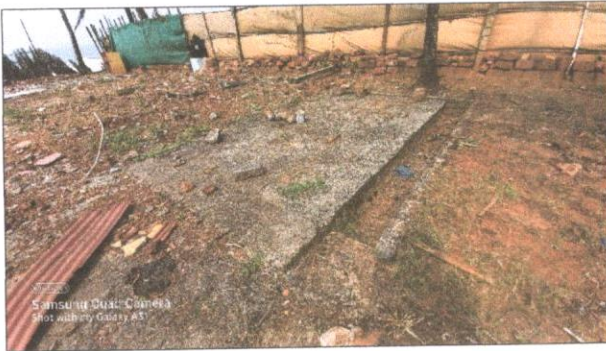
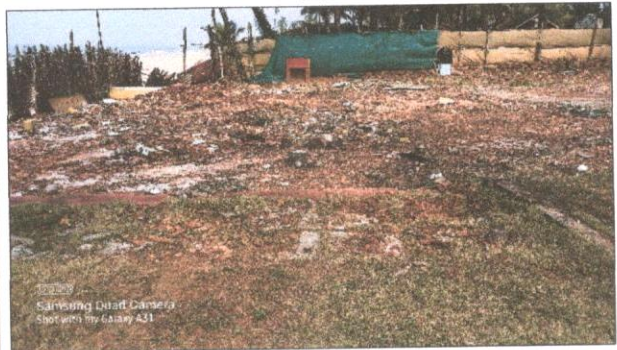
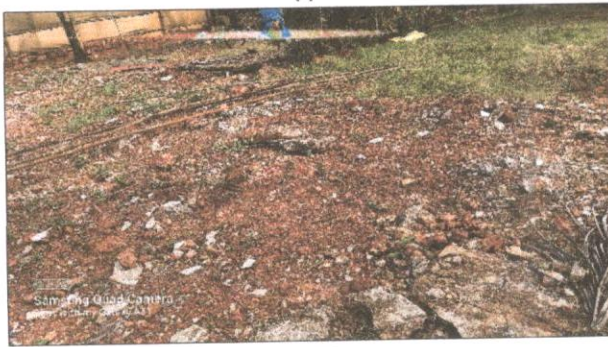
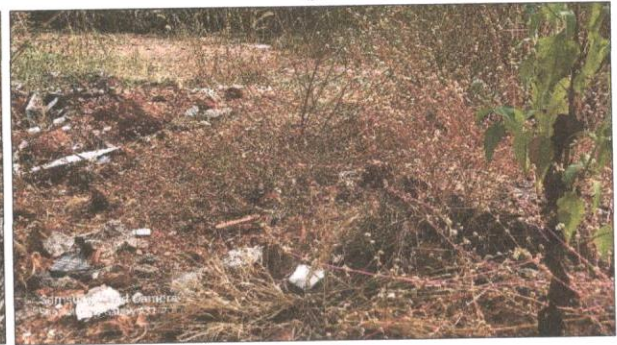
Pics 9: Photos (c) to (l) shows the presence of plinths and construction debris at various locations at the site

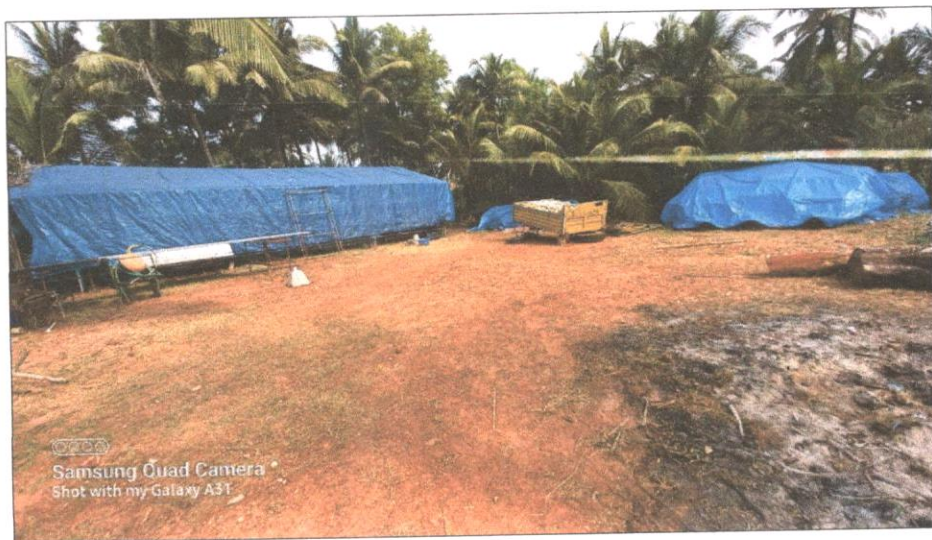
Pic 10: Temporary tent like structures (02 nos.) covered with plastic sheet (with some materials inside) were present at the site.

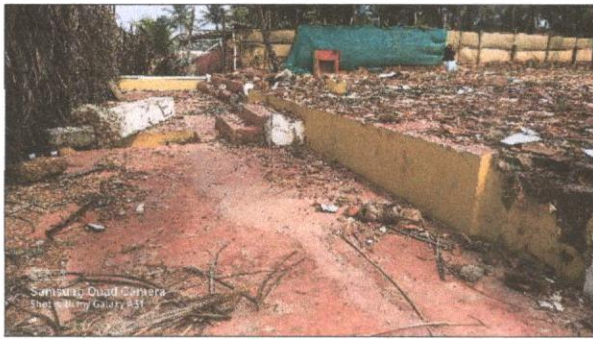
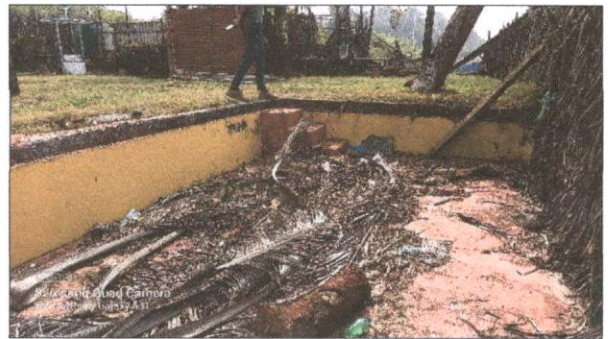
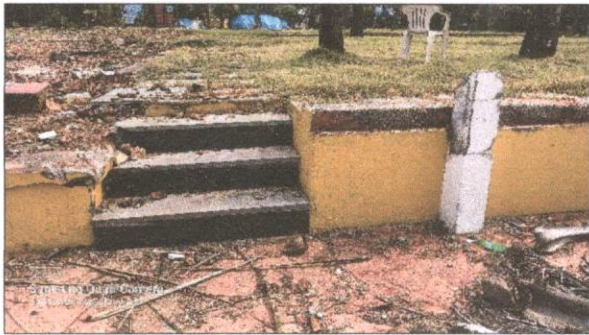
3. The area is sandy in nature with Arabian sea towards the west. The area is fenced on all the sides with wood, coconut palm leaves, green nets, etc. except for cement fencing on the northern side of the property. (As informed by the respondent this cement fence is not constructed by the respondent). On the western side of the property a permanent retaining wall like structure with stairs was seen.

Pics 11: Photos (m) to (o) show retaining wall like structure with stairs existing on the western side of the property.

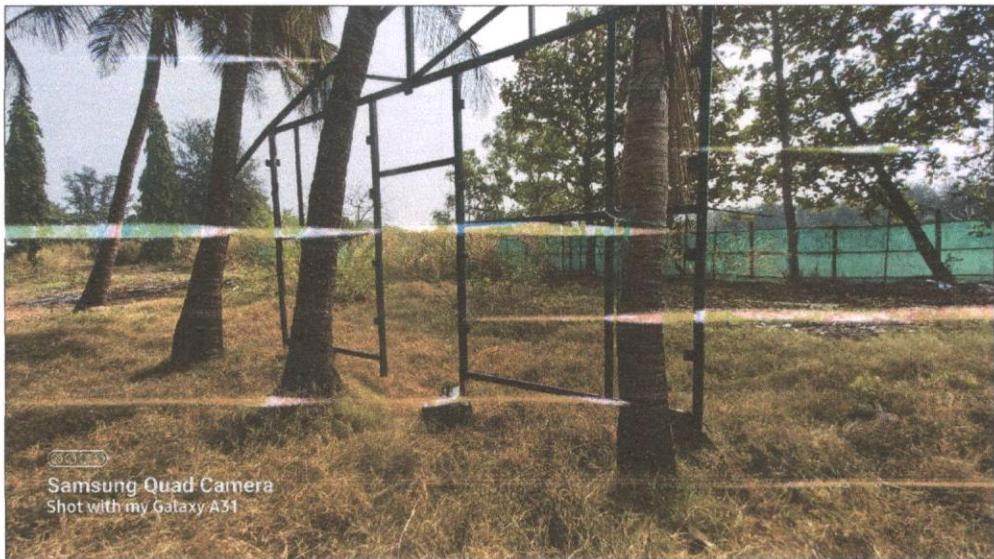
Pic 11: Metal frame existing at the site.

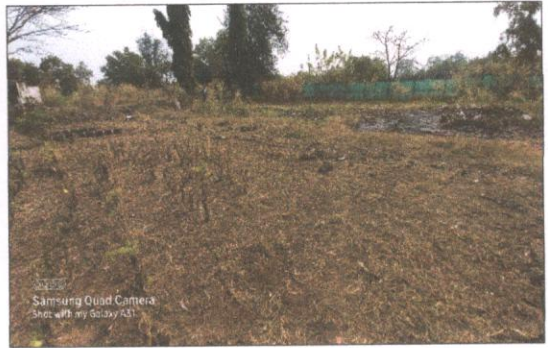
Dead crotons and other plants

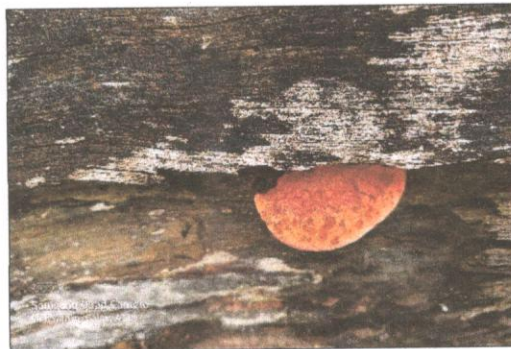
Fungi growing on dead wood
