**Site inspection Report Maxem
Original Application No. 97/2019 (WZ)**

25th September, 2021

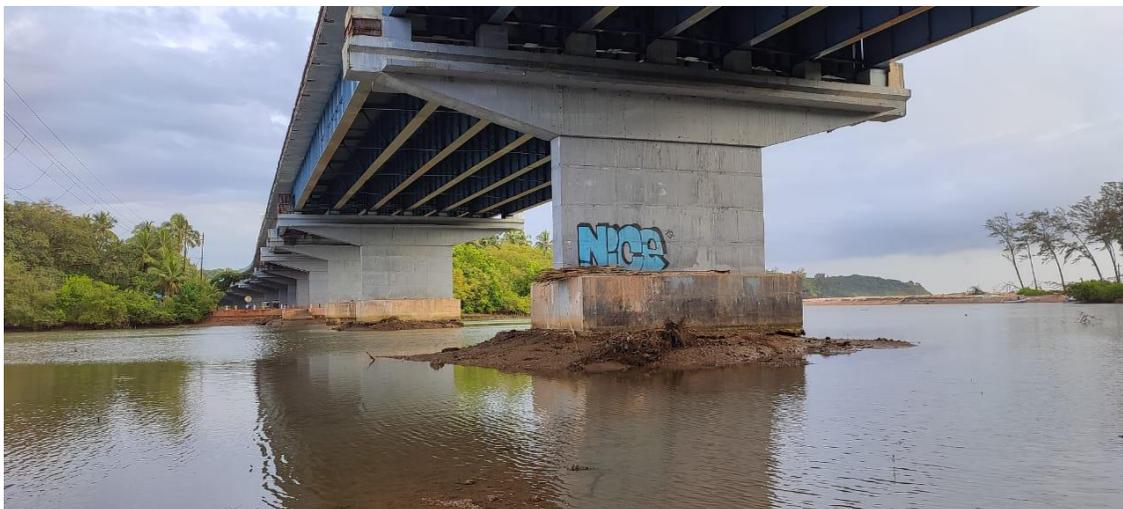
1. Mud deposits in Galgibaga River: Accumulation of mud under three pillars in the riverine area of Galgibaga has been observed.

3. Removal of mud from Galgibaga River and beneath the Maxem bridge must be done after a detailed scientific assessment by an expert institution. This is because, the sediment movement within the given stretch is dynamic in nature as it is constantly influenced by the intervals of low tide and high tide. Otherwise, it may have consequential ecological impact of getting other areas either eroded or accreted.

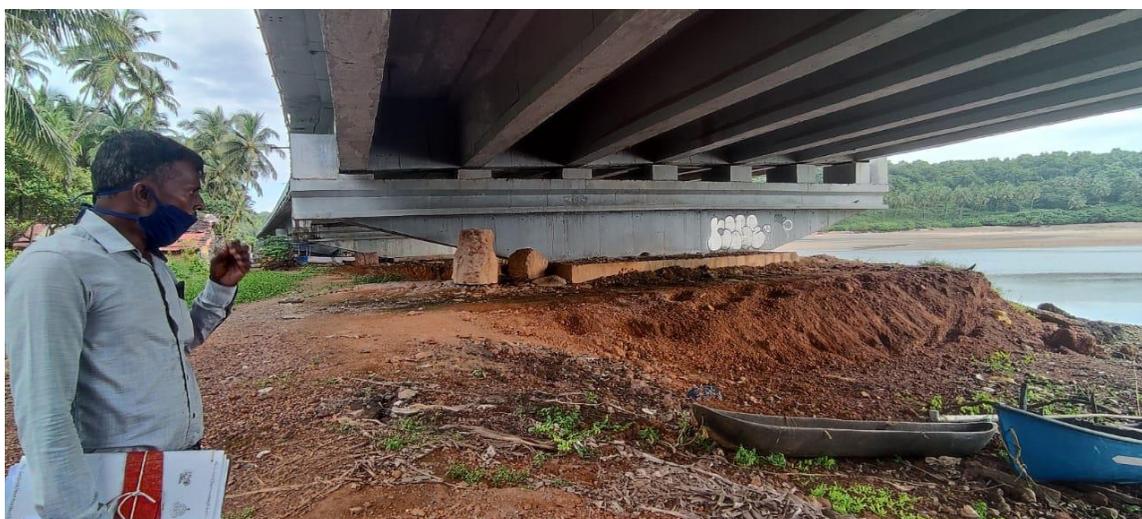
2. Earth filling in Maxem creek: Mud filling exists under the Maxem Bridge.

2. The mud deposited under the Maxem bridge has been compacted and is serving as a protection wall to the life and properties on the landward side from the tidal effect. At the time of inspection, the villagers residing there informed the undersigned that the mud is helping them as a protection barrier from the tidal influence and also from ingress of saltwater. They also informed that the matter of mud removal is in the Hon. High Court of Bombay at Goa.

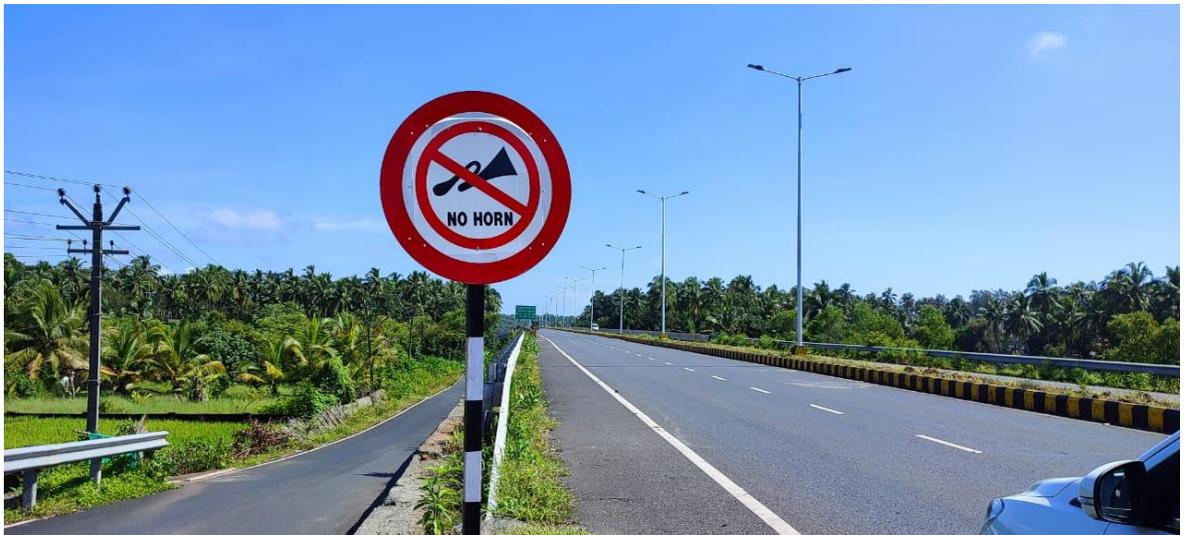
3. No Horn Zone: The PWD has placed No Horn Zone signs on both Galgibaga and Maxem bridge.

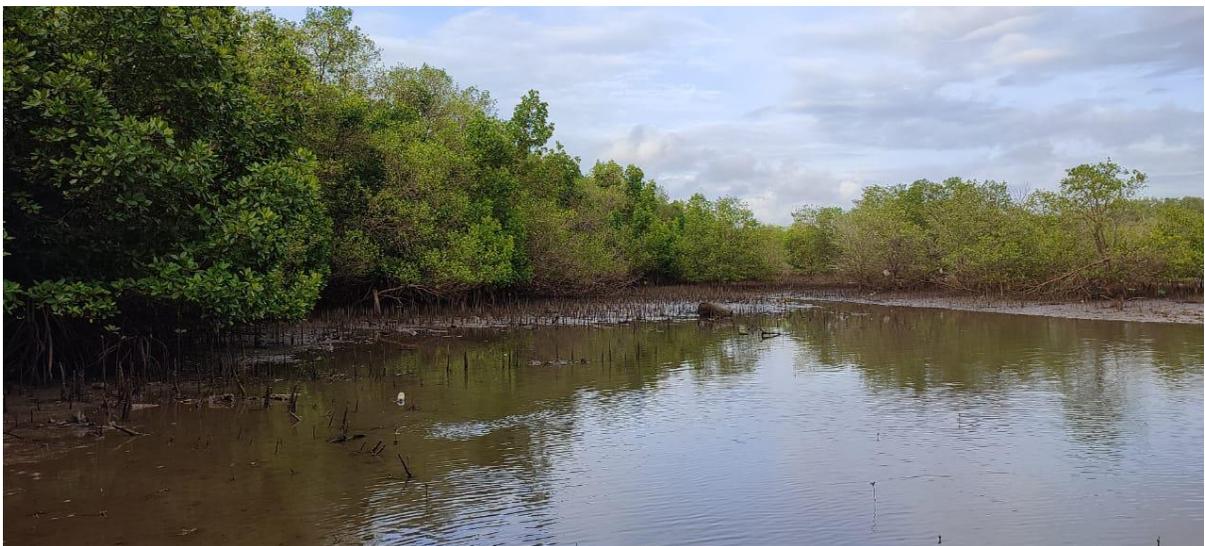
4. Mangrove plantation: PWD has undertaken required plantation in association with the Goa Forest Department. Both sides of the bridge has good and luxuriant growth of mangrove. Natural regeneration has also been observed.

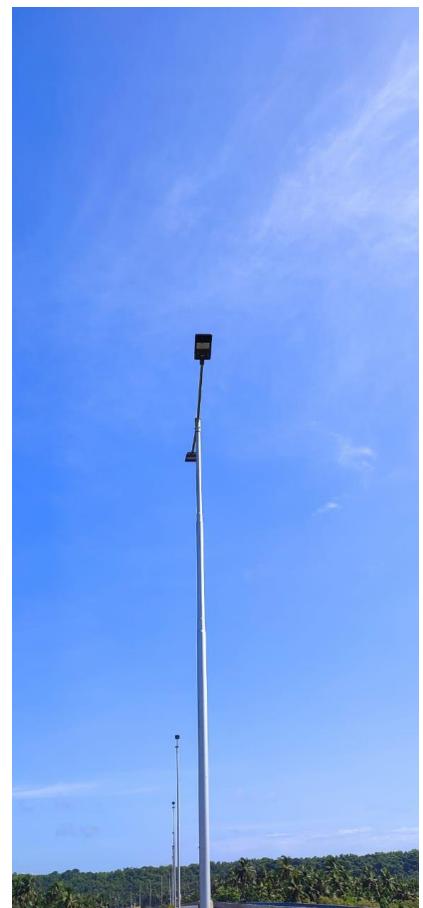
5. Lights on the bridge: As suggested, the PWD has changed the direction of the light panel on the bridge. Directional lightings are a standard practice being followed to avoid distraction of turtle movement. The light fixtures have been painted with a black colour in order to reduce the brightness and light intensity. This safety measure will reduce the light impact on the turtle movement.

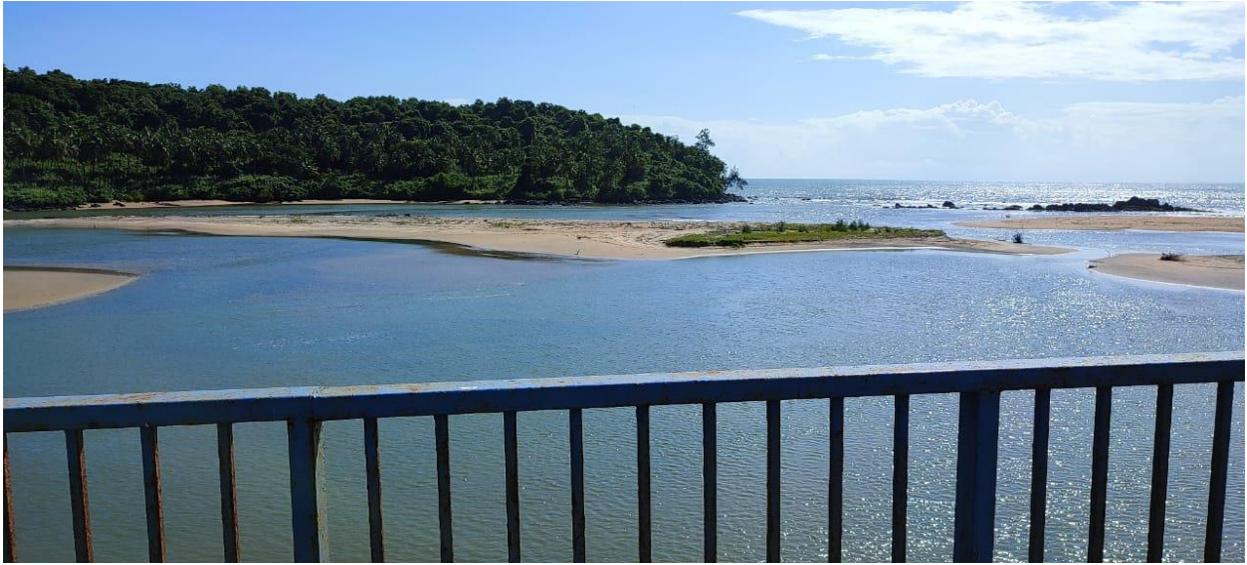
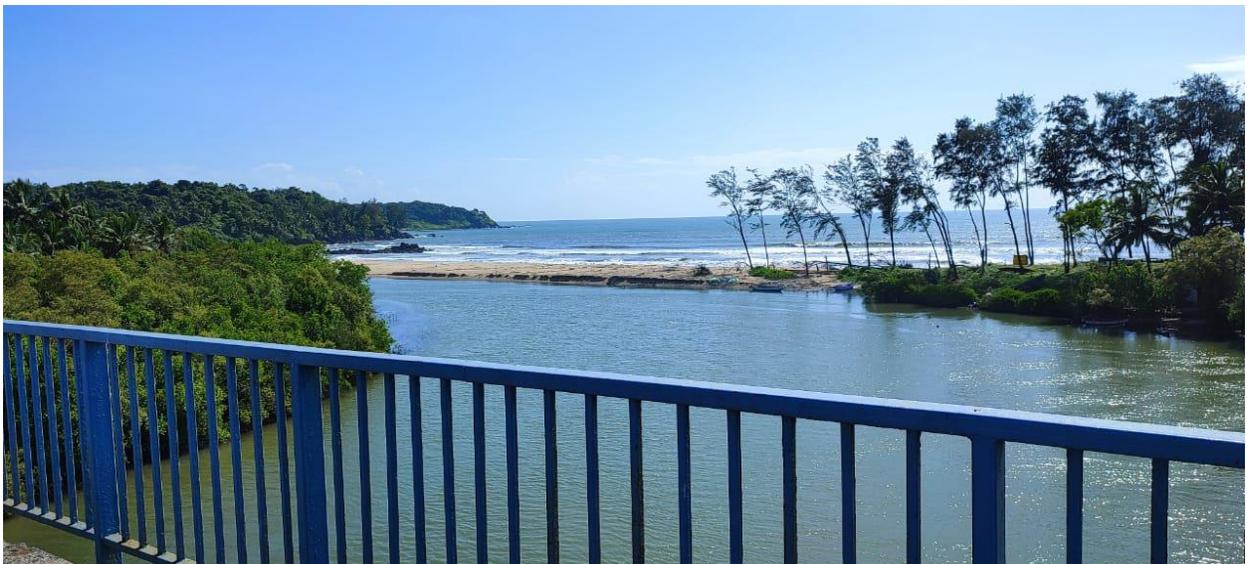
6. Sand bar formation at the river mouth: Sand bar formations has been observed at the mouth of Galgibaga River and Maxem creek.

1. Formation of sand bar at the river mouth of Galgibaga and Maxem Creek may be due to large scale bank erosion as a result of exceedance of carrying capacity (probably due to heavy rains coupled with high tide) and its deposition of the mouth region as a result of wider width at the confluence of estuary to Arabian Sea. Further, location of bridge pillar would also aid/aggravate due to scouring of bottom sediment as a result of gushing of river-water flow downstream. However, this aspect needs a further assessment by an expert agency/institution involved in coastal protection.

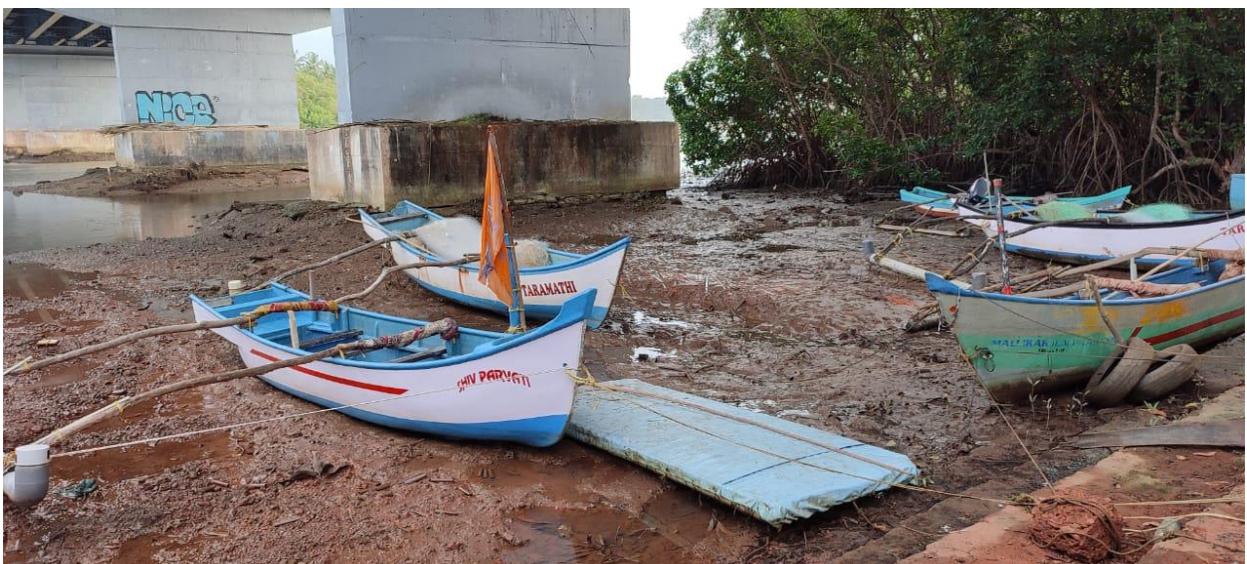
Both river banks under the Galgibaga bridge are being used for parking and unloading of fish catch by the traditional fishing community. Both sides have a mangrove cover and growth has been satisfactory.

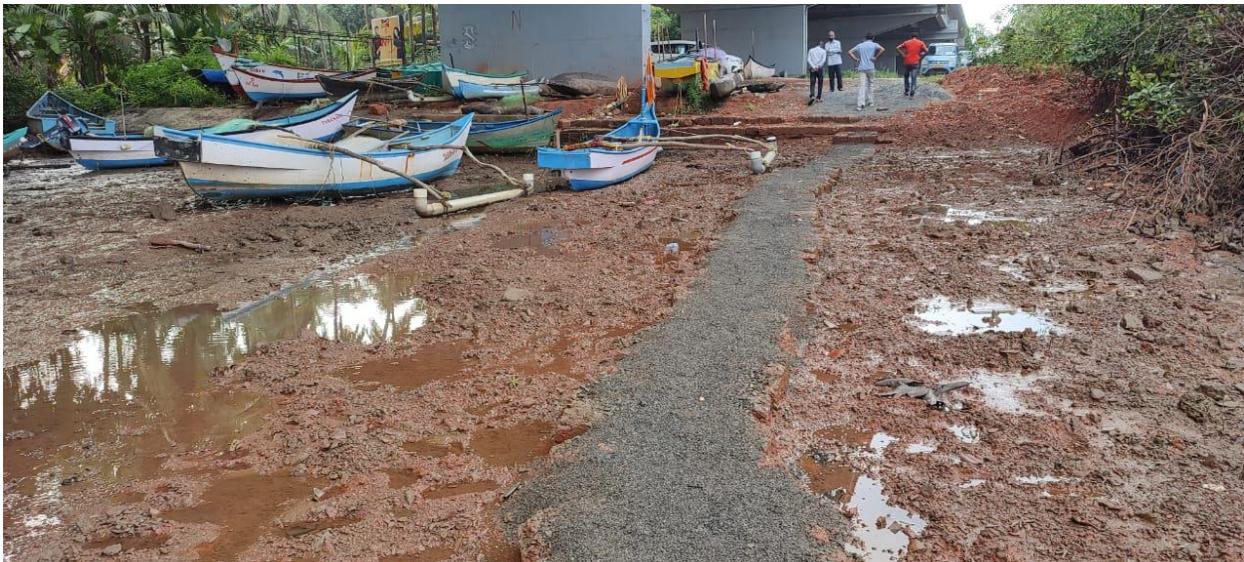
Laterite mud has been observed in between T10 and T11 these pillars. However, Mr. Pagui informed that during the time of Ganesh Visarjan, locals have put a mud and partly concrete pathway to access the water for Ganesh immersion.
