Sub:- Regarding status report of field work done by Expert Committee formed on 22.07.2019 by District Magistrate, Bhilwara in reference to OA No. 288/2019, Bal Kishan Vyas Vs State of Rajasthan.

**Sub: Work Status Report on Investigations of Cracks in the Pur village, Distt. Bhilwara, Rajasthan**

1	Name of work	<b>Studies to investigate the reasons of cracks development in buildings of Pur village, Bhilwara, Rajasthan</b>
2	Institute	<b>CSIR-Central Building Research Institute, Roorkee</b>
3	Site	Pur Village, Bhilwara, Rajasthan
4	Date of visit	28 <sup>th</sup> January 2020 to 3 <sup>rd</sup> February 2020
5	Type of work	Condition assessment of various buildings and monitoring of cracks in building
6	Status of work	<ul style="list-style-type: none"> <li>• Condition assessment of 55 buildings of Pur Village, Bhilwara has been carried out in respect to typology of buildings, structural systems, construction materials, mapping of structural and non-structural cracks, other observations. The identified buildings were marked for monitoring at different locations in Pur village.</li> <li>• During studies, the cracks and other distresses in buildings were properly marked. The plan drawi

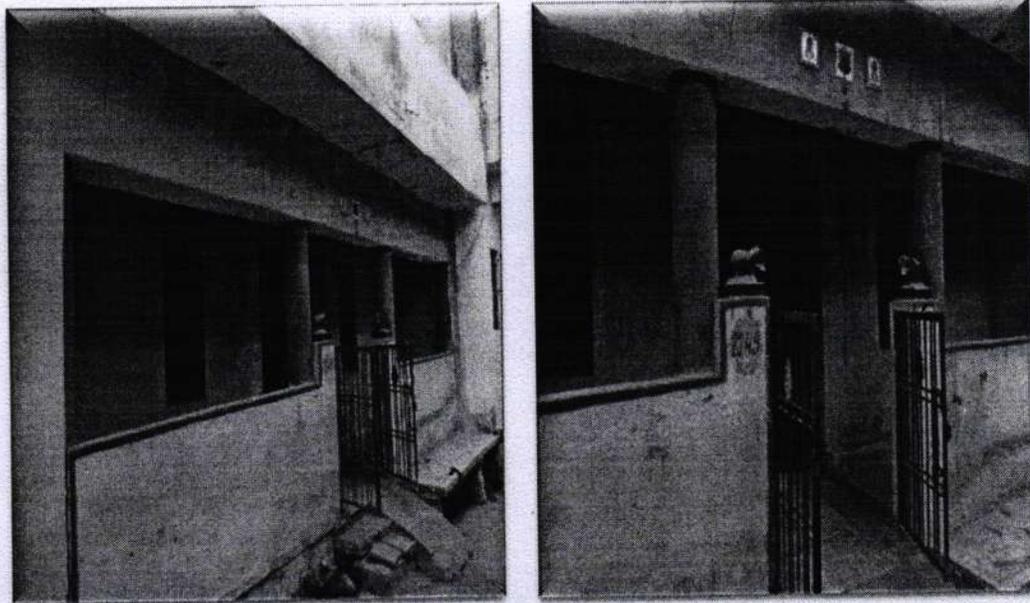
Fig 3. House no. 2249

- No. of Stories built : G+1
- Occupancy: Zero (Building is not in living condition)
- Ground floor of building was built in year 1990 and First floor was built in year 2015
- Major structural cracks observed in building occurring diagonally as shown in fig 5 and 6.
- Some cracks propagating from floor to walls.
- Joints of wall got opened as shown in fig 4
- First Floor ceiling got damaged (Stone chipping out from the first floor roof) as shown in fig 3
- Diagonal cracks observed on parapet as shown in fig 2
- Overhang of building also damaged as shown in fig 2

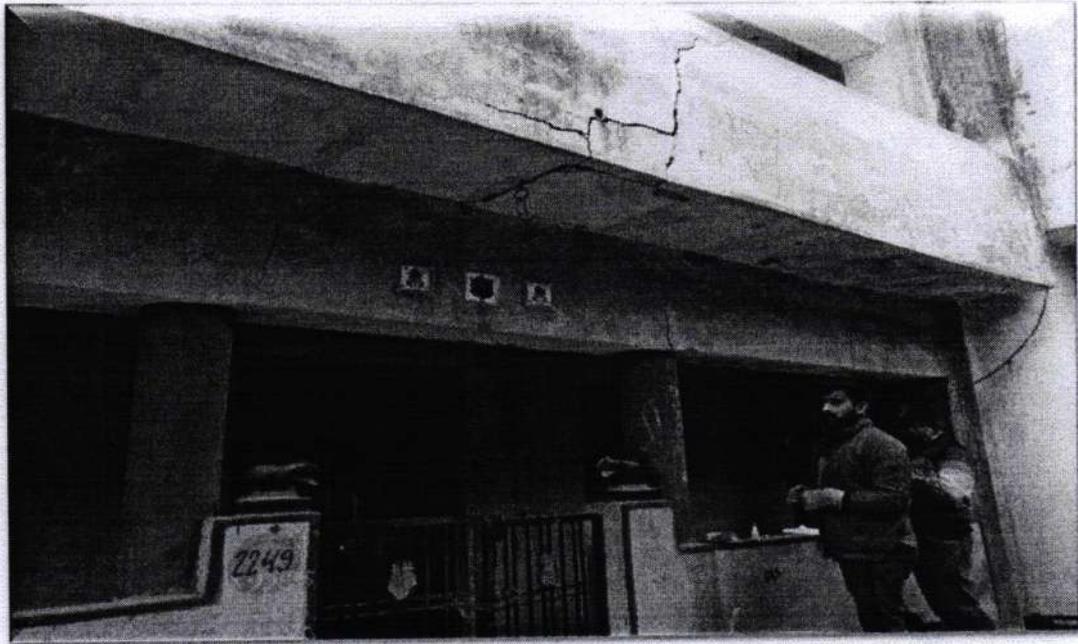
Fig 4. Damaged parapet and overhang

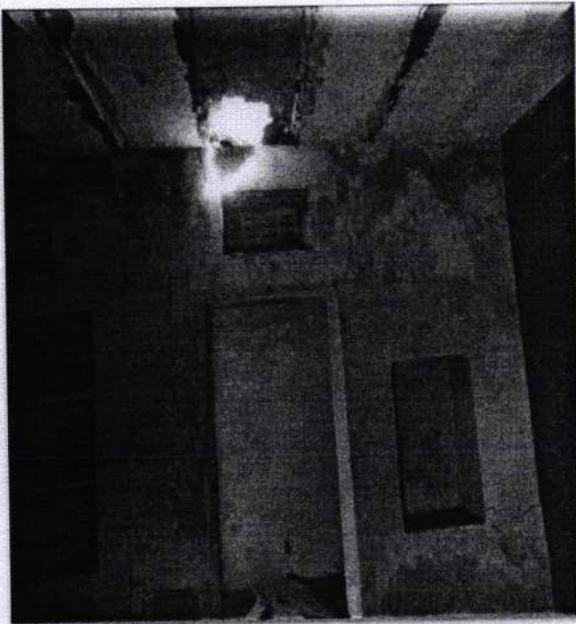
Fig 5. Damaged First floor ceiling

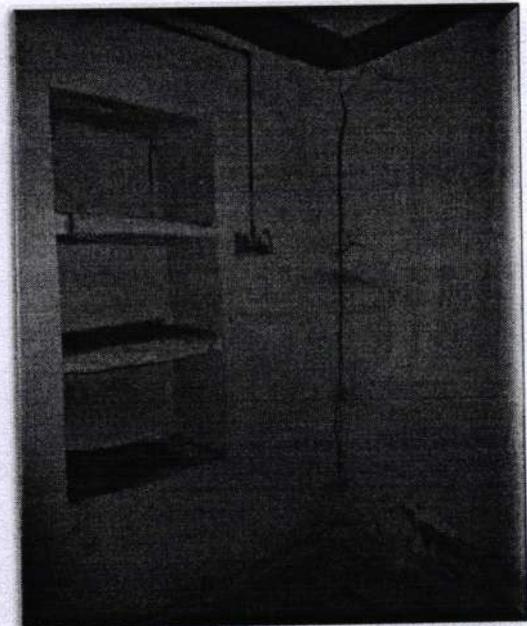
Fig 6. Opened wall joints

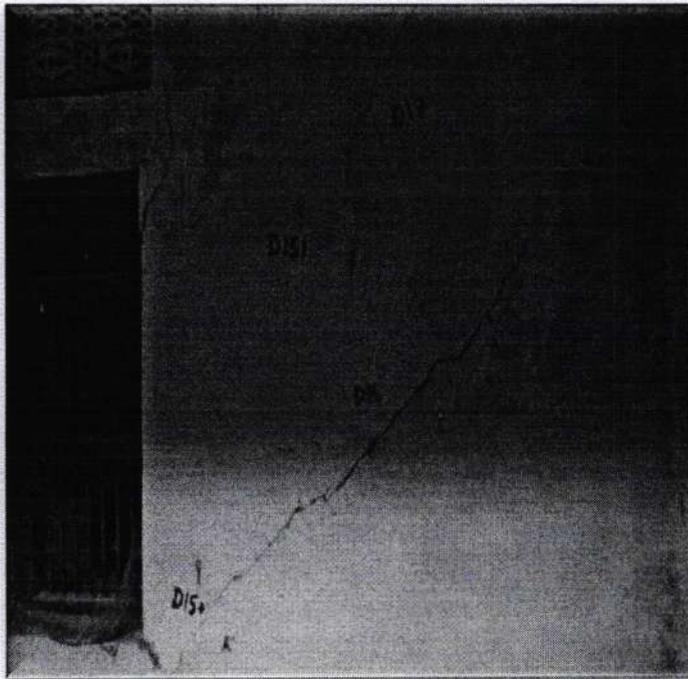
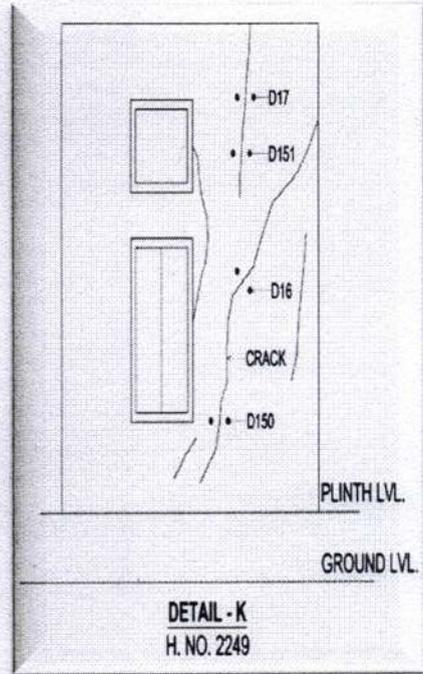
Fig 7. Diagonal cracks in walls with marking with installed studs (outside)

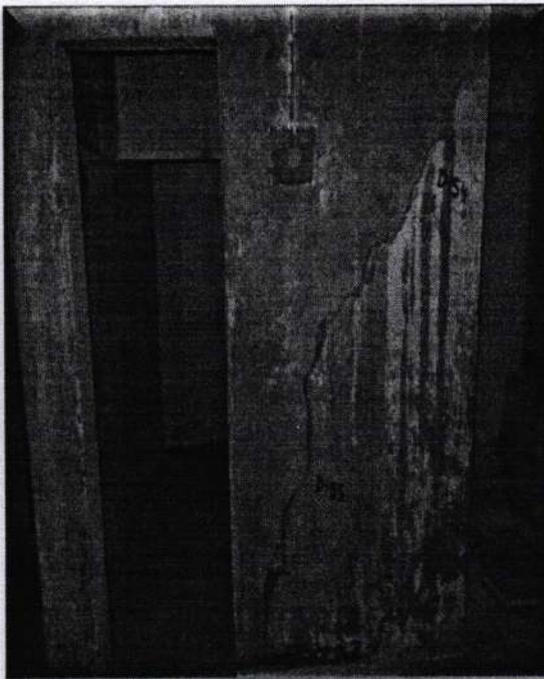
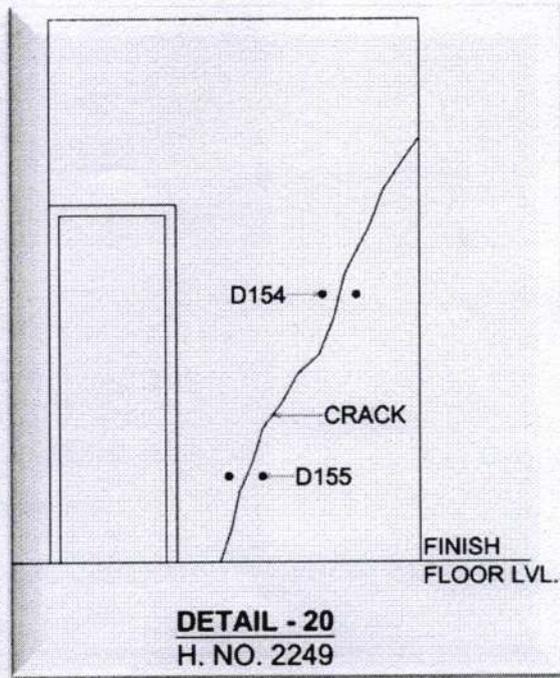
Fig 8. Diagonal cracks in walls with marking with installed studs (Inside)

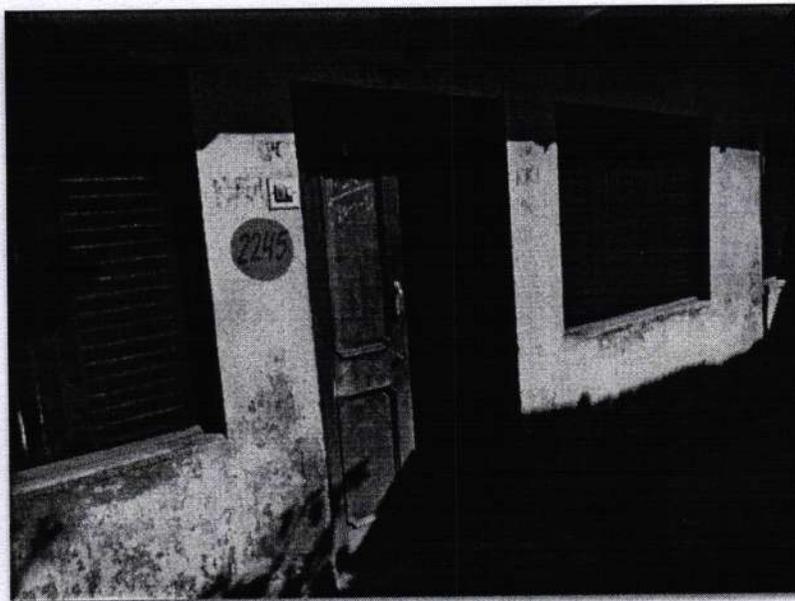
Fig 9. House no. 2245

- No. of Stories built : G+1
- Occupancy: 2
- Building constructed in 1980 and renovates in 2008
- Building is supported on temporary structure (Shoring) as shown in fig 8
- Diagonal cracks observed in walls of the building as shown in fig 11 and 12
- Horizontal cracks observed in ceiling
- Major cracks observed near the joints of walls
- Crack propagates from walls to roof as shown in fig 10
- Stones in slab slides and gap is clearly visible between stones
- Gap between wall and skirting is observed
- Walls joint got opened and separated from each other as shown in fig 9

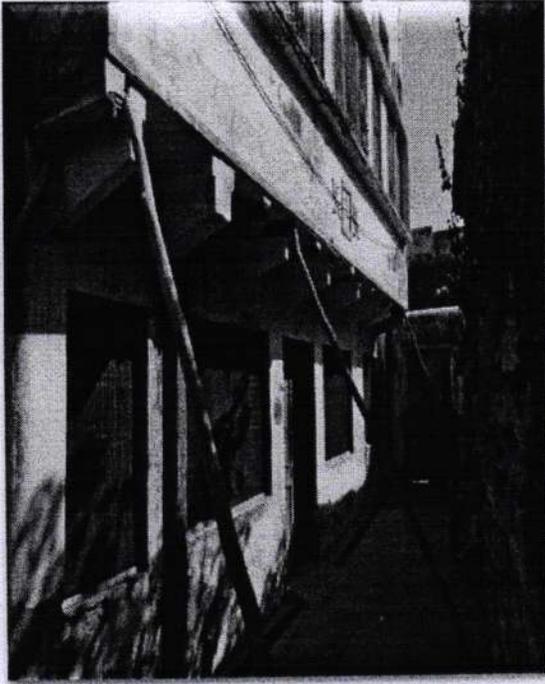
Fig 10. Temporary support (Shoring)

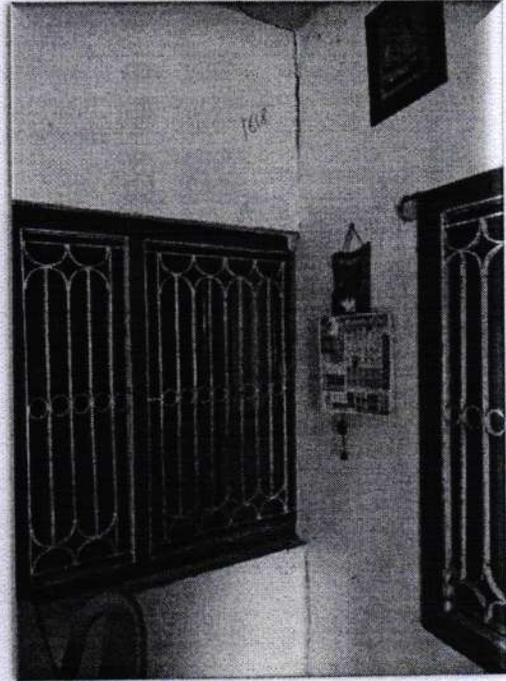
Fig 11. Opened Wall joints

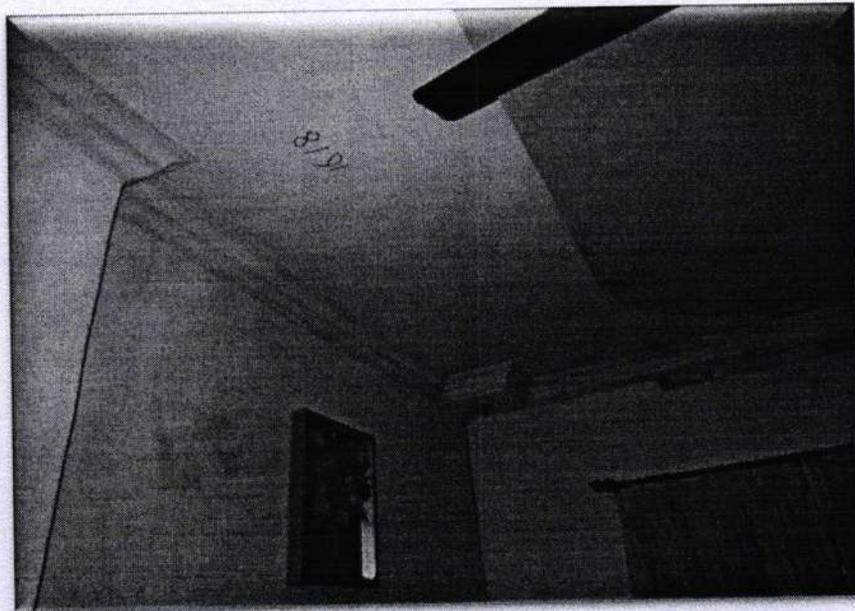
Fig 12. Horizontal cracks in ceiling

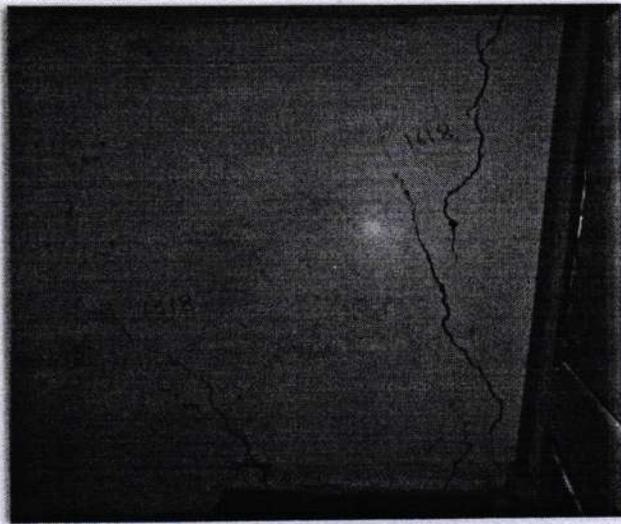
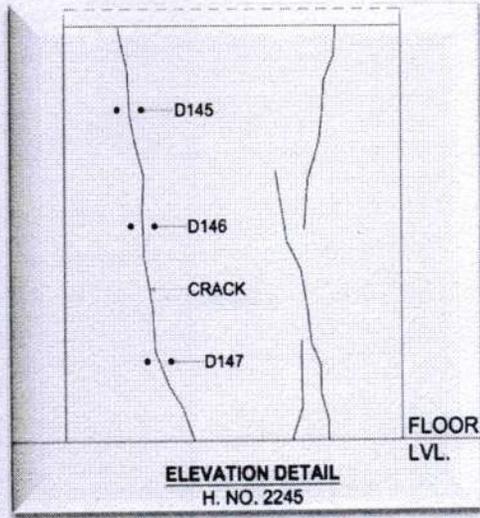
Fig 13. Diagonal cracks in wall with installed demic points

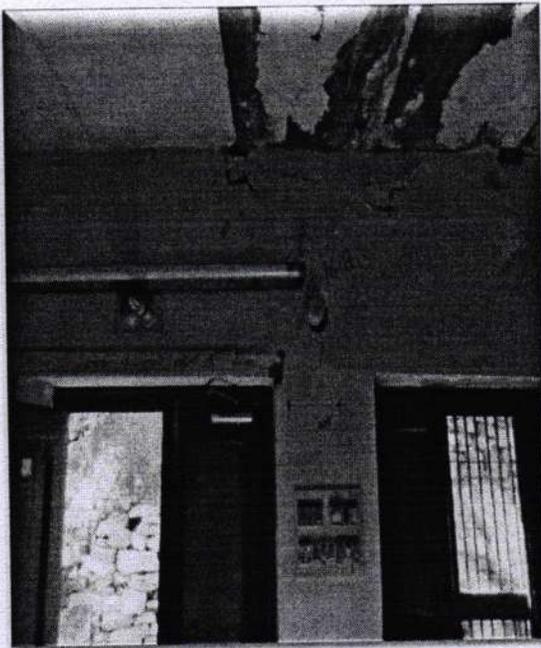
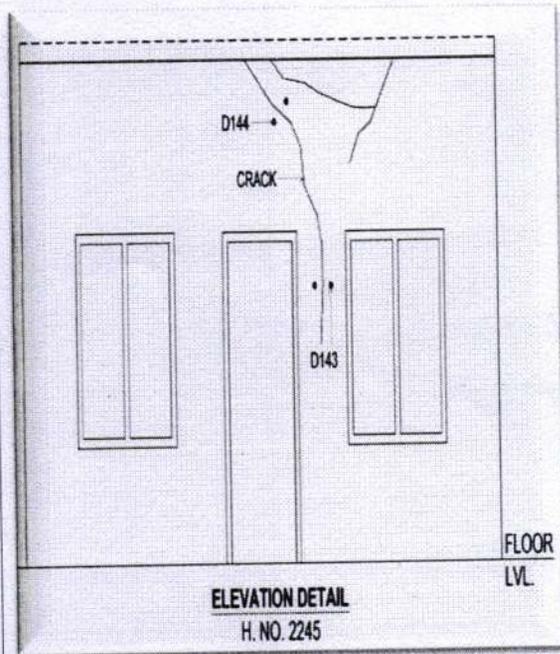
Fig 14. Diagonal cracks in wall with installed demic points

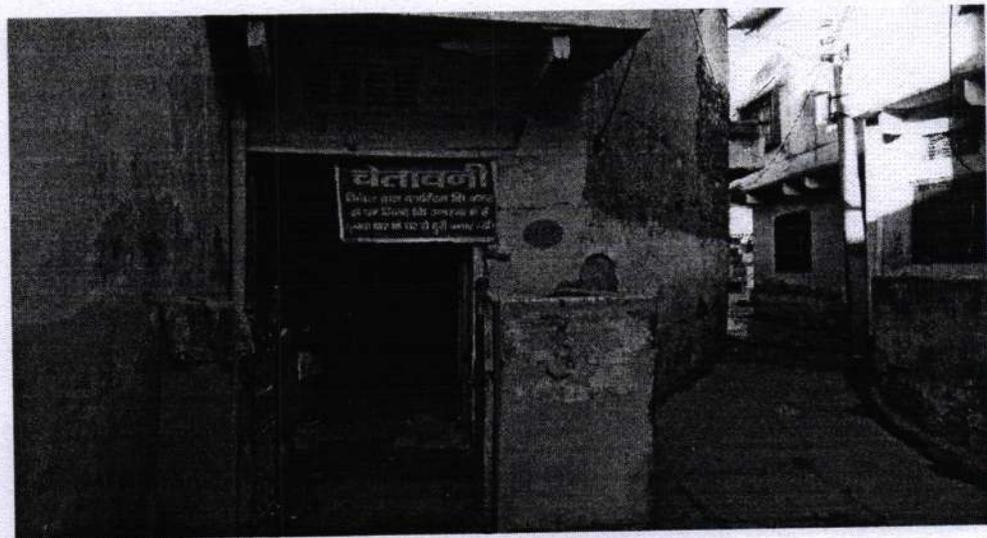
Fig 15. House no. 1353

- No. of stories built: G+1
- Occupancy: 3 people (Building is not living condition)
- Ground floor building was built in year 1990 (30 years old) and First floor was built in year 2010
- Major structural cracks ceiling to wall as shown in fig 15
- Diagonal & vertical cracks observed in wall of the building as shown in fig 15
- Horizontal cracks observed in Ceiling.
- Cracks in walls propagates into floor and ceiling as shown in fig 15
- Joints of walls got opened as shown in fig 14

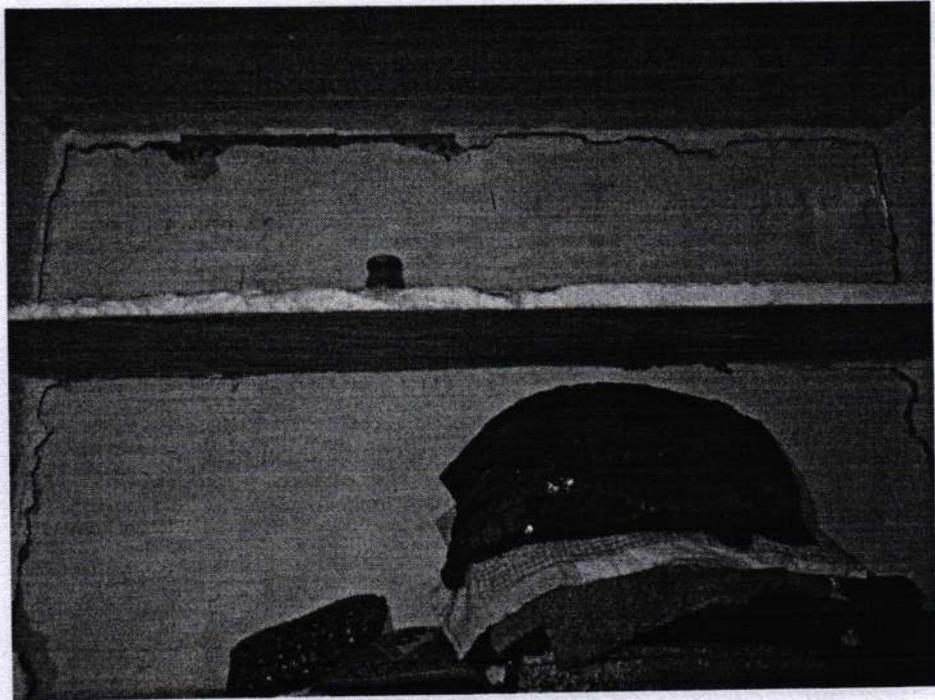
Fig 16. Opened joints of wall

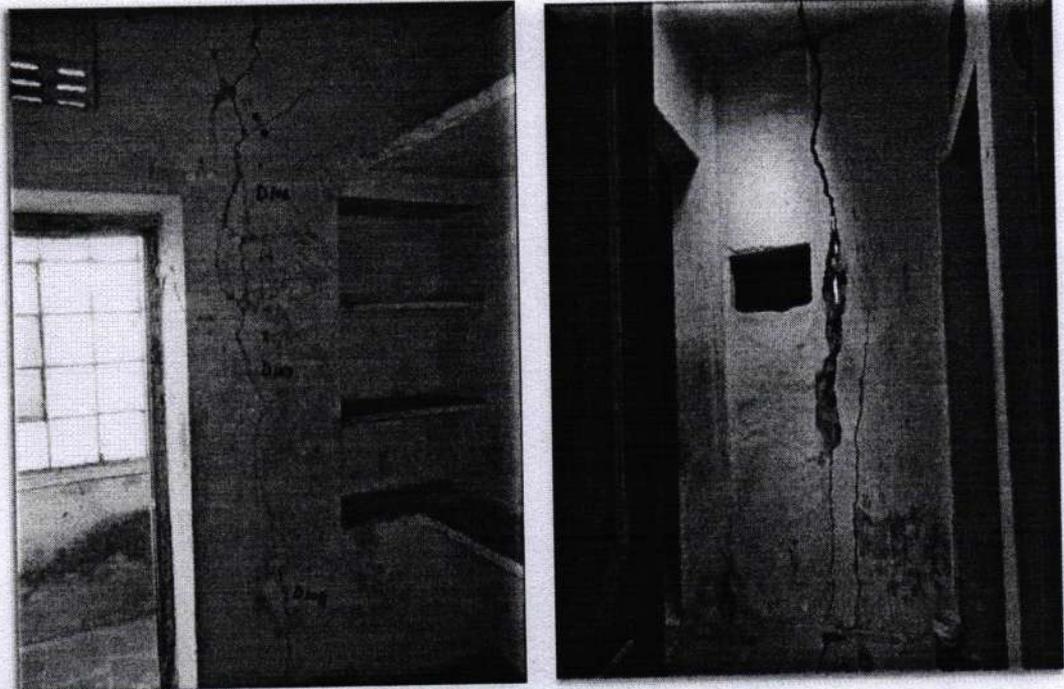
Fig 17. structural cracks on ceiling to wall

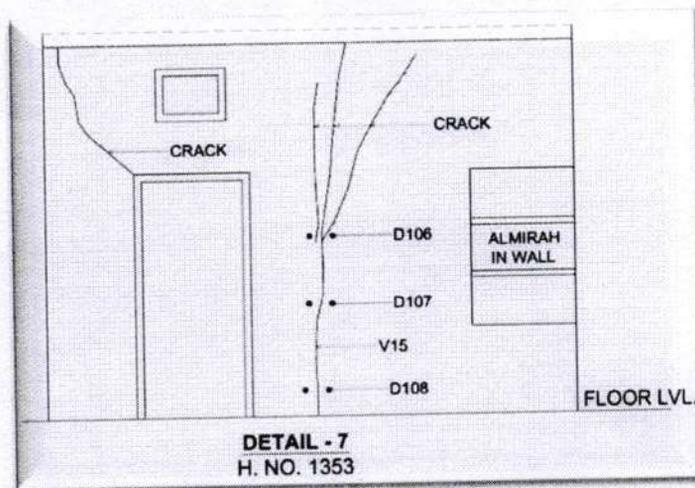
Fig 19. Detailing of Diagonal & vertical cracks observed in wall of the building.
