ORIGINAL APPLICATION NO 662 OF 2024

In re: In the matter of developing cracks in the houses, fertile land of poor villagers and drying up of drinking water sources due to land subsidence in some villages of District Bageshwar.

7	Annexure CCR-5 (COLLY) (A) copy of the still images of various mining sites where non-adherence to the norms is leading to slope failure.	
8	Annexure CCR-6 (COLLY) (A) copy of the still images of various mining sites with visual non-adherence to the norms relating to the dumps of burden.	
9	Annexure CCR-7 (COLLY) (A) copy of the still images of various mining sites with visual non-adherence to the norms relating to the preservation of topsoil.	
10	Annexure CCR-8 (COLLY) (A) copy of the still images and Google Earth Images of various mining sites with visual non-adherence to the norms relating to drainage and water management, forest land usage, cutting of trees for firewood, and damage to forest land.	
11	Annexure CCR-9 (COLLY) (A) copy of the still images of various mining sites using heavy earth moving equipment.	
12	Annexure CCR-10 (COLLY) (A) copy of photographs displaying the poor living conditions of Labour.

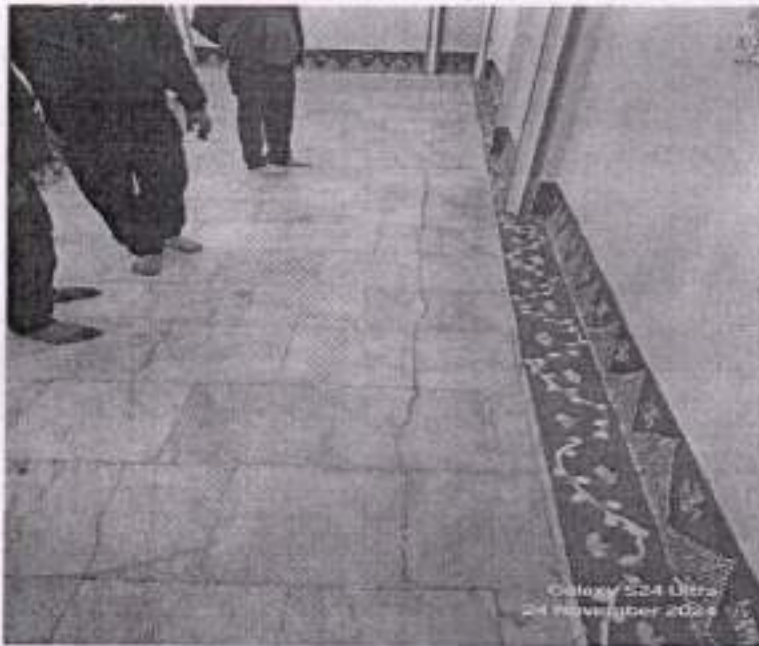
Photo 3- Cracks in flooring of Kalika Temple

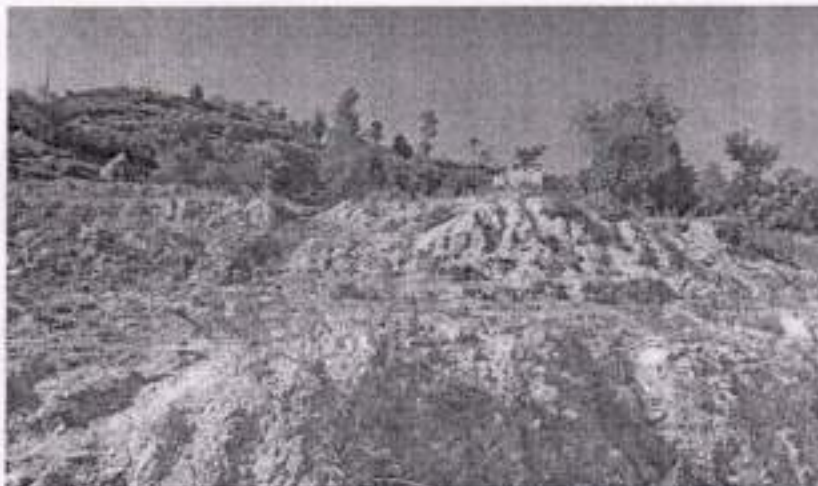
Photo 4: Abandoned Opencast Mine behind Kalika Temple

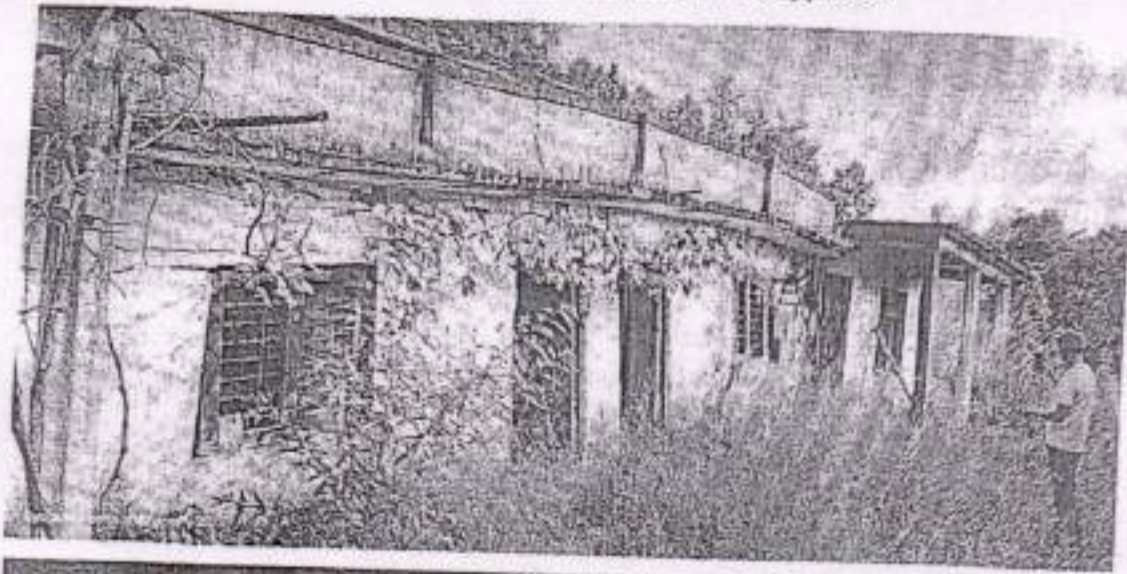
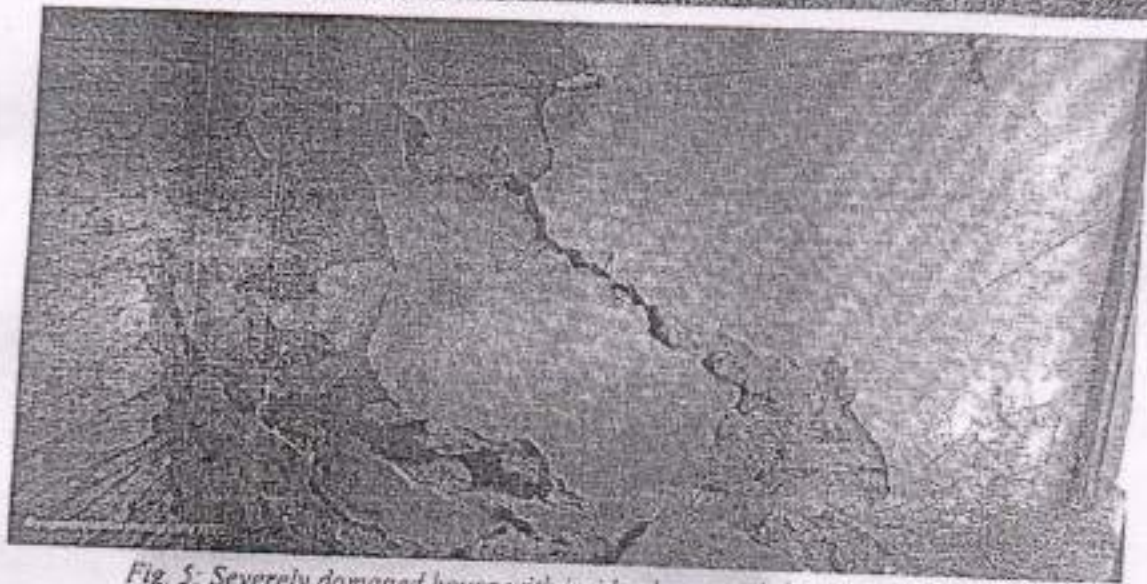
Fig. 5: Severely damaged house with inside photograph from Seri village.

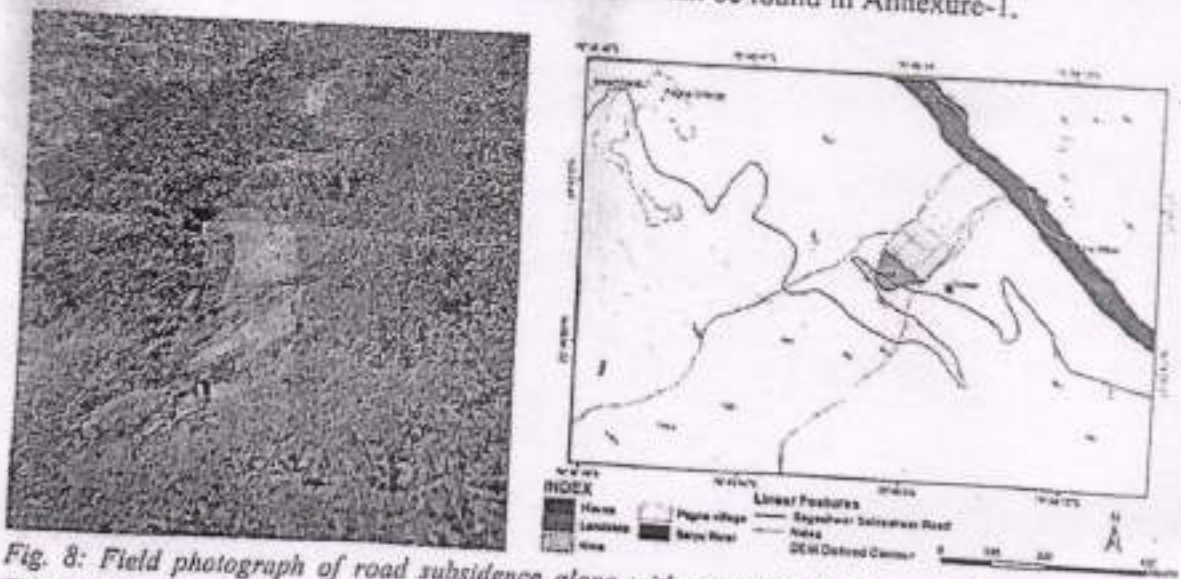
The road subsidence caused due to landslide measures approximately 90 meters in length. 60 meters in width, and 4 meters in depth, with a downslope movement of 1 to 2 meters. A soapstone mine is located just beneath the subsidence area (see Fig. 8). The landslide was triggered by the removal of toe support for soapstone extraction. The failed material consists mainly of weathered soapstone-bearing rock and overburden, categorizing it as a shallow translational failure. The landslide may continue to retrogress until it reaches the overlying competent bedrock, which is dolomitic limestone. A 42-geoparametric data sheet can be found in Annexure-1.

Fig. 8: Field photograph of road subsidence along with map showing ground features of Pagna-Sakteshwar road subsidence location.

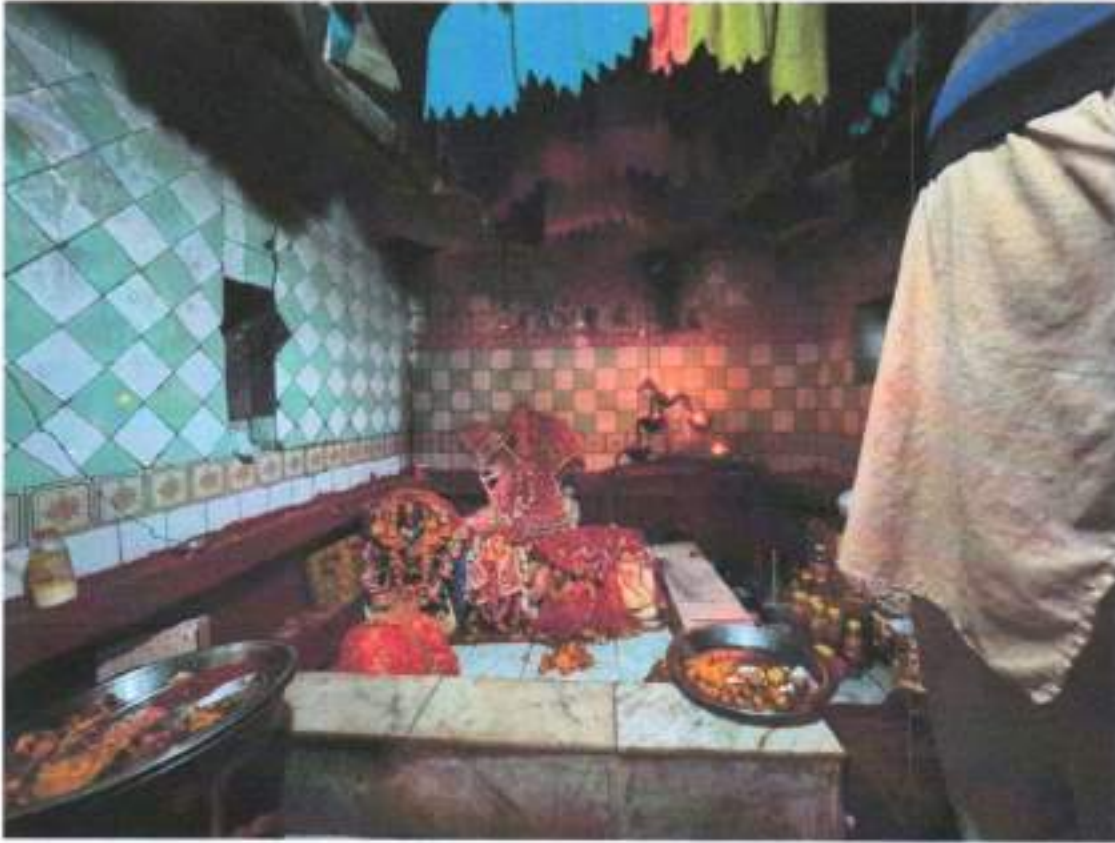
Sanctum of the temple is tilting towards left (UP)
Lateral Cracks on the Floor around Temple (DOWN)

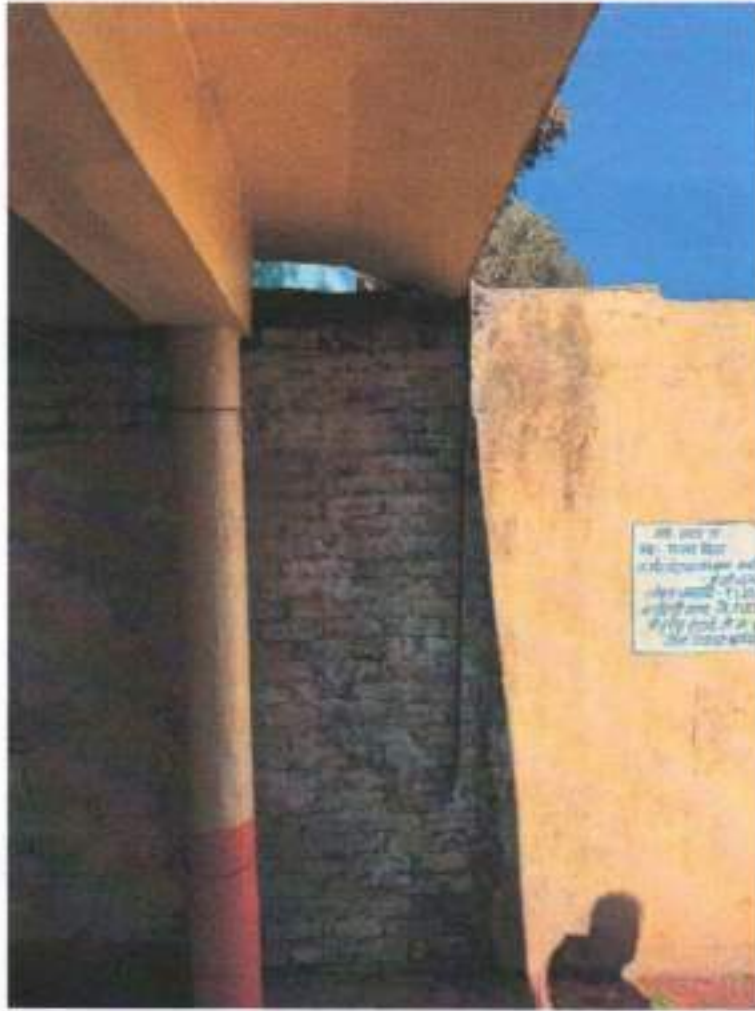
Land subsidence has led to the sinking of roof which is now resting on the wall. (UP)
Cracks on the Floor (DOWN)

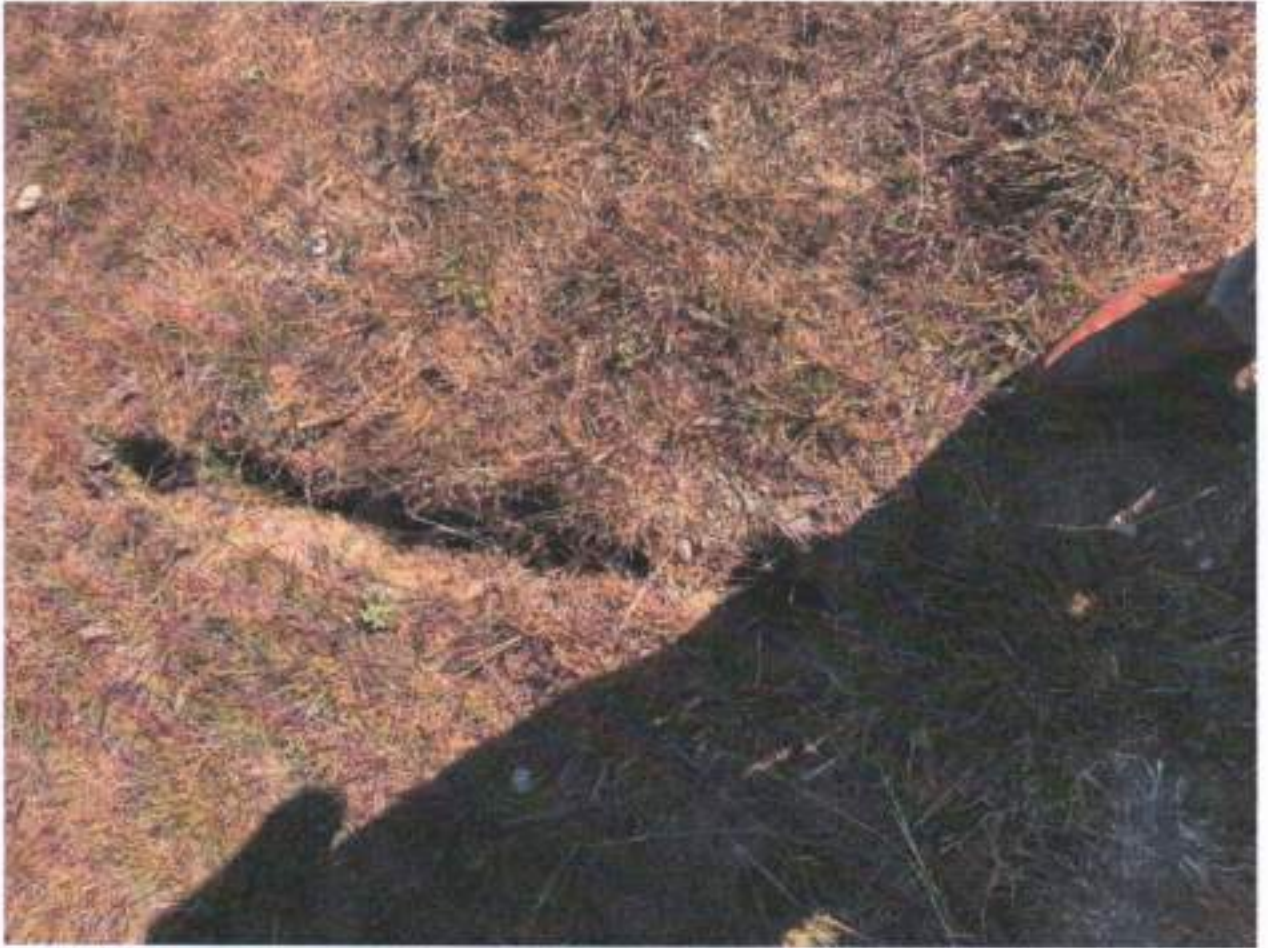
Cracks in Agricultural Fields

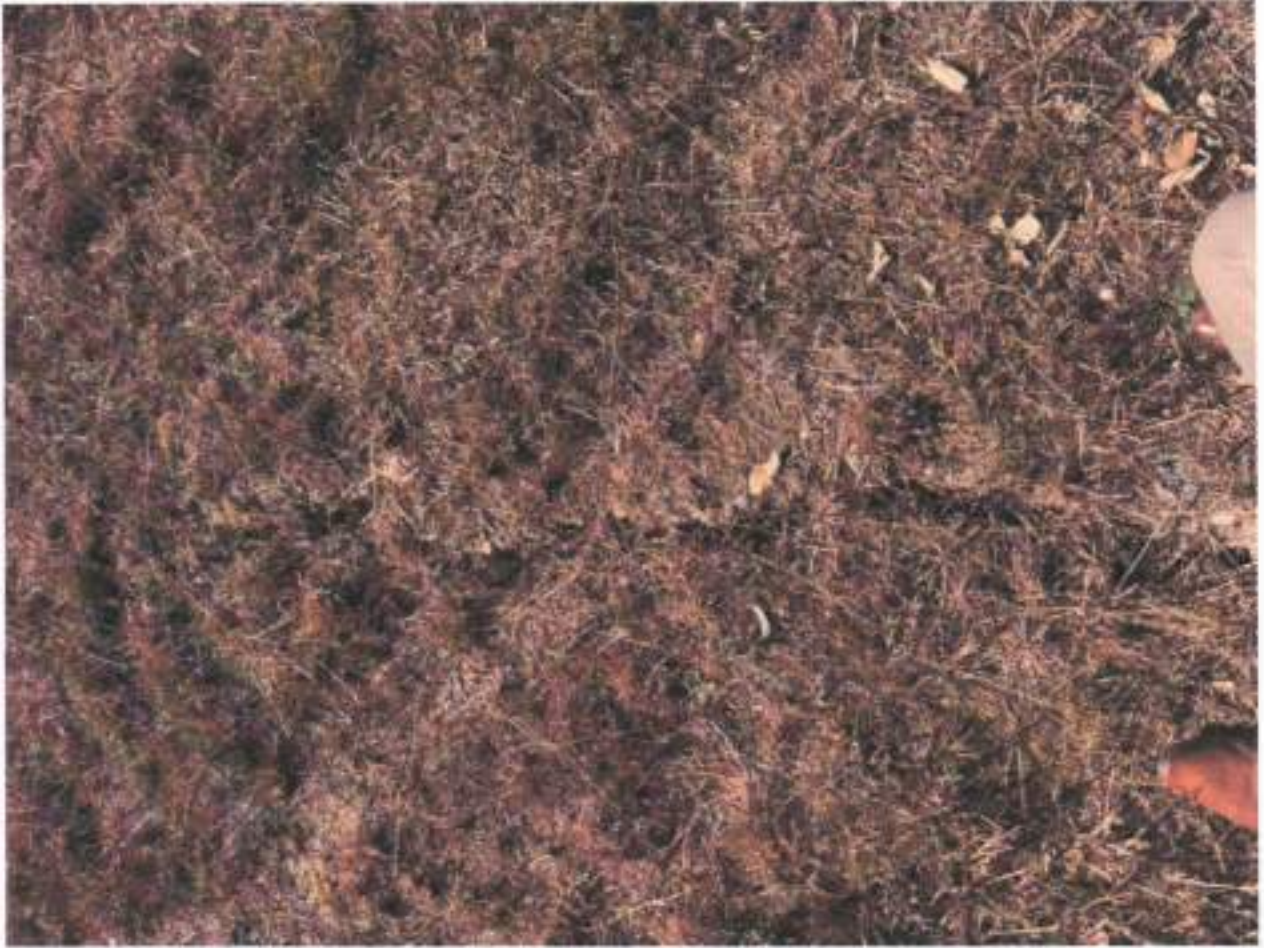
Cracks in Agricultural Fields

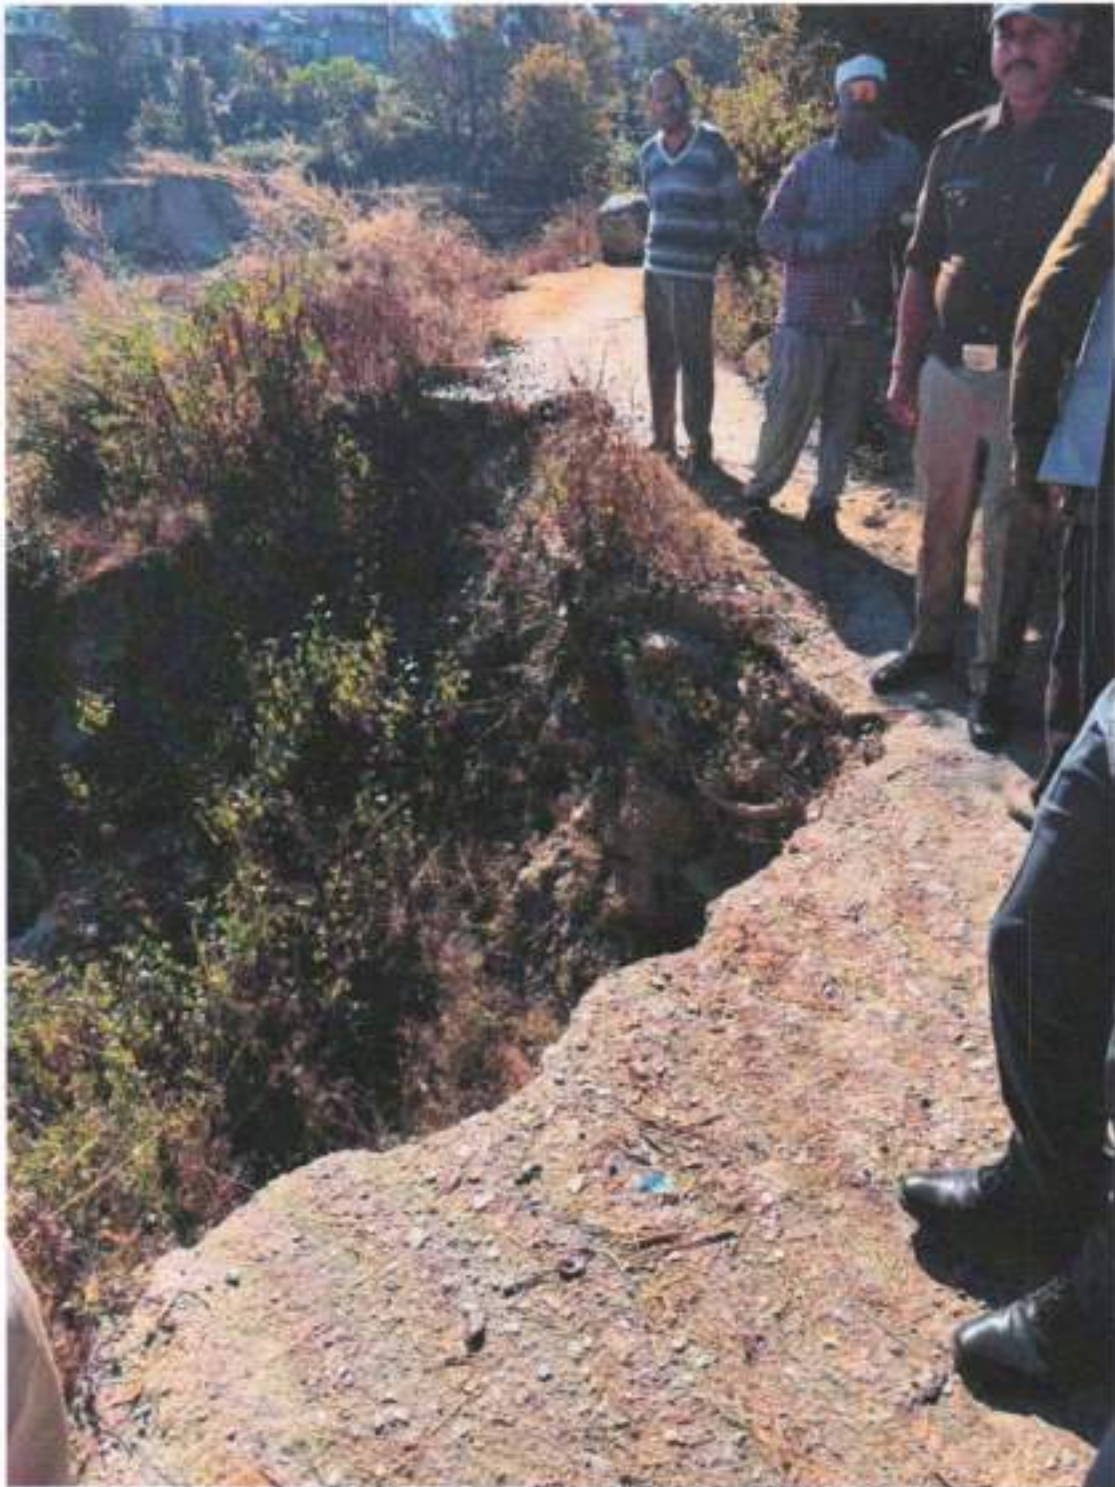
Collapsed footpath in Village Kande Kanyal

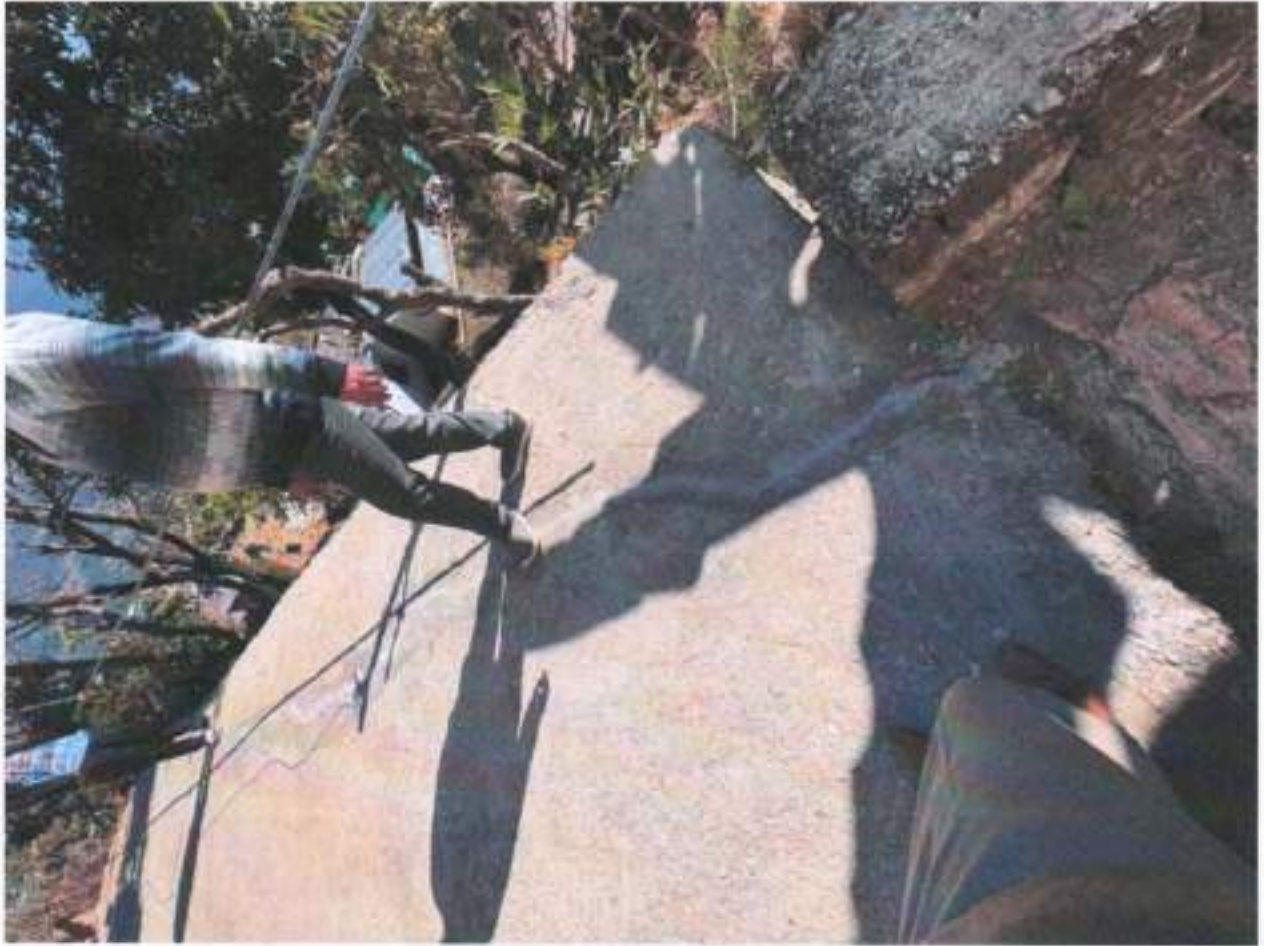
Cracked Floor in front of House in Village Kande Kanyal (UP)
Cracked Staircase from Lintel Slab of House in Village Kande Kanyal (DOWN)

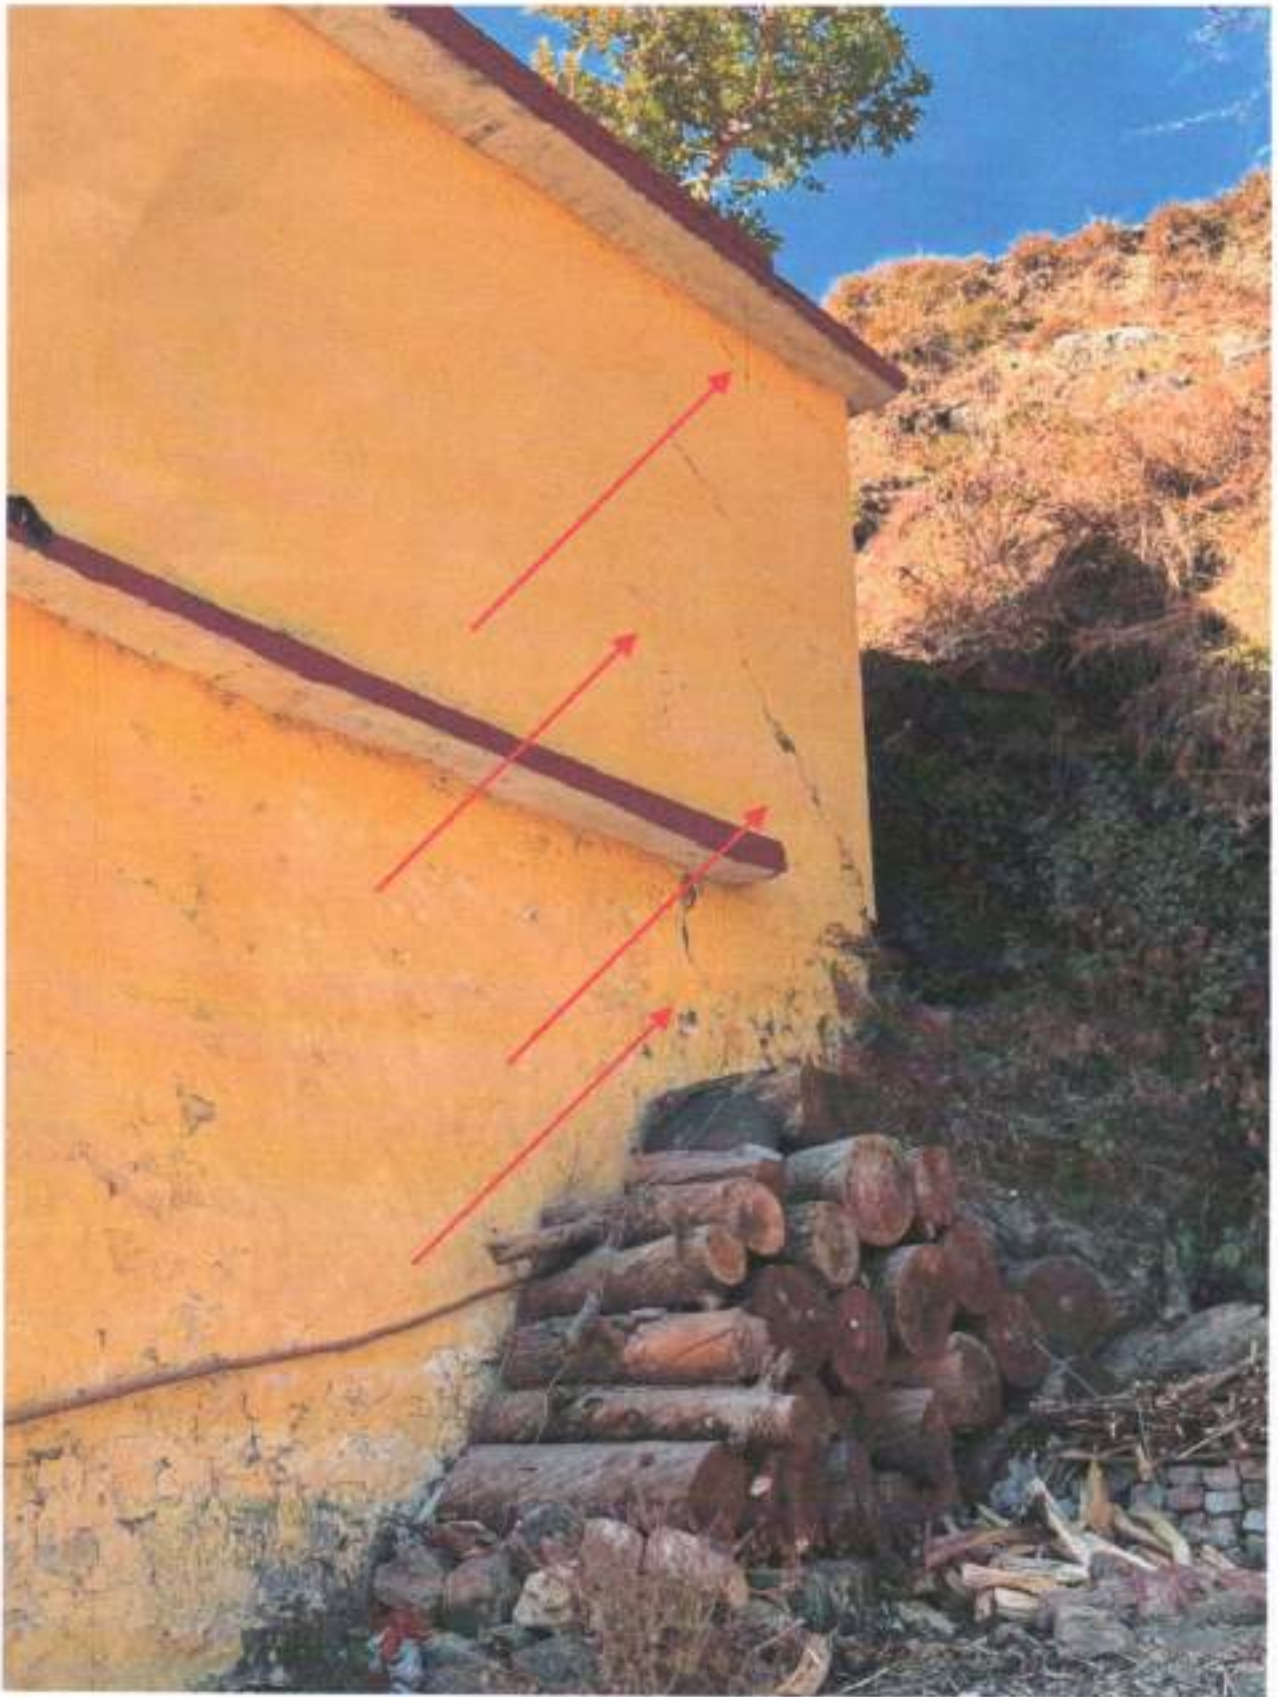
Lateral Cracks appearing in a House in Village Kande Kanyal
These Houses are tilting towards front due to land subsidence due to the mining activities carried out on the downward slope of the hill.

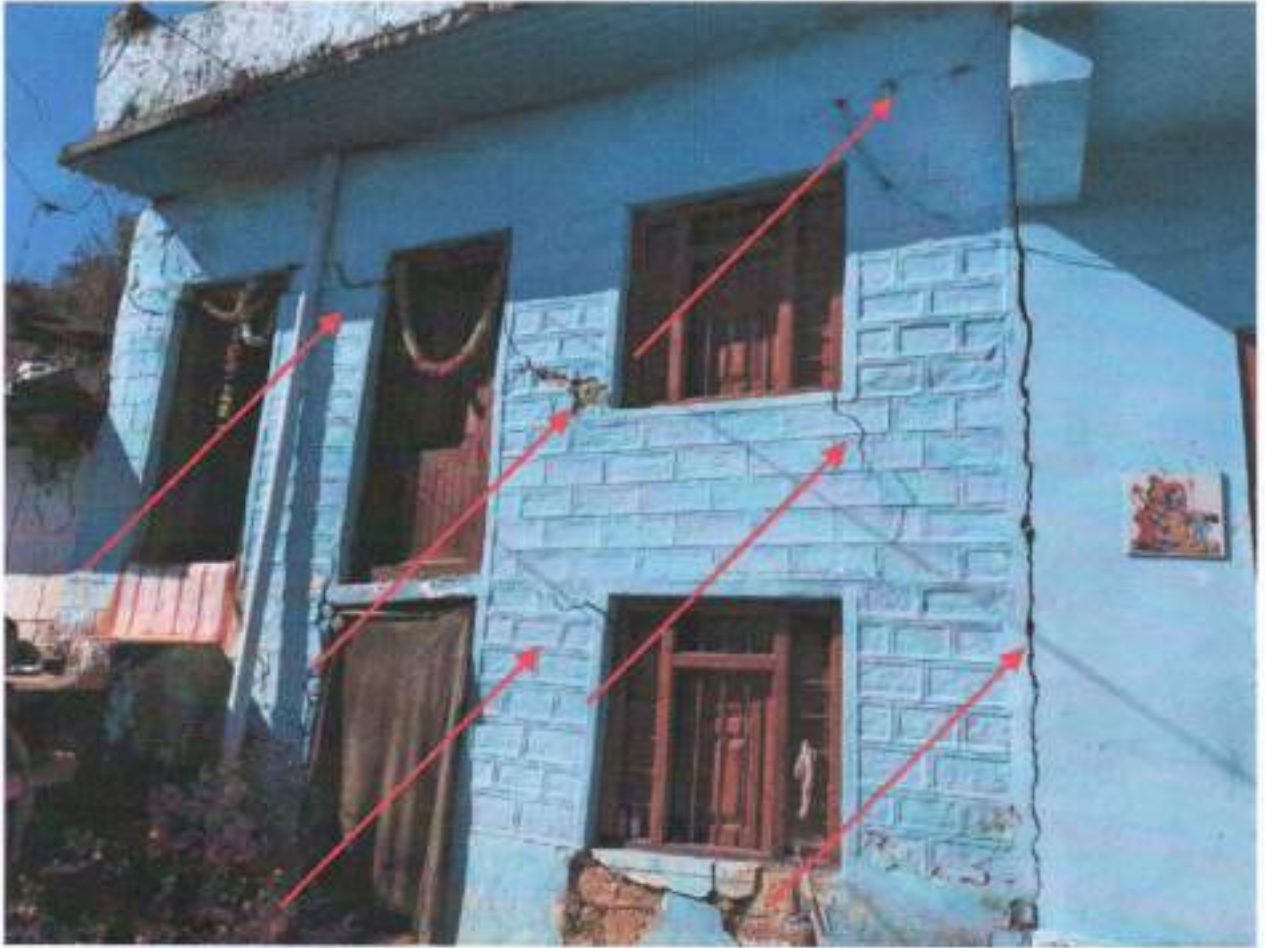
Lateral Cracks appearing in a House in Village Kande Kanyal
 These Houses are tilting towards front due to land subsidence due to the
 mining activities carried out on the downward slope of the hill.

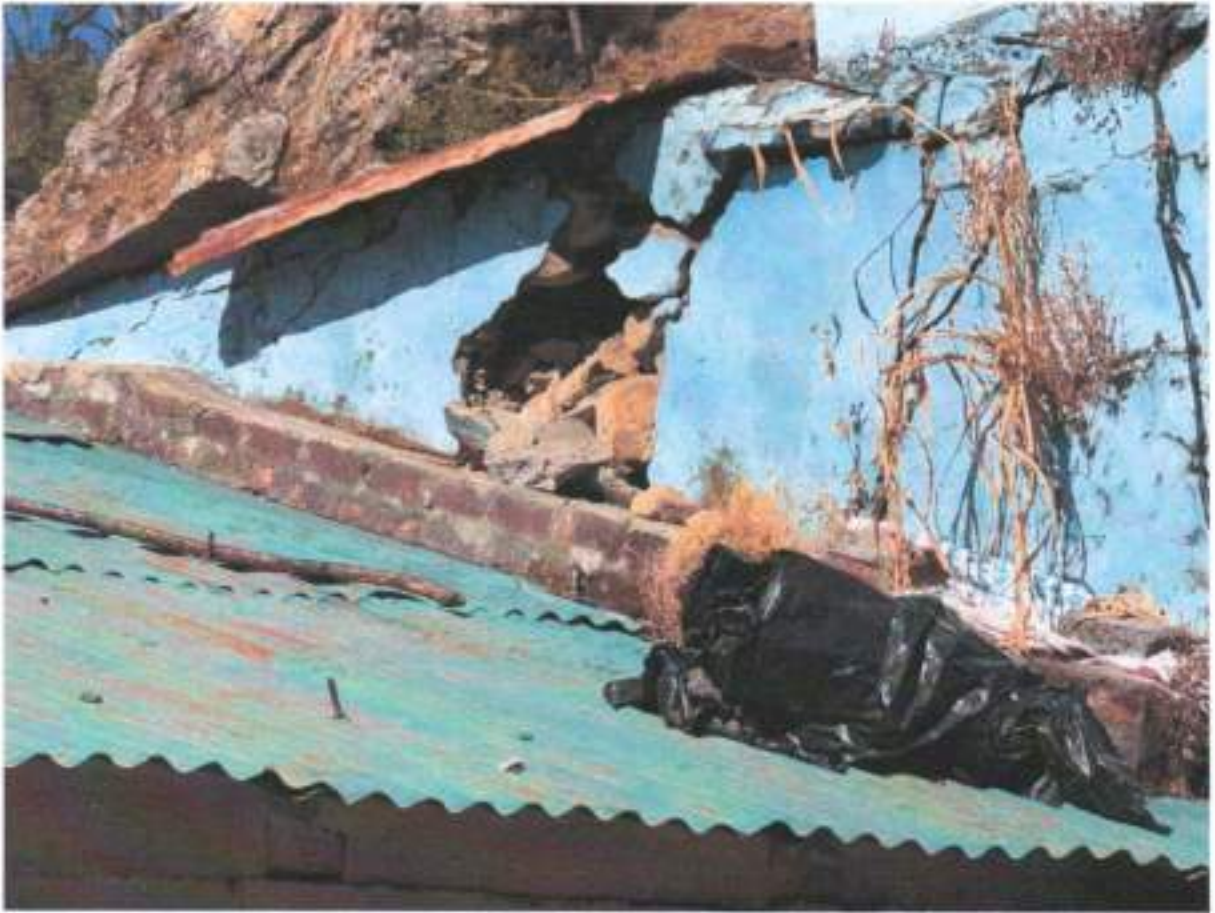
**Cracked and Exposed roof of Bakhli
Cracked Walled and Floor of the Bakhli**

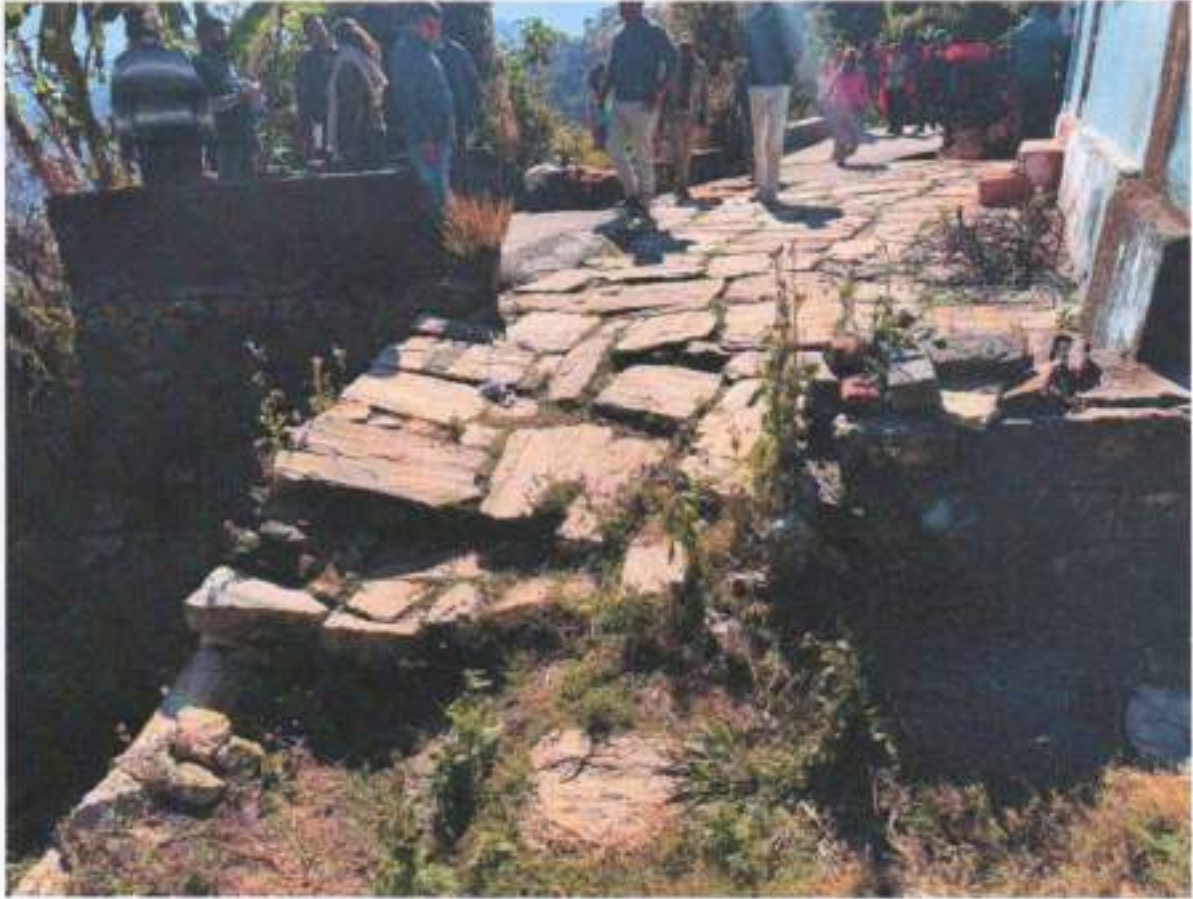
**Settling of Front Porch of the Bakhli of Sri. Kandpal
Failure of Beam/Lintel**

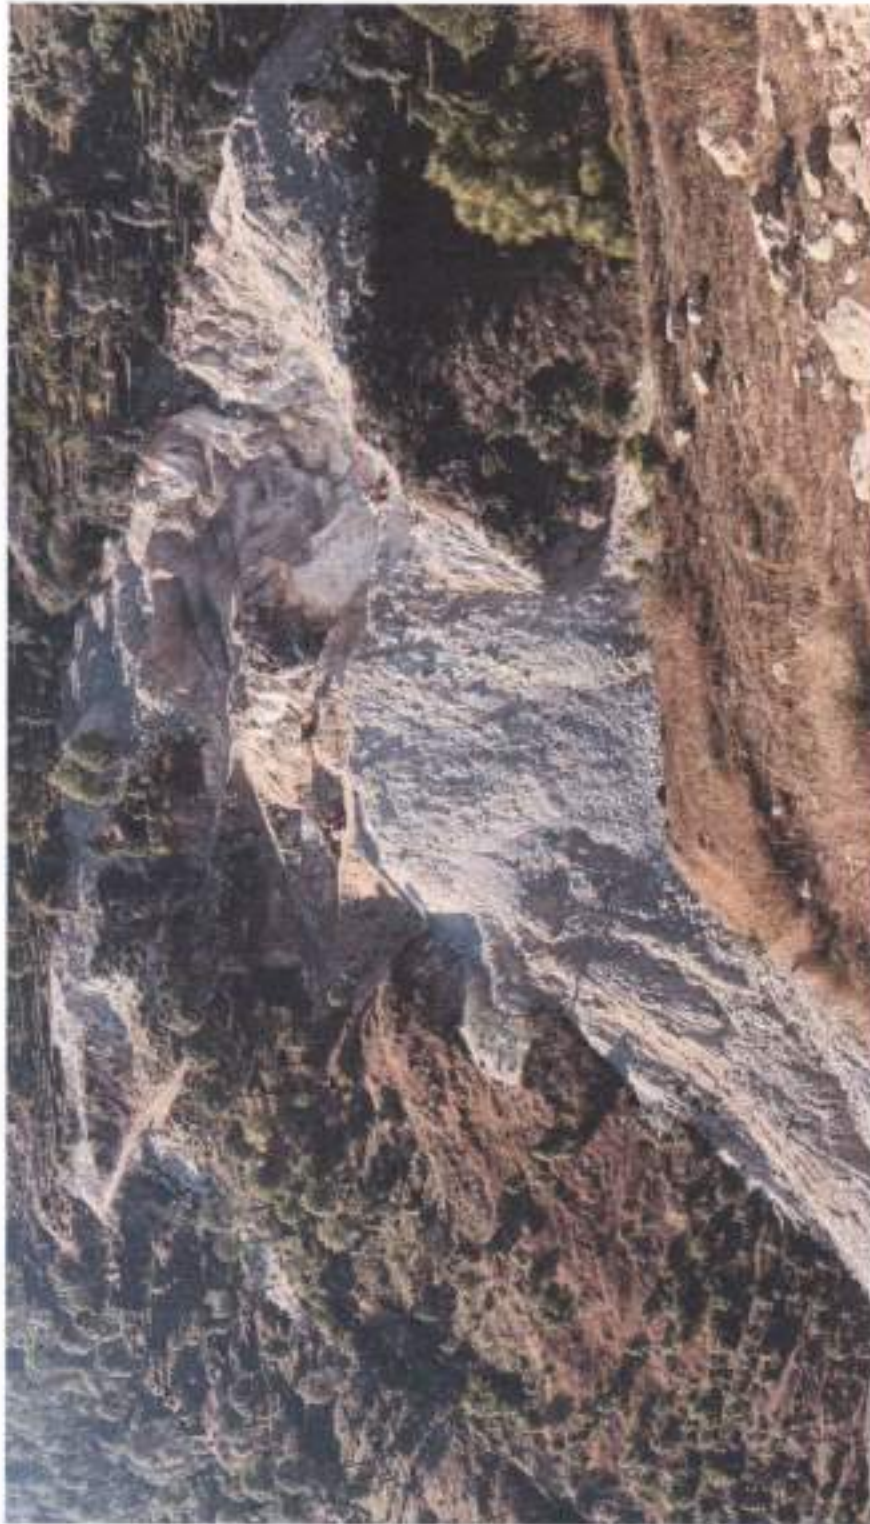
Mine in front of Nandita Tiwari's Mine

- III. The pit slope at the dipmost point exceeds 45° to 55°, contrary to the specified limit, posing a risk to slope stability leading to slope failure.

still images of various mining sites where non-adherence to the norms is leading to slope failure.

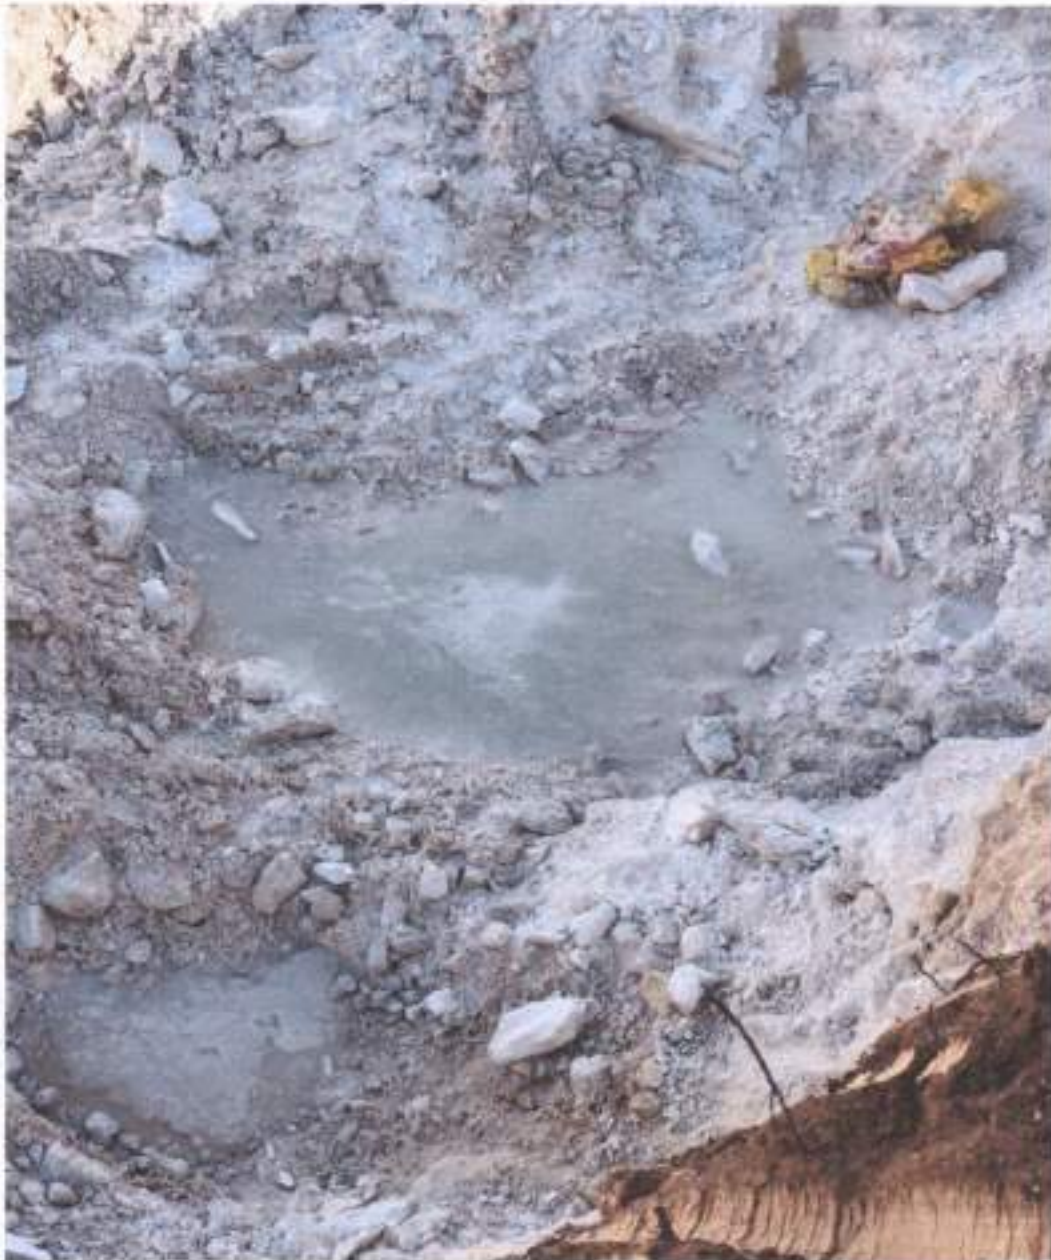
VI. Insufficient attention to drainage and water management, especially during the monsoon season, has resulted in increased rainfall infiltration into exposed slopes, accelerating erosion and subsidence. Garland drains have not been constructed around the periphery of the quarry, undermining stormwater drainage and contributing to water accumulation issues.

Large Water Holes with no drainage
In the Mine at Village Surkali Owned by Thakur Singh Gariya
Clicked from
29° 54' 45.672" N 79° 57' 14.898" E

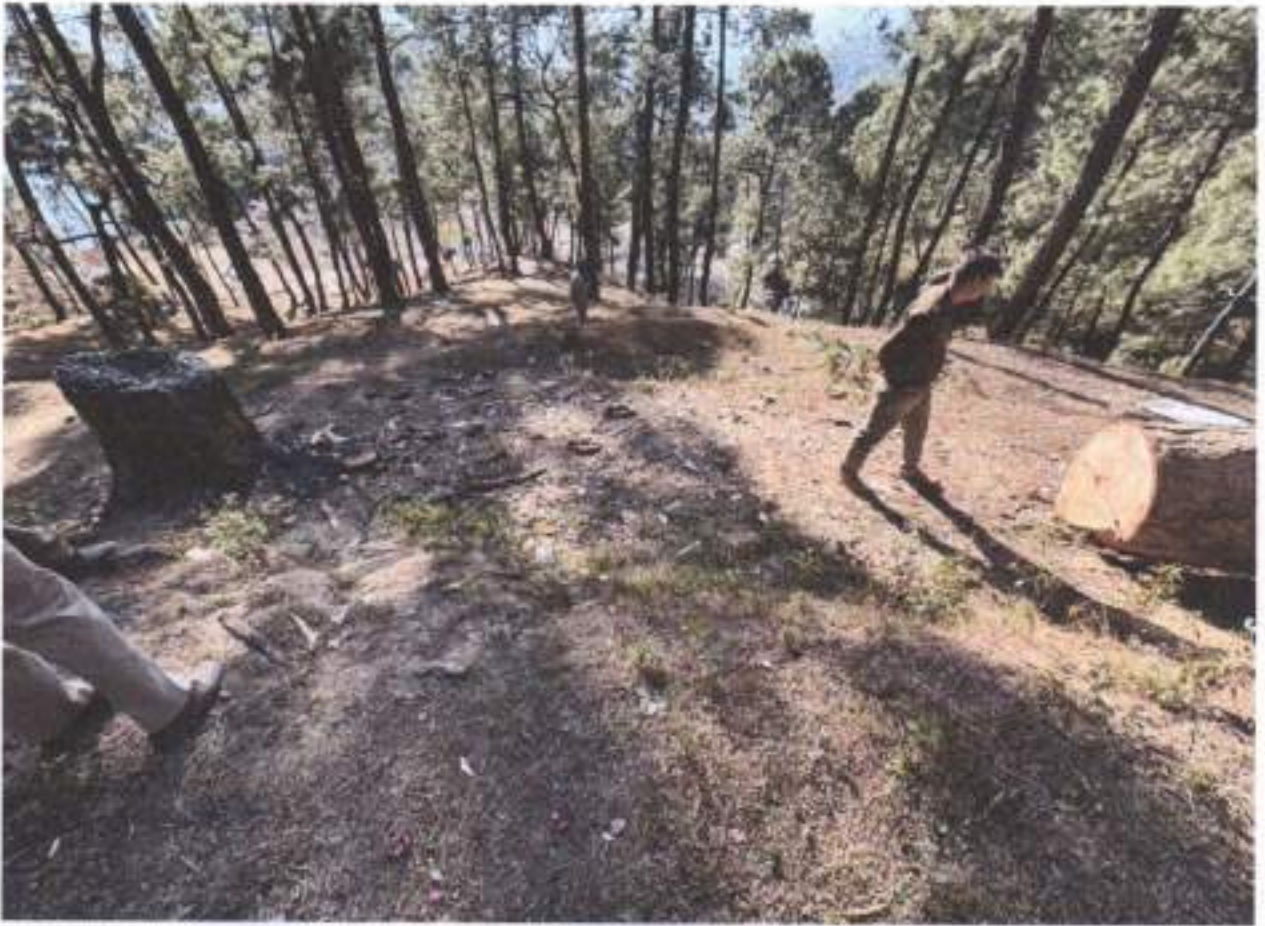
A large pine tree was found in the
Mine at Village Maholi Owned by Surendra Singh Bhauriyal
Clicked from
29° 53' 47.172" N 79° 58' 28.59" E

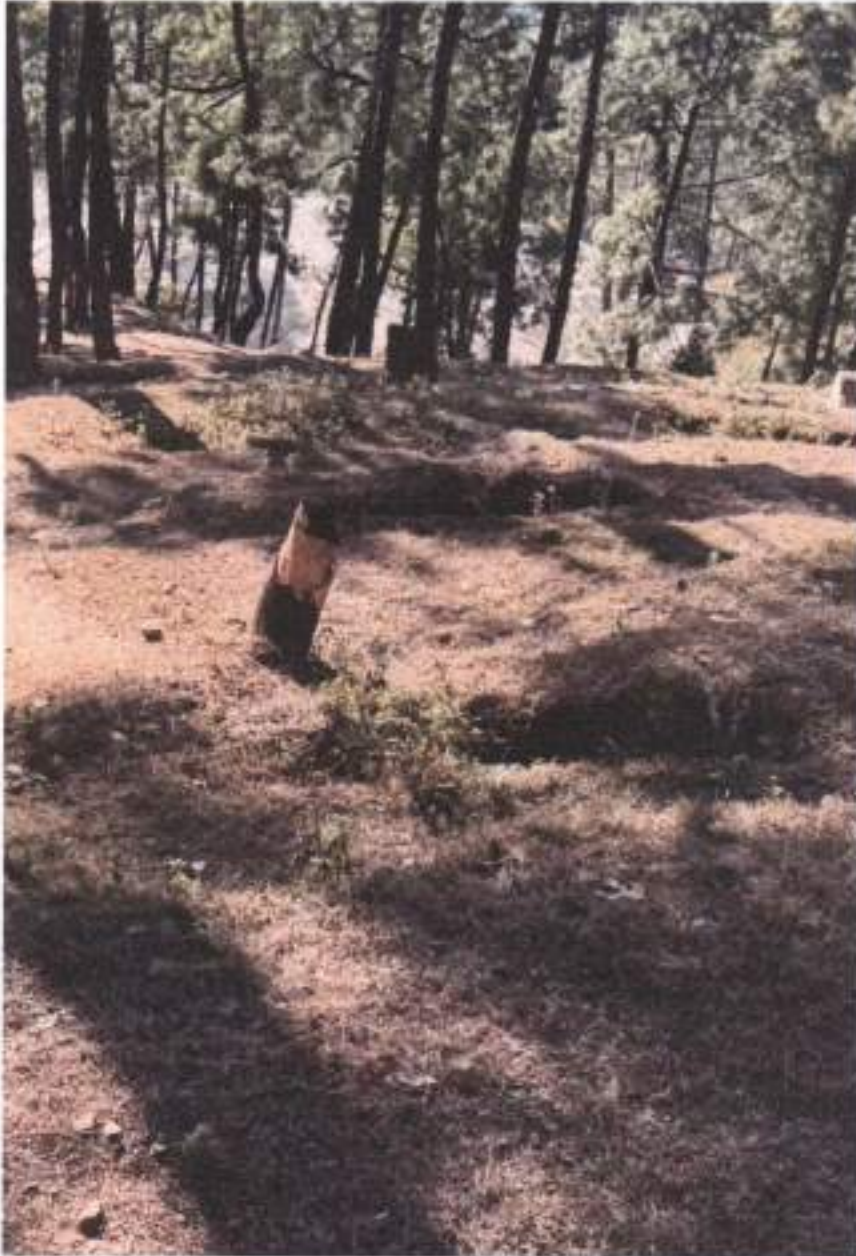
Stump of another pine tree was found in the
Mine at Village Maholi Owned by Surendra Singh Bhauriyal
Clicked from
29° 53' 47.172" N 79° 58' 28.61" E

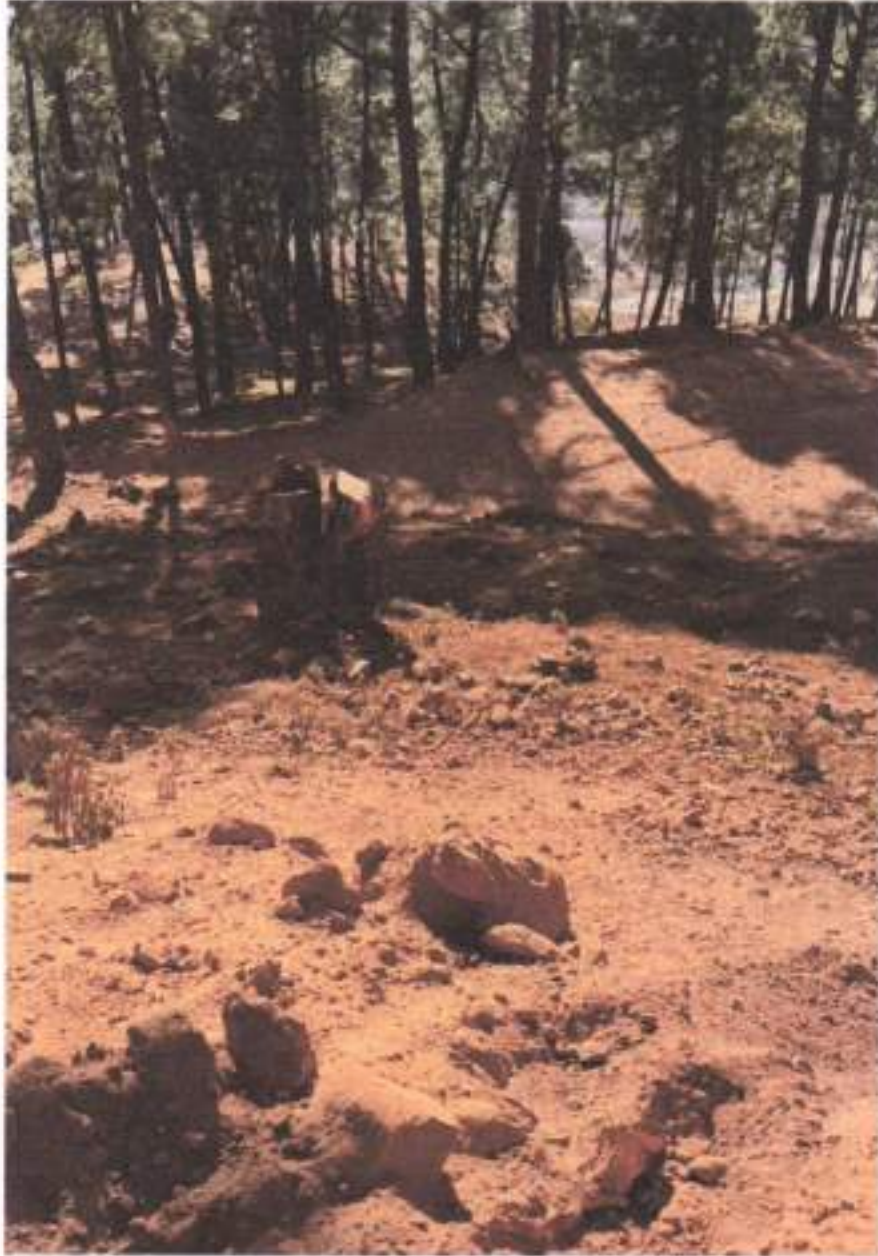
Stump of another pine tree was found in the
Mine at Village Maholi Owned by Surendra Singh Bhauriyal
Clicked from
29° 53' 46.89" N 79° 58' 32.19" E
