ORIGINAL APPLICATION NO 662 OF 2024

In re: In the matter of developing cracks in the houses, fertile land of poor villagers and drying up of drinking water sources due to land subsidence in some villages of District Bageshwar.

7	Annexure CCR-5 (COLLY) (A) copy of the still images of various mining sites where non-adherence to the norms is leading to slope failure.	
8	Annexure CCR-6 (COLLY) (A) copy of the still images of various mining sites with visual non-adherence to the norms relating to the dumps of burden.	
9	Annexure CCR-7 (COLLY) (A) copy of the still images of various mining sites with visual non-adherence to the norms relating to the preservation of topsoil.	
10	Annexure CCR-8 (COLLY) (A) copy of the still images and Google Earth Images of various mining sites with visual non-adherence to the norms relating to drainage and water management, forest land usage, cutting of trees for firewood, and damage to forest land.	
11	Annexure CCR-9 (COLLY) (A) copy of the still images of various mining sites using heavy earth moving equipment.	
12	Annexure CCR-10 (COLLY) (A) copy of photographs displaying the poor living conditions of Labour.

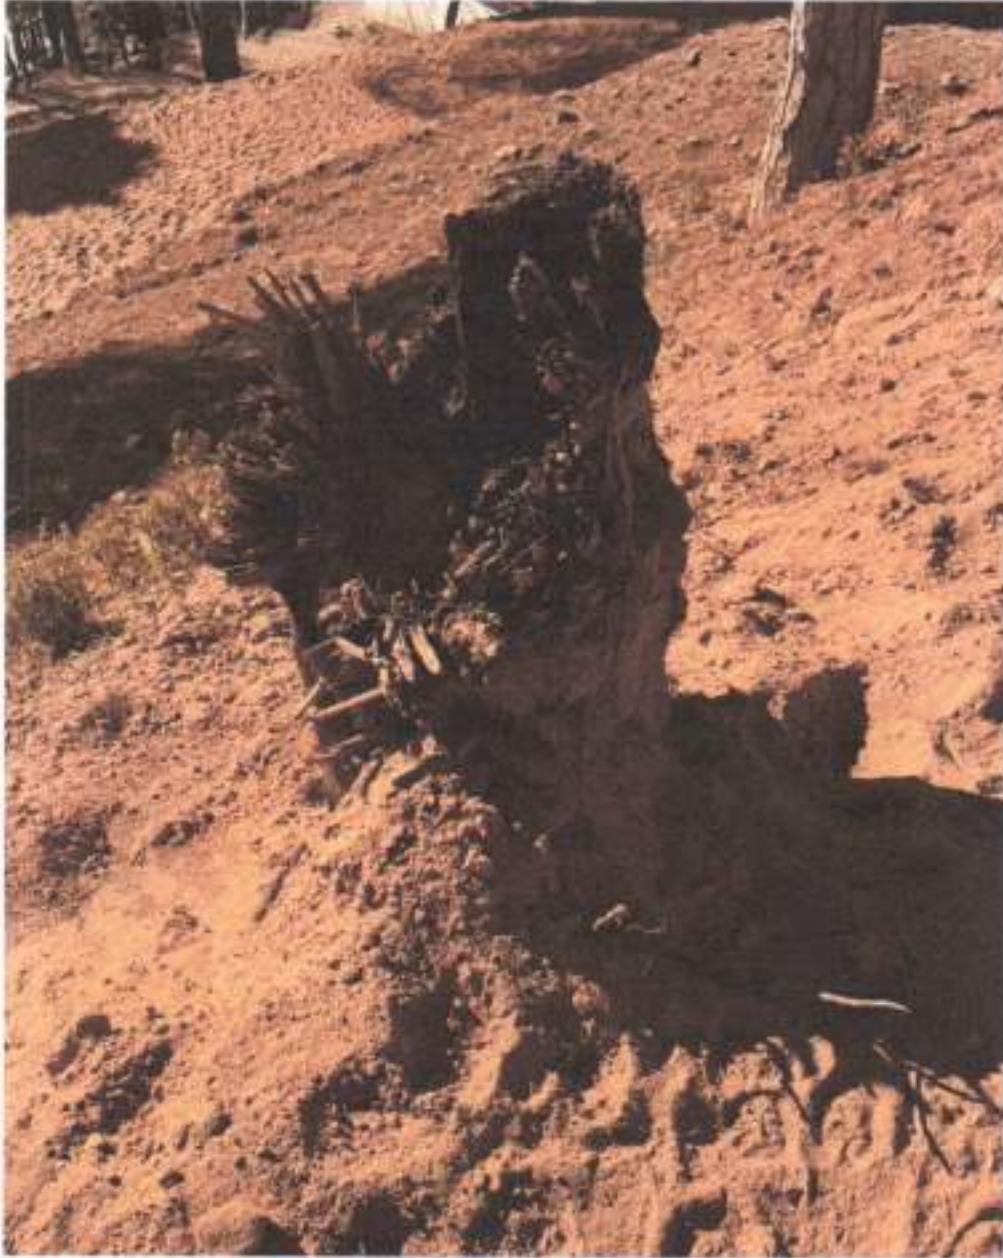
Stump of another pine tree was found in the
Mine at Village Maholi Owned by Surendra Singh Bhauriyal
Clicked from
29° 53' 46.89" N 79° 58' 32.19" E

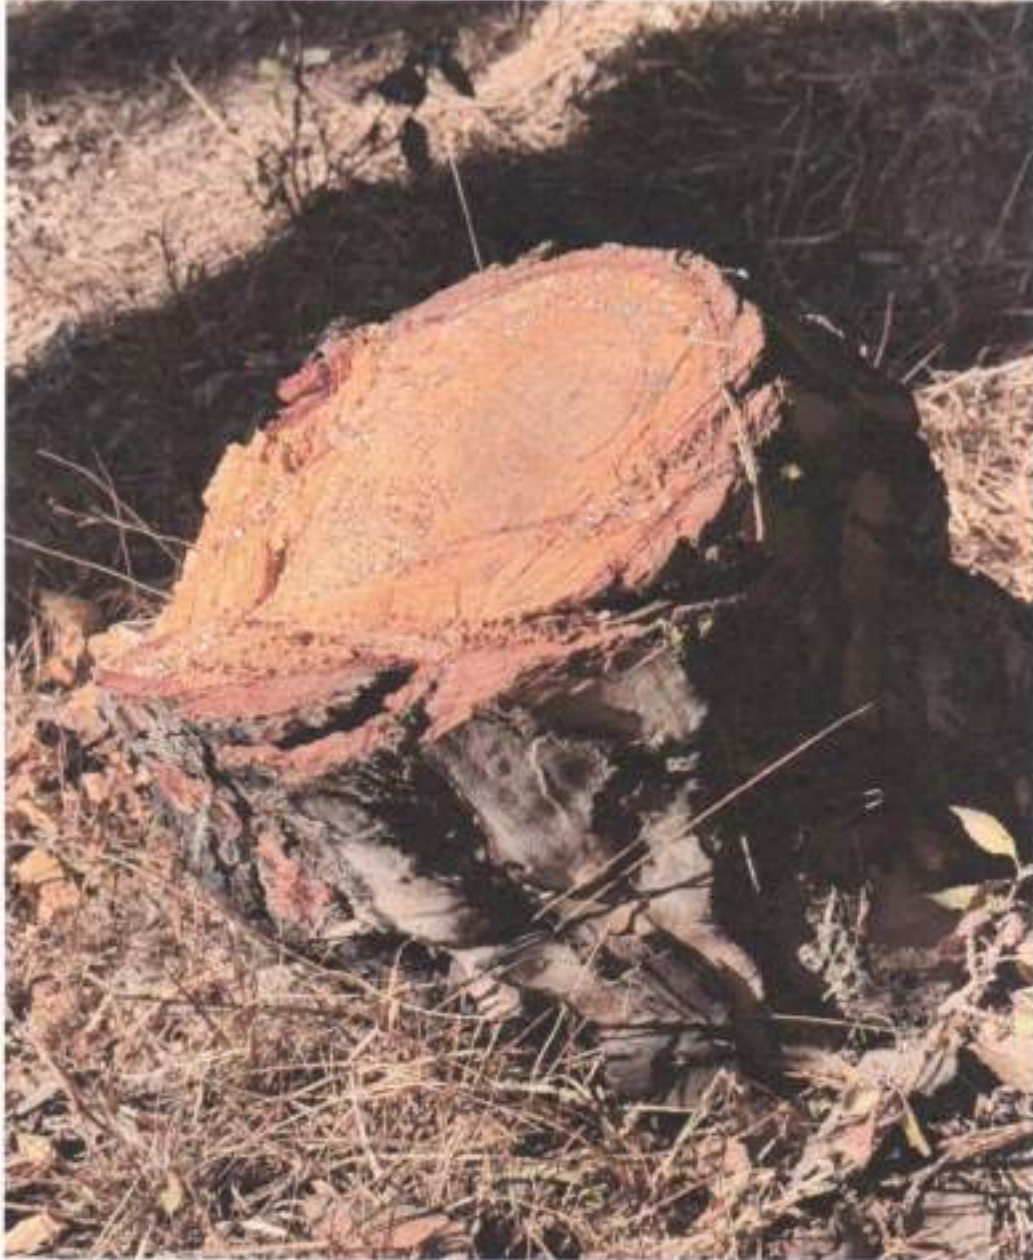
Stump of another pine tree was found in the
Mine at Village Maholi Owned by Surendra Singh Bhauriyal
Clicked from
29° 53' 45.072" N 79° 58' 26.148" E

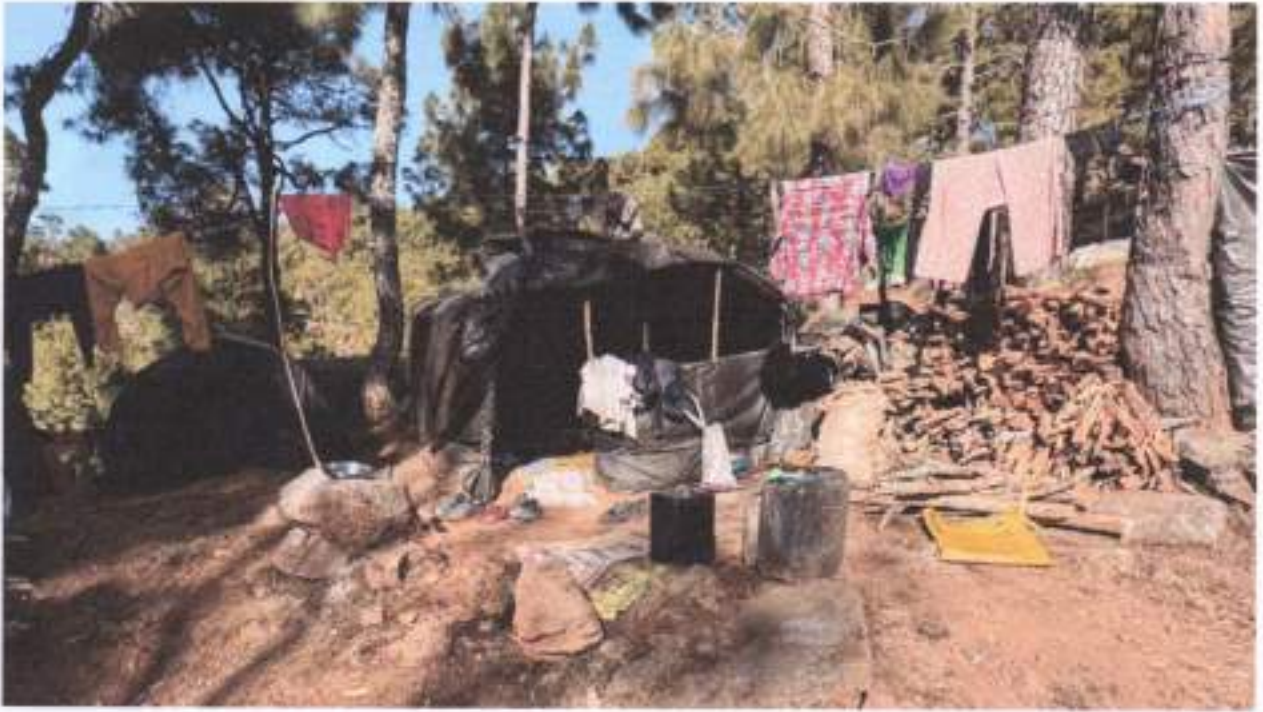
Surendra Singh Bhauriyal's Mine, Maholi, Reema
Living condition of Labourers
