# Report of inspection

**Prof. P.C Mishra as Court Commissioner**

The Honourable Principal Bench of  
National Green Tribunal dt. 09.01.2019 in OA No. 351 of 2018

Report of inspection conducted by Prof. P.C Mishra as Court  
Commissioner appointed by the Honourable Principal Bench of National  
Green Tribunal dt. 09.01.2019 in OA No. 351 of 2018

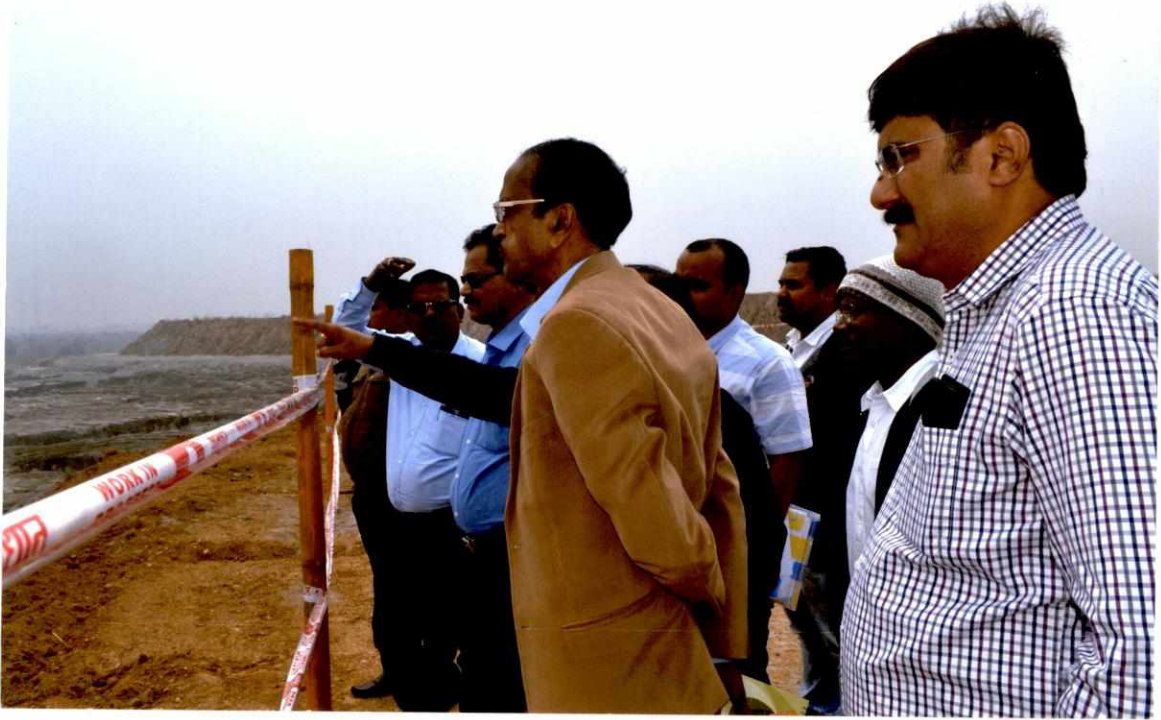
Photo 4: Breached lagoon 2

11. The Commissioner reached the Lagoon 2 site and observed the status of the lagoon 2 in respect to extent of the breach, presence of ash slurry, if any, in the lagoon, leakage, seepage or flow of slurry, if any, and status of the nallah flowing along side of dyke and meeting river Bheden, restoration and remediation of breached Lagoon 2, if any. (Photo 4, 5, 6 & 7)

- 1.The eastern side of the Lagoon 2 of Katikela ash pond was completely breached to the extent of 800 m. The Lagoon 2 is now completely dry and not being used for any purpose. The Commissioner was informed that excavated ash from River bed was transported and deposited in lagoon 2.Part of the ash slurry spilled from the lagoon 2 got deposited in open areas in the open areas between the breached dyke and village boundary.

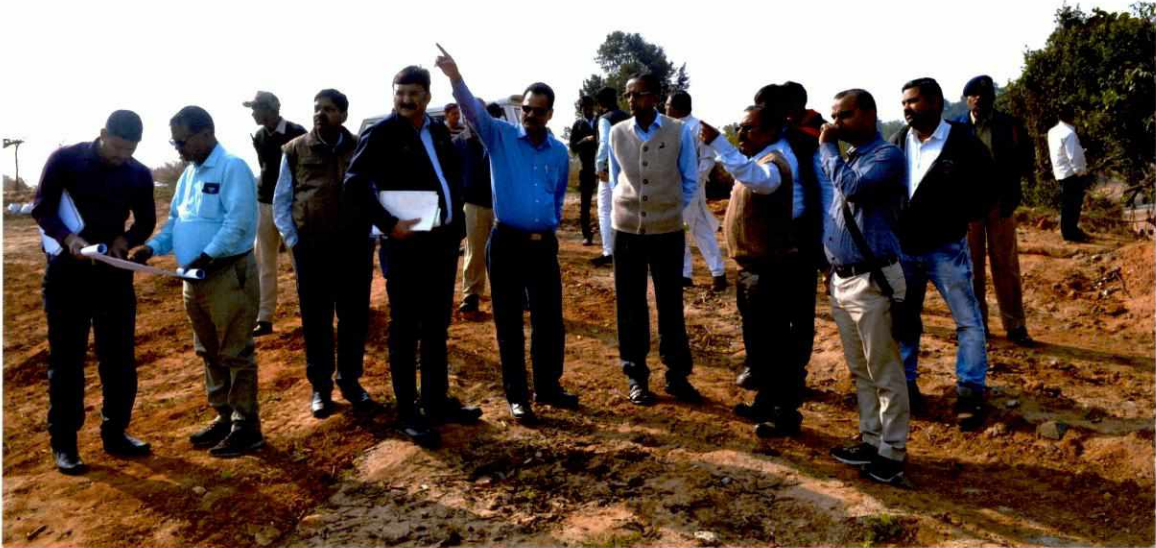
Photo 8: Visit to the Katikela village side

14. The Court Commissioner made spot inspection on the village side of the breached dyke, nallah alongside the breached dyke, meeting point of nallah with the river and walked on the river bed in the upstream where ever accessible. During the visit some villagers of village Katikela came and requested to hear them. They told about the problems of damage of their crop fields, uprooting of some trees, air pollution, and ash water flow to river. They wanted the Court Commissioner to visit their village and listen to other villagers which was politely denied by the Court Commissioner as the village

has not been affected due to the breach.(Photos 8-17).After the field visit ,the Commissioner conducted a meeting in the Hotel to seek further information based on records available .

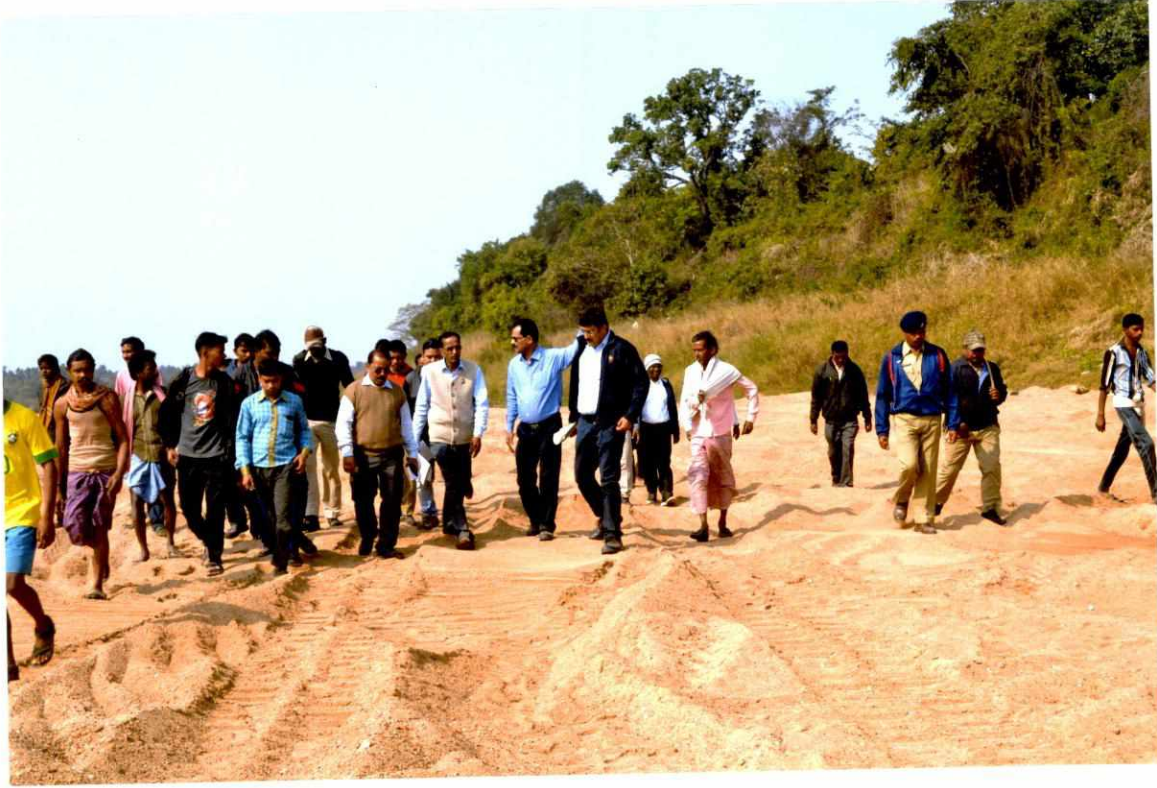
Photo 10: Inspection of river bed

6. The Commissioner visited the river bed of river Bheden from the slurry discharge point i.e the meeting point of Nallah with the river towards upstream, where ever accessible, till Kherual Bridge site and then the Hirma village, through which the river flows, to examine the extent of ash removal. The river distance from discharge point to Hirma village is approximately 12 Km according to GPS and there is complete removal of ash from the river bed. As river Bheden meets river Ib after 3-4 km from Hirma Village and river IB ultimately falls in Hiraakud Dam Reservoir, there is back water flow making the river bed inaccessible beyond Hirma Village. On examination of river bed at Kherual Bridge, algal growth was observed, an indication of favourable environment for plants and animals.

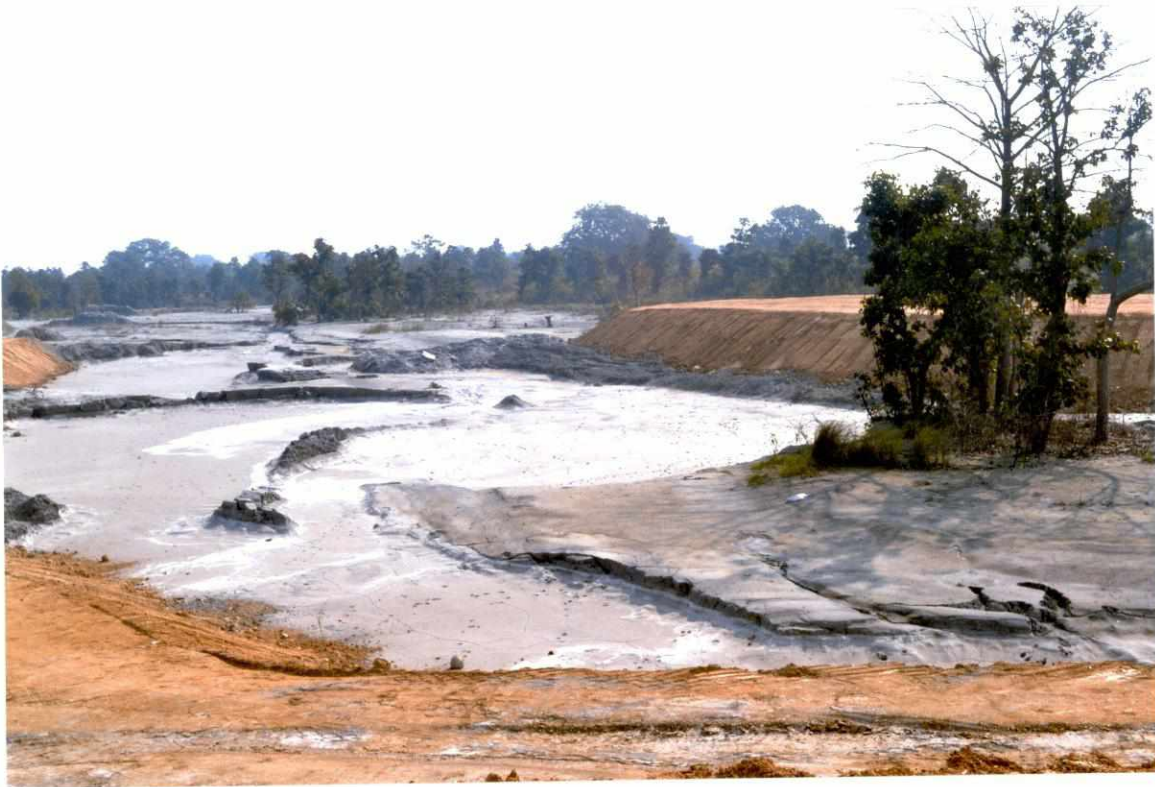
Photo 11: Ash deposit in open land

- 4.In the ash spilled area of 115 AC open land ,on excavation of ash has been undertaken as the consent is awaited from Pollution Control Board.It may be pertinent to mention that out of 115 acre of open area where ash has been deposited ,65 Ac is non agriculture land owned by the Industry and rest are agriculture land owned by villagers as per revenue records. Whole area of 115 Ac now looks like waste land .During 2017-18 with the intervention of district administration the industry has paid compensation to almost 95% of the agriculture land owners for crop loss and paid Rs.50,000/-per ac for ash removal. However ,no ash has been removed by the land owners. In the mean time ,the industry has purchased /acquired about 25 Ac of agriculture land. It

may be better to acquire rest of the land as it may be impractical for individuals to remove such huge quantity of ash and make the land suitable for agriculture.

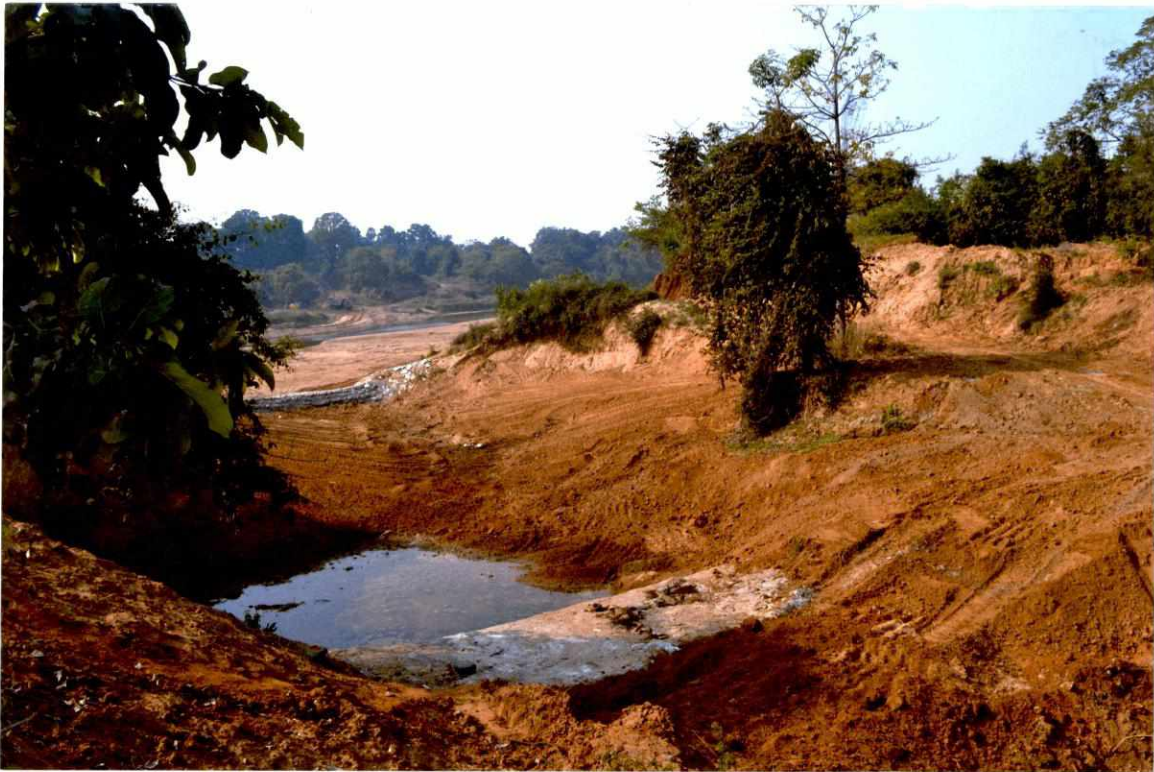
Photo 12: Check dam in the nallah

- 2.The nallah which is a storm water drain flowing alongside the breached dyke and drains to river Bheden is now fragmented due to construction of check dams in order to prevent washed out ash water coming from open areas during rain fall. At present it is dry.
