Joint Inspection Report
(16.10.2019)
of
M/s C.L. Gupta Export Ltd., Amroha,
U.P

In The Matter Of
Adil Ansari Vs. M/s C. L. Gupta Exports
Pvt. Ltd. & ors.

-Prepared by-
The Joint Committee of CPCB, UPPCB &
CGWA

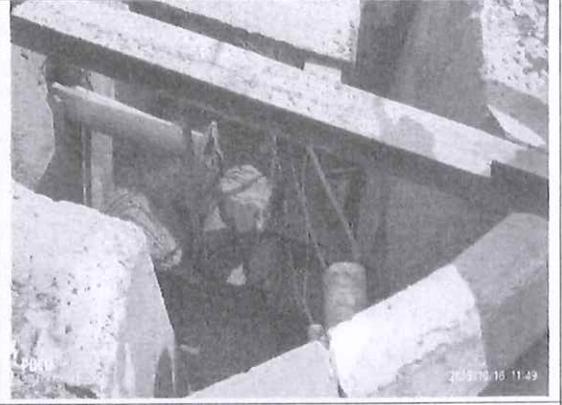
- During the joint inspection dated 16.10.2019, it was observed that, unit has covered the illegal 04 borewells with red cloth only and all the connections of illegal borewells were observed.

2. The unit has another bore well at the entrance of the glass division (Borewell no. 5), which was found closed with the help of red cloth but connections were not dismantled and it was not properly sealed.

Figure 2:Unathorised borewell

3.	As per the permission from CGWA only 02 bore wells are allowed for abstraction of groundwater. The remaining 04 bore wells installed in premises should be dismantled immediately.	At the time of inspection remaining 04 borewells were found just covered with the help of red cloth and all the other connections were observed along with the borewells.	Non-complying

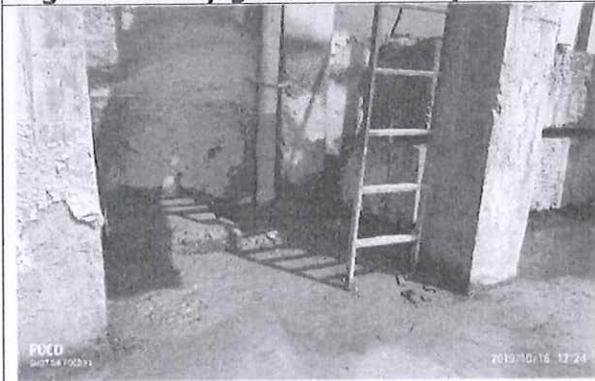
16. During inspection, grinding effluent from glass mfg. unit was also observed going for treatment in STP provided at Glass division. A sample of the same was collected for analysis purpose. Photograph of the same is placed at Section-13. Analysis result of the same is mentioned in following section (Section 7.2.2).

4. The unit is not maintaining logbook for sludge generation from the STP. During visit, no STP sludge was found stored at STP area.
5. The unit is mixing grinding effluent with the domestic effluent and treating the same in STP provided for Glass division.
6. The unit has not installed secondary/biological treatment units in STP.
7. One sample from STP inlet and one from STP outlet was collected for analysis purpose and to assess the performance of the STP. The analysis result of collected samples are provided in Section 7.2.5.

Figure 3: Grinding effluent from glass mfg. section for treatment in STP

- iii. No flow meter is provided at inlet and recycled pipeline of ETP.
- iv. The unit is mixing grinding effluent of Glass division with the domestic effluent and treating the same in STP provided for Glass division and analysis result of samples collected from STP outlet of Glass division found non-complying w.r.t pH-3.08, TSS-230 mg/l and BOD-81 mg/l, hence it can be concluded that mixing of grinding effluent with the domestic effluent is leading to the non-compliance of the Glass division's STP discharge norms as prescribed in the unit's consent and the unit cannot be allowed to utilize the treated domestic effluent for gardening purpose.

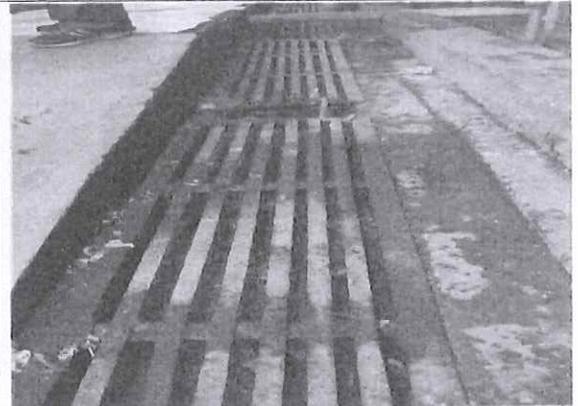
15. The drain meeting the septic tank was found full of sewage waste, due to that there was no flow in the drain and it was found stagnant and was in very bad condition. Photograph of the same is placed at Section-13.

Figure 4: Accumulation of sludge in the STP inlet drain

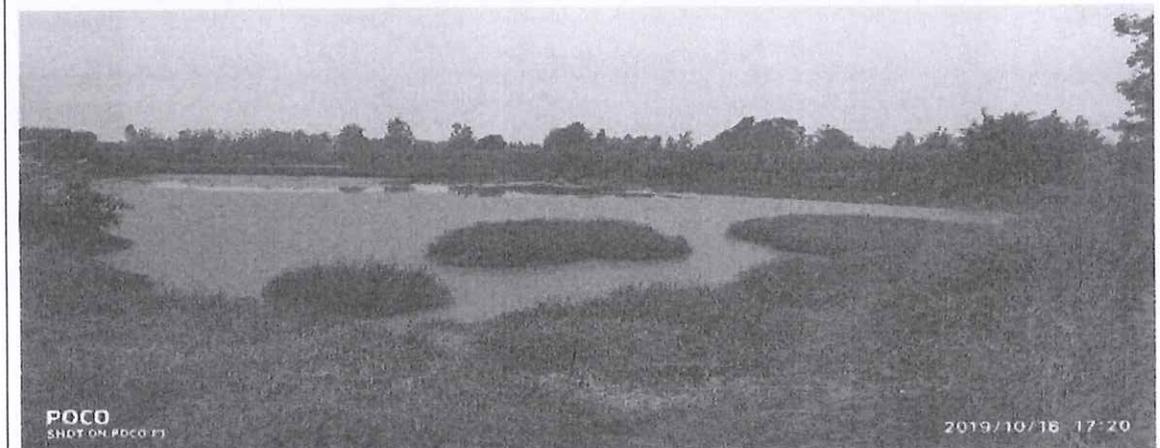
6. The unit is having open channel towards the boundry wall and during inspection, Leakage was also found from the periferrial wall of residential colony's STP, which was going into the Kaccha Pond, which is located behind the unit. Photograph of the same is placed at Section-13.

Figure 5: Kaccha Pond located behind the unit

2.	It should be ensured by the industry that drain/outlets, carrying industrial/domestic wastewater which are connected with Kacha pond are to be dismantled or sealed and no water or wastewater from the premises reach the pond at any time outside the premises.	A Leakage was observed from the periferrial wall of residential colony's STP, which was going into the Kachha Pond, which is located behind the unit. The unit has not dismantled open drain, which is carrying domestic wastewater at the residential colony behind the installed STP.	Non-complying

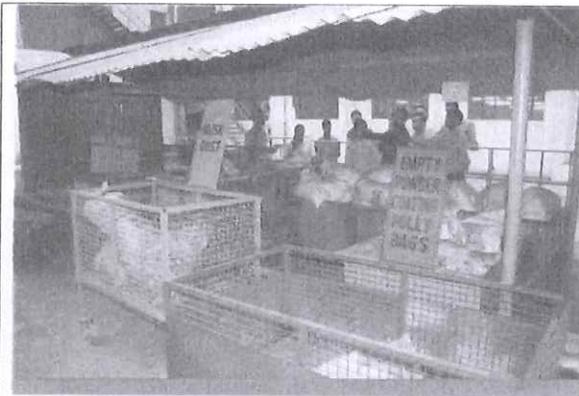
4. Details of remaining categories of hazardous waste except ETP sludge, Gloves/ masks and old batteries sent to TSDF facility from year 2017 to 2019 could not be provide by the unit;
5. During the time of the visit, about 914 kg of ETP sludge including paint sludge, 100 liters of used oil, 100 liters of used diesel, 38 old batteries, 50 numbers of drums/ empty barrels/ containers contaminated with hazardous

6. There were no automatic water sprinkling arrangements, fire alarming systems, flame arresters, smoke/ heat detectors, fire extinguishers and other necessary provisions provided in the storage area as stipulated under the Guidelines for storage of incinerable hazardous wastes;

7. There was no labeling on bags stored with hazardous wastes as per the Rule 17(1) of the HOWM Rules, whereas, the unit is required to label the bags with requisite details as prescribed in Form 8 of the HOWM Rules, 2016;

Figure 6: Hazardous waste storage shed

- iii. As stipulated under the Guidelines for storage of incinerable hazardous wastes, the unit have not provided automatic water sprinkling arrangements, fire alarming systems, flame arresters, smoke/ heat detectors, fire extinguishers and other necessary provisions in the storage area.

- iv. As prescribed in Form 8 of the HOWM Rules, 2016, the unit is required to label the bags with requisite details, while there was no labeling on bags stored with hazardous wastes as per the Rule 17(1) of the HOWM Rules.

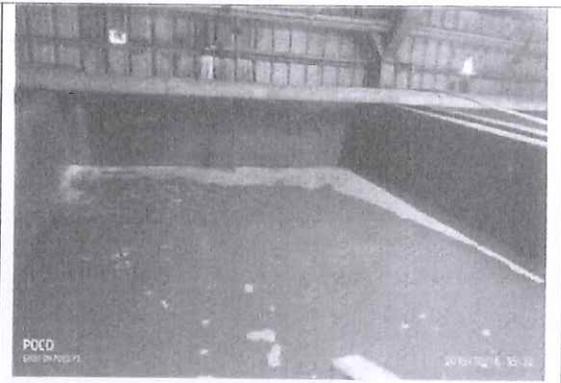
2. In the Metal division, for the treatment of effluent the unit has installed Effluent Treatment Plant of 175 KLPD capacity.
3. The ETP is consisting of Collection tank, pH correction tank, Flocculation tank, Flash Mixer, Lamela type clarifier, Final pH tank, Dual Media filter, Carbon Filter, Micro Cartridge filter, Ion-exchange unit, Ultrafiltration and Treated water storage tank. As informed by the representative of the unit, treated effluent from ETP is utilized again in the Metal mfg. division. ETP is inadequate as it does not have requisite secondary/biological treatment unit.

5. During visit, no ETP sludge was found stored at ETP area and the unit is not maintaining logbook for sludge generation from the ETP, indicating that the ETP is not operated regularly and poor operation and maintenance of ETP.
6. Effluent samples were collected from the Inlet and outlet of ETP for analysis purpose and to assess the performance of the ETP. The analysis result of collected samples is provided at Section-7.3.2.

Figure 7: ETP inlet of metal mfg. unit

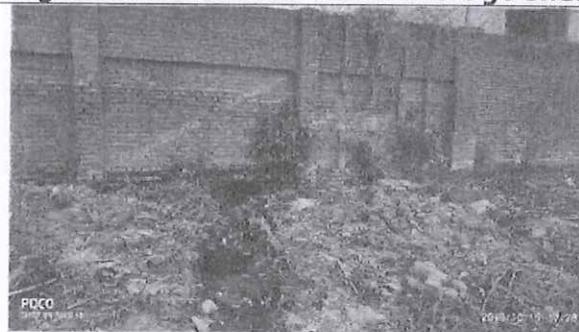
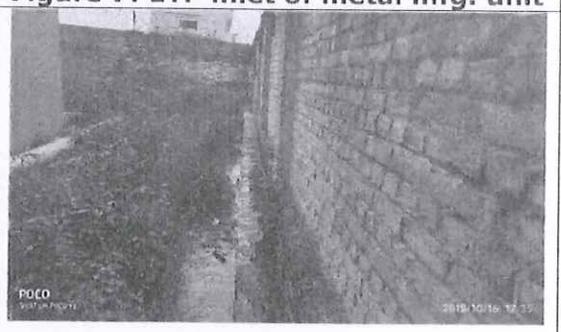
4.	The industry must be strictly followed ZLD process.	A Leakage was observed from the periferrial wall of residential colony's STP, which was going into the Kachha Pond, which is located behind the unit.	Non-complying

Figure 8 Leakage (bypass) from the industry
