BEFORE THE NATIONAL GREEN TRIBUNAL

Original Application No. 02 of 2024 (SZ)

Report of the Tamil Nadu Fisheries and Fishermen Welfare Department on the news titled "Oil leaked in Tamil Nadu's Nagai spreading along coast, say experts"

Report of the Joint Committee on "Assessment of the M/s Chennai Petroleum Corporation Limited-Cauvery Basin Refinery (CPCL CBR) - Nagapattinam Crude Oil Pipeline Leak near Nagore Coast, Nagapattinam, Tamil Nadu".

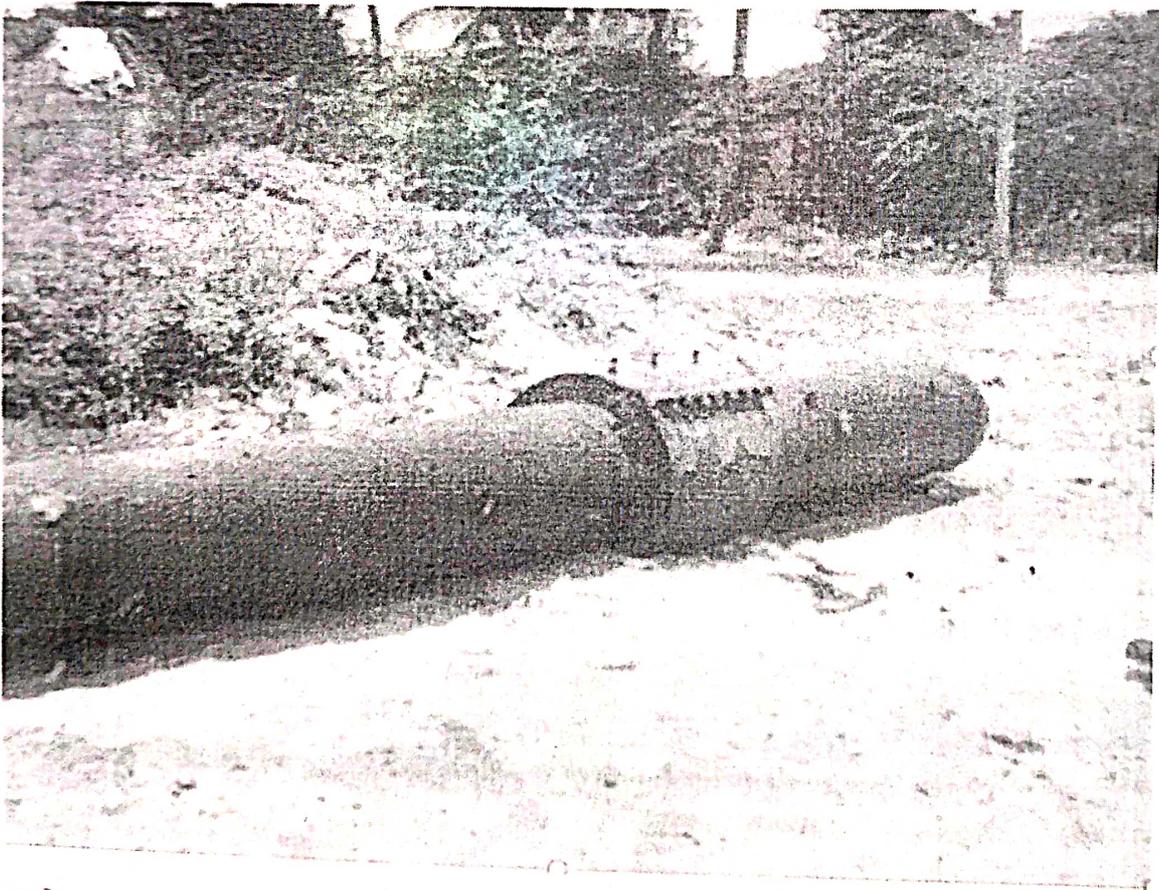
During the committee site visit on April 18, 2023, the committee observed that the leaky portion of the pipeline was removed and kept aside. The clamp provided in the pipeline was not removed. The remaining portion of the base pipeline was found intact with very little damage to the external coating of the pipeline. CPCL officials explained that the damage to the coating material happened

during the removal and shifting of the pipeline by crane and sling. The visual inspection inside the pipeline found normal and healthy condition. The thickness measured at the leaky portion of the pipeline is at permissible levels of 6.1 mm, against the design thickness of 6.35 mm. There was no corrosion or erosion observed in the pipeline and the cause of the leak may be due to an external impact.

During the site visit, CPCL Officials explained that the line was laid at about 1.5 Meters depth in the land area at a distance of 40 meters from the sea. Due to the gradual shifting of the inter-tidal zone and other developments like the Construction of Breakwater at Karaikal Port, and natural calamities such as-cyclones etc., the inter-tidal zone has come into contact with the pipeline. However, the exposure of the pipeline to seawater is a recent phenomenon, and hence, corrosion and a reduction in the thickness of the pipeline did not take place.

Figure 3: Photograph of the removed portion of the pipeline with metal clamp

Industrial Research (CSIR) to carry out the metallurgical analysis of crude pipeline to identify the root cause of the failure. The CMERI metallurgical analysis report has concluded that the pipeline failed primarily due to external object impact force. The CMERI conclusion is furnished below. The CMERI Report is enclosed as Annexure: 6.

- 1) The crack was initiated only on the outside diameter (OD) pipe wall surface of the pipeline
- 2) The plastic collapse on the pipeline was due to the impact of external or foreign objects
- 3) The plastic deformation-induced deformation texture bands within the metal matrix microstructure are evidenced by electron microscopy and optical microscopy.
- 4) The crack morphology on the failed pipeline was predominantly dominated by a brittle fracture due to sudden impact, while a mixed (brittle and ductile) mode of crack propagation was also evidenced.

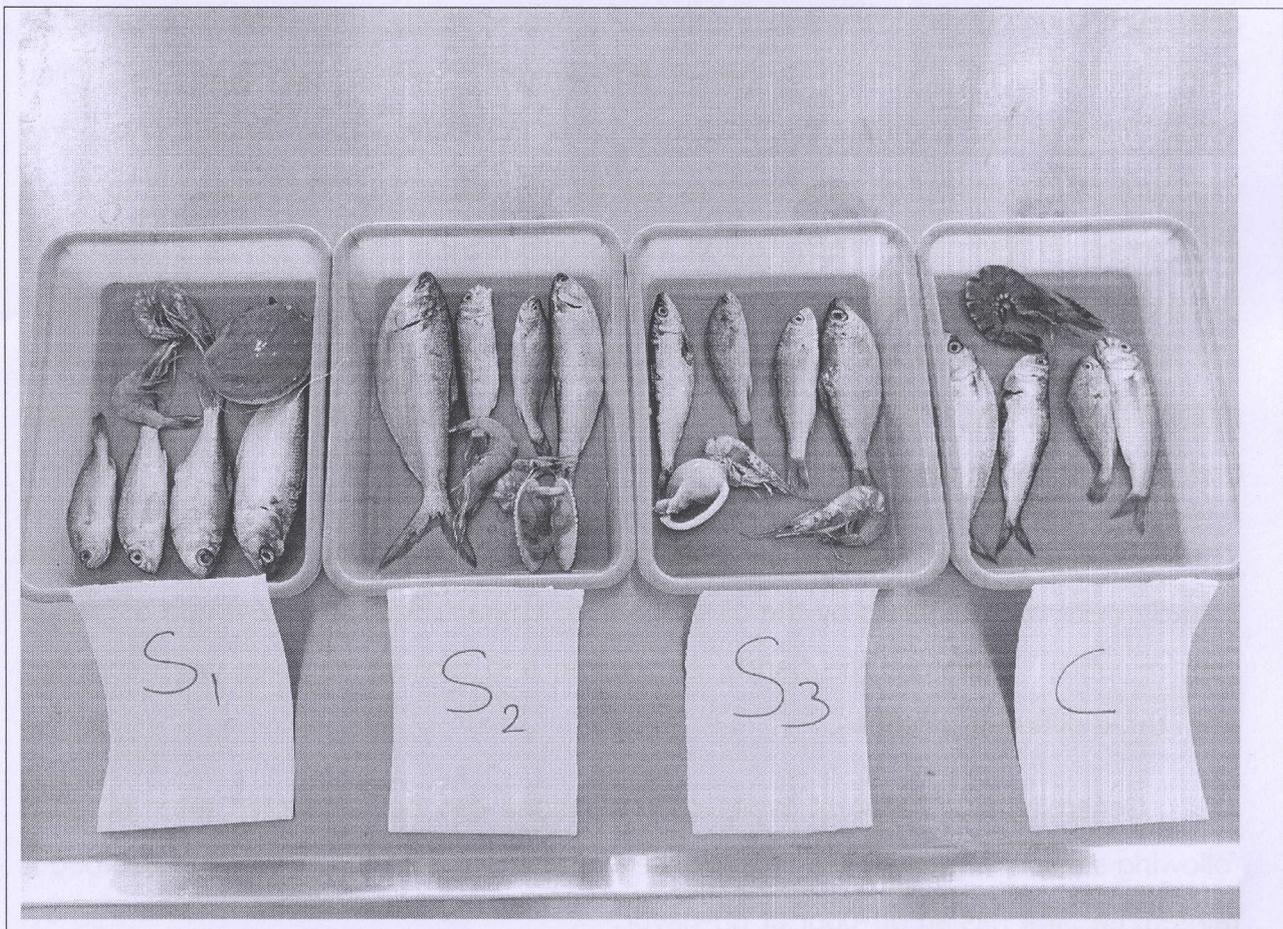
Samples collected from the different sites:

Samples : Finfish, Crustacean and Mollusc

S1- Nagore Landing centre

S3 – Mahalakshmi Nagar Landing centre

C – Vellapallam(Negative control sample) where no influence of the oil spill was noted
