Original Application No. 126 of 2023 (SZ)

**Site Inspection Report on Construction of Road near Odiyur
Lagoon by State Highways Department at Cheyyur Village,
Chengalpattu District**

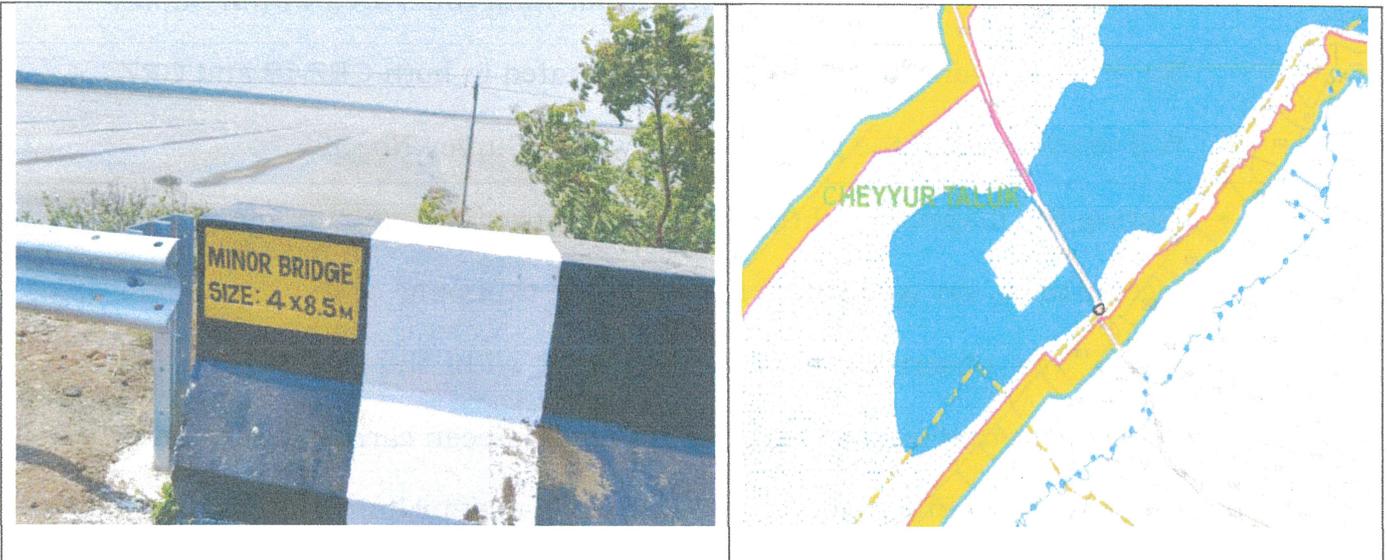
Bridge -1:

- The site inspection was conducted on the Cheyyur-Panaiyur ECR link road, where the road traverses the Odiyur lagoon atop an embankment.
- In the stretch of about 900 meters, there are two existing minor bridges (minor bridge 1 and 2), each measuring 4 * 8.5 meters, with a vent height of about 3.60 meters each (as reported by the State Highways department). These bridges facilitate the flow of water from one side of the lagoon to the other and were reportedly constructed in 2014.

- The two bridges are approximately 350 meters apart from each other, with bridge 1 located in the CRZ-IB (Inter-tidal zone) area within Survey No. 312, 121, and 527, and bridge 2 situated in both CRZ-IB and CRZ-IVB (water area of the lagoon) areas within Survey No. 526.

The bridge was constructed in the CRZ IB (Intertidal Zone) area as per the approved CZMP Map 2011

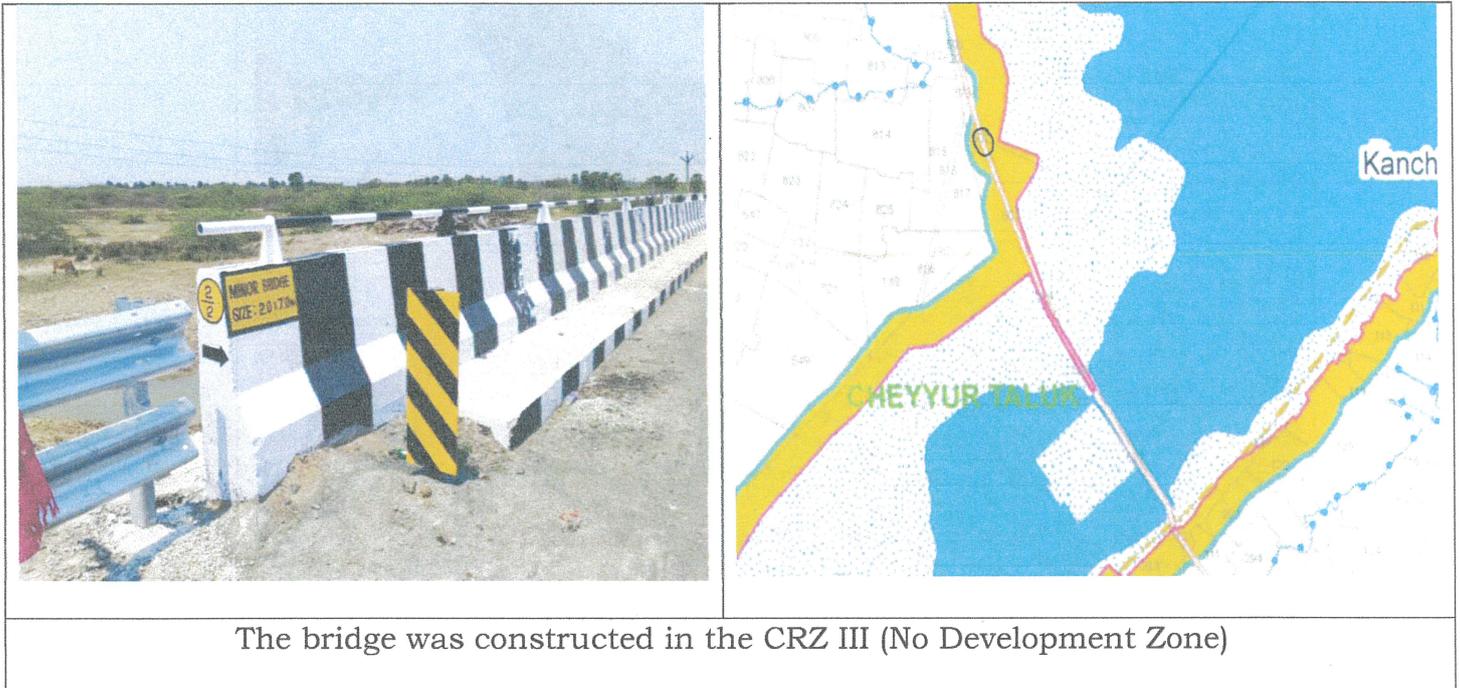
Bridge -3:

- A new bridge (bridge 3) of size 2.0 * 7.0 meters was observed at a distance of 700 meters from bridge 2 in Survey No. 502. According to the State Highways Department, the vent underneath this bridge also facilitates water flow in the lagoon.

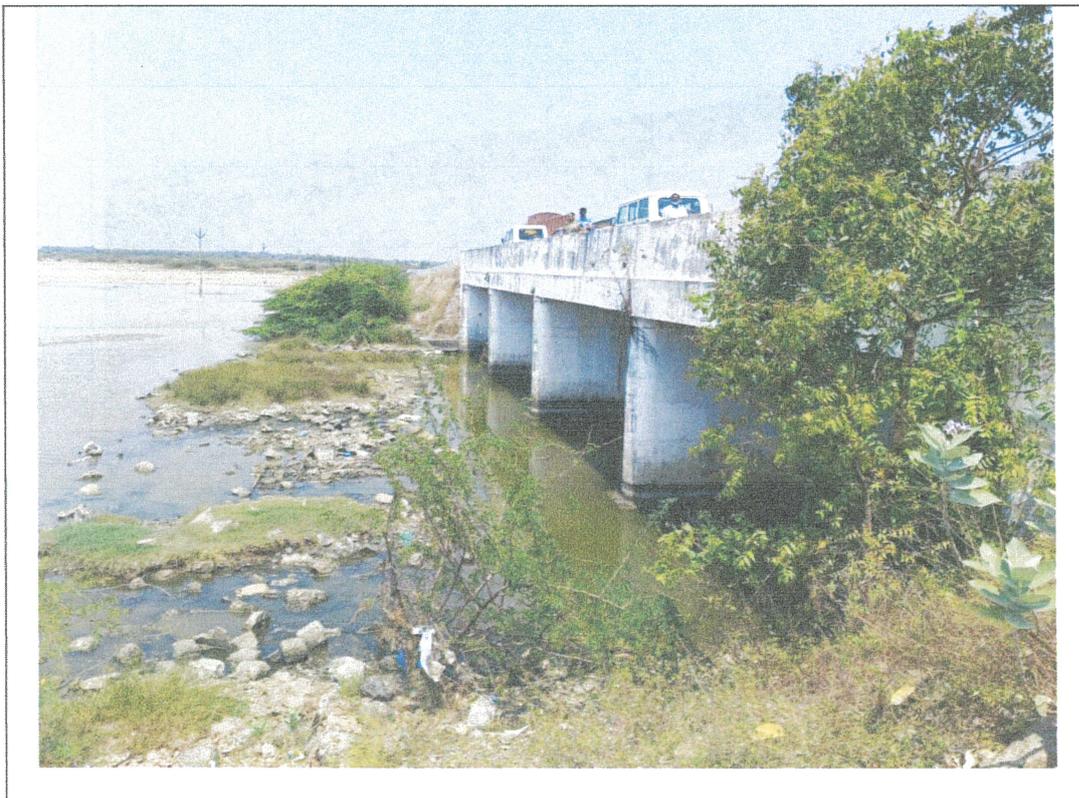
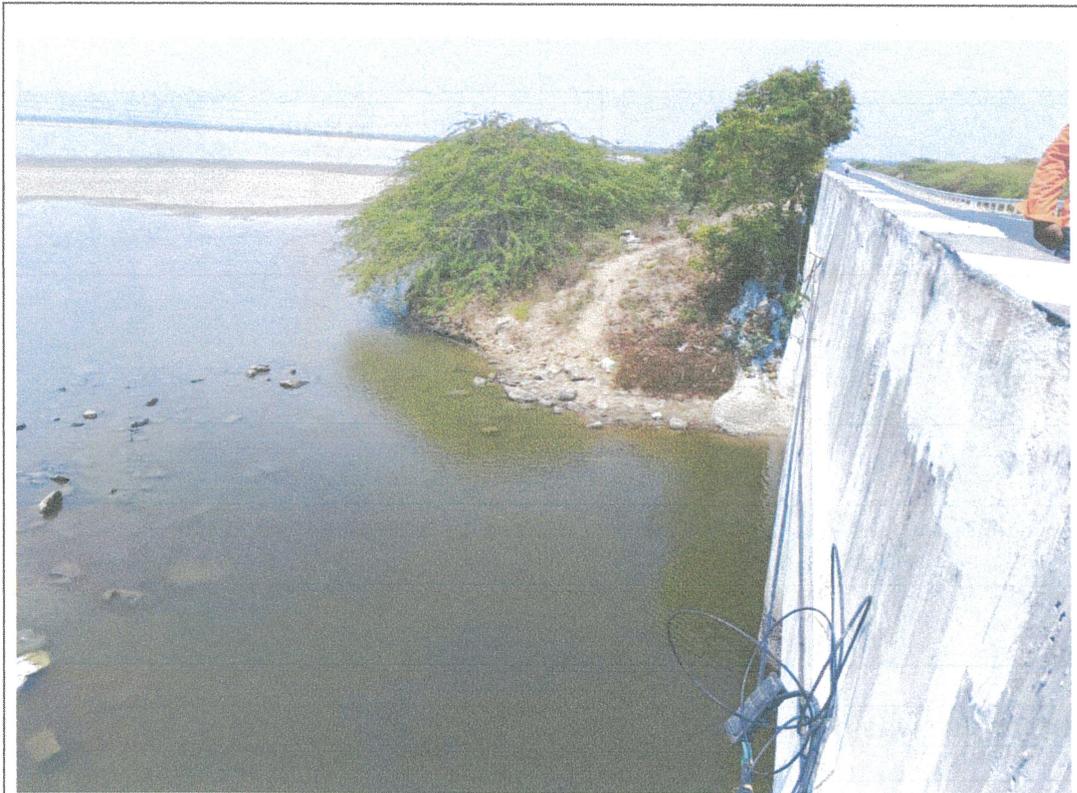
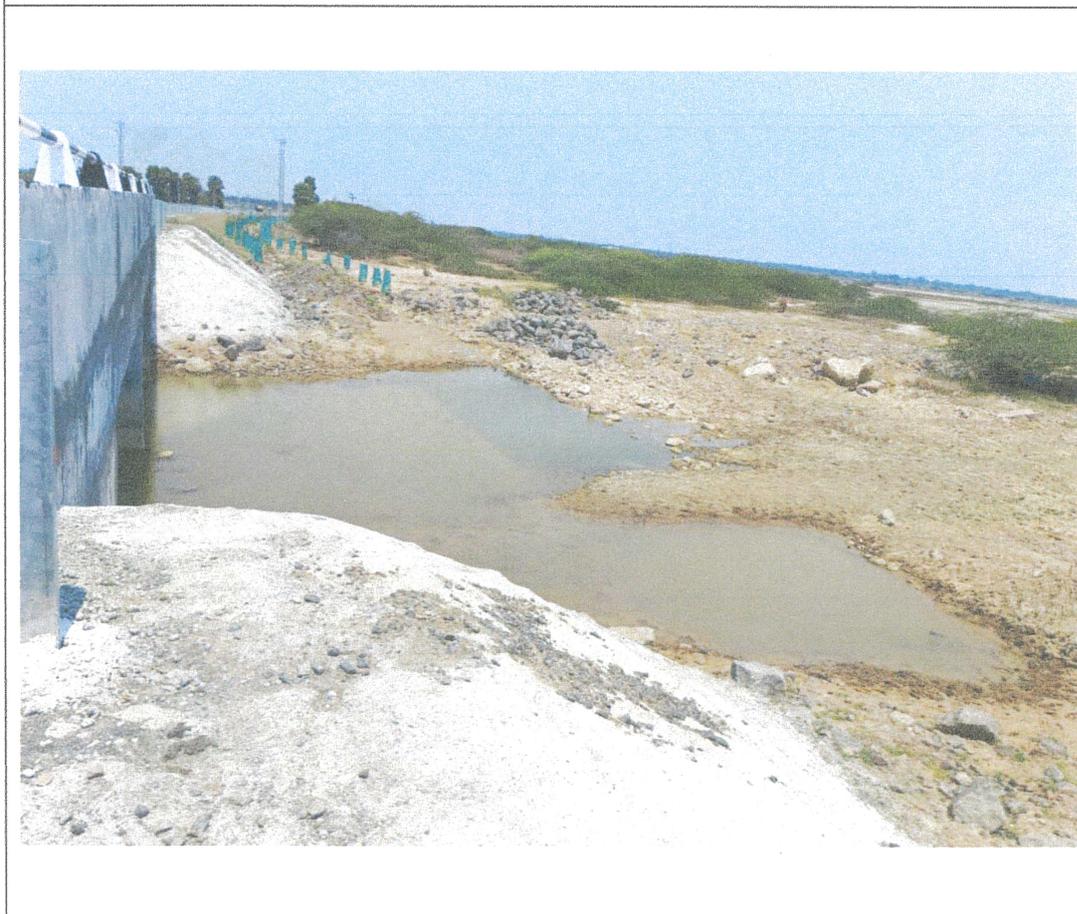
- At the time of site inspection, it was observed that, even though there was meagre water level in the lagoon, water flow was observed across the vents in the two minor bridges. The State Highways department stated that even during heavy rainfall of about 84.50mm recorded at Cheyyur on 03.12.2023 and 04.12.2023 during Cyclone Michaung, no breaches occurred in the CRZ area (i.e., 900m stretch). They also mentioned that tidal exchanges frequently occur through these balancing bridges at this location.

Images captured during the site visit which shows water flowing through the areas where the bridges have been constructed:
