**BEFORE THE NATIONAL GREEN TRIBUNAL  
SOUTHERN ZONE, CHENNAI  
Original Application No. 131 of 2020 (SZ)**

**Joint Committee report on the compliance status of the 8th  
Respondent Unit as on 23-9-2021**

**ASSESSMENT OF CONTAMINATION  
LEVEL AT THE YARD AREA OF  
THIRUMALAI CHEMICALS LIMITED,  
RANIPET**

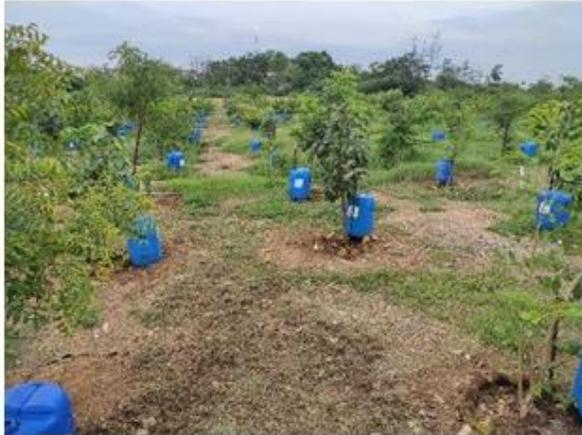
**Plantation carried out in the remediation site**

- It is recommended to develop the contaminated site as a green park with trees, shrubs, and grass. Thirumalai Chemicals Ltd. has started developing the site by turning it into a green zone in the last six months.

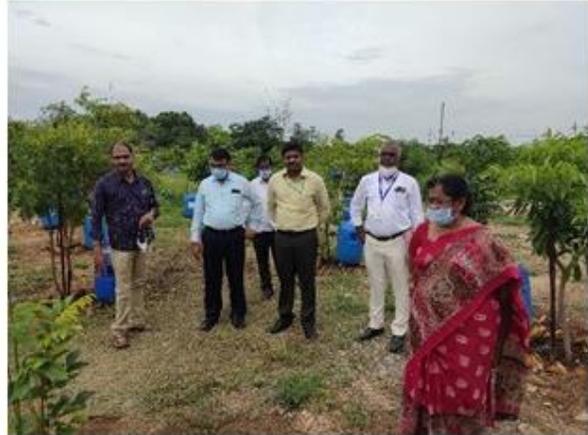
**Committee's visit to the remediation site**

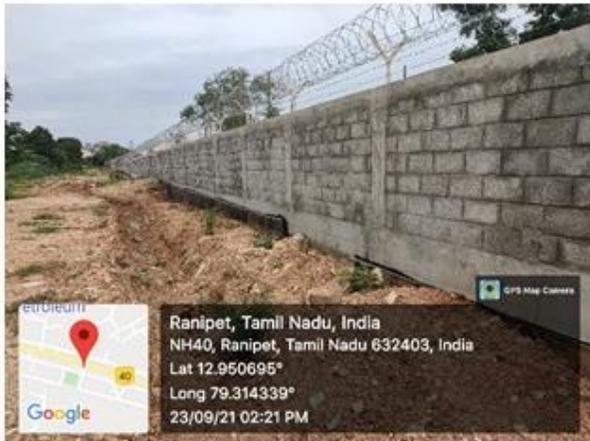
**Retainer wall around the industry unit**

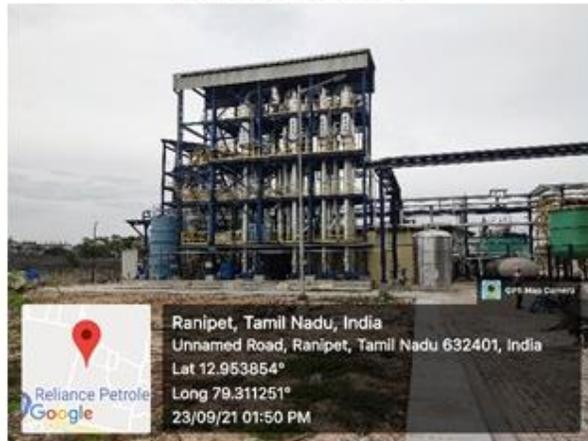
**New ETP with ZLD components**

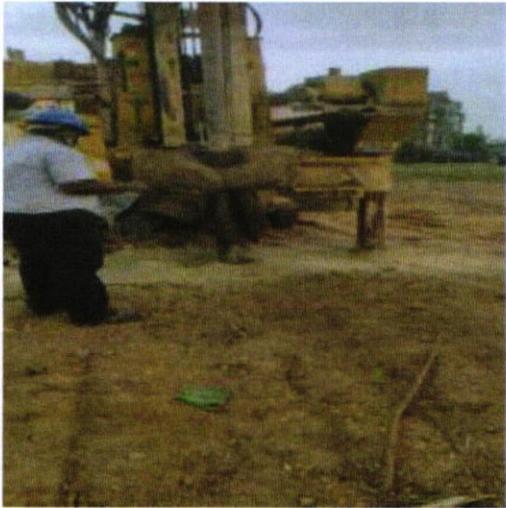
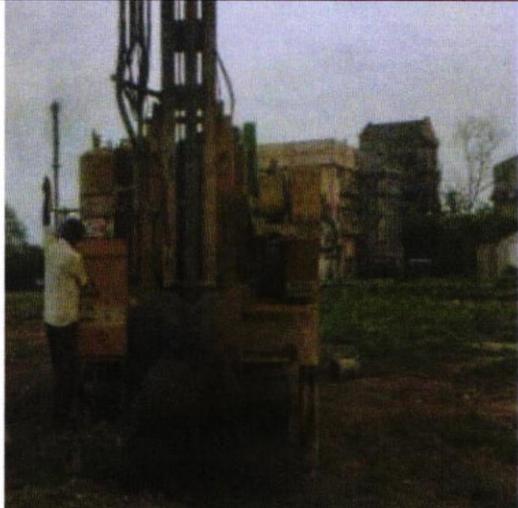
S.No.	Sampling Location details	GPS coordinates	Observed nature of the soil	Remarks
1.	<b>Location 1</b> Near Ponnai road	N12°57'19.4" E079°18'54.3"	0 cm- Muram* (top soil) 0.5 m- Quartzite* (white coloured) 1.8 m- Black coloured soil (contaminated soil) 2.1 m- Hard rock (powder)	Hard rock/Rough stone reached at 2.1 m approx.

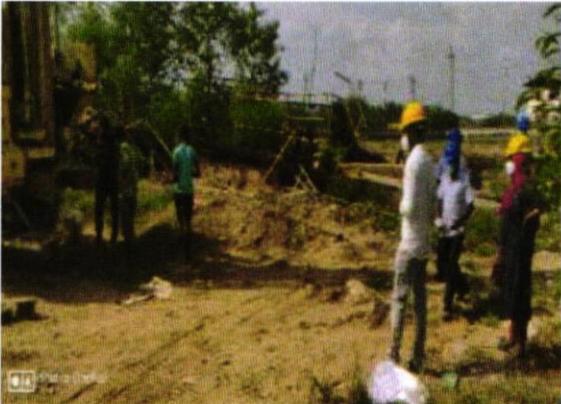
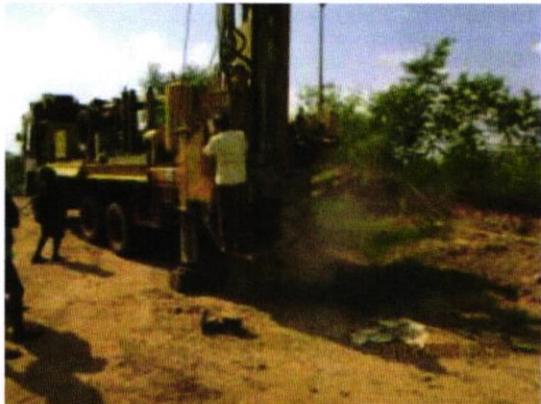
2.	<b>Location 2</b> Near Security room	N12°57'19.2" E079°18'52.7"	0 cm-Muram* 0.5 m- Filled up soil/ weathered rock* 0.9 m- filled up soil 1.8 m- Black colored soil (contaminated soil) 2.7 m- Hard rock	Hard rock reached at 2.7 m approx.

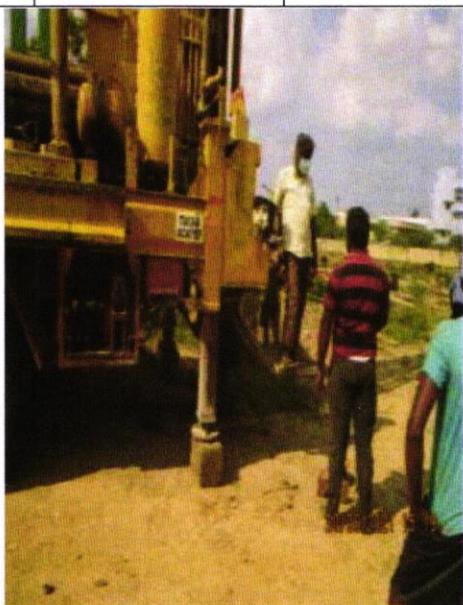
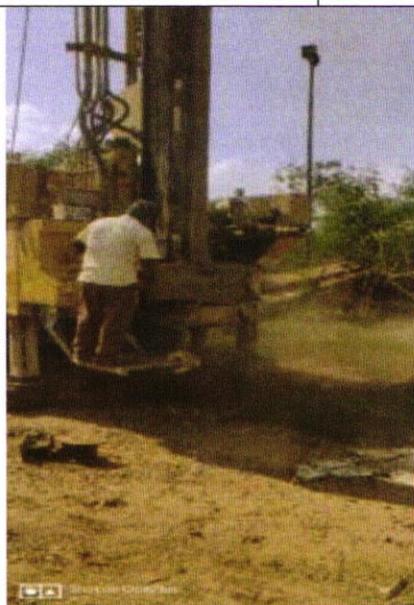
3.	<b>Location 3</b> Near reed bed	N12 <sup>0</sup> 57'20" E79 <sup>0</sup> 18'54"	0 cm- Muram 3.9 m- Hard rock slurry (water was found)	Hard rock reached at 3.9 m approx. A water sample was also collected using a sampler after 15 mins.
----	------------------------------------	--	--	--

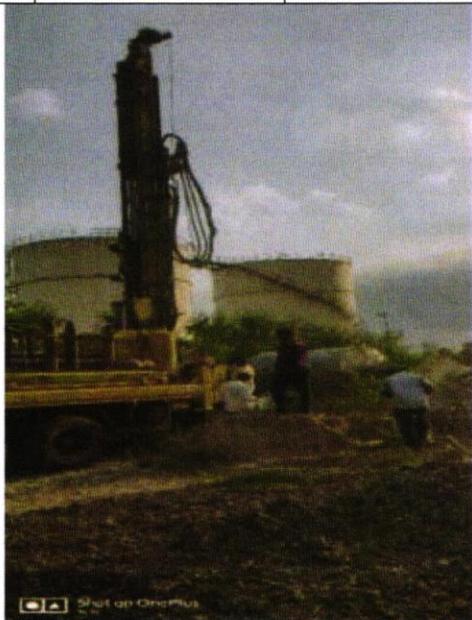
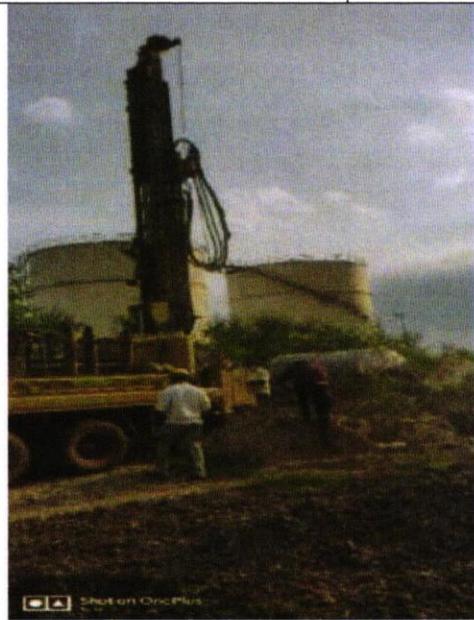
4.	<b>Location 4</b> Light tower entrance area	N12 <sup>0</sup> 57'19.8" E79 <sup>0</sup> 18'51.9"	0 cm- Muram 0.9 m- filled up soil 2.1 m- Hard rock	Hard rock reached at 2.1 m approx.
----	--	--	--	------------------------------------

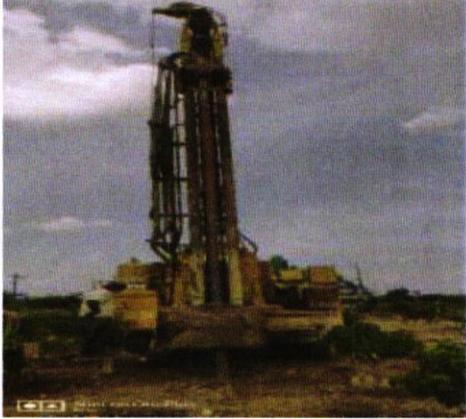
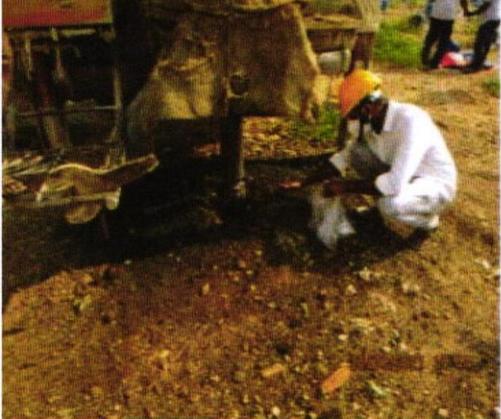
5.	<b>Location 5</b> Near reed bed	N12°57'20.8" E79°18'52.4"	0 cm-Muram 0.9 m- filled up soil 1.8 m- Black colored soil (contaminated soil) 2.7 m- Hard rock	Hard rock reached at 2.7 m approx.

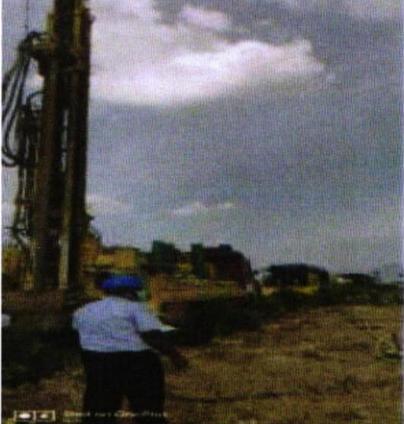
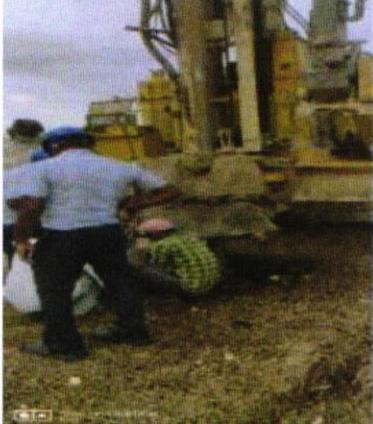
6.	<b>Location 6</b> Front of o-xylene tanks	N12°57'19.3" E79°18'50.7"	0 cm-Muram 0.9 m- Black colored soil (contaminated soil) 1.8 m- Hard rock	Hard rock reached at 1.8 m approx.

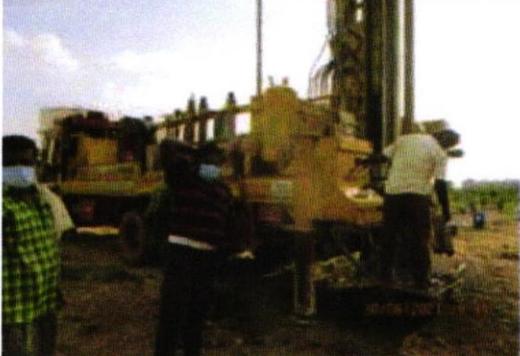
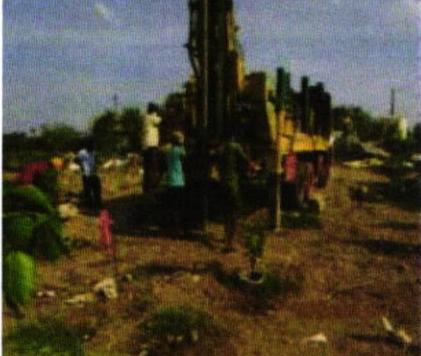
7.	<b>Location 7</b>	N12°57'21.2" E79°18'51.3"	0 cm-Muram 0.9 m- Black colored soil (contaminated soil) 2.4 m- Hard rock	Hard rock reached at 2.4 m approx.

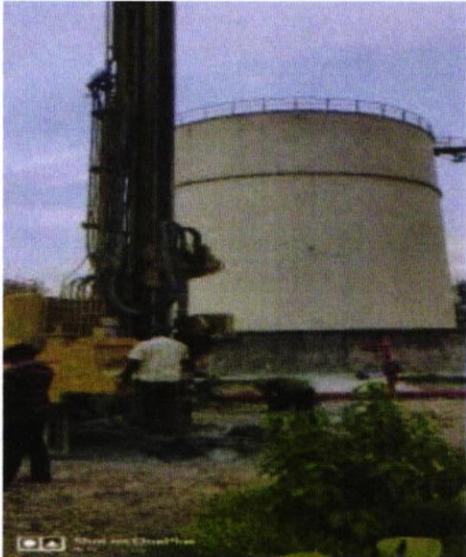
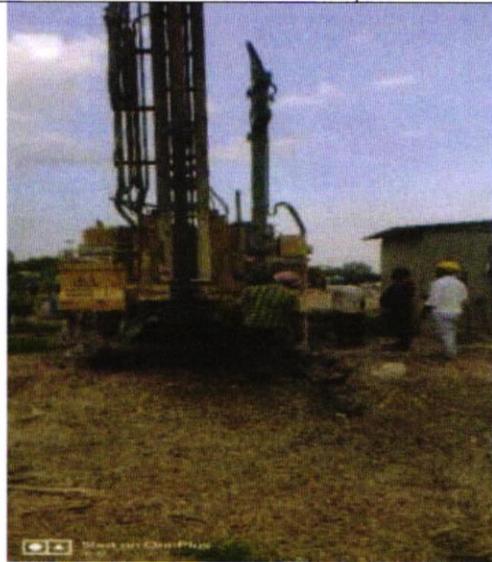
8.	<p><b>Location 8</b> Front of o-xylene storage Near yard shed</p>	<p>N12°57'19.5" E79°18'50"</p>	<p>0 cm- Muram soil* 0.9 m- Muram soil* 1.8 m- Black colored soil 3 m- Black colored soil (contaminated soil) 3.6 m- Hard rock slurry (water was found)</p>	<p>Hard rock reached at 3.6 m approx. A water sample was also collected using a sampler after 15 mins.</p>
----	---	------------------------------------	---	--

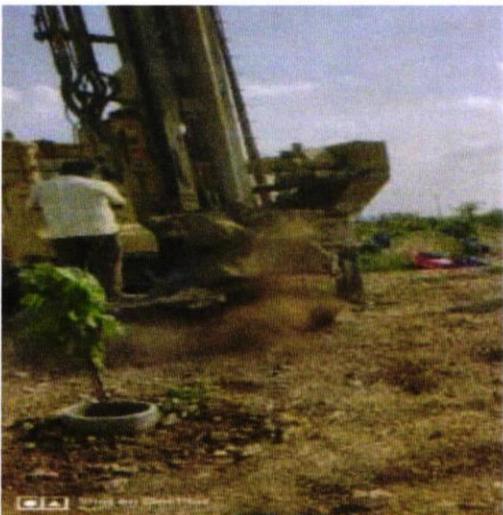
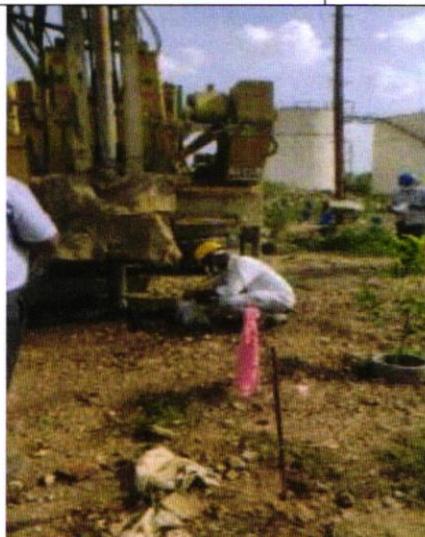
9.	<p><b>Location 9</b> Front of o-xylene storage Near yard shed</p>	<p>N12°57'20.3" E79°18'50.2"</p>	<p>0 cm- Muram soil 0.9 m- Muram soil 1.8 m- Black colored soil (contaminated soil) 3.6 m- Hard rock</p>	<p>Hard rock reached at 3.6 m approx.</p>
----	---	--------------------------------------	--	---

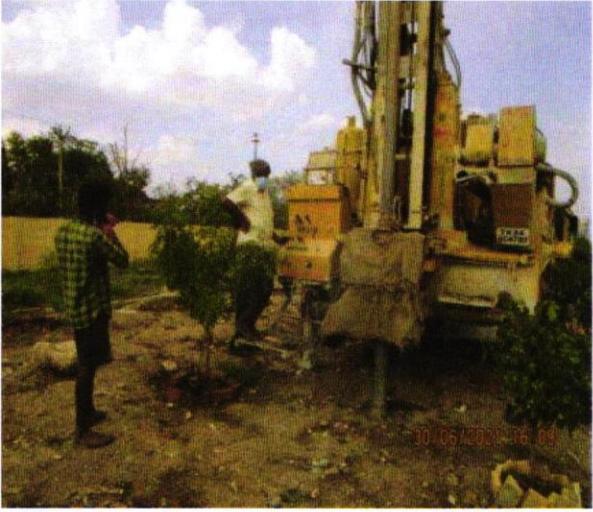
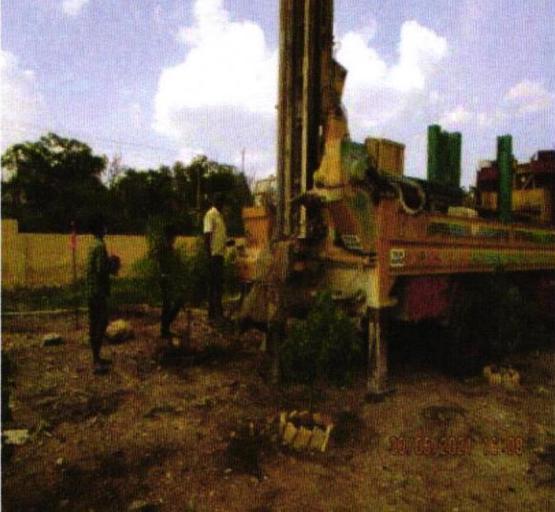
10.	<b>Location 10</b> Near TN warehouse	N12°57'21.6" E79°18'50.4"	0 cm- Muram soil 0.9 m- Black colored soil (contaminated soil) 2.1 m- Hard rock	Hard rock reached at 2.1 m approx.

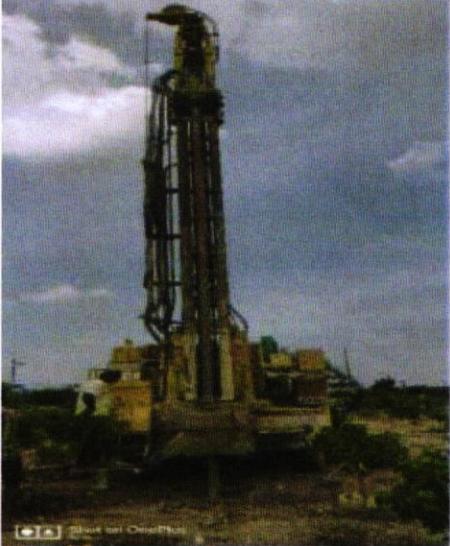
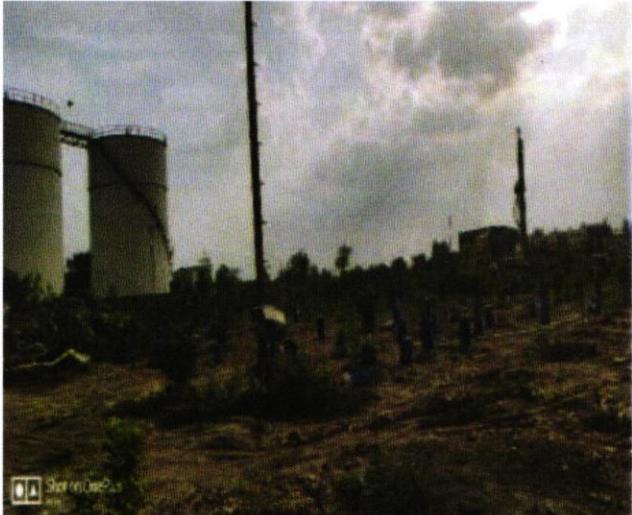
11.	<b>Location 11</b> Near TN warehouse	N12°57'21.1" E79°18'50.4"	0 cm- Muram soil 0.9 m- Black colored soil (contaminated soil) 2.1 m- Black soil & rock powder 3.0 m- Hard rock	Hard rock reached at 3 m approx.

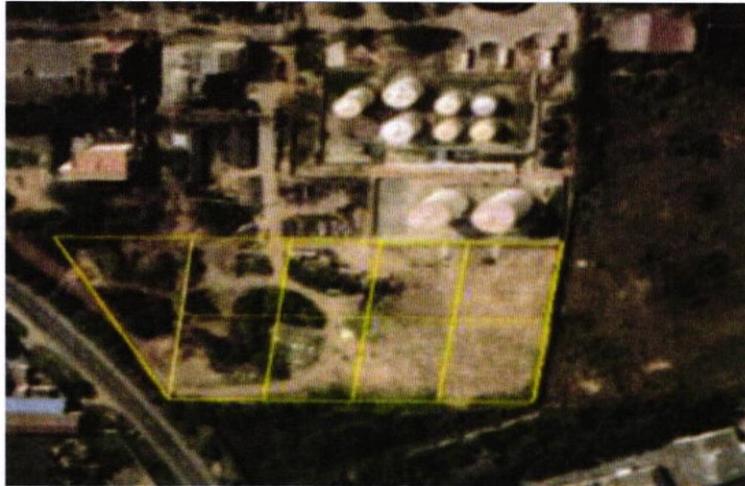
Fig 1. Grids made at the contaminated site of Thirumalai Chemicals for sample collection

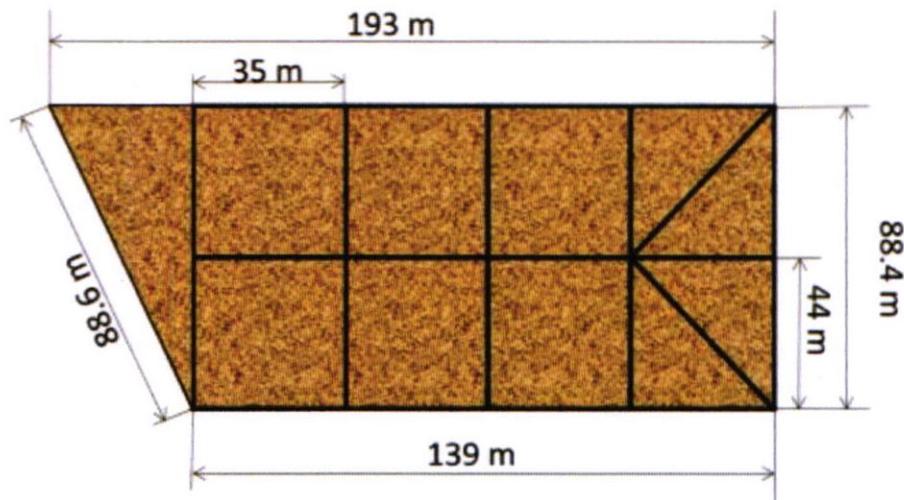
Fig 2. Schematic representation of the contaminated site with the grids made for sampling

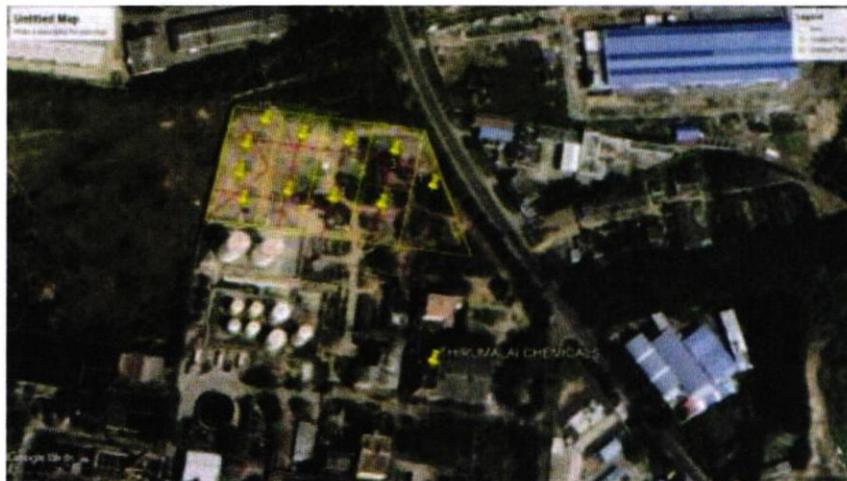
Fig 3. Google earth image of the contaminated site with sampling points

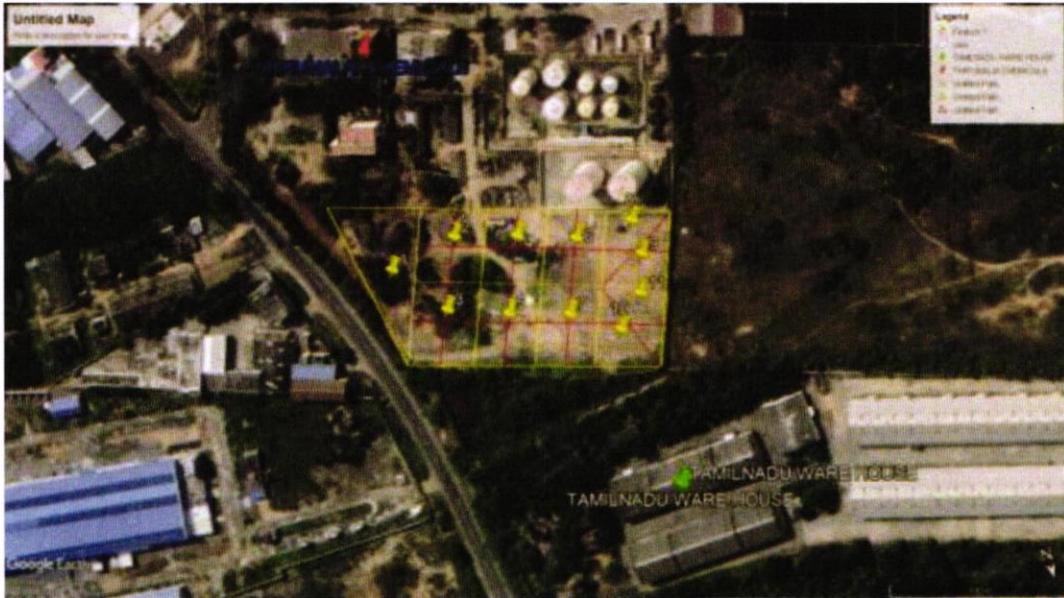
Fig 4. Google earth image of the contaminated site with marked sampling points at each grid

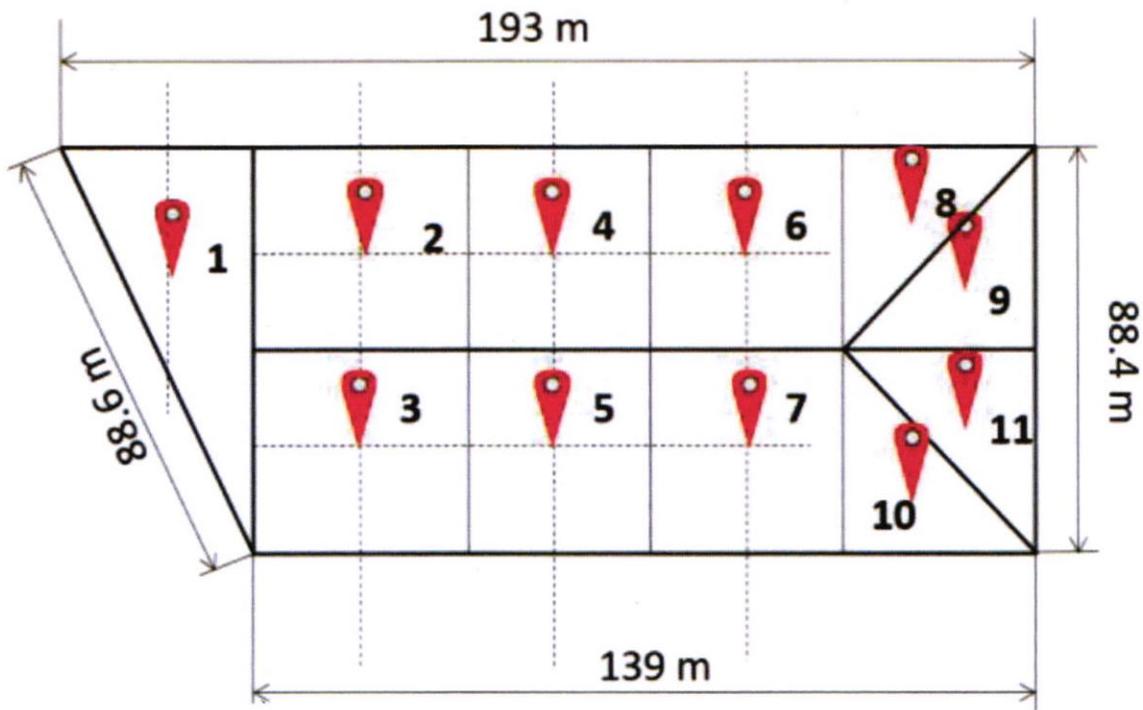
Fig 5. Schematic representation of the site with 11 sampling points marked at each grid
