**BEFORE THE NATIONAL GREEN TRIBUNAL**  
**SOUTHERN ZONE, CHENNAI**  
**Original Application No. 139 of 2024 (SZ)**

## **Site Inspection Report on Construction of Groynes at Chengalpattu District**

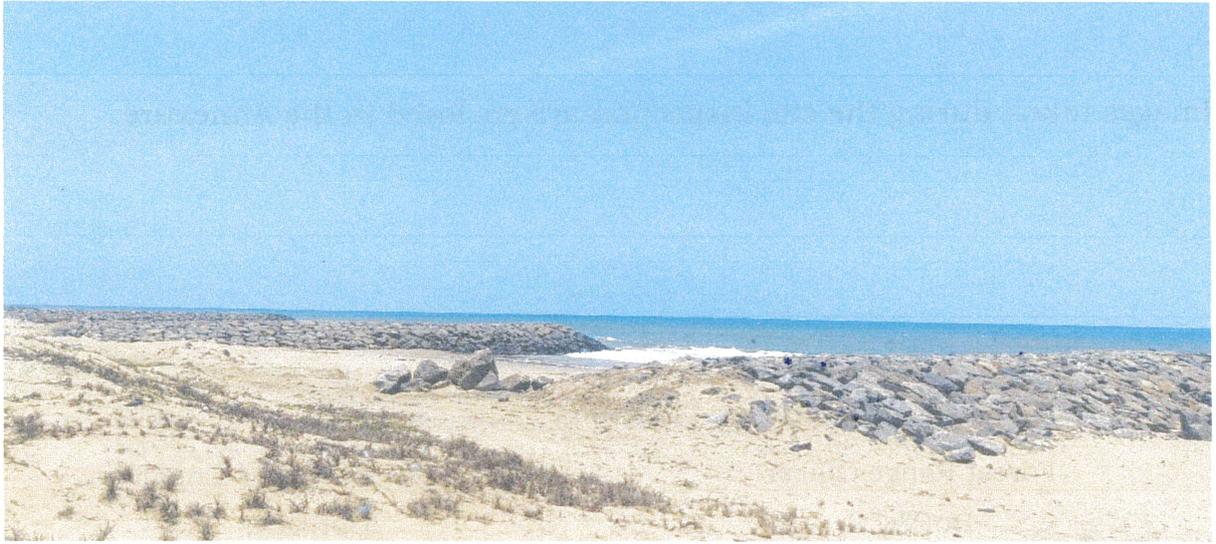
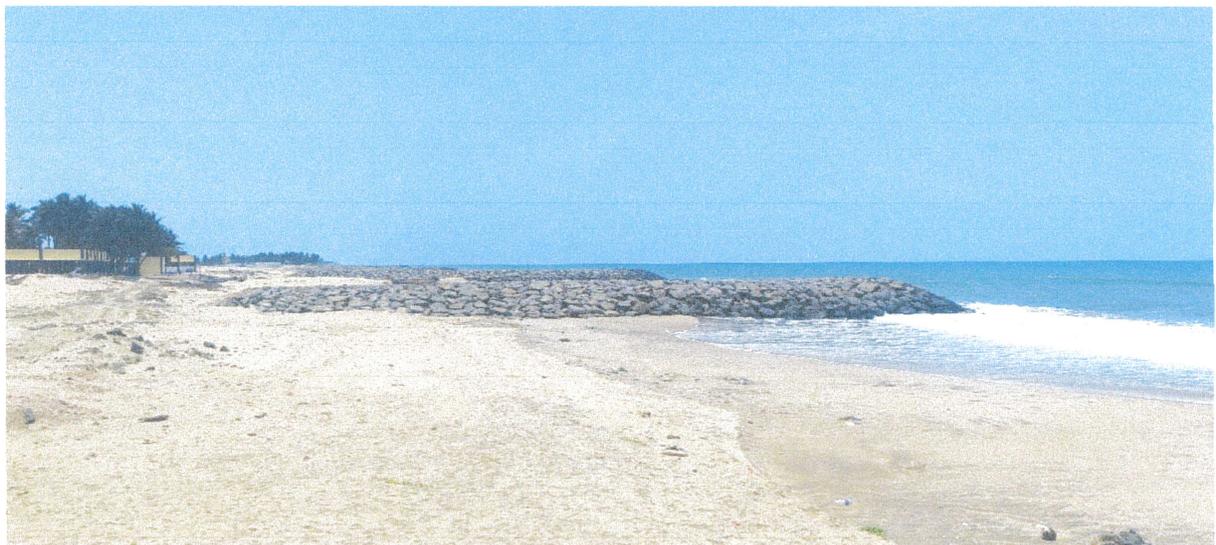
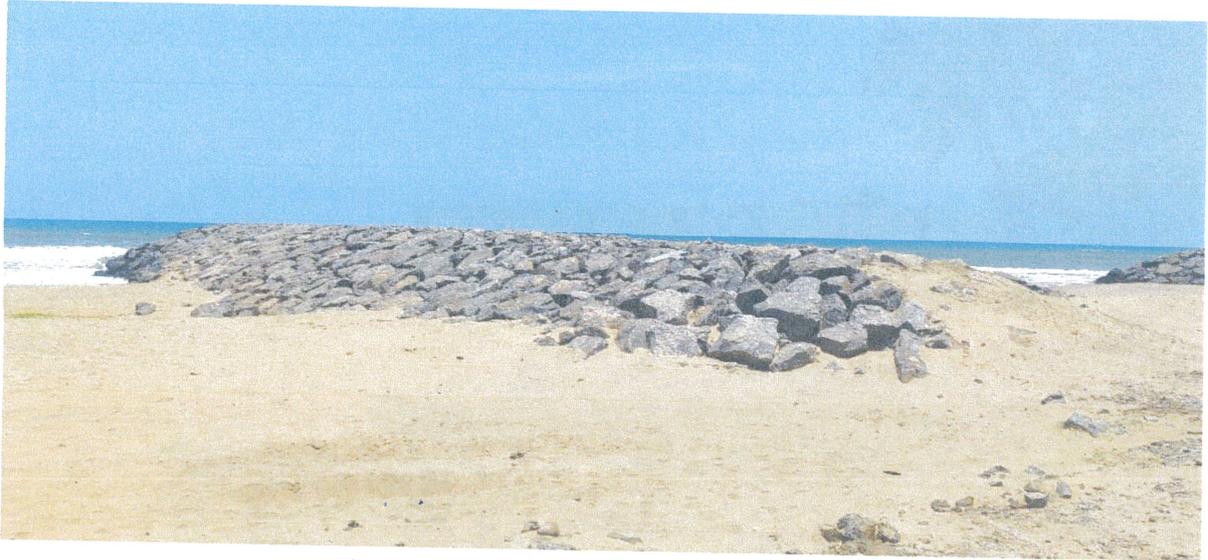
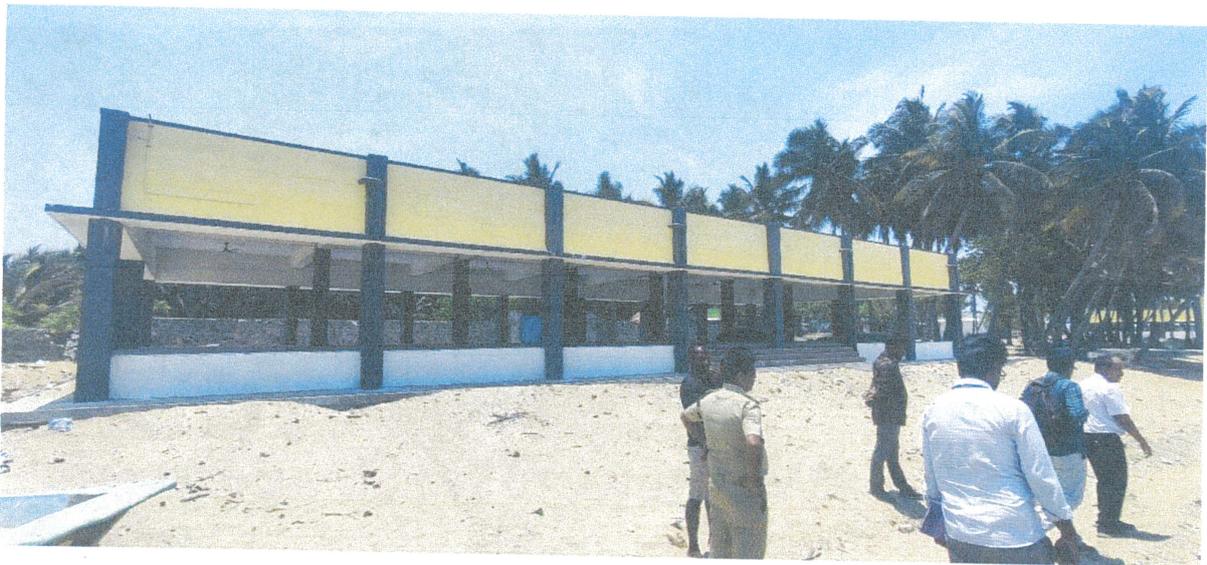
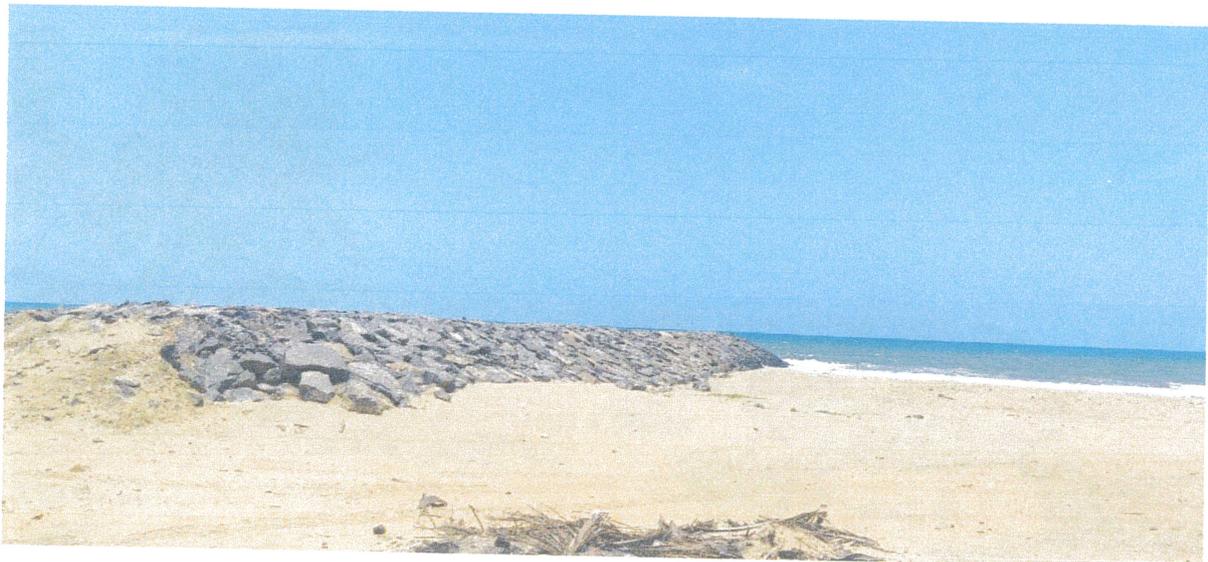
Observation: A total of 6 separate groynes were observed in the vicinity of Thenpattinam village, Cheyyur taluk, Chengalpattu district. One of the

groynes has a length of approximately 80 meters and is located at 12°24'58.90"N 80°7'24.32"E. Two of them are approximately 45 meters in length and situated at 12°25'4.29"N 80°7'26.74"E and 12°24'54.52"N 80°7'20.33"E respectively. The remaining three groynes are approximately 20 meters in length and positioned at 12°25'7.84"N 80°7'28.38"E, 12°25'6.66"N 80°7'27.86"E, and 12°24'52.48"N 80°7'18.48"E respectively.

In addition to the 6 groynes, other observations include:

- An auction hall located at 12°25'1.77"N 80° 7'21.73"E with a size of approximately 30.00m x 12.00m,
- A net mending area at 12°24'58.86"N 80° 7'20.00"E with a size of approximately 30.00m x 12.00m,
- A drying platform at 12°25'1.14"N 80° 7'21.49"E with a size of approximately 20.00m x 15.00m,
- Toilets at 12°25'0.22"N 80° 7'21.16"E.

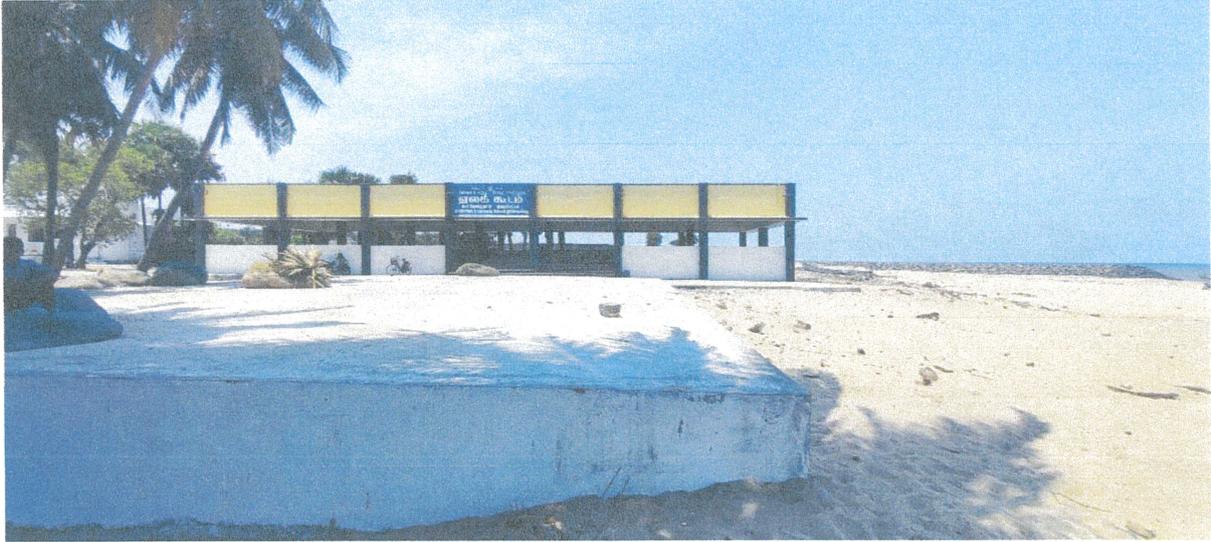
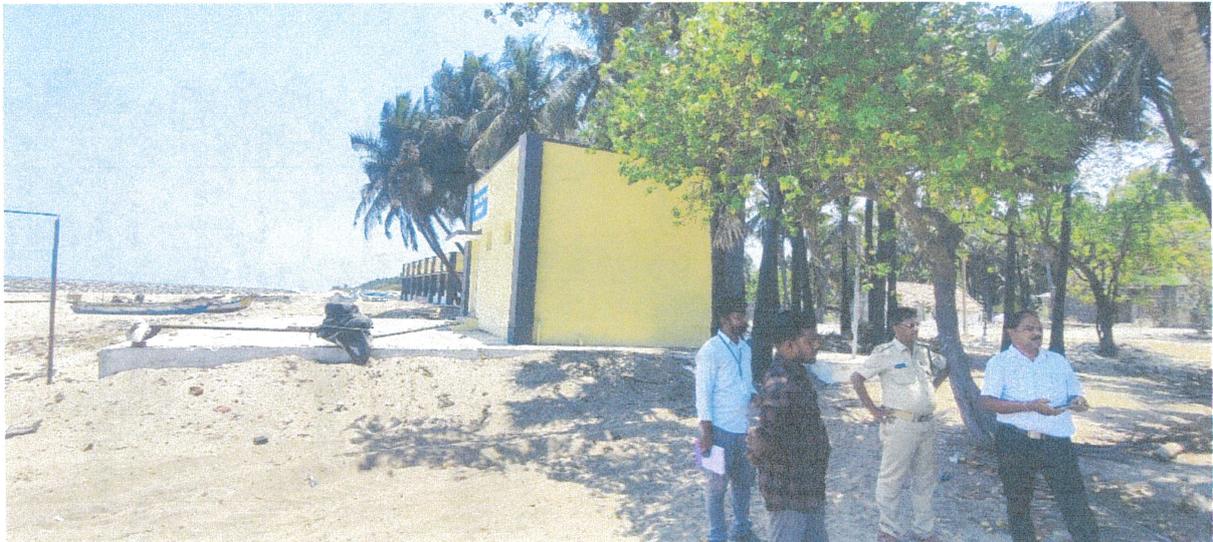
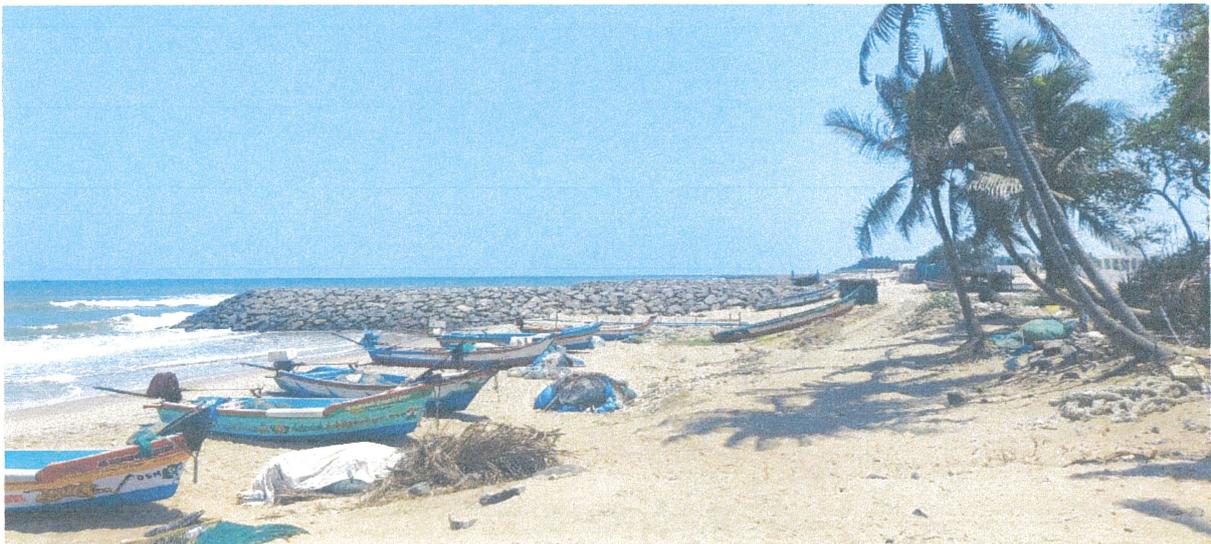
Observation: A total of 6 separate groynes were observed in the vicinity of Vadapattinam village, Cheyyur taluk, Chengalpattu district. One of the groynes has a length of approximately 75 meters and is located at

12°25'24.99"N 80° 7'42.38"E. One of them are approximately 40 meters in length and situated at 12°25'20.81"N 80° 7'37.97"E. The remaining four groynes are approximately 20 to 25 meters in length and positioned at 12°25'17.47"N 80° 7'35.26"E, 12°25'18.89"N 80°7'36.11"E, 12°25'30.75"N 80°7'44.15"E and 12°25'33.11"N 80° 7'45.27"E respectively.

In addition to the 6 groynes, other observations include:

- An auction hall located at 12°25'26.76"N 80° 7'39.84"E with a size of approximately 30.00m x 12.00m,
- A net mending area at 12°25'24.63"N 80° 7'38.51"E with a size of approximately 30.00m x 12.00m,
- Toilet with a size of approximately 6.00m x 5.00m.

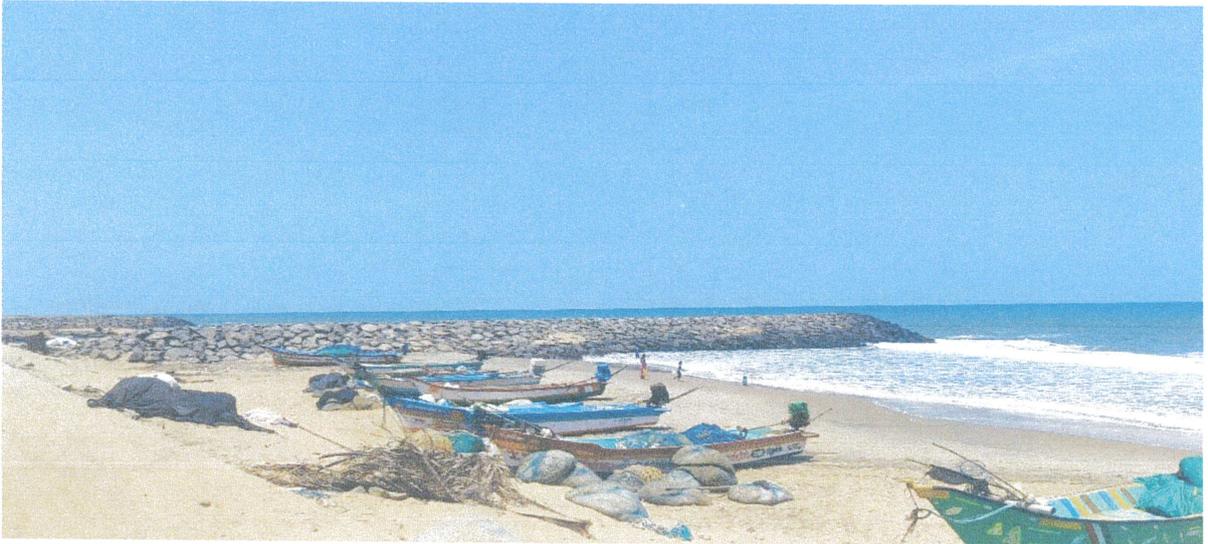
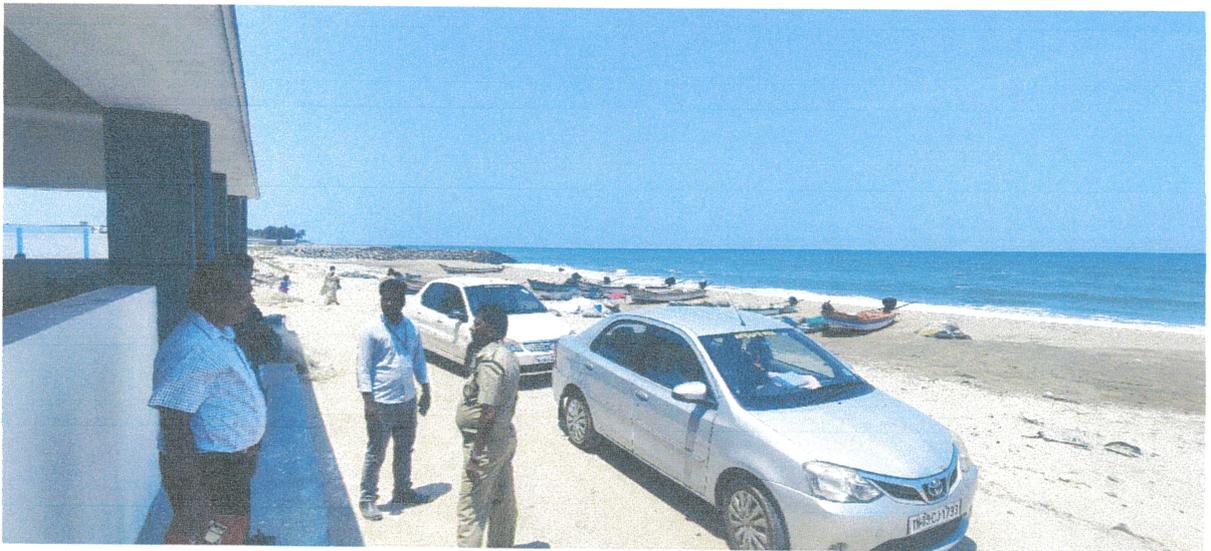
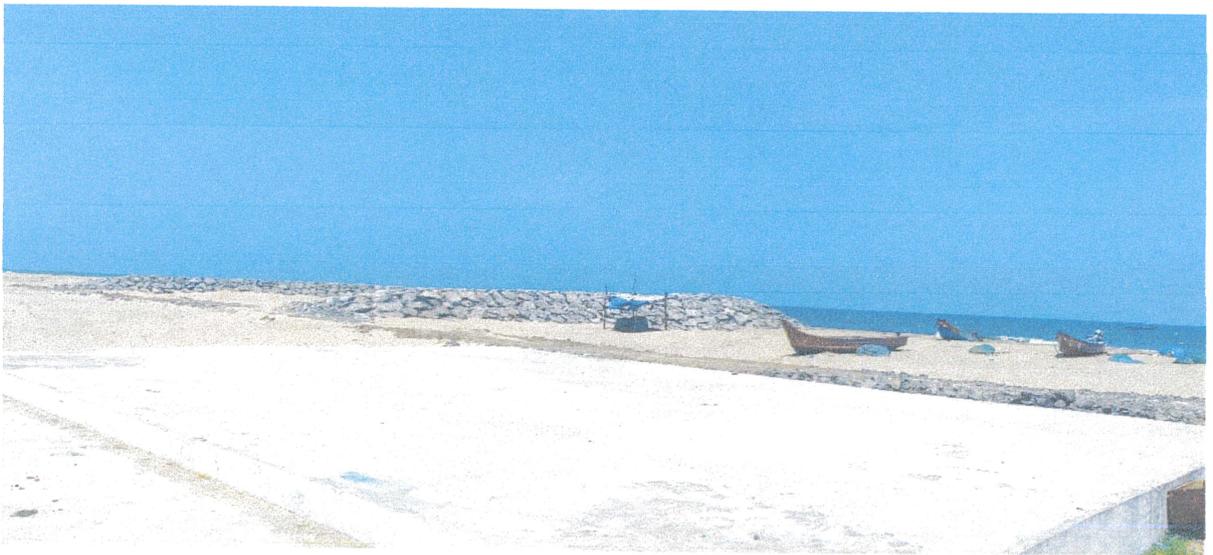
Observation: A total of 5 separate groynes were observed in the vicinity of Kadalur village, Cheyyur taluk, Chengalpattu district. One of the groynes has a length of approximately 80 meters, two of them are approximately 40 meters in length, and the remaining two groynes are approximately 20 to 25 meters in length. All are positioned at the vicinity of 12°27'3.59"N 80° 8'46.37"E.

Apart from the 5 groynes, a net mending area of approximately 30m x 12m and a drying platform of about 20m x 15m were found.

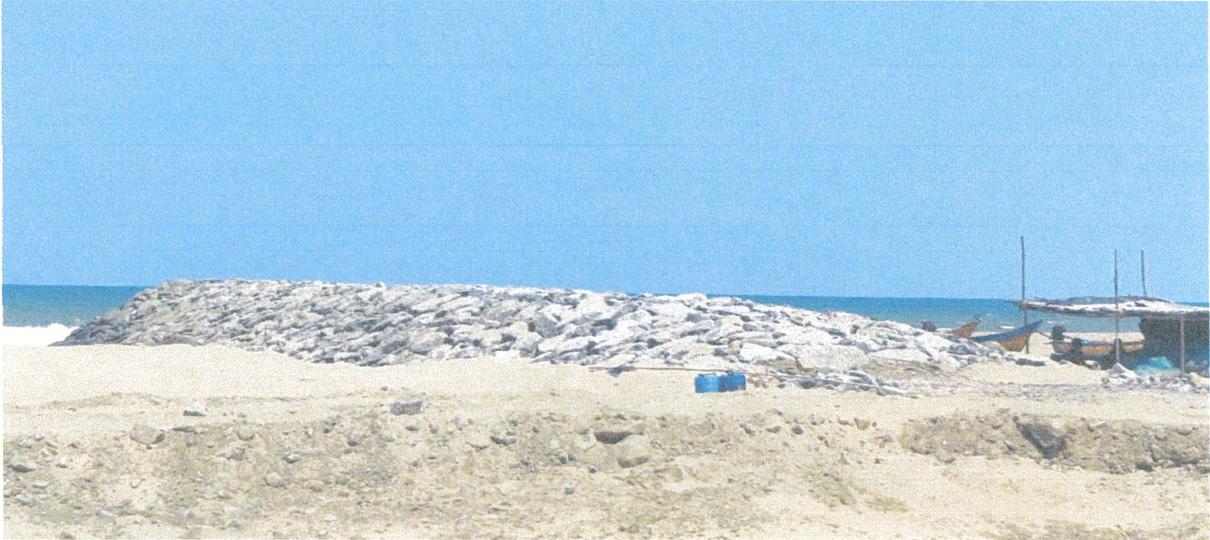
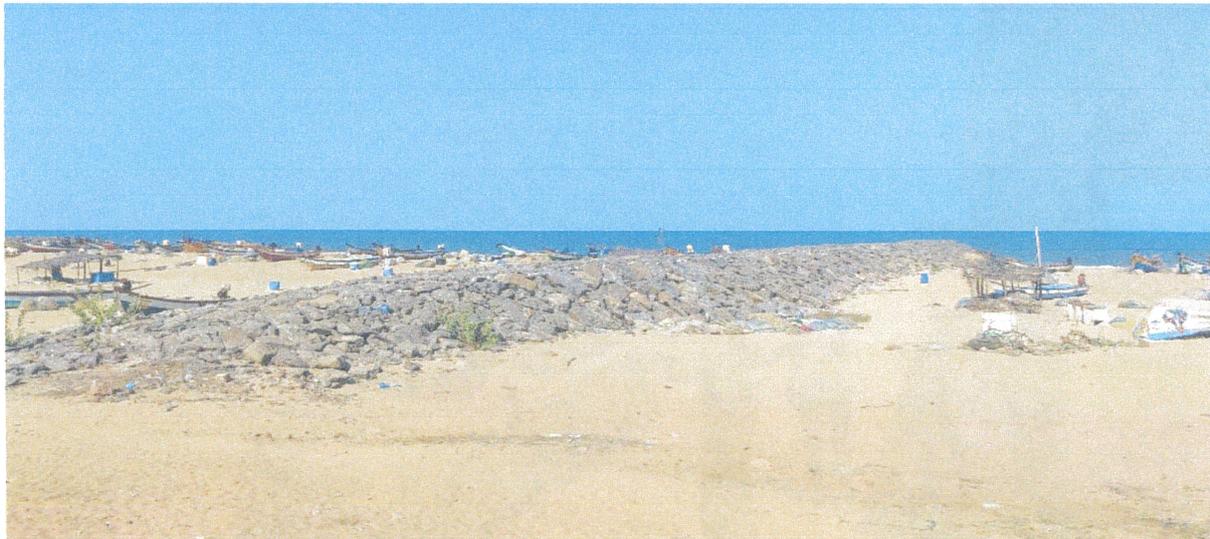
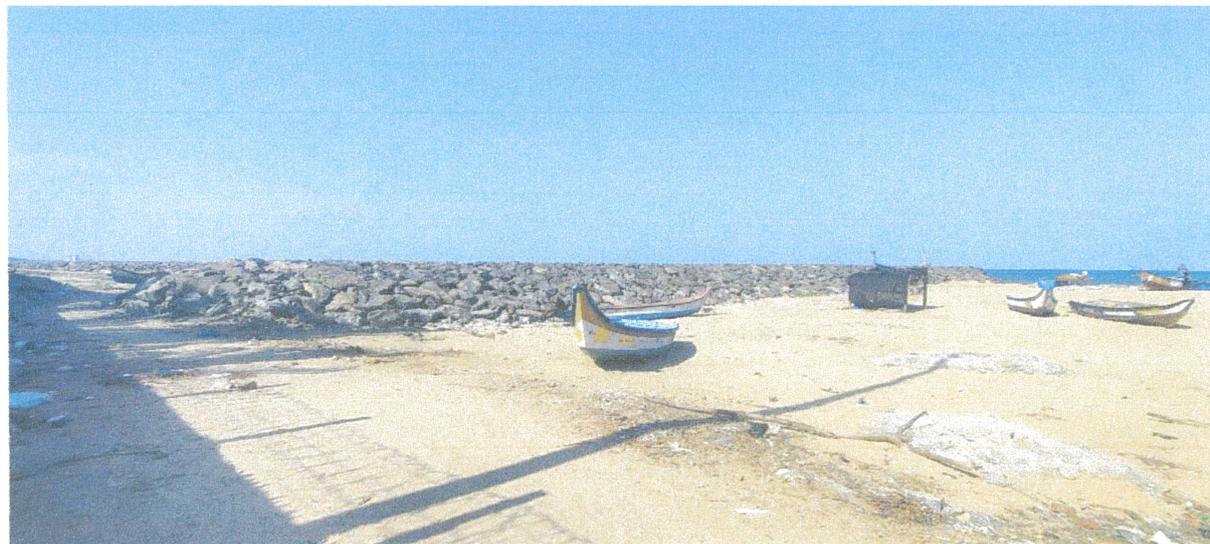
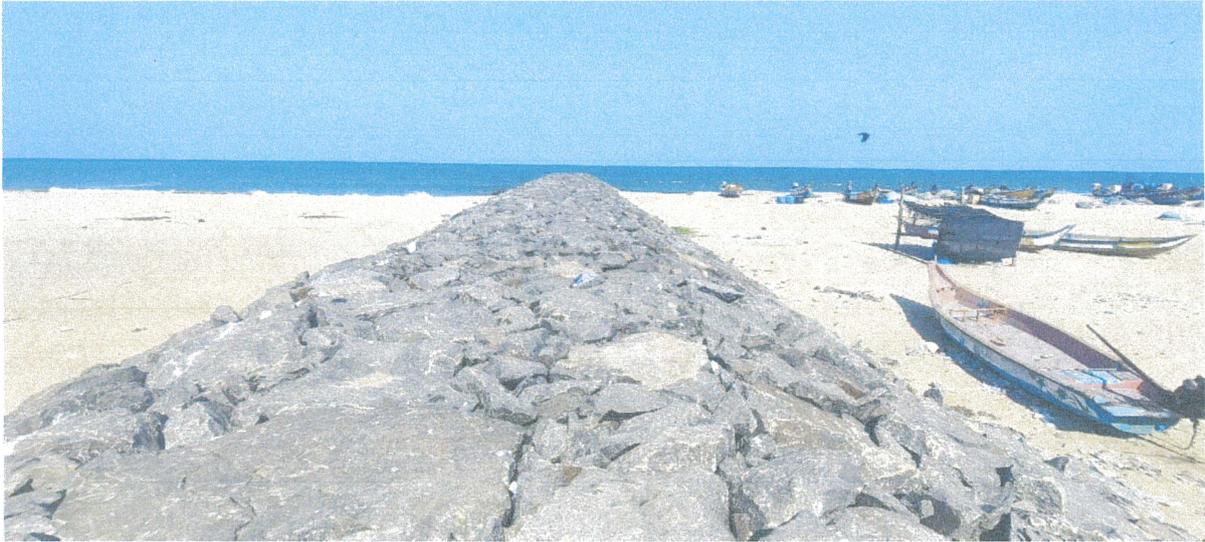
Observation: A total of 7 separate groynes were observed in the vicinity of Pudhupattinam village, Chengalpattu district. Three of the groynes have a length of approximately 75 meters each and are located at 12°29'17.06"N 80° 9'32.59"E, 12°29'21.76"N 80°9'33.73"E and 12°29'26.85"N 80°9'34.23"E respectively. Two of them are approximately 50 meters in length and situated at 12°29'31.53"N 80°9'34.58"E and 12°29'12.37"N 80°9'31.48"E respectively. The remaining two groynes are approximately 20 to 25 meters in length and positioned at 12°29'9.63"N 80°9'30.84"E and 12°29'34.25"N 80°9'34.53"E respectively.

In addition to the 6 groynes, other observations include:

- Two auction halls located at 12°29'18.24"N 80° 9'29.36"E and 12°29'24.64"N 80° 9'30.96"E respectively with a size of approximately 30.00m x 12.00m each.

- Two net mending areas at 12°29'22.16"N 80° 9'30.43"E and 12°29'12.74"N 80° 9'29.04"E respectively with a size of approximately 30.00m x 12.00m each.
- Two drying platforms at 12°29'17.37"N 80° 9'29.08"E and 12°29'23.25"N 80° 9'30.67"E respectively with a size of approximately 20.00m x 15.00m each.
- Two toilets with a size of approximately 6.00m x 5.00m each.

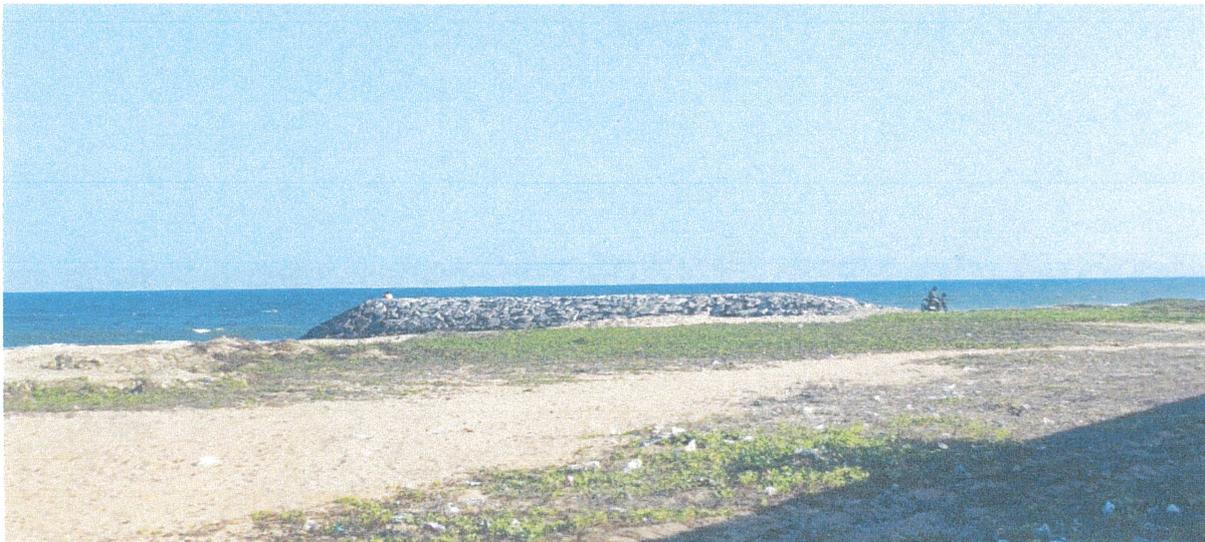
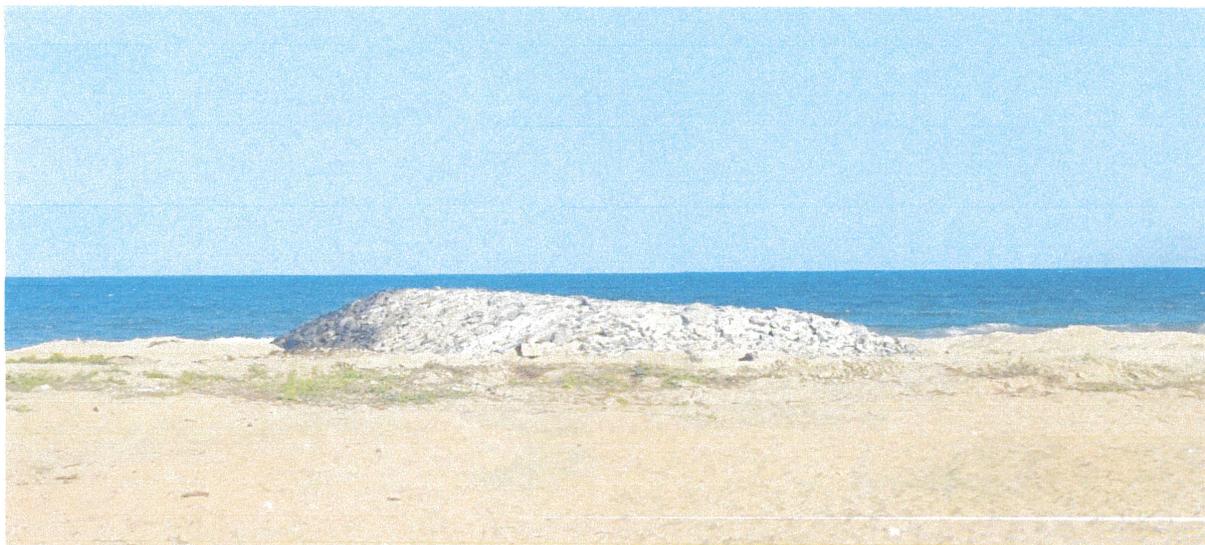
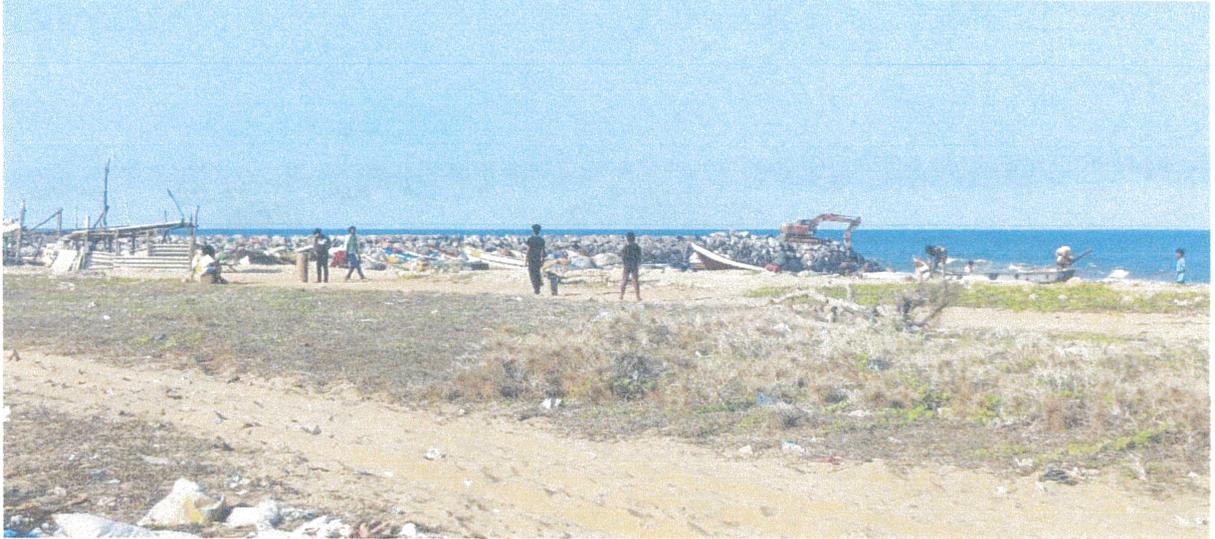
Observation: A total of 6 separate groynes were observed in the vicinity of Thiruvidanthai village, Chengalpattu district. Three of the groynes have a length of approximately 70 - 80 meters each and are located at 12°46'32.83"N 80°15'13.06"E, 12°46'27.47"N 80°15'10.51"E and 12°46'38.46"N 80°15'14.53"E respectively. Three of them are approximately 40 - 50 meters in length and situated at 12°46'41.73"N 80°15'14.72"E, 12°46'43.93"N 80°15'15.14"E and 12°46'24.77"N 80°15'8.82"E respectively.

In addition to the 6 groynes, other observations include:

- An auction hall located at 12°46'34.05"N 80°15'10.15"E with a size of approximately 30.00m x 12.00m,

- A drying platform at 12°46'34.85"N 80°15'10.44"E with a size of approximately 20.00m x 15.00m.

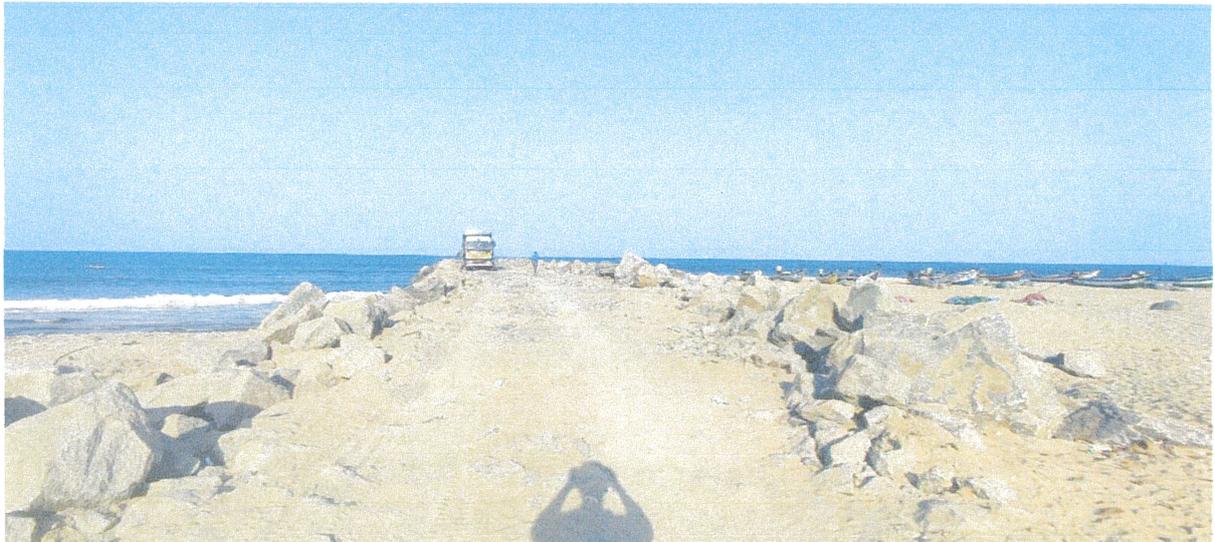
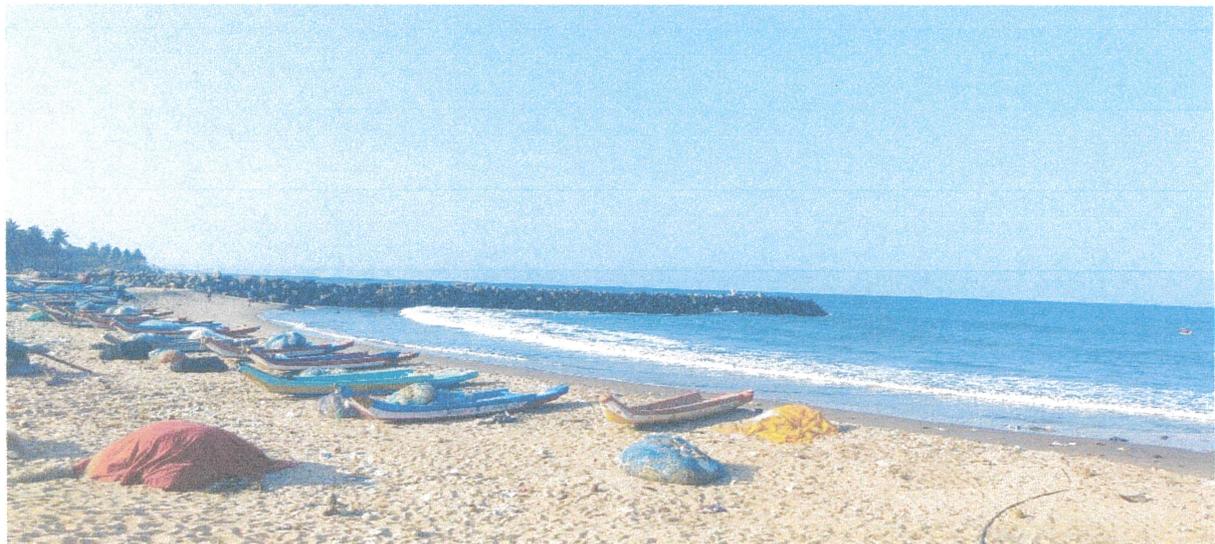
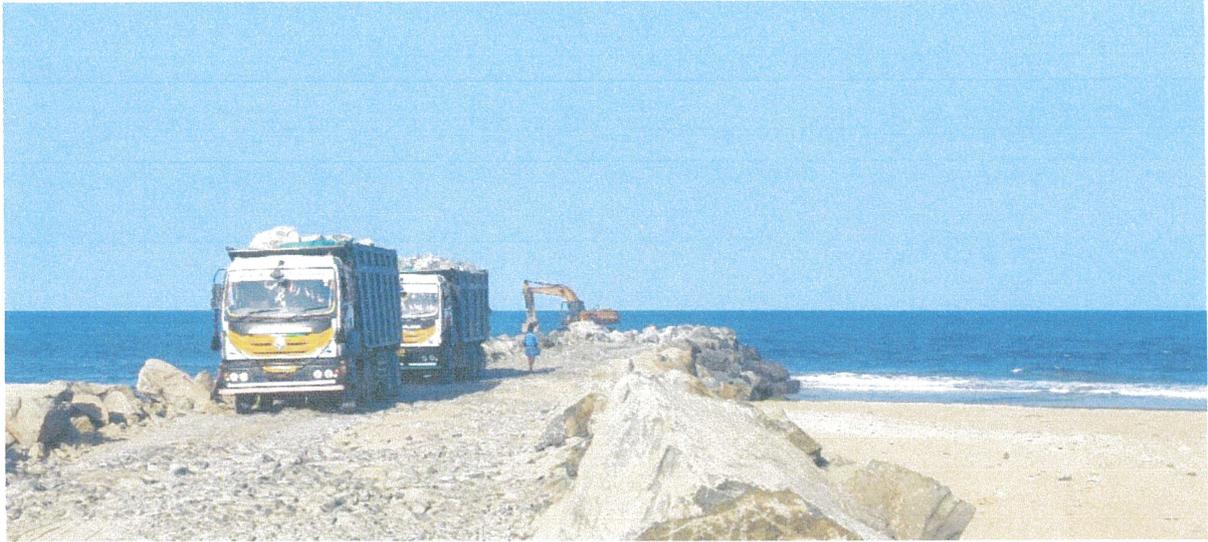
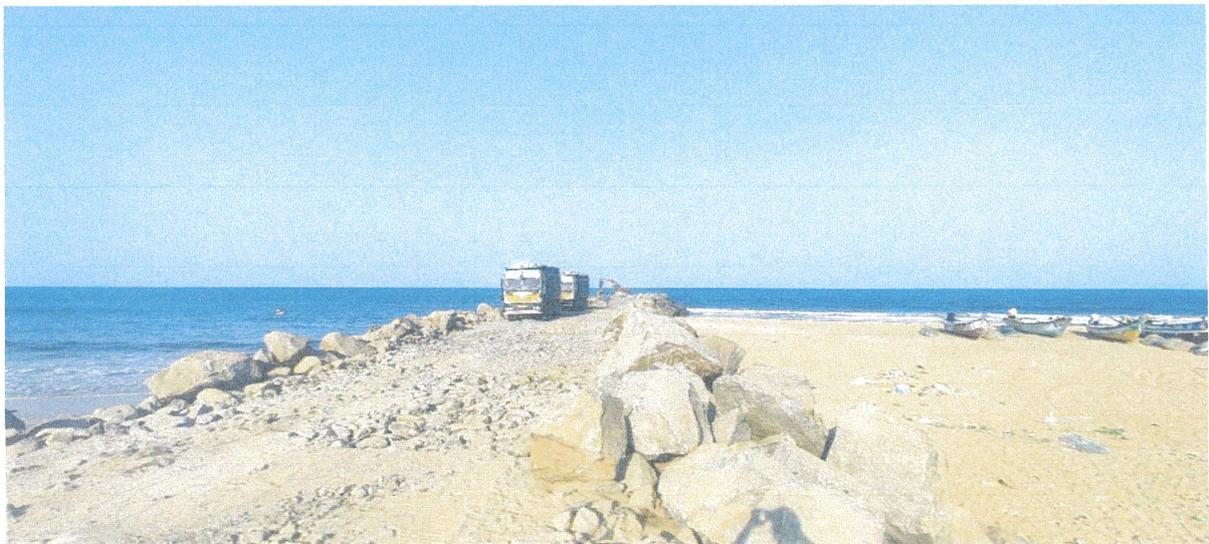
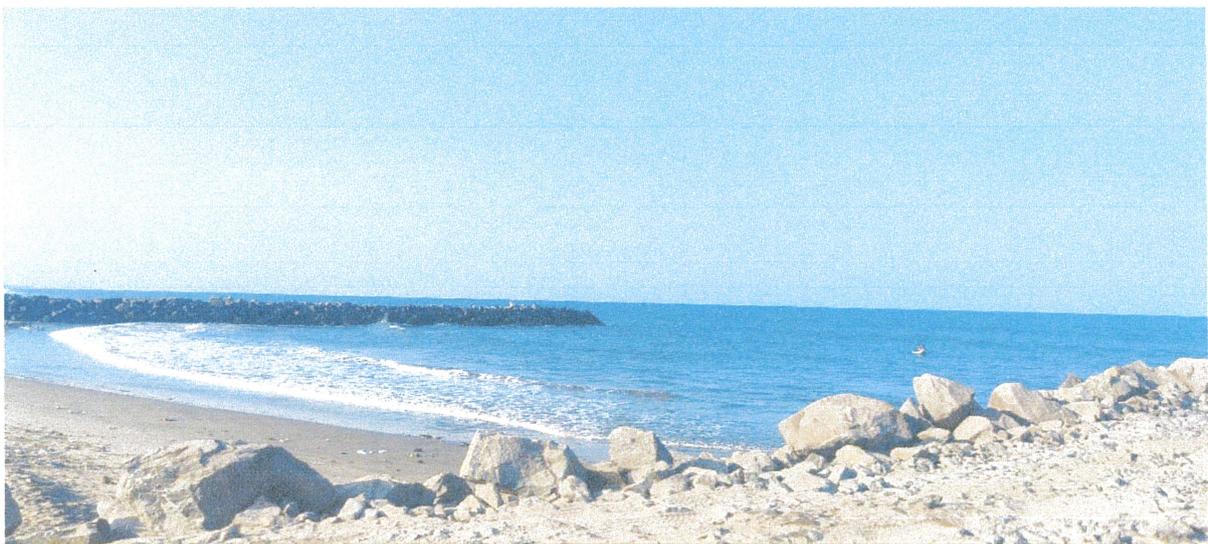
Observation: Two groynes, each approximately 80 to 90 meters in length, were observed in the vicinity of Muttukkadu village, Chengalpattu district. They are located at coordinates 12°49'10.88"N 80°14'53.86"E and 12°49'15.65"N 80°14'52.95"E, respectively. During the inspection, laying of groyne works was noted. Upon inquiry with the site supervisor, it was revealed that they are planning to build a small boat berth in between the two groynes.
